# Eames House Conservation Management Plan

The Getty Conservation Institute

This Conservation Management Plan (CMP) provides a framework for the ongoing care and management of the Eames House, including decisions about its conservation. Based on a thorough assessment of its heritage values, the plan provides policies to assist the Eames Foundation in the long-term management of this National Historic Landmark as a house museum.

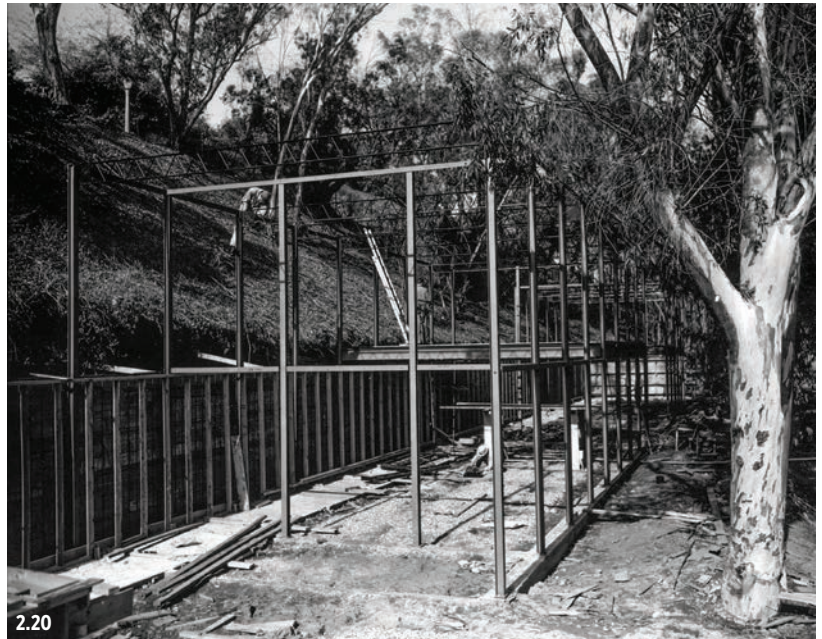
**Figure 2.20** Photo showing the structural steel frame and retaining wall before installation of the roof decking and window units, ca. December 1948.

Excavation of the site began in late 1948 or early 1949, and by March 1949 the retaining wall and steel frame had been completed (fig. 2.20).<sup>28</sup> *Arts and Architecture* (1949c, 30) reported that the frame was erected in a day and a half, with a total of ninety man-hours, while the steel decking and factory sash followed “in short order,” according to Charles Eames (Eames 2015, 69).<sup>29</sup> Although the cost of steel components far outweighed that of traditional wood-frame construction materials, the speed with which the structural elements were erected represented a labor savings. *Architectural Forum* estimated the cost of labor to erect framing lumber at approximately 50 percent of the cost of material, whereas labor to erect the Eames House was approximately 33 percent of the cost of steel. Construction costs for the retaining wall, foundation, and periphery paving were estimated at approximately \$5,000 (Blake 1950, 94). Eames noted that construction of the Eames House cost roughly the same as a “conventional house of good quality,” and commented that the retaining wall was responsible for “more than its share of the cost” (Eames 2015, 69; Blake 1950, 94, 96). These figures cannot be verified, as records documenting the actual cost of materials and labor for the Eames House have not been located. Construction was completed in December, and Charles and Ray Eames moved into their new home on Christmas Eve 1949.

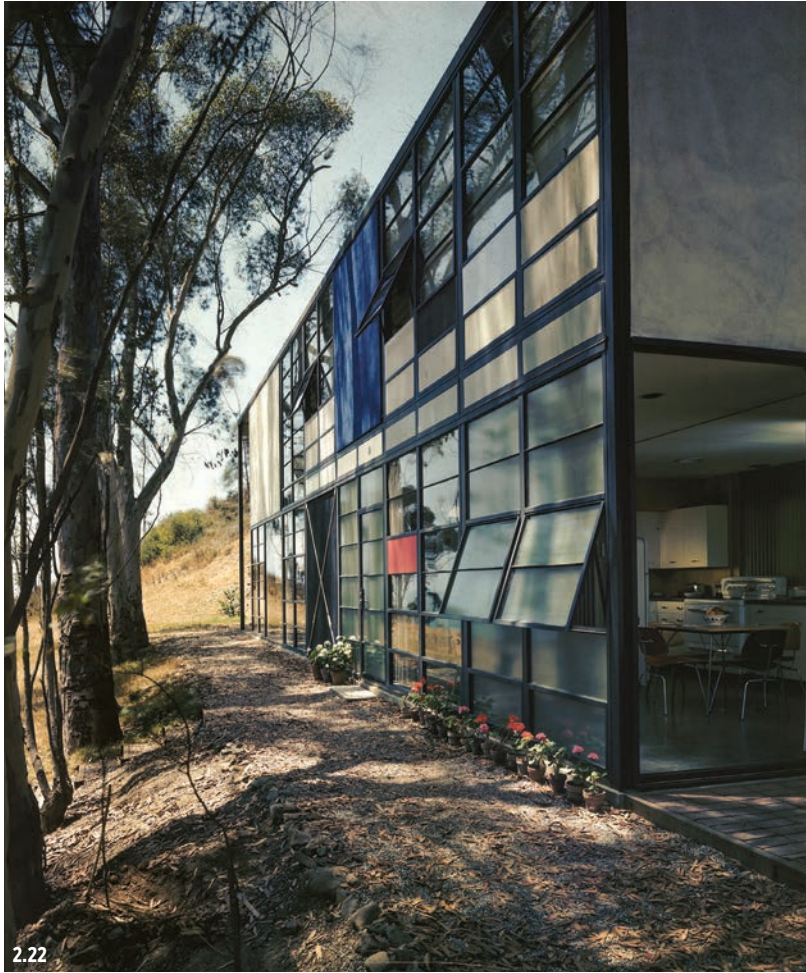
2.22

**Figure 2.22** The Eames House, clad in a complex array of materials, 1950. This view of the residence shows its appearance shortly after construction.

The Eames House's standard, light, factory steel framing forms a delicate structural web that is filled with a variety of materials: transparent, translucent, and wire glass, and opaque panels, some brightly painted (fig. 2.22) and others a soft gray (fig. 2.23). Placement of materials was based on interior organization and the need for light and privacy. Currently a glossy black, the structures' steel frames were originally painted in what Charles described as "a rubber-based #5 coating" from the A. C. Horn Company, which

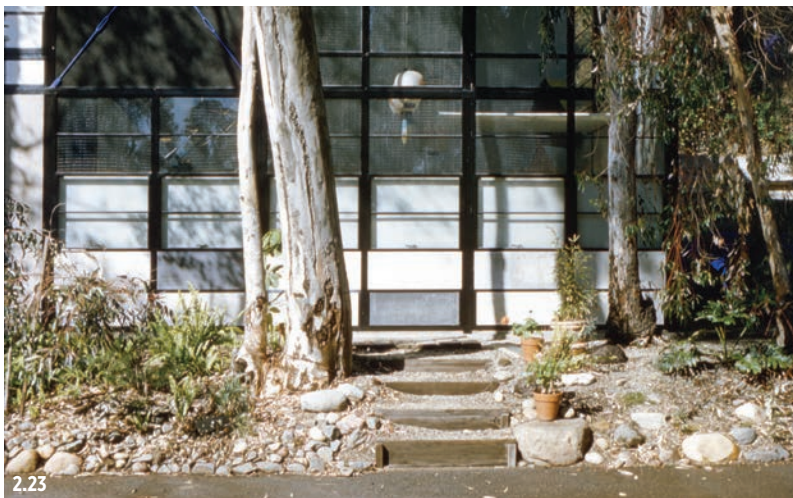
2.23

**Figure 2.23** Cemesto panels on the Eames studio, 1957. Some of these panels were left their natural gray color while others were painted, giving a subtle variation to the east facade's composition.

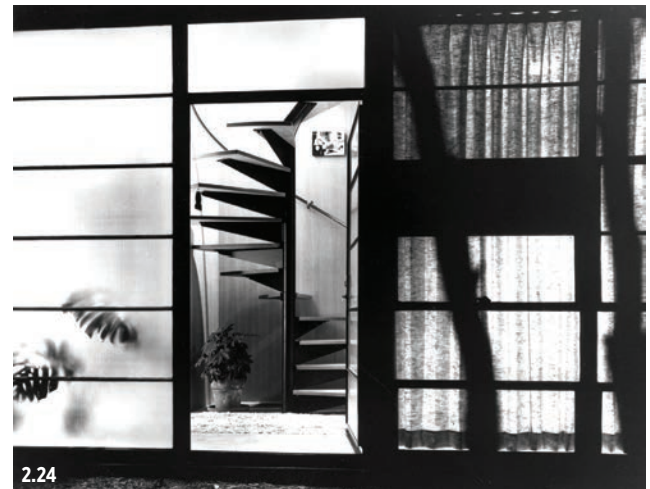
**Figure 2.24** The spiral staircase, as viewed through the open main-entrance door in this early photo. Ray Eames’s painting “For c in limited palette” hangs on the stairwell wall (see fig. 2.53).

The residence is laid out in a compact plan. The door to the main entrance opens directly into a hallway that spans the length of the building and connects the ground-floor interior spaces. Immediately opposite the door stands the spiral staircase, one of the interior’s signature features. Designed and constructed in the Eames Office shop, it fills a narrow stairwell and is illuminated by a skylight (fig. 2.24). Despite the fact that the staircase occupies tight quarters, it has an airy quality that inspired *Interiors* magazine to call it “a cagy masterpiece of space economy” (Gueft 1950, 115). Initially, the floors of the hallway and the living room were bare concrete, but sometime before 1955 they were finished with 9-by-9-inch vinyl asbestos tiles in a warm white.<sup>34</sup>

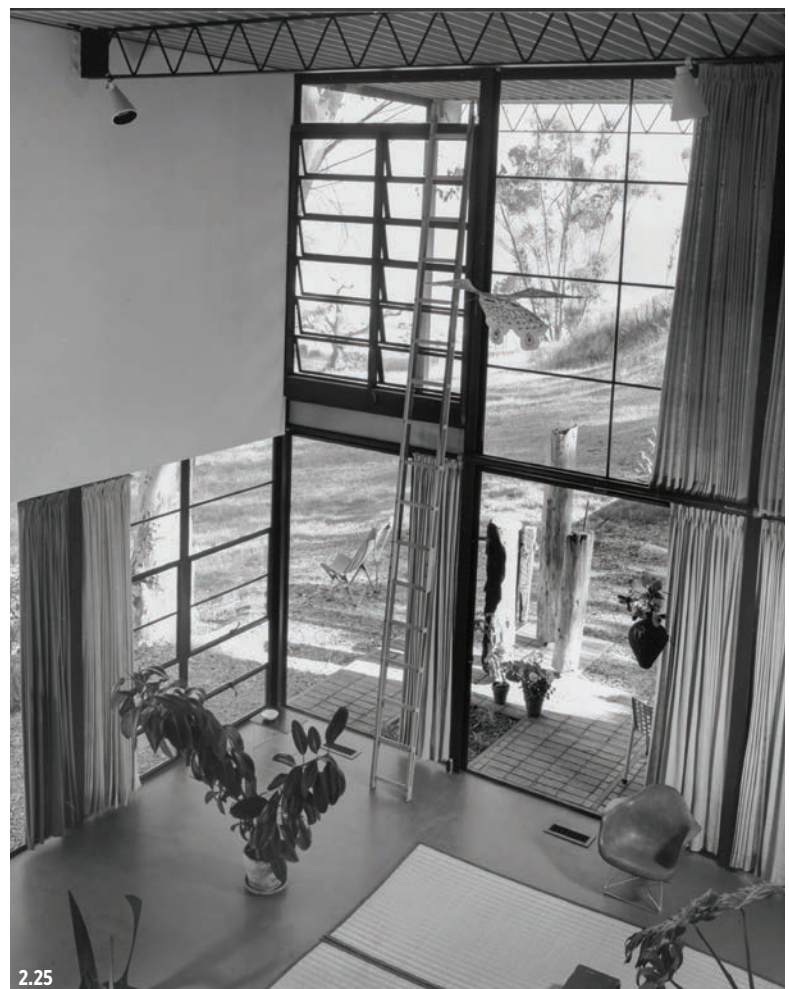
**Figure 2.26** The living room ladder, fabricated in the Eames Office shop, in an early photo. The ladder added vertical circulation to the room. It anchors to a roof truss and can be moved as needed. The top of the tallwood wall paneling can also be seen.

room's ceiling over part of the south court and by the continuation of the tallwood paneling on the west wall of the living room to the exterior west wall of the south court. According to *Architectural Forum*, Eames used wood siding here because he “needed something to nail into” (Blake 1950, 95).<sup>35</sup> A movable ladder, fabricated in the Eameses' own shop, was designed to hook onto the open-web joists (fig. 2.26), giving, in Charles's words, a “vertical circulation to the room” as well as a practical way of hanging objects or changing lightbulbs (Eames 2015, 70).

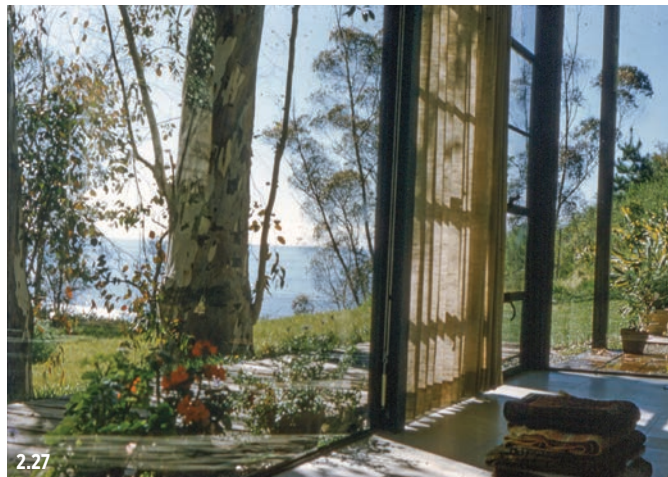
**Figure 2.27** View out the east-facing living room windows through the row of eucalyptus and across the meadow to the Pacific Ocean in the distance, ca. early 1950s. The wooden walkway is visible in the foreground. The south-facing windows at right look out into the south court.

Views of the meadow through the eastern windows are filtered through the towering row of eucalyptus trees that line the front of the building (fig. 2.27). Natural light streams through the two window walls, creating an ever-changing play of shadows cast by the window frames and the vegetation onto the interior surfaces (fig. 2.28). The dark, warm gray paint on the steel frame's interior complements the colors of the tree trunks. The varying sizes of the steel window and door units provide myriad ways of framing the views to the outside. Pleated draperies of natural colored linen and rayon fabric, originally by Deering Milliken, were hung on all living room windows except for one upper section each on the south and east walls (fig. 2.29), adding another layer of texture and providing light control and privacy.

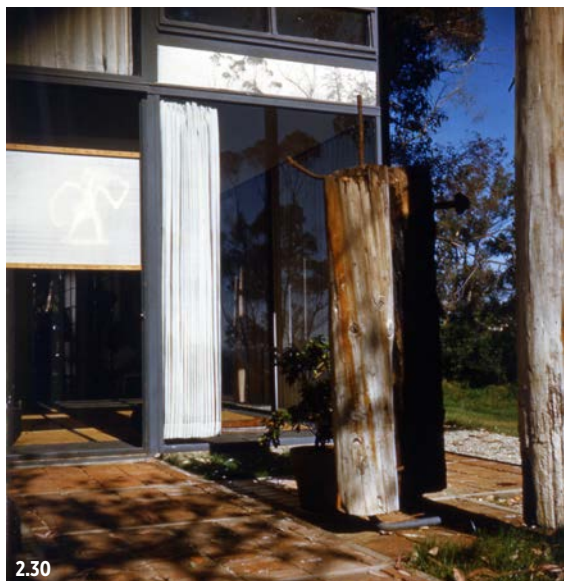
2.30

**Figure 2.30** Detail view of the south court, showing the pier sculpture and the photographic panel above the sliding glass door, 1952.

A key south court feature, constructed in 1949, is a large sculpture composed of three charred wooden ocean-pier piles standing upright, affixed to a metal stand (fig. 2.30). When the pier at Venice Beach, California, was demolished in the late 1940s, Charles and Ray retrieved the piles and brought them to the property because, according to Ray, they wanted to “keep something” to “remember it by” (Kirkham 1990, 136). The unassembled wooden members are visible in photos of the south court under construction in 1949, and the finished sculpture was displayed in the largely unfurnished living room when photos of the Eames House were published in the December 1949 issue of *Arts and Architecture* (Entenza and Eames 1949, 31–32). By mid-1950, the sculpture had been moved to the south court, where it remains to this day.<sup>38</sup>

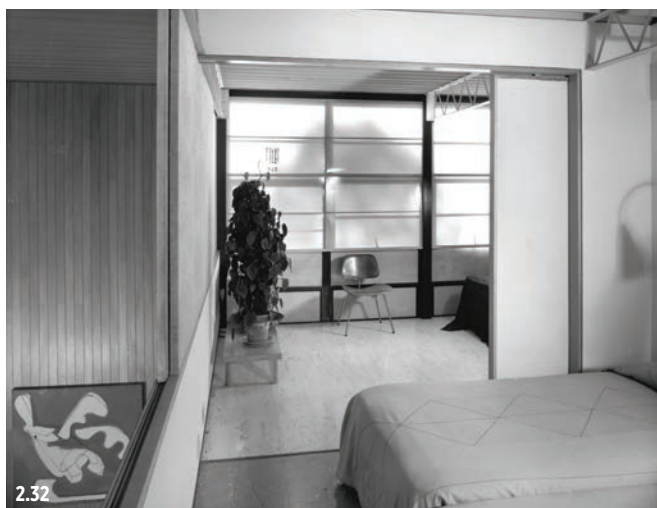
2.32

**Figure 2.32** View across the master bedroom into the second bedroom, 1950. The sliding room divider, seen at right, is partially extended. At left, the sliding panels on the balcony parapet are partially open, allowing a view of the living room’s tallwood wall.

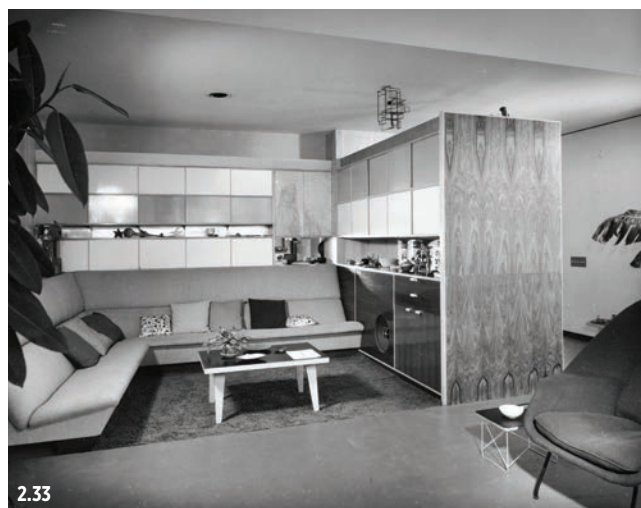
2.33

**Figure 2.33** The living room alcove as it appeared in 1950, showing the custom built-in sofa, cupboards, and cabinetry. Within a few years, the Eameses had removed the bottom row of cupboards to create more open shelf space. The end wall of the alcove is of rosewood.

An alcove with a built-in sofa is nestled into the area beneath the overhanging bedrooms, creating an intimate space that contrasts with the expansive scale of the living room (fig. 2.33). This area forms a sort of inglenook, with a built-in stereo speaker and storage cabinets instead of a fireplace.<sup>39</sup> A two-tiered bank of cupboards with sliding doors occupies the wall above the sofa. Sometime prior to 1958, another row of cupboards located immediately above the sofa

was removed, creating an open space for the display of objects.<sup>40</sup> A small pass-through above the sofa opens to the kitchen. During the first five years, a wooden magazine rack was added to the west wall.<sup>41</sup> The alcove floor is the only carpeted surface in the Eames House. The end wall of the alcove facing into the living room is paneled in rosewood.

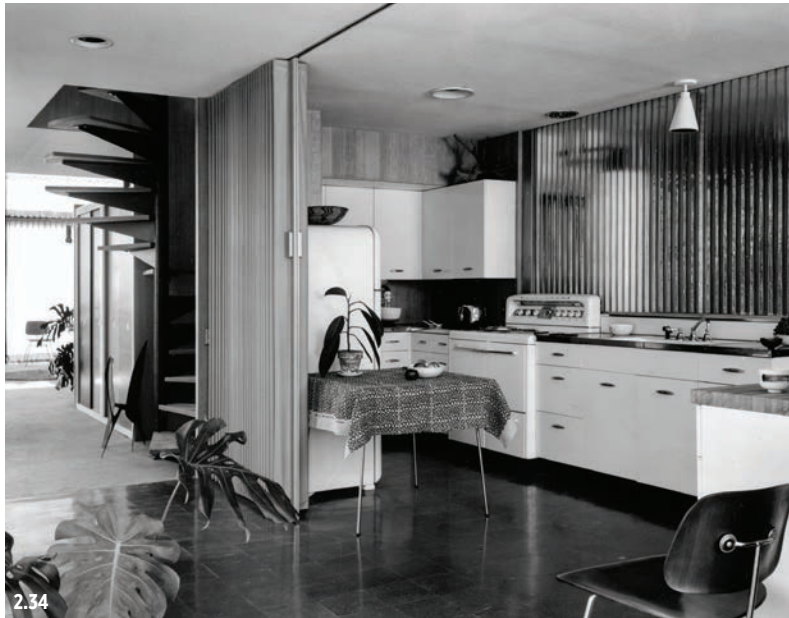
**Figure 2.34** View of the kitchen, 1949. The Modernfold accordion door could be used to close off the kitchen, though in practice the Eameses kept it open. The corrugated glass wall above the kitchen cabinets obscures views of the service area while allowing light into the space.

At the north end of the ground floor are the kitchen and dining areas, which can be closed off from each other by a Modernfold accordion door, though Ray admitted in an interview that it was never used, as she and Charles preferred open living spaces (Jones and Smith 1998, 52) (fig. 2.34). To the rear of the kitchen, a service area is obscured from public view by a translucent, corrugated glass panel. A large sliding

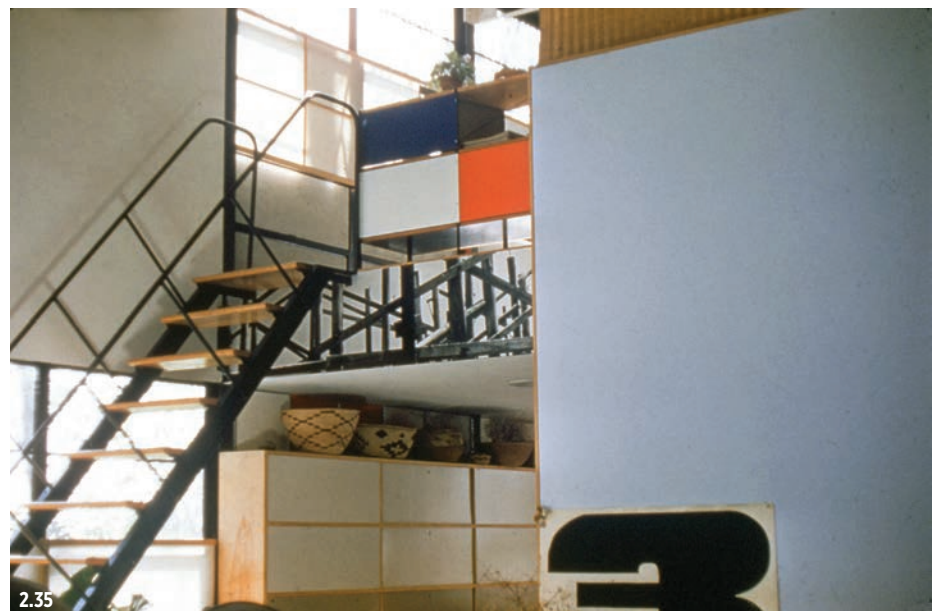
**Figure 2.35** Early view of the simple open-tread staircase, which was built in the Eames Office shop and provides access to the studio loft. The fascia board features a photo mural of a detail of the Venice pier. An Eames Storage Unit fills the gap between the parapet wall and staircase rail.

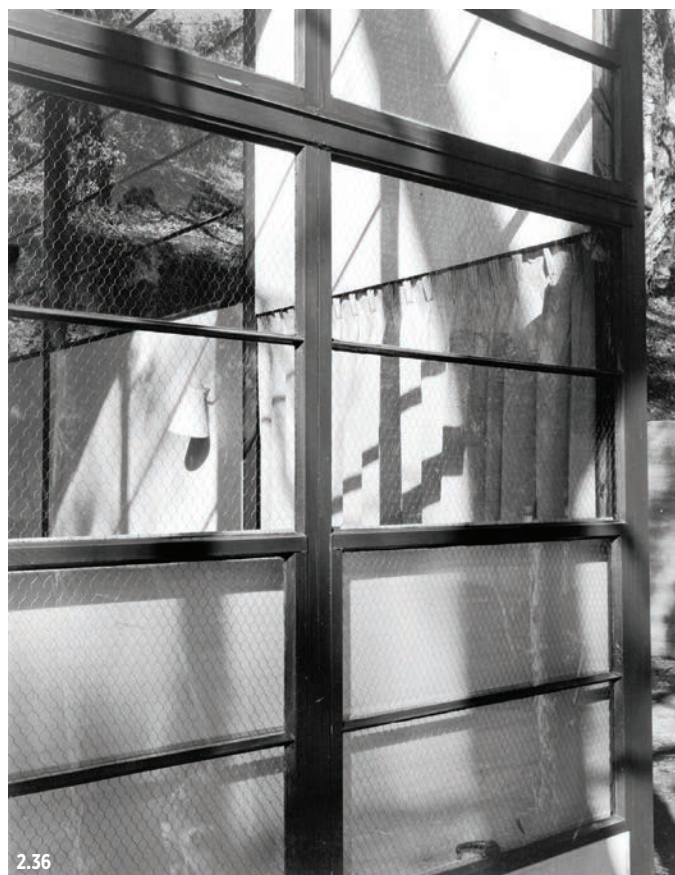
**Figure 2.36** Exterior view of the studio through the east facade, showing the aesthetic effect of the wire glass in the window sash, 1949.

Light streams into the studio space through the steel window sash, filled with a mix of clear glass and polished wire glass. According to Charles, wire glass was used primarily for safety reasons, but it became “an important contributing esthetic element” that was “successful in establishing the plane” while “allowing freedom to look through and beyond” (Entenza and Eames 1949, 33; Eames 2015, 70) (fig. 2.36). A sliding glass door on the north elevation opens to a garden area leading to the carport.

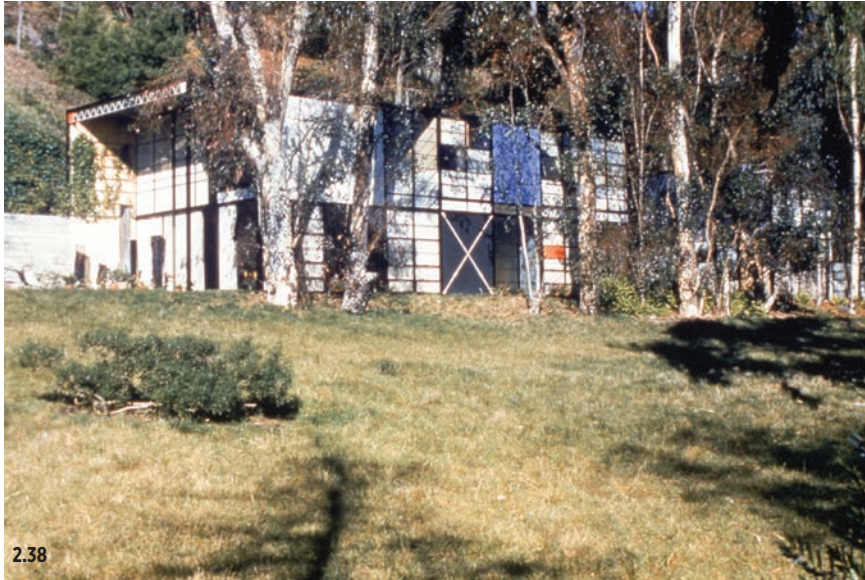
**Figure 2.38** Early view of a portion of the meadow on the Eames House site, planted in rye grass with the east facade of the residence in the distance.

state; it was planted to allow for low maintenance and a natural, informal appearance (fig. 2.38). As Charles described it in the December 1949 issue of *Arts and Architecture*, “The meadow sloping away from the house toward the ocean is planted in rye with scattered wild flowers. The flowers will do their bit in the spring, and the green rye will be allowed to grow yellow during the dry season” (Entenza and Eames 1949, 27). In a 1983 interview, Ray reflected on life with the meadow: “It is wonderful to see all the changing seasons in it—even here in California. Now, in July, it is yellow and dry whereas in spring it is high and full of

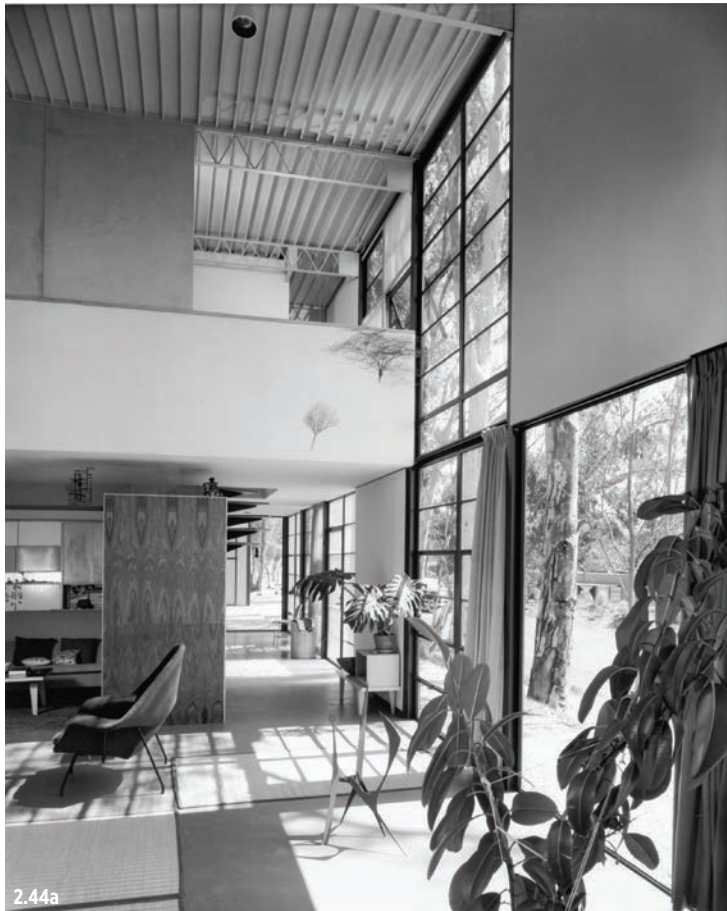
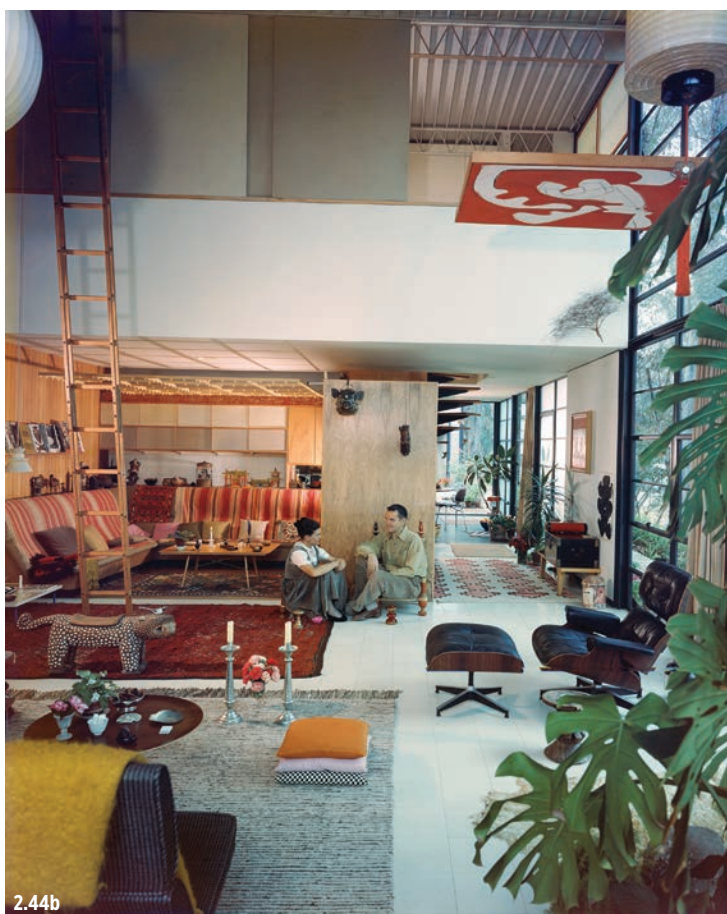
**Figure 2.43** The play of shadows and reflections, blurring distinctions between indoors and out. Here, the hillside and eucalyptus trees are reflected in the south court’s windows, but interior details are also clearly visible, including the open front door and spiral staircase treads, the Truscon ceiling, and shadows of the steel frame on the living room balcony. At right, through the corner of the glazed south and east facades, the meadow and a small forked tree can be seen in this early photo.

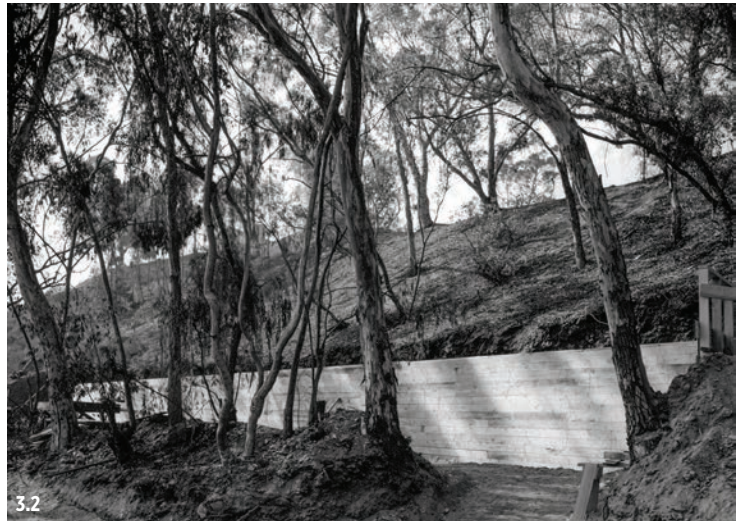
**Figure 3.2** The concrete retaining wall during construction, ca. 1949.

An 8-foot-tall, reinforced concrete retaining wall, nearly 200 feet in length, forms the continuous west wall of the building complex (residence, studio, and courtyards) at the first-floor level (fig. 3.2). Each structure sits on a poured-in-place, reinforced concrete slab. The slabs rest on concrete footings that run continuously under both buildings.

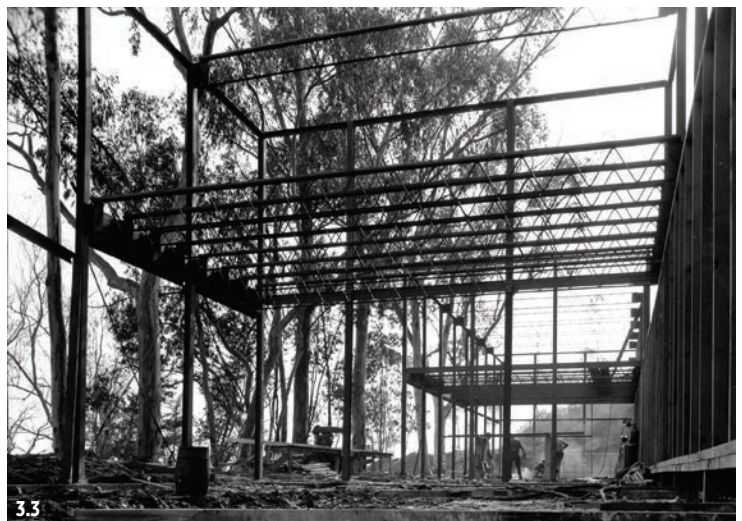
**Figure 3.3** View of the steel frame and web joists during construction, looking south from the studio, ca. 1949. The lower joists will support the studio's second floor.

Both residence and studio are of modular design and rectangular in plan and three-dimensional form. The structure is laid out in two parallel rows of 4-inch H-columns set 20 feet, 4 inches apart on the east and west elevations, with a 12-inch open web joist spanning between each pair of columns. The west row of columns (approx. 9 feet tall) appears shorter than the east row (approx. 18 feet tall) because the west row is partially embedded in the concrete retaining wall, which forms the lower portion of the residence and studio's west walls.<sup>2</sup> The residence is eight bays long, but its southernmost bay is a roofed exterior area partially covering the south court; the studio is five bays in length. In the residence, half of these bays are spanned by web joists at the 8-foot height that support the second floor; in the studio, two of the five bays are divided in this fashion (fig. 3.3). The columns were spaced so that each bay could be infilled by two

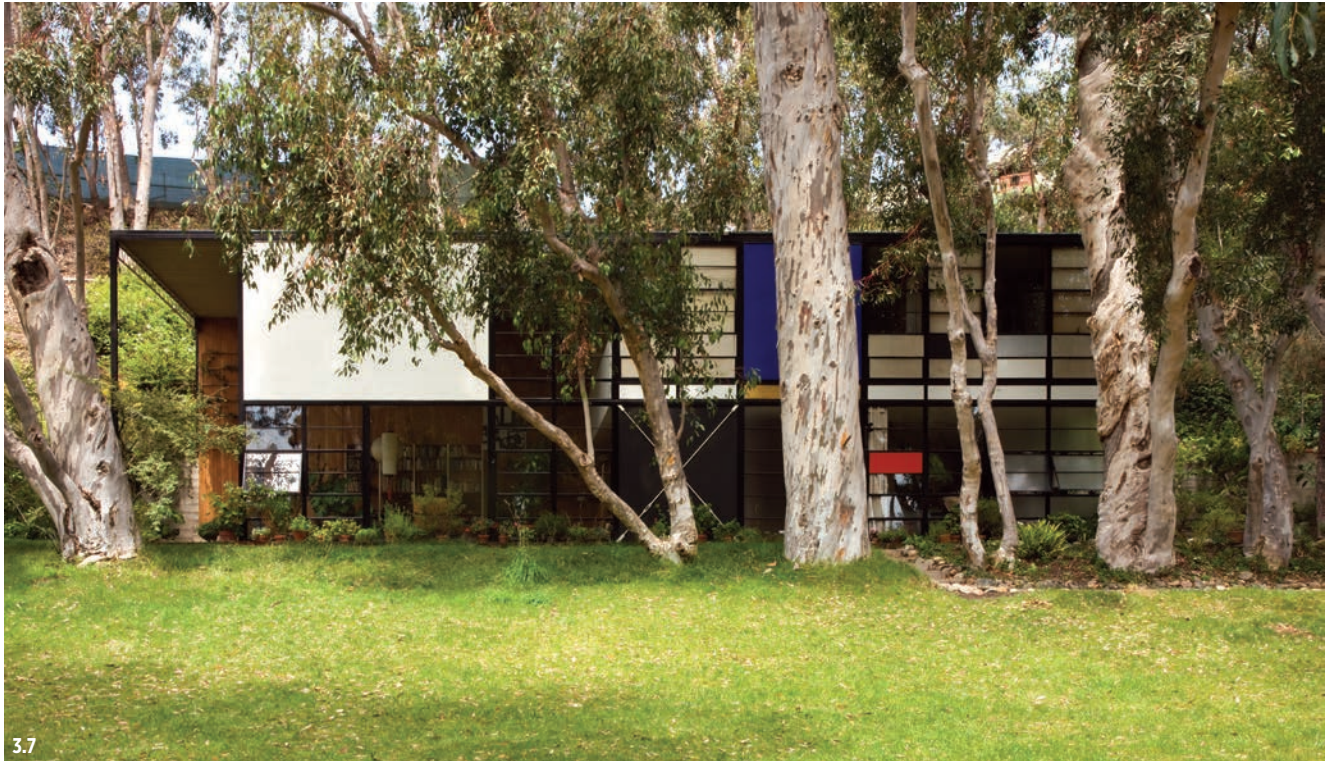
3.7

**Figure 3.7** View of the east elevation of the residence, 2013. The strict geometric order conferred by the building's steel frame is enlivened by the various configurations of architectural sash infilled with glass or solid panels in a variety of textures, materials, and colors.

The residence and studio's external building envelopes are formed of light steel framing that is infilled with a variety of materials. The modular nature of the steel structures confers a strict geometric order to the facades; however, this is interrupted by the various configurations of architectural steel sash that fill the structural bays and hold a variety of infill materials (fig. 3.7). Some sashes have a single large opening, while others are divided into multiple, equally sized lights—as many as two rows of six lights each. A narrow spandrel around the perimeter of each building covers the height of the second-floor deck structure. The spandrel's openings are filled with either glass or opaque materials (fig. 3.8).

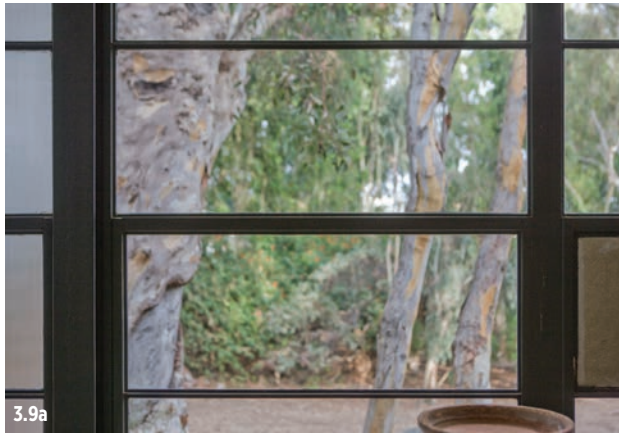
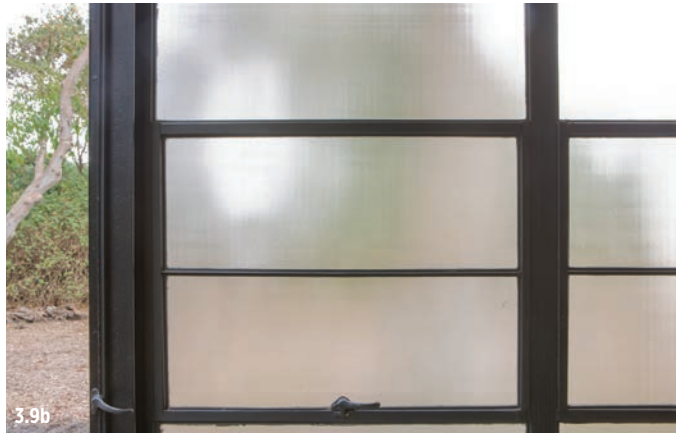
**Figures 3.9a, 3.9b, 3.9c** Three types of glazing were used for aesthetic or functional reasons. The bulk of the glazing is clear glass (a); obscure glass was used for privacy, light control, and visual interest (b); and wire glass was used in the studio and the stairwell skylight for safety and aesthetic reasons (c). All photos: 2016.

On both buildings, window units consist of fixed units, as well as operable awning and hopper units. In the residence, extant original glazing materials include clear polished plate glass; Mississippi Glass Company's Factrolite obscure glass in the bathrooms, the front entrance, and the northeast corner of the dining room; and Mississippi polished wire glass in the skylight. In the studio, extant glazing materials include clear polished plate glass; Factrolite obscure glass in the west wall of the studio balcony and the bathroom; and Mississippi polished wire glass in the three northern bays of the east wall of the studio and the sliding door to the north court. A number of panes of damaged or broken glass have been replaced with tempered, clear float glass or similar glass, particularly following the 1994 Northridge earthquake. Several panes of

wire glass are cracked but remain in place because a suitable replacement material has not been identified (figs. 3.9a–c).

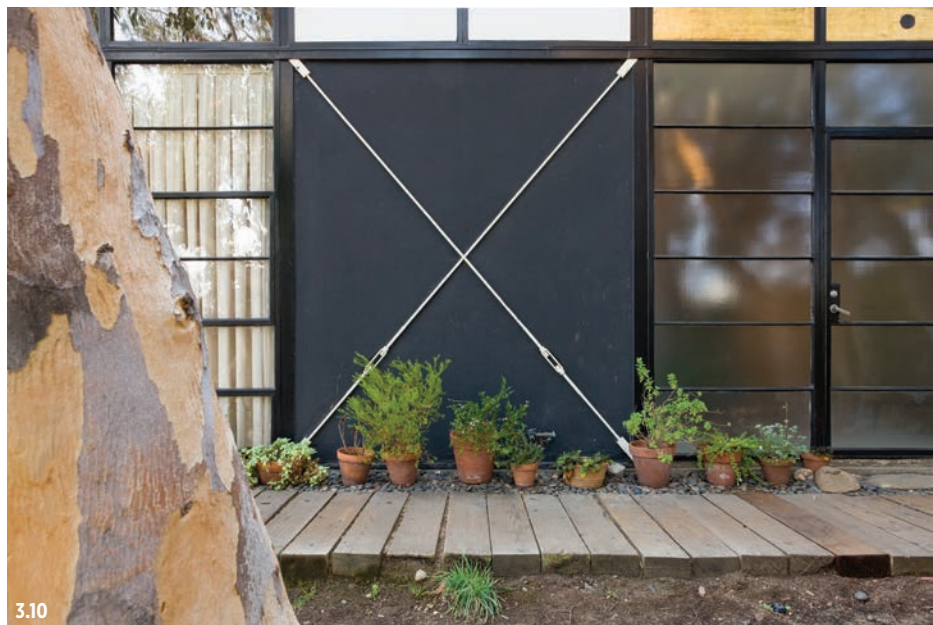
**Figure 3.10** Exposed cross-bracing over a black stucco panel on the residence's east facade, 2016.

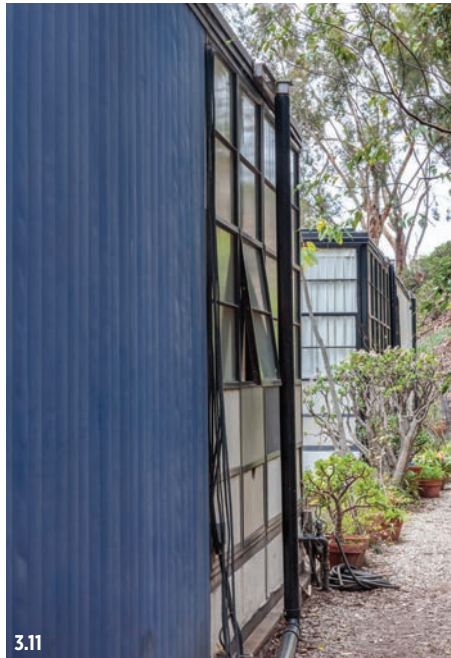
**Figure 3.11** Truscon Ferrobord panel on the studio's west elevation, 2017. Painted, ribbed panels add color and texture to the buildings' facades.

In areas where Truscon window-wall systems are not used, there are larger sections of solid wall constructed of Ferrobord profiled steel decking or framing with a stucco finish. These wall sections vary in size—for example, the largest stucco panels fill a double bay width. They are painted a rich blue, a bright reddish-orange, light beige, white, silver, gray, or black. On the residence's east facade, white painted steel cross-bracing was left exposed over a full-bay-width stucco wall section that is painted black (fig. 3.10). The same approach was taken with blue cross-bracing over a black stucco panel on the studio. Two additional sets of cross braces are hidden beneath painted stucco, one each on the east facades of the residence and studio. On the south elevation of the studio and on the west elevation of both structures, the ribbed steel surfaces of painted Ferrobord panels add to the layering of colors and textures (fig. 3.11). The south elevation of the studio also houses several varnished plywood panels, to the right of and surmounting the door. A small panel with photographic silhouettes of eucalyptus trees—now faded—is featured above the fixed panel to the east of the sliding door to the south court.

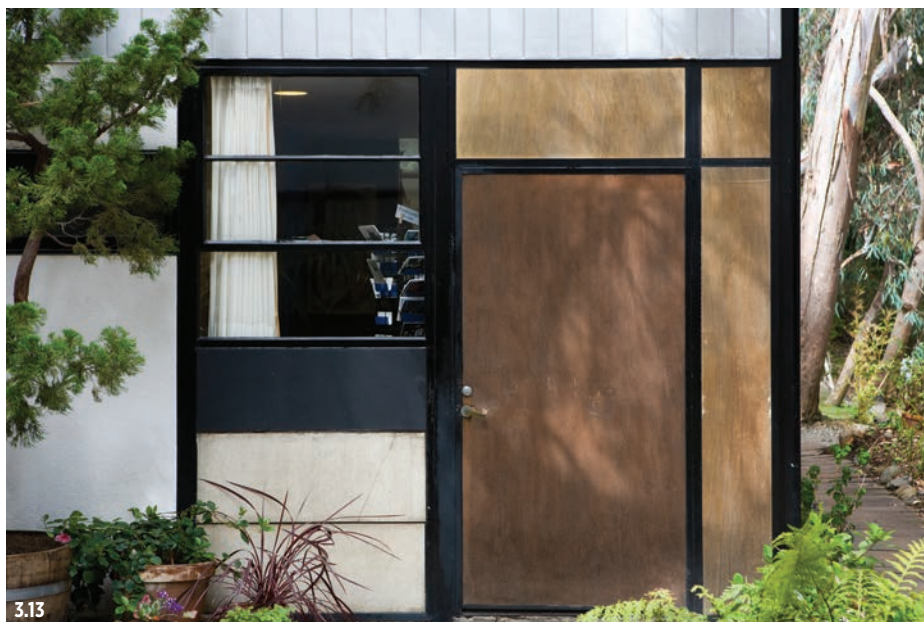
**Figure 3.13** South entrance to the studio, 2017. The wood veneer door has smaller plywood panels above and directly to the right. To the left, a panel of Truscon sash is infilled with a combination of clear glass and opaque panels.

The external doors at the northwest corner of the residence and southeast corner of the studio are flush wood veneer doors set into steel frames and jambs (fig. 3.13). Both open directly into the central court. Large, custom-made, steel-framed sliding glass doors are located in the center of the south elevation and at the east end of the north elevation of the residence, and at the east end of the north elevation of the studio.

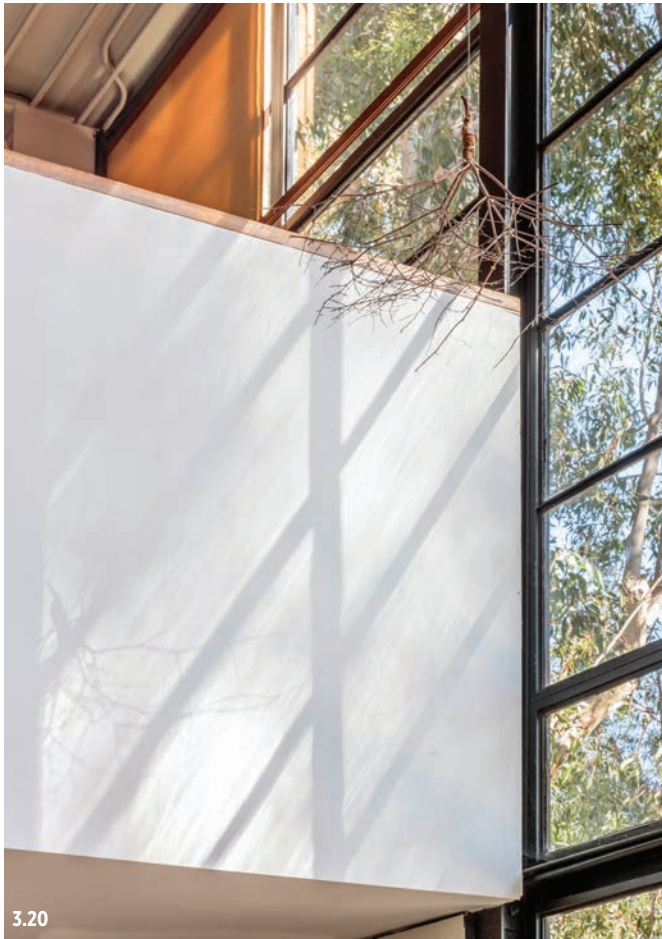
3.20

**Figure 3.20** Balcony parapet of the living room, 2017, showing the interplay between building and nature in the patterns of light and shadow on surfaces.

surfaces (fig. 3.20). The steel frame's warm gray paint echoes the colors in the eucalyptus trunks.

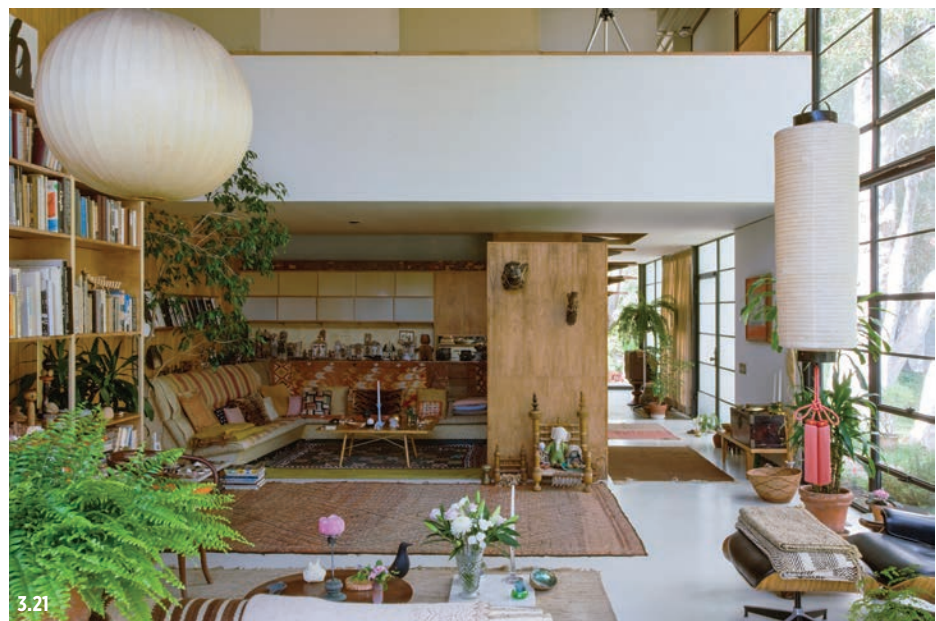
3.21

**Figure 3.21** View of the living room, looking north, 2013. The balcony overhang forms a ceiling for the alcove, an intimate space within the soaring living room. The rosewood wall marks the east side of the alcove and the entrance to the hallway.

loose pile carpet. The back of the freestanding hall closet serves as the east wall of the alcove. Its end, which faces into the living room, is paneled in rosewood (fig. 3.21).

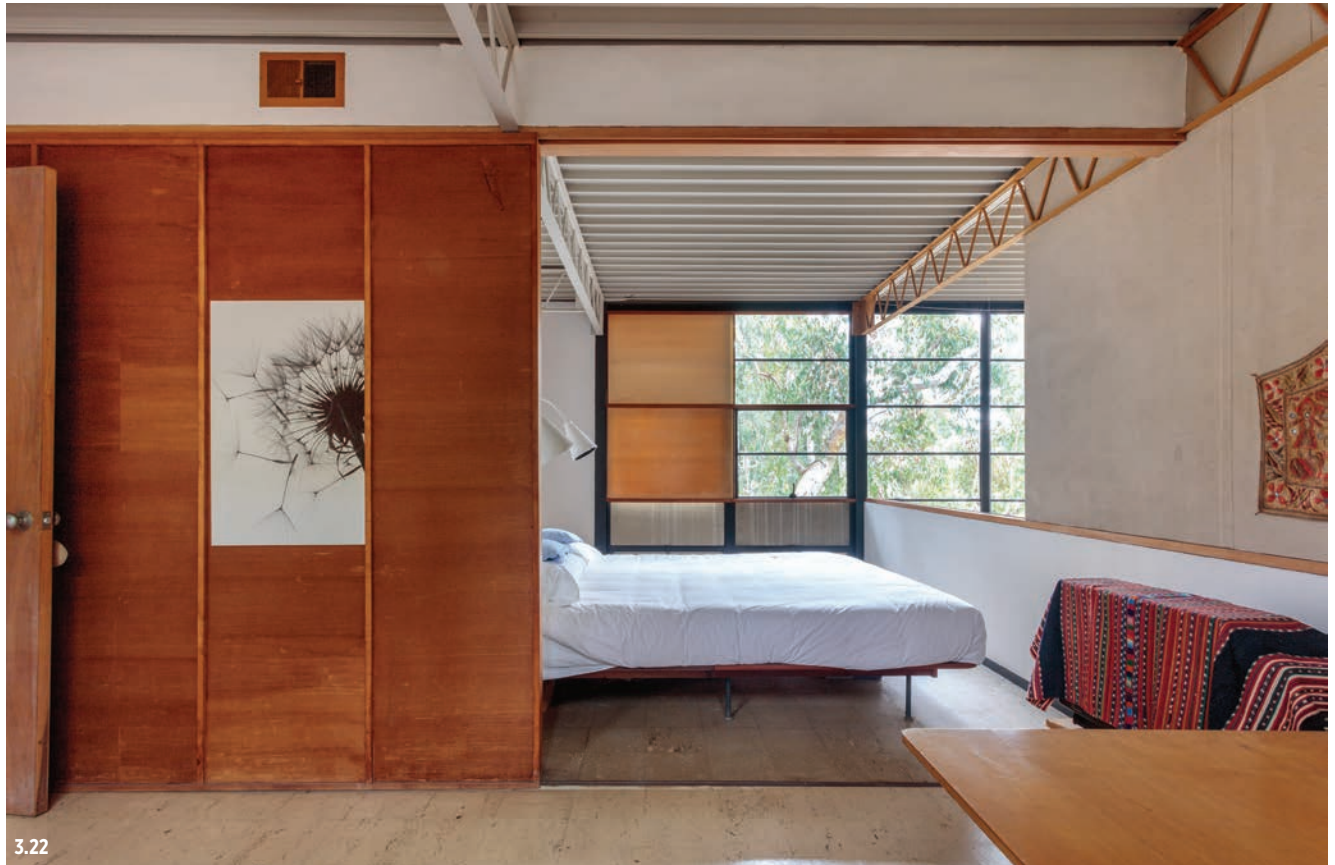
3.22

**Figure 3.22** View into the master bedroom from the guest bedroom, 2017. The sliding wood panel room divider is at left, and the sliding panels on the balcony parapet are at right.

from the hallway at the top of the spiral staircase. A large, fabric-covered sliding wood panel provides a divider between the two rooms; when open, the two spaces are integrated into one large bedroom (fig. 3.22). When closed, a hidden closet in the smaller guest bedroom is revealed. Painted, fabric-covered sliding panels reaching from the balcony parapet to the ceiling can be used to close off the bedroom spaces from the living room. Original wall-mounted, painted-metal gooseneck lamps above the beds provide reading light (fig. 3.23).

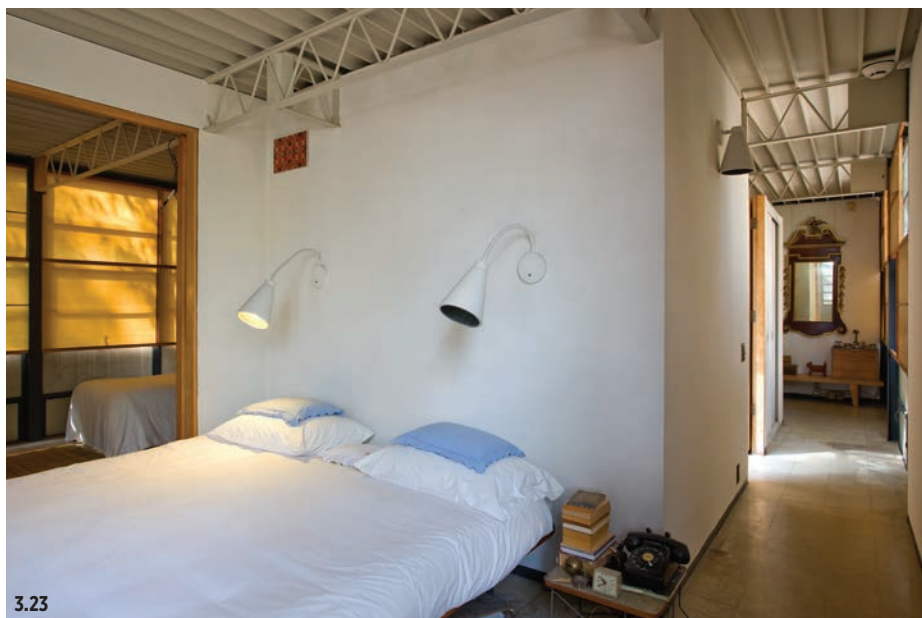
3.23

**Figure 3.23** The master bedroom, 2016. Gooseneck lamps mounted on the wall above the bed provide reading light. At right is the hallway to the dressing area. At left is the guest bedroom with Plyon window shades drawn.

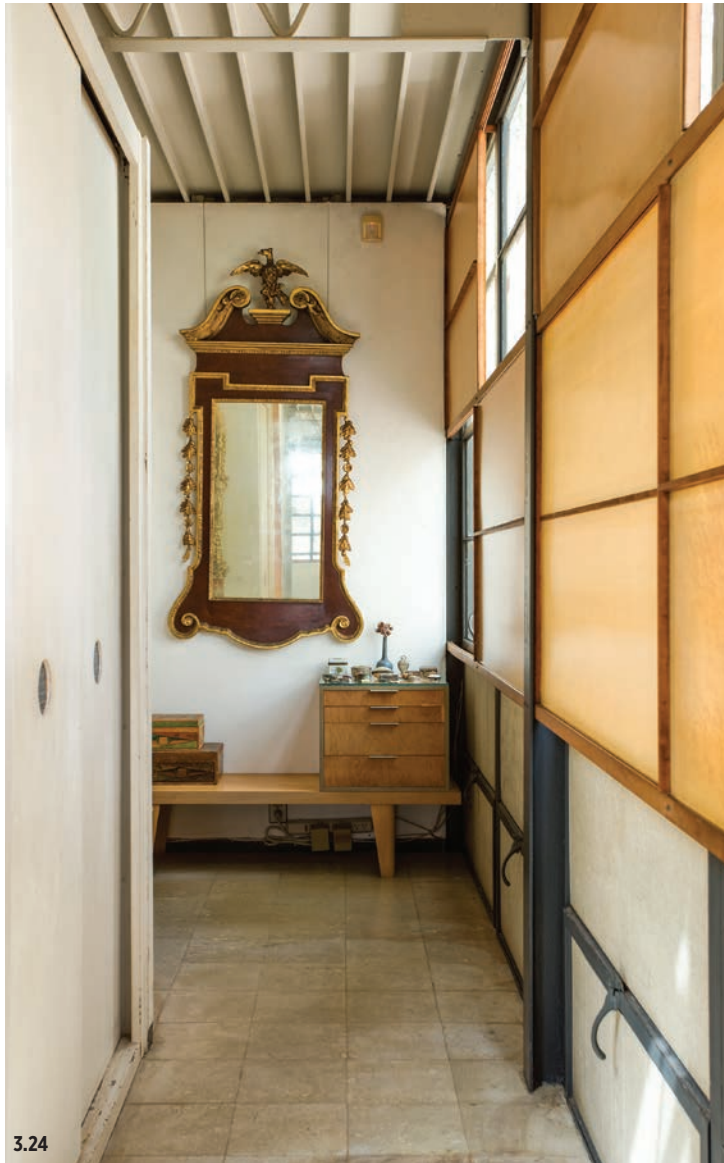
3.24

**Figure 3.24** Upstairs dressing area, 2016. At left, freestanding wooden closets with prefabricated steel door assemblies serve as the hallway wall. Ray's dressing table and mirror are visible on the north wall. At right, Plyon window screens diffuse light, and the opaque material on the lower wall is Cemesto.

downstairs closets; these are also topped with uplighting and are painted a soft white (fig. 3.24). The closet doors' circular recessed pulls are decorated with brightly colored paper insets; many are now faded or worn (fig. 3.25). The west wall of the dressing area is of walnut plywood. In the bathrooms, bird's-eye maple waterproof plywood is applied to the underside of the Ferrobord decking, separated by a layer of Celotex, to reduce condensation (Eames 2015, 69). The bathroom walls are clad in both gray and off-white Micarta plastic laminate wall panel. Charles's bathroom has a shower stall and Ray's has a bathtub.

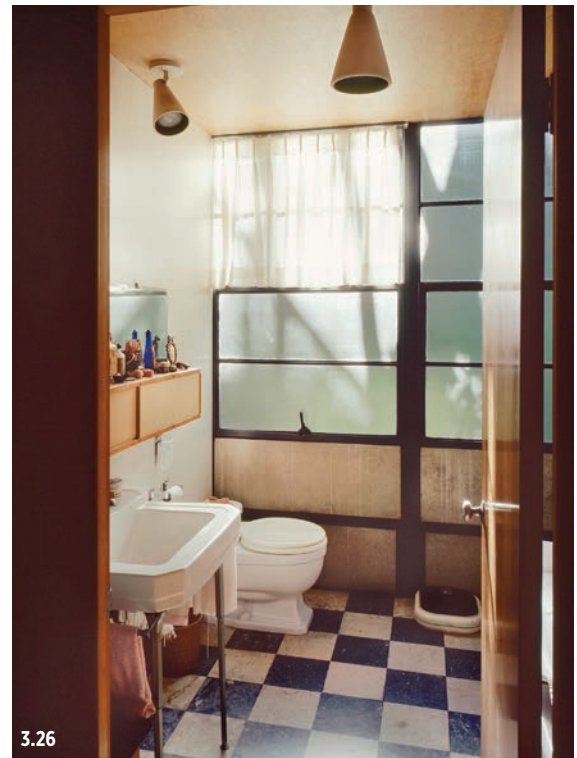
3.26

**Figure 3.26** View of Ray's bathroom, 2013. The floor is clad in Voit rubber tile in a black-and-white checkerboard pattern. The ceiling is clad in bird's-eye maple plywood. Metal light fixtures are mounted on the ceiling. Ray's toiletries sit atop the wall-mounted shelf with sliding Plyon doors.

Original 9-inch-square Voit rubber tiles cover all the upstairs floors. Ray's bathroom floor is laid in a black-and-white checkerboard pattern; the white tiles have aged to cream (fig. 3.26). Charles's bathroom is in a color identified in *Arts and Architecture* as sea sand (Entenza and Eames 1949, 33); it has aged to a bluish green. The rest of the upstairs floor tiles are in one of two beige tones.

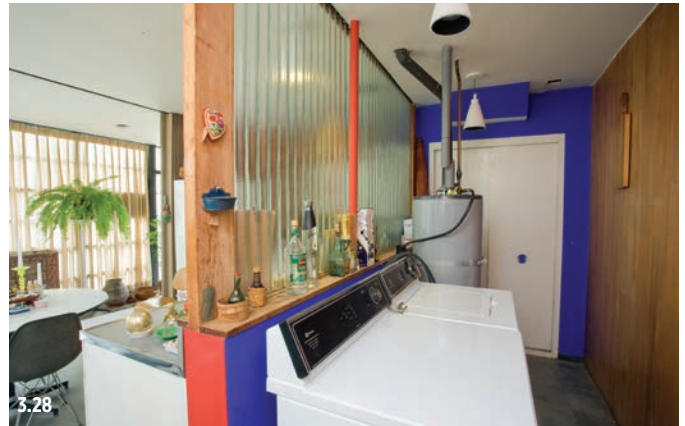
**Figure 3.27** View of the kitchen, 2016. The hallway and staircase are visible at left. The Modernfold accordion door conceals the back of the refrigerator. The original Voit rubber floor tiles are faded and in deteriorating condition. Above the countertop and sink, the corrugated glass panel provides visual interest while allowing light into the utility area.

At the north end of the residence (at ground-floor level) are the dining, kitchen, and utility areas, which are single-story-height spaces occupying the two northern bays of the residence, closest to the studio. The dining and kitchen areas form one space, which can be divided by a Modernfold accordion door; in practice, this door is always kept folded at the south end of the space, maintaining the largest opening to the kitchen (Jones and Smith 1998, 52). The door conceals the rear of the refrigerator (fig. 3.27). Korina plywood paneling carries through from the hallway to the east and south walls of the kitchen. White steel cabinets by Berger Manufacturing are topped with a variety of surfaces, including black, gray, and white plastic laminate, butcher's block, and marble. The original Kelvinator cooking range is extant; the refrigerator is a later replacement. These areas have plaster-finished ceilings covered in painted wall fabric. As in Charles's bathroom, the flooring is original 9-by-9-inch Voit rubber tiles in sea sand that currently appear to be a bluish green (Entenza and Eames 1949, 30). They are in a deteriorating condition.

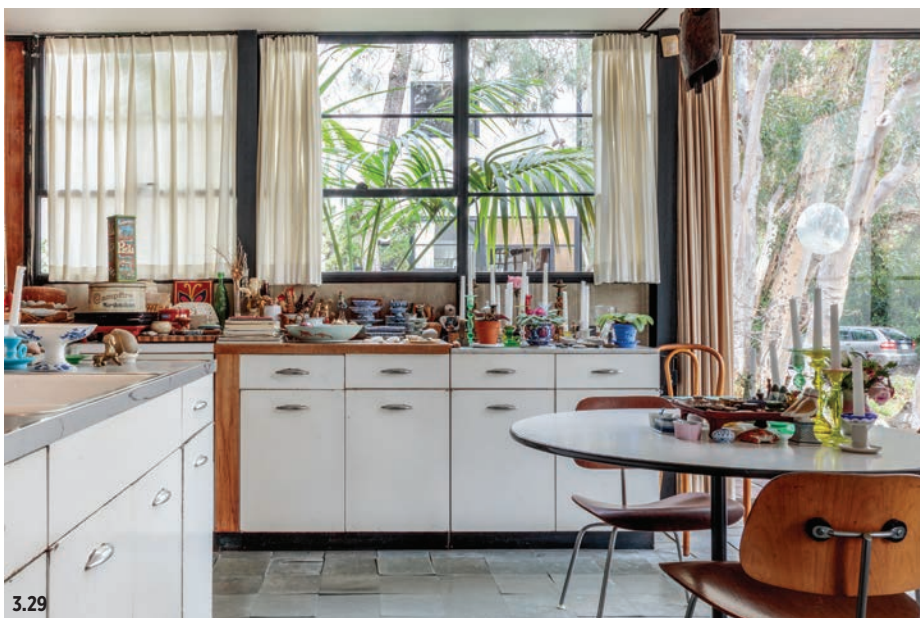
**Figure 3.29** North wall of the kitchen in 2017, showing the prefabricated steel cabinets and window units filled with clear glass and hung with curtains. At right, the steel-framed sliding door opens to the central court.
