# Eames House Conservation Management Plan

The Getty Conservation Institute

This Conservation Management Plan (CMP) provides a framework for the ongoing care and management of the Eames House, including decisions about its conservation. Based on a thorough assessment of its heritage values, the plan provides policies to assist the Eames Foundation in the long-term management of this National Historic Landmark as a house museum.

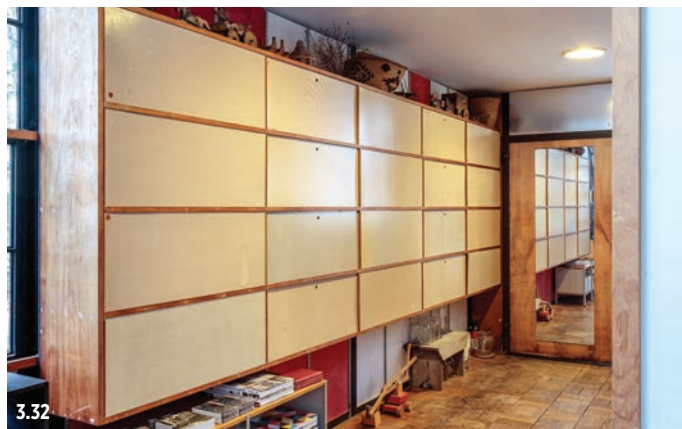
3.32

**Figure 3.32** Custom-built plywood storage cupboards with Plyon sliding doors, mounted on the wall opposite the kitchenette, 2017.

The main entrance to the studio opens off the central court into a single-story space that occupies the width of two structural bays. With the exception of the bathroom, the plaster-finished ceilings in this area are covered in painted wall fabric. A small kitchenette with white steel cabinets similar to those used in the residence is located on the west wall of the entry hall. It includes a kitchen sink but no cooking facilities. The walls in this area are painted a variety of colors, including black, beige, and red, and above the northern bank of kitchen cabinets, a vibrant cobalt blue (fig. 3.31). Opposite the kitchenette, the east wall is lined with wall-mounted plywood storage cupboards that feature sliding doors constructed of Plyon set into wooden frames on wooden tracks (fig. 3.32).

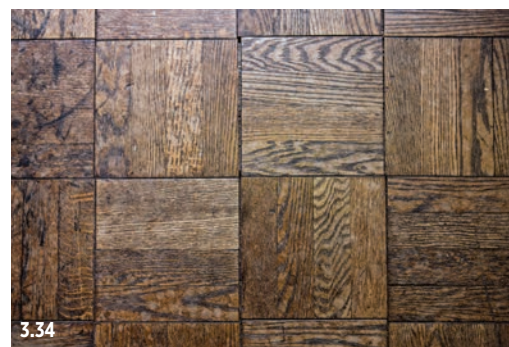
3.34

The studio proper, kitchenette, and service nook are floored in parquet laid in a basketweave pattern over the concrete slab (fig. 3.34); the darkroom parquet is laid end to end (fig. 3.35). The bathroom and loft are floored in rubber tiles similar to those used in the residence.

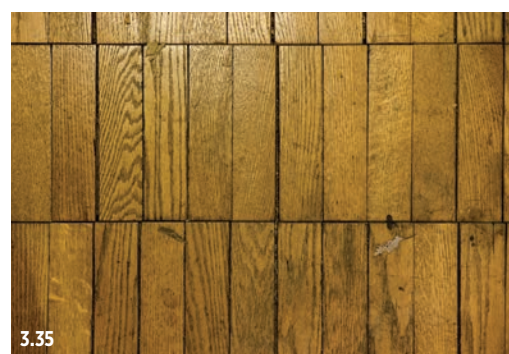
3.35

**Figure 3.35** Detail of parquet floor in the former darkroom, the only room to retain the original end-to-end configuration, 2016.

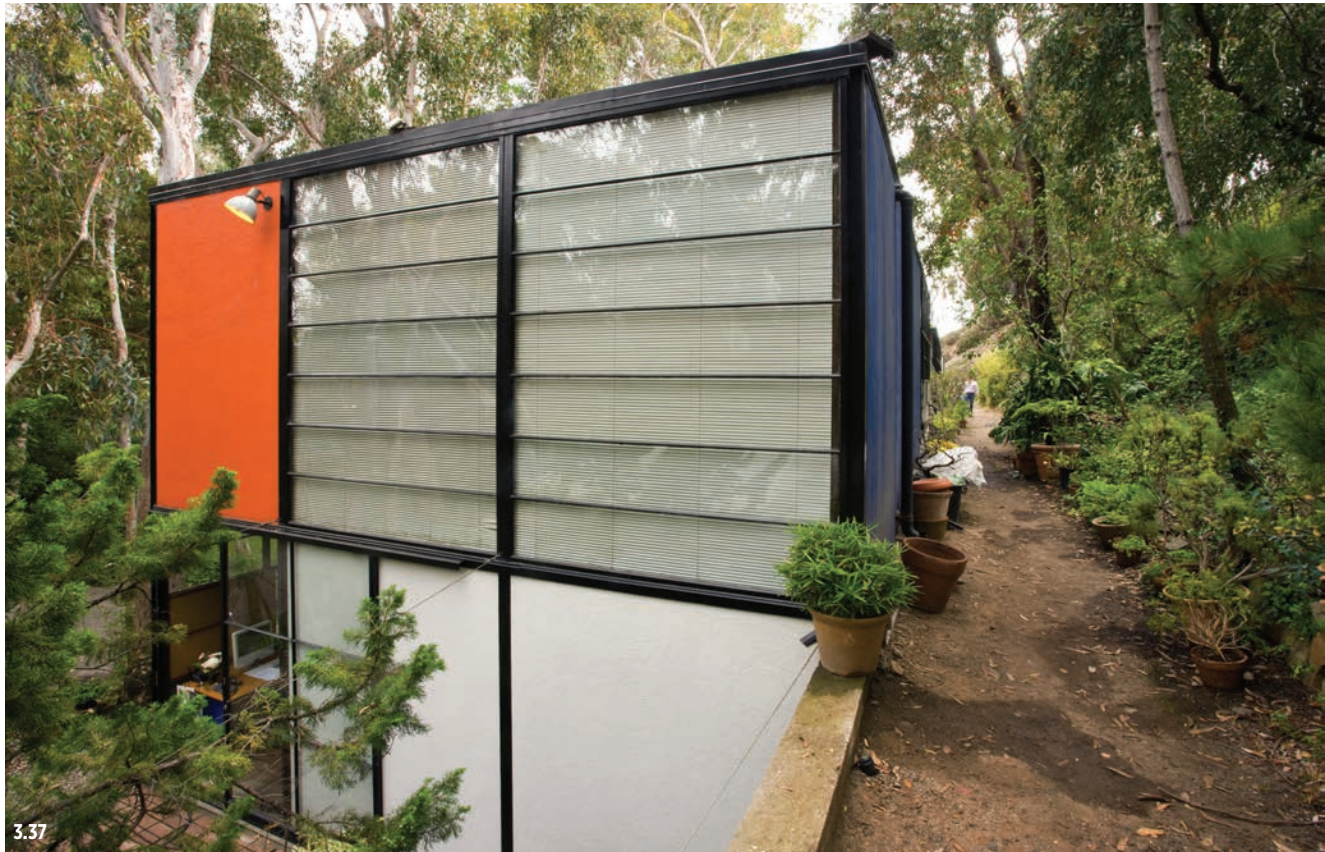
**Figure 3.37** The studio north elevation, as seen from the upper pathway above the retaining wall, 2013. The sliding glass door is at lower left, beneath the brightly painted stucco panel.

The studio itself is flooded with light. The east elevation comprises single- and double-height bays of steel window sash filled with Mississippi polished wire glass. The lower windows house sliding light-diffusion screens made of Plyon set into wooden frames on wooden tracks (fig. 3.36). Light also enters the studio from the north elevation, where two upper bays are filled with clear glass. On the north elevation, a sliding glass door—glazed with wire glass—opens onto the north court (fig. 3.37).

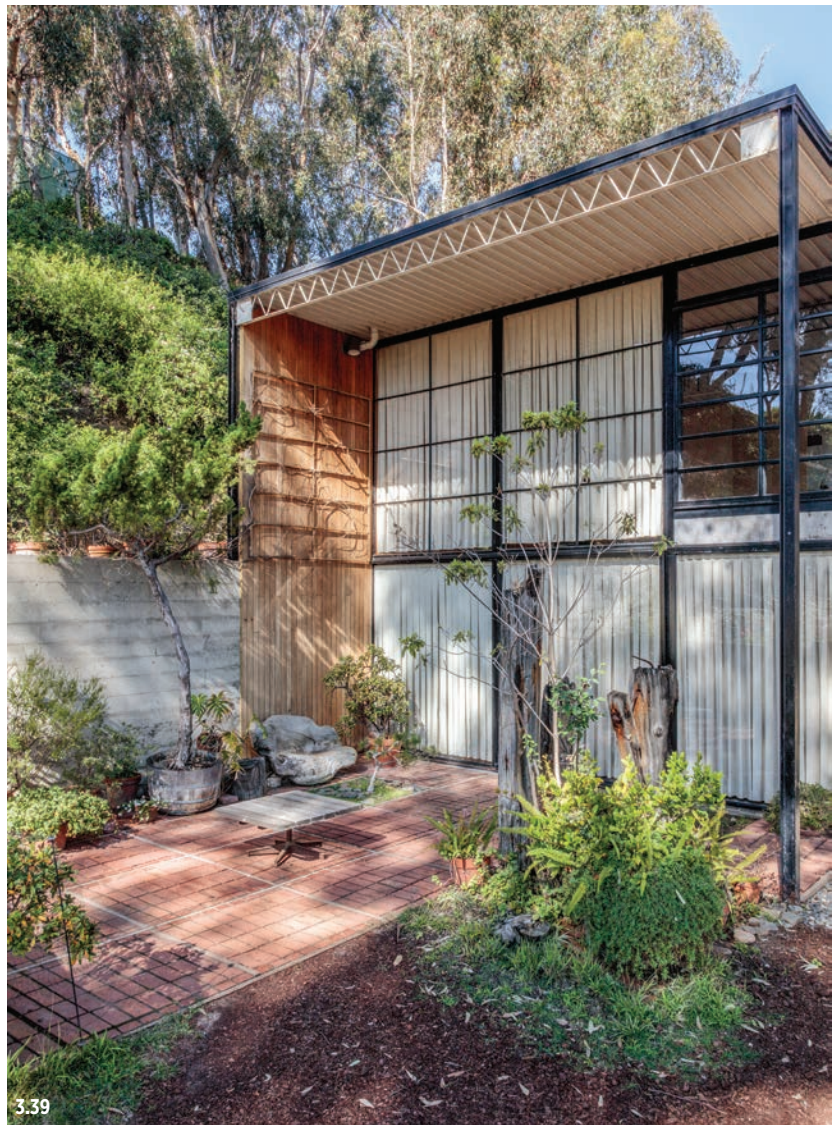
**Figure 3.39** View of the south court off the living room, 2017. The fully glazed south wall and wide sliding door integrate indoors and outdoors. The roof overhang, one structural bay's width, along with the extension of the living room's tallowwood paneling to the exterior, heightens the sense that this is an outdoor room.

At the south end of the residence, the court serves as an outdoor room. It also provides the foreground to views from the living room across the meadow to the ocean below. The south court, accessed by a sliding glass door at the center of the south facade, features a covered area immediately adjacent to the living room where the roof of the residence extends the width of one structural bay to provide shade and shelter (fig. 3.39). The living room's tallowwood paneling and Truscon ceiling extend to the rear wall of the south court, heightening the sense that this is an outdoor room. A gold-painted wooden trellis hangs on the upper portion of the tallowwood wall; the exterior edge of the tallowwood paneling is also painted gold. A small panel featuring a faded photograph of eucalyptus trees is housed immediately above the fixed glazed pane to the east of the sliding door (fig. 3.40).

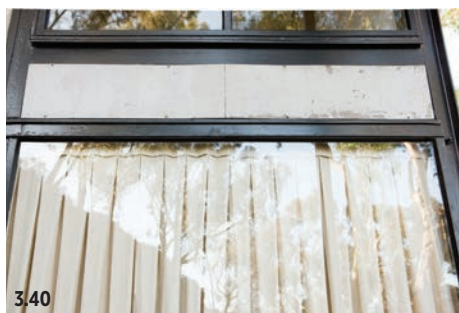
**Figure 3.40** Panel affixed above the wide, easternmost pane on the south elevation of the residence in 2016, featuring a badly faded photograph of eucalyptus trees.

Two important components of the collections are sited on the south court: the photographic panel of eucalyptus trees (see fig. 3.40) and the pier pilings sculpture (see fig. 3.42).

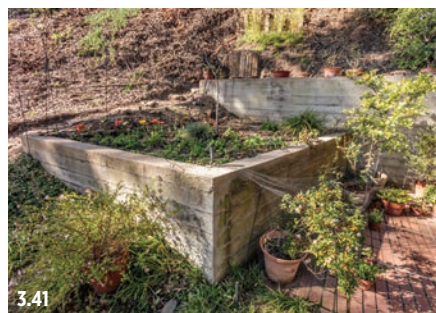
**Figure 3.41** Concrete planter box that abuts the retaining wall and encloses the south end of the south court, 2017. It is planted with flowers and held a small persimmon tree that has since died.

The open area is enclosed to the rear (west) by the concrete retaining wall. It is also enclosed at the south end by a large, raised concrete planter box that abuts the retaining wall and the upper slope. The box is planted with seasonal and perennial flowers and is currently protected by deer netting (fig. 3.41).<sup>5</sup>

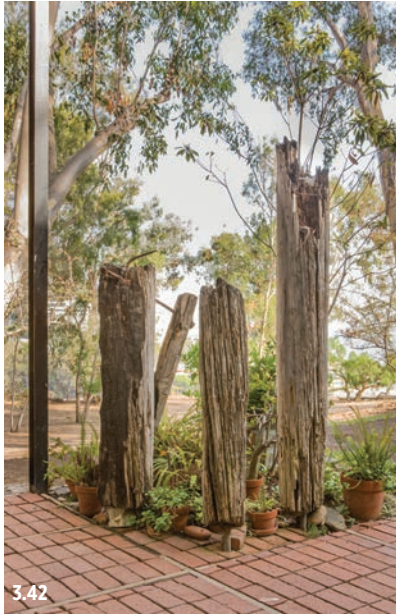
**Figure 3.42** Sculpture of three charred pier pilings installed upright on a metal base, an early addition to the south court, 2016.

A sculpture of three charred pier pilings anchored upright on a metal base stands on the brick-paved area beyond the south court overhang (fig. 3.42). An unpaved square immediately to its north holds potted and planted foliage. A large, bench-like piece of salvaged wood sits on the pavement near the tallowwood wall.

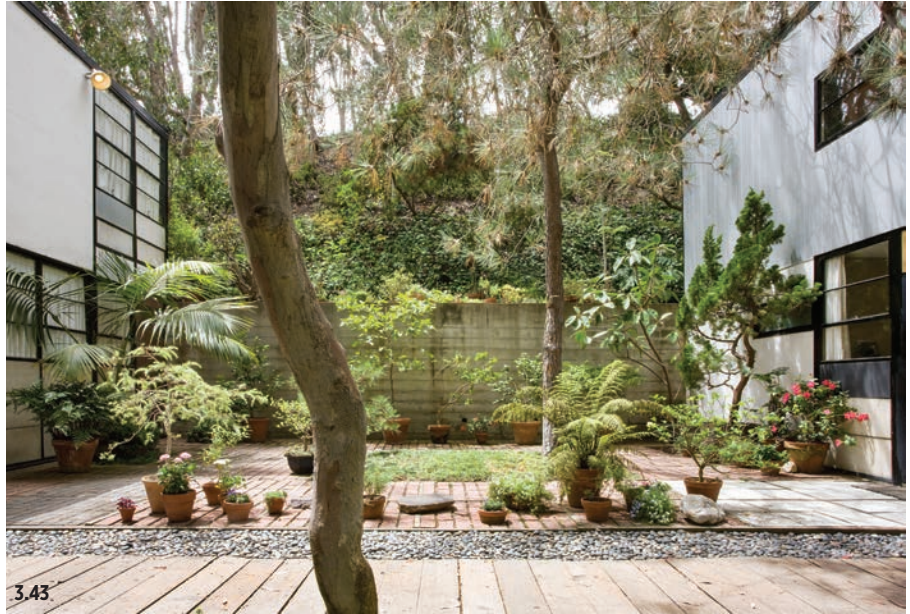
**Figure 3.43** View of the central court, four structural bays in width, 2013. It serves as a connection between the residence (*left*) and the studio (*right*). Enclosed at the rear by the concrete retaining wall, it is paved in a variety of materials and contains an array of plants and trees, both potted and planted.

The central court, which serves as a connection between the residence and studio, is enclosed to the rear by the concrete retaining wall (fig. 3.43). It is equivalent in length to four structural bays. The central court's pavement features 2-inch-wide wooden strips laid in a grid and infilled with a varied pattern of brick and wooden blocks. Marble pavers mark the entry to the studio. Occasional squares within the grid are unpaved and landscaped. Near the center of the court, a larger unpaved area is planted with mondo grass and holds a pine tree. Unglazed terracotta pots planted with annuals and perennials are located on the edges of the central court's paved areas. Sawn whiskey barrels serve as planters for larger plants, including a rubber tree, kentia palm, and yew pine. The building facades facing the court are far less transparent than the primary facades.

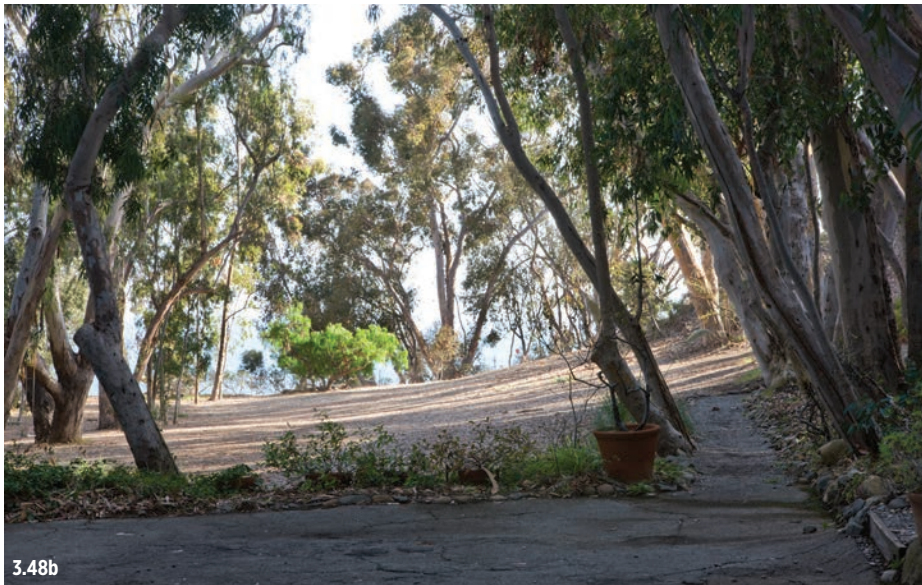
**Figure 3.48b** View from the parking area in 2016 toward the ocean during a period of drought, when the meadow grasses have died back due to lack of rainfall.

A long, shared right-of-way easement leads from Chautauqua Boulevard to the Eames House site and its driveway, terminating in a small, paved parking area. Immediately south, a gently sloping meadow ringed by eucalyptus and other trees opens to a view of the Pacific Ocean. During the wet season, when seed has been planted, the meadow is grassy, with scattered weeds and wildflowers, and dies back during the dry season (figs. 3.48a and 3.48b). Occasional trees and other plantings

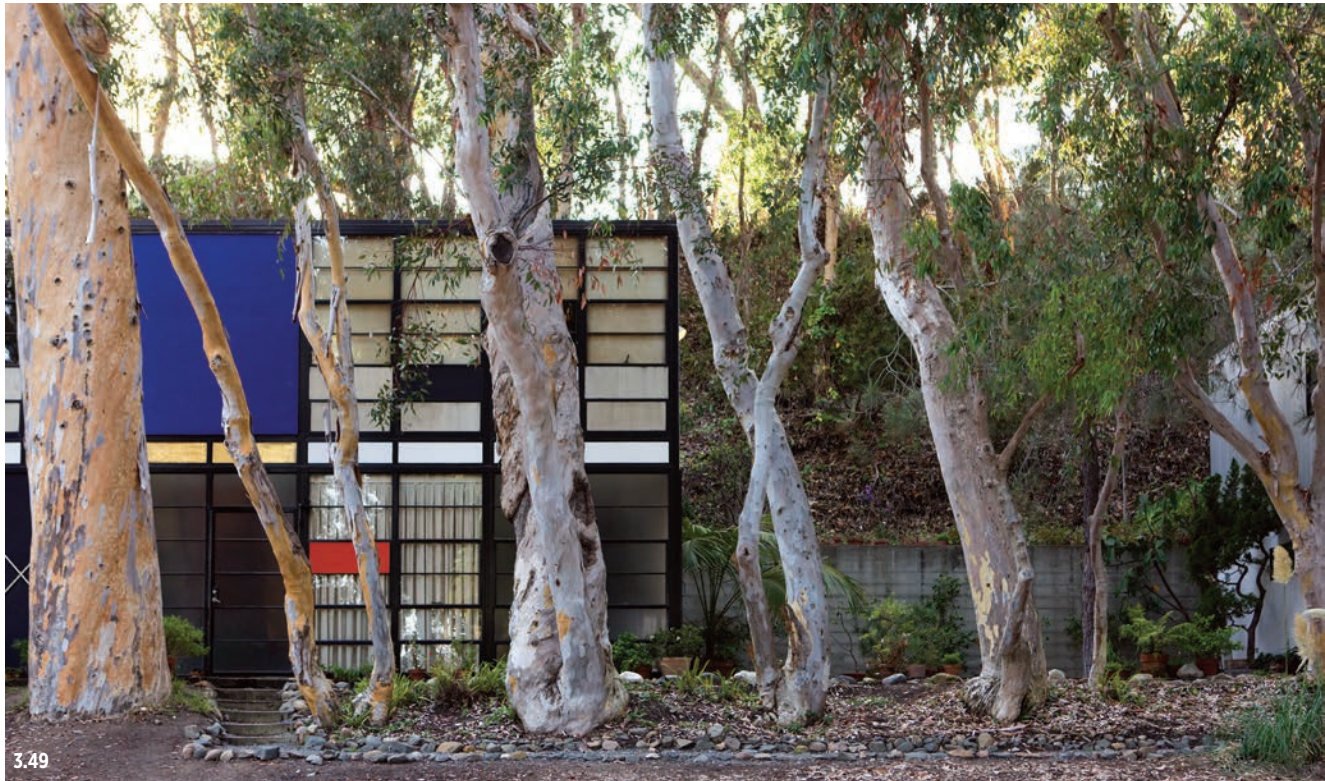
**Figure 3.49** The row of mature eucalyptus in front of the building complex, 2016. The Eameses situated the complex between these preexisting trees and the hillside.

An arborist's study of the site, conducted in the fall of 2014, inventoried 212 eucalyptus trees with trunks 4 inches or greater in diameter (Carlberg Associates forthcoming). Most significant of these is a row of mature eucalyptus originally planted in the 1880s, which defined the location of the building complex. They form a screen in front of the building complex, which is nestled between them and the slope of the hillside behind (fig. 3.49). Sunlight filters through the trees, casting patterns of light and shadow on the interiors and reflections on the external walls.

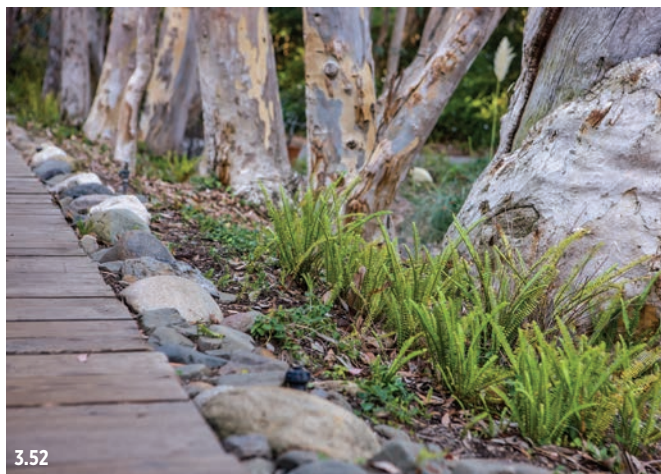
3.52

**Figure 3.52** Central section of understory in 2016, between the two sets of steps leading from the meadow to the building complex. This section is landscaped in a variety of plants.

central section, between the two flights of steps leading from the meadow to the building complex (see section 3.5.6), is planted in an assortment of groundcovers (fig. 3.52). At the southern end of the row, the ground is planted in fescue grass, currently worn bare (fig. 3.53).

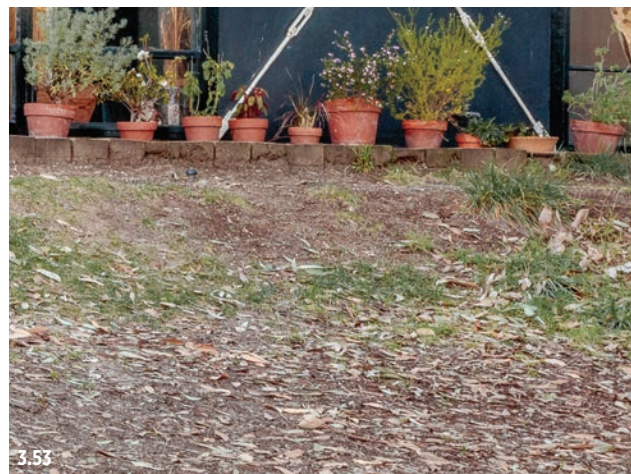
3.53

**Figure 3.53** Southern section of understory in 2017, planted in fescue grass, worn bare following a prolonged period of drought.

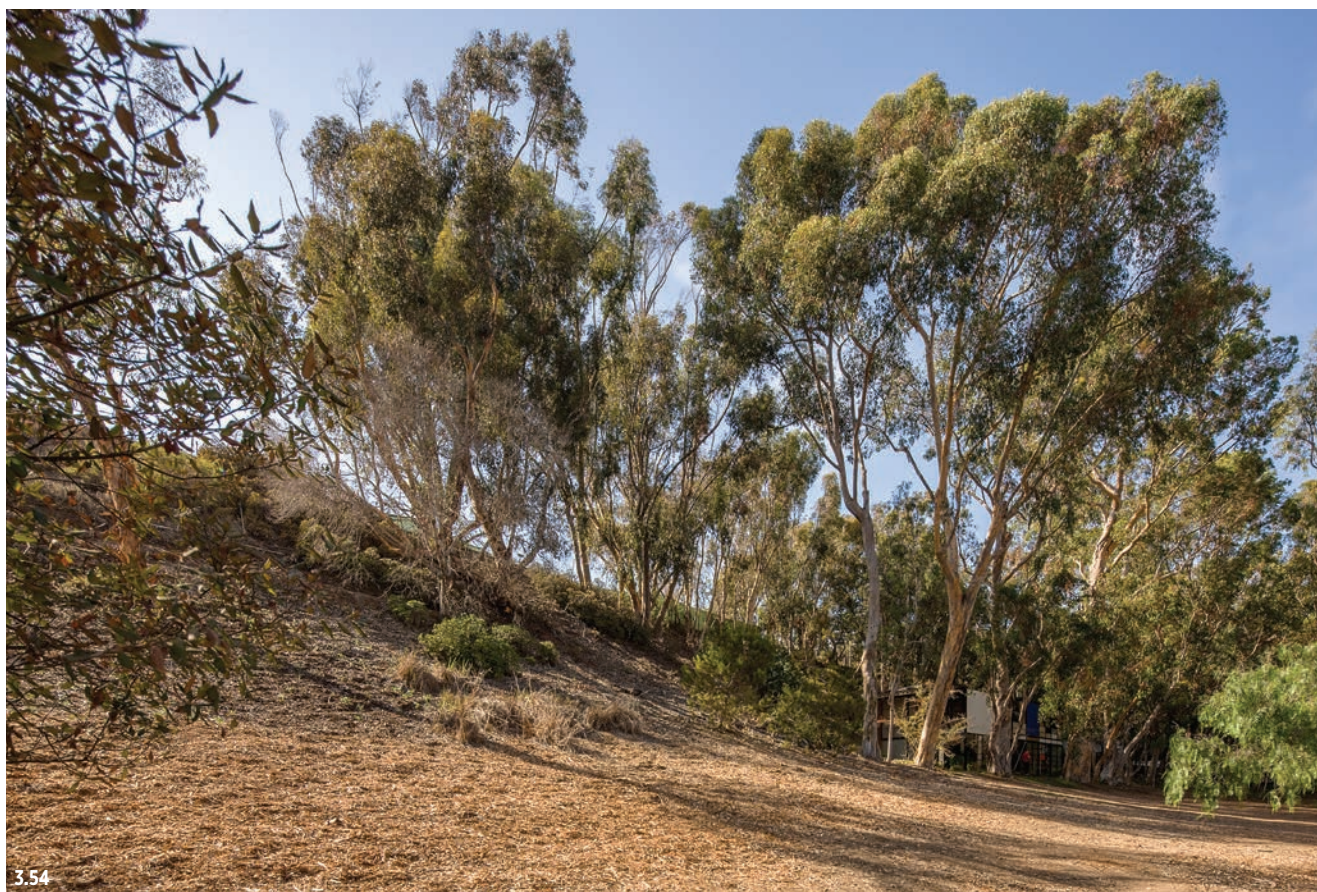
3.54

**Figure 3.54** View of the upper slope, 2016. The western portion of the site rises steeply to the roadway above. The slope is covered primarily in eucalyptus and diverse groundcover. The building complex, visible at lower right, is built into the slope.

On the western portion of the site, to the rear of the building complex, a steep slope rises to Corona del Mar, where the property is edged by a plumbago hedge that covers a chain-link fence. The retaining wall of the building complex is built into the base of this slope. The slope is covered by numerous trees, primarily eucalyptus, with diverse undergrowth and clumps of jade and plumbago (fig. 3.54). The area is irrigated by an automatic sprinkler system with spray heads. Mid-slope erosion above the south court/planter box area has been stabilized with bamboo and railroad ties.

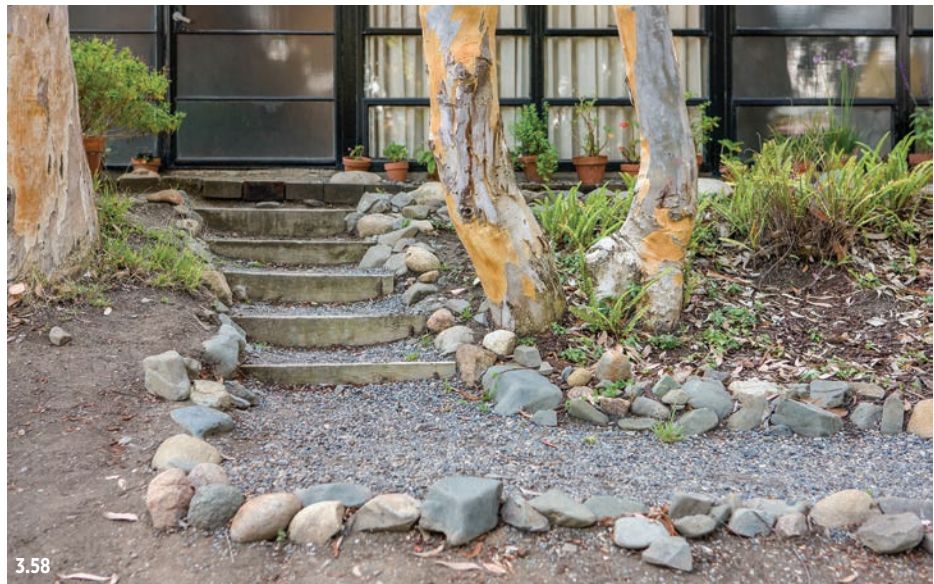
**Figure 3.58** Lower pathway and steps leading to the front door, 2016. The pathway is lined in rubble stone and covered in river rock, and leads across the meadow to the front of the residence.

to the northeast of the studio and to the carport directly north of the studio. A pathway delineated by rubble stone and covered in compacted dirt and small river rock leads from the parking area along the top of the meadow toward the residence to a set of five informal steps. Constructed of board risers with gravel-topped treads, the steps are cut between two trees in the row of eucalyptus and lead to the wooden walkway in front of the residence's main entrance (fig. 3.58). Four similar steps lead from the parking area to the walkway in front of the studio's eastern facade (see fig. 3.51). A second pathway, also covered in river rock, leads from the carport to the studio's sliding glass door.

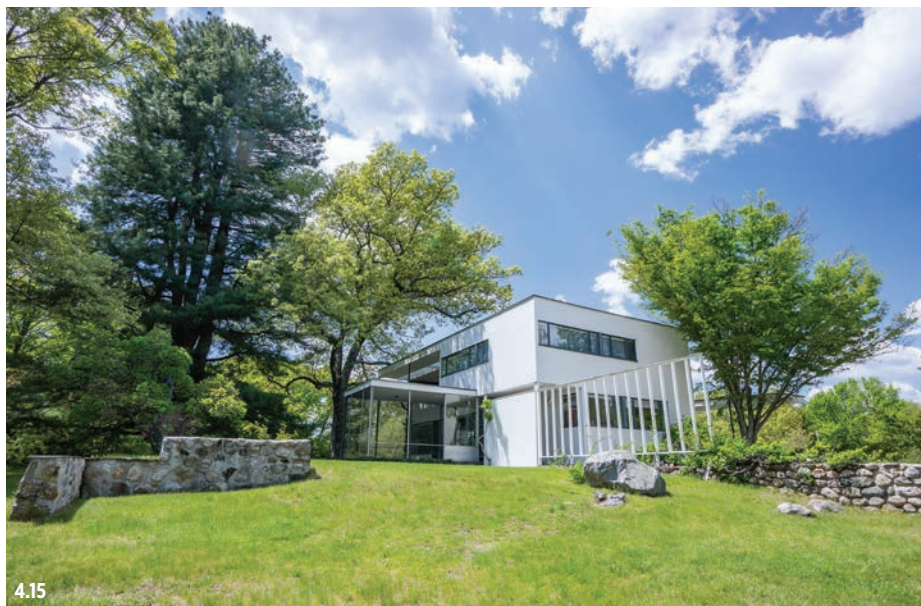
**Figure 4.15** Walter Gropius, Gropius House, Lincoln, Massachusetts (1938), photographed in 2016. The landscape is a significant element of the house's design and is largely intact. Gropius incorporated some preexisting landscape features into his design, such as the old rubble-stone field walls seen at right.

Similarly, the Gropius House, the Homewood, and the Muuratsalo Experimental House possess remarkably intact landscapes (fig. 4.15). The Gropius House and the Homewood are well integrated with designed garden landscapes, and Muuratsalo is located in a heavily wooded lakeside setting. All were constructed on large plots in sparsely built locations and retain high integrity of wider context. Both the Goldfinger and Soane residences were built as infill

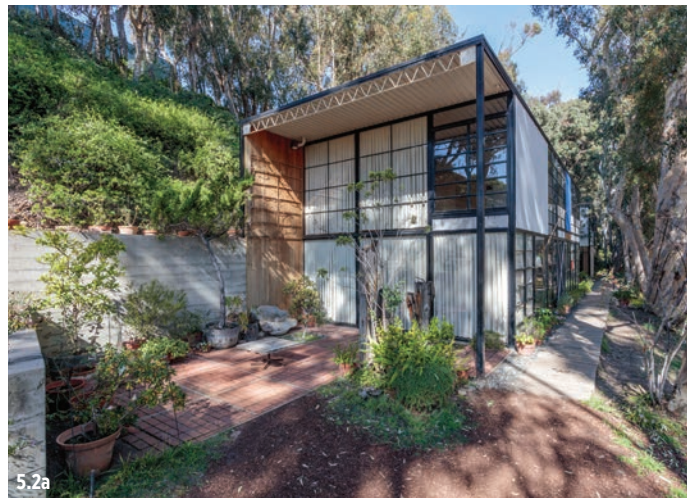
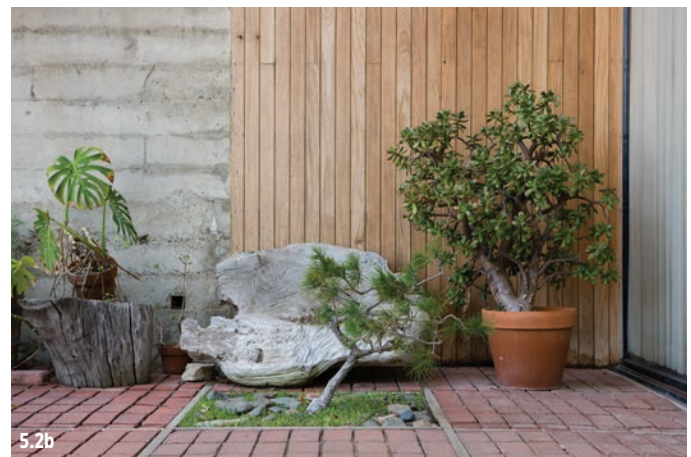
**Figure 5.2a** View of the south court, a major space of the building complex, 2017. The term *element* is used in the CMP to describe the major spaces and structures of the site.

**Figure 5.2b** View of the brick paving and tallowwood wall, components of the south court, 2017. The term *component* is used to describe parts of the larger elements of the site.

The term **element** is used to describe the major spaces and structures of the site, such as the residence and meadow. The term **component** is used to describe parts of an element; for instance, in the case of the Eames House, the roof is an element of the residence and the peppercorn tree is an element of the meadow (figs. 5.2a and 5.2b).

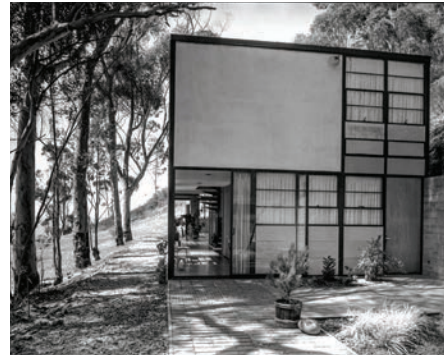
**Figure 5.4**

The form of the building complex integrates indoor and outdoor spaces, as seen in this view of the residence in 1950, looking across the center court to the south.

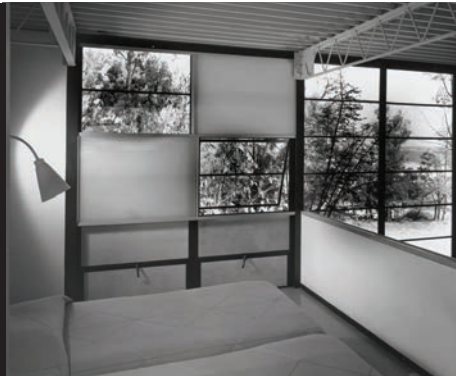
**Figure 5.5** The fabric of the Eames House is characterized by a variety of building materials. This 1950 view of the bedroom shows Plyon window screens, Truscon architectural sash infilled with clear glass and Cemesto panels, and Truscon joists and ceiling.

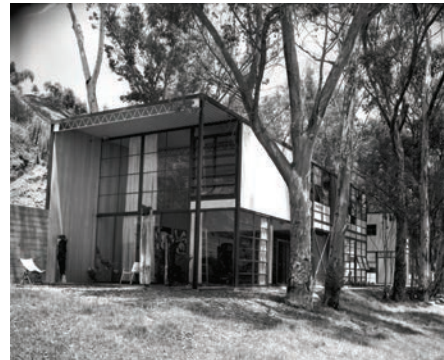
**Figure 5.6** This 1950 photograph shows the building complex placed in relation to the preexisting row of eucalyptus trees, which screened the views toward and away from it across the site to the ocean.

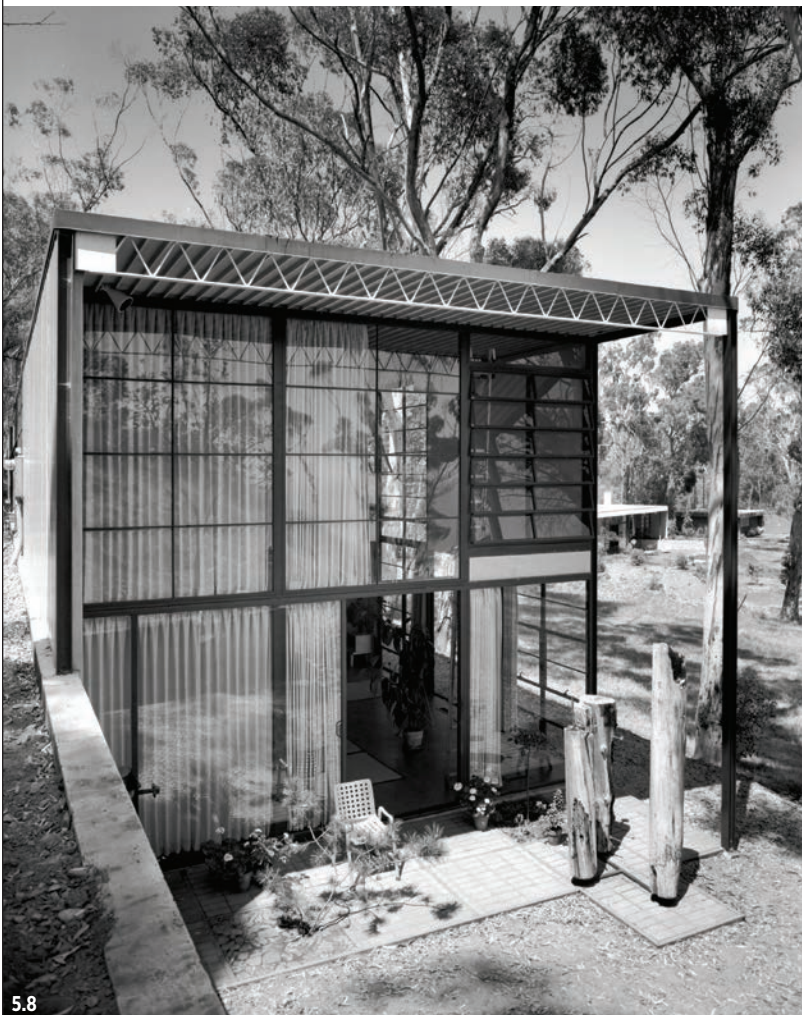
**Figure 5.8** The early shared-landscape relationship between the Eames House and two other Case Study Houses, the Entenza House (No. 9) and the Walker House (No. 18), seen in the background at right in 1950, is evident here.

- **The original land parcel**, the form of which has not been subdivided or further developed since construction, though it has been increased in size with the addition of segments of neighboring land parcels.
- **The extended setting** of the site, which provides evidence of early topographical features and layout as well as the character of the surrounding Case Study group and Pacific Palisades area (fig. 5.8).
- **The interiors, contents and collections**

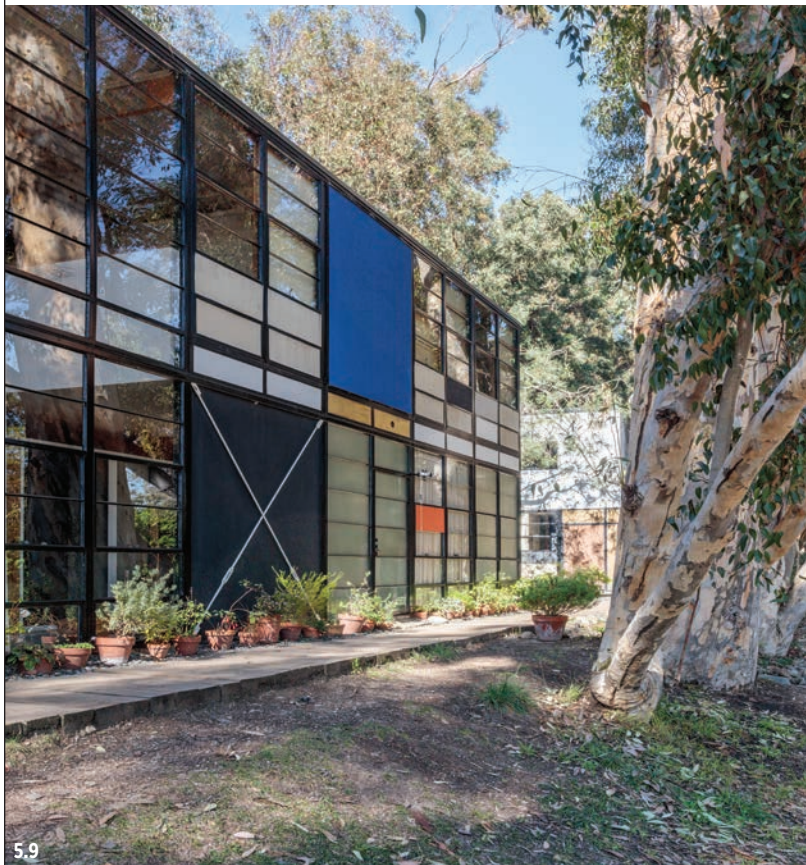
5.9

**Figure 5.9** View of the east facade of the residence, 2017. The honest expression of structure and the creative use of color, texture, and varied materials are among the attributes that demonstrate the aesthetic significance of the building complex.

- ▶The **creative use of color**, material, and texture in the design of the residence and studio, including the main external facades and interior spaces that have contributed to the building's aesthetic and have made it readily recognizable around the world (fig. 5.9).

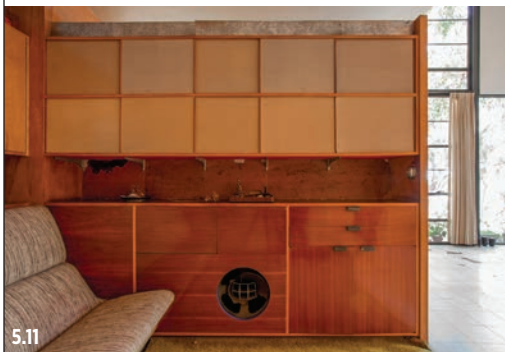
**Figure 5.11** Plyon cupboard doors in the upper level of the living room alcove in 2011, built of one of the many experimental materials used by the Eameses that demonstrate the site's scientific significance.

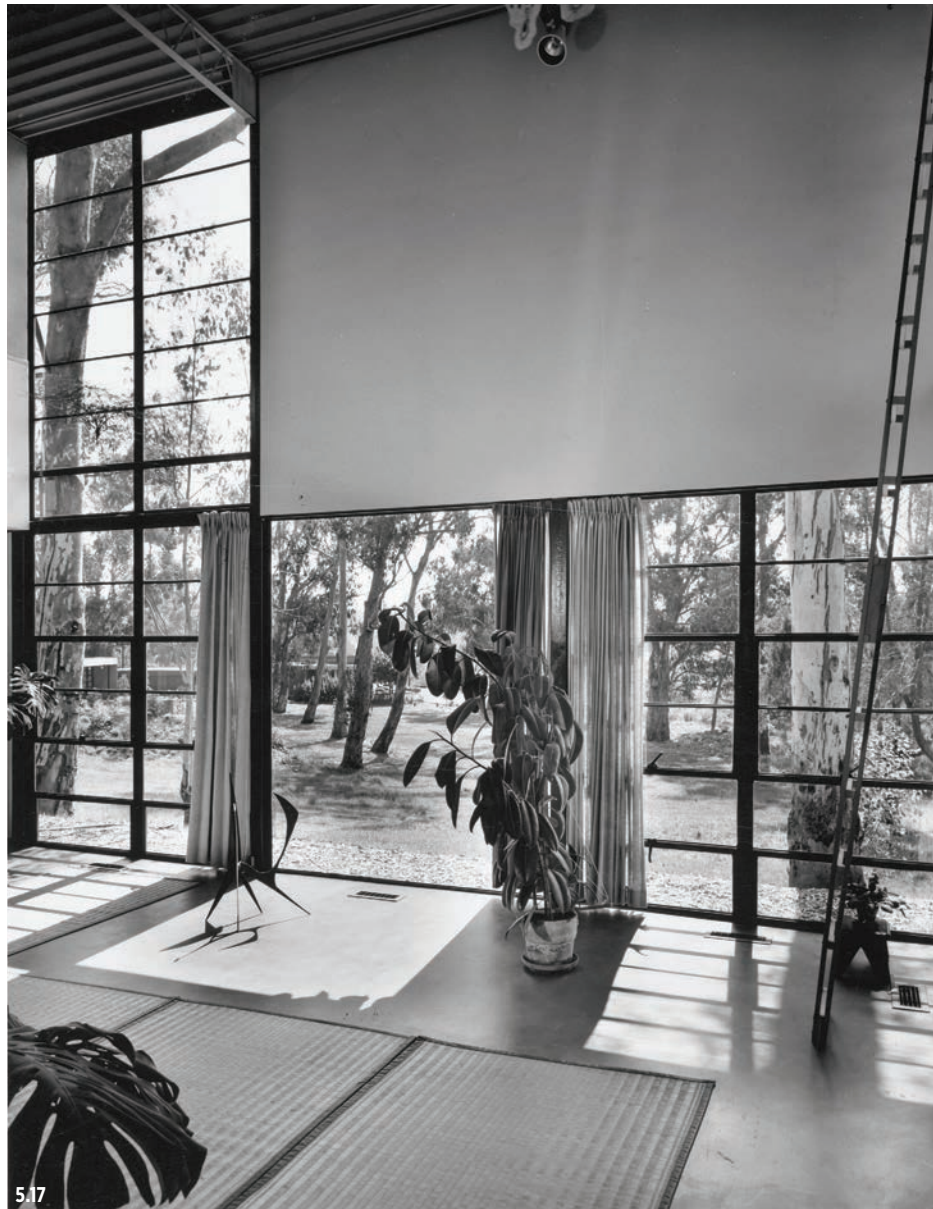
**Figure 5.16** Interior of the studio, 1952. The character of construction materials is honestly expressed through the ribbed underside of the Truscon Ferrobord roofing, which forms the ceiling, the open web joists that support it, and the Truscon steel sash infilled with a variety of materials.

reinforced concrete for the retaining wall, unpainted Cemesto cladding, plywood wall paneling, and the exposed steel frame, roof trusses, and ribbed underside of the metal roof decking that forms the ceiling (fig. 5.16).

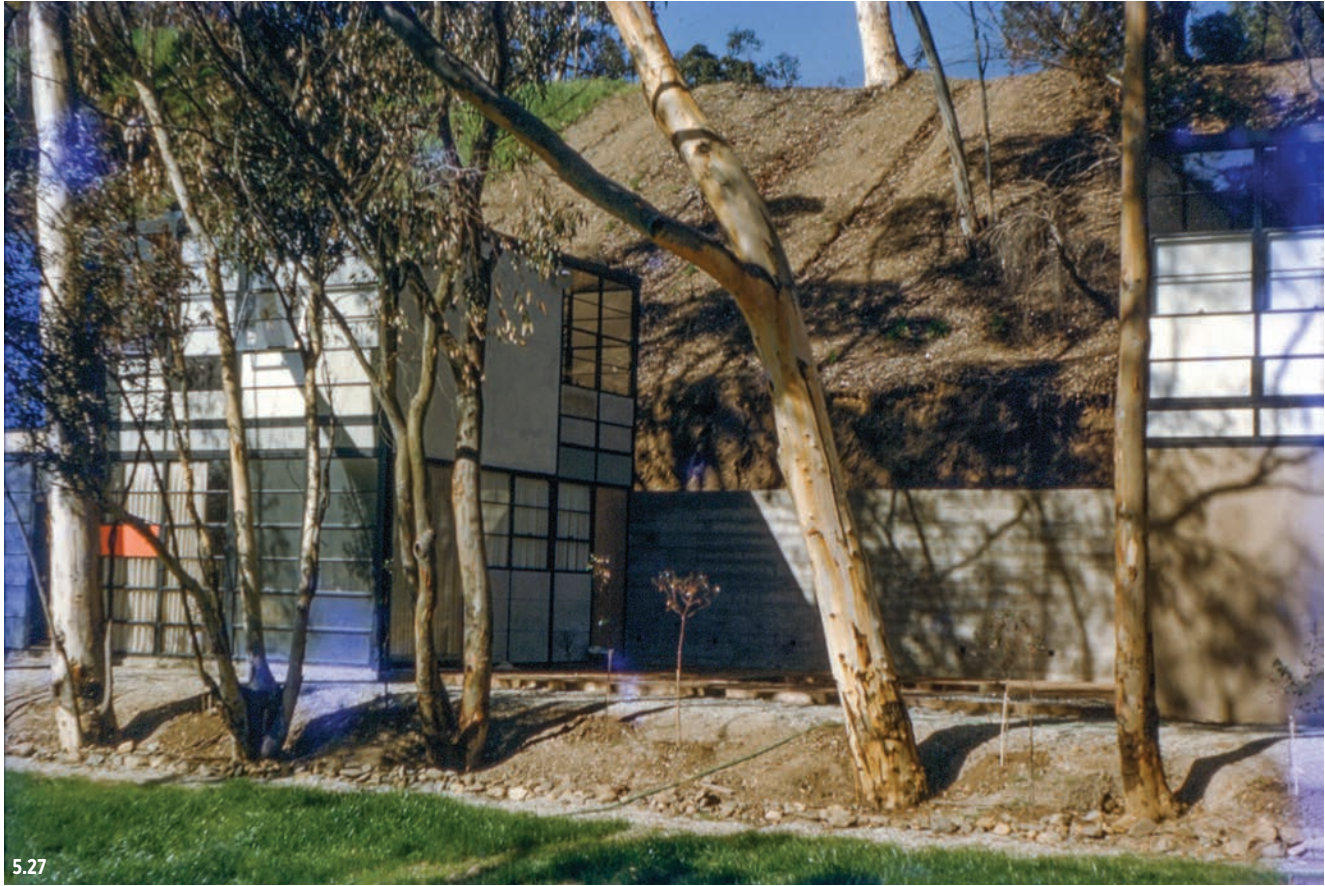
**Figure 5.27** The site under construction, 1949. The final placement of the building complex was sympathetic to the preservation of the site's topographical features, existing trees, the meadow, and significant views to the ocean reflecting the Eameses' understanding of and respect for the site's natural qualities.

(fig. 5.27). These elements and aesthetic attributes of the site were influential in determining the design, form, layout, and siting of the building complex and provide the now iconic setting in images of the buildings and site as a whole.

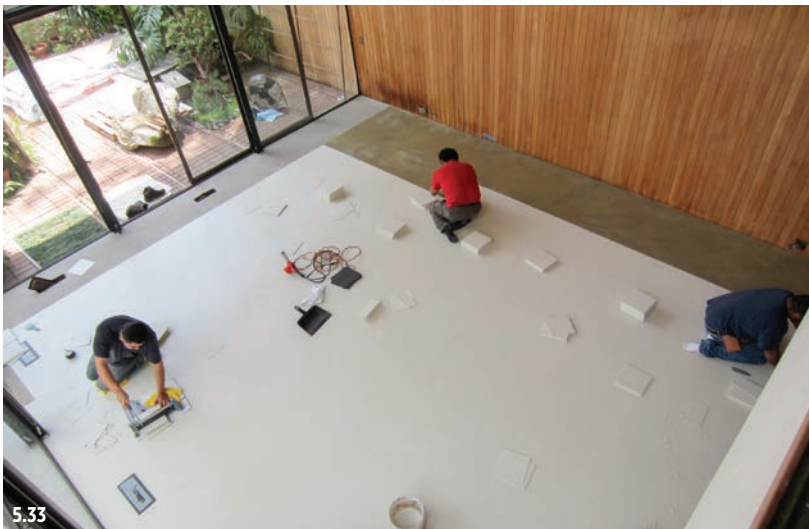
**Figure 5.33** Replacement floor tiles installed and photographed in 2012 reproduced the dimensions, color, and finish of the original tiles.

- 1.** Substitute components or materials that have been installed since Ray Eames's death in 1988, such as the replacement of three damaged Cemesto panels in the studio with plywood, the replacement of floor tiles in the living room and hall of the residence (to maintain functionality and significant attributes of aesthetic character) (fig. 5.33), and the replacement roof on the residence and studio in 2015, which included use of new materials and design features that improve water drainage.

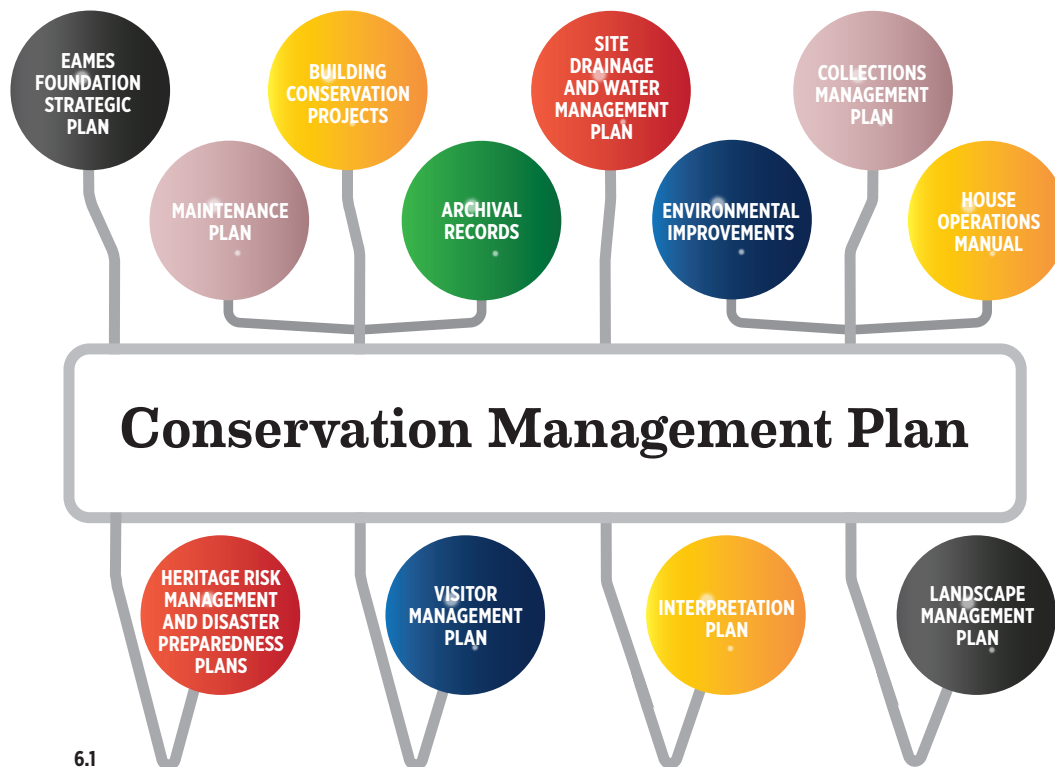
6.1

**Figure 6.1** Diagram showing the CMP as the guiding framework for a range of specific investigations, plans, and policies in support of future actions regarding the Eames House.

The CMP is an overarching management document. It identifies a number of necessary specialist investigations, condition assessment reports, and management plans for the Eames House, as indicated in figure 6.1. These specialist investigations, reports, and plans, which will direct future conservation actions, should follow the CMP approach by first understanding the site and assessing its significance, then developing policies and recommendations that conserve and enhance its significance.

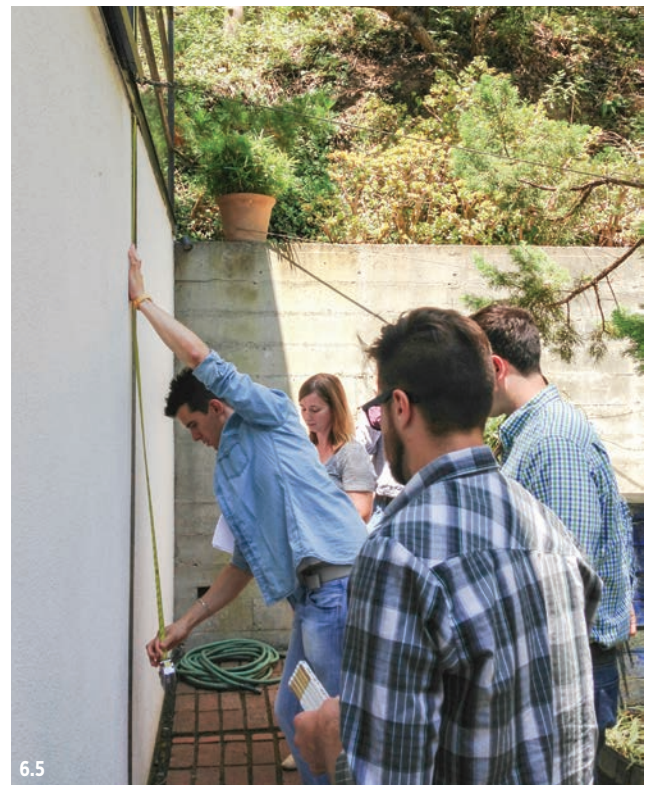
**Figure 6.5** Members of the HABS team measuring the north elevation of the studio in 2013. The HABS drawings form part of the baseline documentation of the site.

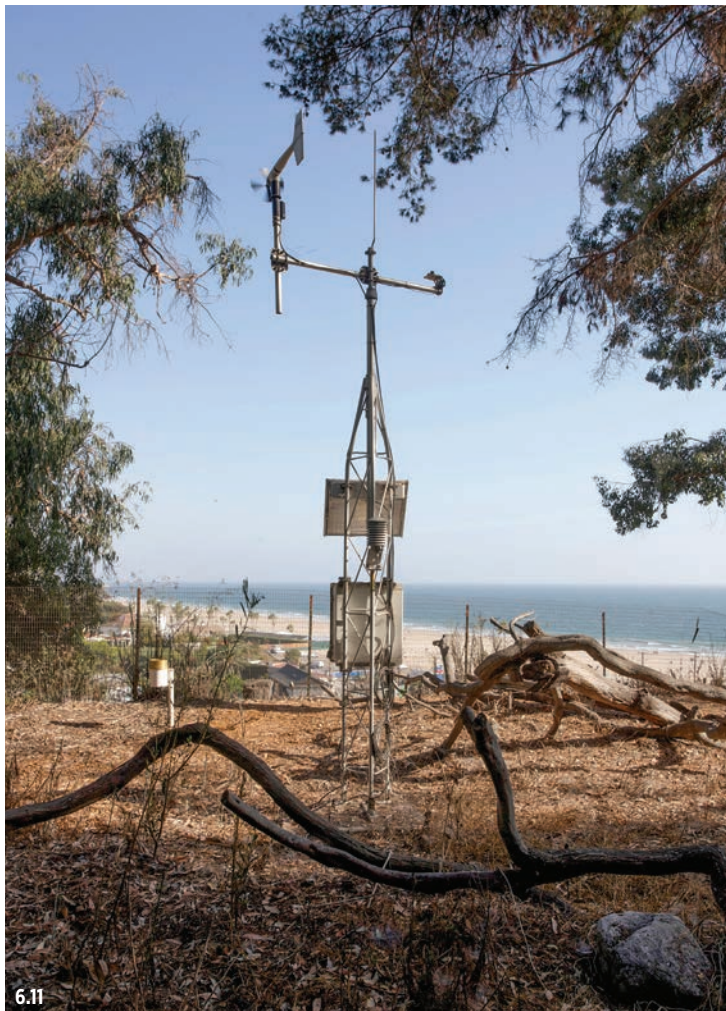
**Figure 6.11** Weather station installed by the GCI in the meadow, 2016. Environmental monitoring began in 2011 to gather baseline temperature, humidity, and wind data that will inform environmental improvement recommendations.

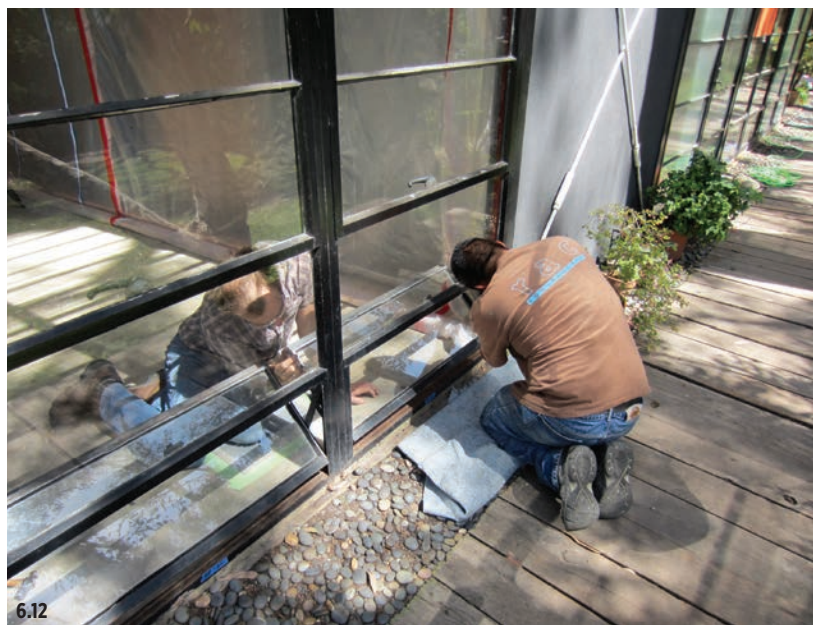
**Figure 6.12** A worker repairing a Truscon hopper window in 2012. Repair of steel components should be carried out as part of a regular, cyclical maintenance schedule.

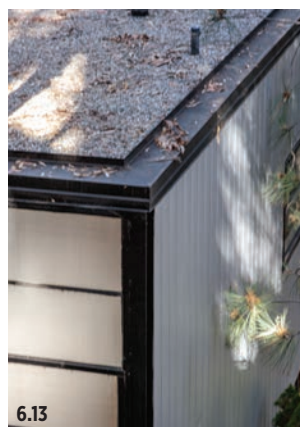
**Figure 6.13** Southeast corner of the studio roof, in 2017, showing the curb added as part of the reroofing campaign in 2014 to improve weather tightness and drainage. Also visible at the top of the wall are the original and later (second) edge flashings.

- Rigid insulation adhered directly to Ferrobord steel substrate. A continuous section of short curb was installed about 6 inches from the perimeter on all sides of both the residence and studio roofs (fig. 6.13). This curb is interrupted at two areas on the west side of each roof, where two short sections of gutter are placed to collect rainwater (fig. 6.14).

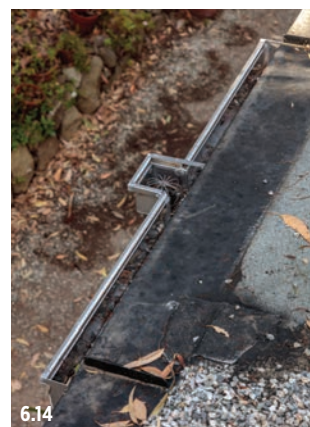
**Figure 6.14** West elevation of the residence, in 2017, showing roof edge and short gutter section installed during the 2014 reroofing. Regular removal of leaf litter is an essential cyclical and preventive maintenance activity.

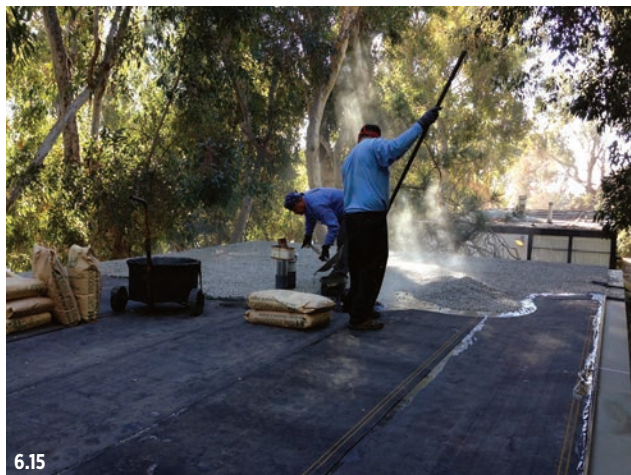
**Figure 6.15** Workers cover the built-up layers of bituminous roofing membrane with hot-mopped asphalt and gravel in 2014.

- Bituminous layers of built-up roofing membrane covered with hot-mopped asphalt and gravel (fig. 6.15).
- There are two pieces of metal edge flashing overhanging the top of the exterior, consisting of an original flashing and a second flashing installed over it in the 1990s.

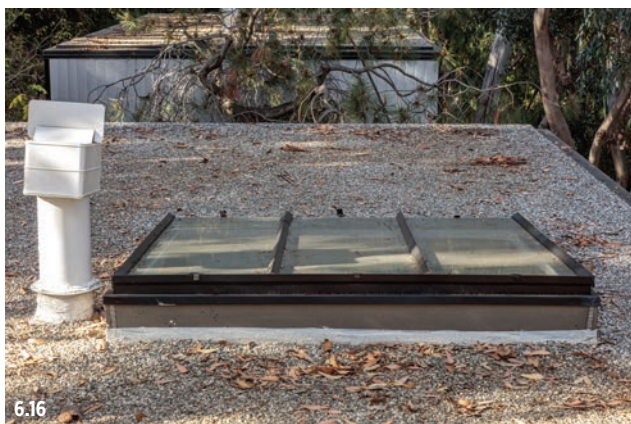
**Figure 6.16** The skylight, with its original wire-reinforced glass, was repaired in 2014 and is now in sound condition and watertight, 2017.

- The original skylight was repaired and raised, and new metal flashings were installed as part of the 2014 reroofing work (fig. 6.16).

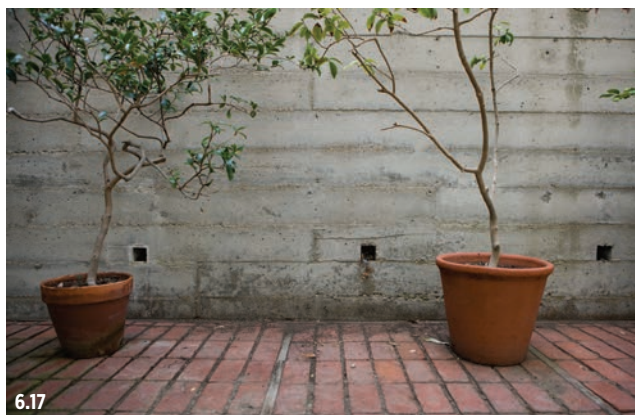
**Figure 6.17** East face of the original concrete retaining wall facing the central court, in 2016, showing three weep holes from the original French drain, which runs behind the wall near the base.

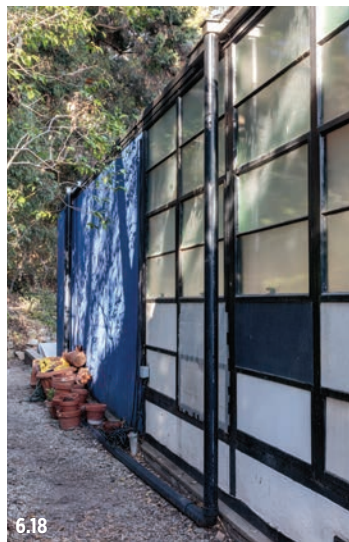
**Figure 6.18** West elevation of the studio in 2017, showing new gutter and rain leaders connected to horizontal storm-water lines that keep all roof water away from buildings. These improvements were installed as part of the 2014 reroofing.
