# Eames House Conservation Management Plan

The Getty Conservation Institute

This Conservation Management Plan (CMP) provides a framework for the ongoing care and management of the Eames House, including decisions about its conservation. Based on a thorough assessment of its heritage values, the plan provides policies to assist the Eames Foundation in the long-term management of this National Historic Landmark as a house museum.

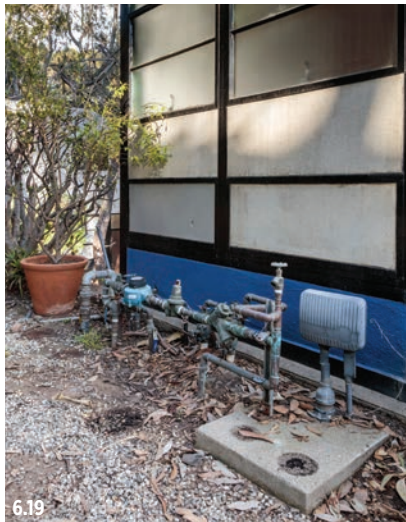
**Figure 6.19** Spigots and pipes on the west elevation of the residence, 2017. The faucets, sprinklers, irrigation system, and watering regime for the upper path and slope are potential water hazards behind the retaining wall and require careful monitoring.

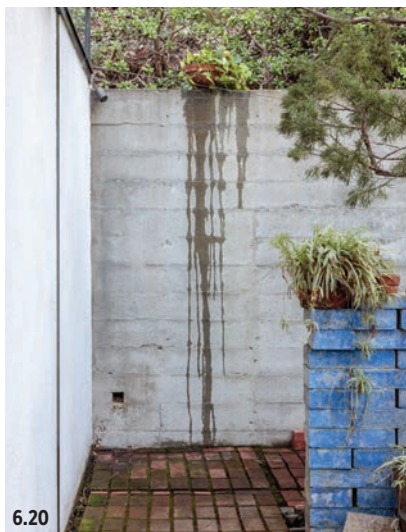
**Figure 6.20** Water draining from a potted plant down the concrete retaining wall, 2017. Watering and splashing from hoses and sprinkler heads along the pathways adds extra moisture loading to the building complex.

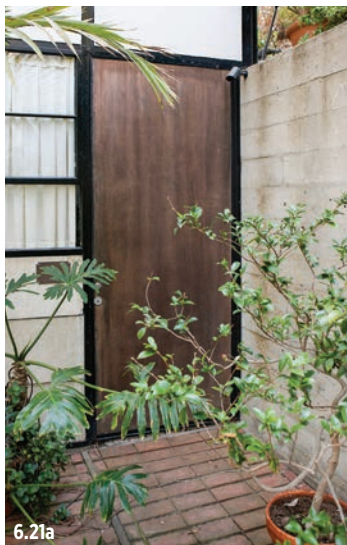
**Figure 6.21a** Entry door to the utility room from the central court, 2016. Mold growth and evidence of damp are observed on the adjacent retaining wall.

**Figure 6.21b** Exposed edge of the concrete floor slab under the utility room door, in 2017, showing damage from impact and water penetration.

- Exposed surfaces generally show little deterioration. Some exposed edges of the slab and the retaining wall show deterioration of concrete and reinforcement where water intrusion has affected fabric and/or impact damage has occurred, such as the top of the retaining wall and slab edges at the utility room door (figs. 6.21a and 6.21b). Mold growth also occurs in limited areas on shaded sections of the retaining wall and exposed slab edges in the courtyards and carport.
- As noted in B2 above, while a section of original waterproof membrane on the outside (west) face of the retaining wall

**B3.3:** Continue the program of identification and repair of concrete deterioration, such as at the exposed edges of slab and retaining wall, particularly where rusting of reinforcing is found. Prioritize repairs to the areas with the most urgent conservation needs.

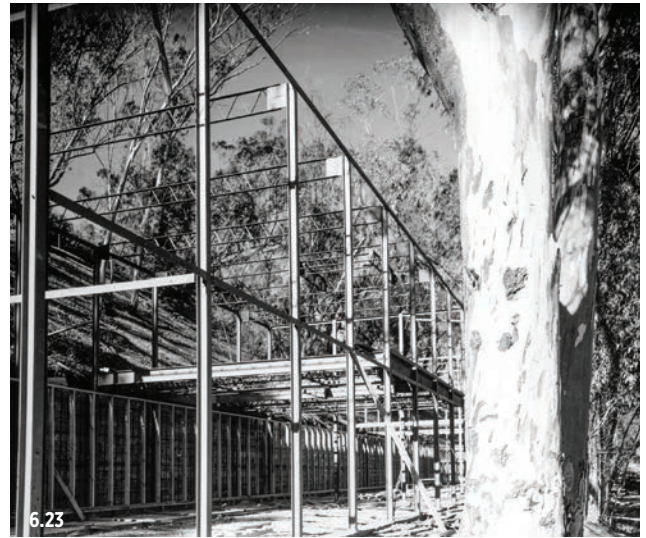
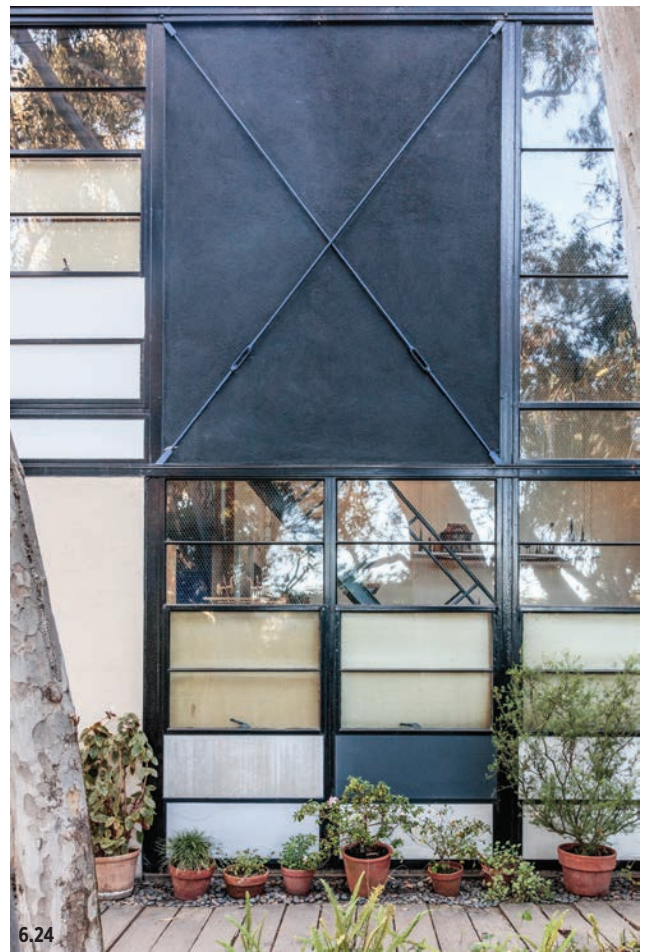
**Figure 6.23** The residence from the southeast during construction, ca. 1949, showing the steel frame and open web joists prior to installation of the roof deck and cladding materials. The modular character of the structure, regular spacing of the structural bays, and use of standard building components are evident.

**Figure 6.24** The studio's east elevation, showing detail of typical steel framing, 2017.

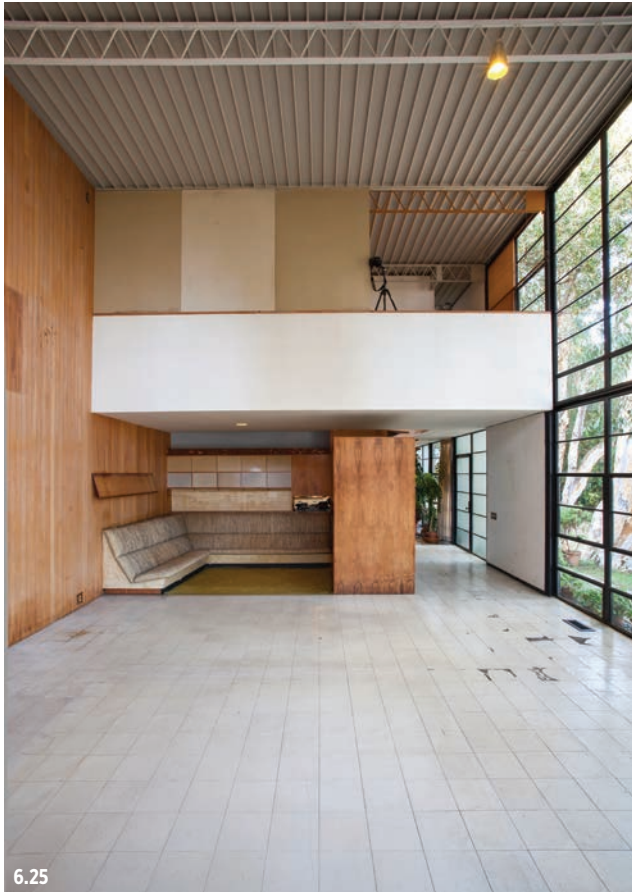
**Figure 6.25** Rare view of the living room in 2011, without its contents, prior to replacement of the floor tiles, showing how the Eameses used the modular nature of the steel structure to create diverse internal spaces.

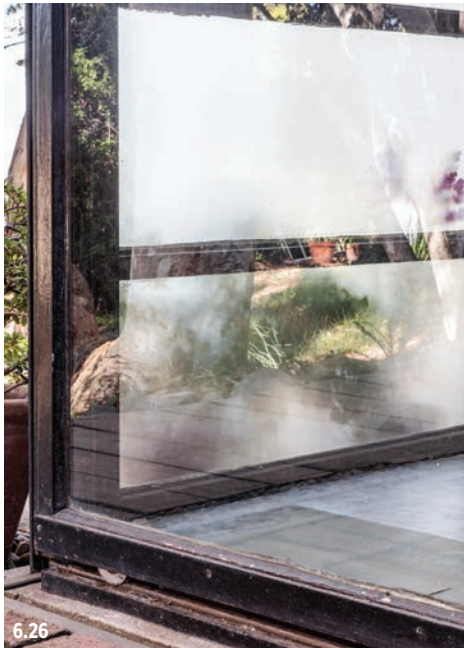
**Figure 6.26** Base plates and sliding door of the kitchen after repair in 2012, maintaining the integrity of the steelwork and restoring the watertightness of the facade. Photographed in 2017.

- Overall, the condition of the structural steelwork and current paint coating is relatively good, with much of the significant fabric having been preserved.
- Works to investigate condition of the external steelwork (2011) identified areas of significant rusting and associated deterioration, including bottom base plate and sliding door elements in a number of locations. Some urgent, high-priority repairs were carried out in 2012 to halt ongoing rusting in these locations and repair the most significant areas of damage (fig. 6.26).
- Elsewhere, there are numerous localized areas of minor deterioration (e.g., rust) or past repairs particularly in vulnerable areas, including horizontal surfaces, junctions between steel and concrete slab, worn surfaces, and fixtures such as sills and tracks for the doors and windows.

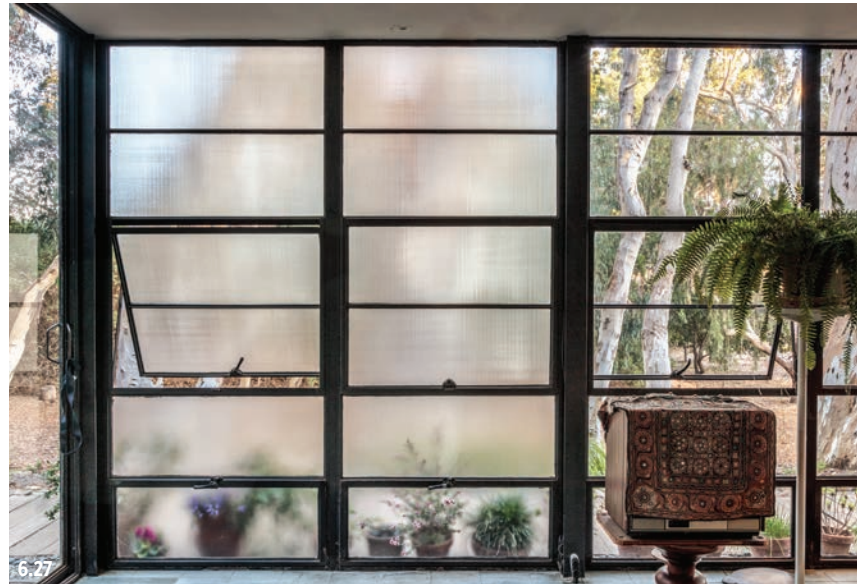
**Figure 6.27** View from the kitchen toward the meadow, 2017. The Truscon steel sash contains operable hopper and awning windows and fixed windows, glazed with either obscure or clear glass. At left is the sliding door.

- Original steel-framed door and window units are fitted within the structural steel framing. These include fixed and opening frames (e.g., awning, hopper, or louver windows, hinged doors, and sliding doors) (fig. 6.27).

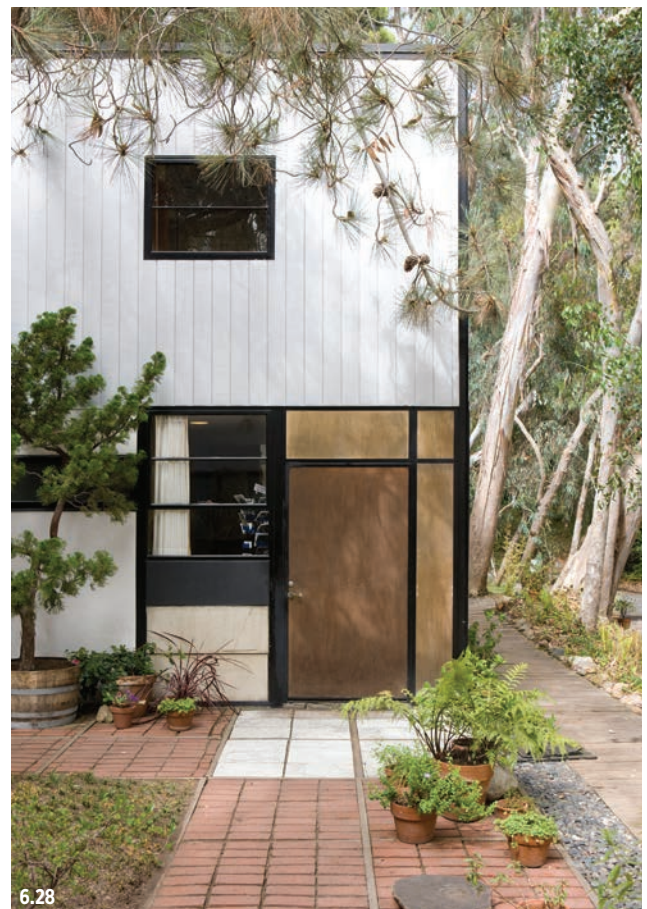
**Figure 6.28** South elevation of the studio, in 2016, showing the Eameses' complex selection of cladding materials. The second story is clad in silver-painted Truscon Ferrobord. On the ground floor, the door and its three surrounding panels are of plywood. To the left of the door, a panel of Truscon steel sash is filled with a mixture of Cemesto and clear glass.

- Most steel-framed windows and doors retain their original hardware, including sliding door tracks, hinges, stays, handles, and catches.
- External cladding elements have a variety of finishes and colors depending on the substrate and the Eameses' aesthetic choices (fig. 6.28). According to the Eames Foundation, the most recent repainting of the steel was undertaken in the mid-1990s.

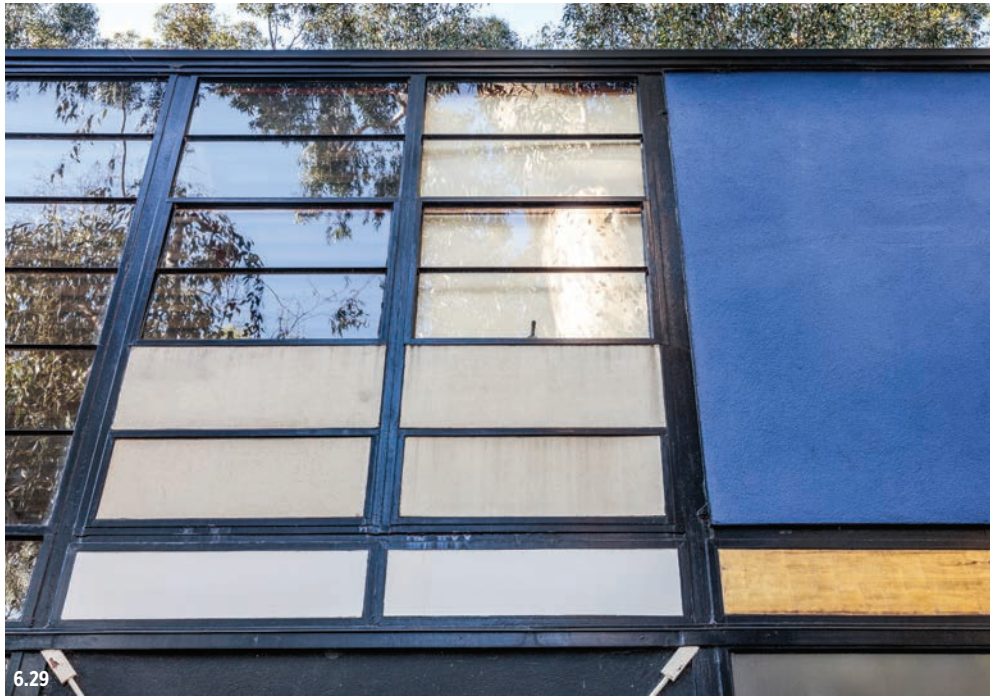
**Figure 6.29** East elevation of the residence, in 2017, infilled with a variety of cladding materials, including solid stucco panels and sections of Truscon steel-framed sash filled with clear glass and Cemesto panels. At lower right is the gold-leaf panel above the front door.

- The careful layout of large and small, solid and glazed infill panels—which vary in materials, color, and finishes—emphasizes the functional and decorative roles of the external cladding as non-weight-bearing infill within the dominant steel structural framing (fig. 6.29).

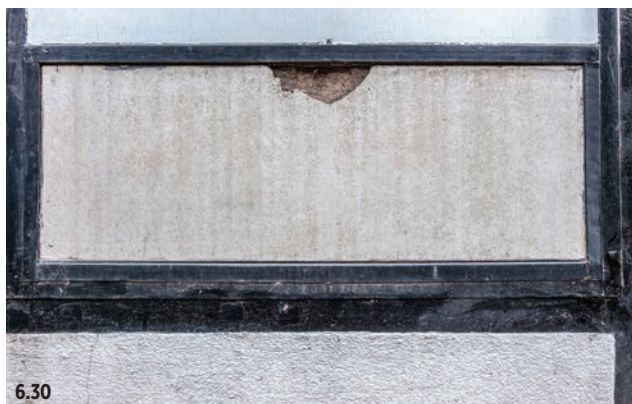
**Figure 6.30** Cemesto panel, studio west facade, 2017. Damaged and deteriorating original Cemesto panels, which contain asbestos, present potential safety hazards.

- Deterioration of original fabric, joints, and sealants, in addition to general wear and tear, has affected external fabric condition including watertightness.
- Environmental performance of the residence and studio is variable. The use of materials and construction techniques with low insulation values contributes to this condition.
- Extensive use of glazing has resulted in high levels of sunlight and heat penetration. Light was and currently is controlled with curtains over certain glazed areas.
- Asbestos-containing Cemesto panels may present a potential safety hazard to site users, particularly as elements deteriorate (fig. 6.30).

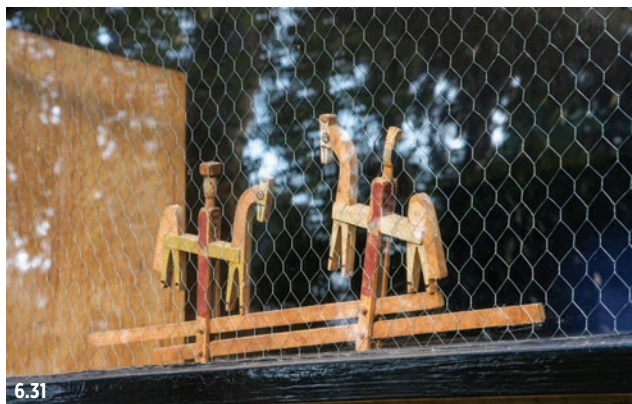
**Figure 6.31** Wire glass in a window of the studio, 2016. Some original building materials, such as wire glass and Cemesto panels, are difficult to source or are no longer available.

- Some original building materials, including wire glass and asbestos-cement (Cemesto) panels, are no longer available, and sourcing equivalent replacement materials may require research and investigation for long-term repair goals (fig. 6.31).
- Plywood panels and doors are particularly vulnerable to weathering from sun and water in exposed locations, particularly where finishes have weathered. The tallowwood wall is also vulnerable to sunlight and water, including splashing from hoses.
- The photo panel is vulnerable to the external environment and will soon be lost.

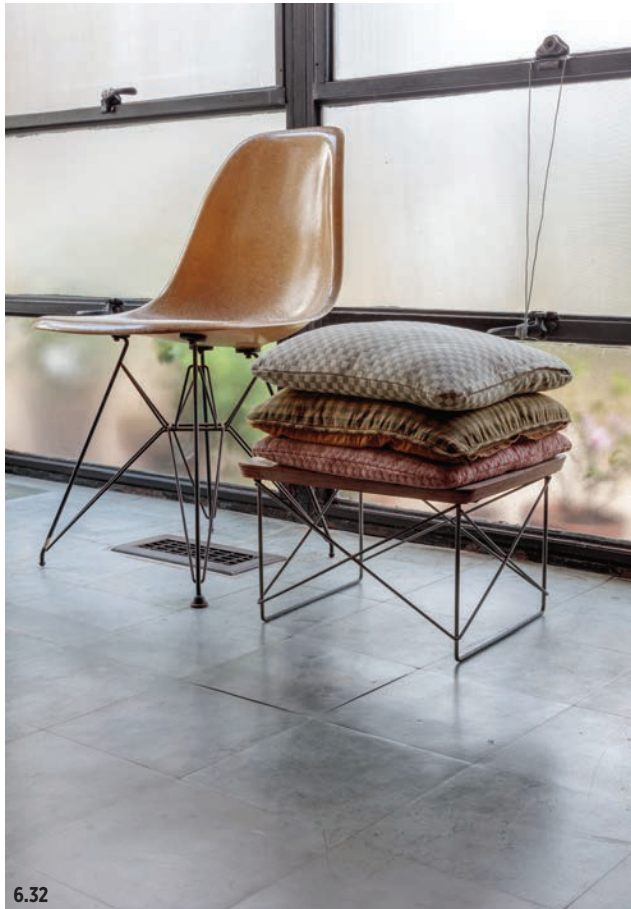
6.32

**Figure 6.32** View of the original Voit rubber tiles in the dining area, 2017. An original floor vent grille, part of the original underslab heating system, is visible under the chair. The kitchen and utility room floors are covered in the same tile.

- Reinforced concrete slabs to ground floors in the residence's kitchen, dining area, and utility room are finished with original rubber tiles (fig. 6.32). Upper floors in both structures were constructed on exposed, original steel framing and finished with rubber tiles (fig. 6.33).
- Residence floors in the living room and hallway, originally exposed concrete slab, were covered in white vinyl asbestos tiles in the early 1950s. Due to severe deterioration, these were removed in 2012 and replaced with modern, custom-made vinyl composition tiles matching the size and layout and closely matching the color of the 1950s flooring.
- Original exposed concrete slab in the studio was covered with wood parquet in 1958 (fig. 6.34).
- The living room alcove is the only carpeted floor surface.

**B6.4:** Consideration should be given to assessing the safety and condition of the original tiles in the kitchen and utility room. If damaged tiles need to be replaced with contemporary compatible tiles for safety, waterproofing, or other reasons, options for limiting the amount of original fabric removed should be considered, particularly in low-traffic areas. It is recommended that samples as well as in situ sections of original fabric be retained and interpreted as part of the overall conservation strategy.

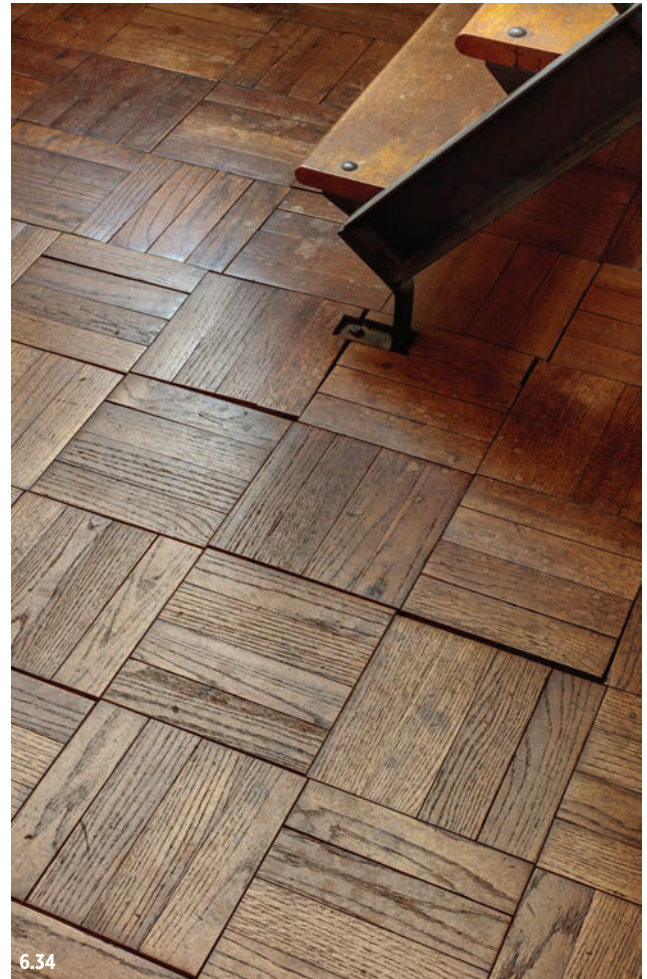
**Figure 6.34** Detail of the parquet flooring in the studio at the bottom of the spiral staircase, showing impact of wear and water damage, 2017.

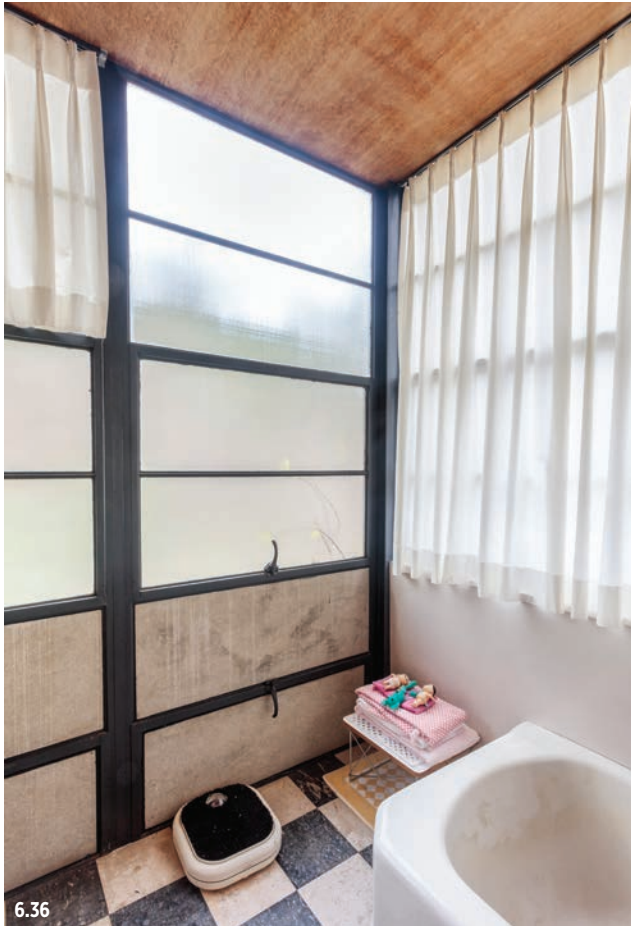
**Figure 6.36** Walls and ceiling of Ray's bathroom, in 2017, featuring a variety of materials, including Micarta plastic laminate, Cemesto panels, and translucent glass set in steel-framed sashes, and bird's-eye maple veneer (on the ceiling). Curtains screen the clear glass windows.

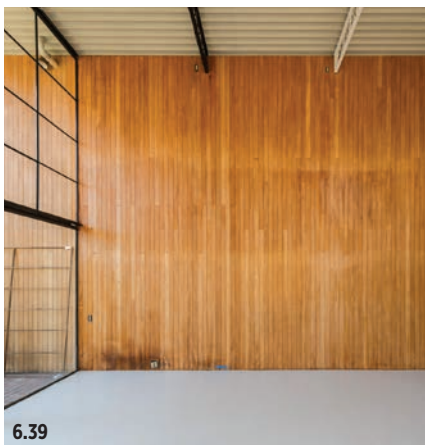
- Original internal walls and finishes vary in condition from good to poor according to location, use, and nature of material. Some areas were not accessible for inspection because of wall coverings, cupboards, storage, and other obstacles.
- Painted surfaces on wall coverings and steelwork, including trusses and decking, are generally good, with some elements repainted at different periods (and in different colors).
- Deterioration of original fabric, joints, and surfaces from age and wear and tear has affected surfaces in the past, as shown by documentary records (Escher GuneWardena Architecture 2011) and physical inspection.
- Tallowwood wall was cleaned and refinished in 2012. Traces of use and age remain (fig. 6.39).

**Figure 6.39** The tallowwood wall in the living room, cleaned and refinished in 2012, with the patina of use and age carefully retained.

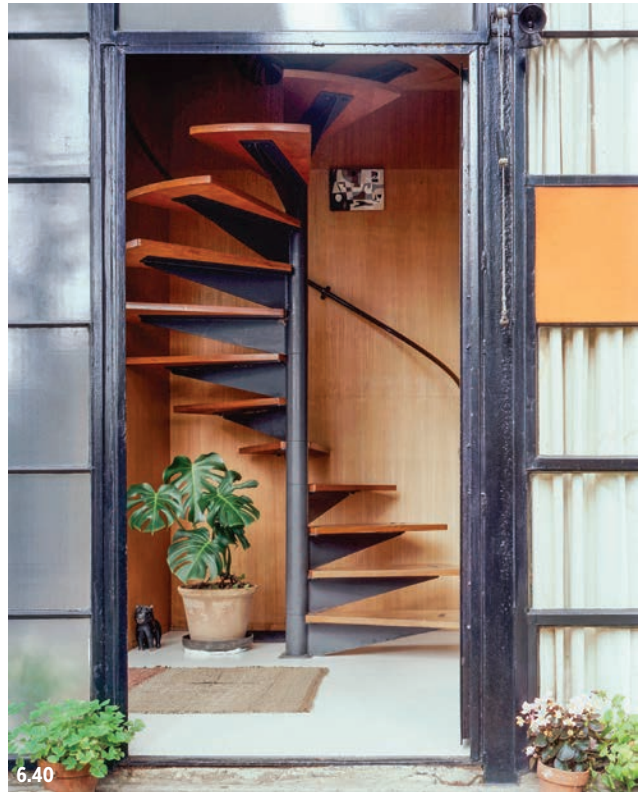
**Figure 6.40** The residence's spiral staircase, as seen through the open front door, 2014. Plywood treads are mounted on custom-made steel flanges that radiate from the central steel column.

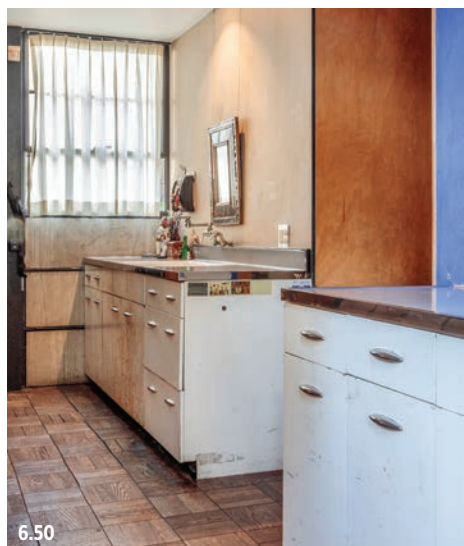
**Figure 6.50** Original prefabricated painted steel cabinets in the studio kitchenette, 2017. The cabinets show rusting of the steelwork caused by the breakdown of painted surfaces and exposure to damp. An ongoing rust removal and surface protection program will be developed.

**B10.4:** An ongoing program of rust removal and surface protection for the metal cabinets throughout the residence and studio should be developed and implemented. This should include appropriate methods to remove rust back to sound fabric, to treat with rust preventatives and reapply a finish coating to match the original detail, and to provide a waterproof seal over steel surfaces. Individual cabinet units may need to be removed and repaired off-site.

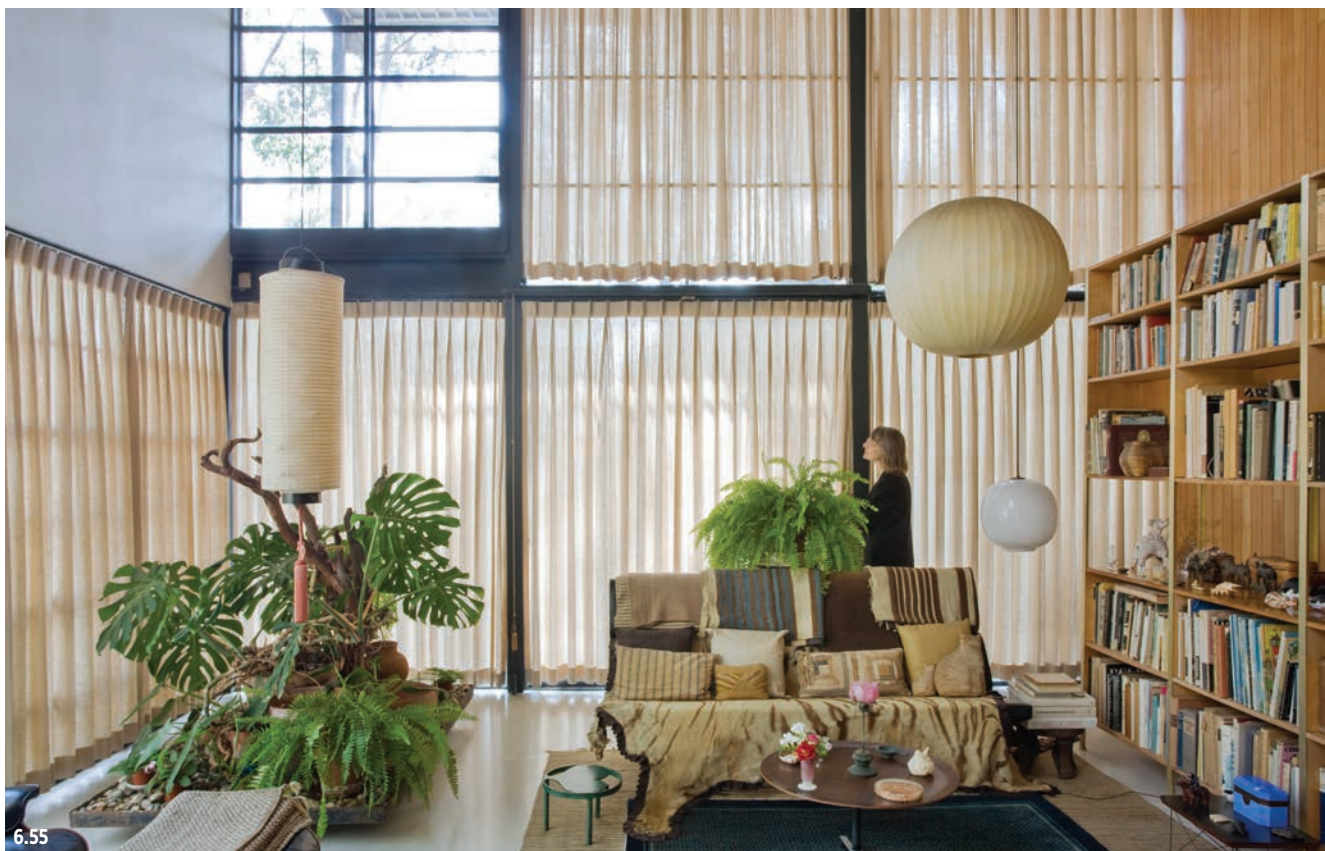
6.55

**Figure 6.55** The living room with draperies drawn to reduce light exposure, 2016. Retention of the collections and contents in situ is of significance, demonstrating a continuity of function and interpretation potential rarely equaled in modern house museums, but exposes the collection to agents of deterioration. Preventive conservation measures, such as the use of curtains here, are required to minimize damage.

- Replacement objects are not adequately identified.
- Agents of deterioration, which include visible and UV light damage, water and water damage, elevated interior temperature, humidity, mold, airborne dust, and pest intrusion (fig. 6.55).

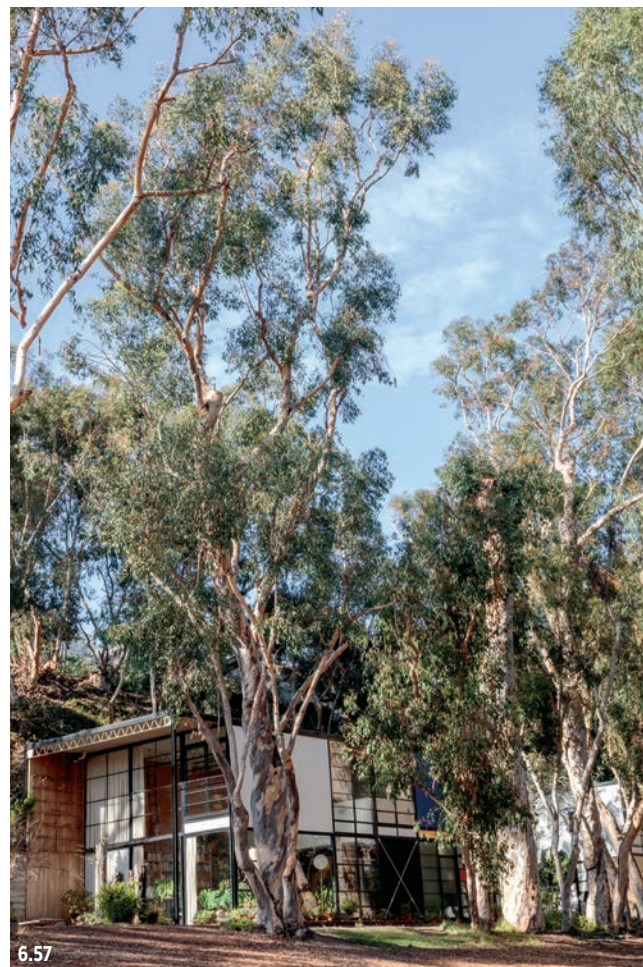
- An arborist report from 2014 indicates that based on the SULE (safe useful life expectancy) classification system, the condition of the trees in the row varies. Five trees have been identified as hazardous and their removal is recommended (Carlberg Associates forthcoming). Others are in adequate to good condition with variable remaining lifespans, girths, and foliage loads.
- The increased girth and size of trees partially obscures significant views toward and from the building complex. This condition affects the aesthetics of the silhouette of the tree trunks against the building complex, as well as the play of light and shadow on the interiors of the building (fig. 6.57).
- Understory plantings appear to be healthy.

**Figure 6.57** The eucalyptus row, photographed in 2017. The row now dwarfs the building complex, obscuring views and altering the aesthetics of the site. Branch drop and leaf litter are significant visitor and building risks that must be managed. As the trees age, succession planting must be considered.

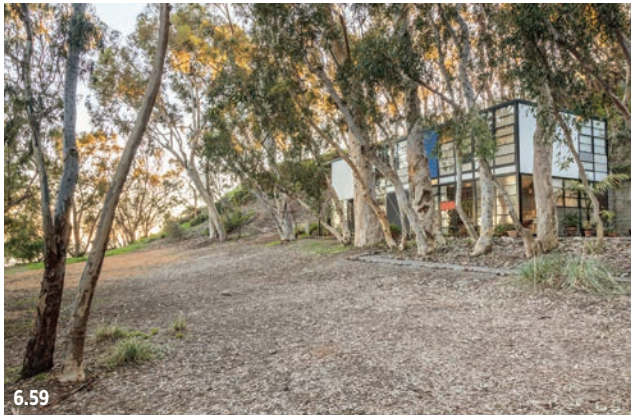
**Figure 6.59** The meadow in dry conditions, 2017. During drought years, the meadow is not sown and leaf litter is retained to reduce dust. Eucalyptus leaf litter needs to be carefully managed, as allopathic oil released by the leaves may suppress grass regrowth and is a potential fire hazard.

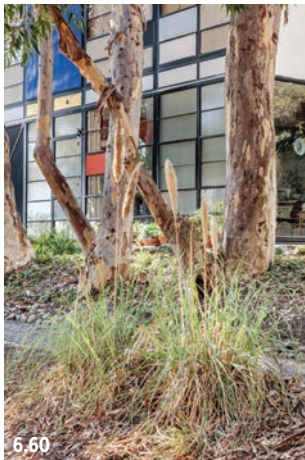
**Figure 6.60** Pampas grass in the meadow, 2017. Managing potentially invasive and flammable plants, such as pampas grass, jade, and plumbago, is an important component of landscape management.

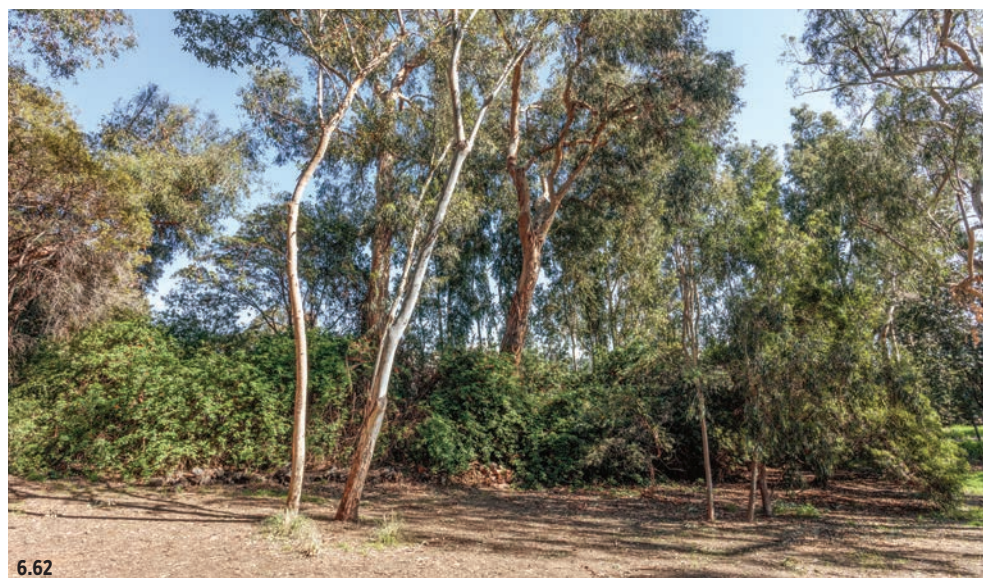
- The berm is now covered with a thicket and is no longer visible. Its structural condition is unknown. It is not known whether the original eucalyptus plantings are extant.

**Figure 6.62** View of the earthen berm from the Eames House, looking northeast, 2017. The berm itself is no longer visible, hidden beneath later plantings that provide privacy between the lots.

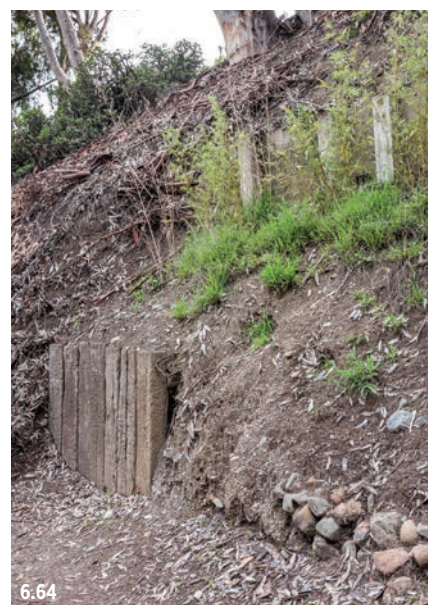
- There is recent evidence of mid-slope erosion above the planter box area of the south court, which has been stabilized with railroad ties and screened with bamboo (fig. 6.64). This is visually intrusive.
- The neighboring site above the upper slope has recently undergone extensive earthwork. There is concern that the sump, when full, may be causing additional pressure on slope stability. Additional water draining from the sump could cause further erosion.
- There are numerous eucalyptus trees across the upper slope (fig. 6.65). An arborist report in 2014 indicates that their

**Figure 6.64** Area of erosion southwest of the building complex on the upper slope, temporarily stabilized with railroad ties and partially screened with bamboo plantings, 2017.

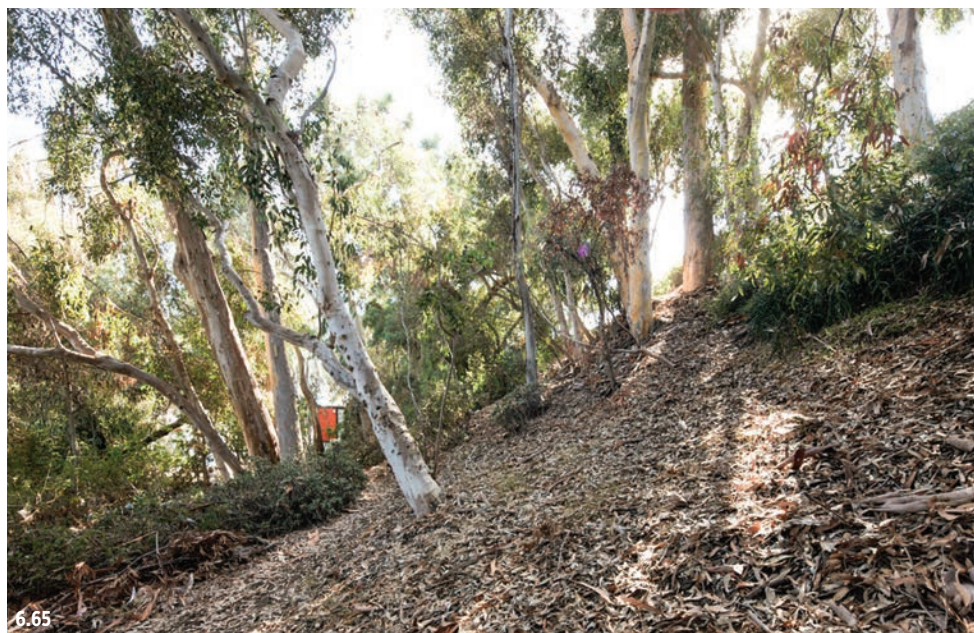
**Figure 6.65** The upper slope area north of the studio, self-seeded with eucalyptus trees and invasive exotic species, 2016.

condition varies. Seven have been identified as hazardous and a few are recommended for removal (Carlberg Associates forthcoming). Others are in adequate to good condition with variable remaining lifespans, girths, and foliage loads. A number of eucalyptus trees at the top of the slope were topped many years ago by neighbors. These and other topped trees around the site have since been restoratively pruned.

**L4.4:** Manage trees on upper slope to ensure their health and longevity. Remove hazardous trees and replace with appropriate species. When trees are removed, leave stumps in place for slope stability.

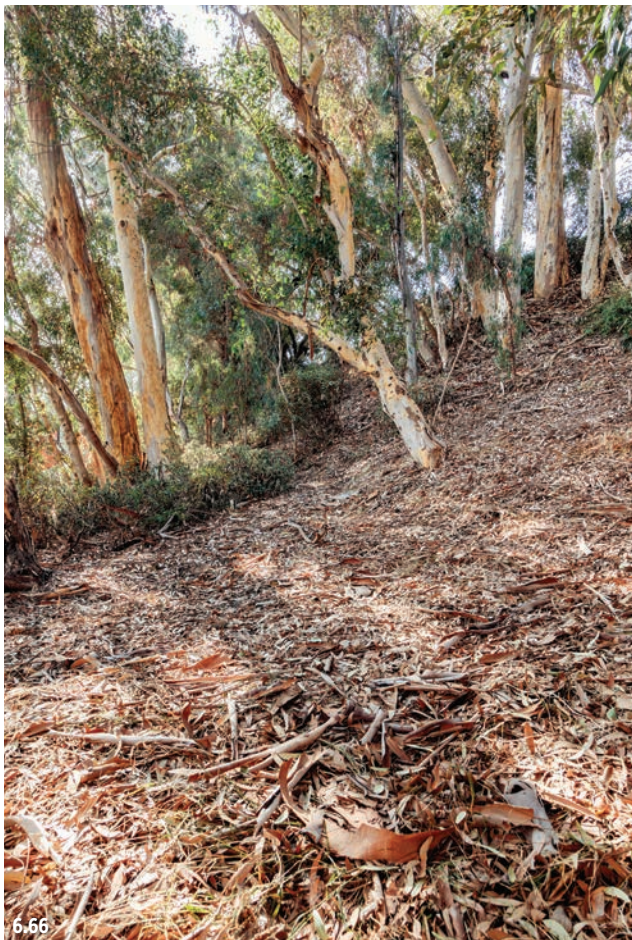
**Figure 6.66** The steep upper slope near the driveway entrance, with a heavy leaf litter load, 2017.

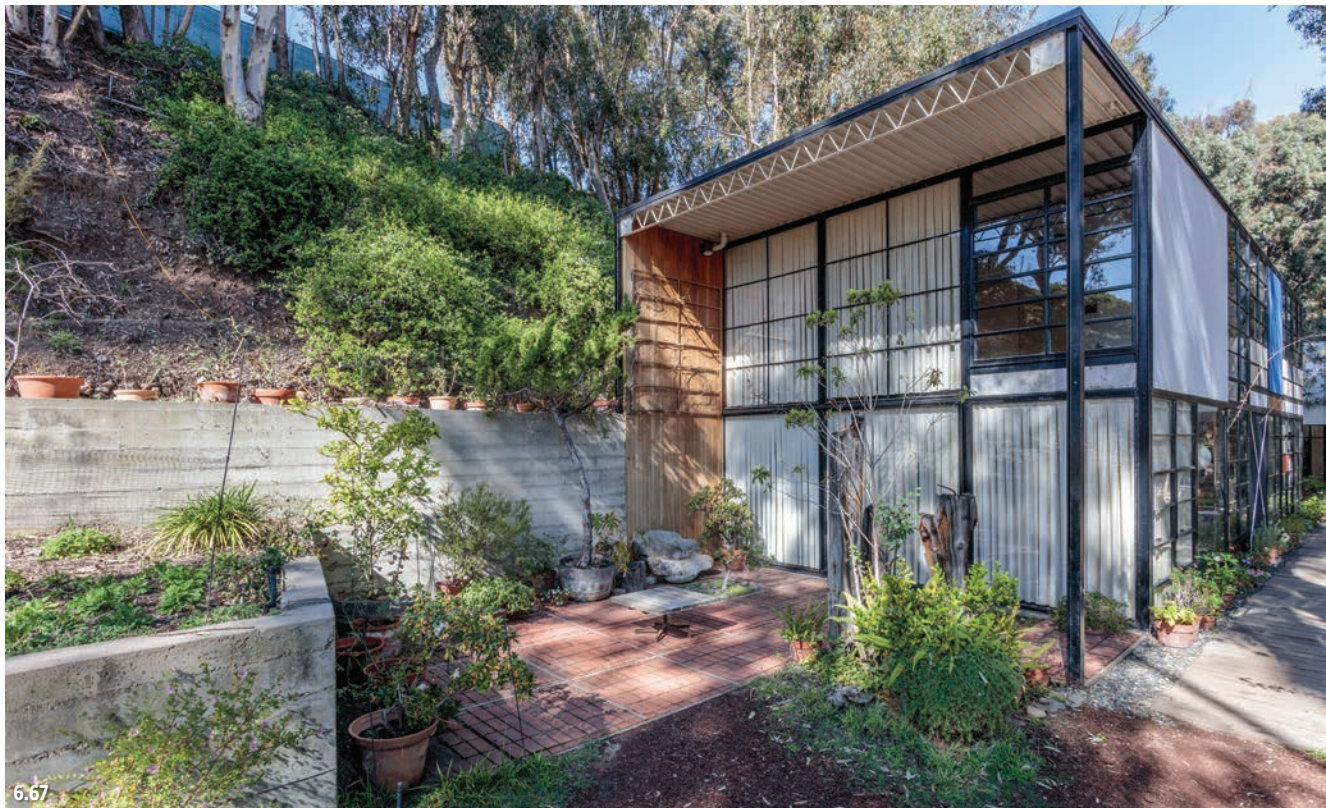
**Figure 6.67** The south court, covered by an extension of the residence roof, 2017. At left is the exposed concrete planter box where Ray grew fresh flowers. The persimmon tree, no longer extant, was planted here.

- > The south court is partially covered by an extension of the residence's roof. It contains an original sculpture constructed of pier pilings on a steel framework. A large, raised, exposed-concrete planter box abuts the retaining wall at the end of the south court (fig. 6.67). It is planted with perennial and annual flowers, which were sometimes used for interior bouquets, and held a persimmon tree (gifted by Eero Saarinen), which died in 2016.

**L5.9:** Maintain the integrity of the concrete planter box and repair as necessary with appropriate materials.

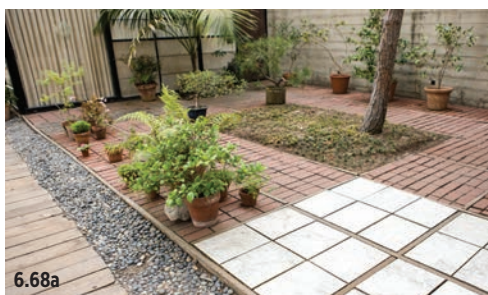
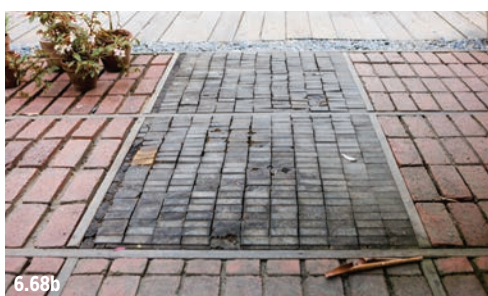
**Figure 6.68a** Central court, showing details of the pavement, 2016. The courtyards are paved in a variety of materials, much of it brick, arranged in a grid pattern formed by wooden strips. Marble pavers mark the entrance to the studio. A large, unpaved rectangle is visible at center. At left, the river rock border and wooden walkway run the length of the entire building complex.

**Figure 6.68b** Detail of wood block and brick pavers in the central court, 2016. Pavers are set between 2-inch-wide wooden strips laid in a grid.

- The three courtyards are paved in a variety of materials and patterns (figs. 6.68a and 6.68b).

- The built fabric and elements of these outdoor spaces is largely original and is in varied condition.
- The courtyard pavements do not provide adequate slope to shed water away from the buildings and retaining wall.
- Some of the plant materials are original, but most are not. They are generally in good condition.
- Deterioration of wood strips between pavers is noticeable in a number of areas, particularly where water accumulates (e.g., adjacent to building and retaining walls).
- The pier sculpture has suffered significant loss due to exposure to the elements and the now-discontinued practice of setting plants on it.
- The planter box appears to be in good condition.
- The carport canvas awning has been replaced several times as it has become worn (fig. 6.70).
- The unmortared blue wall appears to be in good condition, with light flaking of paint.

**L5.8:** Maintain pavers (e.g., wood blocks, marble, and brick) as a level, walkable surface and replace deteriorated elements with appropriate substitute materials.

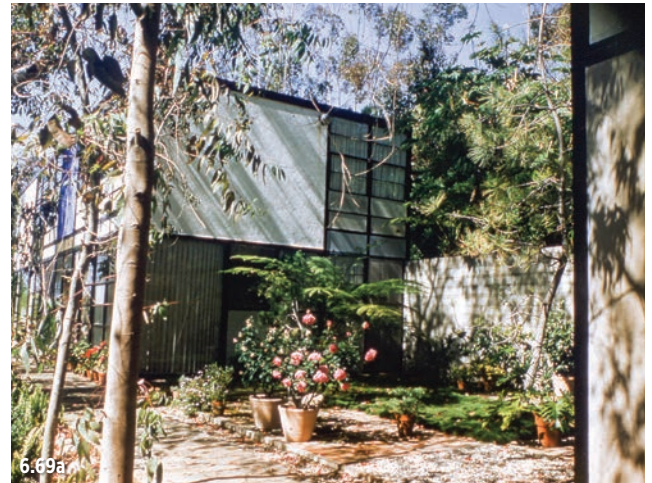
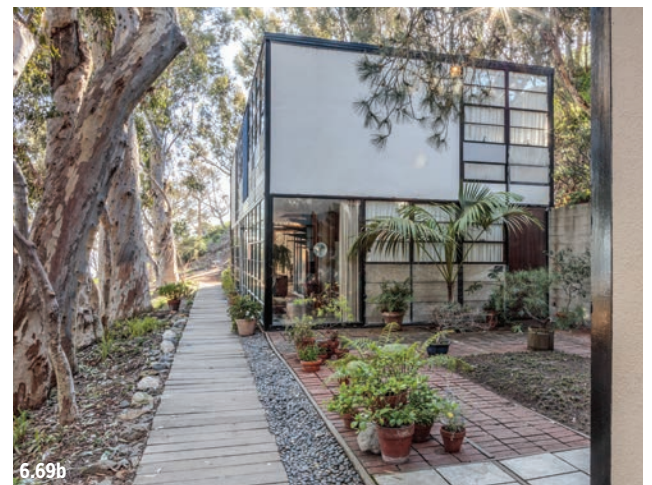
**Figures 6.69a and 6.69b** Views of the central court, in an undated photo (a) taken during the Eameses' occupation and in 2017 (b). All three courtyards served as outdoor rooms filled with plant and floral displays.

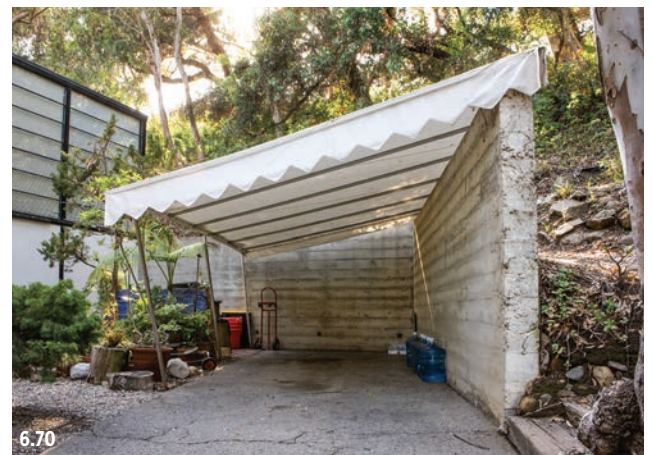
**Figure 6.70** The carport, a canvas awning suspended on a metal frame that is anchored to the north return of the retaining wall, 2016. Foot access is from the north court (left). In addition to providing paved and planted areas, the court is still used for storage and trash cans, as it was originally.

**L5.10:** Replace canvas carport awning as necessary, maintaining original design, materials, and types of knots.

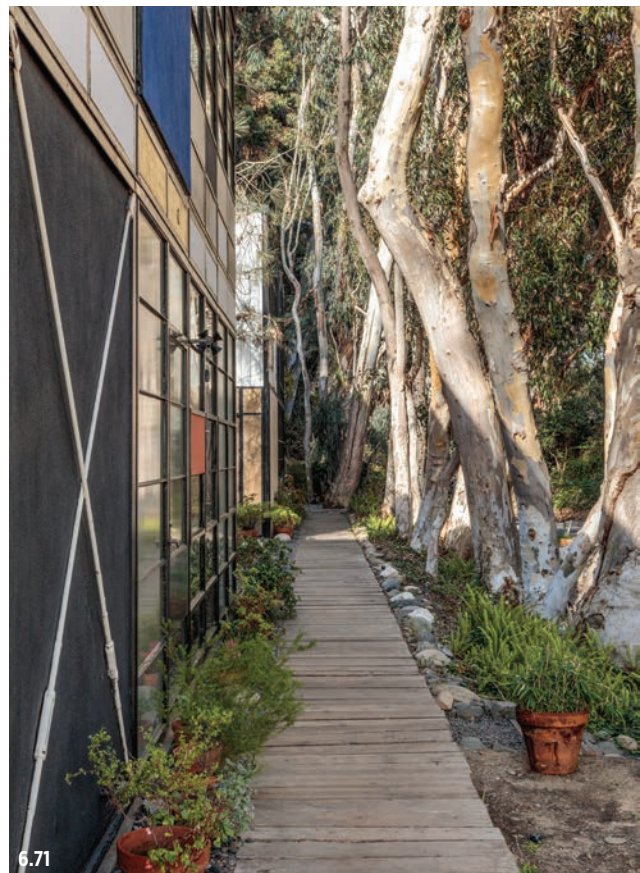
- The wooden walkway on the eastern side of the building complex, between the building and the row of eucalyptus, was originally laid with railroad ties in the early 1950s and replaced with shorter milled lumber circa 1989. The border between the walkway and building complex is covered in river rock and potted plants (fig. 6.71).

**Figure 6.71** The wooden walkway, looking north, running between the building complex and the eucalyptus row, 2017. On the building side, the walkway is lined with river rock and potted plants. The current wooden planks, installed after Ray's death, are narrower than the originals.

- The original railroad-tie wooden walkway was replaced in the late 1980s using lumber of a different dimension. Subsequently,

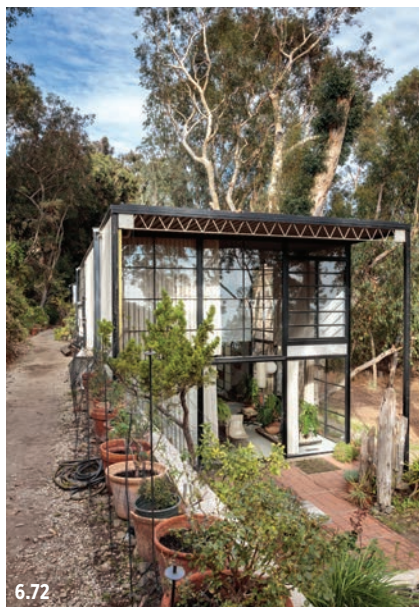
- The upper pathway on the western side of the building complex is covered in pebbles and compacted dirt and gravels (fig. 6.72). It serves as a back-of-house storage area for equipment and pots (fig. 6.73).

**Figure 6.72** The upper pathway, in 2017, west of the building complex above the retaining wall, surfaced with compacted dirt and gravels and lined with potted plants.

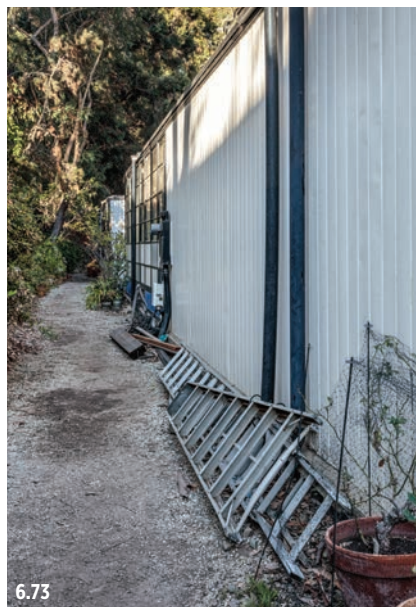
**Figure 6.73** The upper pathway behind the residence, 2017. This area is used for storage of ladders, pots, and equipment, and serves as a plant hospital. Continuation of this historical use must be balanced with current safety needs.

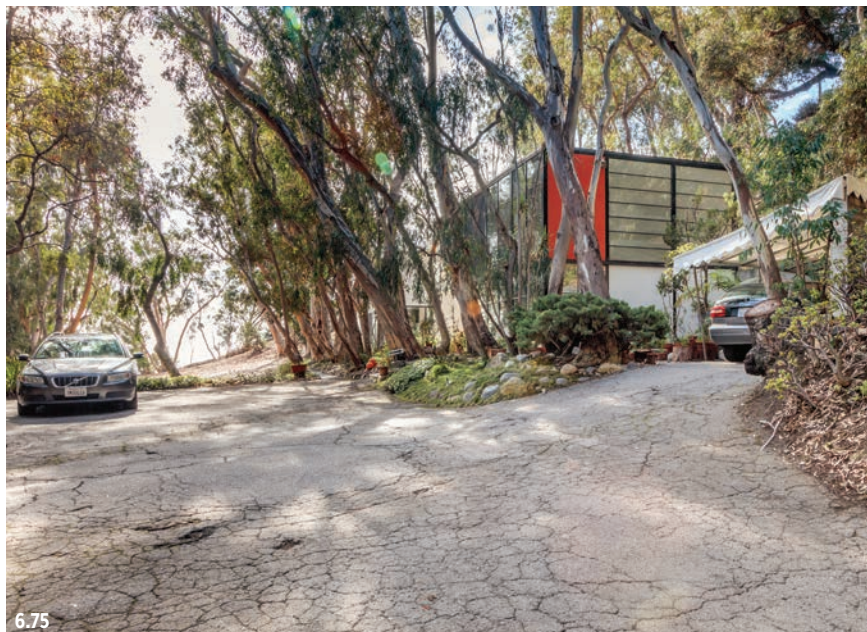
- Other minor pathways are covered in similar materials.
- Steps from the lower pathway to the wooden walkway in front of the residence's main entrance are constructed of board risers with gravel-topped treads (fig. 6.74). Similar steps lead from the lower pathway to the walkway on the eastern elevation of the studio.

**Figure 6.74** The lower pathway, in 2017, leading from the parking area across the meadow to the wooden walkway and the residence's front door. The steps are gravel surfaced and built of board risers.

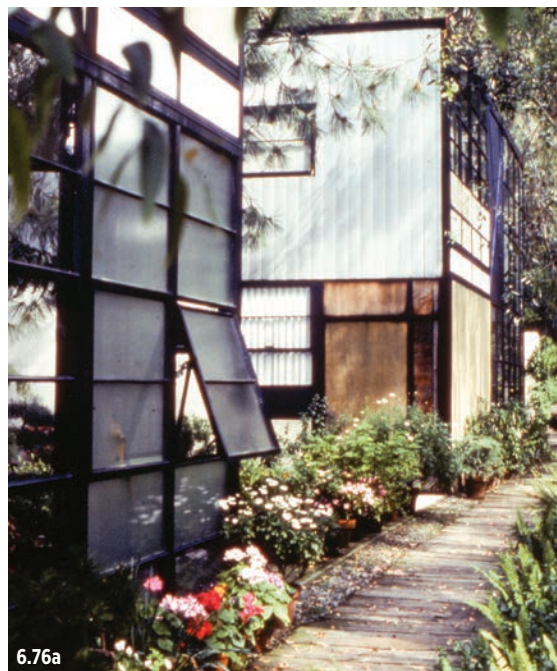
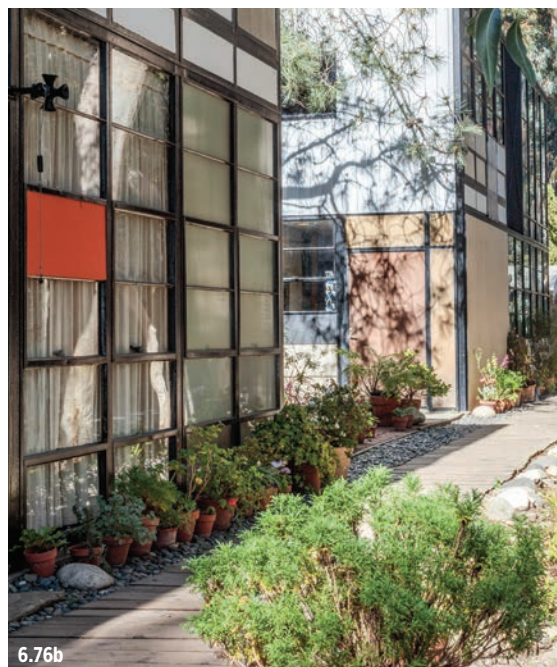
- Annuals and perennials in a variety of unglazed terracotta pots are located in courtyards and along pathways (figs. 6.76a and 6.76b).
- Various trees are planted in sawn whiskey barrels (fig. 6.77), which replaced the original sake barrels.
- An area alongside the upper pathway acts as a plant hospital and storage for pots.

**Figures 6.76a and 6.76b** Views of the east facade of the building, in an undated photo (a) taken during the Eameses' occupation and in 2017 (b), showing potted plants along the wooden walkway. Potted plants were frequently rearranged to provide color, texture, and detail.

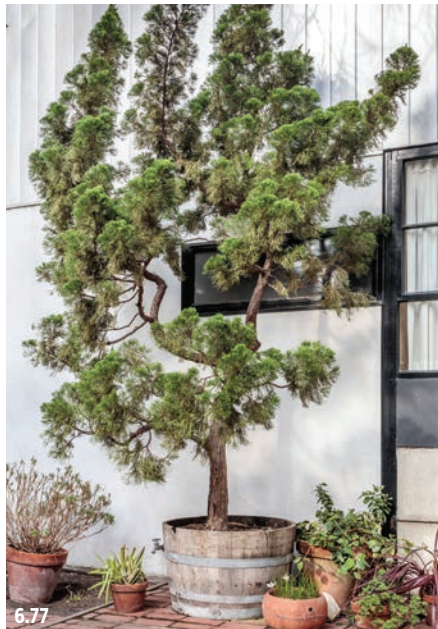
**Figure 6.77** Sawn whiskey barrels serving as planters, 2017. These have replaced the original sake barrels, which became difficult to source.

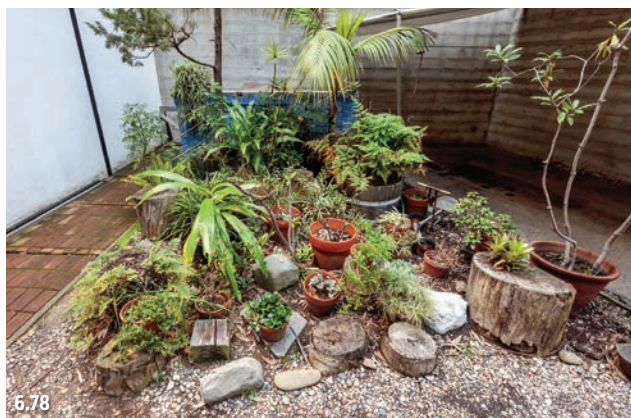
- A key element of landscaping the building complex, potted plants were used and rearranged to provide color, texture, and detail to the courtyards and edges of the buildings, as well as the interiors (fig. 6.78).

**Figure 6.78** An arrangement of potted plants in the north court, set among decorative stones and tree stumps on a bed of small river rock, 2017.
