Getty  
Conservation  
Institute

# Environmental Management at the Government Museum and Art Gallery, Chandigarh

## Analysis and Strategies

### Project Report

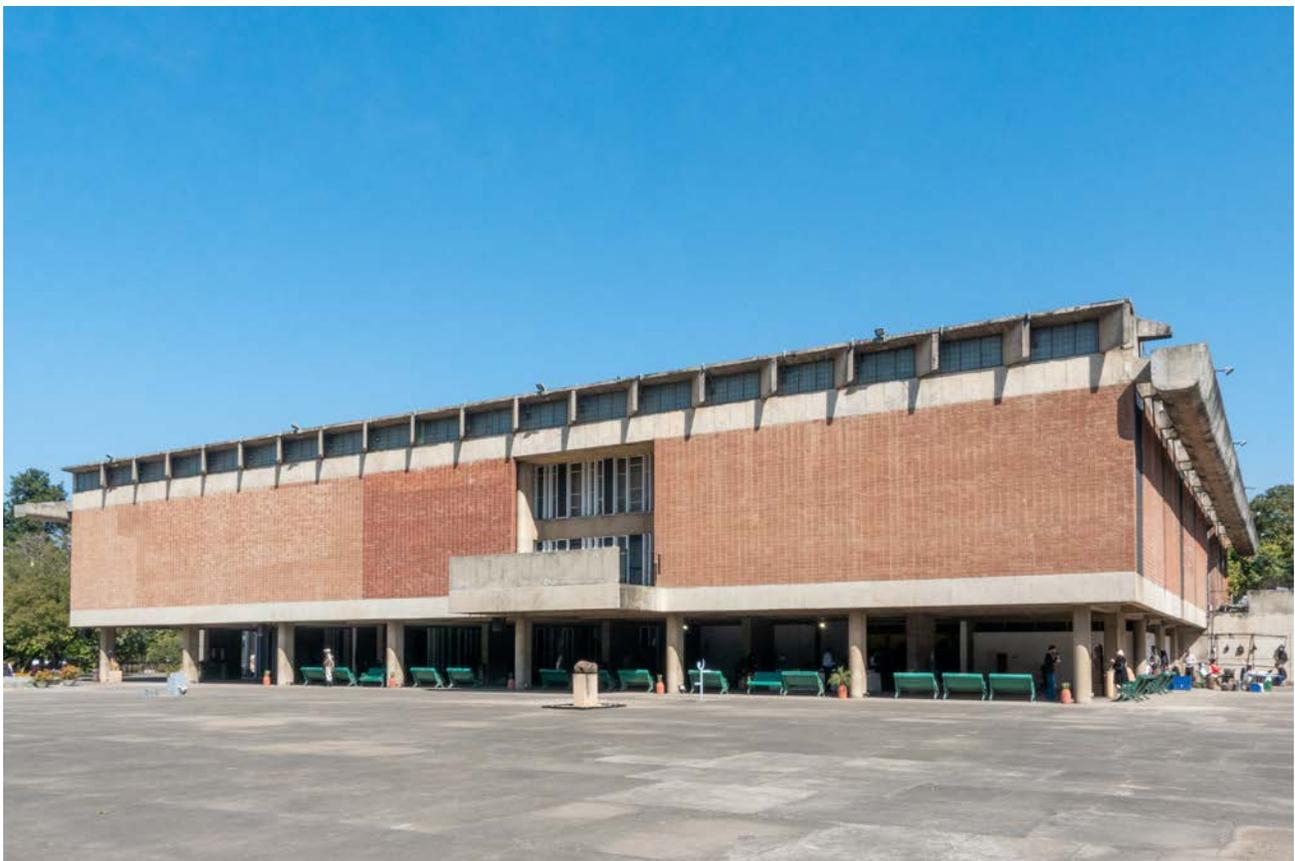
**FIGURE 0.1.**

*Southwest exterior view of the Government Museum and Art Gallery, showing pilotis at the ground floor, a mostly solid first floor and second floor, and rooftop clerestories with angled fins. © Fondation Le Corbusier. Photo: Ana Paula Arato Gonçalves, 2018, © J. Paul Getty Trust.*

The building that houses the Government Museum and Art Gallery is both an iconic work of modern architecture and a vessel to protect and display a significant and renowned collection of artworks (fig. 0.1). It has all the design elements that define Le Corbusier's modernist works and addresses the Indian climate. Le Corbusier familiarized himself with local annual temperature fluctuations, rainfall, and wind direction. Natural ventilation and natural lighting became key aspects of the building's design and are reflected in the form of the building (fig. 0.2). Raising the first floor of this reinforced concrete structure on pilotis allows breezes to enter through openings in the ground-floor walls. Vertical aerators located on all sides of the building's exterior provide cross-ventilation throughout the museum and gallery spaces, allowing for occupant-controlled natural conditioning of the interior (fig. 0.3). On each facade, large undulatory windows, which have fixed glazing occasionally alternating with aerators, let in direct sunlight (fig. 0.4). Rooftop clerestories, which cover the entire roof of the museum (fig. 0.5), bring in indirect light, while a series of angled baffles prevents direct sunlight from entering the building in the hottest months.

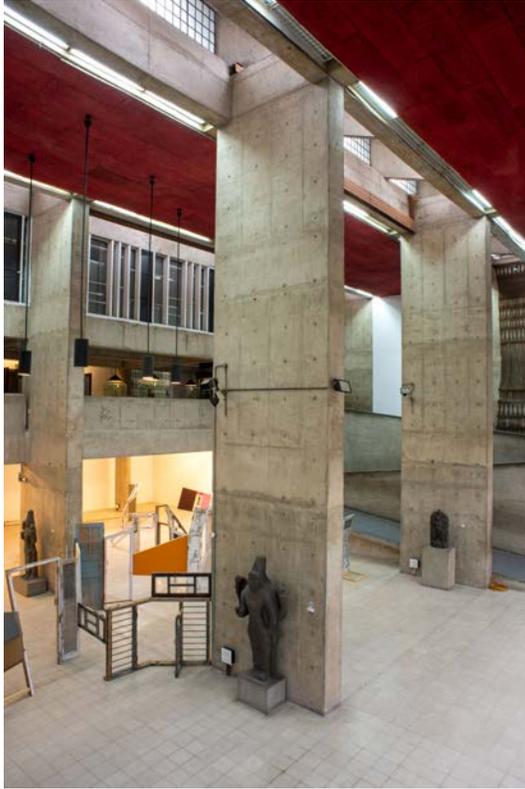
**FIGURE 0.2.**  
 The soaring Great Hall, three stories in height, is the museum's central core, with a ramp (background, right) connecting to the main gallery floor. Controlled natural daylight from the clerestories above brightens the space. © Fondation Le Corbusier. Photo: Tim Webster, 2020, © J. Paul Getty Trust.

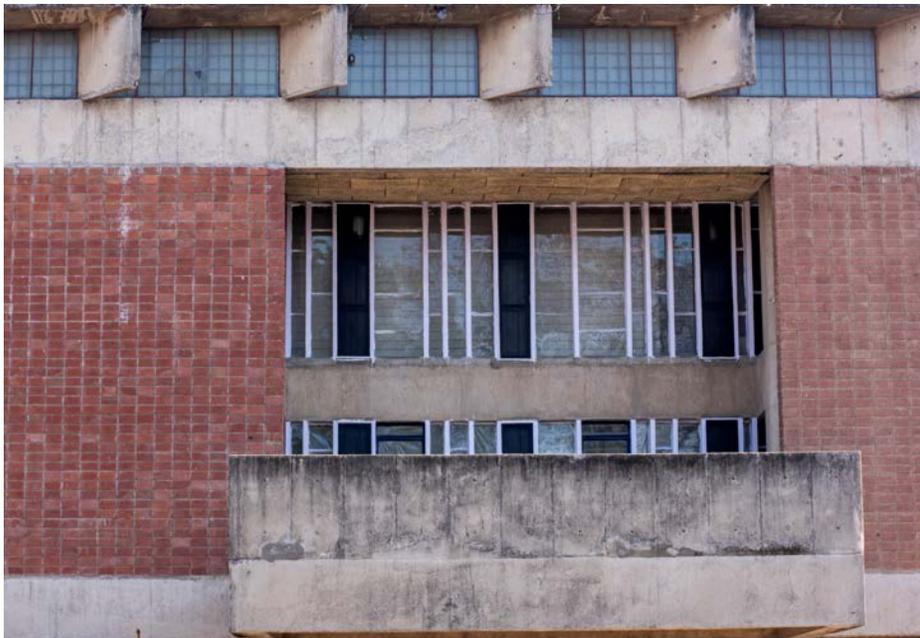
**FIGURE 0.4.**  
 Undulatory windows grouped on each side of the building admit light into the galleries at eye level and alternate with opaque aerators to allow ventilation. © Fondation Le Corbusier. Photo: Tim Webster, 2020, © J. Paul Getty Trust.

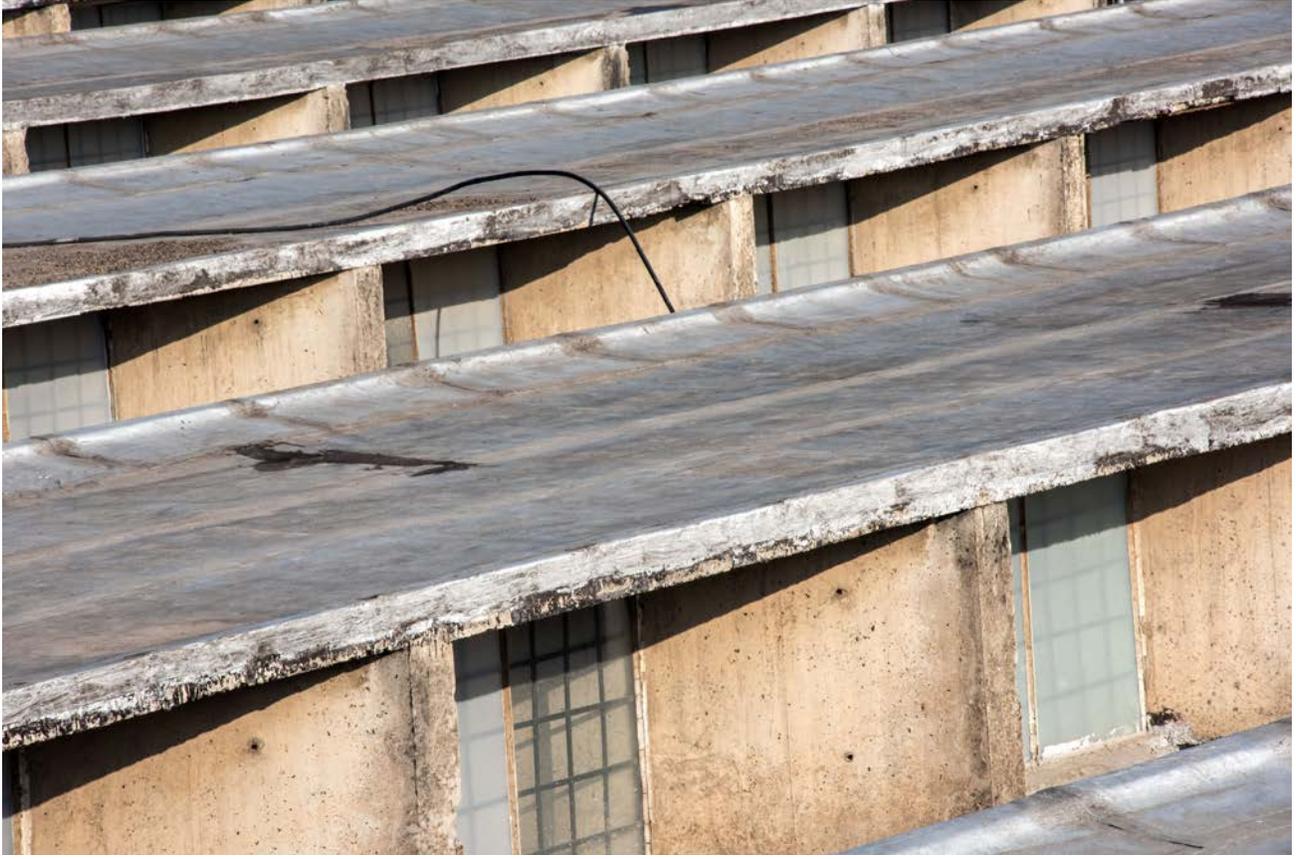
**FIGURE 0.5.**

*Eight parallel rows of clerestories fill the museum's rooftop. © Fondation Le Corbusier. Photo: Tim Webster, 2020, © J. Paul Getty Trust.*

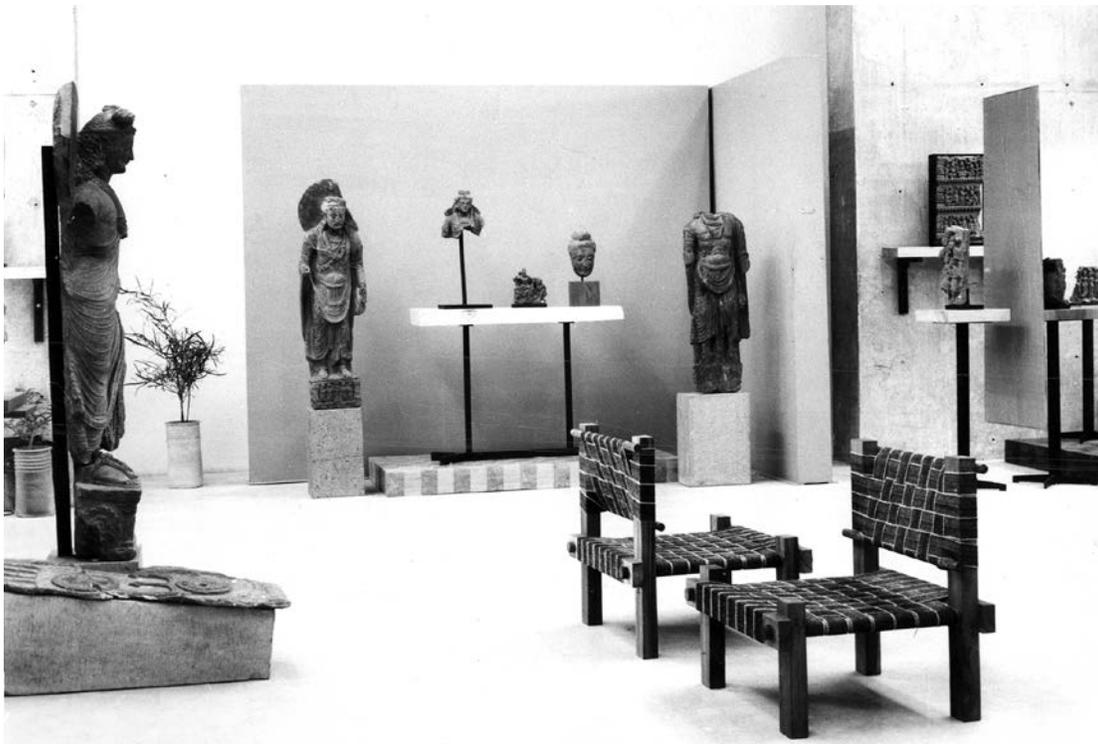
**FIGURE 0.9.**

Stone sculptures are displayed on steel and wood pedestals and stands, allowing viewers to experience the three-dimensionality of the forms. © Fondation Le Corbusier. Photo: Sagar Studio, 1968, © Government Museum and Art Gallery archive.

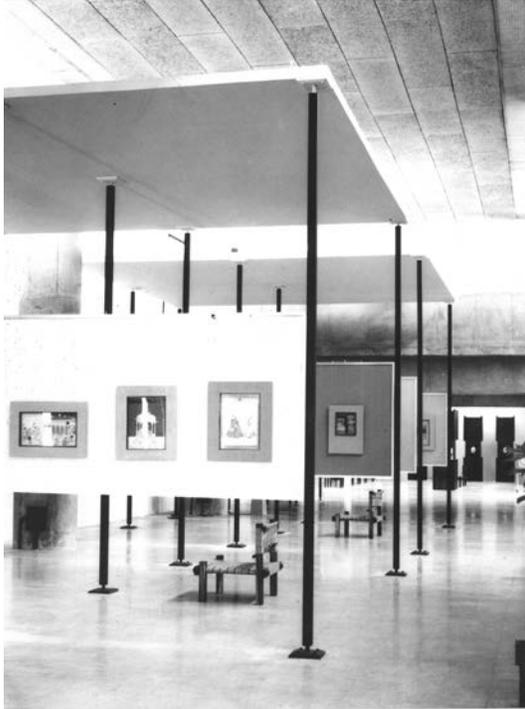
**FIGURE 0.10.**

Miniature art is displayed on freestanding panels, creating an intimate viewing space. The works are covered by a canopy that reflects uplighting while also providing protection from daylight entering from above. © Fondation Le Corbusier. Photo: Sagar Studio, 1968, © Government Museum and Art Gallery archive.

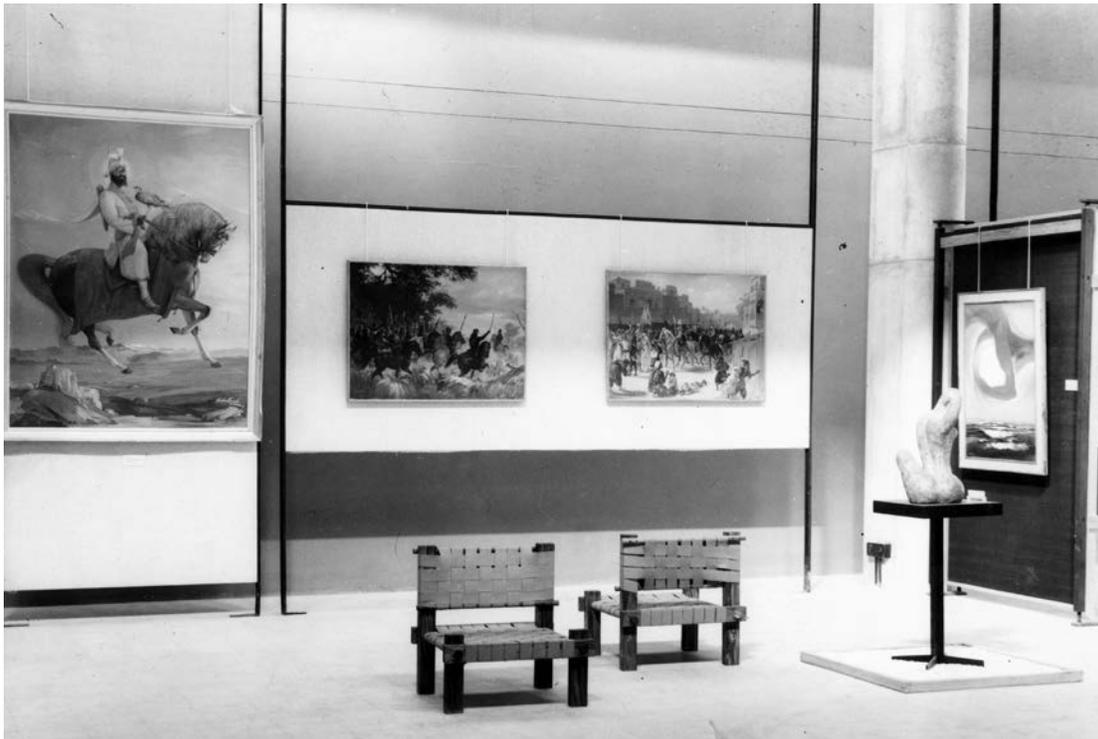
**FIGURE 0.11.**

Contemporary art is displayed on freestanding panels supported by metal stands that span from floor to ceiling. Mounting on panels instead of directly on masonry walls avoids moisture transfer from the walls to the paintings. © Fondation Le Corbusier. Photo: Sagar Studio, 1968, © Government Museum and Art Gallery archive.

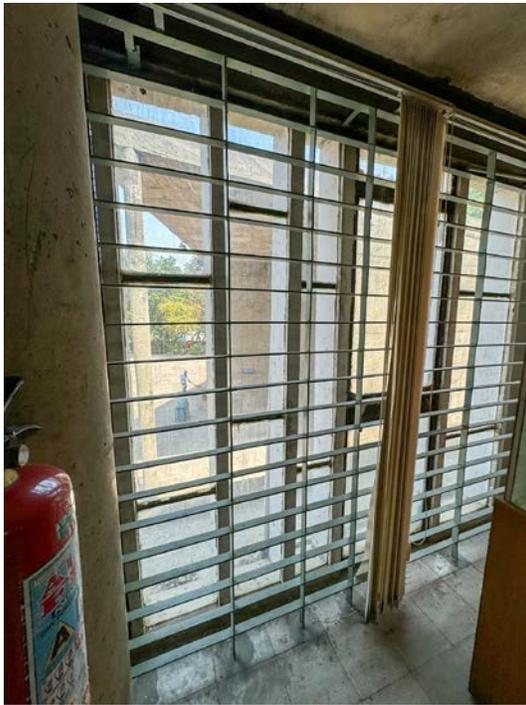
**FIGURE 0.12.**  
*Metal grates are installed in front of the undulatory windows in all galleries. © Fondation Le Corbusier. Photo: Chandler McCoy, 2024, © J. Paul Getty Trust.*

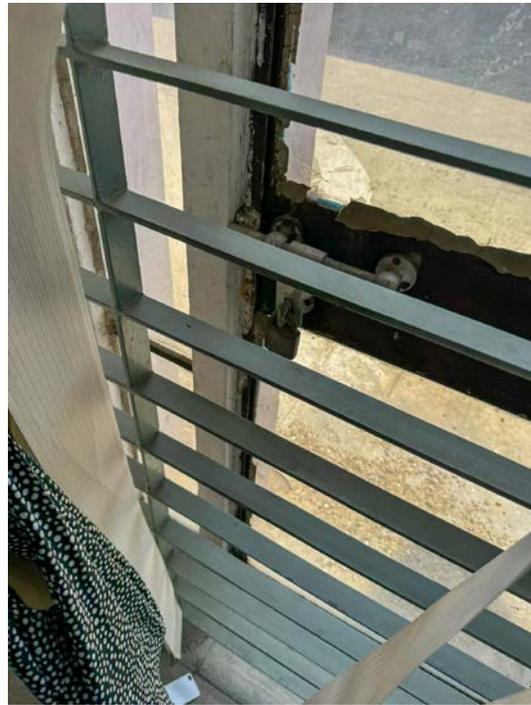
**FIGURE 0.13.**  
*Detail of a metal grate installed in front of an exterior balcony door. © Fondation Le Corbusier. Photo: Chandler McCoy, 2024, © J. Paul Getty Trust.*

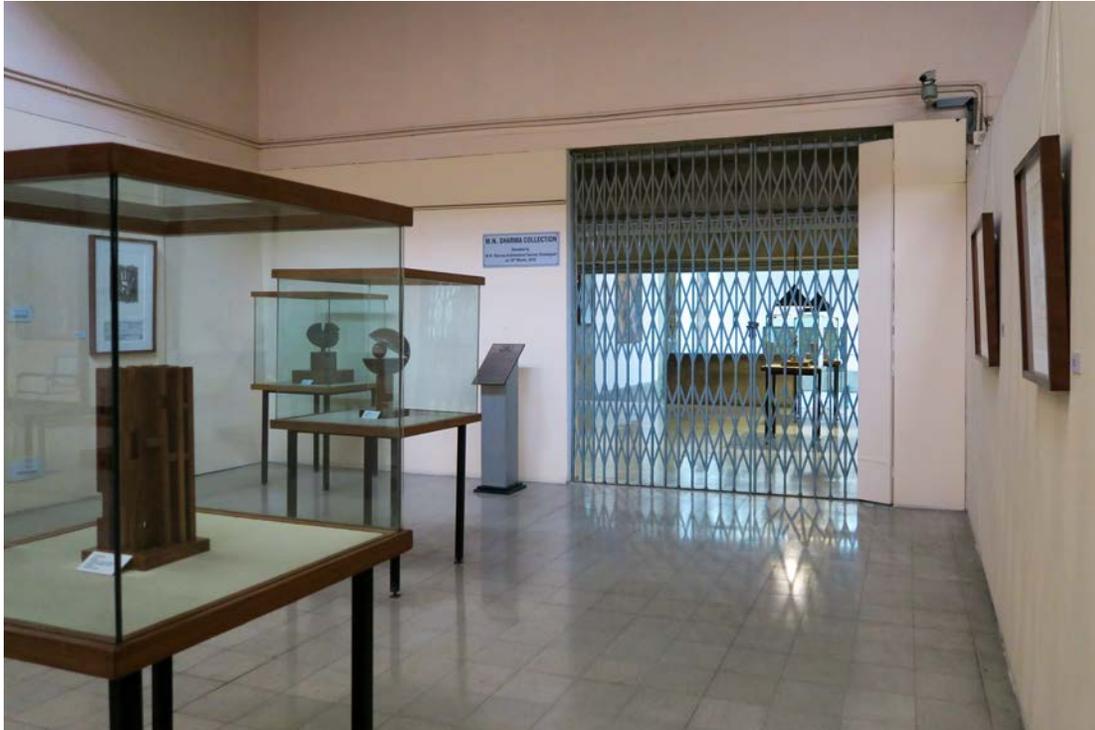
**FIGURE 0.14.**

*Metal grille installed in an interior opening to prevent passage between two galleries. © Fondation Le Corbusier. Photo: Foekje Boersma, 2017, © J. Paul Getty Trust.*

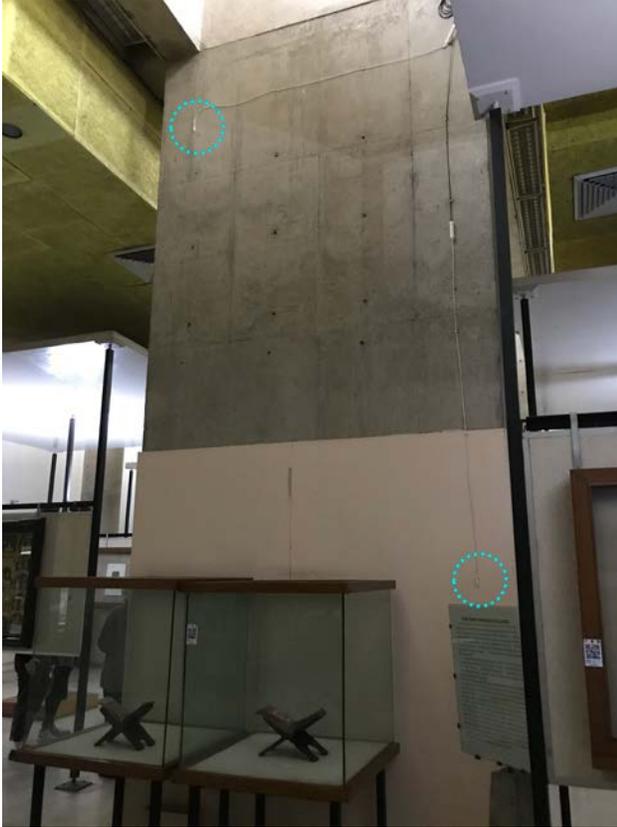
**FIGURE 0.15.**  
*Two sensors measuring temperature and relative humidity installed in the Miniatures Gallery at different heights (indicated by dotted circles). © Fondation Le Corbusier. Photo: Vincent Laudato Beltran, 2020, © J. Paul Getty Trust.*

This monitoring system was installed in late 2019, and data collection began in January 2020. Variations in interior and exterior conditions were recorded, including relative humidity, temperature, visible and UV light, and atmospheric pollutants in the air.

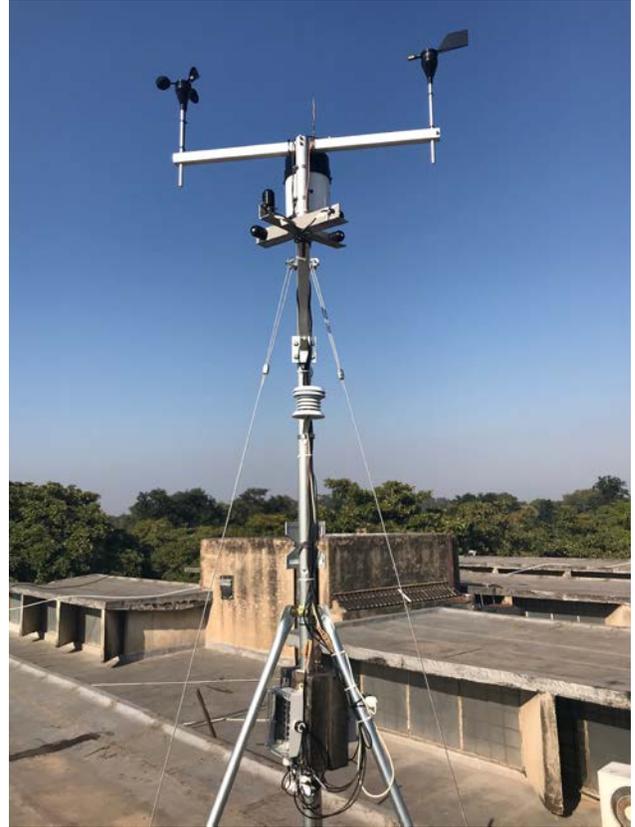
**FIGURE 0.16.**  
*Weather station mounted on the roof of the museum in 2020 for the collection of data on external weather conditions, including wind direction and wind speed. © Fondation Le Corbusier. Photo: Vincent Laudato Beltran, 2020, © J. Paul Getty Trust.*

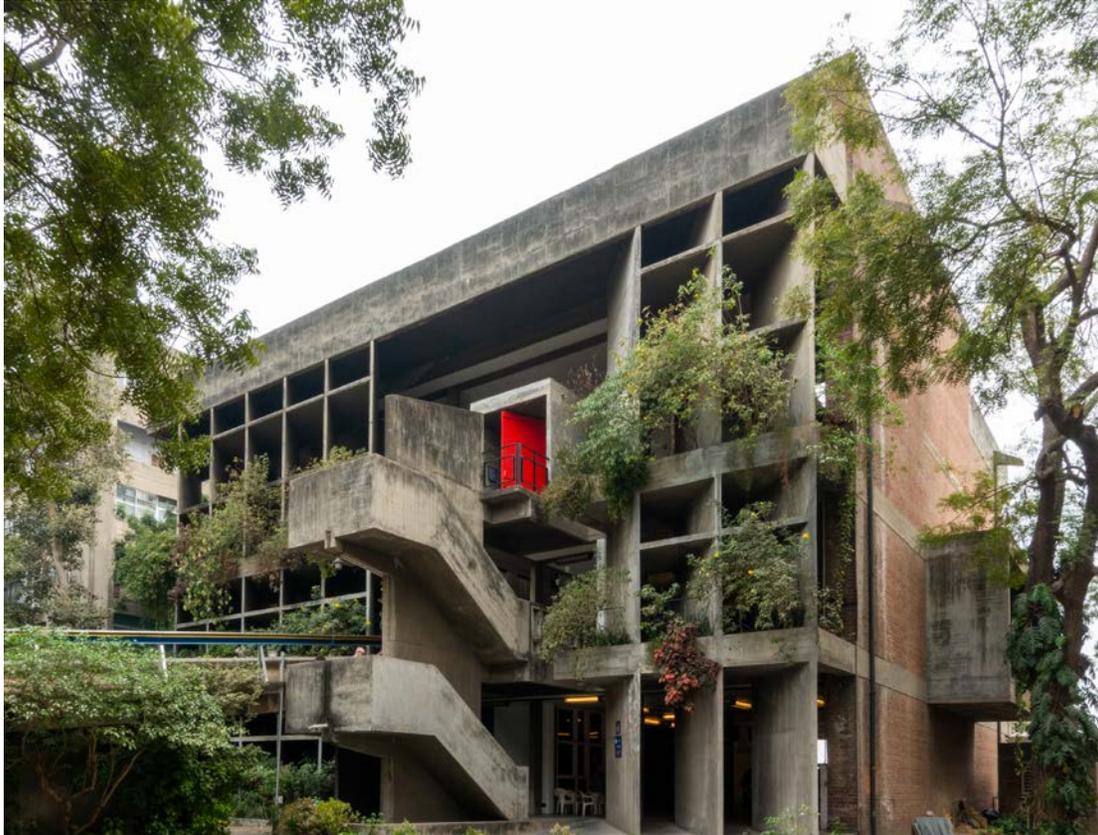
**FIGURE 2.2.**

*Mill Owners Association Building, Ahmedabad (1954), includes brise-soleils on both east and west elevations.*  
 © Fondation Le Corbusier. Photo: Ana Paula Arato Gonçalves, 2018, © J. Paul Getty Trust.

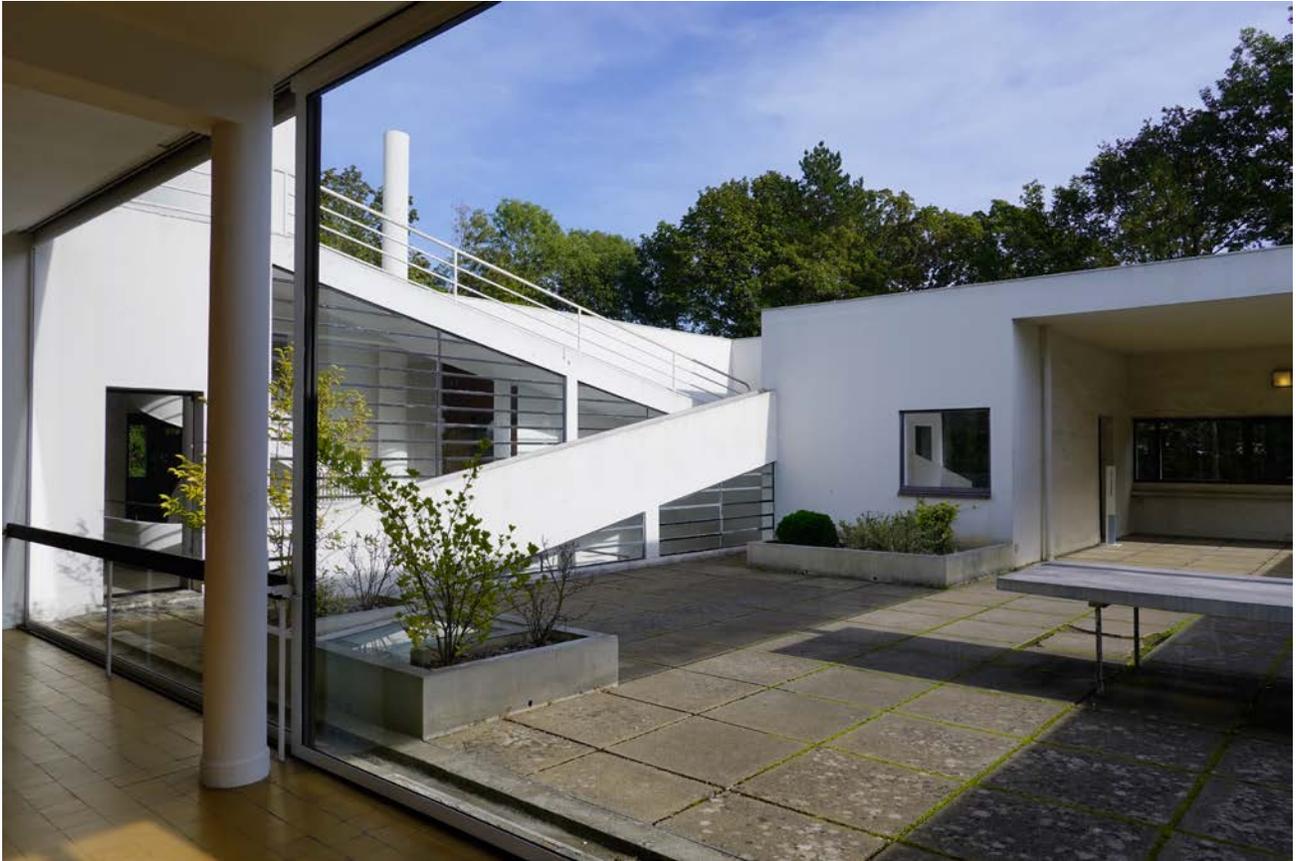
**FIGURE 2.5.**

*Villa Savoye, Poissy, France (1928–29), was designed to allow a maximum amount of daylight into the interior and provide direct access from the interior to the exterior courtyard and roof terrace. © Fondation Le Corbusier. Photo: Ana Paula Arato Gonçalves, 2023, © J. Paul Getty Trust.*

(1928–29), demonstrated his approach to architecture and its relationship to the physical environment through its white forms, slender pilotis, and horizontal ribbon windows (Curtis 2015, 98). The villa maximized the ingress of daylight with its wrapping steel casement windows. The semi-enclosed courtyard, elevated to the level of the main floor, was readily accessed and separated from the living spaces only by a steel-and-glass wall containing operable windows and doors, and its roof terrace further connected the occupants to the sun, views, and breezes (fig. 2.5).

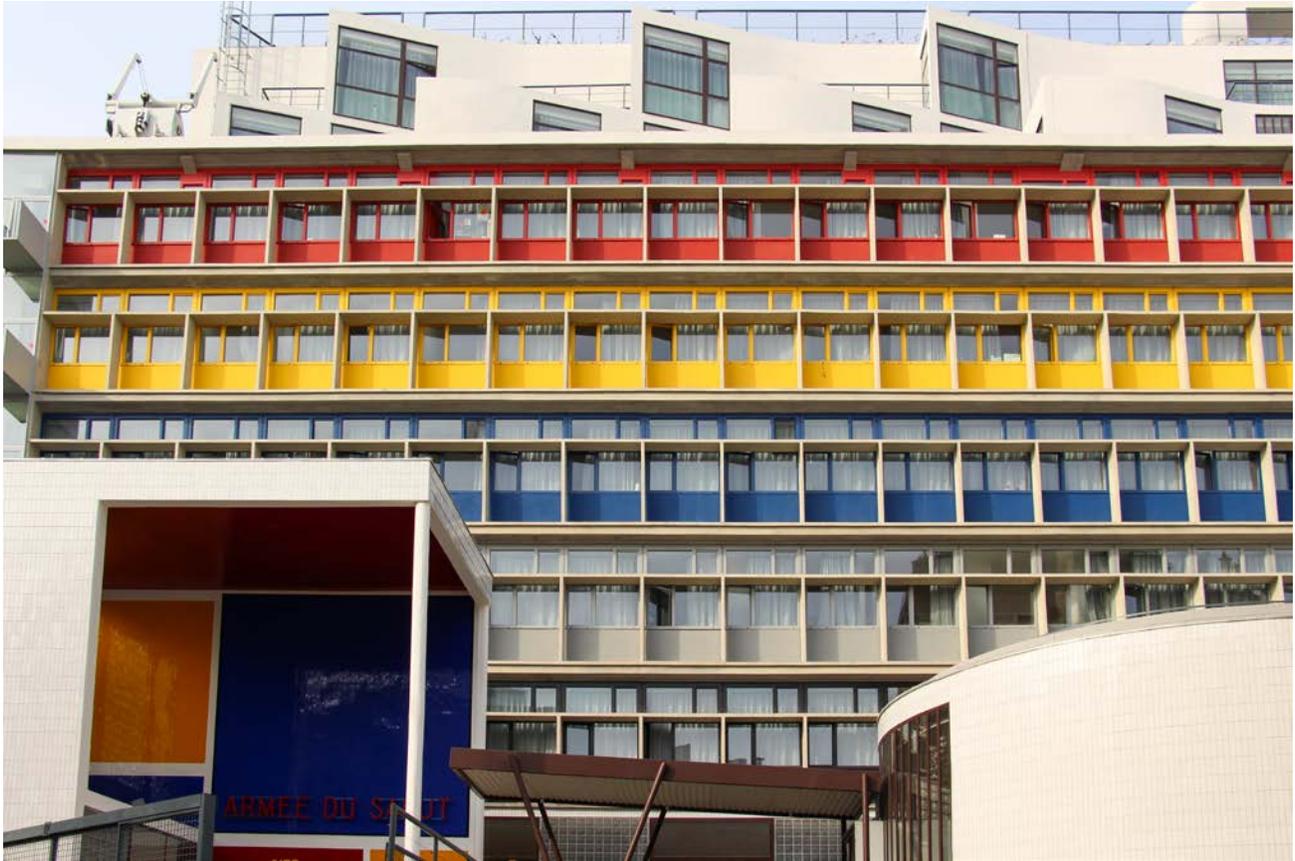
**FIGURE 2.6.**

*La Cité de Refuge, Paris (1929–33), originally featured a sealed metal-and-glass curtain wall on its south facade with mechanical ventilation. This system was not sufficient to provide thermal comfort to the building's occupants. After the structure suffered damage during World War II, a brise-soleil was added, as shown here. © Fondation Le Corbusier. Photo: Fred Romero, 2016, licensed under CC BY-SA 2.0 Generic.*

and automation systems available in 1929 were not advanced enough to produce the results Le Corbusier sought. After the original facade was destroyed during World War II, Le Corbusier was able to redesign it, this time with operable windows and an exterior shading device that later became one of his signature postwar design elements, the *brise-soleil* (Sobin 1996, 221).

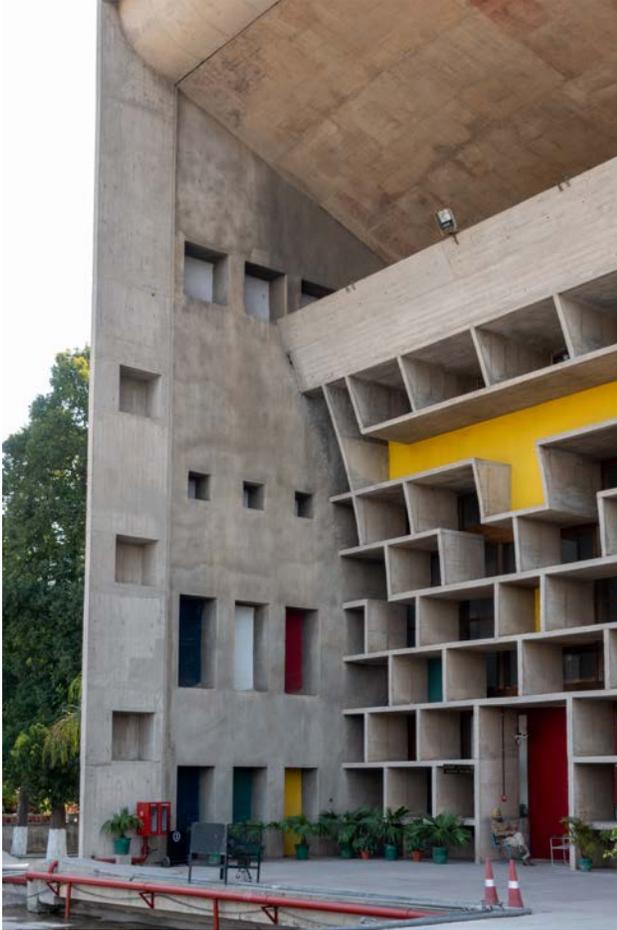
**FIGURE 2.7.**

*High Court of Justice, Chandigarh Capitol Complex (1951–54). Brise-soleils break the sun while operable vertical aerators allow air into the building. The massive roof, separated from the interior spaces, acts as a giant parasol to shade the spaces below. © Fondation Le Corbusier. Photo: Ana Paula Arato Gonçalves, 2018, © J. Paul Getty Trust.*

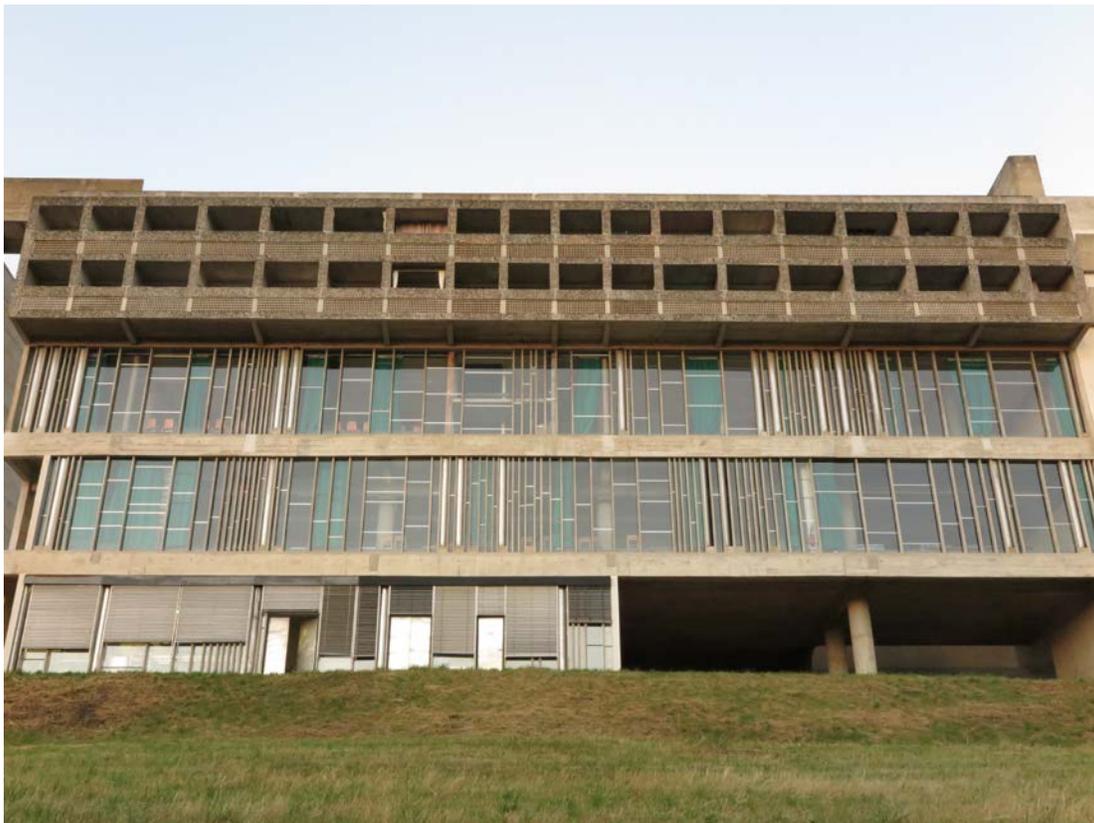
**FIGURE 2.9.** *Undulatory window walls with aerators are used throughout La Tourette monastery (1953–60). © Fondation Le Corbusier. Photo: Sara Lardinois, 2016, © J. Paul Getty Trust.*

Both the undulatory window wall and—for the first time—the aerodynamic aerator were used in Le Corbusier’s design for Sainte-Marie-de-la-Tourette Monastery, Eveux-sur-l’Arbresle, France (1953–60). The undulatory window wall, featuring vertical concrete elements, faces the monastery’s interior courtyard and parts of the outward-facing exterior walls (fig. 2.9). The aerodynamic aerators are incorporated into the undulatory window wall. These elements are used throughout La Tourette in such quantity that they are one of the monastery’s key design elements.

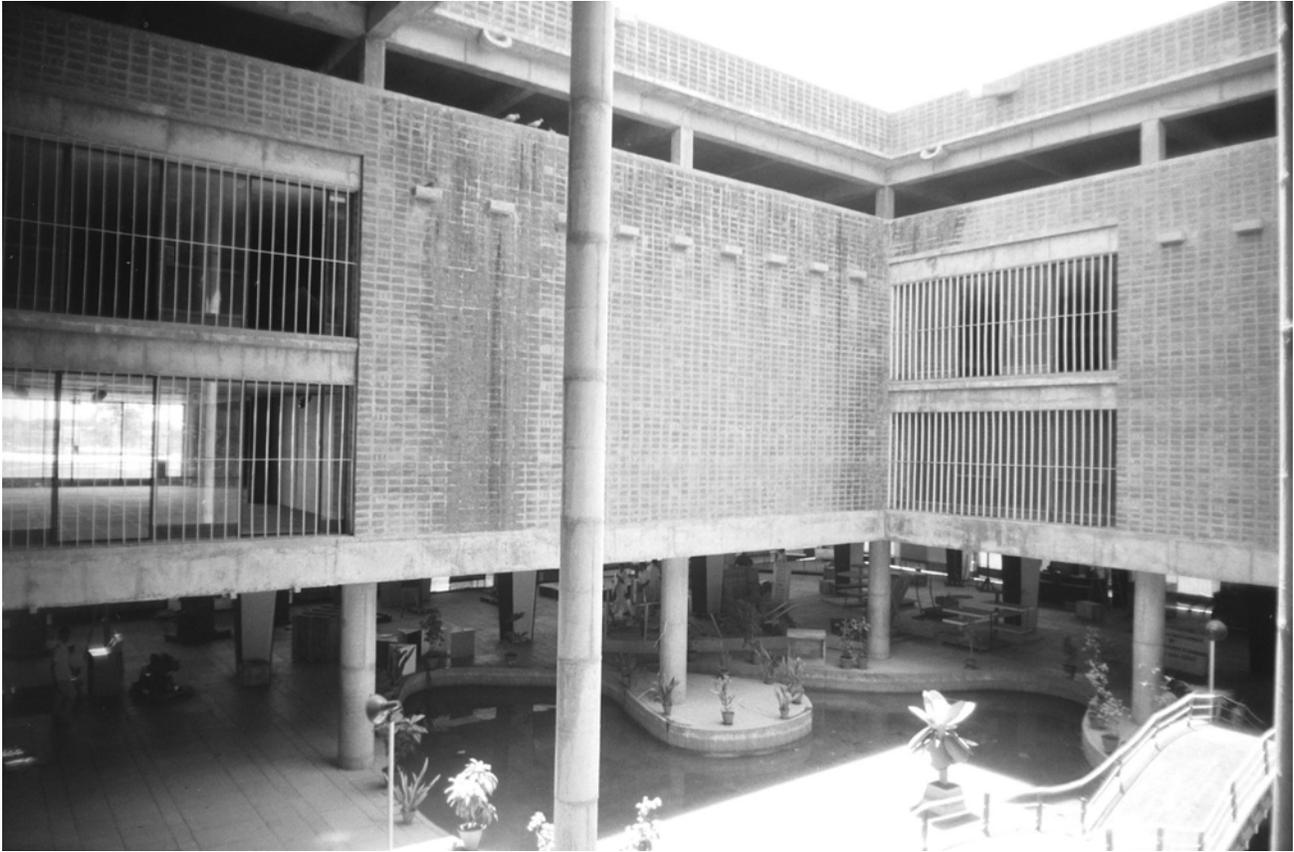
**FIGURE 2.11.**

*Sanskar Kendra, Ahmedabad, the first of Le Corbusier's three museums to be constructed, includes an open courtyard at its center. © Fondation Le Corbusier. Photo: Lucien Hervé, 1954–57, © J. Paul Getty Trust. Getty Research Institute, Los Angeles (2002.R.41).*

All three museums follow the same conceptual scheme and function in a similar way, but each is different in terms of its response to the local context and specific climate. For example, Ahmedabad, 950 km southwest of Chandigarh, has a hot, semiarid climate, and the Sanskar Kendra has a number of features to help keep the building cool during the long periods of heat in this region. The roof was originally designed to be covered with plant material, and the tall, ventilated attic story isolates the interior from extreme solar radiation. A roofless central atrium allows air to flow freely from below and up through the center of the building, encouraging both stack-effect ventilation and cross-ventilation (fig. 2.11). All three museums have a central atrium or Great Hall with different

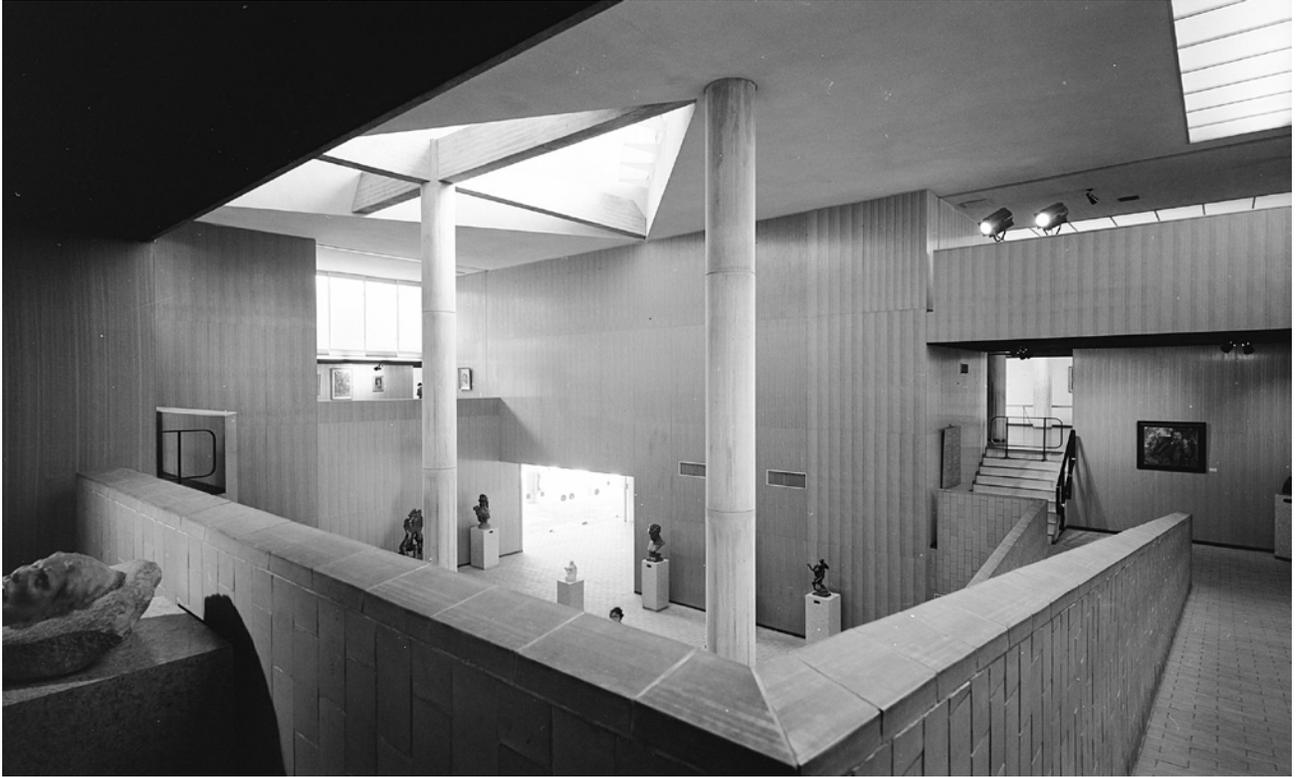
**FIGURE 2.12.**

*Central atrium at the National Museum of Western Art, Tokyo. This is the most enclosed of the three museums, a response to Japan's temperate climate. © Fondation Le Corbusier. Photo: Lucien Hervé, 1957, © J. Paul Getty Trust. Getty Research Institute, Los Angeles (2002.R.41).*

features according to the local climate. Tokyo's National Museum of Western Art is in a temperate climate with four distinct seasons, including hot summers and cold winters, and as such has a closed atrium (fig. 2.12) and the fewest wall openings of the three museums. The Chandigarh museum experiences cool winters, which may explain why it has a roof over the central atrium.

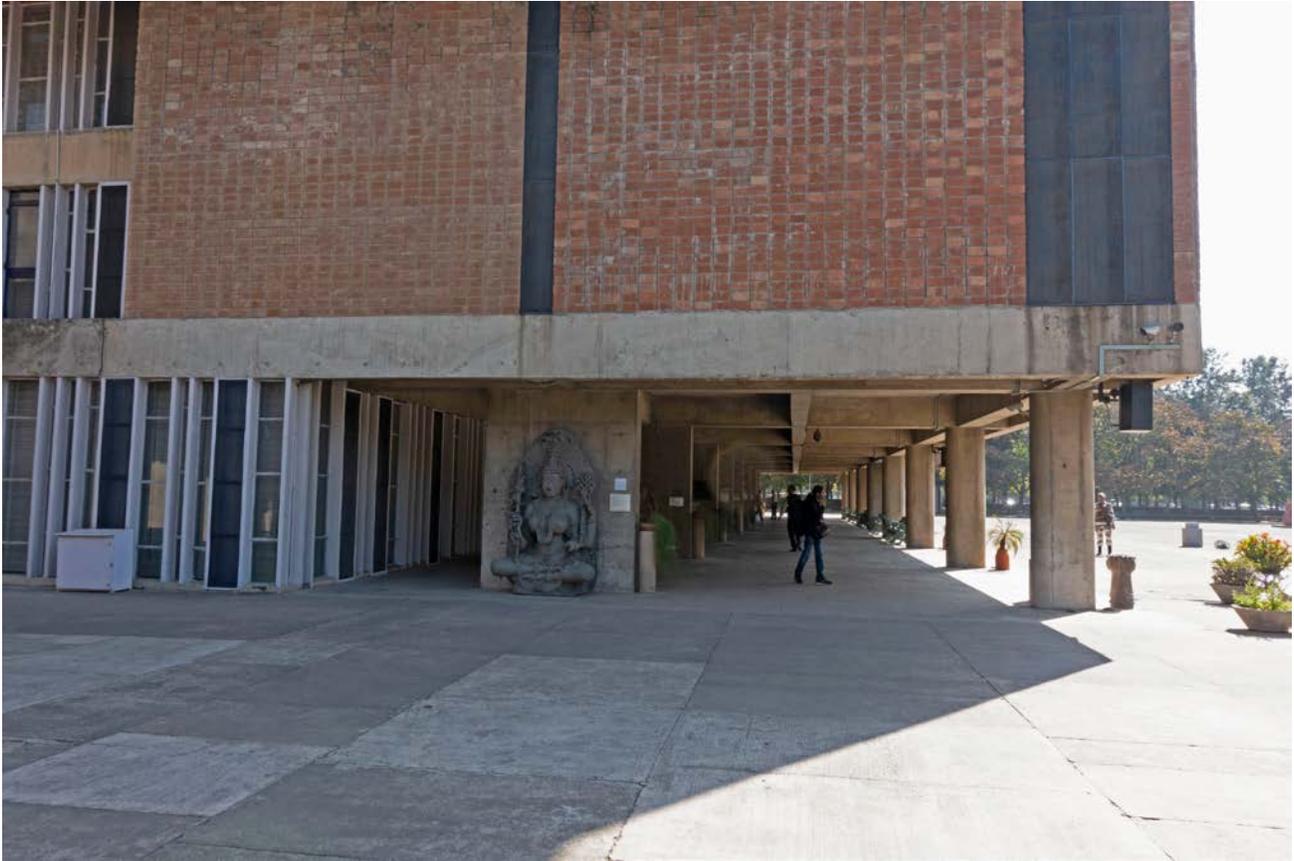
**FIGURE 2.16.**

*The first floor of the museum, supported by pilotis, provides shade over the ground floor along the southwest facade. © Fondation Le Corbusier. Photo: Ana Paula Arato Gonçalves, 2018, © J. Paul Getty Trust.*

- The ground-floor exterior walls and glazed openings are shaded by orientation or by the overhanging first floor formed by the pilotis (fig. 2.16).
- Glazed openings, one on each of the four first-floor exterior walls, consisting of full-height undulatory windows, are set back from the exterior wall plane. The four glazed panels constitute less than 15% of the total surface area of the first-floor walls.

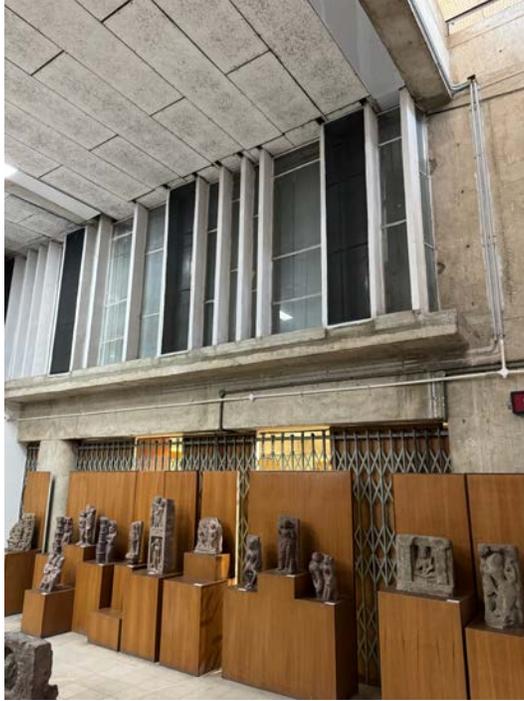
**FIGURE 2.19.**

Exhibit casework and security grilles that block openings, such as the one shown here between the Medieval Sculptures Gallery and Metal Sculptures Gallery, reduce cross-ventilation. © Fondation Le Corbusier. Photo: Chandler McCoy, 2024, © J. Paul Getty Trust.

- Functionality of aerators may be reduced by limited range of movement due to corrosion or debris in the pivot joints.
- Exhibit casework and security grilles placed in air pathways between spaces and in front of aerators reduce cross-ventilation (fig. 2.19).

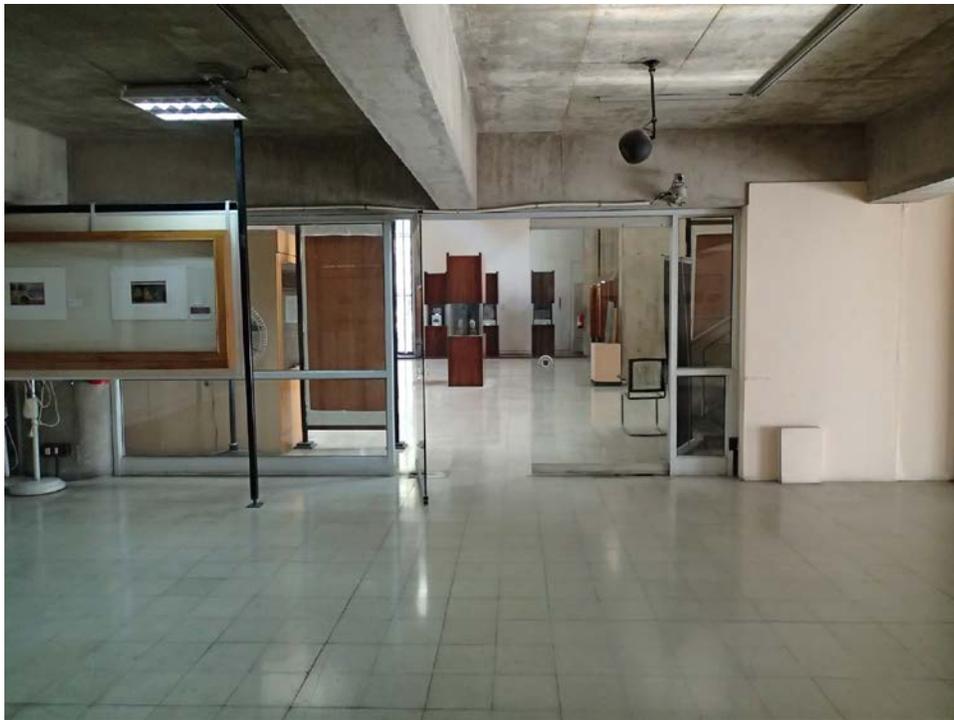
**FIGURE 2.20.**

Glazed partitions and doors installed at the entrance to the Miniatures Gallery reduce cross-ventilation. © Fondation Le Corbusier. Photo: Michael C. Henry, 2018, © J. Paul Getty Trust.

- Cross-ventilation has been reduced by the installation of glazed partitions and doors at the entrance to the Miniatures Gallery. This was done to help contain airflow when the gallery was air-conditioned in 2003 (fig. 2.20).

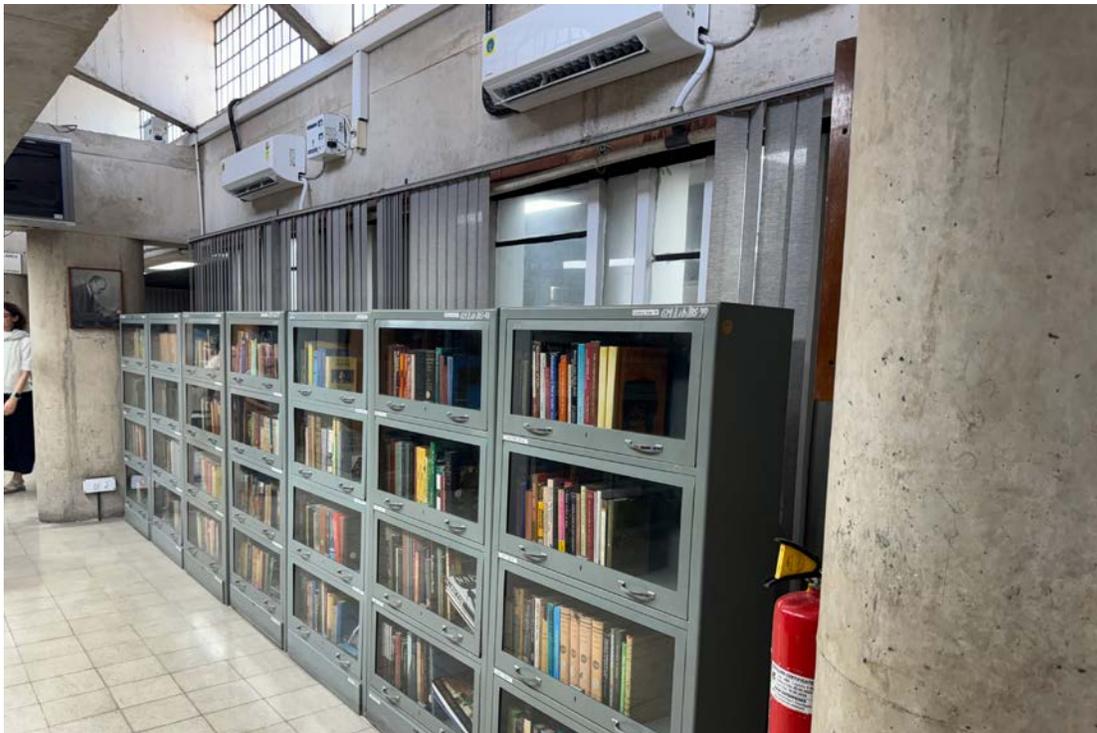
**FIGURE 2.21.**

*Bookcases in the second-floor library block operation of aerators that face the gallery space below. © Fondation Le Corbusier. Photo: Chandler McCoy, 2024, © J. Paul Getty Trust.*

- Stack-effect ventilation is limited due to the lack of air outlets at the clerestory and roof level.
- Stack-effect ventilation is reduced by closure of interior and exterior aerators in second-floor (mezzanine) spaces, including the library (fig. 2.21), the reserve collections for pottery and Gandhara sculptures, the Bir room, and the HVAC mezzanine.

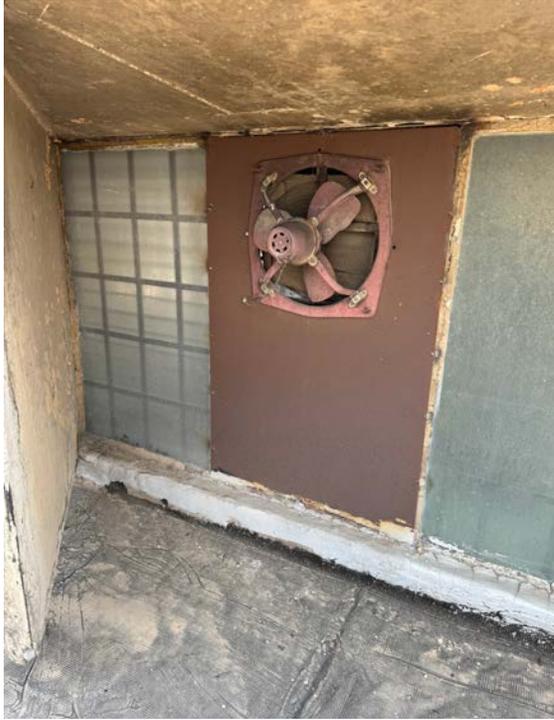
- Two exhaust fans for mechanical ventilation are located in the clerestory above the mezzanine overlooking the Miniatures Gallery (fig. 2.22). Date of installation of these units has not been determined, and they are no longer operating.

**FIGURE 2.22.**  
 One of two exhaust fans for mechanical ventilation installed in the clerestory and no longer operating. © Fondation Le Corbusier. Photo: Chandler McCoy, 2024, © J. Paul Getty Trust.

- The two exhaust fans in the clerestory above the mezzanine overlooking the Miniatures Gallery may not be usable without repairs.
- During the monitoring period, the chilled-water units were not able to maintain temperature of the chilled water. This issue reportedly has been resolved by replacement of the units in 2022.

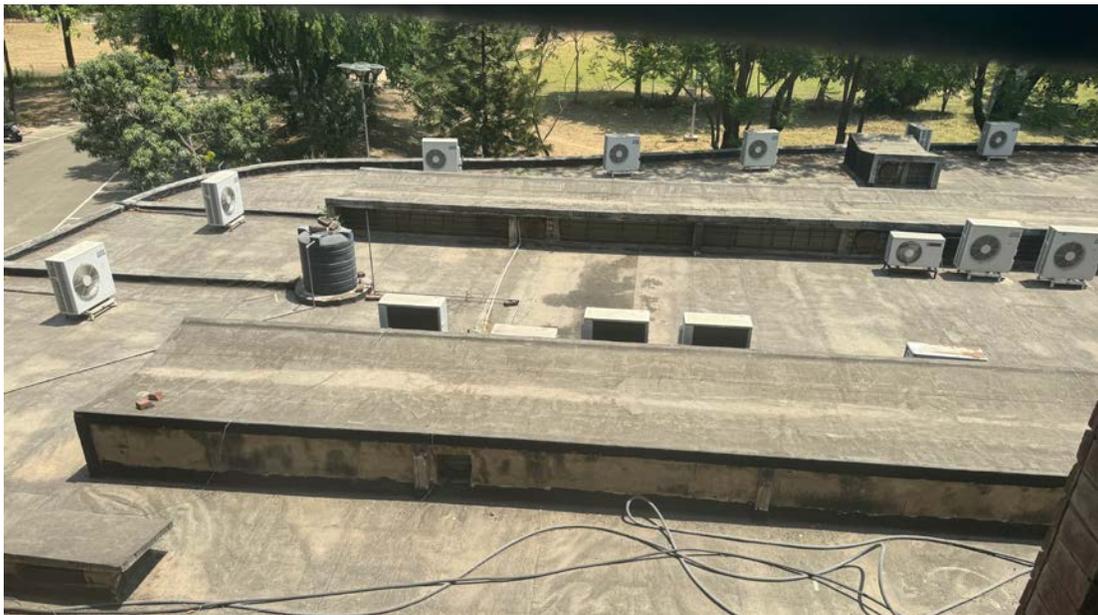
- The ground-floor temporary exhibition gallery in the rear block is served by approximately fifteen ductless heating and cooling units in the spaces with twenty-two air-cooled condensers (1- to 2-ton capacity) mounted on the roof of the rear block (fig. 2.24).

**FIGURE 2.24.**  
 Air-cooled condensers mounted on the roof of the rear block. © Fondation Le Corbusier. Photo: Chandler McCoy, 2024, © J. Paul Getty Trust.
