Getty  
Conservation  
Institute

# Environmental Management at the Government Museum and Art Gallery, Chandigarh

## Analysis and Strategies

### Project Report

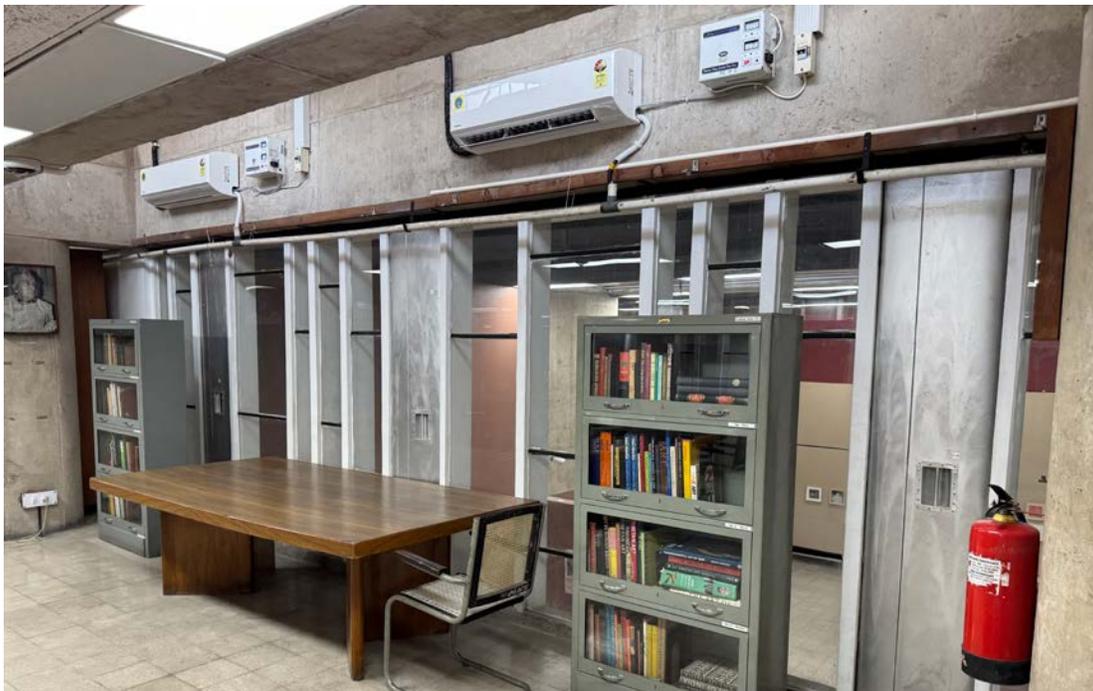
**FIGURE 2.25.**

- The second-floor library and conference room are served by four ductless heating and cooling units in the spaces, with two 2-ton air-cooled condensers mounted next to the first-floor undulatory window and aerators on the northeast wall and two 2-ton air-cooled condensers on the roof of the main block.
- Ductless air conditioners are installed in the library, with air-cooled condensers located on the roof of the rear block now housing the temporary exhibition gallery (fig. 2.25). These units were replaced in 2021.

- The ductless air-conditioning units in the library have a high failure rate. This is apparently due to variability in the quality of the incoming electrical power.

*Ductless air conditioners installed on a wall of the library. © Fondation Le Corbusier. Photo: Chandler McCoy, 2024, © J. Paul Getty Trust.*

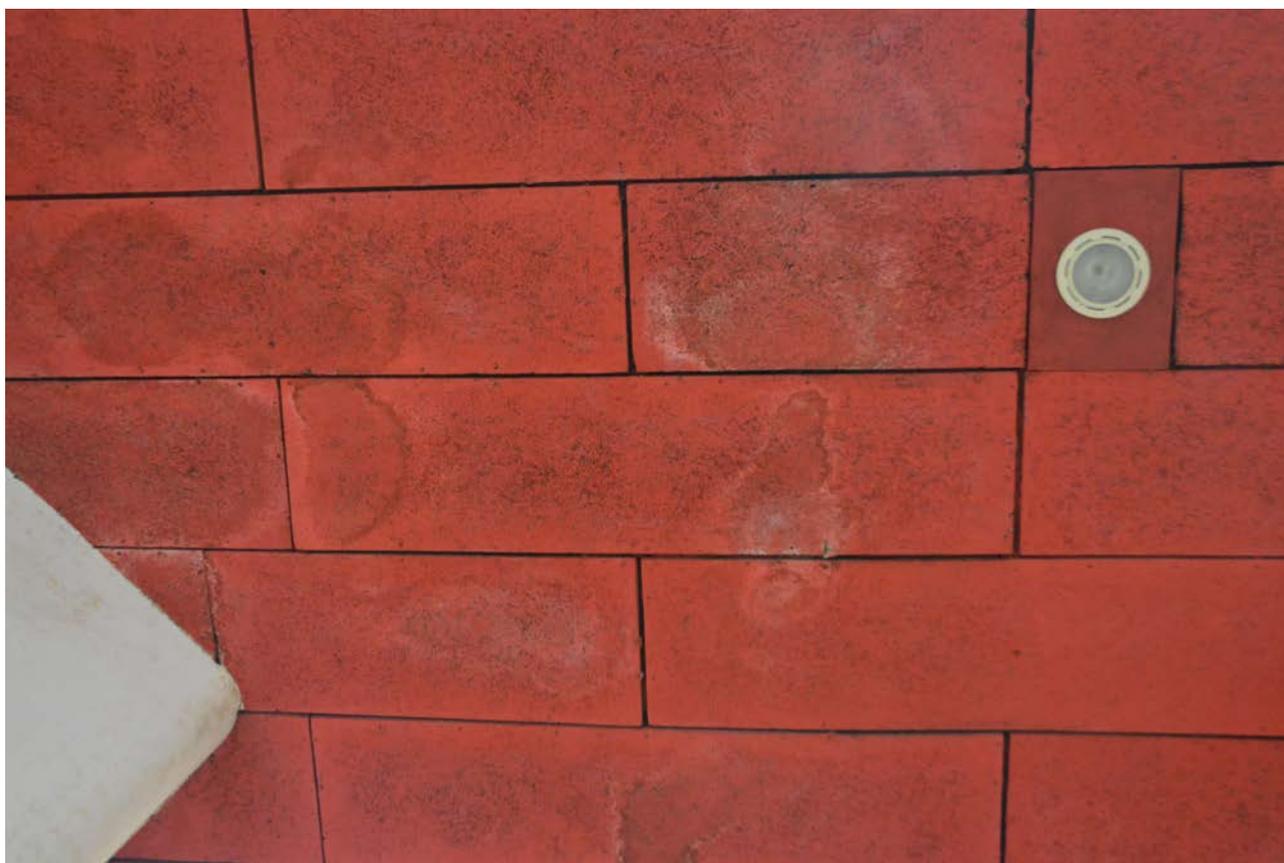
**FIGURE 3.7.**

**Sources.** The main source of water damage comes from minor to heavy rainfall, especially during the monsoon season (fig. 3.7). Malfunctioning air-conditioning or condensation around such equipment could be another source of water damage. Flooding on the ground floor or through aerators could increase the relative humidity indoors, leading to mold and mildew outbreaks, and damage objects and display cases.

*Water damage to the fiberboards on the ceiling caused by rain seeping through the roof of the Coin Section.*

**Paths.** The predominant paths through which water enters the museum are the roof and clerestories. Museum staff report that whenever a roof leak is repaired, the water finds another way to enter, indicating that a comprehensive roof covering replacement is likely needed. Additionally, the CMP (DRONAH 2019) mentions that leakage has occurred through aerators during heavy rain and wind events. Objects and exhibition furniture affected by leaks are currently protected by plastic sheeting (fig. 3.8) or have been relocated. In the exhibition spaces, the majority of objects are elevated off the floor on pedestals and/or in display cases; however, this is not the case in the storage spaces, where bulky items are stored on the ground due to lack of suitable storage furniture and space (fig. 3.9). These objects have limited or no barrier to protect them from potential damage from flooding or leaks.

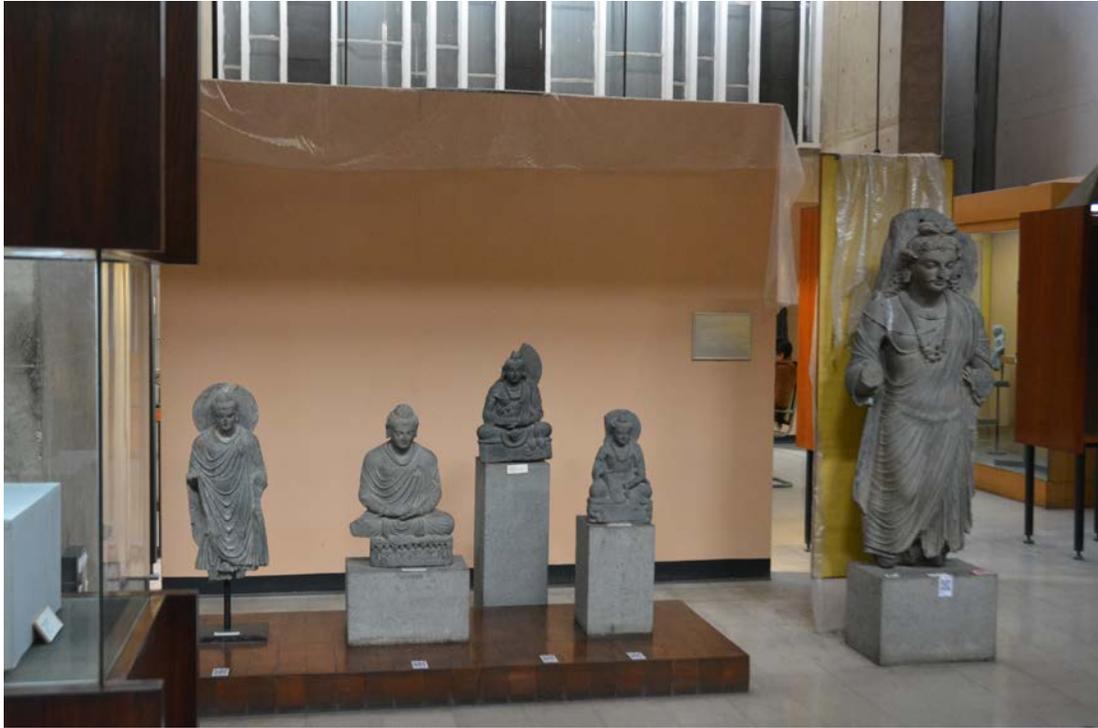
**FIGURE 3.8.**

*Plastic sheeting is used to protect exhibition furniture from leakage in the roof in the Gandhara Sculptures Gallery. © Fondation Le Corbusier. Photo: Annelies Cosaert, 2020, © J. Paul Getty Trust.*

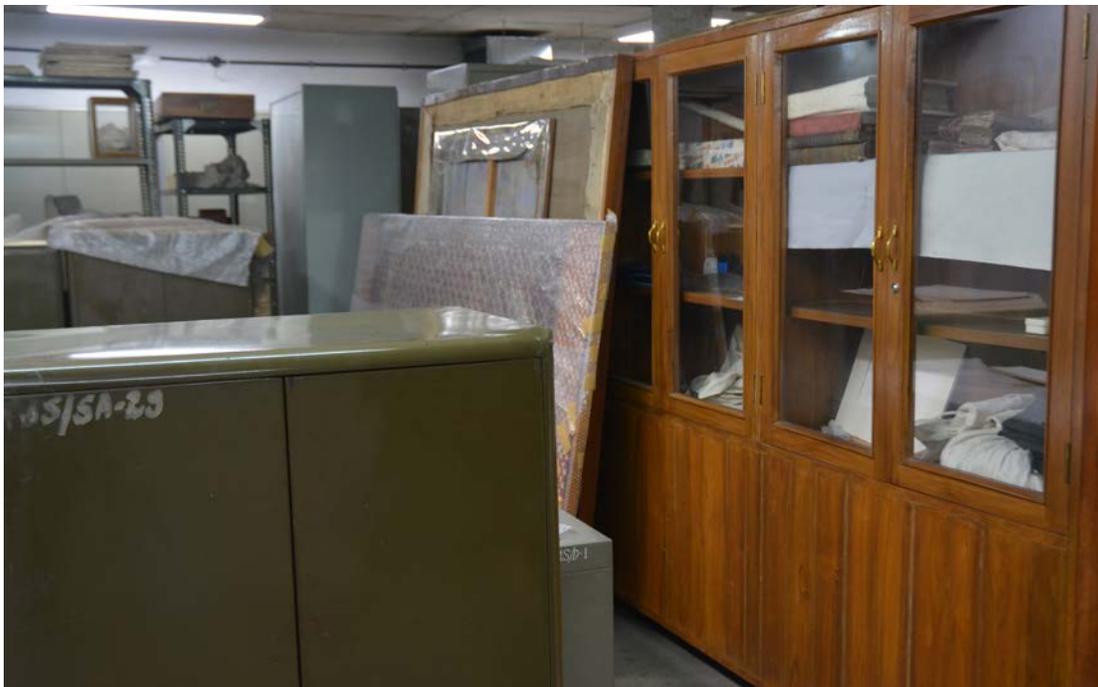
**FIGURE 3.9.**

*In the storage space for miniatures, larger objects are placed against cabinets, some objects are stored on top of shelving units, and some are protected by plastic sheeting. © Fondation Le Corbusier. Photo: Annelies Cosaert, 2020, © J. Paul Getty Trust.*

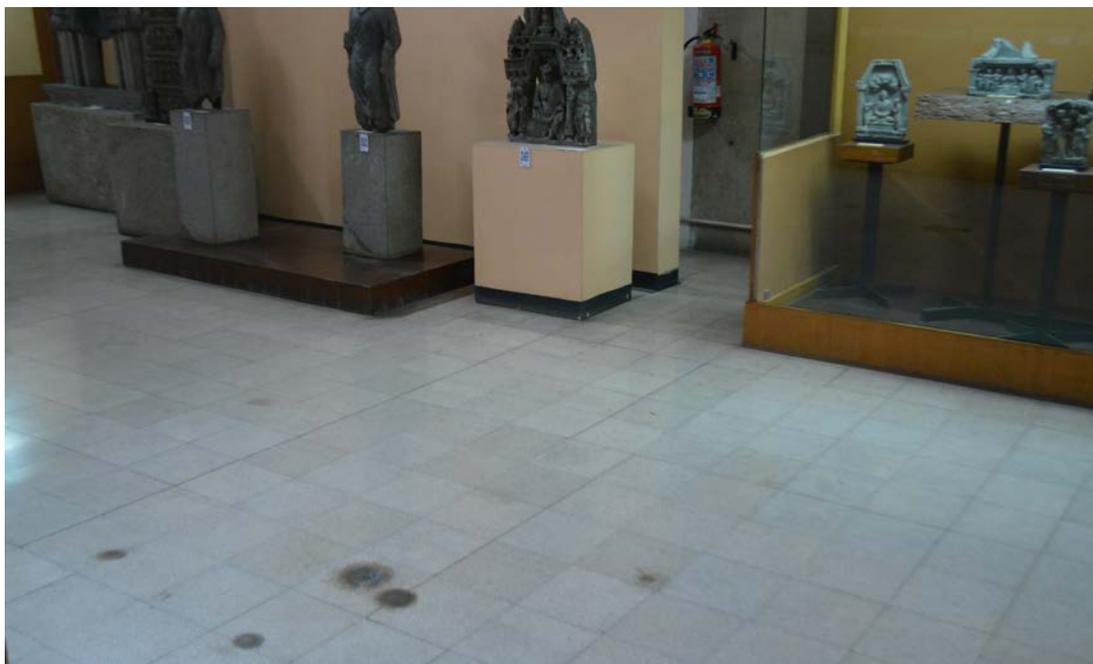
**FIGURE 3.10.**

*Observed effects.* Salt deposits were observed on floors (fig. 3.10), as was staining on exhibition furniture (fig. 3.11) and on objects due to water.

*Salt deposits caused by water percolating through the concrete roof and landing on the floor. © Fondation Le Corbusier. Photo: Annelies Cosaert, 2020, © J. Paul Getty Trust.*

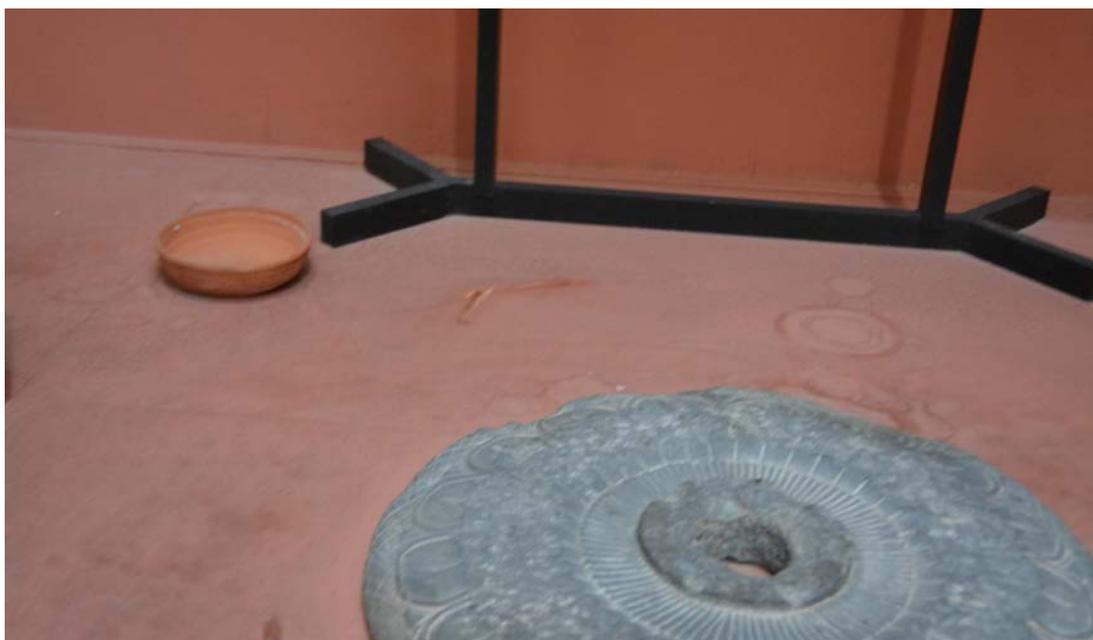
**FIGURE 3.11.**

*Detail of staining from water on exhibition furniture in the Gandhara Sculptures Gallery. Photo: Annelies Cosaert, 2020, © J. Paul Getty Trust.*

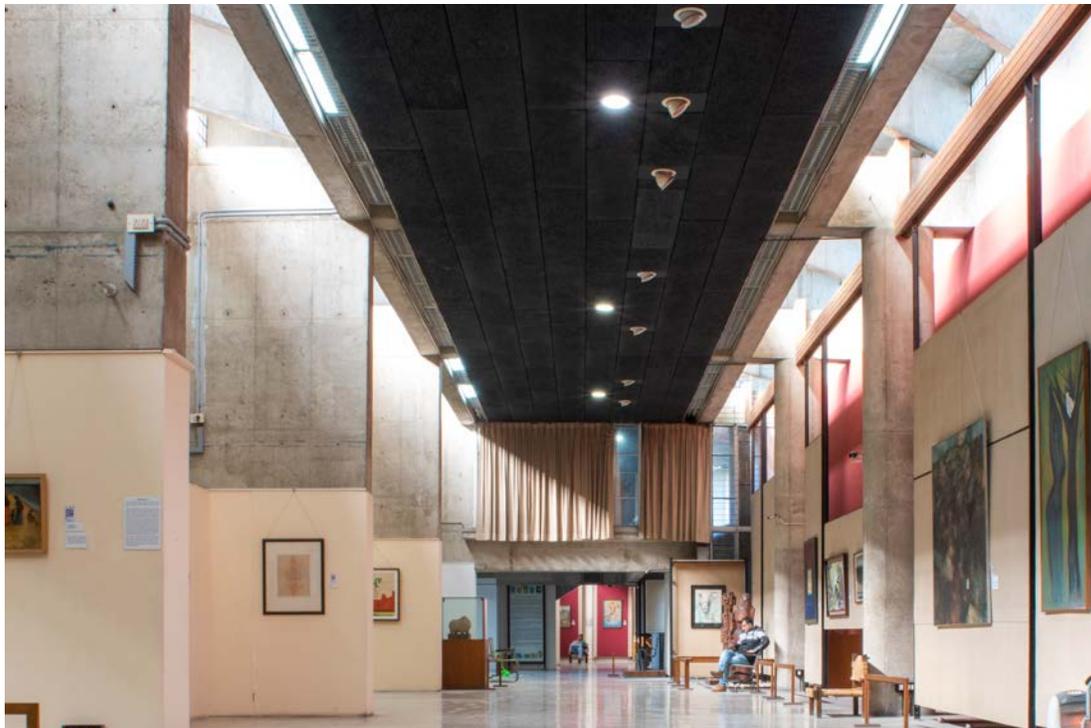
**FIGURE 3.12.**

**Paths.** The predominant sources of high levels of light are the clerestories, which are located above all exhibition spaces that are two or three stories tall (fig. 3.12). The large window openings located on all four sides of the building also let in natural light, but because these windows face rooms that are only one story tall and are recessed a few meters from the main building facade,

Sunlight penetrating exhibition spaces through clerestories in Contemporary Art Gallery II during winter. © Fondation Le Corbusier. Photo: Tim Webster, 2020, © J. Paul Getty Trust.

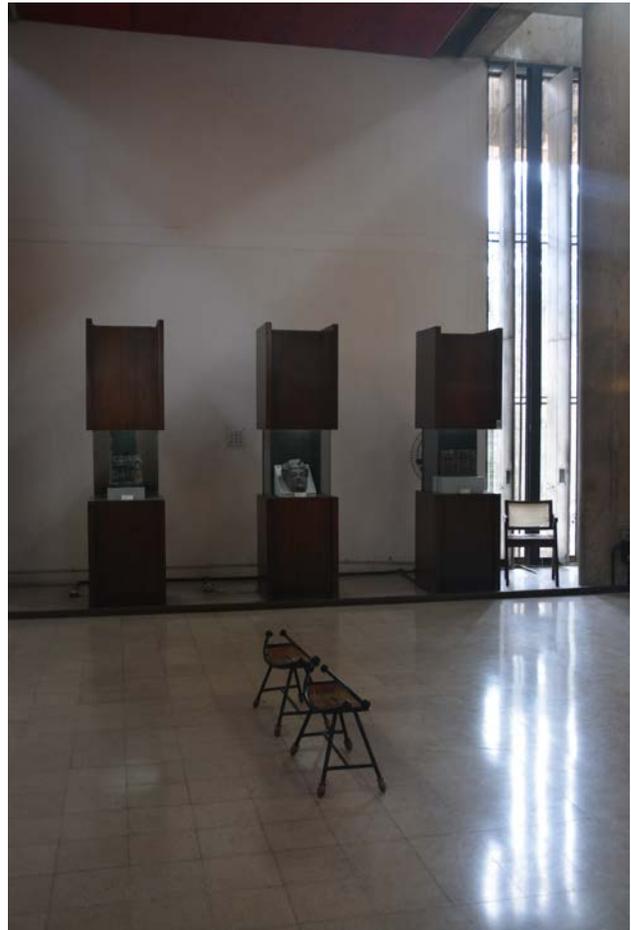
they are somewhat protected and thus also allow in less light (fig. 3.13). Furthermore, these windows are always equipped with some type of blind or curtain. High levels of light are also measured next to open aerators; this light path as well is local, can be traced, and is often blocked by concrete columns (fig. 3.14).

**FIGURE 3.14.**  
*Natural light penetrating through aerators and clerestories in the Gandhara Sculptures Gallery. © Fondation Le Corbusier. Photo: Annelies Cosaert, 2020, © J. Paul Getty Trust.*

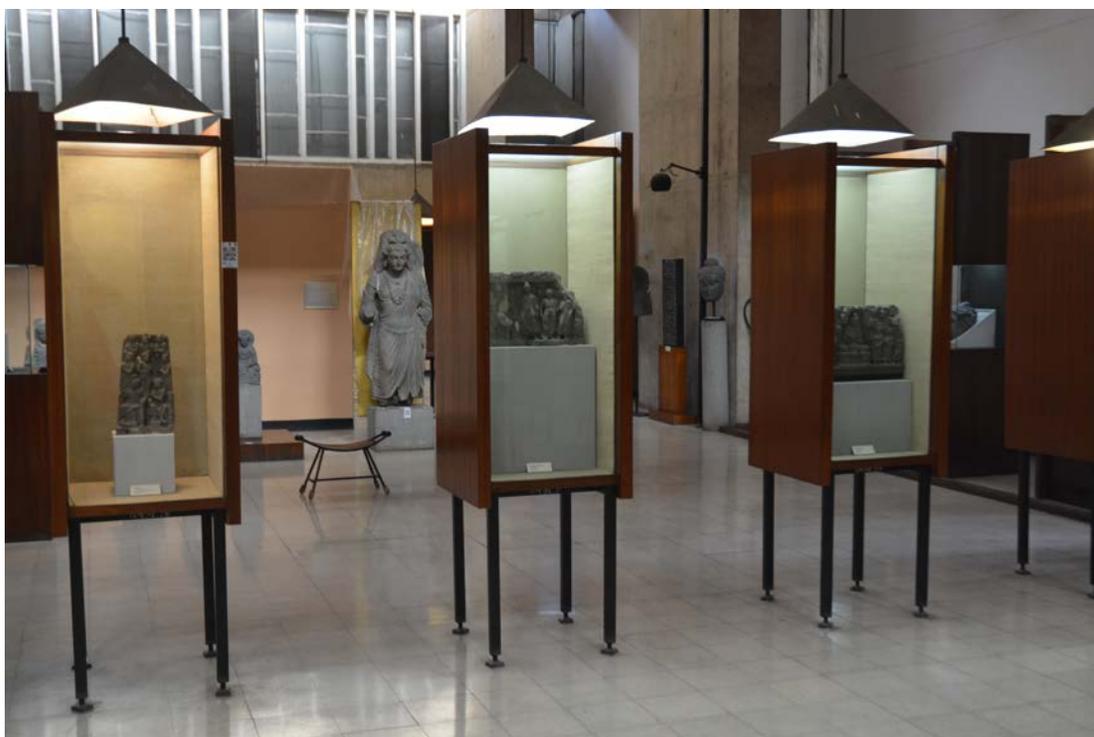
**FIGURE 3.15.**

Artificial light is provided by either original fixtures or new systems. The original fixtures are often in close proximity to the object, which can overexpose and overheat the object (fig. 3.15). Various types of light bulbs are used throughout the museum.

*Original light fixtures in the Gandhara Sculptures Gallery. © Fondation Le Corbusier. Photo: Annelies Cosaert, 2020, © J. Paul Getty Trust.*

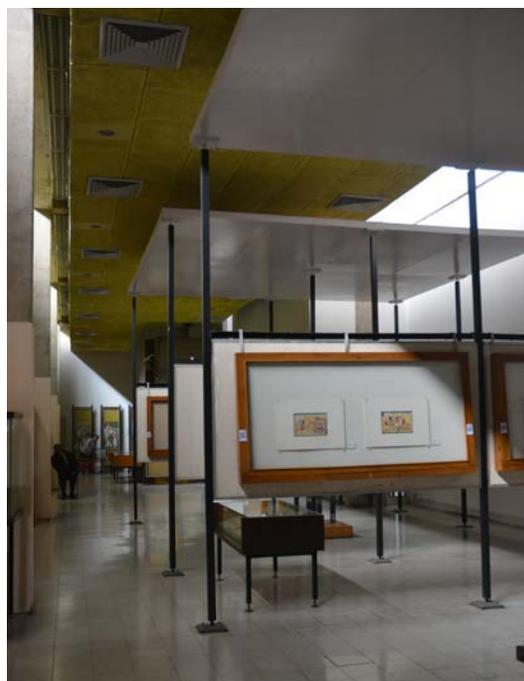
**FIGURE 3.16.**

**Observed effects.** Three material types are particularly sensitive to light damage: paper (fig. 3.16), textiles (of which there were only few on exhibition at the time of assessment), and all contemporary art materials. Fading of the miniatures has been reported based on comparison with historical photographs of these objects. Exhibition furniture textiles also clearly show signs of fading (fig. 3.17).

*Miniature paintings exposed to natural light from the clerestory above. © Fondation Le Corbusier. Photo: Annelies Cosaert, 2020, © J. Paul Getty Trust.*

**Potential effects.** While clear signs of fading were observed, there have been no visible signs of structural instability of artworks believed to be caused by light exposure. However, if artworks sensitive to light damage remain on display for long periods of time unprotected from natural light, they will decay further and fade, and it will become increasingly challenging for the visitor to appreciate their details (this is of great importance for the miniature paintings). If curtains or blinds are removed, objects will need additional protection from exposure to daylight.

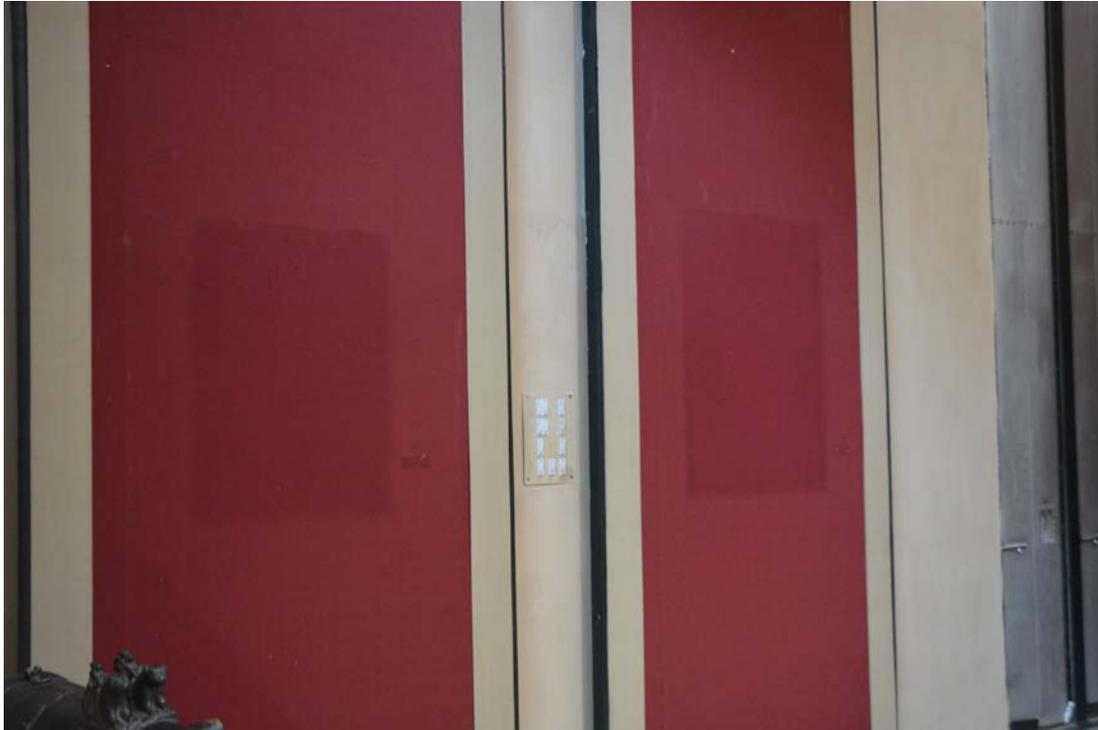
**FIGURE 3.17.**

*Fading of textiles on freestanding panels became evident after artworks were removed in Contemporary Art Gallery I. © Fondation Le Corbusier. Photo: Annelies Cosaert, 2020, © J. Paul Getty Trust.*

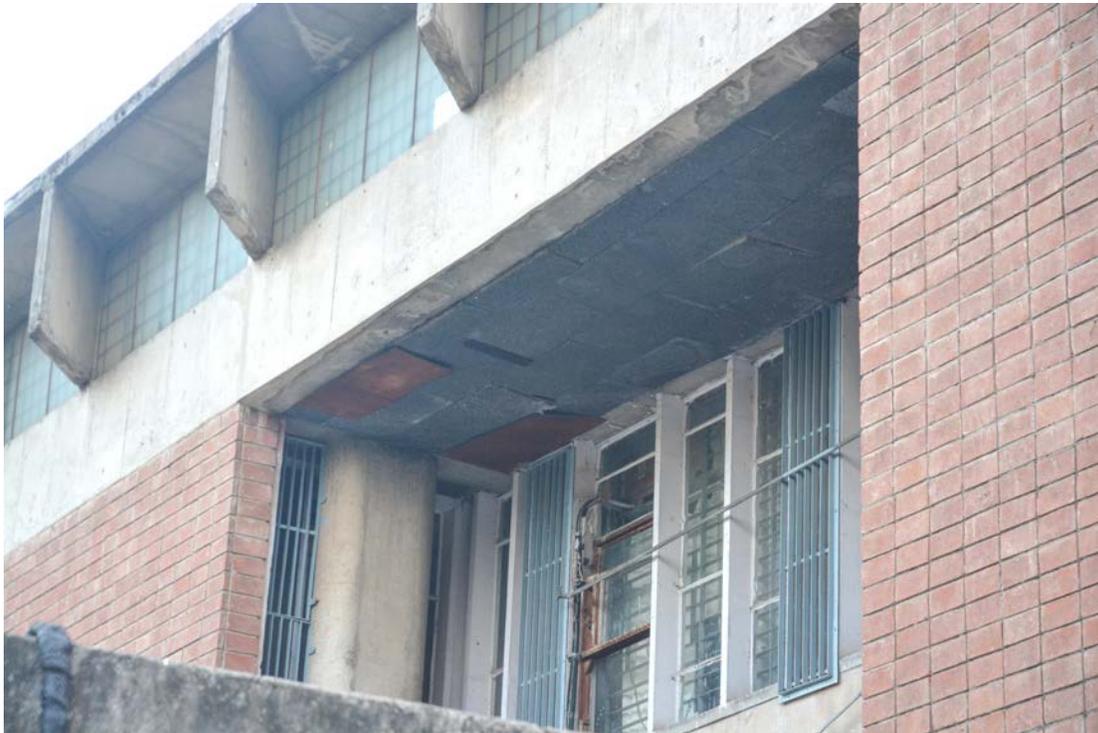
**FIGURE 3.18.**

Damaged fiberboard panels on the ceiling of an exterior recessed window allow pests to enter interstitial ceiling space. © Fondation Le Corbusier. Photo: Annelies Cosaert, 2020, © J. Paul Getty Trust.

**Paths.** Pests can penetrate the building envelope in several places. At the museum, there appear to be two predominant paths of entry. The first is the museum’s reception area, where both the main entrance door and the door to the Great Hall stay open during opening hours. The second path is through the fiberboard used on the ceiling outdoors above the recessed windows (fig. 3.18). This fiberboard is showing signs of decay and may provide a way for small- to medium-size animals to enter the interstitial ceiling space and spread throughout the museum undetected. While storage areas are accessed through a separate entrance and do not have fiberboard ceilings, they are connected to the mechanical room and to one another. Therefore, if an animal enters one of these spaces, it may gain access to the others as well (fig. 3.19). In some cases, screens have been installed in cavities connecting rooms to prevent animals from traveling between them (fig. 3.20). Another issue is the consumption of food in museum spaces. This could attract larger animals such as rodents, birds, and squirrels.

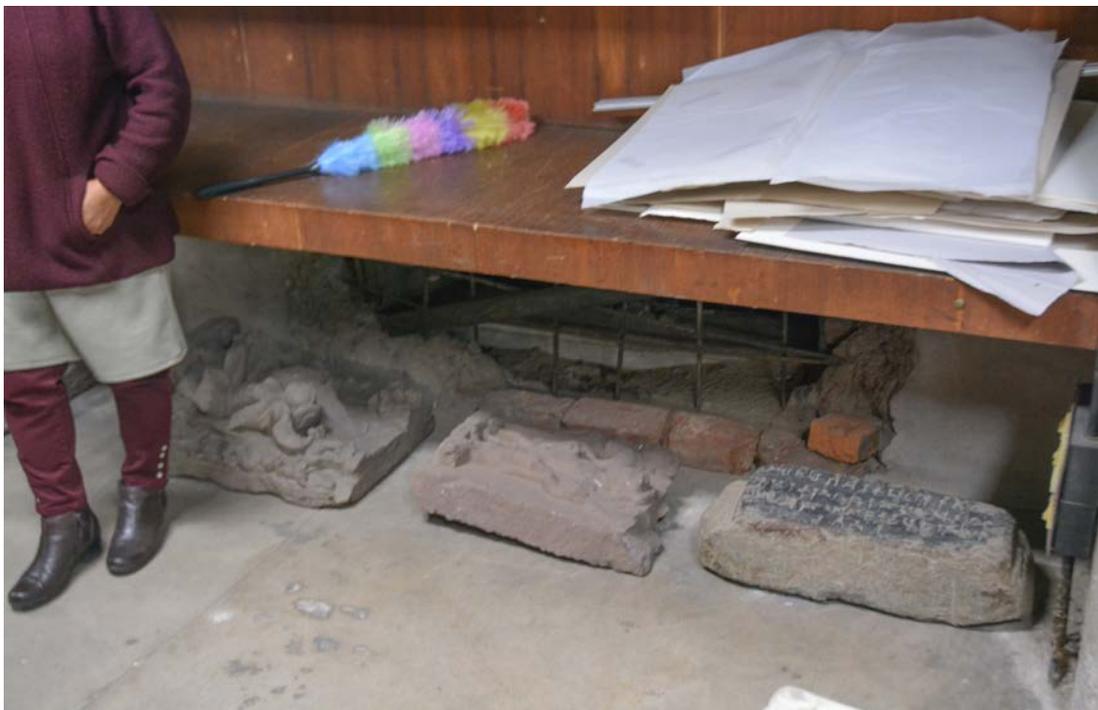
**FIGURE 3.19.**

Wall openings connect the contemporary art storage and miniatures storage with the mechanical room. © Fondation Le Corbusier. Photo: Annelies Cosaert, 2020, © J. Paul Getty Trust.

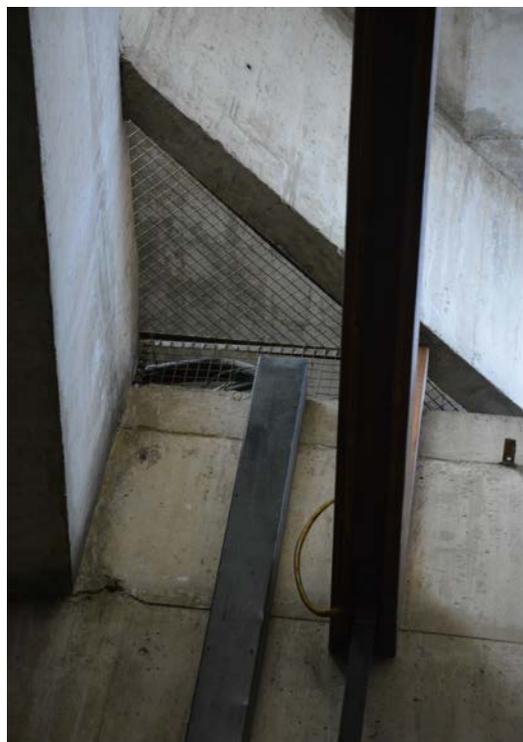
**FIGURE 3.20.** Screen separating two spaces to avoid circulation of birds and larger animals between rooms. © Fondation Le Corbusier. Photo: Annelies Cosaert, 2020, © J. Paul Getty Trust.

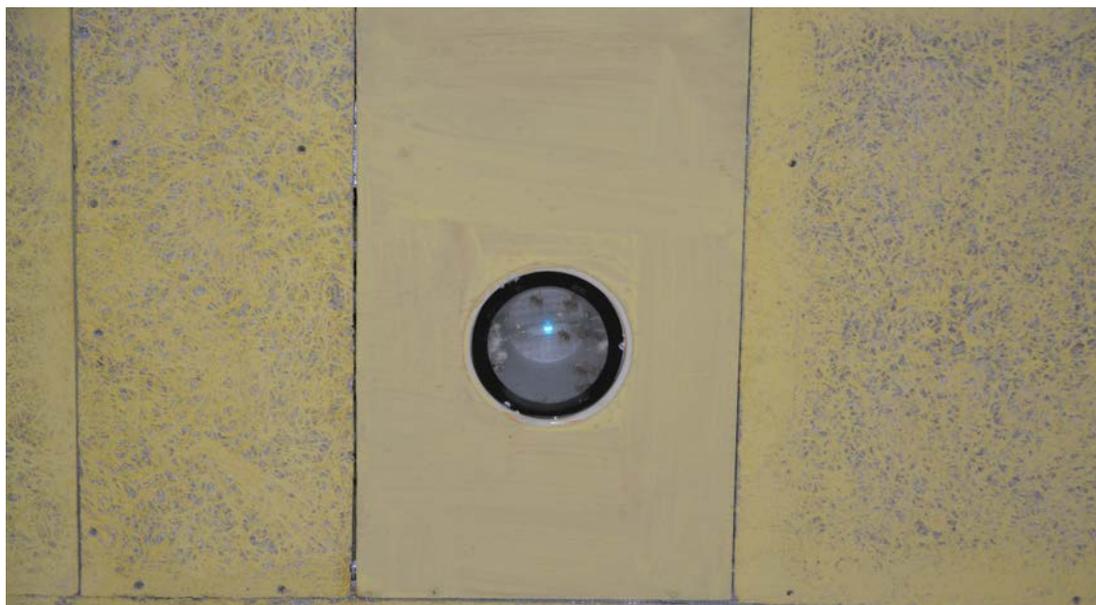
**Observed effects.** Signs of the presence of rodents were observed in the exhibition hall, library, storage areas, and director's office during the 2020 visit. Evidence of animals and insects was also found in exhibition spaces and in the ceiling space (fig. 3.21). However, few objects show visible damage from insects or rodents.

**FIGURE 3.21.** Dead insects visible inside a light fixture mounted in the ceiling. © Fondation Le Corbusier. Photo: Annelies Cosaert, 2020, © J. Paul Getty Trust.

**Potential effects.** If the interstitial ceiling space is found to have large quantities of dead animals or insects and their droppings, cleaning that space would constitute a health hazard and require workers to wear appropriate protective equipment. On the other hand, not addressing this issue could pose a major fire risk for the museum.

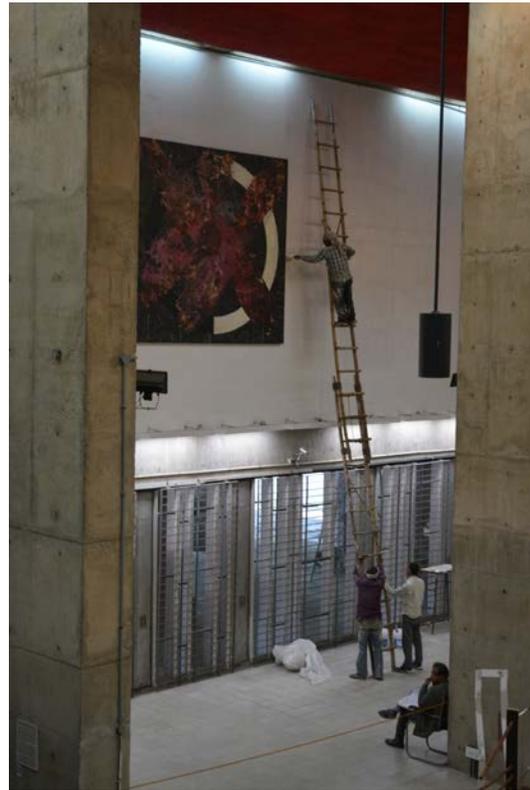
The condition of some exhibition furniture or architectural elements, such as the fiberboard ceiling, can make them unstable, posing risk to nearby objects. Another potential issue is the use of unsuitable mounts for hanging fragile objects. Further, not removing all objects from a space that is being prepared for a new exhibition or that is being renovated can also present the risk of damage (fig. 3.22).

**FIGURE 3.22.** *Painting without removal of contemporary artwork in the Great Hall. © Fondation Le Corbusier. Photo: Annelies Cosaert, 2020, © J. Paul Getty Trust.*

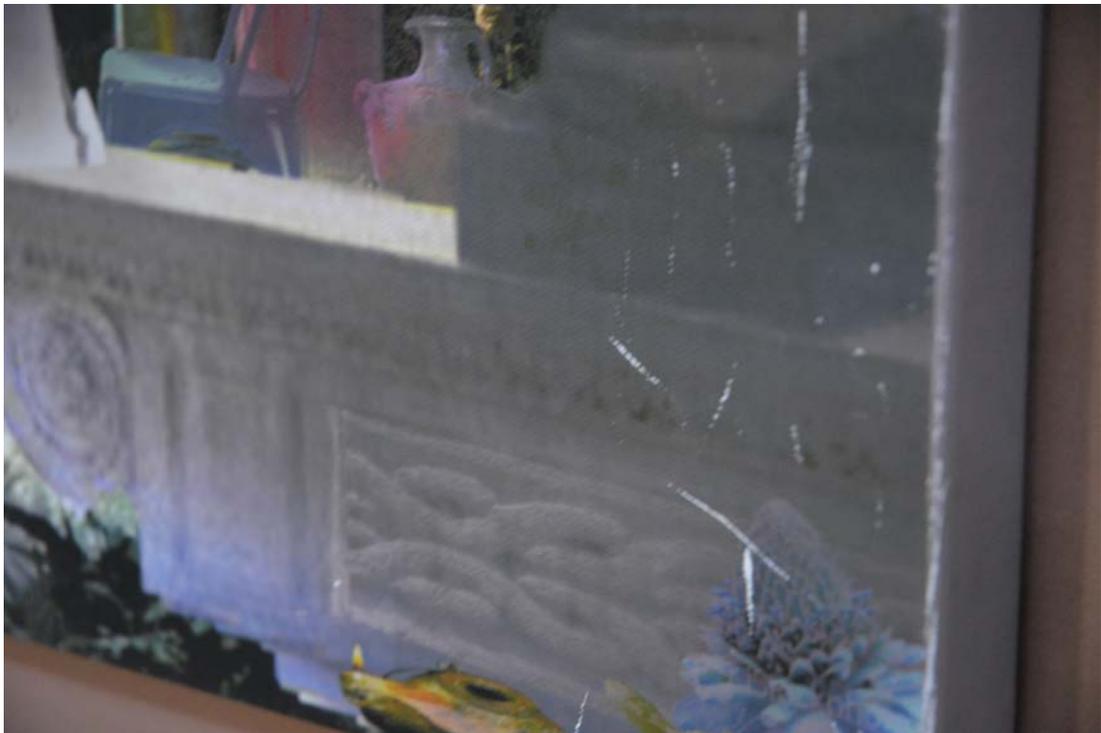
**FIGURE 3.23.**

*Scratches likely caused by a sharp object or by movement from an object in close proximity in Contemporary Art Gallery II. Photo: Annelies Cosaert, 2020, © J. Paul Getty Trust.*

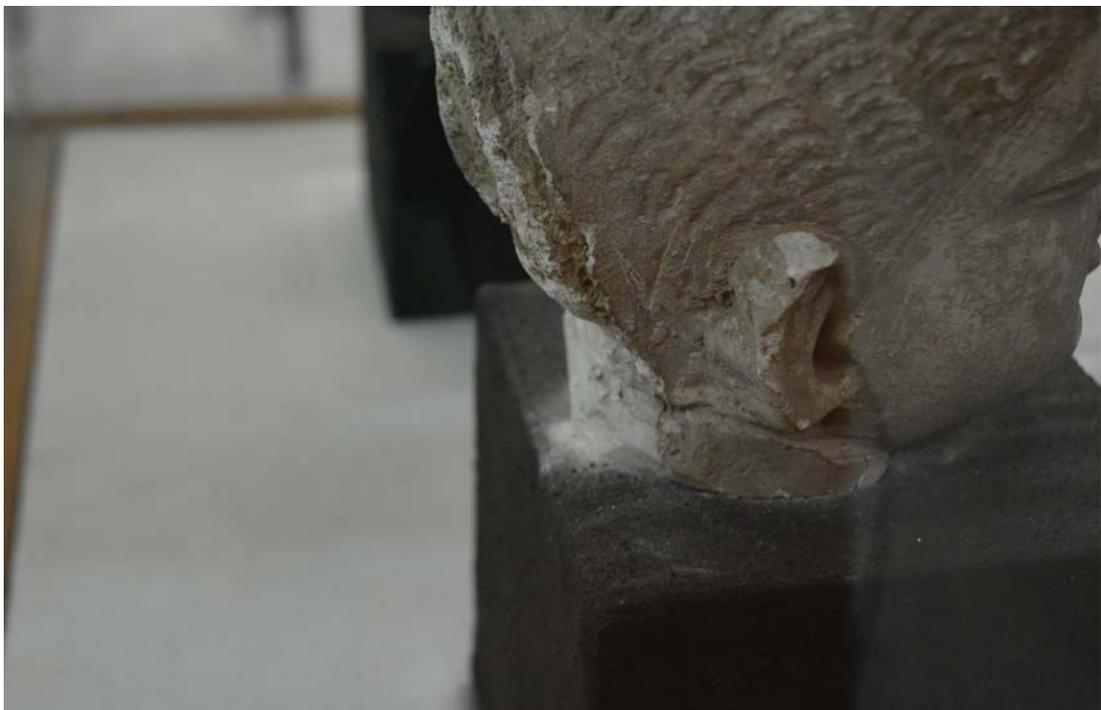
**FIGURE 3.24.**

**Observed effects.** Scratches (fig. 3.23), impact damage leading to loss (fig. 3.24), and paint splatters (fig. 3.25) have been found on works of art caused either by improper handling or by insufficient protection when mounting an exhibit. The rope used to hang two-dimensional works is often made of cotton, an organic material that deteriorates over time and is not recommended for heavier objects. Other mounting techniques were found to cause cracks from the back to the front of the object, weakening its stability. Some book supports are unsuited (fig. 3.26), both in the library and for the exhibition of manuscripts. More well-suited mounts were observed elsewhere in the museum (fig. 3.27), and the way these are used in consultations in the Bir room is appropriate. An angled support for consultation or display of books is recommended, as it causes less strain on the book cover and binding.

*Dent on a Gandhara sculpture that could have been caused by improper handling of the object. Photo: Annelies Cosaert, 2020, © J. Paul Getty Trust.*

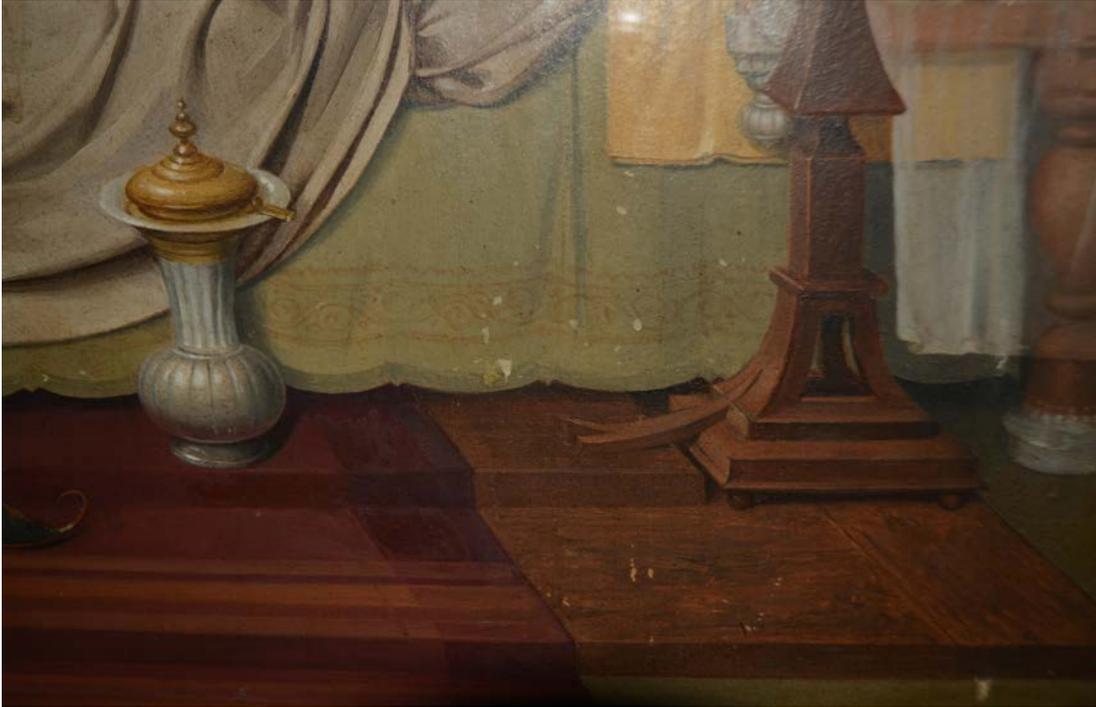
**FIGURE 3.25.**

*Paint splatters on an artwork in Contemporary Art Gallery I, likely originating when the gallery wall was painted in the past. Photo: Annelies Cosaert, 2020, © J. Paul Getty Trust.*

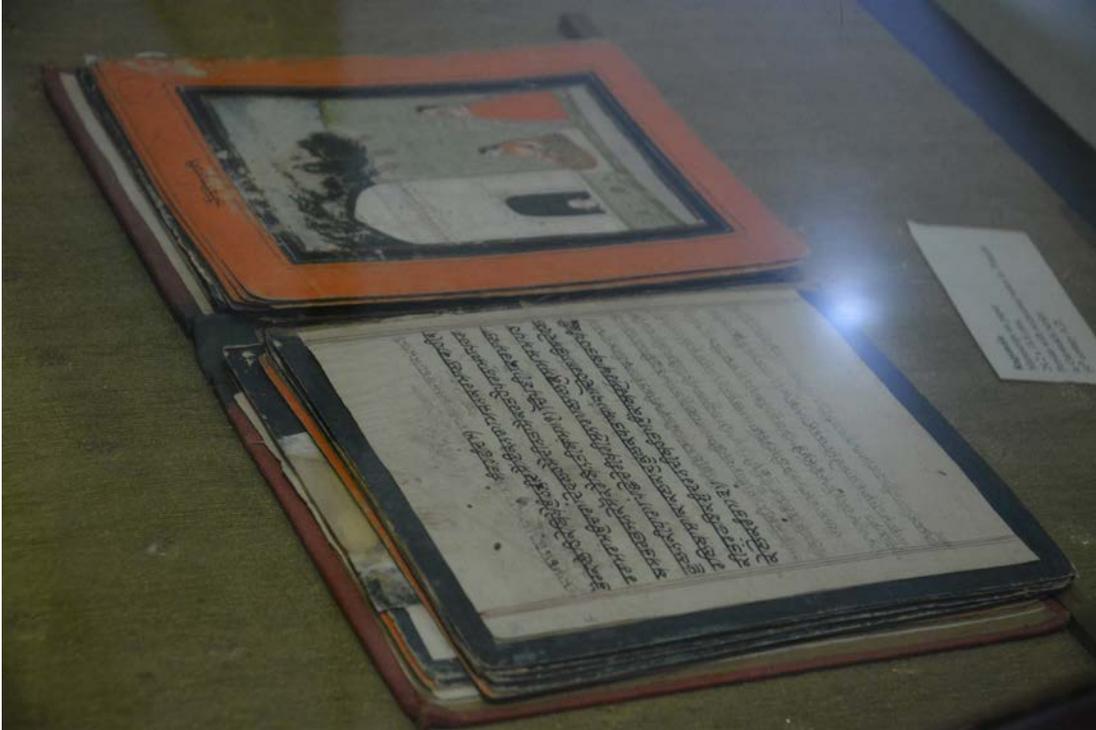
**FIGURE 3.26.**

*This support is flat and not high enough, making it unsuited for book display in the Miniatures Gallery. Photo: Annelies Cosaert, 2020, © J. Paul Getty Trust.*

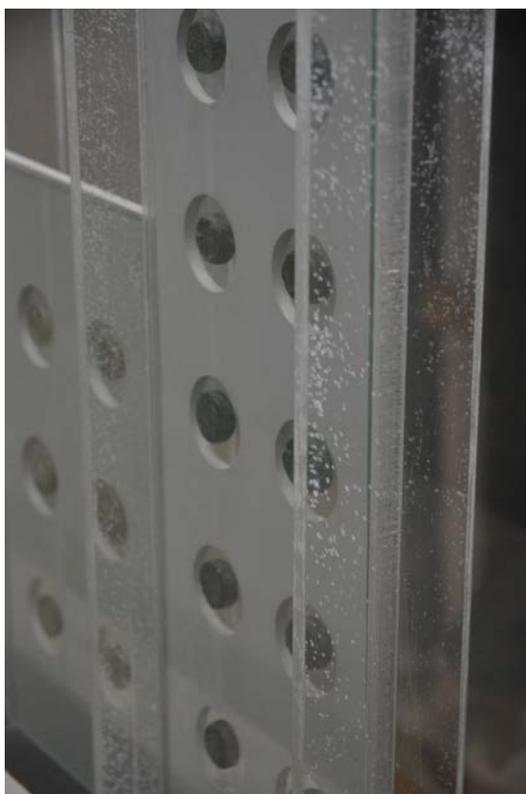
**Observed effects.** The clear acrylic material used in the coins display cases is showing signs of deterioration (fig. 3.28). This material presumably can generate gaseous pollutants that can cause corrosion. In addition, aggressive cleaning materials, combined with other agents, can play a role in the corrosion of metal sculptures and staining of the display case lining. Stains on the lining may also be caused by the board underneath the lining, since these stains have been frequently observed in different types of cases and on non-enclosed exhibition furniture throughout the museum (fig. 3.29).

**FIGURE 3.28.** Coins case made of clear acrylic, showing visible deterioration that can potentially generate gaseous pollutants. Photo: Annelies Cosaert, 2020, © J. Paul Getty Trust.

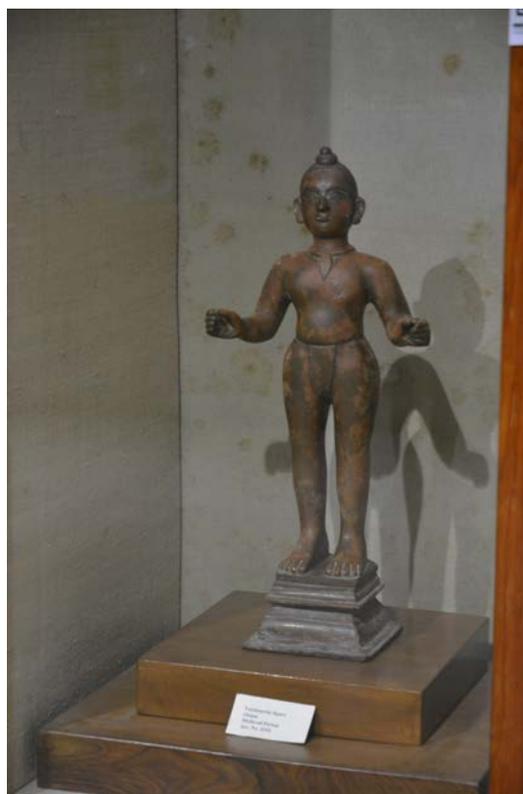
**FIGURE 3.29.** Staining of display case lining in the Metal Sculptures Gallery, most probably caused by a combination of factors, including the board used underneath the lining and high humidity. Photo: Annelies Cosaert, 2020, © J. Paul Getty Trust.

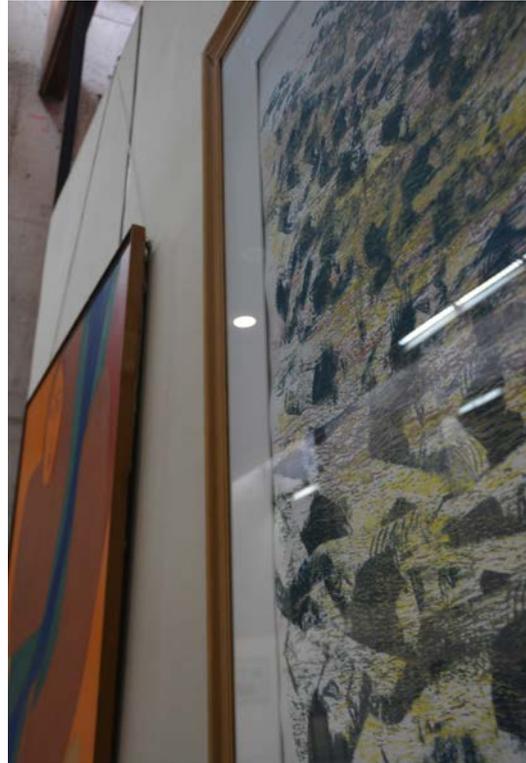
**FIGURE 3.31.**

Some of the works on paper show signs of undulation, or curling (fig. 3.31). Corrosion was observed on metal objects (fig. 3.32), and staining was evident on exhibition textiles. Also noted was deterioration of manuscripts, delamination of paint layers on polychrome wooden sculptures (fig. 3.33), and possibly nonhistorical cracks in wooden sculptures (fig. 3.34).

*Undulation, or curling, appears in a framed artwork on paper in Contemporary Art Gallery II. Photo: Annelies Cosaert, 2020, © J. Paul Getty Trust.*

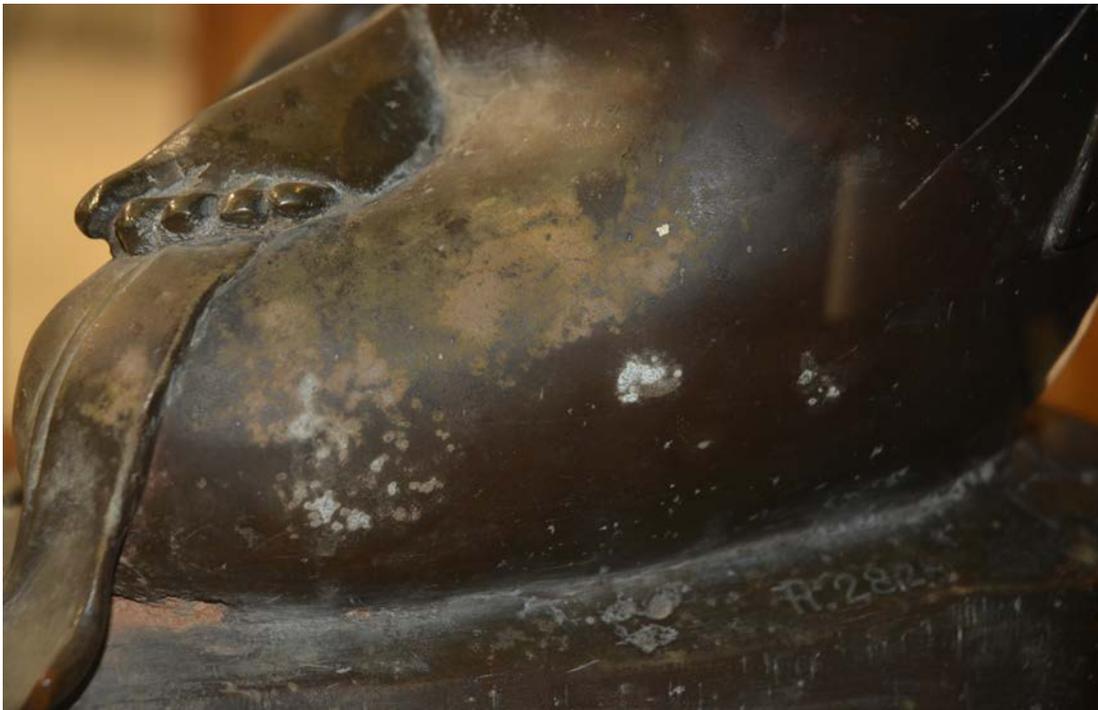
**FIGURE 3.32.**

*Corrosion of a metal sculpture in a display case. Photo: Annelies Cosaert, 2020, © J. Paul Getty Trust.*

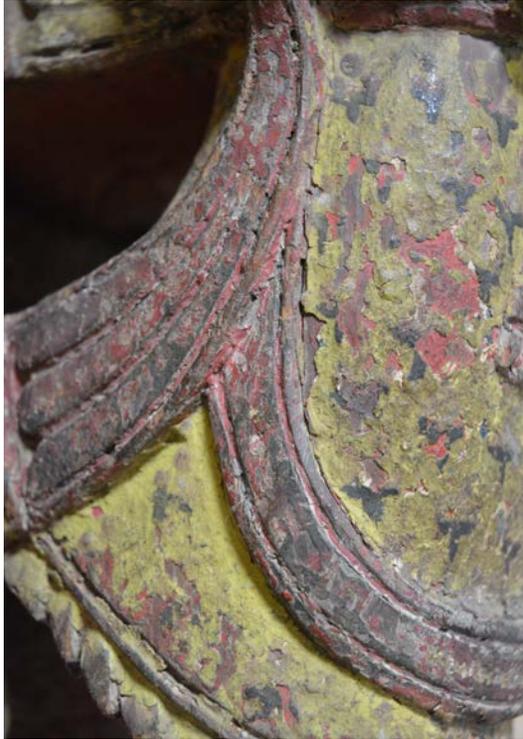
**FIGURE 3.33.**  
*Detachment of paint layer on a polychrome wooden sculpture in the Medieval Sculptures Gallery. Photo: Annelies Cosaert, 2020, © J. Paul Getty Trust.*

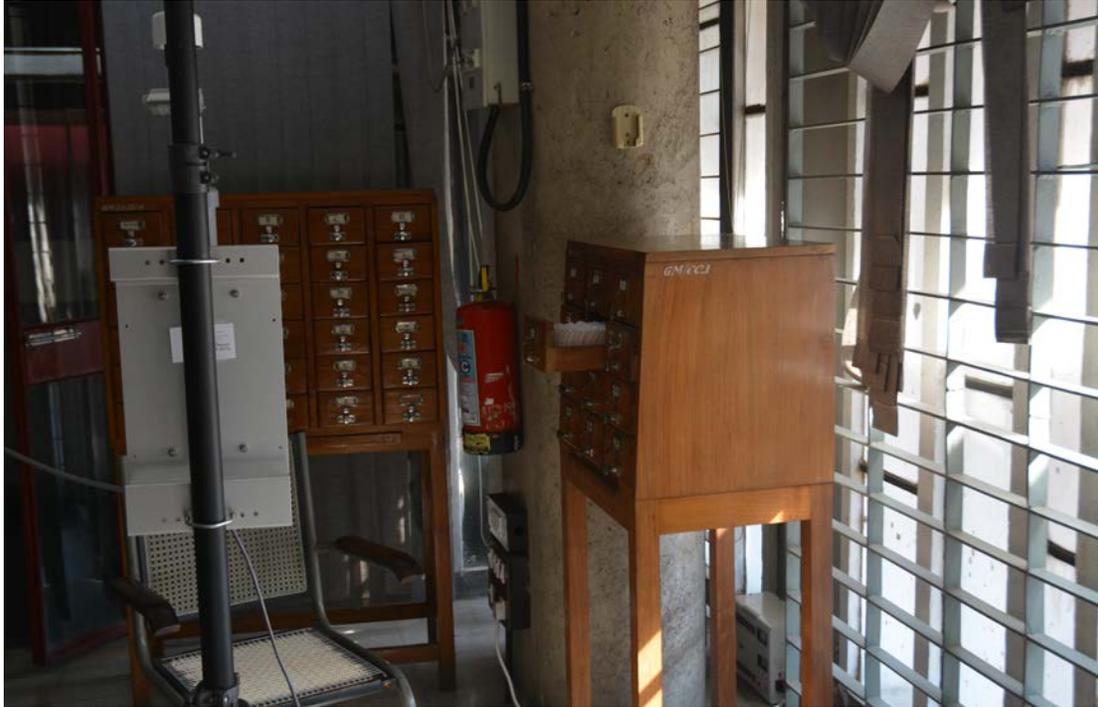
**FIGURE 3.35.**

**Sources.** Visitors, personnel, and professional thieves can be sources of theft and vandalism. After a professional break-in took place in the 1970s at the museum, metal grilles were installed on windows and doors (fig. 3.35).

Grilles were installed on windows and doors after a theft occurred at the museum in the 1970s. © Fondation Le Corbusier. Photo: Annelies Cosaert, 2020, © J. Paul Getty Trust.

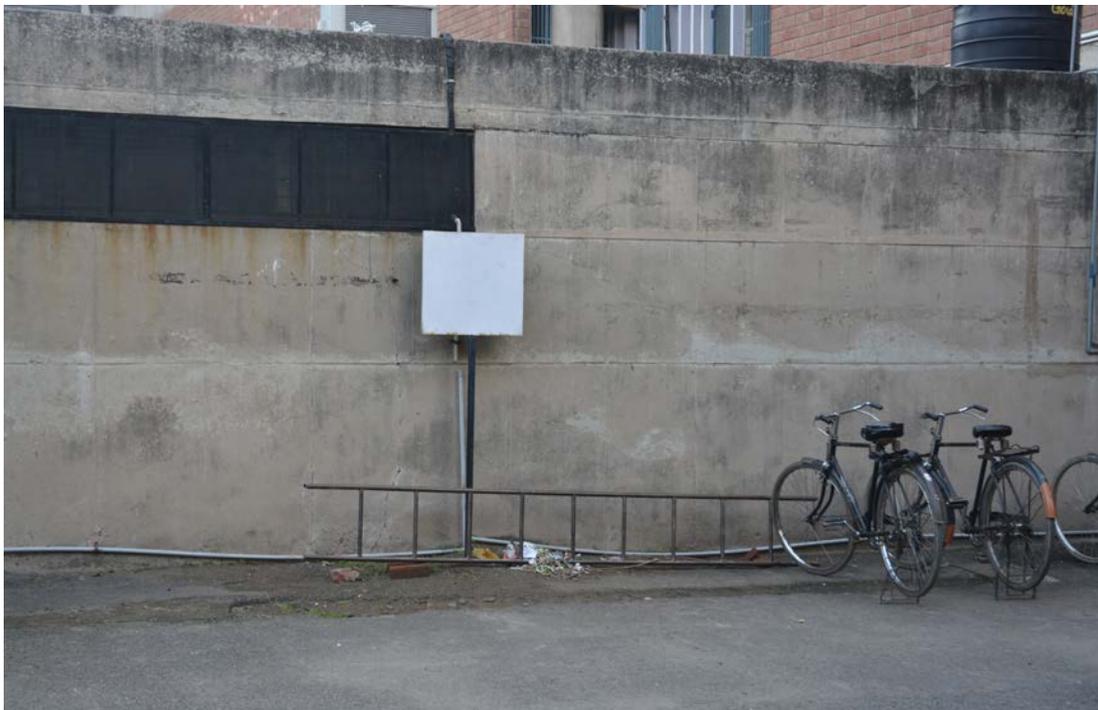
**FIGURE 3.36.**

Window grilles protect against external intruders outside of museum hours. During the 2020 visit, a ladder was found outside next to one of the terraces (fig. 3.36). This can allow a thief or vandal easy access to some of the terraces.

Equipment such as this ladder, lying next to the museum building, can facilitate access for intruders. © Fondation Le Corbusier. Photo: Annelies Cosaert, 2020, © J. Paul Getty Trust.
