Getty  
Conservation  
Institute

# Environmental Management at the Government Museum and Art Gallery, Chandigarh

## Analysis and Strategies

### Project Report

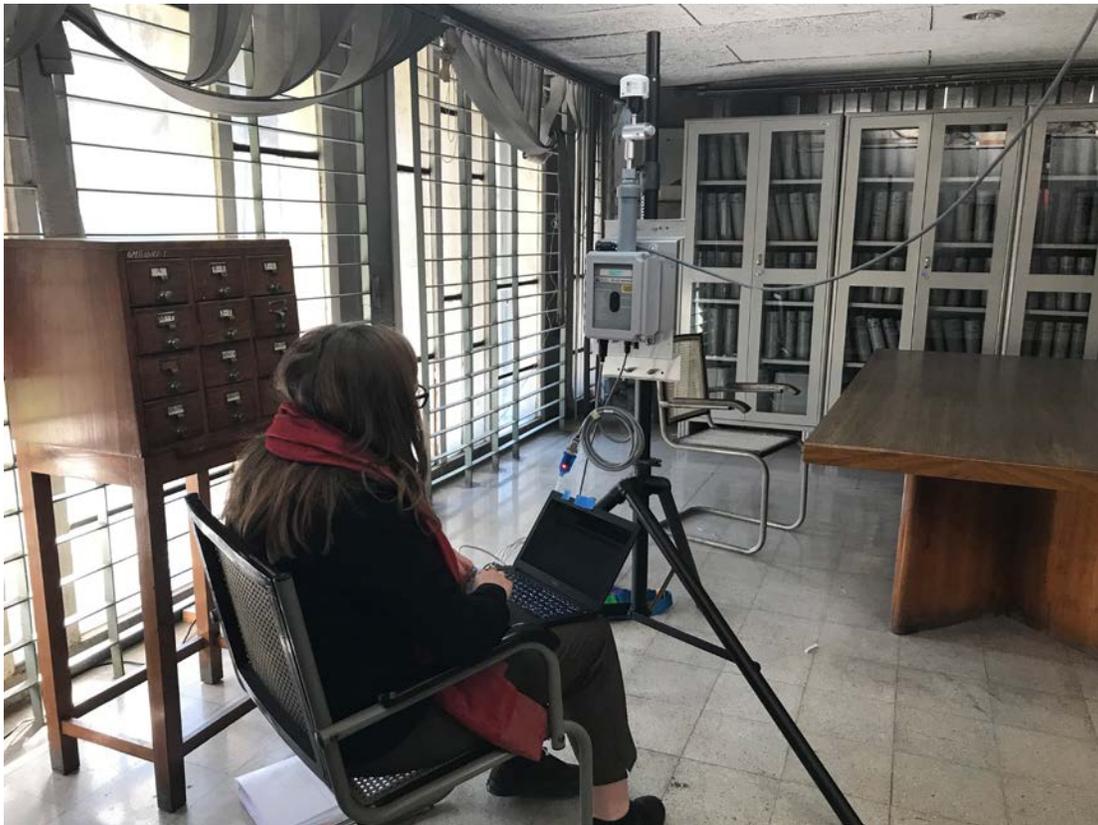
**FIGURE 4.1.**

Particulate data were collected in the library using a Met One Instruments ES-642 remote dust monitor equipped with a PM<sub>10</sub> sharp-cut cyclone inlet; the latter sets the size threshold to particulates with a diameter of 10 microns ( $\mu\text{m}$ ) or smaller. The instrument was mounted on a tripod and positioned within the library next to southeast-facing exterior windows (fig. 4.1). The dust monitor was connected to a HOBO RX3000 data logger in the library (CGMAG2) and collected data (units:  $\mu\text{g}/\text{m}^3$ ) at one-minute intervals. Retrieval of this particulate data occurred during periodic remote downloads from the HOBO RX3000 data logger.

*Met One Instruments ES-642 remote dust monitor positioned next to the southeast-facing windows in the library at the Government Museum and Art Gallery. © Fondation Le Corbusier. Photo: Vincent Laudato Beltran, 2020, © J. Paul Getty Trust.*

Particulate data were collected during museum visiting hours (roughly 10:00 to 16:30) from February 2020 to August 2021; the lack of data available during closed periods was due to a nightly electrical shutdown (note that the ES-642 was powered independently from the HOBO RX3000s in the library). Prolonged periods of missing data occurred from March to June 2020, July to August 2020, and April to June 2021.

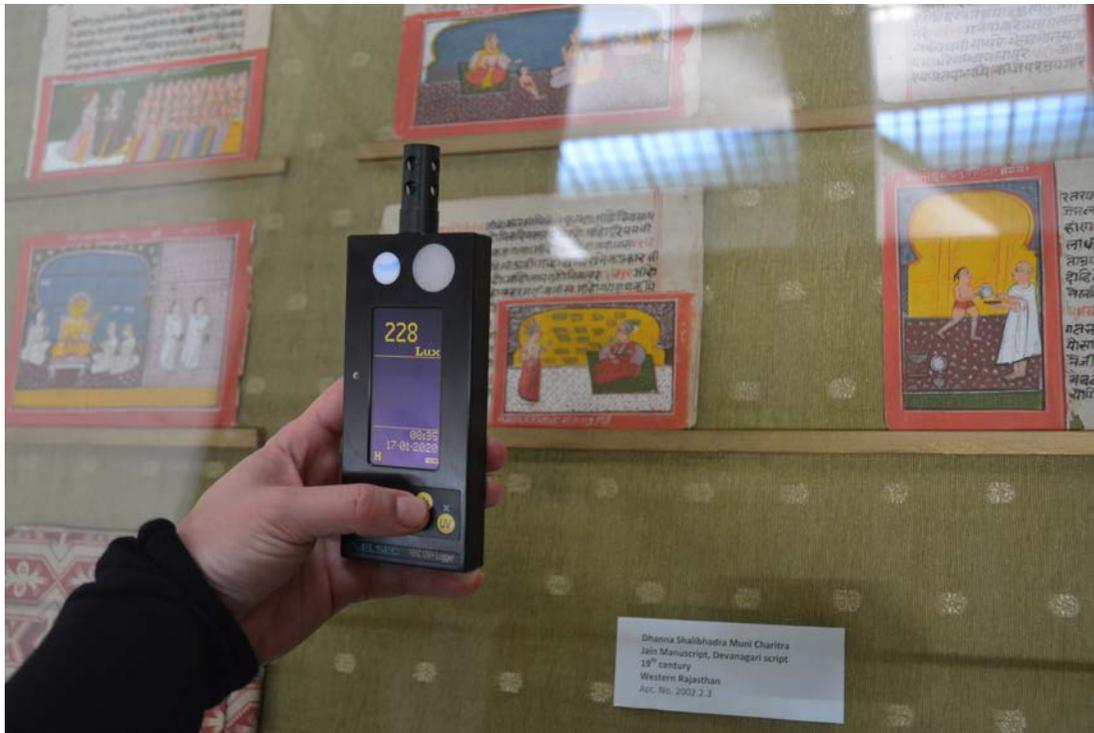
**FIGURE 4.3.** Measurement of visible and UV light in the Miniatures Gallery using an ELSEC 765 environmental monitor. Photo: Annelies Cosaert, 2020, © J. Paul Getty Trust.

Spot measurements of visible light (units: lux) and UV light (units:  $\mu\text{W}/\text{lumen}$ ) were taken with an ELSEC 765 environmental monitor (fig. 4.3). Data were collected between 11:00 and 14:00 from 13 to 19 January 2020. At each location, data were recorded orienting the sensor in five different directions, each corresponding to a letter: (a) facing upward, (b) facing southwest, (c) facing northwest, (d) facing northeast, and (e) facing southeast.

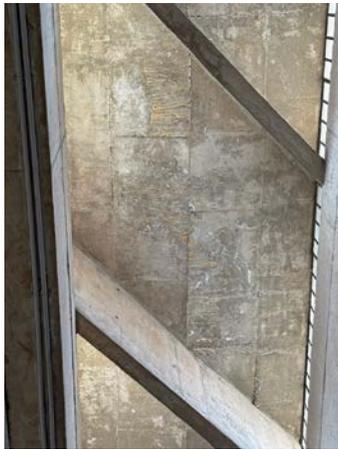
<p><b>FIGURE 5.B1.2.</b> Interior view of the underside of the clerestory roof, showing salt deposits likely caused by water percolation through the concrete slab. © Fondation Le Corbusier. Photo: Chandler McCoy, 2024, © J. Paul Getty Trust.</p>
<b>Supporting Actions Required</b> (supporting actions required to implement the strategy)	<p><b>Supporting Actions Required</b> Removal of existing roof membrane is likely to reveal concrete damage that must be repaired before the new roof system is installed.</p>

<b>Required Actions</b> (actions required to implement the strategy)	<p><b>Required Actions</b></p> <ul style="list-style-type: none"> <li>• Hire an architecture/engineering firm to specify and design a replacement roofing system that incorporates thermal insulation above the roof slab and an exposed surface with high reflectivity and high emissivity.</li> <li>• Based on the above specification and design, fund and implement the replacement of the existing clerestory roof.</li> </ul>

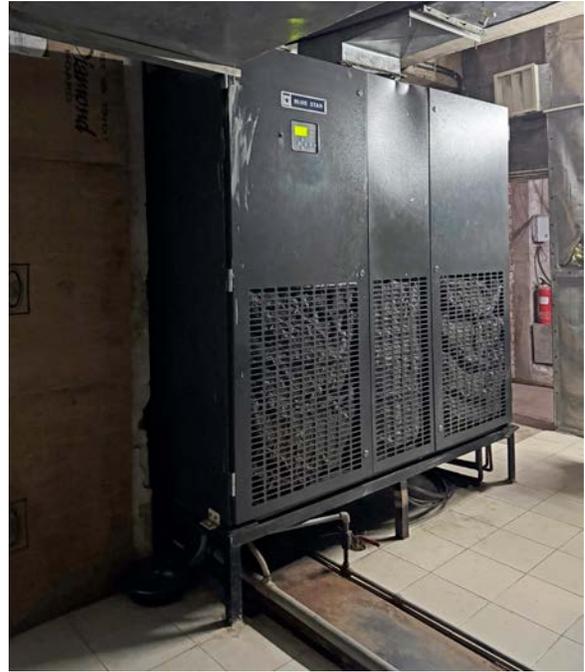
**FIGURE 5.M1.1.**

HVAC unit serving the collections storage room. © Fondation Le Corbusier. Photo: Chandler McCoy, 2024, © J. Paul Getty Trust.

- Engage an architect to survey the walls and ceiling of the storage room and to
  - design closures for any openings that permit entry of particulate or moisture vapor, and

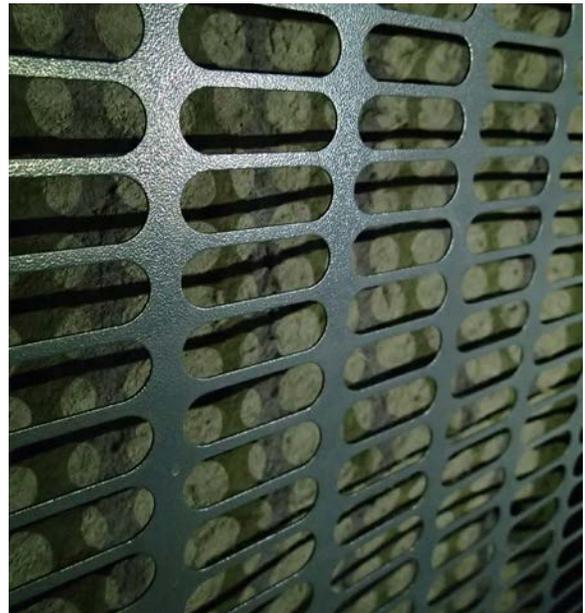
**FIGURE 5.M1.2.**

Heavily soiled air filter on HVAC unit serving the collections storage room. Photo: © Michael C. Henry, 2018.

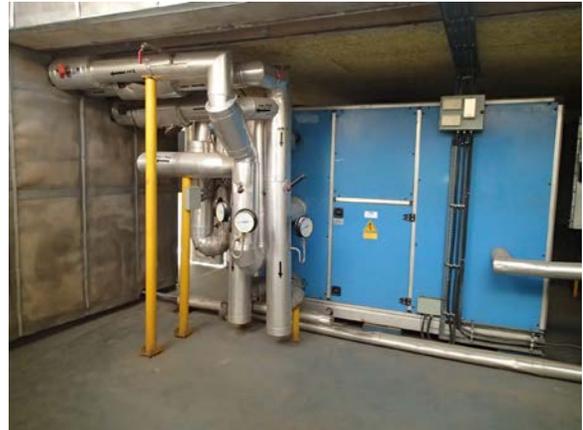
**FIGURE 5.M2.1.**

AHU serving the Miniatures Gallery in second-floor room adjacent to southwest terrace window. © Fondation Le Corbusier. Photo: © Michael C. Henry, 2018.

- Engage a highly qualified contractor to maintain and service the HVAC system on a regular basis and provide on-call emergency service if needed. The service contract should include system controls, chiller, AHU, piping, valves, filtration, condenser/cooling tower, and humidifier.
- Repair the HVAC system so that it is fully functional and operate it 24 hours/day, 7 days/week.
- Regularly service and test the emergency generator that powers the HVAC unit.
- Increase the frequency of filter replacement in the AHU. Verify that condensate pans and drains function and are free of standing water and mold.

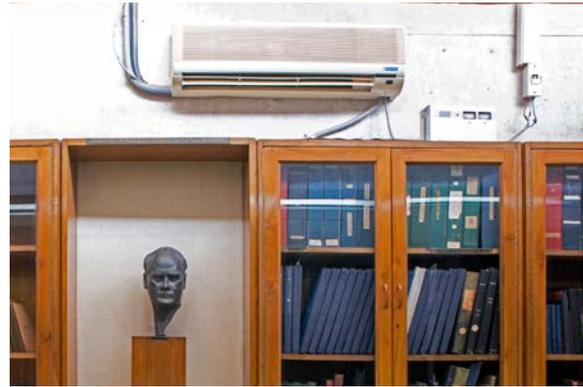
**FIGURE 5.M3.1.**

Fan coil air-conditioning unit and power-stabilizing units in the library. © Fondation Le Corbusier. Photo: Tim Webster, 2020, © J. Paul Getty Trust.

- Implement Extraction Fans Strategy (M4).
- Implement Cases Strategy (O1).
- Reposition library furniture away from aerators to allow for operation and airflow.

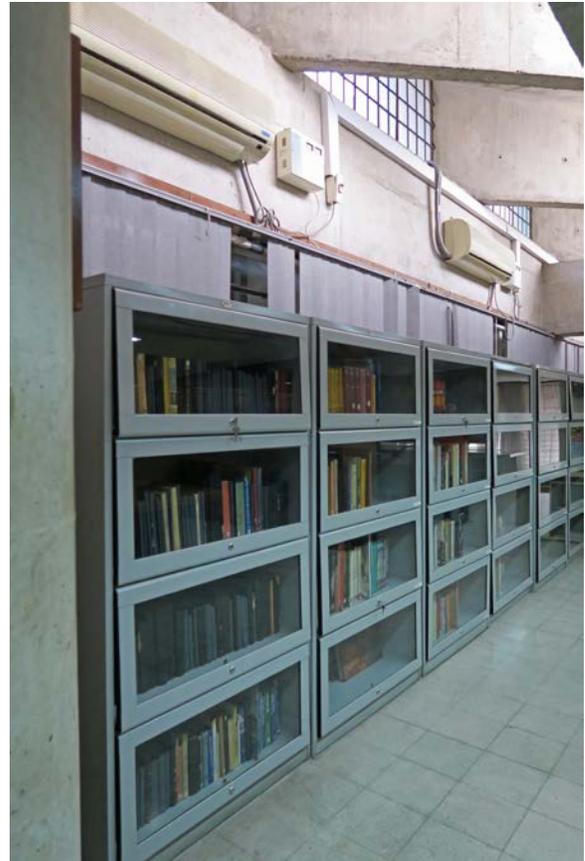
**FIGURE 5.M3.3.**

*Interior aerators blocked by library furniture. © Fondation Le Corbusier. Photo: Foekje Boersma, 2017, © J. Paul Getty Trust.*

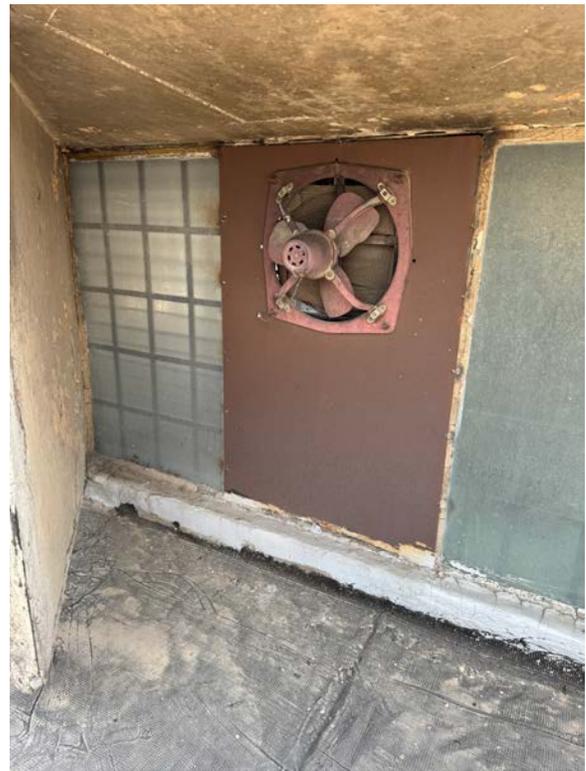
**FIGURE 5.M4.1.**

Existing exhaust fan in clerestory. © Fondation Le Corbusier. Photo: Chandler McCoy, 2024, © J. Paul Getty Trust.

- Engage an architect and an engineer to evaluate and design provisions for using existing extraction and adding more fans to improve the ventilation and seasonal temperature reduction of the Great Hall (fig. 5.M4.2), the first-floor galleries, and the second-floor spaces. Potential issues that must be addressed in the design process include airflow rate, physical size, security, water entry, noise, and electrical power.
- Fund and implement the installation of extraction fans.

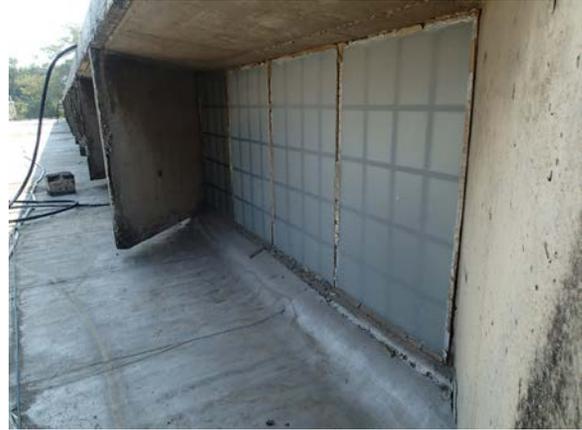
**FIGURE 5.B2.3.**

The distance between the bottom of the clerestory window frame and the top of the terrace concrete slab will limit the thickness of thermal insulation between the roof membrane and the concrete roof slab (fig. 5.B2.3).

*Exterior view of clerestory window at roof level. © Fondation Le Corbusier. Photo: © Michael C. Henry, 2018.*

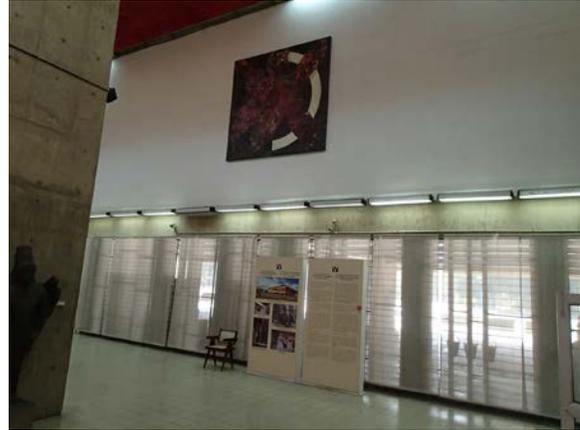
**FIGURE 5.B5.1.**

View of aerators in the Great Hall that are inaccessible due to window shades. © Fondation Le Corbusier. Photo: © Michael C. Henry, 2018.

- Relocate exhibition furniture that is blocking exterior and interior aerators so that airflow is not impeded.
- Operate aerators in exterior walls so that exterior air can be used to lower interior temperature in late pre-monsoon (June), monsoon (July to September), and early post-monsoon (October to November) seasons, provided that interior temperature is maintained at least 8°C higher than interior dew point temperature so that interior relative humidity does not exceed 70% (table 5.B5.1).
- Open second-floor interior aerators (for example, those between the library and the surrounding galleries) when exterior aerators are open. Open entry to Great Hall (doors, grilles, and/or operable glass panels) when

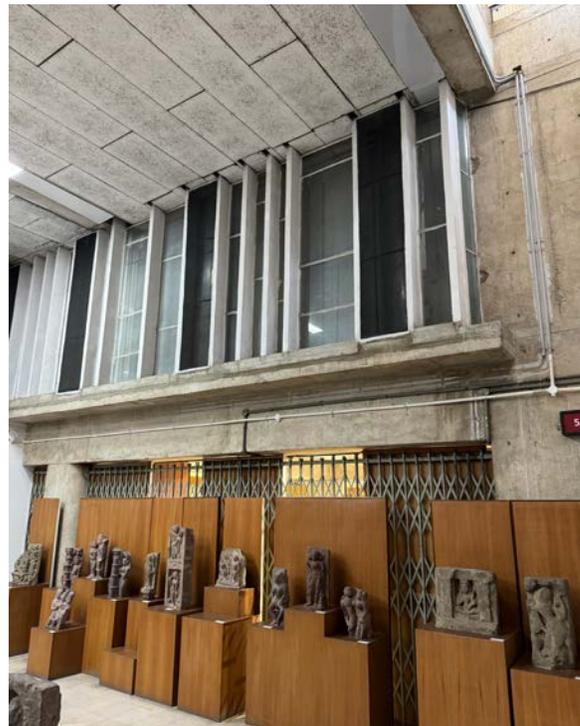
**FIGURE 5.B5.2.**

Grilles and exhibition furniture blocking airflow between the Medieval Sculptures Gallery and Metal Sculptures Gallery. © Fondation Le Corbusier. Photo: Chandler McCoy, 2024, © J. Paul Getty Trust.

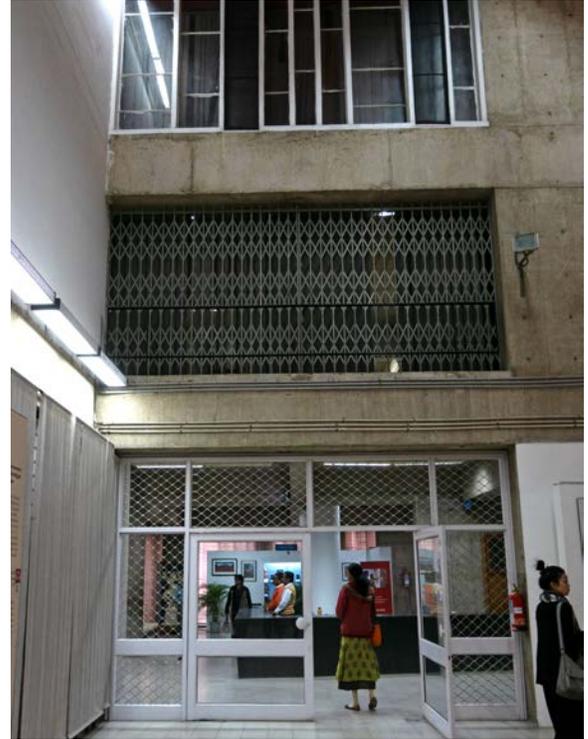
**FIGURE 5.B5.4.**  
View of glass doors at entry to the Great Hall on the ground floor; above, opening to the Medieval Sculptures Gallery blocked by grilles and exhibition furniture on the first floor. © Fondation Le Corbusier. Photo: Ana Paula Arato Gonçalves, 2018, © J. Paul Getty Trust.

For exterior and interior aerators and glass doors at Great Hall entry (fig. 5.B5.5):

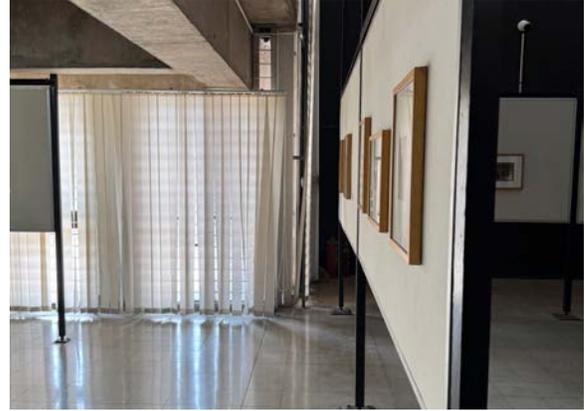
**FIGURE 5.B6.3.**

Vertical blinds at the southwest terrace window. © Fondation Le Corbusier. Photo: Chandler McCoy, 2024, © J. Paul Getty Trust.

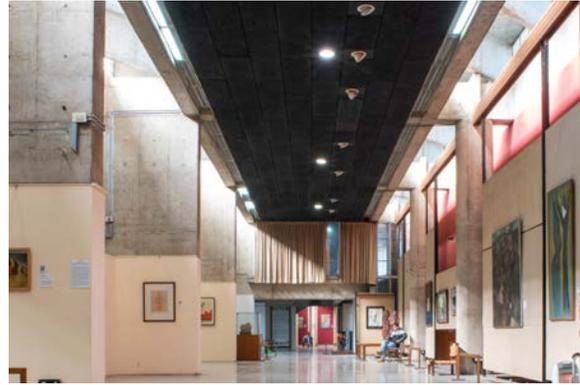
**FIGURE 5.B7.1.**

*View of Contemporary Art Gallery II, showing visible light entering through clerestory windows during winter.*

Direct sunlight enters through the clerestories in Contemporary Art Gallery II during winter, causing light damage to paintings and prints (fig. 5.B7.1).

- Hire an architect to develop a design for light baffles/deflectors or louvers to be installed at clerestory window level in Contemporary Art Gallery II to redirect strong winter sunlight away from collections (fig. 5.B7.2). This will require further measurements and study, such as creation of a digital model and/or a physical prototype to evaluate the visual impact of the baffle/deflector on the architectural significance of the space. The baffle/deflector may be fixed, or it may have features that require seasonal adjustment to account for sun angle and light intensity.
- Install light baffles/deflectors where needed after prototype development.

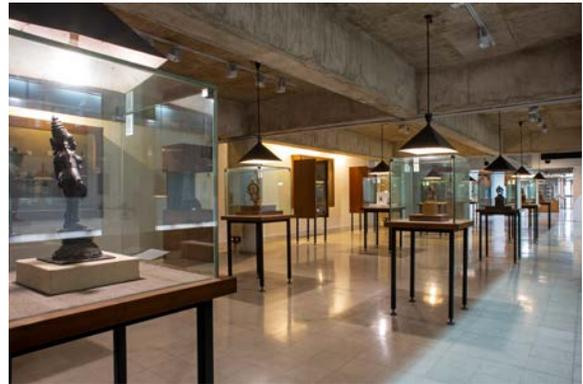
**FIGURE 5.B8.1.**

*Ceiling-mounted light fixtures over exhibit cases in the Metal Sculptures Gallery. © Fondation Le Corbusier. Photo: Tim Webster, 2020, © J. Paul Getty Trust.*

- Hire a museum lighting specialist to design and specify the work necessary to convert the lamps/bulbs of the existing light fixtures and lighted exhibition furniture to museum-quality light-emitting diode (LED) lamps with light levels appropriate to the collections on exhibit. The necessary work may include replacement of wiring, lamp/bulb holders, and switching. Reflectors may need modification for even light distribution, and exposed fixture surfaces may need restoration.
- If possible, the replacement LED lighting in the galleries should be equipped with dimmer controls to adjust illuminance levels according to the vulnerability of the collections.

- Museum staff will need to be trained in cleaning of fixtures, installation of replacement lamps, and operation of dimmer controls.
- Wiring and lamp holders for existing light fixtures should be examined for poor insulation and loose connections, which can pose a fire risk. Wiring and lamp holders should be replaced as needed.

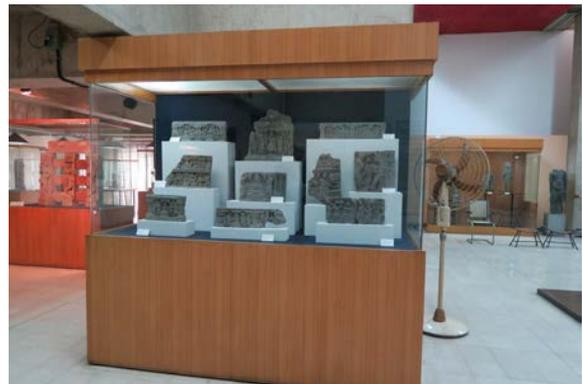
**FIGURE 5.B8.2.**

*Light fixture mounted in canopy of an exhibit case. © Fondation Le Corbusier. Photo: Foekje Boersma, 2017, © J. Paul Getty Trust.*

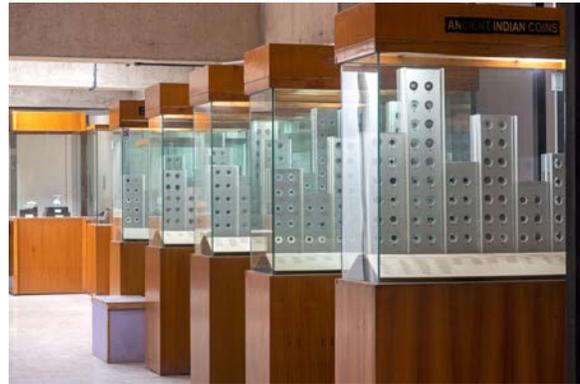
**FIGURE 5.O1.1.**

*Coins cases on display. © Fondation Le Corbusier. Photo: Tim Webster, 2020, © J. Paul Getty Trust.*

- Engage a designer to adapt existing cases to
  - improve airtightness of cases, especially those used for displaying metals and coins, to lower the air exchange rate;
  - improve operation;
  - replace plexiglass in the coins cases (fig. 5.O1.3) with polystyrene coin holders, for example; and
  - add silica gel trays inside cases.
- Adaptation of cases should
  - improve performance without negatively impacting cultural significance and
  - use only new materials (wood, boards, linings, and sealants) of archival quality.

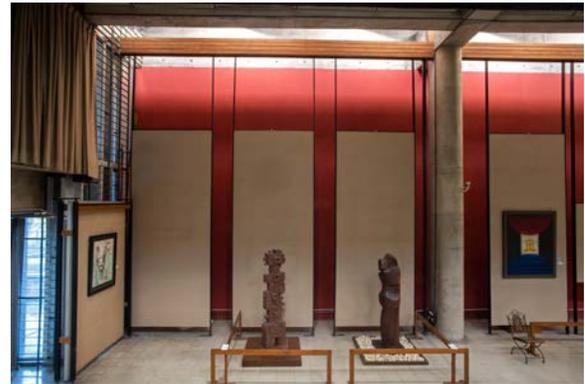
**FIGURE 5.O2.1.**

*Original freestanding panels on the northeast wall help avoid the risk of mold growth. © Fondation Le Corbusier. Photo: Tim Webster, 2020, © J. Paul Getty Trust.*

If paintings are hung directly on the northeast wall, the high humidity in the wall poses a risk of mold growth in the space between the canvas and the wall, created by the stretcher on the back of the painting. Using the existing freestanding panels helps to avoid this risk (fig. 5.O2.1). However, if it is necessary to hang paintings directly on the northeast wall, microclimate frames should be considered.

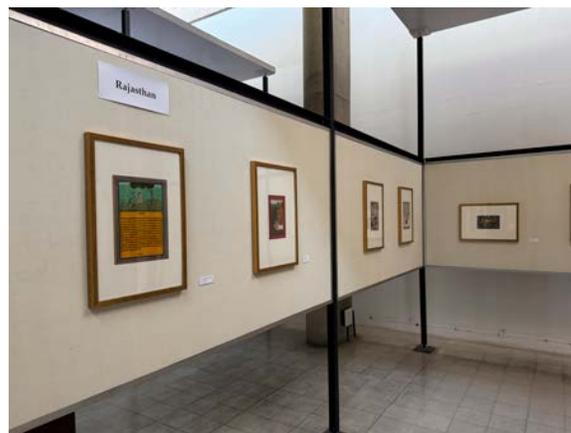
**FIGURE 5.O3.1.**

*Miniatures are the most valuable objects in the museum's collection and can be vulnerable to degradation from high temperatures. © Fondation Le Corbusier. Photo: Chandler McCoy, 2024, © J. Paul Getty Trust.*

To avoid the high temperatures that accelerate chemical degradation, works on paper that are of higher value should be exhibited in cooler seasons and kept in climate-controlled storage during hot seasons (fig. 5.O3.1). Another reason for object rotation is the incidence of direct sunlight on certain walls (fig. 5.O3.2).

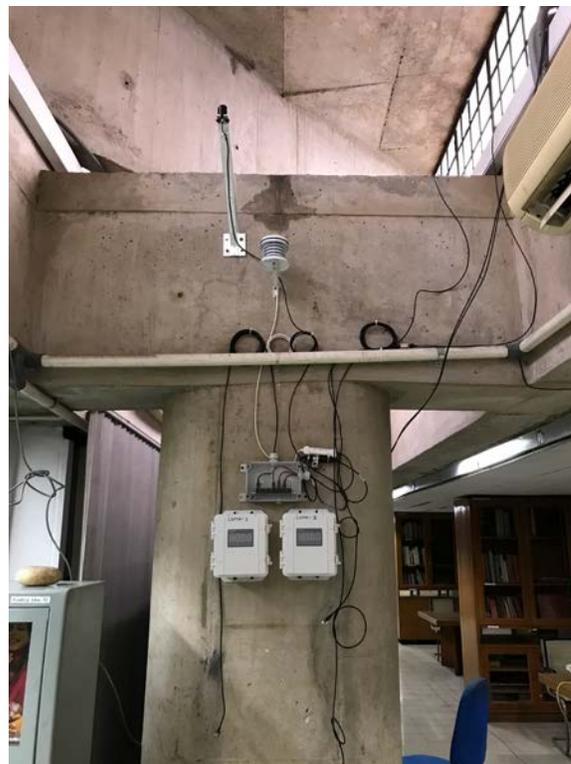
**FIGURE 5.MO1.1.**

Two Onset HOBO RX3000 remote monitoring stations located in the library. © Fondation Le Corbusier. Photo: Vincent Laudato Beltran, 2020, © J. Paul Getty Trust.

The environmental monitoring equipment installed at the Government Museum and Art Gallery by the GCI can be used for continuous monitoring of environmental conditions (figs. 5.Mo1.1, 5.Mo1.2). This is crucial for assessing the efficacy of the implemented strategies and guiding subsequent data-driven modifications. By using the same data collection system used by the GCI, museum staff will be able to make direct comparisons of past and future data that will inform future assessments of the efficacy of the implemented strategies. While the GCI has managed system maintenance and data interpretation up to this point, museum staff can be trained by the GCI to carry out these tasks independently.

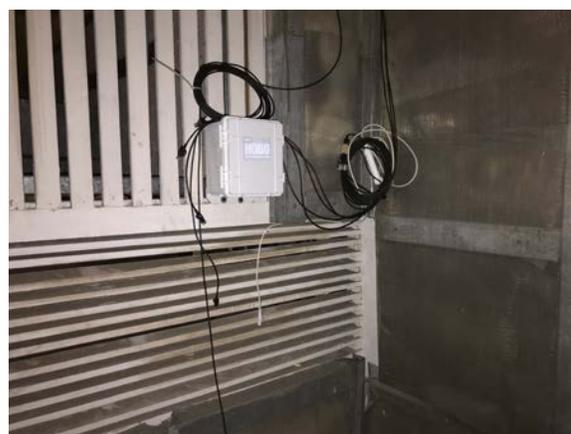
**FIGURE 5.MO1.2.**

An Onset HOBO RX3000 remote monitoring station located in the mechanical room adjacent to the Miniatures Gallery. © Fondation Le Corbusier. Photo: Vincent Laudato Beltran, 2020, © J. Paul Getty Trust.

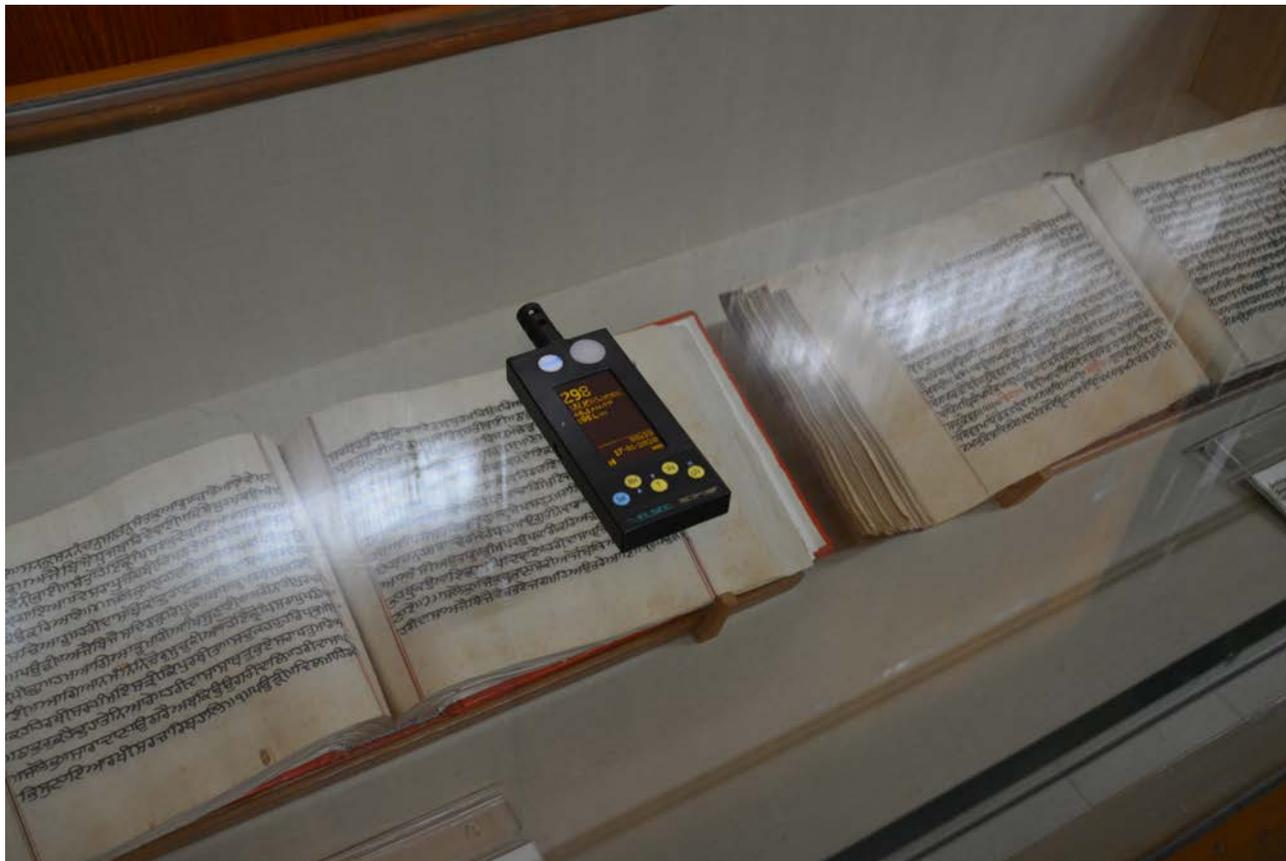
**FIGURE B.1.**

An ELSEC 765 environmental monitor for spot reading of UV (lumen) and visible light (lux) of the natural light. Photo: Annelies Cosaert, 2020, © J. Paul Getty Trust.

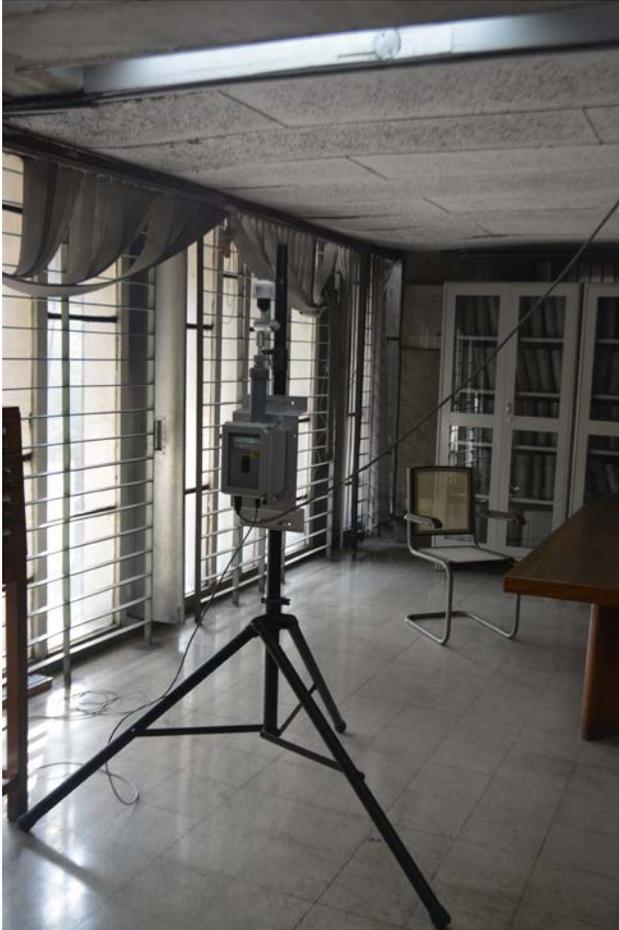
**FIGURE B.2.**

*A Met One ES-642 remote dust monitor, connected to the HOBO RX3000 monitoring station. © Fondation Le Corbusier. Photo: Annelies Cosaert, 2020, © J. Paul Getty Trust.*

Method: remote dust monitor (fig. B.2) and Corrosion Classification Coupons (see fig. 4.2).

- Stabilizers (fig. B.4) were put in place and connected to all electrical equipment, including HOBO RX3000 data loggers (CGMAG1, CGMAG 2, and CGMAG 3) and a pollution monitor (6.01).
- A remote dust monitor equipped with a PM<sub>10</sub> sharp-cut cyclone inlet (6.01) was installed and connected to the HOBO RX3000 data logger (CGMAG3).
- Sensor height was adjusted if within visitors' reach (from 1.6 m to 3.2 m [5 ft 3 in. to 10 ft 6 in.]), and rubber was trimmed off surface temperature sensors (1.09, 2.02, and 3.03).
- Weather station adjustments were made as recommended by Henry and Laudato Beltran.
- Two wireless internet routers were installed (one in the library and the other in the mechanical room).

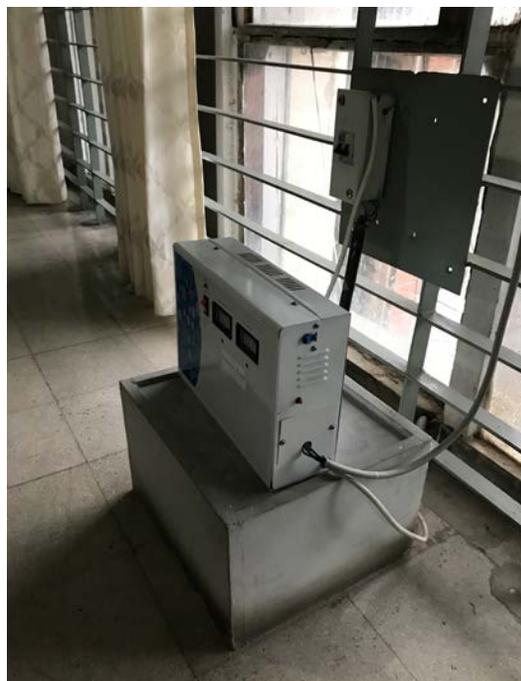
**FIGURE B.4.**

A stabilizer used to control input current to electrical equipment (HOBO RX3000 and dust monitor). © Fondation Le Corbusier. Photo: Vincent Laudato Beltran, 2020, © J. Paul Getty Trust.

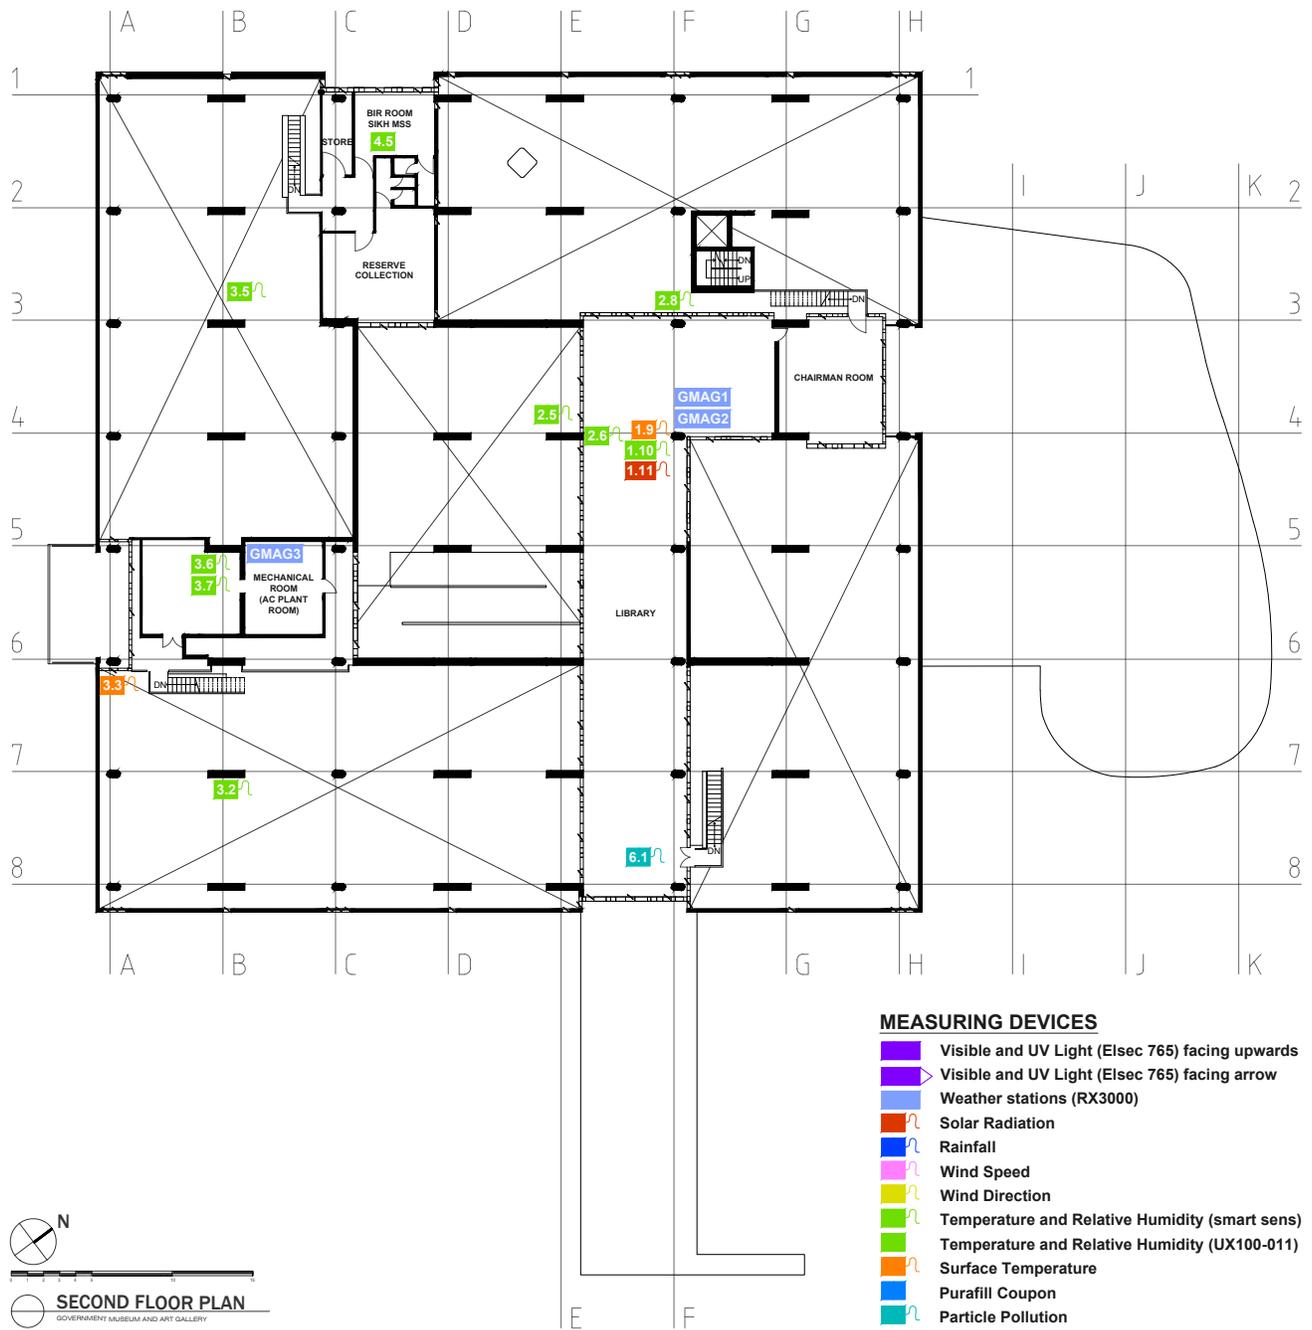
**FIGURE C.3.**

Second-floor plan of the Government Museum and Art Gallery, showing location of sensors. © Fondation Le Corbusier. Drawing: DRO-NAH, modified by Timothy Augustus Y. Ong and Hongye Wang. Image © J. Paul Getty Trust.
