Research on the Upgrade of Traditional Seismic Retrofits for Ancient Buddhist Temples in the Region of Spiti and Kinnaur in the Western Himalayas

Sandeep Sikka and Charu Chaudhry

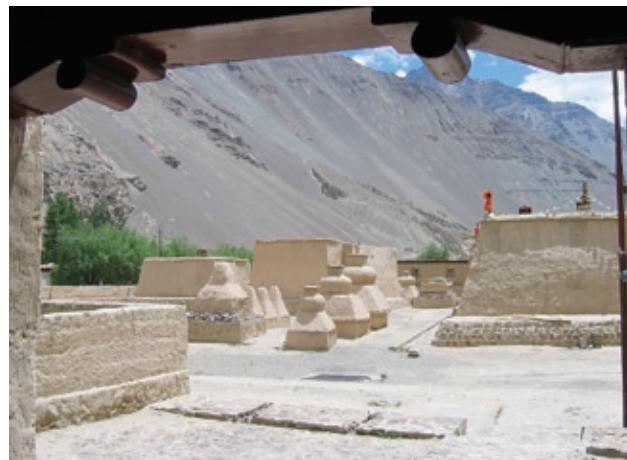
FIGURE 1 The tapered load-bearing adobe walls at a temple in Spiti provide extra stability to the building during seismic vibration.

Buddhist temple design is characterized by rectangular spaces with carefully designed structural members, the result of years of trial and error under extreme climatic conditions and natural disasters. The walls of these historic structures are made of adobe—large, sun-dried mud brick laid in mud mortar. The foundations of rubble-stone masonry generally rest on stable solid ground.¹ The thickness of the walls varies from 2.5 ft. (0.76 m) to about 5 ft. (1.52 m) in some of the early-period structures. A survey of some twenty-five ancient earthen structures in the region reveals that the ratio of the height (h) of the single story to the thickness of the adobe walls (t) lies within the recommended safe limits of $t > h/8$ of the modern Indian seismic code for earthen structures (Bureau of Indian Standards 1993). Vertical measurements show that sometimes the outer faces of the walls are slanted, so that the wall thickness is wider at the base and gradually tapers to the top, providing extra stability to these tall and flexible structures (fig. 1).

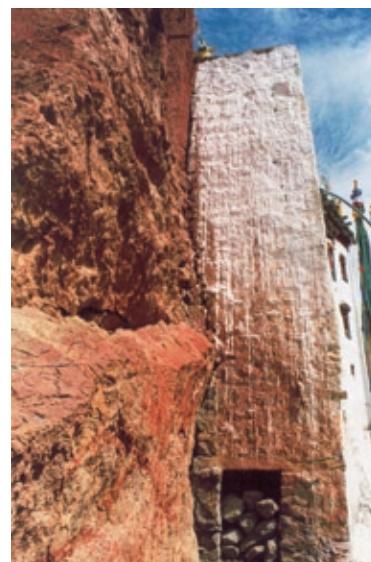
FIGURE 4 Vertical structural crack between buildings and the adjacent hill. This significant detachment was caused by the earthquake.

from the point of anchorage into the adjacent hill, causing major vertical structural cracks (fig. 4).⁴ The process has left the building extremely vulnerable and defenseless to withstand any further seismic vibration.

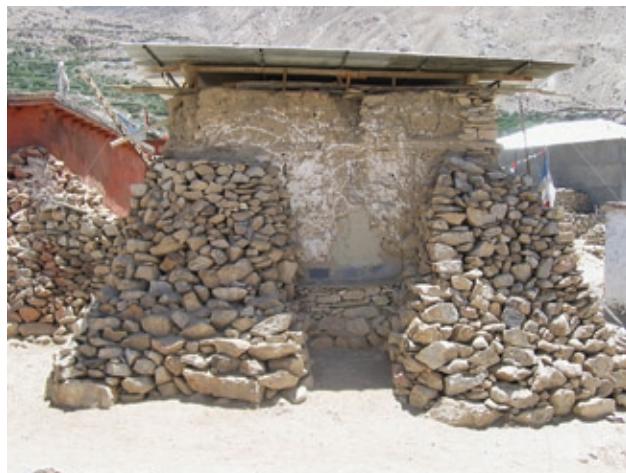
FIGURE 5 Piles of rubble stones stacked against the corners of the buildings after an earthquake in Nako village, to serve as buttresses to halt further outward movement of the masonry walls.

Immediately after the earthquake of 1975, local residents responded to the building movements and structural cracks by instituting remedial measures. The corners of the buildings, which had separated because of the outward movement of the walls, were either filled and stitched with rubble stone masonry, or they were supported externally with piled stone (fig. 5). The piles of stones acted as buttresses to halt further outward movement of the load-bearing walls. The rubble stone buttresses at the temples in the upper Kinnaur village of

Nako are not coherent, and since they were added later, they are not interwoven with the load-bearing walls. During an earthquake, the rubble stone buttresses vibrate independently of the main structure because of the lack of cohesive bonding between the buttresses and the walls. This might eventually cause damage to the outer surface of the adobe wall. Furthermore, the buttresses at the Nako Temple trap moisture inside the gap between the walls and the rubble stone buttresses. The moisture eventually seeps into the walls, causing several other problems of masonry deterioration. Similar adobe or dressed stone buttresses were added to the historic earthen structures at Tabo in Spiti.⁵
