# Conservation of the Architectural Surfaces in the Tablinum of the House of the Bicentenary, Herculaneum

Phase I: Examination, Investigations, and Condition Assessment

## Project Report

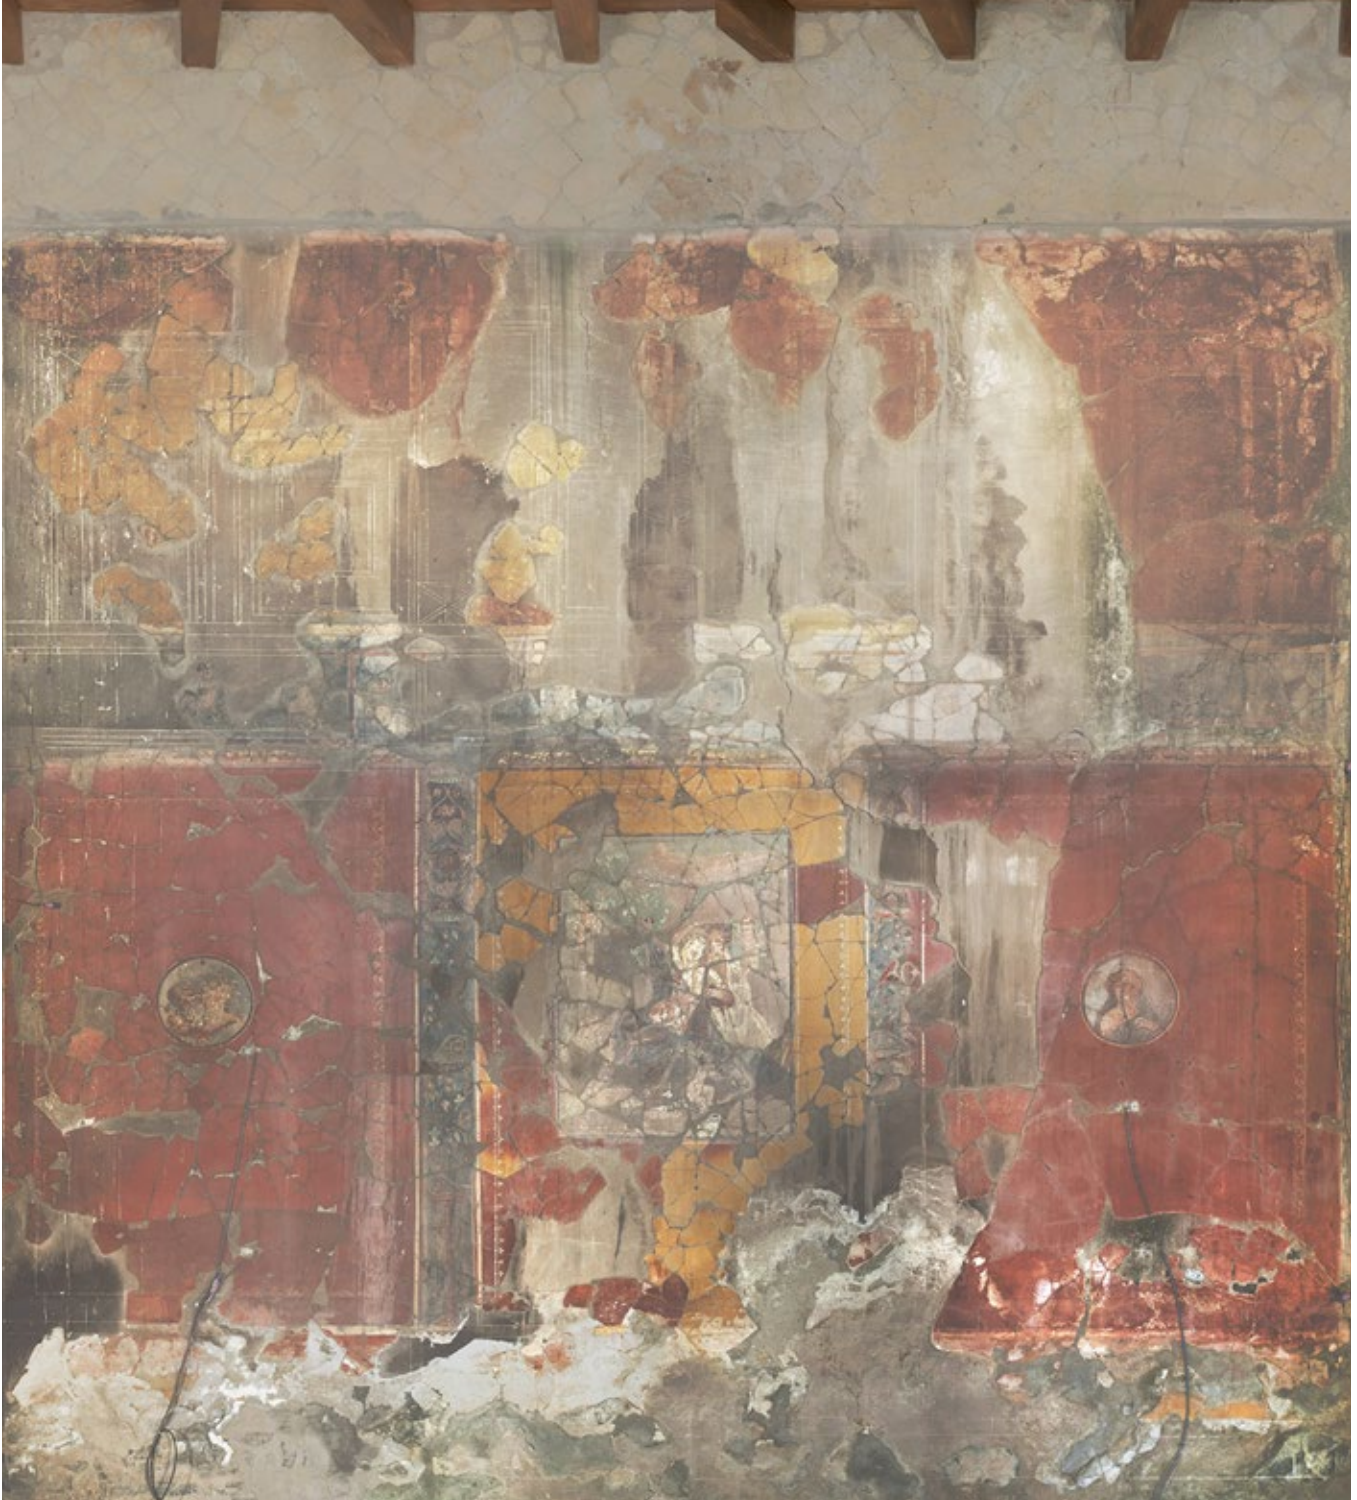
**FIGURE 1.8.**  
East wall of the tablinum of the  
House of the Bicentenary (2011).  
(Photo: Massimo Brizzi)

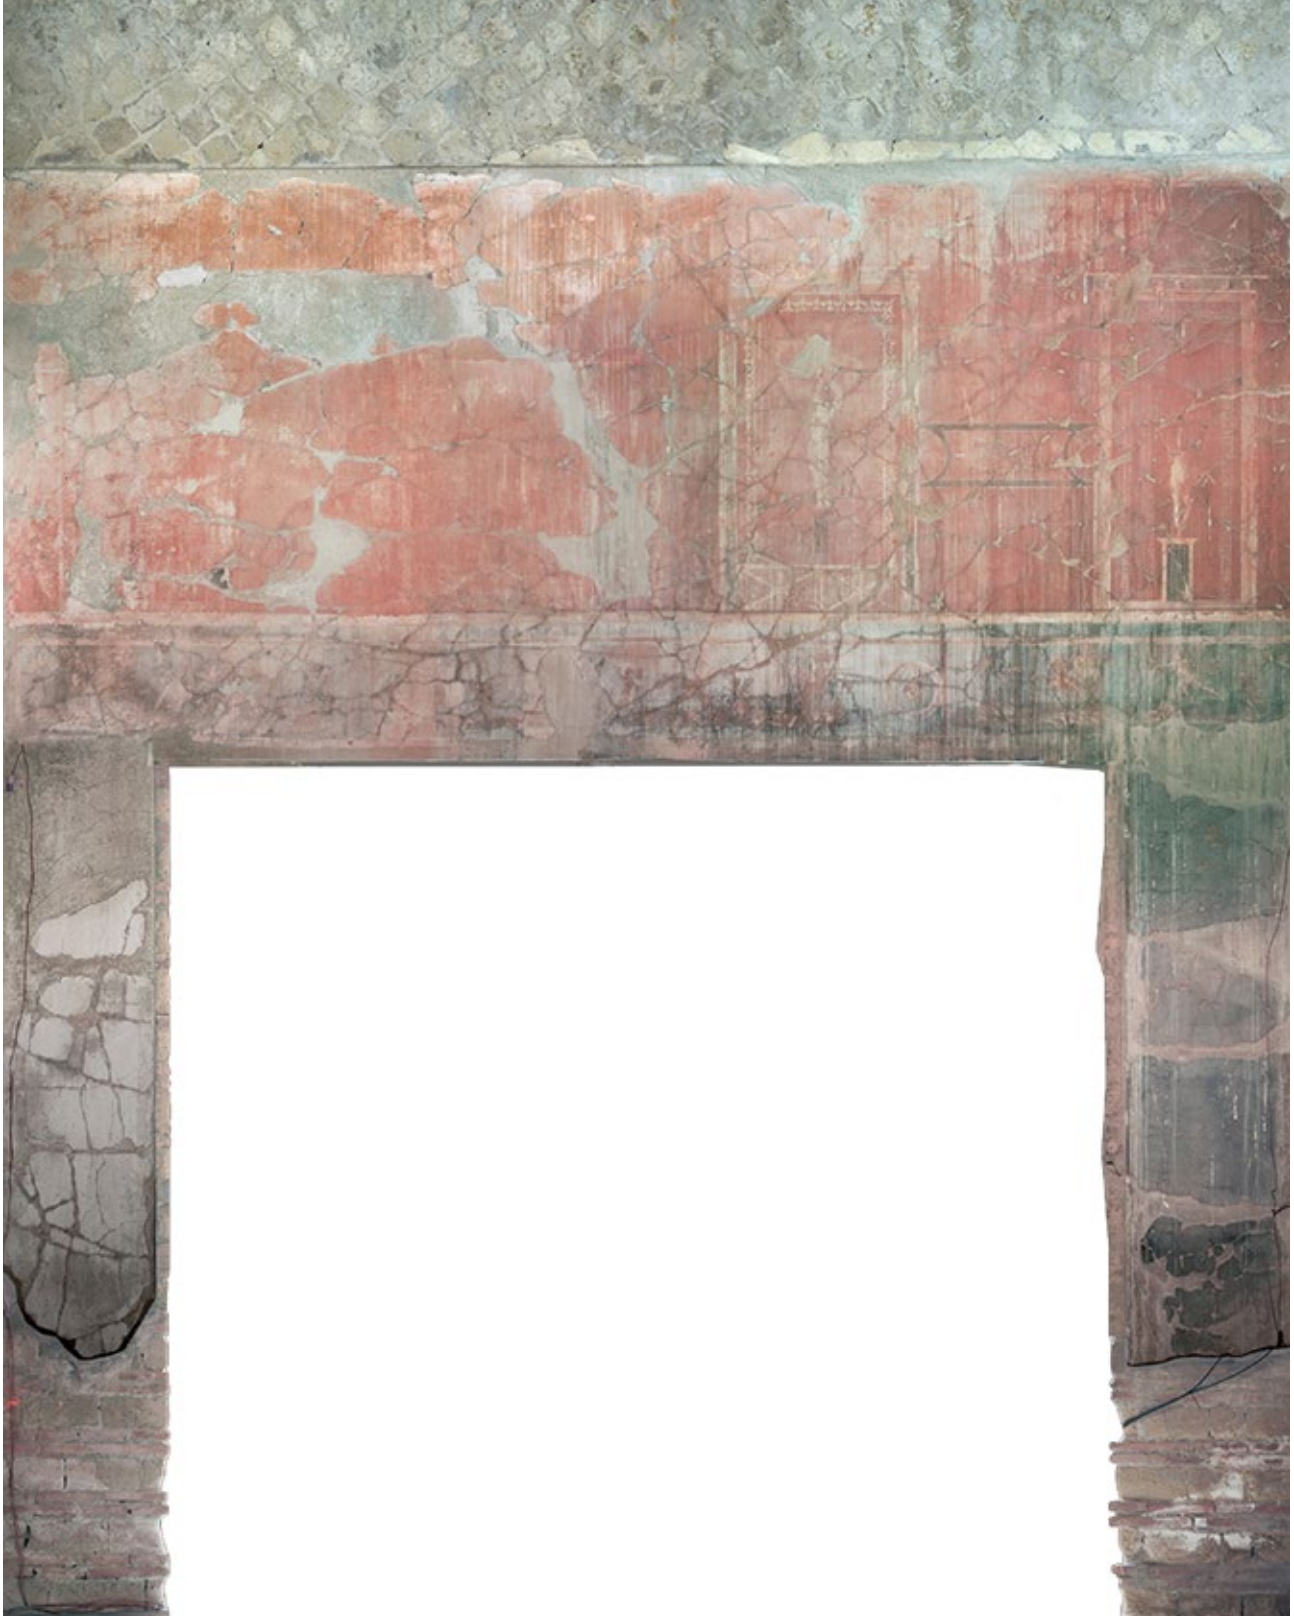
**FIGURE 1.9.**  
South wall of the tablinum, 2011.  
(Photo: Massimo Brizzi)

<p><b>7. Upper walls</b></p> <ul style="list-style-type: none"> <li>Surface coating(s)</li> <li>Paint layer(s)</li> <li>Monochrome background (red/yellow)</li> <li>White lime plaster with crushed marble</li> <li>Gray lime plaster layers with volcanic sand</li> </ul>	<p><b>8. Base of wall</b></p> <ul style="list-style-type: none"> <li>Surface coating(s)</li> <li>Paint layer(s)</li> <li>Monochrome background (black/red/yellow)</li> <li>Gray fine lime plaster with crushed marble</li> <li>Gray coarse lime plaster layers with volcanic sand</li> </ul>	<p><b>9. Lower South wall</b></p> <ul style="list-style-type: none"> <li>Surface coating(s)</li> <li>Paint layer(s)</li> <li>Monochrome background (black/red/yellow)</li> <li>Gray lime plaster layers with volcanic sand and crushed brick</li> </ul> <p>Lower south wall not pictured above. See figure 1.9 for reference.</p>

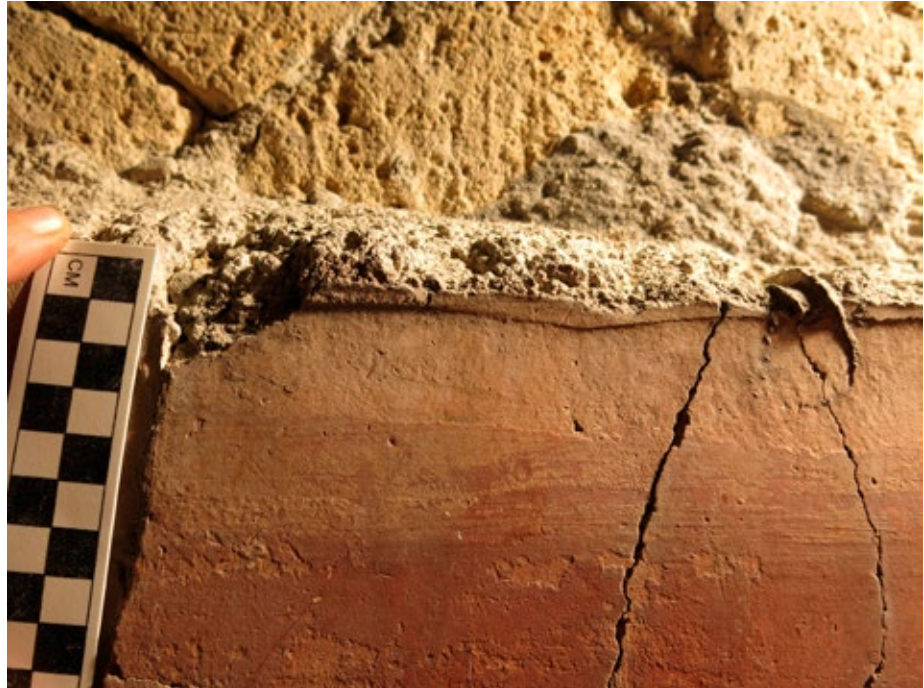
FIGURE 1.12.

Upper border of the east wall, showing a slight curvature and lip of plaster with traces of stucco attachments, where a cornice would have been applied.

The plaster along the upper edge of the wall paintings ends with a curvature and has traces of stucco attachments, indicating the presence of a cornice (fig. 1.12). The ceiling is no longer extant but was likely decorated with polychrome stuccoes, as is commonly seen in other houses at Herculaneum and in the Vesuvian region.

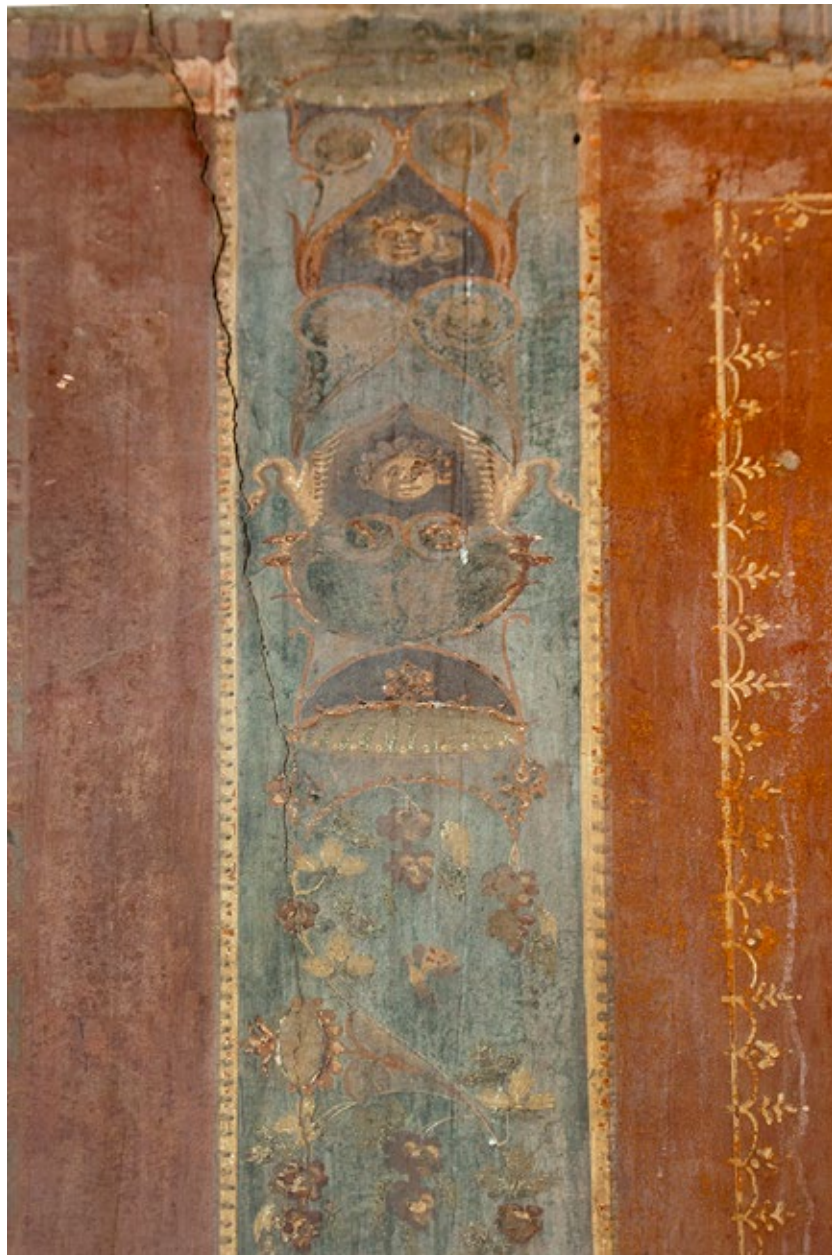
FIGURE 1.20.

Detail of one of two vertical bands dividing the lower register of the east and west walls, showing grotesque decoration painted on a black background.

Two vertical bands, both with black backgrounds, divide the lower register of the east and west walls. The bands are richly painted, showing candelabra and spiraling foliage from which vines branch off, ending in flowers and griffins. The branches have an S shape and are transformed at the top into complex arabesques with shells, swans, masks, and stylized dolphins (fig. 1.20).

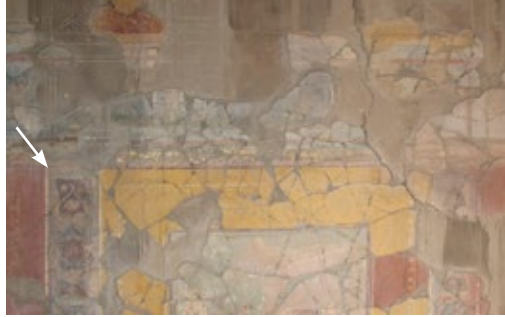
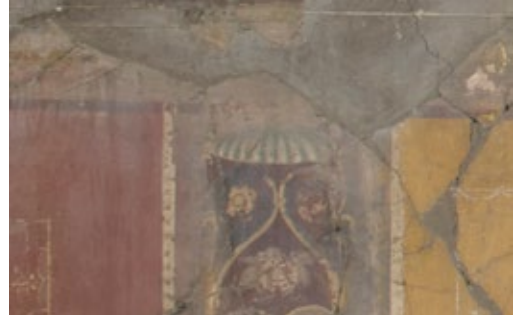
**FIGURE 1.22A (UPPER LEFT),  
DETAIL (UPPER RIGHT).**

Vertical bands on the east wall terminate at the lower edge of the frieze. Detail on right shows the lower edge of the frieze continuing above the vertical band.

An egg-and-dart motif concludes the decoration along the bottom of the frieze. On the west wall, the egg-and-dart motif is interrupted by the top of the vertical bands, which extend up to the lower edge of the frieze band (figs. 1.22a and 1.22b).

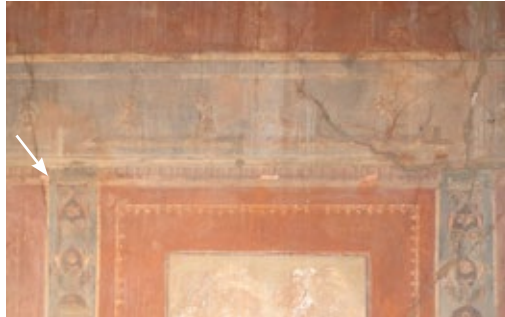
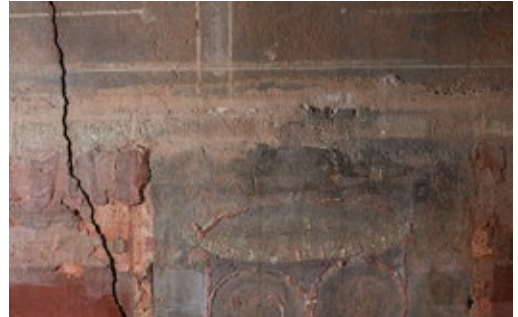
**FIGURE 1.22B (LOWER LEFT),  
DETAIL (LOWER RIGHT).**

Vertical bands on the west wall extend into the frieze, and the egg-and-dart motif is interrupted in this area. Detail on right shows the egg-and-dart motif stopping at the edge of the vertical band, and the top of the decoration of the vertical band extending up through this area.

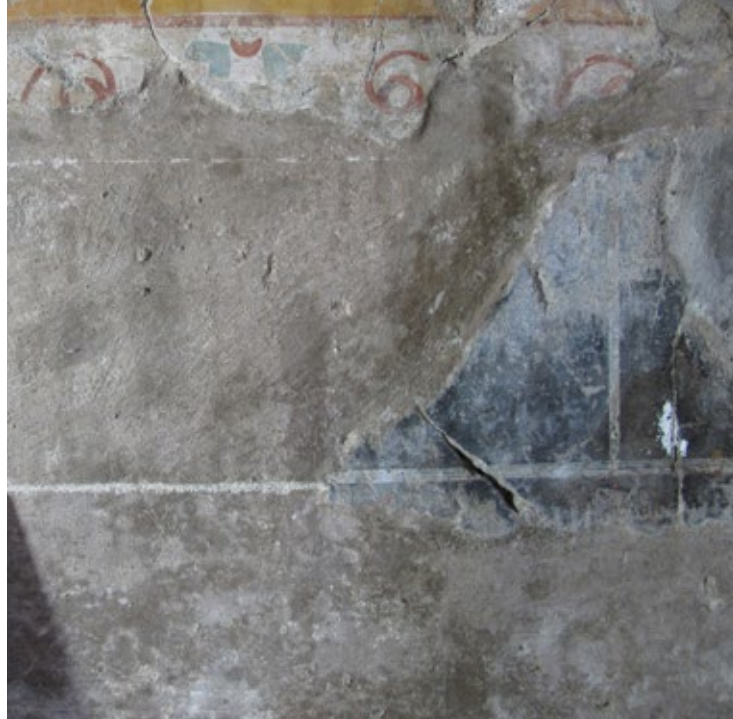
**FIGURE 1.24.**

The base of the wall remains intact only in the southeast corner of the east wall, where traces of a black background can be seen. Over this, geometric and floral decorations are applied, with a yellow-to-red band along the top separating the base of the wall from the lower section.

The base of the walls, extant only on the east wall but fragmentary and largely deteriorated, appears to have a band of black with white lines along the very base of the wall, to imitate masonry and, as described by Maiuri, blue lozenges. Above the black base is a horizontal band decorated with floral motifs, and above this is a horizontal band of color, which is yellow at the south end of the room and red at the north, another indication of yellow converted to red (fig. 1.24).<sup>18</sup>

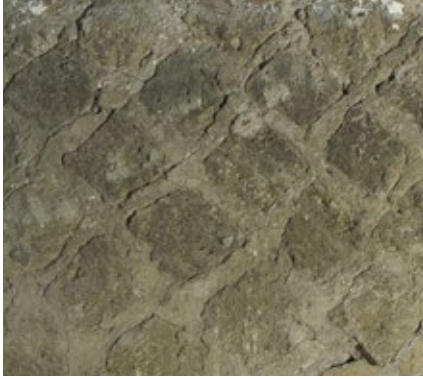
**FIGURE 1.25.**  
Original wall construction of tuff blocks in *opus reticulatum*, an original Roman construction technique in which blocks were placed in a diagonal linear pattern seen along the top of the walls.

The walls of the tablinum were originally constructed of tuff<sup>21</sup> blocks in *opus reticulatum*<sup>22</sup> on the east and west walls and the upper south wall (fig. 1.25). During excavation and reconstruction, walls were either stabilized where possible or demolished and reconstructed. While there is no specific documentation recording which walls were reconstructed or retained, Maiuri made a clear effort to distinguish areas retaining their original wall support from reconstructed wall sections by using similar tuff blocks, but with a different technique of *opus incertum* in place of the original construction in *opus reticulatum*<sup>23</sup> (fig. 1.26). The masonry of the south wall pilasters differs and is in *opus vittatum* (*opus mixtum*)<sup>24</sup> (fig. 1.27).

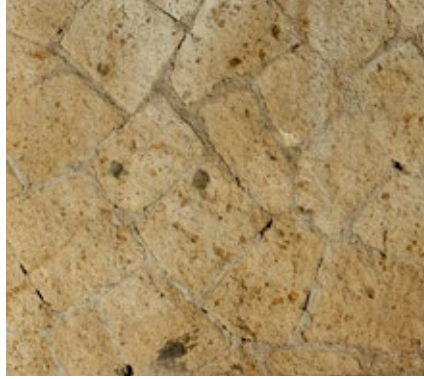
**FIGURE 1.26.**  
Example of 1938 construction technique using *opus incertum*, in which blocks were placed following no regular pattern.

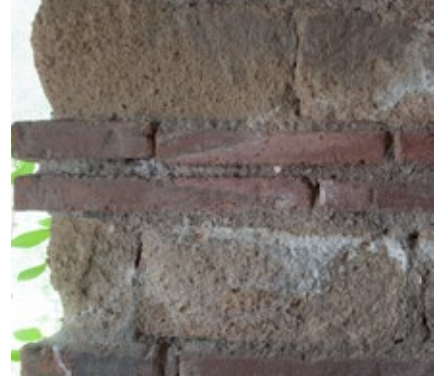
**FIGURE 1.27.**  
View at the base of the south wall, showing the original wall construction in *opus vittatum*, alternating layers of tuff blocks and bricks.

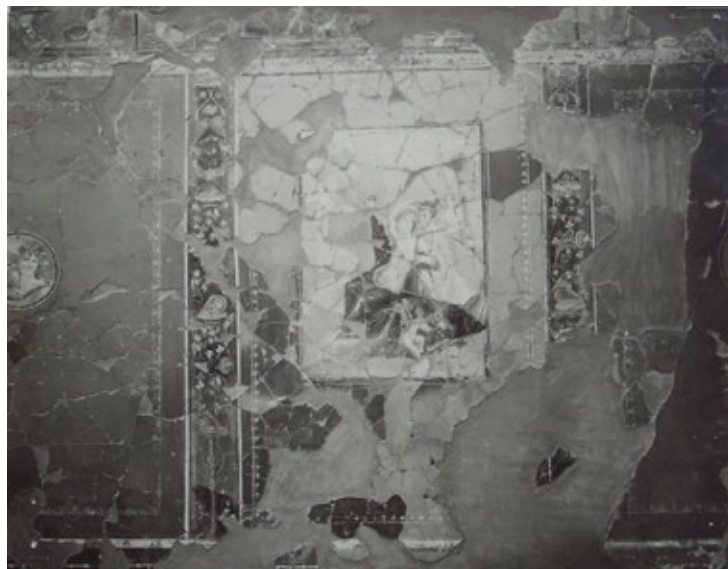
**FIGURE 1.28.**  
View of east wall of tablinum. The wall paintings in the tablinum are a complex system of original paintings and restoration plasters as reconstructed by Maiuri and his team to provide a complete design scheme. (Historical Archives of the Soprintendenza Pompei, Maiuri, C2782)

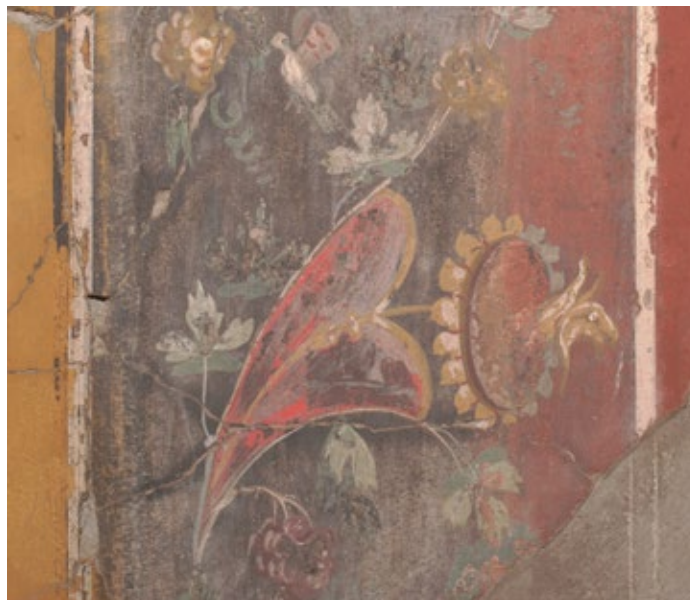
FIGURE 1.32.

Detail of a vertical band on the east wall, showing the range of colors used in the execution of the wall paintings, including white, yellow and red ocher, cinnabar, green earth, Egyptian blue, black, and other pigment mixtures, as well as the alteration of cinnabar to a dark brown.

The paintings were originally executed in a mixed technique over gray, white, or tinted plaster layers, with colors applied as monochrome blocks in the fresco technique, and decorative elements and figurative paintings applied likely in the *secco* technique using pigments mixed with a binder.<sup>37</sup> Although an exhaustive study of the different pigments used has not been carried out, the palette is composed of recognized pigments commonly used in Roman painting.<sup>38</sup> The presence of a number of pigments has been suggested on the basis of non-invasive investigation and material analysis, including lime (white), yellow and red ocher, cinnabar, green earth, Egyptian blue, and carbon black.<sup>39</sup> There has been some alteration of colors, as seen in the conversion from yellow to red ocher and in areas of cinnabar, which have changed from a brilliant red to a dark brown, as seen on one of the vertical bands on the east wall (fig. 1.32).

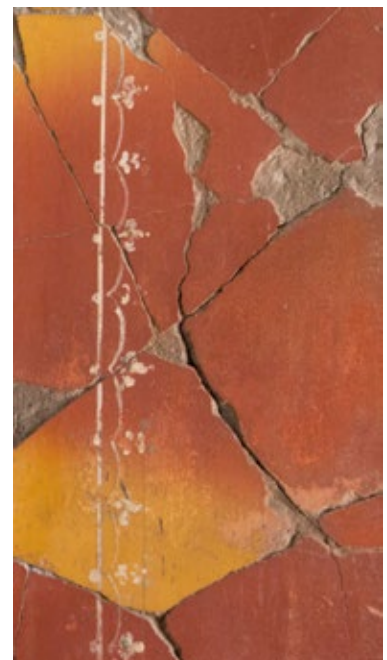
**FIGURE 1.35 (RIGHT).**  
Alteration of yellow to red on individual pieces of plaster, indicating a transformation of yellow ochre to red oxide due to the heat of the eruption of Mount Vesuvius in 79 CE.

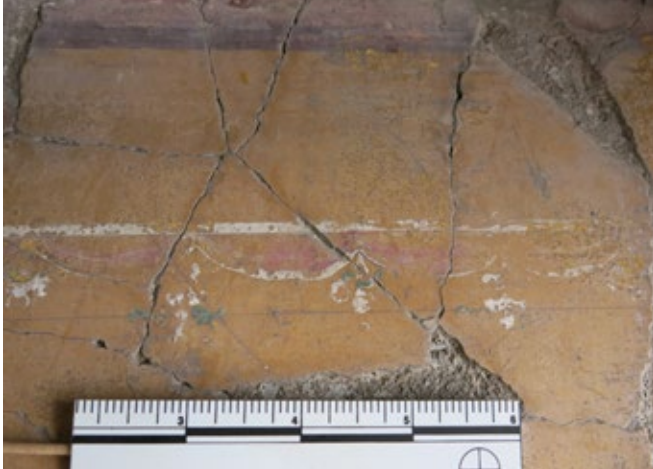
FIGURE 1.36A.

Detail of the decorative border, east wall, over a yellow background with traces of red (identified as cinnabar) in the semicircles.

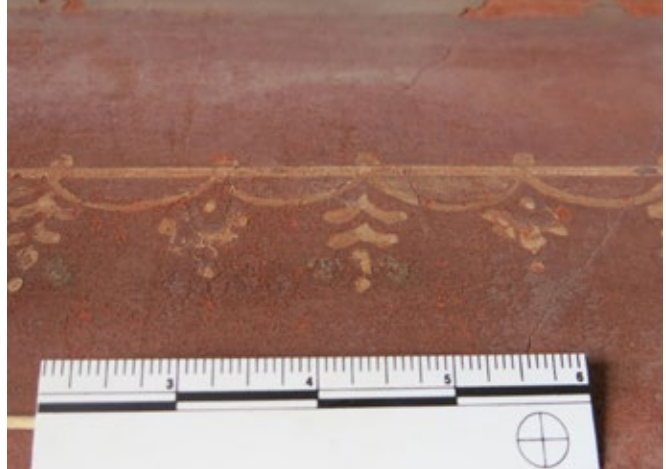
FIGURE 1.36B.

Detail of the corresponding decorative border, west wall, over a red monochrome background altered from yellow, with traces of color (likely cinnabar turned gray-white) in the semicircles.

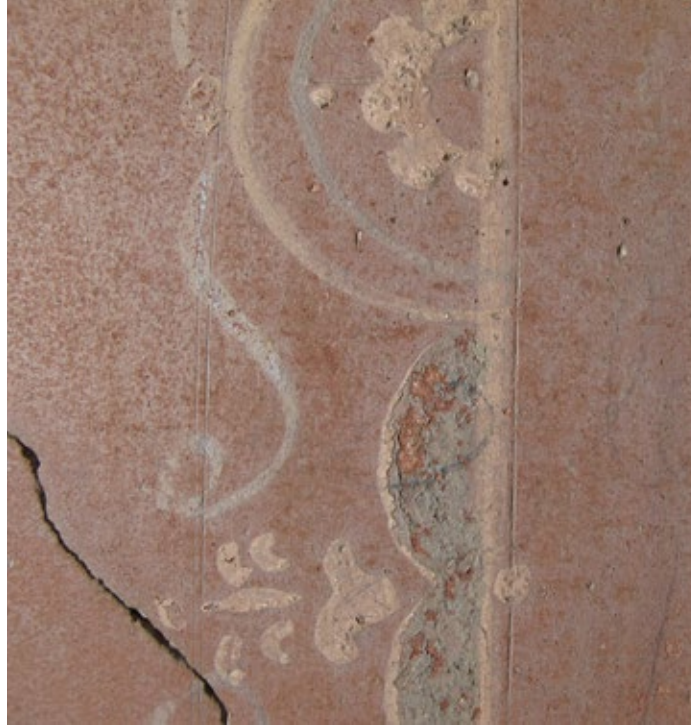
**FIGURE 1.37.**

Detail of the decorative border, showing compass arcs and holes used to lay out the decorative patterns.

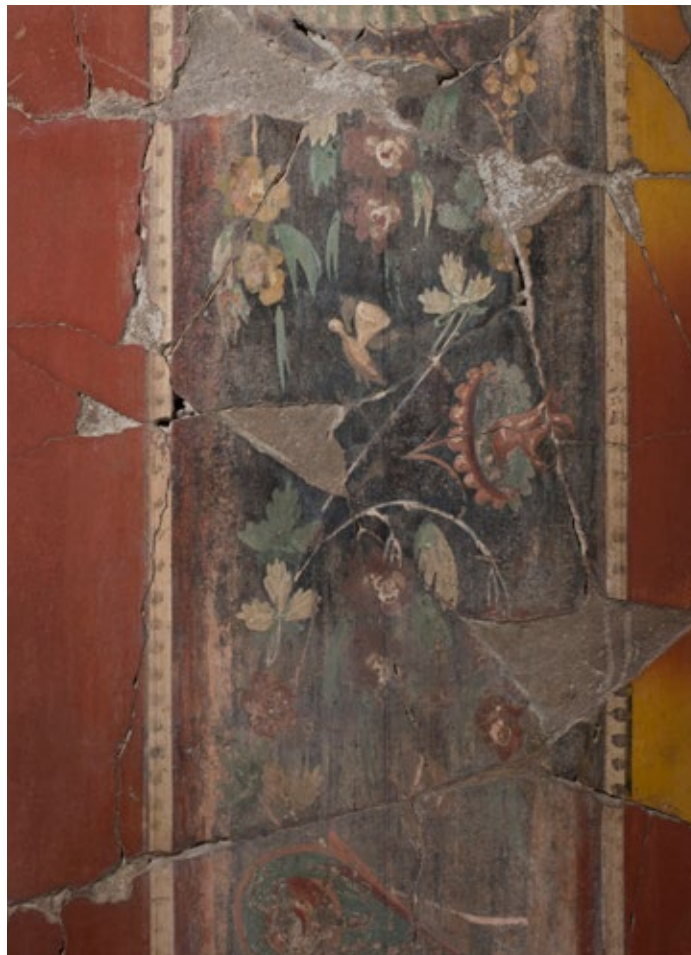
**FIGURE 1.38.**

Detail of vertical band, showing decoration that is thickly applied and built up to create fantastic floral and grotesque designs.

The decorative elements on the vertical bands are built up over a black monochrome background, which in places is applied over the red or yellow of the side and central panels and covers the seam between these panels (fig. 1.38). This black appears to have been smoothed or polished before the application of the decoration. On the vertical bands, the paint of the decorative elements is thickly applied in multiple layers and shows clear impasto, with intricate designs defined by quick, individual brushstrokes and fine detail.

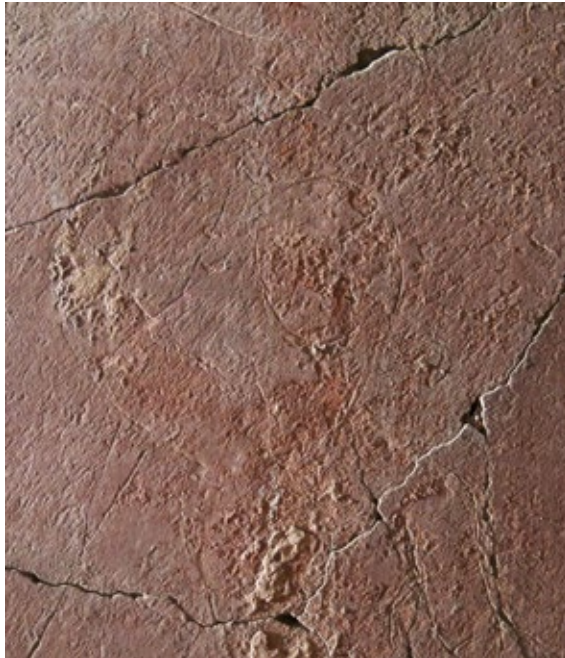
FIGURE 1.39.

Area of upper wall, showing freehand incisions used to lay out the figures. The paint layer has been almost completely lost, and the incision outlining the outstretched arms of the figure is visible.

The figures on the upper walls are painted directly over the monochrome background. Freehand incisions can be seen in places, which loosely provide placement of the figures on the background plaster<sup>42</sup> (fig. 1.39). The figures are executed using a buildup of paint layers to indicate skin tone, clothing, and drapery (fig. 1.40).

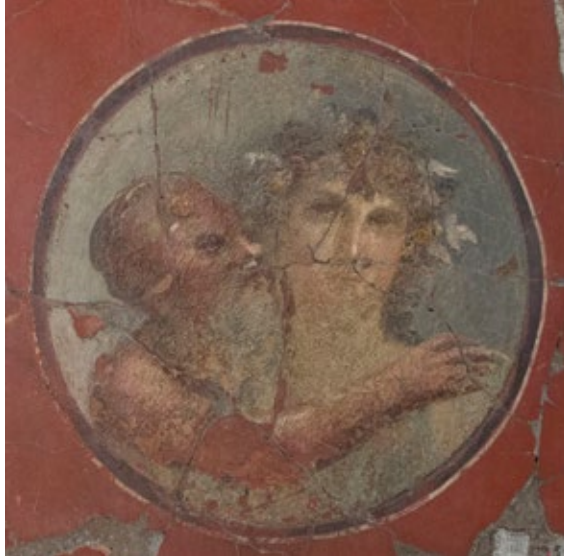
**FIGURE 1.41.**

A medallion painting featuring a bacchante, finely executed on a light-blue ground applied over a monochrome background. Hatching and a buildup of colors are used to create facial features, skin tone, and other details.

The four medallions with bacchante busts are painted over the red monochrome background on the two side panels of the east and west walls. A compass incision into the red monochrome background denotes the circumference of the circles. A light-blue background, composed of Egyptian blue mixed with lime white, appears to have been applied over the entire surface defined by the circular incision.<sup>43</sup> This layer serves as a preparation under the figurative painting and as a background around the figures. A thin white border outlines the circle. The figures are built up of multiple layers of paint,<sup>44</sup> showing thick impasto in different areas of the paintings. Hair, skin, and clothing are painted in intricate detail: fine hatching for the facial features, and a refined technique to depict the drapery of the clothing and details of the hair (fig. 1.41).

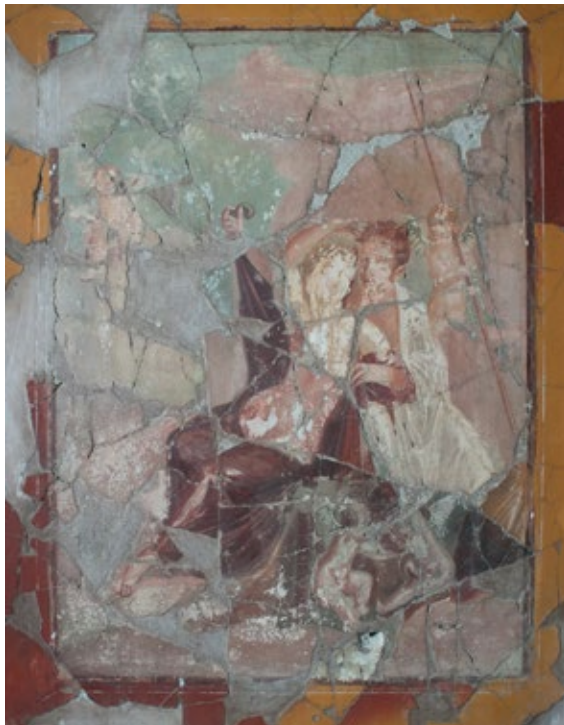
**FIGURE 1.42.**

Rectangular scenes are painted over a thin white preparation, with quick, loose brushstrokes to depict the background, and fine detailing for the figures.

As described earlier in the section “Iconographic Description of the Wall Paintings,” the two central rectangular paintings show mythological scenes. The scenes are carefully executed, each with a complex iconographic scheme and detail in the figures, drapery, and landscape of the paintings. From limited sampling, a thin white preparation can be seen under the paint layers. It appears that the pigments were mixed with a binder for the design layers, as there is a thick impasto, particularly in the figures. The figures exhibit a buildup of paint for shading and modeling of skin tone and drapery of clothing. The background of each scene is more loosely painted with thinner paint layers to suggest landscape and sky (fig. 1.42).

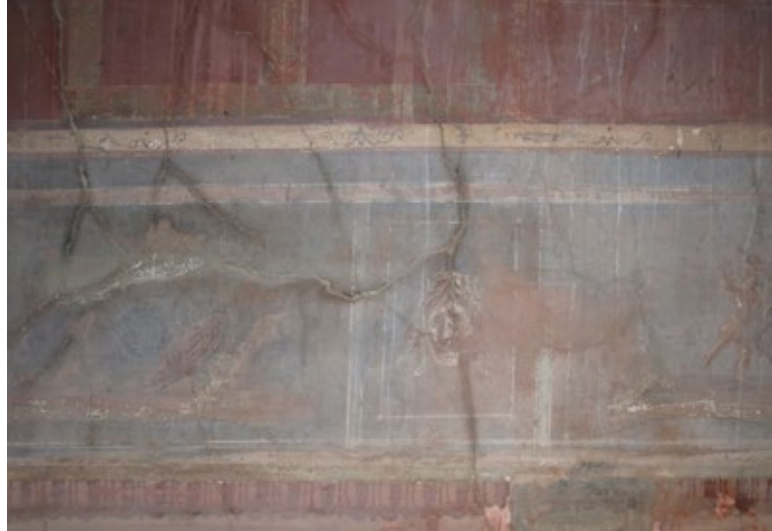
**FIGURE 1.43.**

The frieze is painted over an added band of plaster on a black background with fine figurative painting and details in the landscape. An egg-and-dart border, thickly applied with rapid brushstrokes, completes the lower edge (detail, west wall).

The frieze, which also includes fine figurative paintings, is painted over an additional tinted horizontal plaster band. The edges of the frieze plaster are finished and concealed with a layer of paint, creating decorative borders. The figures are painted with a buildup of multiple layers to show detail, while the landscapes and backgrounds are quickly sketched using individual brushstrokes. The egg-and-dart motif that extends along the bottom of the frieze is a thickly applied bodied paint (fig. 1.43).

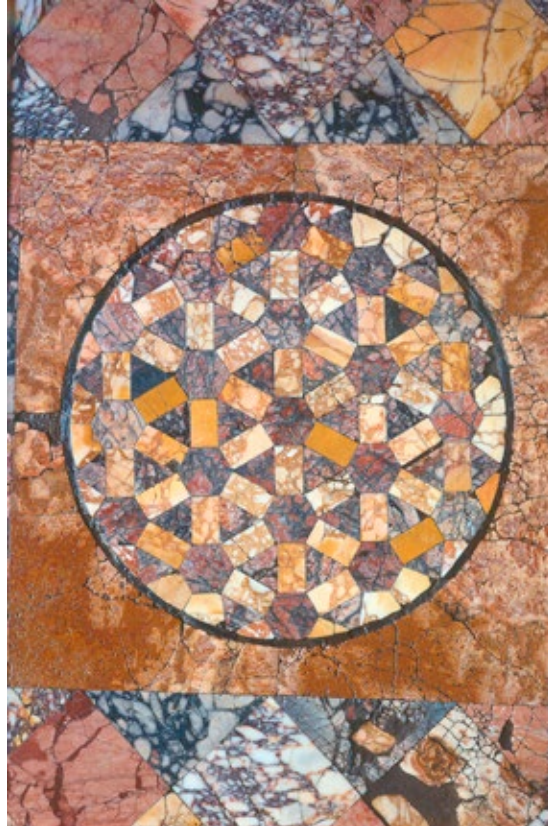
FIGURE 1.45.

Central design of the mosaic pavement, showing a sophisticated geometric pattern of rhomboids in different colored stones. (Historical Archives of the Soprintendenza Pompei, Foglia, 15020b)

sophisticated patterns. The central panel is divided into three sections, measuring in total approximately  $1.45 \times 3.28$  m. The two outer sections are composed of slabs of African breccias, and the central section consists of a disk surrounded by rhomboids in an ornate grid pattern (fig. 1.45) and resembles a polychrome carpet framed by a band of red marble surrounded by a black- (volcanic stone) and-white decorative border with a black-and-white rope motif in *opus tessellatum*, and a stylized border at the north and south ends. The different marbles used in the central *opus sectile* emblem have not been identified, though they do include *giallo antico*.

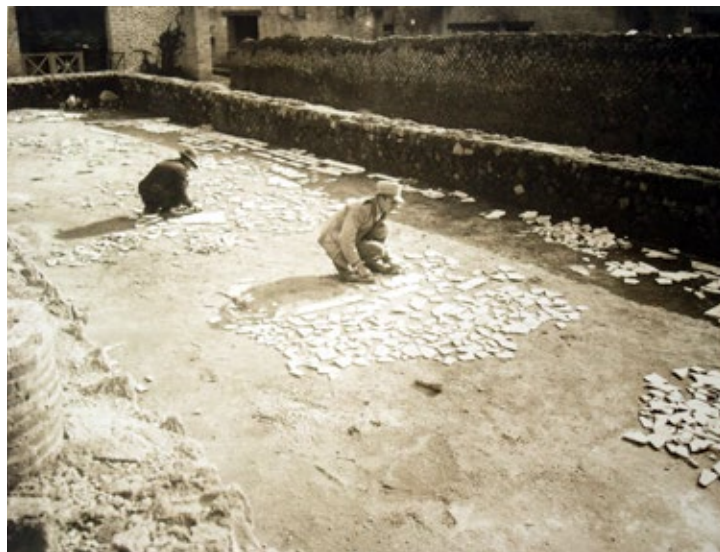
**FIGURE 2.1.**  
Reassembly of fragments at the  
site of Herculaneum, 1935. (Historical  
Archives of the Soprintendenza Pompei,  
Maiuri, inv. C2649)

Although it is clear that this can be considered by no means an accurate quantitative evaluation of treatment processes carried out on the paintings, perhaps their relative frequency suggests that the detachment and reattachment of damaged and probably fractured wall paintings may have been more common than the collection, reconstruction, and remounting of fragments collected from the ground. A contemporary photograph from the site shows that fragment collection and reconstruction was part of standard working practice (fig. 2.1).

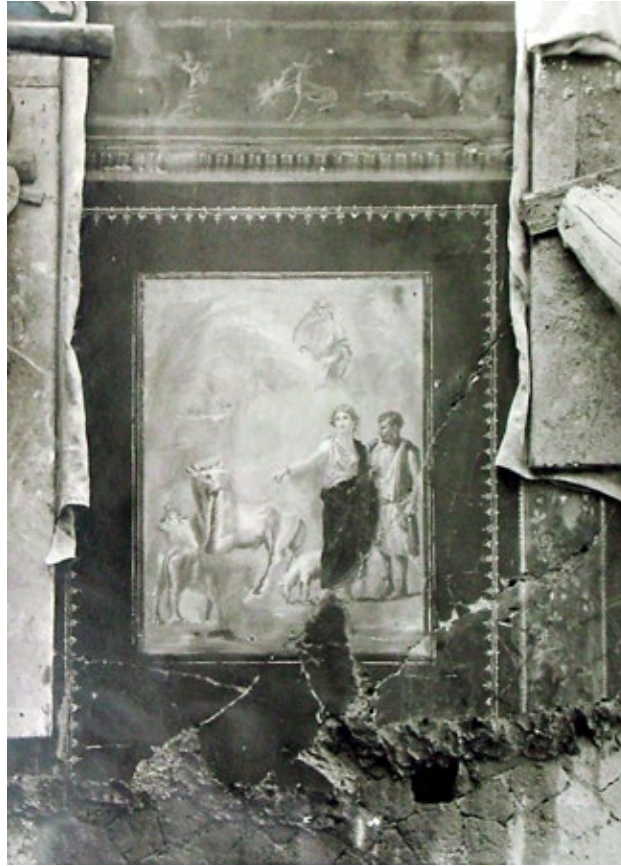
Photograph of the central section of the west wall during excavation. Wood supports with cushioning material have been placed against the walls and shored up. Temporary rough fills run along the bottom of the plasters to hold them in place.

is made of the remaining scene and medallions—neither when they were found nor in what condition. These entries give an idea of the speed with which the room was excavated and the condition of the wall paintings at the time of excavation. The fact that the east wall medallion and the west wall central rectangular scene were described in such detail upon discovery suggests that perhaps these areas were more or less intact when found, or that this is simply an inconsistency in the recording of the work. The assumption that the west wall central rectangular scene was found still on the wall is further substantiated by the historical photograph from the Soprintendenza Pompei archives of this scene being supported by wood props during excavation and reconstruction (fig. 2.2).

Further insight into the excavation, remounting, and reconstruction process can be seen in historical photographs of the work in progress (see fig. 2.2). Most images that have been found in the archives of the Soprintendenza Pompei, however, show the wall paintings, and indeed the house, once excavation and reconstruction had been completed.

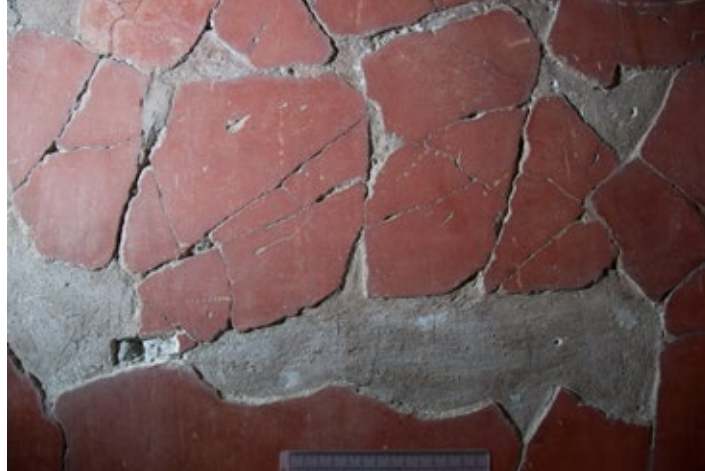
**FIGURE 2.3.**

Reassembled wall painting fragments, upper west wall. Some pieces lie close together, and the joins between them are not filled; some are farther apart, with restoration mortar applied to fill the gaps.

paintings are composed of numerous fragments, more or less densely clumped together, at times with large lacunae filled with restoration mortar (fig. 2.3).

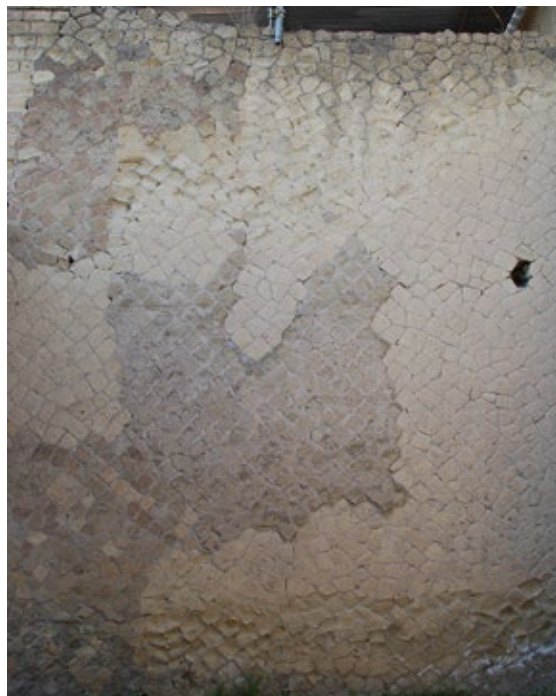
**FIGURE 2.4.**

Rear of east wall in adjoining ambiente 9. Darker portions at left are original Roman tuff.

It is quite likely that a significant proportion of the underlying tuff wall support of the east wall was replaced, as there are large losses in the original plaster, and most of the surviving plaster has been remounted. Additionally, the other side of the wall, in the adjoining ambiente 9, is largely composed of modern *opus incertum*,<sup>5</sup> though a large area of this wall (ambiente 9) is original Roman tuff constructed in *opus reticulatum* (fig. 2.4).

On the other hand, the plaster along the southern edge of the east wall (fig. 2.9) is made up on the whole of quite large fragments that fit closely together. This, together with the reasonably good condition of the corresponding wall in ambiente 9 (see fig. 2.4), suggests that the plasters here may have still been in place at the time of excavation and been in whole or in part detached and remounted, as evidenced by the pattern of cracking and fragmentation.

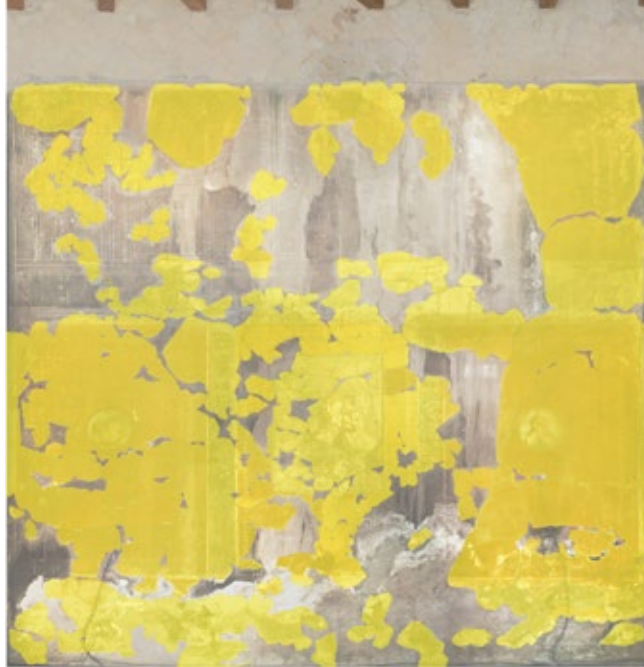
**FIGURE 2.5.**

East wall. Yellow shading indicates original Roman plasters.

The east wall retains less original plaster than the other two walls, with the most severe losses in the upper register (approx. 70%) and the monochrome background of the middle of the lower register (fig. 2.5). About half the plaster is missing from the base of the wall.

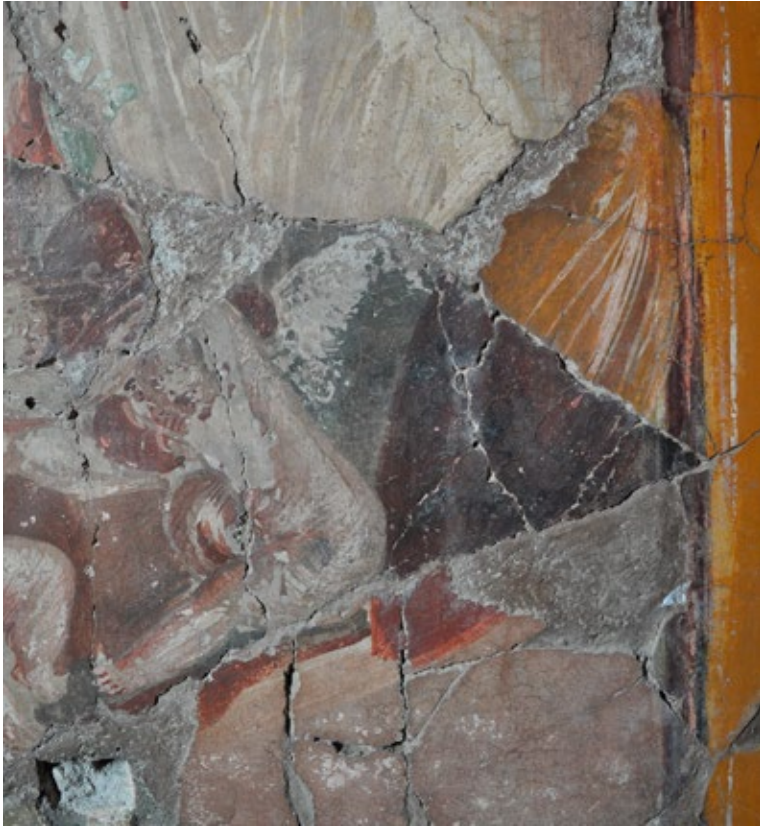
**FIGURE 2.7.**

East wall. In the central scene, the same piece of drapery is yellow on one fragment, brown on another, and red on another.

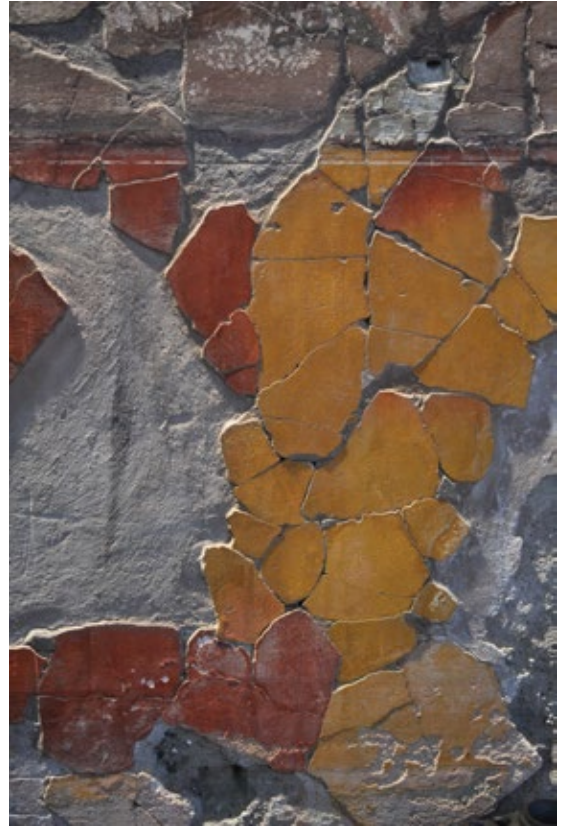
**FIGURE 2.8.**

East wall. Lower register (raking light), showing principally yellow fragments somewhat irregularly fitted together.

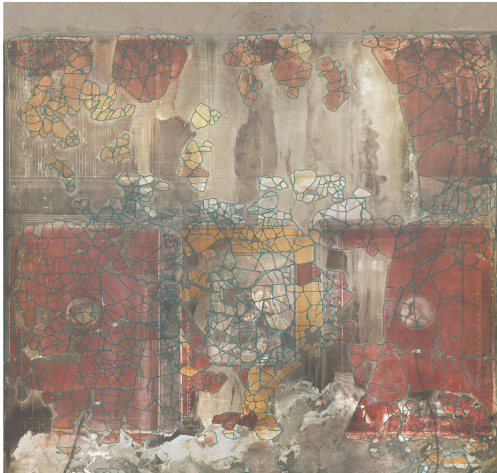
**FIGURE 2.9.**  
East wall. Map of fragments.

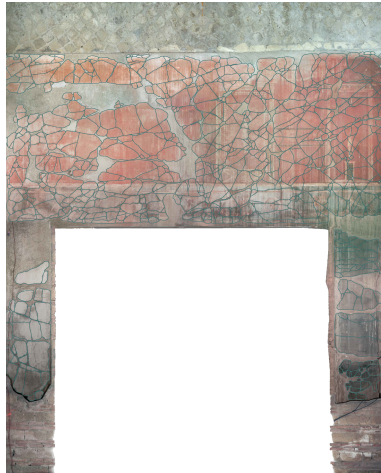
**FIGURE 2.10.**  
South wall. Map of fragments.

The upper register of the south wall (fig. 2.10) is principally composed of medium to large fragments, the western half and the underlying frieze for the most part fitting closely together. The eastern third is instead composed of a much more loose-fitting group of fragments surrounded by a large loss, suggesting perhaps that these were more damaged and detached than fragments in the western part. Although (like the west wall) the monochrome background in the upper register is now entirely red, it is likely the original color scheme incorporated yellow (like the east wall), but here all the original yellow goethite has been converted to red hematite. This suggests that no fragments were protected from the heat of the eruption, and may imply that fewer fragments fell off this wall and were buried.

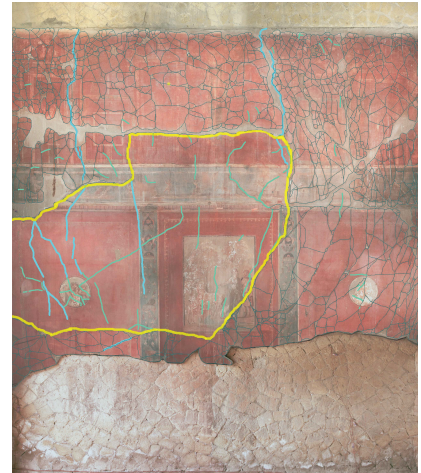
**FIGURE 2.11.**  
West wall. The yellow outline indicates an area without significant fractures. The thicker blue lines indicate cracks. The thin lines indicate fragments.

Like the south wall, the monochrome background of the west wall (fig. 2.11) is now entirely red; however, it is most likely that the original color scheme incorporated panels of both yellow and red in the upper and lower sections, and the central panel may likely have had a yellow background like the east wall. This again suggests that no fragments were protected from the heat of the eruption, and may also imply that fewer fragments fell off this wall and were buried.

However, the third and most notable area is the central-southern section of the lower wall: it contains a single piece of plaster (area outlined in yellow in fig. 2.11) with only a few cracks (indicated by the thicker lines), suggesting that this plaster is the only part of the tablinum not to have been reattached in the 1938 treatment. This idea is further supported by the absence of any traces of backing plaster used to remount fragments (see next section); the upper border of this section of original Roman plaster is not flat and is higher than the adjacent plasters of the upper section and right-hand section, and the original plaster overall is thicker in this area than in any other area in the tablinum.

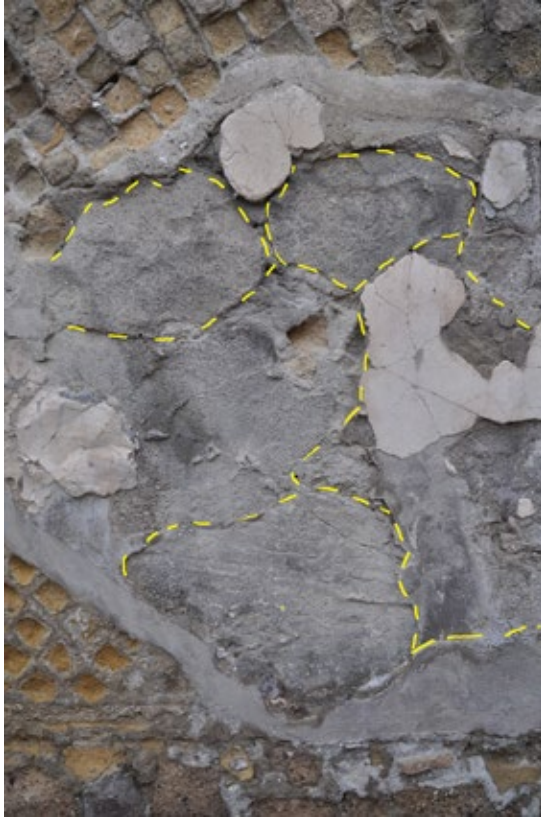
**FIGURE 2.13.**  
A remounted section of plaster from another area of the site that has lost almost all the Roman plaster, exposing the backing plaster and leaving an imprint of the original Roman plaster fragment (shown by the yellow dashed line).

Once set, this formed a rigid support, holding the pieces together in an "island," which could then be attached to the wall. Traces of backing plaster can be seen in examples of deteriorated wall paintings at the site, which have left this layer exposed (fig. 2.13).

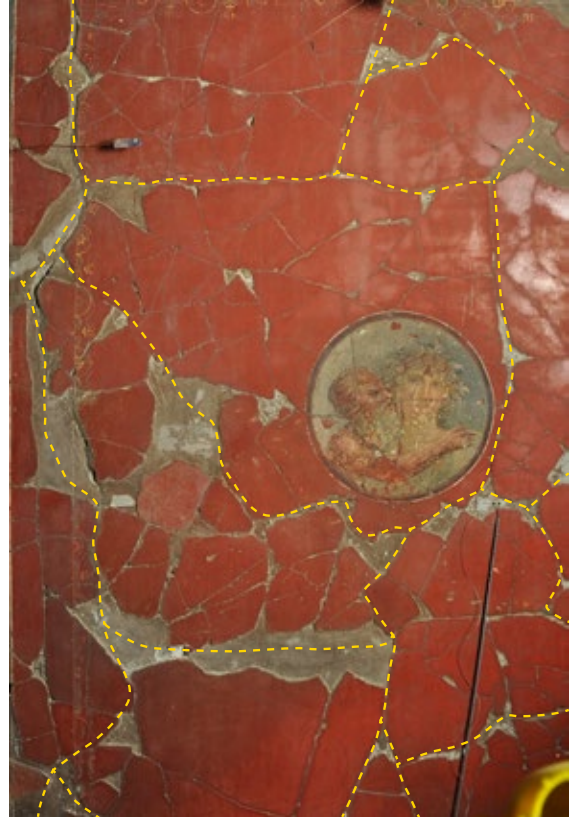
**FIGURE 2.14.**  
Areas of close-fitting pieces on the east wall that likely make up fragment islands, outlined in yellow.

In the tablinum, it is difficult to separate out these individual islands of fragments among the larger areas of remounted wall paintings, though there are a few areas where such groups are discernible (fig. 2.14; see also figs. 2.9–2.11).
