# Conservation of the Architectural Surfaces in the Tablinum of the House of the Bicentenary, Herculaneum

Phase I: Examination, Investigations, and Condition Assessment

## Project Report

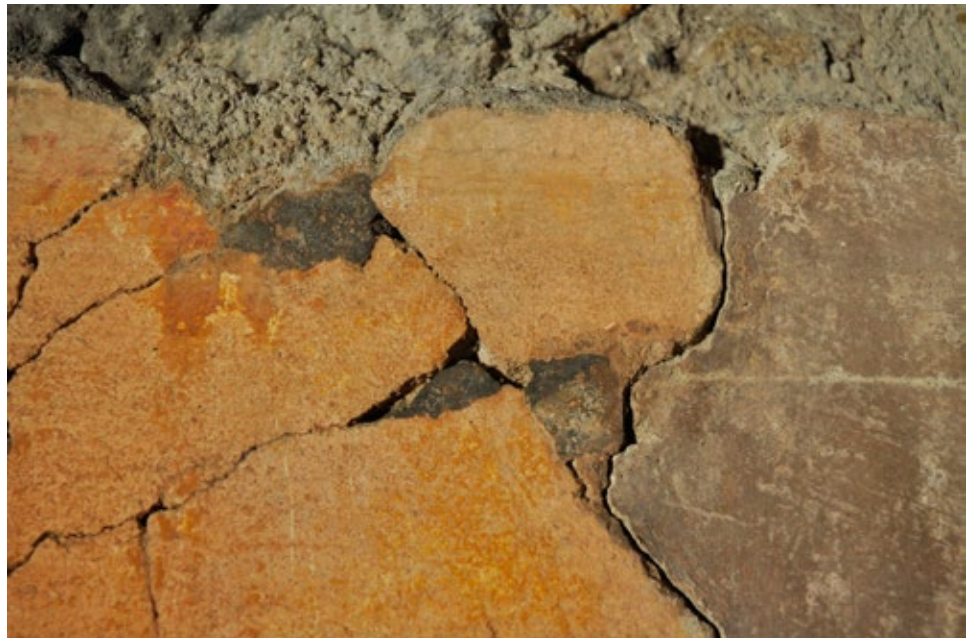
**FIGURE 2.16.**

Tablinum, south wall. A loss in the middle of a recomposed fragment island. Water damage has eroded the upper fill, exposing the underlying dark-gray backing plaster holding the separate surrounding fragments together, seen in the area inside the yellow dashed line.

In general, Maiuri's team did not fill any losses in the plaster up to the level of the paint, preferring to fill them 2–3 mm lower than the paint surface (fig. 2.16). They must have used a system to avoid the cement backing plaster from flowing through to the level of the paint

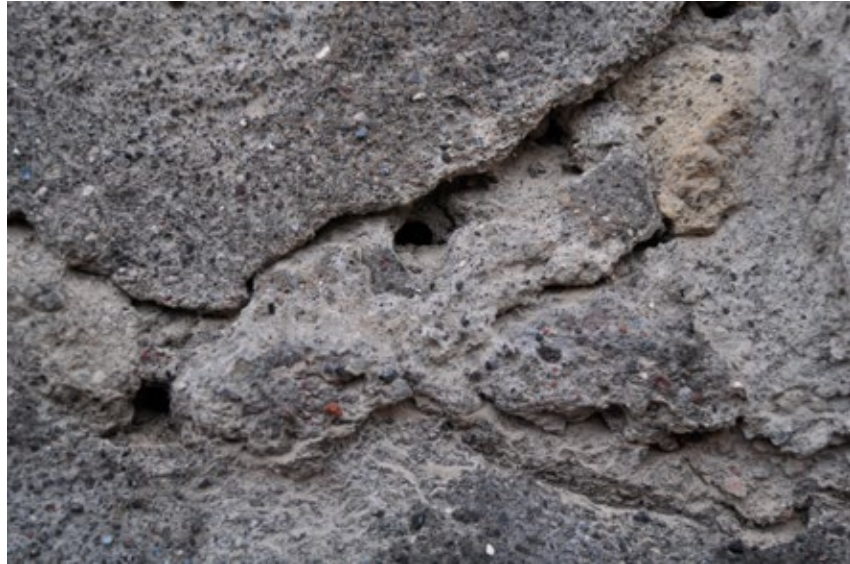
**FIGURE 2.19.**

Anchoring mortar around the edge of a piece of exposed backing plaster that has lost the original Roman plasters. The holes indicate the locations of pins that may have been removed once the anchoring mortar had set.

An anchoring mortar, very similar in appearance and composition to the backing plaster, would have been applied to the wall to adhere the recomposed fragments. The island of fragments assembled on the backing plaster would have been positioned on the wall at that point and held in place by metal pins inserted into the wall along the edge of the fragments until the anchoring mortar had set (fig. 2.17). Clear traces of this anchoring mortar can be seen where it has splashed onto the tuff walls above the upper border of the plasters (fig. 2.18). It is likely the pins were removed or cut where possible once the anchoring mortar had set (fig. 2.19).

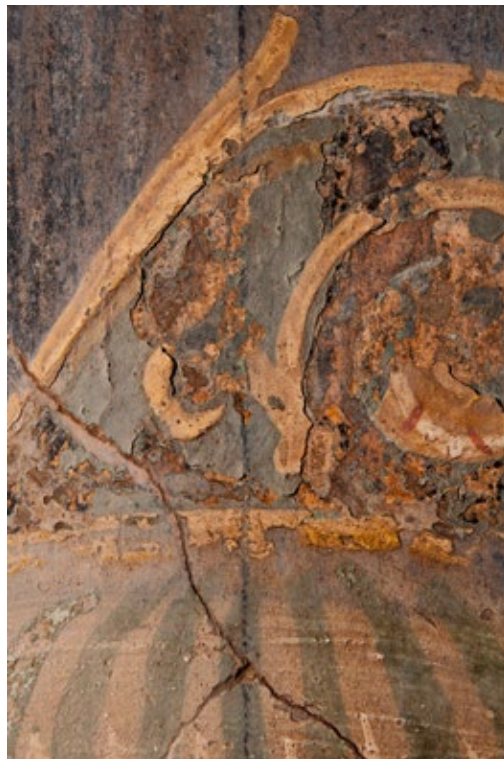
**FIGURE 2.20.**

Pencil line running down the center of the vertical band (east wall, north end), likely added to help align fragments during the remounting process.

Some fragment plates appear to have been aligned during mounting by the use of guidelines drawn on the paint surface: on the northern vertical band on the east wall, a pencil line is drawn down the central axis of the band (fig. 2.20). This, together with a plumb line, may have helped to achieve the correct vertical orientation of the pieces making up the vertical band.

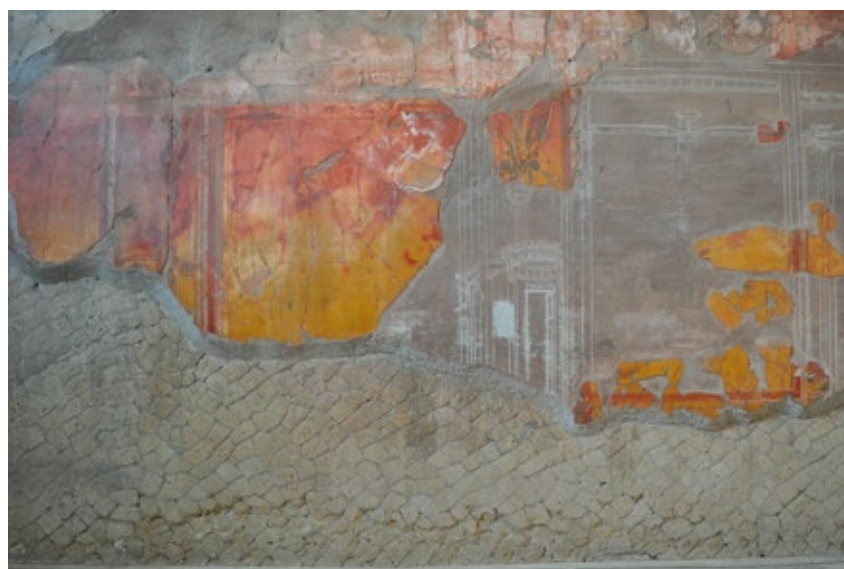
FIGURE 2.24.

Example from another area at the site, showing the different approaches used by Maiuri for the treatment of major lacunae: losses between islands of Roman plaster are filled with a gray lime-wash plaster with connecting design elements sketched in by white incisions. Instead, where there are no connecting islands, the walls are left as bare tuff (mostly modern) (Casa del Bel Cortile, Herculaneum).

On the other hand, when there were very large losses between various fragment islands, as, for example, on the east wall of the tablinum, Maiuri adopted the procedure described in his *Nuovi scavi* mentioned earlier: “si è sovrapposto un intonaco grezzo... solo al fine di rappresentare il disegno schematica della parete a lineeole bianche” (p. 22), that is, a “schematic drawing on the wall with white lines” delineating the basic layout of the decoration, applied on reconstruction plasters, and used to connect surviving decorative elements on the various pieces of original painting. He frequently employed this minimal reconstruction technique in many other areas at both Herculaneum and Pompeii (fig. 2.24).

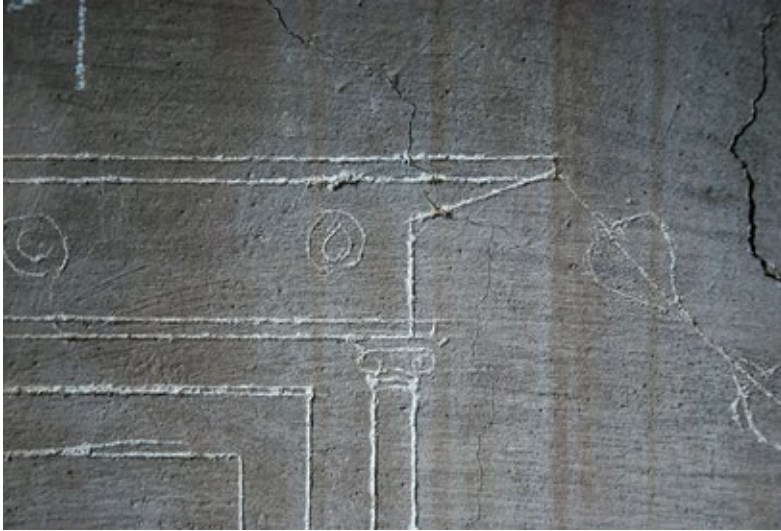
**FIGURE 2.25.** Reconstruction of the basic design of architectural elements on the upper east wall by Maiuri's team in area of large loss made by incising a line through a gray lime wash applied to the surface to reveal the thinly applied fine white lime plaster below.

large areas of loss, it was covered with a thin (1–2 mm) white plaster layer. This, in turn, was covered with a coat of gray-tinted lime wash. The line drawings re-creating the outlines of the decorations were then incised in the surfaces, breaking through the gray covering tint and exposing the white plaster underneath. This created an effect of white lines on a gray background (figs. 2.25–2.26).

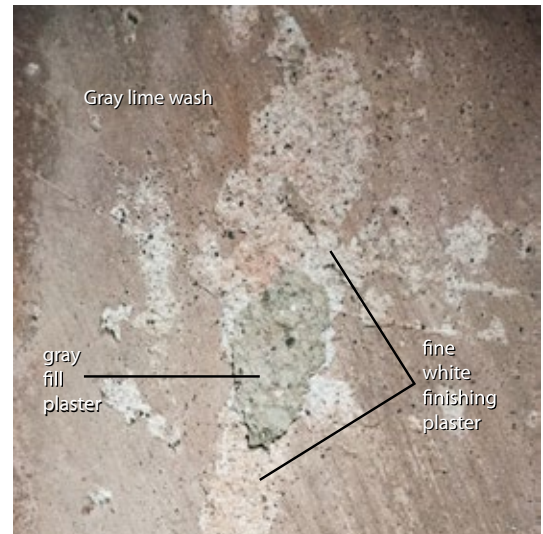
**FIGURE 2.26.** Flaking paint and plaster expose the stratigraphy of the reconstruction plaster in a loss on the east wall: gray lime wash over a thin white plaster covering a thick layer of gray fill plaster.

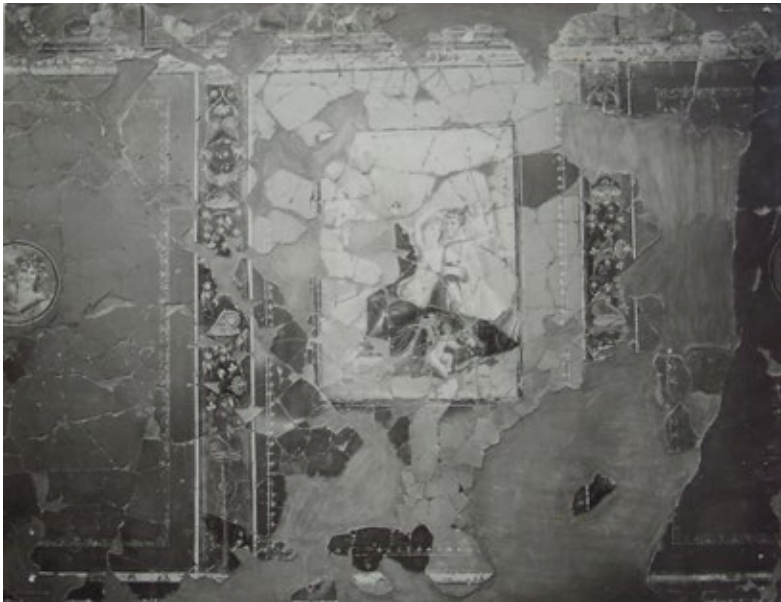
**FIGURE 2.27.** Central section, east wall, 1938, just after restoration and before the *sgraffito* design was incised in the reconstruction plaster surrounding the original fragments. (Historical Archives of the Soprintendenza Pompei, Maiuri, C2782)

This technique is seen in two historical photographs of the east wall that show the wall paintings during reconstruction in 1938 with a large fill (fig. 2.27) surrounding original plaster fragments and the central rectangular scene and, much later, in 1983, with the incised *sgraffito* design (fig. 2.28).

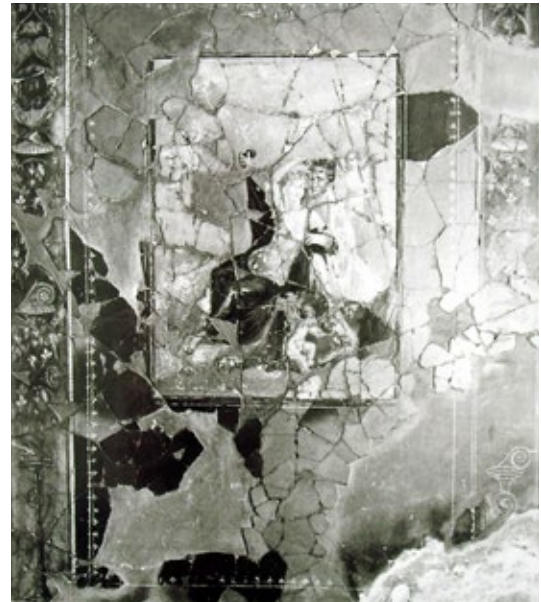
**FIGURE 2.28 (RIGHT).** Central section, east wall, 1983, showing the *sgraffito* design in the reconstruction plaster surrounding the central rectangular scene. (Historical Archives of the Soprintendenza Pompei, Maiuri, D29302)

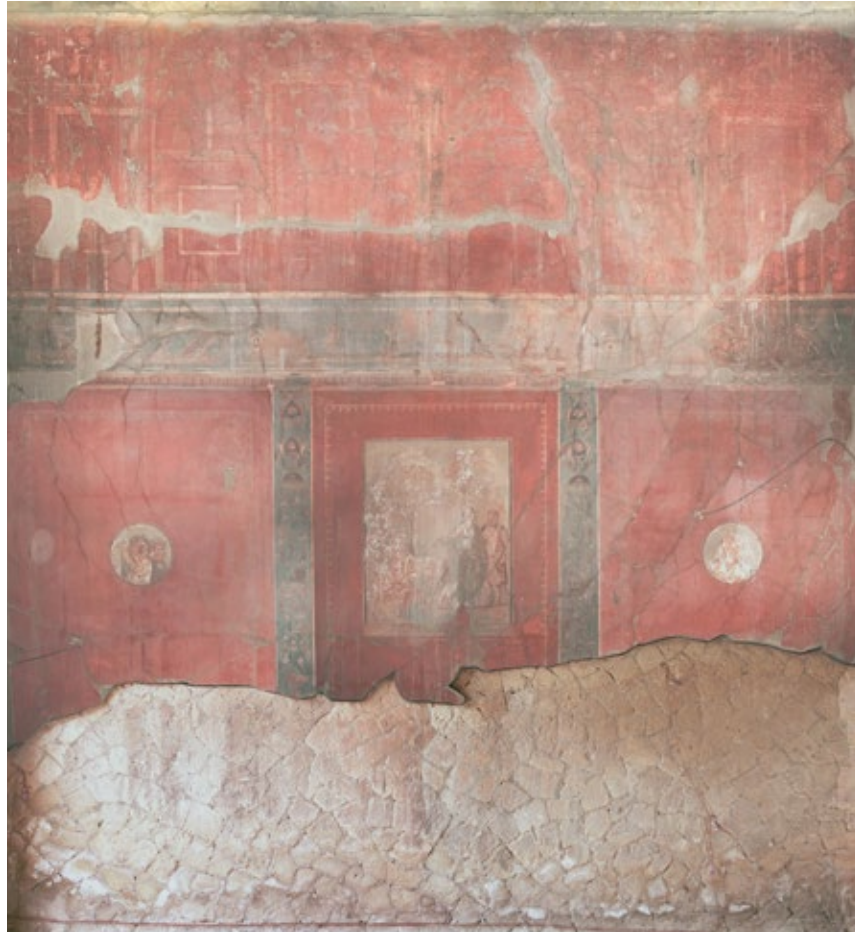
**FIGURE 2.29.**

Overall of west wall of the tablinum, showing the approach used by Maiuri for the treatment of major lacunae with no fragment islands, leaving the bare tuff (mostly modern) along the base of the wall.

In the case of extensive areas with no surviving fragments, such as in the lower parts of the west wall and south wall, Maiuri did not apply any reconstruction plaster, leaving bare the (often reconstructed) underlying wall (fig. 2.29).<sup>9</sup>

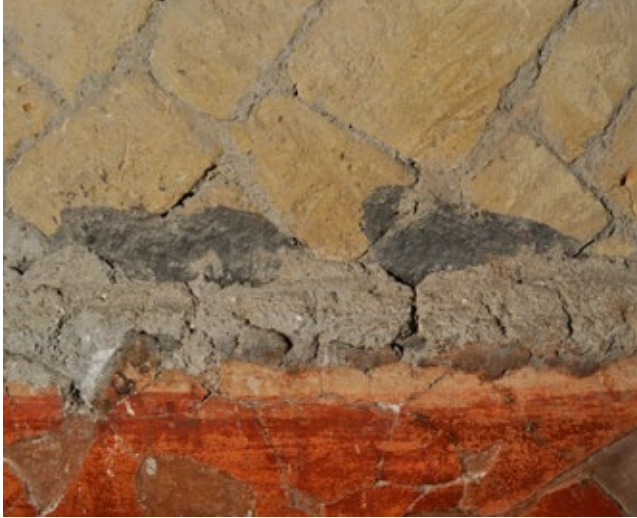
**FIGURE 2.30.**  
Coarse-grained mortar edging partially covering both anchoring mortar and backing plaster.

On both the upper and lower borders of the original and reconstructed plasters, where bare tuff wall begins, a sloped edging plaster was applied. Some of the plaster strip along the upper border has remained in situ and appears to be similar to the rough fill (fig. 2.30).

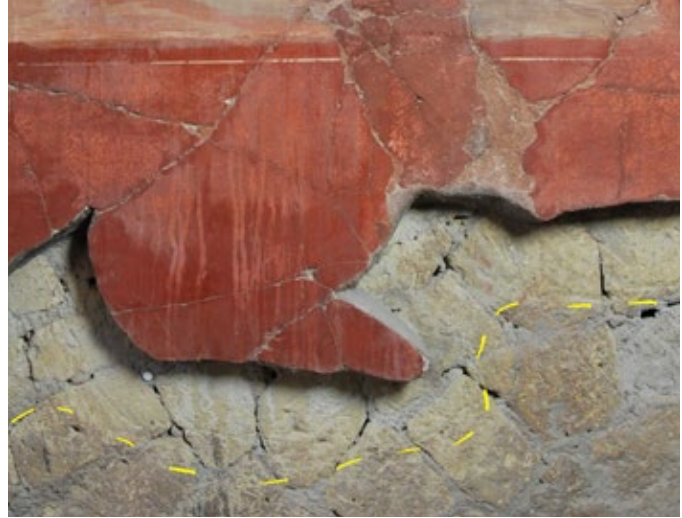
**FIGURE 2.31.**  
Lower edge, west wall. The lighter-colored strip (outlined by the yellow dashed line) is the location of the first sloped edging plaster.

Along the lower edge of the west wall, all of the 1938 edging plaster was removed in a subsequent treatment and was replaced with plaster borders perpendicular to the wall plane. However, the location of the original mortar edging can still be clearly seen as a lighter-colored strip on the tuff wall extending the length of the lower border (fig. 2.31).

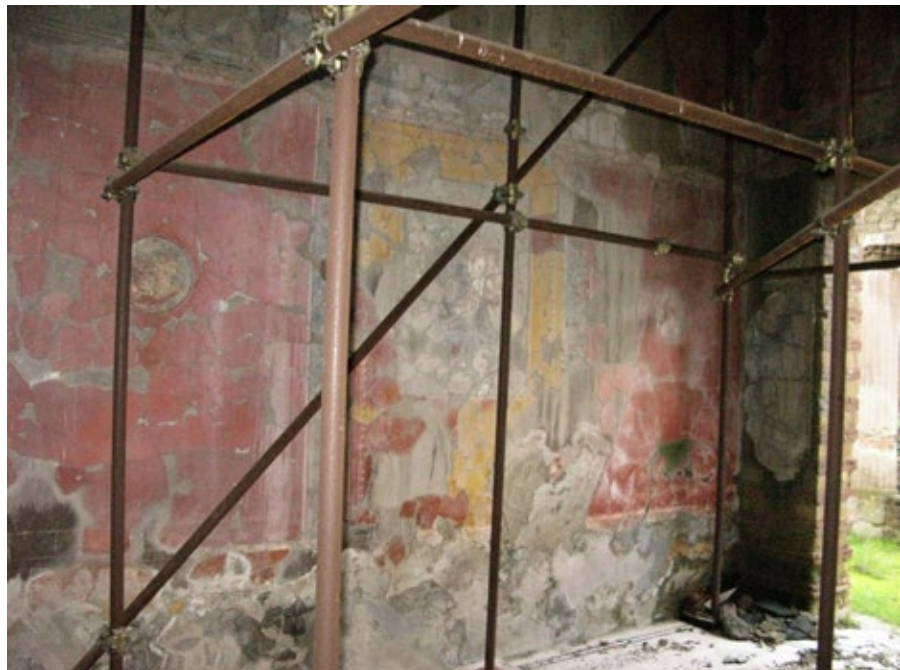
**FIGURE 3.1.**

Southeast corner of the tablinum, showing post-1938 fills along the base of the wall, drips down the surface, and fallen debris from a large hole in the roof.

A cement slab roof was placed over the tablinum at some time in the past; the exact date is unknown, but it was likely at the time of excavation or shortly thereafter as part of the reconstruction of the house. Over time, the cement roof began leaking, which led to infiltration of rainwater. The infiltration continued, presumably over a long period of time, though to date no records have been found that give any detail or information about leaks or the specific damage they caused. However, there is visual evidence of damage in the form of eroded plaster and drips down the surface of the walls in specific locations (see fig. 3.1).

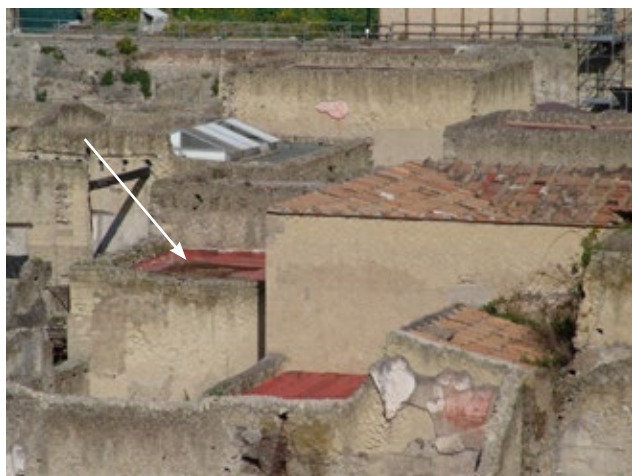
**FIGURE 3.2 (ABOVE LEFT).**

View of roof of the tablinum in 2008, showing pooled rainwater (indicated by white arrow) on the surface.

In 2011, a large hole in the roof was documented by the project team in the southeast corner of the tablinum (fig. 3.2) which allowed infiltration of rainwater and debris to fall down

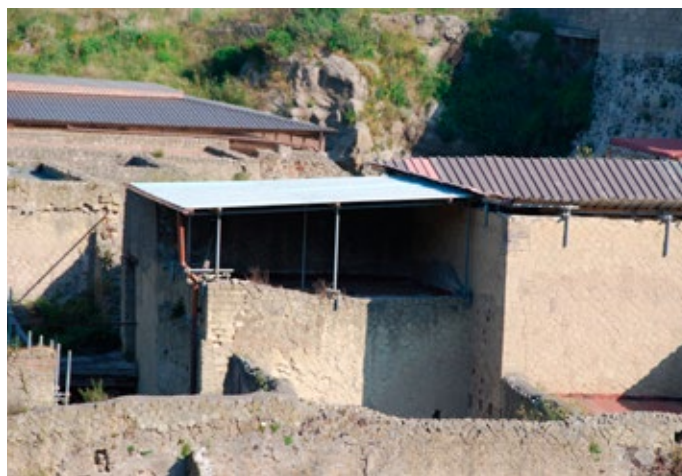
**FIGURE 3.3 (ABOVE RIGHT).**

Temporary metal roof installed over the tablinum in 2011 to address water infiltration from leaks in roof.

the wall paintings and onto the floor, and a temporary sheet metal roof was installed over the tablinum (fig. 3.3) by the Herculaneum Conservation Project (HCP) and the Soprintendenza Pompei. Shortly after this, and prior to the start of conservation of the wall paintings and mosaic pavement of the tablinum, the HCP and the Soprintendenza built a new slab roof over the tablinum (fig. 3.4).

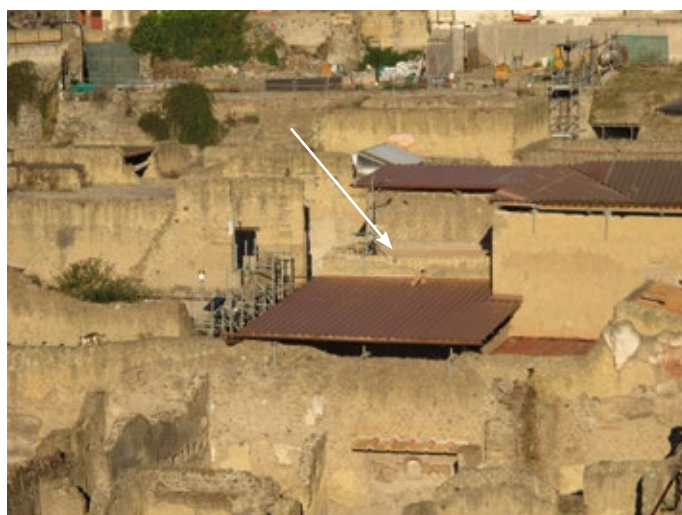
**FIGURE 3.4 (RIGHT).**

View of new slab roof of the tablinum, constructed in 2011 prior to the start of the project to protect the architectural surfaces in the tablinum.

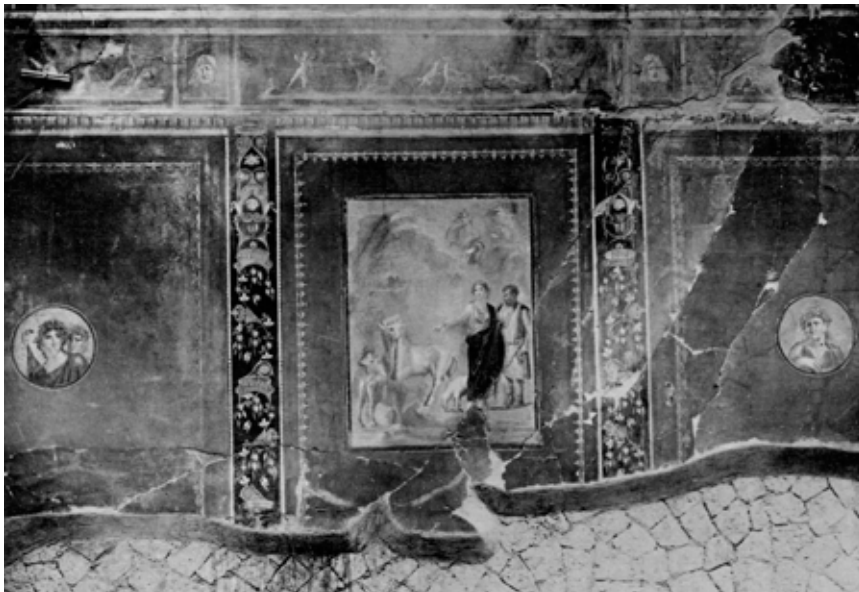
**FIGURE 3.5.**

Historical photograph of the tablinum west wall, showing a wide sloped mortar edging along the lower edge of the wall paintings. (Maiuri 1958, 231)

A wide, sloped mortar edging that extended along the lower edge of the west wall fragments, applied during the 1938 reconstruction (fig. 3.5), was replaced during a later intervention at some time prior to 1978 (fig. 3.6). This repair is especially evident along the bottom edge of the plaster on the west wall, where the current edging runs perpendicular to the surface of the wall painting; traces of an earlier, wider sloped edging can be seen below it (fig. 3.7 and 3.7 detail).

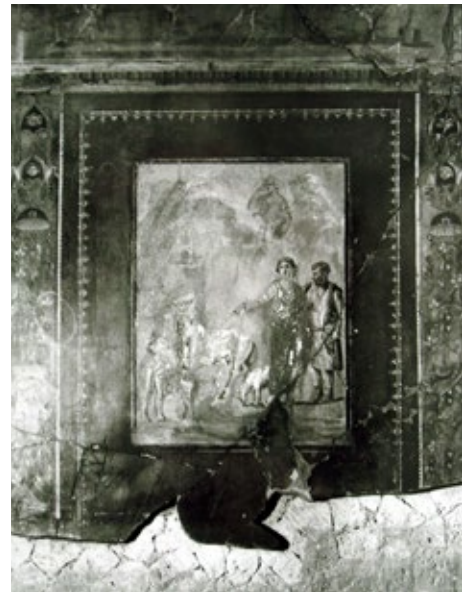
**FIGURE 3.6.**

Photograph from 1978 showing the replaced mortar edging along the bottom of the wall paintings on the west wall of the tablinum.

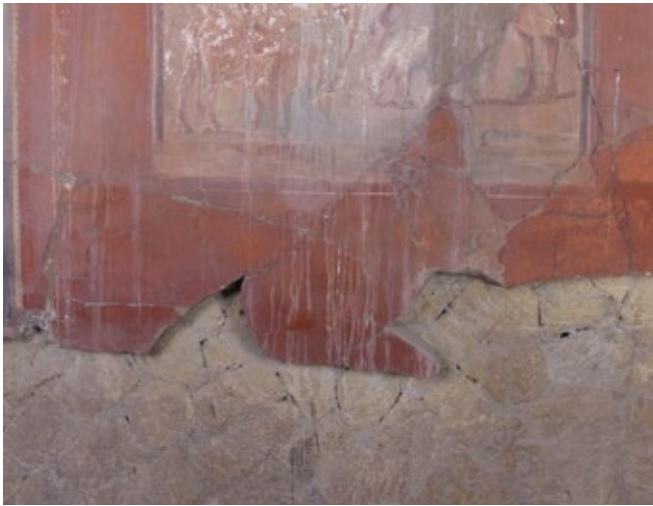
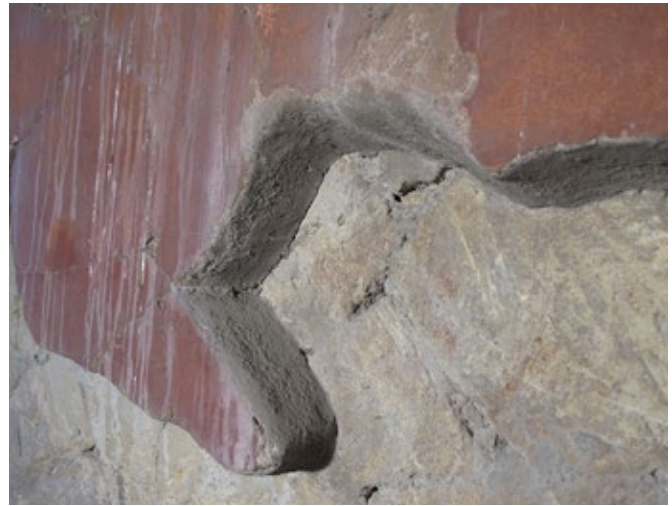
**FIGURE 3.7.**

Photograph from 2011 showing the lower border of the wall paintings on the west wall. Traces of a wider edging border, lighter in color, are evident below the wall paintings along the tuff wall. Detail on right shows edging material.

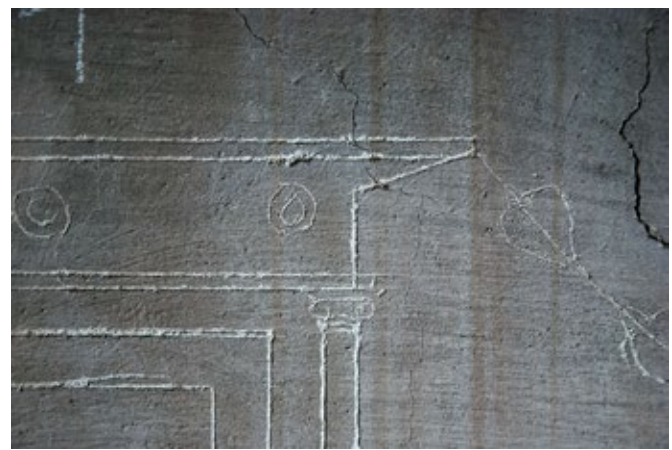
**FIGURE 3.9.**

Maiuri-era incisions that had been covered by a later wash were reinscribed in a later intervention.

At least two hard cementitious washes in either a dark gray or dark purple have been applied over the 1938 original light-gray incised plaster fills (fig. 3.8). Incisions were recut into the secondary repair materials in order to preserve the 1938 incised designs and complete the Roman decorative elements (fig. 3.9). Hard, gray fills, which appear to be post-1938 interventions, are present along the base of the east wall and extend to the ground level. Salt efflorescence occurs in these areas. Analysis has identified the repair material as cementitious and containing sodium sulfate salts. These fills cover original Roman plaster fragments in almost all cases (fig. 3.10).

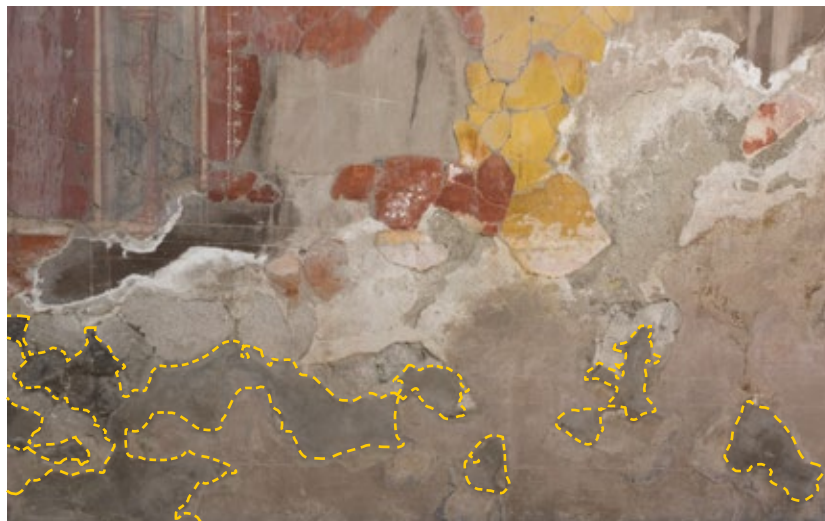
FIGURE 3.10.

Base of east wall, showing hard, gray cementitious fills visible as islands within the Maiuri-era reconstruction plaster. Many of these fills cover original Roman plaster fragments as seen in the areas within the dashed yellow lines.

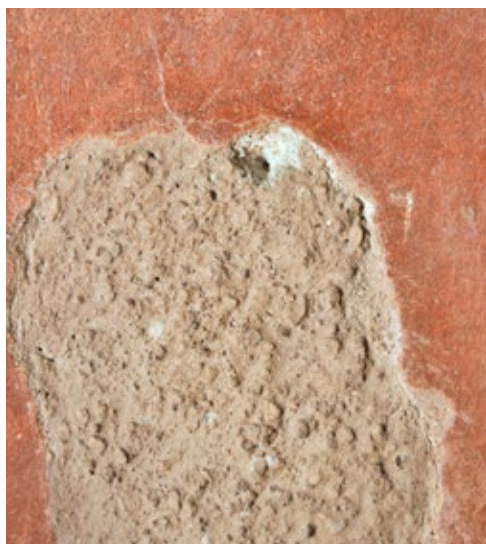
FIGURE 3.11.

Grouting injection hole punctured through a 1938 fill, indicating that at least one grouting campaign had been carried out since that time.

Based on visual evidence, such as grouting injection holes and possible grouting material, it is thought that at least two grouting campaigns were undertaken since 1938 (figs. 3.11 and 3.12).

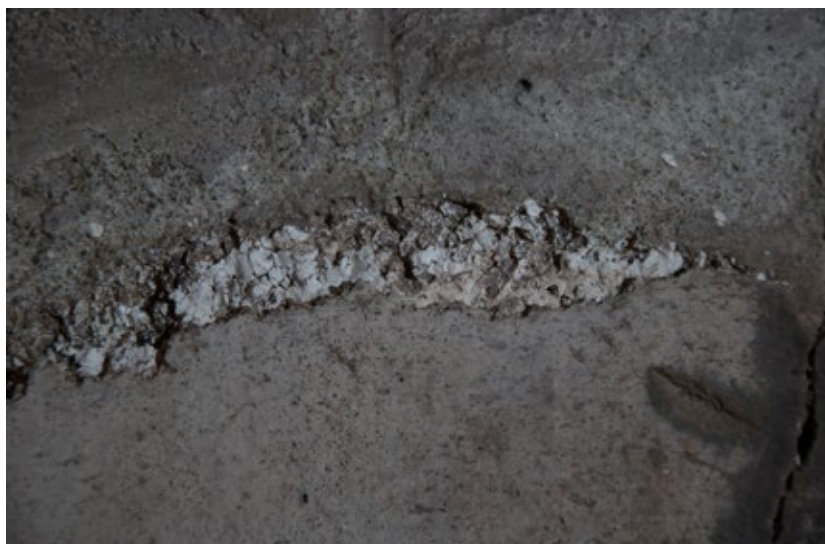
FIGURE 3.12.

Evidence of possible grouting material that is compositionally different from the 1938 grouting mortar.

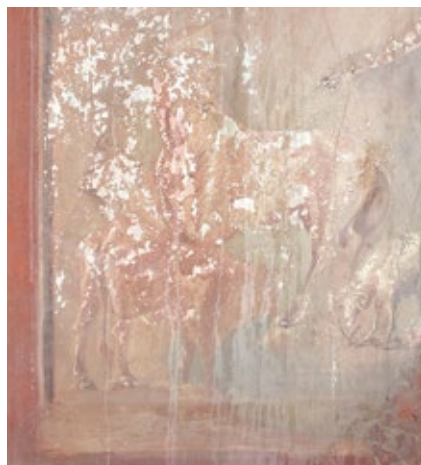
**FIGURE 3.13.**

Lower left corner of rectangular scene on the west wall, showing areas of retouching, notable in losses in the animals and along the ground below them, evident particularly by the absence of the lower brown border. It is not known if this was done as part of the 1938 intervention or post-1938.

Some evidence of retouching can be seen in areas of loss to the paint layers (fig. 3.13). However, it is not known when the retouching was done, or if it was done during multiple campaigns of intervention.

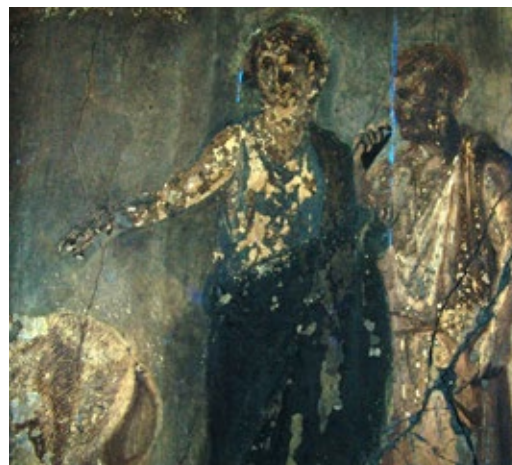
**FIGURE 3.14.**

Rectangular scene on the west wall as seen under UV light, showing different types of organic materials fluorescing on the surface. In the darker areas, coatings may not necessarily have been applied; rather, the pigment may be quenching the fluorescence.

Examination by UV light shows the presence of fluorescing materials on the surface of the wall paintings (fig. 3.14). This is likely related to the presence of restoration materials applied repeatedly to the surface and, in some cases, preferentially on the figurative scenes, vertical bands, and frieze. A difference in surface sheen is visible in images from 1992 in the Foglia photographic archive, where these areas appear glossier and more saturated compared to the surrounding monochrome areas (fig. 3.15). In situ and laboratory analysis confirms the presence of organic materials on the surface of the wall paintings, including beeswax and/or synthetic resins.<sup>4</sup> Further information on the analysis can be found in Graves, Piqué, and Rainer in this volume.

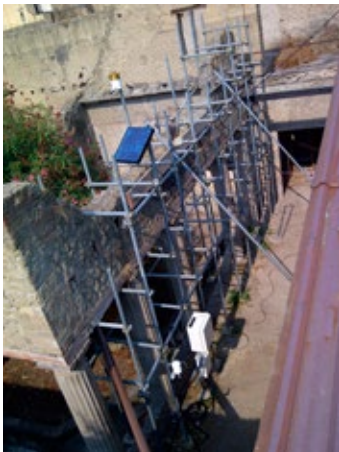
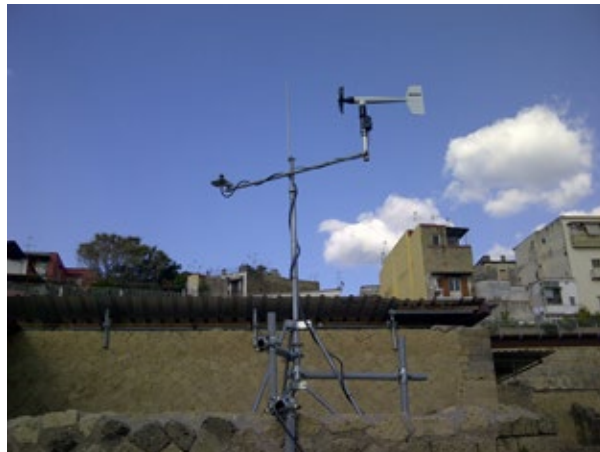
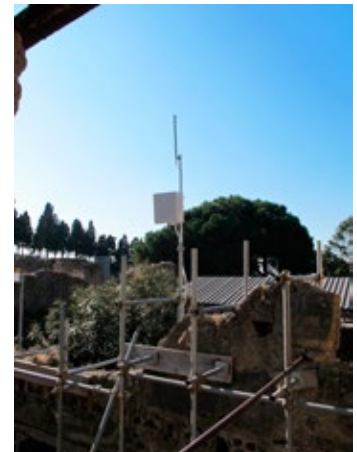
**FIGURE 4.4.**

*Left:* Solar panel, rain gauge, solar radiation sensor, temperature and humidity monitors, and monitoring station are mounted on scaffolding supporting the original columns surrounding the peristyle garden. *Center:* A wind speed and wind direction sensor is mounted on a 9-foot-high tripod on the roof of the tablinum. *Right:* A Wi-Fi receiver is mounted on top of the scaffolding in the peristyle garden.

Monitored parameters for the site climate include temperature, humidity, rainfall, solar radiation, wind speed, and wind direction. Sensors, a monitoring station, and Wi-Fi communication equipment are installed outside the House of the Bicentenary (fig. 4.4). The wind sensor (Wind Monitor, R. M. Young Inc.) is installed on the tablinum roof, where it is less disturbed by wind around surrounding structures, resulting in better capture. Because the circulation area between the tablinum and the peristyle garden has an archaeological foundation for a mosaic floor, the ground soil could not be disturbed in order to install a soil moisture sensor in depth. Instead, the soil moisture sensor was placed on top of the ground soil and covered with a 10 to 15 cm pile of soil 20 to 30 cm southwest from the end of the tablinum's west wall. Manufacturer and model names of the sensors are listed in appendix 4.1 at the end of this report.

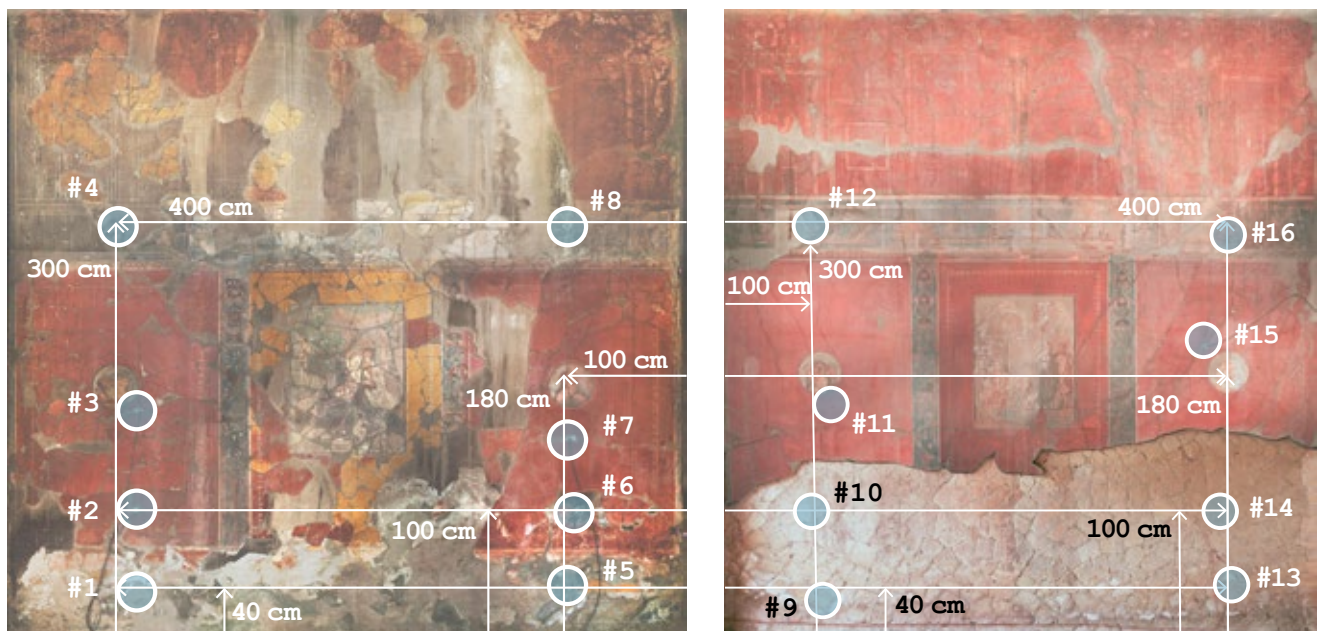
FIGURE 4.5.

Locations of surface-mount temperature sensors adhered to lacunae of wall paintings on the east wall (*left*) and west wall (*right*).

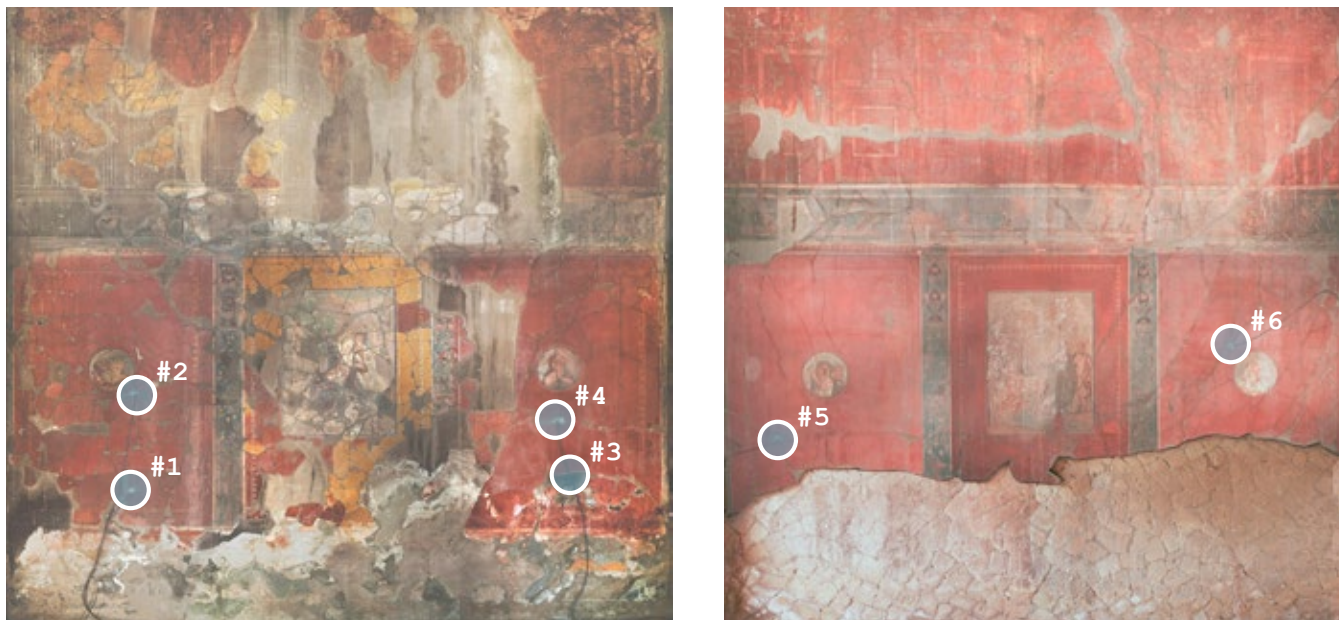
FIGURE 4.8.

Locations and identification numbers for time-of-wetness sensors on the east wall (*left*) and west wall (*right*).

Custom-made time-of-wetness sensors, consisting of pairs of stainless steel pins ( $\frac{1}{16}$ -inch diameter and 1 inch long) wired to the monitoring station, were installed in holes 1 inch apart and  $\frac{1}{2}$ -inch deep, drilled into a lacuna of wall paintings in the tablinum with a metal-filled epoxy adhesive. The sensors measure electrical resistance of the wall material between the pins. Six sensors, four on the east wall and two on the west wall, are installed in lacunae of the wall paintings. The following locations were selected (fig. 4.8):

- Approximately 100 cm (#1) and 160 cm (#2) from the ground along the axis atrium side medallion on the east wall
- Approximately 100 cm (#3) and 150 cm (#4) from the ground along the axis garden side medallion on the east wall

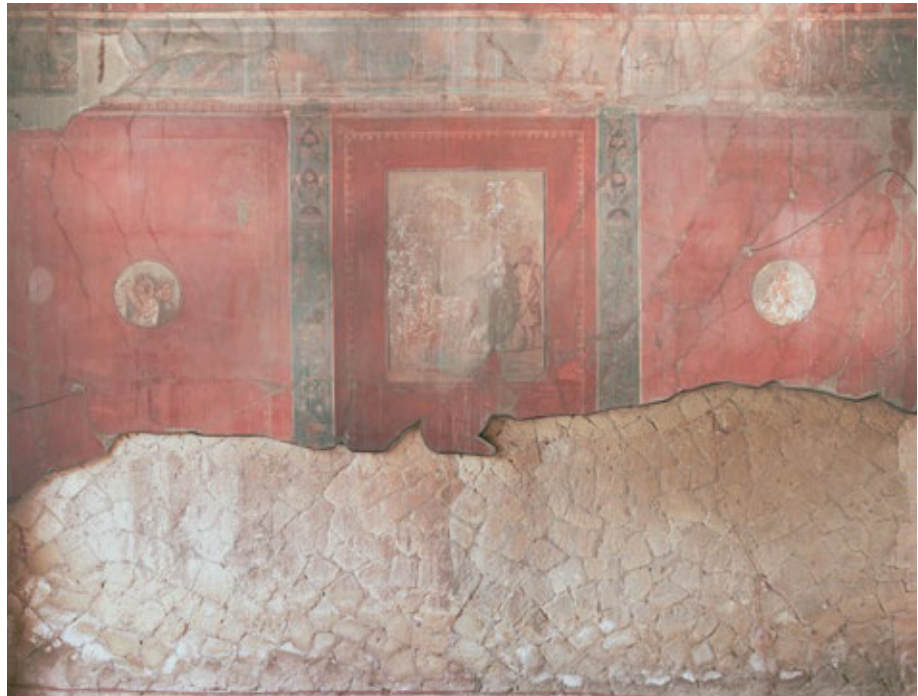
The lower register of the west wall, showing large areas which appear to have remained intact as evidenced by absence of small fragments and cracks unlike the correlating area on the east wall.

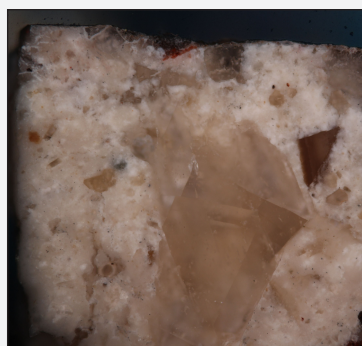
Upper stratigraphy of BCN\_58 (upper west wall, south side) showing the clear absence of a pink-tinted plaster layer.

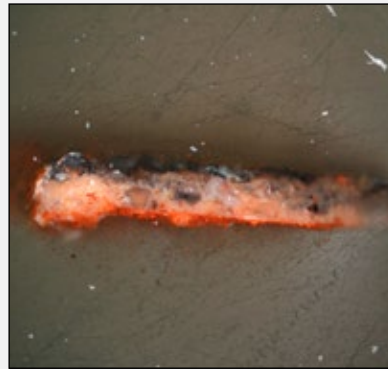
Cross section of the frieze plaster sampled from the peristyle garden-end of the east wall, BCN\_31f, showing layers 3, 4, 5, and 7.

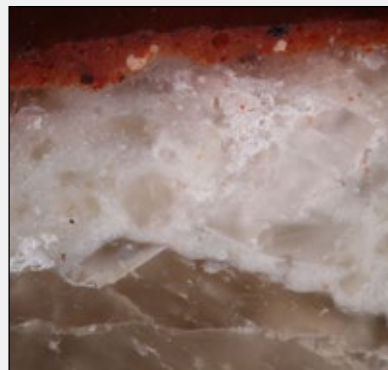
Cross section of the monochrome background and white plaster, found directly underneath the frieze plaster (pictured above), BCN\_31R, showing layers 2 and 3.

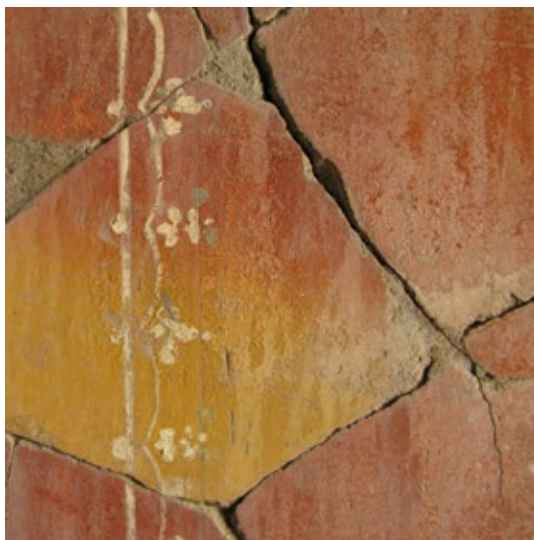
**FIGURE 5.26 (RIGHT)**

Fragment showing conversion from yellow to red, upper east wall.

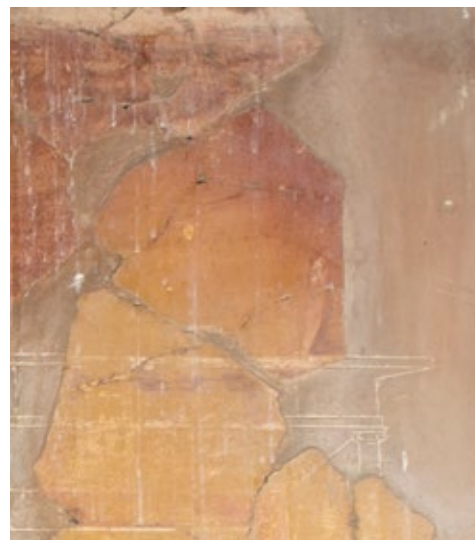
**FIGURE 5.27 (LEFT)**

Basemap of the east wall, lower register, showing the areas that would have been originally yellow but are partially converted to red. The areas at the base of the wall are not represented. Due to the deterioration of this area, it is difficult to determine the exact location of the original yellow background at the base of the wall.

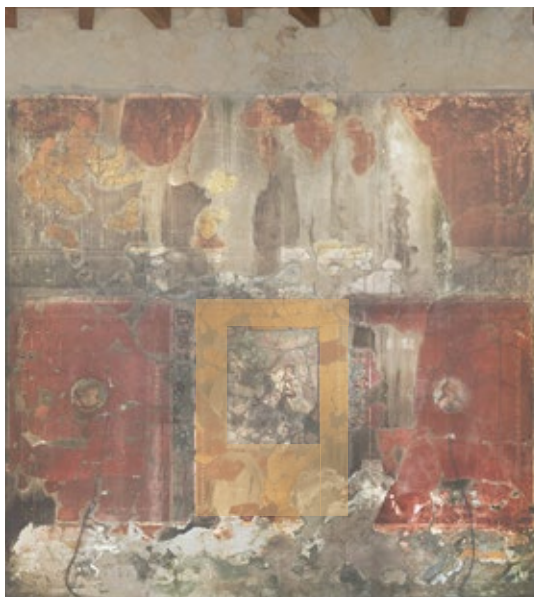
**FIGURE 5.28 (RIGHT)**

Basemap of west wall, lower register, showing the area that would have originally been yellow.

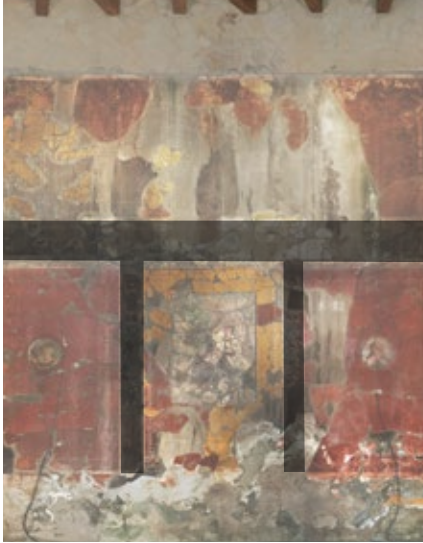
**FIGURE 5.30**

Basemap of east wall, lower register, showing the areas with a black monochrome background. The areas at the base of the wall are not represented. Due to the deterioration of this area, it is difficult to determine the exact location of the original black background at the base of the wall.

A monochrome black background is found in the vertical bands of the east and west walls, the frieze that runs the length of all three walls, the base of the east wall, and the lower pilasters of the south wall (figs. 5.30–5.32). The black pigment, identified by  $\mu$ -Raman in all cases as carbon black, was applied while the various underlying plasters were still fresh in the fresco technique. In most cases, the black is applied over a tinted or gray plaster: pink-tinted plaster for the vertical bands; yellow-, orange-, red-, or brown-tinted plaster in the frieze; gray (lime and volcanic sand) plaster at the base of the east wall; and orange-gray (lime, crushed brick, and volcanic sand) plaster for the lower pilasters of the south wall.

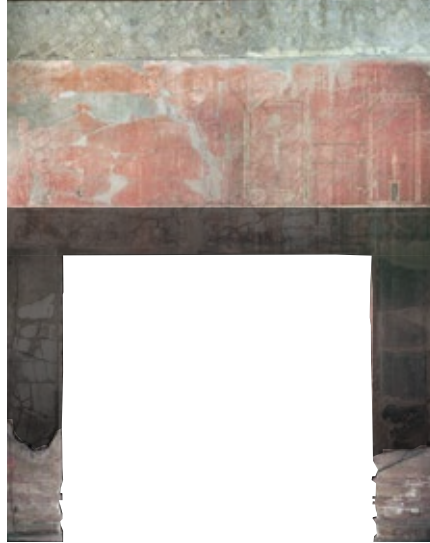
**FIGURE 5.31**

Basemap of south wall, lower register, showing the areas with a black monochrome background.

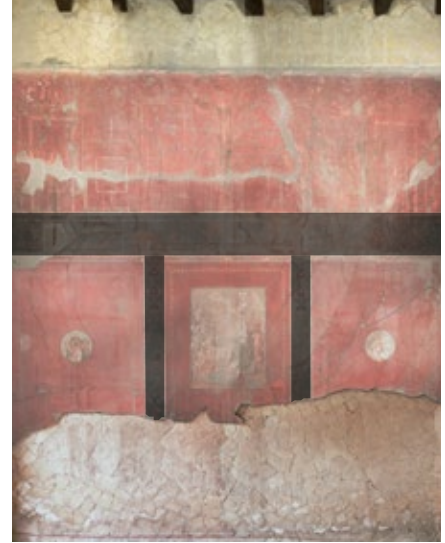
**FIGURE 5.32**

Basemap of west wall, showing the areas with a black monochrome background.

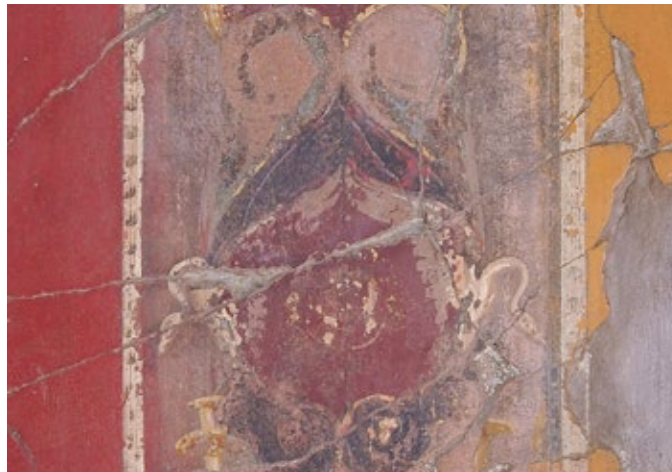
**FIGURE 5.33**

Image showing the pink-tinted plaster layer showing through the abraded black monochrome paint layer of the vertical bands found on the lower register of the east wall.

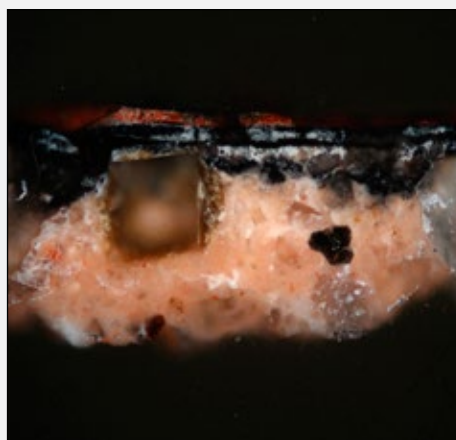
Cross section of W2\_04, black monochrome background painted over a pink-tinted plaster, from a vertical band on the west wall (10x), showing layers 3, 4, 5, 6, and 7.

In the frieze, only one layer of black is observed. Samples from the vertical band and south wall (W2\_04, BCN\_42b, and BCN\_59) have multiple applications of black paint. In these areas, layers are applied above the initial layer of black monochrome background; these upper layers have a higher concentration of underbound black pigment, and interfacial separations are marked by a carbonation layer. This is of interest, as both Vitruvius and Pliny refer to the use of an organic binder needed to fix the black pigments to a wall. Using SEM to examine the cross sections shows interfacial separations between layers, indicating that subsequent applications occurred after a pause that was long enough for a carbonation layer to form. The average thickness of these additional layers is 80 micrometers.

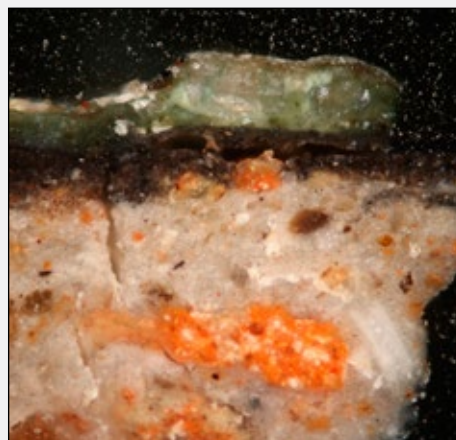
Detail of cross section of BCN\_42b, black monochrome background painted over a gray-orange plaster, lower south wall (20x).

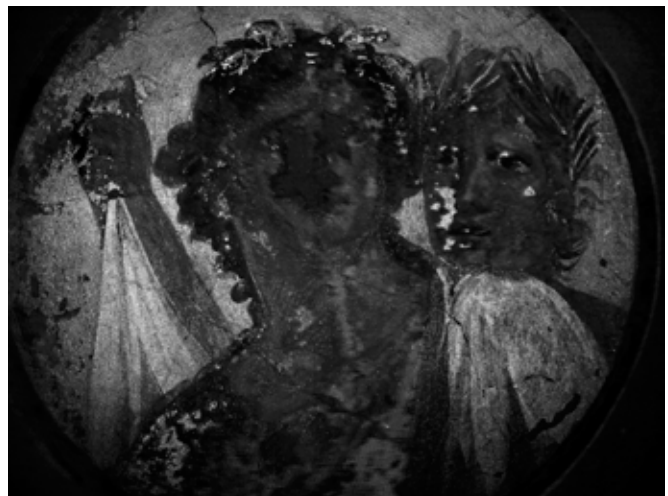
FIGURE 5.37

Medallion imaged with visible induced luminescence capture showing the presence of Egyptian blue.

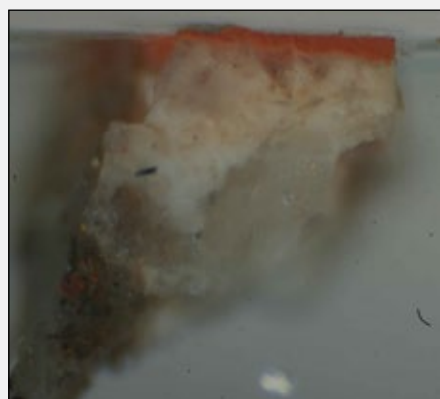
Cross section of E1\_11, east wall, lower register (10x), showing layers 1, 2, 3, and 4.

E1\_11 and E1\_12 were chosen as representative samples due to the fact that, combined, they represent the entire paint stratigraphy found in the medallions.

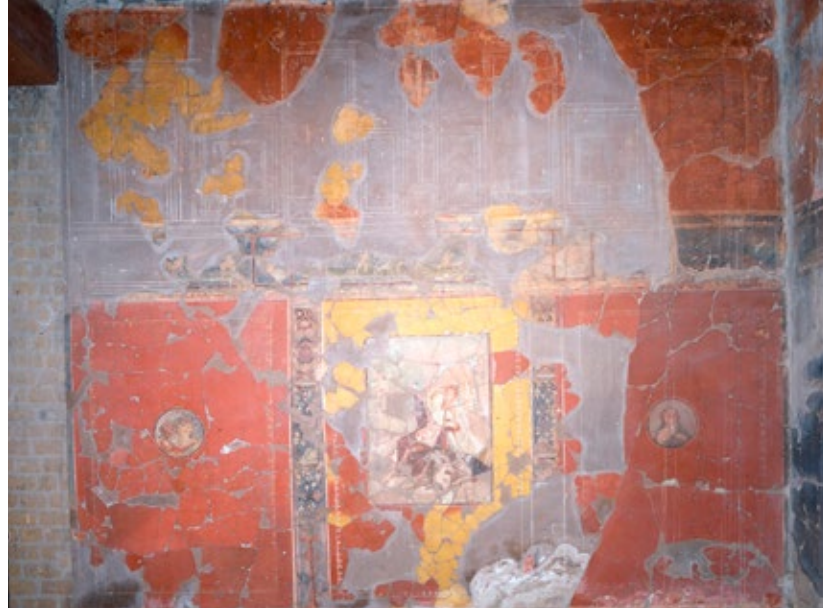
**FIGURE 5.43**

Image of east wall showing Maiuri restoration plaster.

team resulted in a stratigraphy in most areas that is a mix of original Roman and restoration plasters (fig. 5.43). There is very limited literature and documentation detailing the interventions. Oral histories by site custodians report the application of various materials to restore the wall paintings; custodians provided a sample block of paraffin previously applied to them in maintenance interventions. Research by Casoli et al. (2006) confirms by analysis that similar materials were used at Pompeii. Both in situ and laboratory analyses detected the widespread presence of organic materials over the surface of the walls, probably applied during modern interventions. These non-original repair plasters, grouts, and coatings were analyzed to understand if these materials are compatible and/or are causing damage to the Roman wall paintings. Paints and lime washes applied over the repair plasters are also present but were not analyzed at this time.

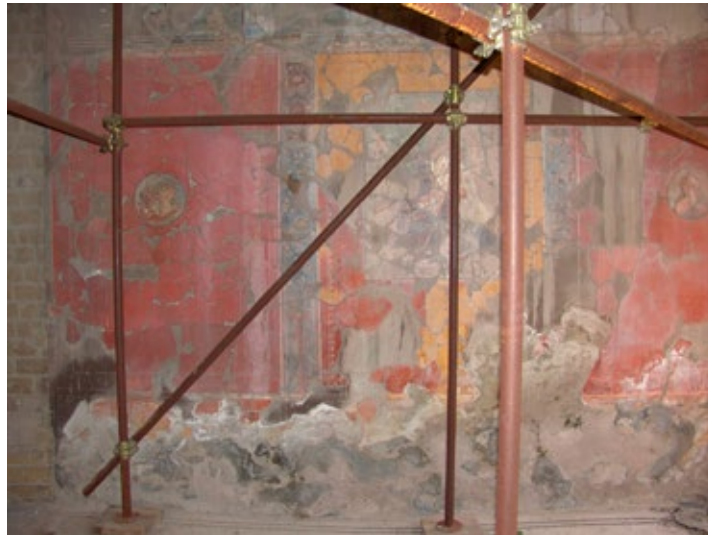
**FIGURE 5.47**

Another issue affecting the paintings, particularly at the base of the east wall, is salt activity (figs. 5.47 and 5.48). Eight areas of visually different salt efflorescence were found along the base of the east and west walls in the tablinum. All were analyzed using XRD and IC. The major salt species identified was sodium sulfate, or thenardite, in all six samples (Mazurek 2015). However, also present in smaller quantities in two samples was aphthitalite, a sodium-potassium salt.

East wall, showing the visible line of salt efflorescence reaching approximately 100 cm from floor along the base of the wall.
