# Conservation of the Architectural Surfaces in the Tablinum of the House of the Bicentenary, Herculaneum

Phase I: Examination, Investigations, and Condition Assessment

## Project Report

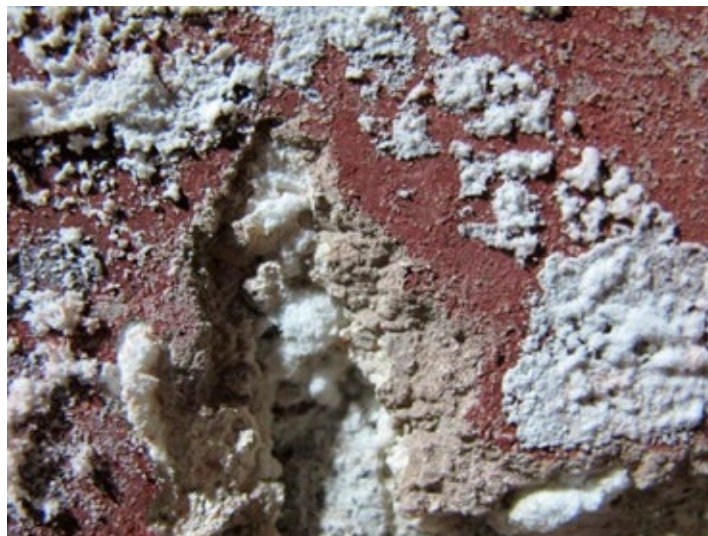
**FIGURE 5.48**

Detail of salt efflorescence.

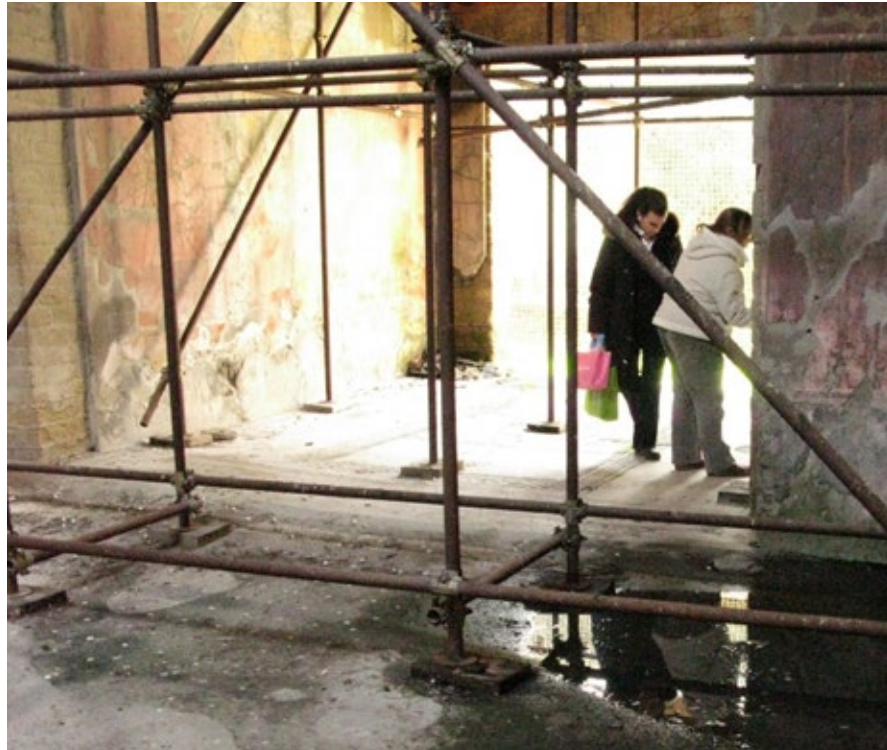
View from the atrium into the tablinum, showing the condition of the interior of the House of the Bicentenary in 2009, noting water infiltration and structural issues. A comprehensive project is under way to address conservation issues of the house. The focus of the GCI project is the conservation of the architectural surfaces of the tablinum.

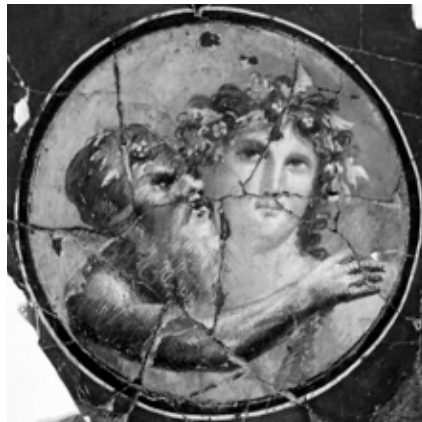
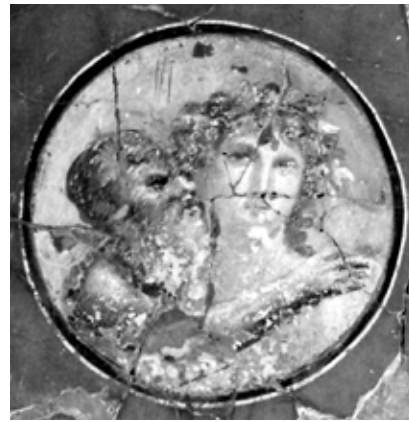
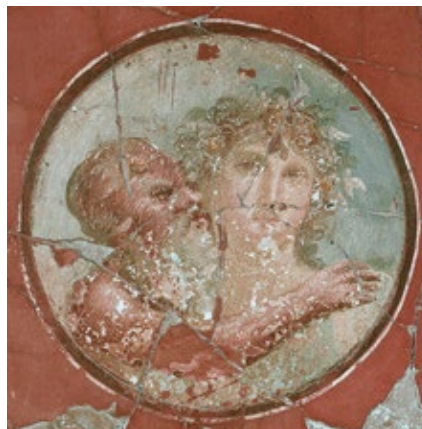
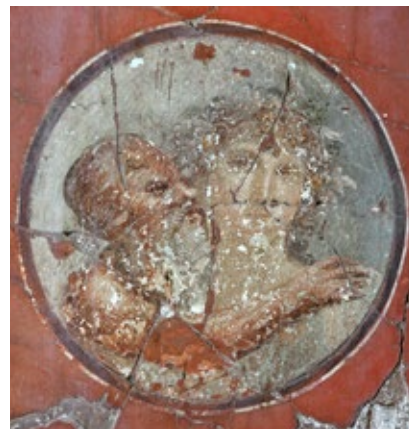
**FIGURES 6.2A–6.2D.**

Severe deterioration of the wall paintings and the figurative scenes in particular, which at the time of excavation were in good condition, was the impetus for the study and conservation of the architectural surfaces in this room. The changes over time are evident in the comparison of historical photographs from the Maiuri archives with recent photographs (figs. 6.2a–6.2d).

Changes over time in condition of the figurative scenes, as shown in this medallion in photographs dating from 1938 (a) to 2011 (d). Progressive flaking and loss of paint can be seen, occurring preferentially in different colors and areas of the painting. (6.2a. 1938 Archivio Maiuri, AZS89 SP, 6.2b. 1978 Archivio Maiuri, D14406 SP, 6.2c. 1992 Archivio Foglia, 150636 SP, 6.2d. 2011)

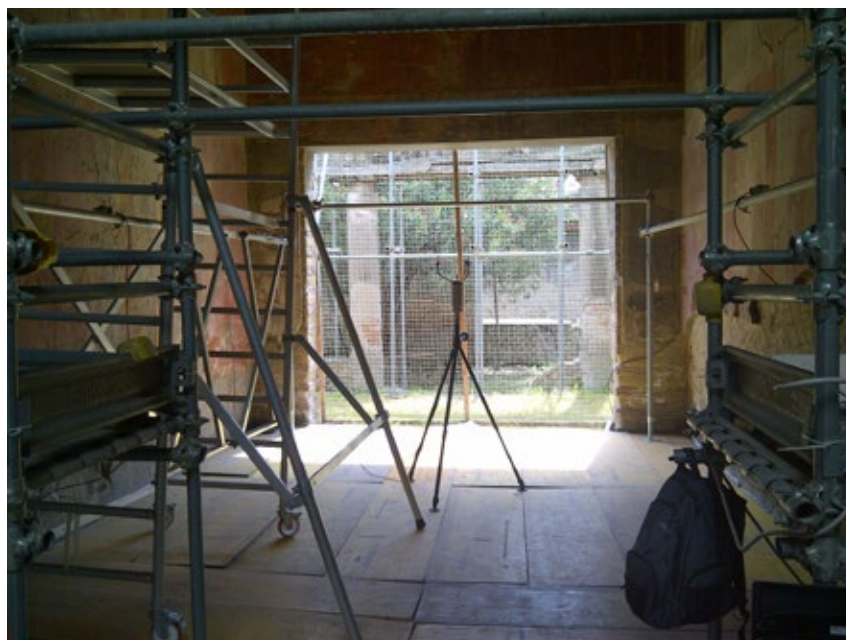
FIGURE 6.3.

View of the tablinum and peristyle garden from the atrium of the House of the Bicentenary in 2012, showing the large opening to the garden covered only with bird netting. A screen door has since been installed to reduce temperature fluctuations, airflow, and solar irradiation.

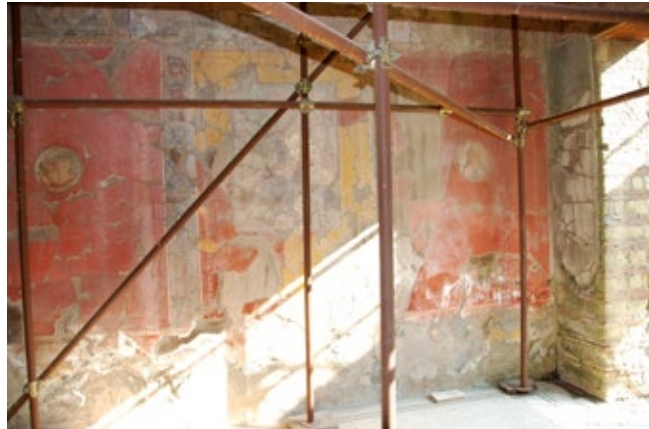
**FIGURE 6.4.**

Environmental conditions are described in detail in Maekawa, this volume. In summary, the tablinum, a semi-confined space, experiences significant diurnal and seasonal fluctuations of ambient temperature and relative humidity, which closely follow those in the adjacent peristyle garden. Until 2013, the opening in the south wall leading to the peristyle garden was secured only with bird netting (fig. 6.3).<sup>3</sup> Direct sunlight irradiates portions of the walls at certain times of the year, causing additional spikes in surface temperature and fluctuation of relative humidity (fig. 6.4). Wind passes through the House of the Bicentenary and exac-

Until 2013, bird netting over the large opening to the peristyle garden allowed the walls of the tablinum to be exposed to direct sunlight at different times of the day depending on the season.

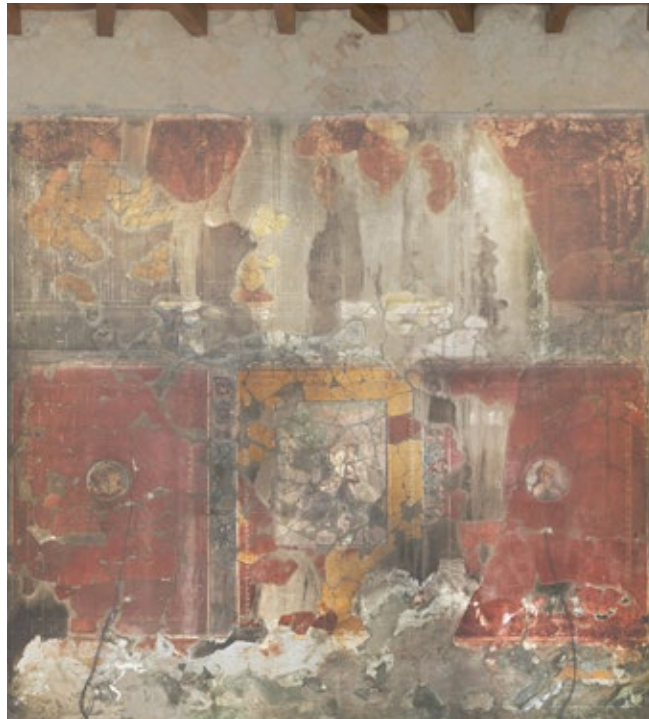
**FIGURE 6.5.**

High moisture content in the lower walls has activated salts and led to degradation of original and restoration plaster at the base of the east wall.

erbates fluctuations in the environment of the tablinum. The lower walls have high moisture content (90%–100%) up to 100 cm on the east, south, and west walls. This is particularly critical on the east wall, which retains original plaster and paint along the base. Areas on the east wall with high moisture content correspond to areas of salt efflorescence, visible erosion, and deterioration of plaster and paint (fig. 6.5). These conditions are also degrading the exposed tuff along the base of the south and west walls (fig. 6.6).

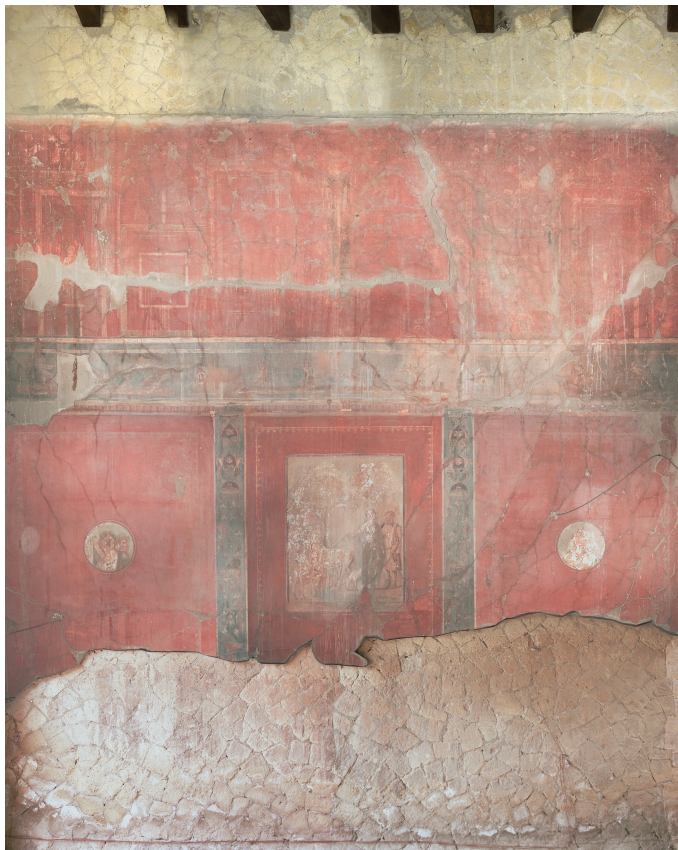
**FIGURE 6.6.**

Deterioration of the exposed tuff related to salt activity can be observed along the base of the west wall.

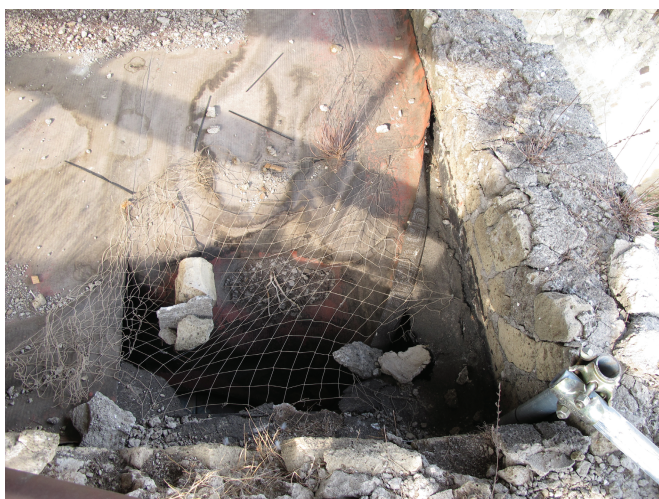
**FIGURE 6.7.**

A large hole in the roof over the tablinum led to water infiltration in the past, particularly in the southeast corner of the room. In 2011, a new slab roof was installed.

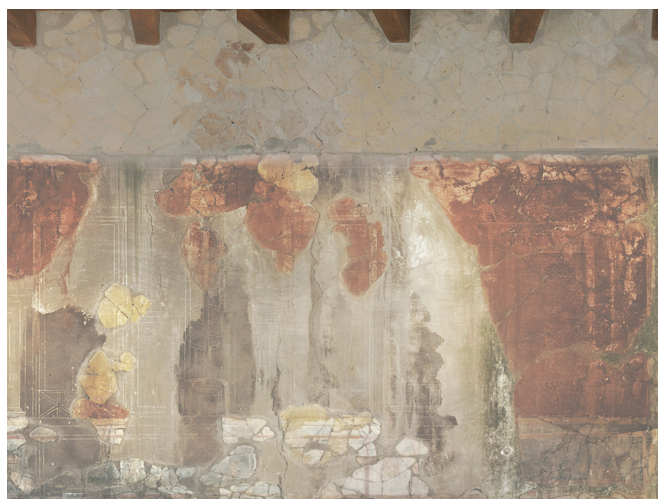
**FIGURE 6.8.**

Damage along the south end of the upper east wall includes powdering and spalling tuff, drips down the wall, and biogrowth, the result of the roof leak and water infiltration.

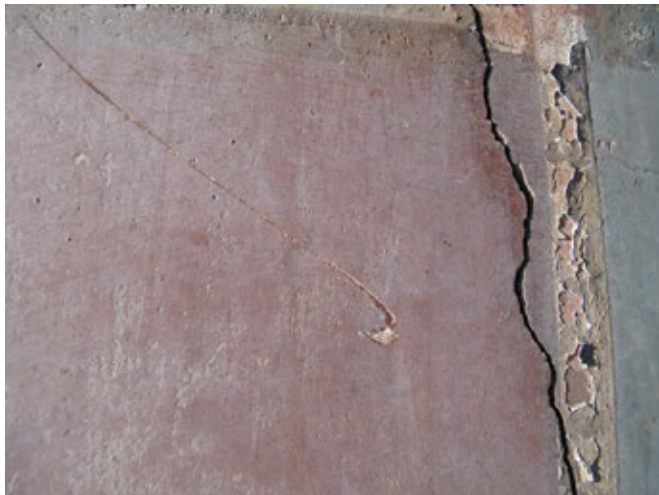
**FIGURE 6.9.**  
Open vertical cracks are observed in all four corners of the tablinum.

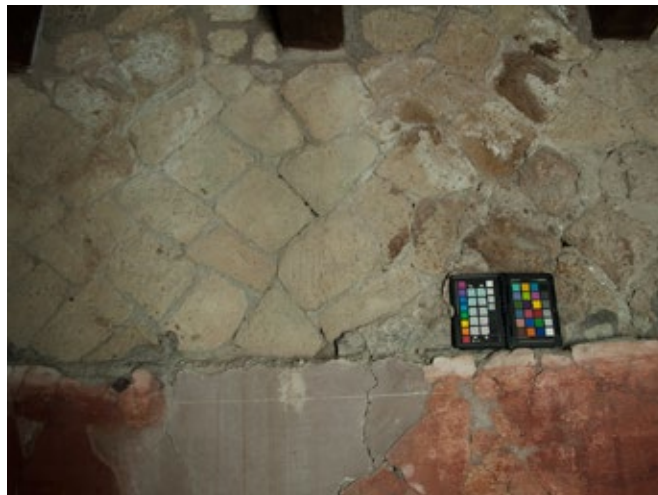
**FIGURE 6.10.**  
Tuff blocks on the upper east wall are spalling and powdering in areas of previous water infiltration.

In areas at the top of the east wall, along the south wall, and along the base of the west wall, some tuff blocks exhibit spalling and powdering. These conditions appear to be related to previous water infiltration and salt activity (fig. 6.10).

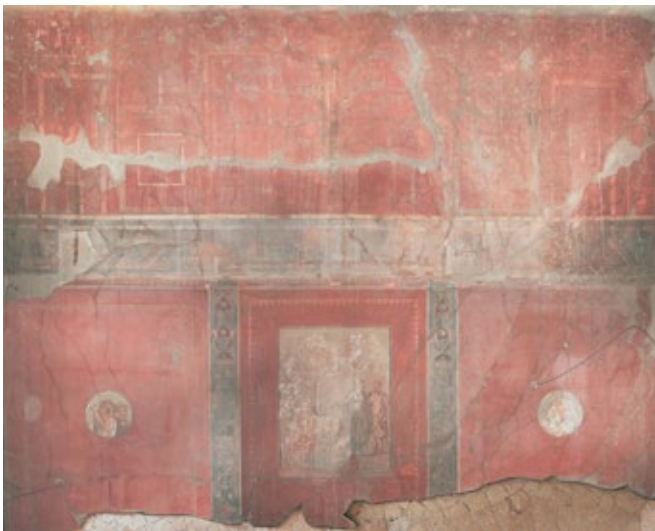
**FIGURE 6.11.**  
Significant vertical and diagonal cracks are visible on the east and west walls of the tablinum.

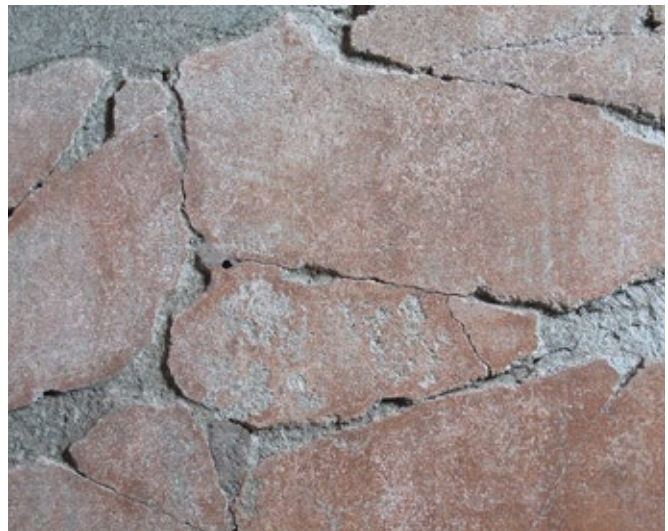
**FIGURE 6.12.**  
Detail of the south wall, showing decohesive plaster and powdering paint layers.

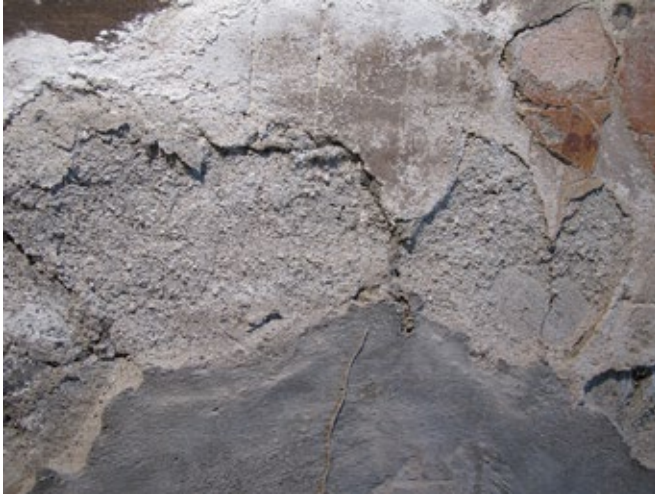
**FIGURE 6.13.**

The base of the east wall (the lower 160 cm) retains original Roman plaster fragments, partially covered by a combination of lime-based 1938 reconstruction plasters and later cementitious repair plasters. This area is severely deteriorated; conditions include detachment, losses, decohesion, and salt efflorescence, which is principally located on the original plaster. The area has been subject to ground moisture and capillary rise due to water from the peristyle garden and previous roof leaks that pooled at the base of the wall. Additionally, as the adjacent triclinium (Ambiente 9) was exposed to the elements until 2013, when it was reroofed by HCP and SANP, water also pooled at the base of the east wall on the triclinium side. Salt efflorescence can be seen in some areas up to 160 cm, the height of the capillary rise. Clearly, the entire zone has undergone treatments in the past, as evidenced by the presence of cementitious fills applied in post-1938 interventions (fig. 6.13).

Detail of the base of the east wall, showing cementitious fills partially covering original Roman plaster fragments and resulting in deterioration from salt activity.

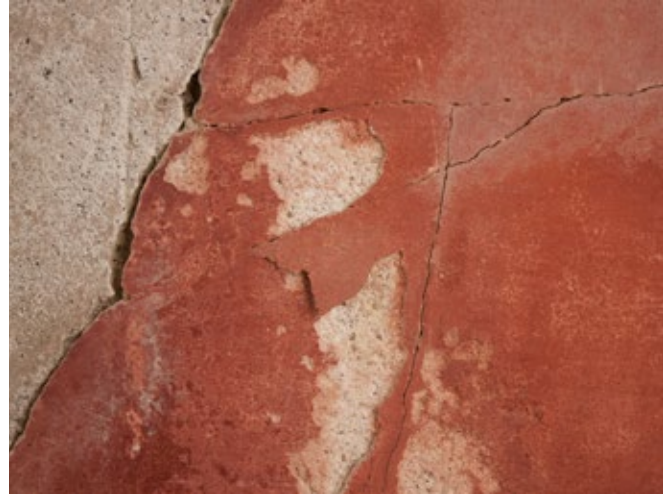
**FIGURE 6.14.**

The lower east wall exhibits loss of the uppermost layer of plaster associated with thin delaminations of plaster and paint in areas of salt activity (fig. 6.14).

Thin delaminations of the uppermost plaster occur along the lower east wall in areas of water infiltration and ongoing salt activity.

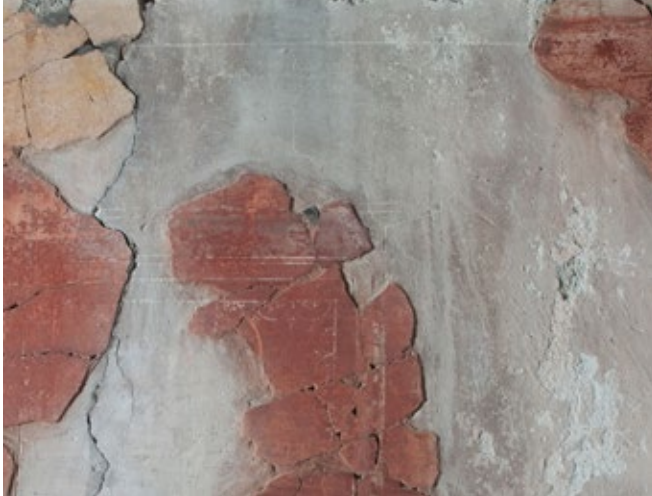
FIGURE 6.15.

Upper east wall at the south end, showing 1938 reconstruction plaster that is spalling and friable in the area of previous water infiltration from roof leaks. Cracks in this area have been repaired in the past with different colored materials.

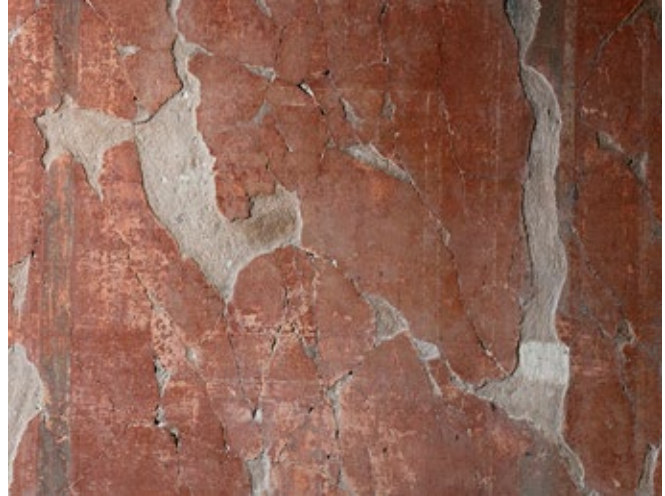
FIGURE 6.16.

Smaller Maiuri-era fills exhibit a thick, tinted layer in some areas.

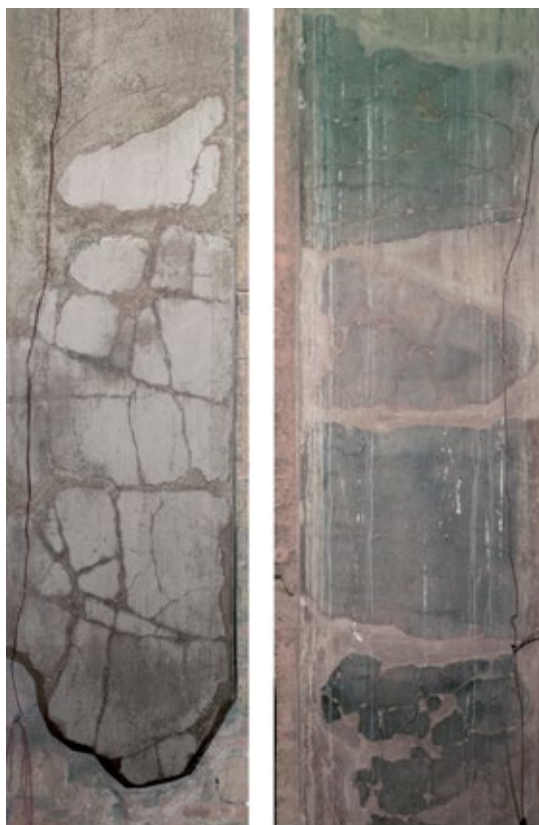
FIGURE 6.18.

On the lower south wall pilaster to the east of the opening to the peristyle garden, the black monochrome background has washed away, leaving the underlying plaster exposed. To the west of the opening, the black monochrome background of the pilaster on the lower south wall is fairly stable with little powdering, although the density of the black color varies across this area (fig. 6.18).

On the lower section of the south wall, the black paint layer on the east side (left) has been washed away; on the west side (right), the layer is more coherent, although the condition varies across the surface.

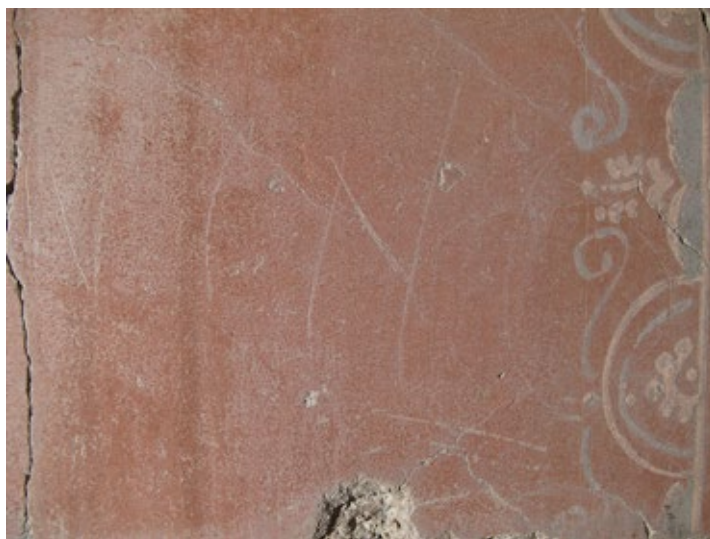
FIGURE 6.19.

Graffiti scratched into the east wall at the south end.

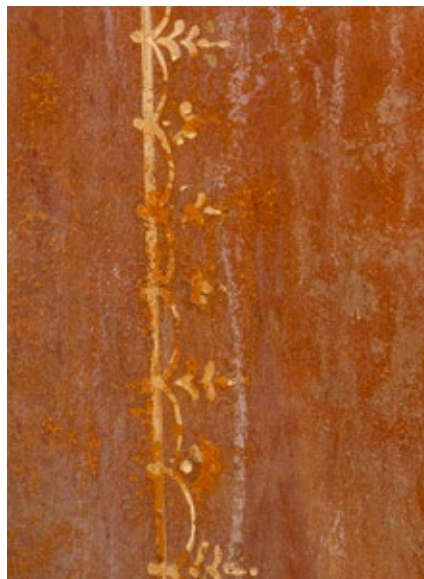
Much of the architectural decoration on the upper south and west walls, and in places where decoration remains on the upper east wall, has a distinctly eroded or abraded appearance. Only traces of figures and decoration can be seen (fig. 6.22). Traces of green and purple can be seen in the decoration on the upper east wall but are mostly lost on the upper south and west walls. Where green remains on the upper west wall, it is slightly darkened.

**FIGURE 6.22.**  
On the upper walls, architectural decoration and figures applied directly over the monochrome background on the upper walls are abraded and eroded.

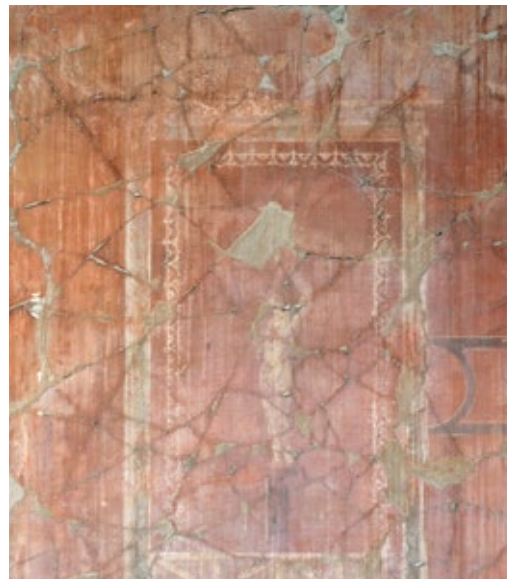
In many places on the decorative borders, losses are concentrated in areas where paint was applied most thickly and in specific colors, particularly green and red, which are almost completely lost (fig. 6.23).

**FIGURE 6.23.**  
Decorative borders are composed of different designs executed with thickly applied paint, which exhibits widespread flaking and loss, particularly in specific colors such as green and red.

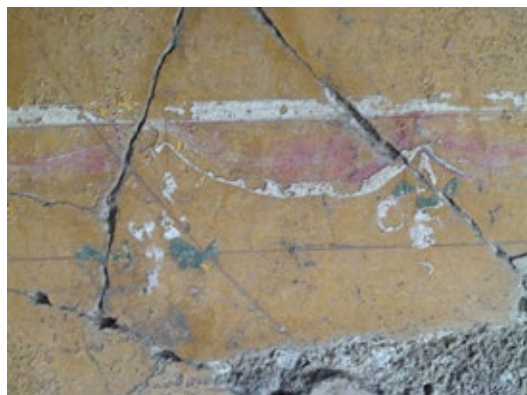
**FIGURE 6.24.**

Powdering, flaking paint, and paint loss affect the painted decoration within the vertical bands. This appears to be frequently associated with paint thickness and with specific colors, especially details executed in green earth. Painted details on all four vertical bands are lifting and show micro-flaking, flaking, and paint loss (fig. 6.24).

Painted detail on a vertical band, applied over a black background, exhibits micro-flaking, flaking, and paint loss.

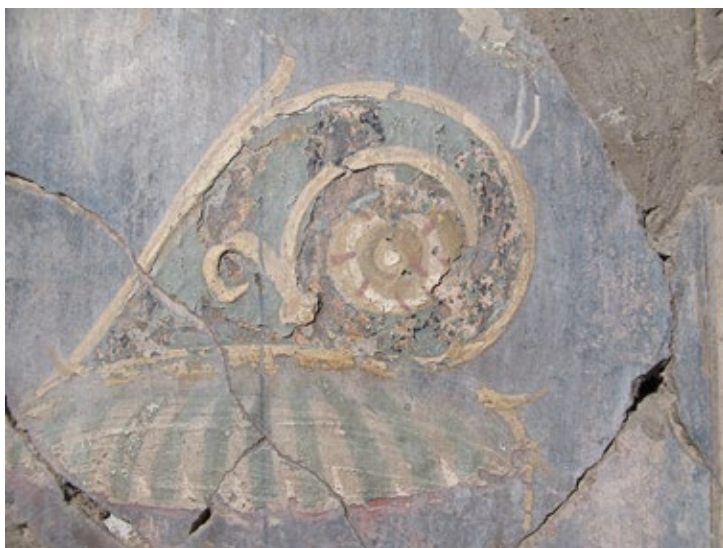
**FIGURE 6.25A–6.25B.**

On the east wall, significant portions of the south vertical band are lost. The edges of the black background of both vertical bands on the east wall have been partially washed away in areas of previous water infiltration, exposing the red or yellow monochrome background underneath (fig. 6.25a), and on the north vertical band, the original pink-tinted plaster is exposed in places (fig. 6.25b). Alteration of cinnabar from a bright red to a dull brown-black can be seen in some of the decorative elements on the vertical bands (see fig. 6.25b).

The vertical bands show flaking, cupping and loss. On the vertical bands of the east wall, the black has washed away in areas, revealing the original pink-tinted plaster on the north end and red or yellow underneath. Note also the alteration of cinnabar from bright red to brown-black in the floral decoration of the south vertical band.

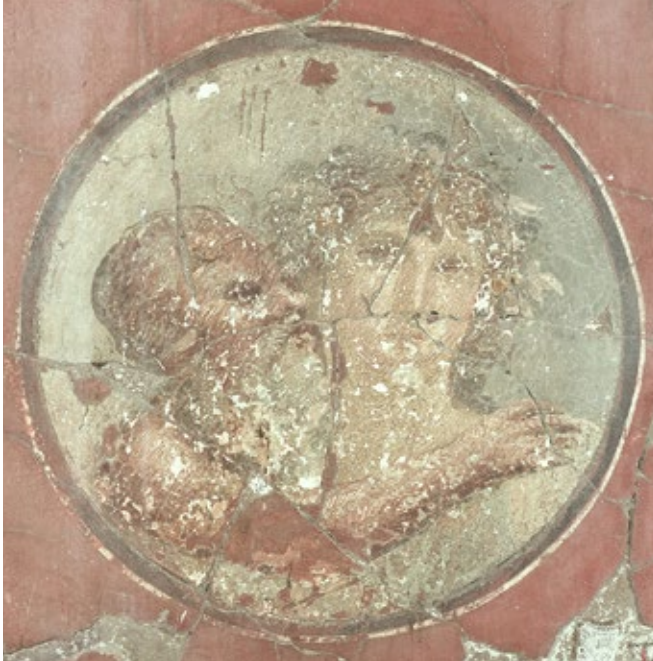
**FIGURE 6.27.**

The medallion at the north end of the east wall shows extensive flaking, cupping, and lifting over the majority of the surface, particularly in the design layers (fig. 6.27). Across the surface of the medallion, 30%–35% of the painted decoration is lost, and the remaining paint is in precarious condition. The underlayer is decohesive/powdering, which leads to lifting and flaking of the painted design layers above, caused by a lack of adhesion between the powdery underlayer and the more stable paint layer above. There is both loss of the design layers down to the monochrome background and flaking with paint loss of the upper design layers.

Medallion at the north end of the east wall, exhibiting severe cupping, flaking, and loss of paint in the design layer, exposing the monochrome red background in several places.

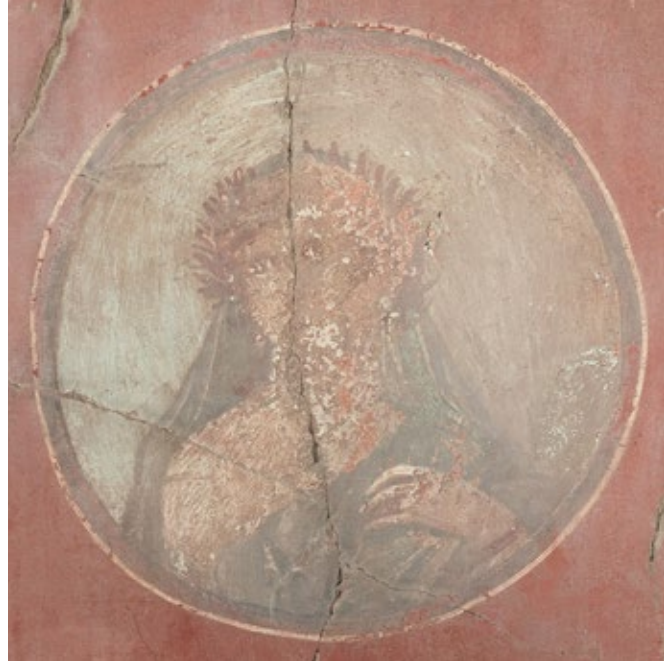
**FIGURE 6.28.**

The medallion at the south end of the east wall is in more stable condition. There is localized lifting, cupping, and flaking, and some paint loss (approximately 10%–15%) but much less of the design layer is affected (fig. 6.28). The preparation layer is decohesive where it is exposed and may be powdering under the upper design layers.

Medallion at the south end of the east wall, showing a loss in the face exposing the monochrome background, and localized flaking and cupping on the figure and background.

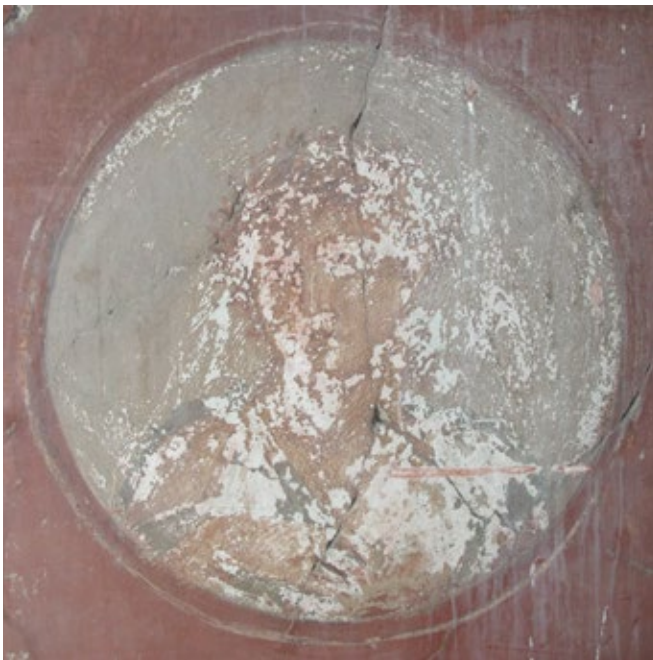
**FIGURE 6.29.**

The medallion at the north end of the west wall shows severe flaking, cupping, and lifting over the majority of the surface, concentrated on the robe and in places on the figure's neck and face. There is some loss down to the monochrome background layer. Most of the loss is down to the exposed underlayer, which is decohesive/powdering, leading to lifting and flaking of the design layers. There is approximately 25%–30% paint loss on this medallion, and the remaining paint is in precarious condition. A deep scrape along the lower right half of the medallion measures approximately 10 cm (fig. 6.29).

Medallion at the north end of the west wall, presenting severe deterioration of the figure's robe, neck, and face, with most of the loss down to the exposed underlayer. A deep scrape is seen on the lower right.

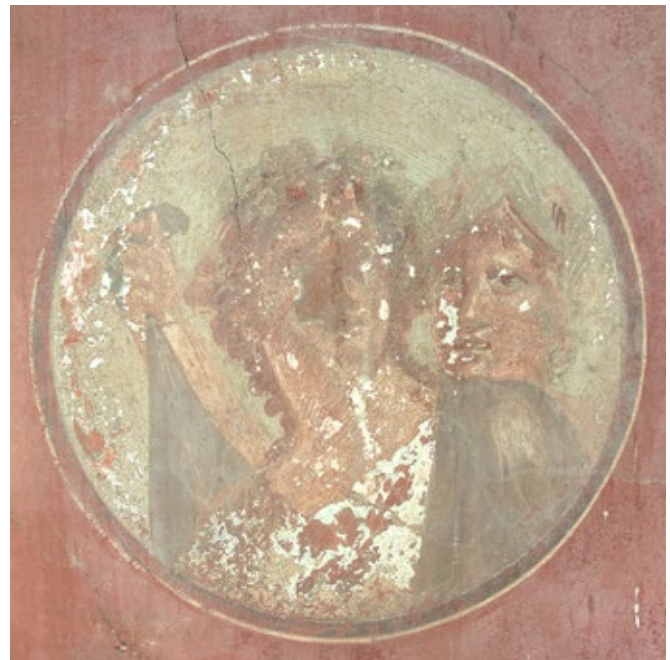
**FIGURE 6.30.**

The medallion at the south end of the west wall is lifting, cupping, and flaking with approximately 15%–20% loss. The face of the figure in the foreground is nearly lost, with a large lacuna exposing the red monochrome layer. Additionally, there is extensive loss in the figure's tunic and along the left edge of the blue background. The majority of loss on this medallion is down to the light-blue background. The exposed underlayer is decohesive/powdering, leading to lifting of the design layers and areas of paint loss, exposing the monochrome background and upper design layers (fig. 6.30).

Medallion at the south end of the west wall, exhibiting severe damage exposing the monochrome background in the face and robe of the figure in the foreground. The majority of the design layer is severely cupping, lifting, and flaking. The decohesive preparation layer is exposed in these losses.

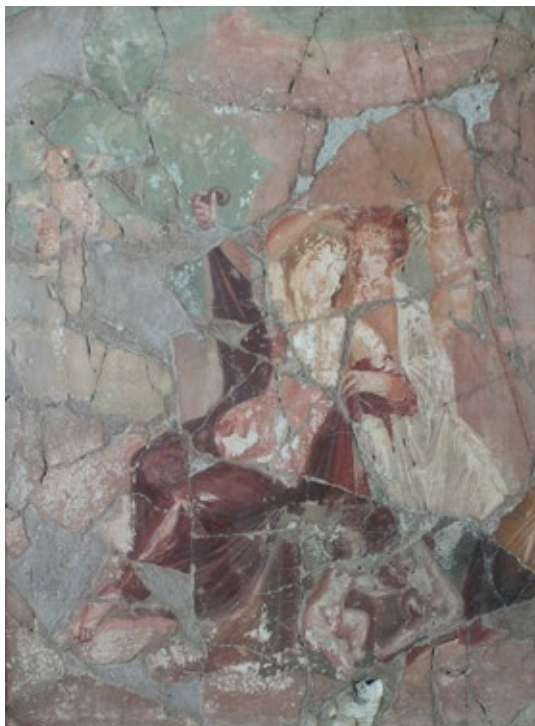
**FIGURE 6.31.**

In the rectangular scene on the east wall, the majority of loss is concentrated on the figures (fig. 6.31). The features on the face, chest, and upper arms of Venus and the face of Mars are mostly lost, leaving the powdery white preparation exposed (fig. 6.32). Details found in historical photographs, such as the cupids and the symbolic weapons of Mars, are barely visible. Loss occurs mostly down to the powdery/decohesive white preparation layer

The central rectangular scene on the east wall exhibits severe deterioration concentrated mainly on the figures. Many details, including Mars's weapons, are barely visible.

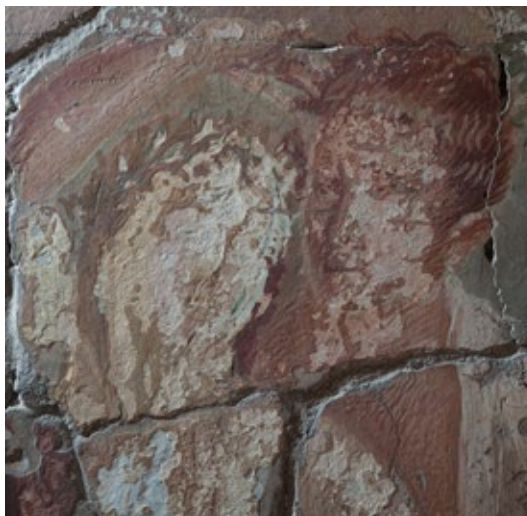
**FIGURE 6.32.**

Detail of rectangular scene on the east wall, showing severe loss of paint in the faces of Venus and Mars and the chest and arms of Venus, exposing the decohesive white preparation layer.

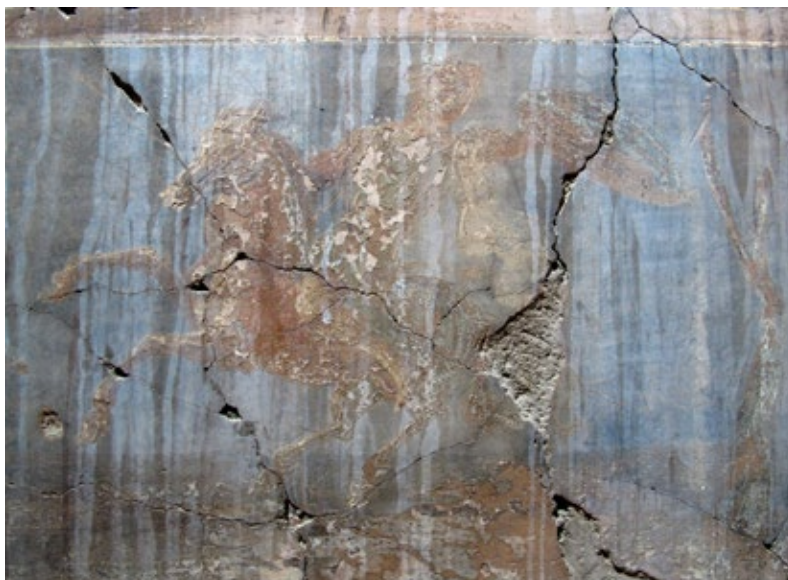
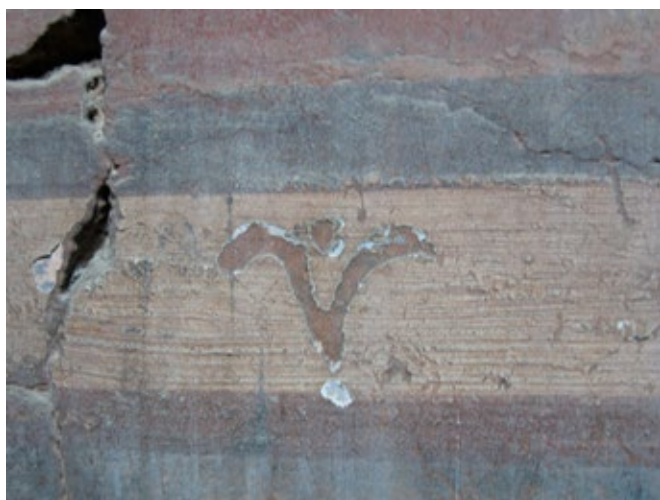
**FIGURE 6.34.**

The paint layer of the frieze exhibits powdering, flaking, and loss. In the painted figures and decoration, paint is also abraded and decohesive/powdering. Primarily on the center section of the west wall, the design and black background of the frieze are abraded and worn, exposing the lower tinted plaster layer (fig. 6.34). The frieze on the east wall is fragmentary, with less than 50% remaining.

Detail of figurative painting on the frieze, showing powdering, flaking and exposure of the lower tinted plaster layer, all of which is obscured by the white drips due to water infiltration and excess wax.

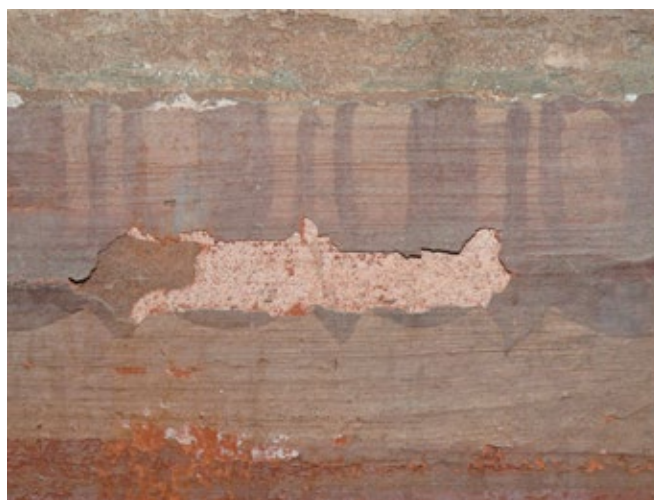
**FIGURE 6.35.**

Where paint was most thickly applied, there are some occurrences of loss of the entire painted decoration, exposing the red background (fig. 6.35). Along the egg-and-dart motif, which extends along the lower edge of the frieze, there are areas where the paint is poorly adhered to the underlying plaster, and large flakes and losses are visible (fig. 6.36).

In some areas of the frieze where paint was most thickly applied, the entire painted decoration has been lost, leaving the red background below exposed.

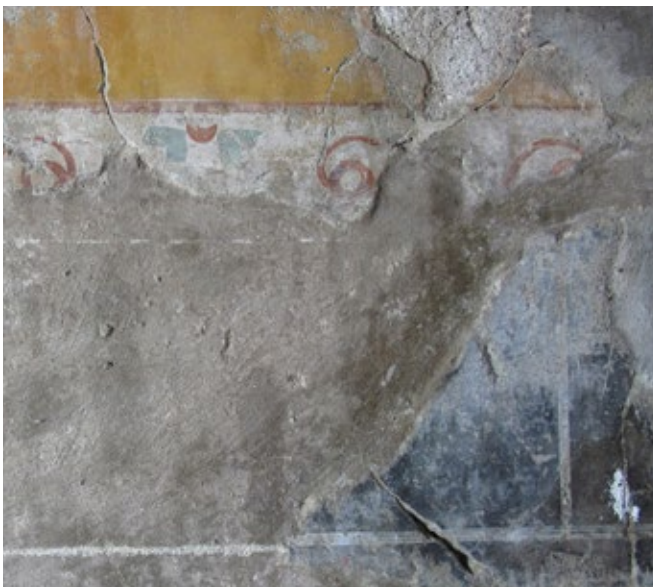
FIGURE 6.37.

Along the base of the wall, original painted plaster is extant only in the southeast corner on the east wall (fig. 6.37) with some traces of painted plaster along the base of this wall, which is severely deteriorated, and numerous fills that cover the original plasters in many places. For the most part, the paint and plaster layers exhibit efflorescence, powdering, pitting, and loss caused by chronic cycling of salt deliquescence and crystallization, due to capillary rise of both groundwater and standing water following rain events. Moreover, the severe degradation of this area has led to the subsequent and repeated application of fills in maintenance interventions post-excavation and reconstruction. A series of hard gray cementitious fills covers original Roman plaster, with traces of color in some places. The combination of capillary rise and the cementitious nature of these repair fills has led to salt activity in this area, and salts have crystallized and accumulated on and in the original Roman plaster around the repair fills, leading to further deterioration and necessitating their removal (fig. 6.38). The base of both the south and west walls is exposed tuff and brick in *opus vittatum*, and tuff blocks in *opus incertum*, respectively, and the entire Roman stratigraphy is lost.

Remnants of original painted decoration along the base of the wall are extant only in the southeast corner on the east wall with traces of paint on original plaster in some places along the base of this wall.

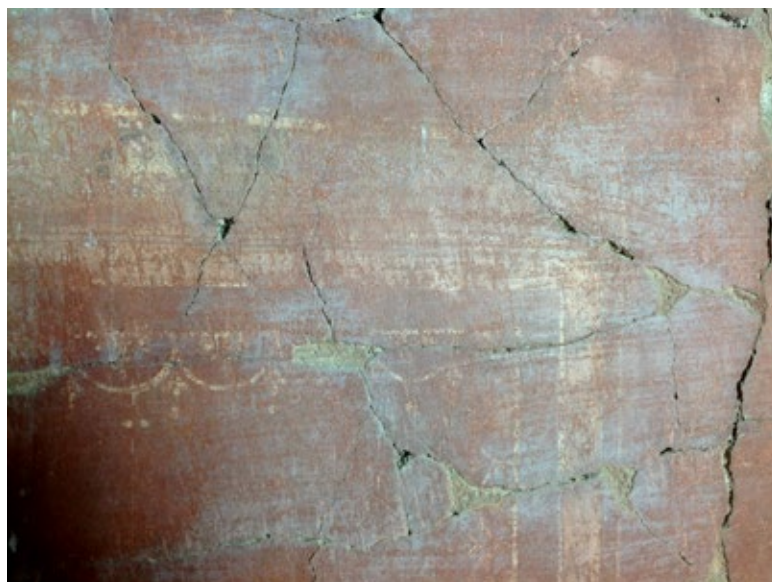
**FIGURE 6.39.**

Detail of the upper west wall, showing clear brushstrokes and wax accumulated on the surface of the wall paintings that creates a variable and dull sheen.

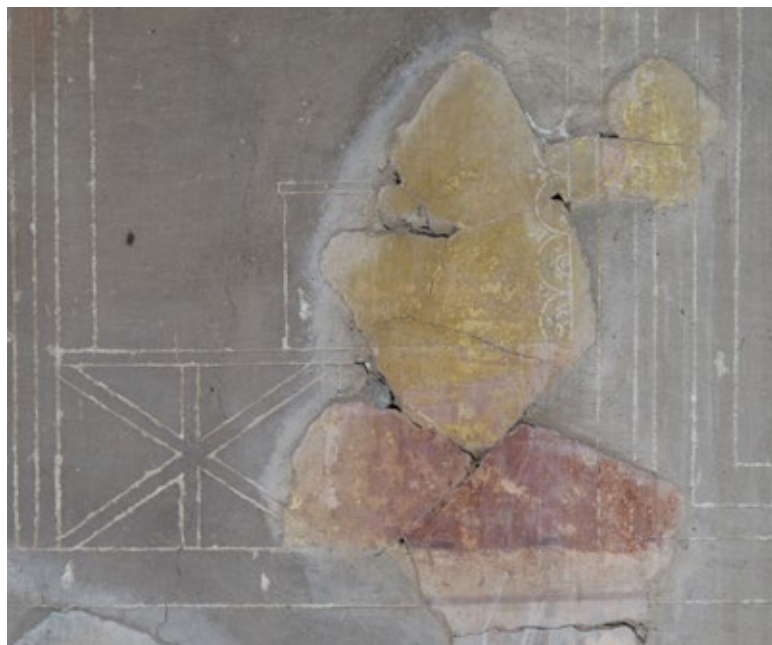
**FIGURE 6.40.**

Detail of the upper east wall, where wax can be seen overlapping the 1938 reconstruction plaster surrounding original Roman plaster fragments.

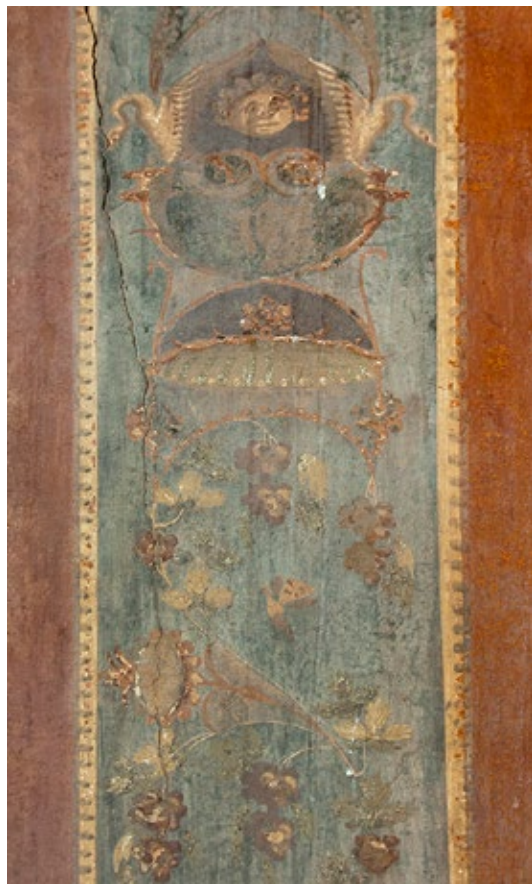
FIGURE 6.41.

Detail of vertical band on the west wall, showing a disfiguring white haze over the black monochrome background and decoration, giving the band a blue-gray cast. In this case the white veil is a crust attached to the underlying paint.

On areas with a black background, including the vertical bands, frieze, and lower south wall, the haze gives the background a blue-gray cast, which, on the frieze, obscures the figurative painting. On the vertical bands, the white haze is a crust that is firmly attached to the paint beneath and appears to be composed of multiple layers (fig. 6.41). It is most evident on the two vertical bands on the west wall.

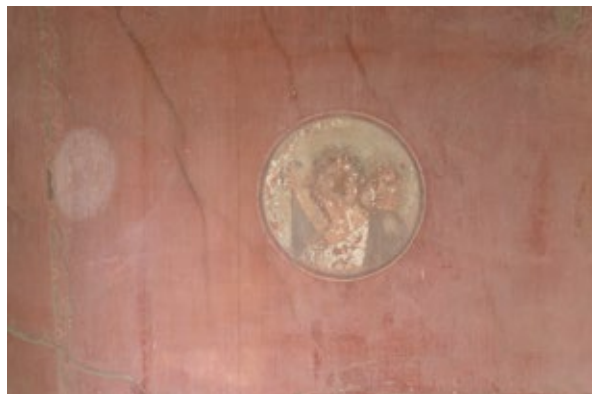
FIGURE 6.42.

Distinct, oval-shaped white spot next to the medallion at the south end of the west wall, most likely caused by light from a lamp placed close to the wall. Tape marks from the tracing can also be seen around the medallion.

A distinct, oval-shaped white spot measuring approximately 4 × 8 cm is observed next to a medallion at the south end of the west wall (fig. 6.42). This likely corresponds to the previous placement of a lamp close to the wall for tracing of the medallion; the illumination from the lamp appears to have heated the surface and re-formed the wax in this location. Tape marks are also visible around the medallion.

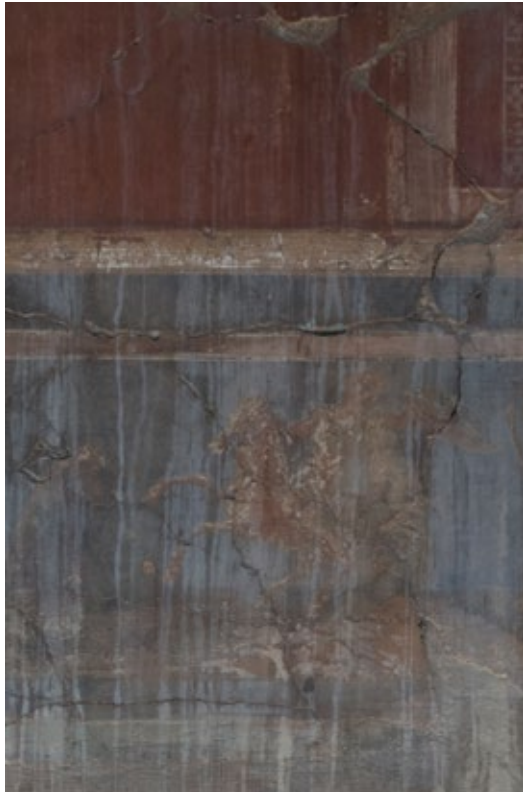
**FIGURE 6.43. (LEFT)**

Detail of upper south wall and frieze. White drips are caused by a buildup of wax on the degraded surface, and also a washing away of the paint layer that exposes the underlying white plaster.

away of the paint layer, exposing the underlying plaster (fig. 6.43). White drips extend down the upper south wall on the west side and are particularly noticeable on the frieze. There are white drips down the west wall, especially at the south end, at the south end of the east wall, and in other locations across all three walls.

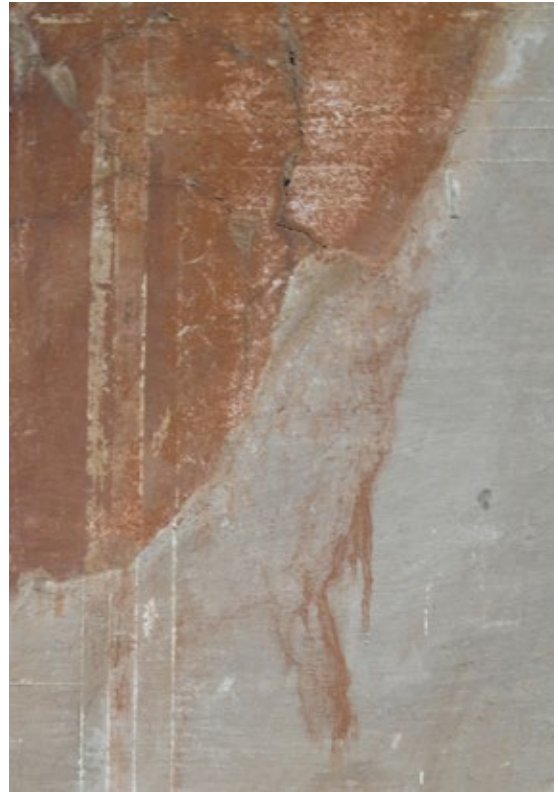
**FIGURE 6.44. (RIGHT)**

Red drips on the upper east wall are likely powdering pigment from the original painting, washed down the wall by previous water infiltration.

On the north and center sections of the upper east wall, drips of red pigment are visible and are likely original powdering pigment from original Roman plaster that has been washed down the surface of the reconstruction plaster by water infiltration (fig. 6.44). A dark brown drip at the south end of the upper west wall is possibly a stained coating used on the beams above (fig. 6.45).

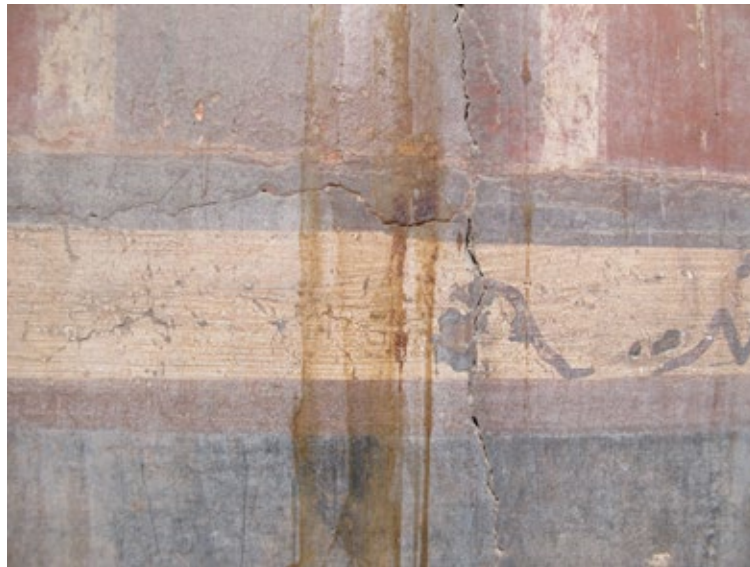
**FIGURE 6.45.**

Detail of the south end of the upper west wall, showing a brown drip that most likely is from a stain used on the beams above.

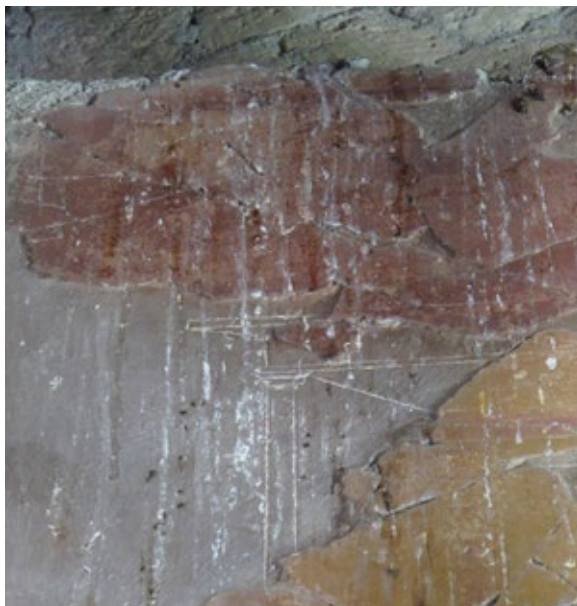
**FIGURE 6.46.**

Drips of bird excrement can be seen on both the east and west walls at the north end of the room, and on the south and west walls in the southwest corner of the room, suggesting that the upper edges of the wall paintings have served as suitable perching locations (fig. 6.46).

Drips of bird excrement on the east wall. The upper edges of the wall paintings serve as ideal locations for birds to perch.

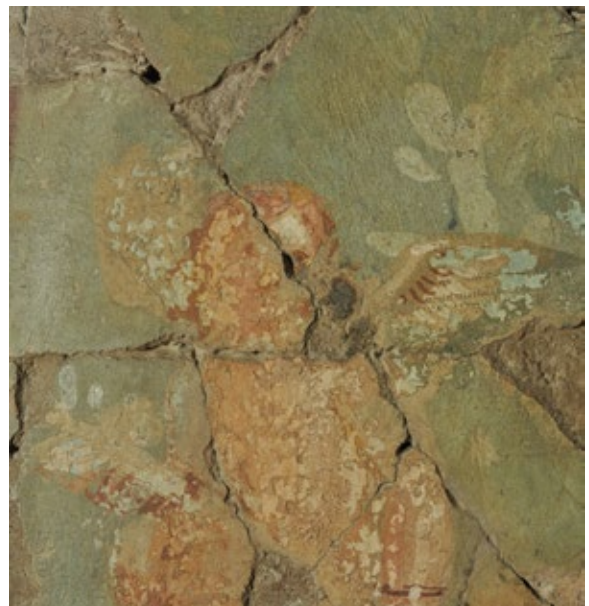
**FIGURE 6.47.**

In addition to the wax, which was applied over the surface of the wall paintings, the rectangular scenes and medallions exhibit a glossy surface and appear to have a discolored coating (see Rainer and Graves, this volume). Both the scenes and medallions have a yellowed appearance (fig. 6.47). A coating on the rectangular scenes, particularly, is hard and well adhered to the paint layer below, unlike the surrounding areas of monochrome background. Some figures in the frieze also appear to have a coating, which can be seen by the difference in sheen and by the evidence of brushstrokes.

The medallions and rectangular scenes have an uneven and discolored appearance with traces of a yellowed coating.

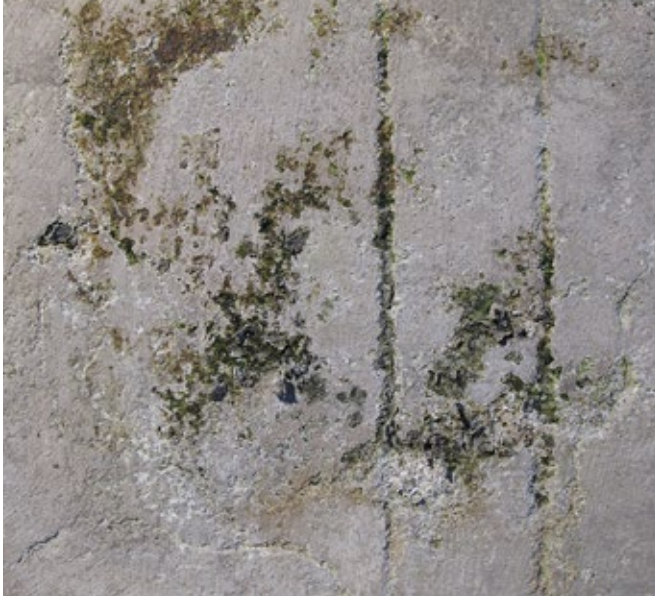
**FIGURE 6.48.**

Traces of microbiological growth are present in a number of forms: as dark-green marks on the reconstruction plaster at the south end of the east wall (fig. 6.48); much more extensively, as green deposits in the southeast corner of the room extending almost down to ground level (fig. 6.49); as a dark-green patina in patches on the exposed tuff of the upper south wall, and more sporadically, on the tuff of the upper west wall. A pink biopatina, a form of bacteria, is also visible over the original and restoration plaster along the base of the east and west walls (figs. 6.50 and 6.51). First observed in 2014, this biopatina showed a vari-

Detail of the south end of the east wall, showing biogrowth appearing as dark-green marks and black-green deposits.
