# Conservation of the Architectural Surfaces in the Tablinum of the House of the Bicentenary, Herculaneum

Phase I: Examination, Investigations, and Condition Assessment

## Project Report

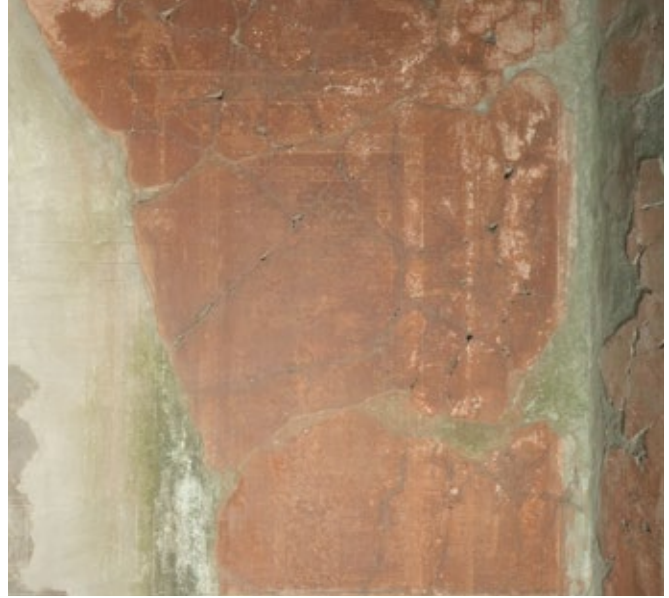
**FIGURE 6.49.**

The southeast corner of the tablinum shows a green microbiological growth that follows drips in areas of previous water infiltration and covers post-1938 fills.

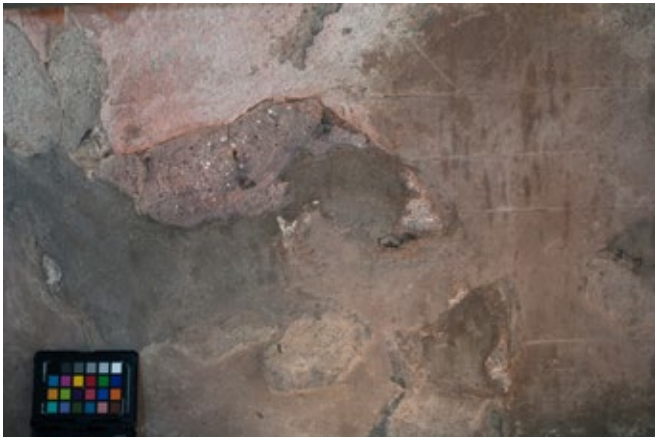
**FIGURE 6.50.**

A pink biopatina along the base of the east wall covers original and reconstruction plaster. This form of bacteria appears to be sensitive to both light and salts, and fluctuates according to environmental conditions.

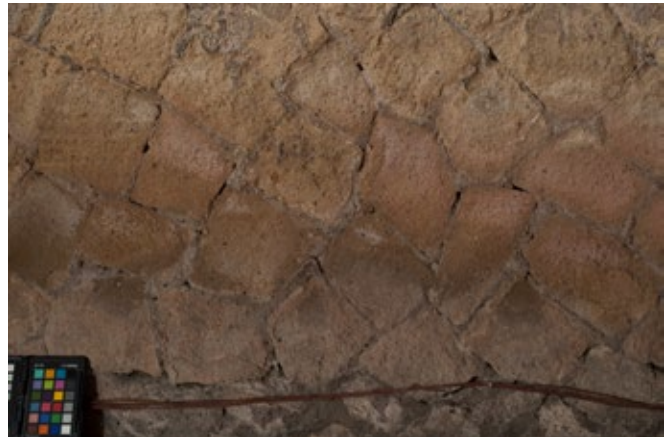
**FIGURE 6.51.**

The same biopatina, visible on the exposed tuff along the base of the west wall. This biopatina is also present along the base of the walls in other parts of the house.

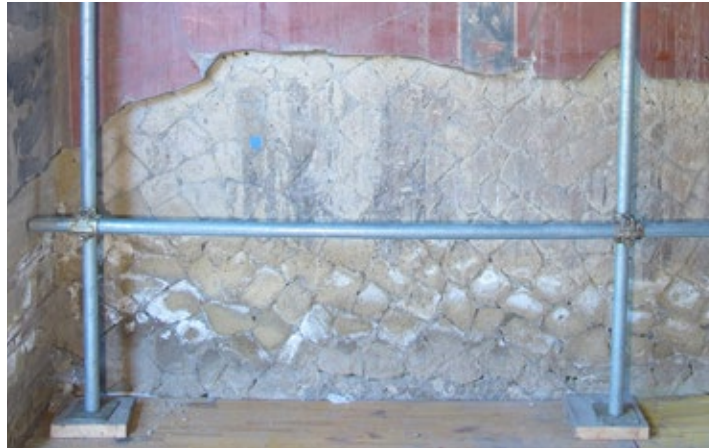
**FIGURE 6.52.**

Salt efflorescence can be seen mostly along the base of the walls up to approximately 1 m high on all three walls: on exposed tuff on both the west wall (fig. 6.52) and the south wall (fig. 6.53), and on original and restoration plaster on the east wall (fig. 6.54), and has caused spalling, pitting, and erosion (fig. 6.55). Reconstruction tuff blocks on upper walls

Base of the west wall, showing a tideline of salt efflorescence on the exposed tuff.

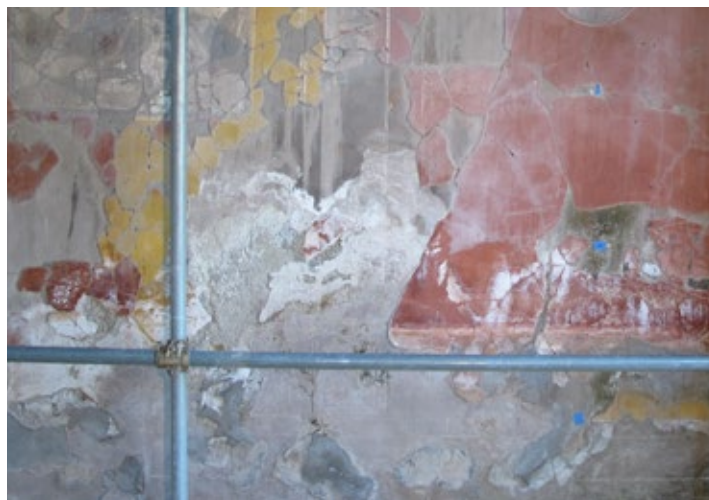
**FIGURE 6.54.**

Salt efflorescence has caused extensive deterioration along the base of the east wall in the original and restoration plasters, leading to erosion and loss of plaster.

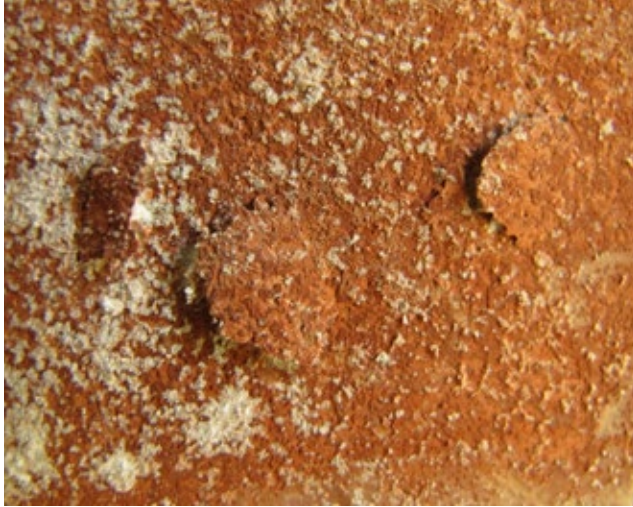
**FIGURE 6.55.**

Detail of damage caused by salt activity in the lower east wall, where the original painted plaster is spalling due to subfluorescence of salts.

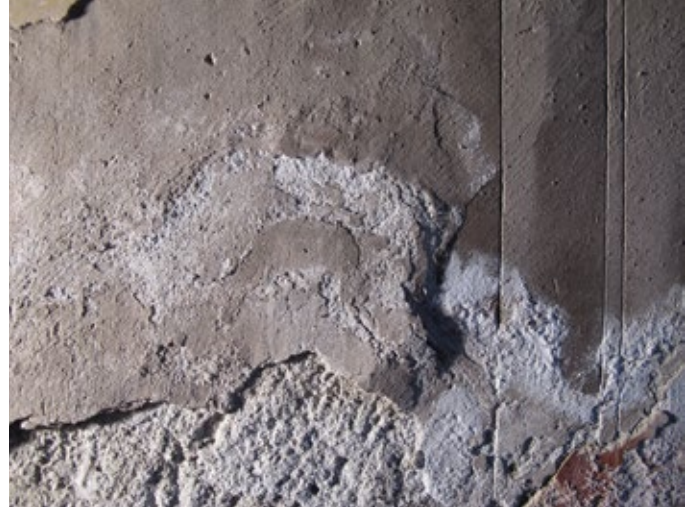
**FIGURE 6.56.**

Subsequent repairs using cementitious plasters have led to salt activity, resulting in further damage to the surrounding original and 1938 reconstruction plasters.

reconstruction plasters in these areas (fig. 6.56). The majority of salts found on the walls of the tablinum are made up of sulfates (Graves, Piqué, and Rainer this volume).

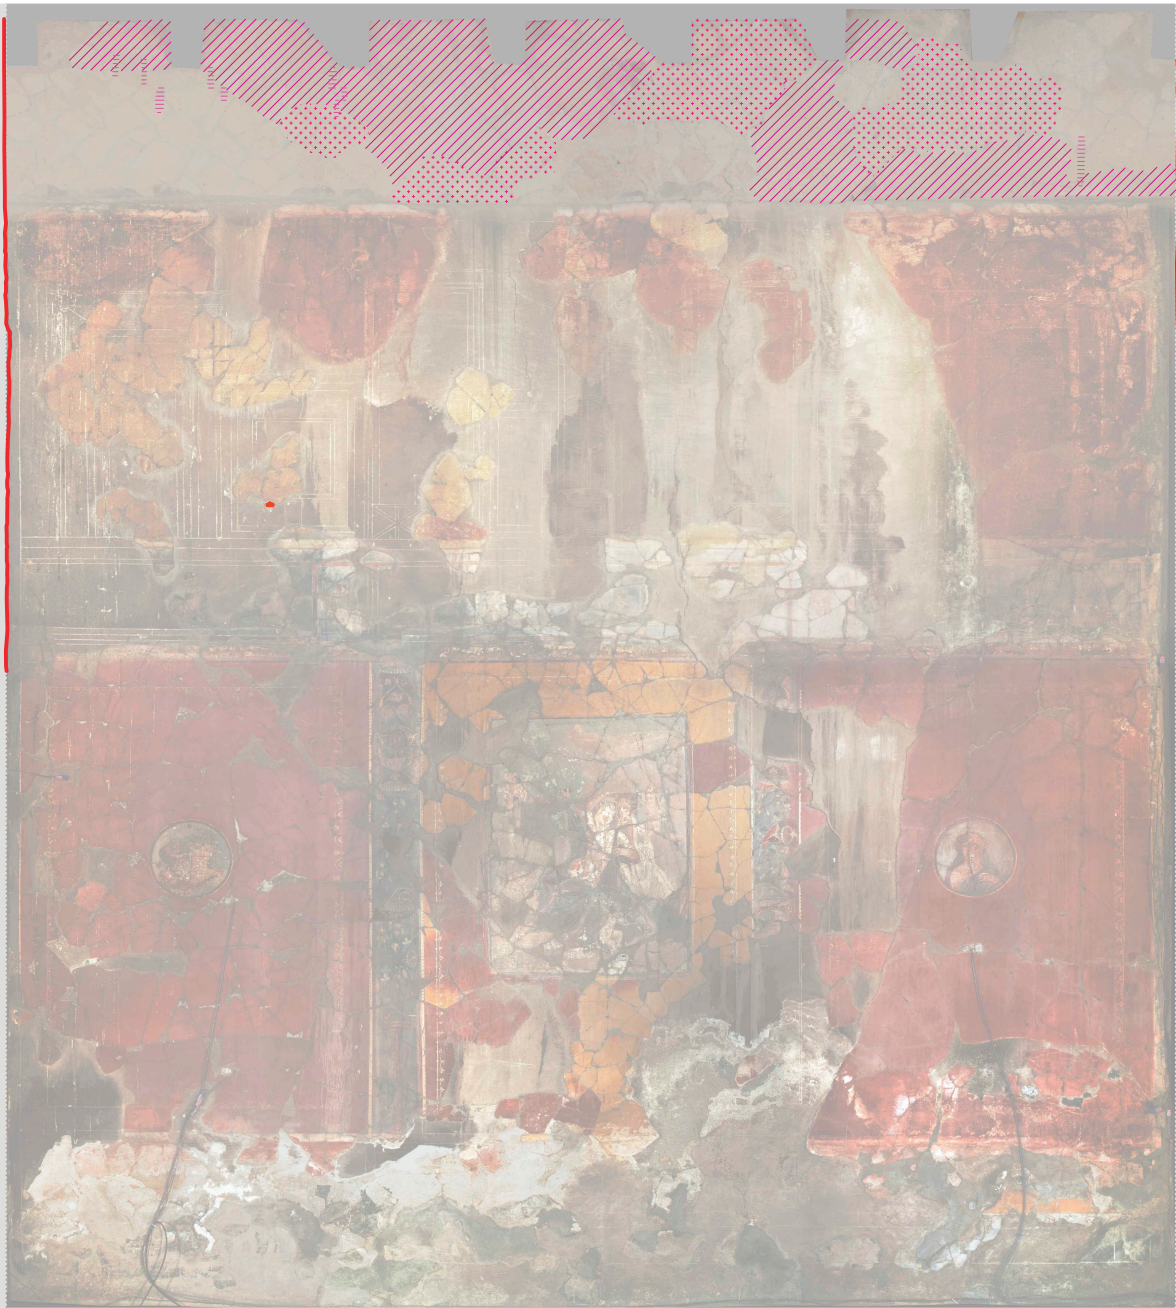
### Casa del Bicentenario, Tablinum, East Wall - Overall [EW]

Presence of crack in portion of the wall not included in the rectified photography

#### CONDITIONS: STRUCTURAL AND TUFF

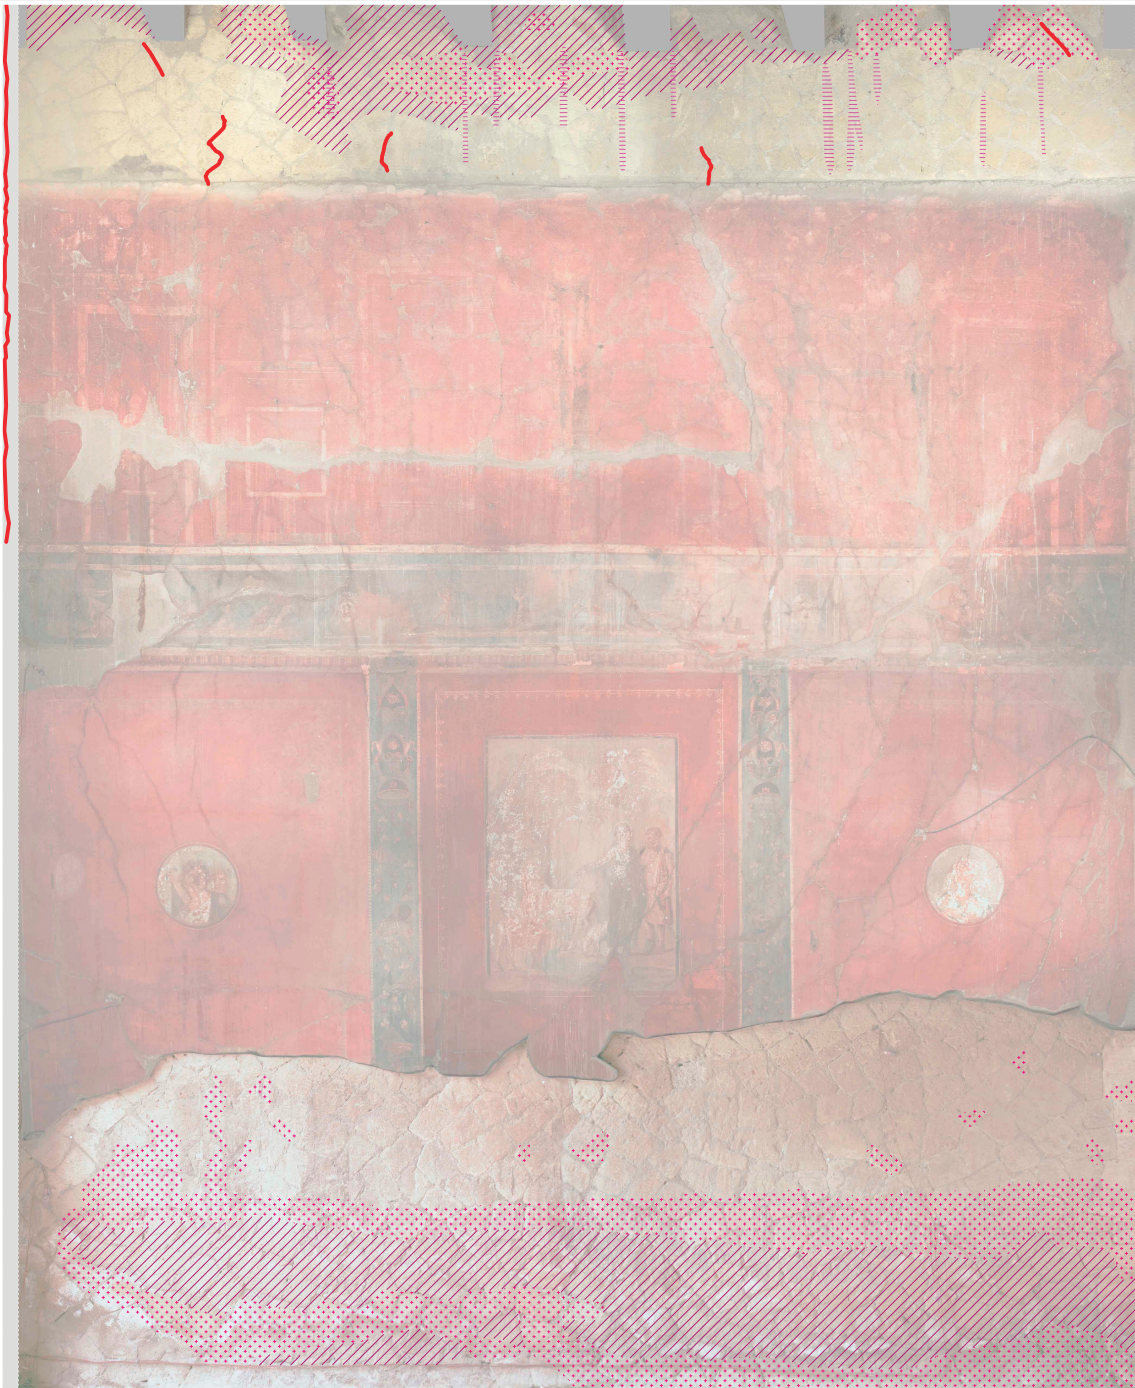
### Casa del Bicentenario, Tablinum, West Wall - Overall [WW]

Presence of crack in portion of the wall not included in the rectified photography

#### CONDITIONS: STRUCTURAL AND TUFF

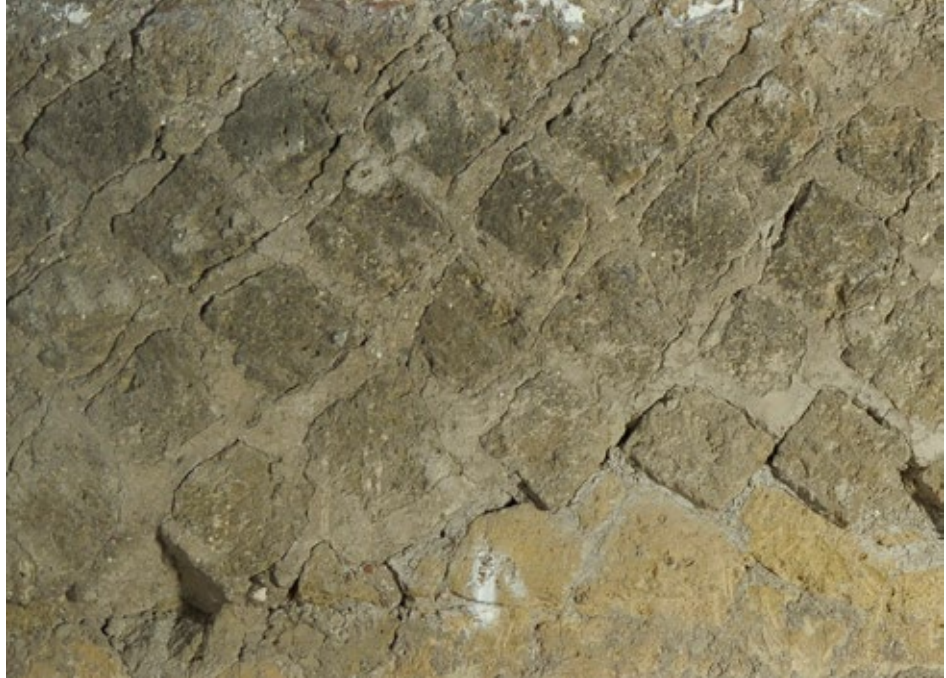
### ***Opus reticulatum* tuff**

A form of brickwork used in ancient Roman architecture, consisting of diamond-shaped tuff bricks, set into a mortar core in regular diagonal courses.

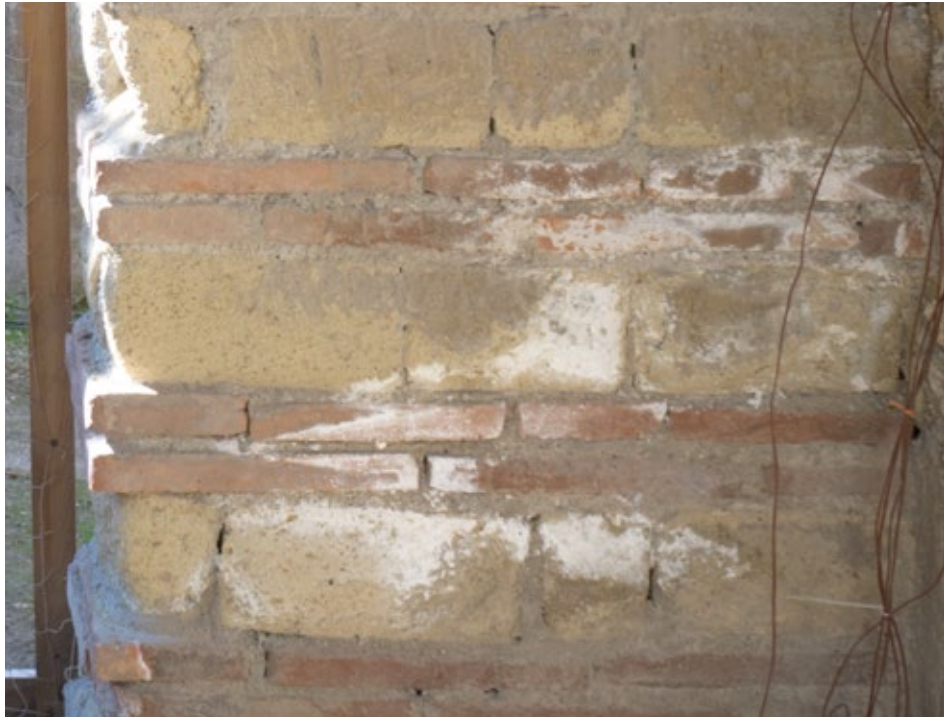
### ***Opus vittatum* tuff and brick**

A Roman construction technique using alternating tuff and brick courses applied horizontally and parallel to each other, also referred to as *opus mixtum*.

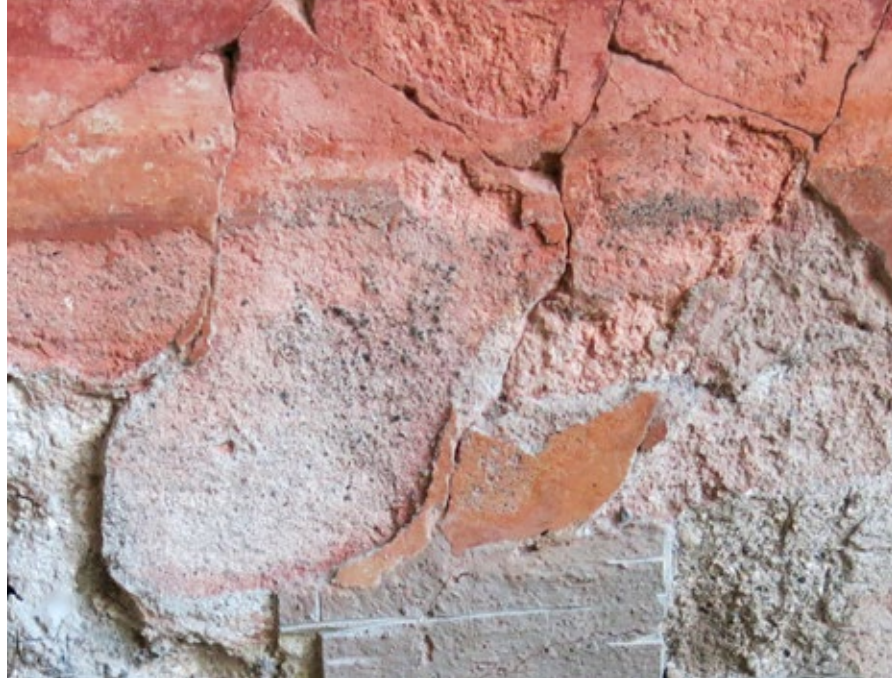
### Plaster join

Area where the plaster applied during different sessions of work abuts or overlaps. Two types are present:

Type 1: *Pontata*, rectangular sections of painted plaster applied and painted in the fresco technique in a single day, corresponding to the height of the scaffolding used.

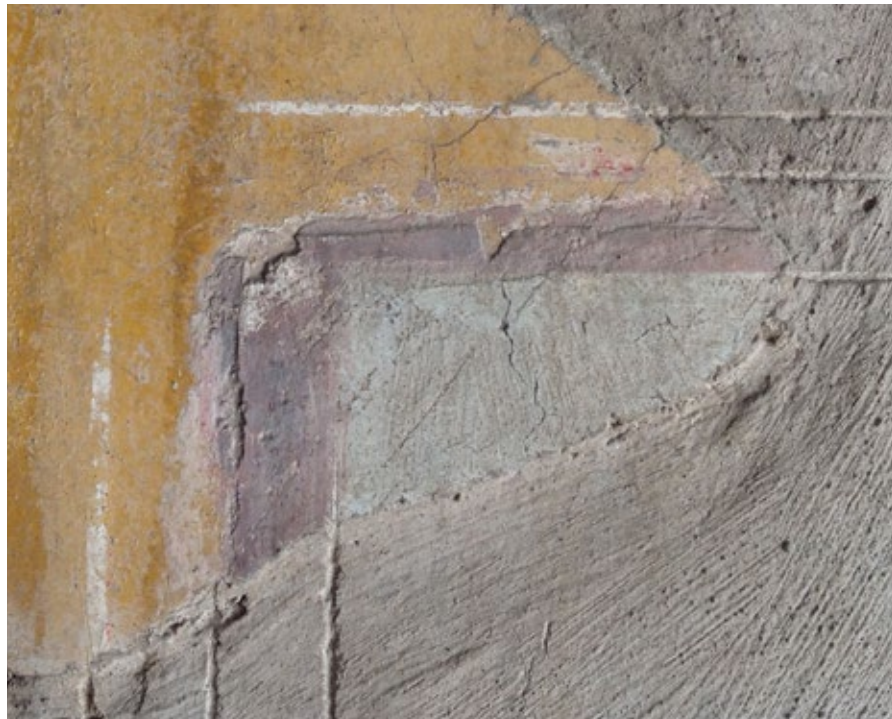
Type 2: The addition of plaster applied to a surrounding or adjacent painted plaster (e.g., rectangular scenes/inset plaster and frieze), creating an overlap of plaster layers.

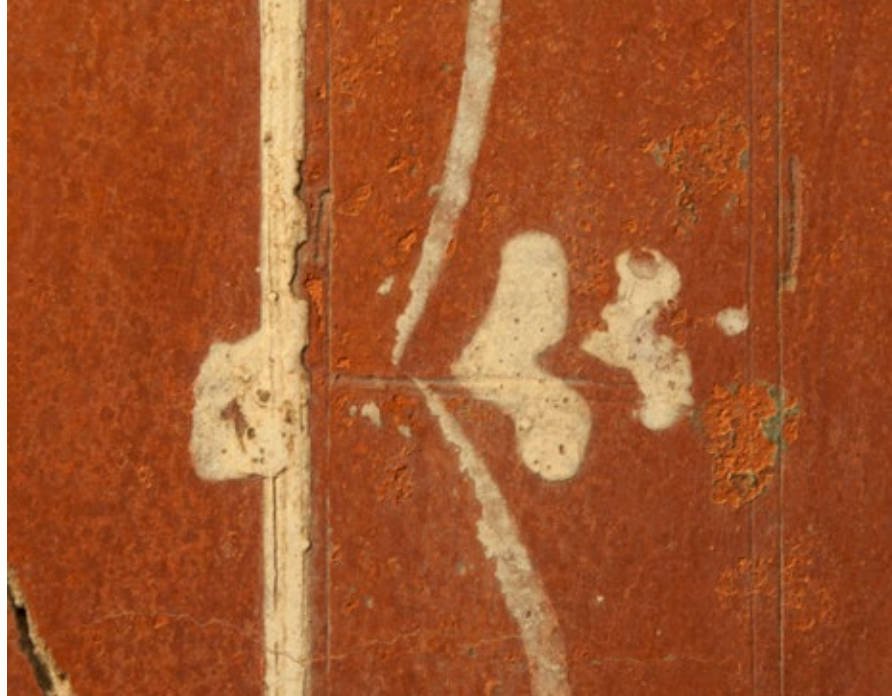
*Type 1.*

An incision made in the fresh plaster to lay out the design. Two types are observed; differentiated by the technique used.

Type 1: An incision made with a straight edge for a precise line, used primarily for laying out decorative borders.

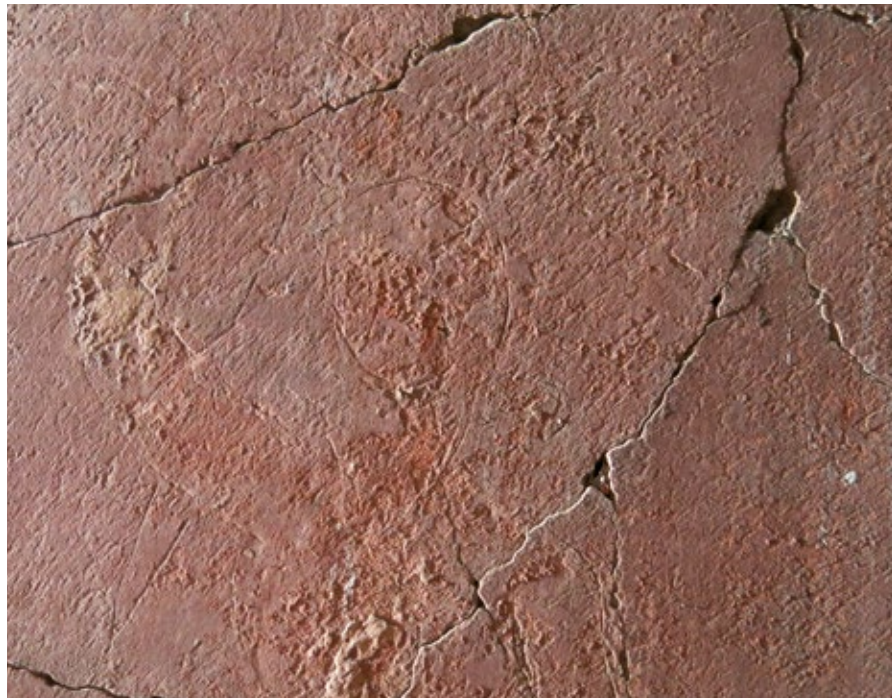
*Type 2.*

Type 2: An incision made by freehand drawing, seen in the figures on the upper wall.

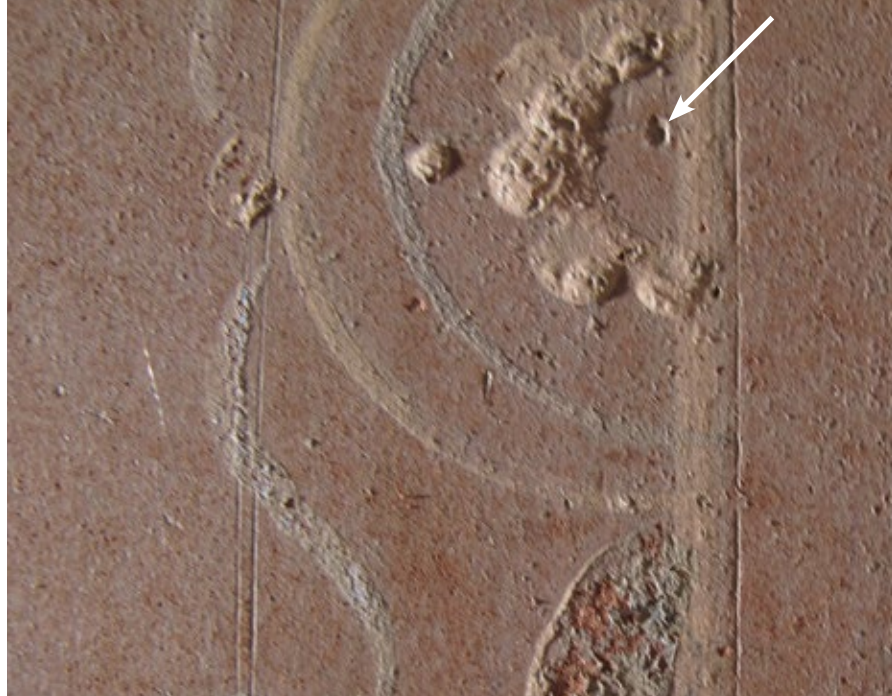
### Compass point

Evidence of the preparatory technique using a compass as an instrument to lay out decorative elements, such as arcs and circles, applied over the monochrome background, in which the sharp point of the compass left a mark in the plaster at the center of the arc (see arrow).

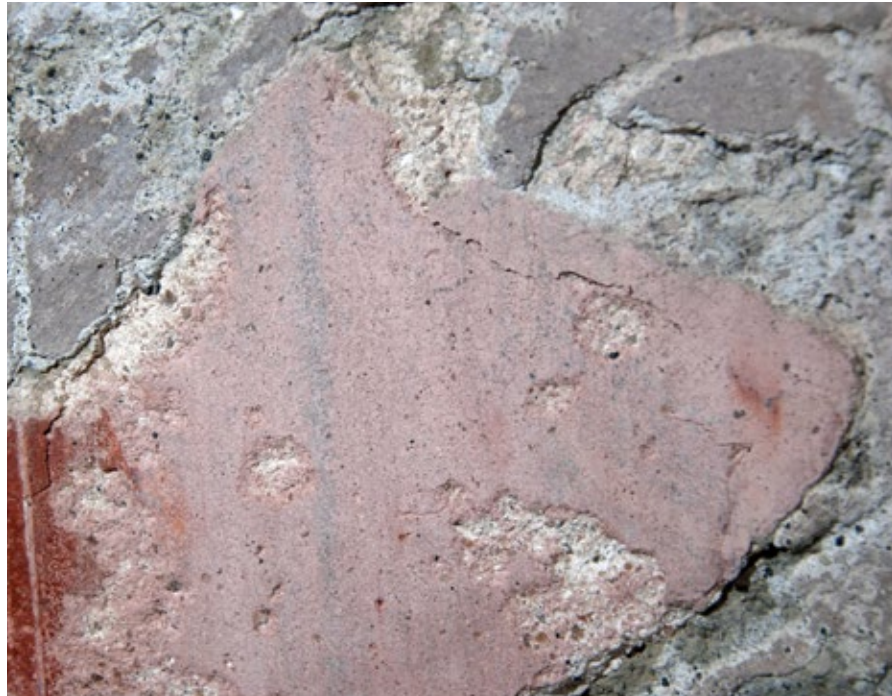
### Tinted plaster

A Roman lime-based finishing plaster tinted with a small amount of pigment.

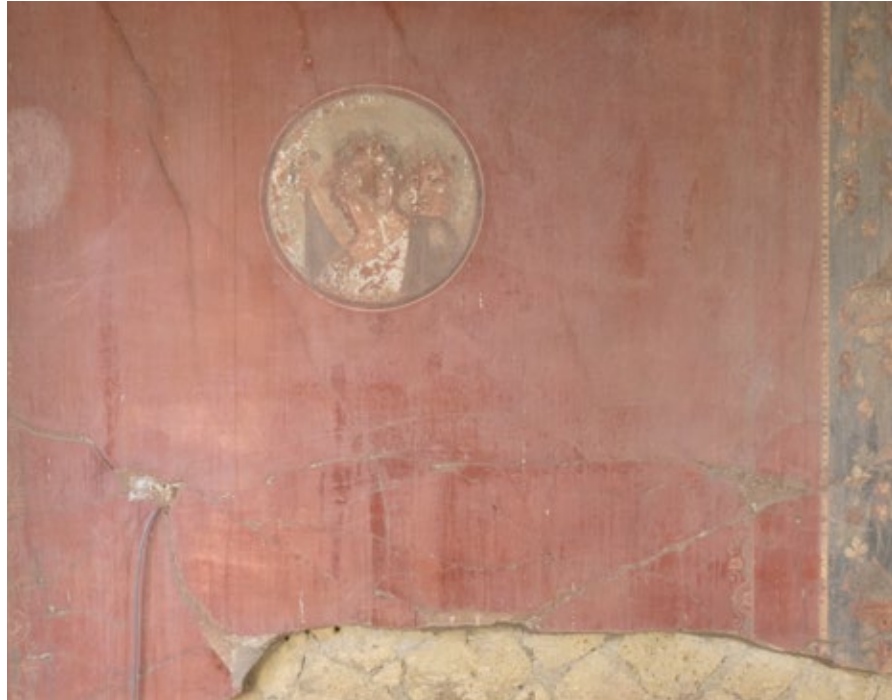
### Monochrome background

A solid panel of color—yellow, red, or black in the case of the tablinum—painted in the fresco technique, over which the decoration is applied.

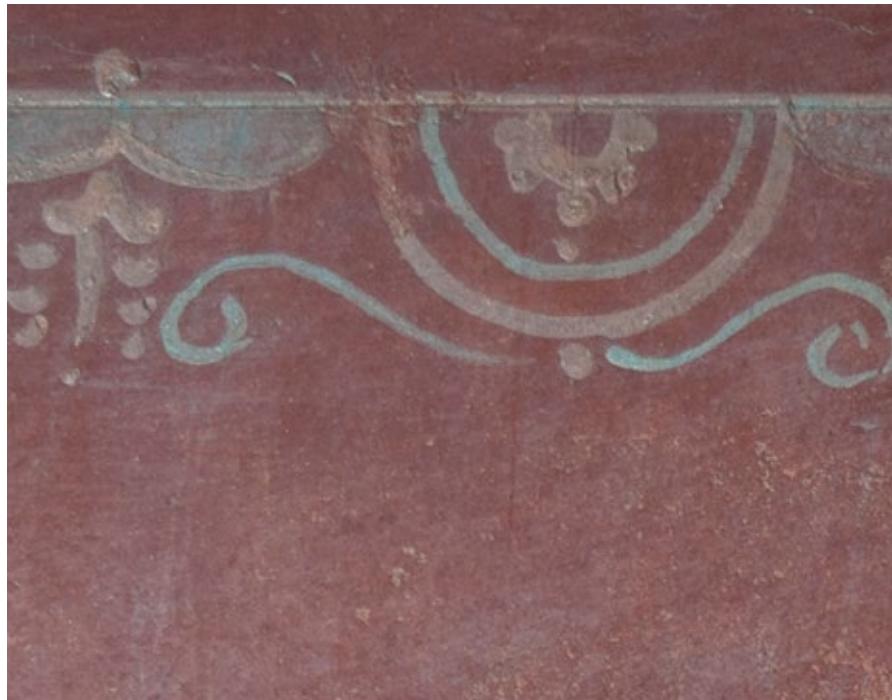
### Decorative elements

Painted decoration applied over the monochrome background in one or more layers to create architectural, floral, or figurative designs. The paint layers were built up using pigment in binder to form impasto layers of decoration.

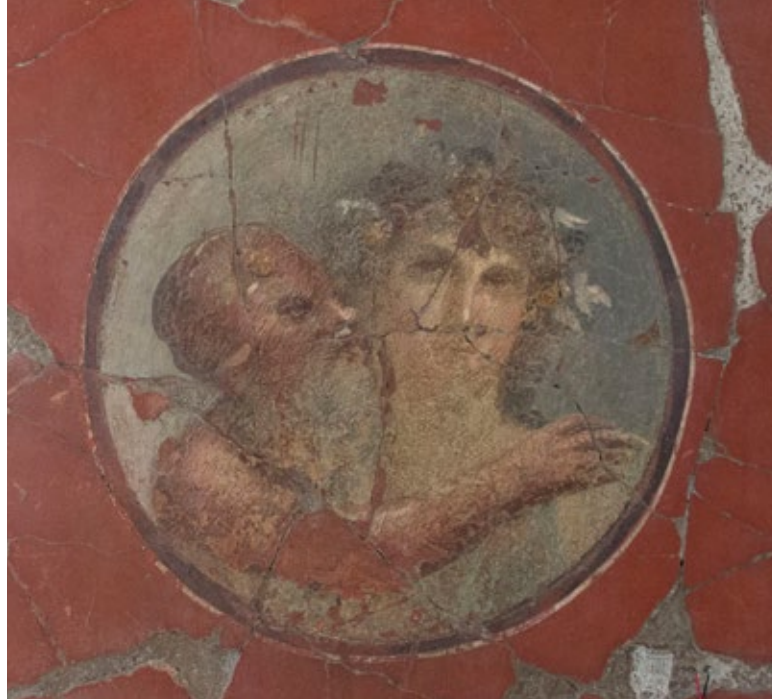
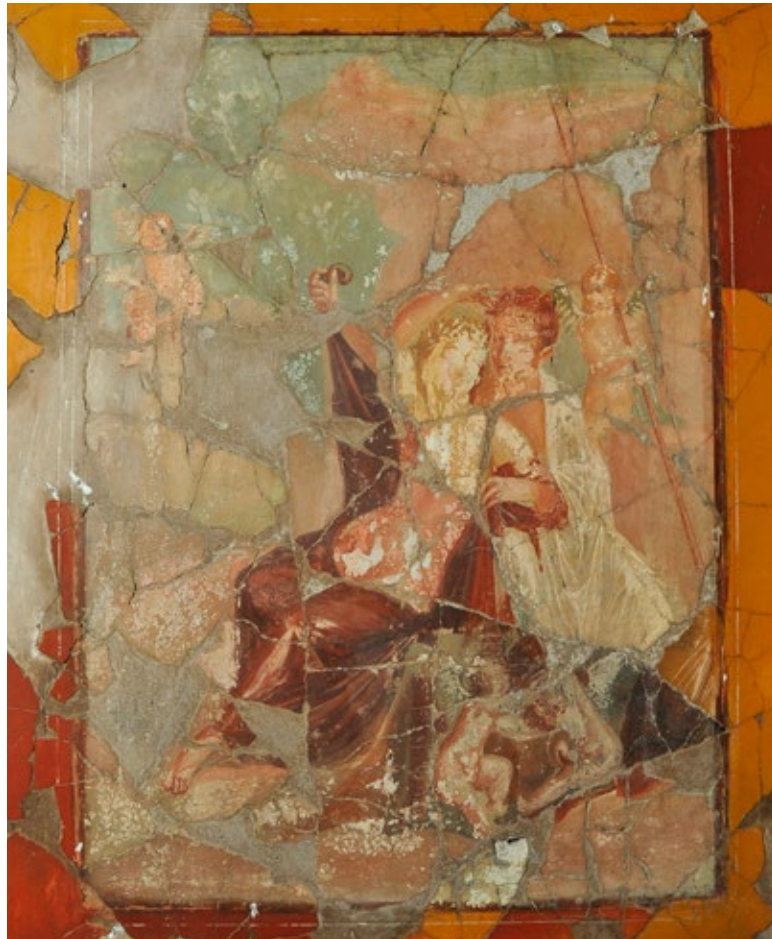
### Figurative scenes

Type 2: *Rectangular scenes*, large paintings of mythological scenes in the center of the walls. These paintings are executed over a fine white plaster composed of lime and crushed marble inset into the wall paintings applied directly over the pink-tinted plaster, with no presence of the monochrome background. The preparation layer is composed of lime white, with the possible additions of shell white and gypsum.

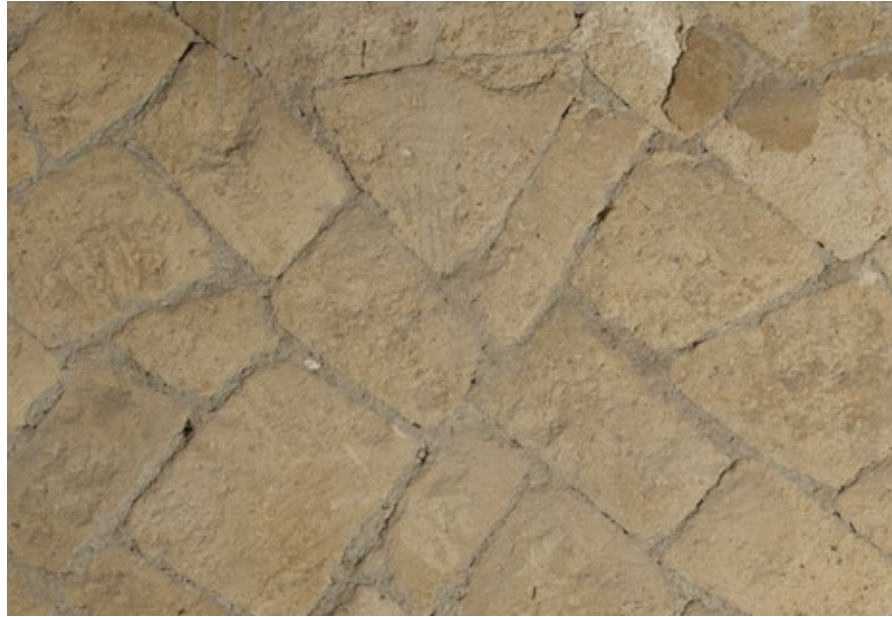
### ***Opus incertum* tuff**

Tuff blocks used in the 1938 reconstruction of architectural features of the buildings destroyed by the eruption of Mount Vesuvius. Walls were partially or completely reconstructed in *opus incertum* in order to visually distinguish them from original Roman walls (e.g., *opus reticulatum*, *opus vittatum*).

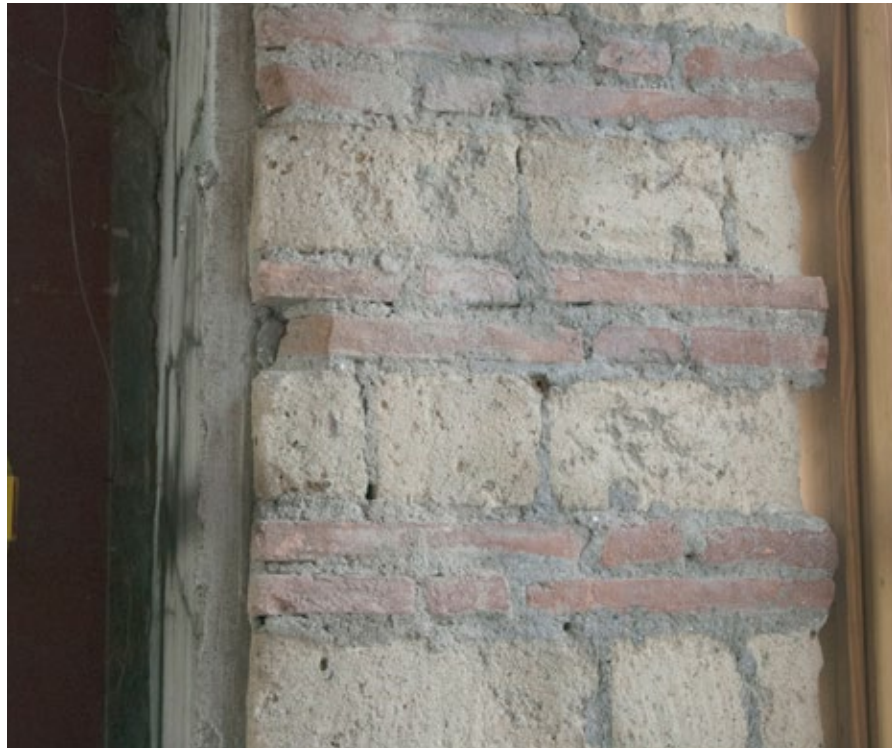
### ***Opus vittatum* tuff and brick**

A Roman construction technique using alternating tuff and brick courses applied horizontally and parallel to each other that was emulated in the 1938 reconstruction of architectural elements, also referred to as *opus mixtum* by Maiuri's team.

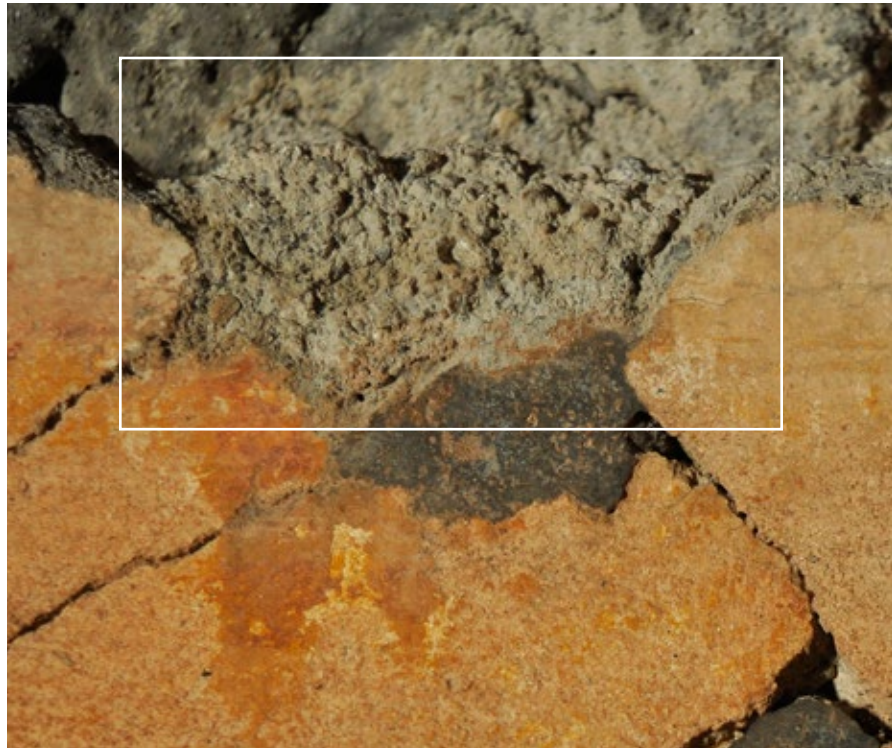
#### Grouting mortar

Light-gray friable mortar used during the remounting process of the 1938 reconstruction to fill areas of void between plaster layers.

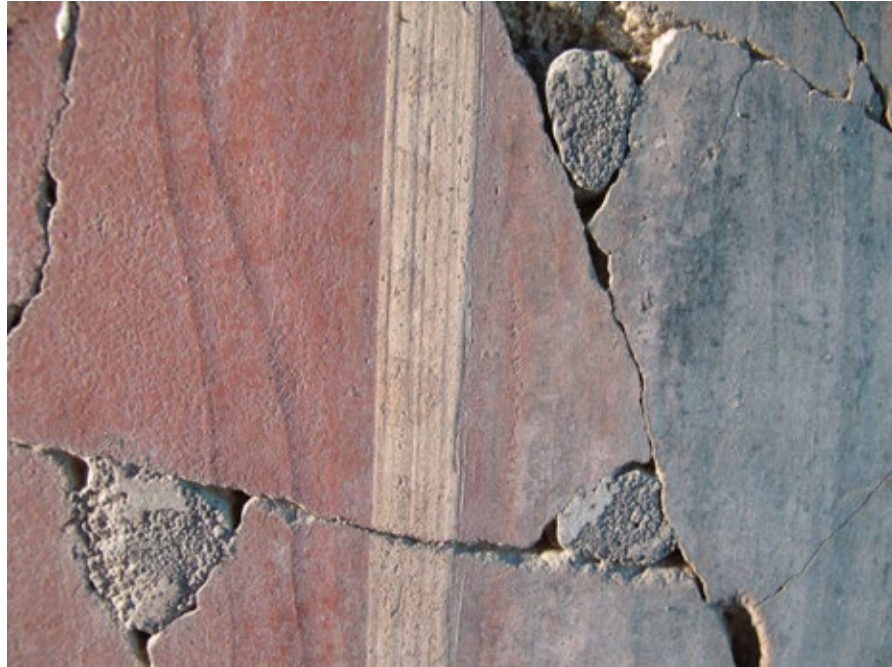
### Backing plaster

Dark-gray plaster repair material, composed of lime and calcium aluminate cement (CAC) and used to reassemble fragments during the 1938 remounting and reconstruction of the wall paintings. In places, this material is visible between wall painting fragments where it has seeped through cracks and gaps, and is flush with the original Roman painted surface.

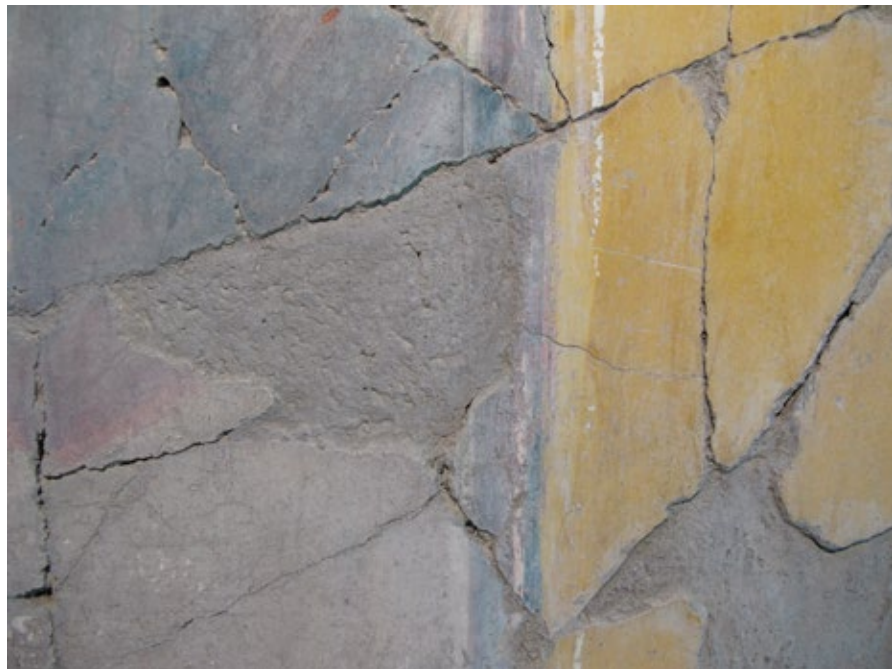
### Rough fill

Gray lime-based repair plaster with occasional incised lines. It is applied to be slightly below surface level of the remounted fragments.

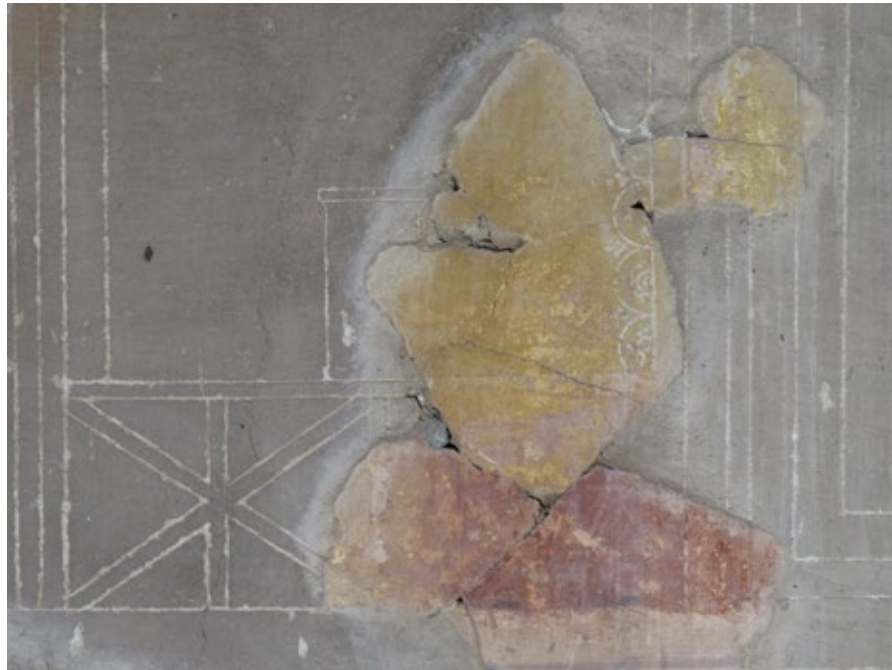
### Reconstruction plaster

Gray fill plaster covered by a thin white fine plaster with a gray lime wash over it, used to fill large lacunae, and incised with lines to reconstruct the missing design (see below).

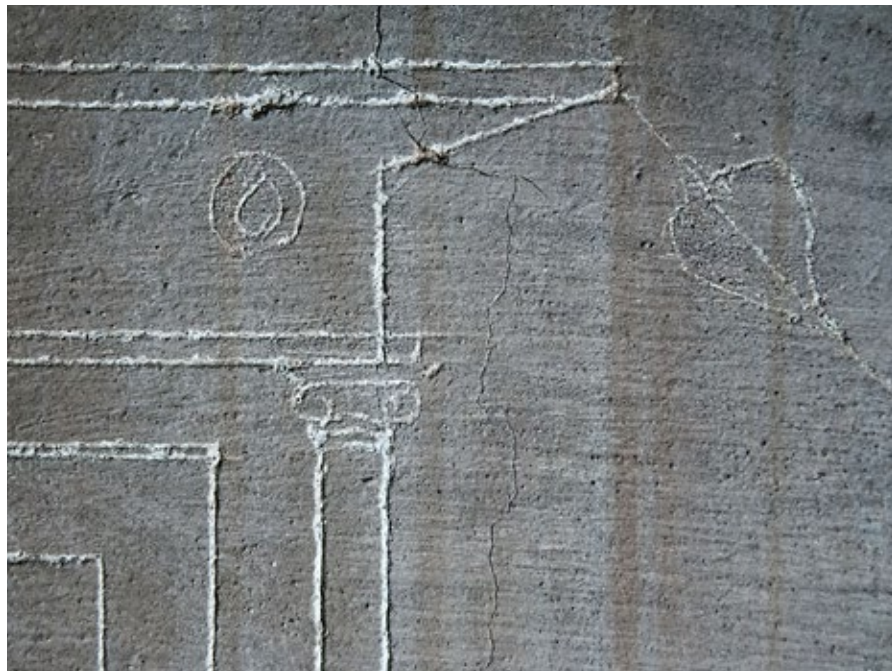
### Incision

Thin outlines cut into the 1938 reconstruction plaster to imitate and complete the Roman decorative scenes in large areas of loss.

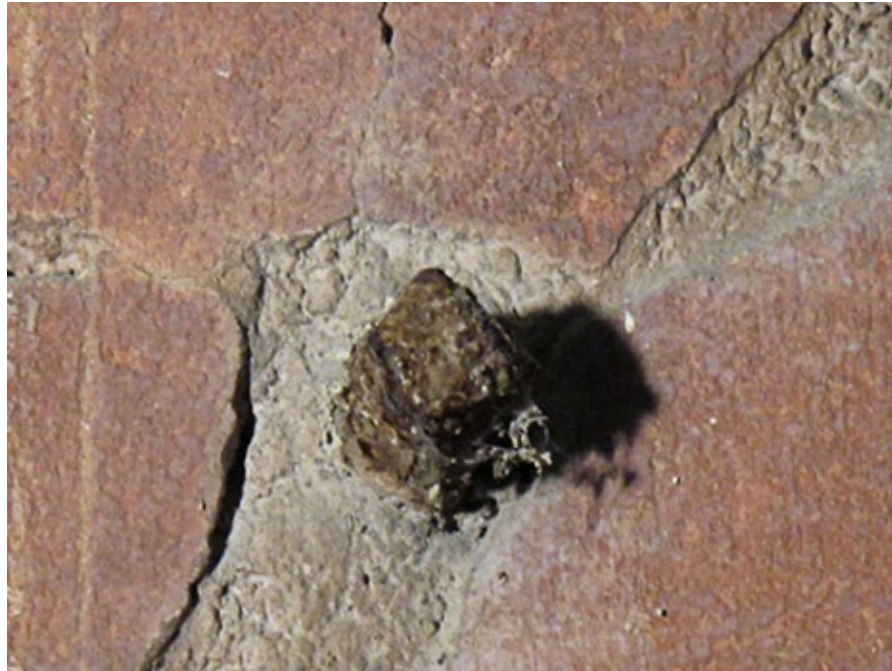
#### Metal element

A metal component that was inserted into the tuff during the 1938 reconstruction as an anchor or pin to hold wall paintings in place.

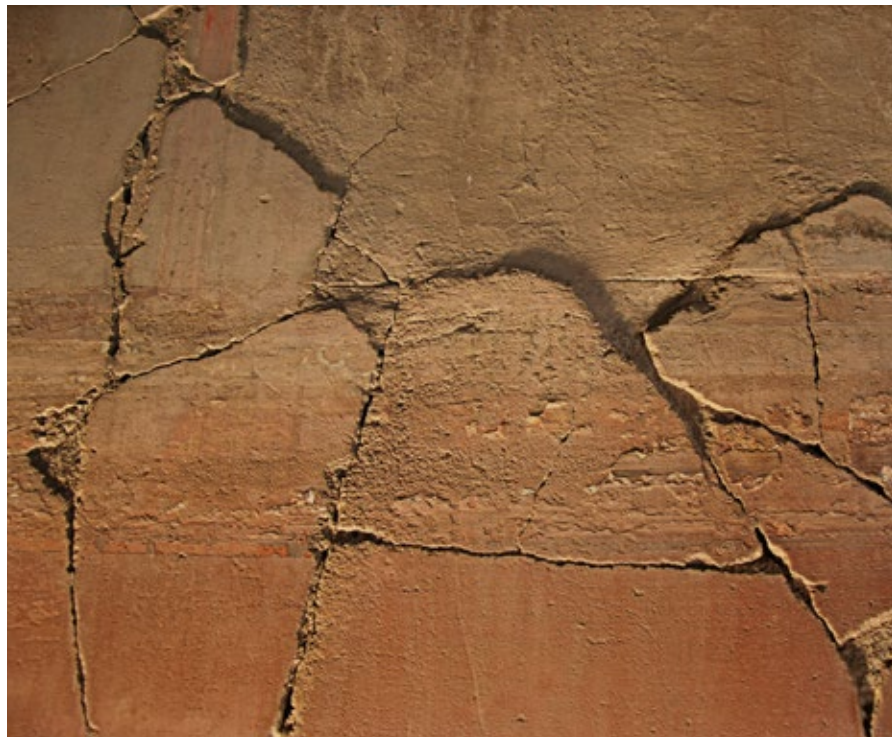
#### Remounted fragment

Pieces of original Roman painted plaster, often with worn edges, remounted during the 1938 reconstruction.

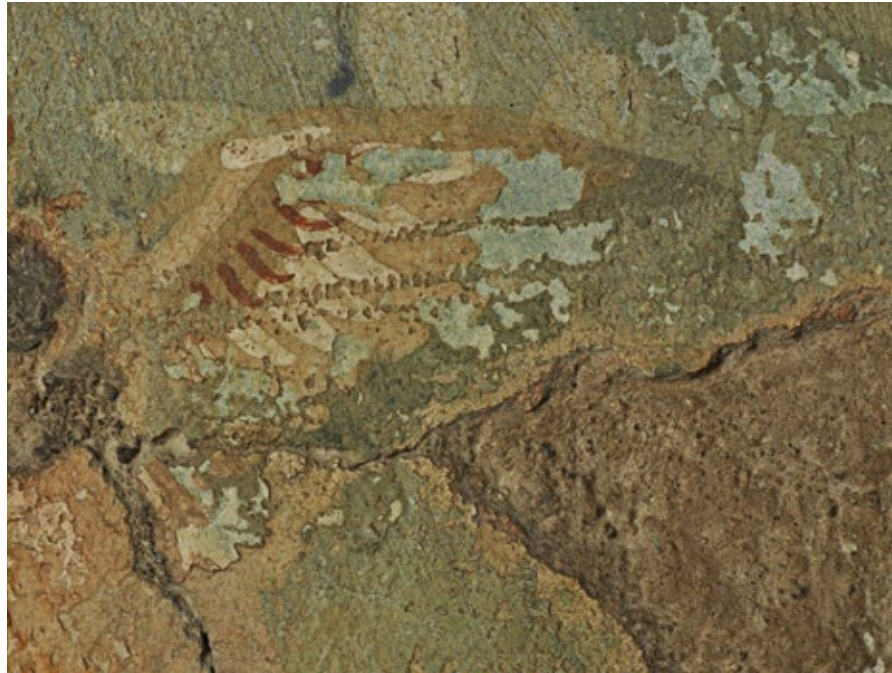
*Type 1.*

Marks made on the painted surface thought to be associated with the 1938 excavation reconstruction and remounting process. These include impressions from tools and pencil marks.

Type 1: A variety of scratched or imprinted marks, likely made from tools during the excavation and reconstruction process.

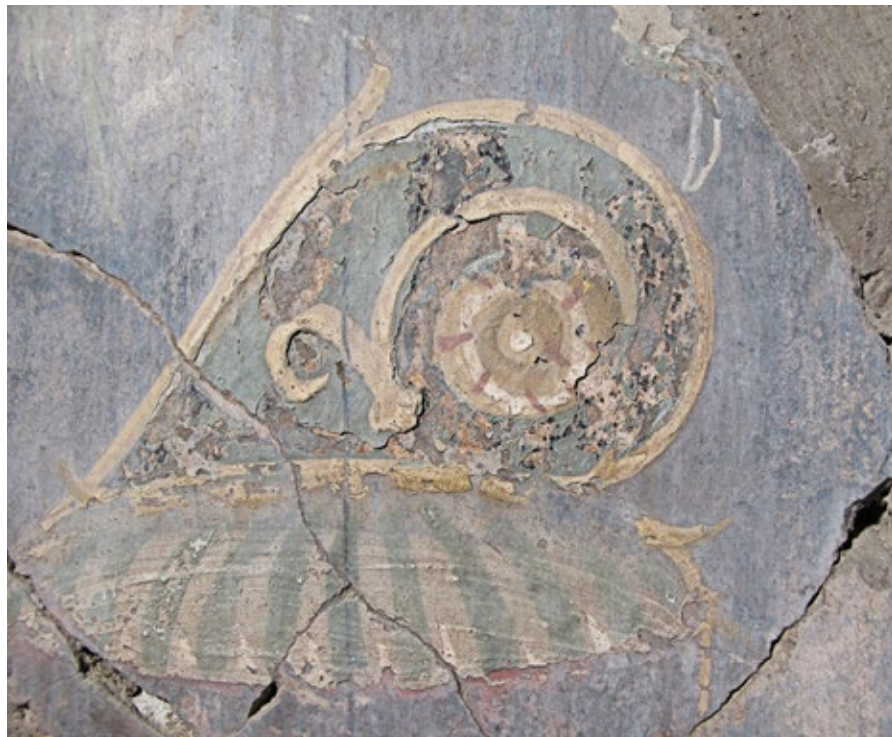
*Type 2.*

Type 2: Marks on the surface made with pencil, likely used to align fragments during the remounting process.

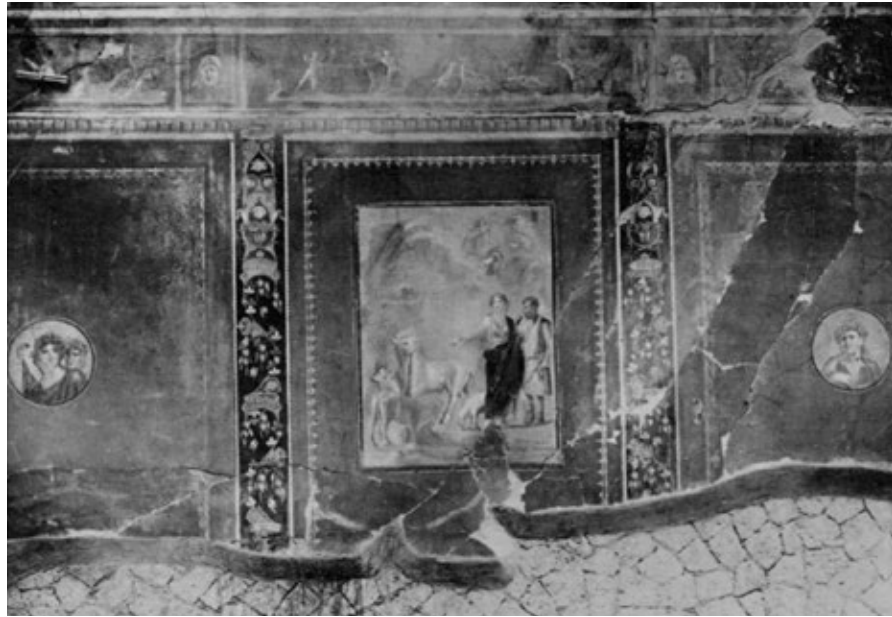
### Edging

Mortar fill applied to both the upper and lower borders of the original and reconstructed plasters, applied as a wide and sloped edging during the 1938 reconstruction. The edging material appears to be similar to the gray fill plaster.

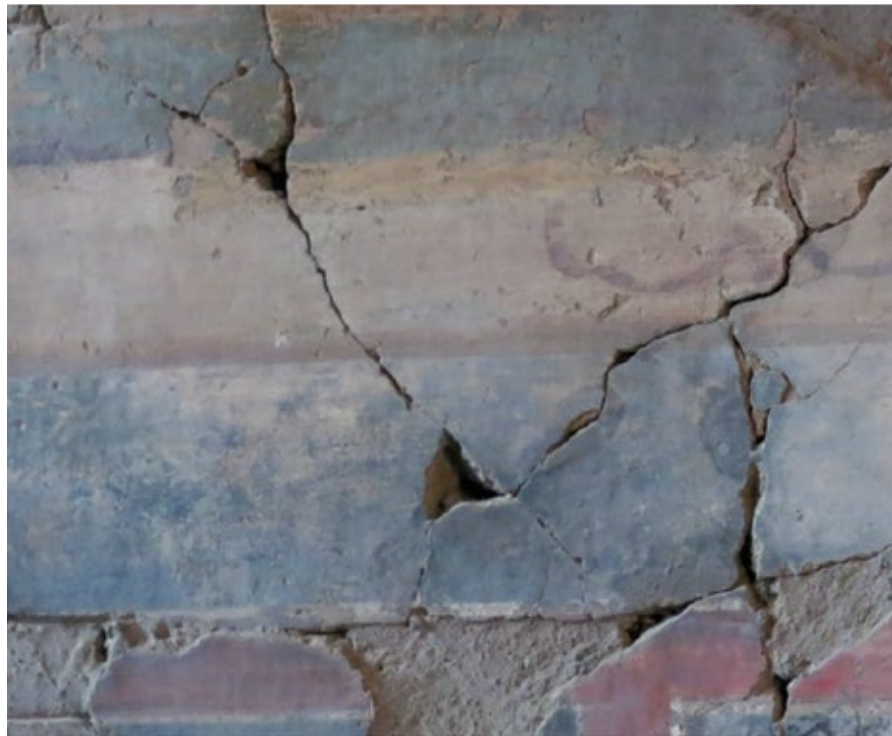
### Unfilled area

Small gaps between remounted fragments that were left unfilled during the 1938 reconstruction process.
