# Conservation of the Architectural Surfaces in the Tablinum of the House of the Bicentenary, Herculaneum

Phase I: Examination, Investigations, and Condition Assessment

## Project Report

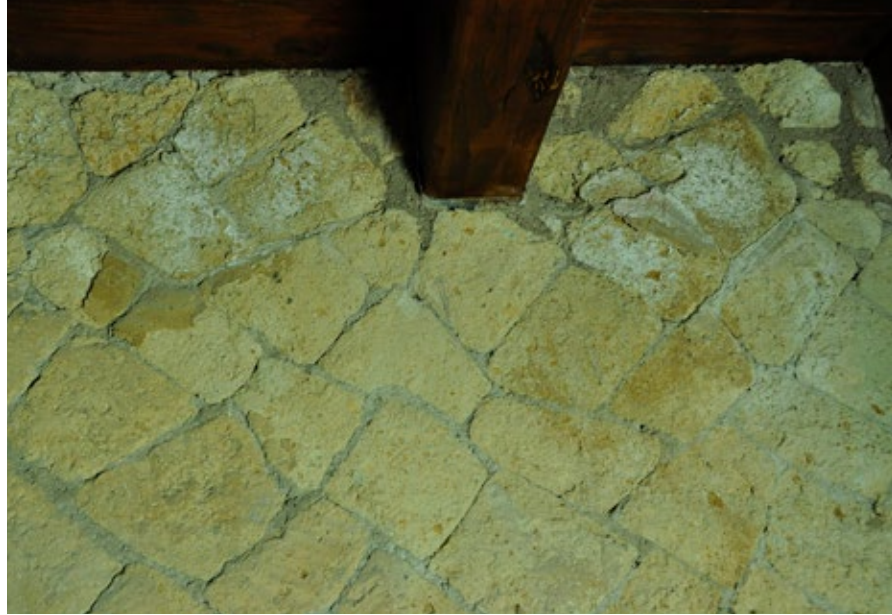
### Post-1938 tuff

Tuff blocks used in post-1938 interventions to make necessary repairs laid in *opus incertum* with a different mortar used in the joins from the 1938 reconstruction mortar.

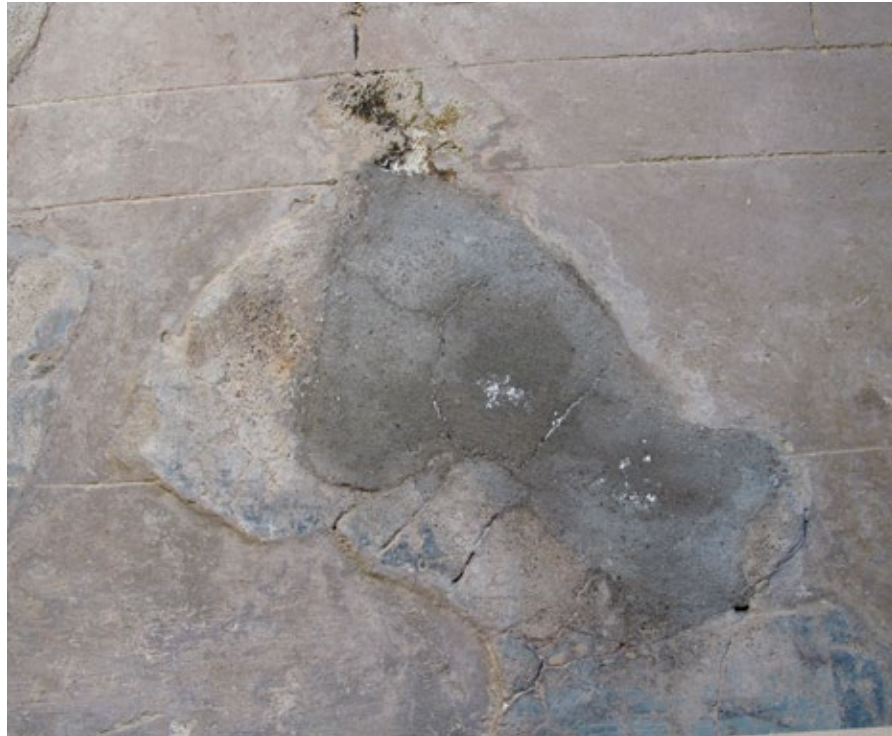
A range of materials used to fill losses occurring since 1938, for example very hard, dark gray, cementitious repairs (pictured); predominantly present along the lower east wall.

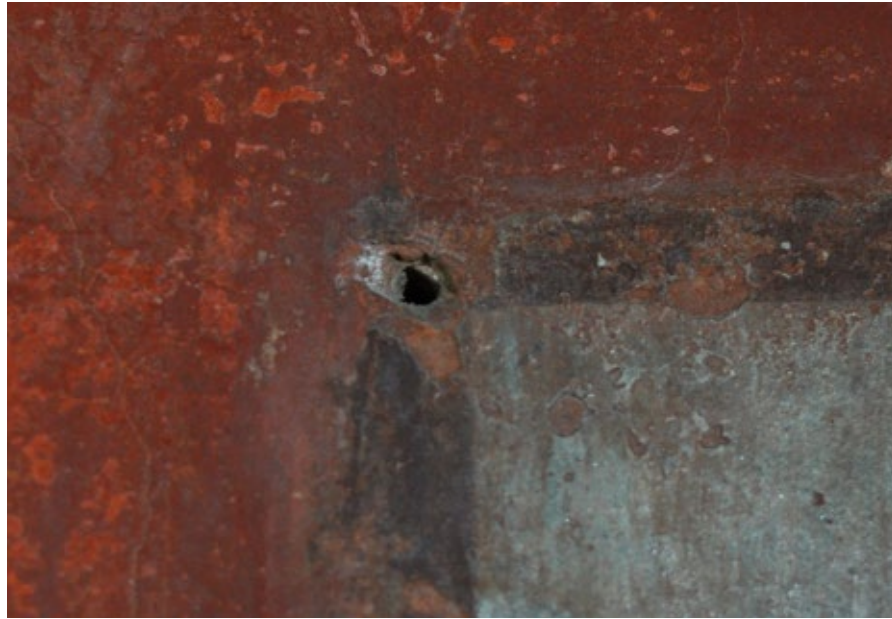
### Injection hole

A puncture made through the Roman or modern plaster to inject grout during a previous intervention.

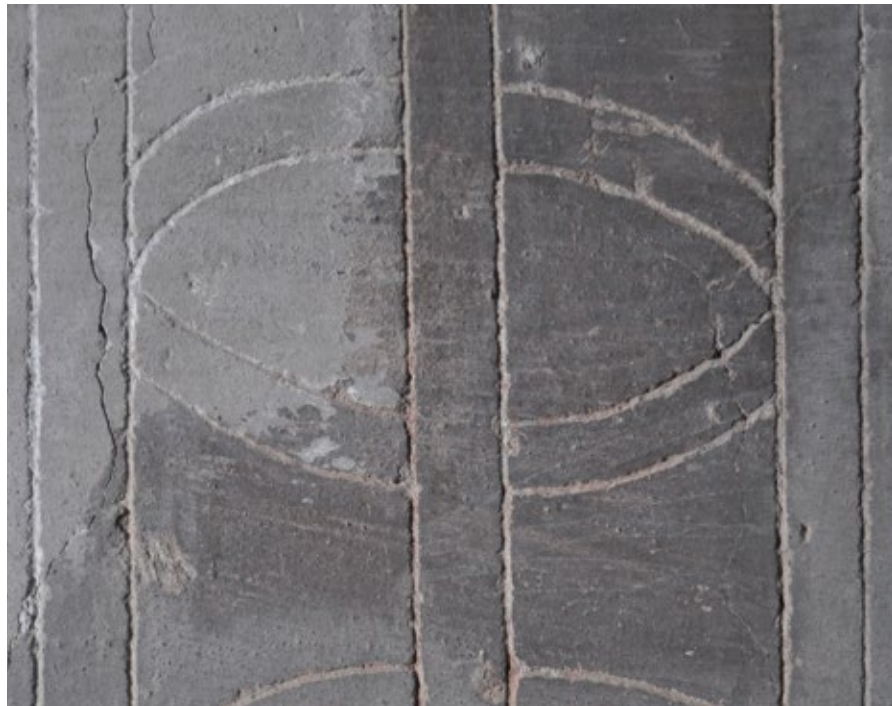
Thin (1–2 mm) cement- and/or lime-based layer(s) of repair materials applied over the 1938 reconstruction lime wash. The dark-gray cementitious wash can be seen on the right-hand side of the image.

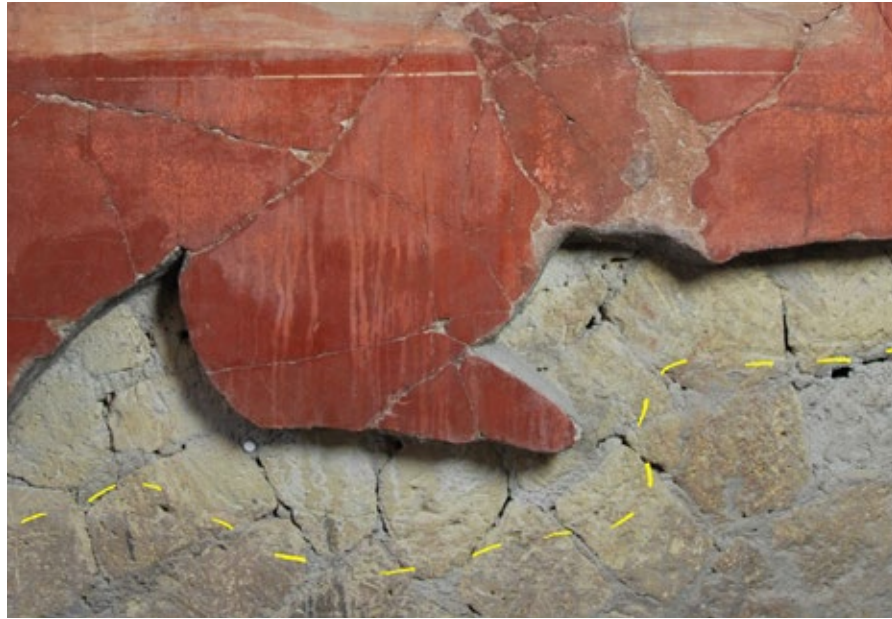
### Traces of 1938 edging

Traces of the 1938 edging applied during the reconstruction and remounting process (highlighted with yellow line), which was later removed and replaced with less visible repairs (see below).

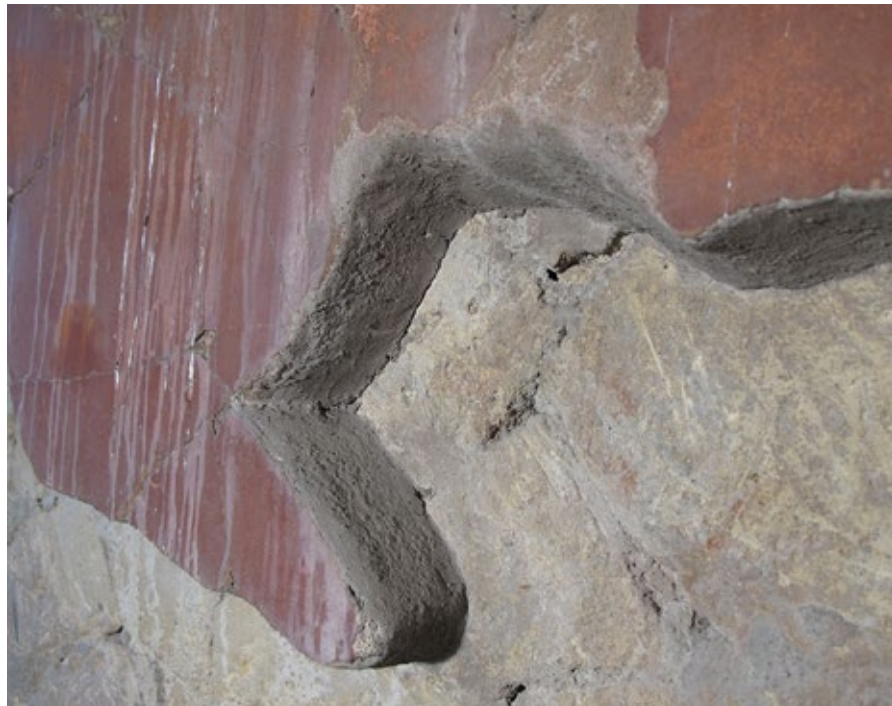
### Edging

Fill mortar applied to the lower edge of the wall paintings (e.g., lower west wall); this edging was applied to be perpendicular to and flush with the original Roman plaster, in order to be less visible.

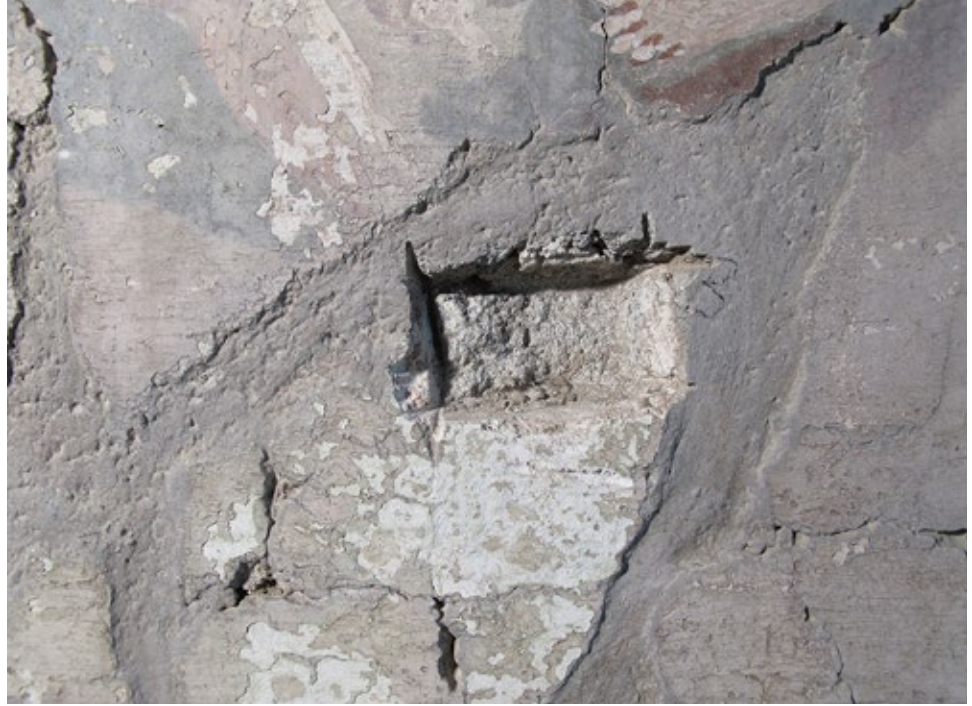
### 2004 sample location

Sample taken in 2004 prior to the current project.

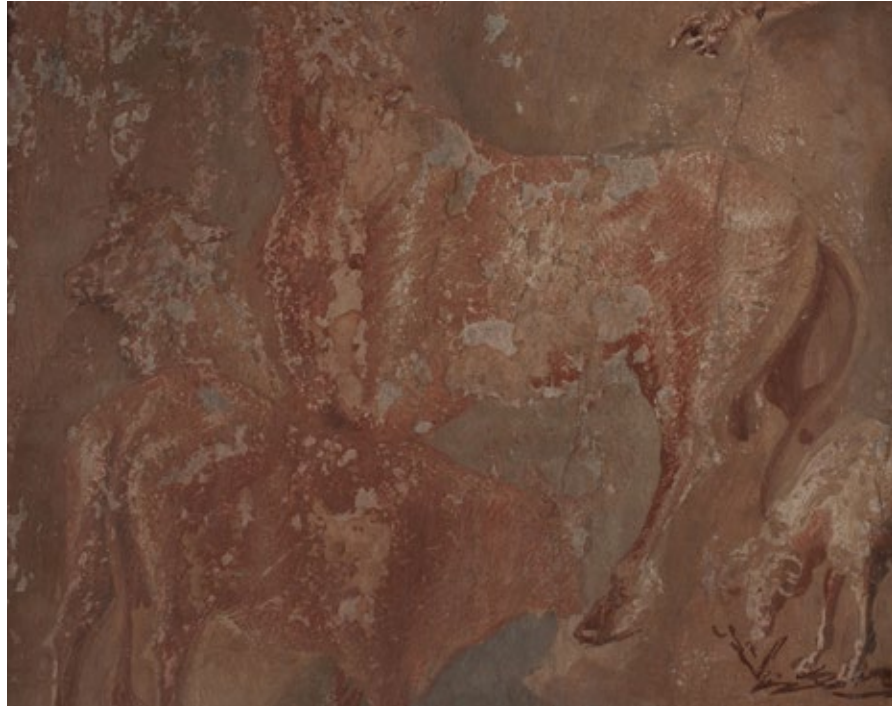
### Reintegration

Application of color to reintegrate areas of loss into the original design layer during a previous intervention.

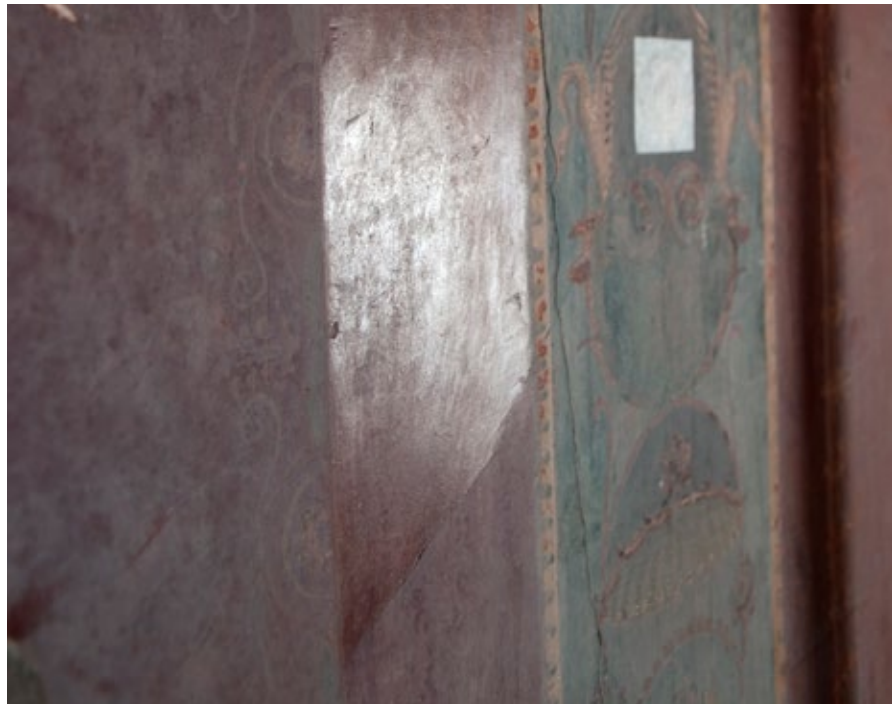
### Coating: wax

One or more applications of beeswax and/or paraffin wax applied on the surface of the paintings during the 1938 remounting and reconstruction and in maintenance campaigns since 1939.

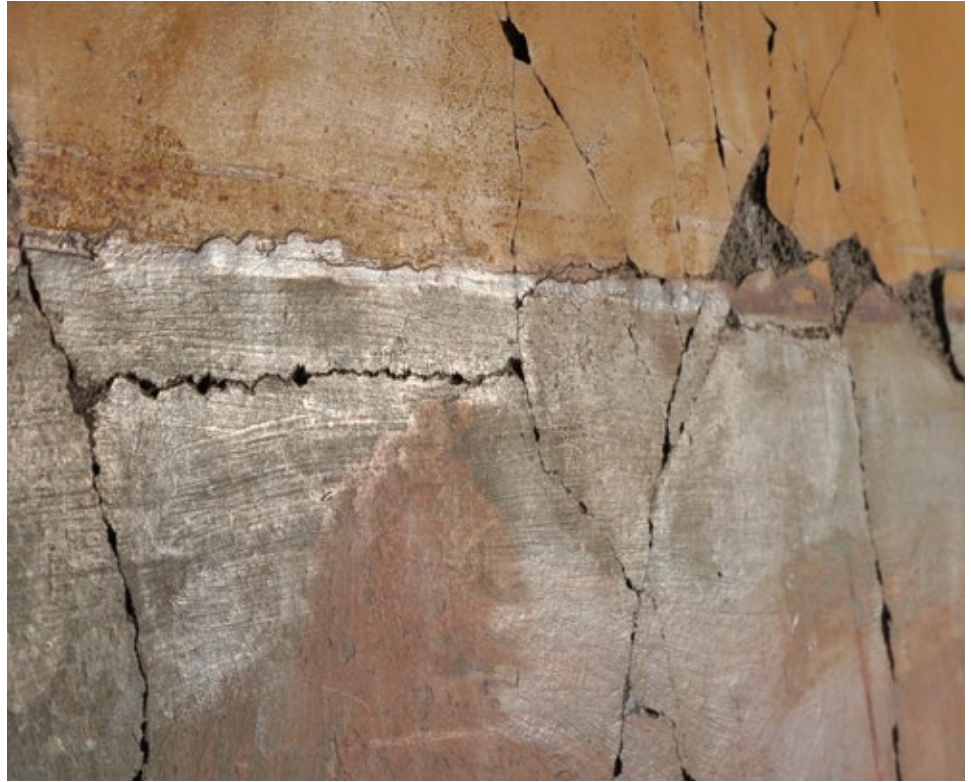
One or more applications of unidentified coating(s) applied to the wall paintings, particularly noticeable in the rectangular scenes and vertical bands.

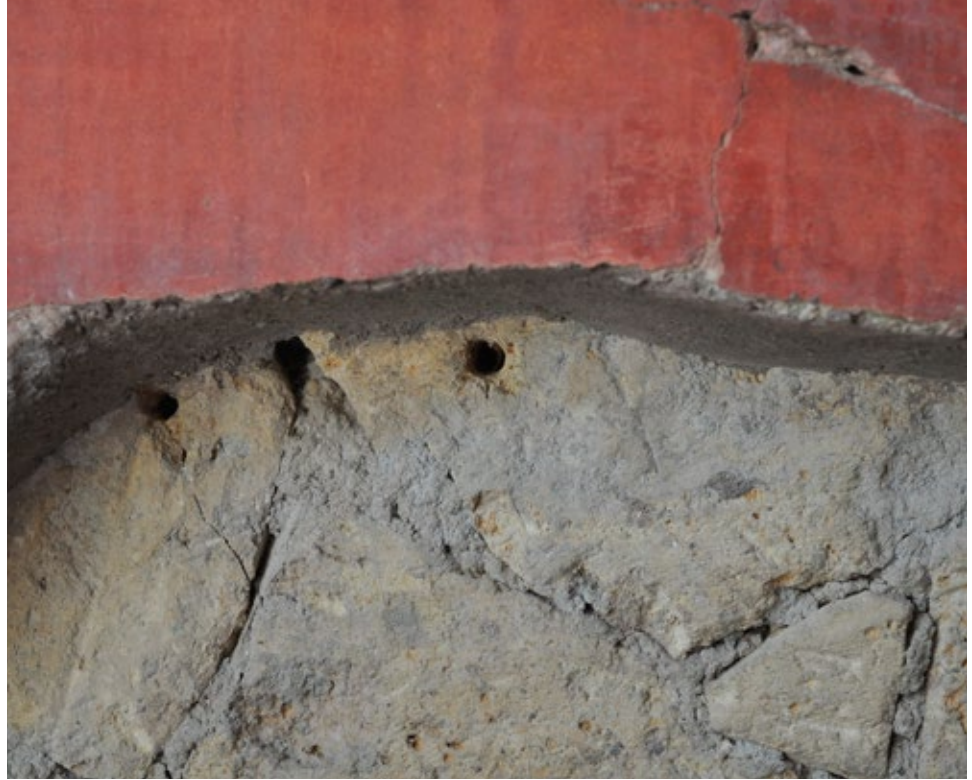
**Structural crack**

A fissure that traverses the  
plaster and wall support.

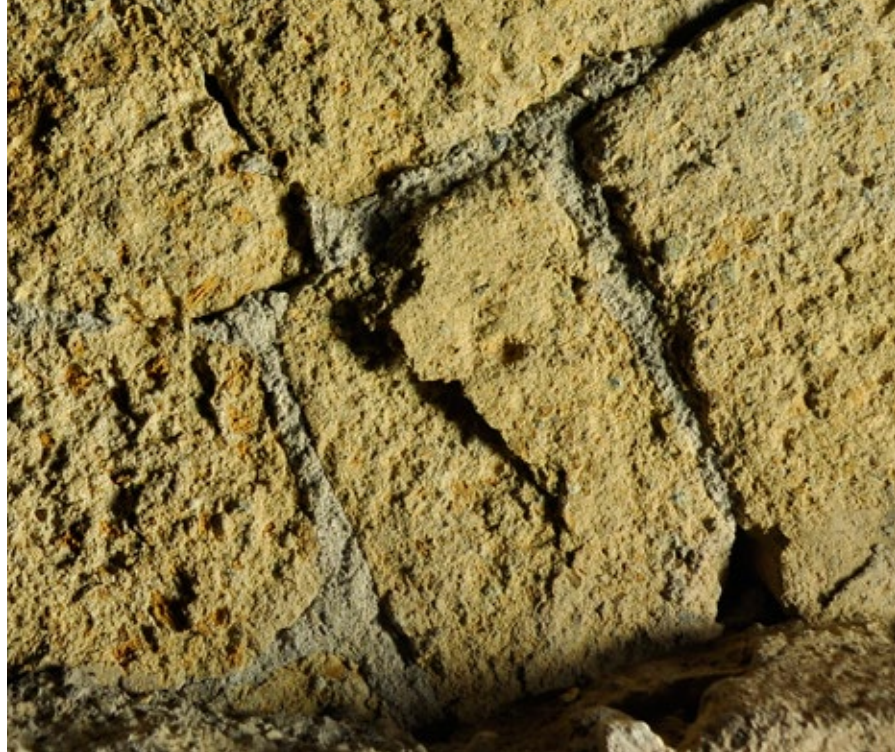
Fragments of tuff that are  
detaching from the block.

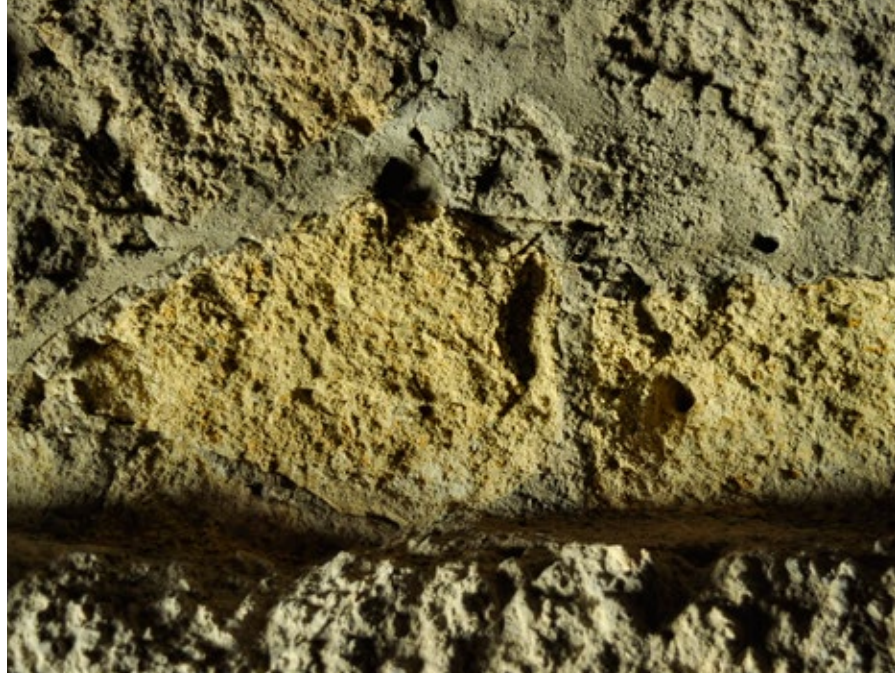
**Powdering**

Decohesion of the tuff.

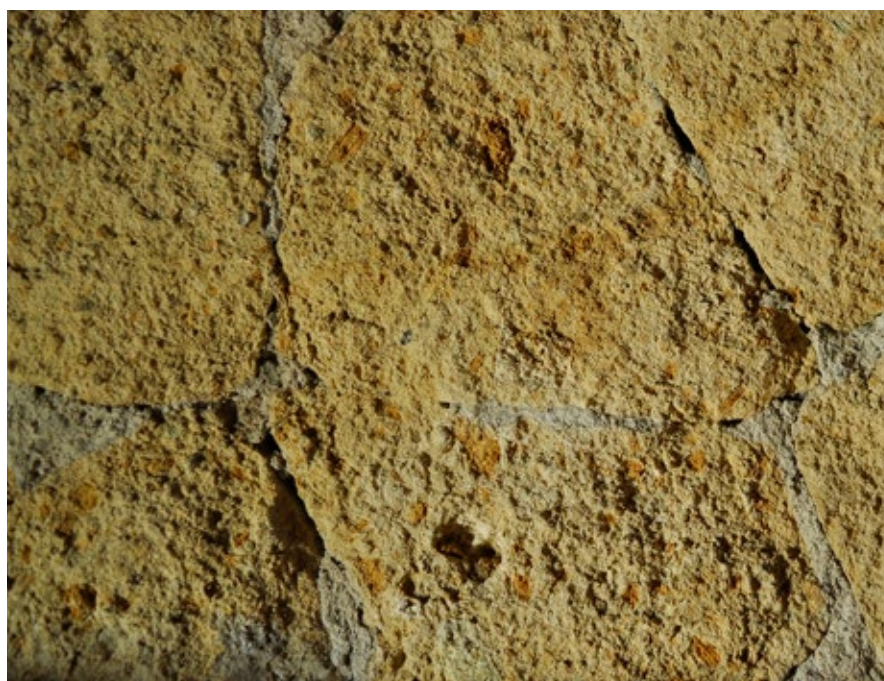
**Abrasion/Erosion**

Areas of tuff with an uneven surface caused by the partial loss of the upper layers.

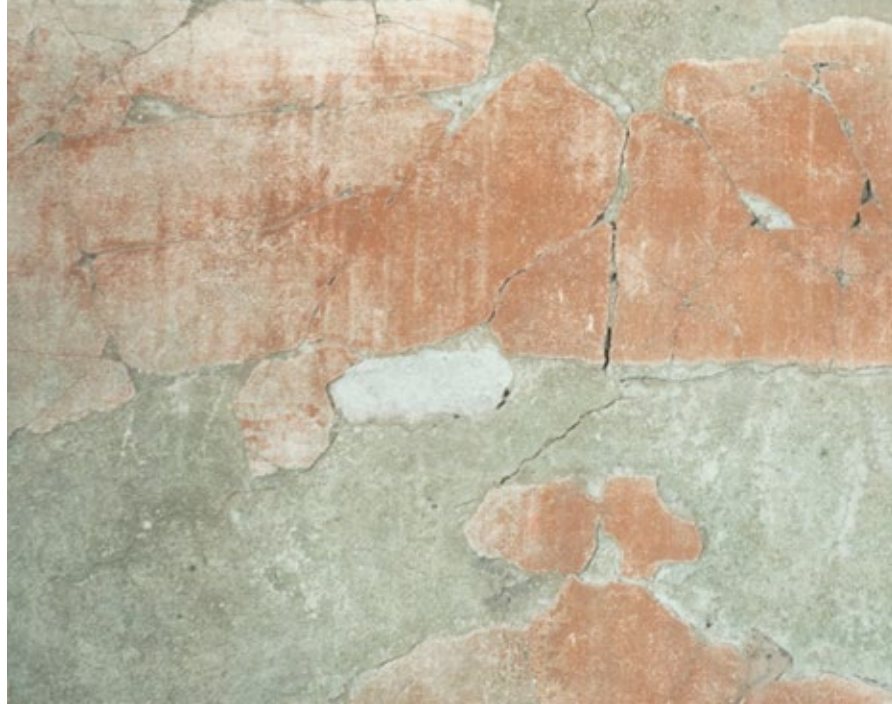
Loss of original and/or 1938 reconstruction plaster to a variable or undetermined depth. This differs from gaps between plaster fragments in which plaster fragments were not remounted.

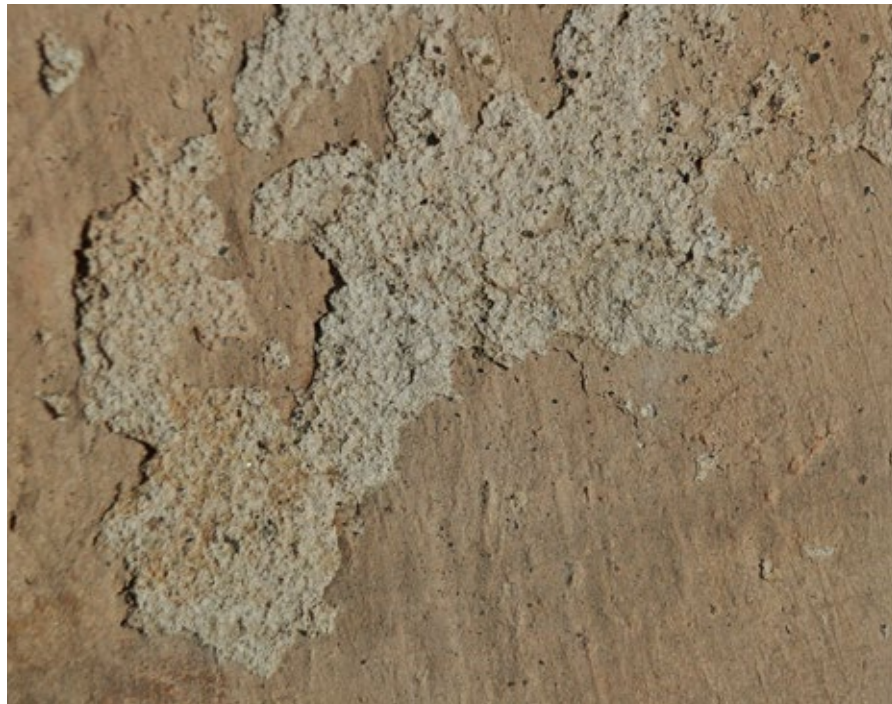
**Loss of lime/cement wash**

Areas where lime or cement wash applied as finishing restoration layer is missing, exposing the underlying 1938 reconstruction plaster

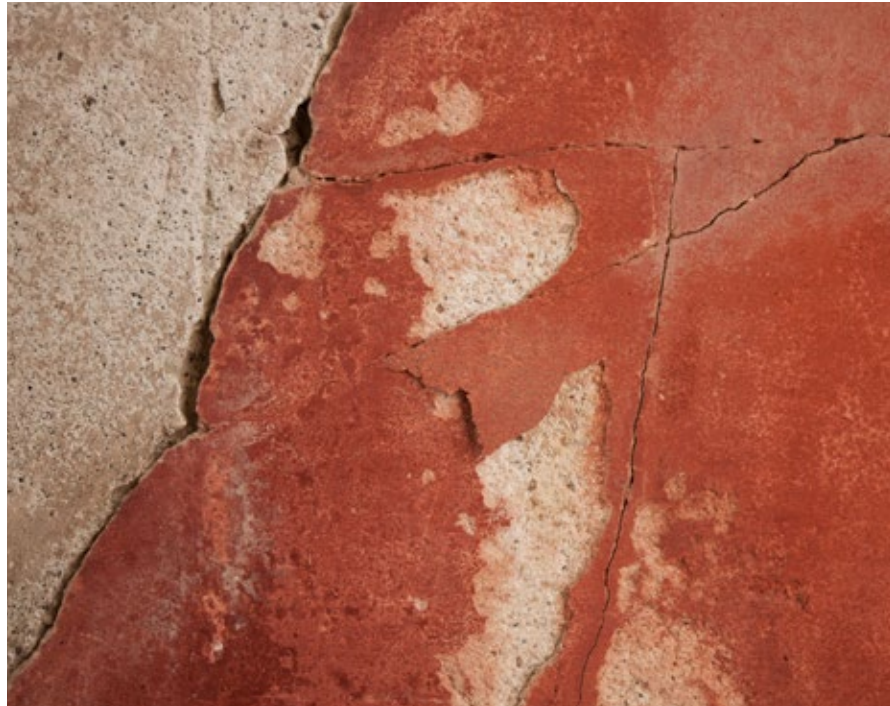
*Type 1.*

Lack of adhesion between plaster layers, resulting in detachment of varying thickness and depth, including thin delamination and deep voids. This condition affects the original and restoration materials and can be present as visible detachment or blind voids between the plaster layers or plaster and wall support.

Type 1: Thin delamination, which occurs within upper plaster layers and leads to loss of the upper plaster layer(s).

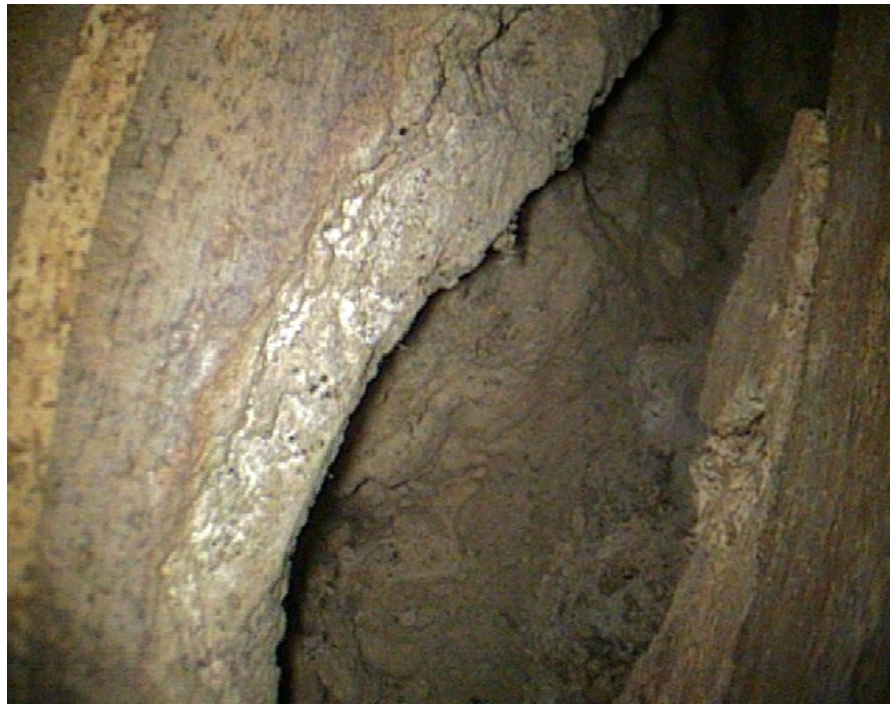
*Type 2.*

Type 2: Deep voids behind the surface, which may be related to cracks and/or to areas where 1938 grouting mortar has eroded or never penetrated.

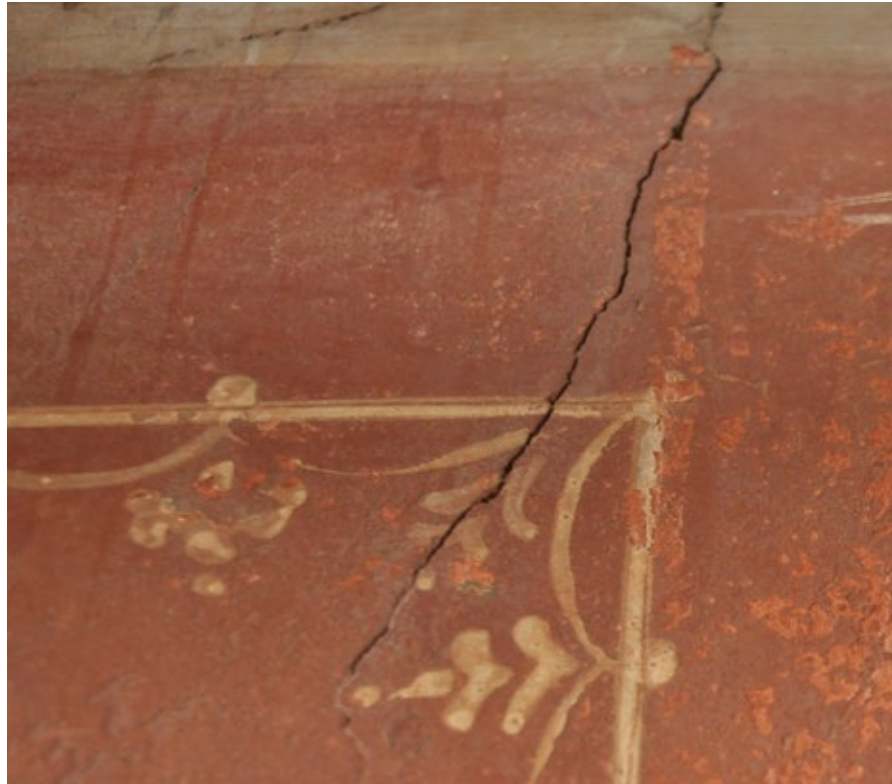
*Type 1.*

Type 1: Open cracks greater than 1 mm, which have occurred since the 1938 remounting and reconstruction.

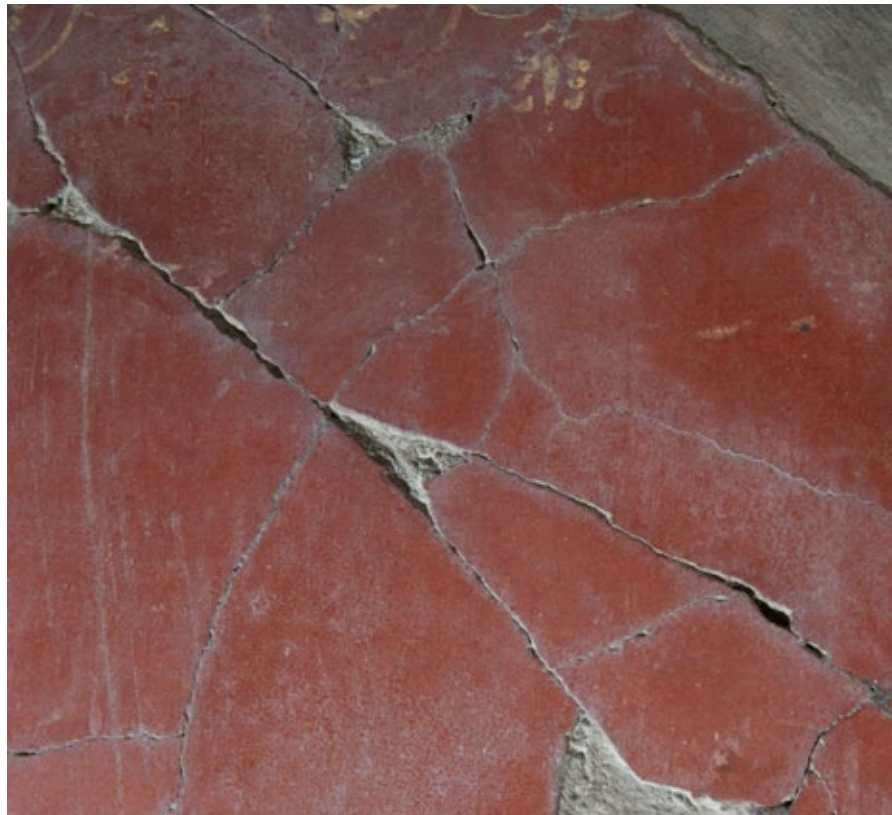
*Type 2.*

Type 2: Small, tight fissures less than 1 mm that are not active, located within plaster fragments.

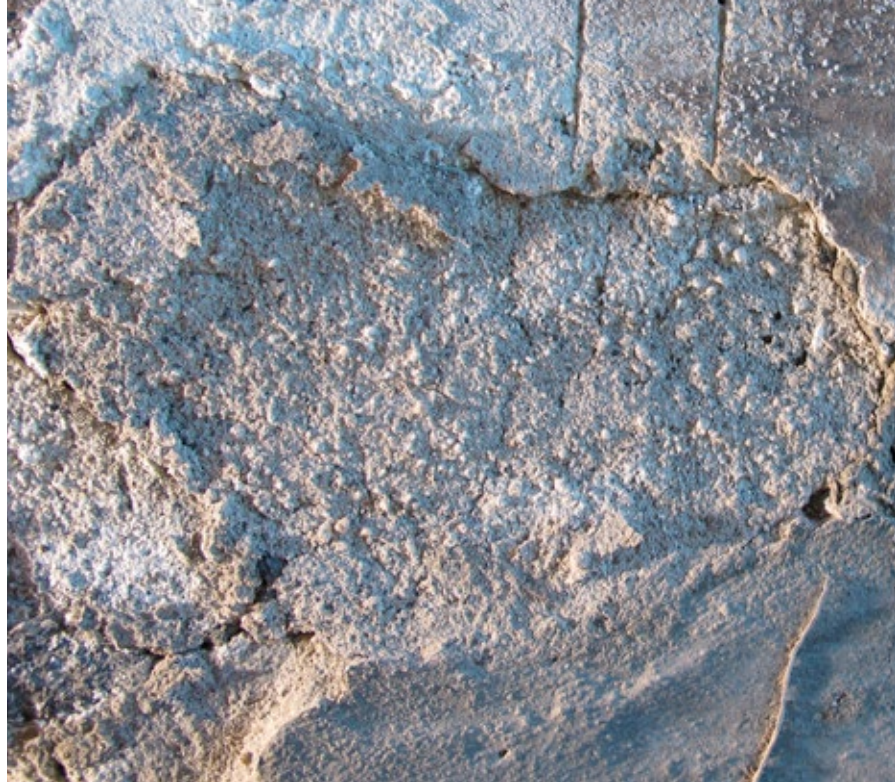
#### Powdering

Decohesion that occurs within the plaster, found predominantly along the lower east wall.

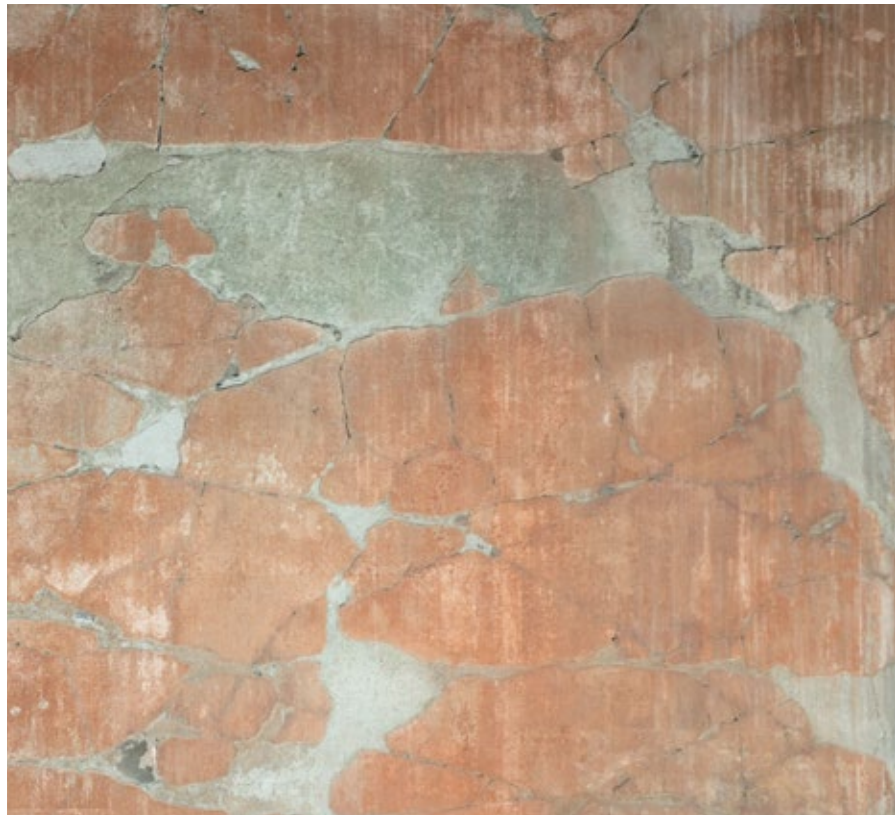
#### Abrasion/erosion

Partial loss of a smooth plaster, causing an uneven surface and exposed aggregate.

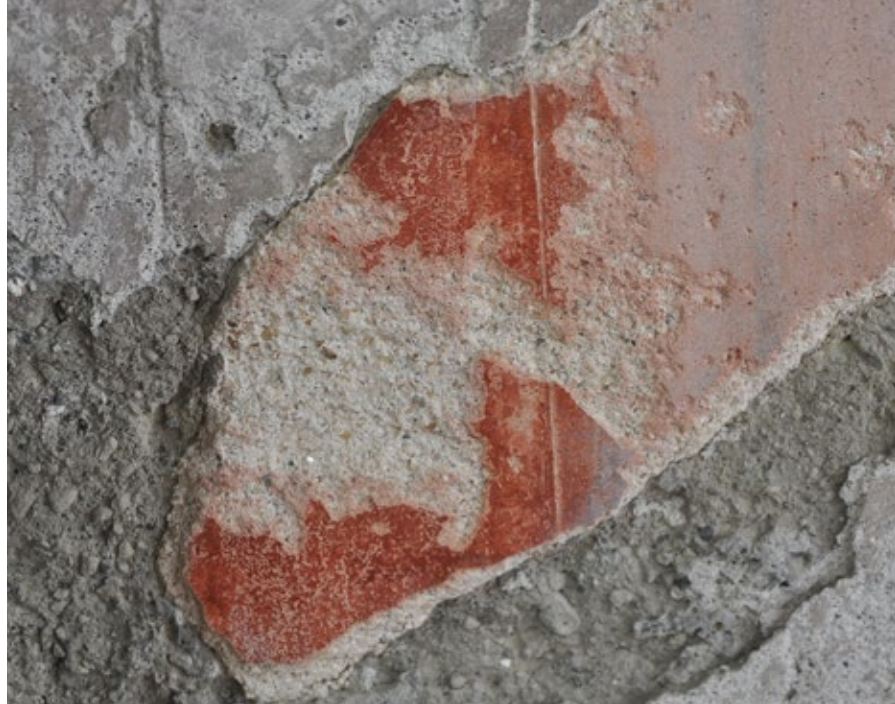
**Loss: monochrome**

Complete loss of the monochrome background layer, exposing the underlying plaster.

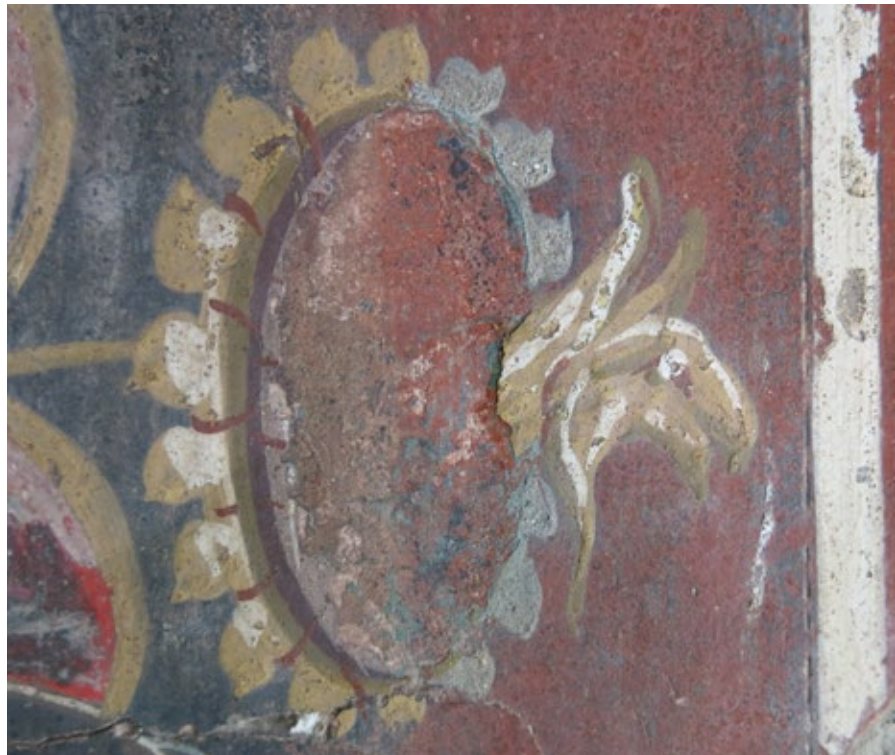
**Loss: design layer(s):**

Partial or complete loss of the upper paint layer(s), exposing the underlying paint layer or the monochrome background, or, in the case of rectangular scenes, the complete loss of paint exposing bare plaster.

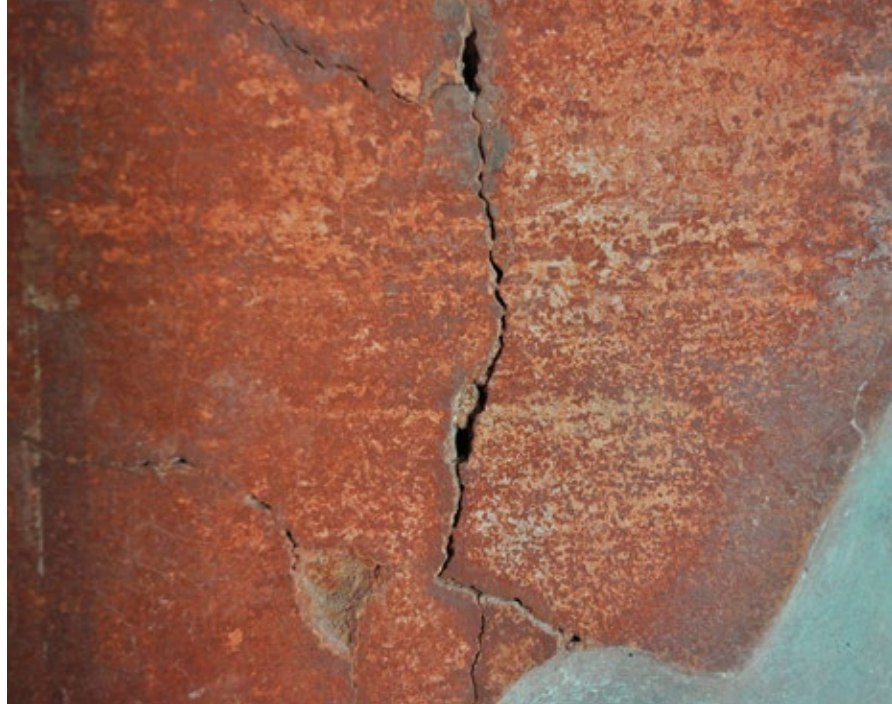
#### **Abrasion/erosion: monochrome**

Partial loss of the monochrome background, resulting in a reduced thickness of the paint layer and/or small areas of monochrome paint interspersed with small areas of partially or fully exposed plaster.

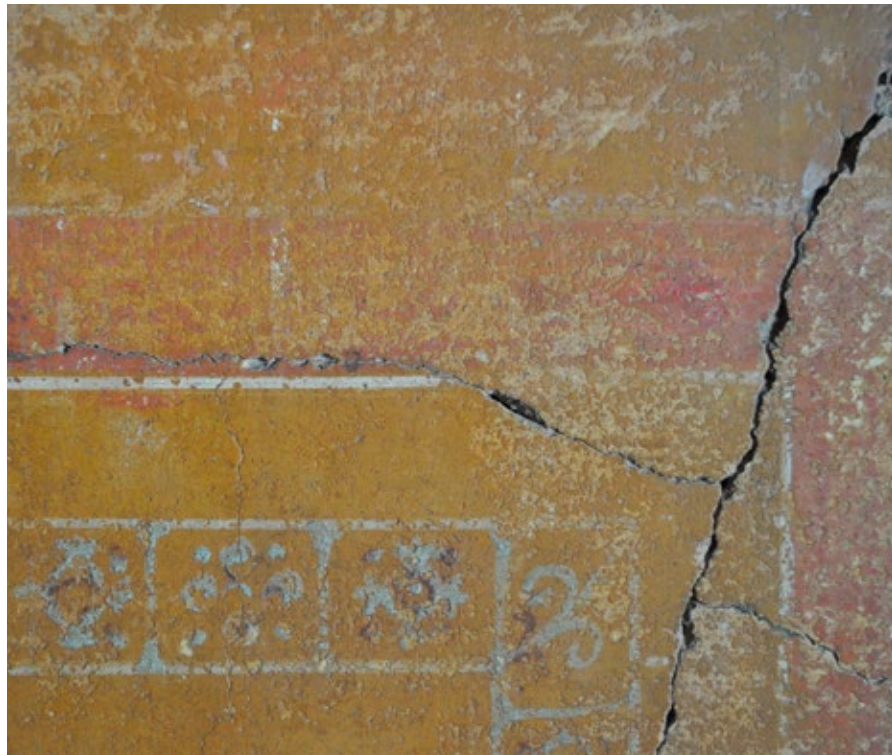
#### **Abrasion/erosion: design layer(s)**

Partial loss of painted decoration that results in a reduced thickness of the paint layer and/or small areas of painted decoration interspersed with small areas of partially or fully exposed monochrome background.

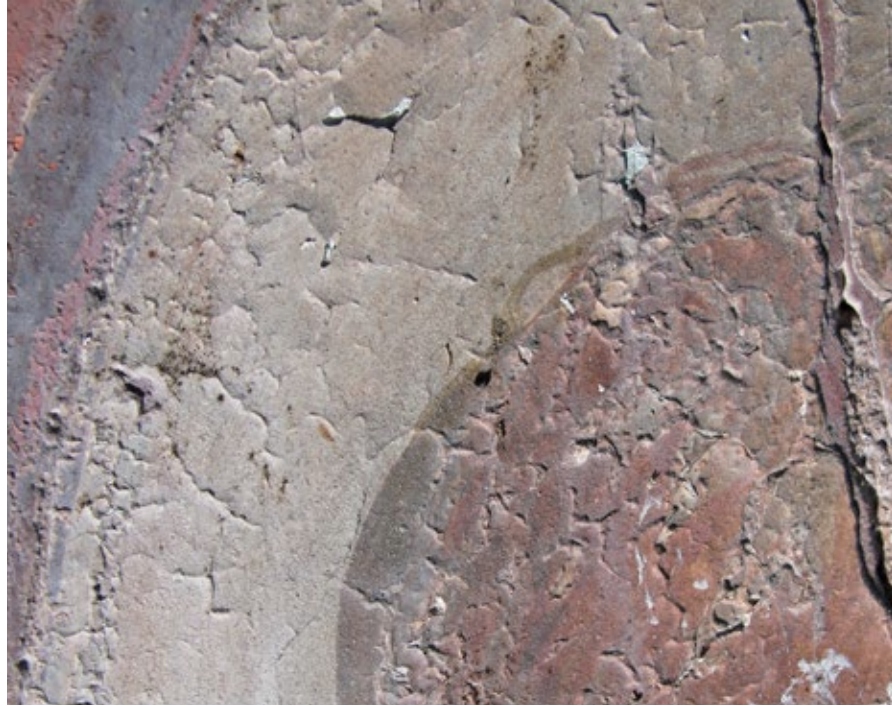
### Incipient flaking

Initial stage of delamination between the design layer(s) and the monochrome background layer, where paint may be lifting but not yet actively flaking and edges are not exposed; often associated with micro-flaking.

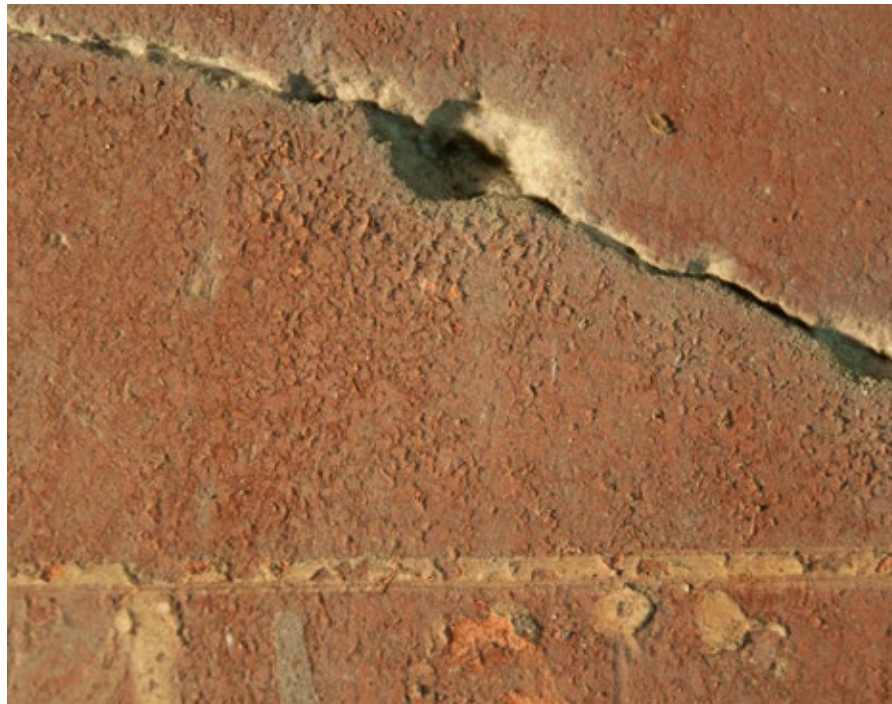
Lifting and/or cupping of the paint layer(s) on a micro scale <1 mm.

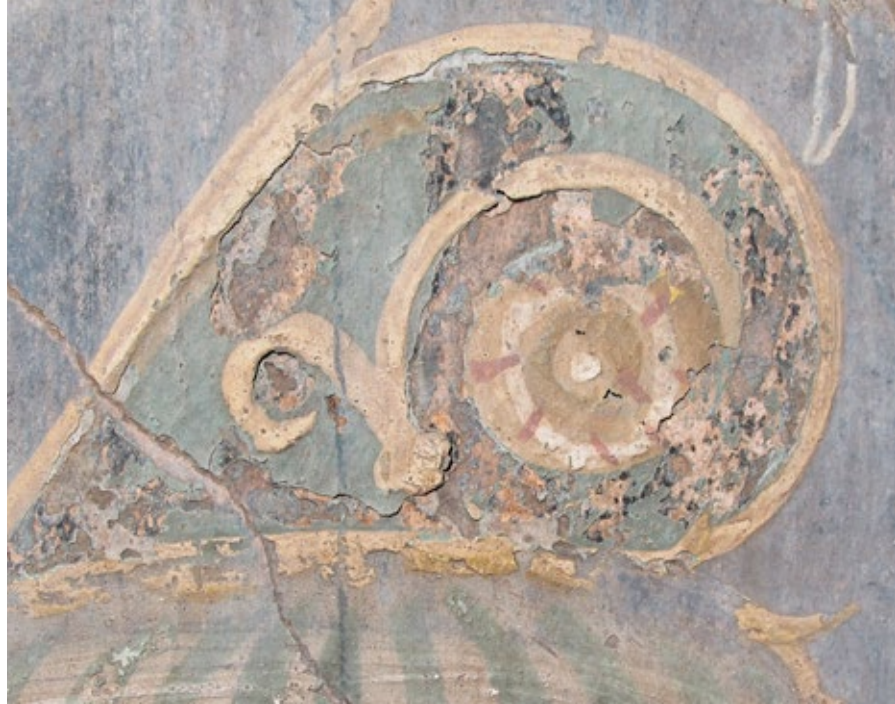
### Flaking

Lifting and/or cupping of paint layer(s) greater than 1 mm.

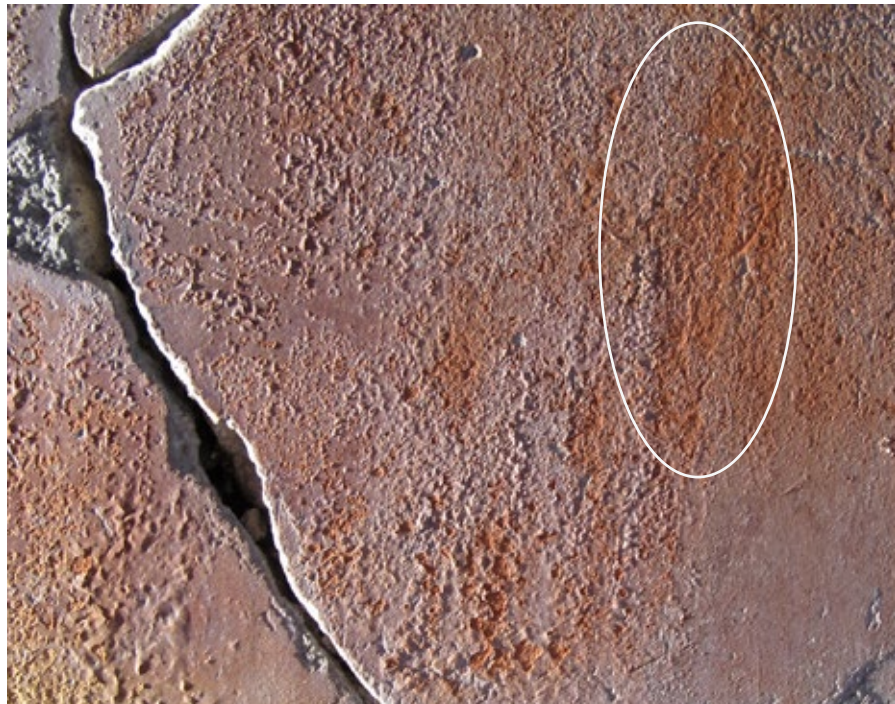
### Powdering

Lack of cohesion within individual paint layer(s) (indicated by white circle). This condition may also occur under a layer of stable wax.

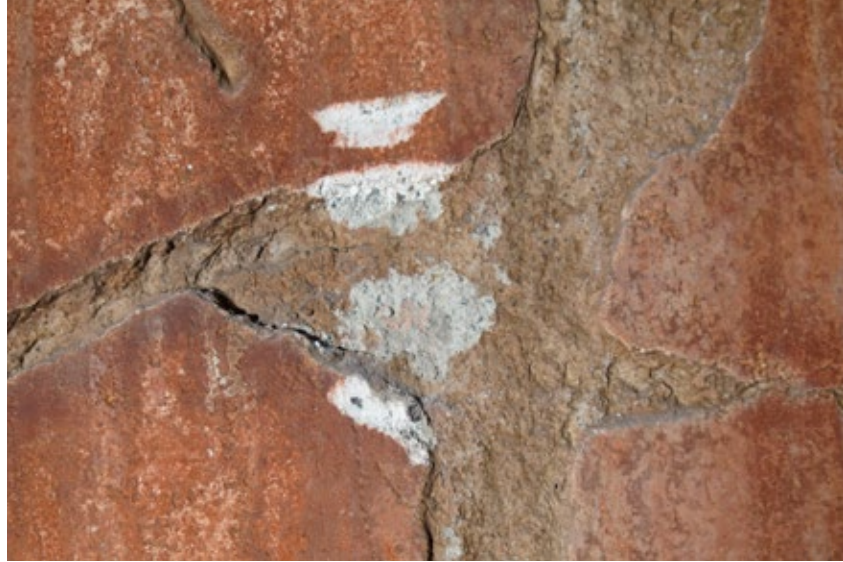
### Mechanical damage

Type 1: Unintentional nick, scrape, scratch, gouge, or abrasion on the surface.

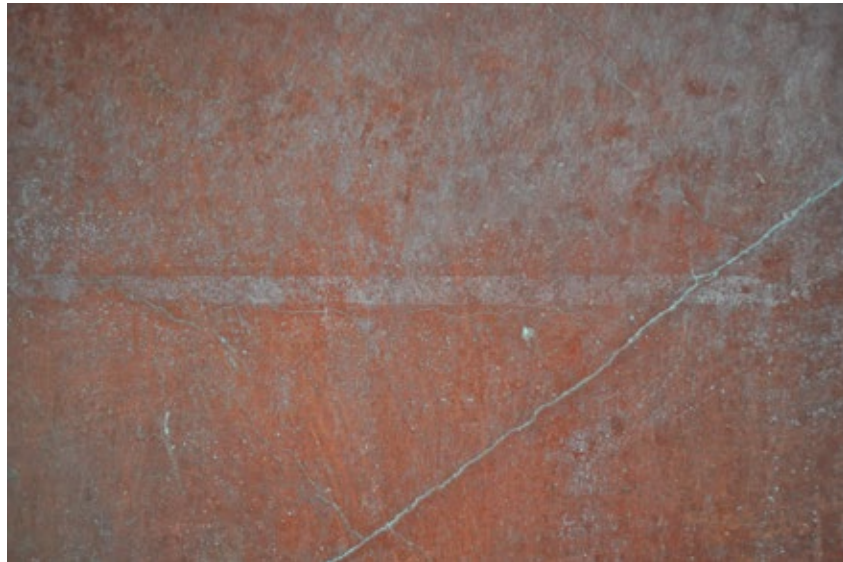
Type 2: Tape marks visible on the surface of the monochrome background layer.

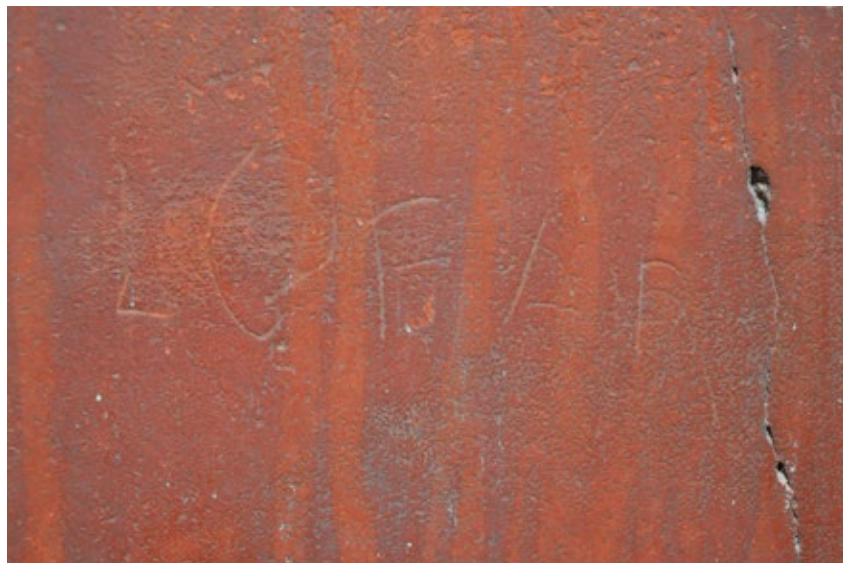
### Graffiti

Intentional marks scratched into the surface of the painting.

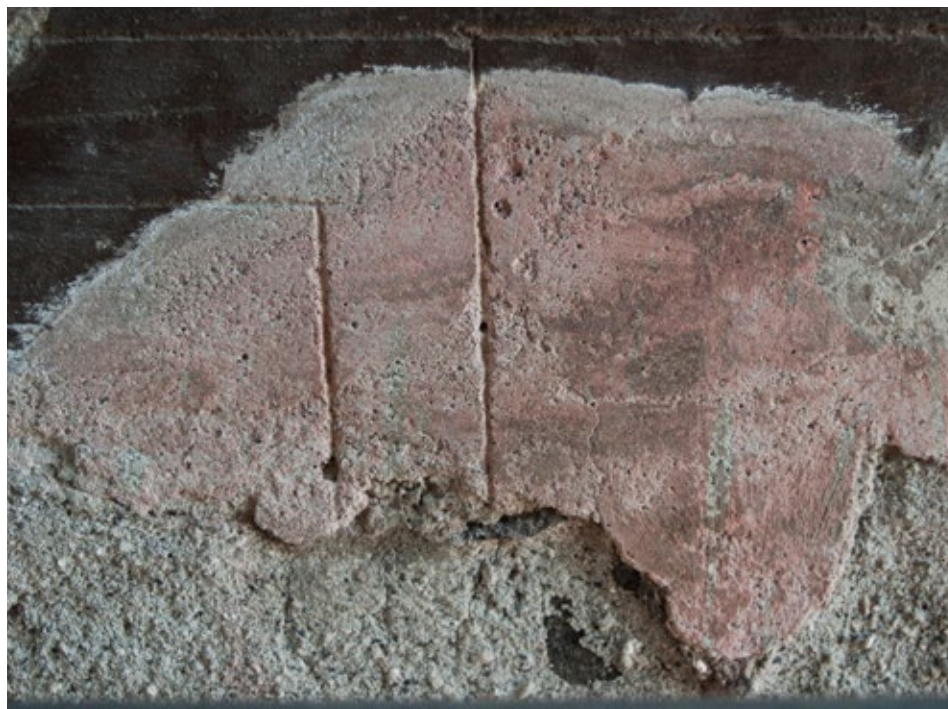
**Pink biopatina**

Pink microbiological growth occurring along the base of walls in the House of the Bicentenary; variable in height and extent depending on environmental conditions.
