# Conservation of the Architectural Surfaces in the Tablinum of the House of the Bicentenary, Herculaneum

Phase I: Examination, Investigations, and Condition Assessment

## Project Report

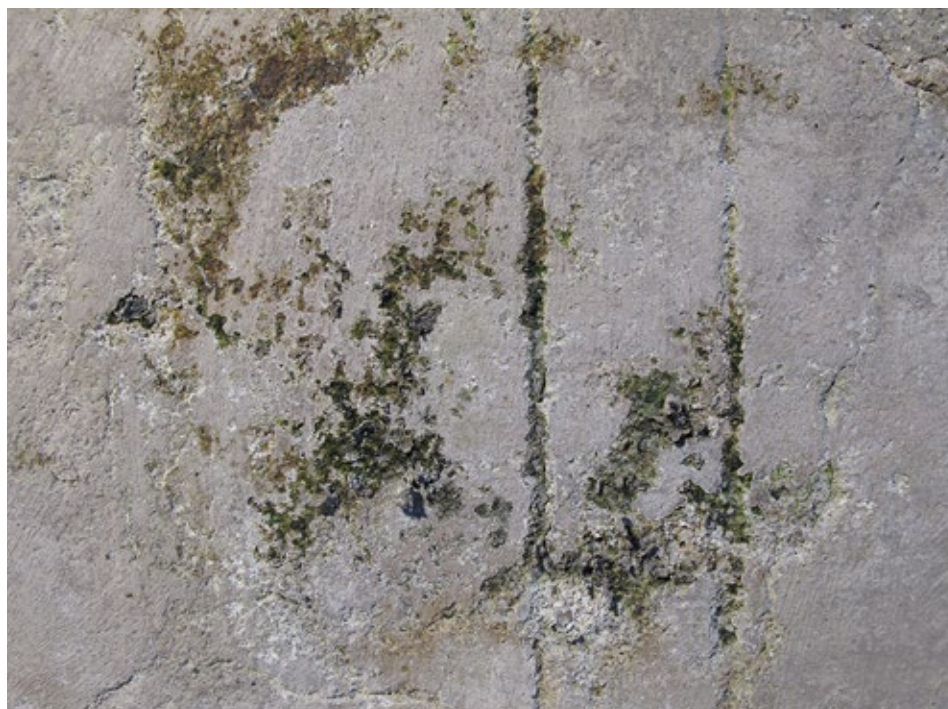
**Microbiological growth: other**

Microbiological matter of various origin on surface.

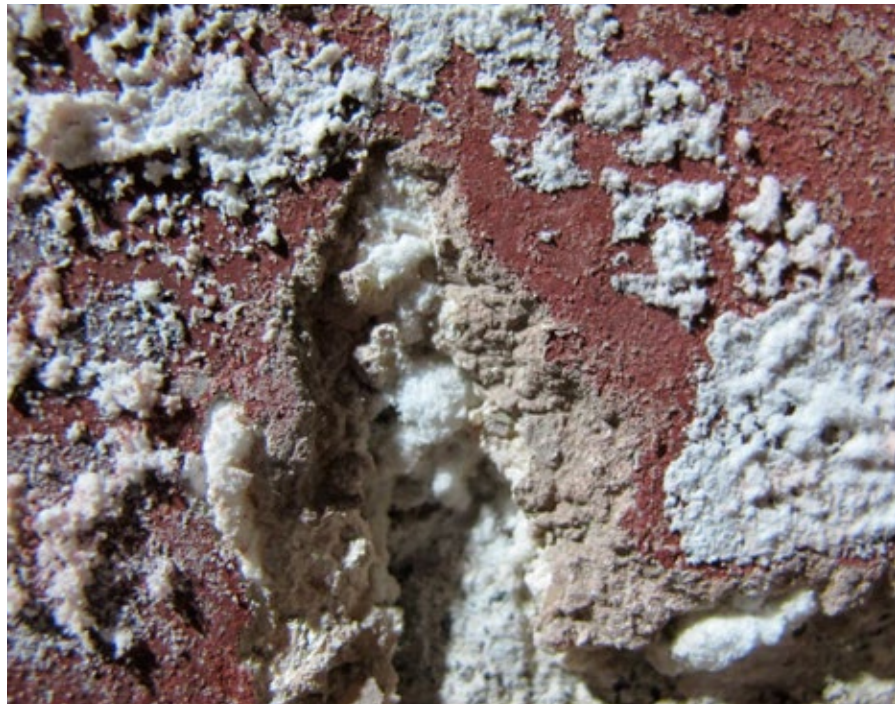
Efflorescence 2016

Deposits of crystallized salts, appearing as a white veil, powder, or crust on the surface or within the paint and/or plaster layer(s).

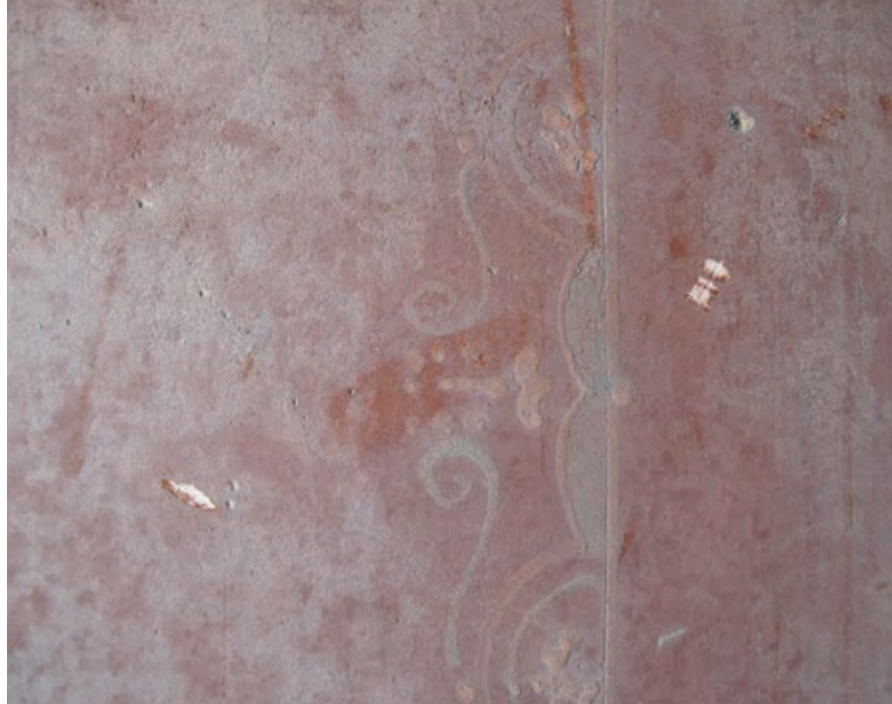
### White haze

An opaque film or veil obscuring the painted surface.

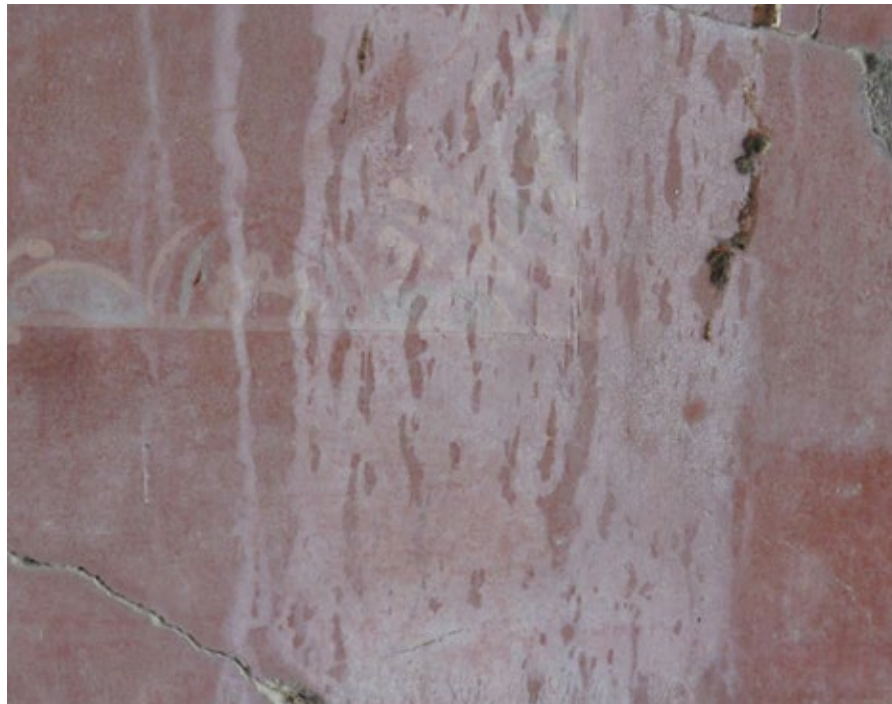
### White drip

Two different types of white drips are present:

Type 1: Thickly applied restoration coating materials (primarily wax, but also carbonation layer or other surface accumulations) that have become opaque over time and obscure the original paint layer(s) (pictured at right).

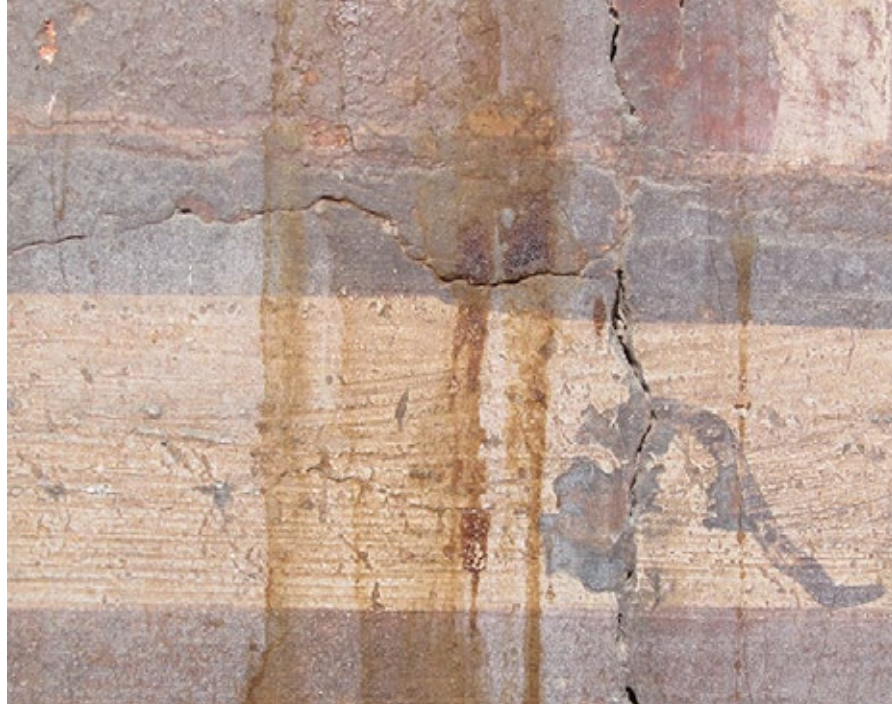
#### Dark drip

Discolored materials that have run down the surface of the wall.

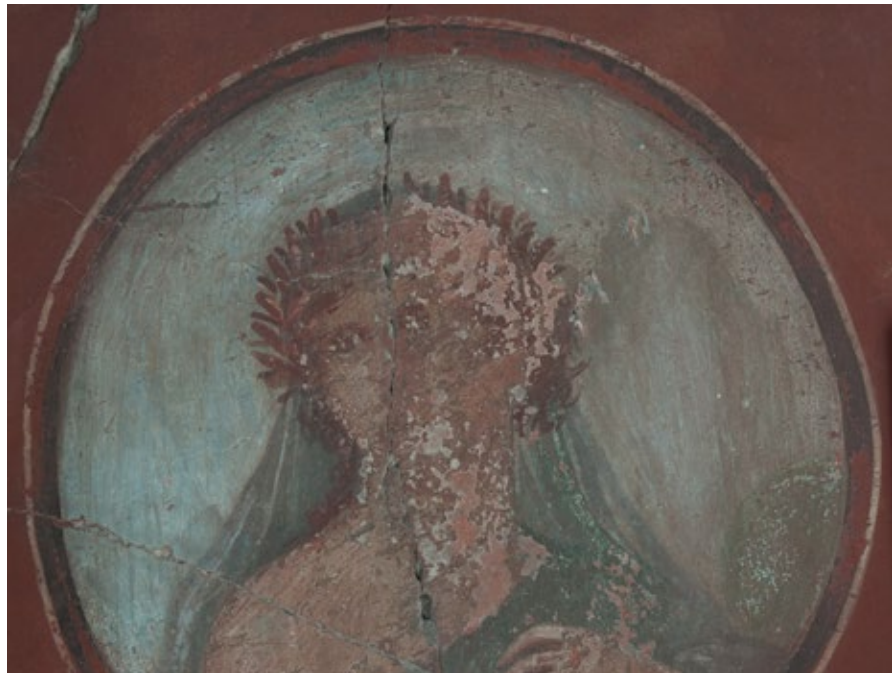
#### Discolored coating

Previous restoration materials applied on the surface of the wall paintings that have yellowed or discolored over time.

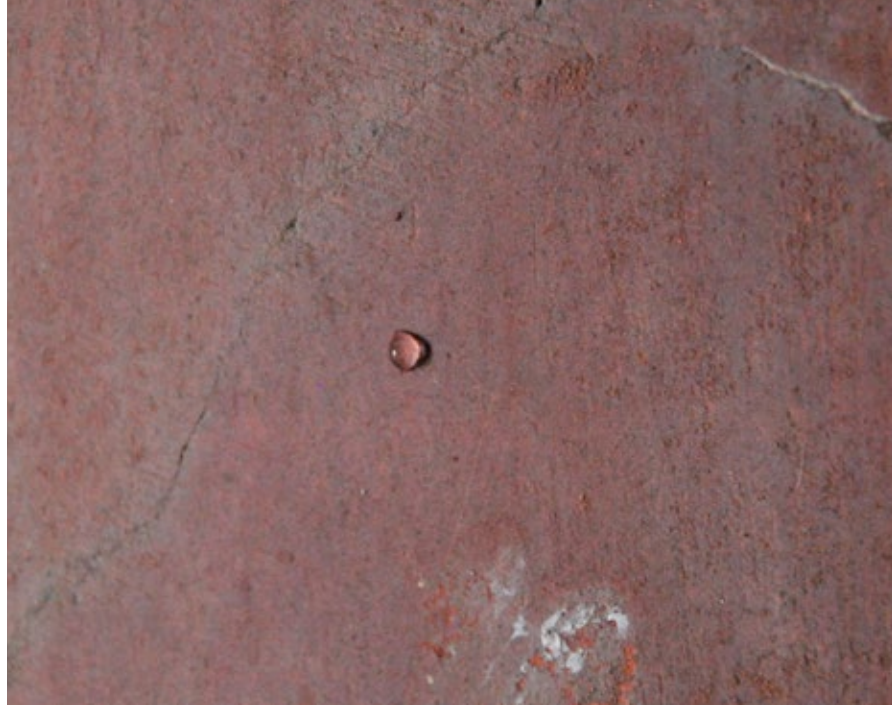
### Stable wax

Coherent, compact layer of wax that covers the painted plaster in areas. In some cases it has become opaque (see white haze) and in others it remains a fairly transparent layer.

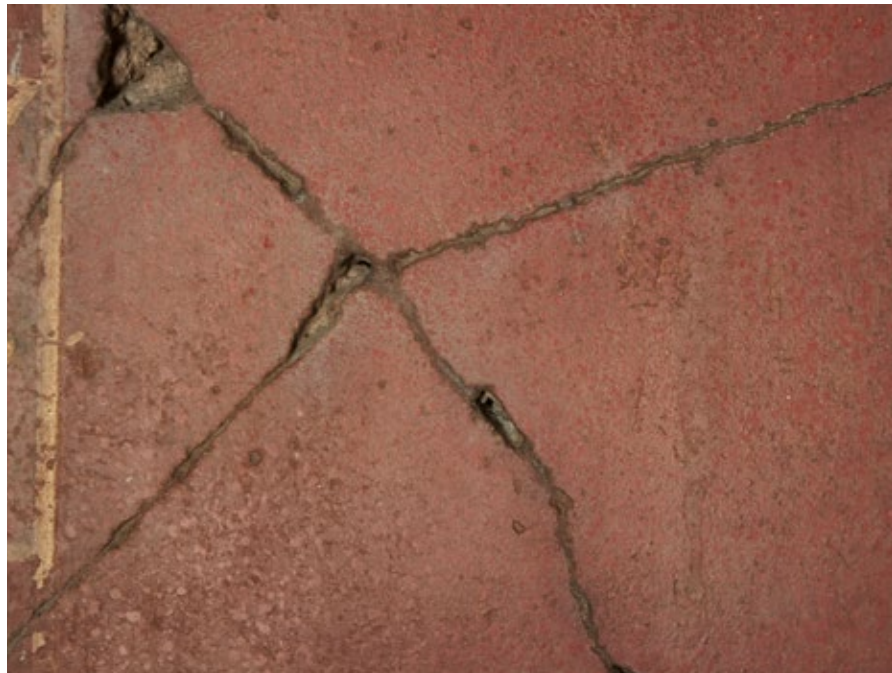
### Discontinuous/ broken wax

A disrupted wax layer present in areas on the surface of the wall paintings, frequently associated with micro-flaking.
