CONDITION ASSESSMENT: WORKING WITH INFORMATION

Recording Streetscapes

Condition Survey

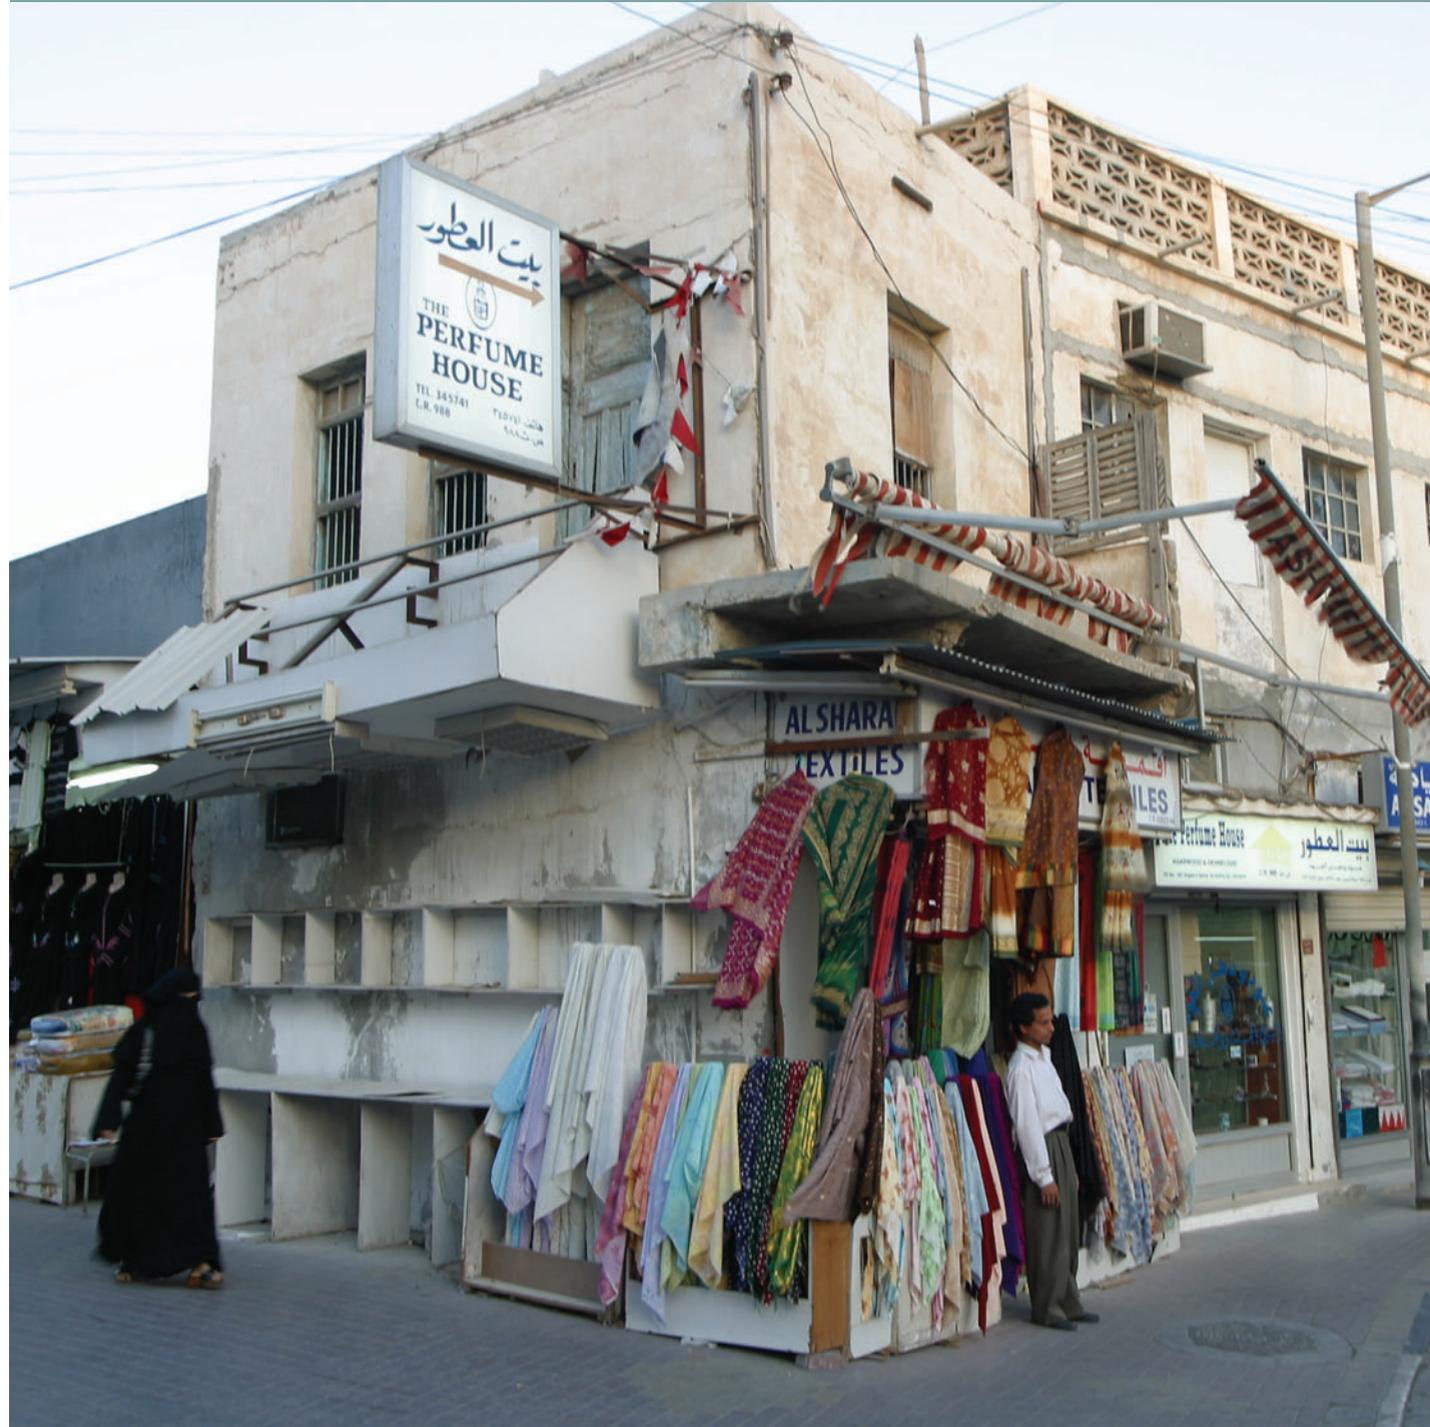
The corner of Sheikh Hamad Avenue and Tujjar Street, Qaysariyyah Souq, in the heart of Muharraq, Bahrain. The souq suffers from exposure to the natural elements, neglect, and inappropriate development. Photo: © Salim Elwazani and José Luis Lerma.

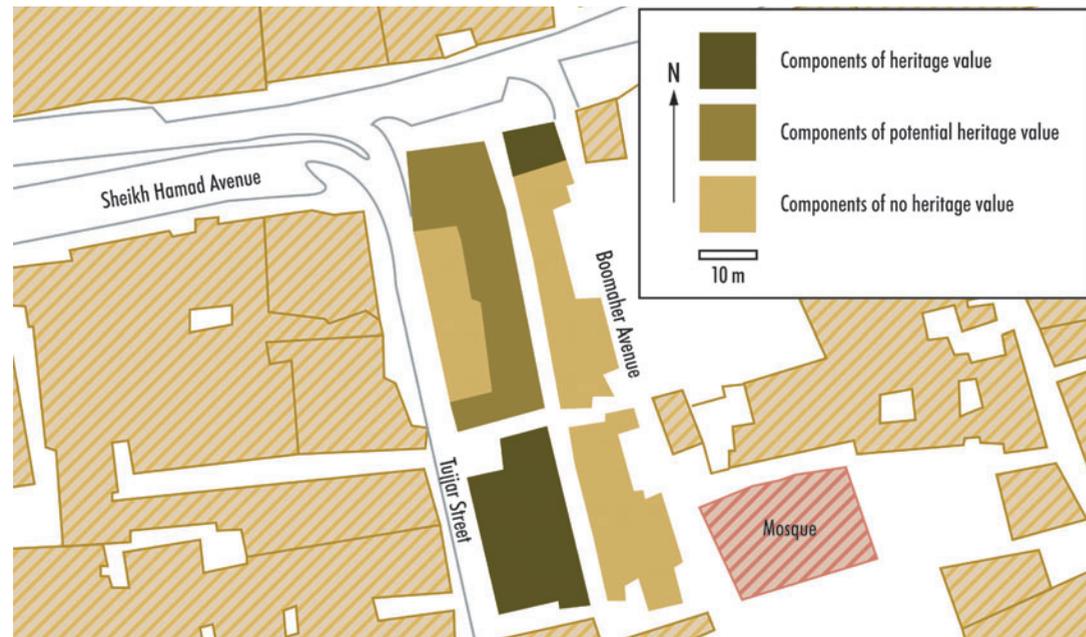
Map of the Qayseriyyah Souq, showing major avenue boundaries, central and auxiliary alleys, and building components of heritage value. Not only are the original visible buildings at risk, but archaeological vestiges are said to be buried within the souq. Map: Steven Rampton.

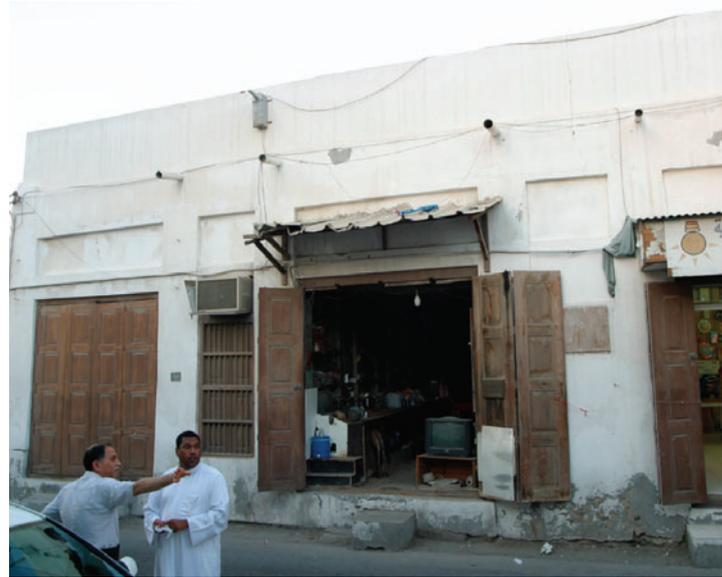
Unrectified photograph of a storefront, taken at an angle. Photo: © Salim Elwazani and José Luis Lerma.

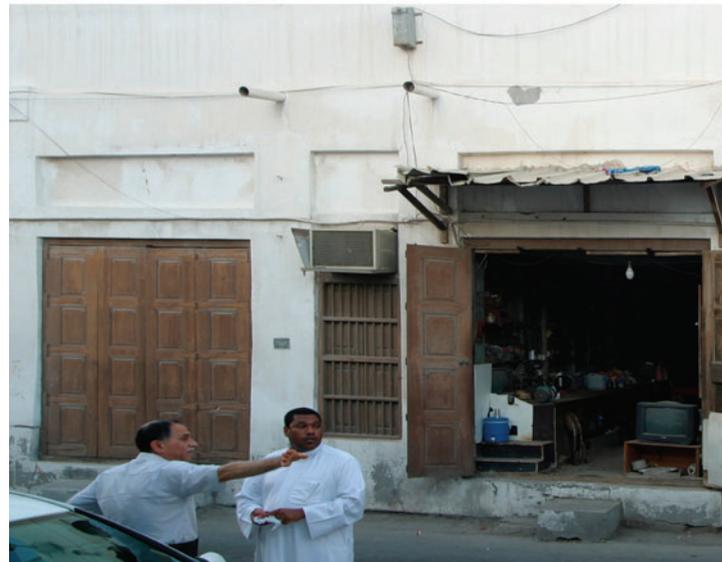
Rectified photograph of the same storefront. Rectification removes perspective, angle, and camera lens distortion to create an image that is on one plane and measurable. Photo: © Salim Elwazani and José Luis Lerma.

perspective, angle, and camera lens distortion, and creates a measurable image that is on the same plane as the building. This method is the most appropriate when the building surface is geometrically flat. Buildings having multiple flat surfaces positioned in different planes can also be rectified: each plane is separately rectified, then brought into one reference plane. Rectified imagery worked particularly well in the souq, as the building facades are relatively flat and images had to be taken at extreme angles with a wide-angle lens in the narrow streets and alleys.

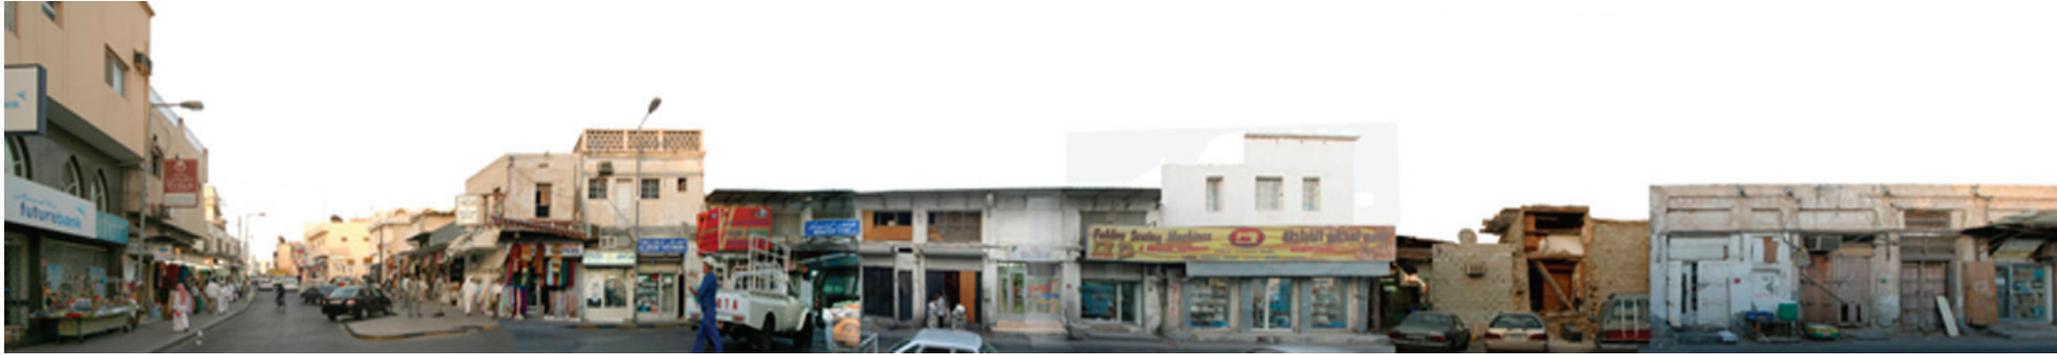
Mosaic of Souq West elevation on Tujjar Street.
Photos: © Salim Elwazani and José Luis Lerma.

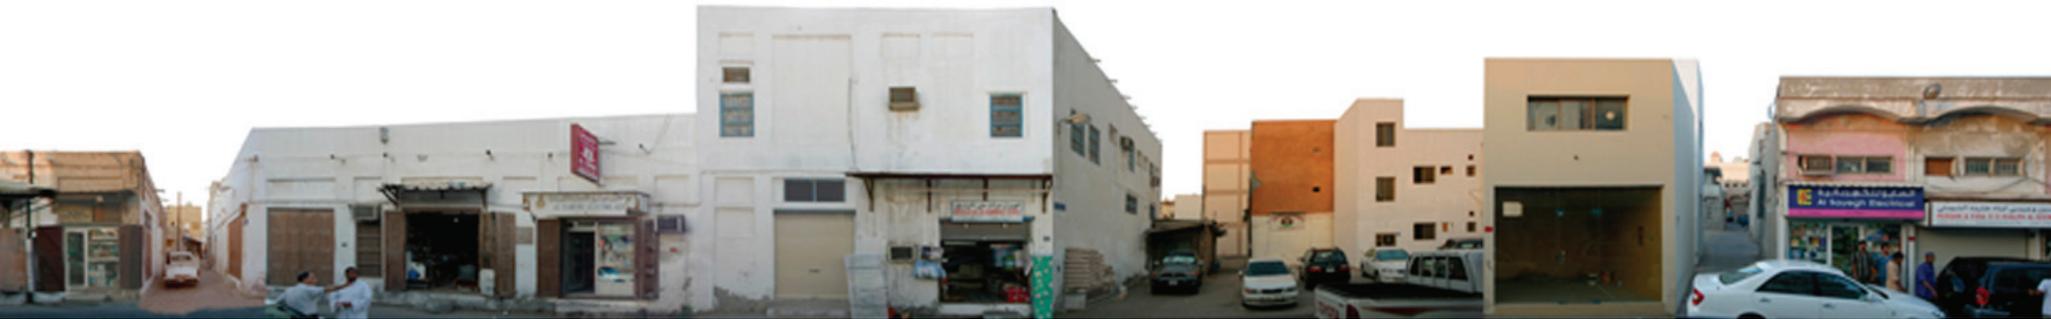
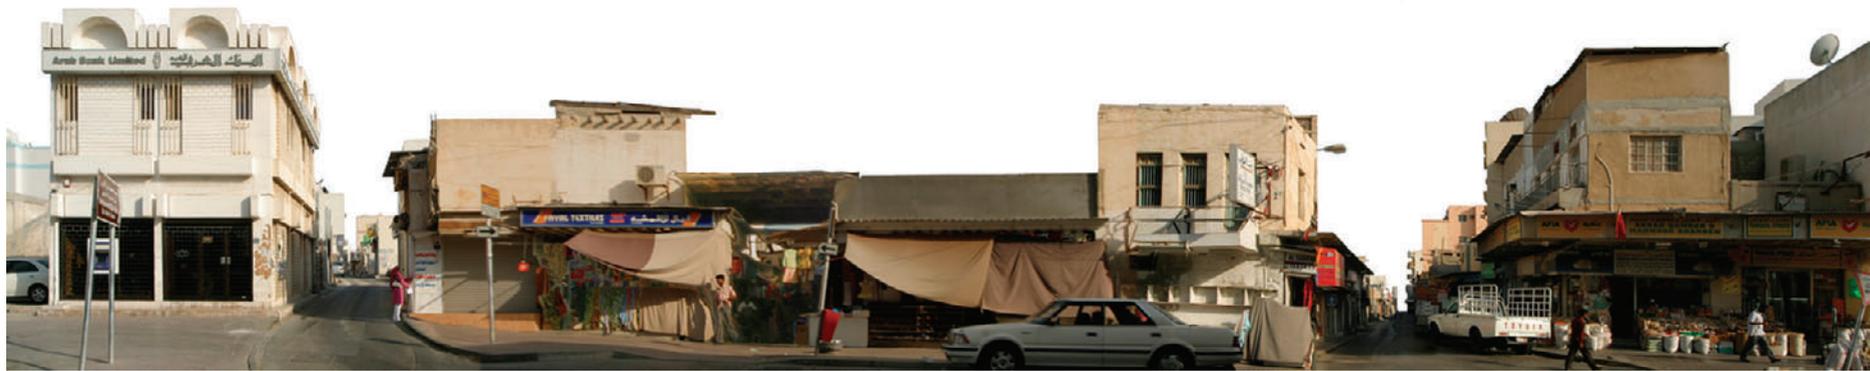
Mosaic of Souq North elevation on Sheikh Hamad Avenue.
Photos: © Salim Elwazani and José Luis Lerma.

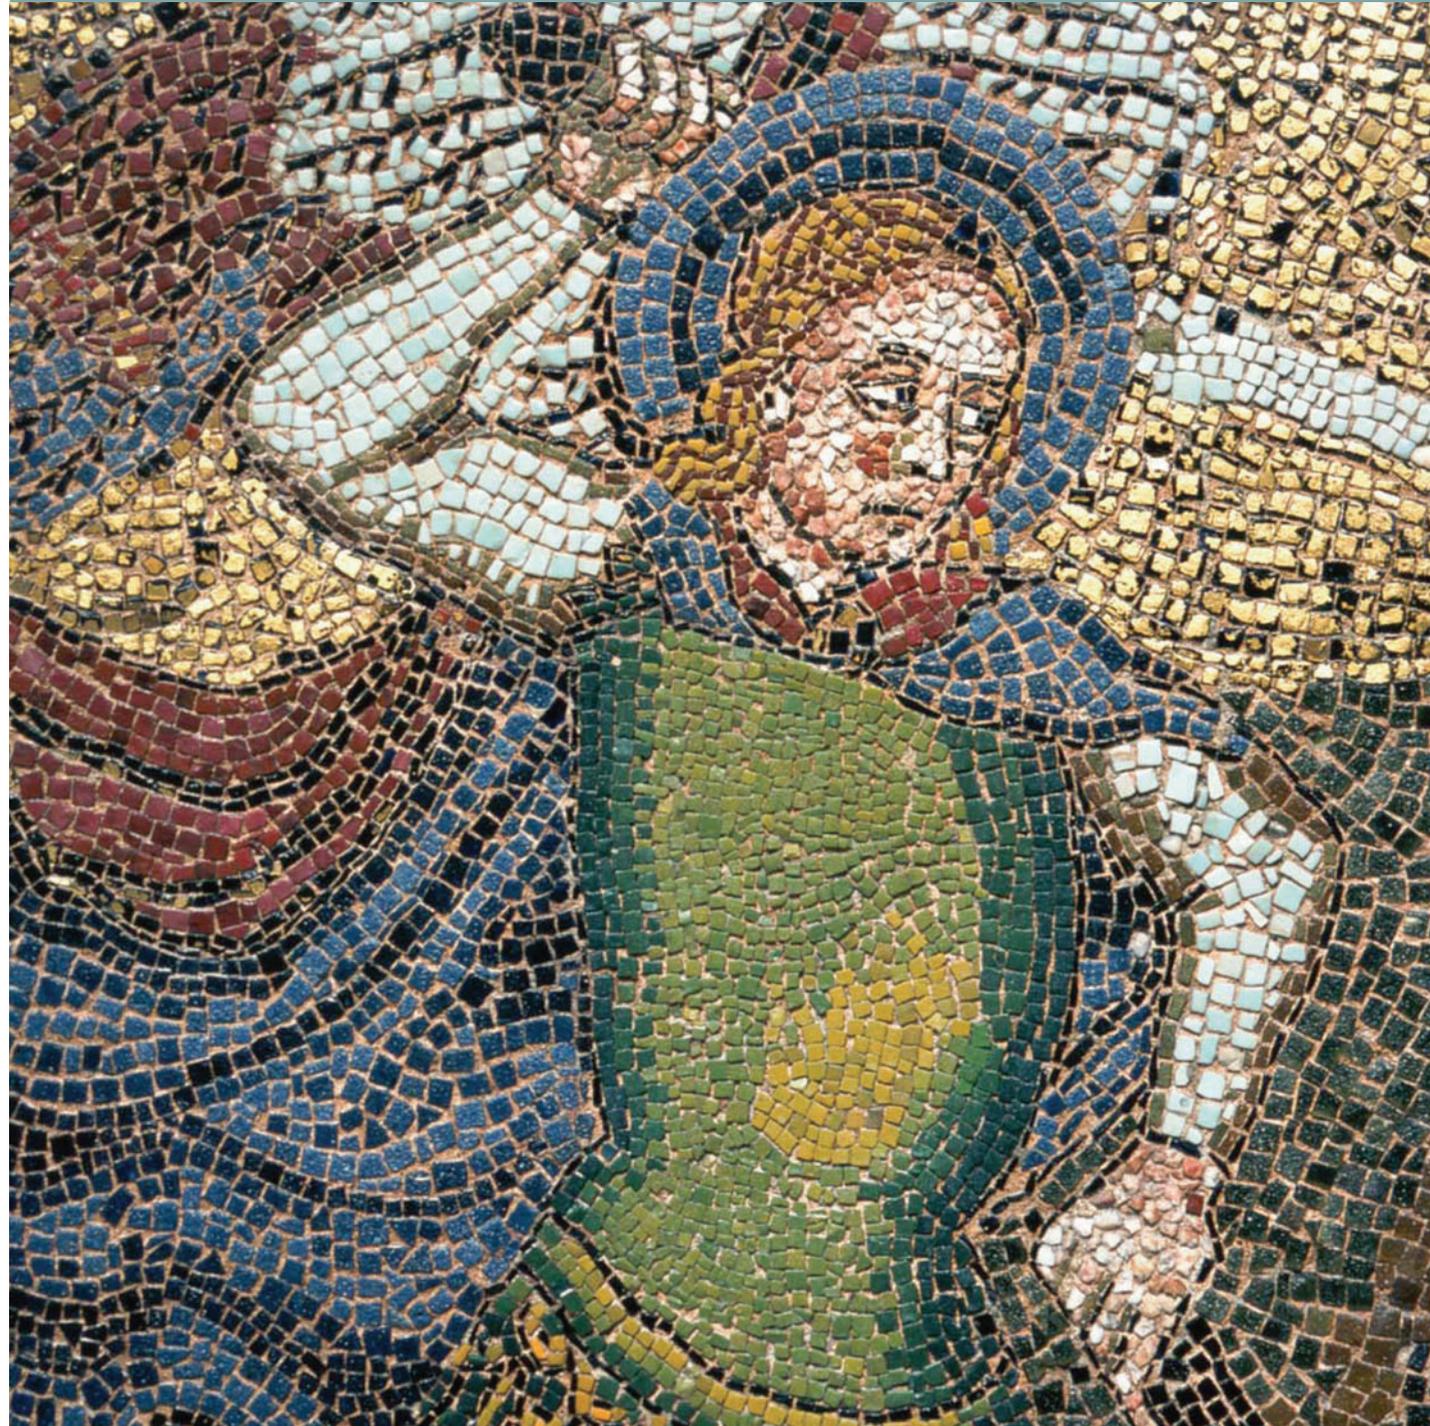
Detail of an angel, shown after cleaning, in the *Last Judgment* mosaic, above the entrance to St. Vitus Cathedral, Prague.
Photo: Dusan Stulik.

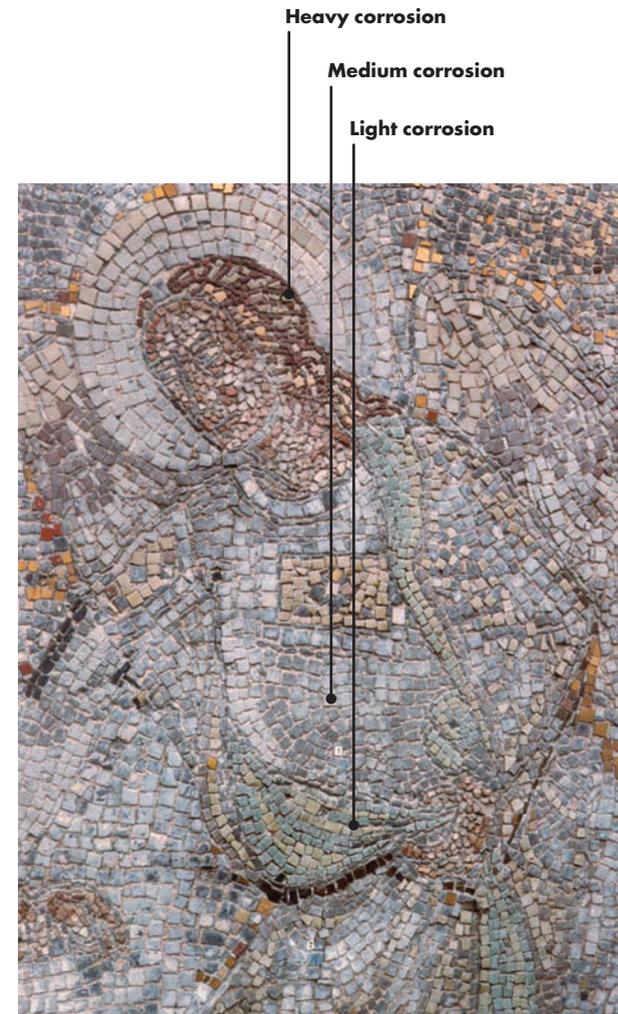
Detail of a figure in the mosaic prior to cleaning, showing levels of corrosion. Photo: Dusan Stulik.

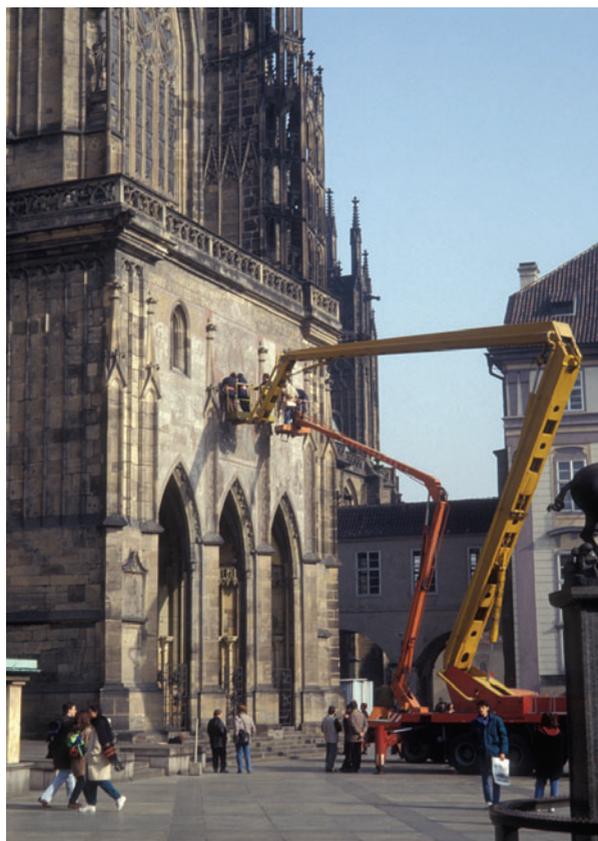
Conservators at St. Vitus Cathedral inspecting the mosaic, recording conditions on transparencies overlaid on rectified photographs of the facade. Photo: Dusan Stulik.

In the third step, the distortion-free images and measurements were imported into AutoCAD, a computer drafting program, and sent to the conservators. Using this program, a grid was then drawn every 20 centimeters over each image, both vertically and horizontally. This, along with a naming standard, created a coordinate system that allowed the team to reference specific sections of the mosaic. For example, Christ passing judgment is located at LJCBC B4. This refers to the *Last Judgment* (LJ), center panel (C), before conservation (BC), column B, row 4. Four rows by four columns were then printed at a scale of 1:4 on A4 heavy-weight paper. A4 transparencies were also printed with a corresponding grid in order to align properly with the image of the mosaic. This proved to be a good size, as it was manageable on a clipboard yet still provided an acceptable level of detail. By using the base map image and transparency overlay, conservators could work on the scaffolding to manually record important features.

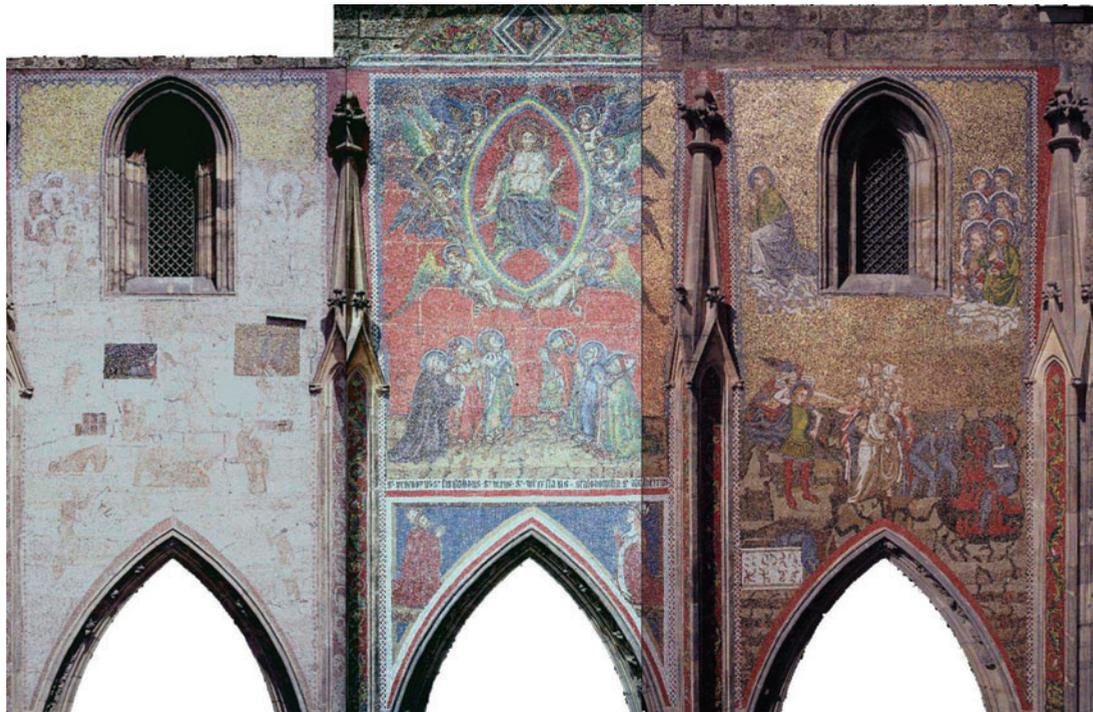
Rectified images of the facade, showing its state before conservation (*left*), after treatment (*center*), and after gilding (*right*). Images: Jaroslav Zastoupil.

PhoTopoL, the digital images were then rectified, or transformed, and correlated to fit actual dimensions of the mosaic. The removal of distortion and the placement of the images to exact scale were crucial, as each of the three panels was photographed separately during different phases of the work. This allowed images taken before, during, and after conservation of each panel to align exactly.

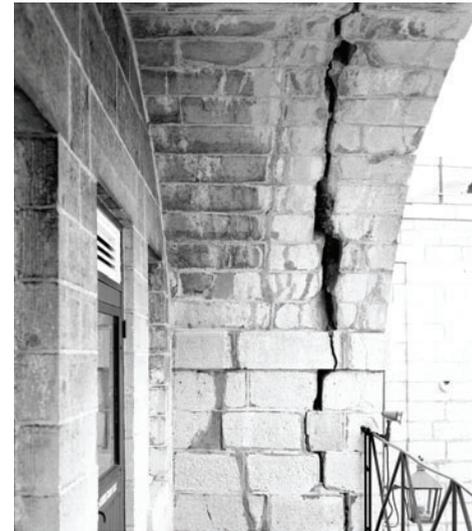
Fractures and spalling of the limestone blocks in an archway of the redoubt. The mortar joints had also deteriorated significantly. Photo: © Fort Henry National Historic Site of Canada–Archives.

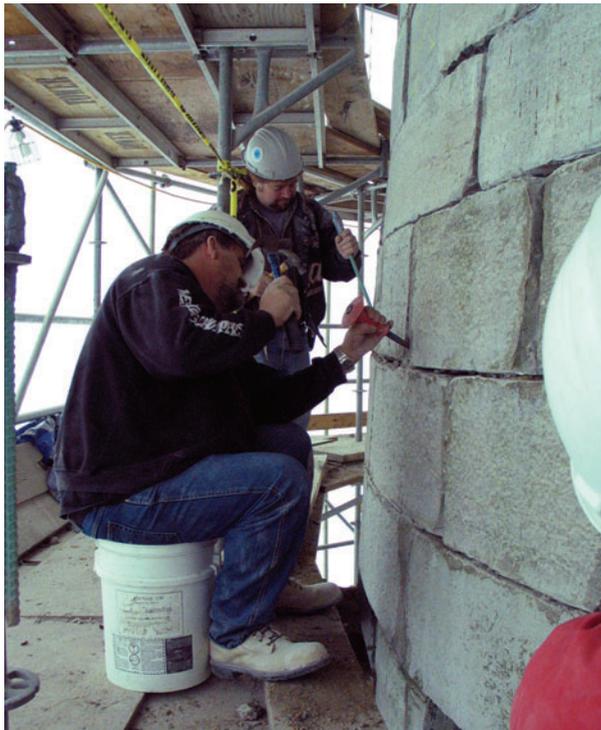
Workers removing deteriorated mortar from the East Branch ditch tower for repointing. Photo: © Fort Henry National Historic Site of Canada–Archives.

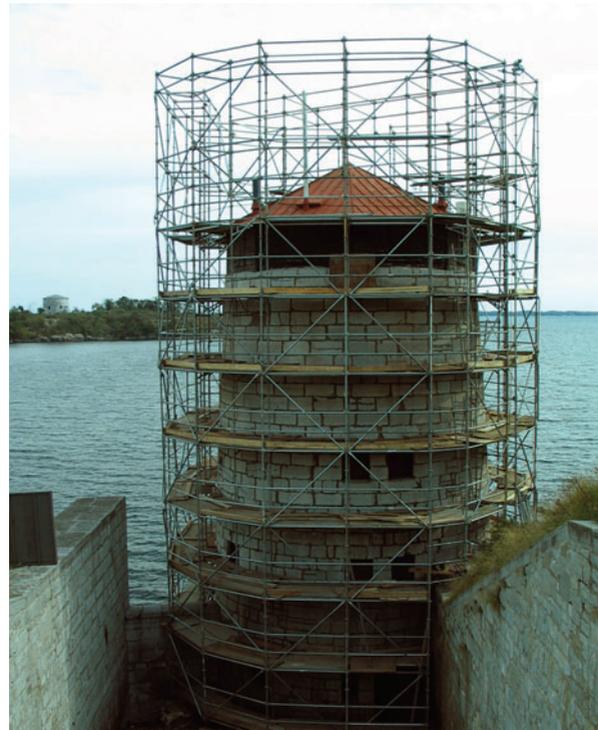
The scaffolded East Branch ditch tower during the restoration project. Photo: © Fort Henry National Historic Site of Canada–Archives.

project commenced in 2004 to waterproof, repair, and stabilize the redoubt, and in fall 2006, conservation work was begun on the East Branch ditch tower to restore the roof and repair the stone walls. This work continues in 2007 on the West Branch ditch tower. Other conservation projects currently in the planning and implementation stages include the repair and repointing of the advanced battery and the north wall of the redoubt. Each intervention reflects a commitment to respecting the established heritage character of the site.

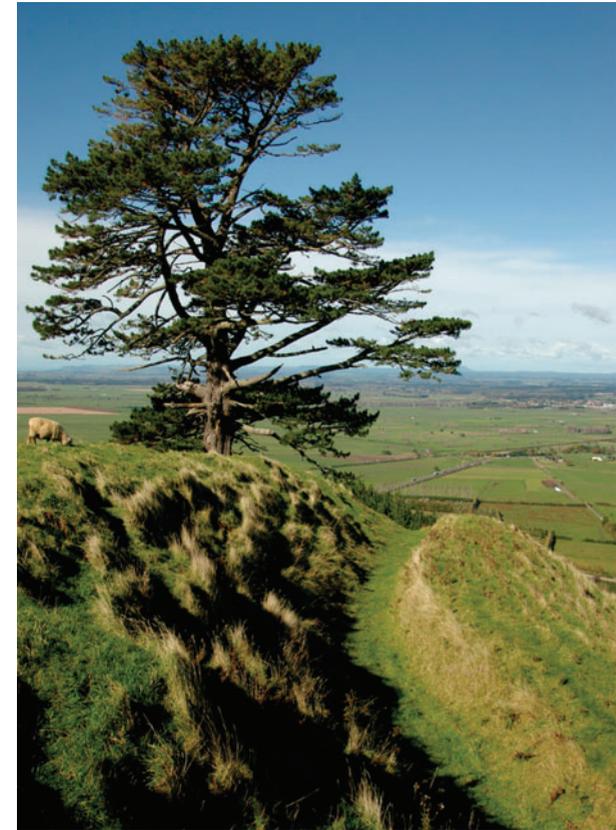
Prominent lateral defensive ditch and terracing on Karangaumu pā. Photo: Kevin L. Jones © New Zealand Department of Conservation.

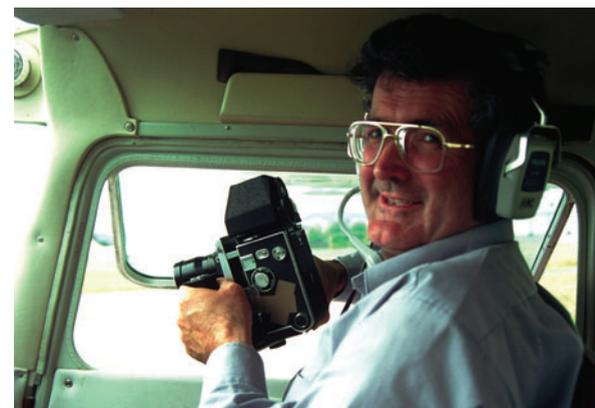
The author preparing to take oblique aerial photographs of pā on the North Island of New Zealand. Photo: Kevin L. Jones © New Zealand Department of Conservation.

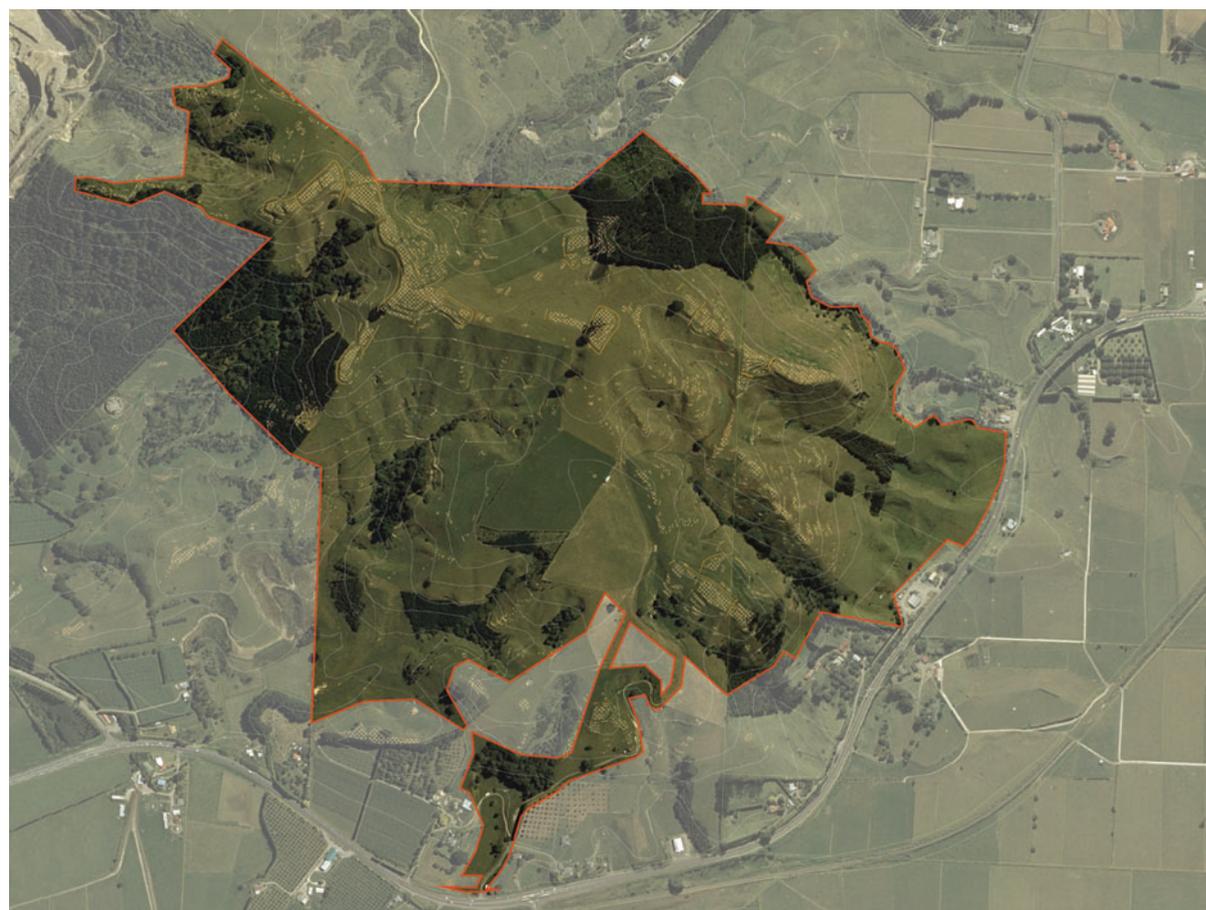
Orthophotographic aerial photography of the entire Papamoa Hills Regional Park. Photo: Fugro Airborne Surveys © Environment Bay of Plenty, New Zealand.
