International Course on the Conservation of Earthen Architecture

ACCOMPANYING ESSAYS

Edited by
Benjamin Marcus
Alessandra Sprega
Claudia Cancino
Gayathri Hegde

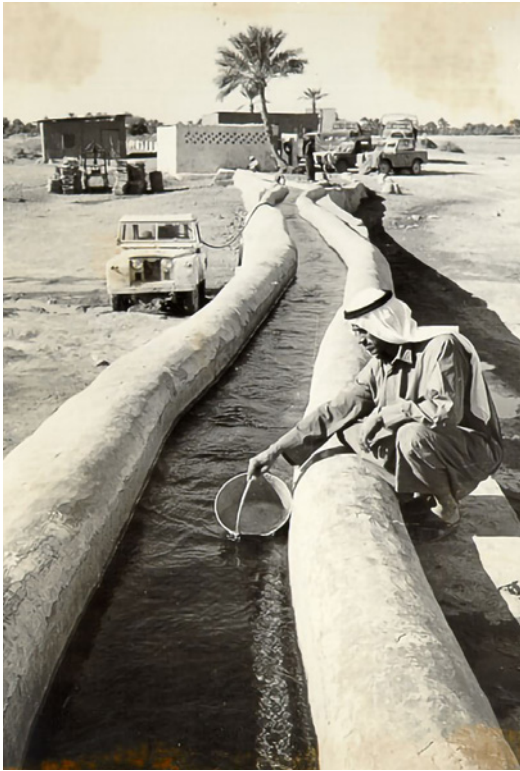
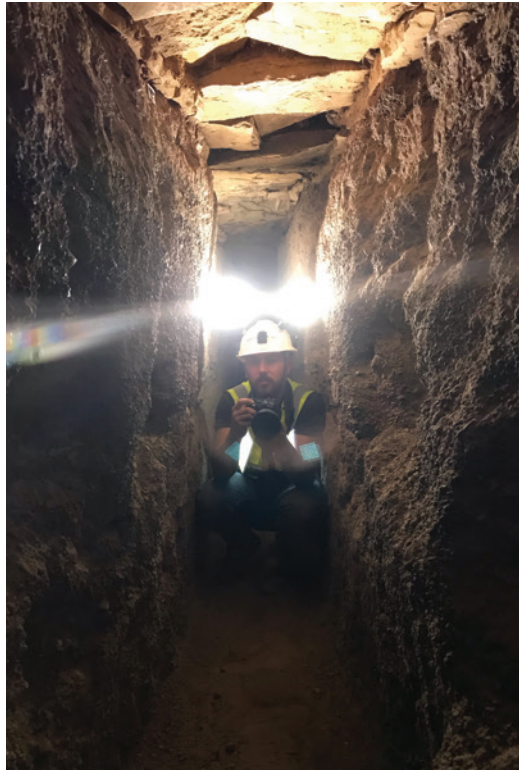
FIGURE 1.5. Aflaj of Al Ain: (a) shows a falaj channel as it comes to the surface near the oasis of Al Ain in the 1960s, while (b) shows the interior of a stone-lined underground tunnel revealed during recent archaeological work. Source: Peter Sheehan, DCT.

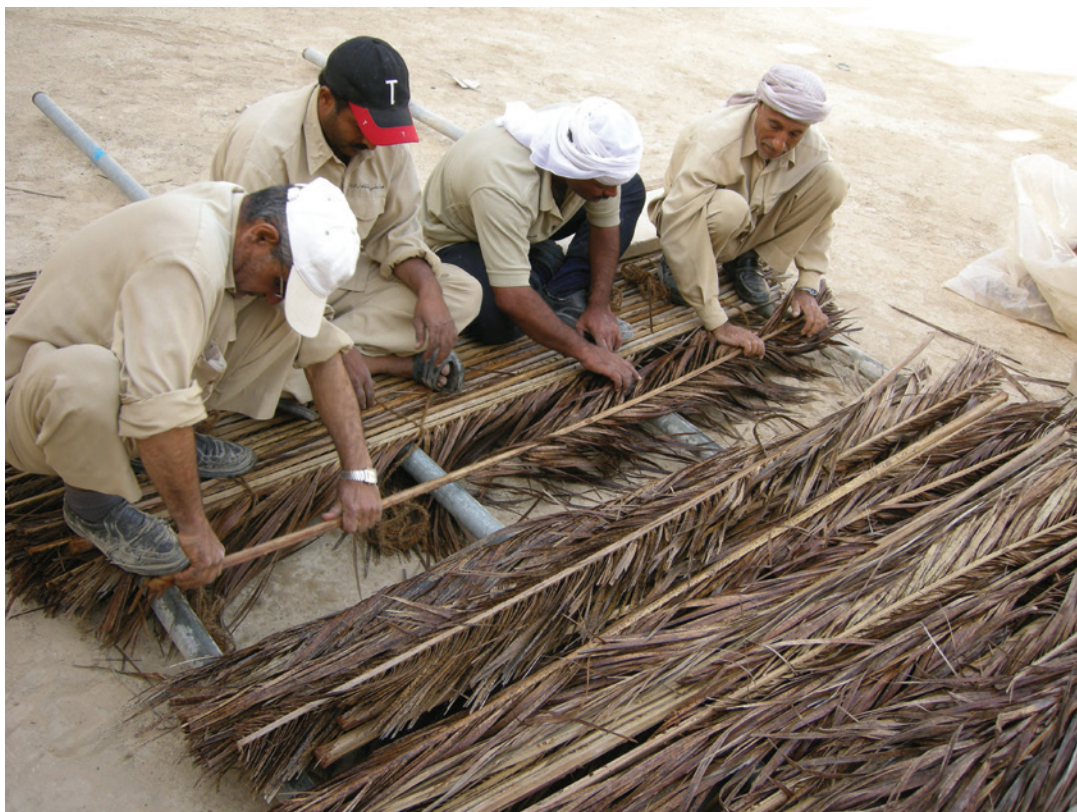
FIGURE 1.9. Earthen building production of palm-leaf mats for use in roofing. Source: Peter Sheehan, DCT.

All these buildings combine traditional materials and techniques that utilize the thermal qualities provided by thick earthen walls with limited small openings for light and air. Floors are made of beaten earth, and roofs of earth are laid over palm logs and palm mats (figure 1.9). Waterproof *sarooj* plaster is made by firing a mixture of clay and manure. In summer, cooling is achieved by opening windows at floor level to the night breezes and closing them during the day to let the hot air rise and escape through the small vents in the upper parts of the walls. Permanent dwellings are often supplemented by temporary structures using a range of palm-leaf (*arish*) typologies as well as the *bayt al-shaar*, a large portable tent made from animal hair.

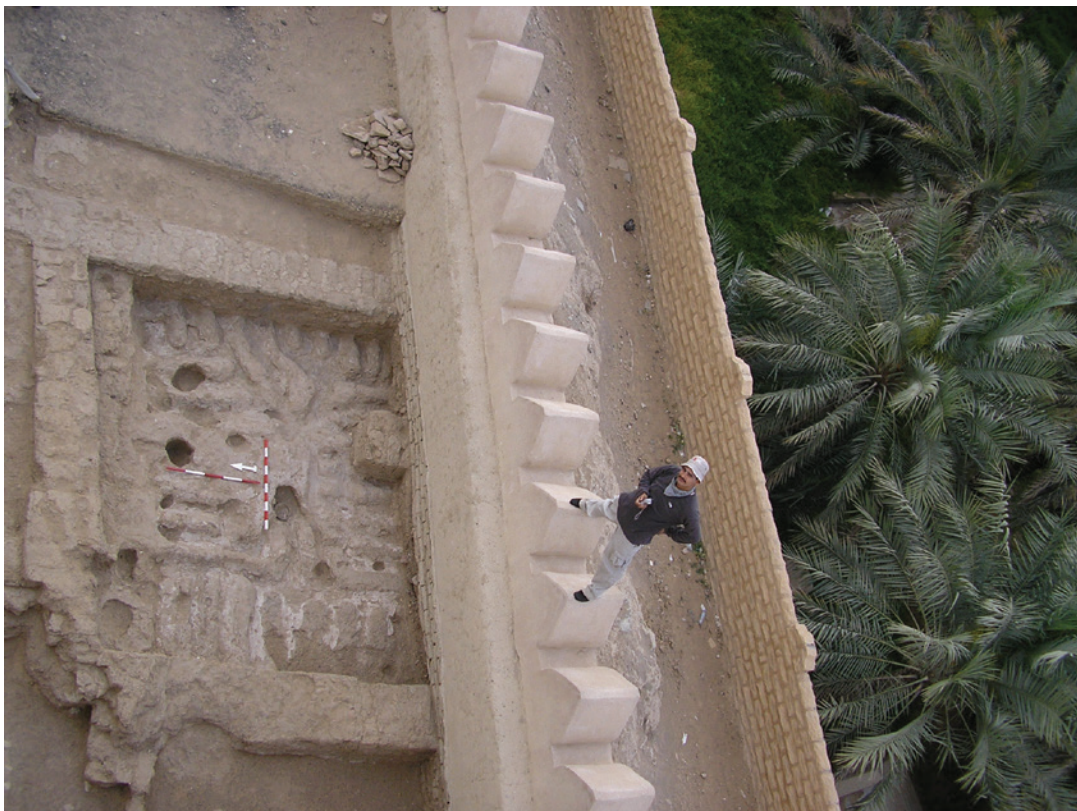
FIGURE 1.10. An example of a *madbasa* (date press) revealed during archaeological excavations at the Bayt bin Ati. Source: Tim Power, DCT.

vernacular construction in the form of the *madbasa*, or date press, known from the second millennium BCE onward. In a date press, layers of the fruit are stored in a sealed room, and their juices (*al-dibs*) are allowed to trickle through a network of plaster channels set into the floor and collected in earthen jars.

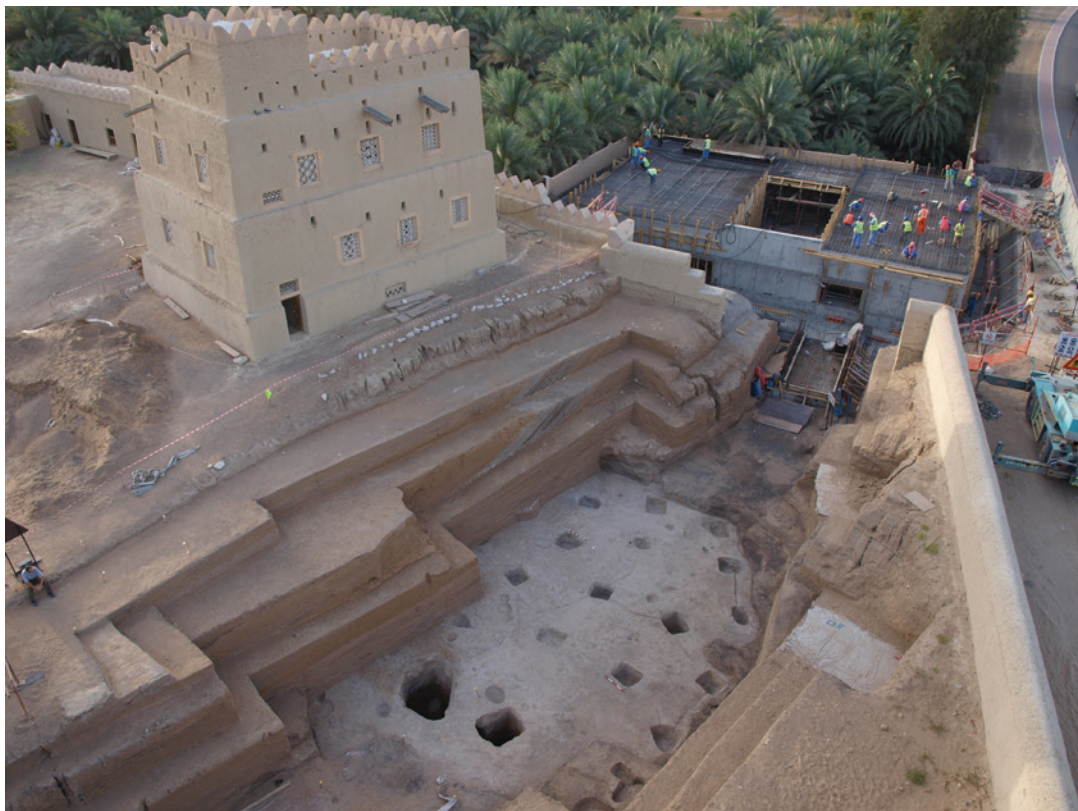
FIGURE 1.11. The basement of Bayt bin Ati following the excavation of a 5 m-deep archaeological sequence spanning more than three thousand years and encompassing the development of the cultural landscape from the Iron Age to the present day. Source: Tim Power, DCT.

Many of the alternating cycles of activity and abandonment within this cultural landscape are represented in the archaeological record revealed during the conversion of the Bayt bin Ati, a historic earthen building rebuilt in the 1980s and repurposed between 2009 and 2011 as Al Qattara Arts Center (Power and Sheehan 2011a). Works here revealed an archaeological sequence with 5 m of stratigraphy spanning more than three thousand years and encompassing the development of the cultural landscape from the Iron Age to the present day.

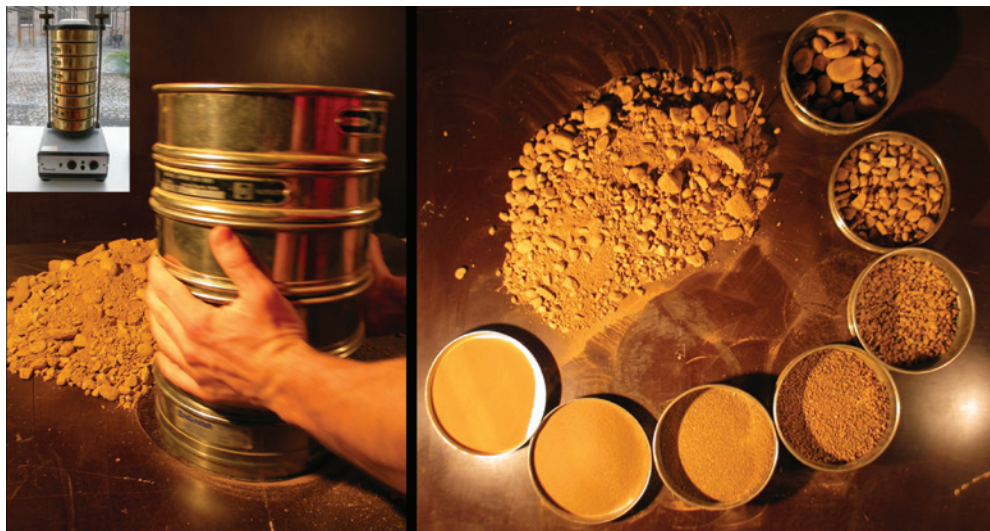
FIGURE 2.4. Sieve set used for the particle-size analysis of the coarse fraction of soils (gravel and sand). After sieving, the mass of material retained on each sieve is weighed, and the cumulative passing percentage is calculated. *Source:* Fontaine and Anger (2009). The inset shows a sieve set on a mechanical shaker. *Source:* Schroeder (2016).

In sieve analysis, the sample is first gently crushed (while trying to avoid breaking individual particles) and subsequently dispersed in a large volume of demineralized water or, preferably, in a solution of a dispersing agent such as sodium hexametaphosphate (NaHMP, 40g/l). This allows for complete separation of all particles, including the fine fraction that would otherwise remain agglomerated or attached to the surface of the coarse particles. The slurry is then filtered on a 60 μm size mesh sieve. The retained material is washed on the sieve, recovered, and dried in an oven. It is then ready for the sieving procedure, which is performed on a stack of sieves with calibrated mesh sizes, varying from larger to smaller from the top down (figure 2.4). The amount of sieved material should be

At the end of the sieving operation (about ten minutes of shaking), the mass of material retained on each sieve, MR_N , is recorded (N is the order of the sieve, starting from the top). The cumulative mass retained on a sieve of order N , CMR_N , is obtained by summing all the sieves of a lower order: $CMR_N = MR_1 + MR_2 + \dots + MR_N$. The cumulative passing percentage, CPP_N , is obtained using the following relation, where MS_d is the total mass of the sample that was sieved:

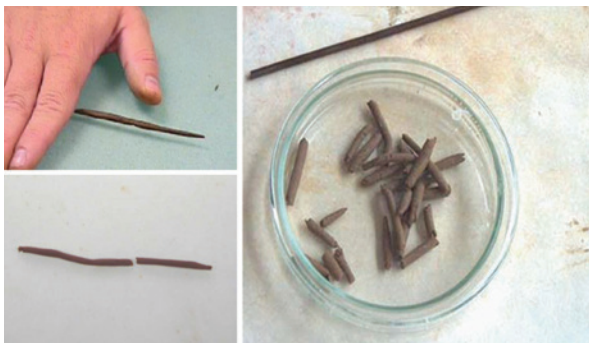
FIGURE 2.13. The PL is determined by remolding a small ball of moist plastic earth and manually rolling it out into a 3 mm thread (min. length: 5 cm). The PL is the moisture content at which the thread crumbles into 1 to 2 cm pieces before being completely rolled out (ASTM D4318). Source: Schroeder (2016).

thread until it reaches a point where it crumbles (figure 2.13).

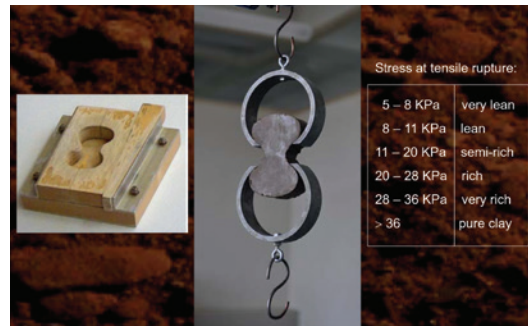
FIGURE 2.15. The wet cohesive strength test of soils and the mold used to shape the specimen. Source: Schroeder (2016) and ZRS, Christof Ziegert.

The wet cohesive strength test, also called the figure-eight shape test, is a measure of the tensile strength of soil samples in the standard consistency state, which is a plastic humid state. To prepare the sample, a ball is made with 200 g of soil kneaded on a nonabsorbing surface. The ball is then dropped from a height of 2 m.

It is dropped again until standard consistency is reached when the ball flattens by 50 mm. The sample is then pressed into a wooden mold in the shape of a figure eight. After demolding, it is placed between two metal claws, and an increasing load is suspended on the lower claw until the sample ruptures in its narrowest section. The load at rupture is converted into a value of tensile strength (unit:

pascal; i.e., newton/m²). Elements of the test are shown in figure 2.15.

However, this rationale has obvious limits. In a totally dry material, there is no more water to form capillary bridges, and cohesion collapses. On the other hand, when there is so much water that every void is flooded (saturated state), there is no air-water interface, and capillary bridges can no longer exist. Again, cohesion collapses. Yet in this state, the material may remain so highly viscous that it behaves as if there was still some cohesion. This is the wet cohesive strength measured using the figure-eight test (see figure 2.15).

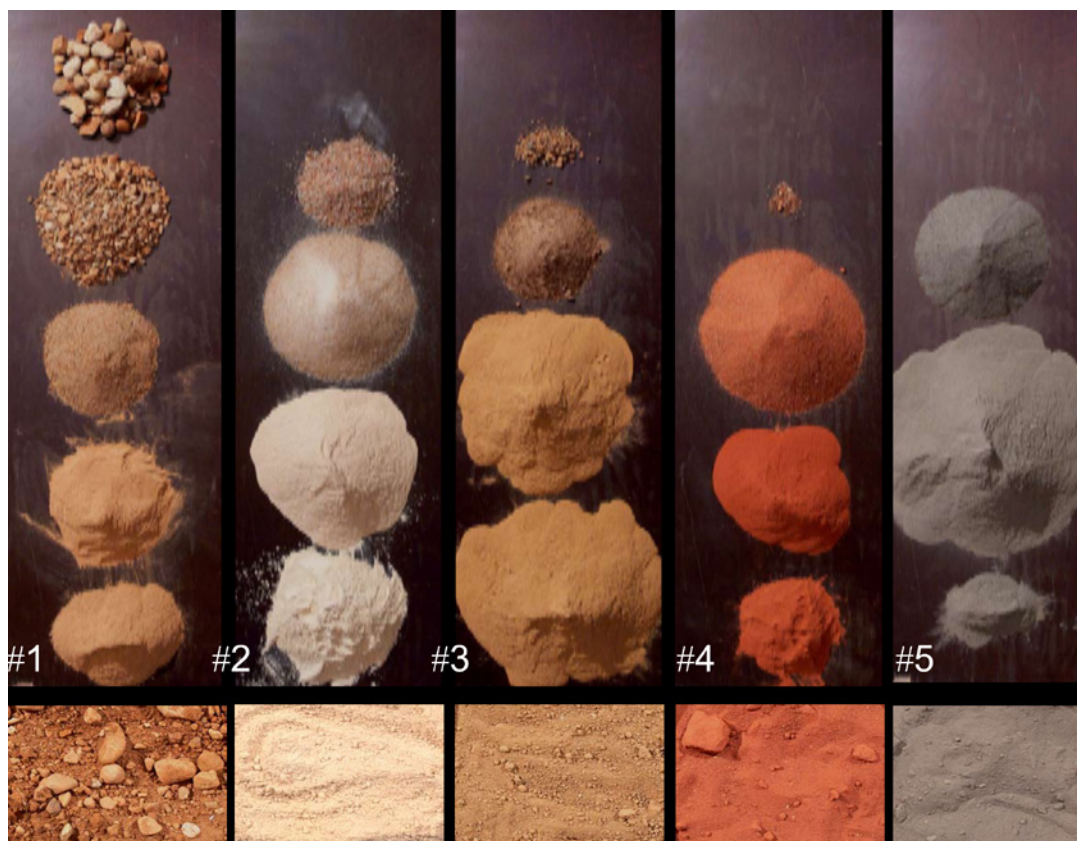
FIGURE 2.23. Five soil materials considered for earthen construction. Source: Laetitia Fontaine and Romain Anger. Soil #1 is a well-balanced mixture of stones, gravel, sand, silt, and clay, all present in roughly equal amounts. After compaction, it becomes a real, natural, very hard concrete containing enough clay to be highly cohesive and enough coarse grains to be rigid and avoid cracking. This earth is good for rammed-earth construction. Soil #2 contains many fewer stones and gravel. It is easier to work and to model by hand. Yet the amount of sand is large enough to avoid cracking when the material is used in the plastic state. This earth is ideal for making molded bricks. It is good for adobe construction. Soil #3 is very fine earth. It contains almost no stones and gravel, and the sand fraction is very small. It is very sticky when wet, but it cracks when it dries. Mixed with straw and/or sand to avoid cracking, this type of earth may be used as a filling material in a wooden frame. It is good for cob construction. Soil #4 contains neither stone nor gravel. It contains sand, silt, and clay in well-balanced amounts, but the clay fraction is smaller than in adobe earth, whereas the sand fraction is larger. This prevents cracking even when the material is mixed with a lot of water. This is an ideal material for coatings and mortars implemented in the viscous state. Soil #5 is very fine. It contains no stone, no gravel, no sand, and very little clay. The clay content is too small to impart some cohesion to the mixture. Using this material would lead to strength problems. Do not use it as it is.

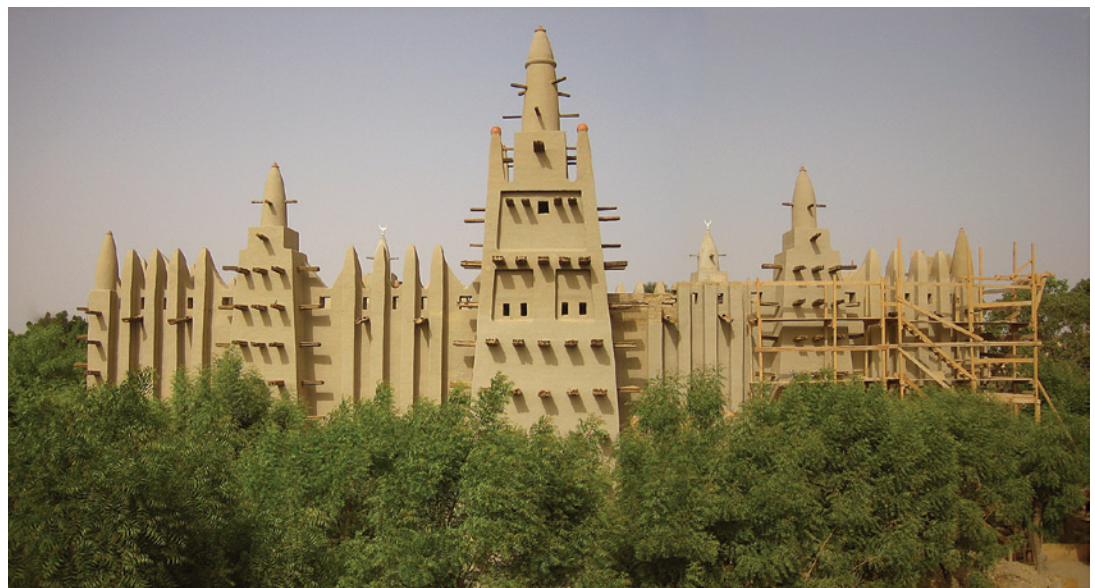
FIGURE 3.4. The mosque of Mopti in Mali, built entirely of adobe, restored in 2006. Source: Wilfredo Carazas Aedo.

Adobe is one of the easiest building materials to manufacture, requiring only a simple mold and proper clay preparation. Multiple adobe blocks are stacked to form physical structures (walls) that are joined together to construct beautiful buildings, from simple dwellings to grand palaces and mosques. Adobe is one of the easiest building materials to manufacture, requiring only a simple mold and proper preparation of the clay. Multiple adobe blocks are stacked to form physical structures (walls) that are joined together to construct beautiful buildings, from simple dwellings to large palaces and mosques (figure 3.4).

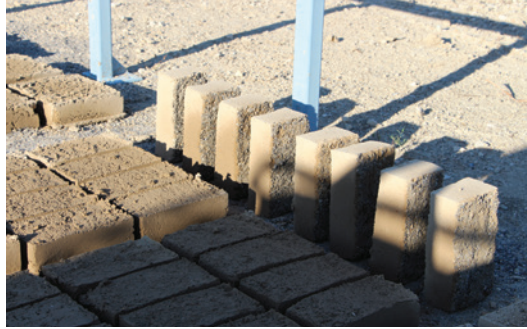
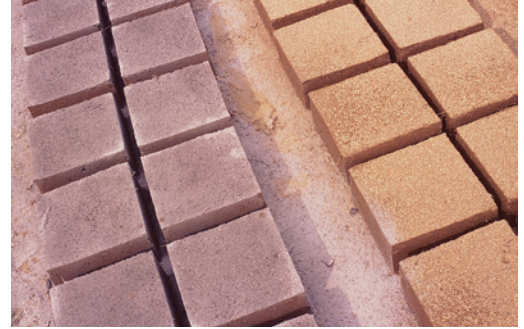
FIGURE 3.5. (a) Coniform adobe blocks and (b) their placement in a wall. This was a common building practice in Peru's Sechin culture. *Source:* Wilfredo Carazas Aedo.

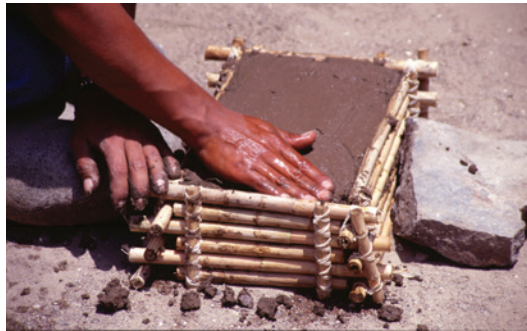
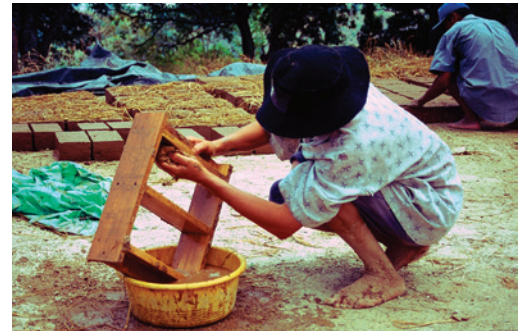
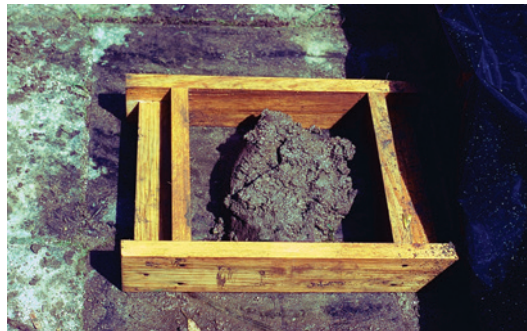
FIGURE 3.6. (a) Rectangular adobe blocks and (b) square adobe blocks. Source: Wilfredo Carazas Aedo.

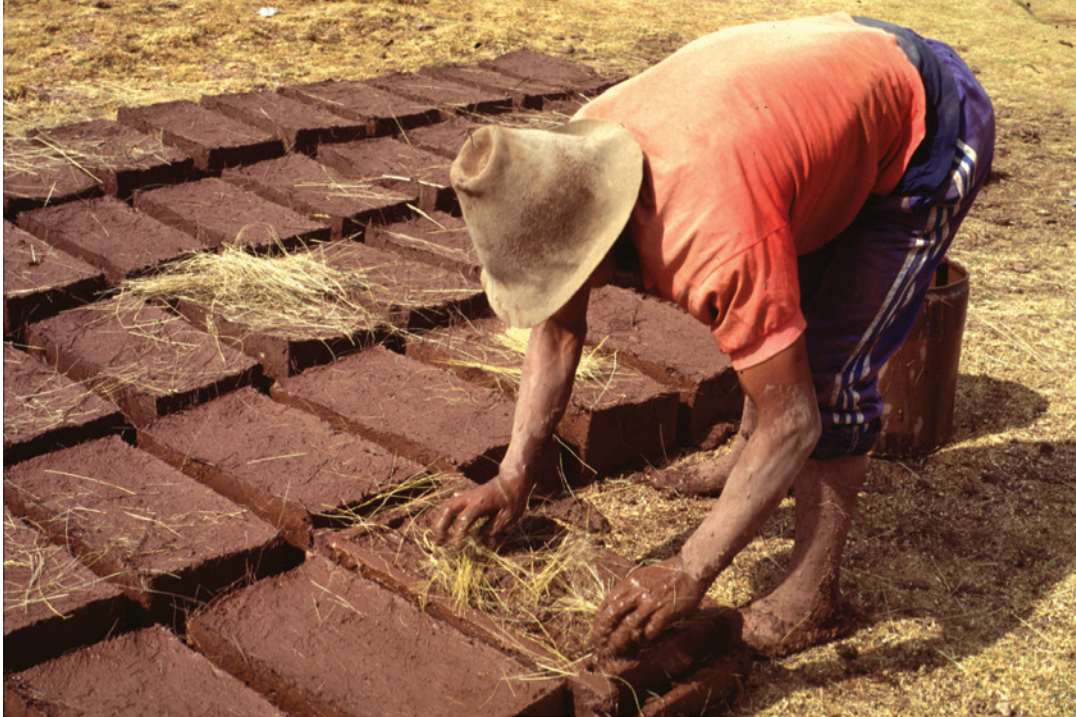
FIGURE 3.8. Individual artisan production of adobe.
Source: Wilfredo Carazas Aedo.

Adobe production methods vary according to the geological characteristics and the climatic conditions of a given region. One of the easiest forms of production involves the use of a simple mold (single-unit production) in which the entire extraction, preparation, and molding process is carried out using a minimum of tools and equipment (figure 3.8).

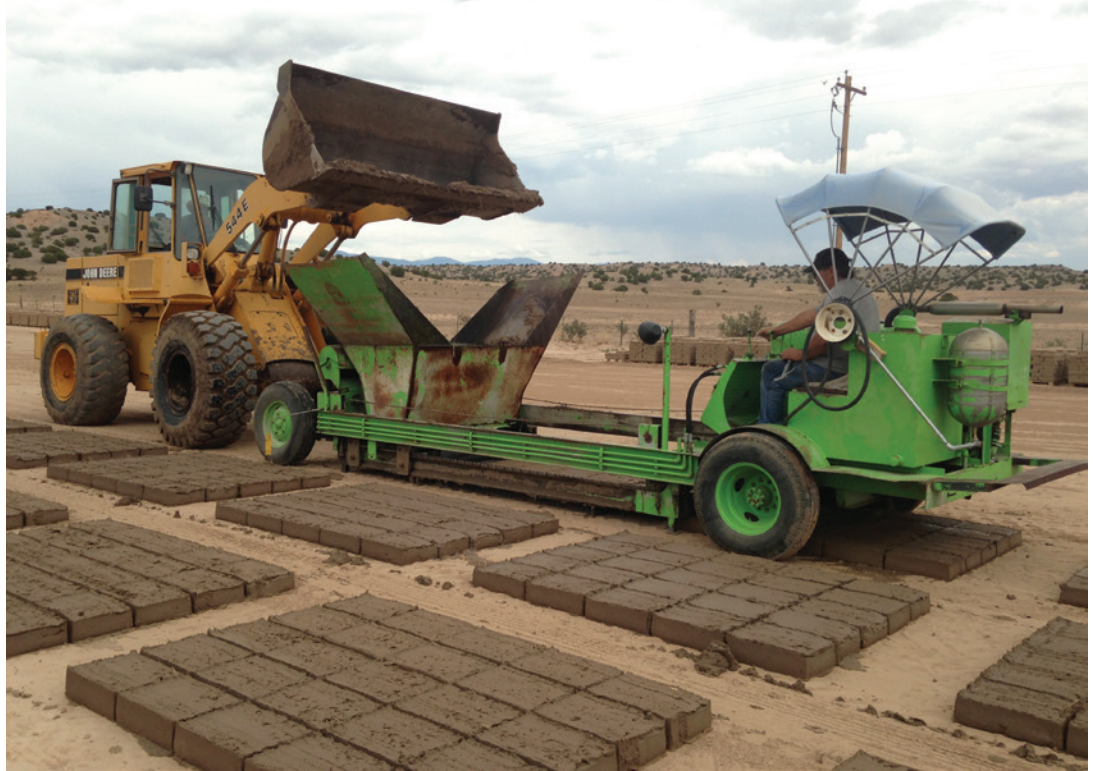
FIGURE 3.9. Industrial production of adobe. Source: Wilfredo Carazas Aedo.

Other forms of adobe production rely on the use of special tools and machinery, which allows for large-scale production of thousands of adobe blocks in a single day (figure 3.9). For example, in the US city of Albuquerque, New Mexico, there are industrial adobe production companies that serve regional demand.

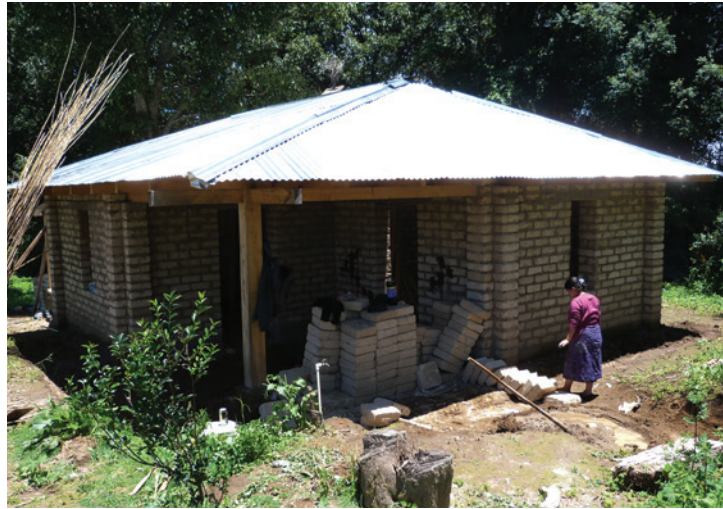
FIGURE 3.11. (a) Adobe dwelling in Guatemala built using earthquake-resistant buttressing construction method. Source: Wilfredo Carazas Aedo. (b) Diagram of the buttressing adobe construction method using vertical reinforcement with bamboo. Source: Wilfredo Carazas Aedo.

In recent years, after extensive research and experiments conducted by universities, research centers, and other institutions around the world, new adobe building methods have been developed that enable structures to better withstand earthquakes. These methods are known as seismic-resistant adobe construction techniques and involve reinforced adobe masonry, which is adobe masonry that has been strengthened and made more compatible with the earth, giving it increased tensile strength (figure 3.11).

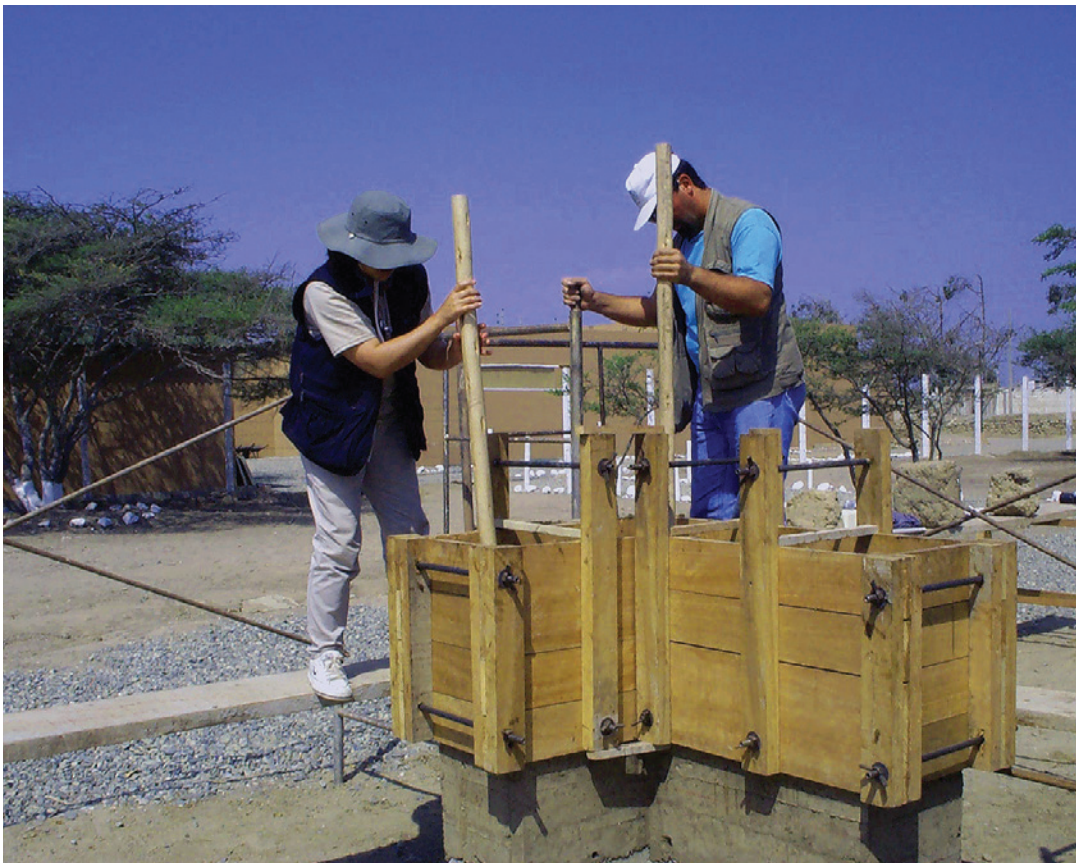
FIGURE 3.15. Traditional formworks use a combination of wood and attachment elements including metal anchors. Source: Wilfredo Carazas Aedo.

Numerous kinds of formworks, from the simplest and most traditional to highly sophisticated, may be selected depending on the context and the capacities of the building site. Traditional formworks and tools are generally manufactured in an artisanal manner and employ a combination of wood and attachments such as ropes, tensioners, and certain metal components (figure 3.15). The ramming tool is typically wood but may be metal in some cases.

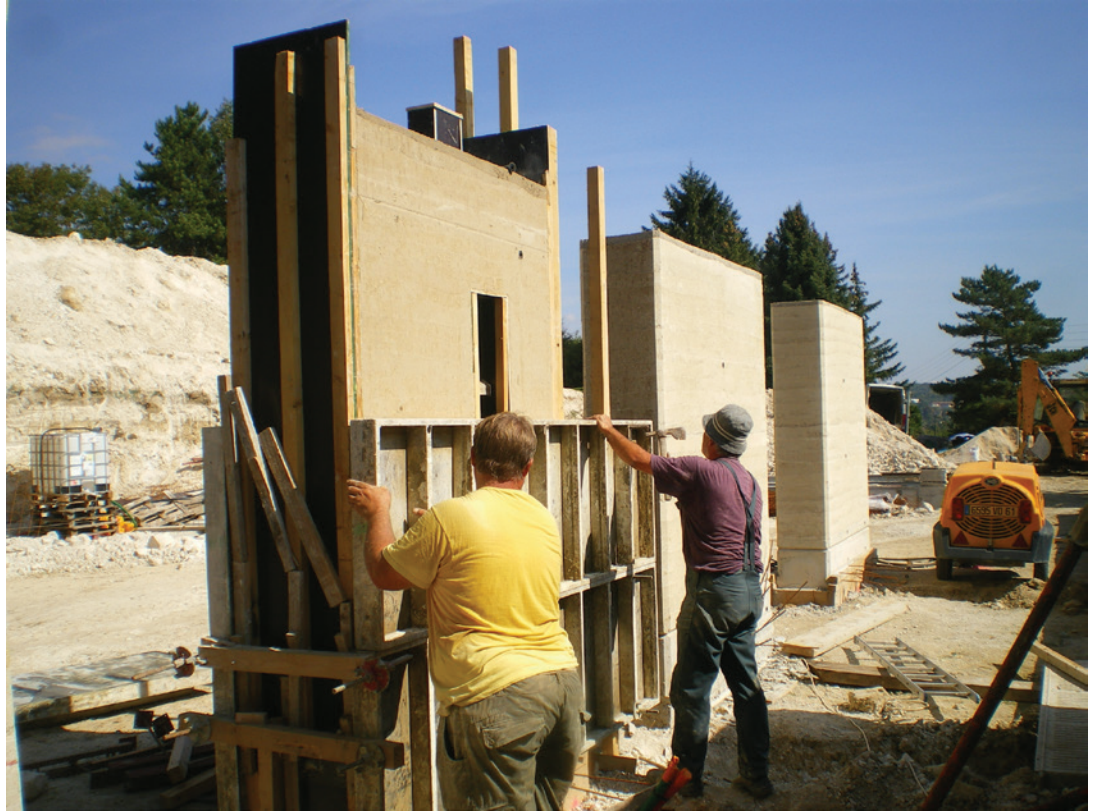
FIGURE 3.16. Many form-works for rammed-earth construction are repurposed for use in industrial construction. Source: Wilfredo Carazas Aedo

Today, there are metal and wooden formworks manufactured specifically for rammed-earth building, though many of these are repurposed formworks designed for use with cement and aggregates in conventional industrial construction (figure 3.16). Similarly, mechanized tools and implements, such as pneumatic compactors, mixers, conveyors, and lifters, are currently used in contemporary earthen building as well.

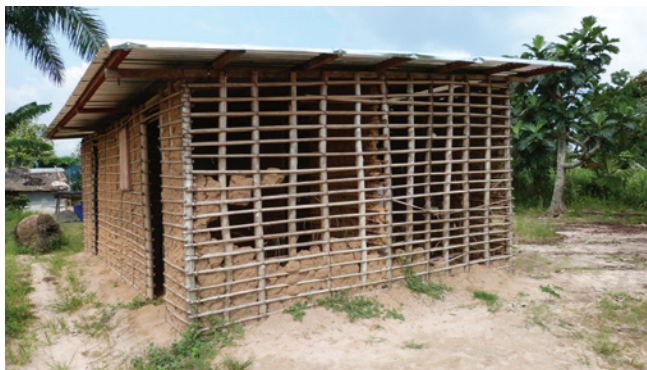
FIGURE 3.19. (a) Rural dwelling, Owando, Republic of the Congo, constructed using the framework method. (b) Drawing of the framework method. Source: Wilfredo Carazas Aedo.

Several methods are used in wattle and daub construction. The relatively simple and economic framework method is used throughout the world and is popular in Latin America, Africa, and other regions, especially in rural areas (figure 3.19a). It uses rough-cut timbers (called *horcones* in Latin America) or thick, whole bamboo for the main corners and main support beams, which are reinforced horizontally with split bamboo or cane reeds (figure 3.19b). The infill is earth and straw, with stones sometimes placed between the horizontal supports.

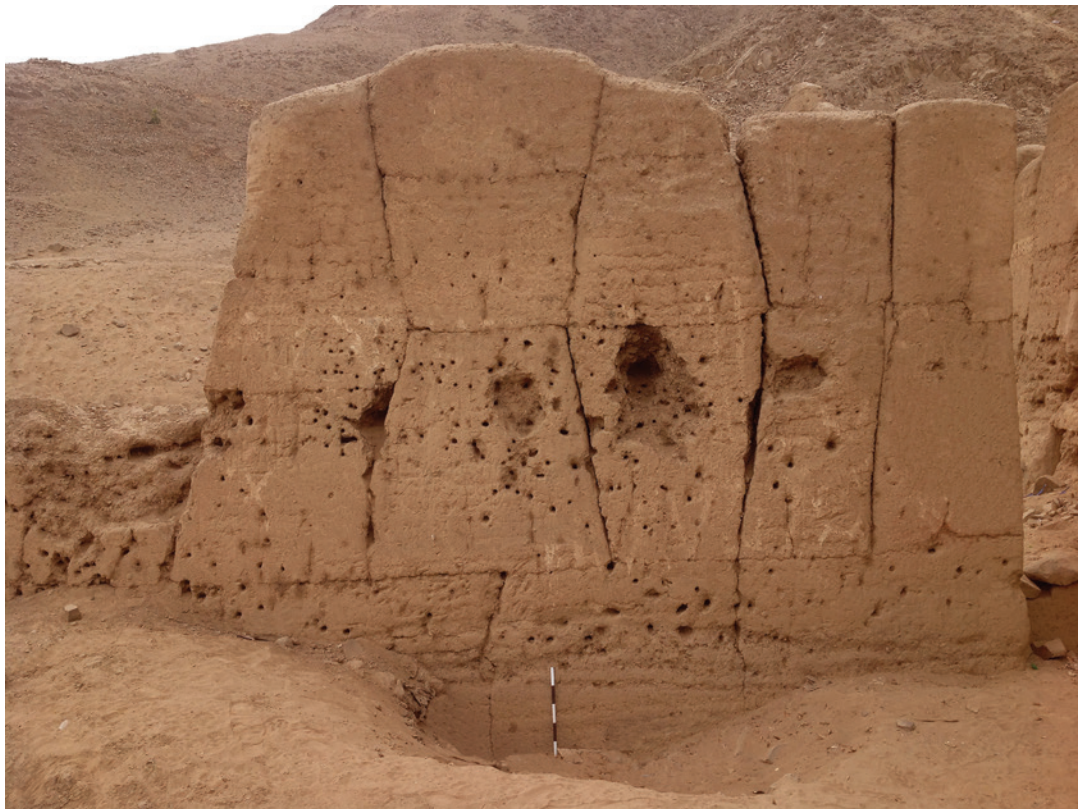
FIGURE 3.25. Wall of warehouses of the archaeological site Cerro Respiro, Callao, Lima, Peru. Source: Henri E. Torres.

In Latin America, adobe construction was used in pre-Columbian times, as evidenced by archaeological ruins on the Peruvian coast, such as the archaeological complex of Cerro Respiro in Callao, Peru (Torres 2021). The structures of these archaeological complexes are often confused with buildings constructed using the rammed earth technique, but the finished walls have characteristics more similar to those of cob construction (figure 3.25).

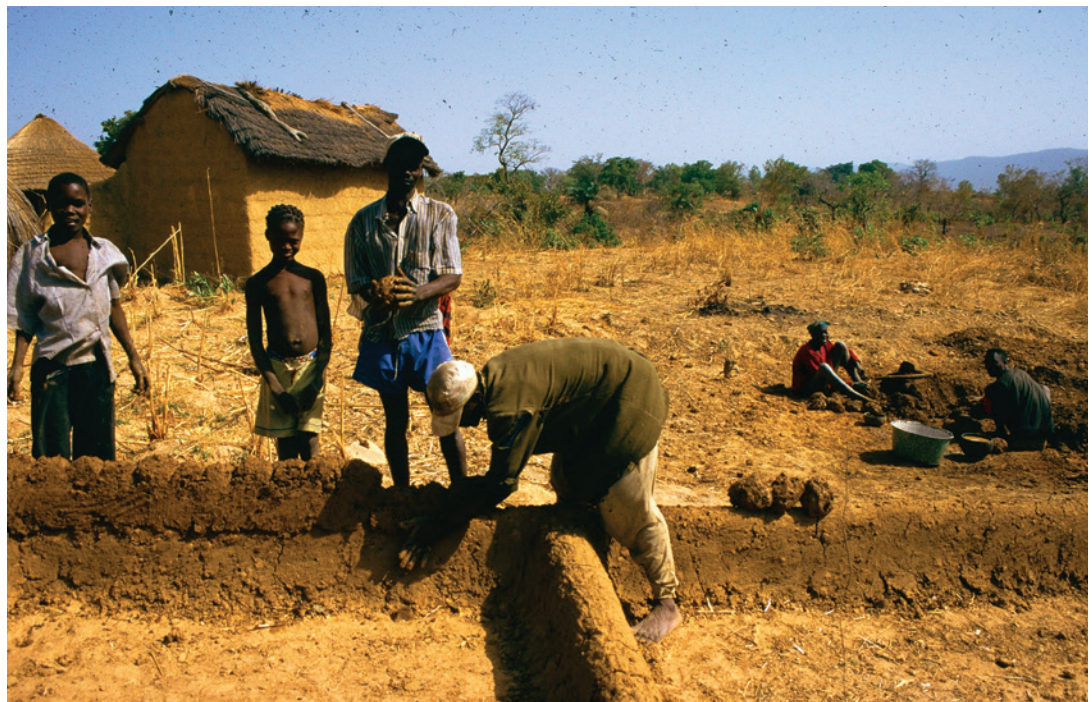
FIGURE 3.26. Traditional cob construction, West Africa.
Source: Wilfredo Carazas Aedo.

The cob wall construction process is unique in that it is done in stages, with certain height restrictions: layers average 50 cm in height, which gives the wall a degree of stability in its plastic state and allows it to dry quickly in order to receive the next layer (figures 3.26 and 3.27). It also enables the builder to stand on top of the wall while working on it.

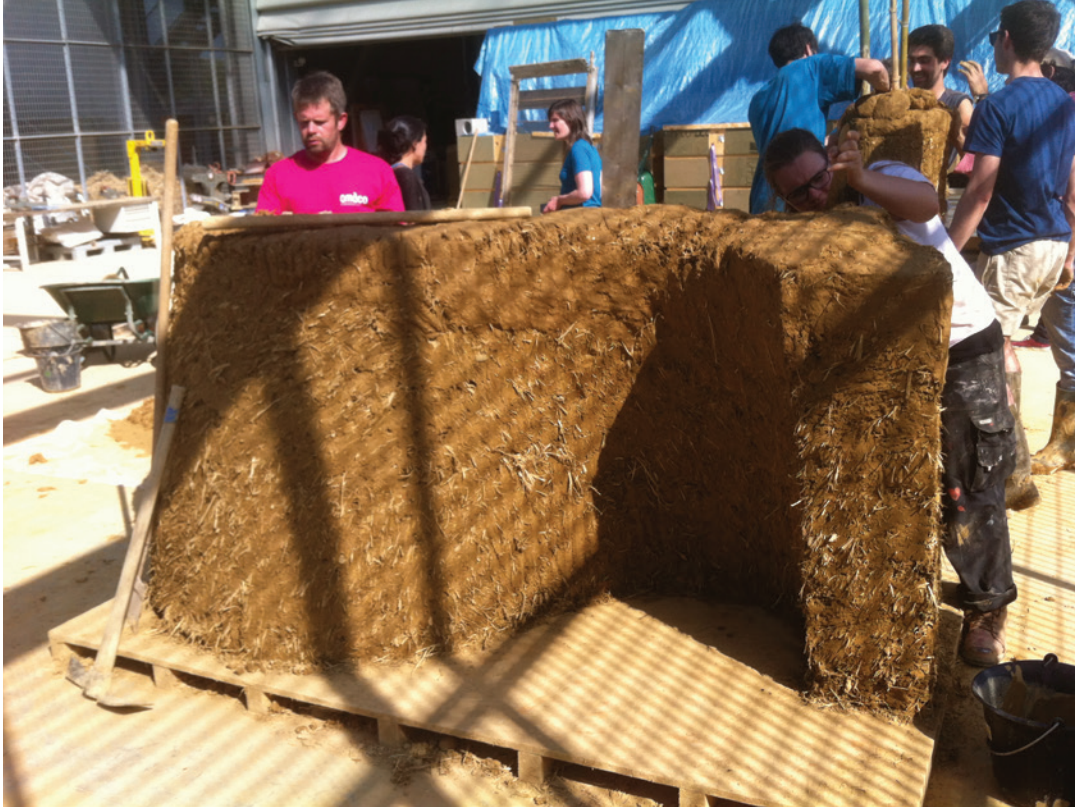
FIGURE 3.27. Traditional cob wall, Europe. Source: Wilfredo Carazas Aedo.

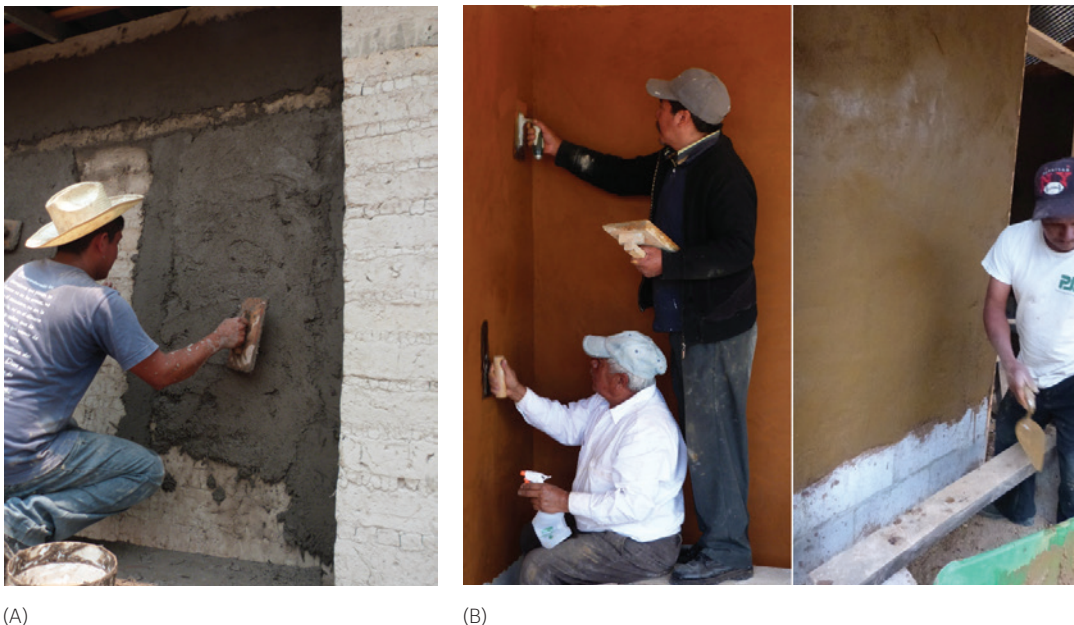
FIGURE 3.33. (a) A technician creates an initial base layer of earthen plaster on a wall. (b) Technicians apply the second, refining layer of plaster to a wall. Source: Wilfredo Carazas Aedo.

The first serves as the base and involves creating a smooth, uniform surface with a thickness of 0.5 to 2 cm (figure 3.33a). This layer is generally covered by a thinner second, refining layer that varies between 0.5 and 2 mm thick.

For the second layer, the surface quality can vary from a simple monochromatic layer to one that uses elaborate colors and textures; generally, the thickness is very thin, from 1 to 3 mm (figure 3.33b).

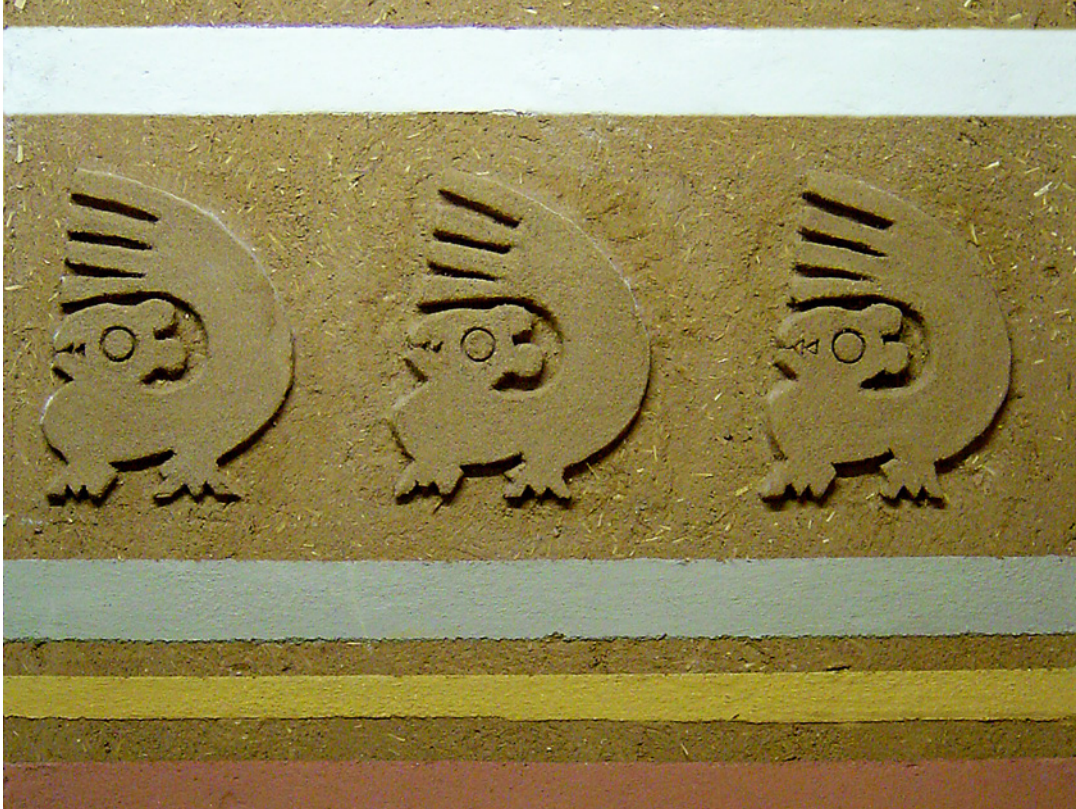
FIGURE 3.37. Carved reliefs (thickness 10 mm) in a wall surface. Grenoble, France. Source: Wilfredo Carazas Aedo.

- **Reliefs.** Reliefs are designs or figures that protrude from the wall surface. They are made by first increasing the thickness of the earthen plaster to an average of 2 cm, then carving or cutting away the mortar in the shape of the desired figure (figure 3.37).

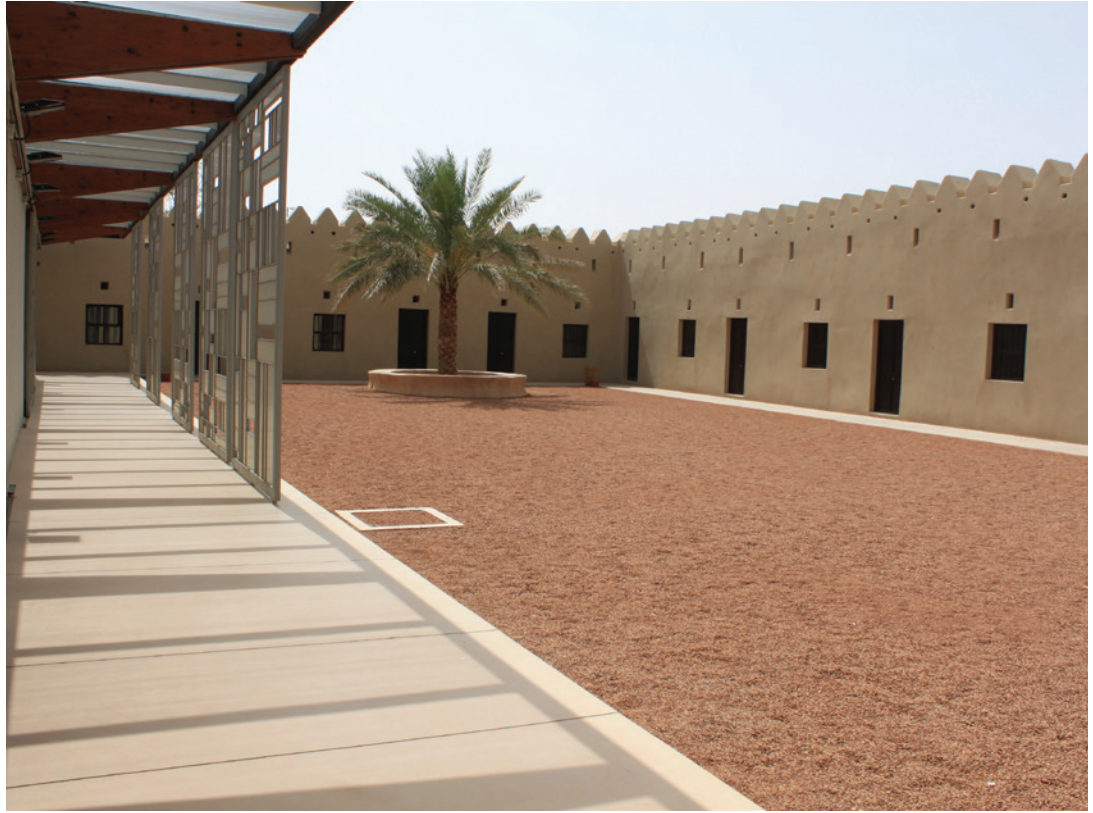
FIGURE 4.4. Photo of the courtyard of Al Qattara Arts Center, Al Ain. The new building at left houses classrooms; the rooms in the external fortification wall in the background and to the right have been repurposed as offices. *Source:* DCT Abu Dhabi.

In March 2011, a section of the fort was rehabilitated and repurposed as Al Qattara Arts Center. This project combined new and traditional construction materials and techniques. A new building was constructed at the corner of the fort to hold classrooms, while rooms in the extant external fortification wall were turned into offices (figure 4.4). Insulation and service networks were installed under a new sacrificial layer of mud, either below ground or below the surface of the walls. The newly added building was intentionally designed to be modern, in contrast with the traditional building. During the project, archaeological remains from the Bronze Age were discovered while workers were digging the foundations for the machine room (figure 4.5).

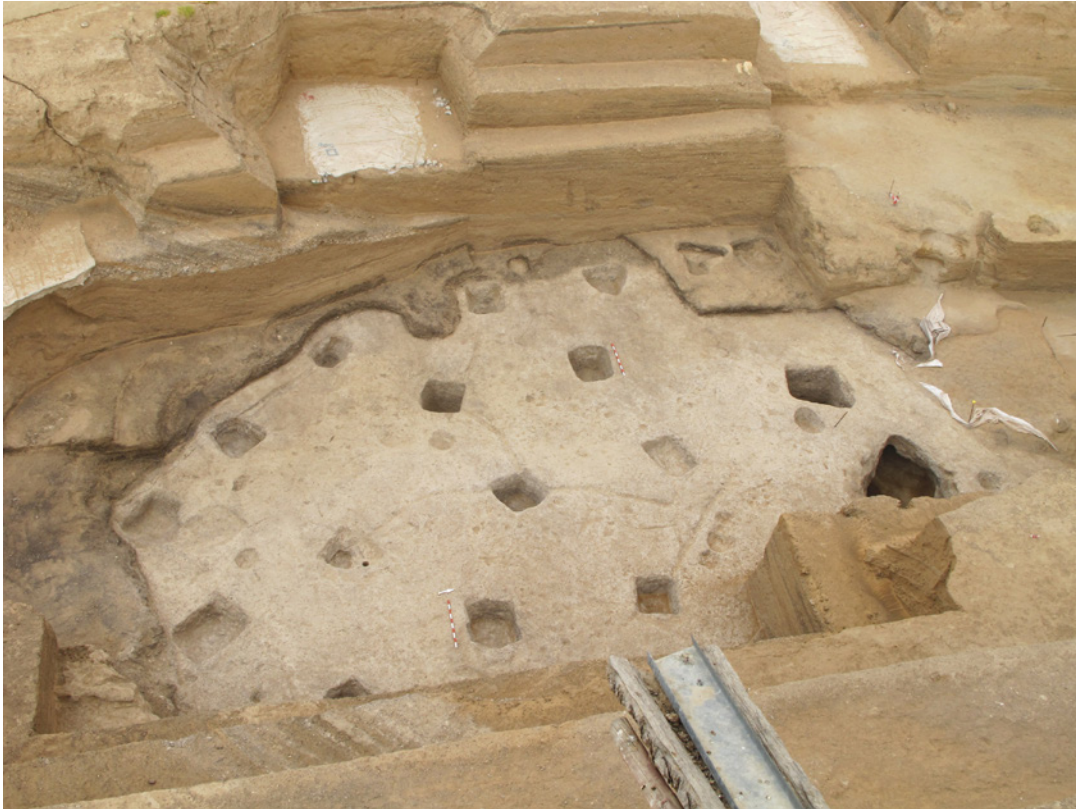
FIGURE 4.5. Photo depicting the archaeological features from the Bronze Age discovered during the dig for the foundations of the new structure at Al Qattara Arts Center, Al Ain. Source: DCT Abu Dhabi.

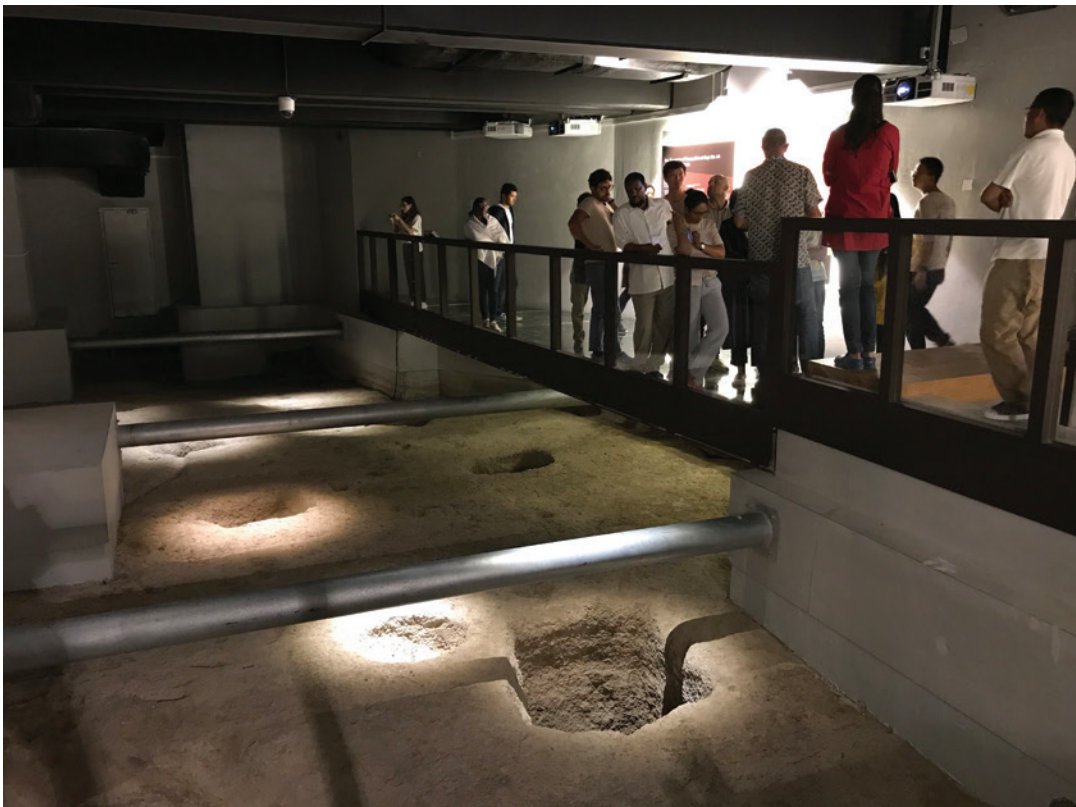
FIGURE 4.6. Photo of a segment of the uncovered Bronze Age archaeological features, displayed in the basement of Al Qattara Arts Center, Al Ain. Source: DCT Abu Dhabi.

The rare nature of this discovery, which clearly linked the Islamic-period fort to the Bronze Age, led to modifications in the new building's design. It was decided to incorporate and display the remains in the basement of the arts center (figure 4.6). While the overall approach to the conservation of the building was based on its political and social values, the archaeological elements that were uncovered during the works are being conserved, presented, and managed according to their scientific and educational values (Chabbi et al. 2012).
