International Course on the Conservation of Earthen Architecture

ACCOMPANYING ESSAYS

Edited by
Benjamin Marcus
Alessandra Sprega
Claudia Cancino
Gayathri Hegde

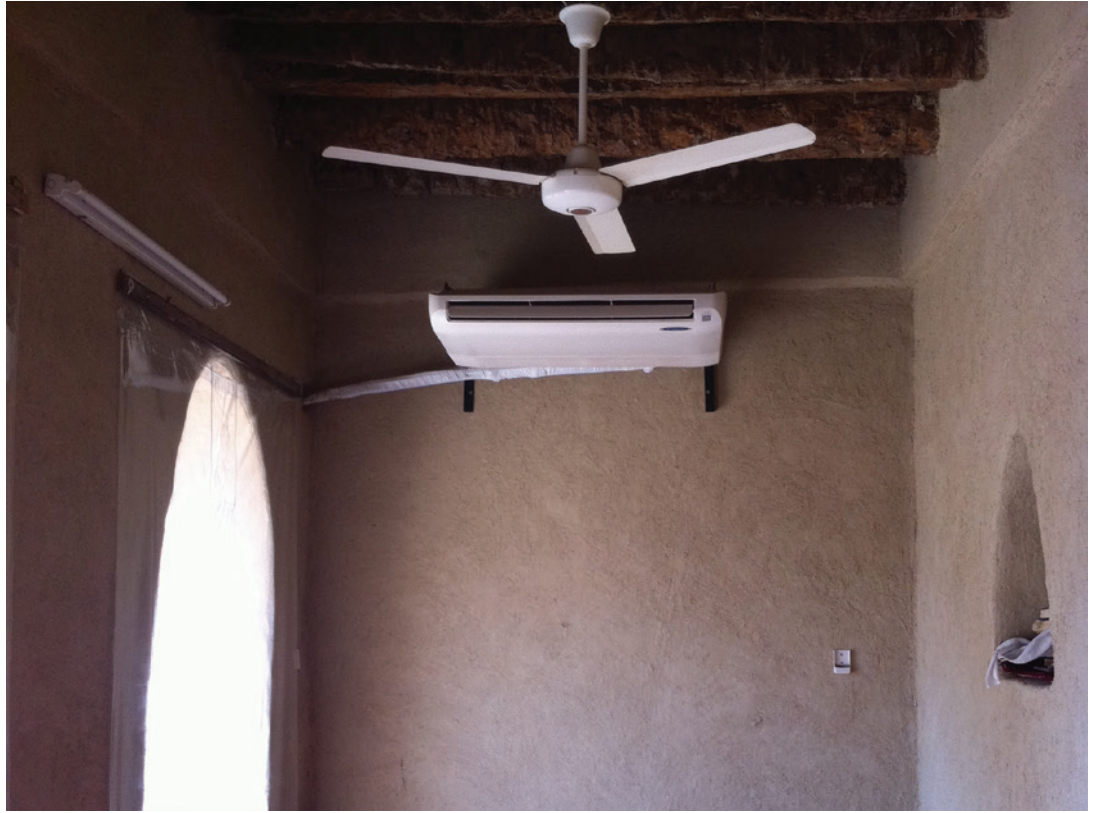
FIGURE 4.7. Photo of the interior of Khumaysani Mosque, Al Ain, showing air-conditioning and ceiling fan upgrades necessary to ensure its status as a functioning mosque. Source: DCT Abu Dhabi.

Khumaysani Mosque is another earthen vernacular building within Al Ain that represents a high social value. Also of high religious and spiritual value, it is, most importantly, living heritage. Its original function remains as relevant today as it was at the time of its construction and during its history. Khumaysani is one of the few surviving nineteenth-century mosques in Al Ain. Located to the north of Al Qattara Oasis, it was reconstructed in the 1990s and continues to be used for the five daily prayers. It is a typical example of Al Ain mosques built of mud brick with a palm-beam roof. An arcaded patio leads to the prayer room. The building is enclosed by a low boundary wall with a small gate. The approach to conservation is to ensure the mosque's sustained use while monitoring and maintaining the historic fabric. Accordingly, service installations were upgraded, including the air-conditioning unit, water tank, ablution facilities, and other practical utilities (figure 4.7). Although these additions impact the aesthetics of the building and the material fabric, they were installed in a minimally invasive way and were necessary to ensure that the mosque remains in use. The mosque is being conserved and managed according to its social, religious, and functional values.

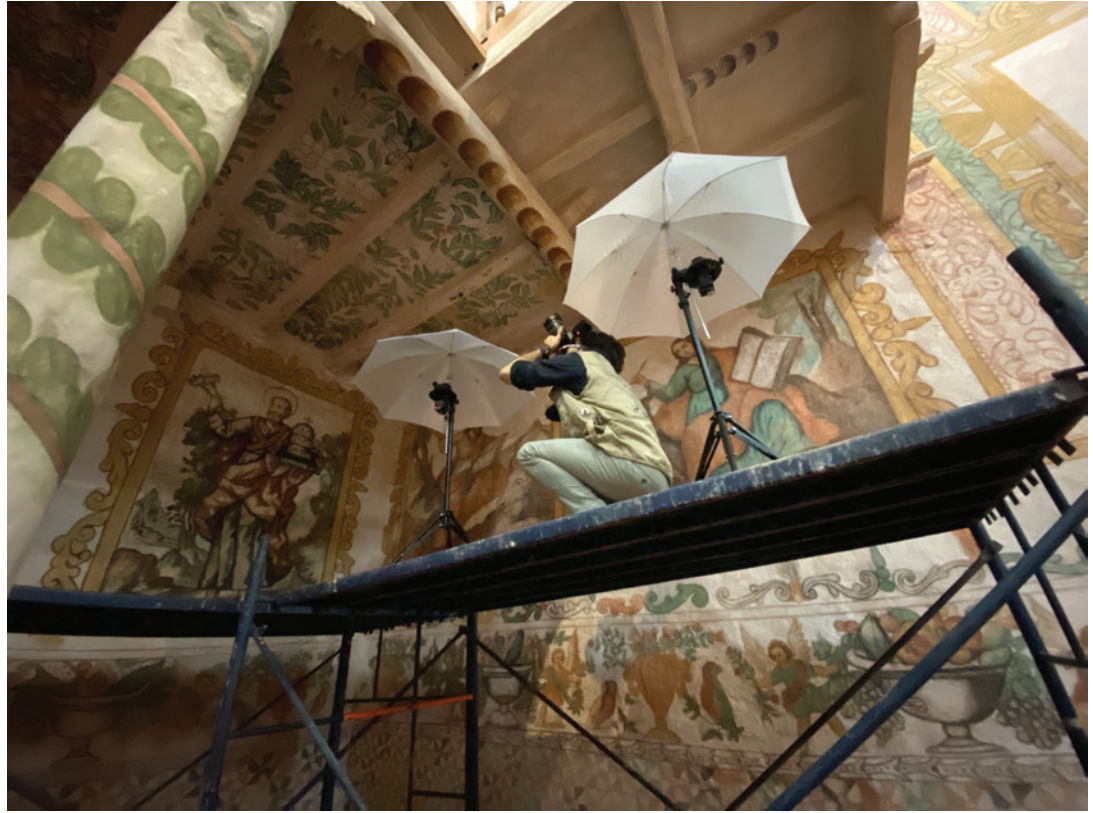
FIGURE 5.1. A technician photographs historic decorated surfaces of the interior of the church of Santiago Apóstol de Kuñotambo, Cusco, Peru. Source: Mario Santana Quintero.

The growth of the field of conservation has yielded vast quantities of heritage information using various techniques, from long-established practices such as photography and sketching by hand to emerging technologies, including building information modeling (BIM), machine learning, and digital fabrication (figure 5.1). Documentation plays a vital role in defining a heritage place's significance, integrity, and spatial extent, as well as identifying potential threats, and is crucial to understanding, protecting, and managing the place. Heritage professionals must understand the various recording techniques that are available to them, along with their applications and expected products.

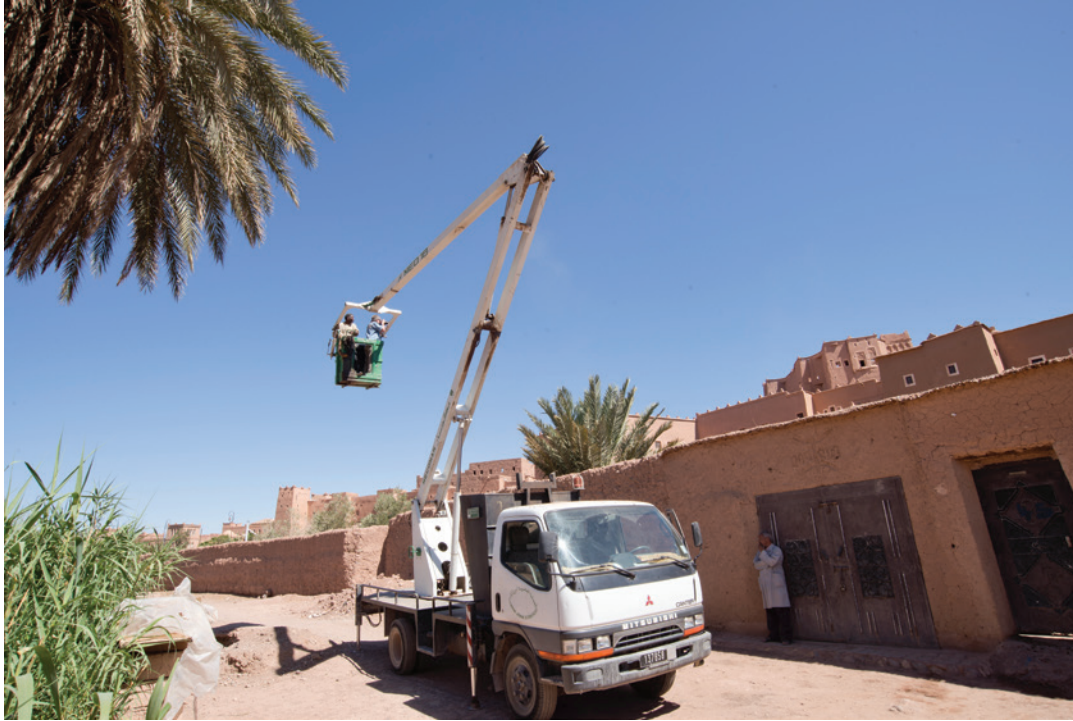
FIGURE 5.3. Technicians use an engineer's streetlight repair lift to photograph the site context for photogrammetric recording at the Kasbah of Taourirt, Ouarzazate, Morocco. *Source:* Mario Santana Quintero.

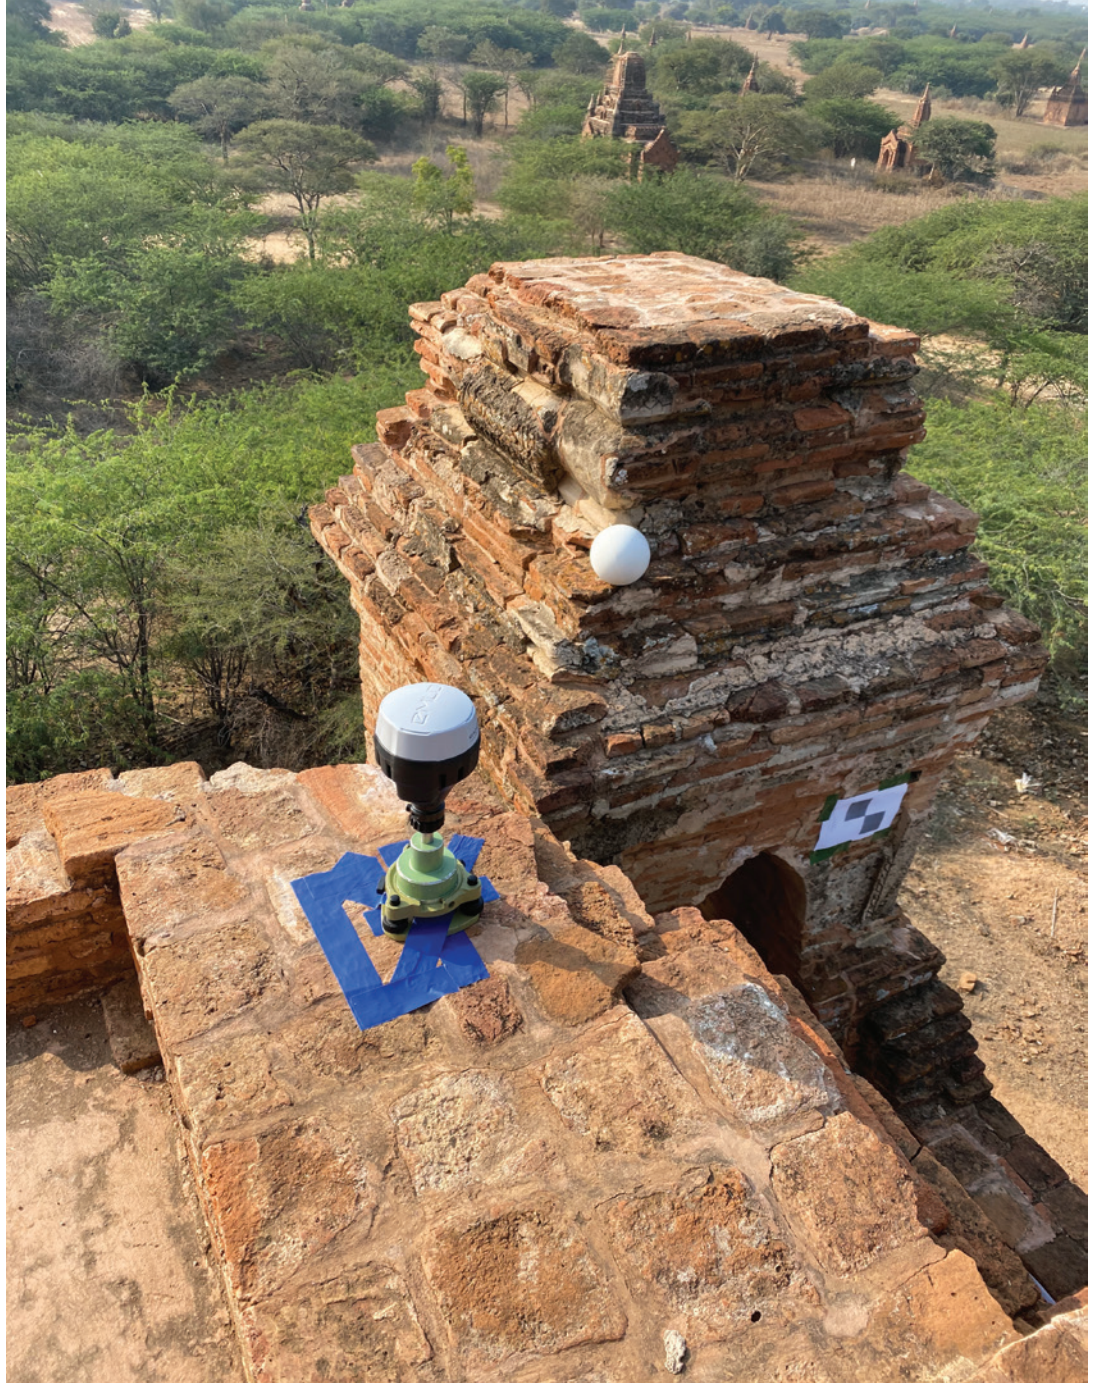
FIGURE 5.4. In site documentation, a GNSS device is used to record coordinates to georeference a survey network at the Tha-mu-ti-hpaya temple (Bagan World Heritage Site, Myanmar). Source: Mario Santana Quintero.

The role of Global Navigation Satellite Systems (GNSS) is to provide accurate geolocation of heritage places for establishing the basis and control system as mentioned in section 5.2 (figure 5.4). These devices operate by capturing signals from different segments: satellites, users, corrections from antennas, and control stations (Barazzetti 2020). Signals from space are emitted by different satellites in GNSS constellations (e.g., GPS, QZSS, BEIDOU, GALILEO, and GLONASS) and are captured by the user segment using antennas. The control segment involves one master control station and five monitoring stations. GNSS technology is used to produce maps at different scales and accuracy to record landscapes especially (Historic England 2015, 11–13)

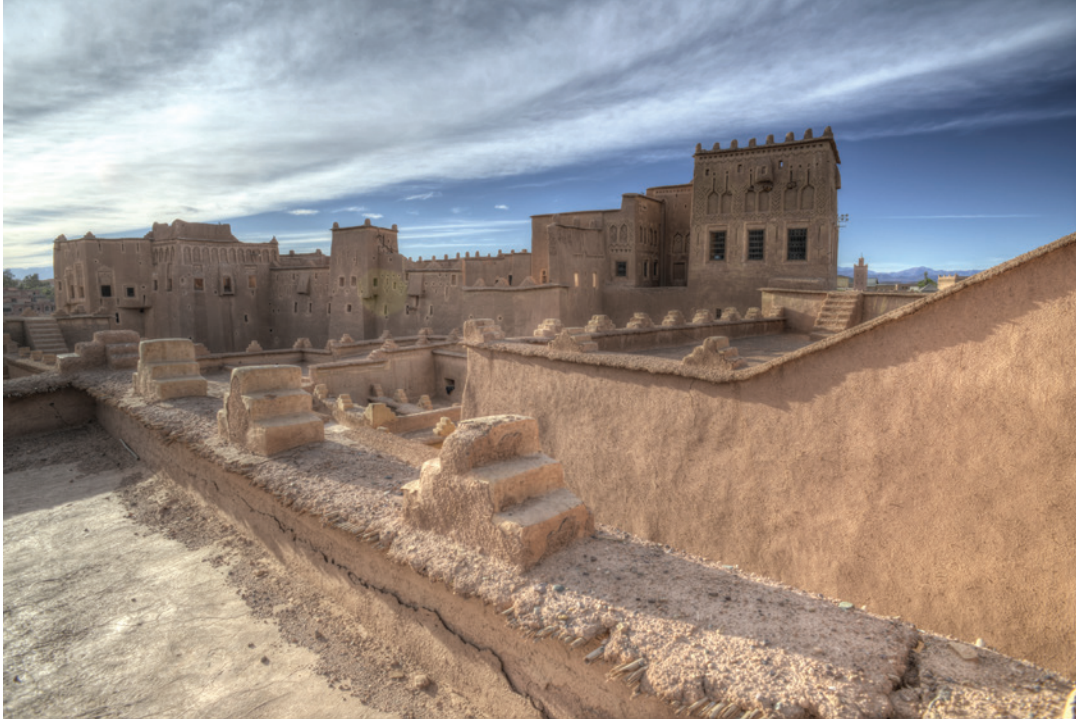
FIGURE 5.5. Example of context photography capturing geometry, texture, shape, and color at the Kasbah of Taourirt, Morocco. Source: Mario Santana Quintero.

A photographic portfolio for a heritage place is used to document the current conditions of various contexts throughout the site. It is a quick, reliable way to capture the geometry, texture, shape, and color of subject matter with various levels of detail (figure 5.5). Photography is an efficient method for visually recording various character-defining elements that compose a site and providing clarity for other types of records, such as field

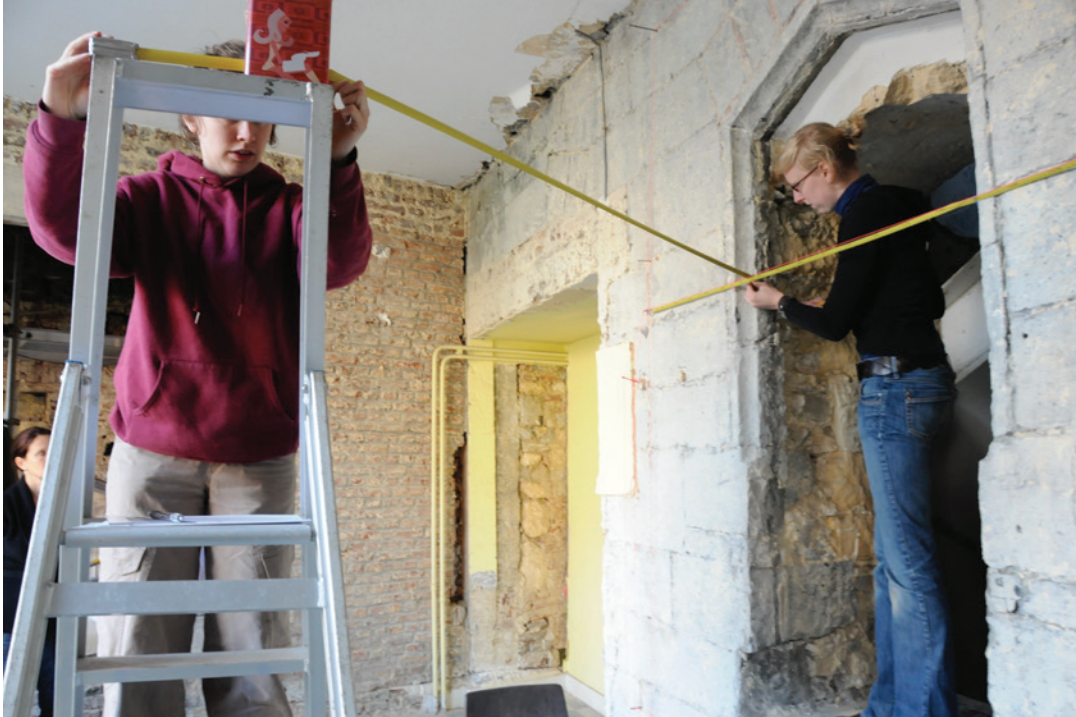
FIGURE 5.7. Technicians conduct a hand survey to prepare a field note using trilateration at a historic building in Liège, Belgium. Source: Mario Santana Quintero.

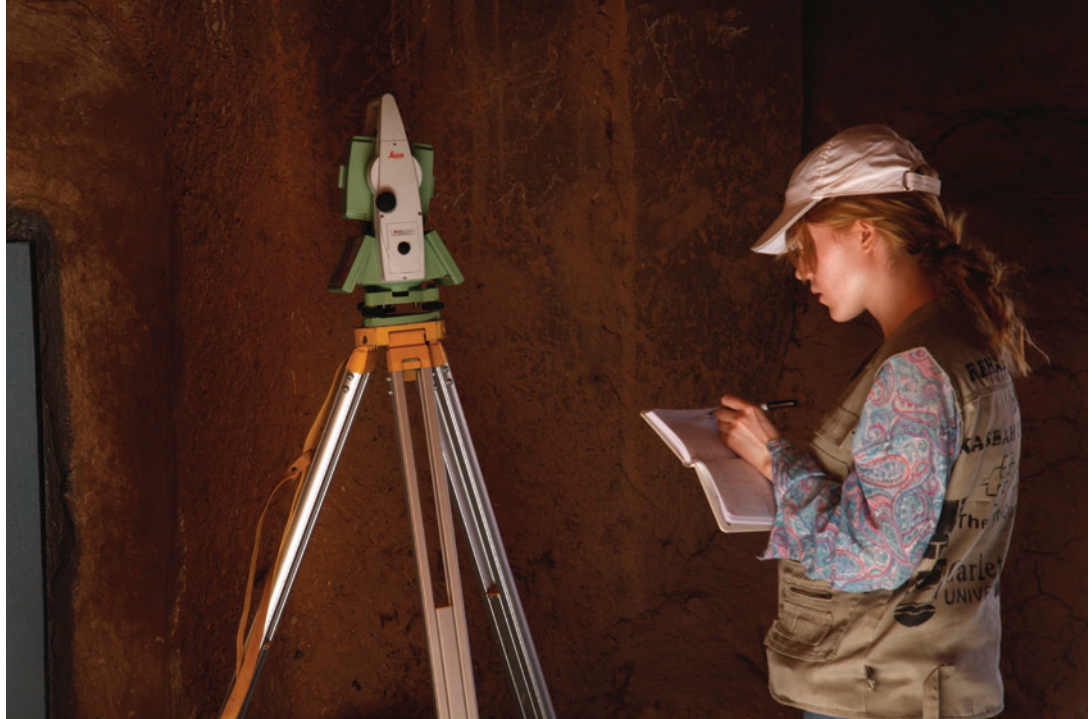
FIGURE 5.8. A technician conducts a total station measurement in the interior of the Kasbah of Taourirt, Morocco. Source: Mario Santana Quintero.

A total station measures vertical and horizontal angles and distances and combines them to determine a 3D coordinate (figure 5.8). The distances are measured by transmitting a beam from

the station toward a prism, target, or object and calculating the distance using the time it takes for the light to bounce back to the instrument. The vertical and horizontal angles are measured with a built-in theodolite, using a horizontal azimuth and the vertical distance as references. The telescope used for orienting the device is attached to a graduated electronic horizontal circle for measuring the angle of rotation (horizontal) and a vertical circle to measure the angle of inclination (vertical). The instrument's height above the ground and the height of the reflector or target above the ground may also be required. Once the measurements have been obtained, trigonometry is used to determine the unknown measurements needed to complete the survey.

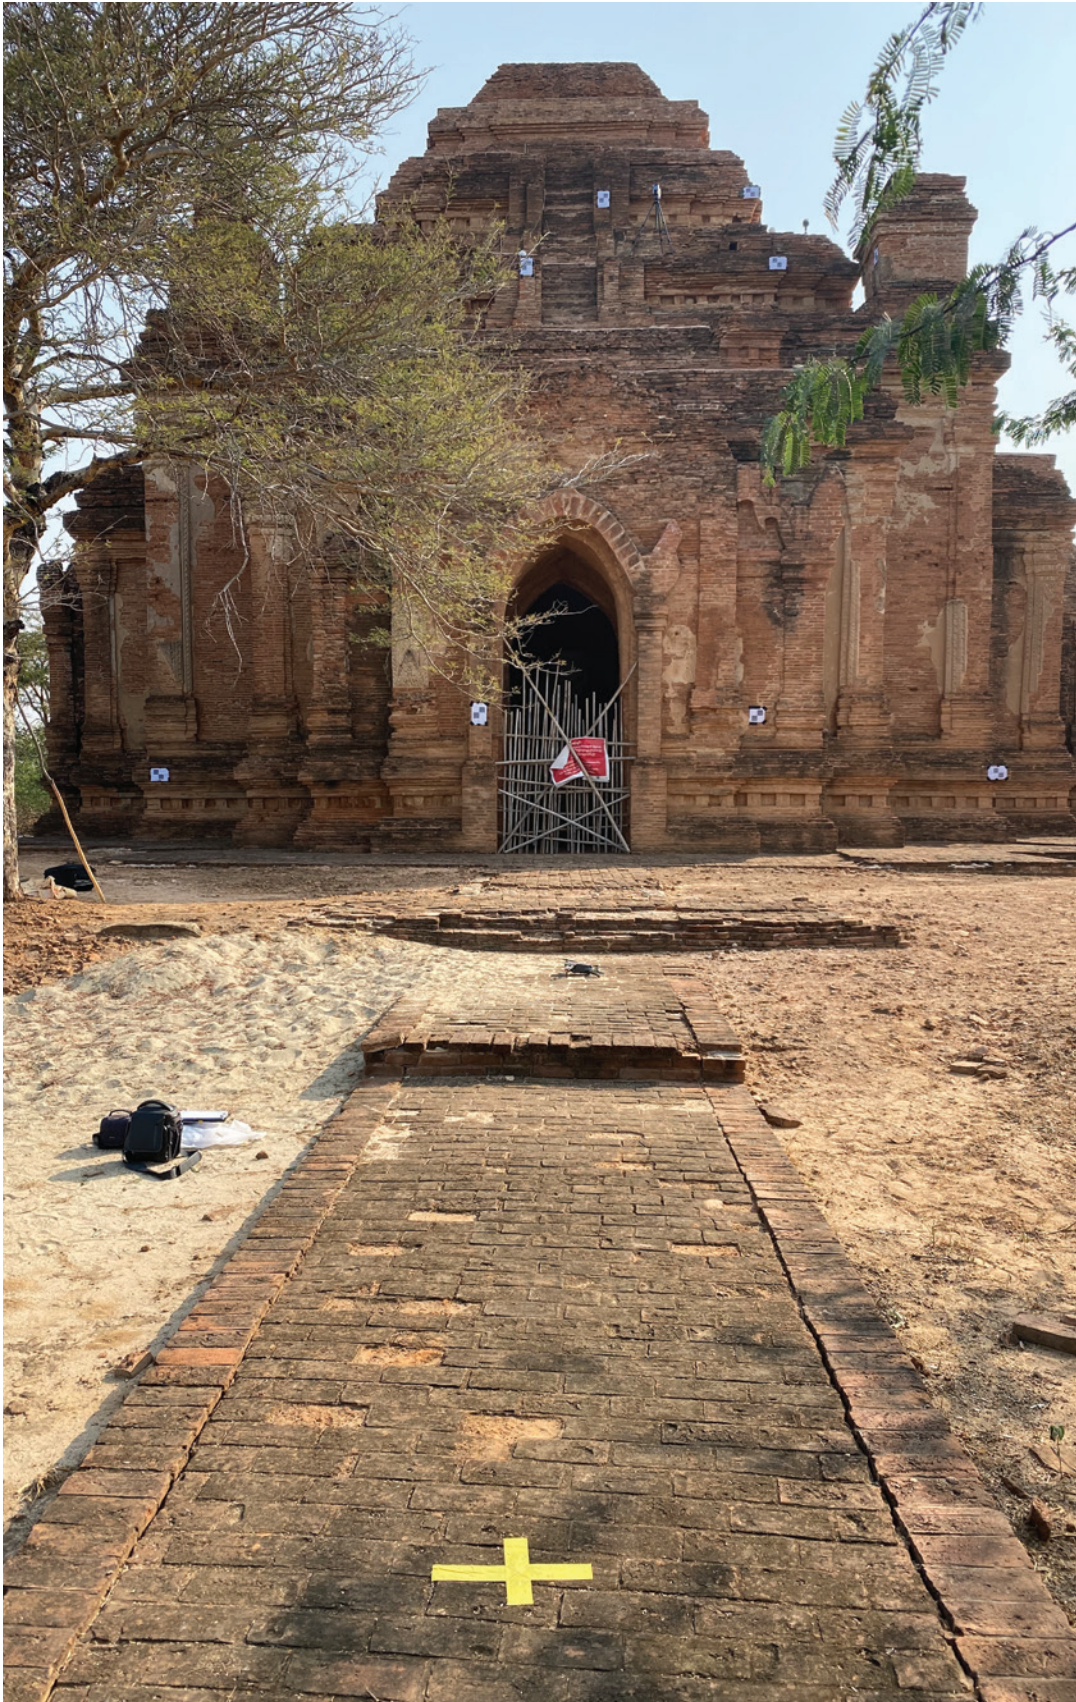
FIGURE 5.11. Example of terrestrial and aerial targets to record a historic site that are measured using a total station, GNSS, correction services, and RTK networks to produce more accurate photogrammetric results (Tha-mu-ti-hpaya temple, Bagan World Heritage Site, Myanmar). Source: Mario Santana Quintero.

A site inspection can be conducted by taking aerial views of the heritage place to assess the condition of rooftops, understand the ancient city wall of an archaeological site, or assess the extent of damage from an earthquake. Correction services and real-time kinematic (RTK) networks are used to improve the accuracy of RPAS devices. This allows subcentimeter points to be produced from the measured features. The geographic coordinates are commonly used to measure other control points to reference data collected through photogrammetry and 3D scanning using a total station (figure 5.11).

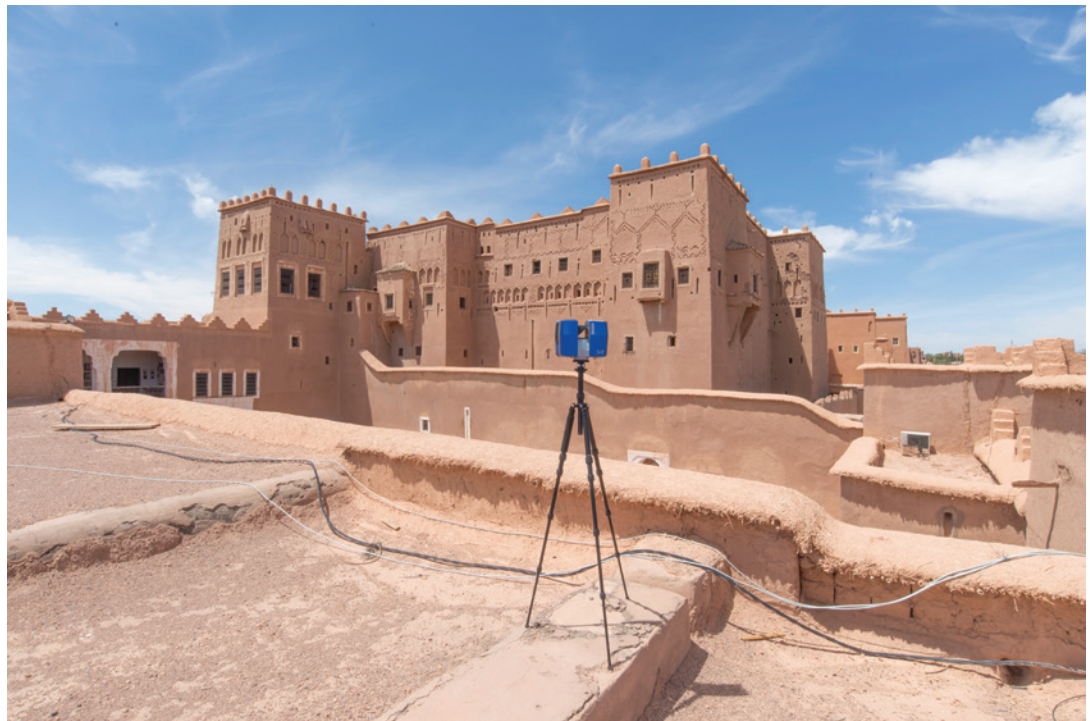
FIGURE 5.12. A laser scanner is positioned for site recording at the Kasbah of Taourirt, Morocco. Source: Mario Santana Quintero.

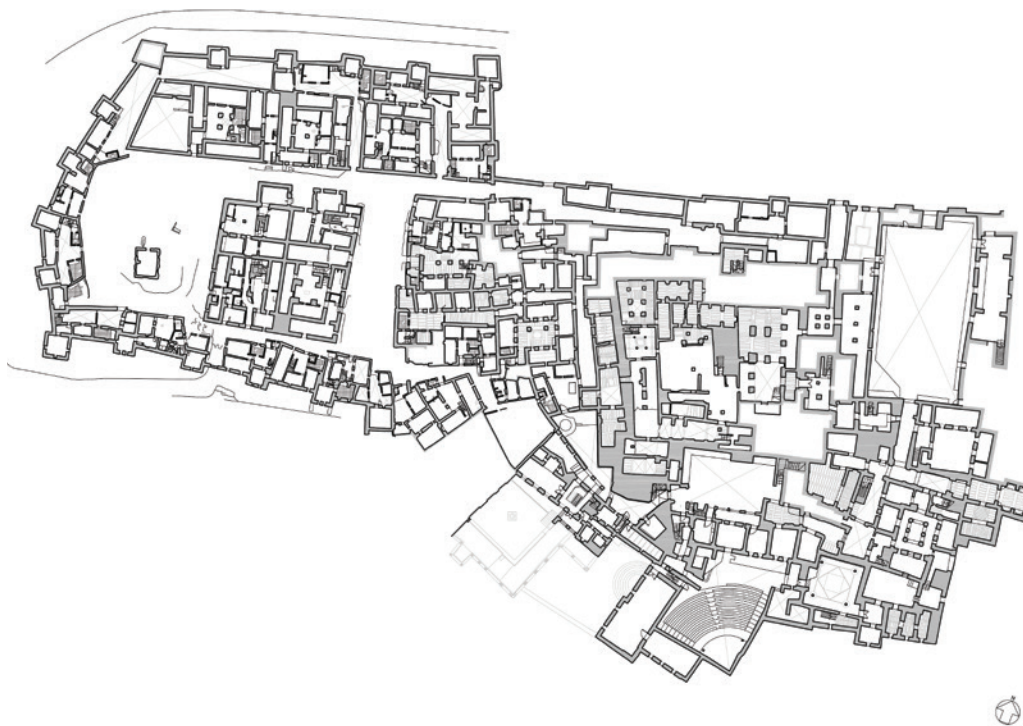
FIGURE 5.13. A measured line drawing of the floor plan of the Kasbah of Taourirt, Morocco. This record has been produced with total station survey, photogrammetry, and CAD. Source: Carleton Immersive Media Studio.

The resulting point clouds are imported directly into CAD together with orthophotos to produce the drawings. The 3D point clouds are sliced using sophisticated visualization, and CAD manipulation features and drawing commands are used to trace the plans and sections (figure 5.13).

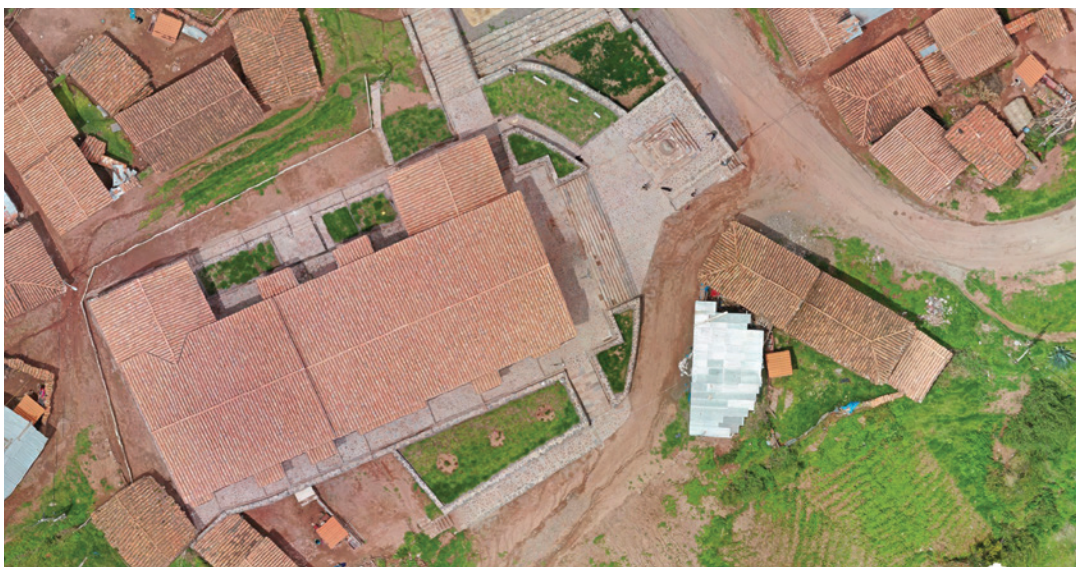
FIGURE 5.16. Contextual image of the site of the church of Kuñotambo, Peru. This record has been produced with aerial photography and photogrammetry to produce an ortho-corrected image of the site. Source: Miquel Reina Ortiz and Mario Santana Quintero, Carleton Immersive Media Studio.

The final technical dossier included relevant measured drawings done at different scales, including floor plans, roof plans, inverse ceiling projections with ortho-corrected images (including site context), elevations (including site context), and longitudinal and transversal sections (figures 5.16–5.19). Ortho-corrected photographs were also produced for the interior surfaces of the church's main spaces and decorated surfaces and ceilings (figure 5.20).

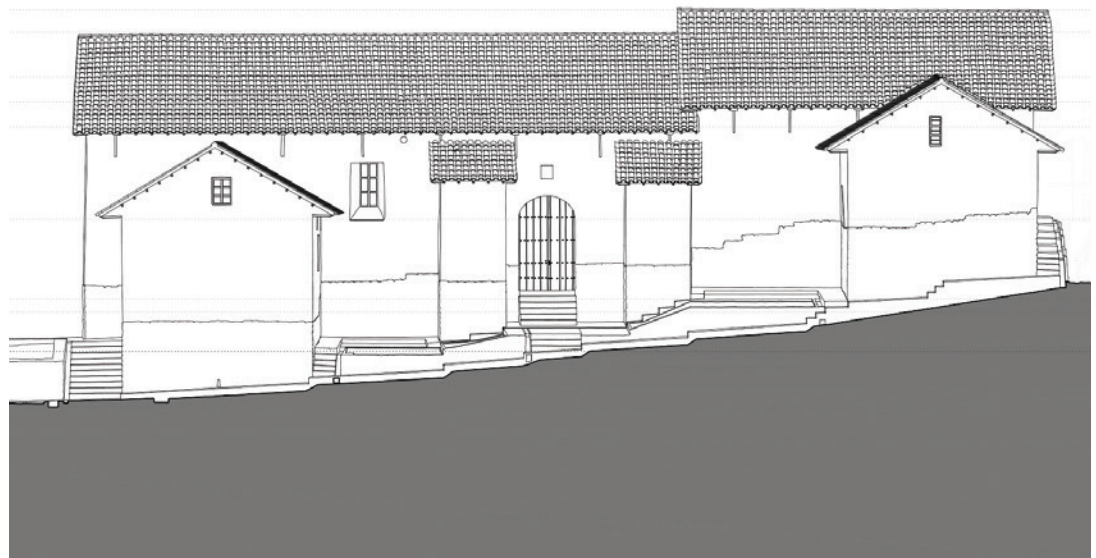
FIGURE 5.18. A measured drawing of the north elevation of the church of Kuñotambo, Peru. This record has been produced with the total station survey, aerial photography, and photogrammetry to produce an ortho-corrected image, which has been traced using CAD. *Source:* Miquel Reina Ortiz and Mario Santana Quintero, Carleton Immersive Media Studio.

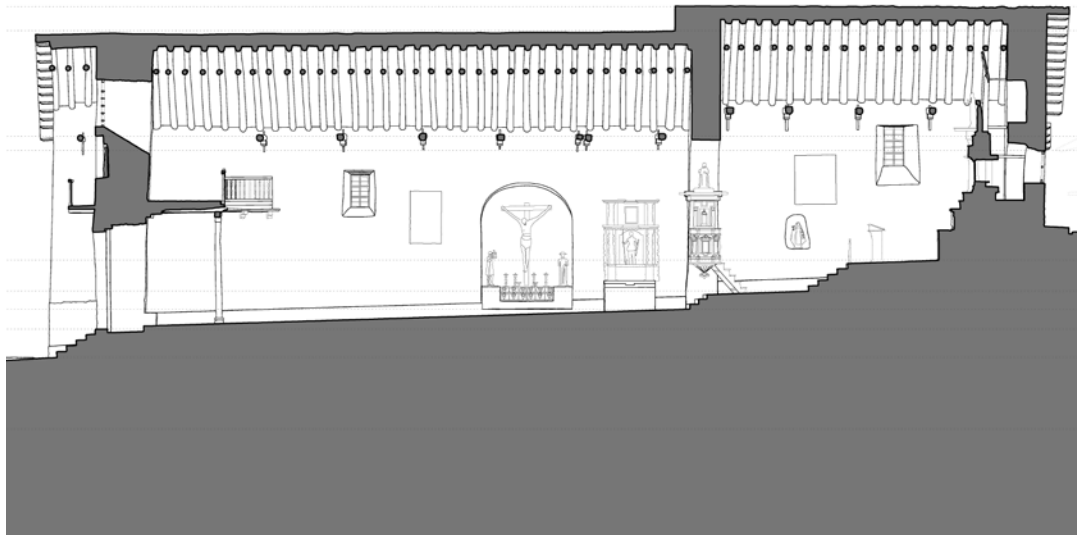
FIGURE 5.19. A measured drawing of the cross section of the church of Kuñotambo, Peru. This record has been produced with the total station survey, 3D scanning data, and photogrammetry to produce an accurate record. CAD has been used to trace and produce the line drawing. *Source:* Miquel Reina Ortiz and Mario Santana Quintero, Carleton Immersive Media Studio.

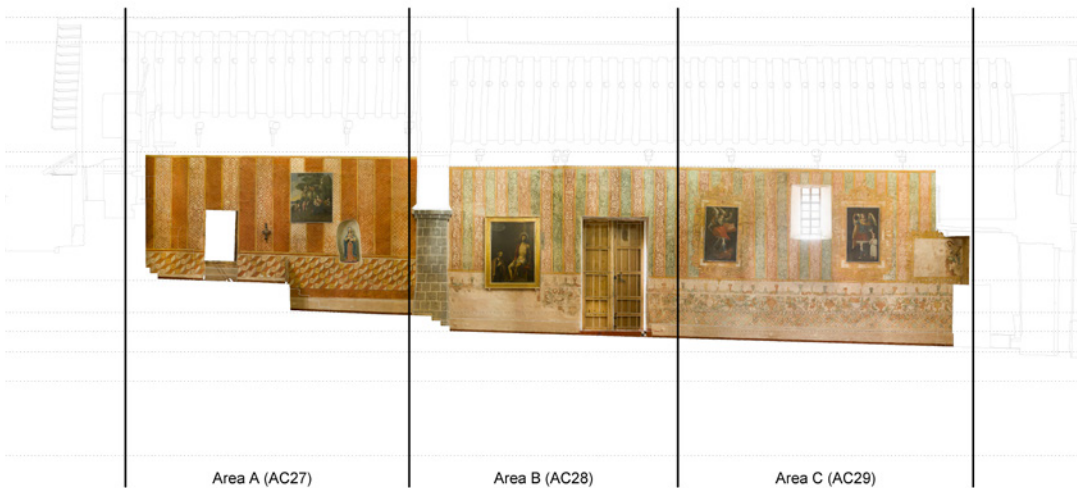
FIGURE 5.20. An ortho-corrected image of the decorated surfaces of the church of Kuñotambo, Peru. This record has been produced with the total station survey, 3D scanning data, and photogrammetry to produce an ortho-corrected image, which has been traced using CAD. *Source:* Miquel Reina Ortiz and Mario Santana Quintero, Carleton Immersive Media Studio.

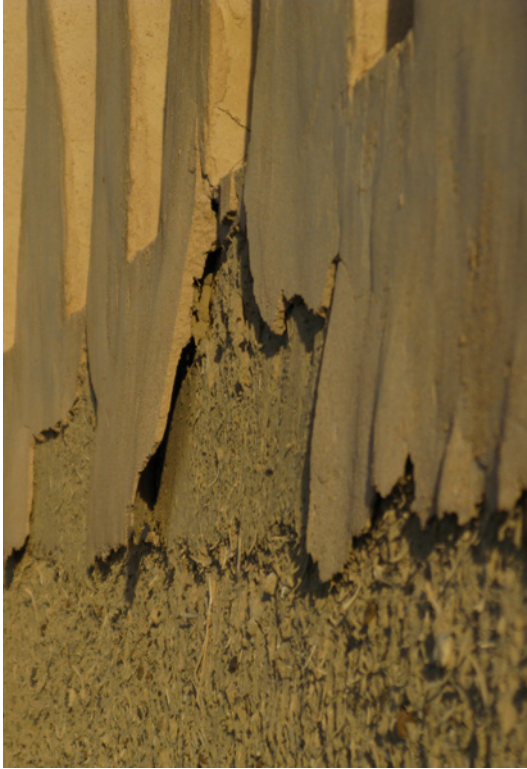
(A)

FIGURE 6.1. (a) Detachment of plasters from an earthen wall, Al Jahili Fort, Al Ain, United Arab Emirates (UAE). (b) Disaggregation of the earthen surface, Uruk, Iraq. Source: ZRS, Christof Ziegert.

Detachment is the lack of adhesion between the render and the earthen building material substrate (figure 6.1a). There are several factors that will cause this, but the most common one is when the top layer of render is too hard or of a different composition, such as cement-based renders or earthen plasters with significantly differing composition from the earthen substrate. Due to thermal stress, the firmer render then detaches from the substrate. However, the damage pattern can also be caused by salt transport and salt crystallization in the transition layer from the substrate to the top render. The damage mechanism can often be detected by tapping on hollow areas.

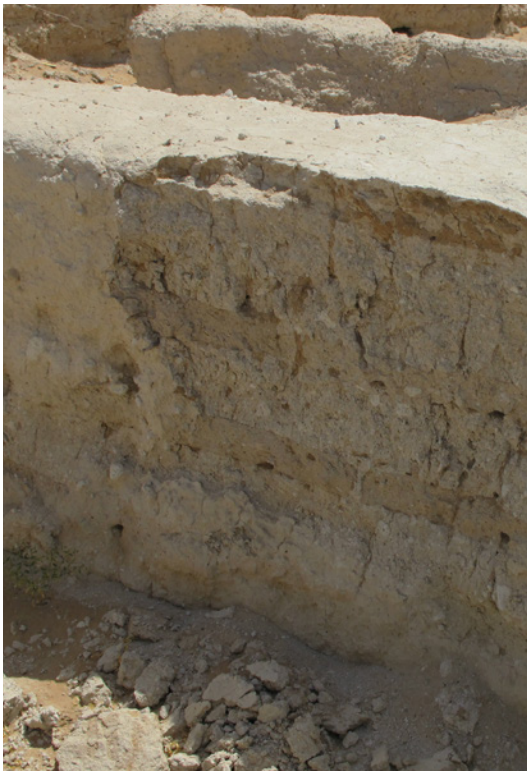
(A)

FIGURE 6.2. (a) Planar detachment and flaking on a mud-brick wall. Hili 17, Al Ain, UAE. Source: Benjamin Marcus (b) Archaeological site of Uruk, Iraq. Source: ZRS, Jasmine Blaschek.

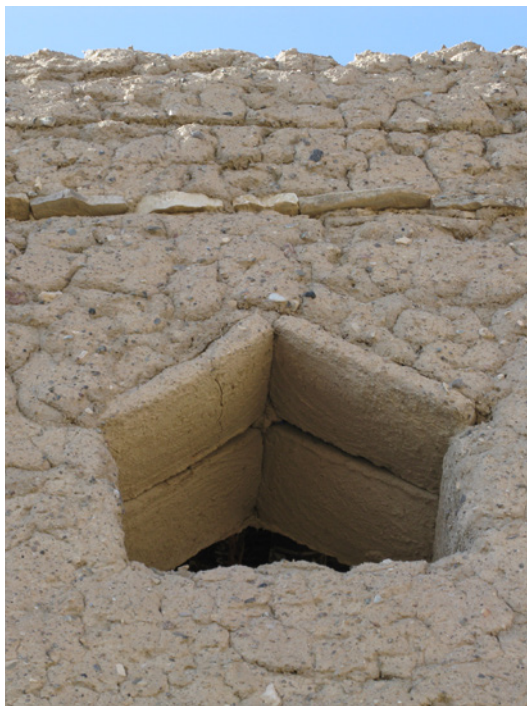
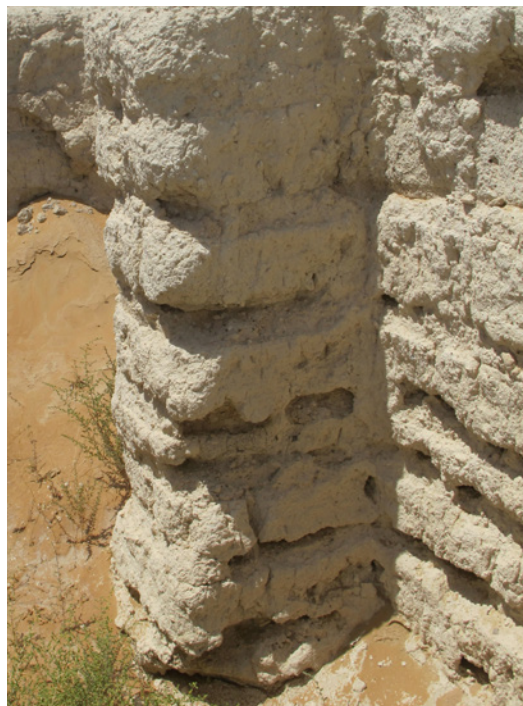
FIGURE 6.3. (a) Plaster cracking in an earthen house in Bahla, Oman. Source: ZRS, Christof Ziegert. (b) Alveolization of a wall at Hili 17 archaeological site, Al Ain, UAE. Source: Benjamin Marcus.

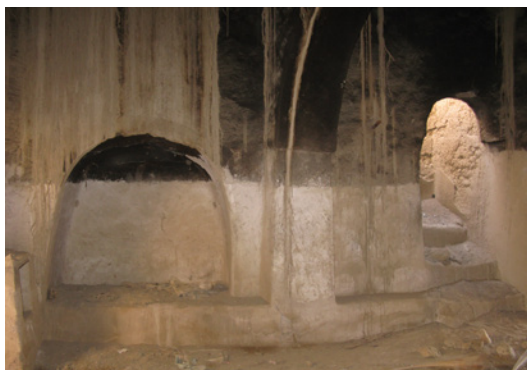
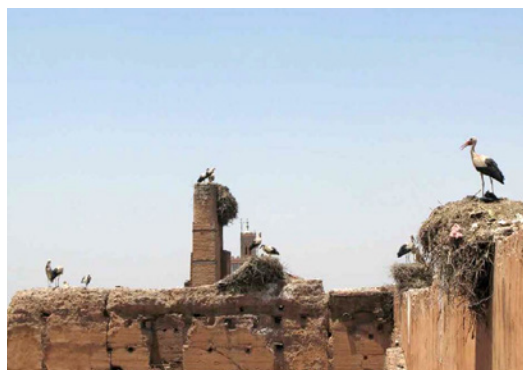
FIGURE 6.4. (a) Carbon deposit on walls, Bahla, Oman. Source: ZRS, Christof Ziegert. (b) Birds nest over an earthen wall, El Badi Palace, Marrakech, Morocco. Source: Elena Macchioni.

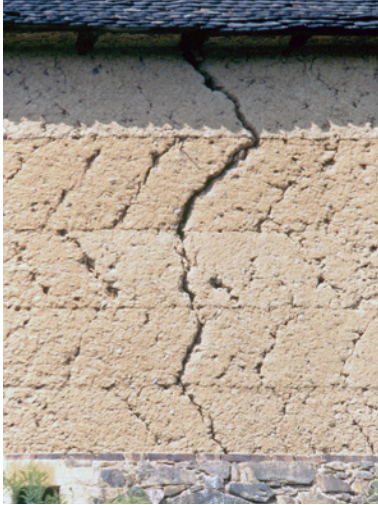
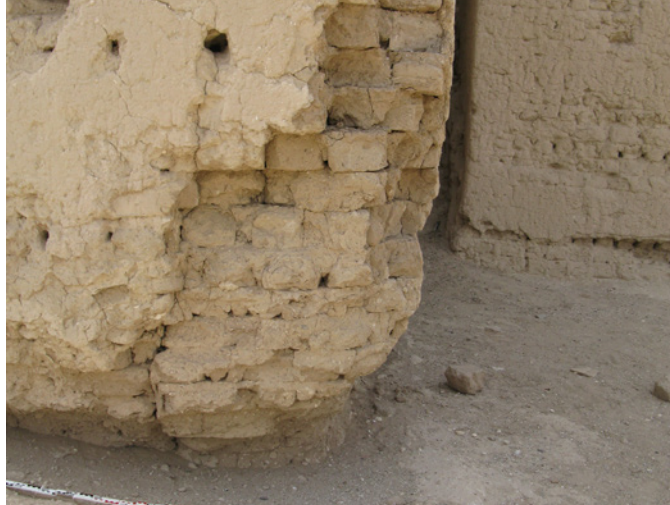
FIGURE 6.5. (a) Structural crack at a cob barn in eastern Germany. (b) Basal erosion (coving) of an earthen building in Al Ain, UAE. Source: ZRS, Christof Ziegert.

The combination of *humidity and salts* is a major factor of deterioration in most places. Moisture in the ground or drainage issues in the site can combine with salts to create conditions favorable to basal erosion. If moisture rises by capillary action through the foundation and the lower walls of the building, when it comes in contact with the air above the ground, the moisture evaporates through the building surface, and salts crystallize during this evaporation process, leading to subsurface salts, or efflorescence. In earthen buildings, efflorescence and moisture, combined with wind and other deterioration factors like precipitation, can lead to rapid loss of wall thickness. When a wall that is 80 cm thick has lost 20 to 30 cm of its base near ground level, it can

be considered structurally compromised, and this can quickly become a priority or emergency condition (see figure 6.8b).

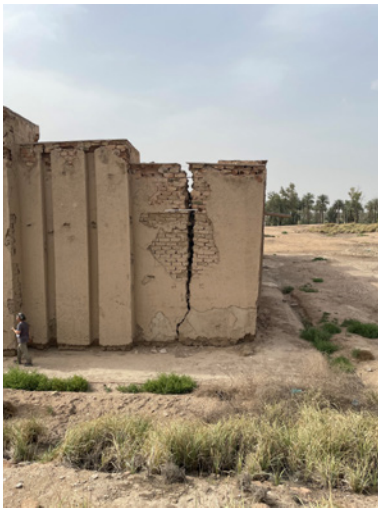
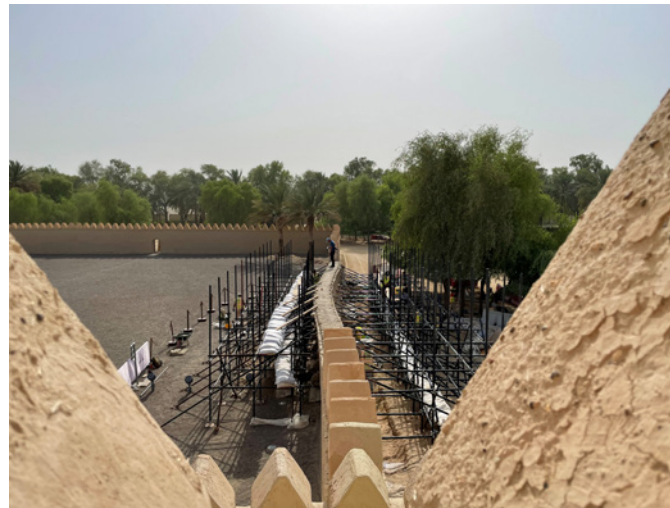
FIGURE 6.6. (a) Drainage issues and cracking lead to out-of-plane movement, Babylon, Iraq. (b) Out-of-plane movement of a courtyard wall, Al Jahili Fort, Al Ain, UAE. Source: ZRS, Christof Ziegert.

Out-of-plane movement is the shifting of masonry from its original vertical orientation. Walls can lean if not connected to other walls, if they have no lateral restraint or when foundations are not properly constructed. This can ultimately lead to complete or partial collapse of the wall, especially if the center of gravity moves outside the middle third of the wall, thus introducing tensile stresses (figure 6.6).

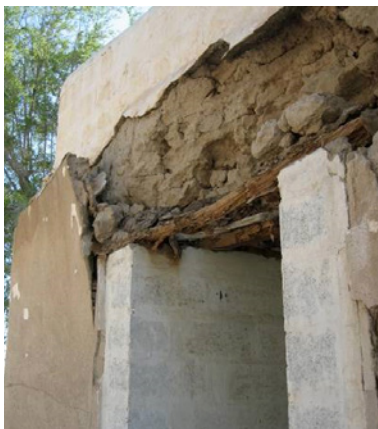
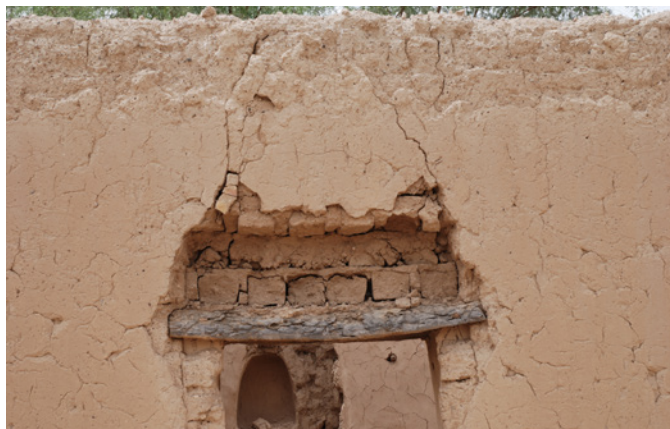
FIGURE 6.7. (a) Deformation of earth block masonry due to improper conservation measures with cement-based materials, Al Jahili Mosque, Al Ain, UAE. Source: Louise Cooke, Enrico Fodde, Sandeep Sikka, and Julio Vargas-Neumann (2012). (b) Missing masonry, House of Saif and Khalfan Bin Abdallah Al-Zhahiri, Jimi Oasis, Al Ain, UAE. Source: Benjamin Marcus.

The movement and cracking of the wall often result in the shifting of the wall surface significantly beyond the normal irregularities of historical wall surfaces out of plane. The resulting significant deviation from the plane of the wall and its surface is usually associated with mechanical failure of the wall and/or finish (figure 6.7a).

Partial or major loss of earthen walls are commonly caused by the damage or failure of other structural elements (such as lintels, beams, roofs, etc.) or deterioration of the material itself (figure 6.7b). A major loss is when the area lost is greater than approximately half a square meter and at least around 10 cm in depth, as measured from the present plane of the wall surface.

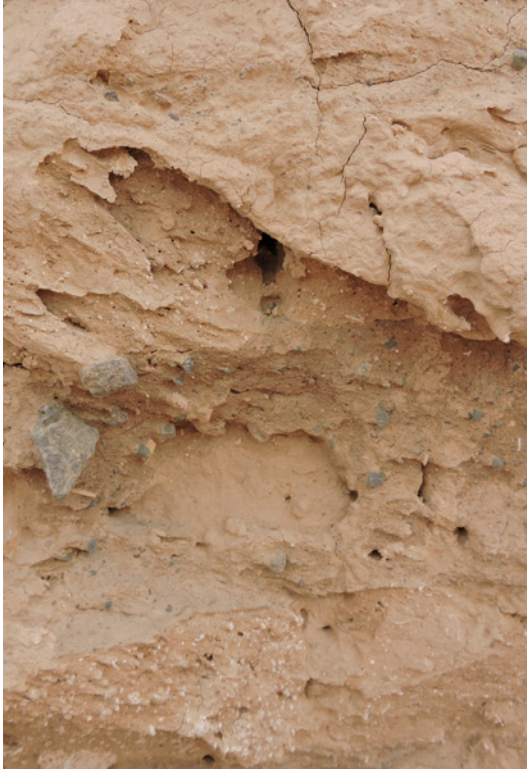
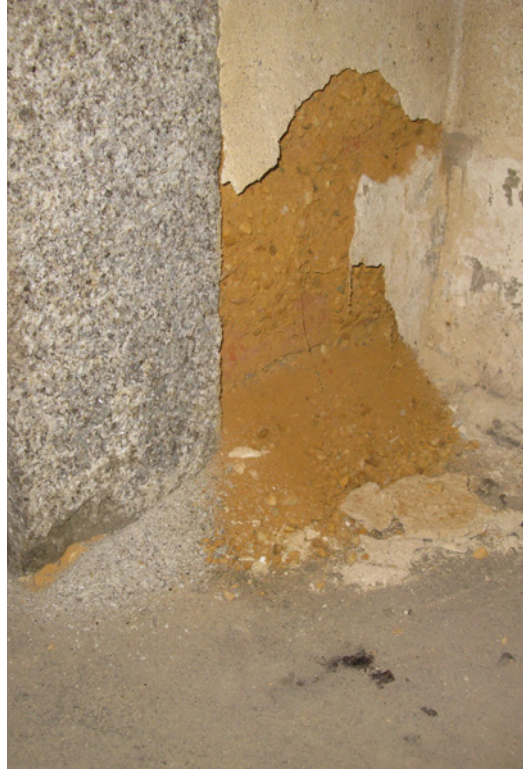
FIGURE 6.8. (a) Wind erosion at an early Islamic city wall near Al Ula, Saudi Arabia. (b) Salt damage. Source: ZRS, Christof Ziegert.

Wind impacts earthen sites by driving blown precipitation or sand in arid environments, which can erode the surface of walls that face prevailing winds. For example, in the sites of Al Ain, northern and northwestern facades often face much higher rates of deterioration than south-facing walls due to the presence of windblown sand and rain driven by wind (see figure 6.8a).

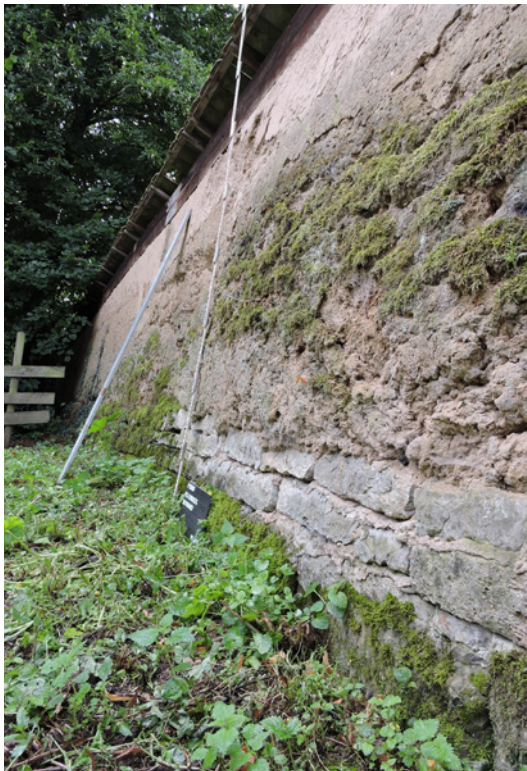
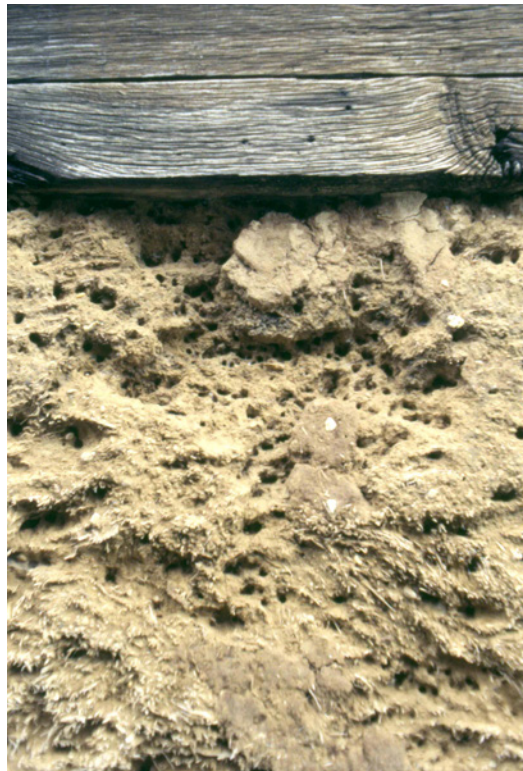
FIGURE 6.9. (a) Vegetation/biological decay. (b) Insect attack. Source: ZRS, Christof Ziegert.

Earthen material can be directly affected by the *presence of insects* such as wasps and bees, which make their homes in earthen walls (see figure 6.9b). Termites can also indirectly affect the structural stability of buildings by destroying elements such as lintels, roof beams, and timber structural ties.

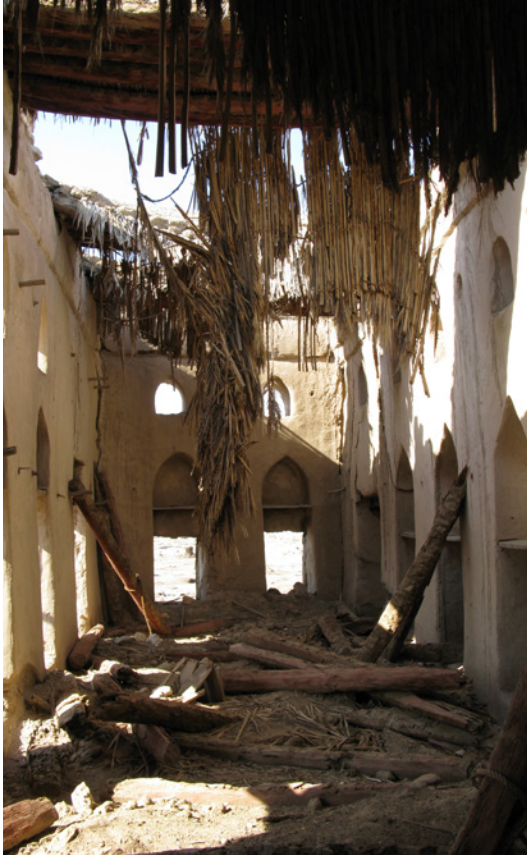
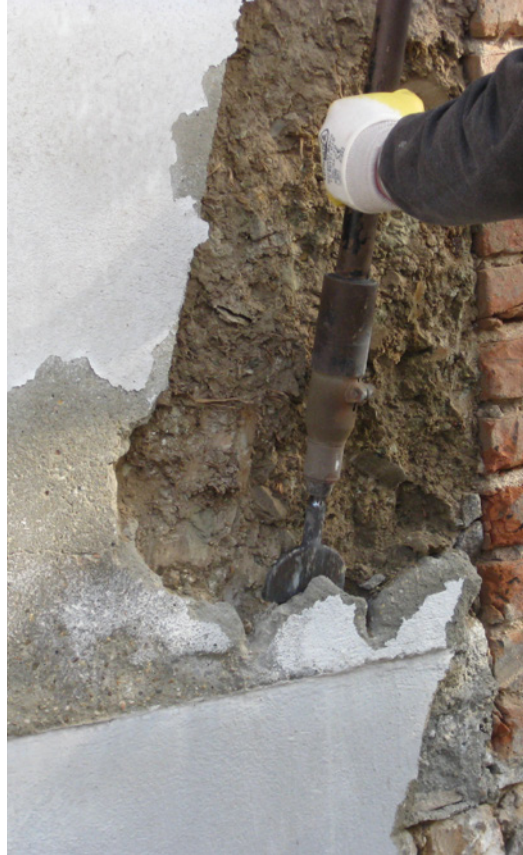
FIGURE 6.10. (a) Abandonment, Bahla, Oman. (b) Removal of a cement plaster as an inappropriate intervention. *Source:* ZRS, Christof Ziegert.

The addition of incompatible materials to earthen buildings, especially in seismic zones, can result in damage or even collapse of the structure (see figure 6.10b). Additions such as concrete

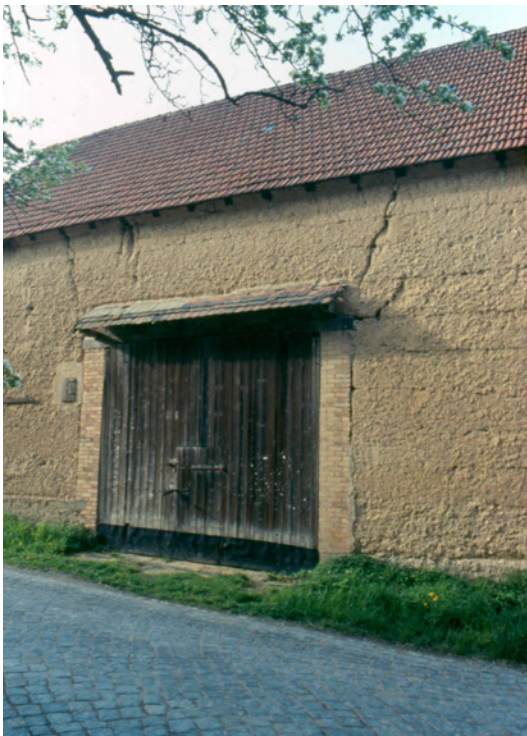
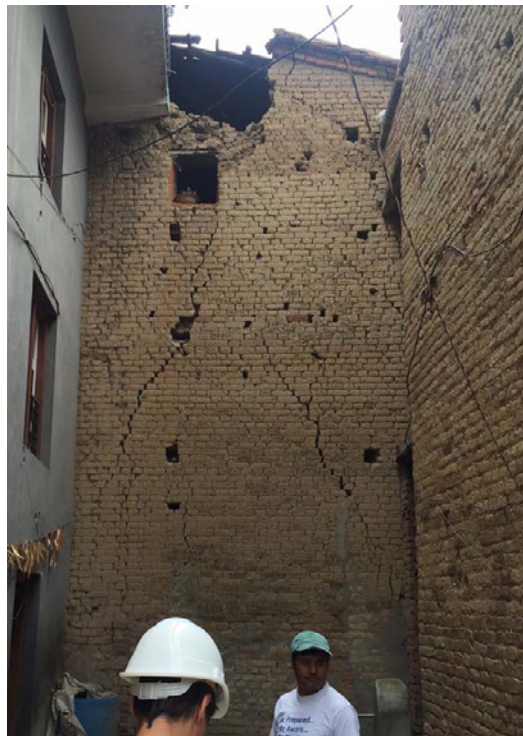
FIGURE 6.11. Cracks in solid earthen walls caused by different stiffness of materials and earthquakes. *Source:* ZRS, Christof Ziegert.

ring beams, columns, or block insertions are incompatible with earth and will respond inadequately to changes in humidity, temperature, or even seismic movement (see figure 6.11).
