International Course on the Conservation of Earthen Architecture

ACCOMPANYING ESSAYS

Edited by
Benjamin Marcus
Alessandra Sprega
Claudia Cancino
Gayathri Hegde

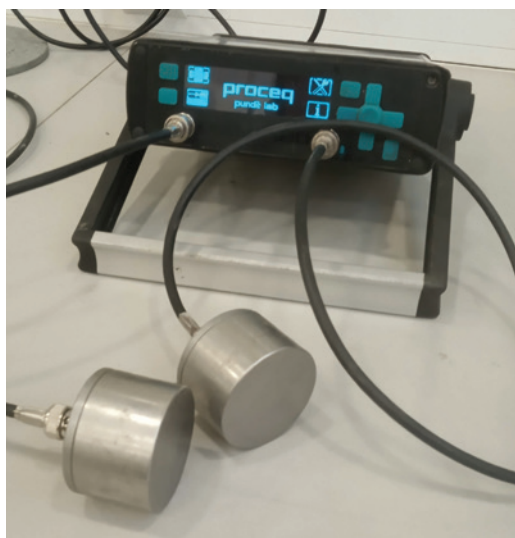
(A)

FIGURE 6.16. Ultrasonic testing detects detachments, voids, cracks, and areas of deterioration in a wall: (a) test equipment, including probes; (b) diagram showing direct and indirect configurations of the probes. Source: University of Minho.

Different configurations of this equipment exist depending on the position of the two probes (figure 6.16a). The direct method consists of placing the probes opposite each other, either on parallel faces or on perpendicular faces. In the indirect method, the probes are placed on the same face as the element; this is commonly done when it is not possible to access all faces of the element (figure 6.16b).

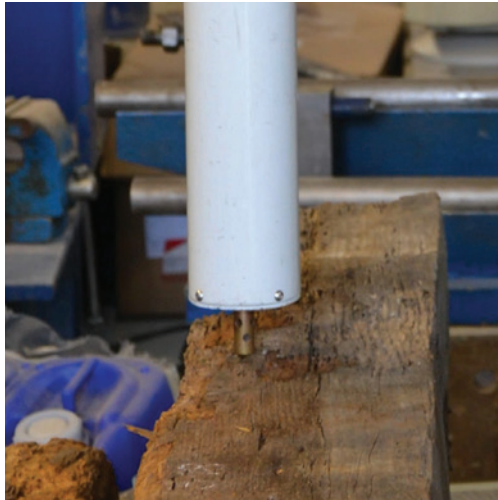
(A)

FIGURE 6.19. A Resistograph measures resistance to determine the presence of cracks, voids, and other defects in wood elements: (a) the drill bit being applied to wood material; (b) typical result showing inconsistencies in a wooden element. Source: University of Minho.

a small-diameter drill bit to penetrate a surface and record the material's resistance; a low resistance implies the presence of defects or weakened material (figure 6.19). It is usually used on wood to determine sections of the elements that are usable, and it may be used, in a different version of the equipment, on masonry to test the effective depth of the consolidation treatment.

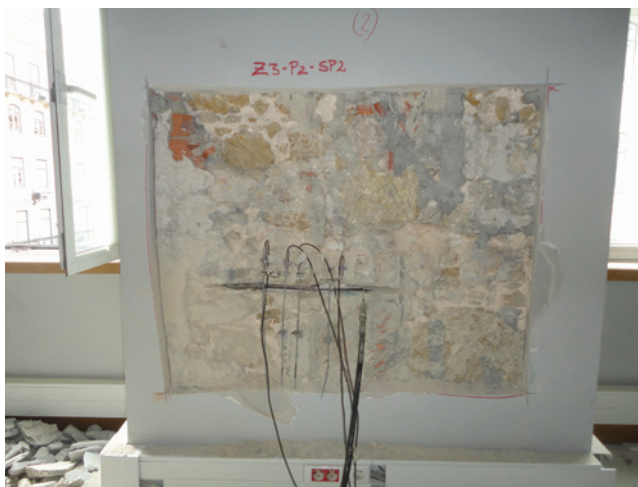
(A)

FIGURE 6.20. Flat jacks are used to measure compressive stress levels: (a) execution of a single flat jack test; (b) diagram showing an in situ setup for a double flat jack test with horizontal jacks, removable extensometer for reading displacements, and oil pump. Source: University of Minho.

Flat jacks can be used to determine the compressive stress level in earthen walls (single flat jack test) and the compressive strength and elasticity modulus of the material (double flat jack test; see figure 6.20). A flat jack consists of a thin metal pad equipped with two holes—an inlet and an outlet—that allow pressurization of oil through a hydraulic system. Cuts are made in the walls to be tested, and the jack is then positioned and pressurized. The single flat jack test is based on the principle of partial stress release and involves a horizontal cut, followed by controlled stress compensation (see figure 6.20a). The double flat jack test is like a uniaxial compression test (see figure 6.20b).

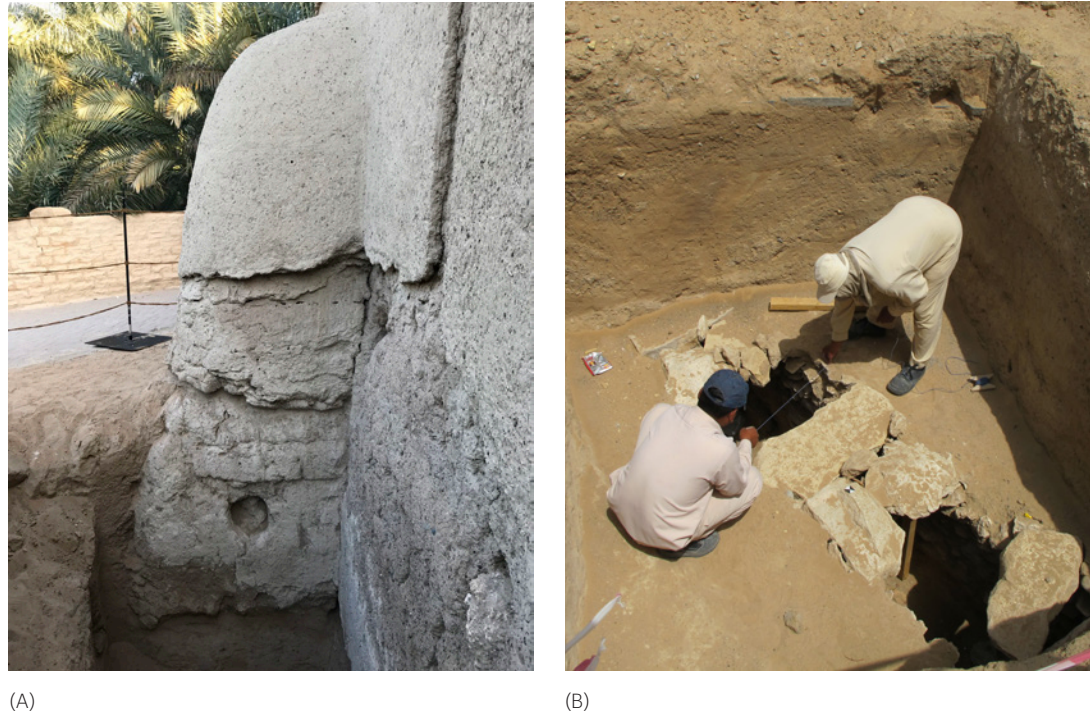
FIGURE 6.29. (a) Bin Ati al Darmaki Mosque (West), showing a series of superimposed mihrabs created by successive rebuilding of the mosque over time. (b) Excavations at Bin Ati in the Al Qattara oasis showed the stratigraphic sequence on the site. *Source:* DCT Abu Dhabi.

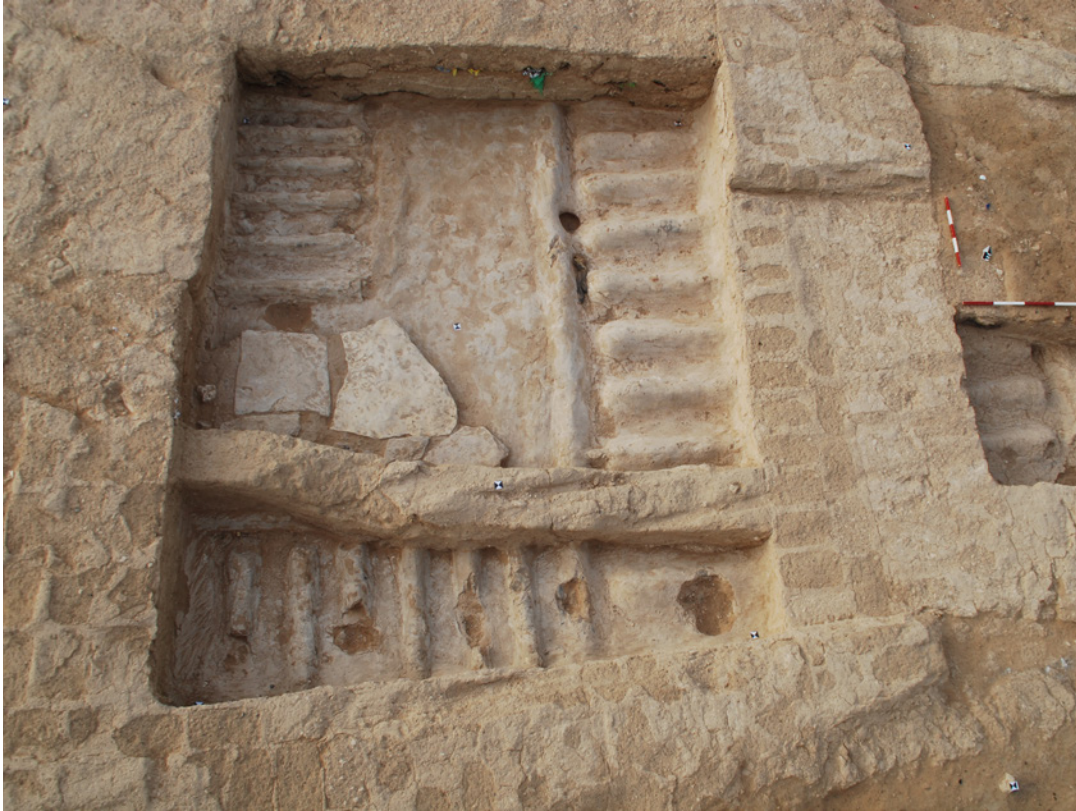
FIGURE 6.31. This madbasa or date-press was revealed during excavations at the house of Rashid Al Dhaheeri in the historic village of Khrays on the southern edge of Jimi Oasis in Al Ain. Source: Peter Sheehan.

from Zayed University, Abu Dhabi. The Al Ain Oases Mapping Project (2013–17) documented the oasis landscape and identified surviving historic components (figure 6.31). Systematic documentation of the individual oasis plots was used to help develop a comprehensive conservation plan for the boundary walls (Sheehan et al. 2017).

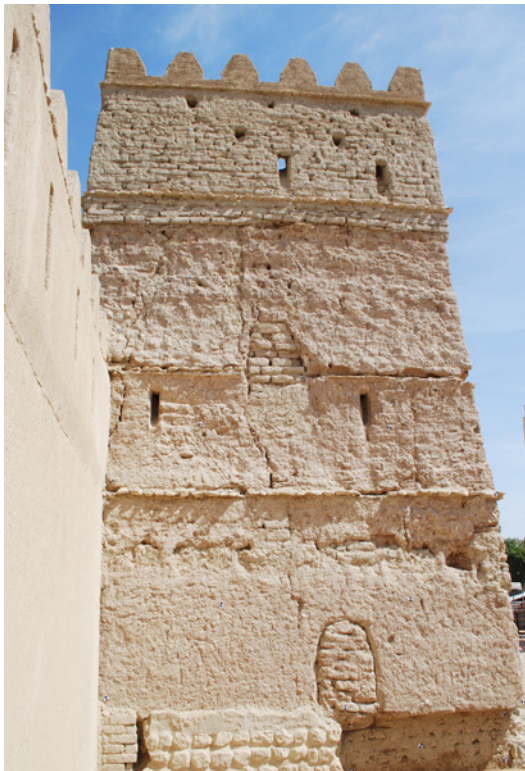
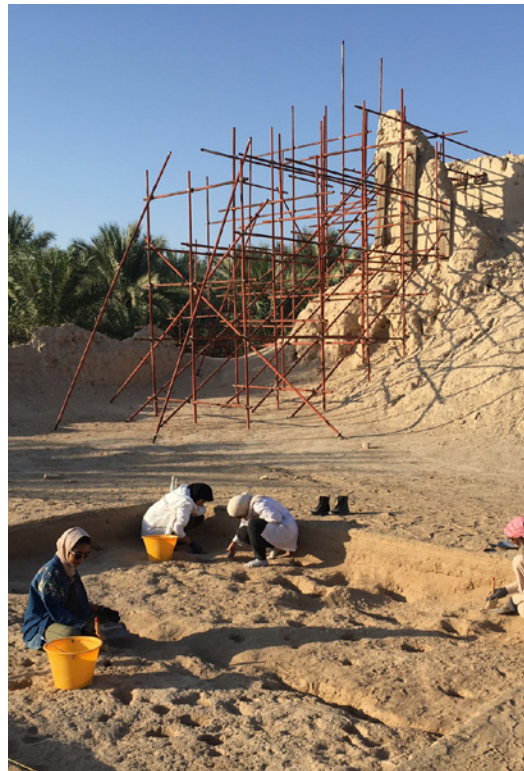
FIGURE 6.32. (a) Qasr Al Muwaiji, evidence of multiple construction phases revealed by archaeological investigation. (b) Bin Hadi Field School. Source: DCT Abu Dhabi.

Since 2007, several DCT projects carried out in Al Ain have focused on combining the rehabilitation and conservation of large historic earthen buildings with their adaptive reuse for cultural purposes. Written historical records for these buildings are relatively rare, so the archaeological investigation has been key to understanding the site context and development of the structures over time, as well as providing much of the subsequent educational and interpretive content. These projects began with the rehabilitation of Al Jahili Fort from 2007 to 2008. This fort was built by Sheikh Zayed the First at the end of the nineteenth century. In 2008, another major project was launched, this time to conserve Qasr Al Muwaiji, a fort built in the early twentieth century by Sheikh Khalifa bin Zayed bin Khalifa, son of Sheikh Zayed the First. From 1946 to 1966, it served as the *diwan* (seat of government) of Sheikh Zayed bin Sultan Al Nahyan (Power and Sheehan 2011b; El-Masri and Sheehan 2009; Sheehan 2012) (figure 6.32a).

The same general principles have been applied to selective investigations undertaken during limited emergency conservation at several other historic earthen buildings at Al Ain, including the Bin Biduwa House in Al Qattara Oasis and the Bin Hadi House in Hili Oasis (Sheehan et al. 2017) (figure 6.32b). The identification of archaeological horizons and key relationships proved to be a major source of information for understanding the development of these buildings. The baseline survey, desktop study, and visual inspection, followed by the careful location of test pits and opening-up works, formed the key interface between archaeology and conservation interventions, allowing us to facilitate repairs and increase our knowledge of the buildings.

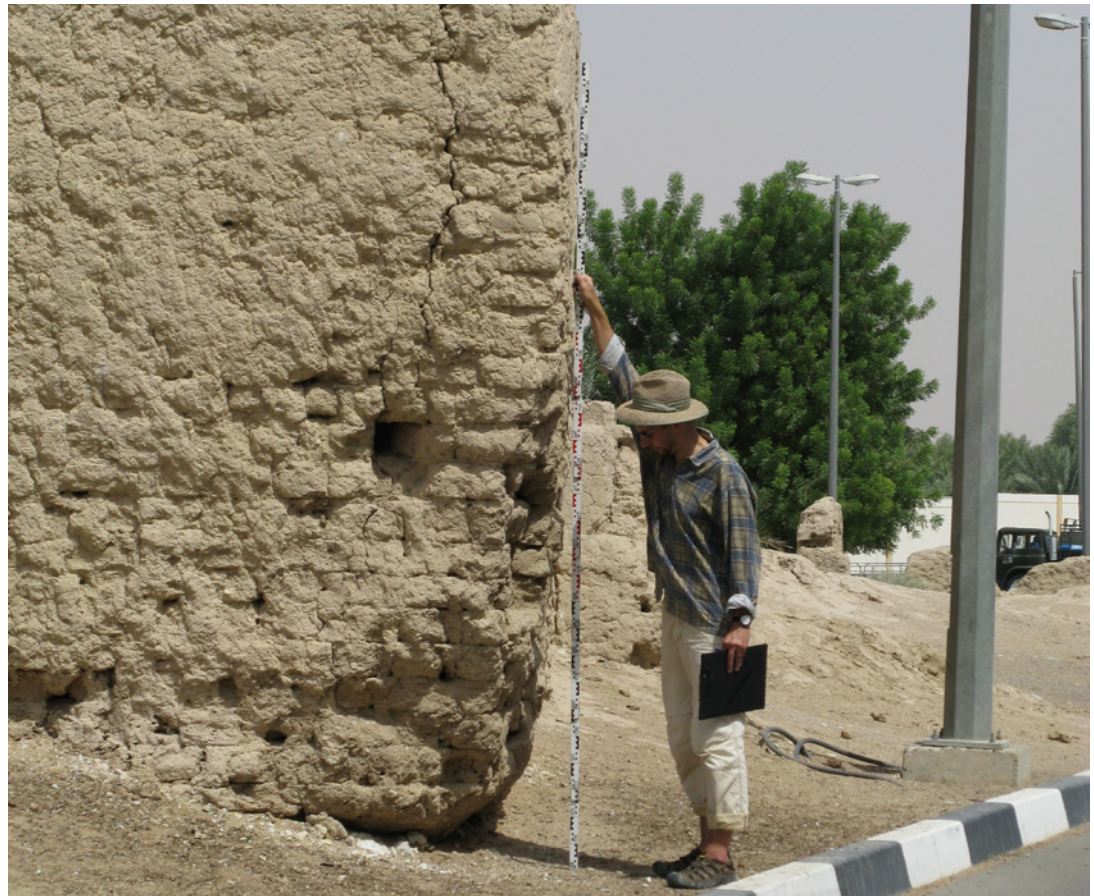
FIGURE 7.1. Structural assessment of a threatened earthen building with a serious crack directly on a public area, Al Ain, United Arab Emirates (UAE). Source: ZRS, Christof Ziegert.

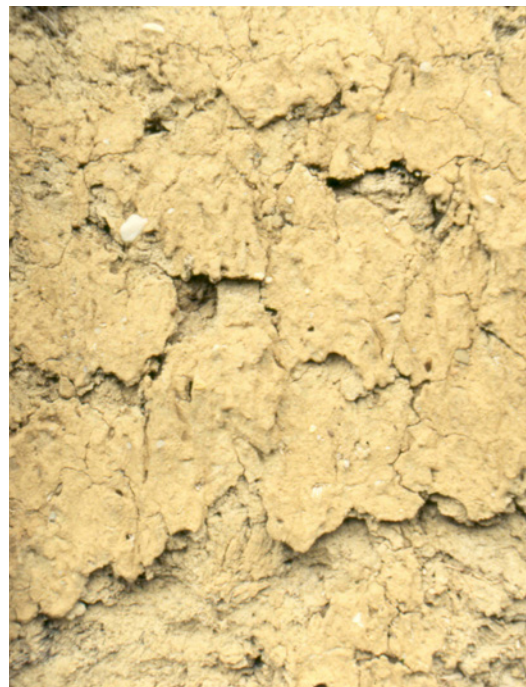
(A)

FIGURE 7.6. Muwajji Fort, Al Ain, after removal of damaged plaster, preparation of the surface, and reintegration of losses. Source: ZRS, Christof Ziegert.

Finally, the repair is completed with a finishing layer of earthen mortar, lime wash, or lime plaster, depending on the historical precedent (see chapter 8 for a complete overview of earthen plasters and finishes). Figure 7.6 illustrates these various phases, including the prepared historic material (rough surface), deep repairs (blocks), and an initial test of the new plaster layers.

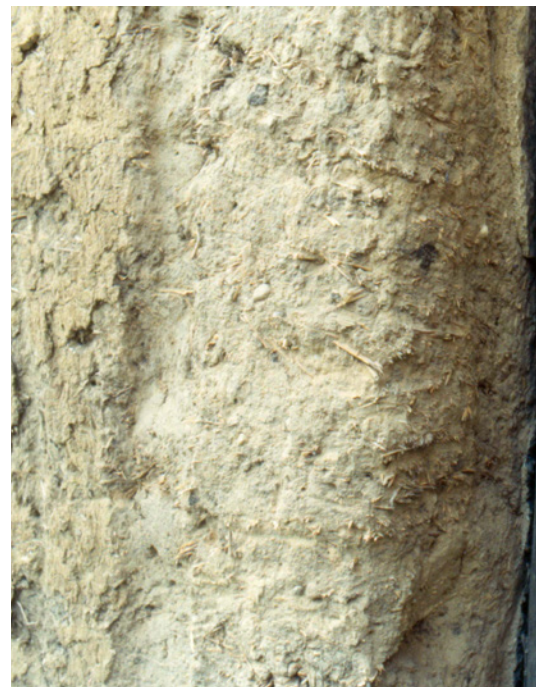
(B)

FIGURE 7.5. Delaminated surface of an earthen building, Saxony, Germany (a). Section of wall showing sound surface after removal of delaminated surface. Note the yellow straw (b). Saxony, Germany. Source: ZRS, Christof Ziegert.

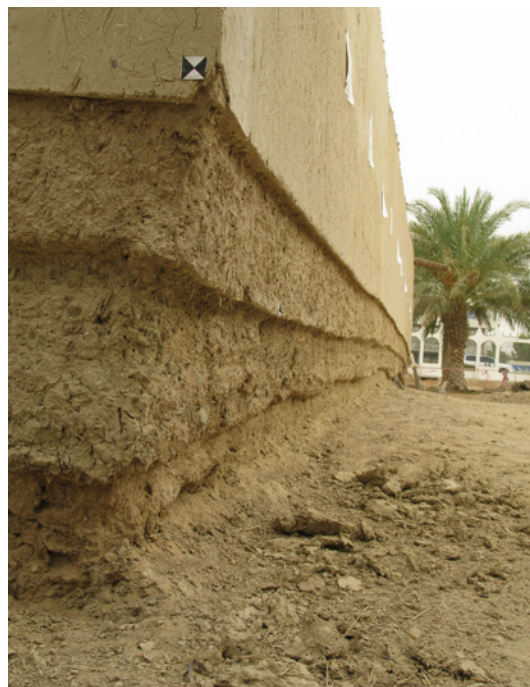
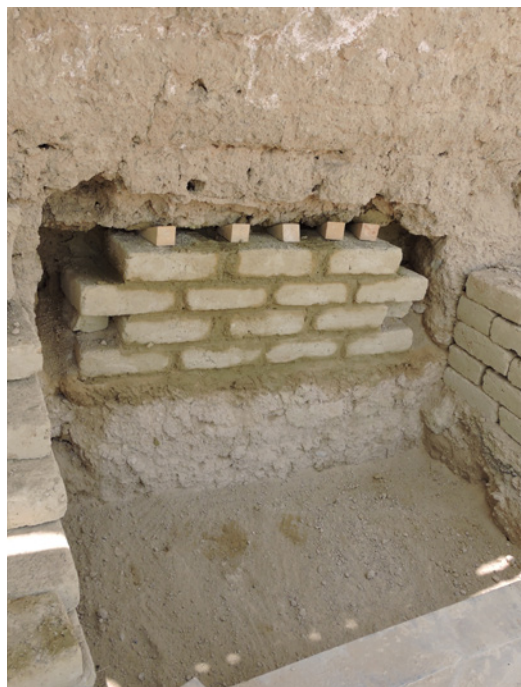
FIGURE 7.9. Al Muwaiji Fort, Al Ain, with stepped removal of damaged material (a). Al Jahili Fort courtyard wall, Al Ain, with area of eroded wall base removed at right angles and partial repair in place (b). Source: ZRS, Christof Ziegert.

To ensure proper load transfer, the existing historical material upon which the repair bricks will be placed should be cut out in a rectangular shape, which gives the new mud bricks a sound base. For the best connection, the mud bricks should be properly bonded, with headers and stretchers in the different layers and the brick header (those placed perpendicular to the wall)

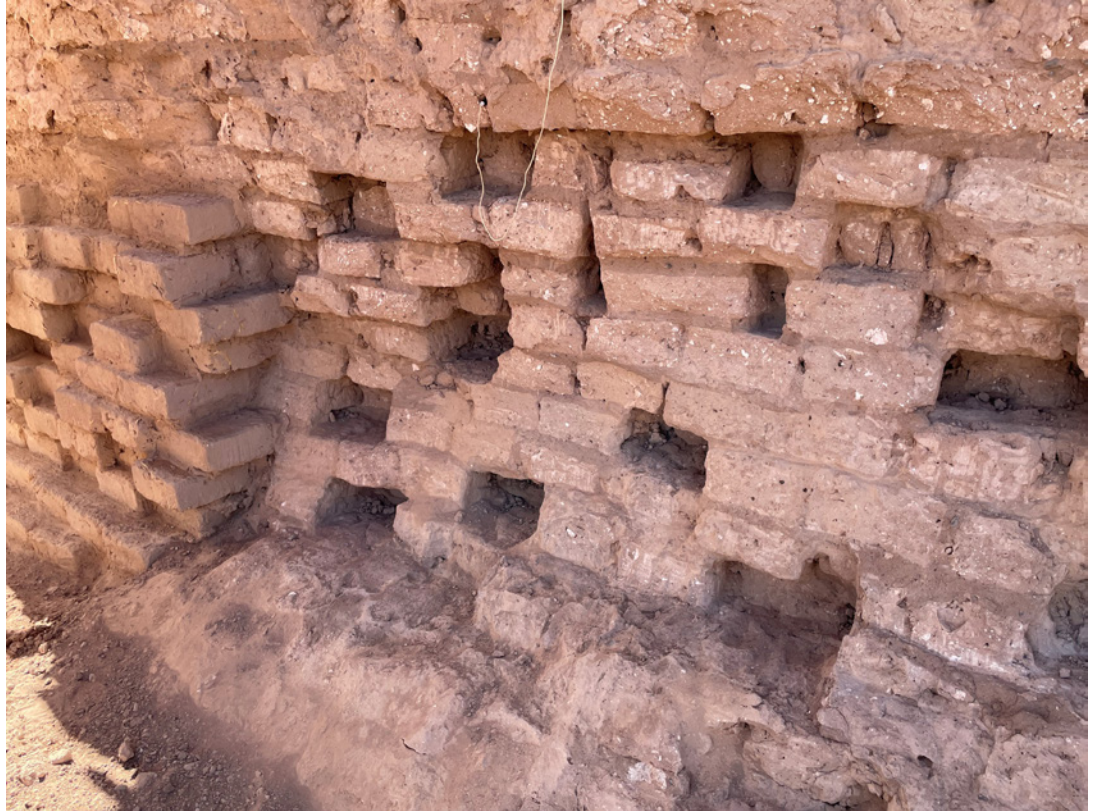
FIGURE 7.11. In addition to interlocking, (a) vigorous blowing off of the dust and (b) subsequent repeated gentle wetting are basic requirements for good bonding between the existing and supplementary masonry. Source: ZRS, Michelle Härder.

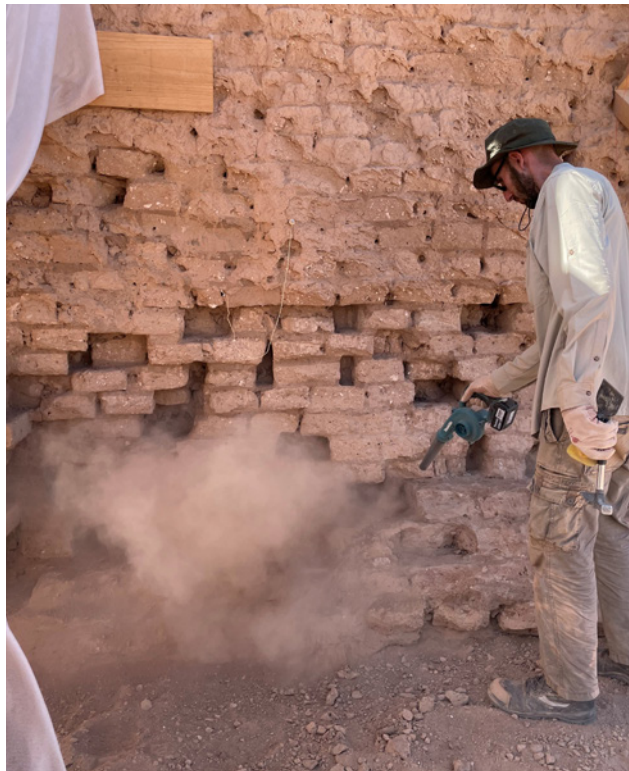
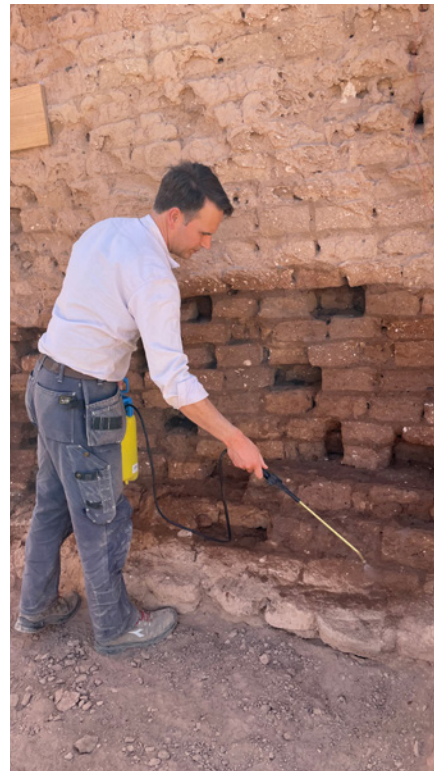
FIGURE 7.12. Small residential building in Germany in which the damaged plinth in the splash water area (up to 30 cm above ground level) was replaced with mud bricks. Source: ZRS, Christof Ziegert.

During this incremental replacement process, repaired sections should never be placed directly adjacent to a newly repaired section so that the load transfer and overall stability of the structure can be maintained. Staggering the sections helps distribute the stresses evenly and prevents any concentration of weakness in one area (figure 7.9). It is an important step to prevent undermining the structure and to ensure that the repaired base or wall remains structurally sound and capable of withstanding loads over time. Equally important is the techniques of execution, including proper cleaning and wetting of repaired areas (figure 7.10, 7.11). Depending on the geometric conditions, such as wall thickness and distance between the transverse walls, the wall to be repaired must also be supported laterally (figure 7.12, 7.13).

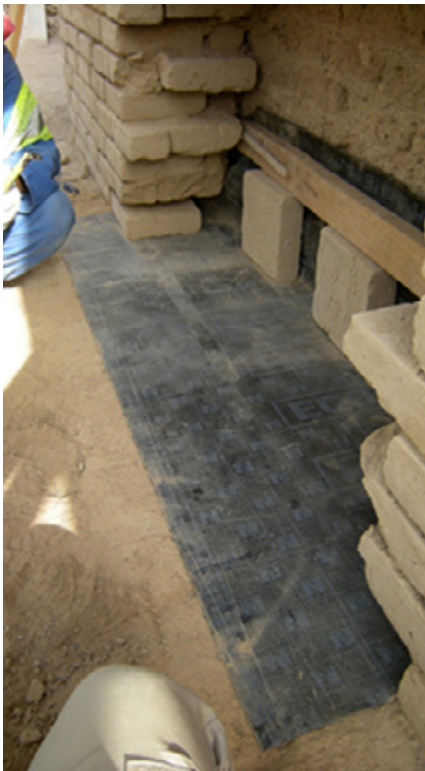
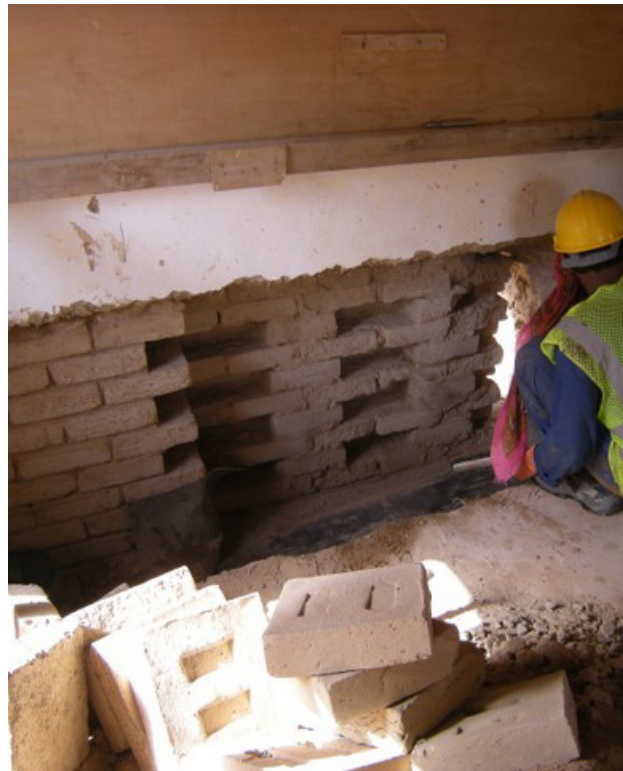
FIGURE 7.13. Muwajji Fort, Al Ain, with replacement of the material over the entire cross section and installation of a horizontal moisture barrier. Source: ZRS, Christof Ziegert.

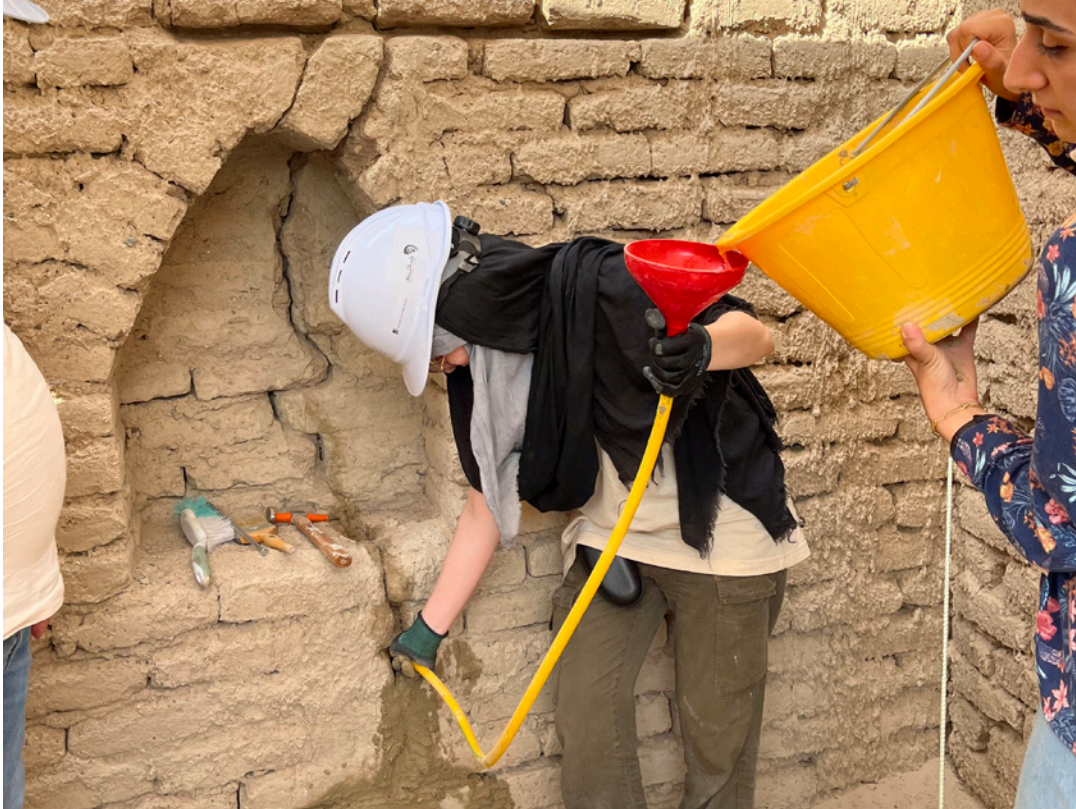
FIGURE 7.15. Example of gravity-fed grouting of an earthen wall using an earthen grout with sand aggregate. Source: Benjamin Marcus.

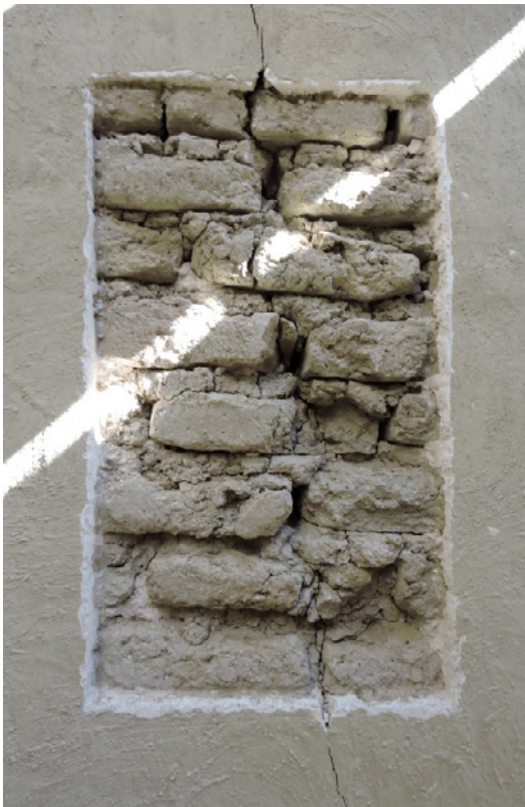
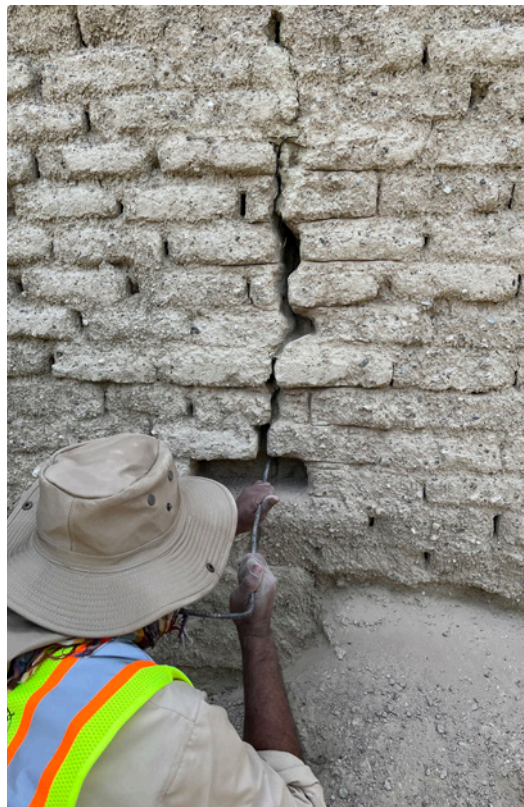
FIGURE 7.16. Stitching of cracked earth block masonry with earth blocks at the Murabb'a Fort Tower, Al Ain, UAE. Source: ZRS, Christof Ziegert.

Grouts can be applied to earthen walls either through a gravity system, in approximately 30 cm lifts, or through pressure grouting from below (figure 7.15). Each lift should be given sufficient drying time before the next injection of grout. In each case, the crack must be sealed from the outside with earthen mortar to prevent the loss of the liquid grout (figure 7.15). The choice of grout should be compatible with the specific earthen material used in construction. Regular maintenance and inspection of the cracks are also necessary. The term stitching means physically connecting two sides of a crack by inserting a material that spans the crack, rejoining the two parts of the wall. Cracks in earthen walls can be stitched with a variety of materials, including new earthen blocks, wood, or textured fiberglass rods (figure 7.16). In Al Ain, new

earthen blocks are generally used for stitching. In this case, the cracked earth blocks are to be replaced with a new, whole block. Following this, the crack is grouted with liquid mortar to fill the space.

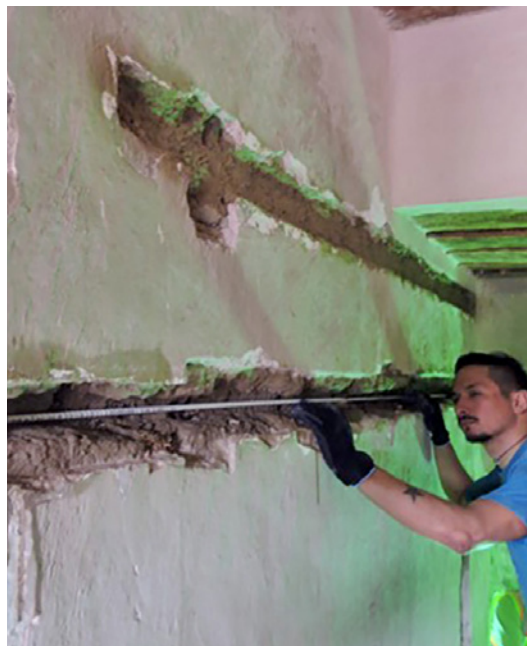
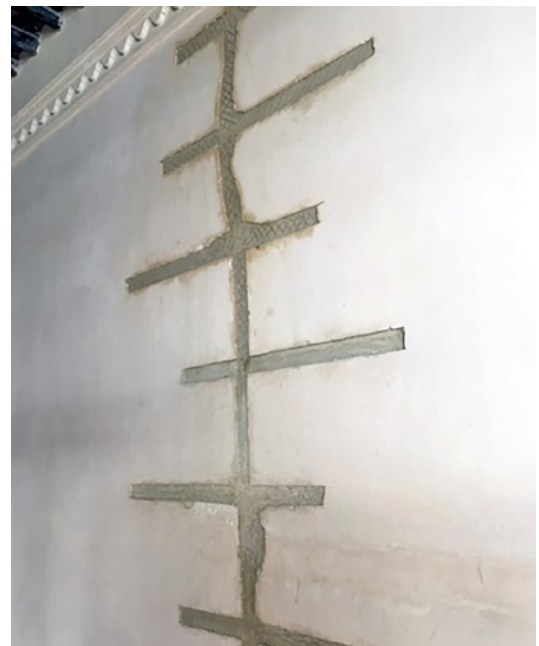
FIGURE 7.17. Stitching of cracked earth block masonry with fiberglass bars (a). The arrangement of the needles should be staggered (b).
Source: ZRS, Christof Ziegert.

Needling is another stitching technique that can be used to increase the connection between the two sides of a crack in an earthen wall. This involves cutting slits about 5 cm wide and 10 cm deep perpendicular to the crack banks and inserting fiberglass rods embedded in hydraulic lime mortar (figure 7.17). Fiberglass needles have a low thermal expansion coefficient and a low Young’s modulus (how easily a material can stretch or deform), making them more compatible with earthen material than metallic rods such as stainless steel, for example.

Properly set into the wall with mortar, the needles provide additional reinforcement, helping to stabilize the structure and prevent further cracking. For corner cracks, a combination of needles with end anchors may be necessary. This is because the separated corner may not provide sufficient anchorage length for the needles alone. By combining fiberglass rods with a surface anchor, the structural integrity of the corner can be restored effectively. Needling is a mostly nonreversible intervention and should be used only if other options for strengthening are not possible or not appropriate.

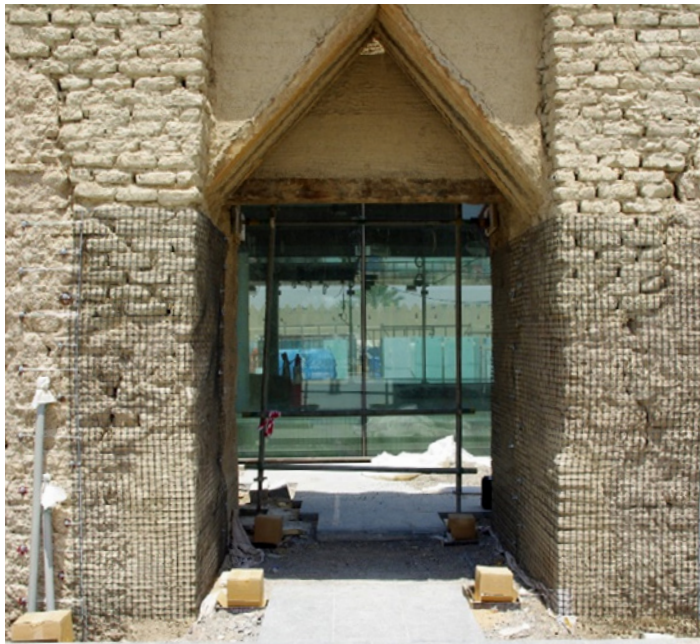
FIGURE 7.18. A polypropylene geomesh wrap is anchored to an entrance at Muwajji Fort, Al Ain, to strengthen the union of original nineteenth-century masonry and earth blocks added later during restorations in the twentieth century. Source: ZRS.

The mesh is anchored into sound masonry at two ends so that it binds the masonry tightly. Anchoring of the mesh can be done with steel bars and screws or bolts to fix the assembly in place. This technique provides an additional layer of support, helping to distribute forces and prevent movement. A mesh wrapping intervention was carried out at the southern gate of Muwajji Fort, Al Ain, to stabilize the intersection of earth block masonries of different periods. The nineteenth-century masonry and a 1980s restoration were not well joined, and the mesh wrap ensured that the two masonry zones acted as one structural unit (figure 7.18). After the wrapping, the area was covered in earthen plaster.

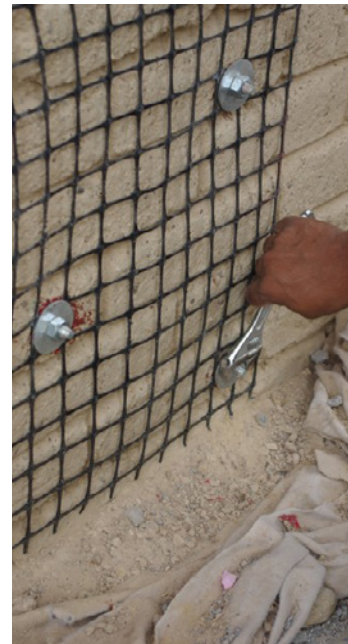
FIGURE 7.19. Horizontal reinforcement of the joints with geomesh strips. The positioning follows possible tensile stress orientations. The material is spread into the joint mortar. Protective masonry reinforcement at the White Temple in Uruk, 3500 BCE. Source: ZRS, Christof Ziegert.

Additionally, in some instances, horizontal reinforcement using geomesh can be employed to further enhance the strength of the structure (figure 7.19). This is useful, for example, for geometrically difficult additions to existing structures or to improve earthquake resistance, as explained later in this chapter.

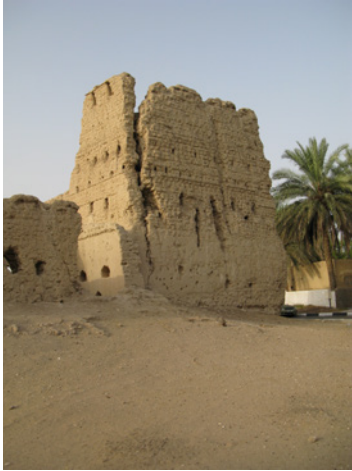
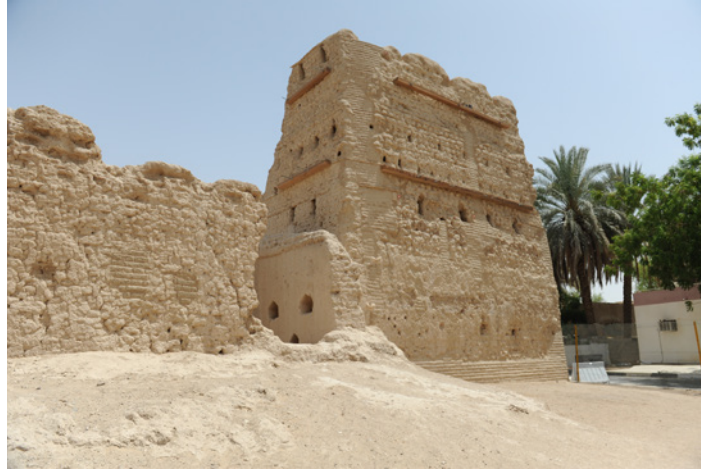
FIGURE 7.20. Various examples of timber and metallic anchoring systems used to create or restore the connection between walls. Source: ZRS, Christof Ziegert.

In cases where walls require strengthened connection and higher tensile forces are expected, systems of anchoring may be necessary. This can involve re-creating the boxlike structural stability of a building through a series of long timber or metallic anchors fixed in place with a perpendicular end such as a wooden or metal plate. This system is often used to strengthen wall connections where the existing floor beams are not adequate to do so or when the floors or roofs have been lost and the structure will be stabilized as a ruin (figure 7.20).

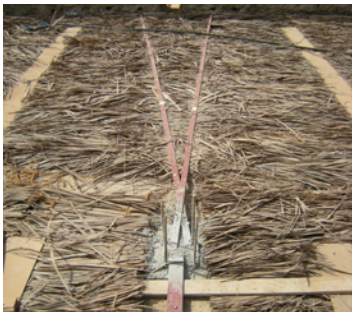
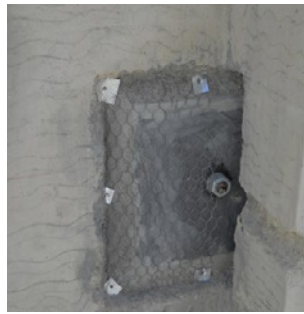
FIGURE 7.21. A ring beam in fiberglass to be filled in with lime mortar. Old Palace, Doha, Qatar. Source: ZRS, Christof Ziegert.

Often these traditional ring beams are rotten or eaten by termites and other insects and must be replaced. Because this is almost impossible when the ring beam is located between the floors of a multistory building, it can be replaced by narrower systems such as fiberglass rods and the remaining cavities are filled (figure 7.21).

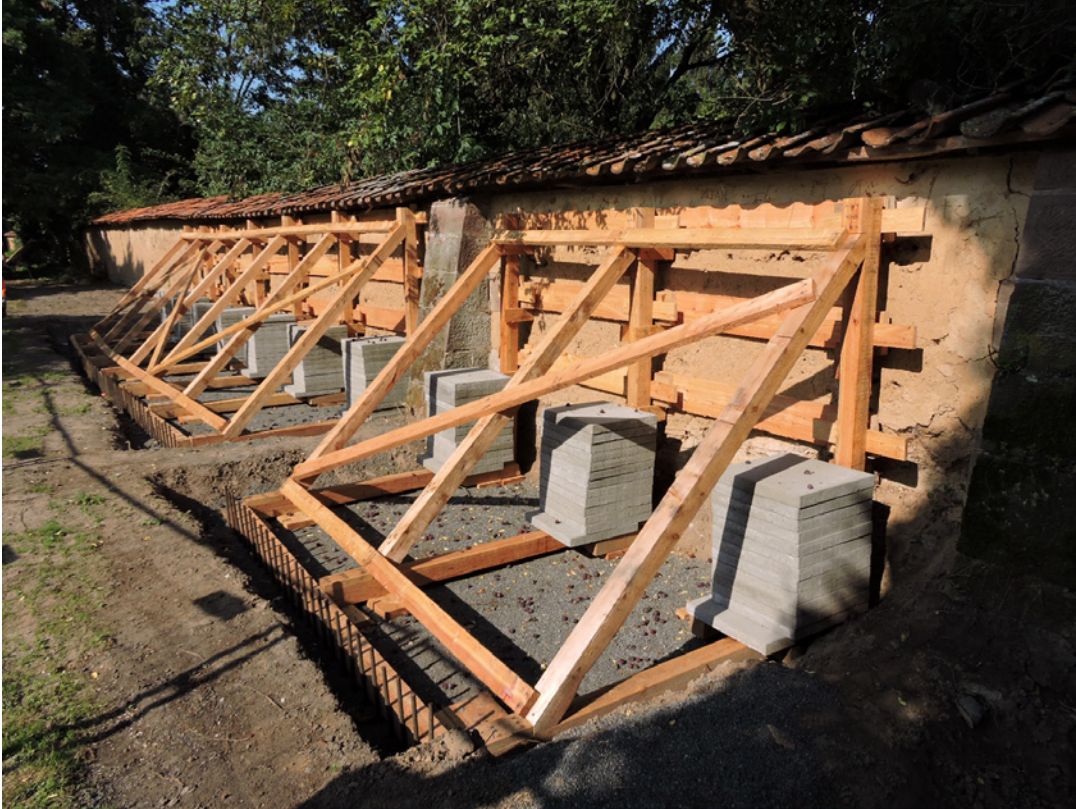
FIGURE 7.23. Timber system for an unstable earthen wall in Germany. Source: ZRS, Christof Ziegert.

For structural interventions, stabilization of the building system via external or internal shoring is a high priority. This provides temporary protection from further damage or collapse while the building is undergoing repairs. Shoring materials can range from simple wooden single-beam supports (figure 7.22) to more sophisticated systems made from steel or wood (figure 7.23). Buttresses are often added as a permanent structural solution for walls that lack lateral stability and support or are in seismic zones and are vulnerable to collapse during a seismic event. Buttresses significantly change the visual appearance of a structure, so they must be carefully considered as a modern solution for permanent structural support (figure 7.24).

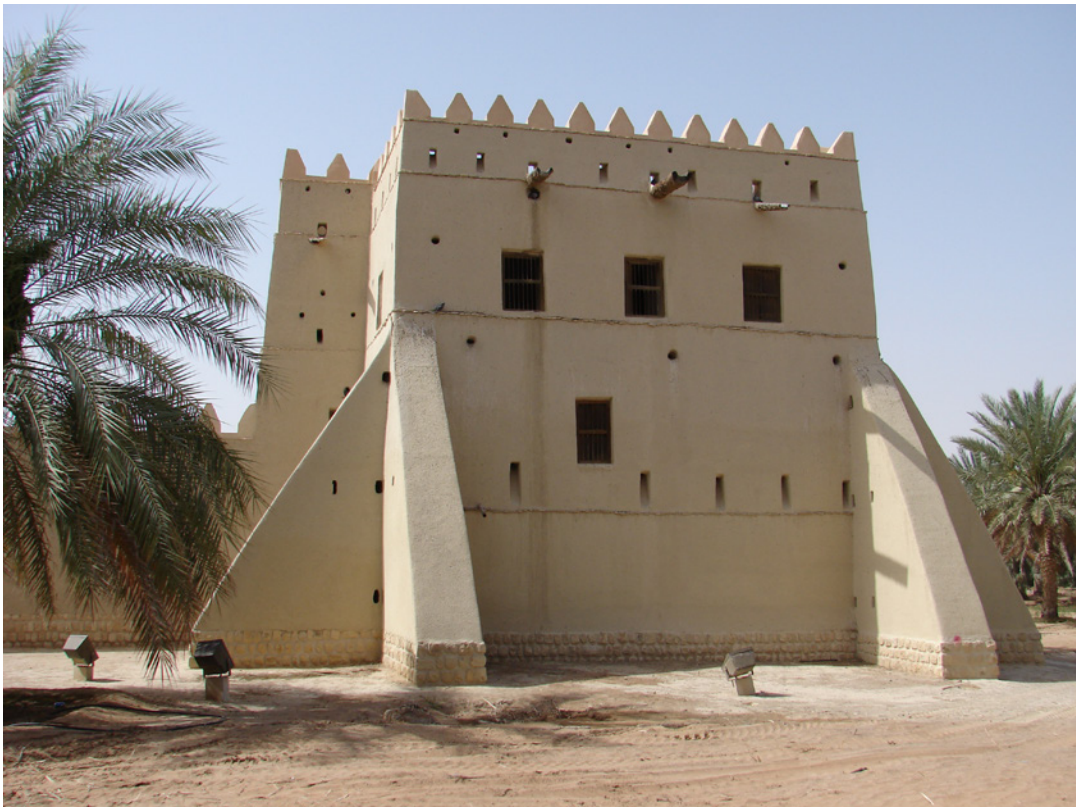
FIGURE 7.24. Historic mud-brick masonry buttresses at the North-West-Tower of the Muwajji Fort, Al Ain, UAE. Source: ZRS, Christof Ziegert.

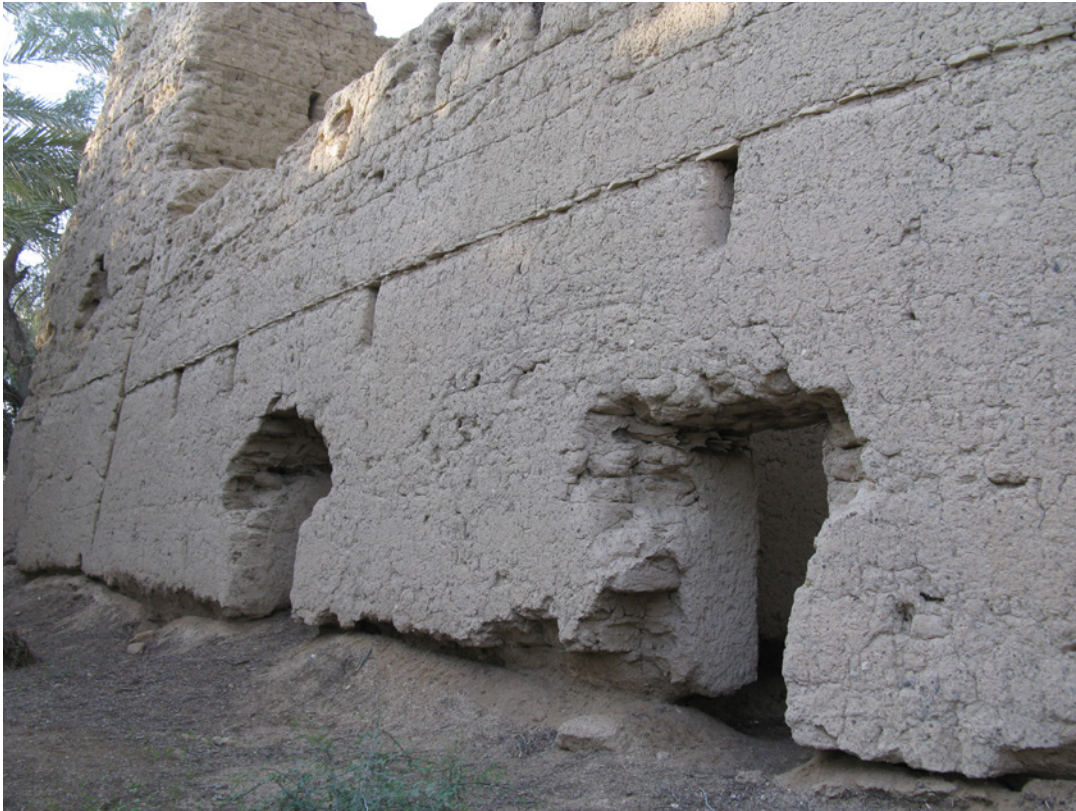
FIGURE 7.25. Bin Biduwa House in its former state, close to collapse. Al Ain, UAE. Source: ZRS, Christof Ziegert.

The building had long suffered from rising damp and basal erosion due to active irrigation around its foundation. Once the irrigation was stopped, archaeological investigation confirmed the age and construction chronology of the structure as well as revealed deep basal erosion that affected both sides of the foundation (figure 7.25), severely reducing the wall profile and the structural stability of the massive walls.

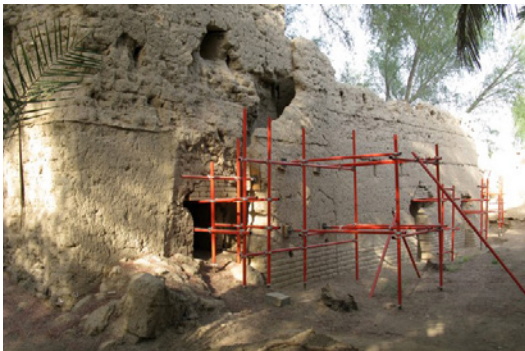
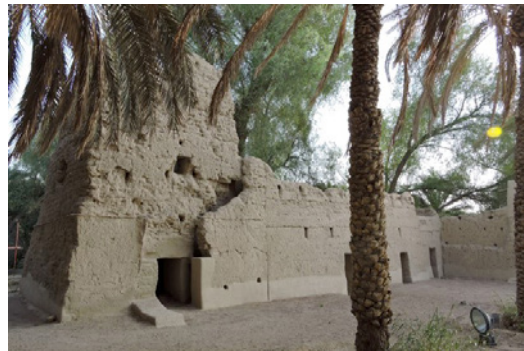
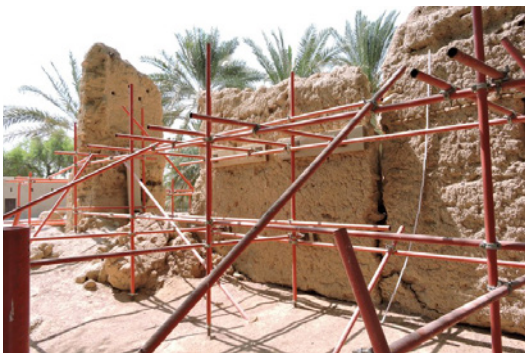
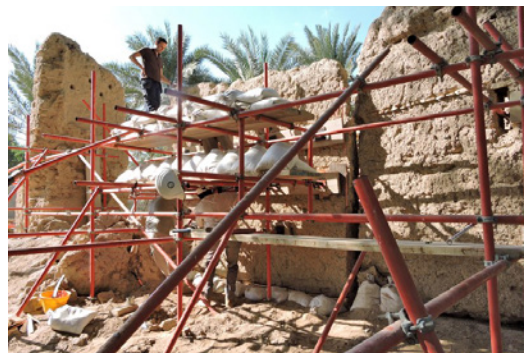
FIGURE 7.26. (a) Stages of repair and (b) in the safe stage, able to stay without support and without hazard for the visitors. (c) Straightening of a wall section of 20 m². (d) pushing the wall back into alignment using shoring, jacks and counterweights. Bin Biduwa House, Al Ain, UAE. Source: ZRS, Christof Ziegert.

In some areas, reconstruction of lost components was carried out to structurally support the remaining original components. This measure had to meet the condition that historical geometry could be achieved again without conjecture, based on historical photos and archaeological evidence of the foundations. The added components were finished with a smoother earthen plaster to be differentiated from the original components (figure 7.26a and b).

One notable example of the reconstructed components was the main old gate. The gate had partially collapsed, and the adjacent walls suffered from some structural instability. An approximately 20 m² section of wall, which had to be supported by shoring due to its extreme inclination, was straightened gradually in one day (figure 7.26c and d). The special challenge here was that the wall needed to be pressed up evenly over the entire surface to prevent it from breaking into several pieces. Once straightened, the walls were reconnected with new mud brick and earthen grout to rejoin the wall to the larger structure.

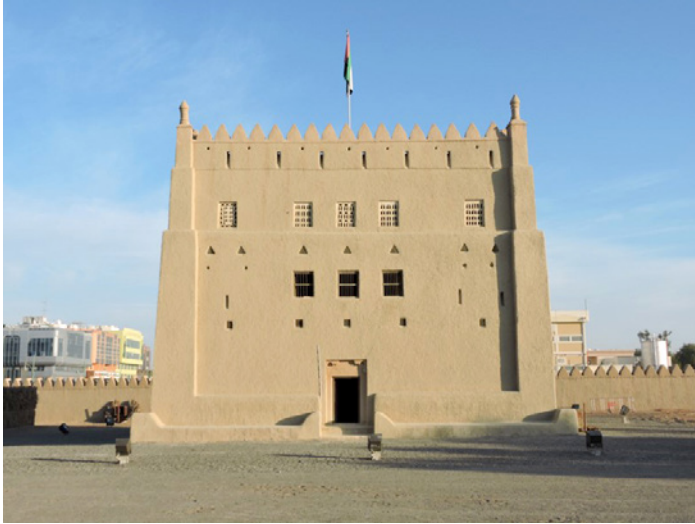
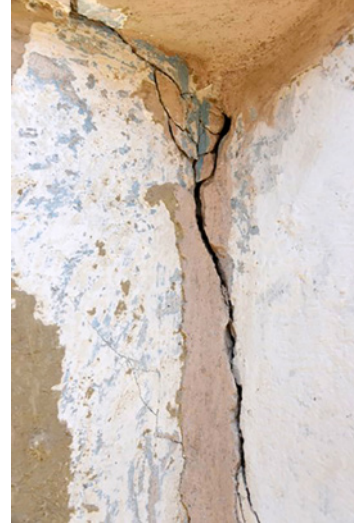
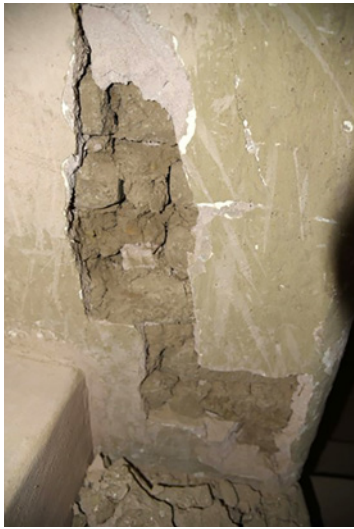
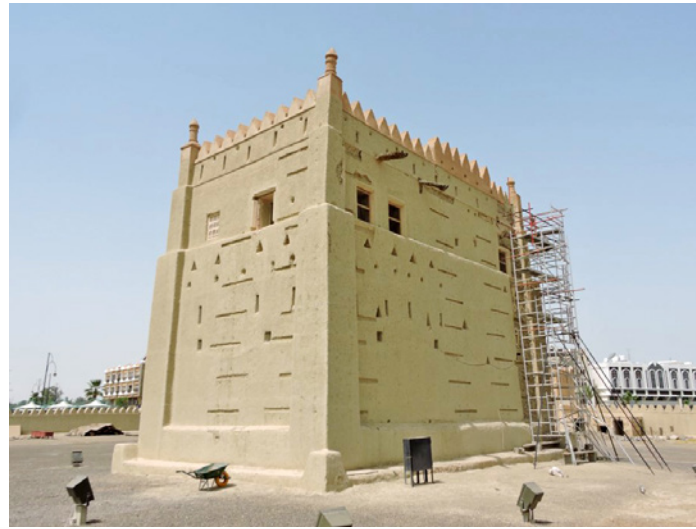
FIGURE 7.27. (a) Murabb'a Fort Tower, Al Ain. (b and c) Structural cracking was prevalent throughout the building, risking potential collapse. (d) View of Murabb'a Fort exterior showing structural interventions before being replastered. Source: ZRS.

The main structure of the Murabb'a Fort, in the city center of Al Ain, is its tower. Built of earthen blocks, the tower is one of the few three-story earthen block buildings in the UAE (figure 7.27a). The tower has historic value as the first police station in the region. The building is to be made accessible to the public again. For this, stability needed to be reestablished, and an appropriate level of safety needed to be achieved.

A part from the stabilization of the north wall, it was urgently required to strengthen the staircase column to prevent a collapse (figure 7.27b and c). The following options were considered:

The needling option was chosen, as it was the least destructive choice and maintained the authenticity of the historic elements while preserving historically significant fabric (figure 7.27d).

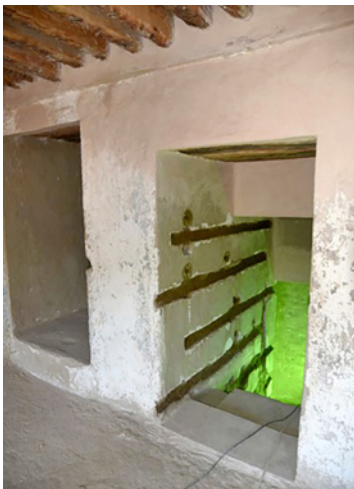
FIGURE 7.28. Insertion of fiberglass needles across critical cracks. Source: ZRS, Christof Ziegert.

For needles to be laid transversely and diagonally, access channels were drilled out. The mortar, prepared in a liquid state, was filled in the access channels to flow in by gravity prior to the insertion of the needles. Once inserted, each fiberglass stitch was mortared in place and covered with earthen plaster (figure 7.28).

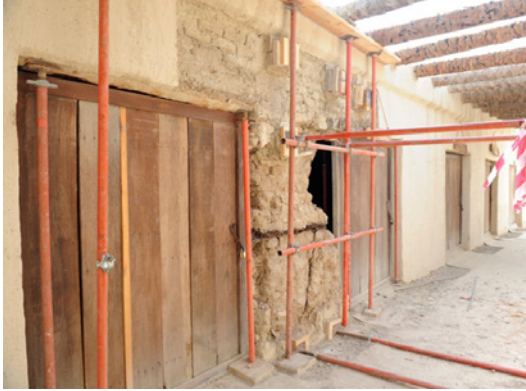
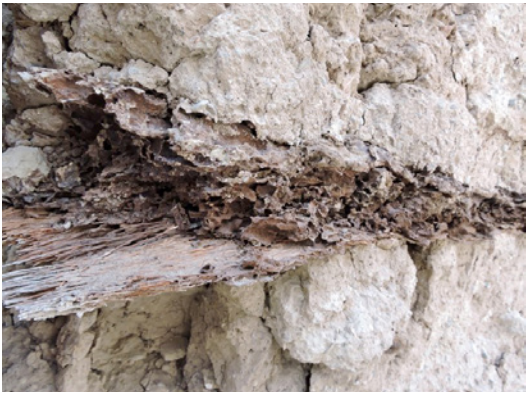
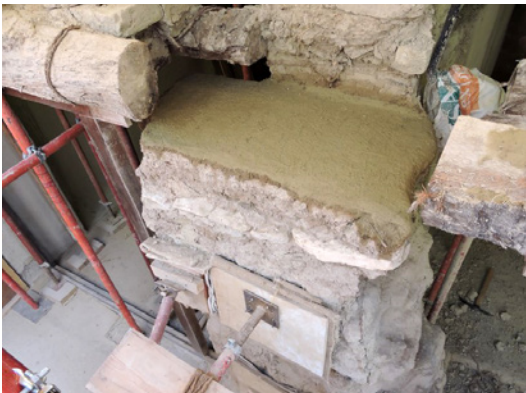
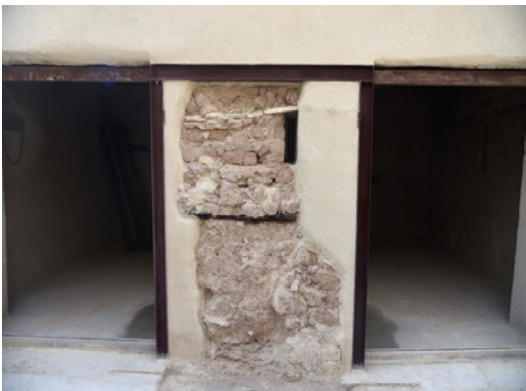
FIGURE 7.30. Collapsed masonry because of a flat-tened damaged lintel. Al Ain, UAE. Source: ZRS, Christof Ziegert.

In 2018, without any external influences, settlement and cracks were noticed on a column between the shop windows, and a shell of earth block masonry fell into the interior of one of the shops. The building investigation showed that there were wooden lintels over a former window opening from an earlier construction phase and that these beams had been completely undermined by termite infestation and had lost their structural integrity (figure 7.30).

As a result, compression had occurred at the height of the beams, which led to the settlement of the upper section of the column and the roof, as well as the formation of cracks in the adjacent transversal wall. The wall was significantly weakened and, because of its function as a central load-bearing pillar, required careful structural intervention to strengthen it and support the weight of the wall and roof above.
