International Course on the Conservation of Earthen Architecture

ACCOMPANYING ESSAYS

Edited by
Benjamin Marcus
Alessandra Sprega
Claudia Cancino
Gayathri Hegde

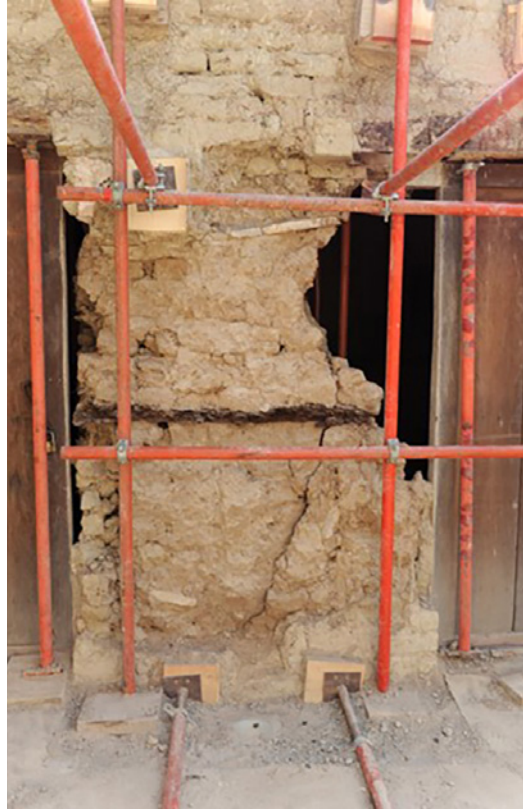
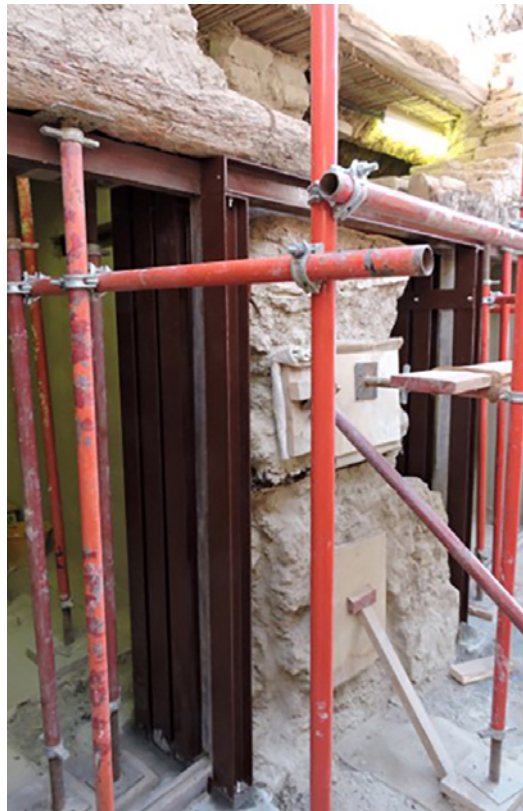
FIGURE 7.31. The slimline frame integrated for support blends in visually with the doorframe system. Al Ain, UAE. Source: ZRS, Christof Ziegert.

The last of these options, which was able to structurally support the load and resist termite damage, was chosen and successfully implemented (figure 7.31). Visitors can now experience the different building phases of the building at this point, and its stability has been reestablished.

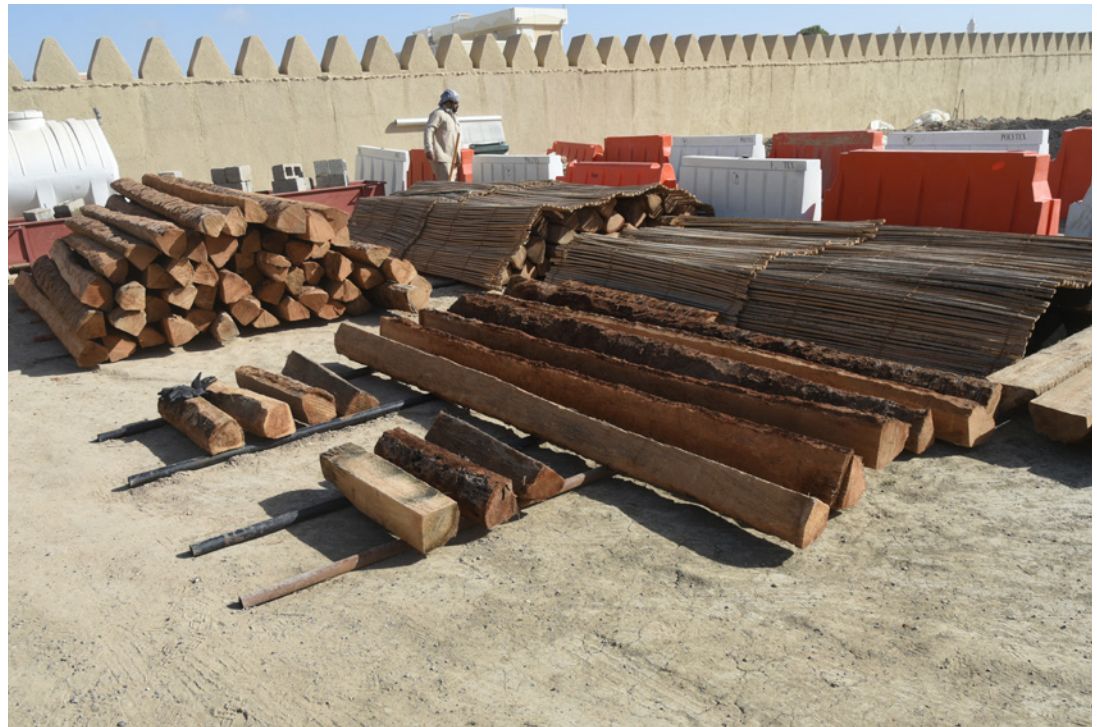
FIGURE 7.32. Stored roofing materials, including woven mats and palm trunks. Source: DCT Abu Dhabi.

Since the Bronze Age (circa 3000 BCE), the ubiquitous construction materials for roofing in desert areas of the region have been earth and palm trees. And so, naturally, most of the vernacular buildings in the seven oases of Al Ain were historically built of mud-brick masonry and mud mortar and made use of the palm tree trunk, the palm fronds or branches, and the palm leaves to construct the roofs (figure 7.32).

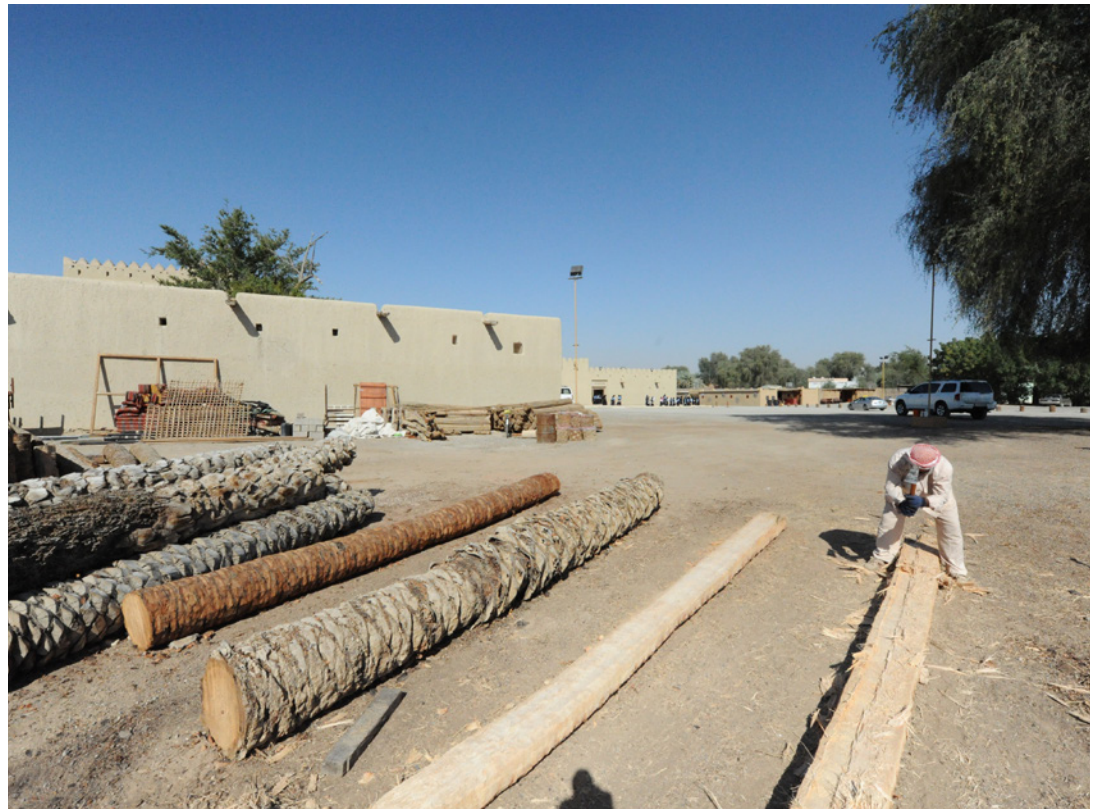
FIGURE 7.34. Traditional method of preparing palm beams at the DCT workshop: palm trunks are usually sourced from old trees, dried over a period of three to six months, cut down to size, and stored until needed. Source: DCT Abu Dhabi.

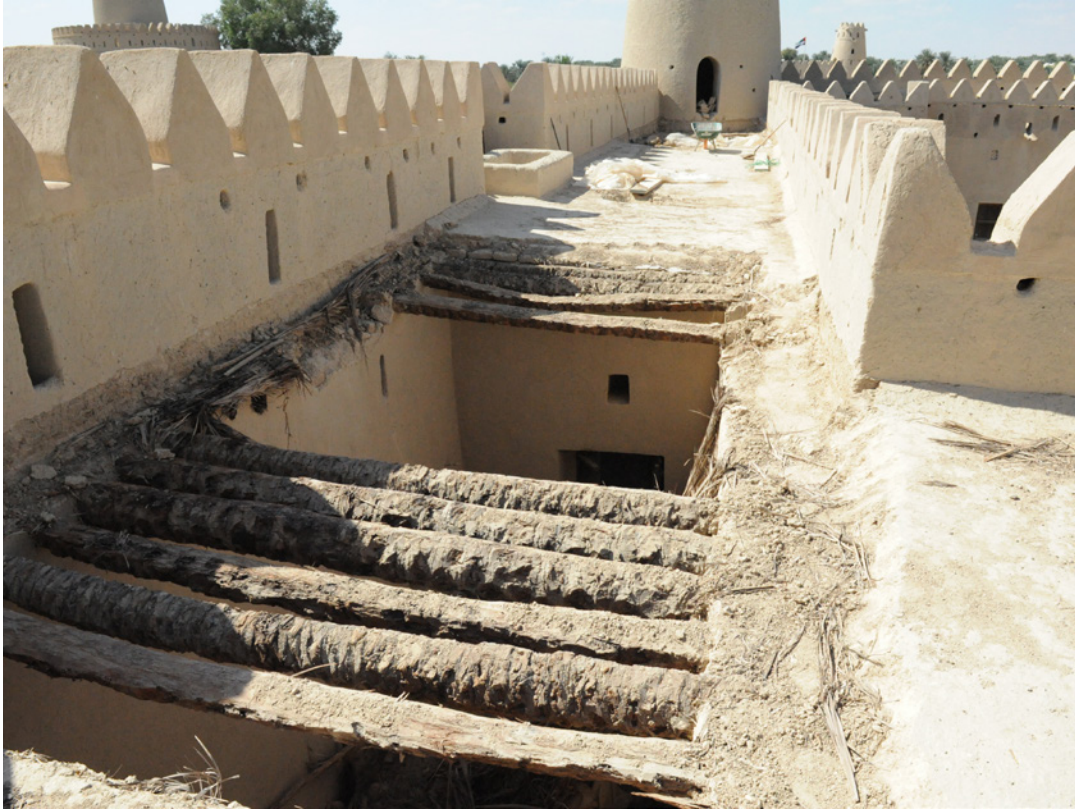
FIGURE 7.35. A closer look at the layers of the roof at Al Jahili Fort before restoration: after removing the layer of mud and palm branches, the beams were exposed. The rectangular opening leading to the water spout can be seen in the background. *Source:* Aqeel Ahmed Aqeel, DCT Abu Dhabi.

(figure 7.35). The beams are laid alongside each other, about 25–30 cm apart and in opposite directions to counterbalance the strong and weak points of the trunk and evenly distribute the weight of the roof. The beams' ends are generally encased by the masonry (figure 7.36), which continues about three mud-brick courses (50–80 cm) above the level of the beams.

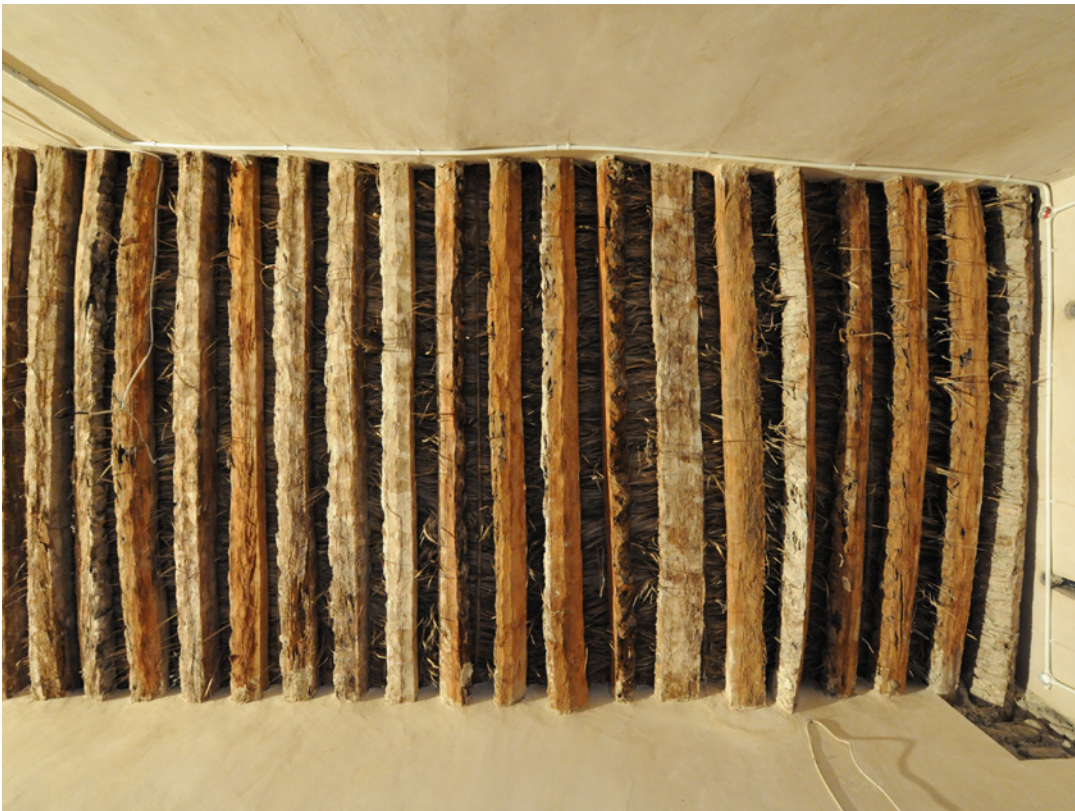
FIGURE 7.36. Looking up at the ceiling in Al Jahili Fort, showing the palm beams from the interior. *Source:* Aqeel Ahmed Aqeel, DCT Abu Dhabi.

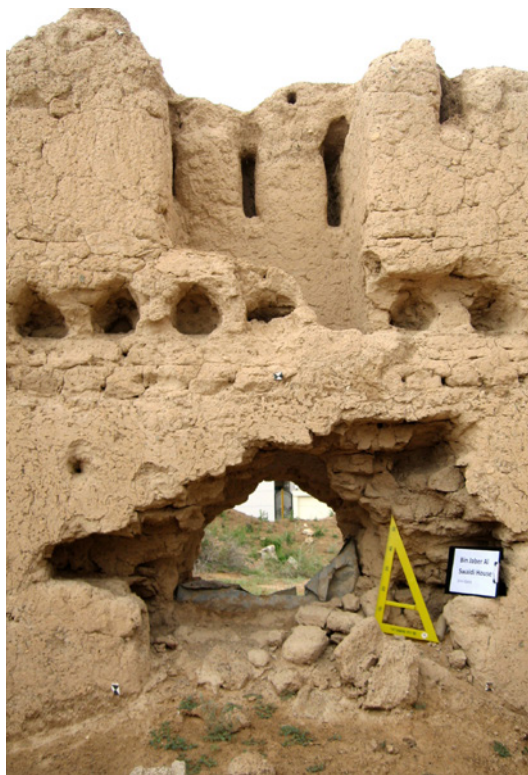
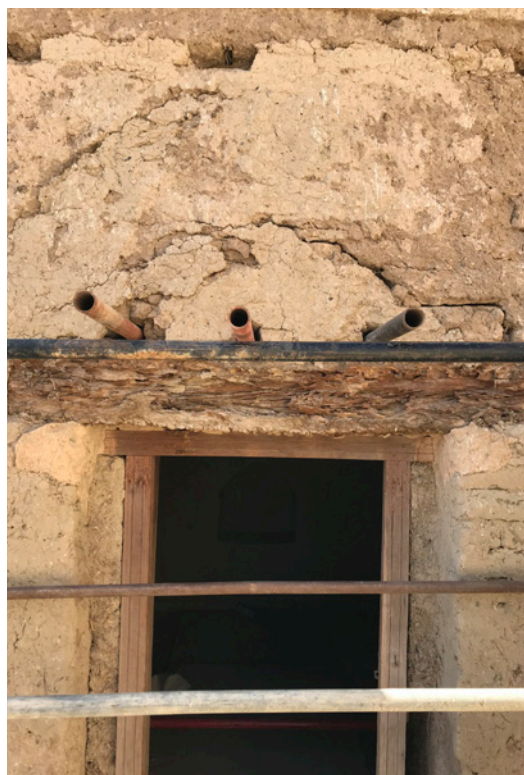
FIGURE 7.37. (a) A building without its roof: the round cavities in the walls of Bin Jaber House used to hold the roof beams. The absence of a roof led to the deterioration of the mud-brick walls. *Source:* A. Malekabbasi, DCT Abu Dhabi. (b) Severe termite infestation caused the beam above the door in Bin Hilal Fort to sag. *Source:* DCT Abu Dhabi.

The degree of infestation is a function of the site environment, the type of wood substrate, and the size of the nests and their location with regard to the building. Not only can termite nests be unsightly to the appearance of the building, but the burrowing nature of these insects can rapidly affect the structural integrity of the infested elements, with the risk of losing original and historical fabric. Termite infestation must be professionally assessed, including the extent of the infestation and degree of damage, identification of termite species and wood species, and proposed solutions that are compatible with conservation aims and methodology.

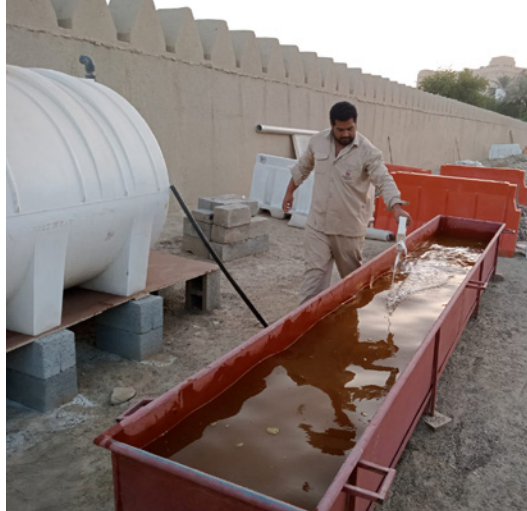
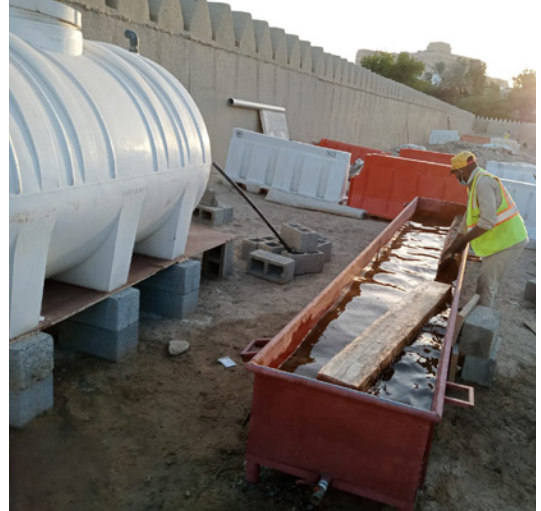
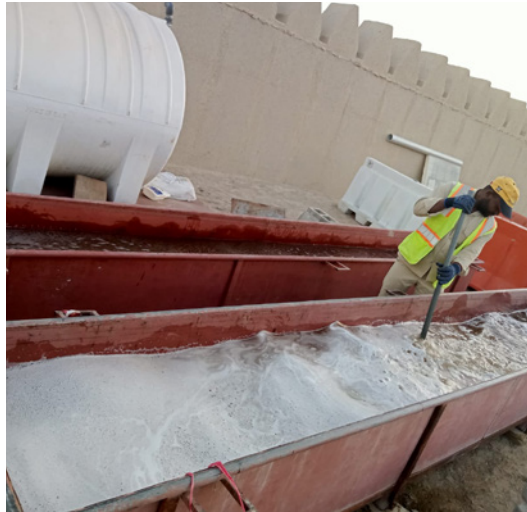
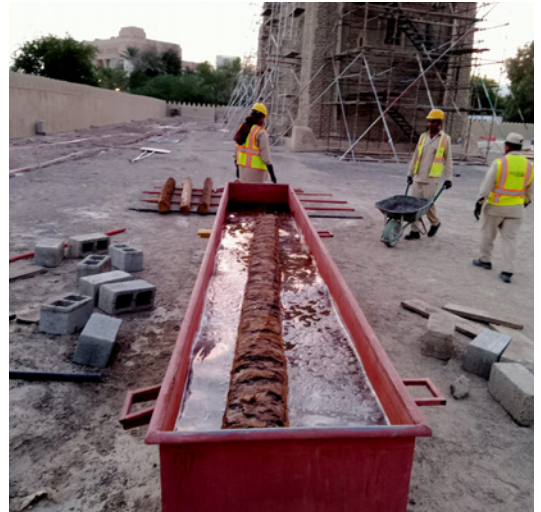
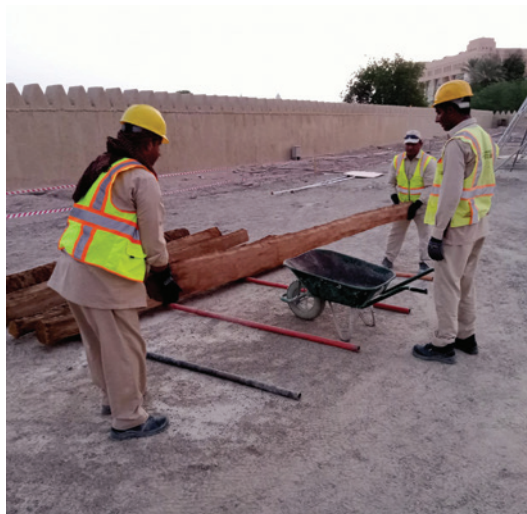
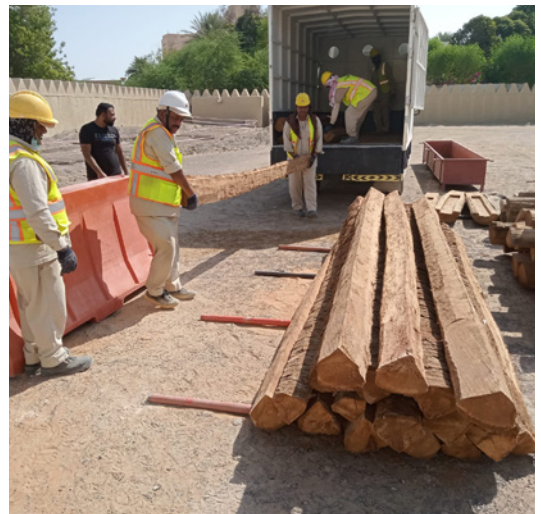
FIGURE 7.38. Prior to installation in a building, the wooden elements are chemically treated to prevent termite infestation: they are first soaked in a chemical bath for a day and then dried for about three weeks depending on climatic and environmental conditions. Source: DCT Abu Dhabi.

Chemical pretreatment of beams includes borate-based treatments such as disodium octaborate tetrahydrate, and these are commonly used to protect wood against termites. These chemicals are effective at deterring termite infestations and can be applied as sprays or absorbed into the wood via a soaking tub (see beam treatment process, figure 7.38). In all cases, a monitoring regime is necessary to check the effectiveness of the implemented methods.

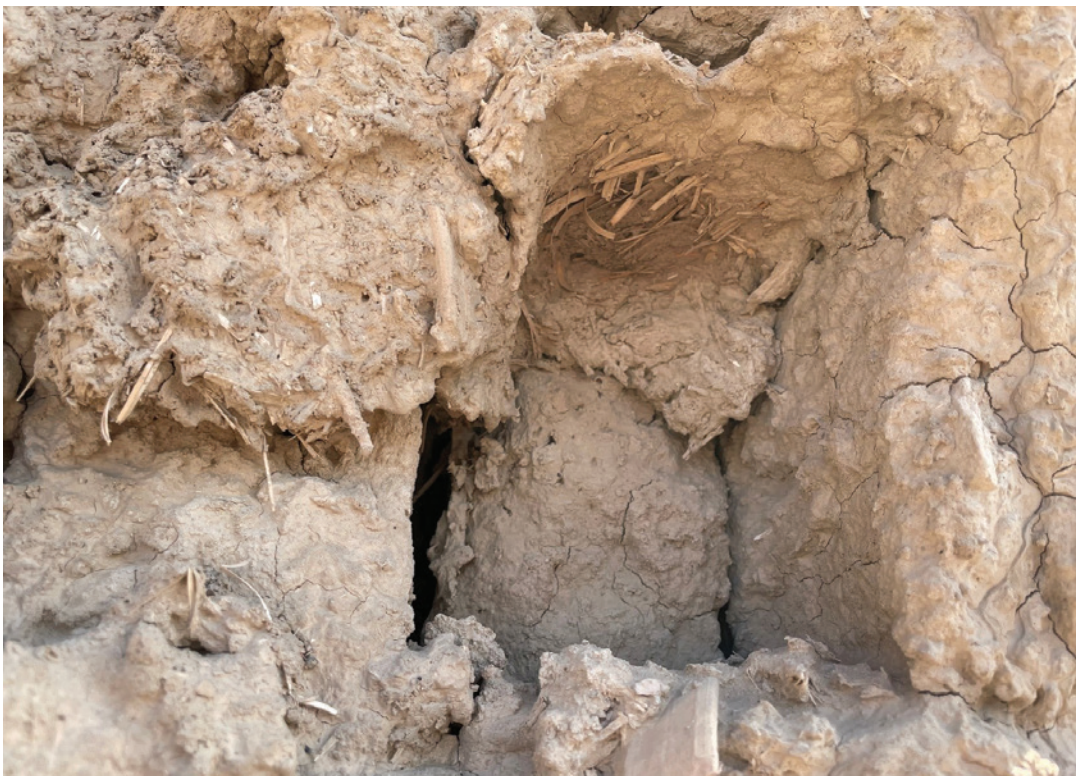
FIGURE 8.1. Historical earthen plaster made of earth and fiber. Source: ZRS, Christof Ziegert.

Historic earthen plaster consists of suitable earth—in some cases, aggregates including larger grained gravel—and fibers (figure 8.1). However, mixing additional gravel into historic earthen plaster was not a common practice, as sand was more expensive. Additional gravel reduces the shrinkage ratio of earthen plaster and increases water resistance. However, it also influences workability and visual appearance (figure 8.2). Traditionally, various additives, such as cow dung and cactus juice, were also added to earthen plasters to increase water resistance. Soaking an earth-straw mixture over a period of days to weeks causes fermentation, resulting in a workability similar to adding cow dung. Adding cement, lime, or gypsum to earthen plasters—to shorten curing time—is not recommended, as these binders dominate the behaviors of the plaster, and the resulting mixture is more of a stiff cementitious plaster rather than an earthen plaster.

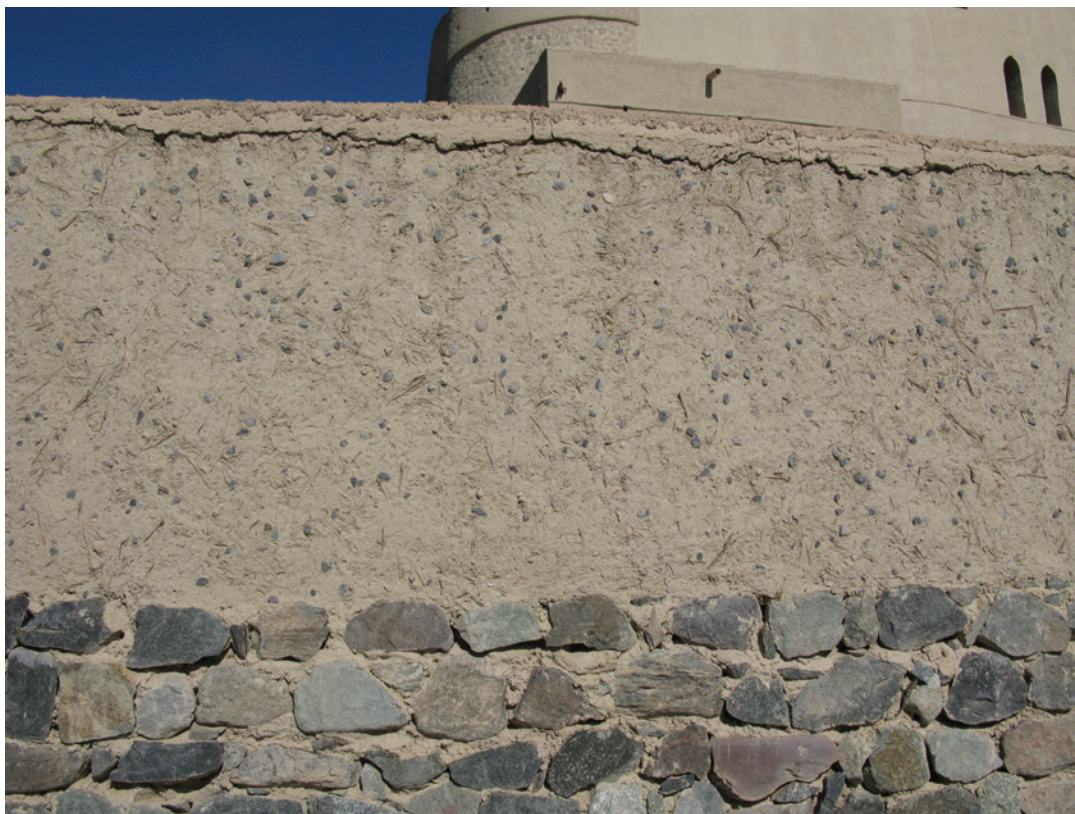
FIGURE 8.3. The different fibers of the base and top plaster can be seen in the core drilling. While the base coat contains coarser straw fibers, fine flax shives are visible in the top coat. *Source:* ZRS, Christof Ziegert.

The amalgamation of plant fibers and mineral aggregates is pivotal in enhancing the structural integrity of this material (figure 8.3). This composite proves effective in reducing the impact of shrinkage by absorbing tensile forces. Moreover, the introduction of plant fiber aggregates serves a dual purpose: they facilitate improved processability, particularly evident in the material's heightened suppleness, with cellulose fibers demonstrating exceptional efficacy in this aspect. Additionally, these fine fibers play a crucial role in bolstering water retention capacity. As reinforcements, they adeptly absorb tensile forces, effectively managing stress stemming not only from subsurface pressures but also from temperature-induced fluctuations.

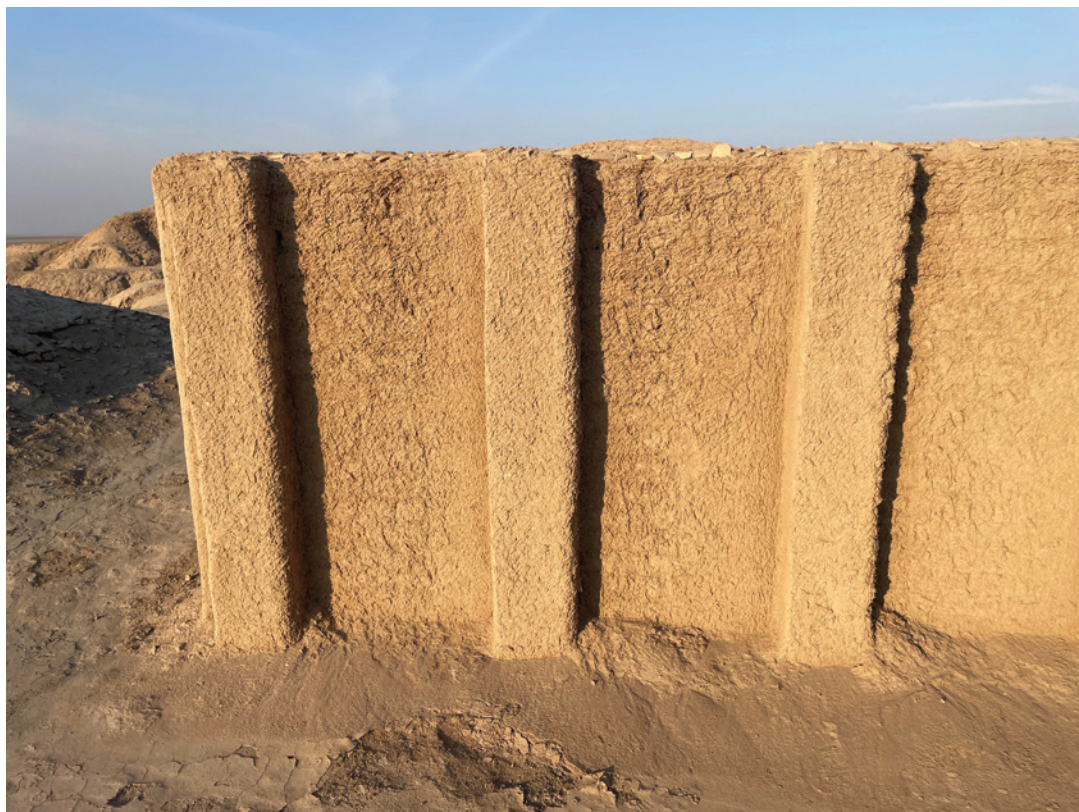
FIGURE 8.5. Earthen plaster sacrificial coating and capping on an archaeological site. The different color tones of the wall and the capping are problematic. With erosion, the color of the supplementary mortar will become mixed with that of the existing material. *Source:* Alessandra Sprega.

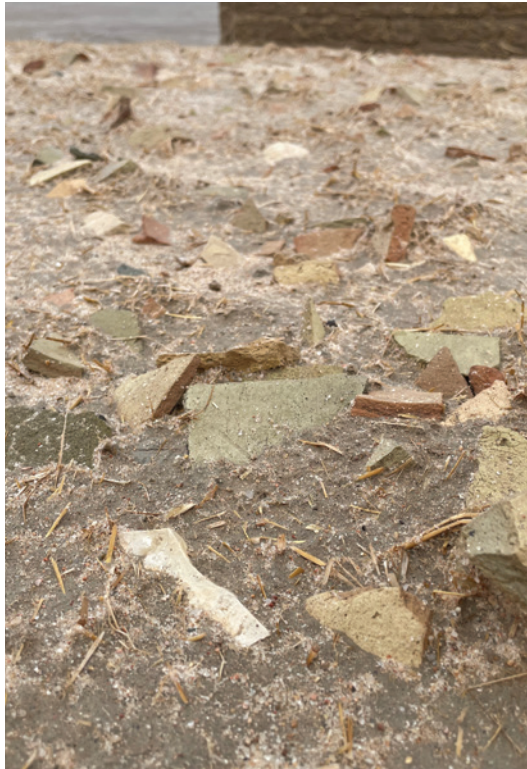
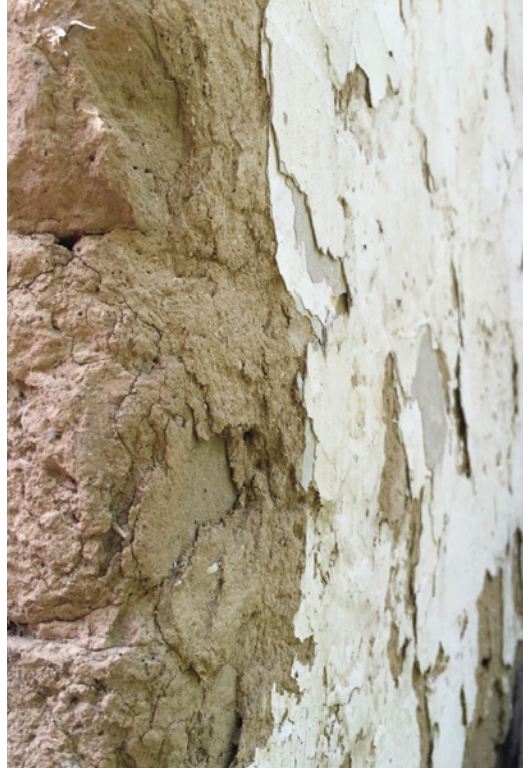
FIGURE 8.6. (a) Earthen plaster as capping on an archaeological site. The embedded ceramic shards significantly increase the weather resistance. Source: ZRS, Jasmine Blaschek. (b) Layer of lime wash over earthen plaster. Source: ZRS, Christof Ziegert.

Earthen plasters on historic buildings are often covered and protected with lime wash or thin lime-plaster layers to increase their weather resistance (figure 8.6b). Lime mortars should be soft and elastic. The choice of lime, however, only partially determines the plaster properties; the type of aggregates and the mixing ratio are equally important. Depending on weather conditions, lime wash should be reapplied after five years. Lime wash is light and flexible and allows for easy and fast application on earthen structures. However, it offers only limited weather resistance. If it is not maintained properly, imperfections may occur, causing the coating to look unattractive and become counterproductive, as water can penetrate the cracks. No or minimum hydraulic additives should be used in lime plasters; otherwise, the plaster will become stiff and separate from the substrate.

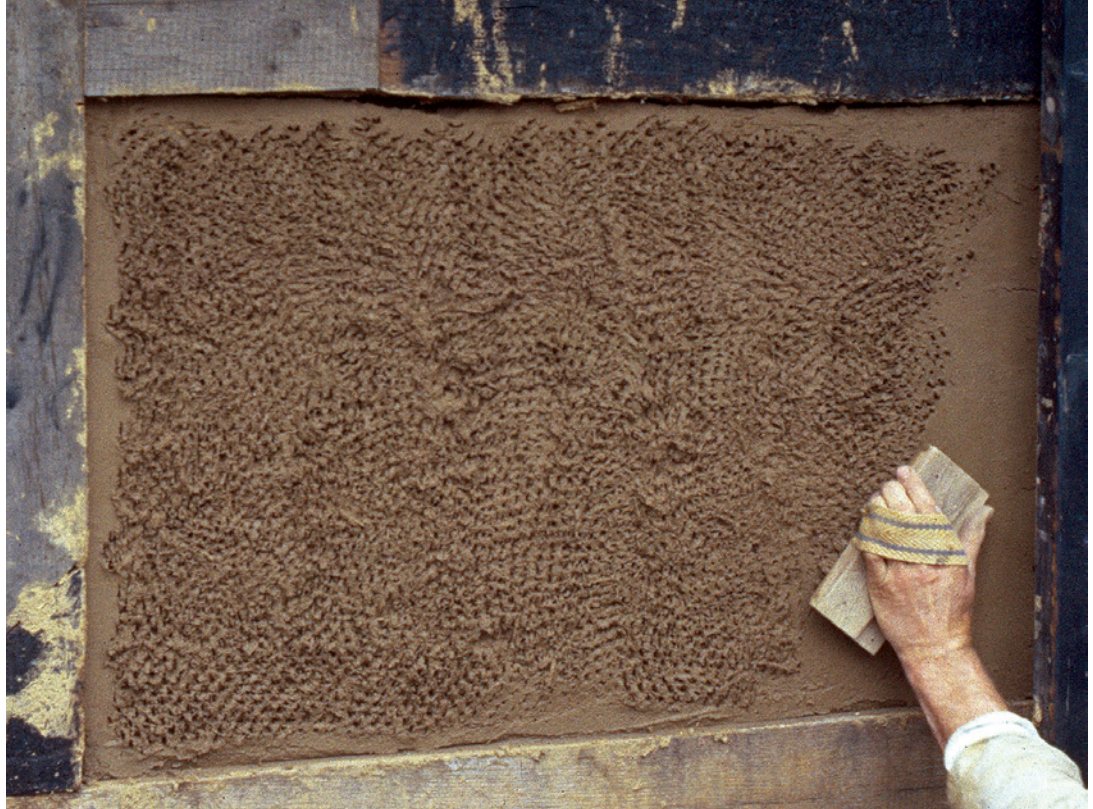
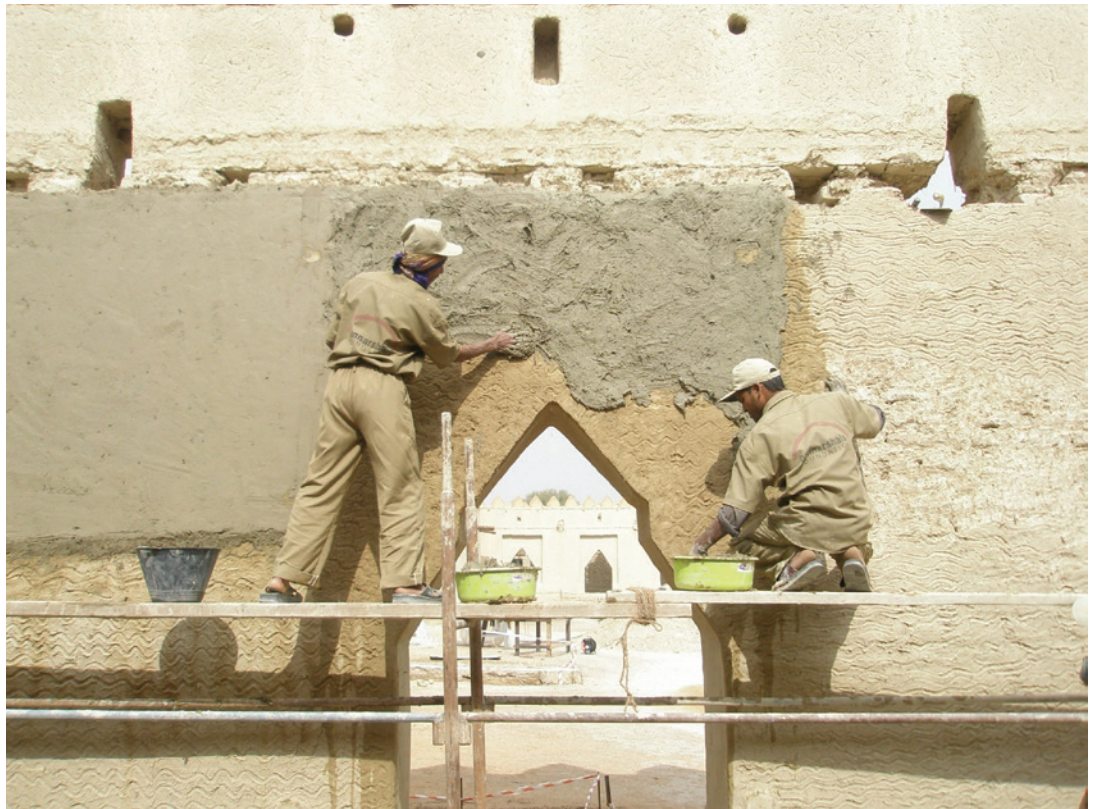
FIGURE 8.8. Application of earthen plaster on a masonry wall. *Source: ZRS.*

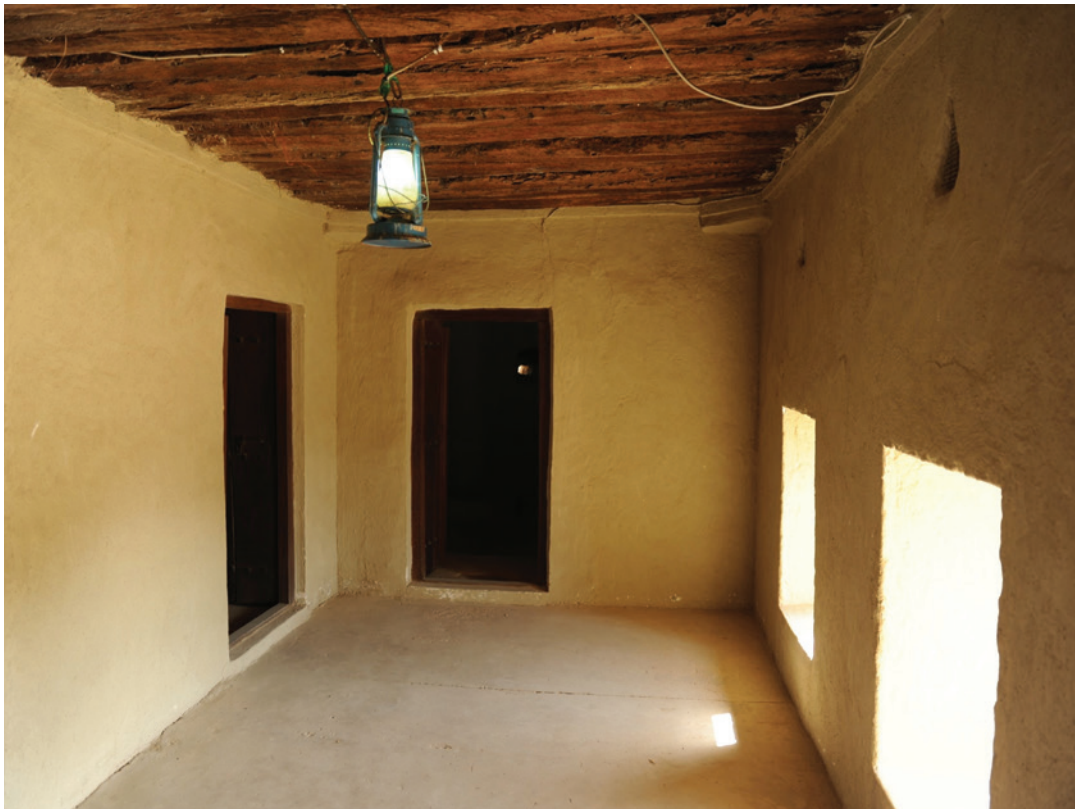
FIGURE 8.9. Earthen plaster in an indoor application.
Source: ZRS, Christof Ziegert.

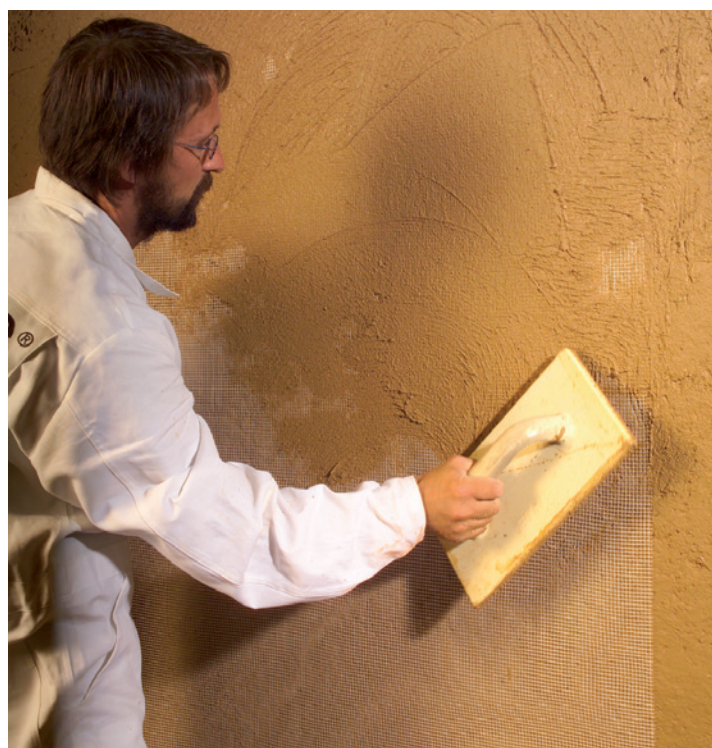
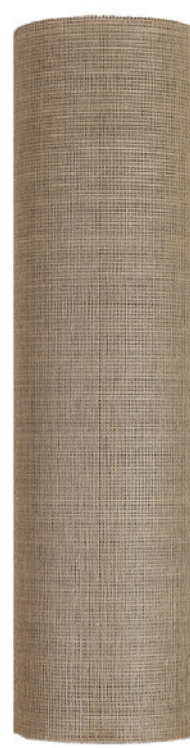
FIGURE 8.11. Insertion of flax fiber mesh. Source: CLAYTEC.

In historical plasters, fibers took over the reinforcement function and prevented cracks. However, as fibers are not always evenly distributed or ideally aligned, safe systems of plaster reinforcement with fabrics are often preferred today. The fabrics used in earthen plasters are often made of flax fibers or jute (figure 8.11). However, plastic or fiberglass fabrics are also used.

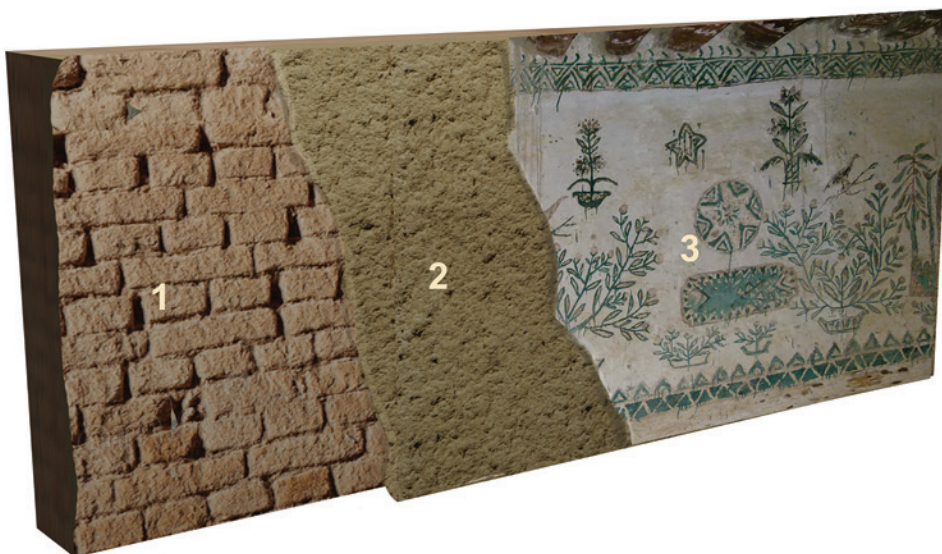
FIGURE 8.12. Stratigraphy of a decorated surface, showing (1) support, (2) render, and (3) layer of paint. Source: Clemencia Vernaza.

As shown in figure 8.12, the minimal stratigraphy of a decorated surface is formed by the substrate, the plaster, and the paint layer. In earthen architecture, the substrate can be made of adobe, rammed earth, cob, wattle and daub, or poured earth. The plaster is normally earth based, but lime-based and gypsum plasters are also common. Variations of this typical stratigraphy can include an intermediate layer called fine plaster, traditionally made of earth, gypsum, or lime, which provides a smooth surface to receive the paint layer.

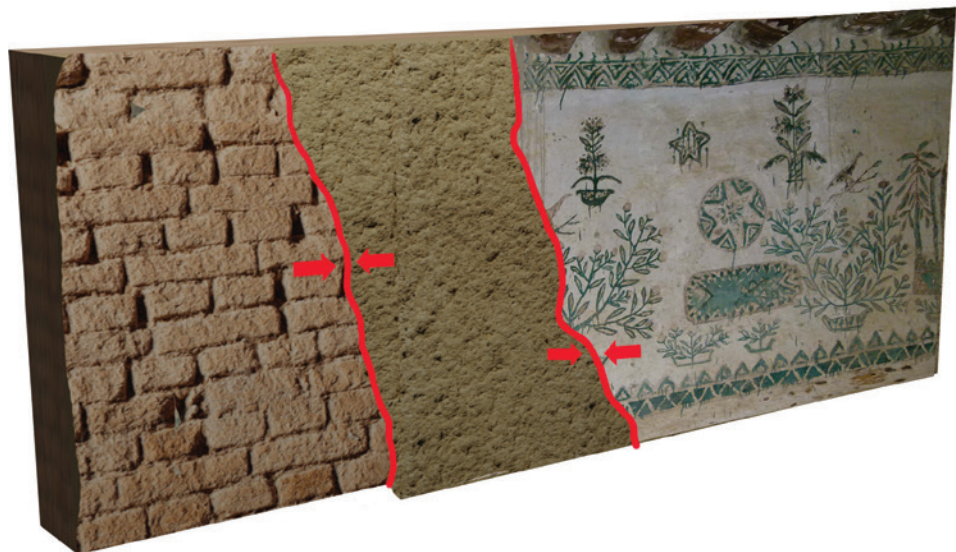
FIGURE 8.15. Locations of lack of adhesion, or detachment (in red), between support and render and between render and paint layer. Source: Clemencia Vernaza.

Lack of adhesion can occur due to internal or external factors and can appear between two layers: between support and plaster, between two plasters, or between fine plaster and paint layer (figures 8.15 and 8.16a). To repair, it is necessary to reconnect the layers by means of an adhesive. Stabilization of decorated surfaces refers to correcting the failure in the system caused by lack of adhesion and/or lack of cohesion.

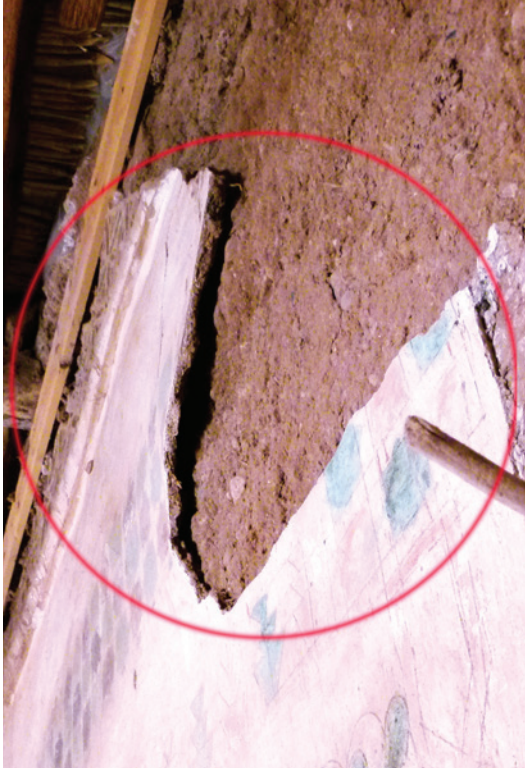
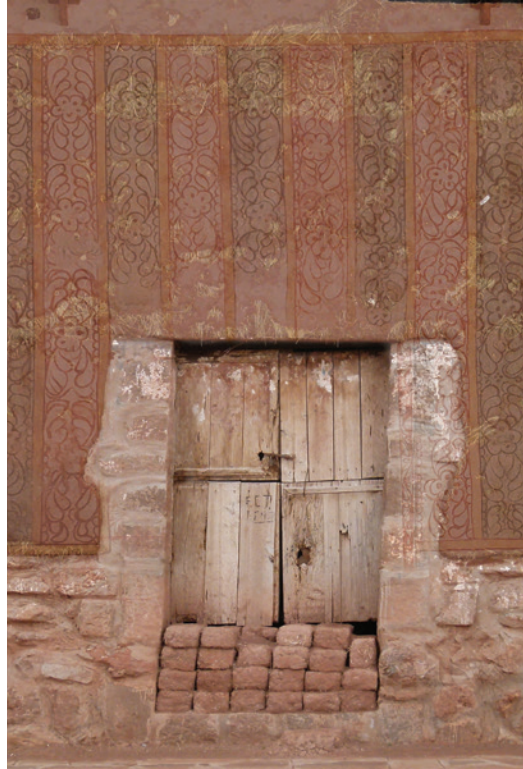
FIGURE 8.16. (a) Detachment between render and paint layer on a wall at the Kasbah of Taourirt, Ouarzazate, Morocco. (b) Photoshop montage from an adobe building in Peru and mural painting from Kuñotambo. Source: Clemencia Vernaza.

characteristics (figures 8.16b and 8.17). To address this, it is necessary to bond particles within the layer by means of a consolidant.

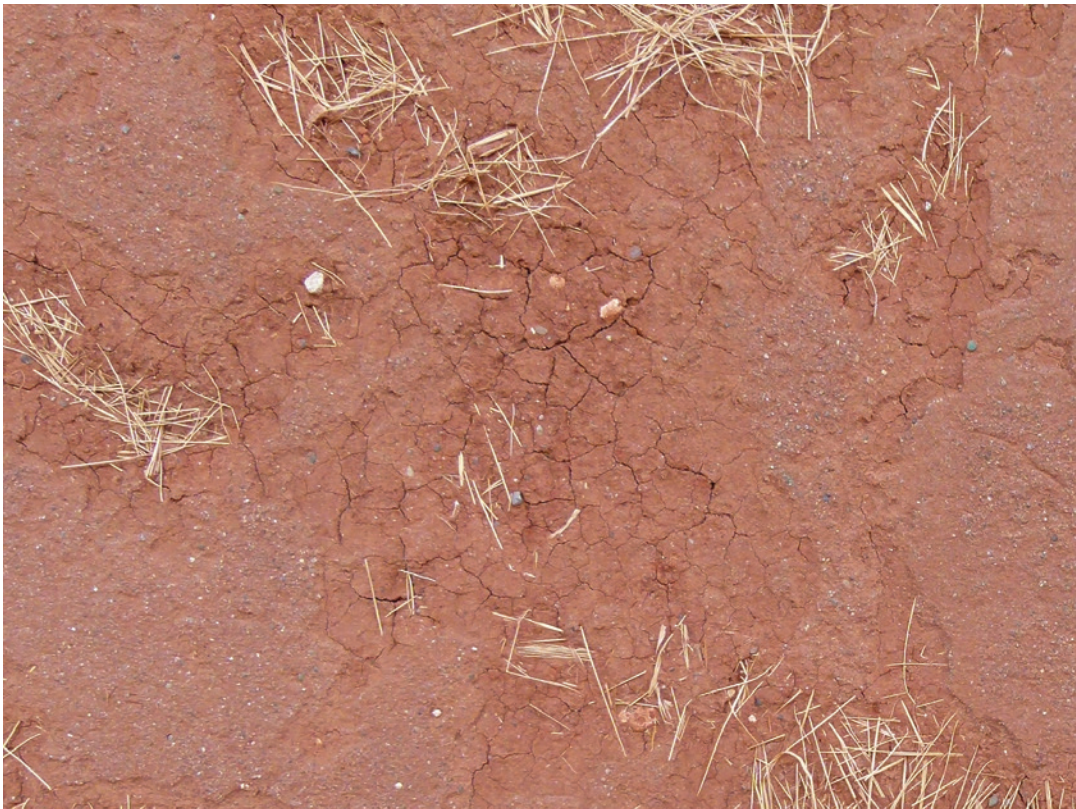
FIGURE 8.17. Detail of figure 8.20 showing the lack of cohesion of a weathered wall from a private house in Peru. Source: Clemencia Vernaza.

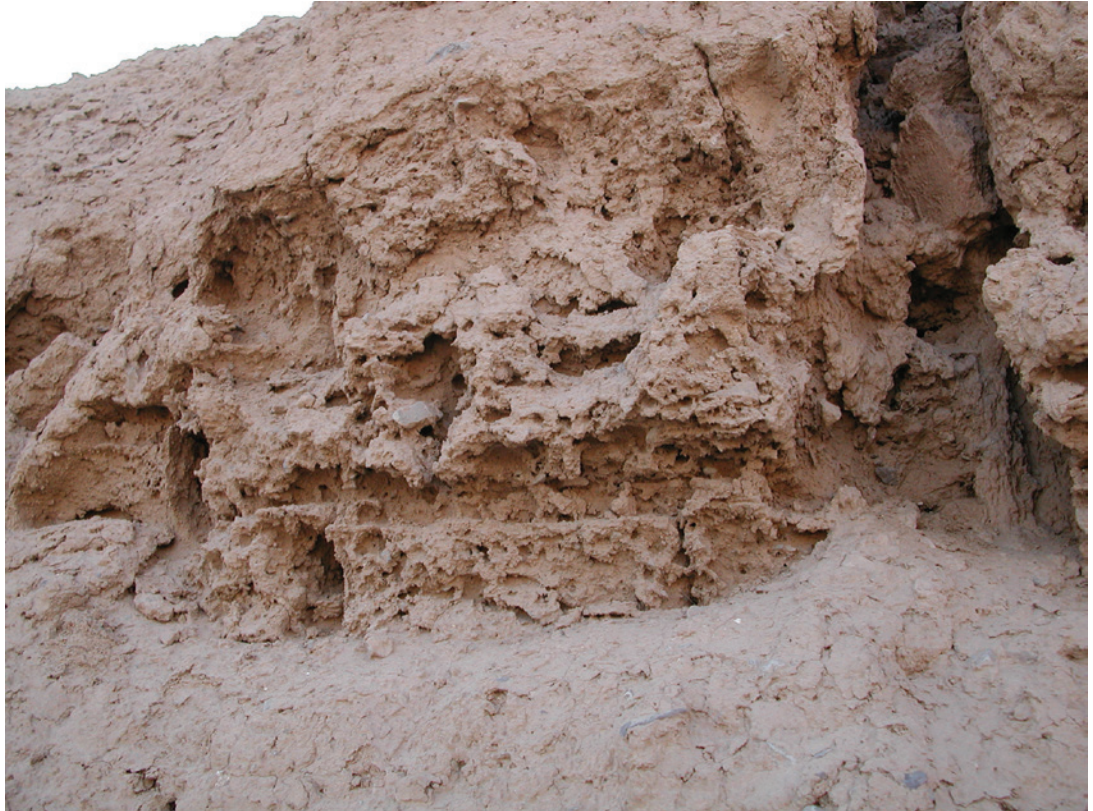
FIGURE 9.1. View of a portion of the exterior wall of the ancient city of Nisa, Turkmenistan, showing evidence of wind and water erosion. Source: Gaetano Palumbo.

Deterioration of an earthen archaeological structure begins immediately after its excavation. Once exposed to the elements, earthen archaeological features start to show different types of damage, depending on the type of environment surrounding the structure. In a dry environment, exposure causes the rapid loss of material due to wind erosion and the drying up of the layers closer to the surface (figure 9.1). This poses a special challenge if the excavated site has original plaster coatings or decorations such as surface paint or other details preserved on its surfaces.

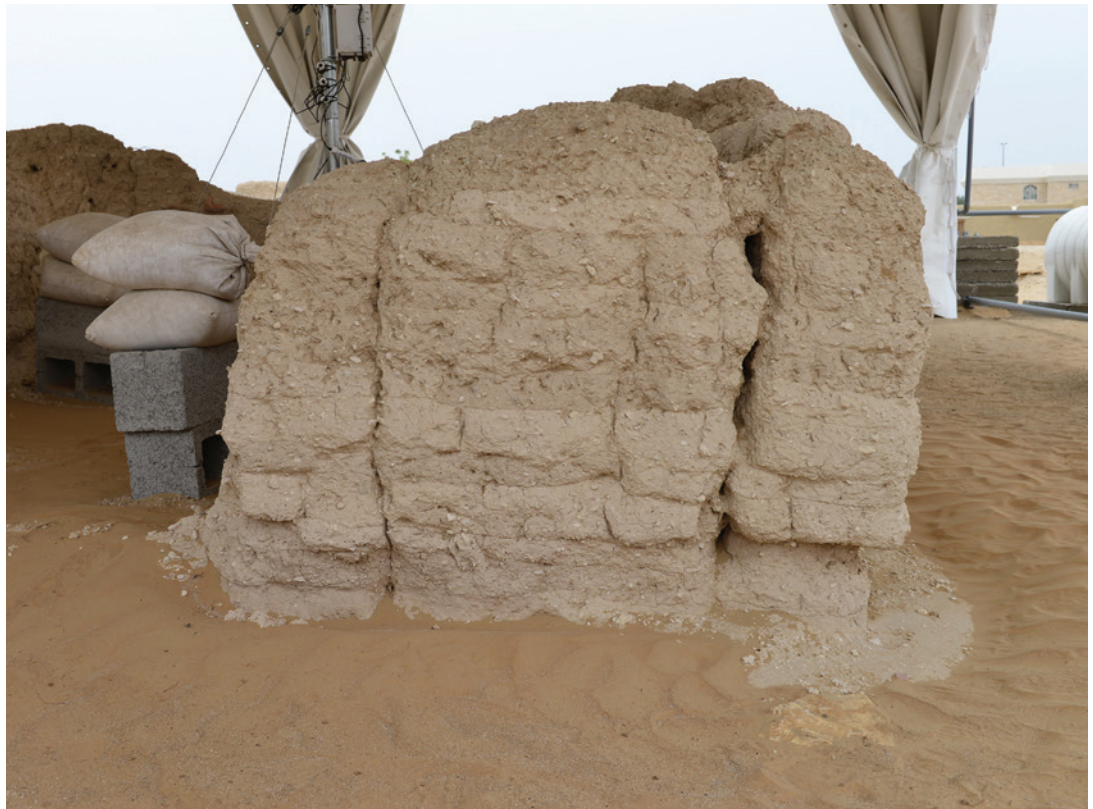
FIGURE 9.2. View of Hili 2, Al Ain, an Iron Age archaeological site, showing a vertical separation in the wall of a residential building. Source: Gaetano Palumbo.

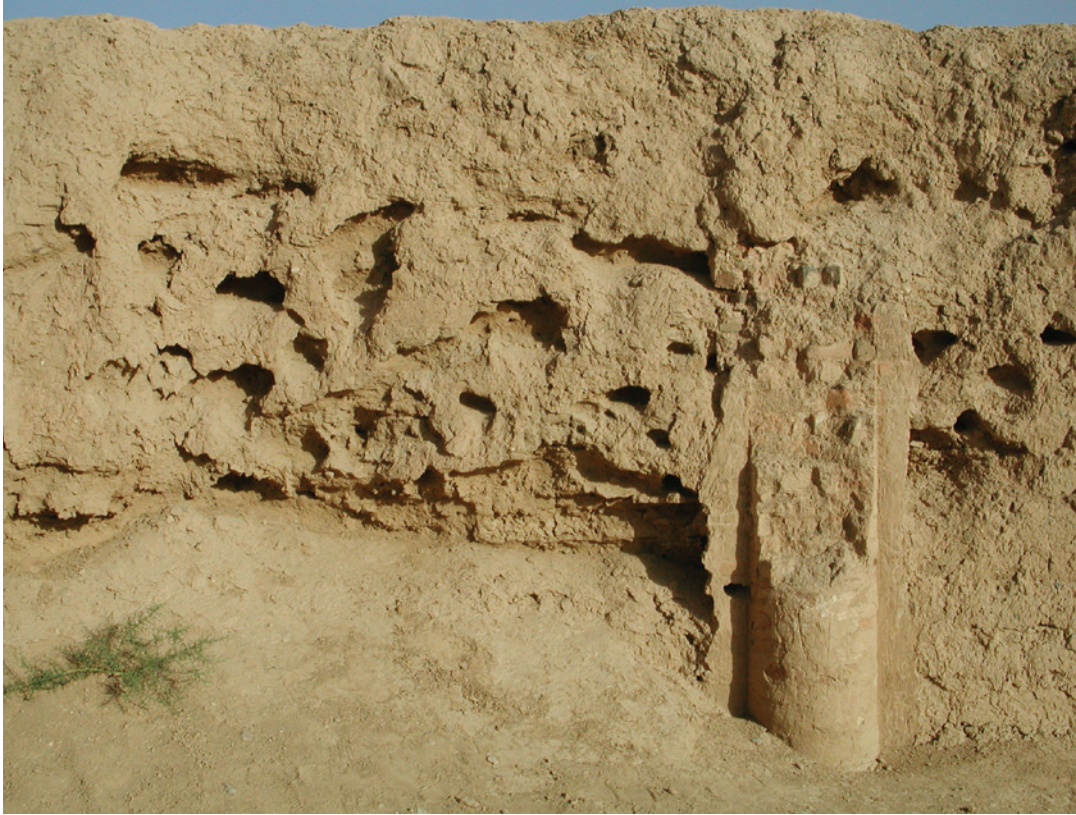
FIGURE 9.3. Portion of a wall at Nisa, Turkmenistan, showing cracks and holes in the exposed surface in which birds have nested. Source: Gaetano Palumbo.

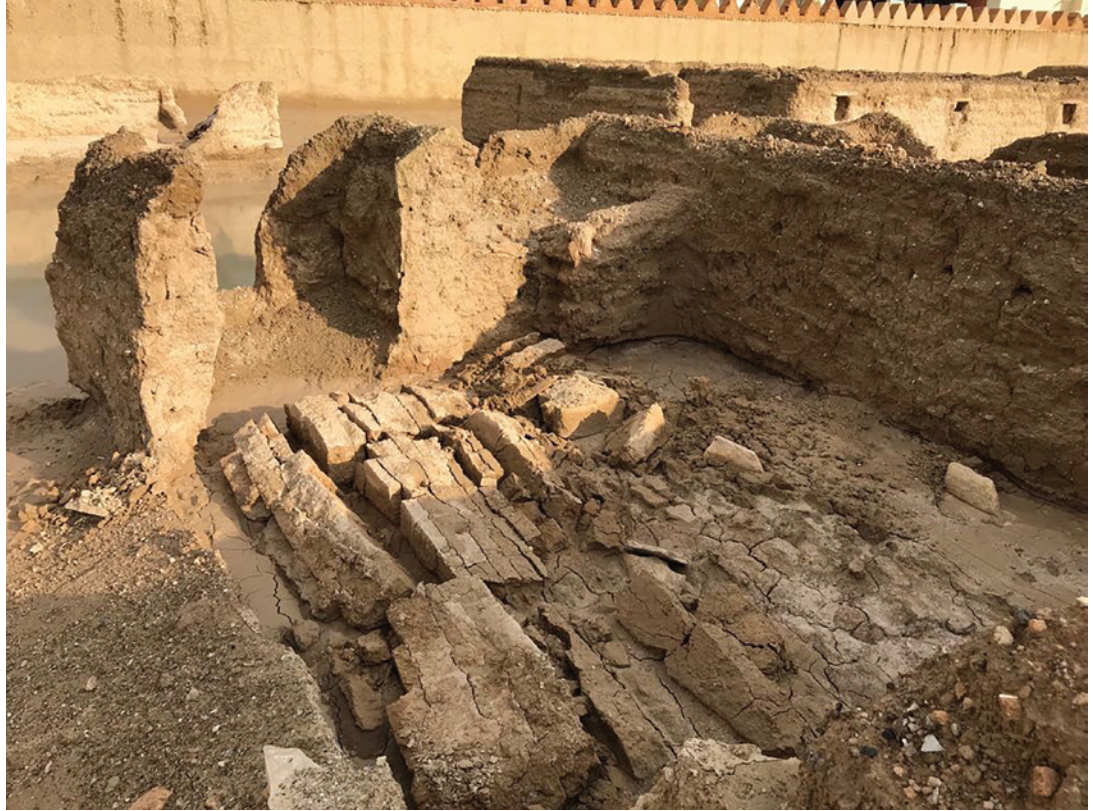
FIGURE 9.5. View of a structure at Hili 2, Al Ain, UAE. The bottom of the wall has been undercut by stagnant water and rising damp. Source: Gaetano Palumbo.
