International Course on the Conservation of Earthen Architecture

ACCOMPANYING ESSAYS

Edited by
Benjamin Marcus
Alessandra Sprega
Claudia Cancino
Gayathri Hegde

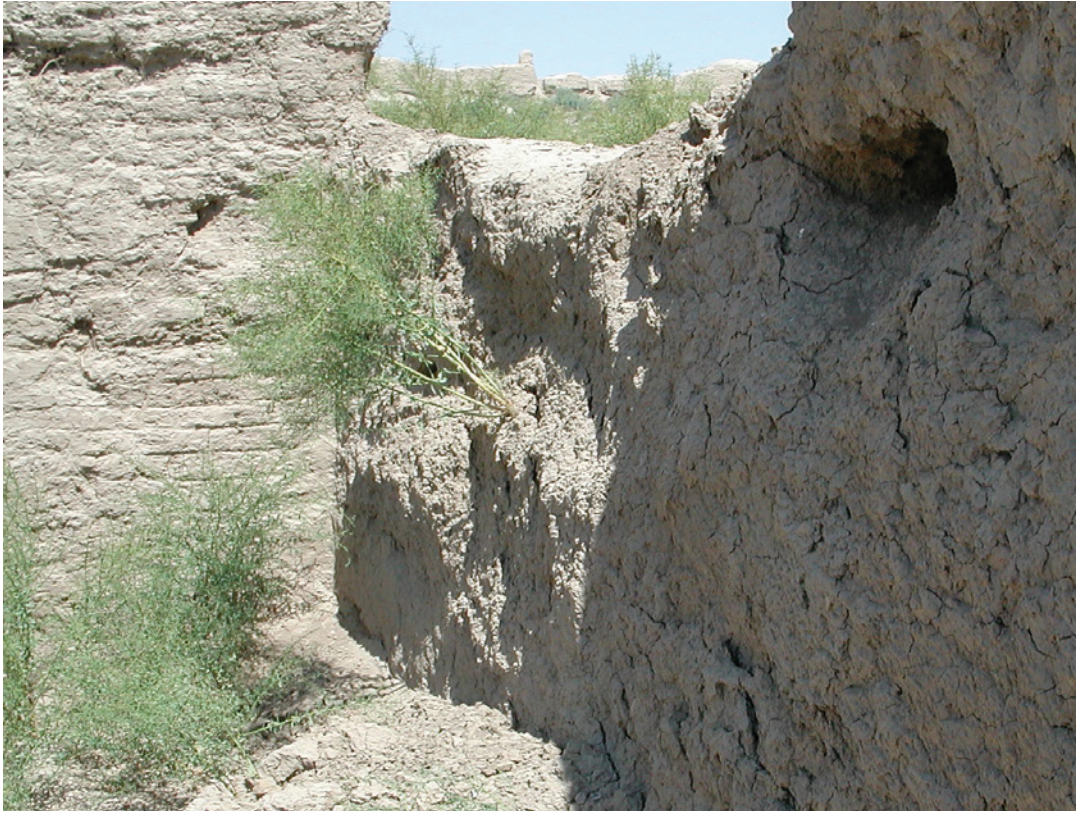
FIGURE 9.6. Portion of a structure at the archaeological site of Merv, Turkmenistan, showing vegetation growth at the base and from within a wall. Source: Gaetano Palumbo.

Animal burrowing is also frequent in this environment, as is the growth of vegetation at the base of the walls or of lichens and mosses on their surfaces (figure 9.6). Roots either within or at the base of walls may weaken the entire structure as the plant grows (figure 9.7). If dead, the rotting vegetation will leave voids into which water may penetrate, further weakening the core of the structure.

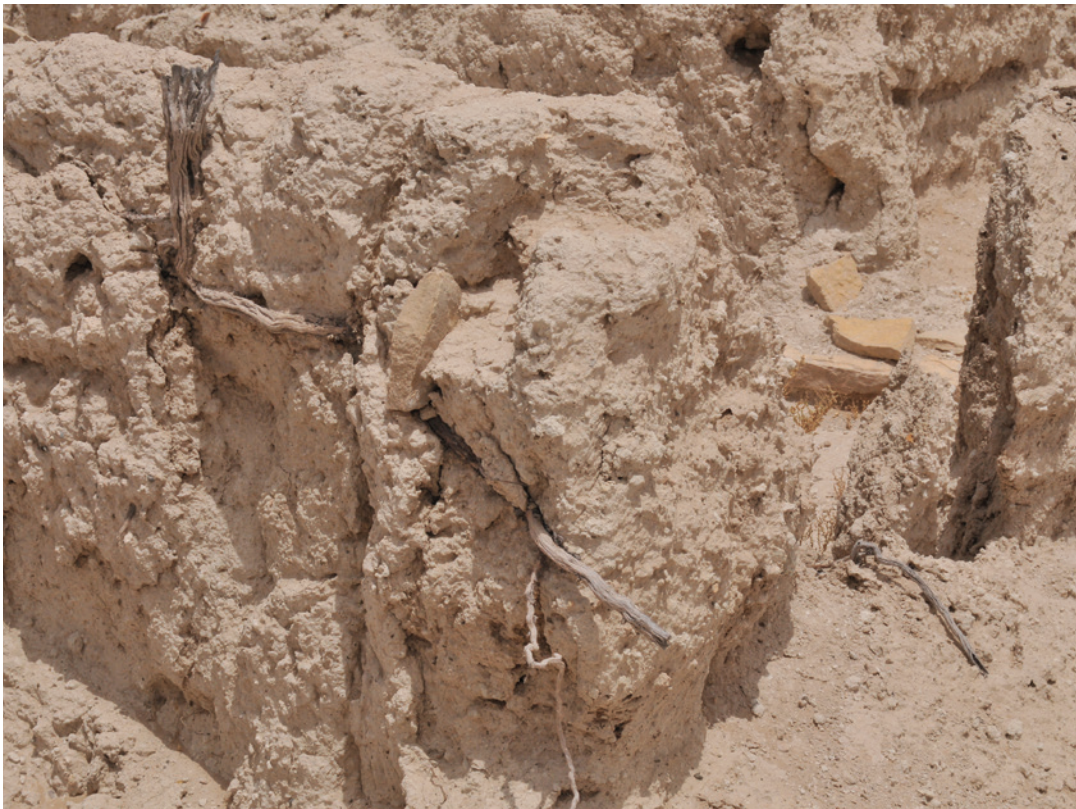
FIGURE 9.7. Roots embedded in a wall at Hili 17, Al Ain, UAE. As the vegetation continues to grow, the roots may weaken the entire structure. Source: Gaetano Palumbo.

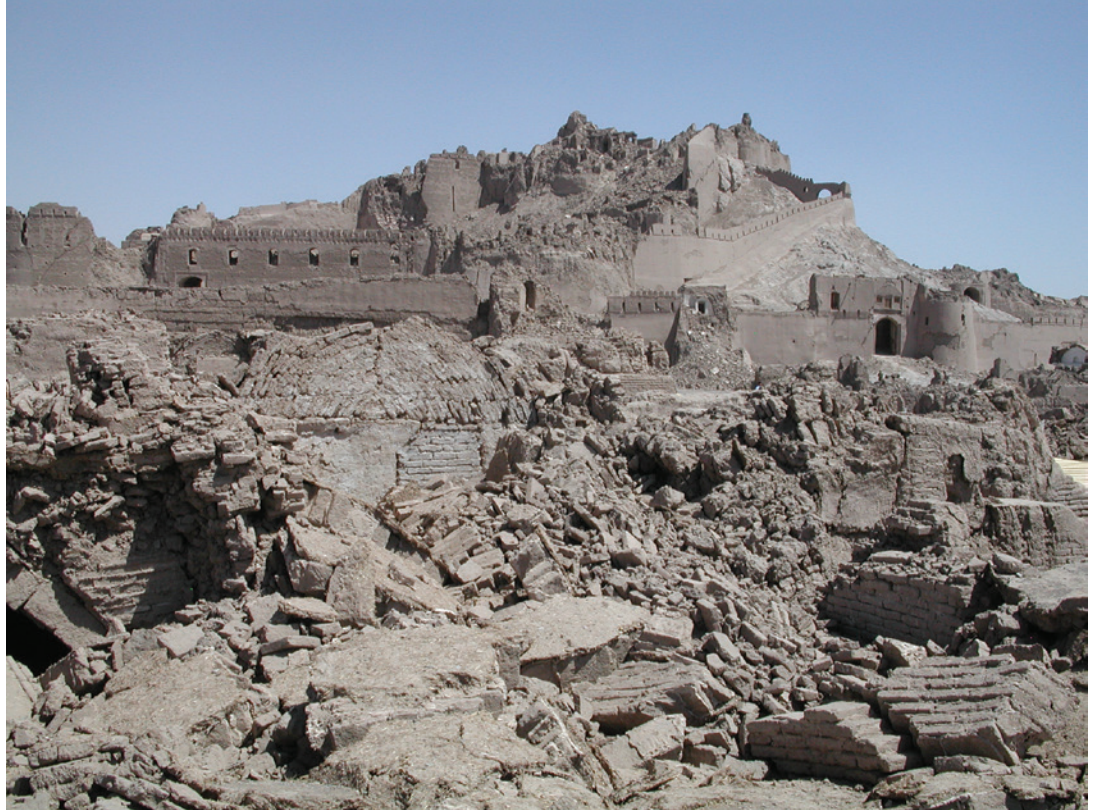
FIGURE 9.8. View of the earthen citadel at Arg-e Bam in Bam, Iran, showing extensive damage following a powerful earthquake in 2003. Source: Gaetano Palumbo.

particularly disastrous for archaeological ruins, which have lost the capacity to withstand the motion caused by seismic waves and thus behave as freestanding structures (figure 9.8).

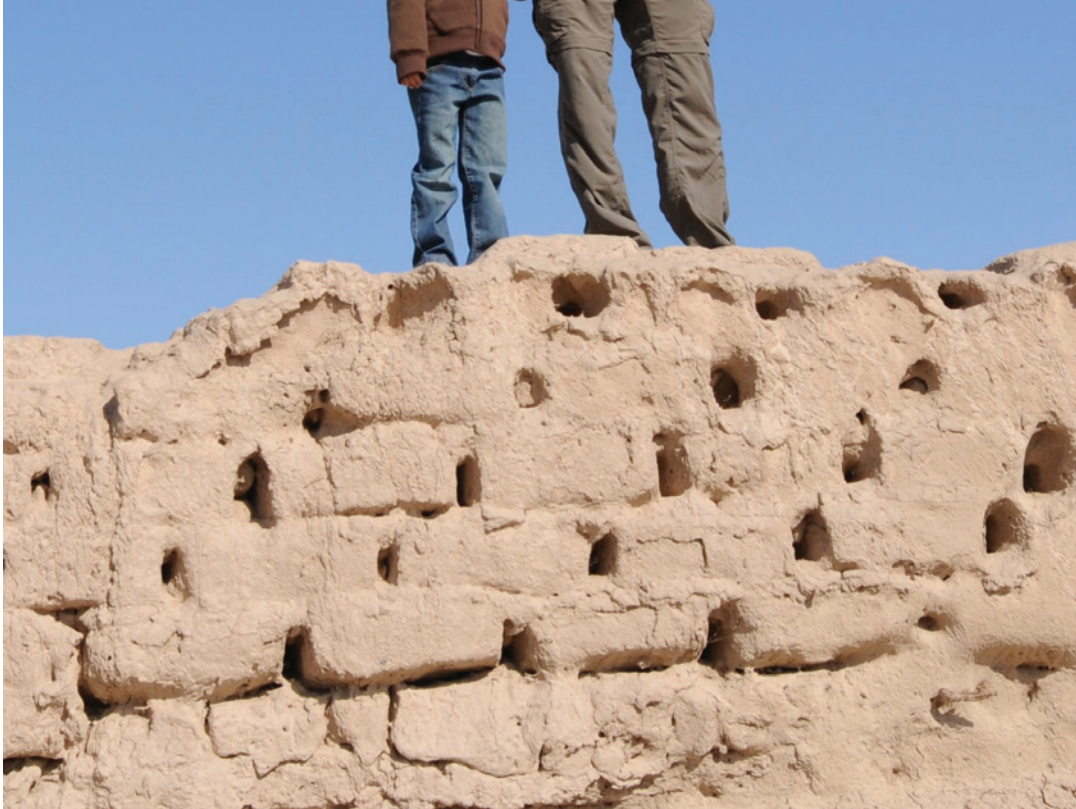
FIGURE 9.9. Visitors stand on a mud-brick wall in the excavation area of the buried city of Kazakl'i-yatkan, Uzbekistan. Damage to an archaeological site is often caused by human action and a lack of awareness of the fragility of earthen structures. Source: Gaetano Palumbo.

Finally, damage to an excavated archaeological site is frequently brought on by human actions, such as vandalism, botched conservation interventions, or trampling by visitors unaware of the weakness of the structure (figure 9.9). The use of incompatible materials during the conservation process may cause further deterioration, as these may affect the overall stability of the structure or accelerate the loss of surface layers (figure 9.10).

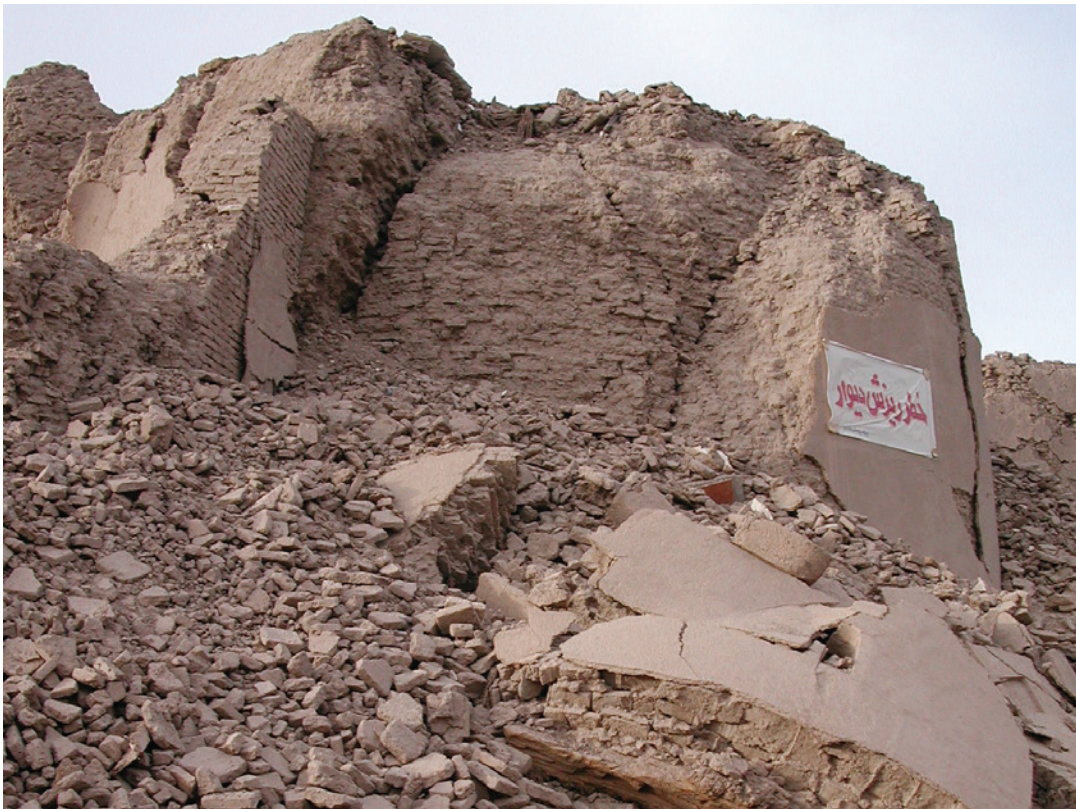
FIGURE 9.10. View of damage at Arg-e Bam, Iran. The outer layer of this tower, a modern addition, collapsed following the 2003 earthquake. Source: Gaetano Palumbo.

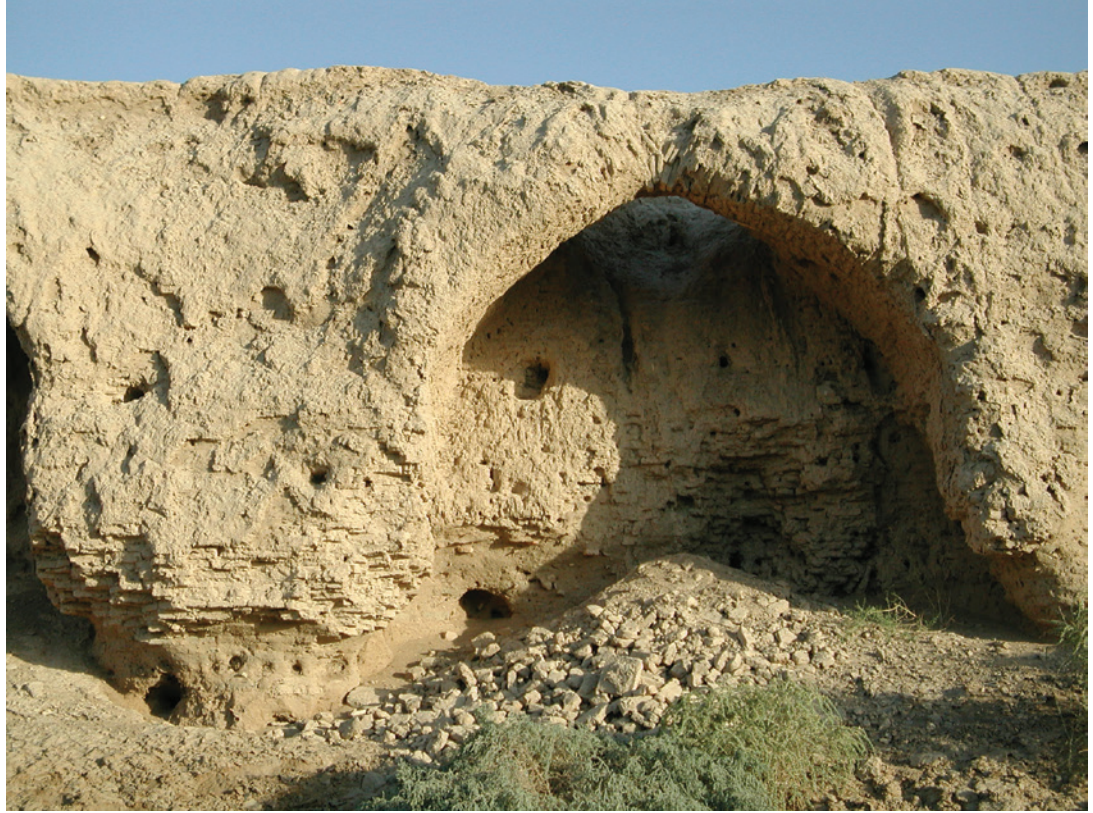
FIGURE 9.11. Portion of the walled city of Abdullah Khan Kala, Merv, Turkmenistan, showing damage to the foundation at the base of the wall caused by rising damp. Source: Gaetano Palumbo.

1,000 hectares of earthen architectural remains, both excavated and unexcavated. These include structures that are above ground and whose decay has been accelerated due to changes in the height of the water table, affecting their foundations (figure 9.11). Other sites, such as Dura-Europos in Syria or Pendjikent in Tajikistan (figure 9.12), have been extensively excavated over the last century but were never structurally consolidated and are now a mass of indistinguishable ruins. Not only is the physical fabric of these structures being lost, but also the scientific information they hold, as well as their potential to be a vehicle for social and economic growth at the local and regional level.

visible on the surface or revealed by excavation activities. Moreover, the development of irrigation agriculture in the region surrounding the site caused the water table to rise to levels never reached in the history of the site. In fact, some areas of the site remain constantly wet, even in summertime. This has caused visible decay at the bases of most of the walls of the extant structures due to either water stagnation or salt accumulation following capillary action, in which salts migrate from the ground to the walls (see figure 9.11).

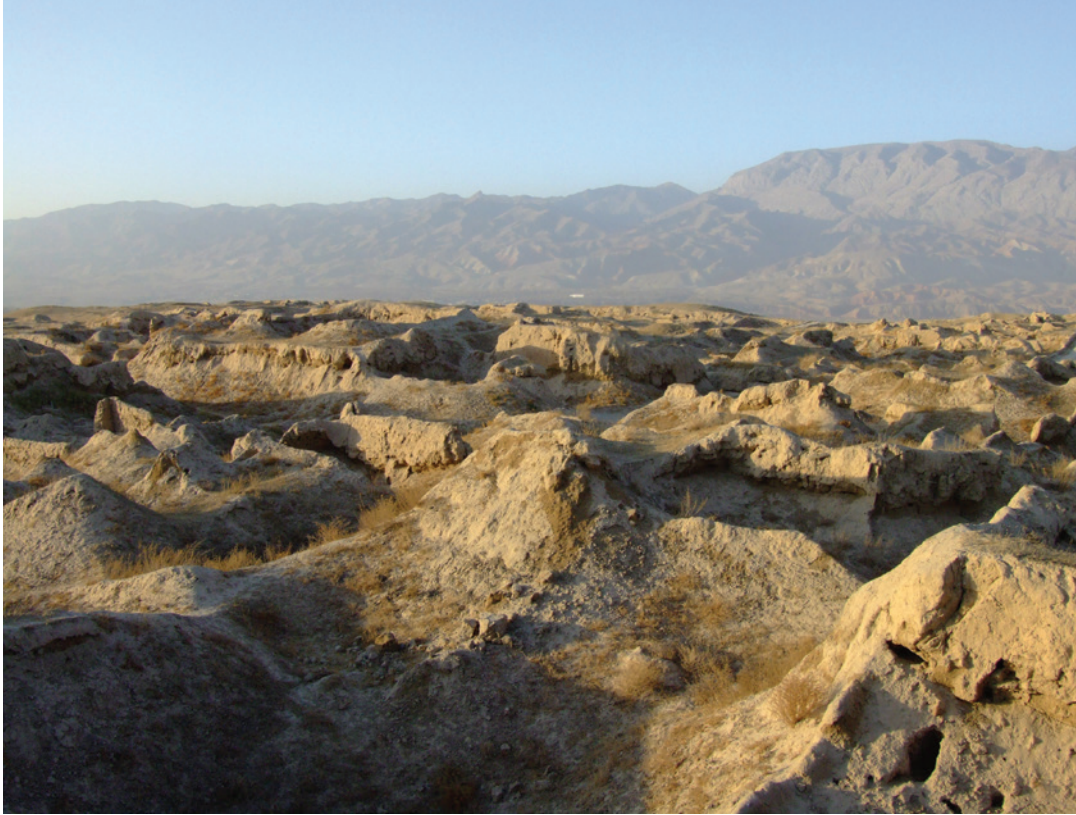
FIGURE 9.12. View of the archaeological site of Pendjkent, Tajikistan. Lack of consolidation following excavation has rendered the structures unrecognizable. Source: Gaetano Palumbo.

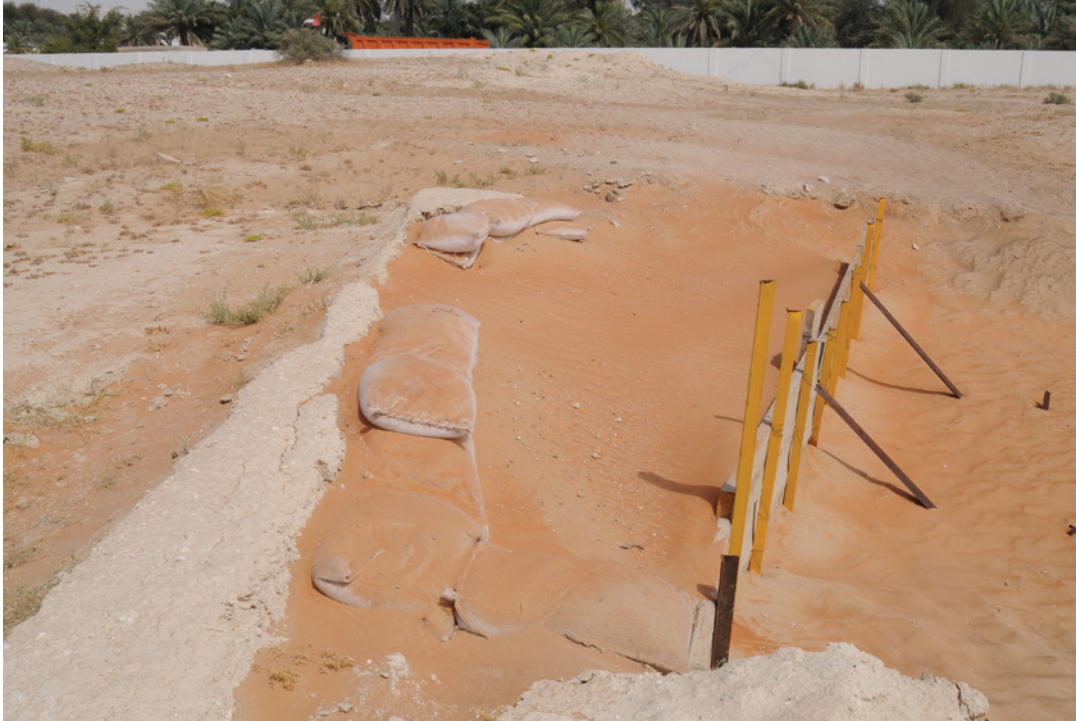
FIGURE 9.13. Partial reburial of House 1, Rumailah Iron Age archaeological site, Al Ain, UAE. Temporary conservation solutions such as this may be carried out to minimize exposure of the site. Source: Gaetano Palumbo.

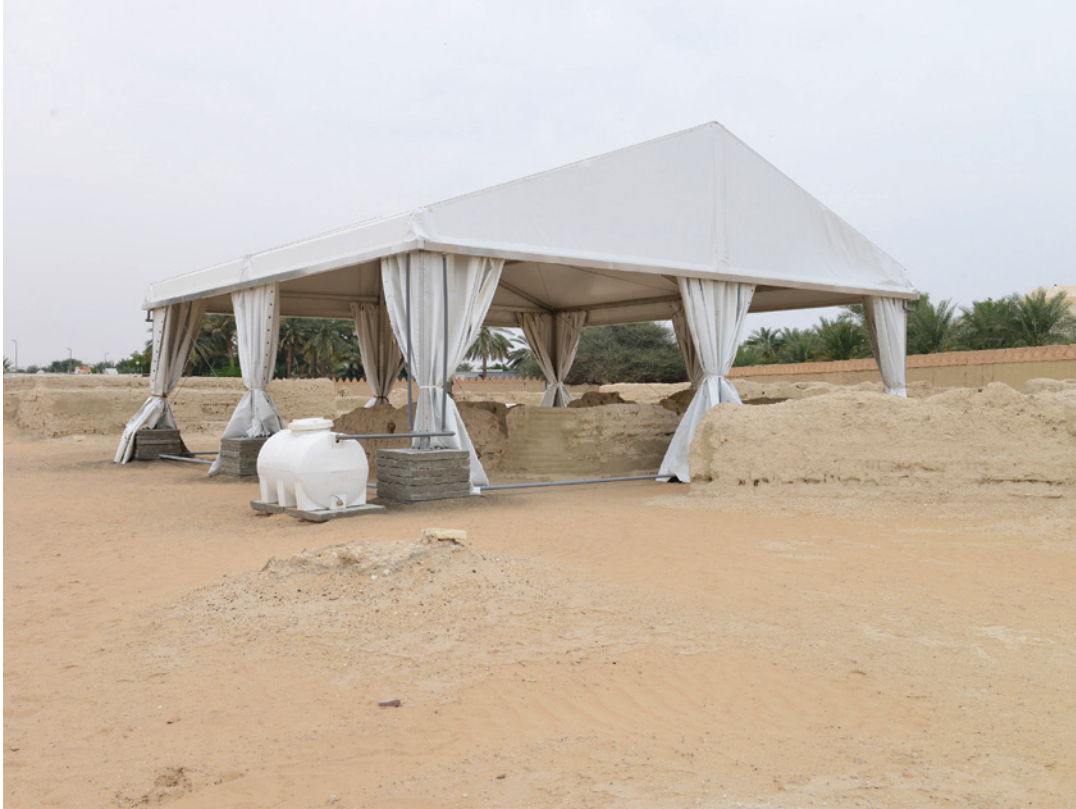
FIGURE 9.14. Temporary shelter erected over an excavated house at Hili 2, Al Ain, UAE. Source: Gaetano Palumbo.

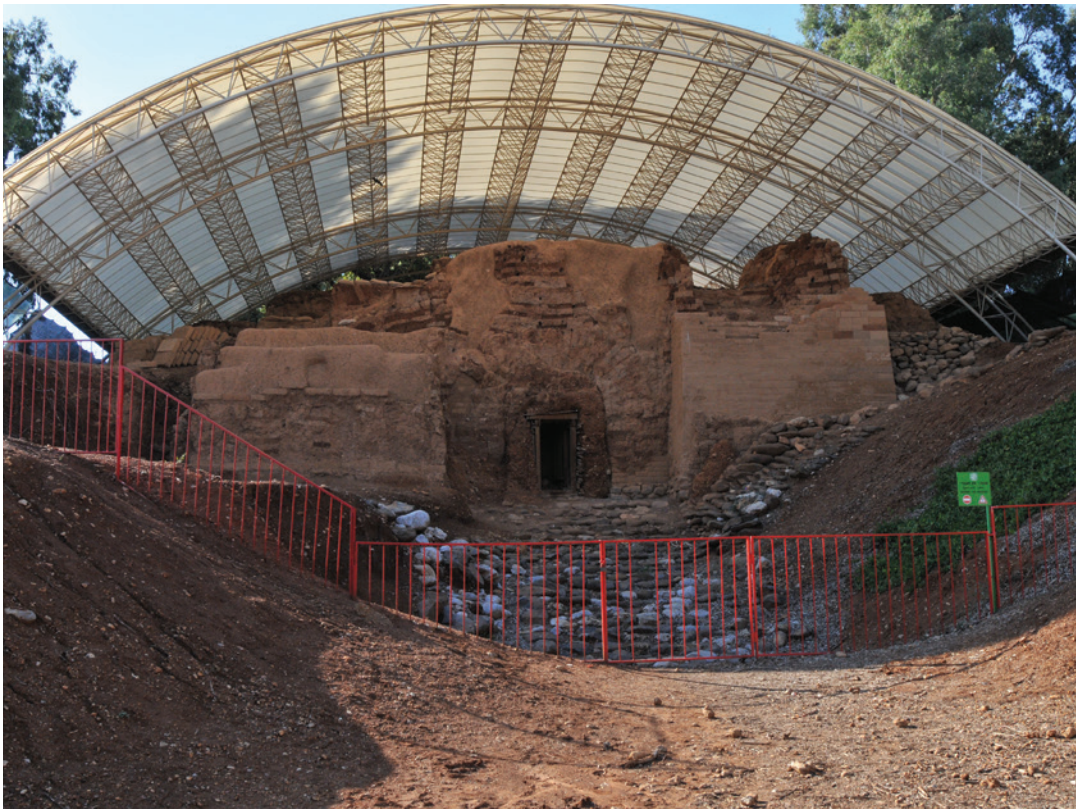
FIGURE 9.15. Permanent shelter constructed over the Bronze Age gate at the archaeological site of Tel Dan, Israel. Source: Gaetano Palumbo.

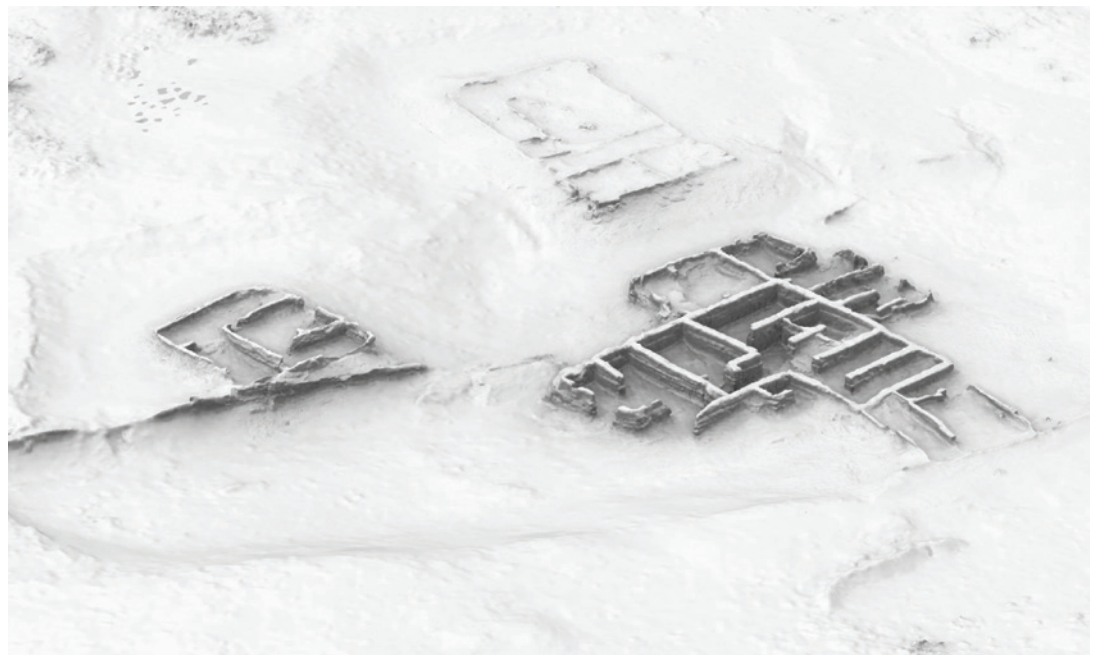
FIGURE 9.16. A 3D model derived from the laser scanning project conducted at the site of Hili 17, Al Ain, UAE, in 2011. Source: DCT Abu Dhabi.

Digital technologies may assist with the interpretation and presentation of earthen archaeological sites, although there are obstacles to their deployment, such as the cost to purchase equipment and produce digital models of the site and the rapid aging of the software and hardware used for such projects. In an ideal scenario, 3D models of single-site components or an entire site can be easily generated and provide visual support for presentation in a museum or visitor center environment or through apps installed on visitors’ smartphones or tablets (figure 9.16).

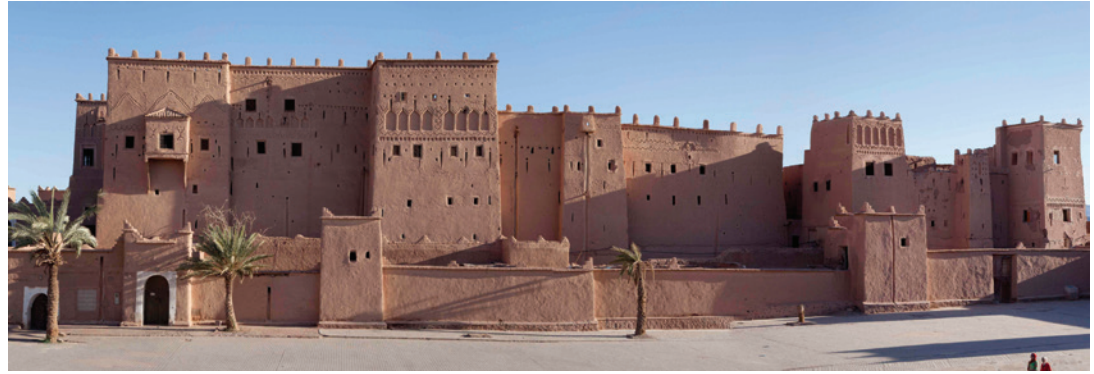
(A)

FIGURE 10.2. (a) Kasbah Tourirt, Ouarzazate, Morocco. (b) Base documentation showing the elevations of the complex. Source: Carleton University CIMS for the J. Paul Getty Trust.

Rehabilitation projects require understanding the physical layout of a building, its major features, and its historic and current significance. This information-gathering process includes complete documentation of the site, including plans, sections, elevations, and photography or scanning data (figure 10.2). In order to record the history and significance of the building, archival data such as historic photos, aerial images, building records, and other historical sources should be consulted.

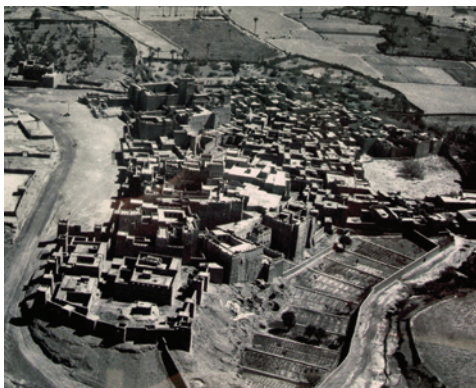
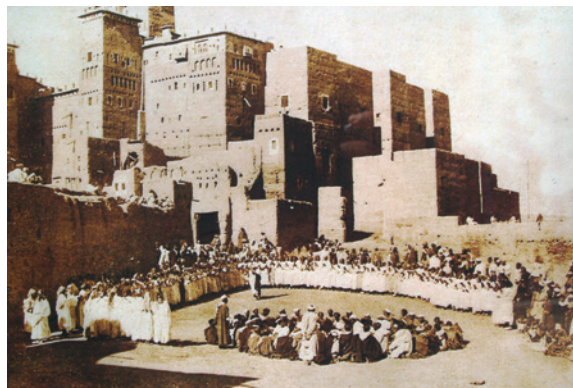
FIGURE 10.4. Historic aerial photographs and images provide vital information necessary for understanding building use and conditions over time. Source: CERKAS.

building plans, roads and circulation routes, evidence of abandonment through collapsed roofs, and past restorations (figure 10.4).

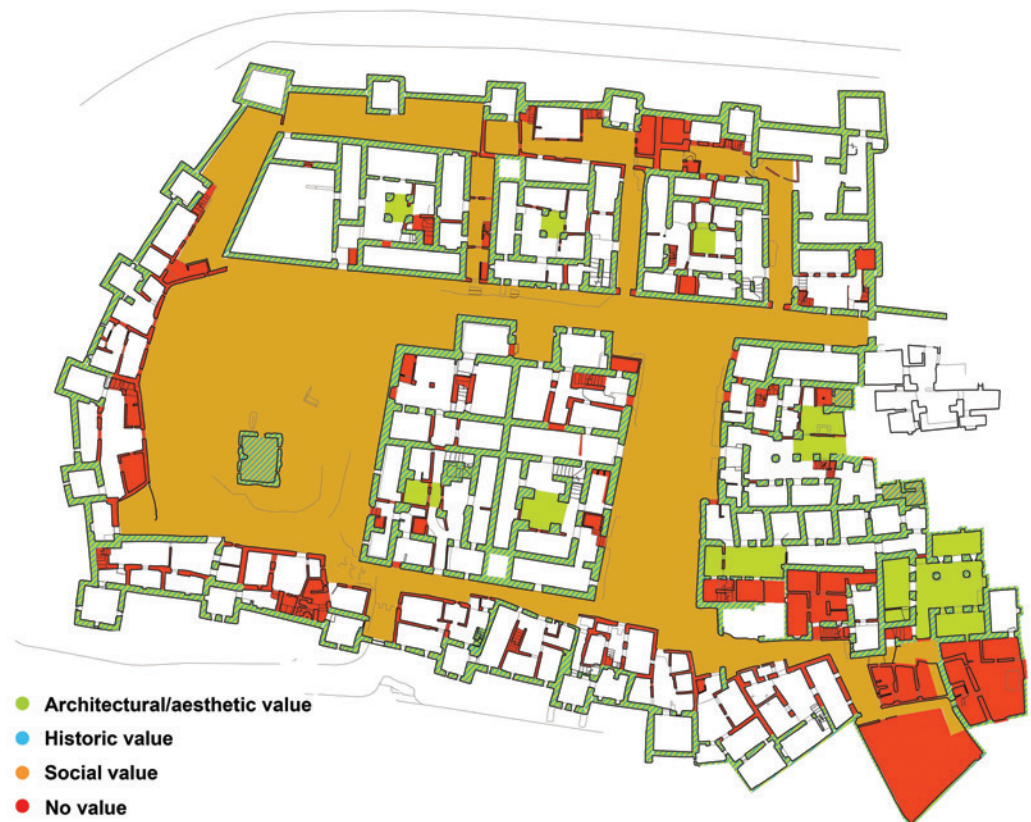
FIGURE 10.5. Mapping of values at the Kasbah of Taourirt, Ouarzazate, Morocco. Source: Elena Macchioni for the J. Paul Getty Trust.

An example of this process was carried out at the Kasbah of Taourirt in Ouarzazate, Morocco (figure 10.5). Stakeholders in that project, including the Ministry of Culture, the Municipality of Ouarzazate, and the project team members, identified the values of the site, drafted a statement of significance, and then mapped these values using documentation of the site to determine which elements were most significant decorative features, forms, circulation, etc. (Marcus, Cancino, and Boussalh 2017).

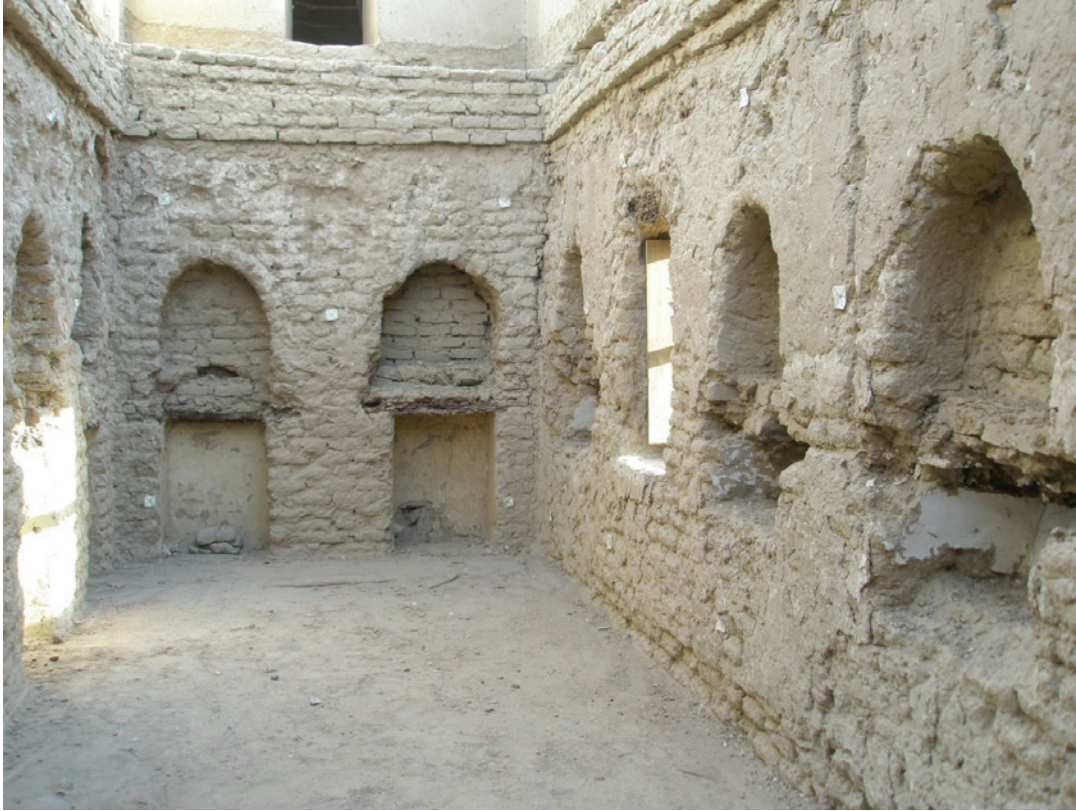
FIGURE 10.11. Building investigation after removing the first layer of plaster. *Source:* DCT Abu Dhabi.

The project began with site investigations that included archaeological, material, structural, termite, and condition assessments. Although good photographic archives and oral histories were available, archaeological investigation was instrumental in gaining a detailed understanding of the original fabric, which in turn informed the site's works and design. After removing the first nonsignificant layers of plaster from the original walls, a thorough documentation of the layers underneath was carried out. In addition, archaeological excavations brought to light more precise information that helped in the design of the mechanical, engineering, and plumbing (MEP; figures 10.10 and 10.11).

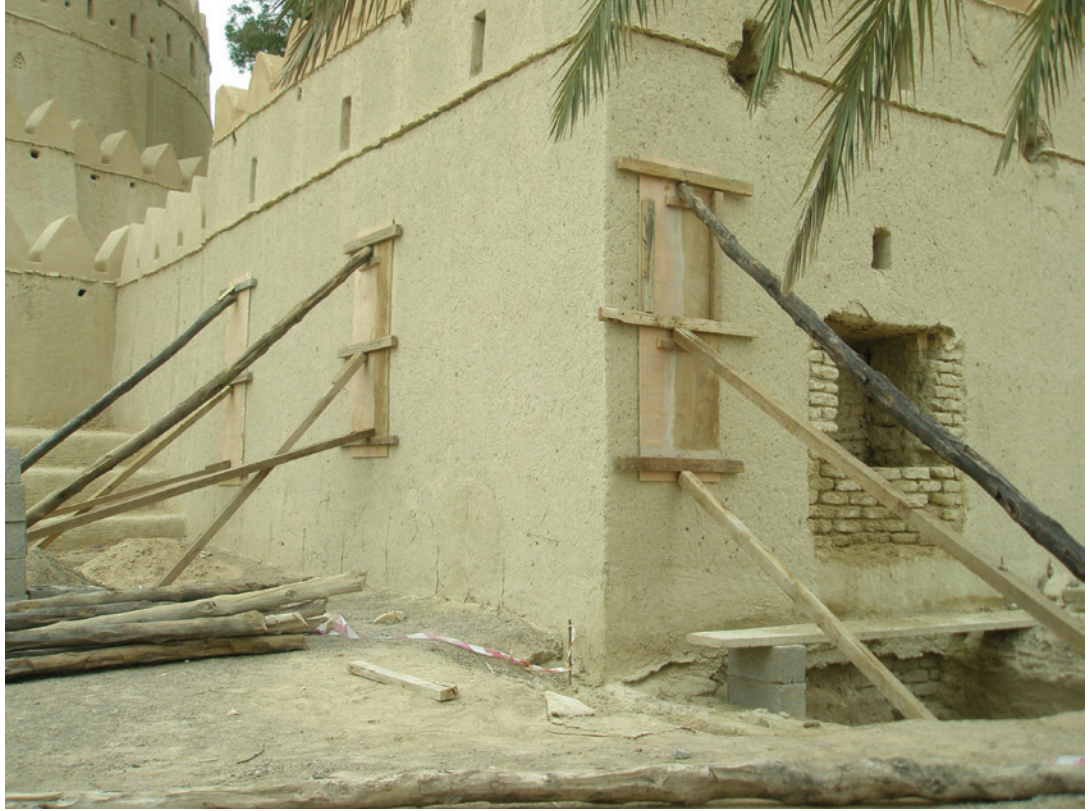
FIGURE 10.13. View of the temporary exhibition space at Al Jahili Fort during installation of the cooling system and MEP. Source: DCT Abu Dhabi.

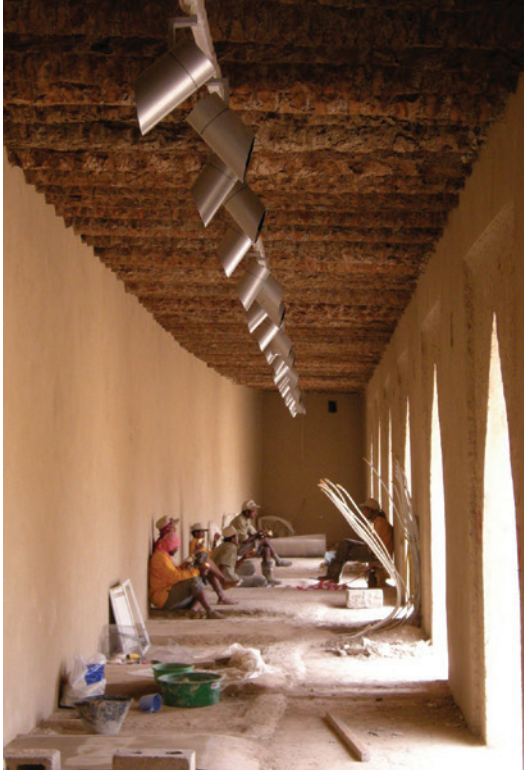
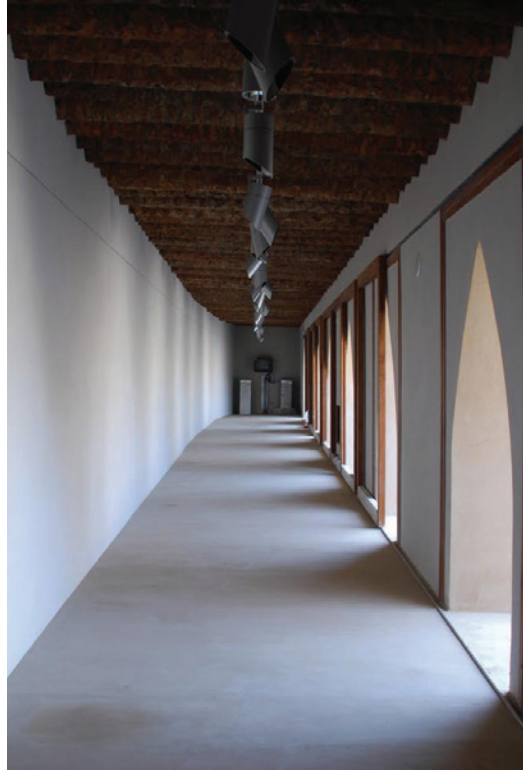
FIGURE 10.14. (a) View of the temporary exhibition space at Al Jahili Fort after application of the first layer of plaster, backfill, and roof. (b) View of the temporary exhibition space at Al Jahili Fort following placement of the final plaster, fixtures, doorways, and flooring. Source: DCT Abu Dhabi.

Following the assessments, the site works consisted of several major tasks that began with the dismantling of the roof and proceeded with the removal of 1980s nonsignificant plaster; excavation of service trenches for MEP; material preparation; treatment and installation of wooden elements; installation of the modern cooling system; application of new plaster; flooring; laying of the roofs, including the waterproof layer; sitewide enhancement; exhibition installation and wayfinding; replacement of the fixtures; activation of the spaces; and finally, opening it to the public. To illustrate, three of these stages in the fort's temporary exhibition space are shown: installation of the cooling system and MEP (figure 10.13); application of the first layer of plaster, backfill, and roof (figure 10.14a); and the space after placement of the final plaster, fixtures, doorways, and flooring (figure 10.14b).

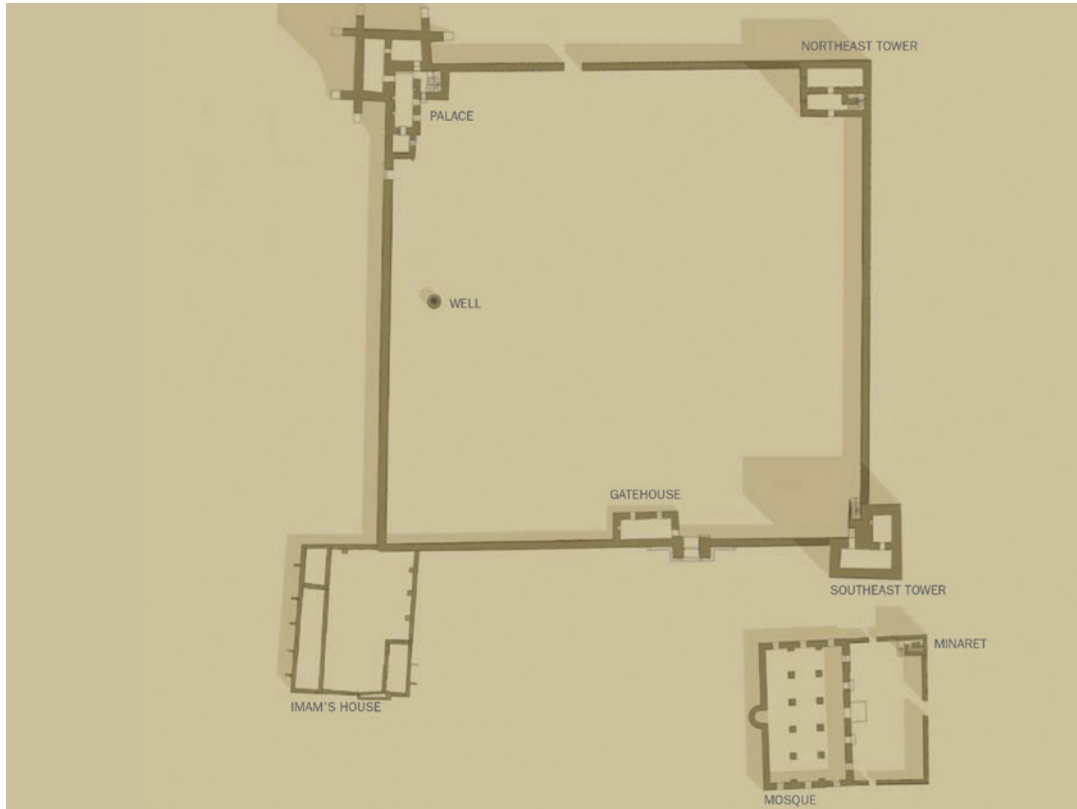
FIGURE 10.16. Site layout with the different components. Source: DCT Abu Dhabi.

In conceptualizing the design, project team members sought to introduce a new, modern venue in which to host the exhibition, integrating it with the fort's layout while respecting the building's architectural spirit and without impacting the underground archaeology. A major site enhancement and landscape design was inspired by the oasis theme. The northwest earthen tower was rehabilitated to allow public access to the new exhibition; it now has a climate control system with audiovisual elements and *majlis* (sitting areas for cultural and social gatherings) on the top floor.

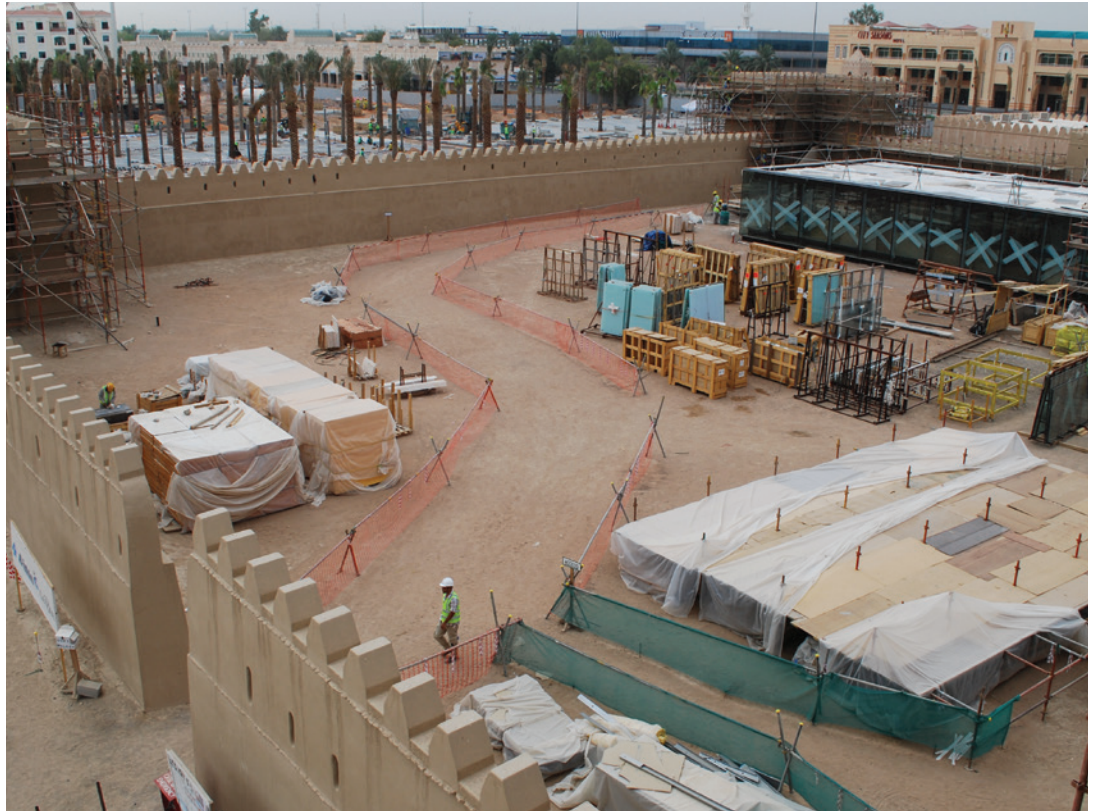
FIGURE 10.22. Reintegration of the mud bricks in the base of the walls. The adjacent traditional water channels are cleared and ready for consolidation. Source: DCT Abu Dhabi.

Construction of the new venue was done in parallel with conserving the existing building (figure 10.21). Structural improvements were undertaken at the south main gate and the northwest tower. The stone layer at the bottom of the walls, which had been added in 2005, was dismantled and replaced with mud bricks. A careful conservation was also performed on the courtyard water channels as well as the southeast and northeast towers (figure 10.22).

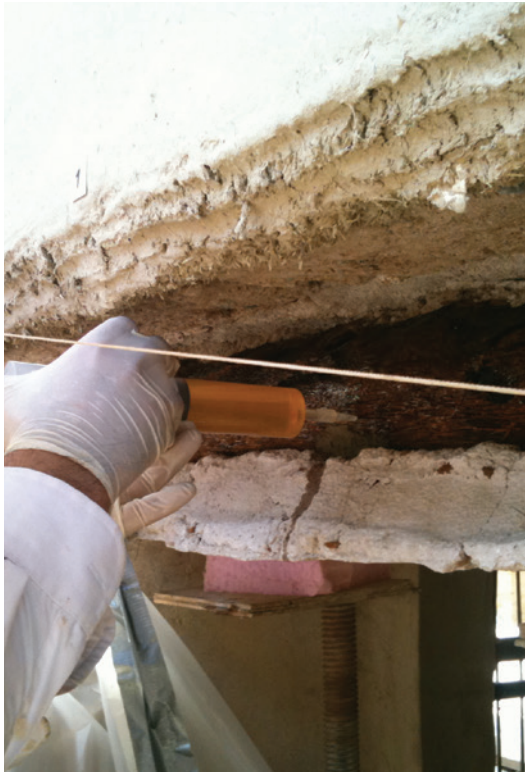
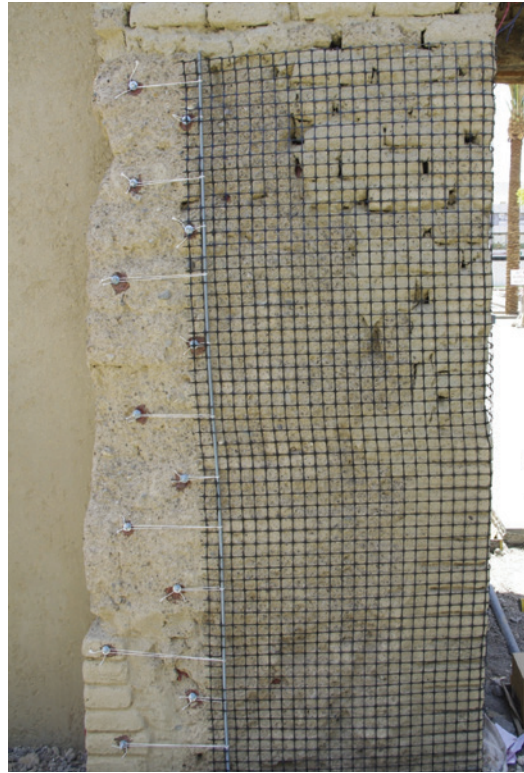
FIGURE 10.23. (a) A technician injects epoxy resin into a wooden lintel in the northwest tower of Muwajji Fort to help improve its condition following conservation. (b) Detail of a column of the south gate at Muwajji Fort. A geogrid compensates for poor connection between building phases and transfers the tensile forces to a larger area instead of a localized point. Source: DCT Abu Dhabi.

The northwest tower was a hot spot of conservation activity during the project, since it was the only tower out of the three that was rehabilitated and integrated into the new exhibition venue. One of the challenges was to restore the old historic wooden lintels. These lintels, which spanned the doors and windows of the tower, were extensively deteriorated. After careful condition assessment and lab testing, conservation methods were carried out such as epoxy resin injection into the lintels to improve their condition and strength (figure 10.23a). Another challenge at this tower was the structural load-bearing capacity of the floors to receive visitors. The solution involved retaining the roofs, which were made from traditional palm beams, and installing new floors built from laminated wood beams. These beams were carefully inserted and integrated with the roof without compromising the building's integrity.

The main south gate presented another issue. After the top plaster was removed, it was discovered that the two columns of the gate were constructed in two different phases. Unfortunately, these two phases were not integrated using the best building techniques, which could lead to failure. The building fabric was historically significant and could not simply be reconstructed. Following a thorough structural assessment, the issue was resolved with an innovative solution that employed a geogrid consolidation system for both columns (figures 10.23b and 10.24).

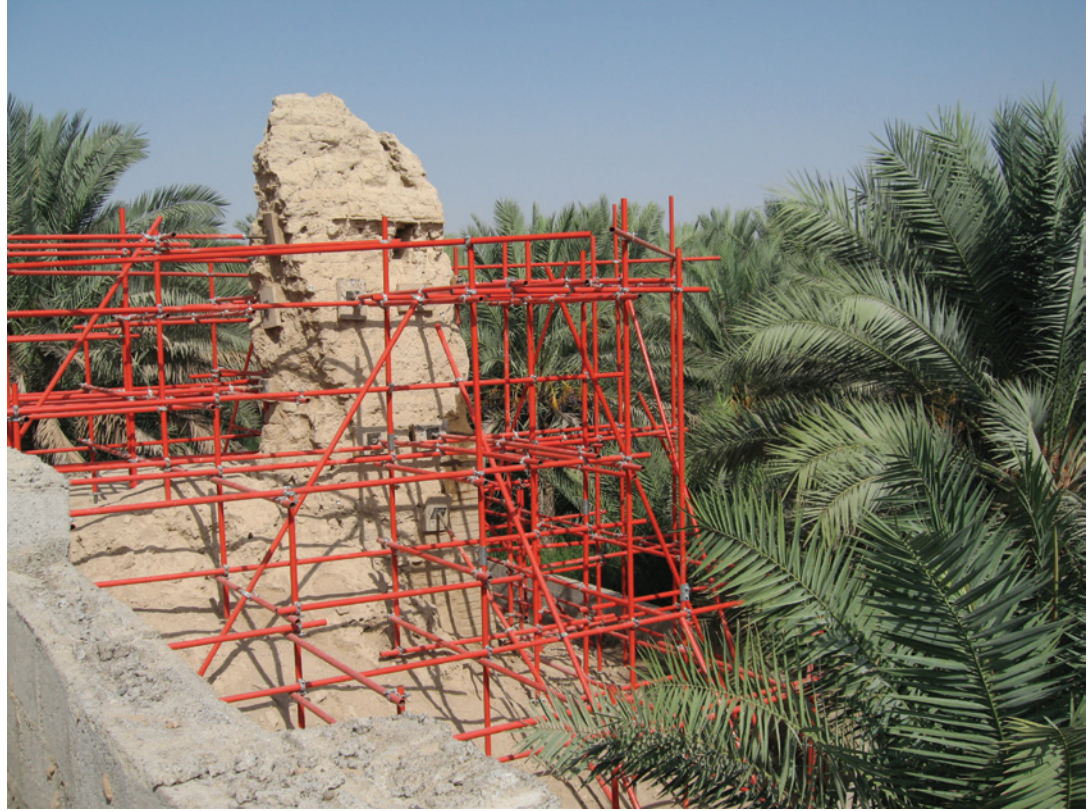
FIGURE 11.1. Scaffolding structural supports around Bin Suroor Southern House in Al Ain. Source: DCT Abu Dhabi.

The Bin Suroor House features the remains of a residential building, with one freestanding wall, and is situated on a farm on the edge of a cliff. The main threat is the state of conservation of the original building materials, which suffer from continuous deterioration induced by environmental factors. The structural stability of the site has become critical. In addition, a new concrete boundary wall was built very close to the site. The main preventive and emergency conservation response was to install structural supports around the wall to protect it from any imminent structural failure (figure 11.1). This is a temporary emergency action until long-term solutions are implemented.

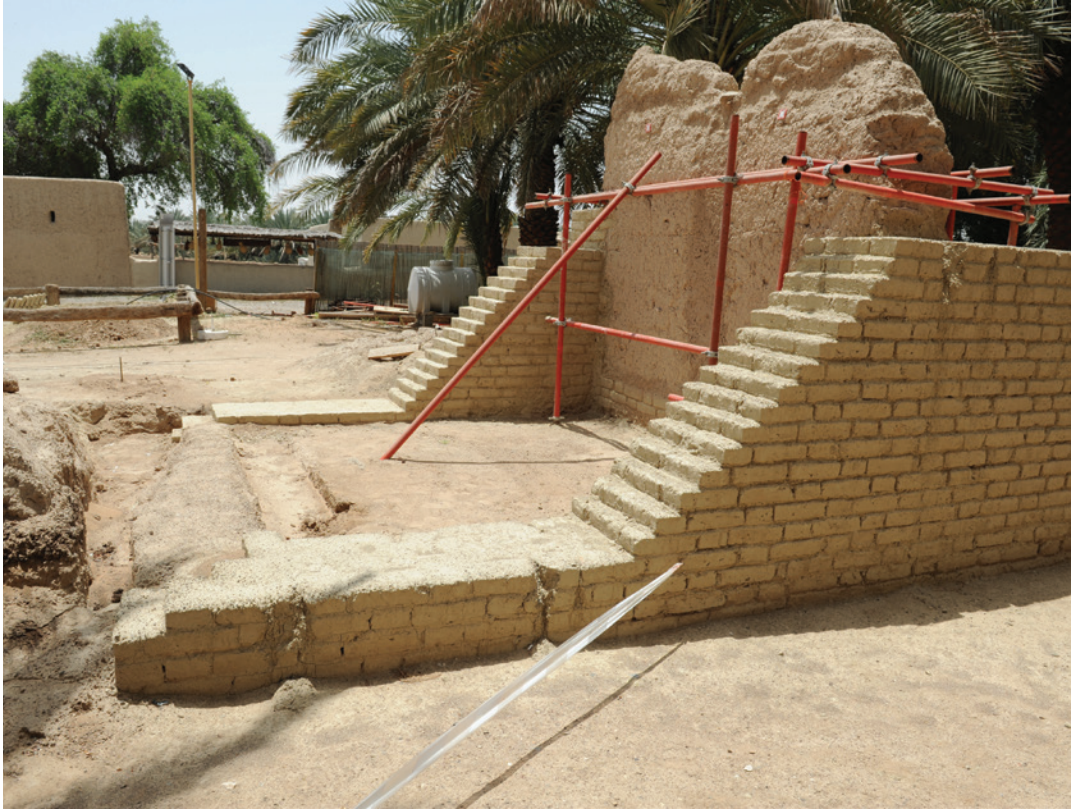
FIGURE 11.2. Freestanding wall at Bin Biduwa House, Al Ain, supported by the partially reconstructed walls. Source: DCT Abu Dhabi.

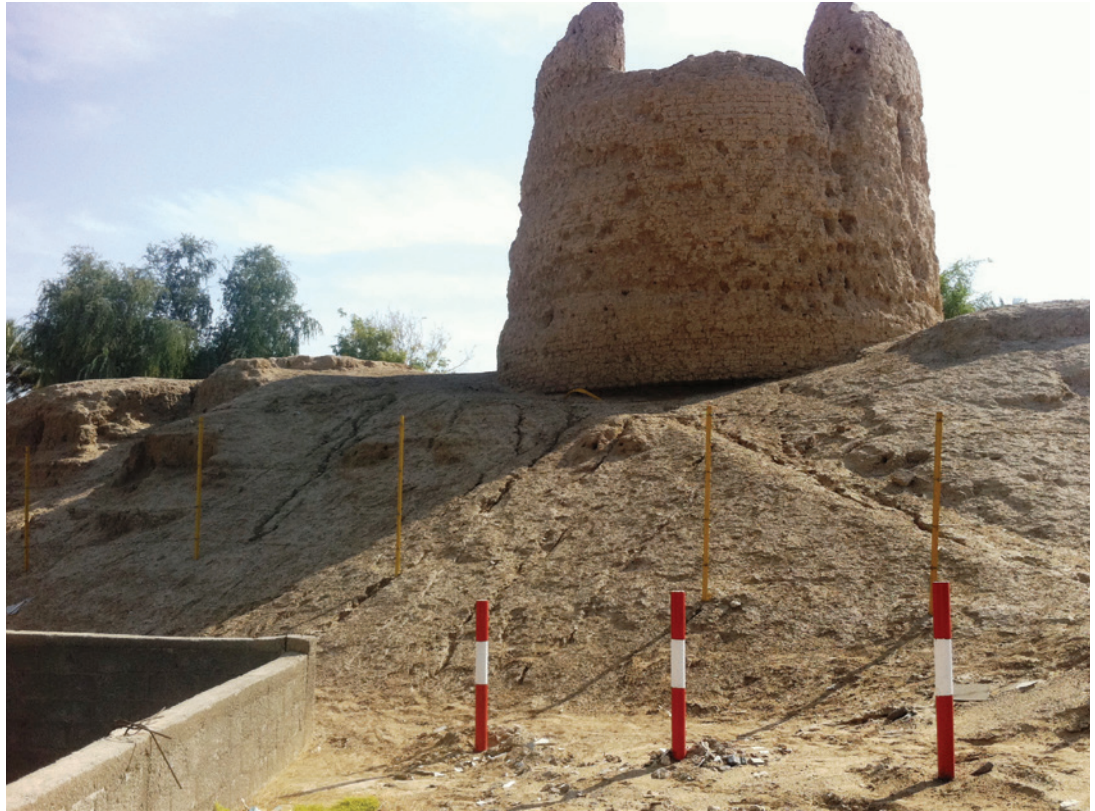
FIGURE 11.3. Daramkah Tower, Al Ain, before building the wall buttress. Source: DCT Abu Dhabi.

At Daramkah Tower, the earthen tower was built over a small hill. Over time, the hill eroded from rain and local floods, which exposed part of the wall at the base of the tower (figure 11.3). There were concerns that if this continued, it would affect the structural stability of the wall base. In response, a wall buttress was built to reshape the cliff in this area and direct water away from the wall base (figure 11.4).
