International Course on the Conservation of Earthen Architecture

ACCOMPANYING ESSAYS

Edited by
Benjamin Marcus
Alessandra Sprega
Claudia Cancino
Gayathri Hegde

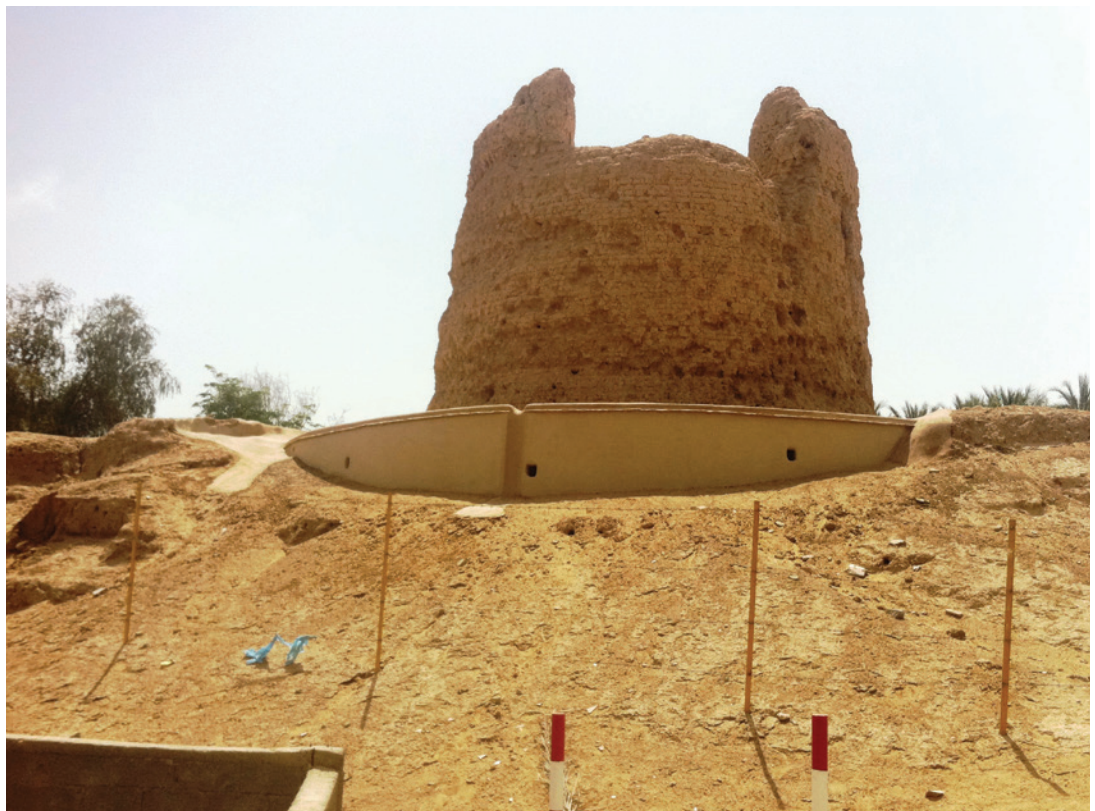
FIGURE 11.4. Daramkah Tower, Al Ain, after building the wall buttress. Source: DCT Abu Dhabi.

At Daramkah Tower, the earthen tower was built over a small hill. Over time, the hill eroded from rain and local floods, which exposed part of the wall at the base of the tower (figure 11.3). There were concerns that if this continued, it would affect the structural stability of the wall base. In response, a wall buttress was built to reshape the cliff in this area and direct water away from the wall base (figure 11.4).

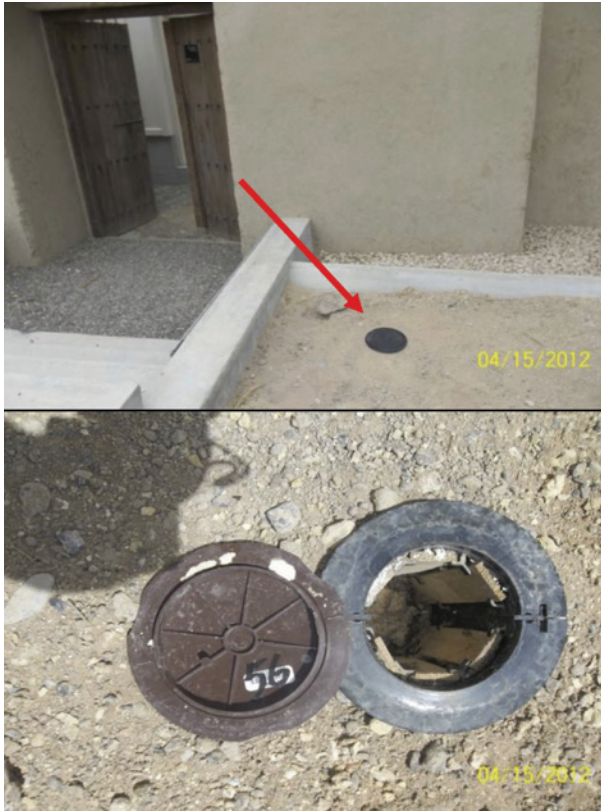
FIGURE 11.5. Termite baiting stations around Muwaiji Fort, Al Ain. Source: DCT Abu Dhabi.

Muwaiji Fort was rehabilitated as an exhibition space for His Highness Sheikh Khalifa bin Zayed Al Nahyan, president of UAE. As an earthen fort with traditional wooden elements, Muwaiji was under imminent threat from termite infestation, which not only has an aesthetic impact on the fabric but also may compromise the structural stability of the wooden roofs. The main challenge posed by termites in earthen buildings is that the insects can burrow paths hidden behind the mud plaster from ground level to the roof without any visual indications on the surface. To prevent that from happening, a termite baiting system was implemented to detect any infestation before it impacts the building itself. Baiting stations were placed all around the fort and monitored monthly by termite specialists (figure 11.5).

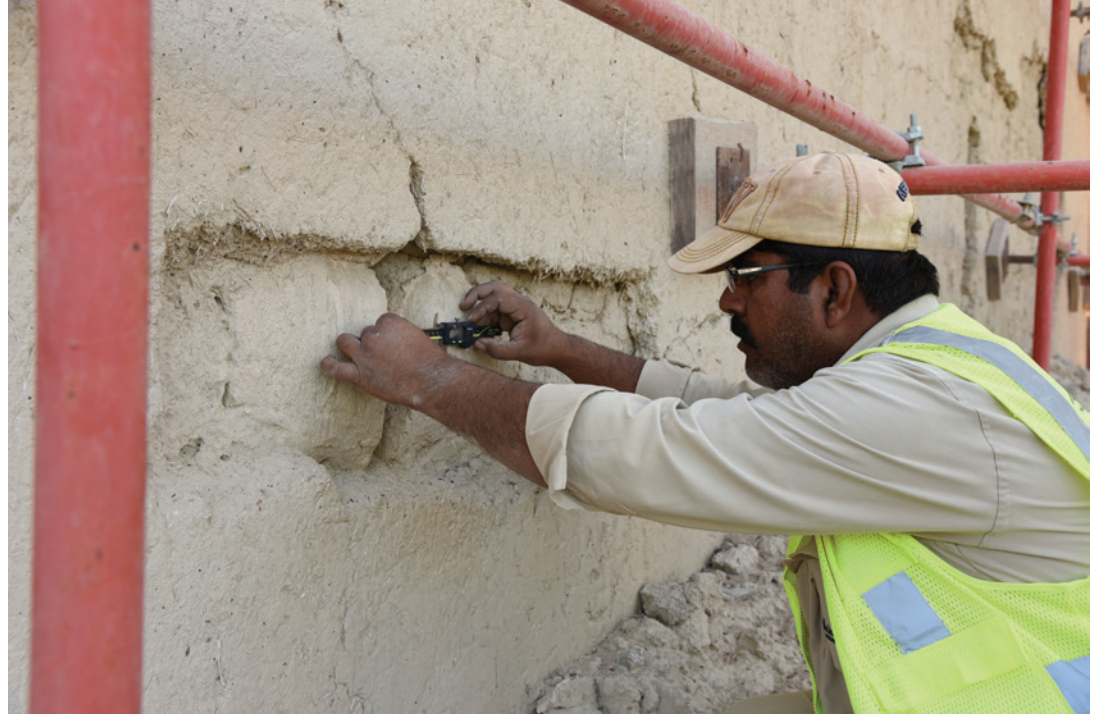
FIGURE 11.6. Monitoring cracks at Muraijeb Fort, Al Ain. Source: DCT Abu Dhabi.

these new layers, assessment and monitoring of the buildings' structural behavior was carried out. Monitoring was done by placing indicators over cracks in the walls (figure 11.6) to record the building's movement and better understand its behavior to predict any possible failures (Muhammad 2013).

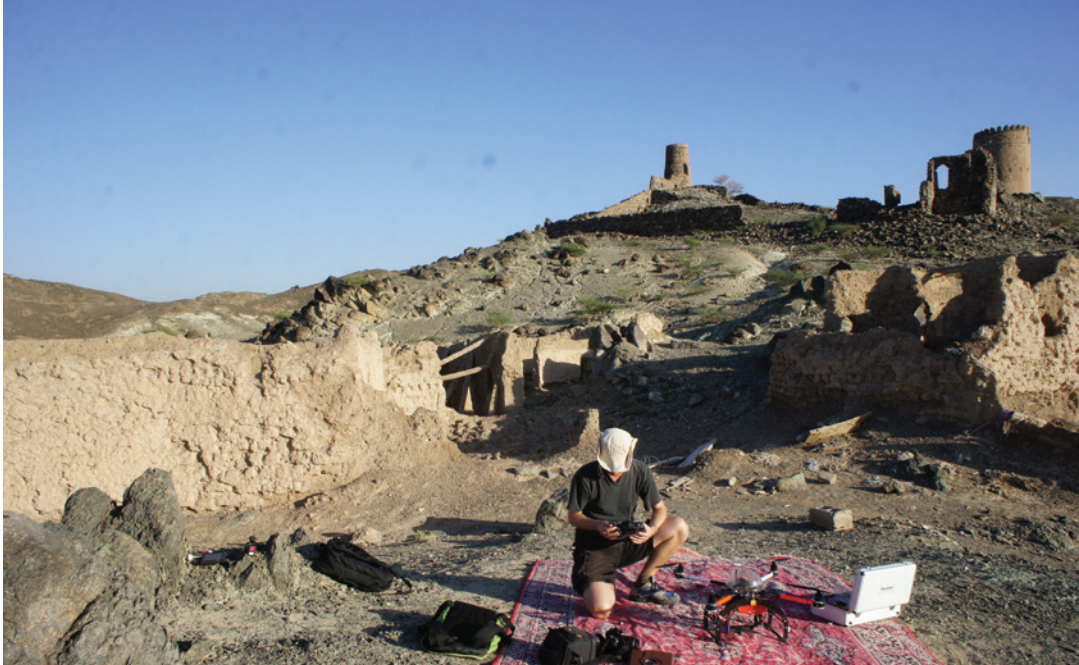
FIGURE 12.8. Preparation for drone photography in Mudayrib. Source: ArCHIAM Collections and Ministry of Heritage and Tourism, Oman.

captured by a drone, orthorectified using Agisoft or similar photogrammetric software (figures 12.8 and 12.9).

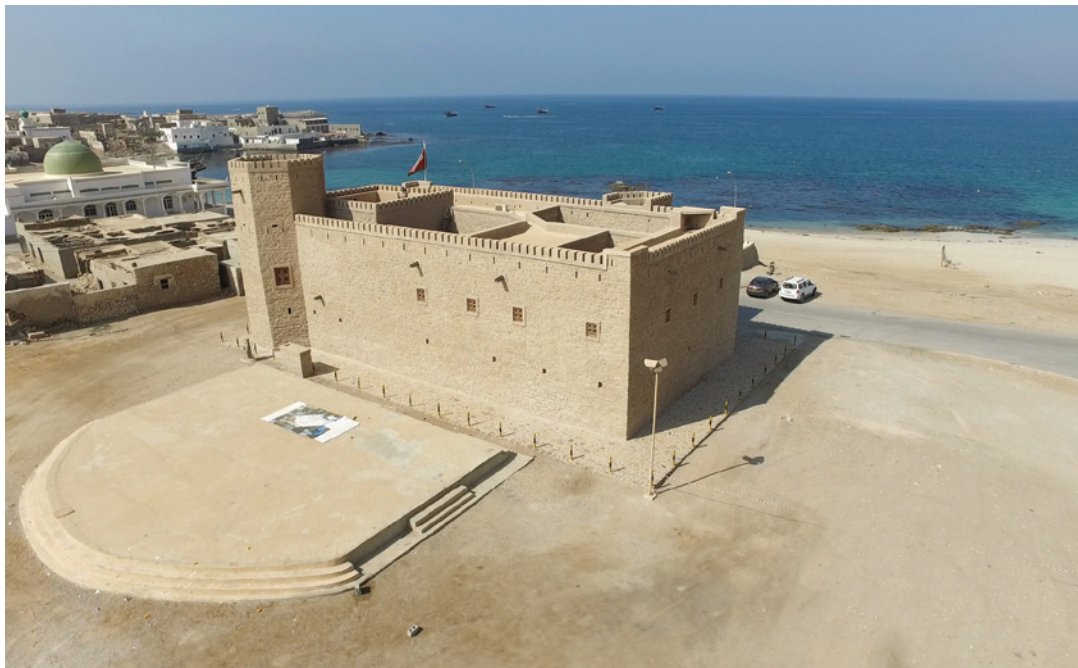
FIGURE 12.9. Aerial photograph of Harat Al Bu Rashid settlement quarter in Sinaw oasis. Source: ArCHIAM Collections and Ministry of Heritage and Tourism, Oman.

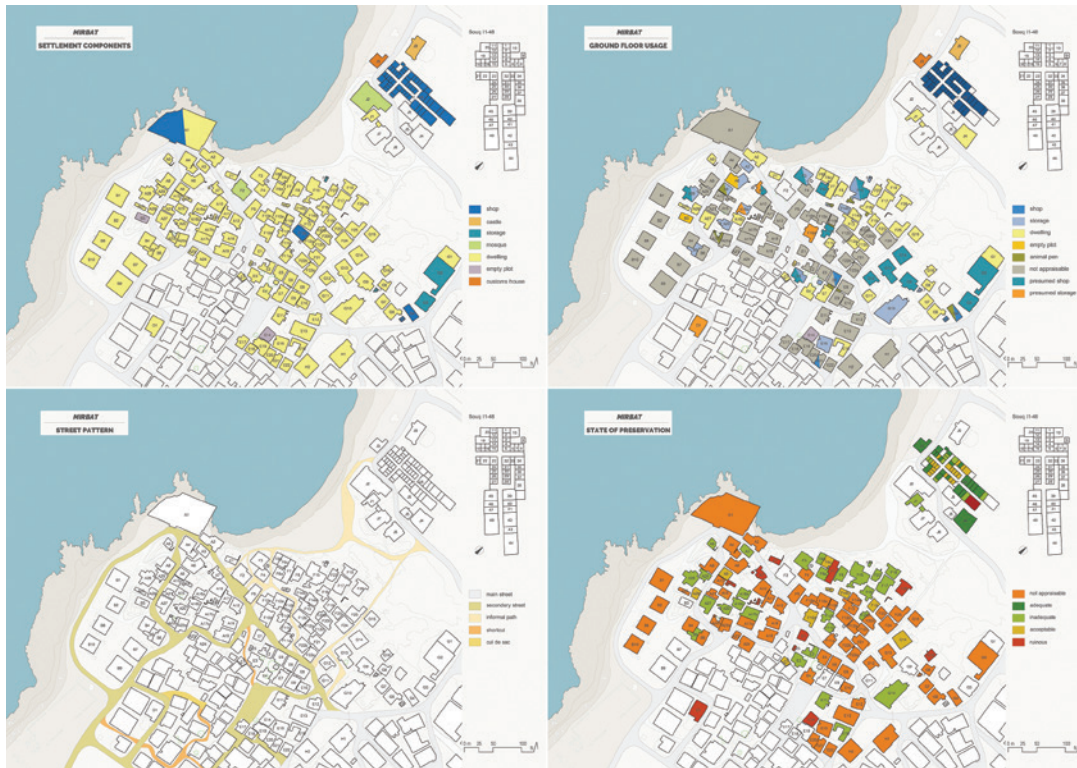
FIGURE 12.11. Architectural and urban mappings of the coastal village of Mirbat. Source: ArCHIAM Collections and Ministry of Heritage and Tourism, Oman.

- *Architectural and urban mapping.* Data in this category contribute to the definition of urban and architectural significance, spatial ordering, hierarchy, connectivity, typological variations, and so on (figure 12.11).

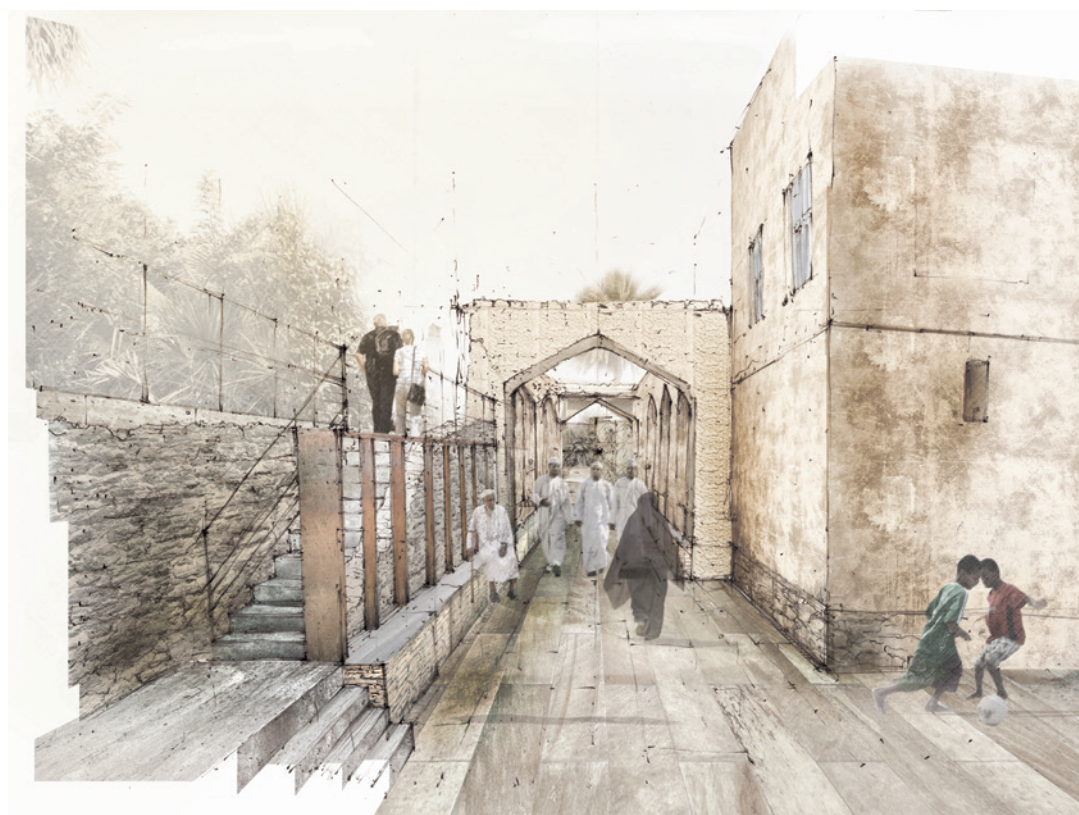
FIGURE 12.14. Master plan sketch drawing for Harat as-Suwawfah and Harat Al Bu Rashid quarters in Sinaw oasis. Source: ArCHIAM Collections and Ministry of Heritage and Tourism, Oman.

The proposal for the master plan is sketched out, suggesting zones of activity and introducing appropriate programs and supporting infrastructure while retaining the character of the settlement (figure 12.14). Other visualization techniques aid the testing and resolution of smaller-scale design interventions (figures 12.15 and 12.16). These context-specific proposals are informed by thorough precedent studies analysis (Bandyopadhyay et al. 2015; Bandyopadhyay, Quattrone, Goffriller, and al-'Abri 2016, 2014c; Bandyopadhyay, Quattrone, Goffriller, Reza, and al-'Abri 2014a, 2014b, 2014c).

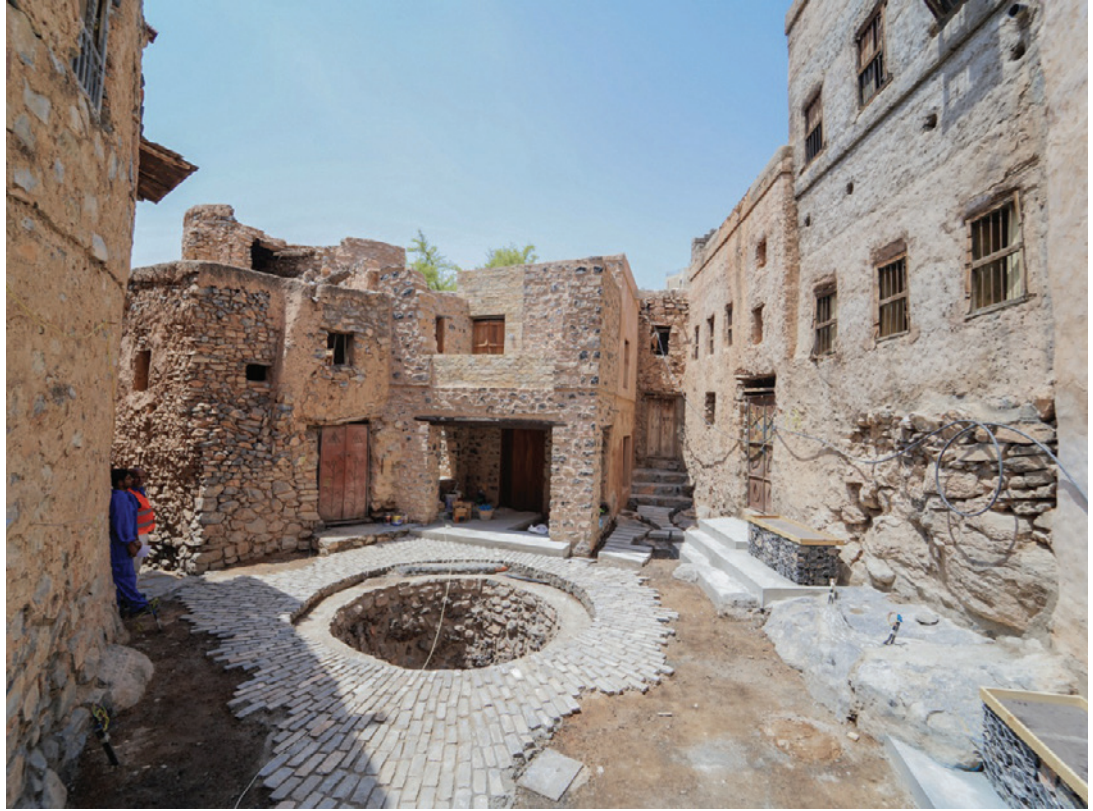
FIGURE 12.19. Adaptive reuse of a dilapidated dwelling as a café-restaurant in Misfat al-'Abriyin village; rear view from the oasis. Source: ArCHIAM Collections and Ministry of Heritage and Tourism, Oman.

Part of this master plan has been realized through architectural and urban interventions that included the restoration, rebuilding, and adaptive reuse of three traditional stone buildings; the rehabilitation of interconnecting public spaces and pathways; and the development of a parking area (figures 12.18, 12.19, and 12.20; Bandyopadhyay et al. 2015).

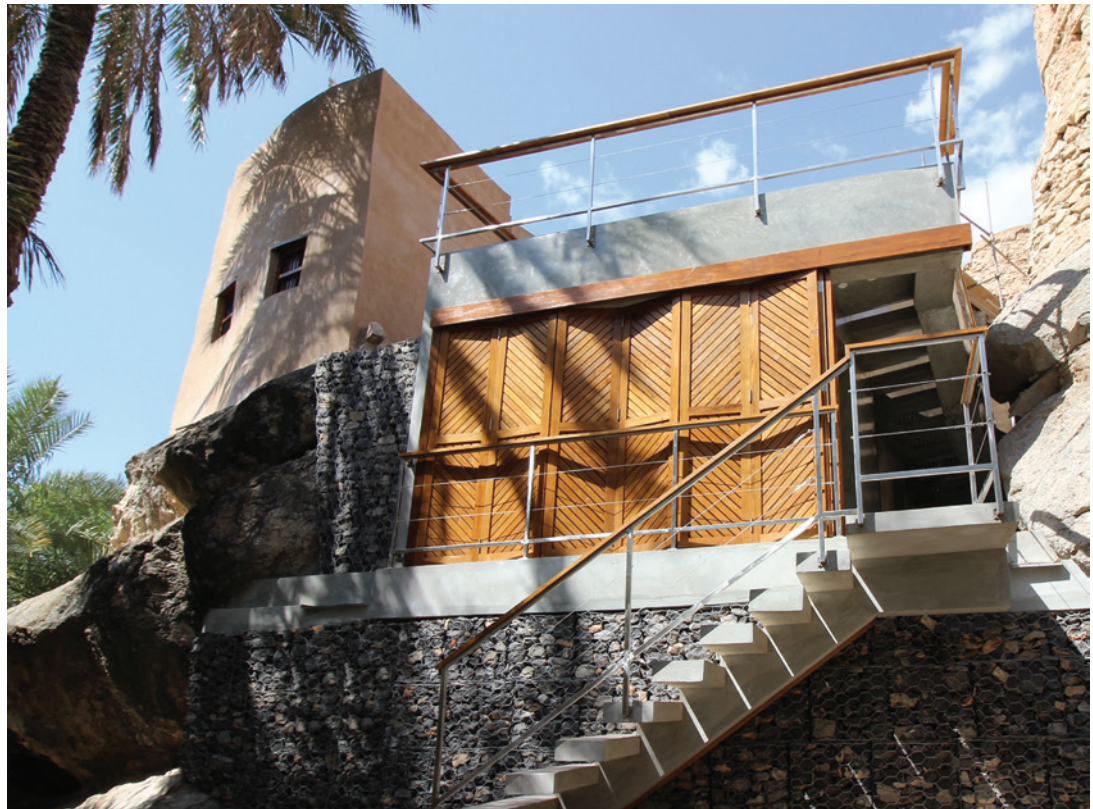
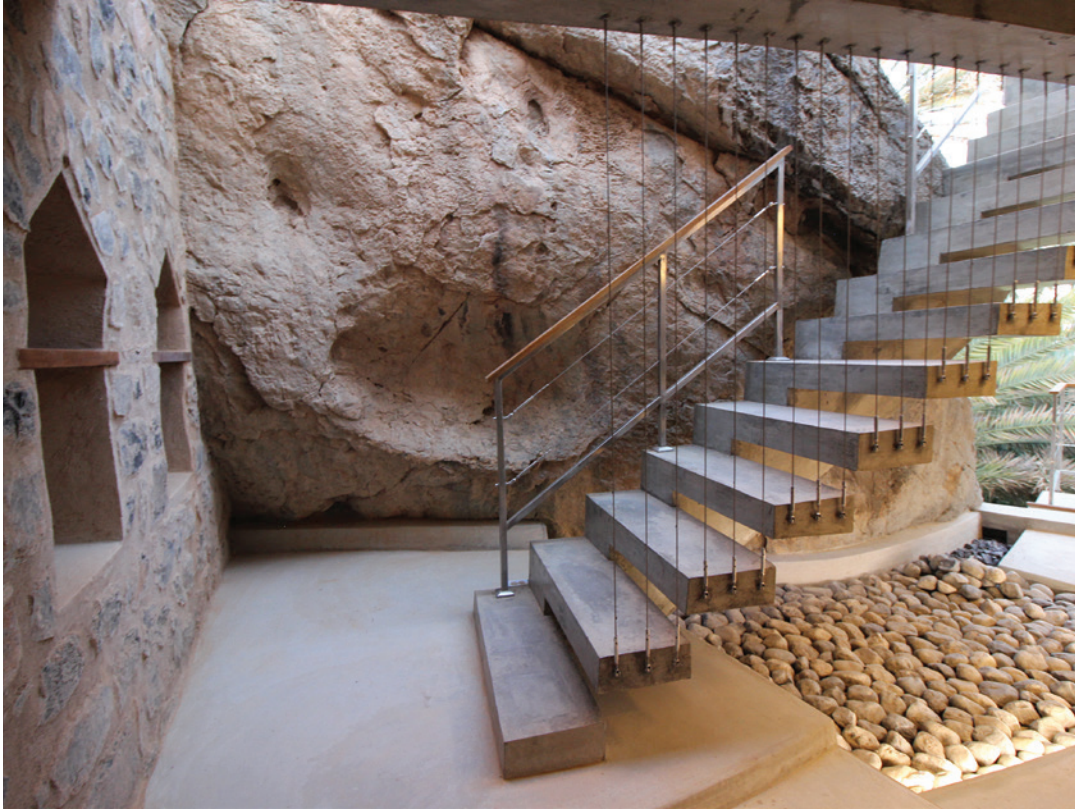
FIGURE 12.20. Adaptive reuse of an old dwelling as a café-restaurant in Misfat al-'Abriyin village; internal view of the installed new staircase. Source: ArCHIAM Collections and Ministry of Heritage and Tourism, Oman.
