## SUSTAINABLE CLIMATE CONTROL FOR HISTORIC BUILDINGS IN HOT AND HUMID REGIONS

**Shin MAEKAWA<sup>1</sup>, Franciza TOLEDO<sup>1</sup>**

**ABSTRACT:** To preserve both the cultural collections and the historical buildings that house them, a technologically simple yet robust climate control system was installed in two small rooms containing the Historic Archive of the Canary Islands, located in a municipal building of the city of La Laguna on Tenerife Island, Spain. The building is a late 19th century massive masonry building located in a sub-tropical climate site. The system was designed to maintain the RH level (less than 75%) necessary for preventing microbial activities in collections in cultural institutions by operating residential-type ventilators and a heater under a humidistatic control. Interior and exterior climates as well as interior levels of microbial activities and dust deposition were monitored, before and after the installation of the systems. After nearly one year of operation, we have confirmed that the system not only successfully eliminated events of high RH but also stabilized it. The annual temperature variation was significantly reduced, although daily var

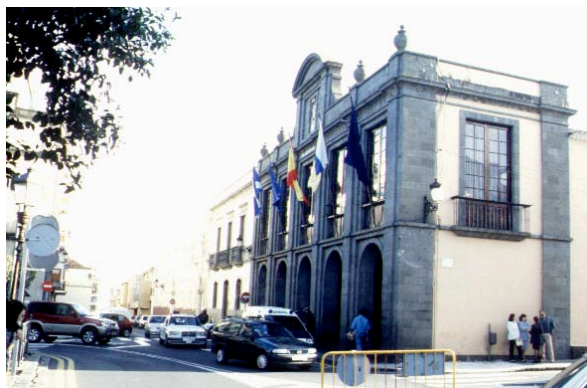
**Figure 1:** Façade of the Ayuntamiento de La Laguna complex with its three historic buildings. The first one on the left is where the Historic Archive is located.

The Historic Archive is housed in a late 19th century building that originally belonged to the Dominican Nuns. It is a two-story building with an above-grade basement that surrounds a patio (Fig. 1).

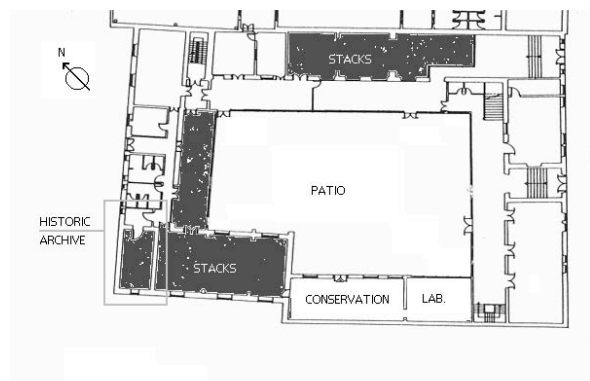
**Figure 2:** First floor plan of the municipality building, showing the rooms where the stacks are located (gray areas), the patio, the conservation laboratory, and the two rooms where the alternative climate control system was installed (highlighted by a rectangle).

The Historic Archive, located at the west corner of the building, consists of two rooms (6.6 m x 3.2 m with ceiling height of 2.3 m; and 1.7 m x 2.5 m with the ceiling height of 4.0 m) connected by a door (2.4 m high x 0.9 m wide). Entry is made through a normally closed door (2.4 m high x 0.9 m wide) into the smaller of the rooms (Fig. 2). Although access is limited, archivists enter the rooms daily.

The smaller room had a northwest-facing window (0.6 m x 0.5 m) at 2.5 m from the floor, and the larger room had a 0.7 m x 1.14 m window facing the southwest, but both were permanently closed for security and environmental reasons. A two-meter high steel shelf was affixed to the two longest walls, and smaller movable shelves covered other walls, including windows. All shelves were filled with archival documents. Most of the documents were unbound and placed in document cases made of acid-free paper or polypropylene.

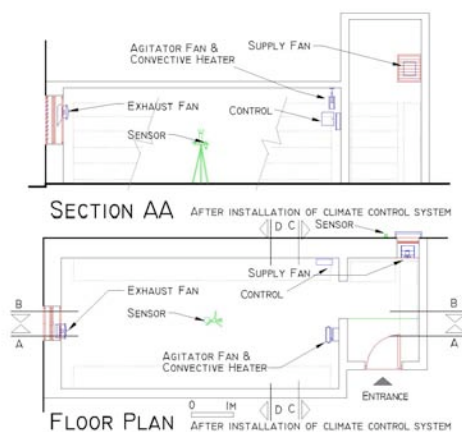
**Figure 3:** Plan and cross section of the two rooms where the alternative climate control system was installed, showing where the mechanic units and sensors are located.

The climate control system, installed in the Historic Archive in May 2000, consisted of a set of supply and exhaust fans for ventilation, and a set of agitator fan and a convective heater for heating the rooms. We also made a slight modification to the entrance area (as described below and shown in Fig. 3). The ventilator set-up was designed to produce 6-8 air changes per hour. The heater (rated 1.5 kW) was selected to produce an increase of only few degrees in the space. These items were all off-the-shelf residential use equipment.

An anti-microbial filter and a gravity-operated shutter were placed with the supply fan for controlling the quality of the fresh air and to limit the amount of infiltrated air through the fan. The exhaust fan was also equipped with a spring-loaded shutter that opened only during fan operation. These fans were placed in the existing windows at the two ends of the connected rooms to provide cross ventilation in the space. The heater and agitator fan were mounted on a wall and ceiling, respectively, segregating the rooms. They were operated together to avoid localized heating and to distribute the heat as evenly as possible in the space.

These fans and the heater, along with two (RH and air temperature) sensors—one in the center of the room and the other just outside of the building—were connected to a programmable controller [9]. The controller activated the ventilator whenever the outside RH was below 70% and the inside RH was higher than 70%. The ventilator ran until the inside RH was reduced to 65% or less.

The small heater/agitator fan was activated when both external and internal RH levels were above 75%. The heater ran until the inside RH was reduced to less than 70%, or the outside RH had fallen below 70%, at which time the ventilator would activate.

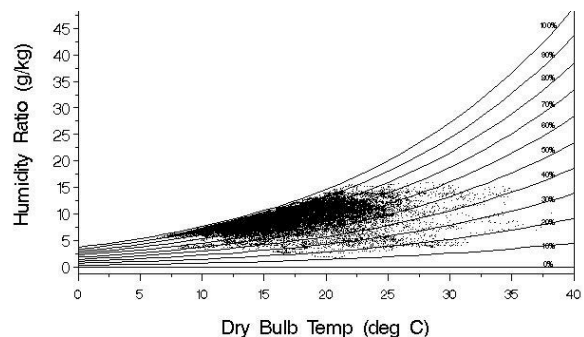
**Figure 4:** Psychrometric chart showing climate conditions in La Laguna, Tenerife Island. Each data point represents a 15-minute reading.

Figure 4 shows temperature and RH values measured outside the building, plotted on a psychrometric chart. Annual temperature means were identical at 17.1°C, and RH means were 77.5 and 80.4% in 1999 and 2000, respectively. Typical daily variations were 10°C and 30% RH.

This climatic pattern was erratically disturbed by Saharan winds (strong southwesterly winds originating in the Sahara Desert), raising the temperature (maximum of 38.16°C measured on July 3, 1999) and lowering the RH (minimum of 12.28% on November 9, 1999).

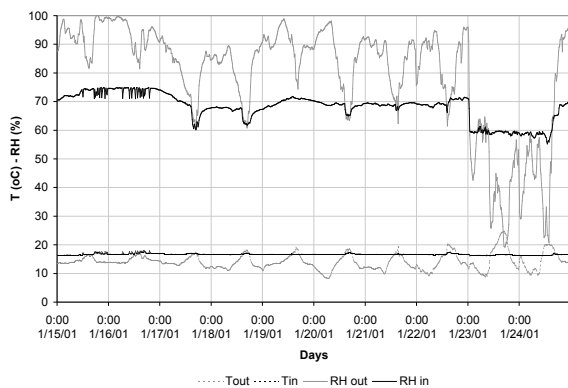
**Figure 5:** Operation of the climate control system installed in the Historic Archive, in the second half of January 2001.

Figure 5 shows climates of both in the Historic Archive and the outside of the building during the second half of January 2001. In this period, three typical climatic events occurred while the climate system was operating.

It possibly rained on January 15<sup>th</sup>-16<sup>th</sup>, with the outside RH remaining at nearly 100%. During the two-day event, the Archive's interior RH was successfully maintained at less than 75% by heater activation, resulting in a temperature increase of only 1.3°C (from 16.5 to 17.8 °C).

A period between January 17<sup>th</sup> and 22<sup>nd</sup> was clear days, and the interior RH was maintained at safe levels by operating the ventilator. The ventilator was activated from approximately 12-6 PM, at which time the outside RH dropped to less than 70%, and the ventilator was deactivated once the RH inside the building reduced to less than 65%.

On the 23<sup>rd</sup> and 24<sup>th</sup>, during the Saharan winds, the climate system deactivated both the ventilator and heater. While the outside RH dropped to 20% (January 23, 2001, 5:30 PM), a low air infiltration rate combined with the moisture content of archived documents to maintain 60% RH in the room. And the large thermal mass of the building kept the room's temperature at 16.6°C when the outside temperature rose to 24.7°C (January 23, 2001, 4:30 PM).

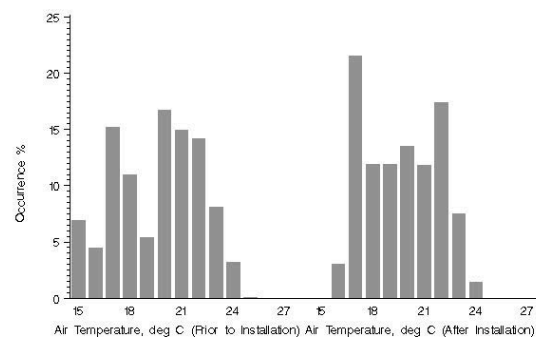
**Figure 6:** Distribution of air temperature values, before and after installation of the alternative climate control system in the Historic Archive.

The inside temperature was very stable, as expected for a massive building, with an annual average of 19.5°C (a maximum of 24.5°C and minimum of 14.8°C). In the Historic Archive, the standard deviation was only 2.4°C prior to the installation of our climate control system. Histograms of the room's temperature and RH are shown in Figures 6 and 7.

Although the annual mean values of room temperatures recorded before and after the installation of the climate system were similar, at 19.5°C and 19.6°C respectively, the distribution was noticeably changed after installation (Fig. 6). Occurrences of both low and high temperature events were significantly reduced, and temperature was confined to a narrower range.

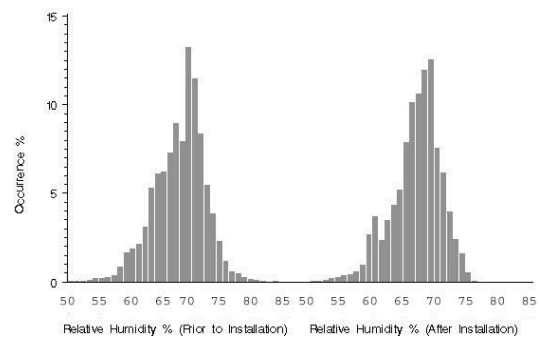
**Figure 7:** Distribution of relative humidity values, before and after installation of the alternative climate control system in the Historic Archive.

The annual RH average slightly decreased from 68% to 67%. However, more importantly, we successfully managed to keep the RH to less than 75% at all times. Less than 4% of the measurements were higher than 72.5% RH (Fig. 7). The minimum as well as the distribution of low RH values were also unchanged, indicating that our effort to limit air infiltration was successful.
