## V. Site-wide Threats and Considerations

### 2. Assessment of flash flooding

## Part V.1. Environmental monitoring

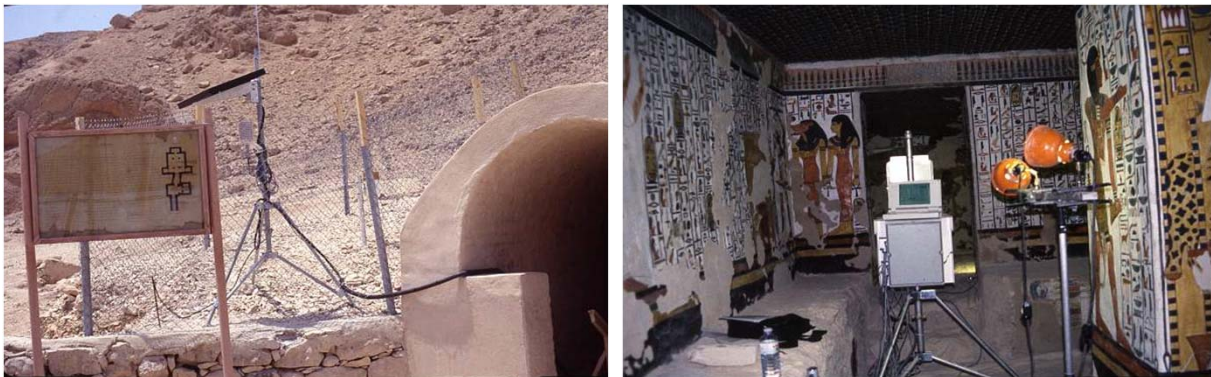
The environmental monitoring station installed at the tomb of Nefertari (QV 66) in August 1991. Left image shows a solar panel and sensors installed on a tripod just outside the entrance arch. Right image shows station's datalogger in the burial chamber.

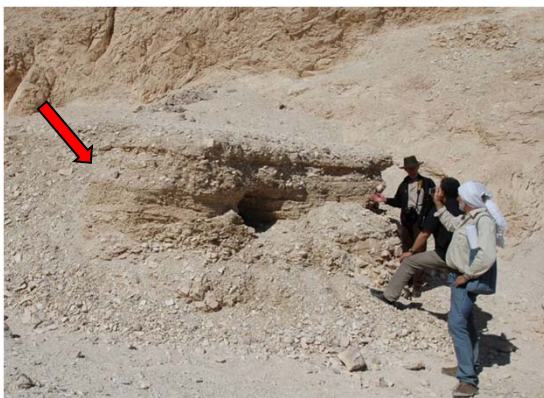
Section of alluvial stratigraphy left intact by the Franco-Egyptian mission.

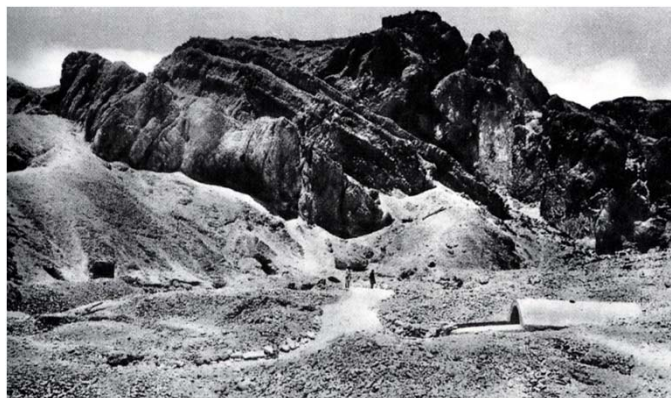
View of Valley at the time of Schiaparelli's mission, looking west from near QV 66 (Nefertari), showing build-up of flood debris. (Image: Schiaparelli 1923)

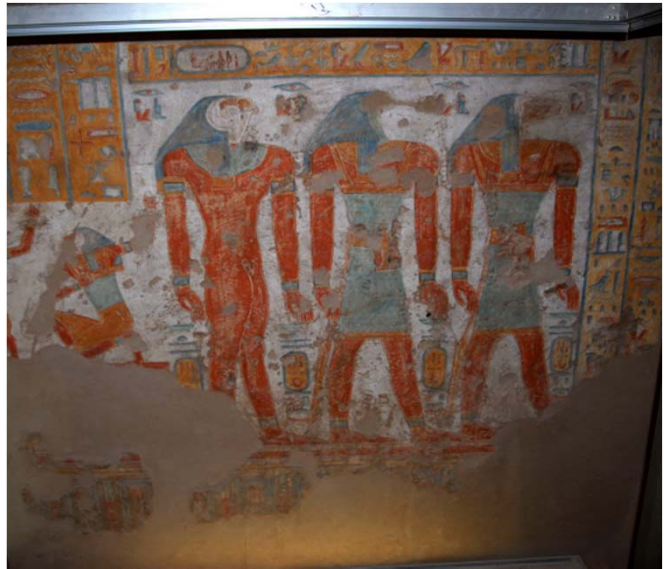
Loss of painted plaster at the wall base of tomb QV 52 (Tyti) presumably due to historic flooding. The tomb, open to general visitation, is in a vulnerable position near the main drainage channel.

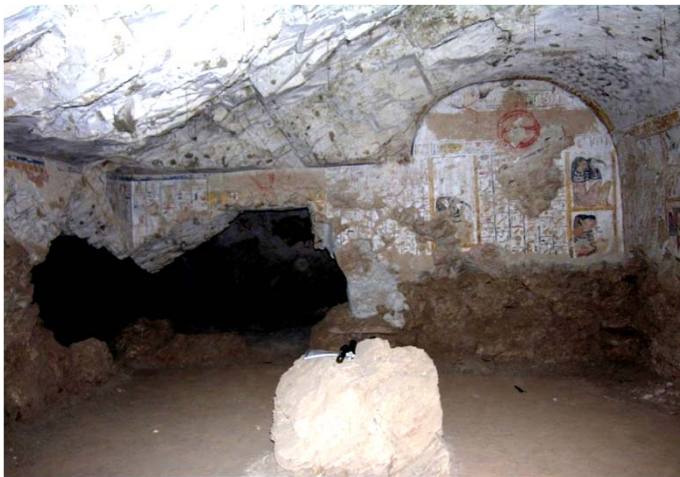
- The clay-rich rock into which tombs are constructed (comprised of marls and shales) swells when wetted, resulting in severe rock damage and, in cases, collapse. The shaley rock of tombs on the south side of the main wadi is particularly susceptible to such impacts, although marls are susceptible to such deterioration as well (as evidenced by QV 60).

Rock collapse, deterioration, and loss of painted plaster in the lower walls of tomb QV 60 (Nebettauy) due to repeated flooding, including in 1994.

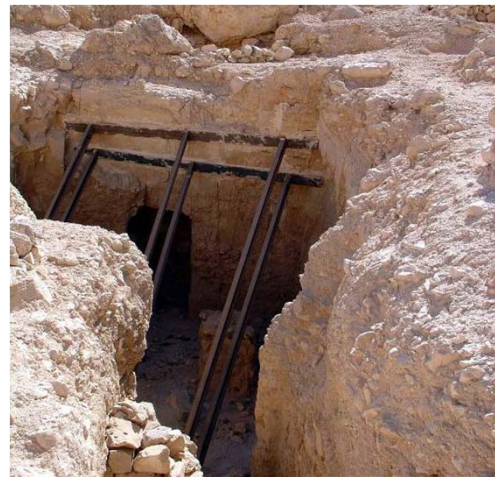
View of roof collapse of tomb QV 34, which is in an area where most tombs contain shale susceptible to water damage.

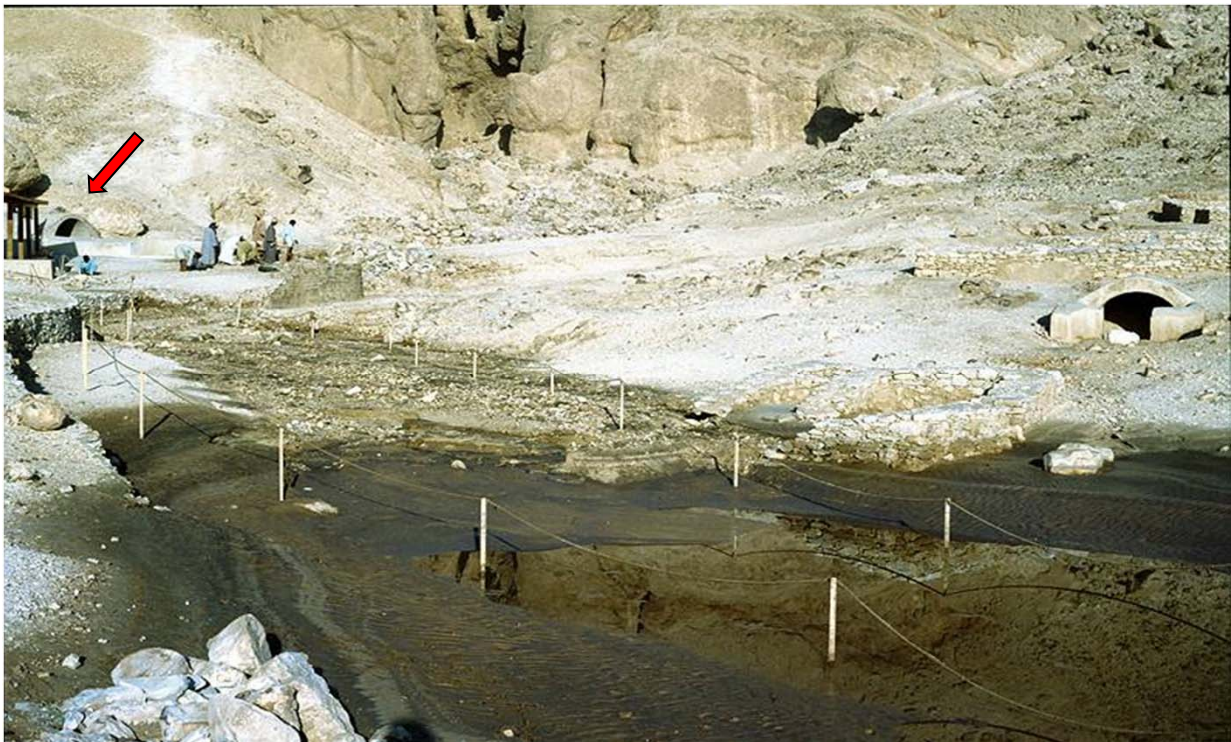
Water standing in the wadi after the 1994 flood. QV 55, one of the three tombs open to general visitation, is indicated by arrow. In the foreground are the foundations of Rameside-era and Coptic-era structures and tomb QV 58, now a magazine, on the right. (Image: CNRS)

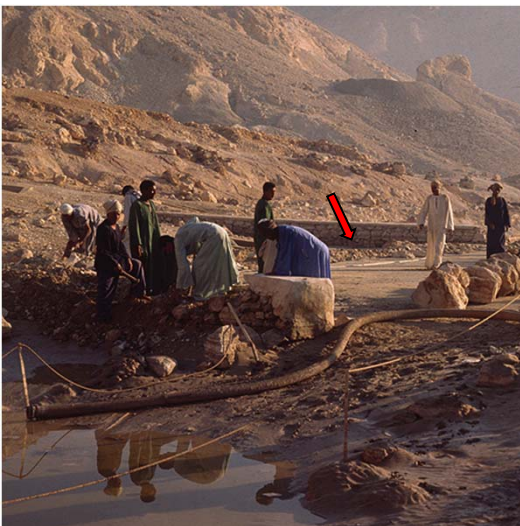
The former parking area was removed after the flood (Image: CNRS).

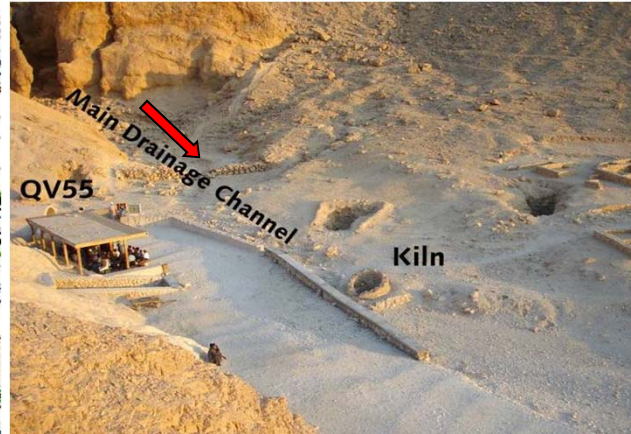
The ancient Roman or Coptic kiln is in the path of the main drainage flow near tombs QV 55 and 53. The direction of flow is indicated on the map and image by arrows. A wall was constructed in 2007 along the north side of the visitor path next to the kiln, which almost completely constricts the channel on the kiln's south side.

Location where the kiln obstructs the main drainage channel.

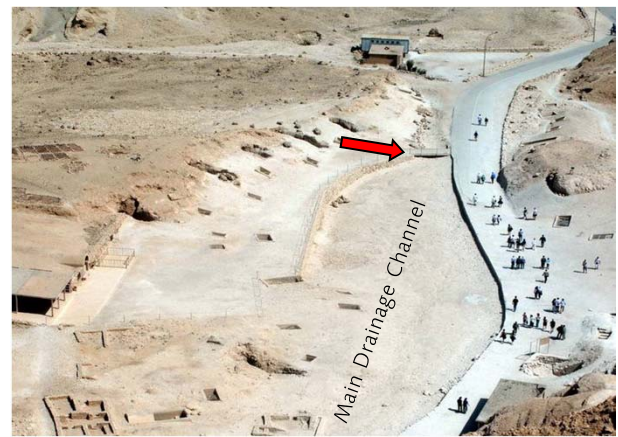
View of main drainage channel looking downstream showing channel narrowing and point of constriction at bridge (arrow).

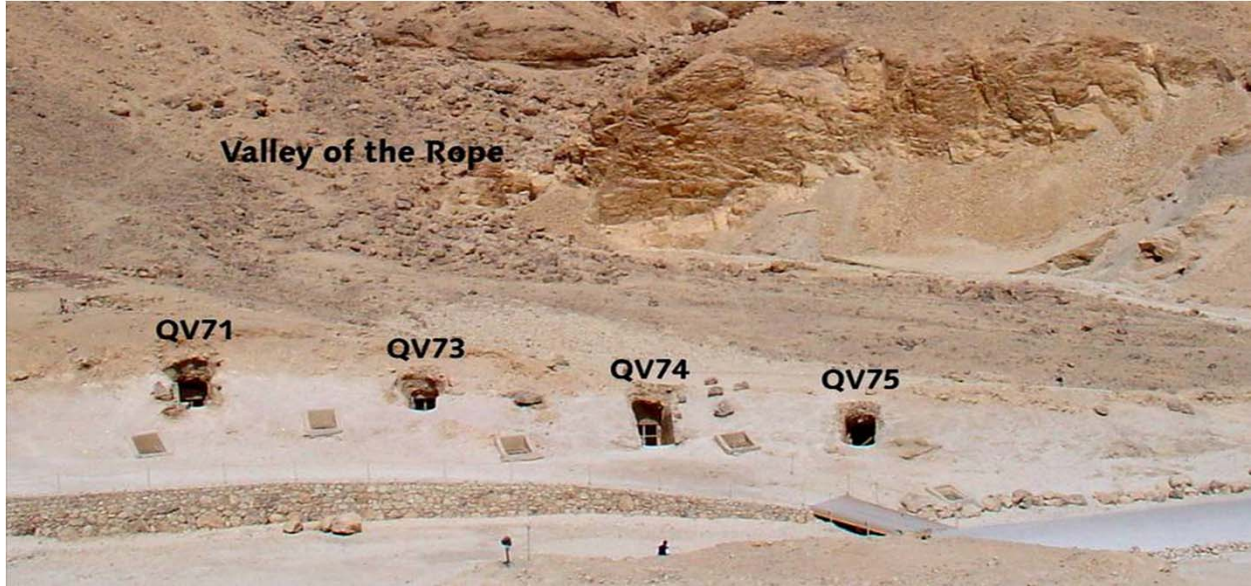
If a substantial flood event occurs, tombs QV 71 – 75 are vulnerable from upslope overflow from the Valley of the Rope drainage path to the north. The chief of the SCA site guardians indicated that QV 71 and 73 flooded in 1994 (2009 pers. comm.).

General view of Area 4 showing the Valley of the Rope outflow in the background.

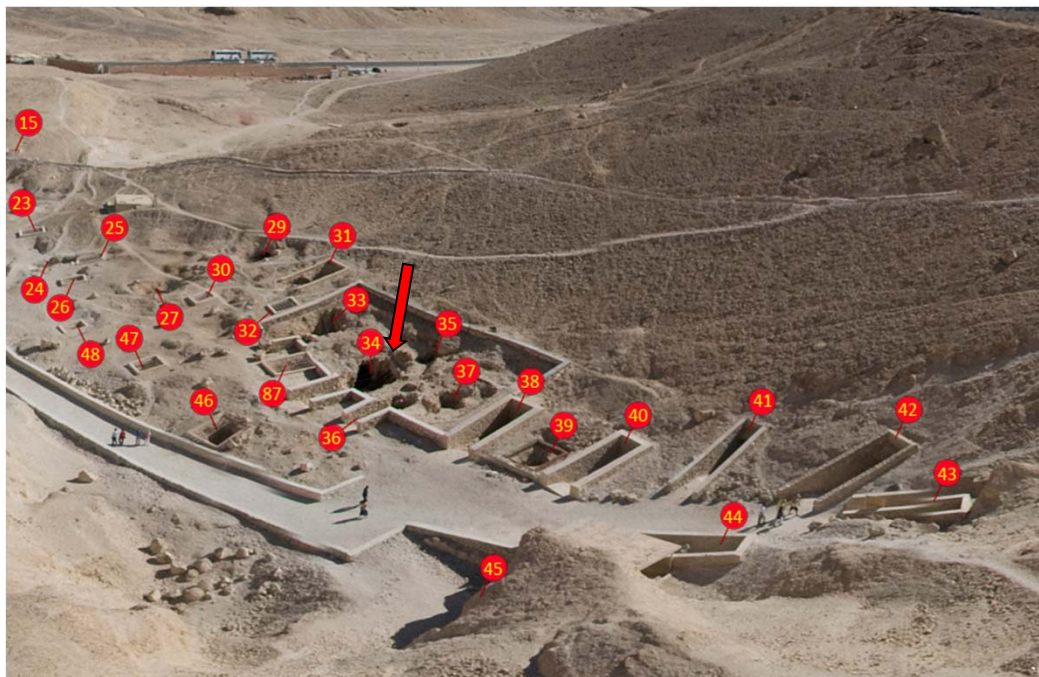
Many of the tombs in Area 5 contain expansive shale and in some areas this rock is exposed at the ground surface. This area also includes the collapsed roof of QV 34, which is highly susceptible to water infiltration and further damage. The SCA built a wall around this unstable area in 2009.

General view of Area 5, with arrow indicating QV 34 with collapsed roof.

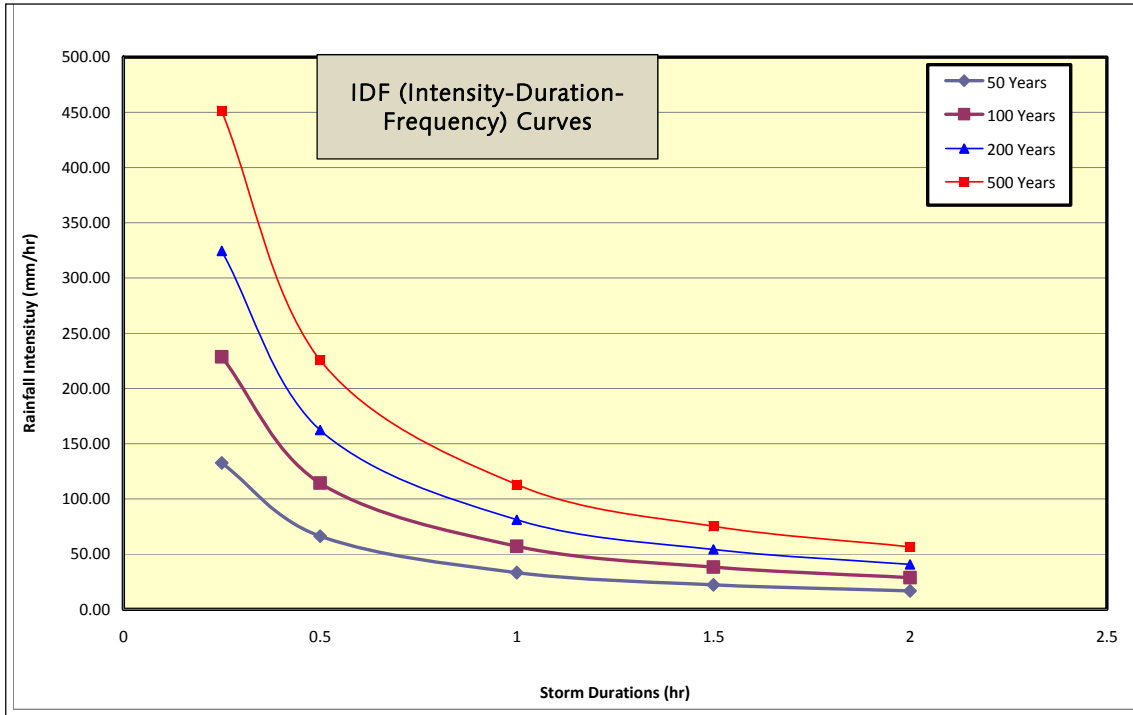
As a next step, a time series analysis was conducted over the period of simulated storms for return periods ranging from 50 to 500 years and storm durations of up to 2 hours. Based on the daily rainfall data recorded at Luxor airport station, the graph below (Intensity-Duration-Frequency curves) shows the extreme value plots of maximum daily rainfall. This plotting confirms that peak storm events in the Luxor area are typically of short duration, and begin with heavy rainfall that rapidly lessens in intensity.

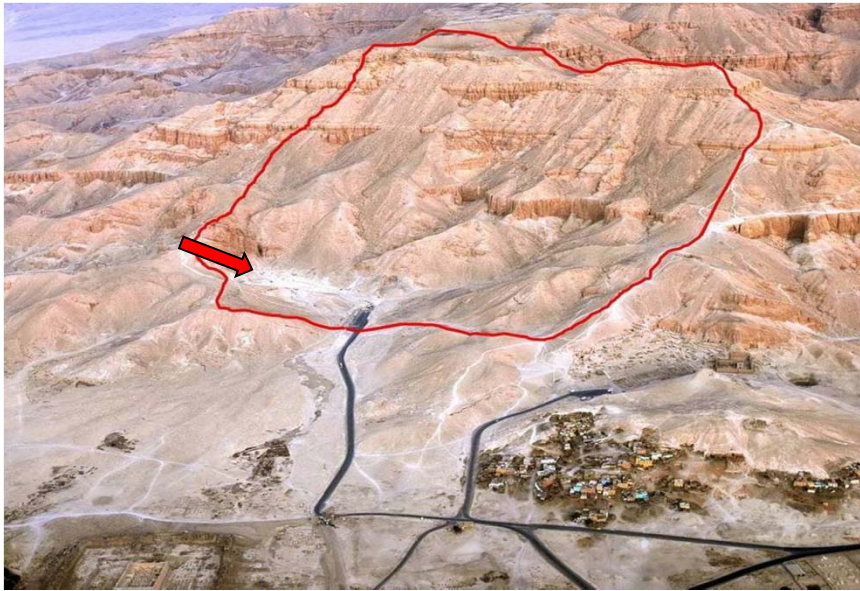
The QV rainfall catchment area, which extends to the top of the Theban Mountain, covers 104 hectares (more than 1 km square). The concentration of tombs at the base of the mountain is indicated by the arrow.

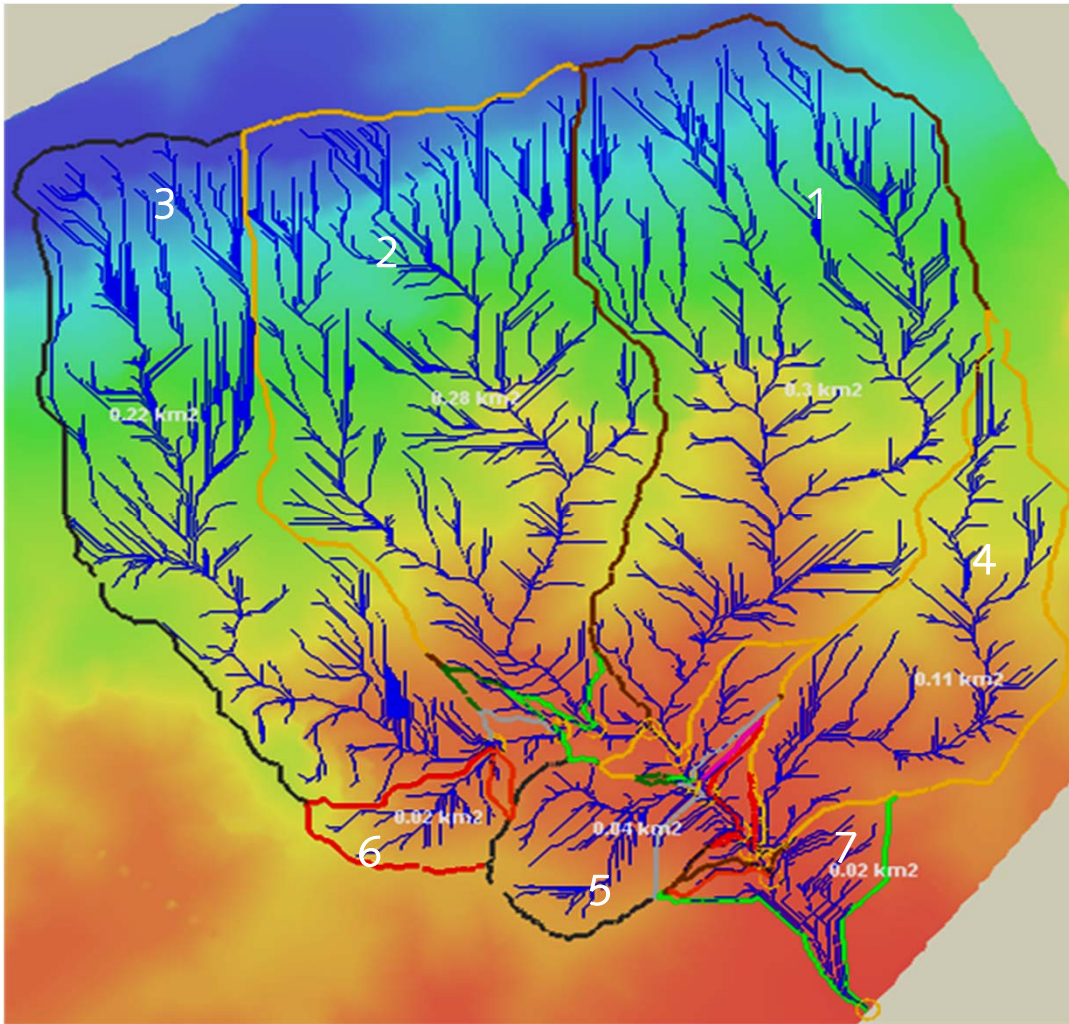
The analysis using WMS software confirmed that the total QV rainfall catchment area is about 1.04 km<sup>2</sup> (104 hectares). This modeling divided the QV catchment into five major sub-catchments, as shown in the figure below. The characteristics of each major sub-catchment are contained in Table 3 that follows. The analysis also identified two other minor sub-catchments, each with areas of approximately 0.02 km<sup>2</sup>, that are not included in the table. These minor sub-catchments, labeled 6 and 7 on the map below, include what is referred to in this report as the southwest branch of the QV main wadi (identified as no. 6). The background color of the figure below indicates relative elevation above sea level of the QV topography, with orange and red indicating the lowest elevations and green and blue indicating the highest.
