## VI. Site Elements

## VI. Assessment of Site Elements

### Introduction

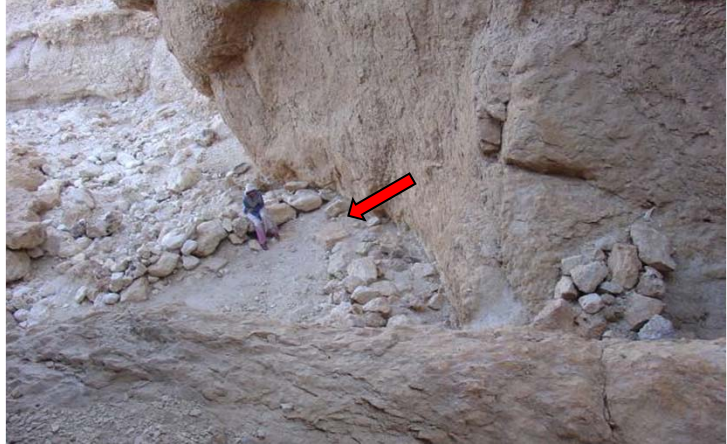
View looking down from the Grotto to the Cascade, with arrow indicating what CNRS has identified as the first barrage (2 on plan).

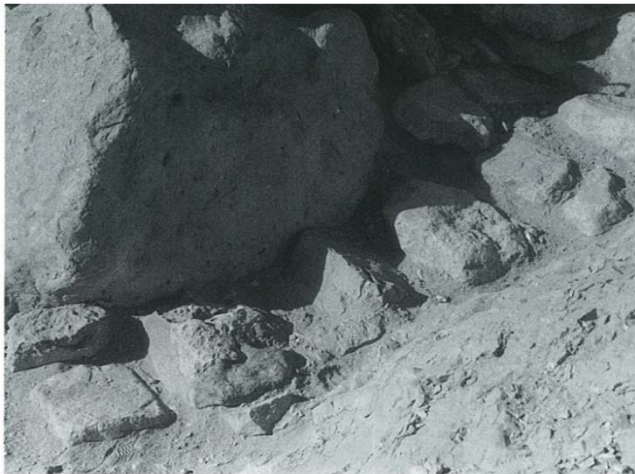
Rock paving steps (5 on plan), as excavated, on the path leading from the lower to the upper basin (Image: CNRS).

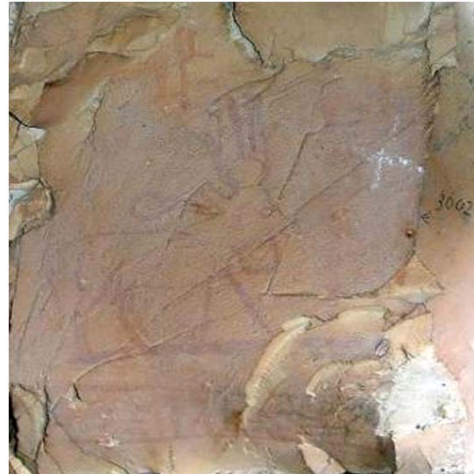
Rock painting of Hathor (3002) in red ochre with a sun disk and two ostrich plumes atop its head.

The rock substrate within the Grotto in the area of rock art 3001-3015 accessed during this assessment appears in good condition. The two red paintings appear as if they may have degraded since photographs taken by CNRS were published in 1989 given that they now appear less visually prominent. However, without access to high resolution color photographic documentation taken in the 1980s it is not possible to determine whether they have actually lost pigment. Rock art 3016-3019 was not accessed for assessment.

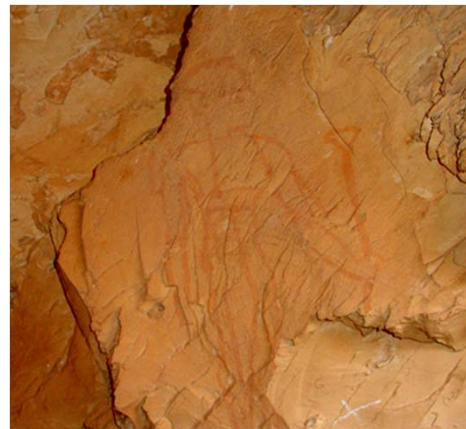
Rock painting (3007) in red ochre of a goddess holding a papyriform cane.

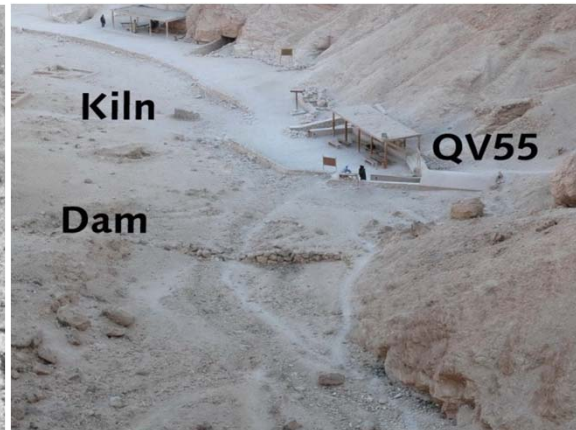
View from upstream side of Dam within context of drainage channel and in relation to QV 55, the adjacent visitor path, and the kiln.

Comparison of CNRS photographs from the late 1980s with current conditions shows that extensive debris was removed from around the Dam in the late 1980s, particularly from its east (downstream) side. Although removal of the debris exposed the entire structure to investigation and made it more visible from the visitor trail, these changes have also made the Dam more susceptible to disturbance by flood. Leblanc has stated (2007 pers. comm.) that the Dam was largely disrupted during the November 1994 flood and that the CNRS-SCA mission afterward reassembled affected parts of it to its prior state.

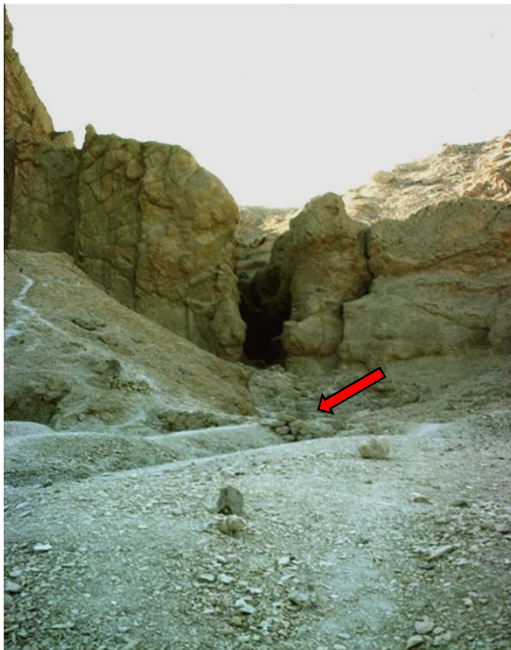
1987 view of Dam (indicated by arrow) before clearance of debris on its downstream side (Image: CNRS).

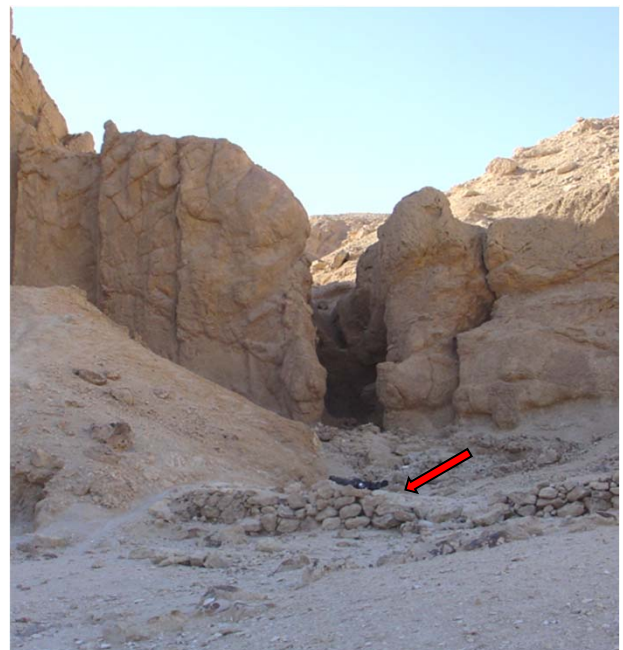
2008 view showing Dam (indicated by arrow) after debris clearance.

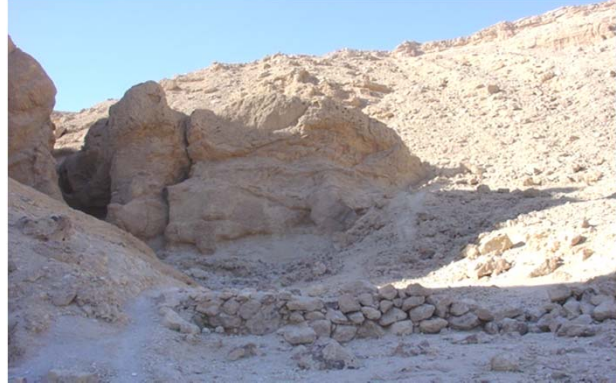
2008 view of Dam in 2007.

The faces of the structure made of large rubble are generally stable, although some of the stones are undercut from erosion, with only debris underneath them. The smaller rubble pieces in the core of the structure are in some cases loose.

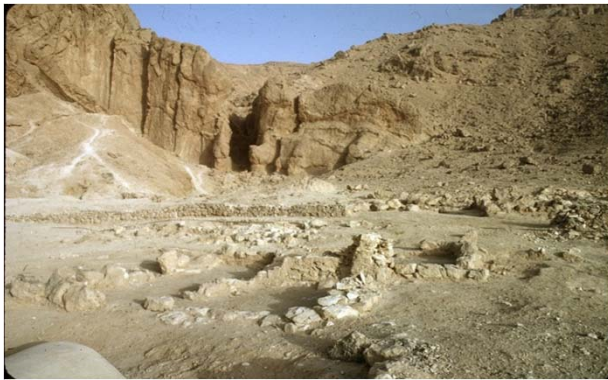
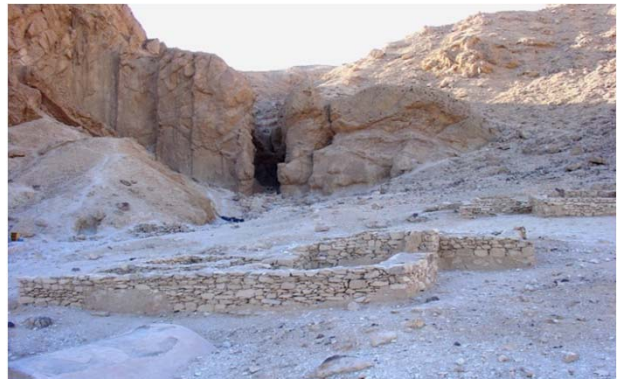
Comparison of House 1, from the southeast, following excavation in 1987 (left, Image: CNRS) and in 2008, after restoration by CNRS (right). The barrel arch over the entrance to QV 58 is at the bottom left of both images.

As noted previously, remains of the Tomb Workers' Structures after excavation mainly consisted of rubble foundations and lower courses of dry-laid masonry walls, with some remnants of interior and exterior earthen plaster. In 1988 the Franco-Egyptian mission stabilized the structures' remains and partially restored their walls to make the structures' plans legible to visitors. What is visible today is primarily new materials covering ancient wall remains. The restored structures appear stable and in good condition, with the exception of one area of House 2 where limestone blocks have been displaced from the mortar in which they had been imbedded during CNRS restoration work in the late 1980s.

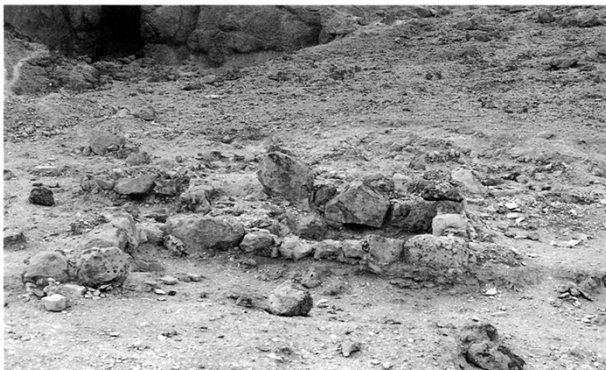
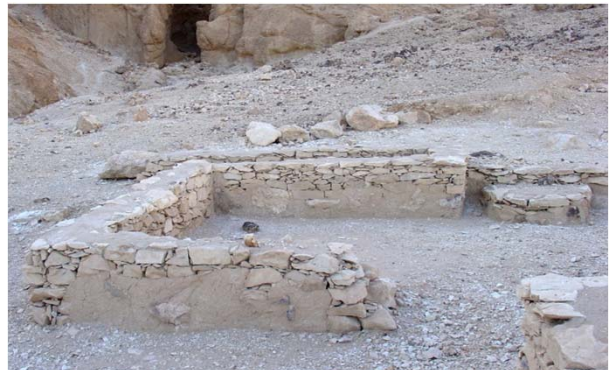
Comparison of northwestern part of House 2, from the southeast, in 1985 following excavation (left, Image: CNRS) and in 2008 (right).

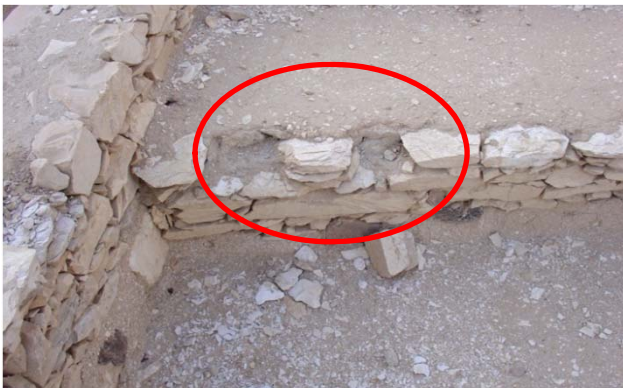
Damage to House 2 where limestone blocks have been displaced from the mortar in which they had been imbedded through CNRS restoration work in the late 1980s.

- **Stabilize walls:** Some of the reconstructed walls have loose stones, which should be stabilized with mortar.
- **Protect from visitor impacts:** If visitor circulation is routed nearby, create unobtrusive barriers to prevent visitors from being able to stand or sit on the structures. SCA inspectors and guardians should prevent visitors or other individuals from standing or sitting on the structures.
- **Protect from flood:** The primary means for protecting the structures from flood will be through constructing a flood diversion wall on the upslope side of the structures to divert water runoff to the main drainage channel.

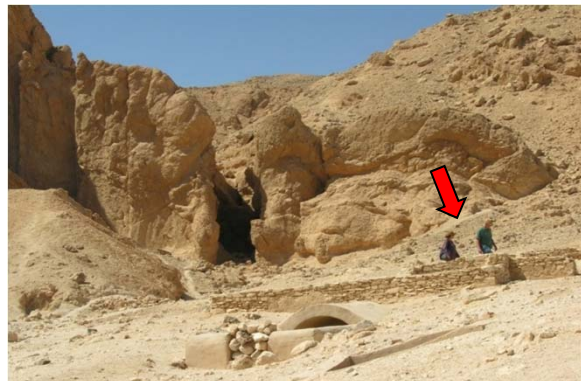
- **Visitor and site personnel impacts:** Due to the structures' close proximity to the visitor trails along the main wadi and in front of the tomb of Nefertari, they are susceptible to damage by visitors who leave the trail and climb onto them, or by security personnel who use the informal path between QV 80 and QV 55.
- **Flooding:** Although it is not known how they were affected by the 1994 flood, the structures appear to be risk from flooding, generally due to water runoff washing down from the hill slope to the north.
- **Exposure to the elements:** The structures' earthen plasters are susceptible to weathering and erosion from rainfall, water runoff, and wind.

Tourists (arrow) who have left the authorized visitor path and are walking through the area of the Tomb Workers' Structures.

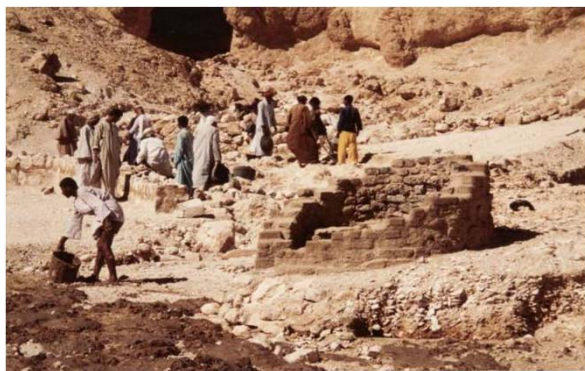
Workmen clearing debris from around the Kiln following the 1994 flood. (Image: CNRS)

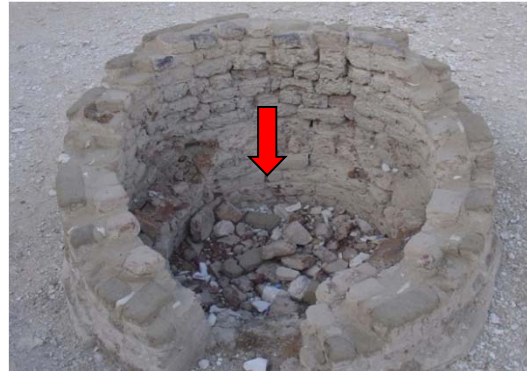
Kiln in 2008. Note bricks that have fallen within the Kiln's interior (arrow).

The Kiln is generally stable. However, several bricks that once formed part of it have fallen within the structure, and two additional bricks were found just outside it; a few loose bricks also rest on top of its wall, and many loose fragments of brick are present in the interior face (some of these loose or fallen bricks may be from the restoration). A few of the lowest course of bricks on the southern, lower side of the structure are undercut. Cracks are present, presumably due to shrinkage, between the mudbricks and the re-pointing mortar. The low masonry wall just below the Kiln also appears stable.

- **Protect from flood:** To protect the Kiln from flood, it is recommended to relocate it further away from the base of the wadi on higher ground nearby. If the Kiln is moved as a structure then it should be stabilized with mortar repairs beforehand. If it is moved brick by brick then prior stabilization is not required, and fallen bricks and fragments can be replaced after the structure is moved.
- **Monitoring and maintenance:** The condition of the Kiln should be monitored regularly and loose bricks should be stabilized and fallen bricks re-instated in their original location.

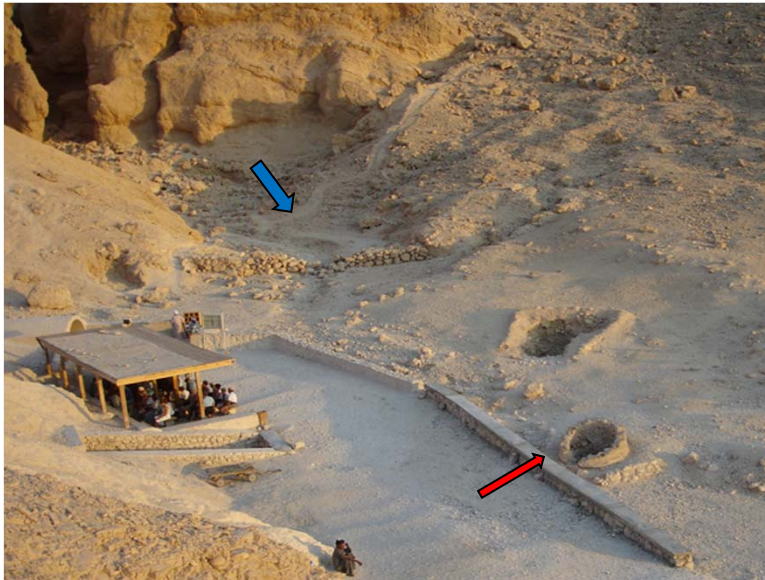
The location of the Kiln (red arrow) within the main QV drainage channel, with the direction of flow coming from the Valley of the Grand Cascade indicated by the blue arrow.

- An potential threat to the survival of the Kiln is flash flooding. It is located in the direct path of drainage from a rainfall catchment area exceeding 19 hectares. It impedes floodwater flow in the main wadi and would likely be destroyed or else severely damaged by a large-scale flood event. This threat is compounded by the construction in 2007 by the SCA of a low wall along the visitor trail next to the Kiln, which will further constrict the flow of drainage around the Kiln.

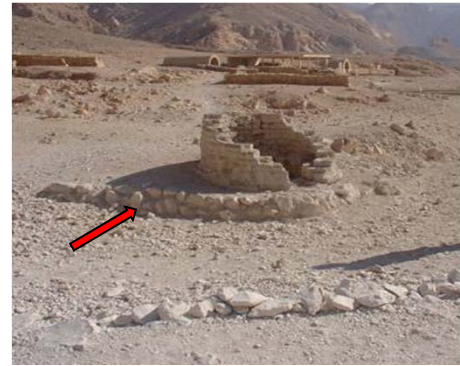
Kiln and stabilized ancient masonry wall (arrow) below it as seen from the visitor trail.

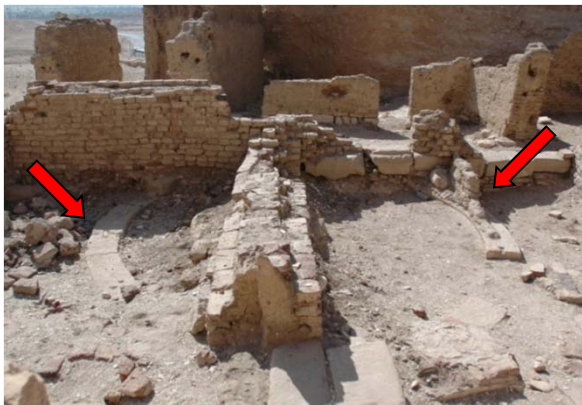
Circular stone remains of the Roman sanctuary.

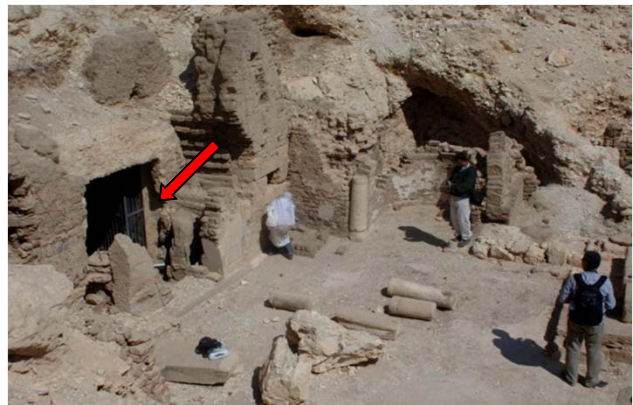
The church and entrance to tomb QV 95 (arrow).

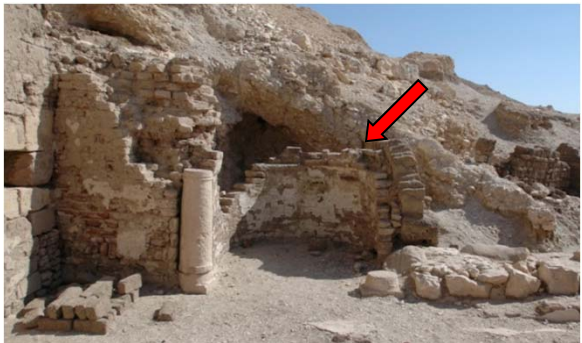
The church apse with remains of white finish plaster on its wall.

Church (12): Fragments of undecorated white plaster remain on the church walls. They are generally in a fragile condition. On the west wall, a few large areas have been lost since 1995 (note CEDAE photo 32320), and one area of plaster is now partially detached and at high risk of loss. A small area of plaster loss on the east wall adjacent to the apse has occurred since 1995 (see CEDAE photo 32325), as has substantial areas of loss inside the apse (see CEDAE photo 32326), with remaining plaster in areas cracked and partially detached from the wall. Areas of the north wall west of the entrance to QV 95 contain red, and to a lesser extent yellow, pigments.

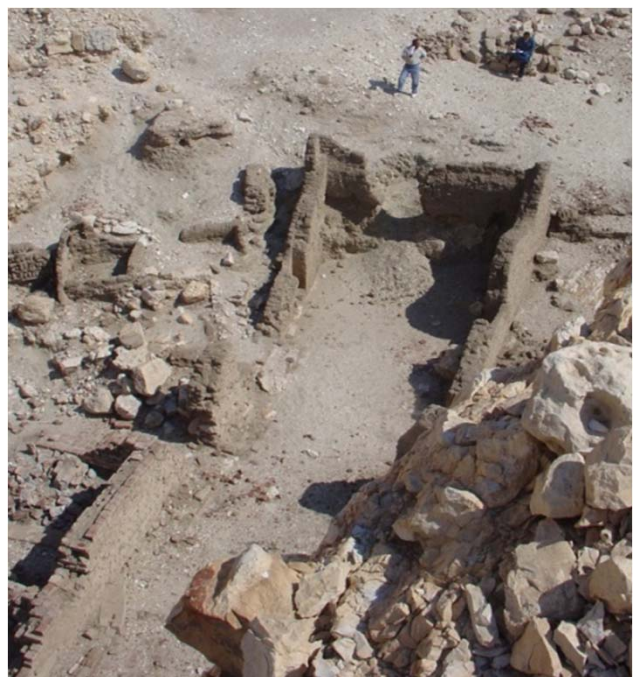
The Vestibule.

Vestibule (2): A large gap in the east wall appears to be at a location where water runoff may enter from the hill slope to north. Shale bedrock under this east wall has eroded significantly since 1995, leading to loss of support and causing structural cracks to appear in the remaining mudbrick wall to both sides of this gap. One mudbrick section of the north wall (directly south of room 3) is leaning inward, apparently due to the lateral pressure caused by the soil present at a higher level against the outside of the wall. One section of the south wall has been incised with Arabic graffiti (north of room 5). This space's far western wall has lost original material at its base. This area of loss has been filled with dry-laid fired bricks.

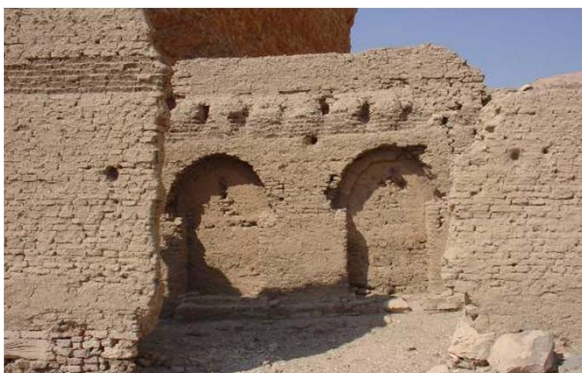
Mudbrick walls of the Arcaded Hall.

Arcaded hall (4): The height of the westerly wall and south section of the easterly wall make them susceptible to collapse, particularly given that they are essentially free standing. The westerly wall has some contact with the rocky spur outcropping on its south end. The westerly wall also has a vertical crack running essentially through its entire vertical height; this crack is located approximately above the division between where masonry blocks are underlying the wall and where there is no masonry foundation. This differential in support may have contributed to the crack's formation. Both walls have relatively small holes in them, with some appearing to be inhabited by birds.

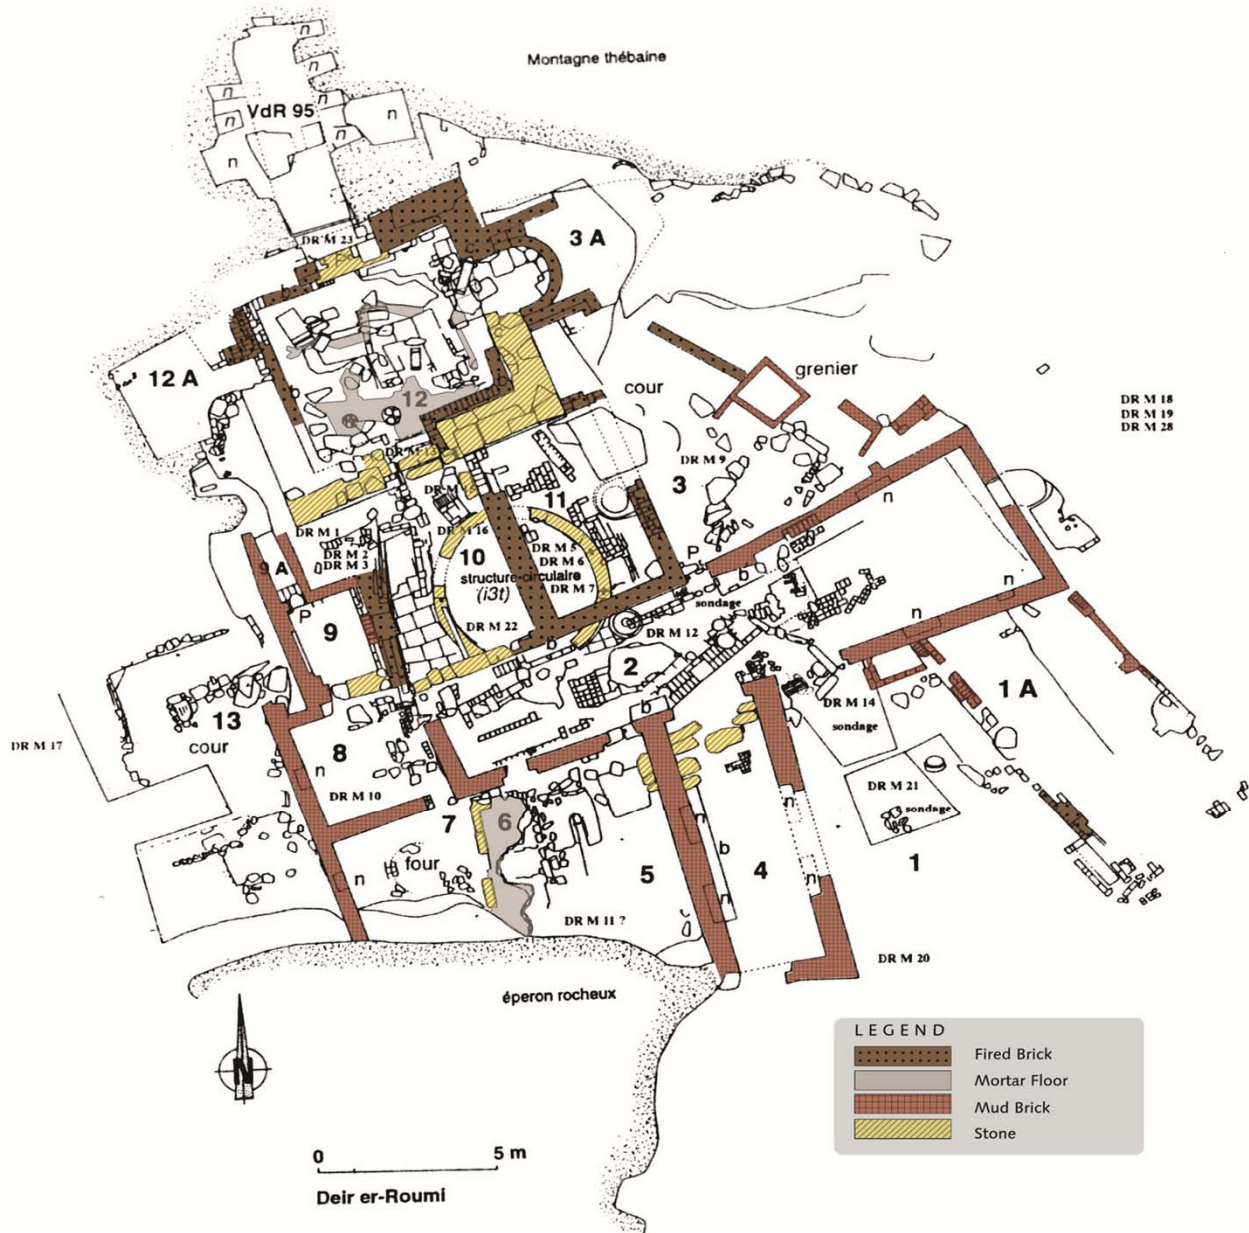
Indication of primary building materials of walls and other architectural features [plan from Augé and Lecuyot 1998, 108, adapted by GCI for condition assessment]. (Base plan: CNRS)

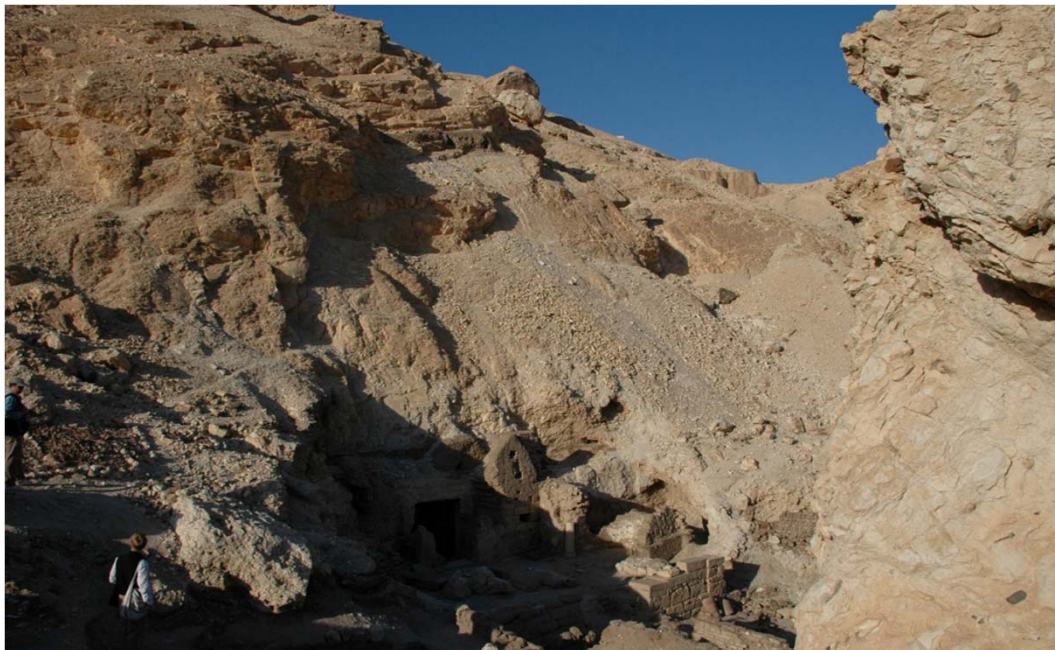
Hill slope to the north of Deir er-Rumi, which puts the site at risk of further deterioration from water runoff and rock fall.

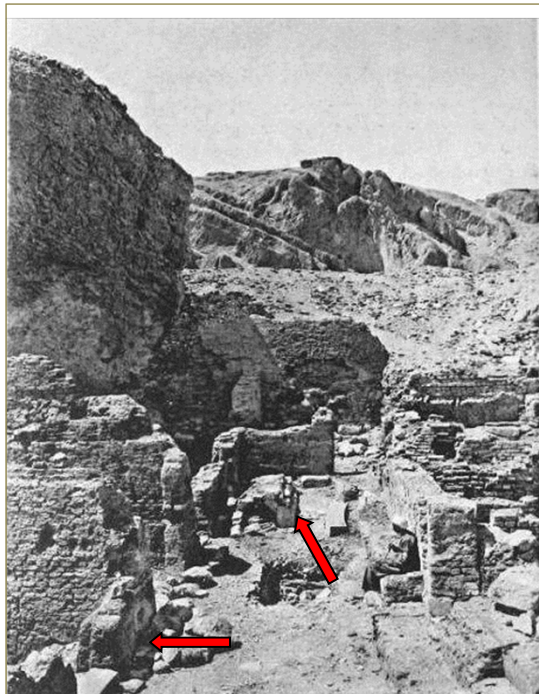
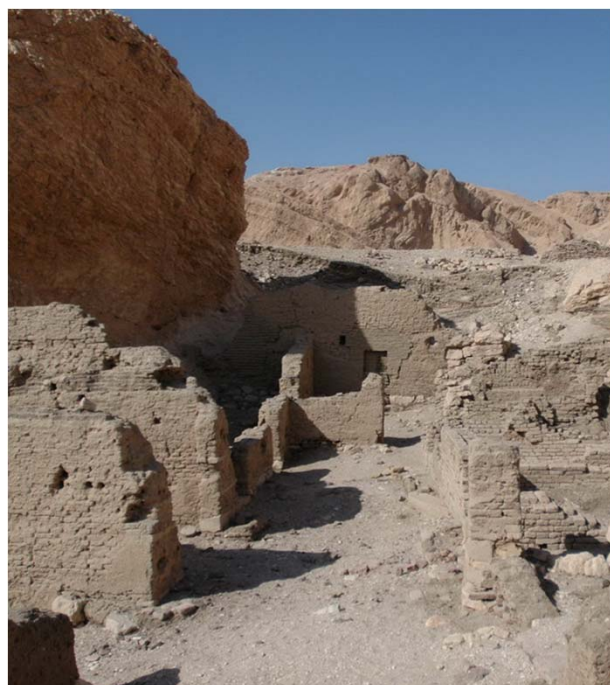
Comparison of conditions between the time of the Schiaparelli mission work (ca. 1906) (Image: Schiaparelli 1923) and 2007, view from the east end of the vestibule toward the west, generally shows standing structures remaining intact and localized significant areas of loss (arrows).

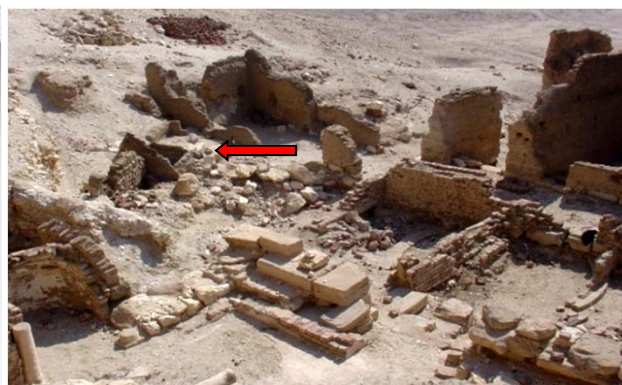
Comparison of conditions between 1988 (left, Image: CNRS) and 2008 showing the extent to which CNRS cleared the site of loose materials, and significant loss to the mudbrick granary (arrows).

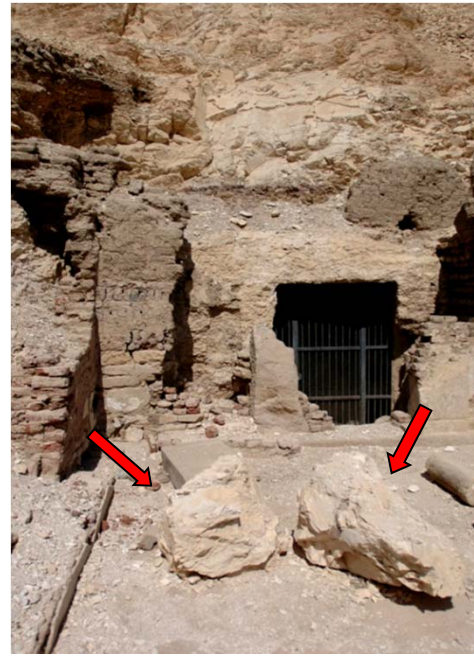
Church (12): CEDAE photographs from 1995 show significant areas of plastered floor surfaces intact in the church. The church floor, made of a pinkish colored layer of mortar-like plaster, is partially visible today, but to a large extent has been covered by fine rock debris that has been deposited by hillslope erosion from above. Two large boulders rest on the church floor, having fallen from the hill slope to the north since CEDAE photographed the site in 1995. Some visible areas of floor surface exhibit significant cracking. The rock fall mentioned appears to have cracked the church floor in the area where the boulders fell.

Boulders (right) that have fallen on the church floor since June 1995 (left, Image: CEDAE 95).

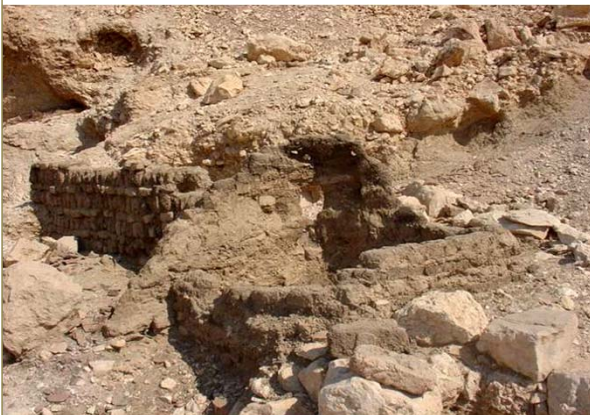
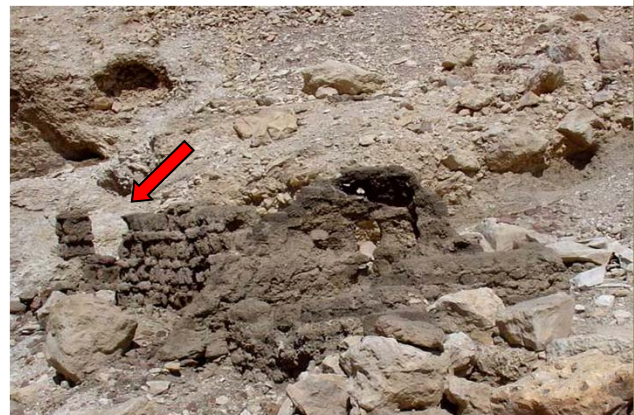
Granary (3): Remains of the granary storage receptacle are in fragile condition due to the decay of their earthen materials, and susceptible to damage from rock fall and water runoff from the hill slope to the north; most of the upper south side has been lost since 1988 (based on comparison with photo by Lecuyot that follows); a section of the fired brick top of the wall protruding to the northwest from the granary has been lost since February 2005; this loss appears to have been caused by rock fall, as a few large rocks are lying immediately to either side of the loss.

Comparison of March 2006 (left) and February 2008 (right) views of the granary showing loss of section of fired brick wall projecting to northwest, apparently due to rock fall.

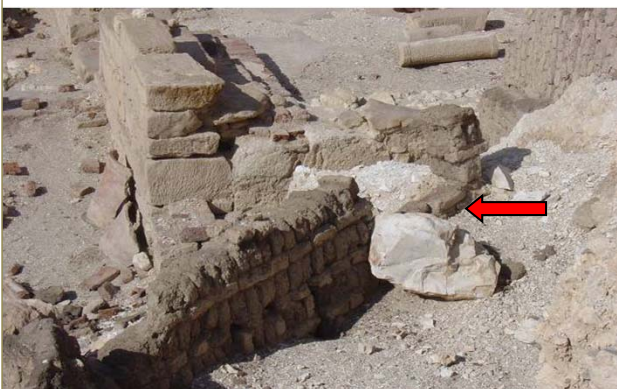
February 2008 image showing large rock leaning against lost wall section of granary.

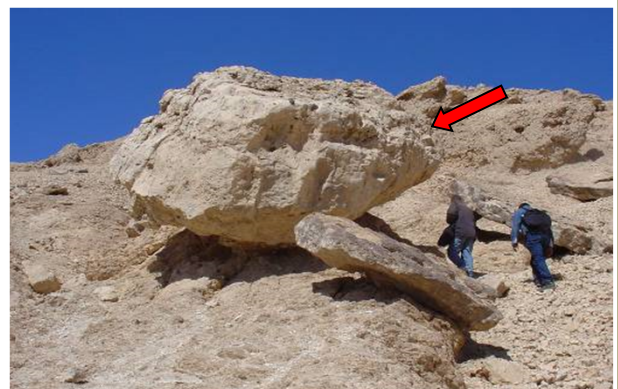
Massive boulder on slope above Deir er-Rumi that threatens the fragile ruins.

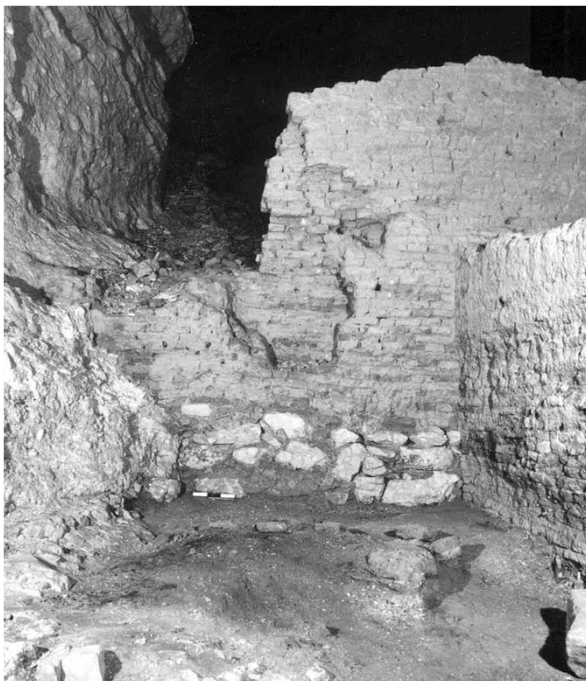
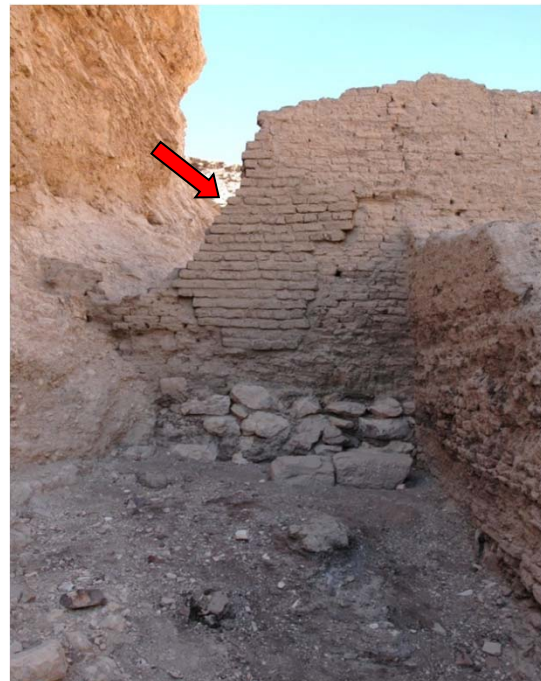
Southwest rooms (5, 6, 7, 8): The northerly walls of rooms 5, 6, and 7 all appear stable. The west walls of rooms 7 and 8 were partially restored with mudbrick infills after the 1995 CEDAE photography. The infill materials are harder than the original mudbrick; there is cracking at the interface between the infill and original mudbrick in the walls of both rooms, which may have been caused by the difference in the hardness of the materials. The foundations of the same wall, on the west side of rooms 7 and 8, have also been exposed due to recent excavation to their west and are now susceptible to erosion and being undermined.

Area of modern mudbrick infill (right) since June 1995 (left, Image: CEDAE 95) on the west wall of room 7. The repair material (arrow) is harder than the original material.

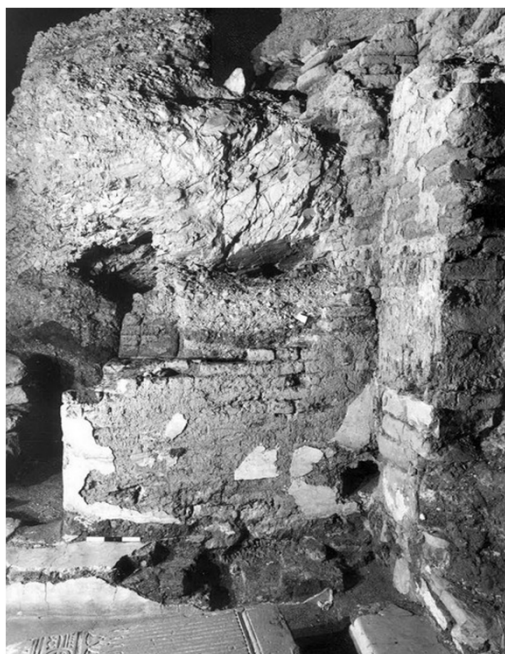
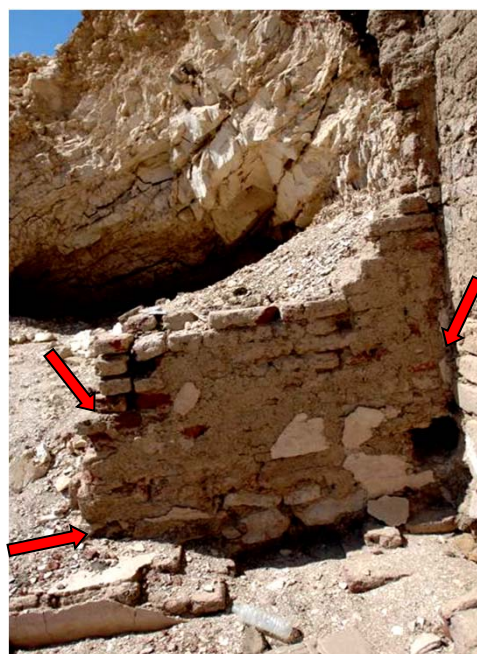
Comparison of 1995 (left, Image: CEDAE 95) to 2007 (right) of west wall of church, showing loss of large fragments of wall plaster in two areas. Some of the remaining fragments are partially detached and at risk of loss. The stratigraphic material in the annex above and to the rear of the wall apparently eroded due to rainfall drainage.

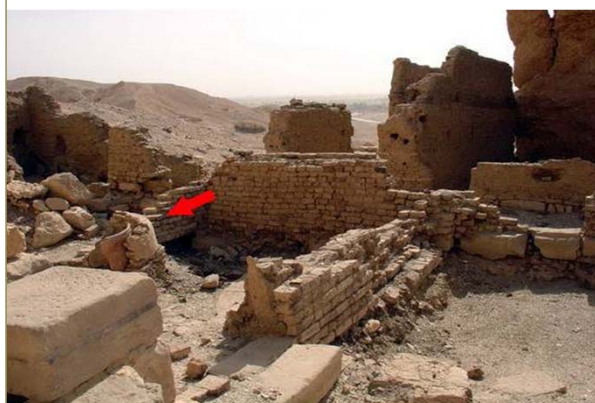
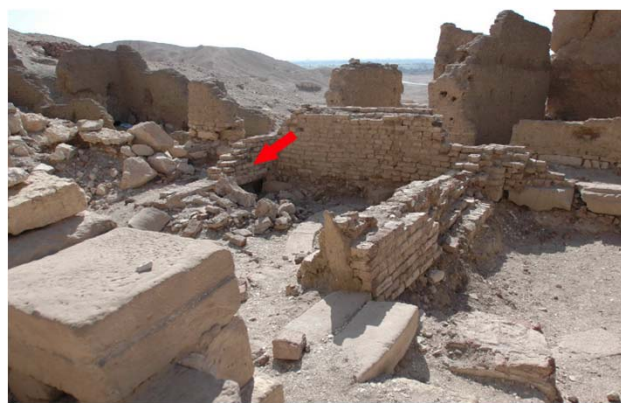
Baptismal font (11): Comparison of GCI photos shows that part of the font was in place in the baptistry in January 2005, whereas in February 2007 it was completely knocked over. Lecuyot has noted that it was damaged in 2007 by vandals (Lecuyot, pers. comm., 2010).

- **Vandalism:** Vandalism is another possible cause of significant damage of the site. In recent years the remains of the baptismal font in room 11 have been shattered. Lecuyot believes the cause was vandalism (Lecuyot, Pers. Comm, 2010). In addition, one section of the south wall of the Vestibule [2] has been incised with Arabic graffiti.

Comparison of February 2005 view of baptismal font partially intact (left) and in February 2007 destroyed, presumably by vandalism.

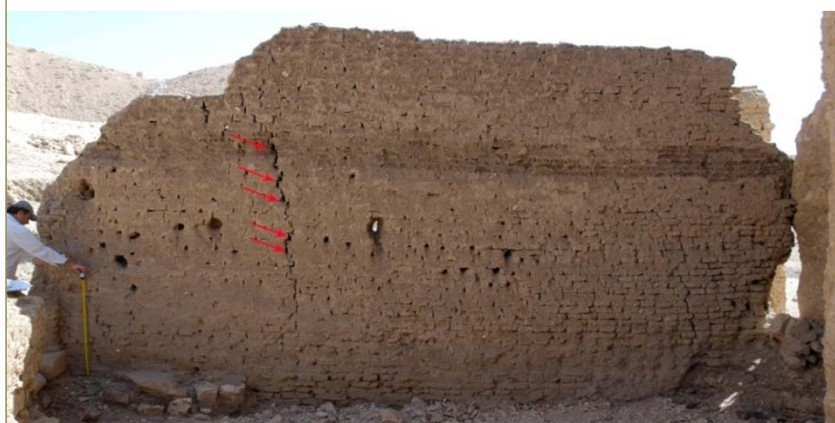
The vertical crack (indicated by arrows) running through the westerly wall of the arcaded hall (4).

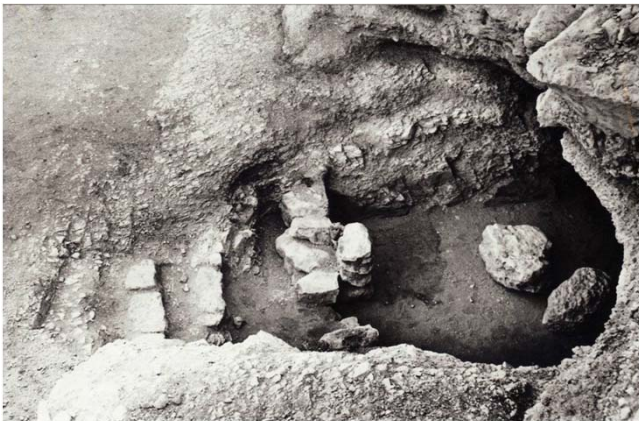
QV 1 entrance at the time of its clearance by CNRS in 1985. (Image: CRNS)

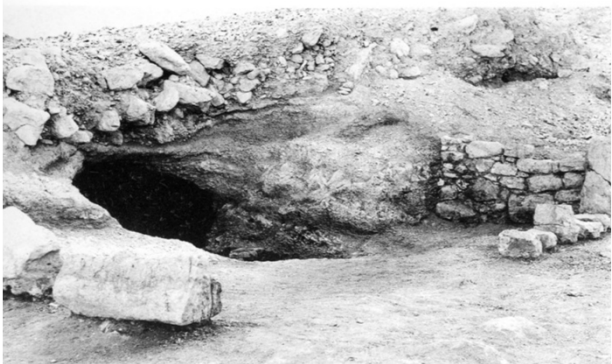
QV 1 viewed from the northwest after its excavation in 1985 showing a low masonry wall at the west side of its entrance. (Image: CNRS)

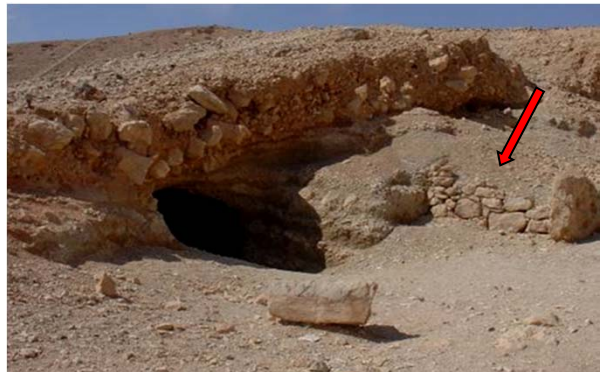
A similar view of QV 1 in 2006 showing loss of stones in the upper part of the masonry wall (indicated by arrow) and around the shelter's opening.

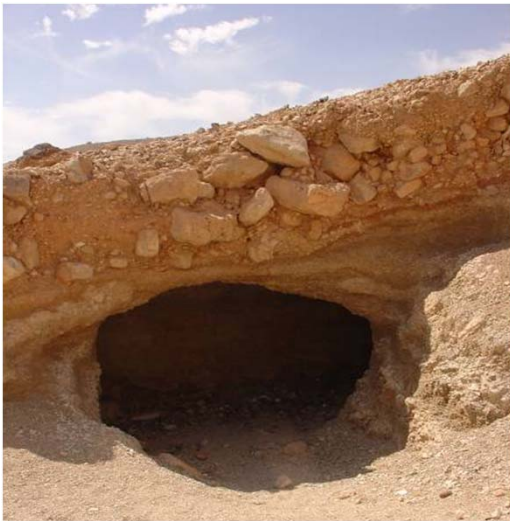
QV 1 entrance in 2006, with stone steps evident in 1985 image no longer visible.

- QV 1 should not be visited by tourists. It should also not be used by site personnel for storage or for dumping trash.
- Convey the significance of QV 1 to site personnel and stress the importance of not using it.

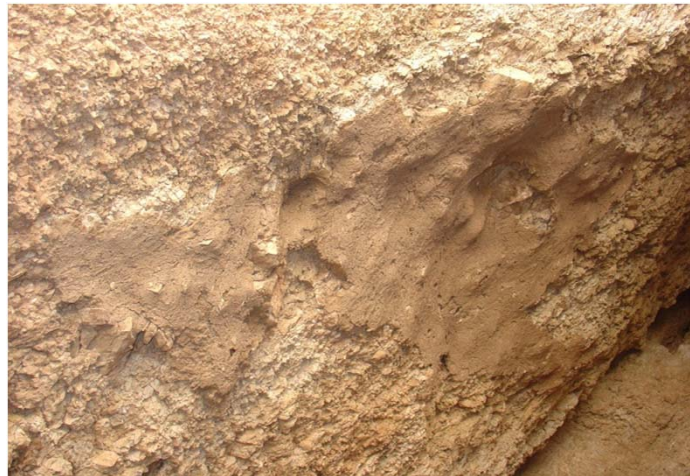
Inside the cavity, patches of rough earthen plaster containing straw (known locally as *mouna*) exist on its walls (upper and lower parts) and ceiling. Photos from the time of its clearance in 1985 by the Franco Egyptian mission show that a few stone steps existed at the site's north entrance. A low wall built with rubble stones and dried mud is present outside the cavity on the west side of the courtyard entrance.

Earthen plaster within QV 1.

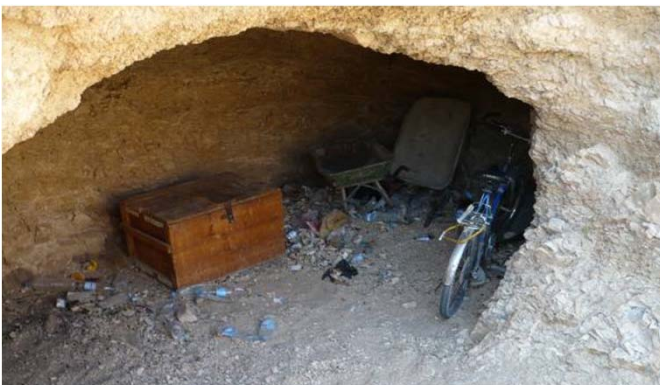
Use of QV 1 in 2007 by site personnel for the temporary storage of bicycles and work materials.

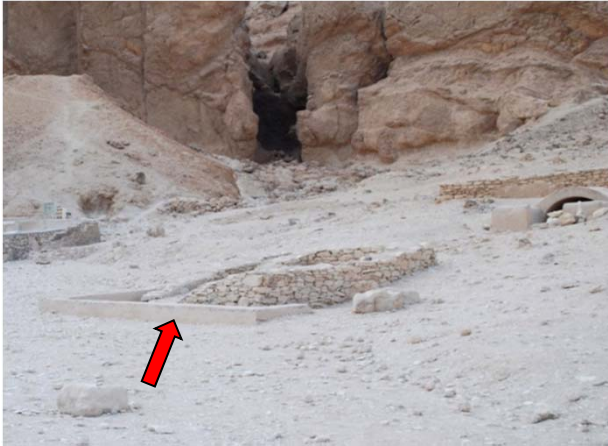
2009 view of Structure II from the southwest, with low masonry wall (arrow) constructed by CNRS to protect it from flood waters flowing through the main drainage channel.

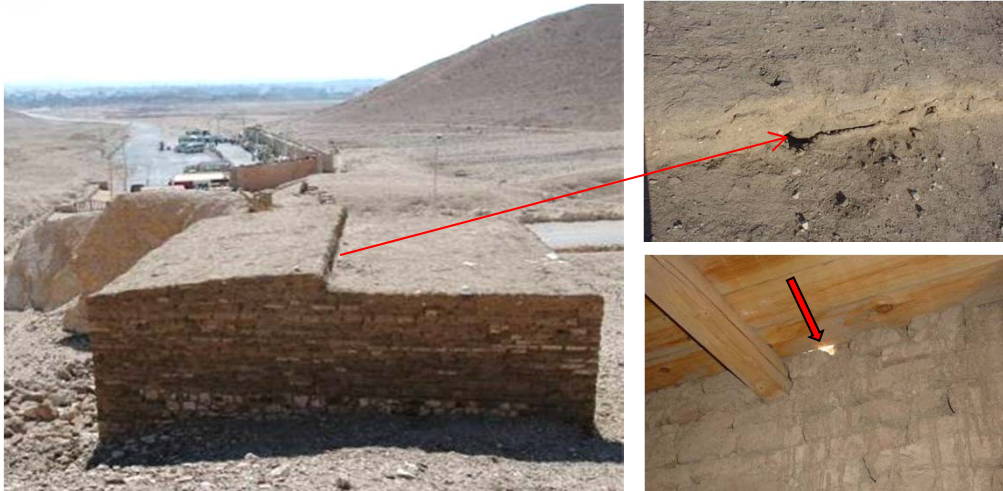
Left: North elevation with site entrance and parking area in background. Upper right: Detail of the hole in the building's roof at the juncture between the two levels. Lower right: Interior view of the hole in roof (arrow), with mud drip lines below providing evidence of water infiltration.

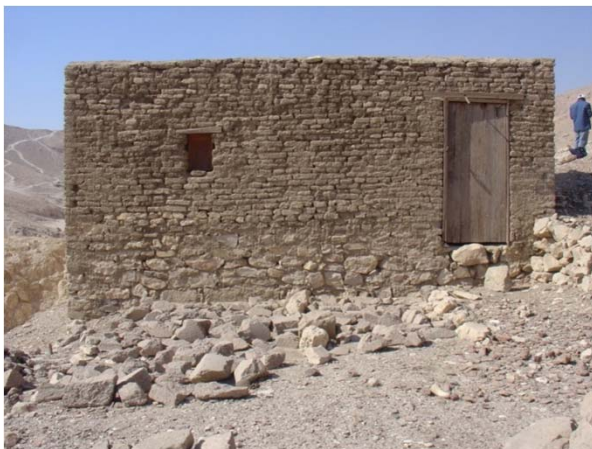
East elevation with door and window.

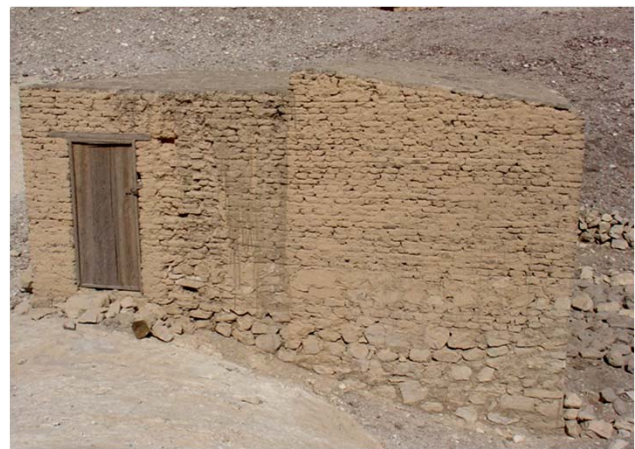
South elevation with door.

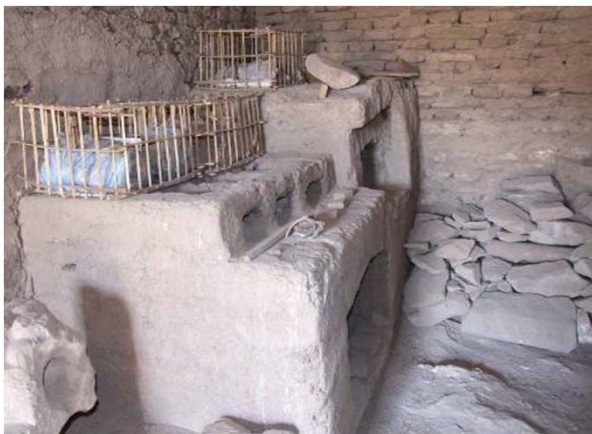
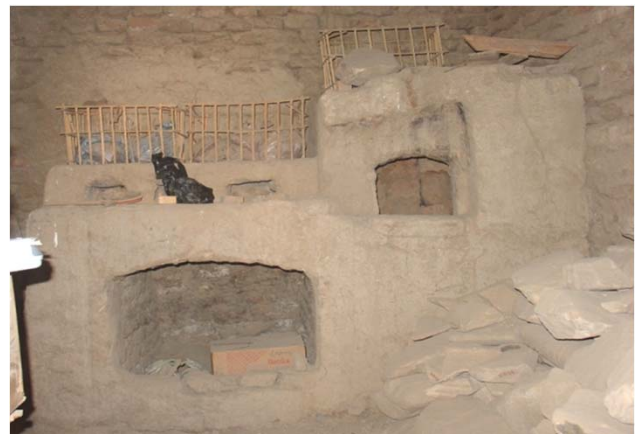
Side (left) and front (right) views of Italian mission's mudbrick oven on the interior of building. Archaeological study materials are stacked on and around the oven.

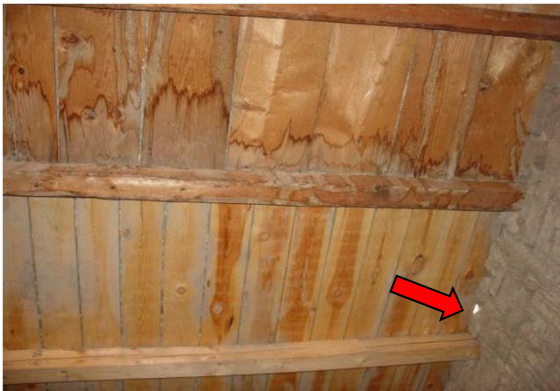
Interior view of water stains on the wooden ceiling adjacent to the hole in the roof (arrow).

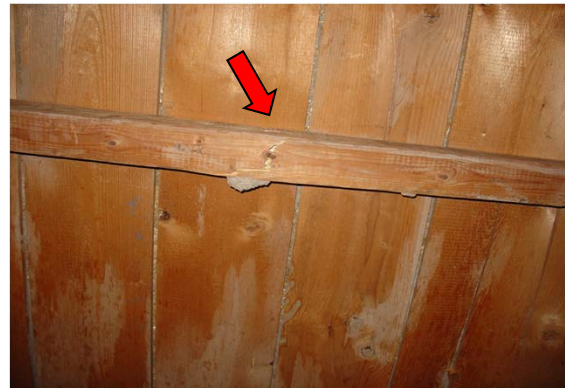
Crack in the middle of the beam supporting the roof in the southeast room. The roof sags in this area.

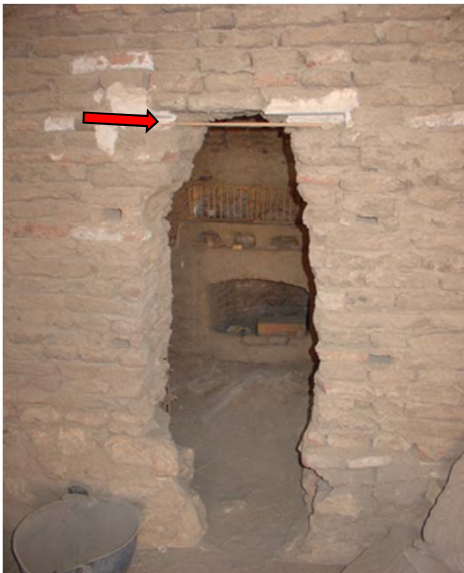
View of missing lintel (arrow) in doorway between the northeast room and the west room.

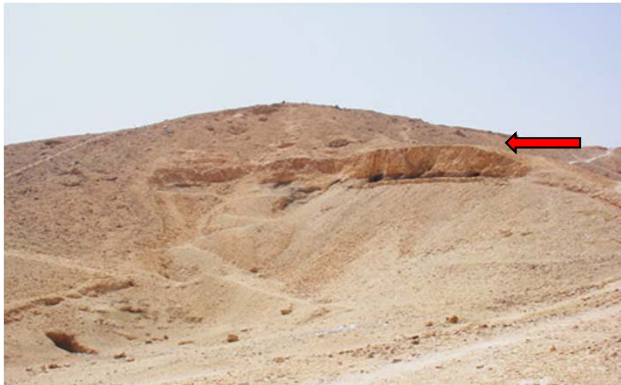
View of the hermit shelters at the top of the Valley of Prince Ahmose cut into a dark, shale rock layer (arrow).

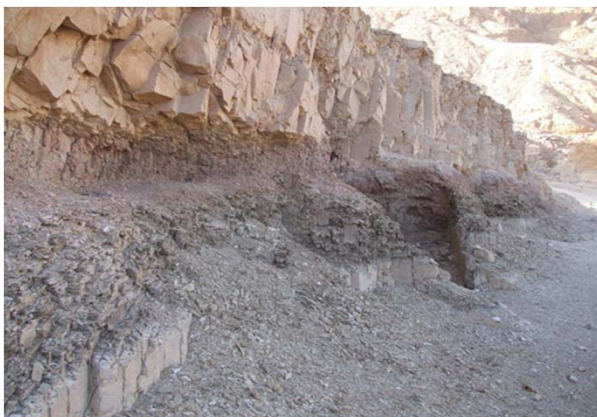
North-facing view of geologic context showing dark, friable shale overlain by fractured marl.

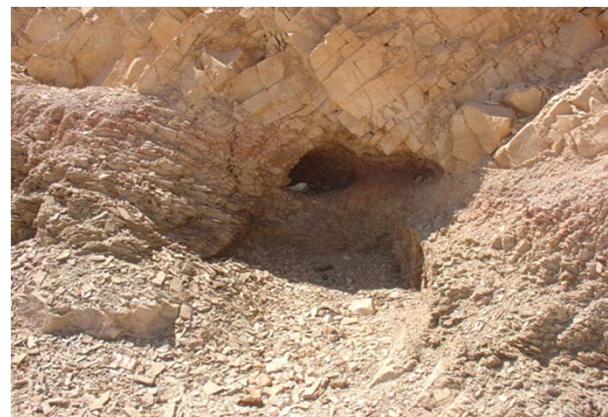
The northern shelter (1 on plan) has no roof and no plaster remaining. The two middle shelters (2 and 3 on plan), which are connected to each other, were constructed more elaborately than shelters 1 and 4. The northerly of these two middle shelters (2) is square and connected to the terrace by a narrow passage in its eastern wall. It was topped by a mudbrick dome that rested on four mud-plastered, mudbrick arches (Lecuyot 1993, 272). The dome has collapsed and only three of its supporting arches remain. This cavity also has a small hole in its marl bedrock ceiling that connects to the ground surface above. Modern mudbrick walls were built by the French-Egyptian mission to close the two openings to this cavity in order to protect it.

Hermit Shelter 1. 2006 view of remains.

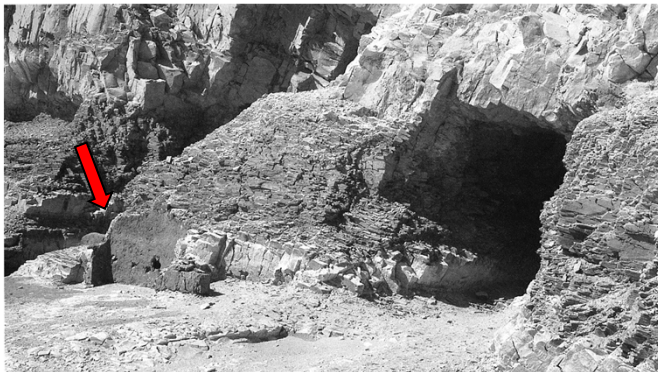
Hermit Shelter 2. View of the north entrance after clearance by Franco-Egyptian mission in 1986, with exposed mud plaster remains (arrow). (Image: CNRS)
