## VI. Site Elements

## VI. Assessment of Site Elements

### Introduction

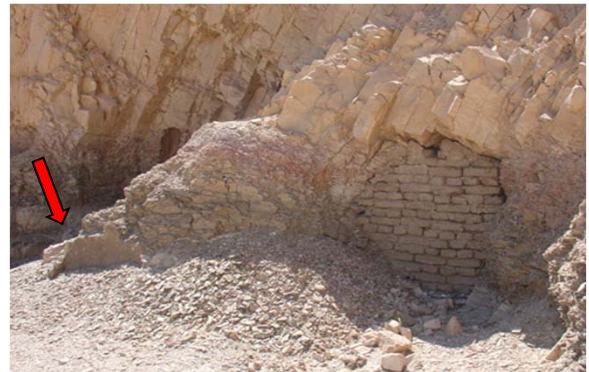
Hermit Shelter 2. View of the blocked, north entrance at the time of the assessment (2006), with mud plaster remains (arrow) largely covered by talus debris.

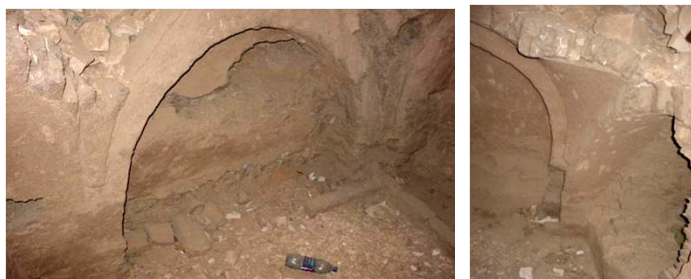
Hermit Shelter 2. Interior view (2007) showing parts of three of four remaining mudbrick arches that supported a dome.

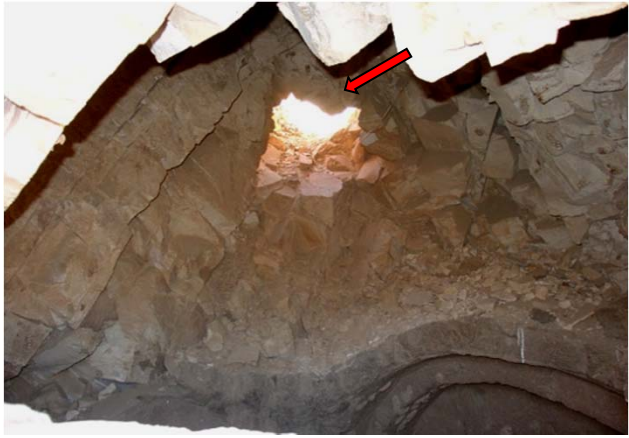
Hermit Shelter 2. Interior view (2006) of hole in the marl rock ceiling (arrow) of shelter 2, with part of mudbrick arch to lower right.

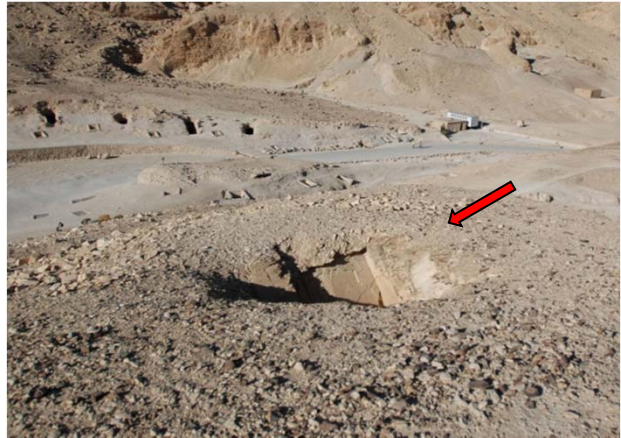
Hermit Shelter 2. Exterior view (2006) of hole in the ceiling (arrow).

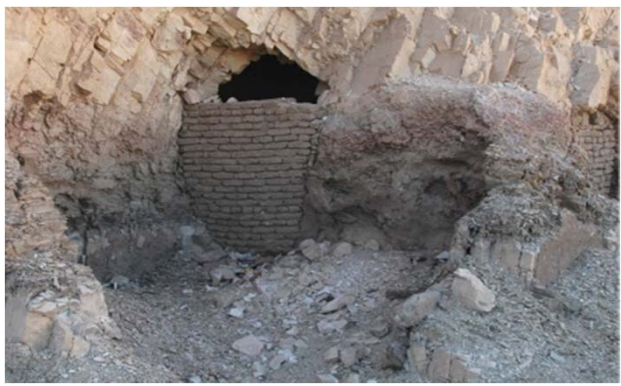
Hermit Shelter 3. View (2007) of shelter at the time of this assessment showing the mudbrick bench and shelter floor covered, and hence protected, by talus debris, and the south entrance to the northerly middle shelter blocked by a modern mudbrick wall.

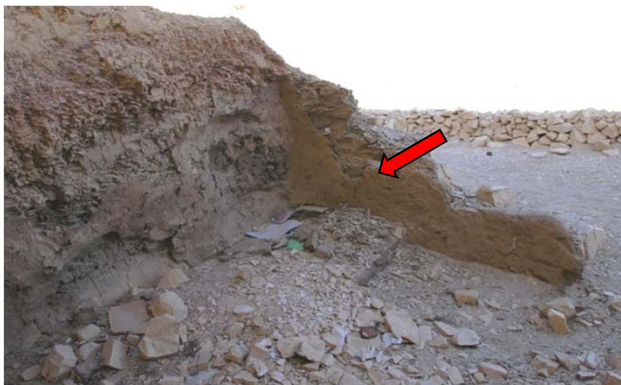
The southerly of these two middle cavities (3) opens directly to the terrace. It has remnants of a *mastaba*, a low mudbrick bench, along its north wall. Like the northerly cavity, the most southerly (4 on plan) has no roof and no plaster remaining, and is essentially a simple cavity in the rock.

Hermit Shelter 3. View (2007) of shelter showing extant mud plaster attached to vertical surfaces and remnants of a low mudbrick bench, or *mastaba* (arrow).

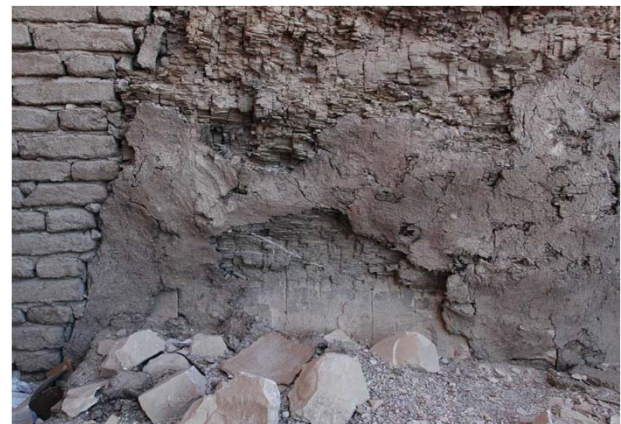
Hermit Shelter 3. Detail view (2007) of exposed mud plaster on the wall of shelter.

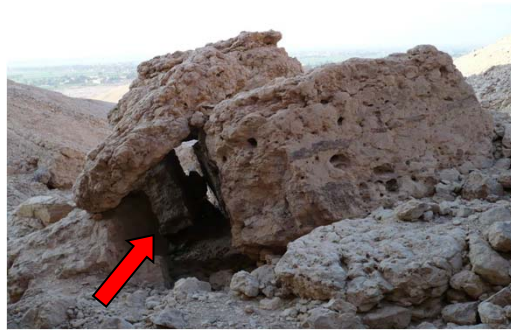
View of the Dolmen in 2007 from the north showing entrance (arrow).

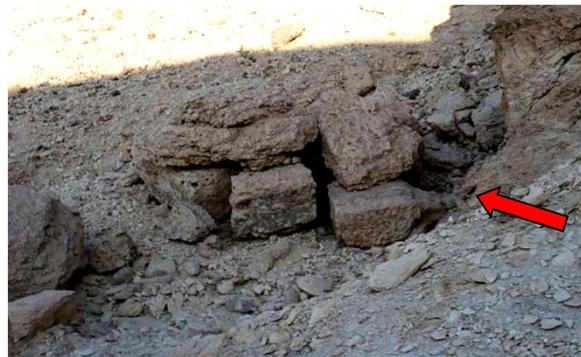
View of the Dolmen from above.

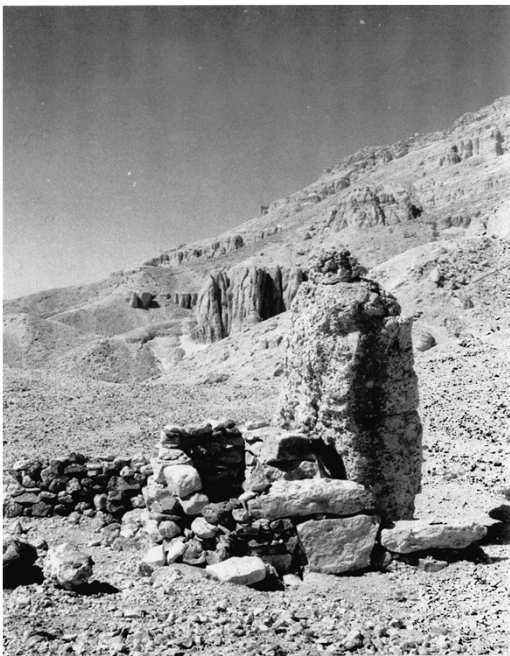
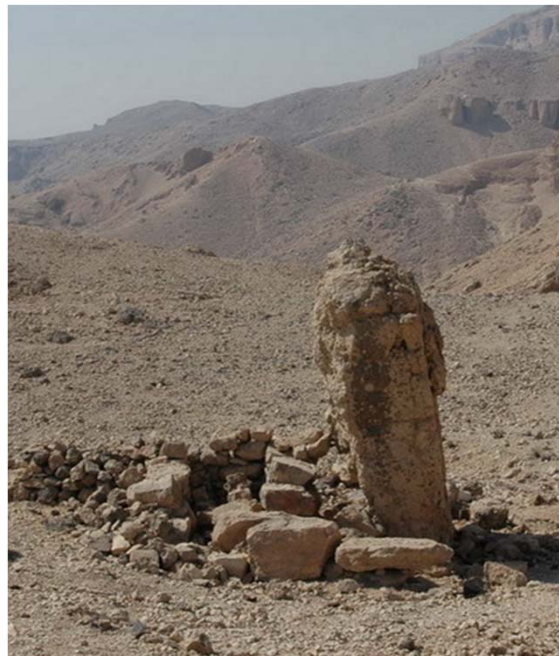
Views of the Menhir from the east in the 1960s (left, Černý, Desroches Noblecourt and Kurz 1969-1970, GMT I/1, pl. LXXXI, CNRS) and in 2007 (right).

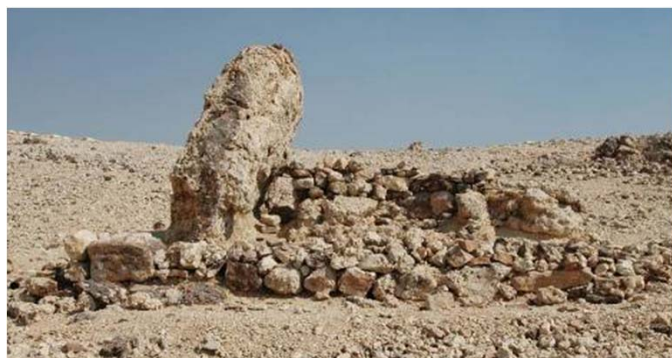
View of the Menhir from the west.

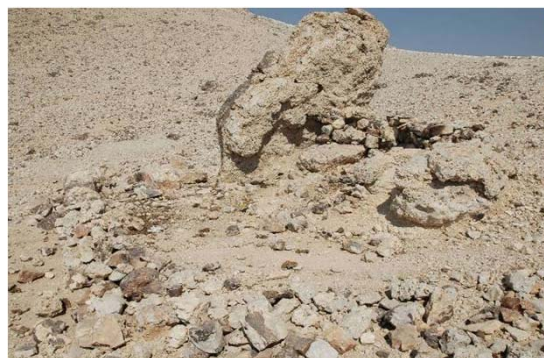
View of the Menhir from the south.

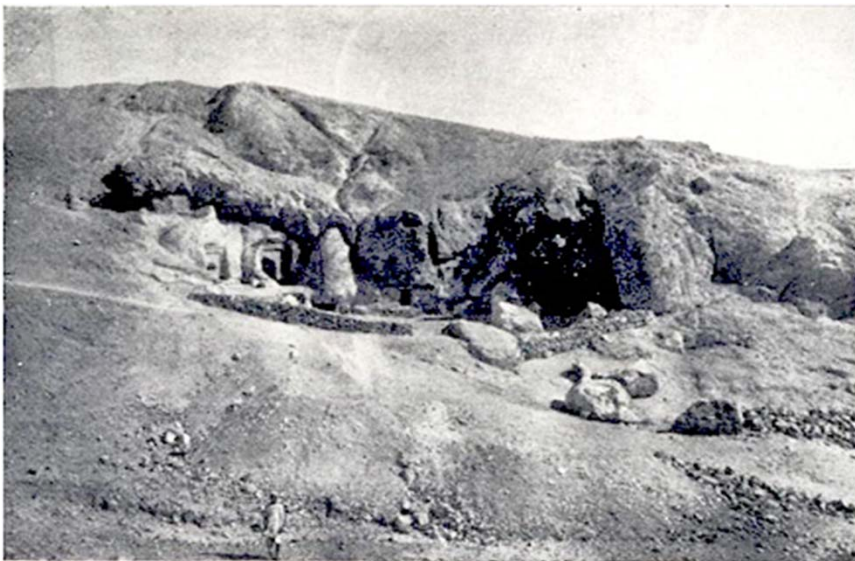
The sanctuary in 1926 (Image: Bruyère 1929-1930)

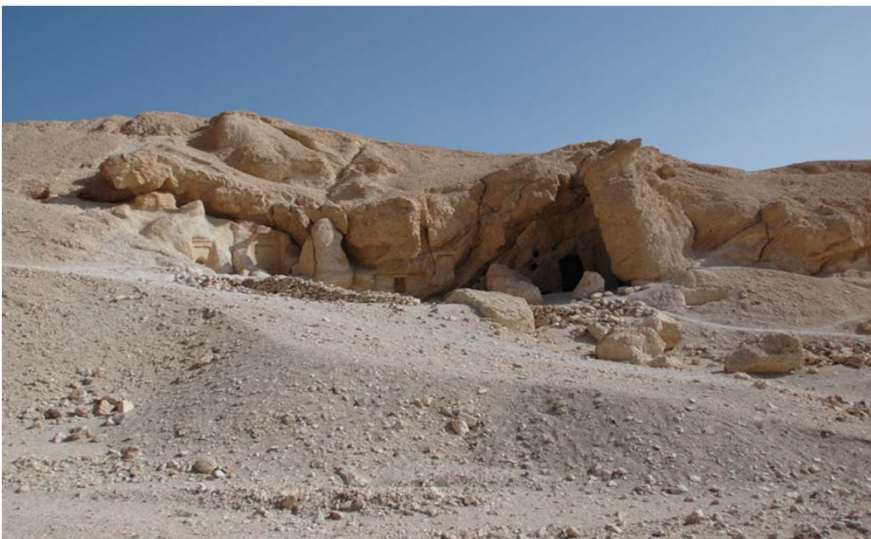
The sanctuary in 2007

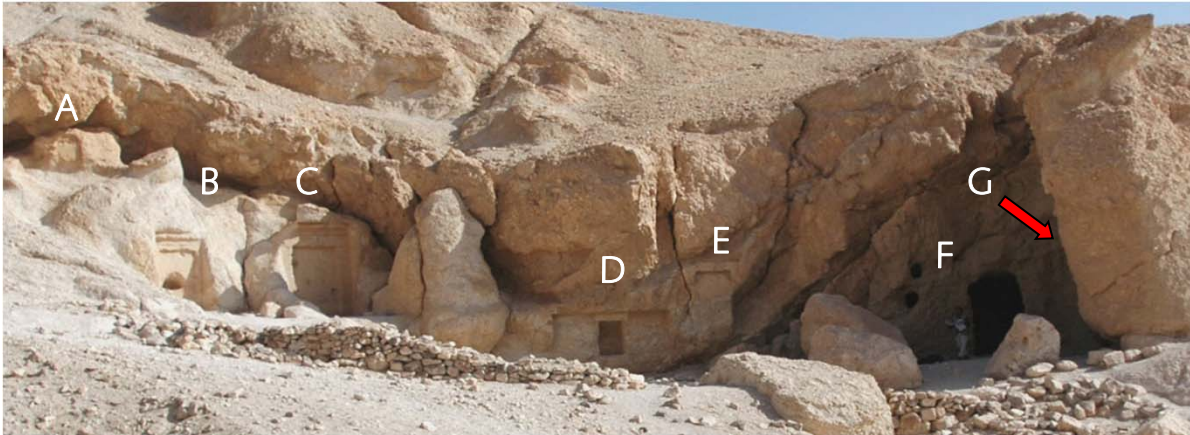
General view of Chapels A through G in 2007.

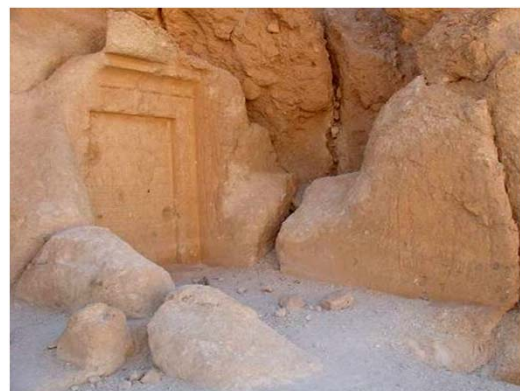
**Chapel C:** Chapel C (5m L, 2.10 W, 2.40 H), located southwest of Chapel B, is carved from the bedrock, as is a 1m thick wall that separates it from Chapel B. Its southwest wall contains traces of inscriptions and drawings, including a vizier standing before Meretseger with offerings (Bruyère 1930, 34; Porter and Moss 1964, 707) and a large stele carved into the east wall of the first room with the name of Rameses III. The presence of decorative pigments (mostly red and yellow, with traces of blue) on the stele and side wall surfaces shows they were originally painted. The top part of the stele has been eroded from behind due to the shaley marl layer and a fissure running behind it. Fractures run diagonally through the top part of the stele and through its southwest wall, continuing in two locations through the wall dividing it from Chapel B. Between Chapels B and C are remnants of a low, partially extant masonry wall.

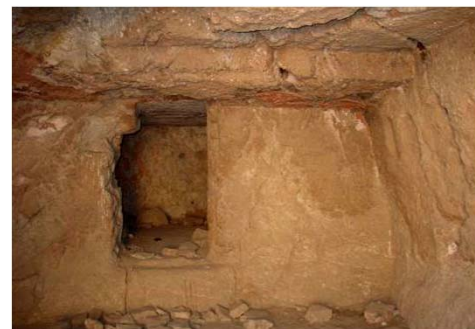
The offering room has a flat ceiling and a pit in the floor at the east corner (1.70m depth), which Bruyère interpreted as belonging to the pharaonic period, with later reuse as a meditation space during the Coptic period (Bruyère 1930, 42). Remains of offering niches are carved into wall surfaces, most in the shape of stelae. Three niches are found on the north wall, one on the east, and ten on the west wall. Localized areas of gray plaster overlying mud plaster painted red, blue, and brown remain on the south wall and the ceiling near the south and east walls, indicating the room was previously plastered and painted.

Chapel F offering room

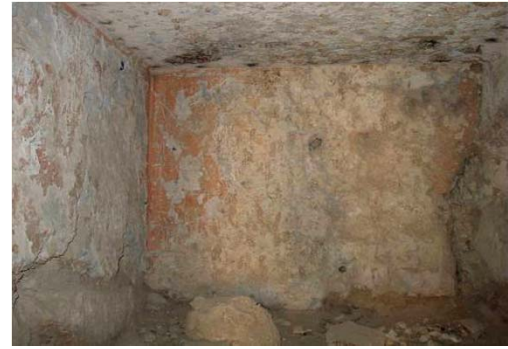
At the back (or southeast) wall of the offering room is the entrance to the rear chamber, or *naos*, with its opening 0.60 meters above the floor of the front chamber. The *naos* is 3.30m long, 2.08m wide and 1.78m high with a flat ceiling. Like the offering room, the *naos* has extant painted plaster on its walls, with mainly red but also traces of blue pigment remaining. Bruyère recorded that all walls were decorated, depicting Hathor, Osiris, Min and other deities. The decoration is now largely lost, although traces are still visible on the south and west walls.

Chapel F *naos*

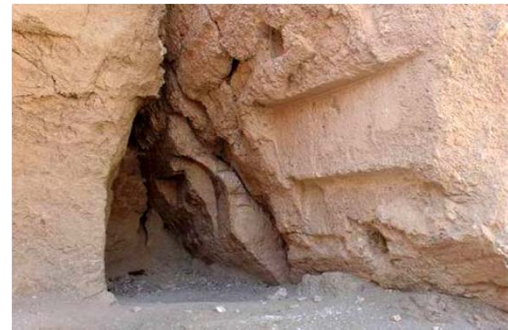
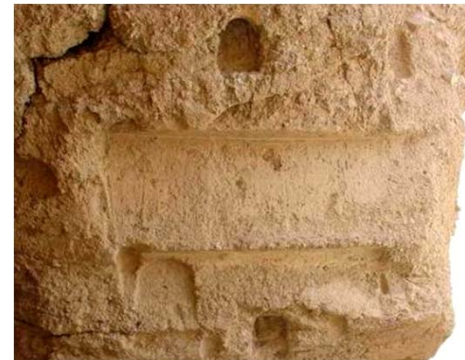
**Chapel G:** The chapel is rectangular in shape (3.50m L, 2.70m W, 1.40m H) and appears to have been transformed from a natural cave. The workmen who created the sanctuary seem to have incorporated a fault plane of fault F2 in the chapel's wall surfaces. The chapel appears to have been comprised of two rooms, one above ground and one below, with niches for votive stelae on the west walls. On the west wall, gypsum or lime plaster was applied over poor quality breccia stone to serve as a smooth surface for decoration. Some niches appear to have earth plaster as a base layer. Votive stelae to Amun, Ptah, Isis, Osiris, and other deities were engraved and painted there. The small amount of paint remaining is red (or possibly brown), blue, and white in color. All decoration is today badly damaged and only partially visible. To the southwest, the second room had a flat ceiling that was partially vaulted and may have been a shrine. In the 1920s a pit was evident in the ground (shown on the Bruyère plan) leading down to a subterranean chamber (0.9m L, 0.97m W, 3.80m D) within the chapel. The pit and chamber are today buried. In the chapel, a fragment of a limestone offering table was found. Bruyère suggests that it may have been reused as a tomb after the pharaonic period. Bruyère noted regarding Chapel G that "The Copts lived there and left corpses and some traces of a long stay." (Bruyère 1930, 46, 48).

Above: Chapel G showing both west wall (right) and southwest area; below: detail of west wall with carved niches.

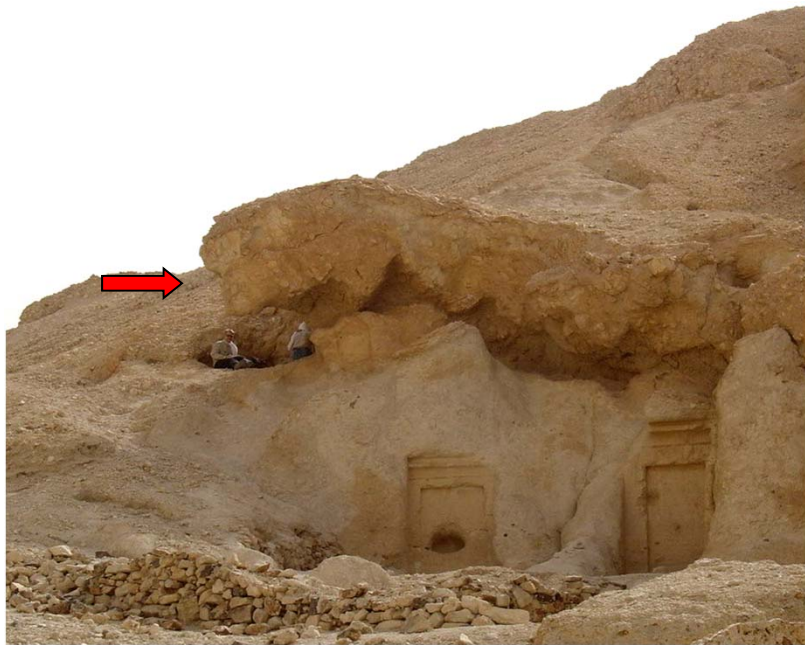
Breccia rock outcrop above chapels A and B undercut by preferential erosion of the shaley marl layer underlying it. The breccia outcrop's lack of structural support, particularly in the area of Chapel A (indicated by arrow), puts it at risk of collapse.

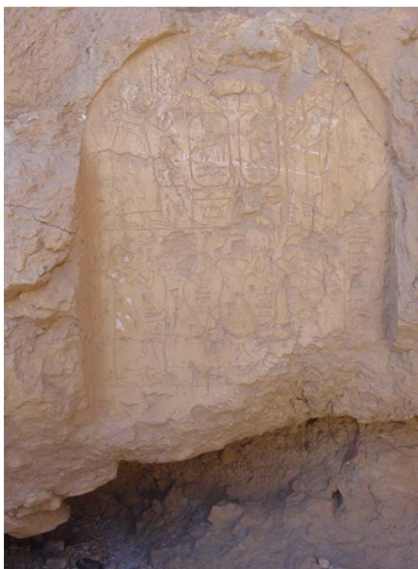
**Chapel A:** Chapel A was constructed into both the breccia rock that overlays a shaley marl layer, and into limestone below. Two embedded stelae were removed and only the cavities where they were situated remain. Of the two remaining stelae, the one to the upper right has been severely affected by vandalism, exhibiting extensive white scratch marks that appear to be relatively recent given their lack of patina. The lower left stele has the name "Hassan" scratched onto it in Arabic script. The bottom of this stele has been partially lost through rock deterioration as it is located directly above the heavily eroded shaley marl layer which has undercut the breccia above.

Lower left stele showing rock erosion at its bottom.

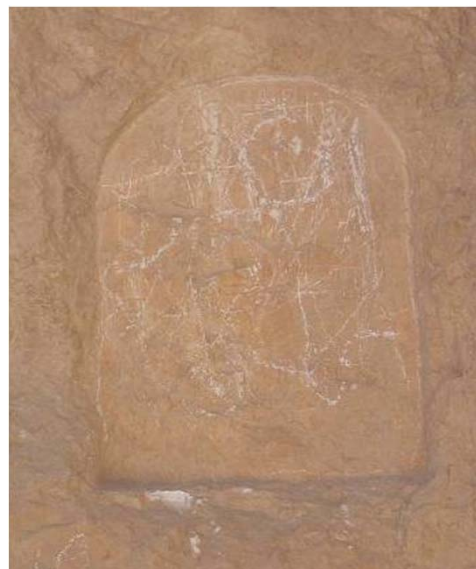
Upper right stele exhibiting extensive damage by scratching.

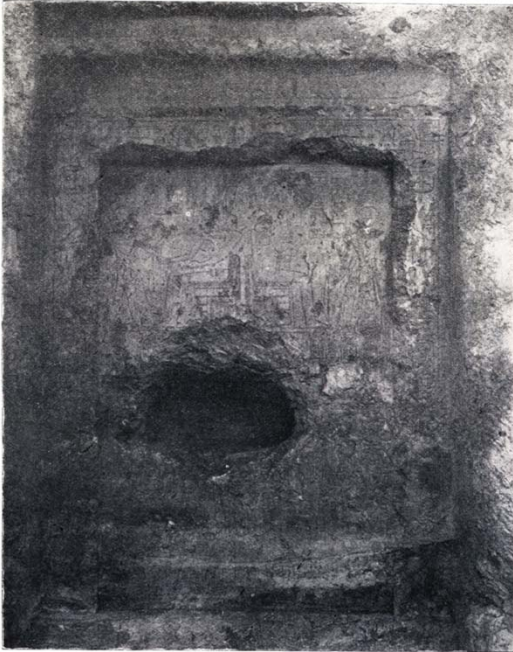
**Chapel B:** The large hole in the middle of the stele was present at the time of the first known photograph of the site by the Schiaparelli mission (ca. 1906). Bruyère interprets it to be an ancient niche rather than damage. The degraded and whitish appearance and lack of patina of the remnants of the side walls of the stele appear to indicate active rock deterioration, presumably due to surface moisture and wet-dry cycles. The chapel has been damaged by modern graffiti in scattered areas, but to a lesser extent than other chapels at the site. The carved threshold at the base of the stele shows signs of cracking and crumbling.

Stele in 1926. (Image: Bruyère 1929-1930, 20)

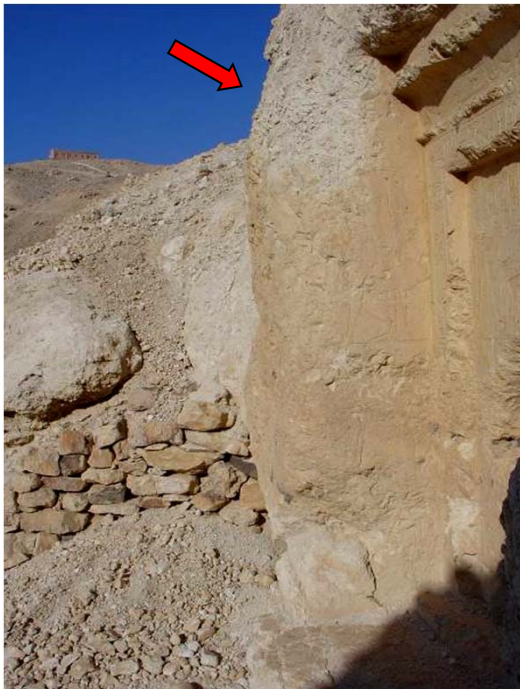
Left jamb of stele, with area of active rock deterioration indicated by arrow.

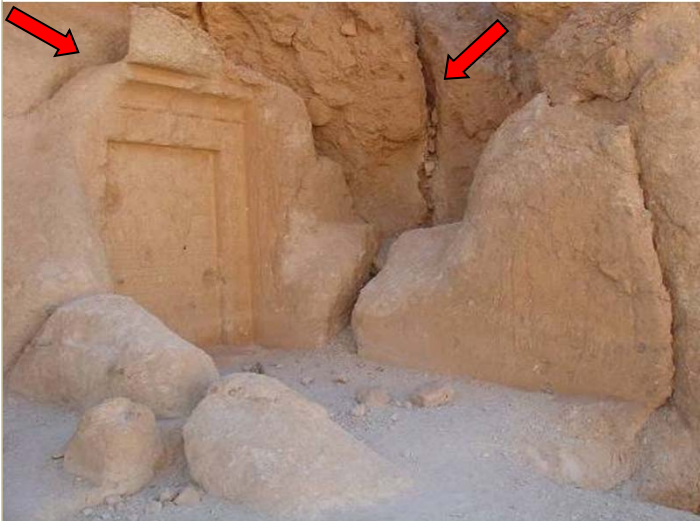
Erosion and surface flaking at the top and behind the stele (left arrow) and fracture running through the middle of the chapel (right arrow).

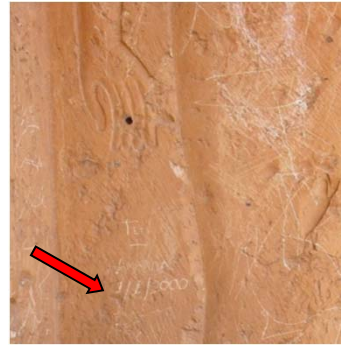
**Chapel C:** The extant decoration of Chapel C is less exposed to the elements than Chapel B, with the southern part of the chapel more sheltered than the northern. Given the apparent continuing rock erosion and flaking behind the upper part of the stele, the top of the stele may eventually collapse if it is not protected and stabilized. The southwest and northeast walls of the chapel are intersected by substantial geologic fracture. These walls appear to have experienced significant losses. A fragment of the far right part of the molding at the upper right of the stele was lost between February 2007 and February 2008. The cause is not known. The decorated surfaces of Chapel C have also been extensively damaged by modern graffiti.

Left: Graffiti scratched onto the south (right) jamb. Below: graffiti on stele iconography.

- Limiting the visual prominence of existing graffiti damage has been shown to reduce occurrences of new graffiti. Where possible, deep graffiti incisions should be visually reintegrated with surrounding decoration to lessen the visual prominence of this type of graffiti damage.

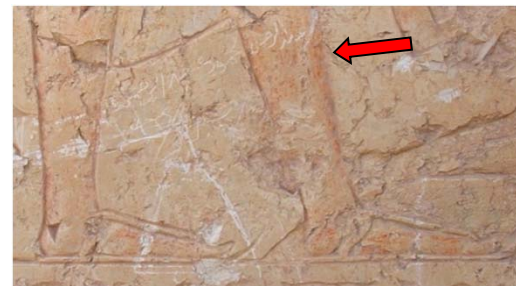
Comparison of Chapel C in 1926 (left, Image: Bruyère 1929-1930, 32) and 2008 (right). Arrow to right indicates location of loss of a fragment of the stele molding between February 2007 and February 2008.

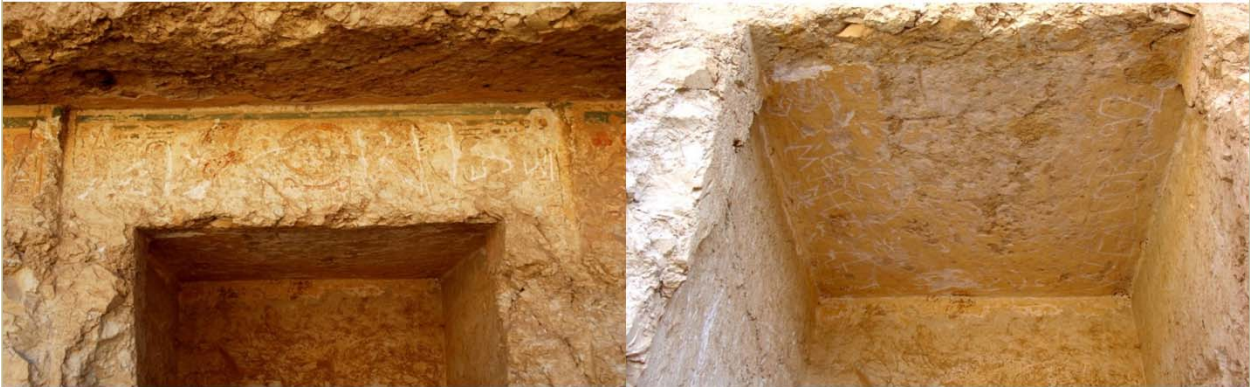
Graffiti damage to the decorated surfaces of the stele of Chapel D.

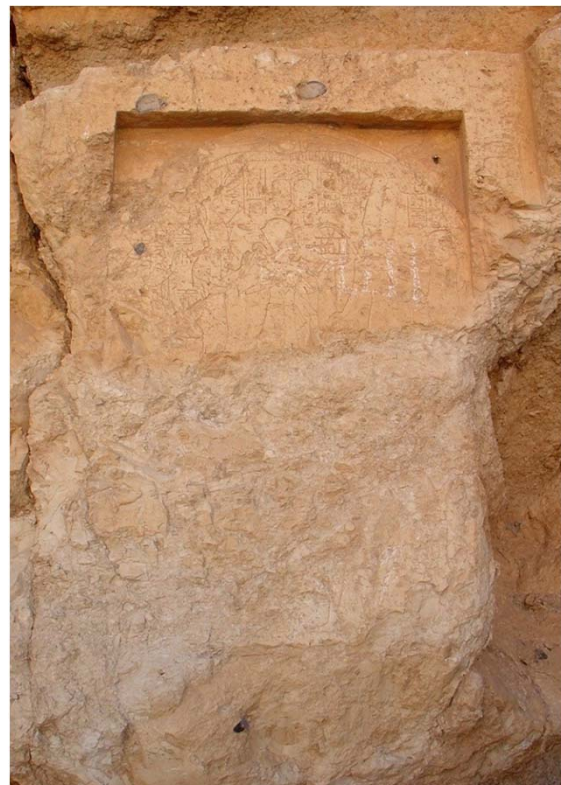
Comparison of areas with decorated surfaces of Chapel E recorded (left) by Lepsius (top register 1844) and Bruyère (bottom register 1926) and areas intact in 2005 (right). (Drawings: Lepsius; Bruyère 1929-1930, Pl VI).

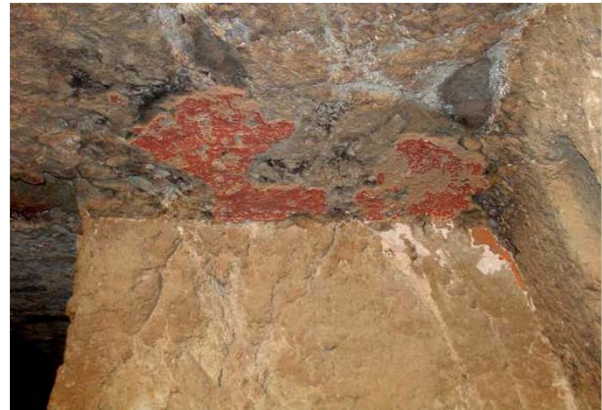
Area of extant red painted plaster on the ceiling of the southwest corner of the outer chamber.

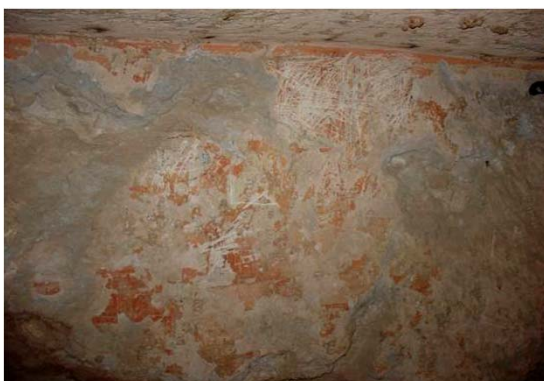
In the *naos*, or rear chamber, the west wall has lost extensive areas of rock. Decorated earthen plasters in the *naos* have been damaged extensively by apparently modern incised graffiti. The south wall also exhibits signs of charcoal graffiti. There are also extensive remains of wasp nests on the walls and ceiling, although no recent wasp activity was observed.

Area of red painted plaster on the west wall of the *naos* that is substantially degraded, in areas by scratching.

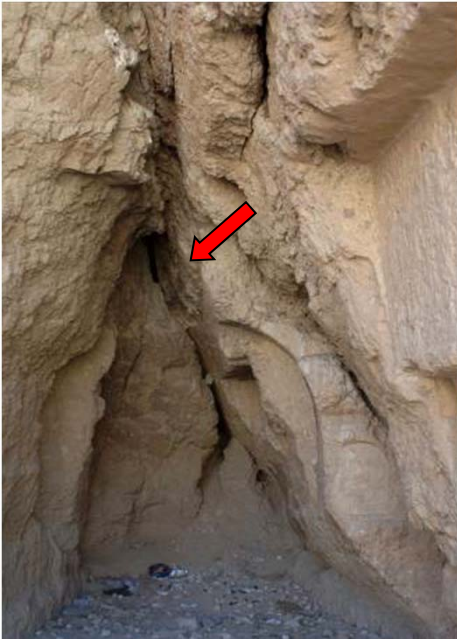
Fault (F1) running vertically through the southwest room of Chapel G.

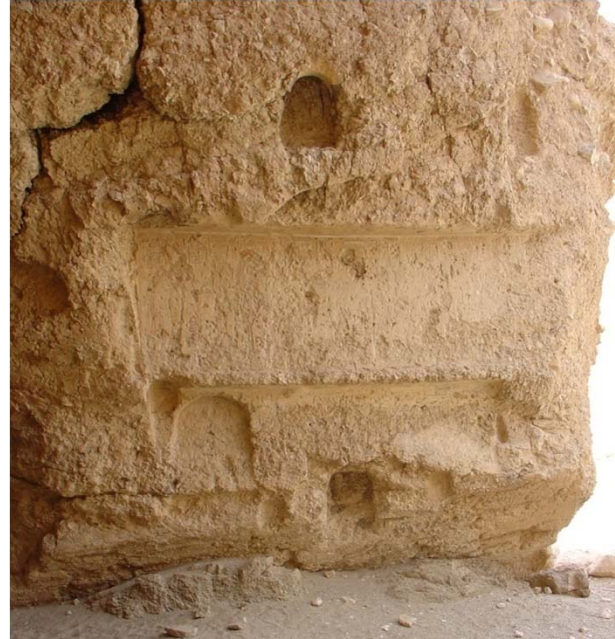
Western wall of Chapel G, which has been extensively damaged by graffiti.

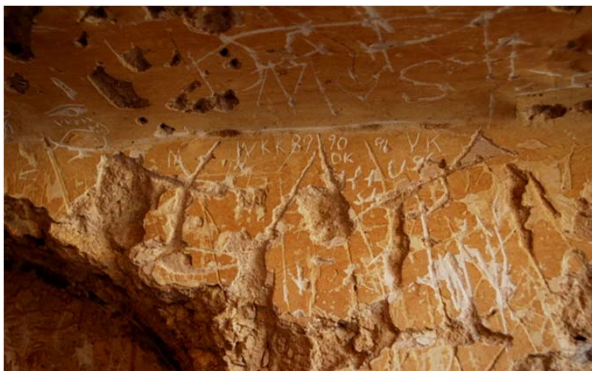
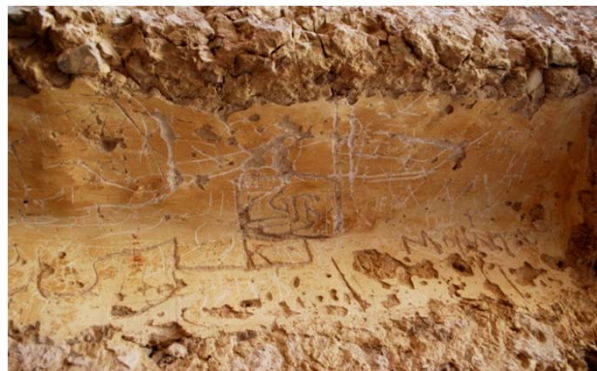
**Chapel G:** A substantial vertical opening runs directly through the southwest room of the chapel, which coincides with a geologic fault (F1) and marks the interface of the breccia rock to the west and the shale rock to the east. On the western wall, the lower register of the stele has been severely damaged by graffiti, which has been incised deeply into the plaster. The better preserved decoration on the western wall is on the upper half of the upper register, out of reach from graffiti damage and better sheltered from the elements. The remaining plaster and paint on the western wall generally appears stable, and the entire chapel is well sheltered from the elements. The eastern wall and rock cut arch leading to the rear chamber is no longer preserved as it is cut out of the weaker shale rock.

Examples of incised graffiti damage to the western wall of Chapel G.

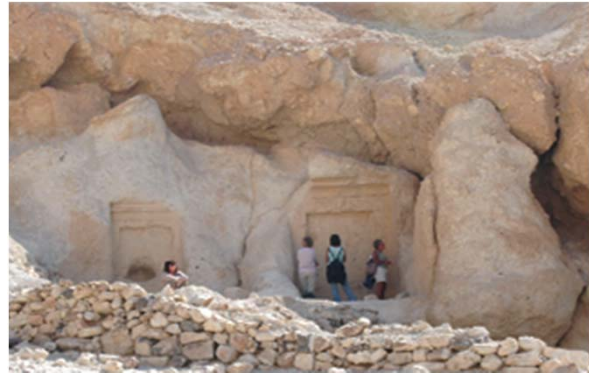
• **Graffiti, vandalism, and tourism-related impacts:** The most aggressive cause of recent damage to the decorated surfaces of the site has been modern graffiti and vandalism. The sanctuary is located along a regularly traversed tourist trail between Queens Valley, Deir el-Medina, as well as Kings Valley and Deir el-Bahari, and the site is not guarded, nor are there barriers or signs preventing entry. Tourists have been observed touching the stele surfaces. Donkeys allowed by tour guides to rest there may contribute to the abrasion of rock surfaces. (See Part II, Appendix 5 for recent interventions by SCA to address this problem)

Unsupervised tourists visiting the sanctuary.

- The site should not be open to visitors, unless a guard is permanently stationed there, due to its vulnerability to damage, particularly from graffiti. Visitors with special permission should only visit the site with an SCA inspector or guardian.

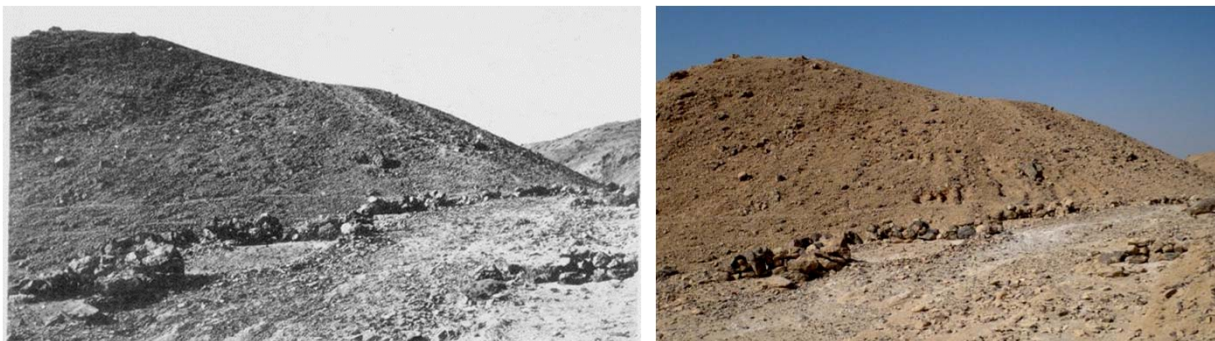
At the beginning of the twentieth century, the Schiaparelli mission found one group of shelters - approximately 10 to 12 in number - on top of the ridge between the Valley of the Rope and the Valley of the Three Pits (southwest of tombs QV 92, 93, and 97). (For the purposes of this report these are referred to as Group 1; see satellite image at the beginning of the Site Elements section of this report for location).

Early twentieth century view by Schiaparelli mission (left) (Image: Schiaparelli 1923) and 2007 view (right) of the remains of Group 1 shelters on the ridge between the Valley of the Rope and Valley of the Three Pits.

- The Observation Posts should not be accessible to visitors.
- The Group 1 shelters should be better documented.
- The condition of all shelters should be monitored annually.

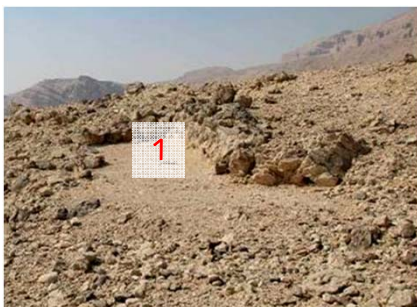
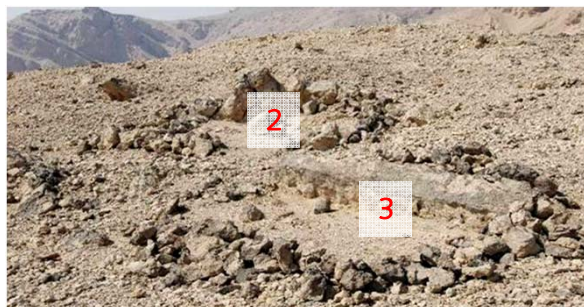
Bruyère in 1934-35 located and investigated (Bruyère 1939, 240), and Farina in 1936 investigated, the second group of these shelters, three in number and to the east, on the ridge between the Valley of Dolmen and Valley of the Three Pits (southwest of tomb QV 89). (For the purposes of this report these are referred to as Group 2; see satellite image at the beginning of the Site Elements section of this report for location). In 1991 CNRS recorded and numbered these structures 1 through 3 (see photos and plan that follow). Two shelters (2, 3) located close together are on the upper slope to the north, while the other (1) is slightly lower on the slope. Structure 2 appears to have had two rooms and the others a single room. The floors of the structures appear to have been cut into the hill slope.

Remains of Group 2 shelters [numbered 1, 2 and 3] located at the top of the ridge between the Valley of the Dolmen and the Valley of the Three Pits.

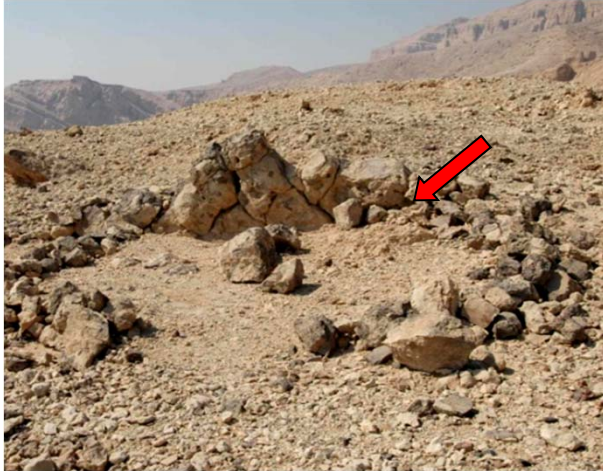
View of shelter 2 (Group 2) from the east.

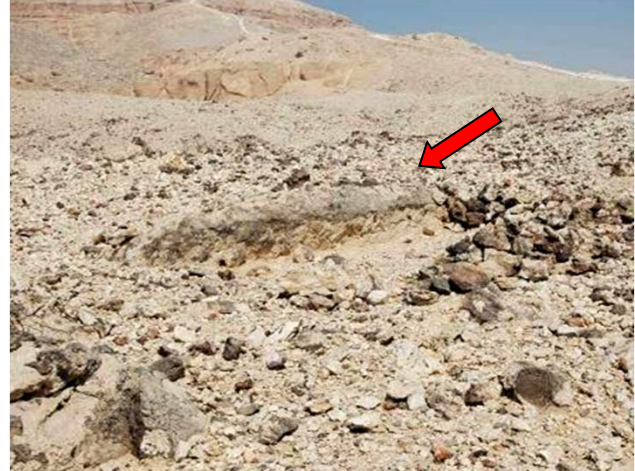
View of shelter 3 (Group 2) from the west.

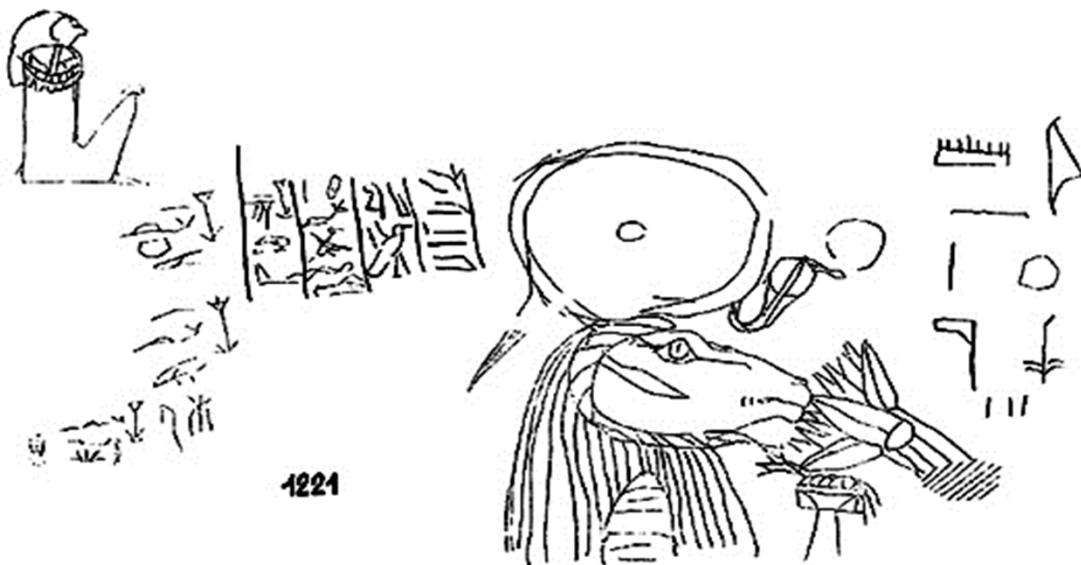
Recording of graffiti #1221 located in the Valley of the Three Pits, which includes a representation of a ram's head with a solar disk (Černý 1956, pl. 28). (Drawing: CNRS)
