Description of area

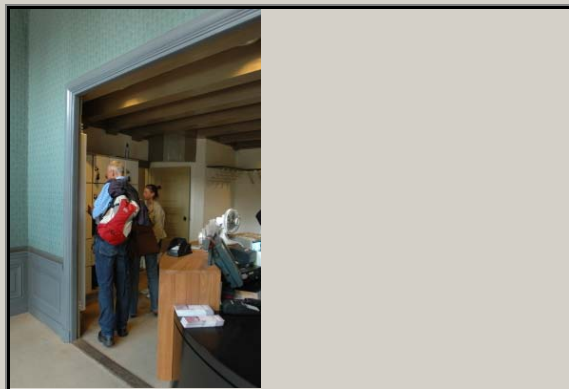
Area reference	Area name	floorlevel	Area orientation
1	antechamber	0	windows SE, facing canal
date	floor space m2	ceiling height m	volume m3
	20	0	0

treatment history
was a shop in 17th C, extended in 1770, restored in 2003

nr windows	type outside windows	status daytime	status night time	frequency of window use
3	single glass with secondary glazing on the inside. Shutters on the inside.	closed	closed	
		surface area m2	UV measures	IR measures
		18

comments	occupation observation	optimum capacity
surface wood paneling 59 m2	room fills during busy days	4
		maximum capacity
		5
		fire regulations
		0

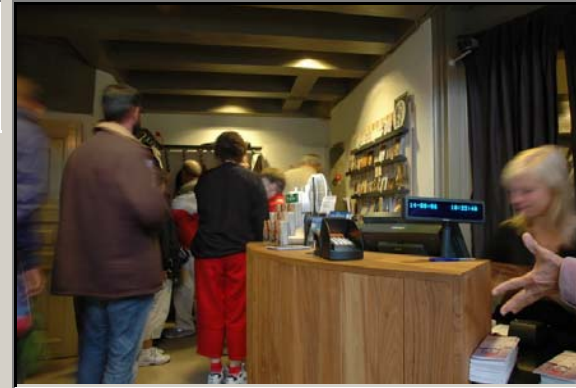
Area reference	Area name	floorlevel	Area orientation
3	Reception	0	next to antechamber
date	floor space m2	ceiling height m	volume m3
	12	0	0

comments	occupation observation	optimum capacity
surface stucco walls 19 m2	this area gets crowded - people put bags and coats away. Both start and end of routing. Both sale of tickets and souvenir shop	0
		maximum capacity
		0
		fire regulations
		0

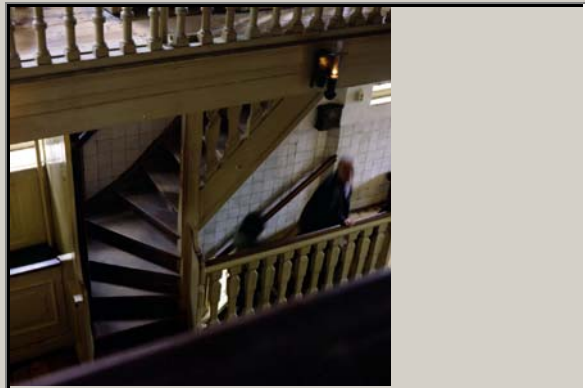
Area reference	Area name	floorlevel	Area orientation
4.4	stairs in the front	3	Church-1st gallery
date	floor space m2	ceiling height m	volume m3
1663-1667	0	0	0

In the 1970's, the original steps were covered with new protective steps. These new steps have been integrated in the stairs, with subsequent loss of original material.

comments	occupation observation	optimum capacity
minor abrasion (3mm max) of steps, especially in the middle part towards the front of the step. Abrasion and grime deposition on railing and posts.		0
		maximum capacity
		0
		fire regulations
		0

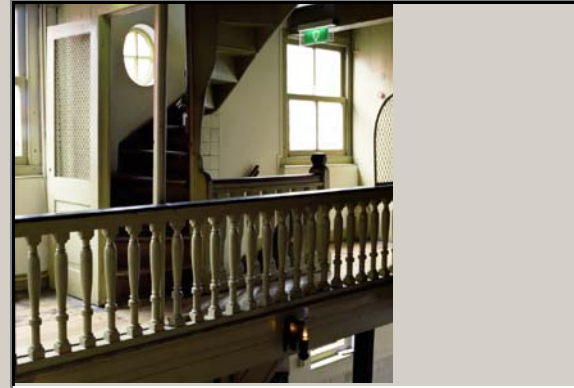
Area reference	Area name	floorlevel	Area orientation
4.5	stairs in the front	4	1st -2nd gallery
date	floor space m2	ceiling height m	volume m3
1663-1667	0	0	0

treatment history
 In the 1970's, the original steps were covered with new protective steps. These new steps have been integrated in the stairs, with subsequent loss of original material.

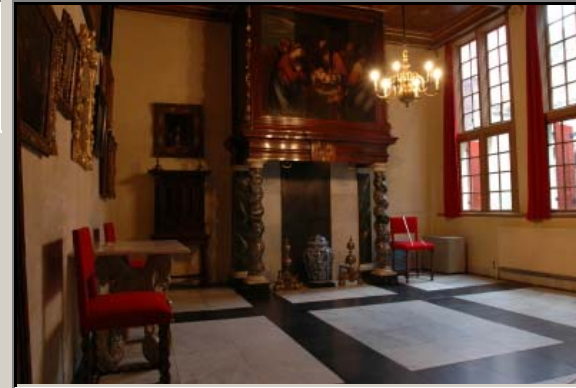
2000 floor conserved, ceiling cleaned and cracks repaired

local humidifier	climateT observation	climate RH observation
Defensor P14 @ 50%	Annual change from 13.1°C in March to 27.8°C June 2005. Very stable in winter (Nov-May) at appr 18°C. Majority of daily fluctuations between 0.2 and 2.5°C, average of 1.27 °C.	Annual change from 70% in July to 28% in Feb 2005. Mean daily fluctuation of 6% RH. During summer, RH between 45 and 70% with most of the daily fluctuations at less than 10%.
local dehumidifier		
Trion 50%

Daily vacuum cleaning, 1 x month damp mopping with natural soap (Ecover) - also dependent on the season and the weather. Restoration of floor expected 1 x per 100 years.

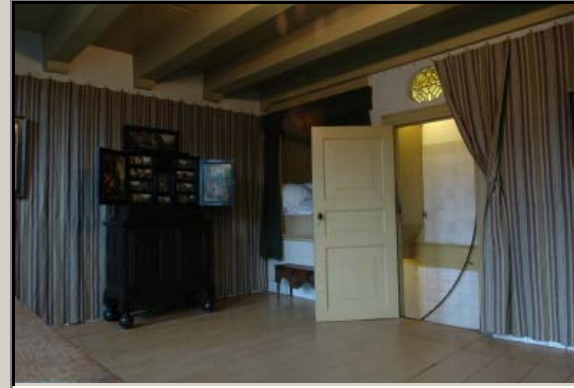
treatment history
restored in 1954-1961, 2001

local humidifier	climateT observation	climate RH observation
no	Annual change from 15.3 C in Jan. to 28.3 C in Sept 2005. T is more stable during winter (Nov-April), with a typical daily fluctuation of about 2 C. From spring to fall daily fluctuations remain same, however T varies from day to day (with max 5 C).	Annual change from 29.3% in Feb. to 75.2% in July 2005. Typical annual RH cycle of 45% is expected. Daily fluctuations vary from day to day between 3% and 20%. 3-5% as lower limit on many days, 10% on regular basis and 20% on 2 occasions during summer.
local dehumidifier		
no

comments	occupation observation	optimum capacity
small alcove with bed in NW wall. Surface stucco walls and also textile 50 m2, tiled walls 2.5 m2.	Occupation is less than 5, with high extremes of 15-20.	5
		maximum capacity
		6
		fire regulations

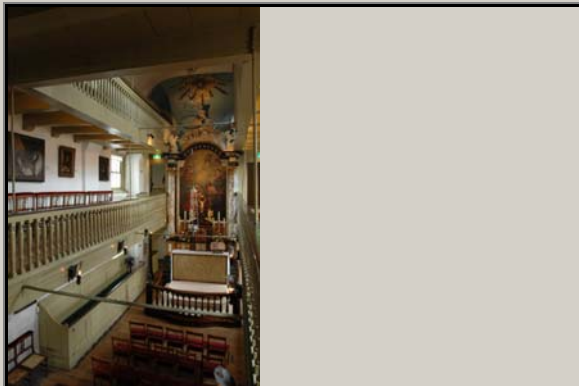
1735: old altar replaced by new one which was moved forward, while openings in upper floors were extended towards canal-side. Long beams, supported by rods from roof, down long sides and balustrades fixed to them to form galleries.

local humidifier	climateT observation	climate RH observation
2 defensors P14 - on SE end, behind statues of Peter and Paul.	Annual change from 12.9 C in March 1 to 28.1 C in June 2005. T very stable in winter (Nov-May), appr. 19 C, increasing to upper 20's during spring and summer months, with larger day-to-day fluctuations (mainly between 0.3 and 2 C, average 1.5 C).	Annual change from 72% in July to 34% in Feb 2005. Mean daily fluctuation of 5% RH. During summer, RH 50-65% with daily fluctuations appr. 5%. RH drops early Nov. to 40-50% throughout winter.
local dehumidifier

comments	occupation observation	optimum capacity
surface stucco walls 62 m2, tiles 40 m2.	Occupation is less than 10, with high extremes of 20-40. Church (including balconies) seats 87, used for weddings (30x year), christenings, Sunday mass (1st Sunday of each month), special mass, concerts, etc. On occasion in the past >100 people.	15
		maximum capacity
		19
		fire regulations
		86

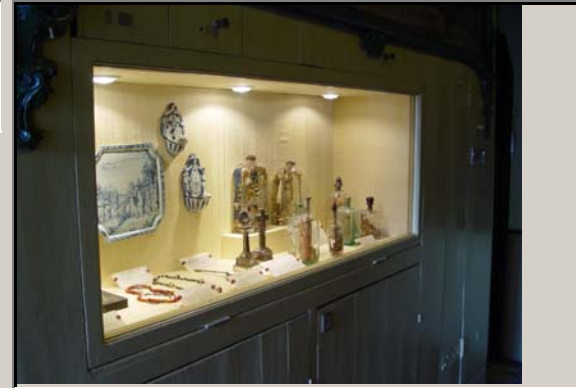
Area reference	Area name	floorlevel	Area orientation
21	cabinet with small relics	3	behind altar
date	floor space m2	ceiling height m	volume m3
	0	0	0

local humidifier	climateT observation	climate RH observation
	Measurements by ICN (2003-2004) inside the showcase show that T increases by 7 °C within the first hour and there is a 10 °C difference between the day and night situation.	
local dehumifier

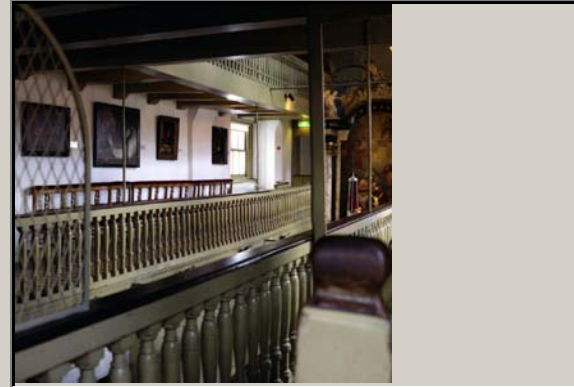
One rod (near the altar, on the SW side) was broken (first noticed in the 1970's and not repaired until 2001).

local humidifier	climateT observation	climate RH observation
2 defensors P14 on both sides of organ and 2 defensors P14 on both sides of altar	Annual change from 12.9 C in March 1 to 28.1 C in June 2005. T very stable in winter (Nov-May), appr. 19 C, increasing to upper 20's during spring and summer months, with larger day-to-day fluctuations (mainly between 0.3 and 2 C, average 1.5 C).	Annual change from 72% in July to 34% in Feb 2005. Mean daily fluctuation of 5% RH. During summer, RH 50-65% with daily fluctuations appr. 5%. RH drops early Nov. to 40-50% throughout winter.
local dehumifier

comments	occupation observation	optimum capacity
1735: old altar replaced by new one which was moved forward, while openings in upper floors were extended towards canal-side. Long beams, supported by rods from roof, down long sides and balustrades fixed to them to form galleries		3
		maximum capacity
		3
		fire regulations
		0

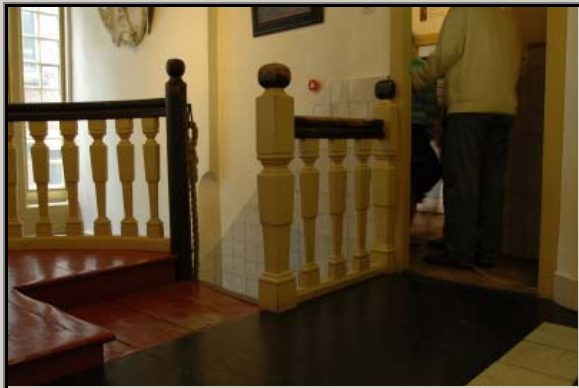
Area reference	Area name	floorlevel	Area orientation
43	Stairs and landing	0	to 17th century kitchen
date	floor space m2	ceiling height m	volume m3
	0	0	0

treatment history
The landing and stairs were moved here in 1952. Stairs are 17th century.

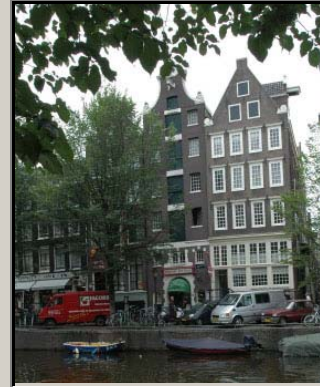
Area reference	Area name	floorlevel	Area orientation
62	facade canal side	0	SE
date	floor space m2	ceiling height m	volume m3
	0	0	0

treatment history
woodwork painted in 2001, 2005
