TECHNICIAN TRAINING FOR THE CONSERVATION OF MOSAICS

PART 2
THE CONSERVATION OF DETACHED MOSAICS

Mosaics detached and relaid in situ on
reinforced concrete:
their deterioration, in situ maintenance treatments
and documentation

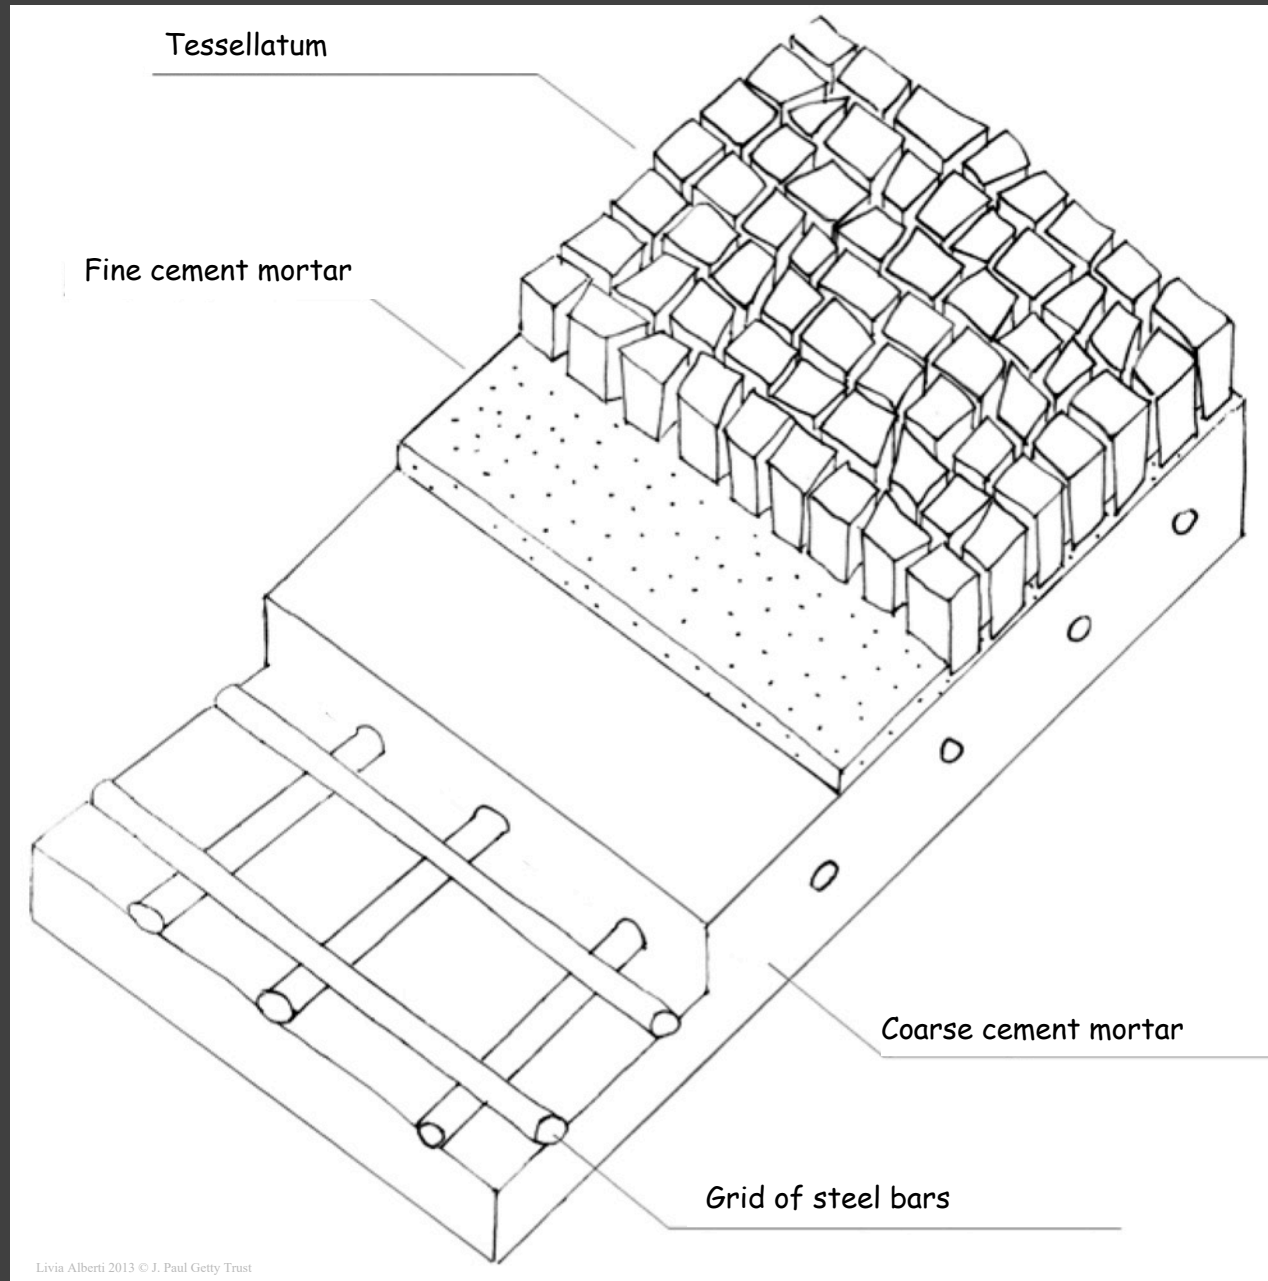
Panel reinforced with steel bar grid

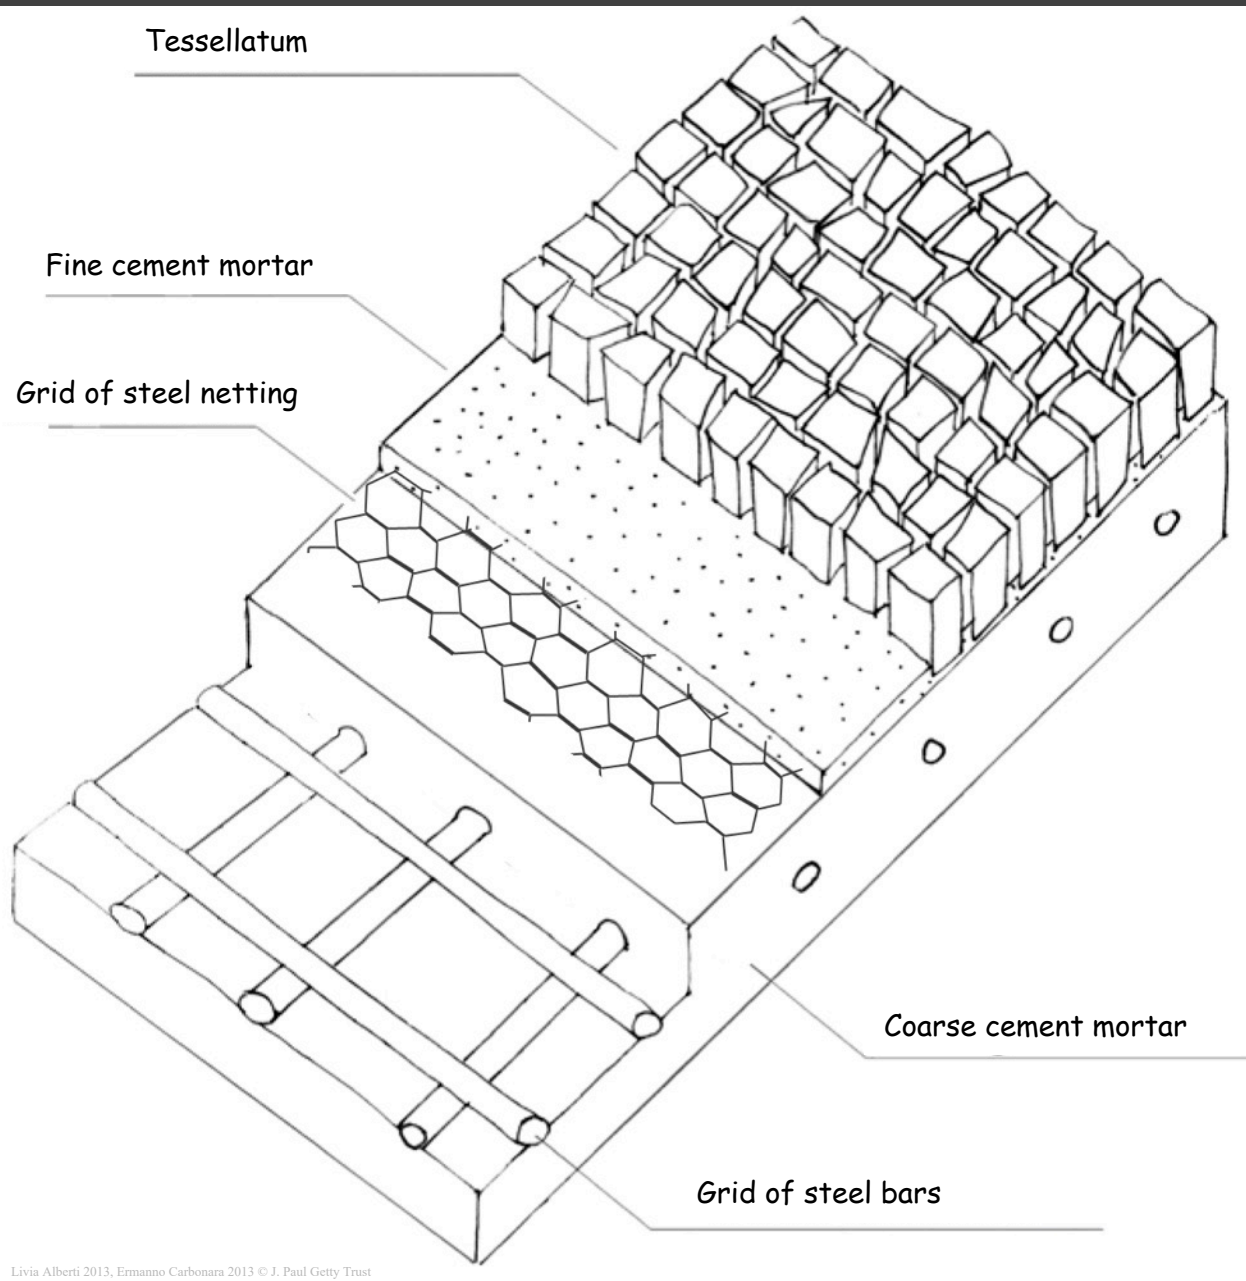
Panel reinforced with steel bar grid and wire

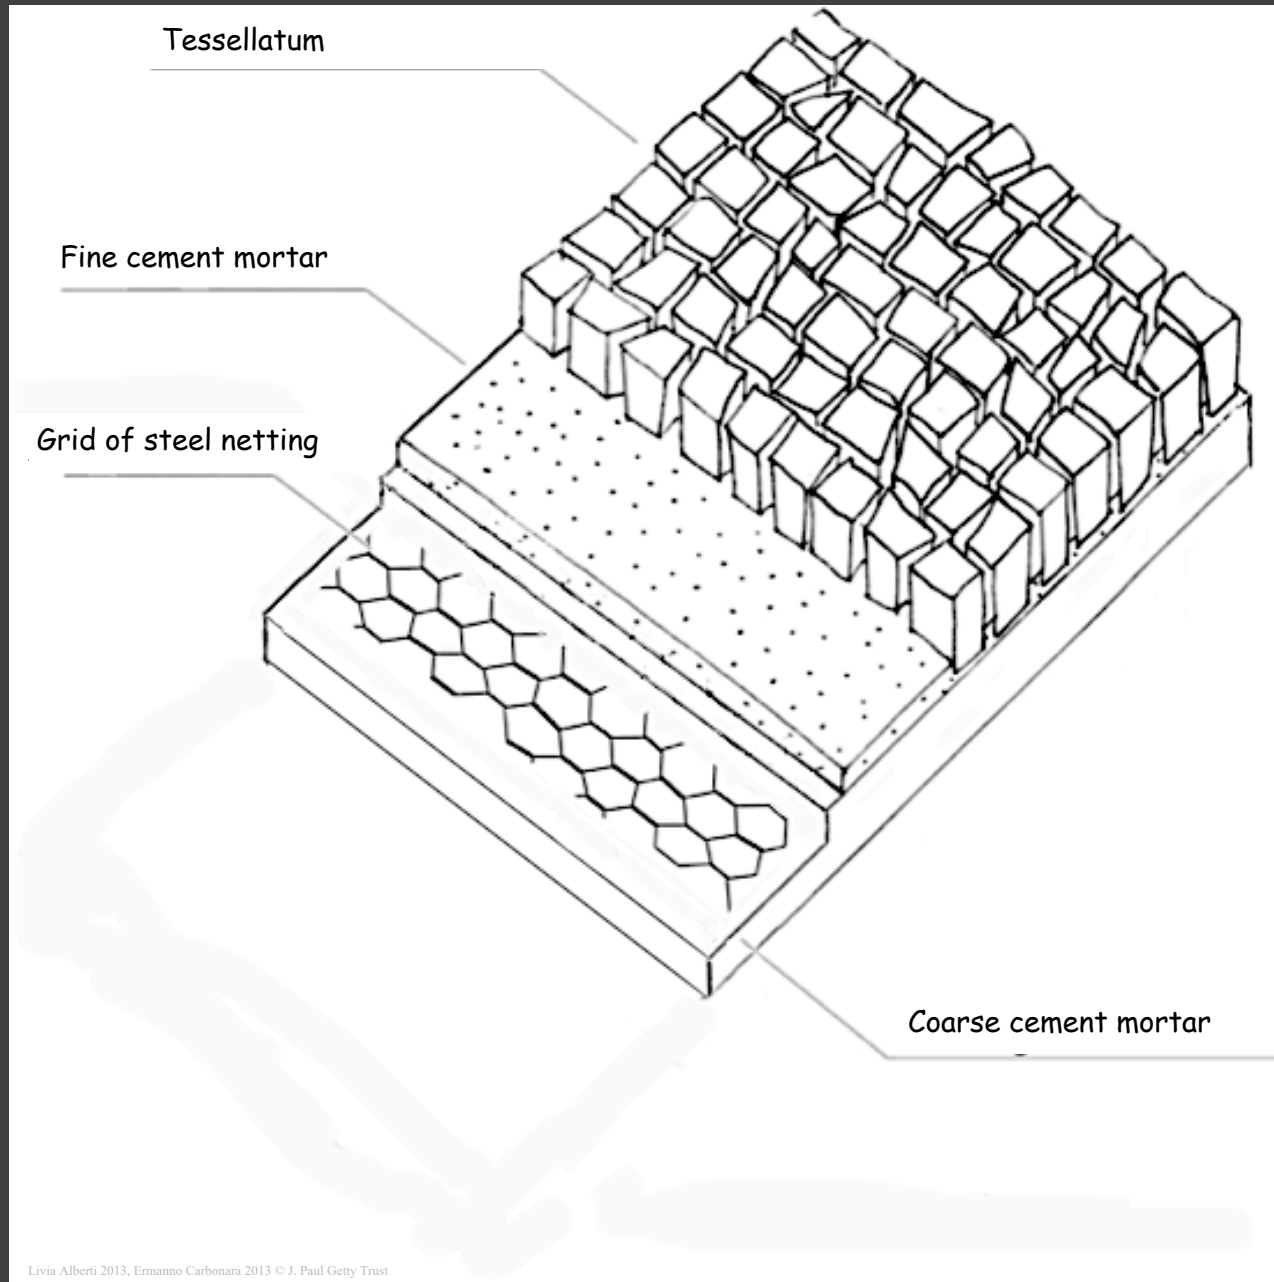
Panel reinforced with steel wire

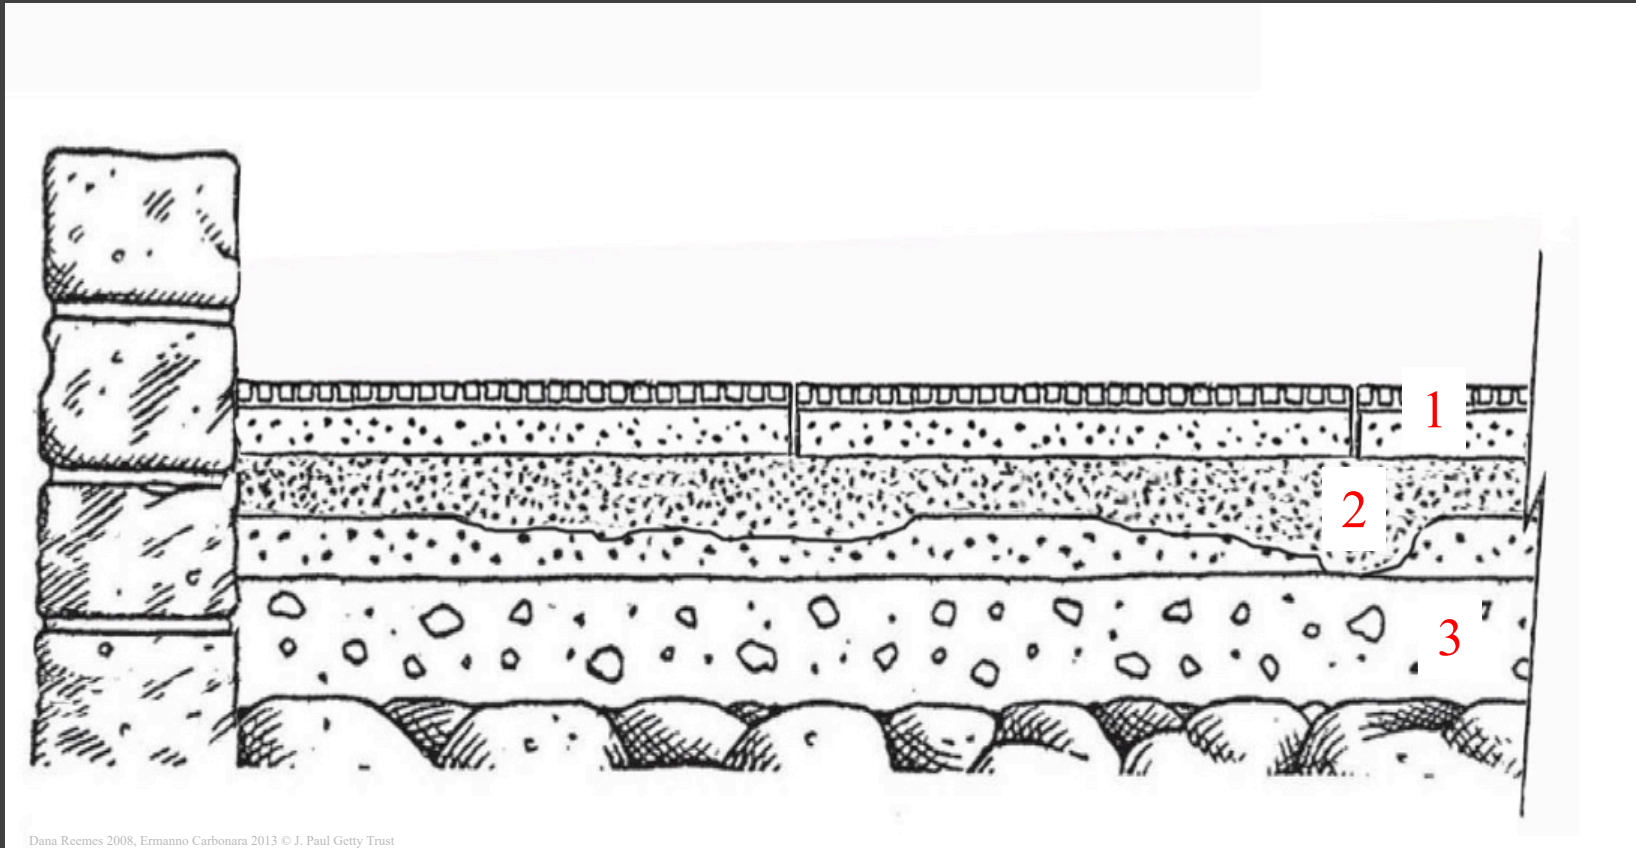
Example of on-site installation of reinforced concrete panels

1 Mosaic panels

2 Layer of sand

3 Original preparatory layers of mortar

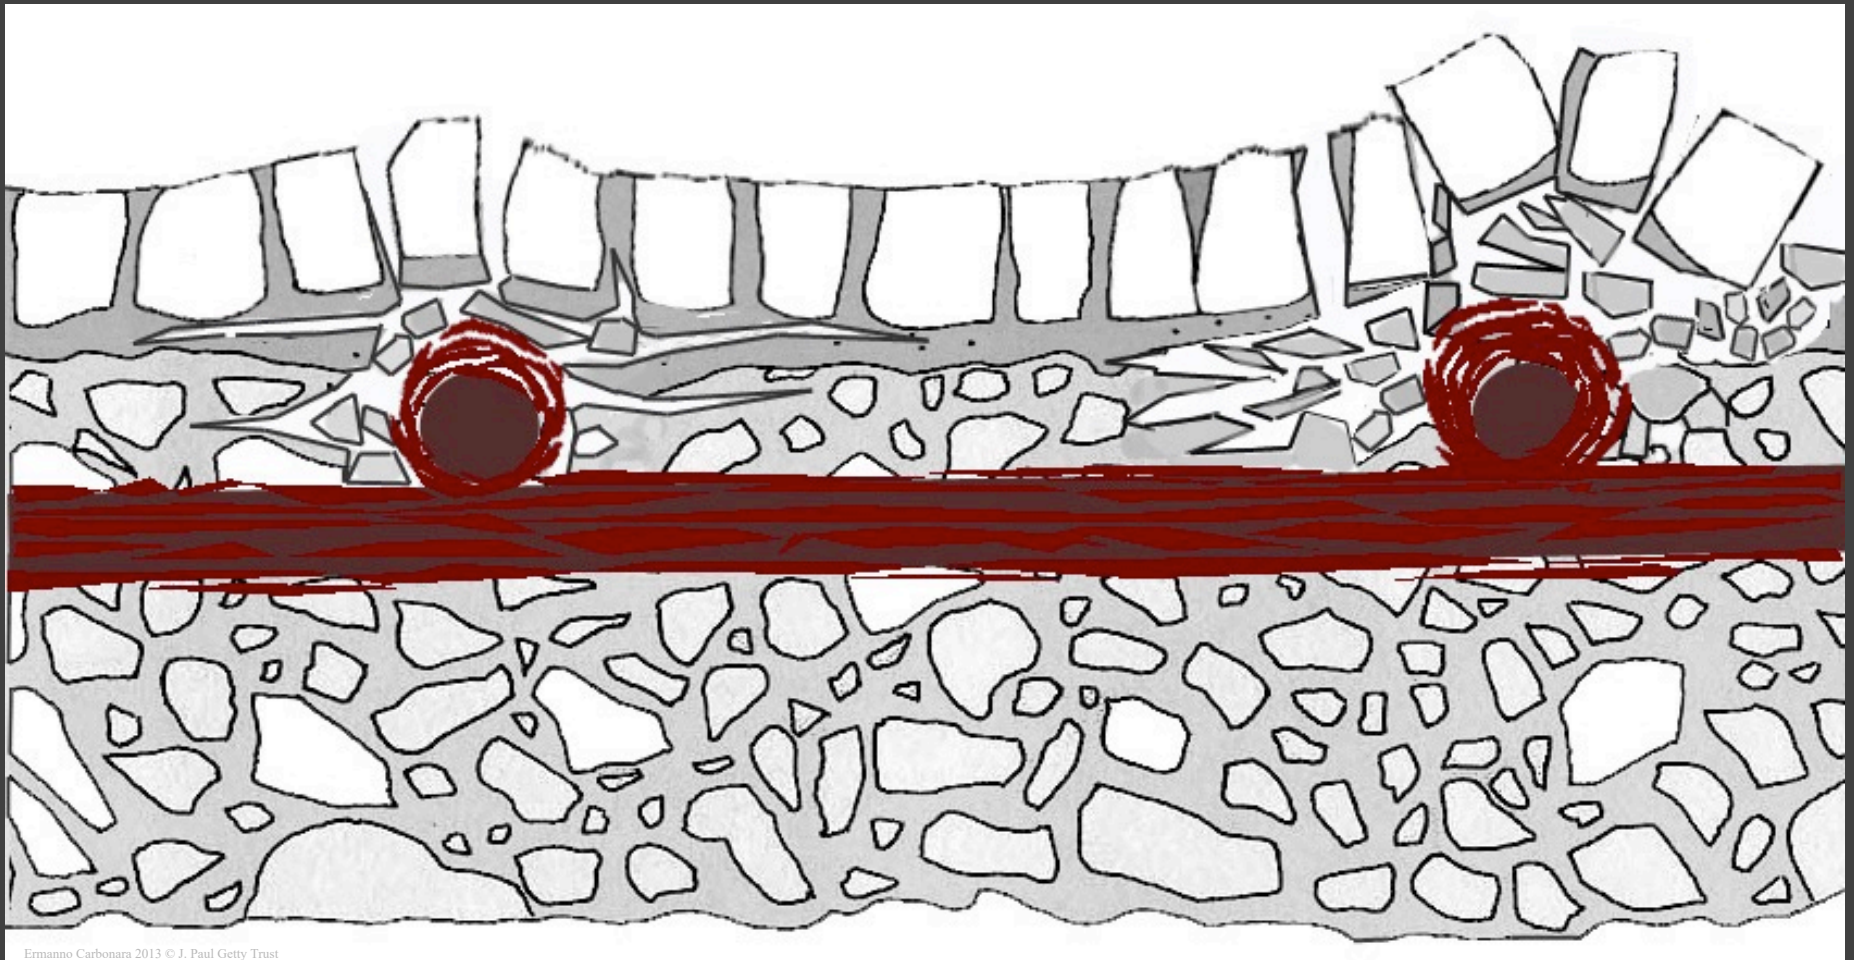
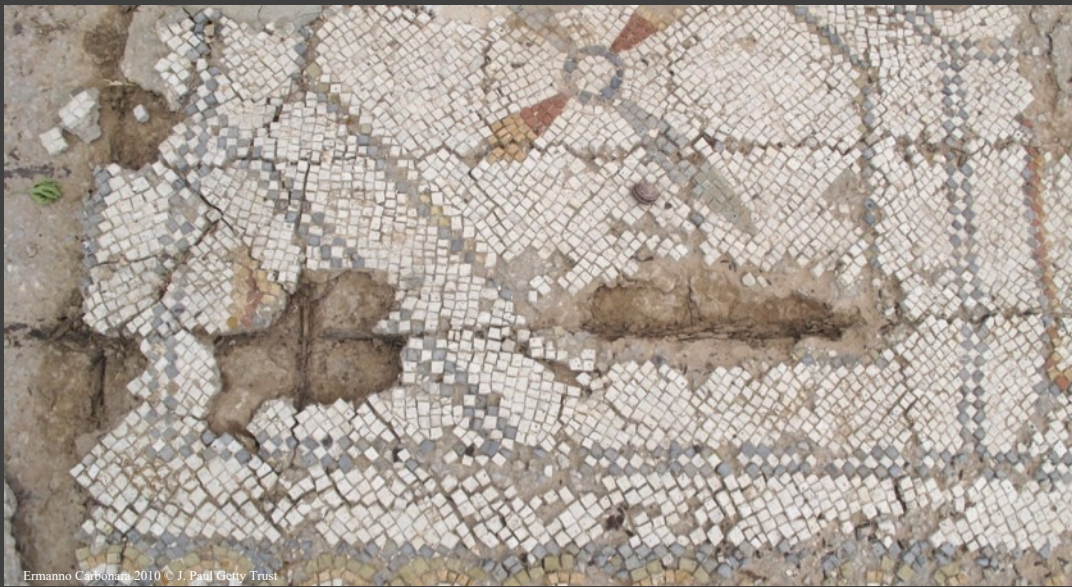
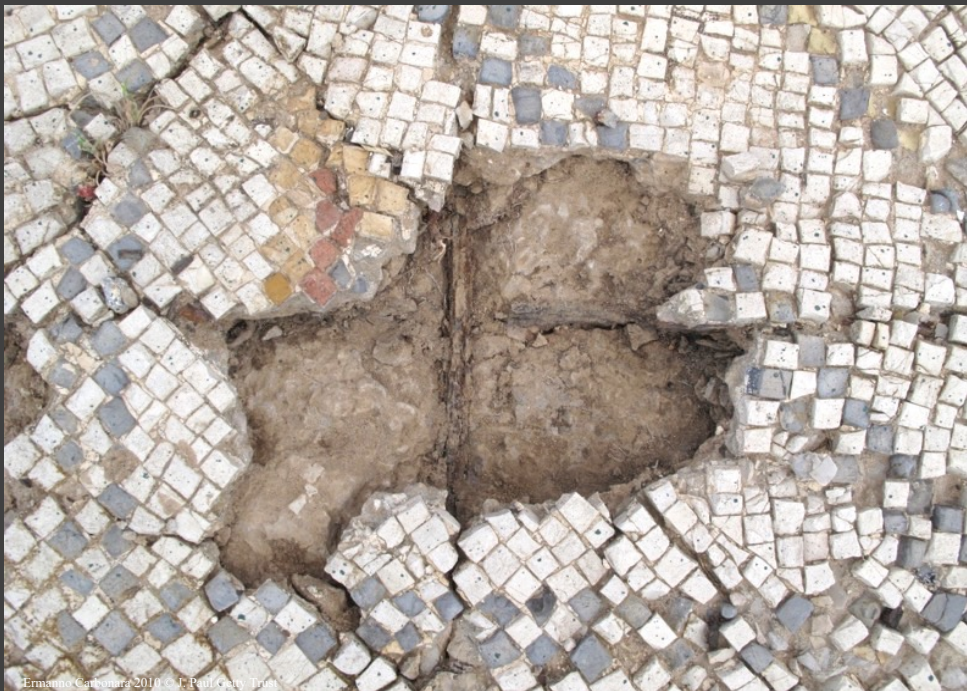
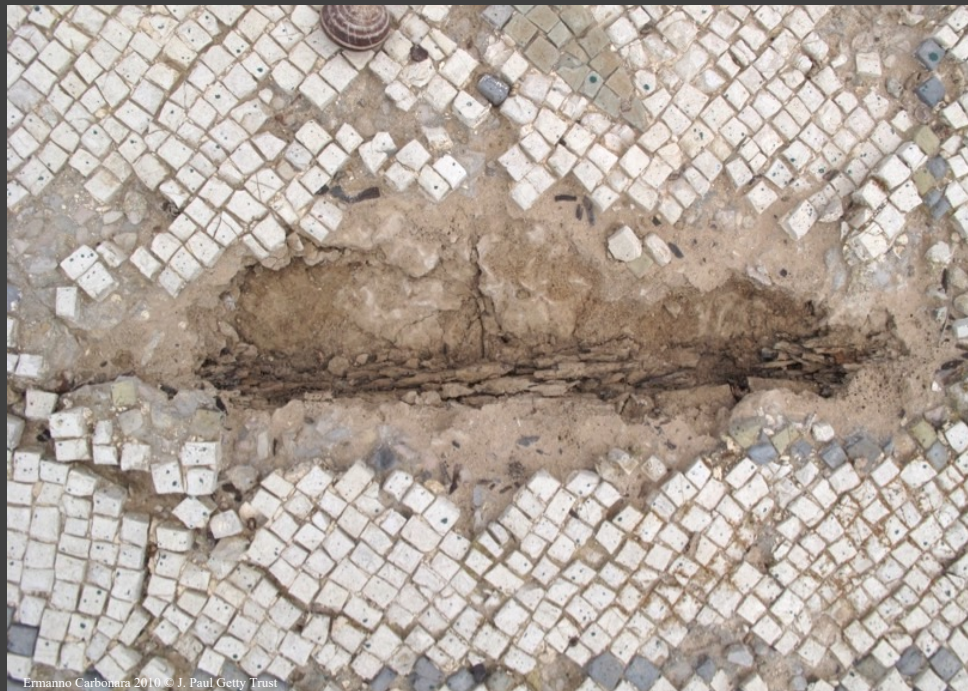
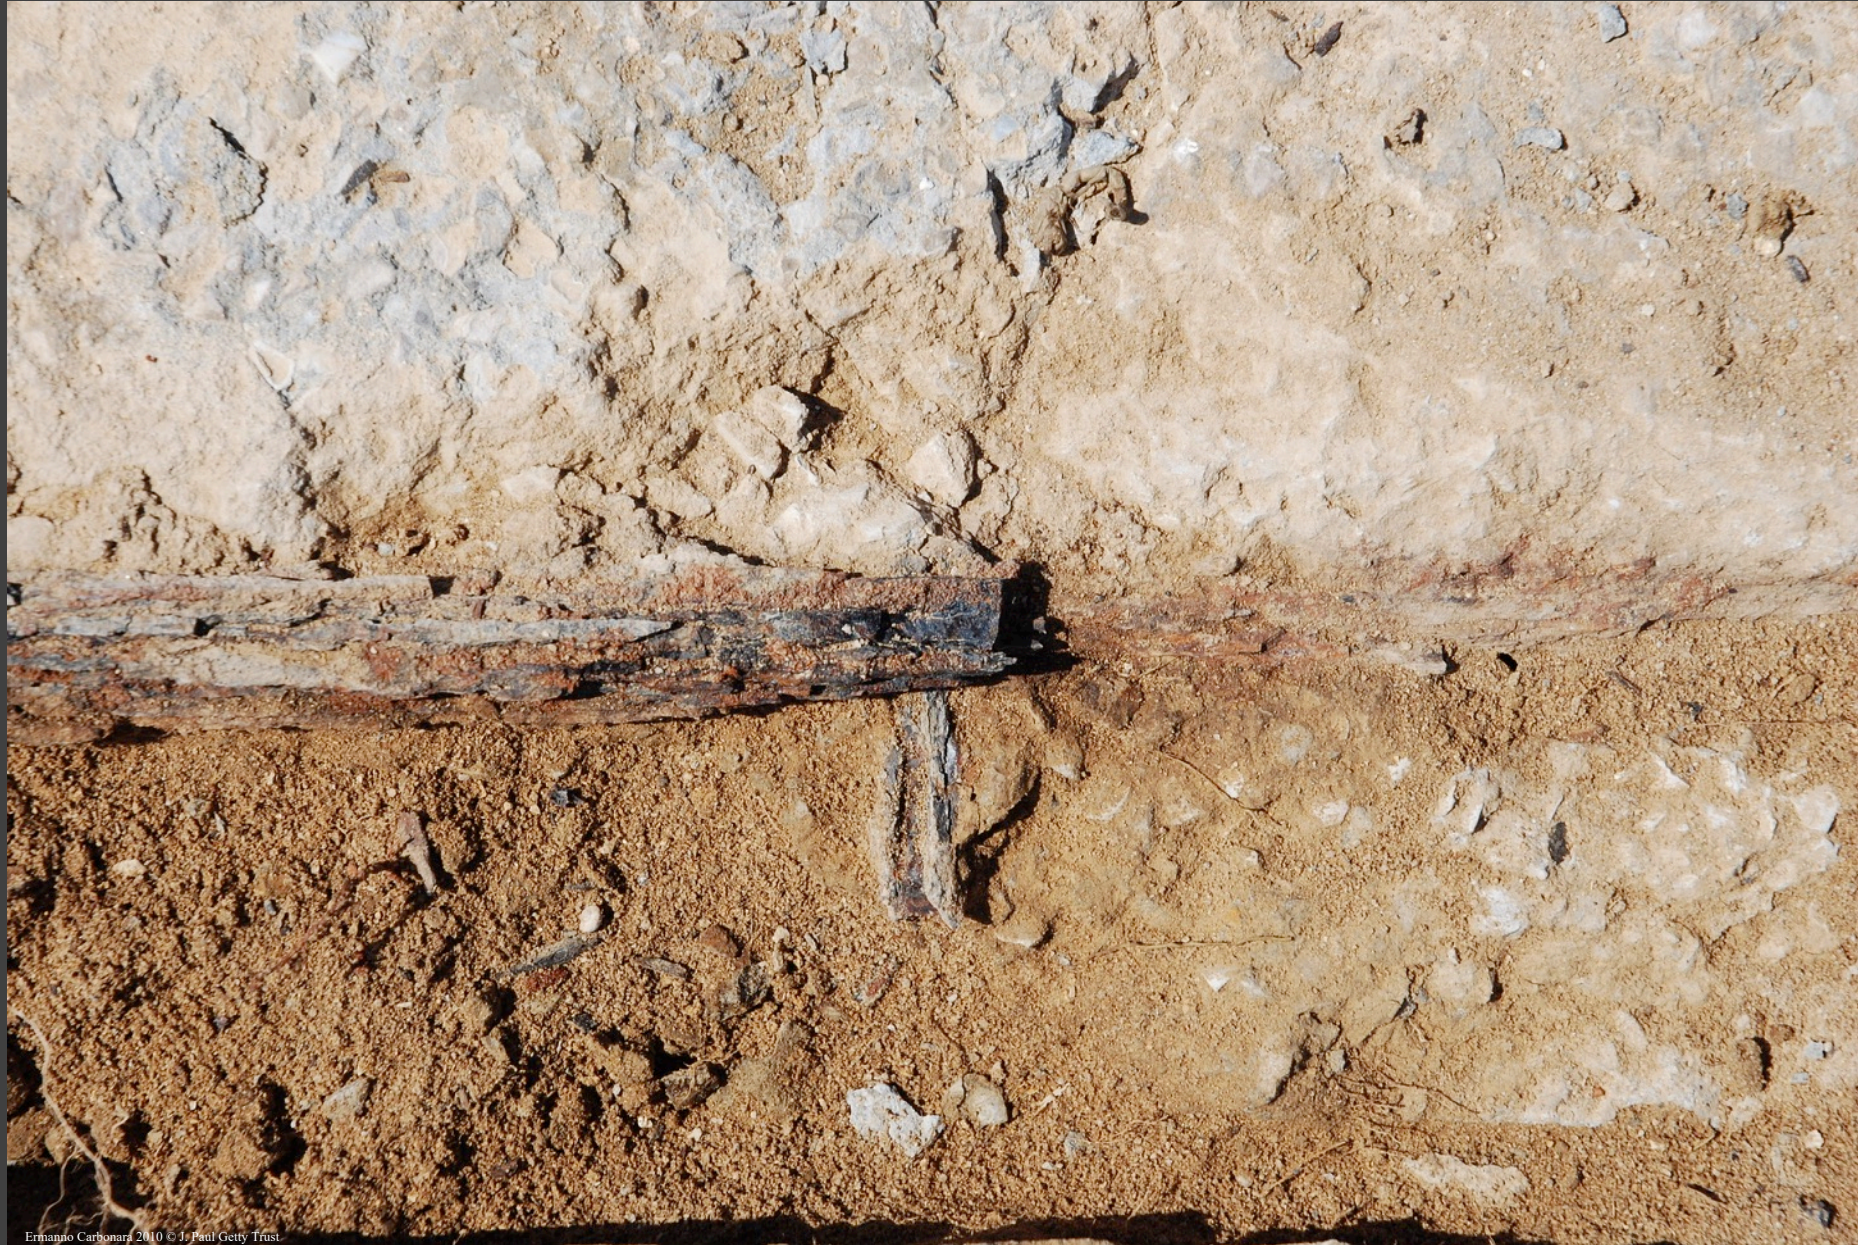
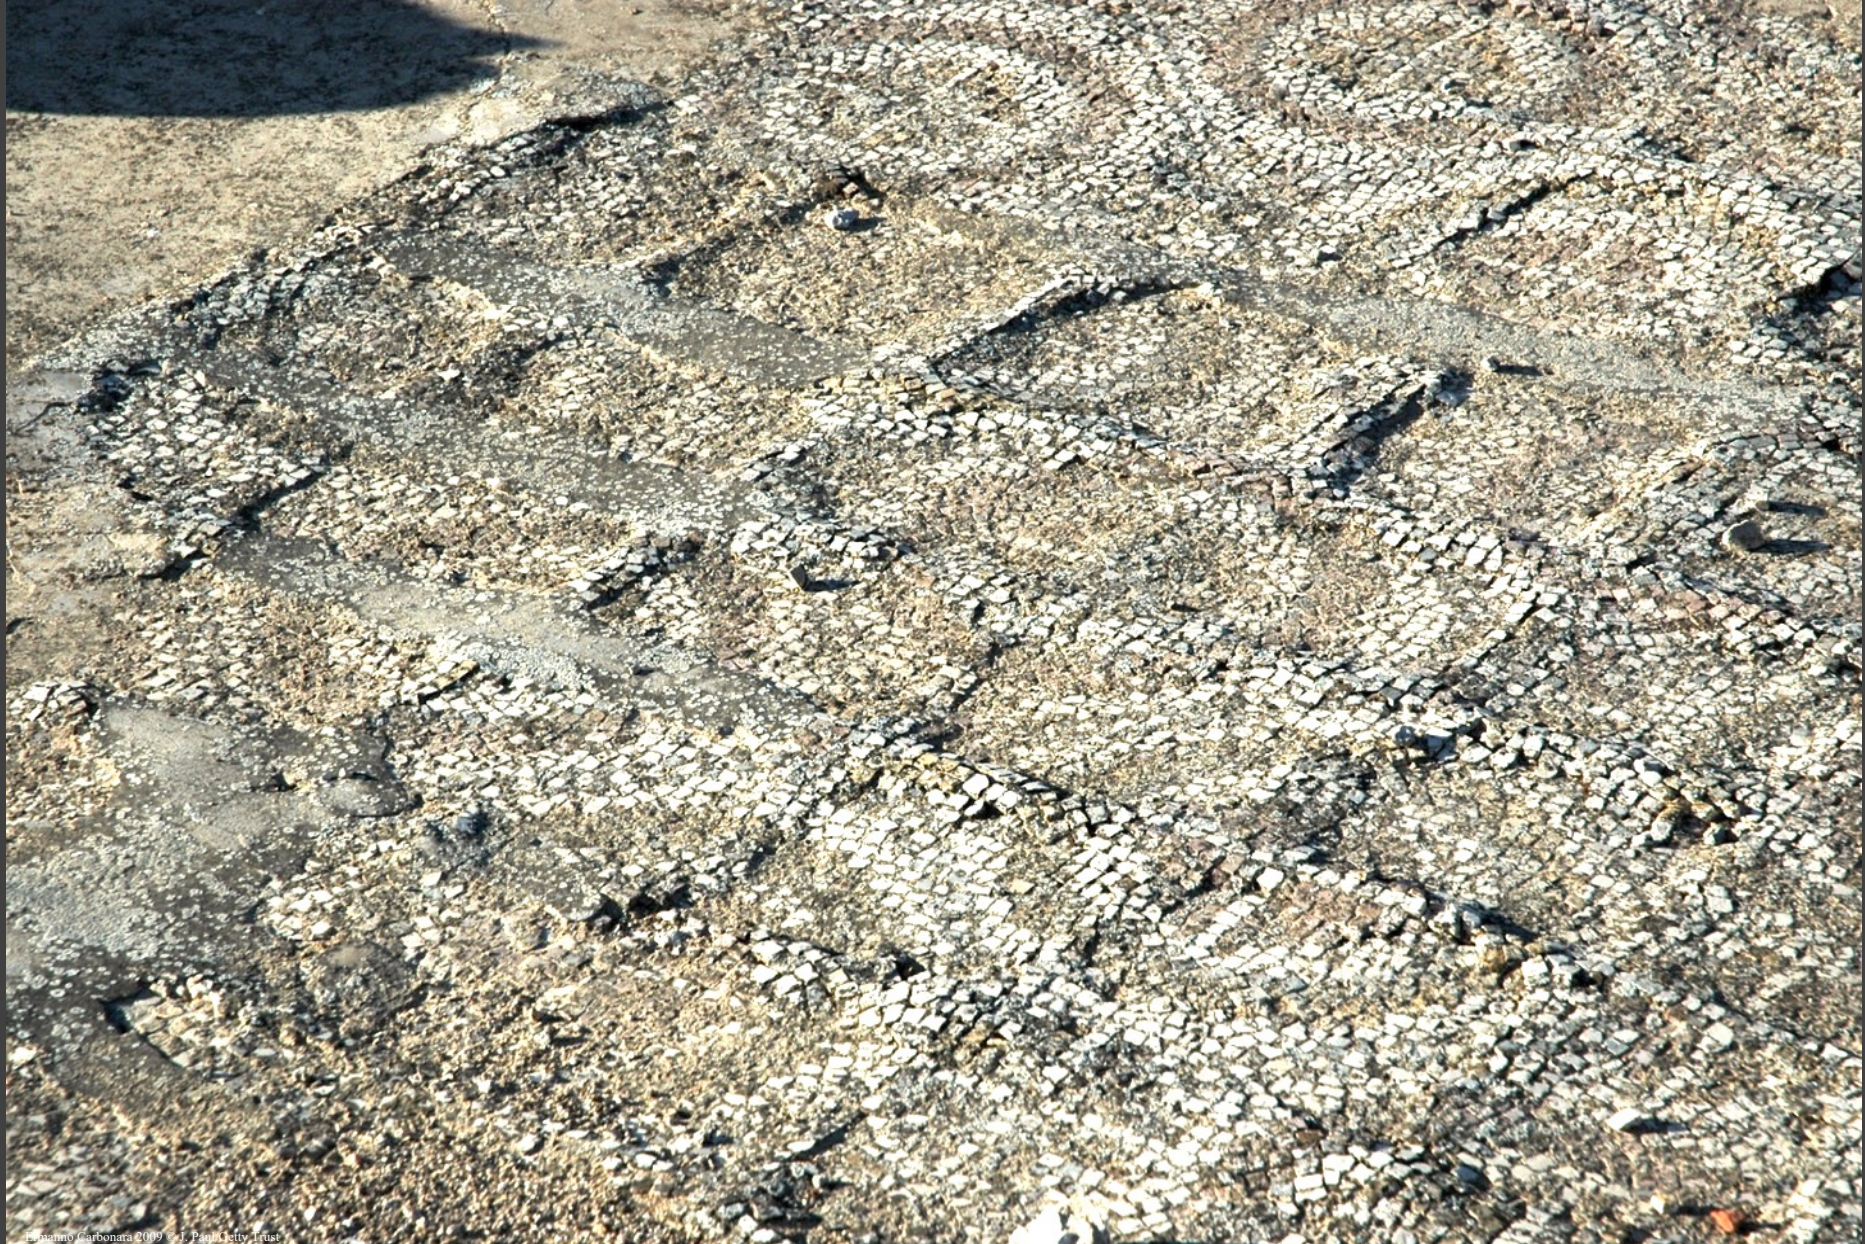
Corrosion of steel bars in the concrete

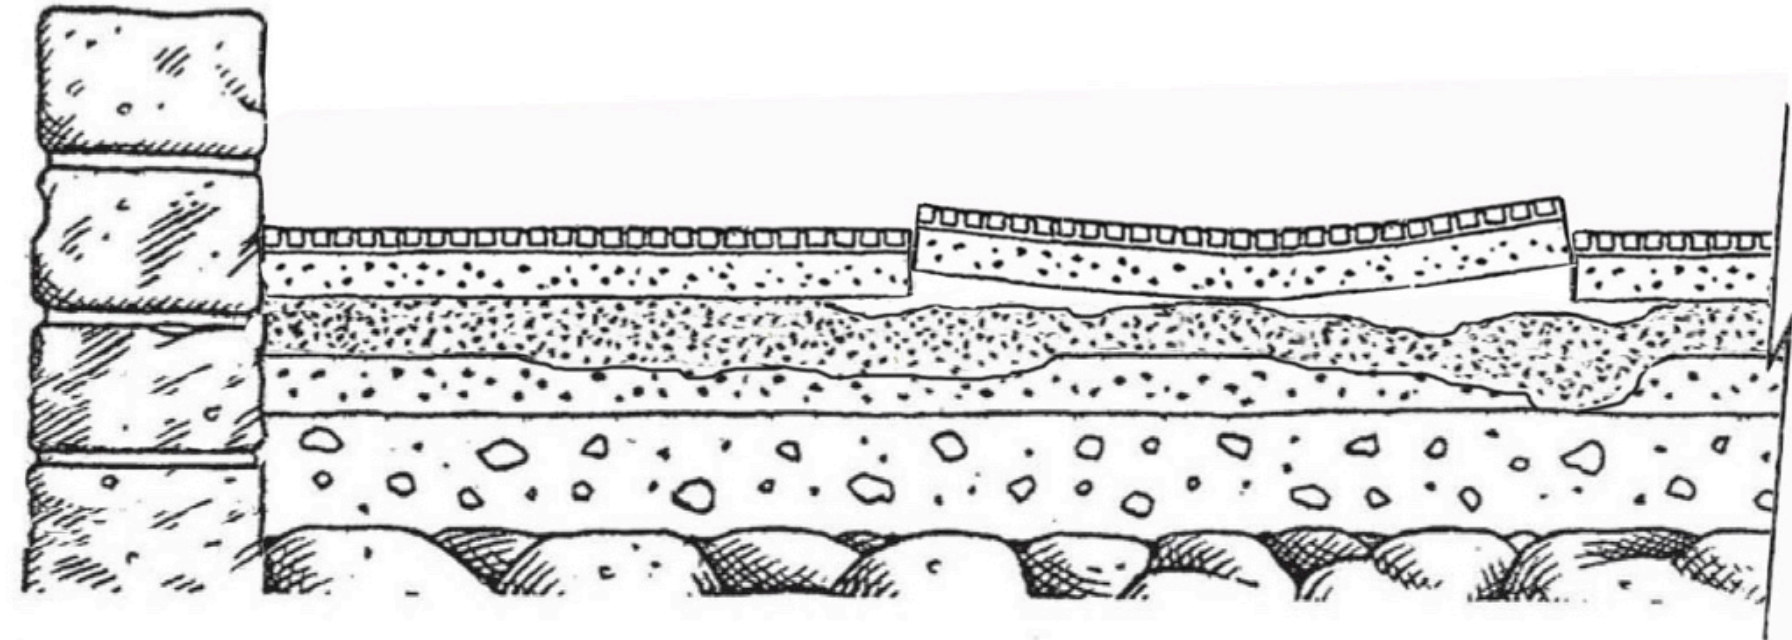
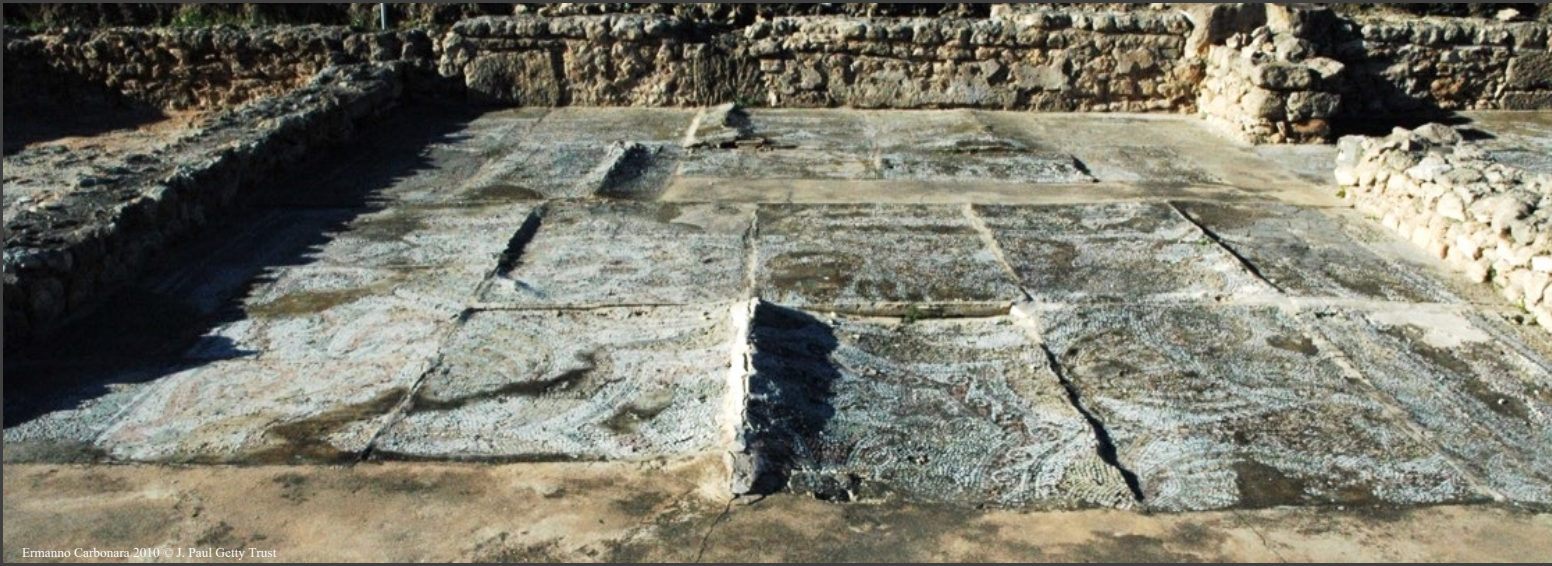
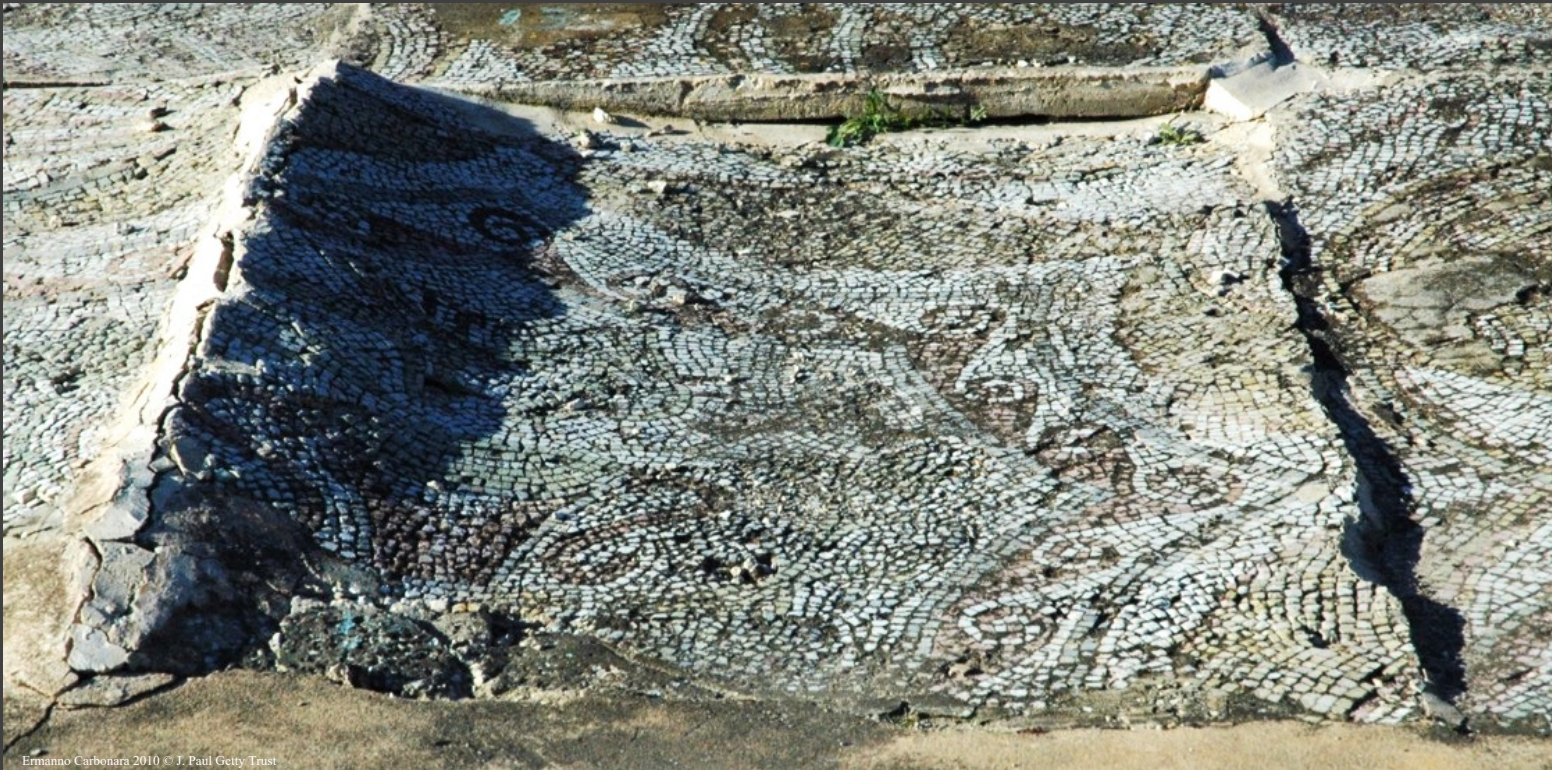
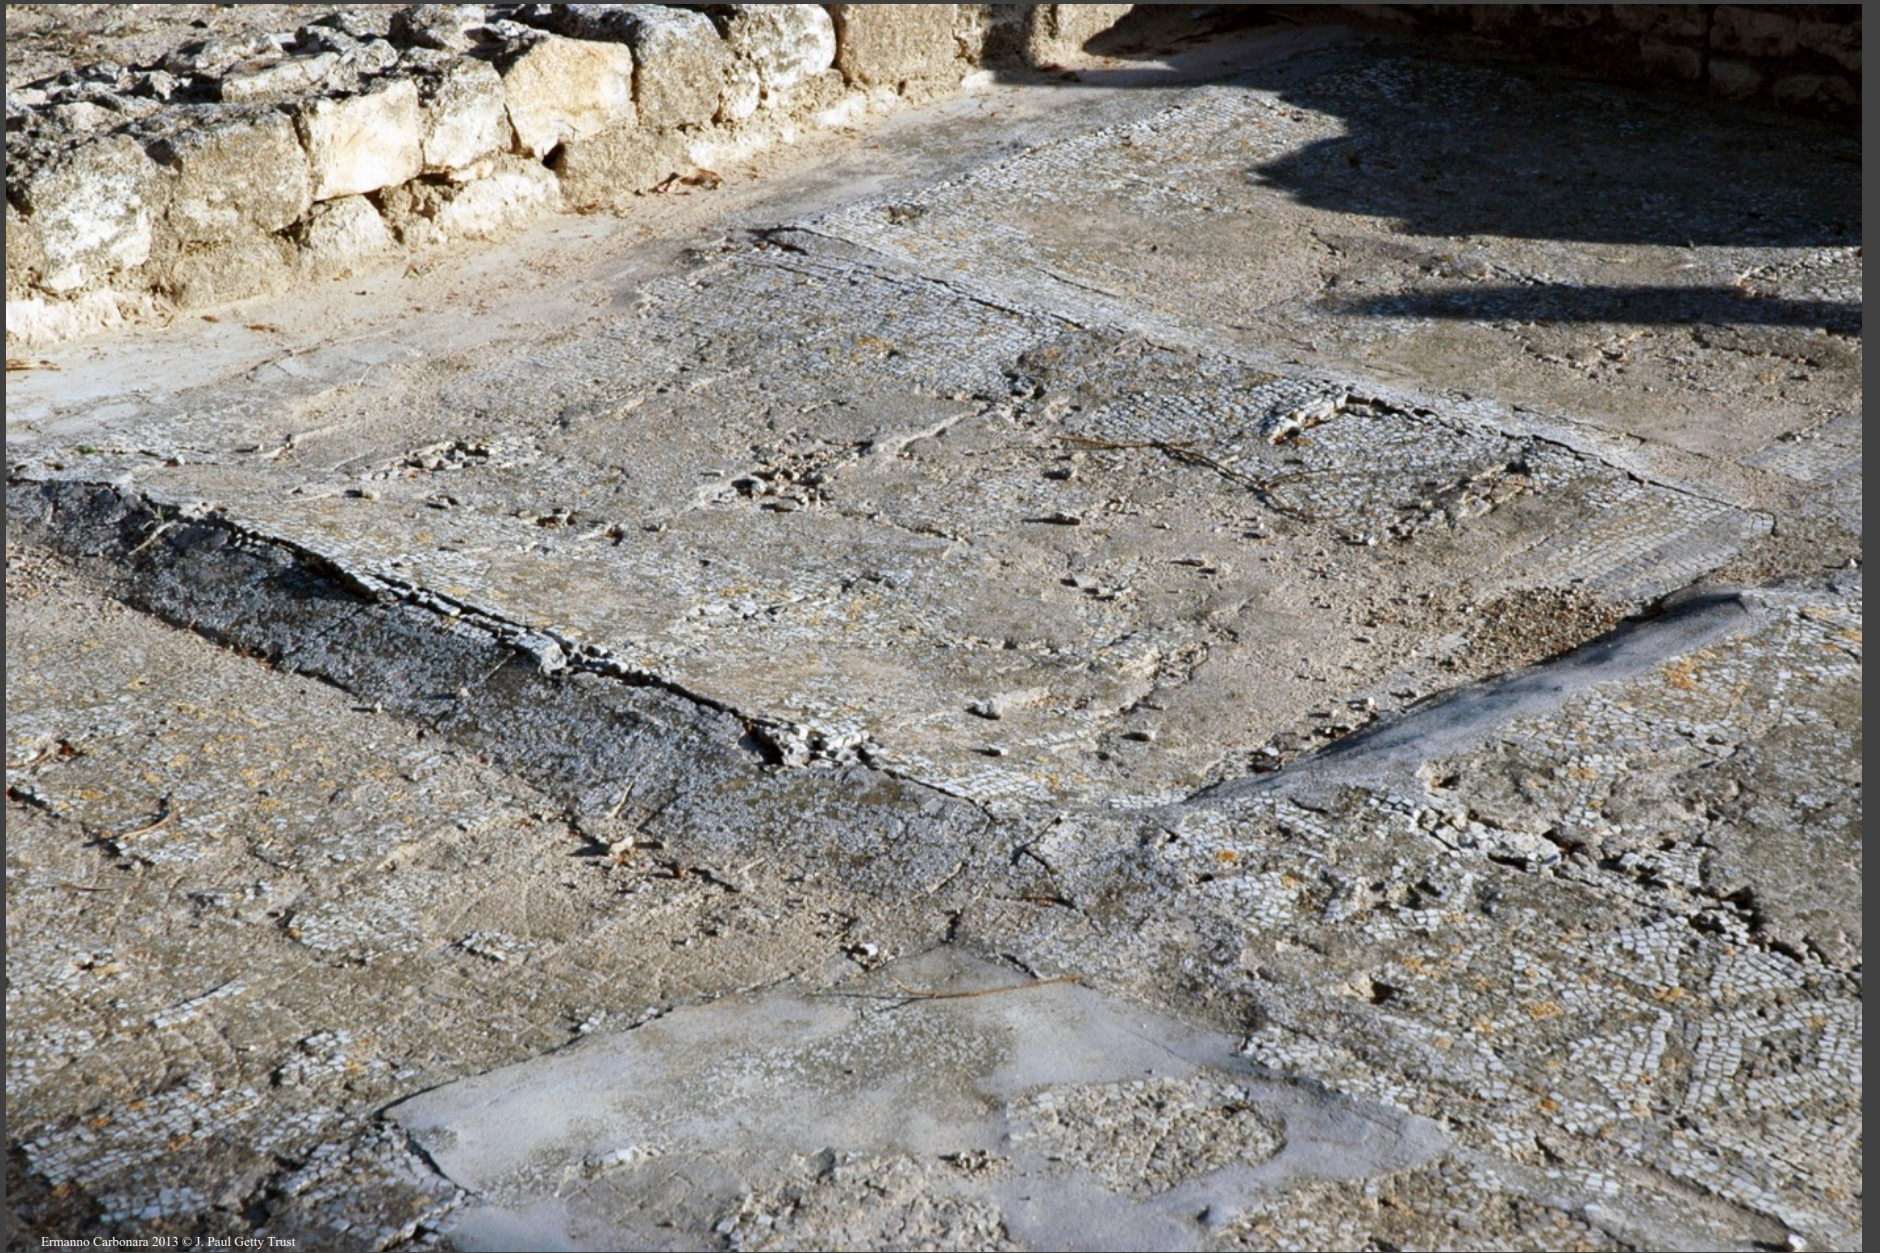
Deformation of mosaic support panels

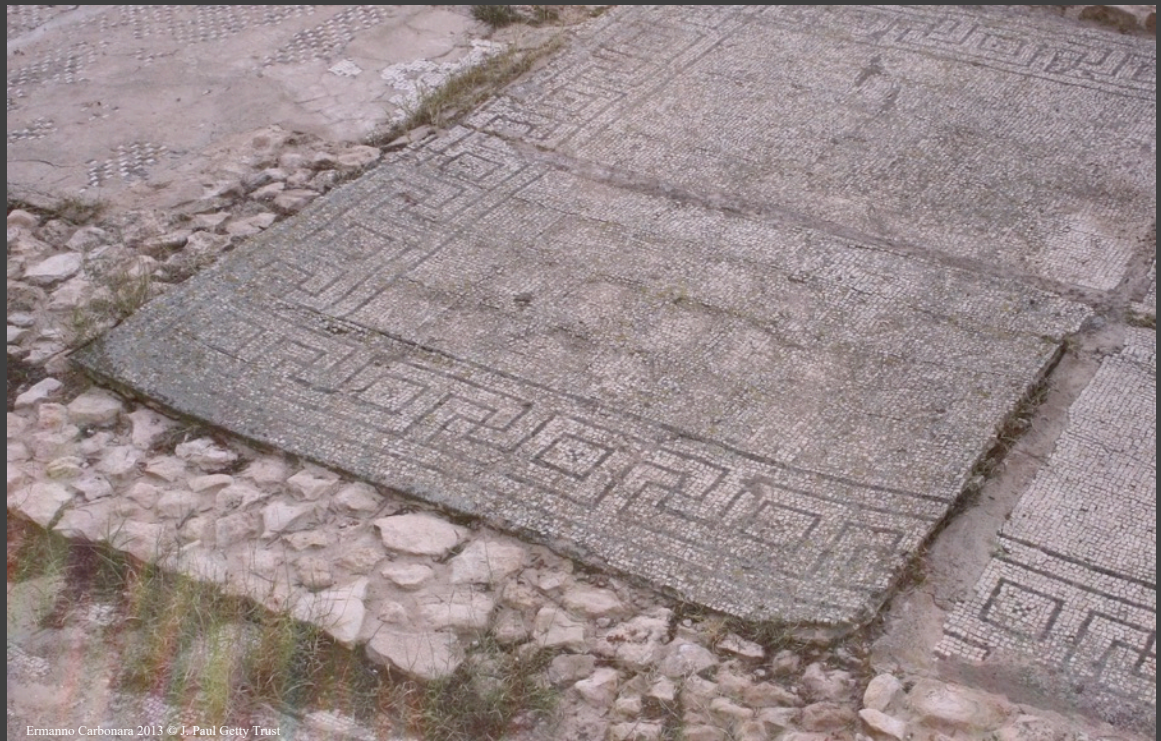
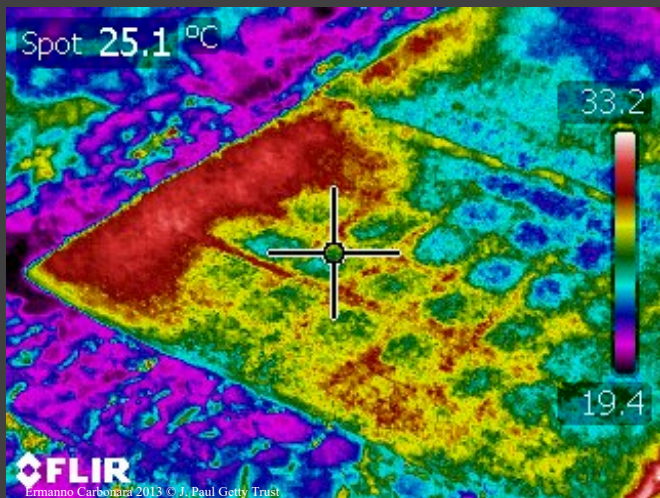
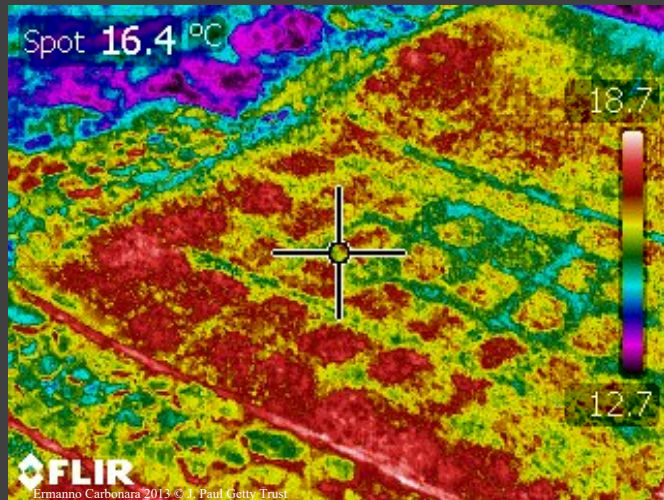
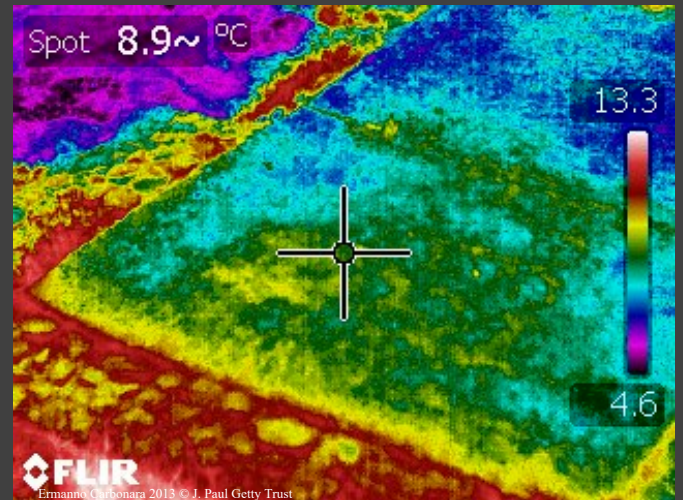
The effects of solar radiation on deteriorated and exposed panels of mosaics relaid on site.

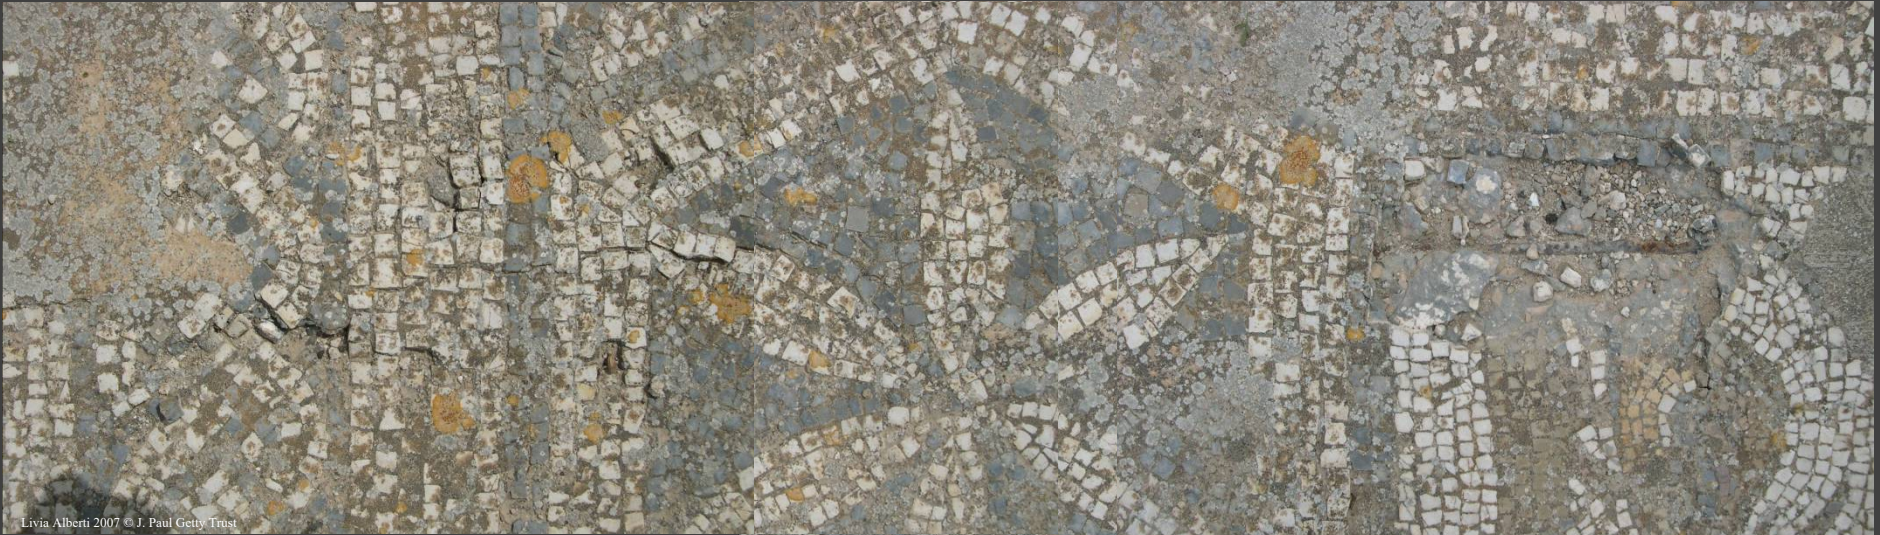
Stabilization by removing sections of the tessellatum using protective facing

Before stabilization
