TECHNICIAN TRAINING FOR THE CONSERVATION OF MOSAICS

PART 2
THE CONSERVATION OF DETACHED MOSAICS

Mosaics detached and relaid in situ on
reinforced concrete:
their deterioration, in situ maintenance treatments
and documentation

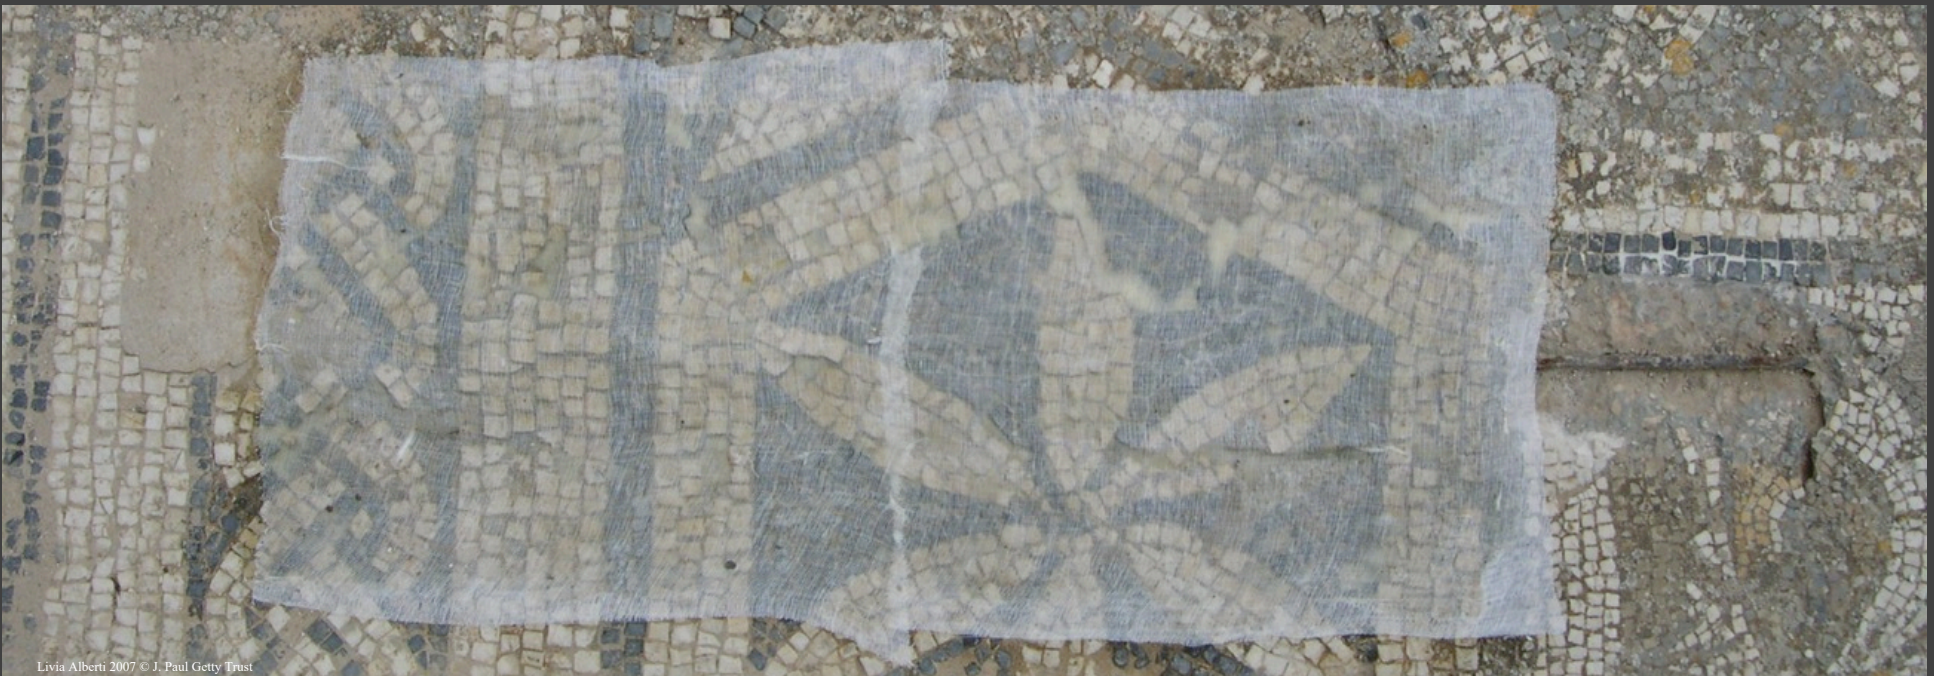
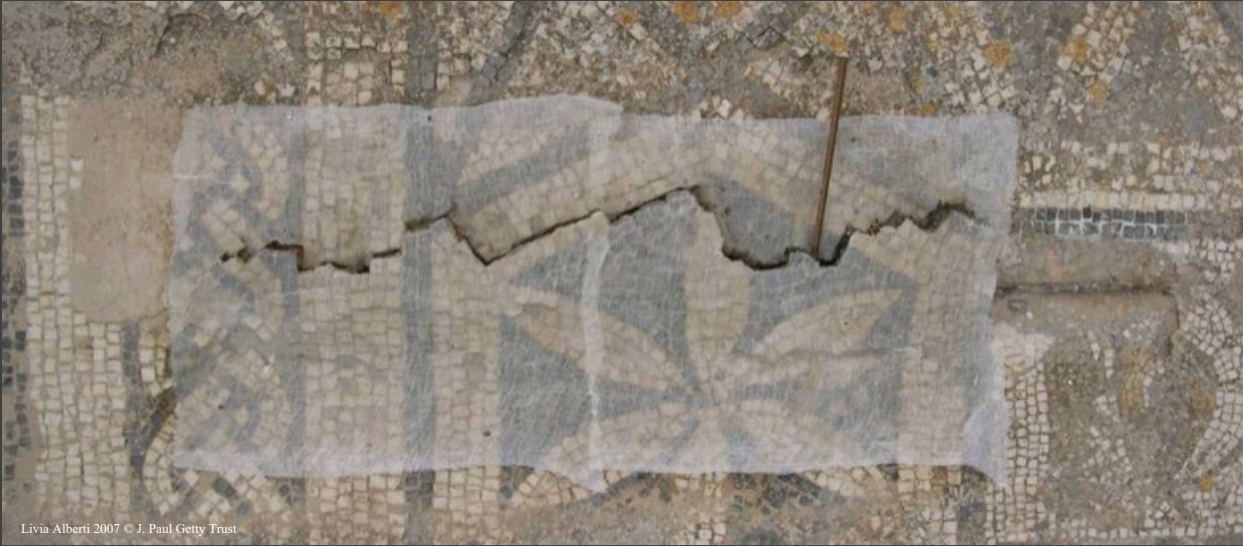
Protection of the area with facing

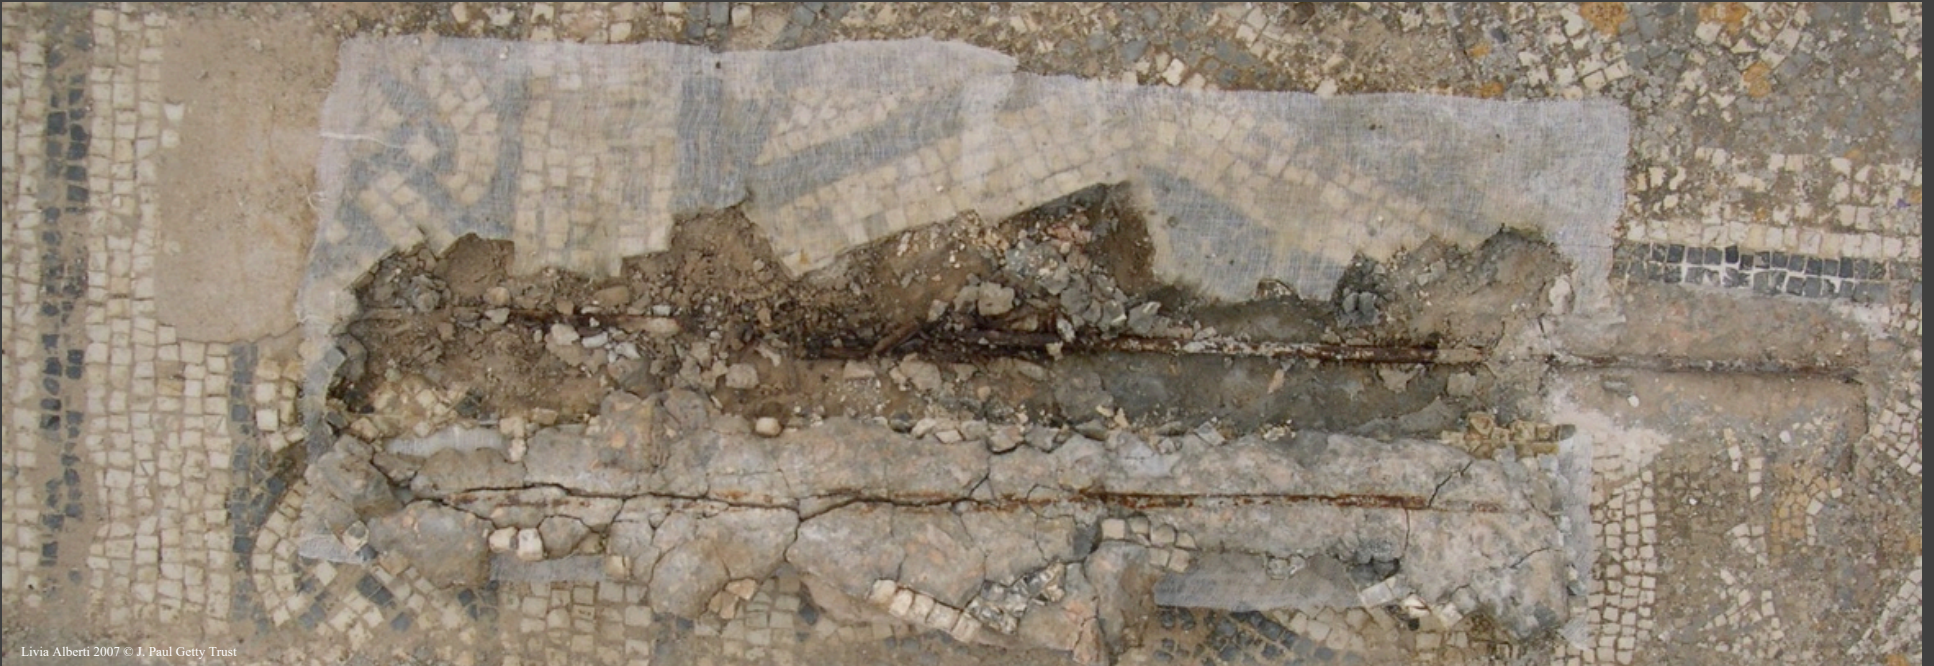
Temporary removal of the section of tessellatum located above the corroded bar

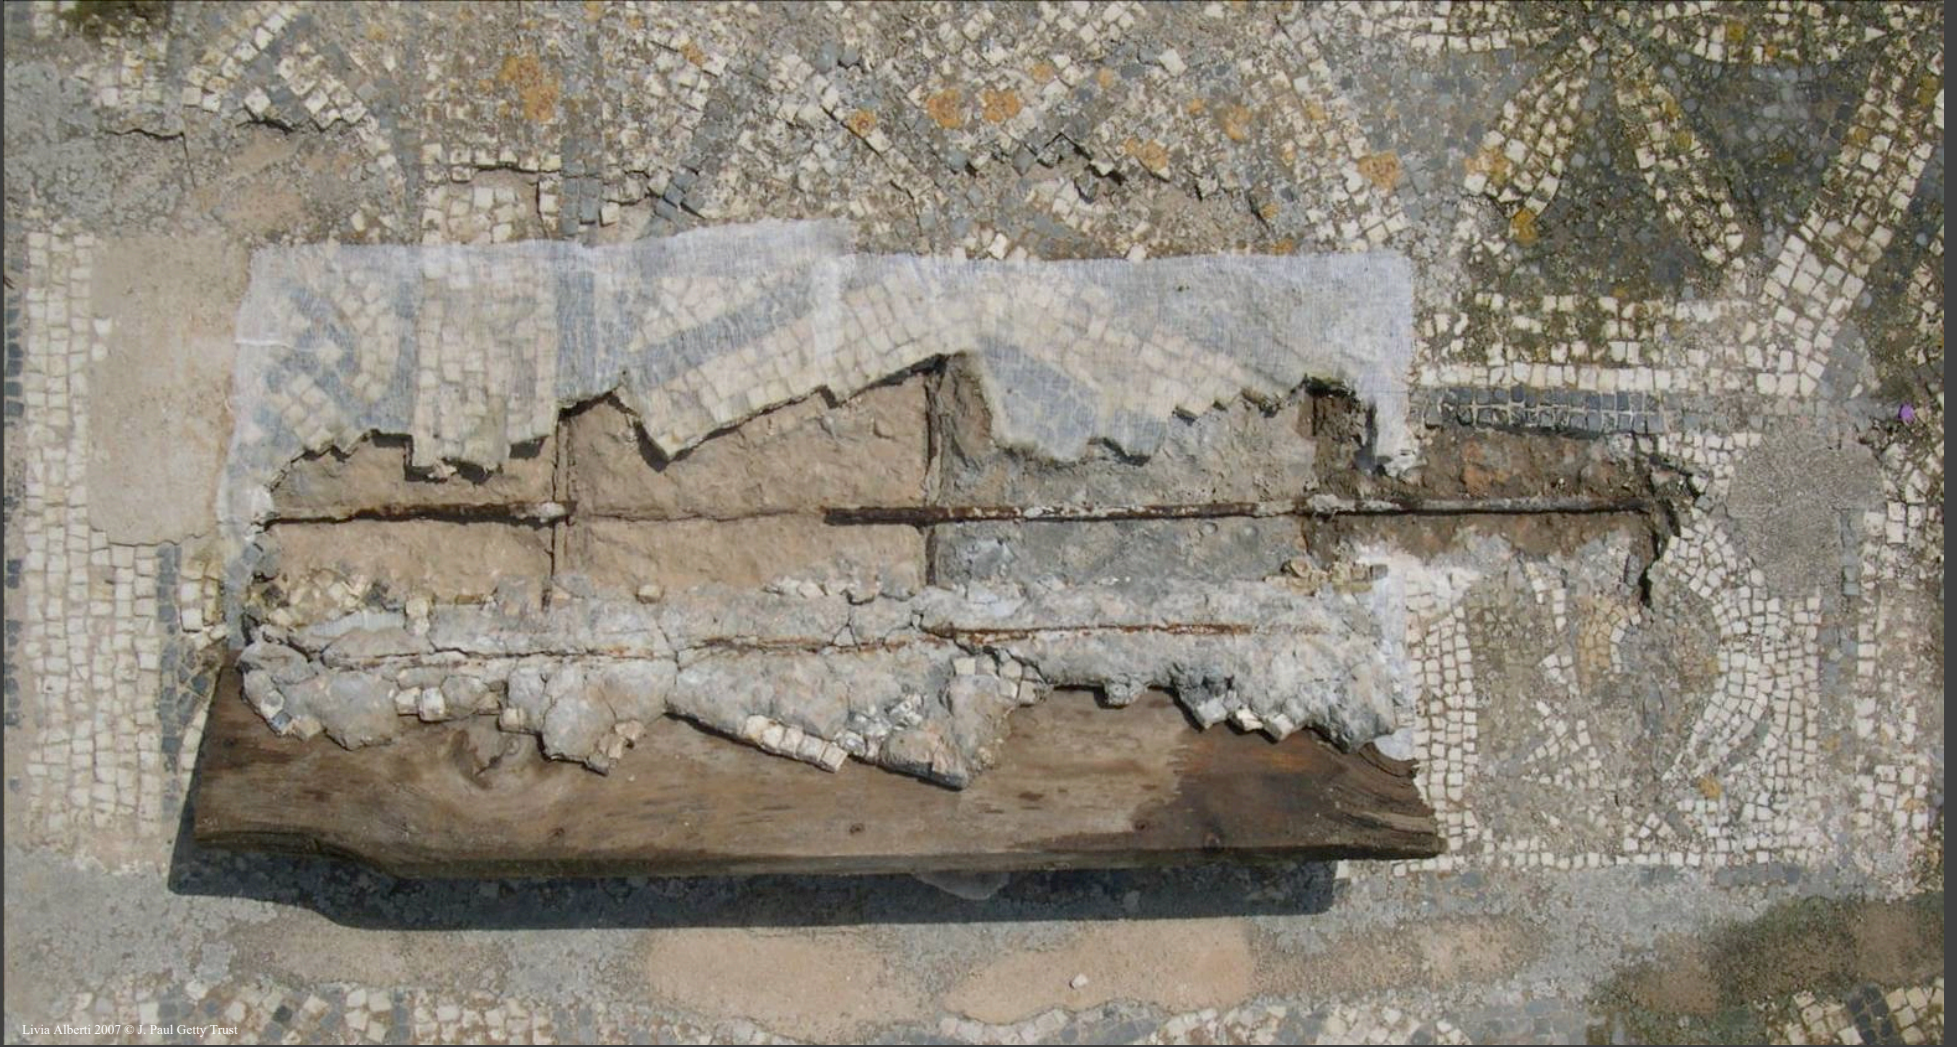
Removal of the bar remains and cleaning of the area to remove debris

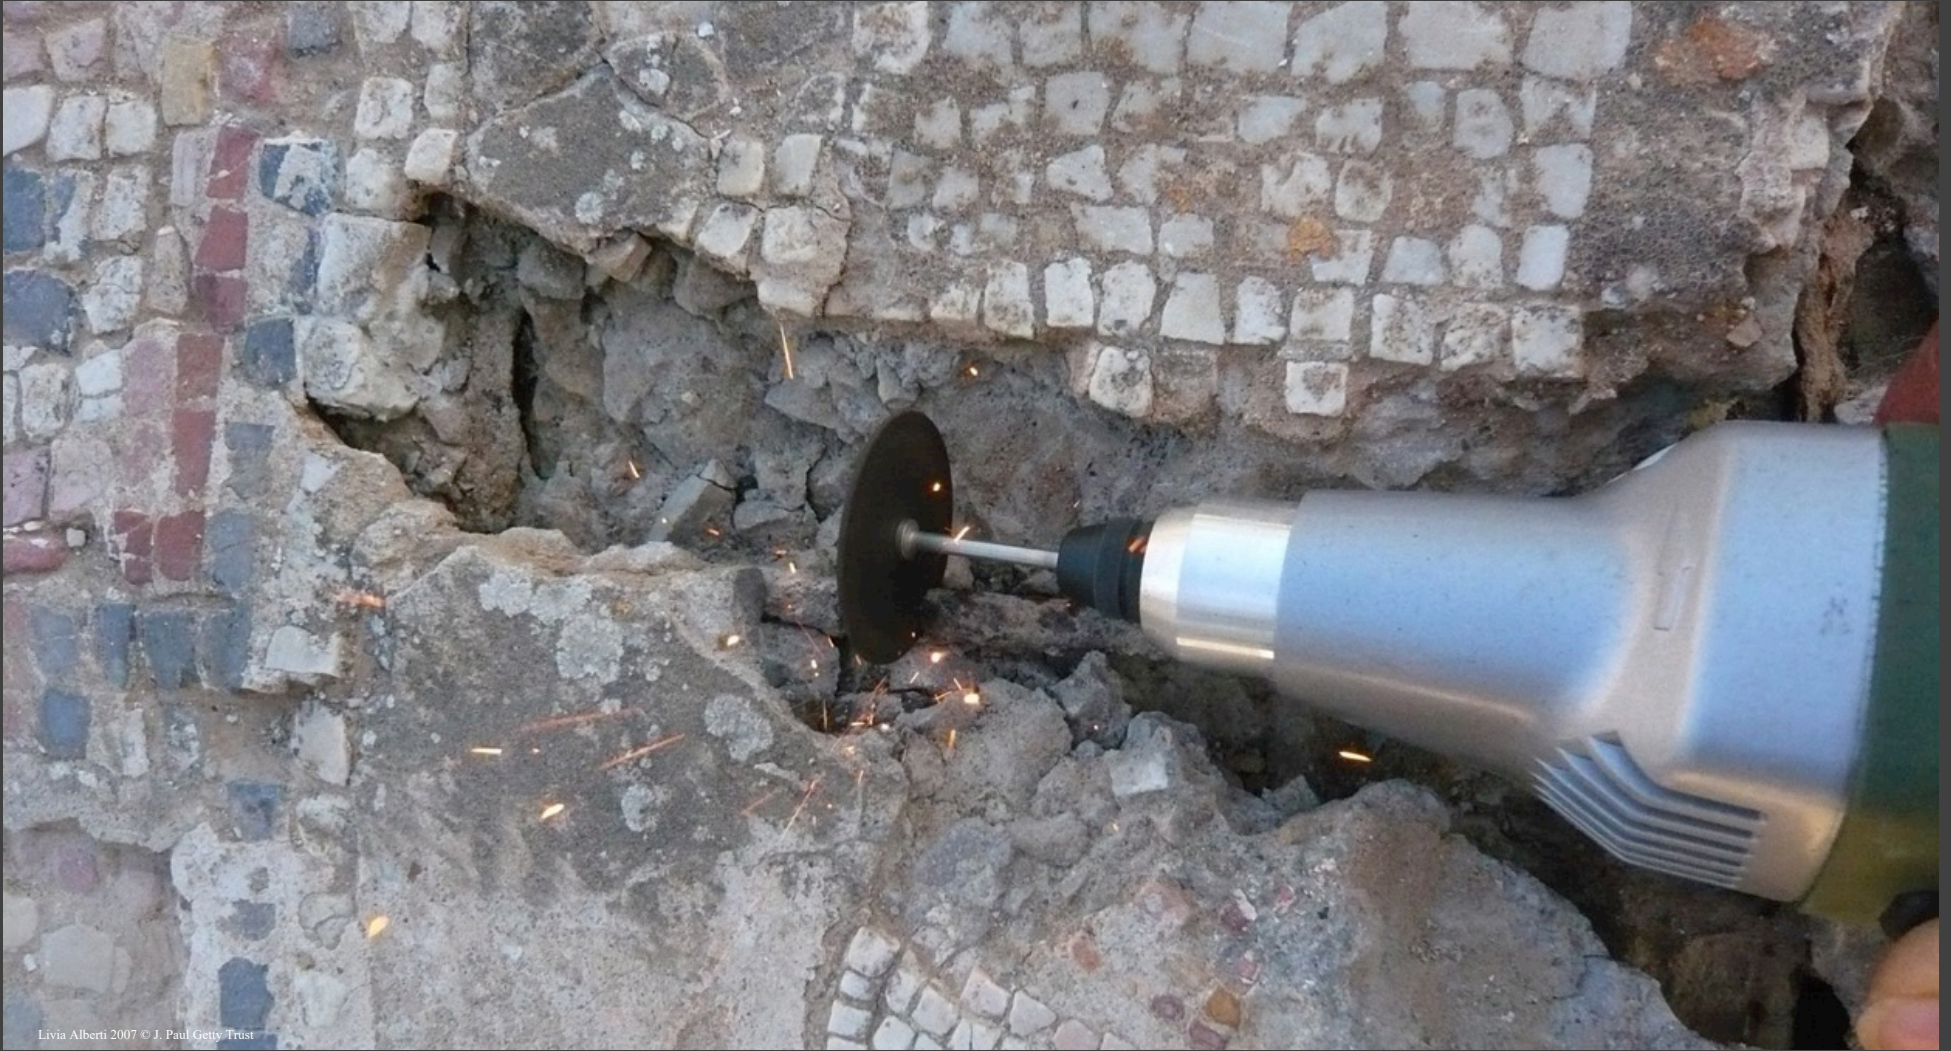
Cutting the steel bar

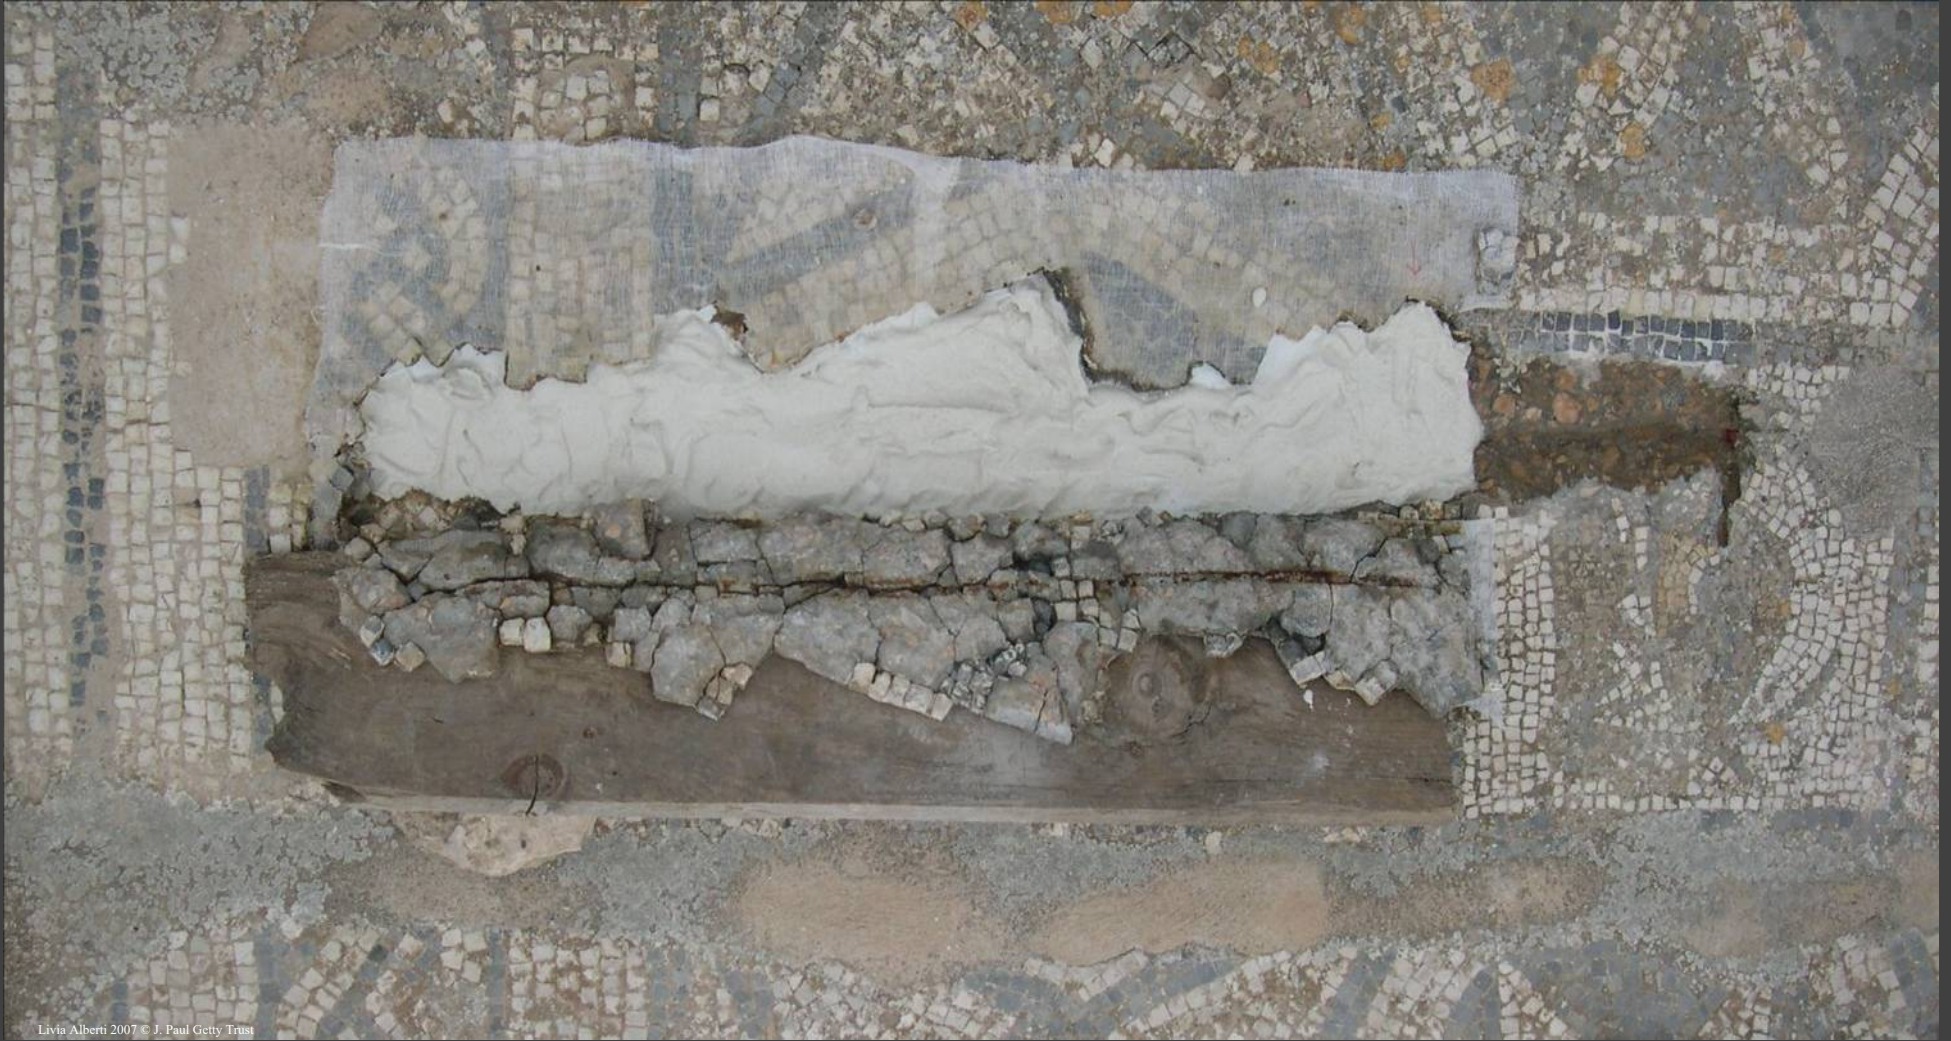
Filling with mortar the space left by the removed bar and concrete debris

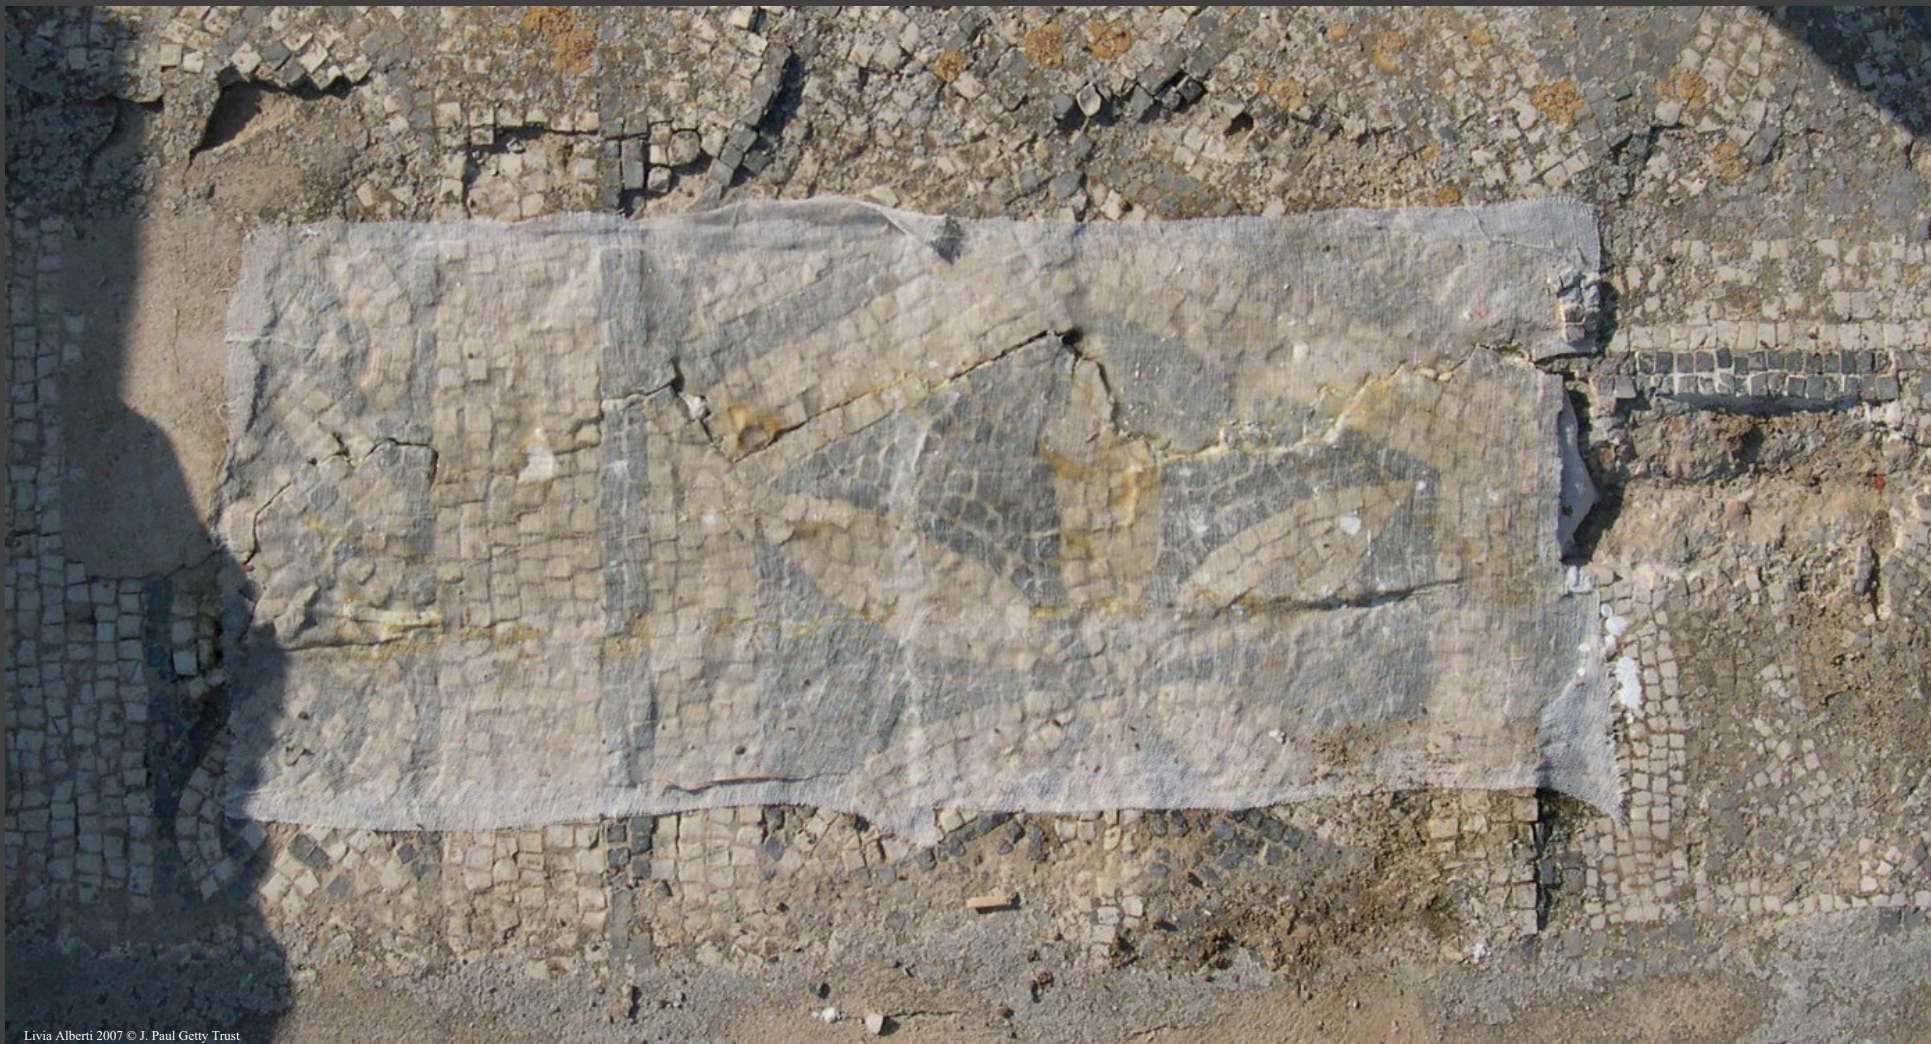
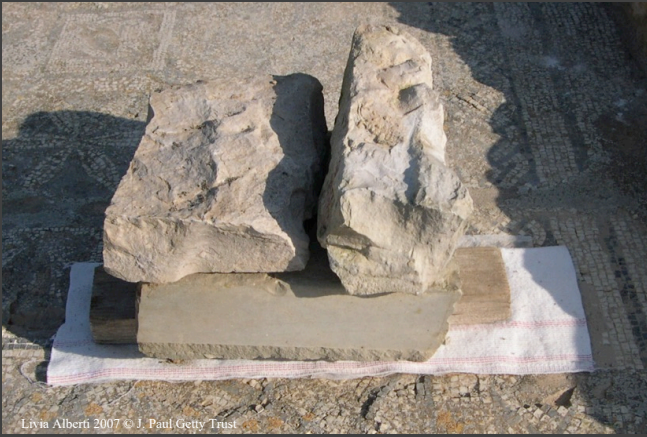
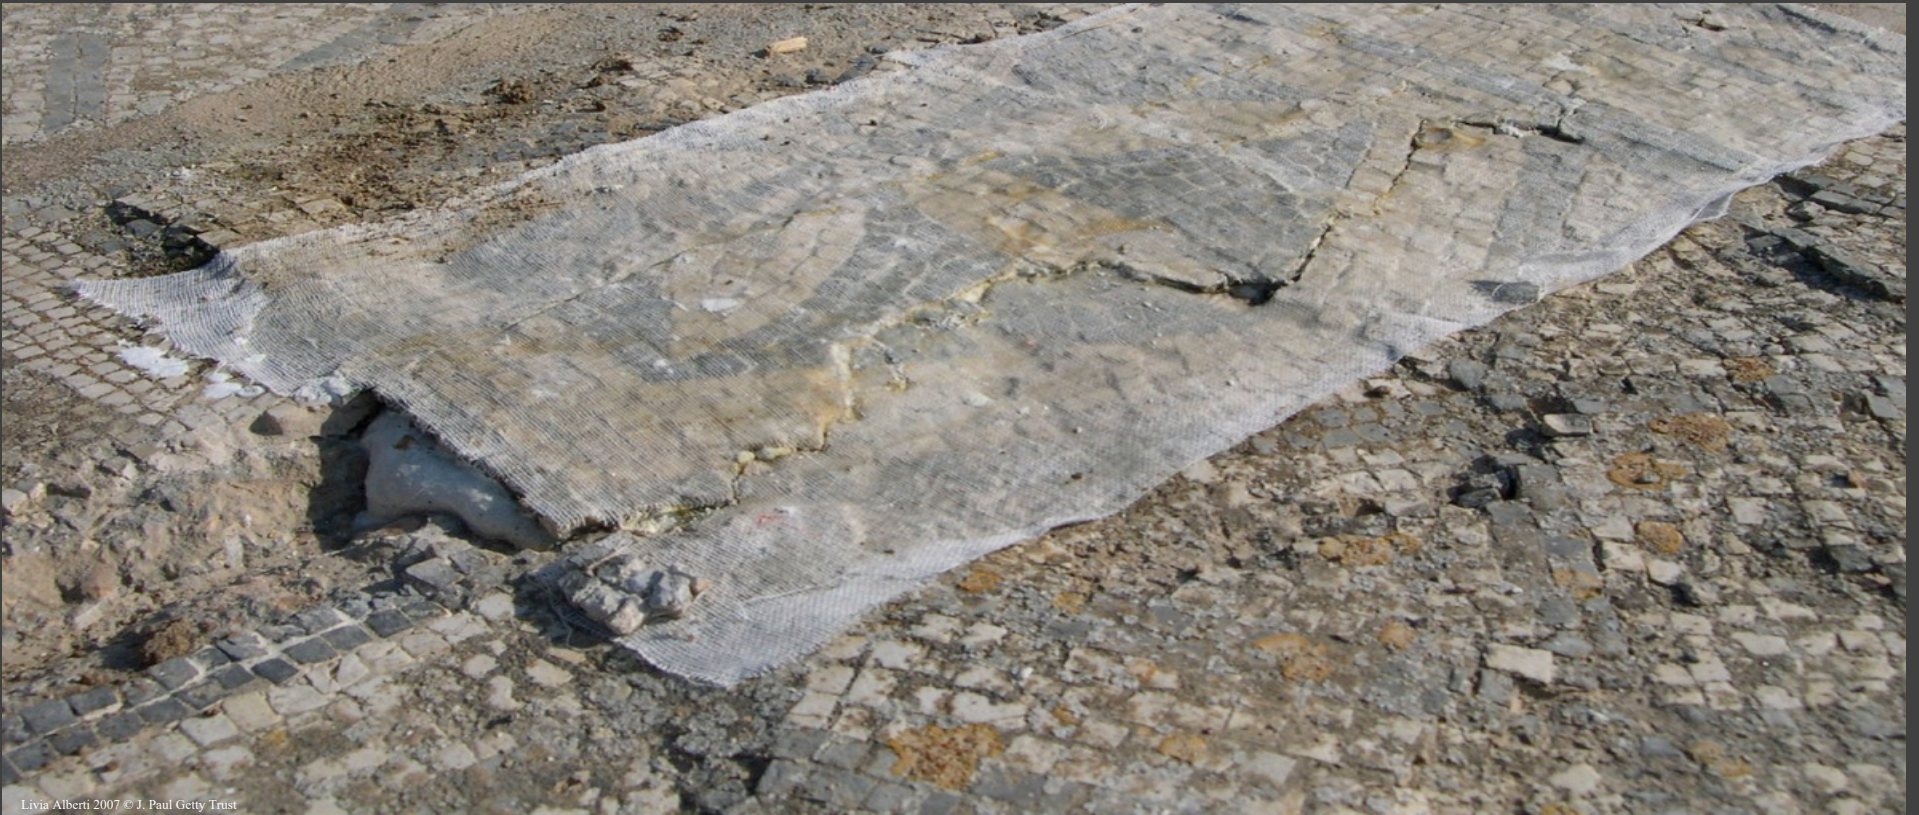
Resetting the previously removed tessellatum section

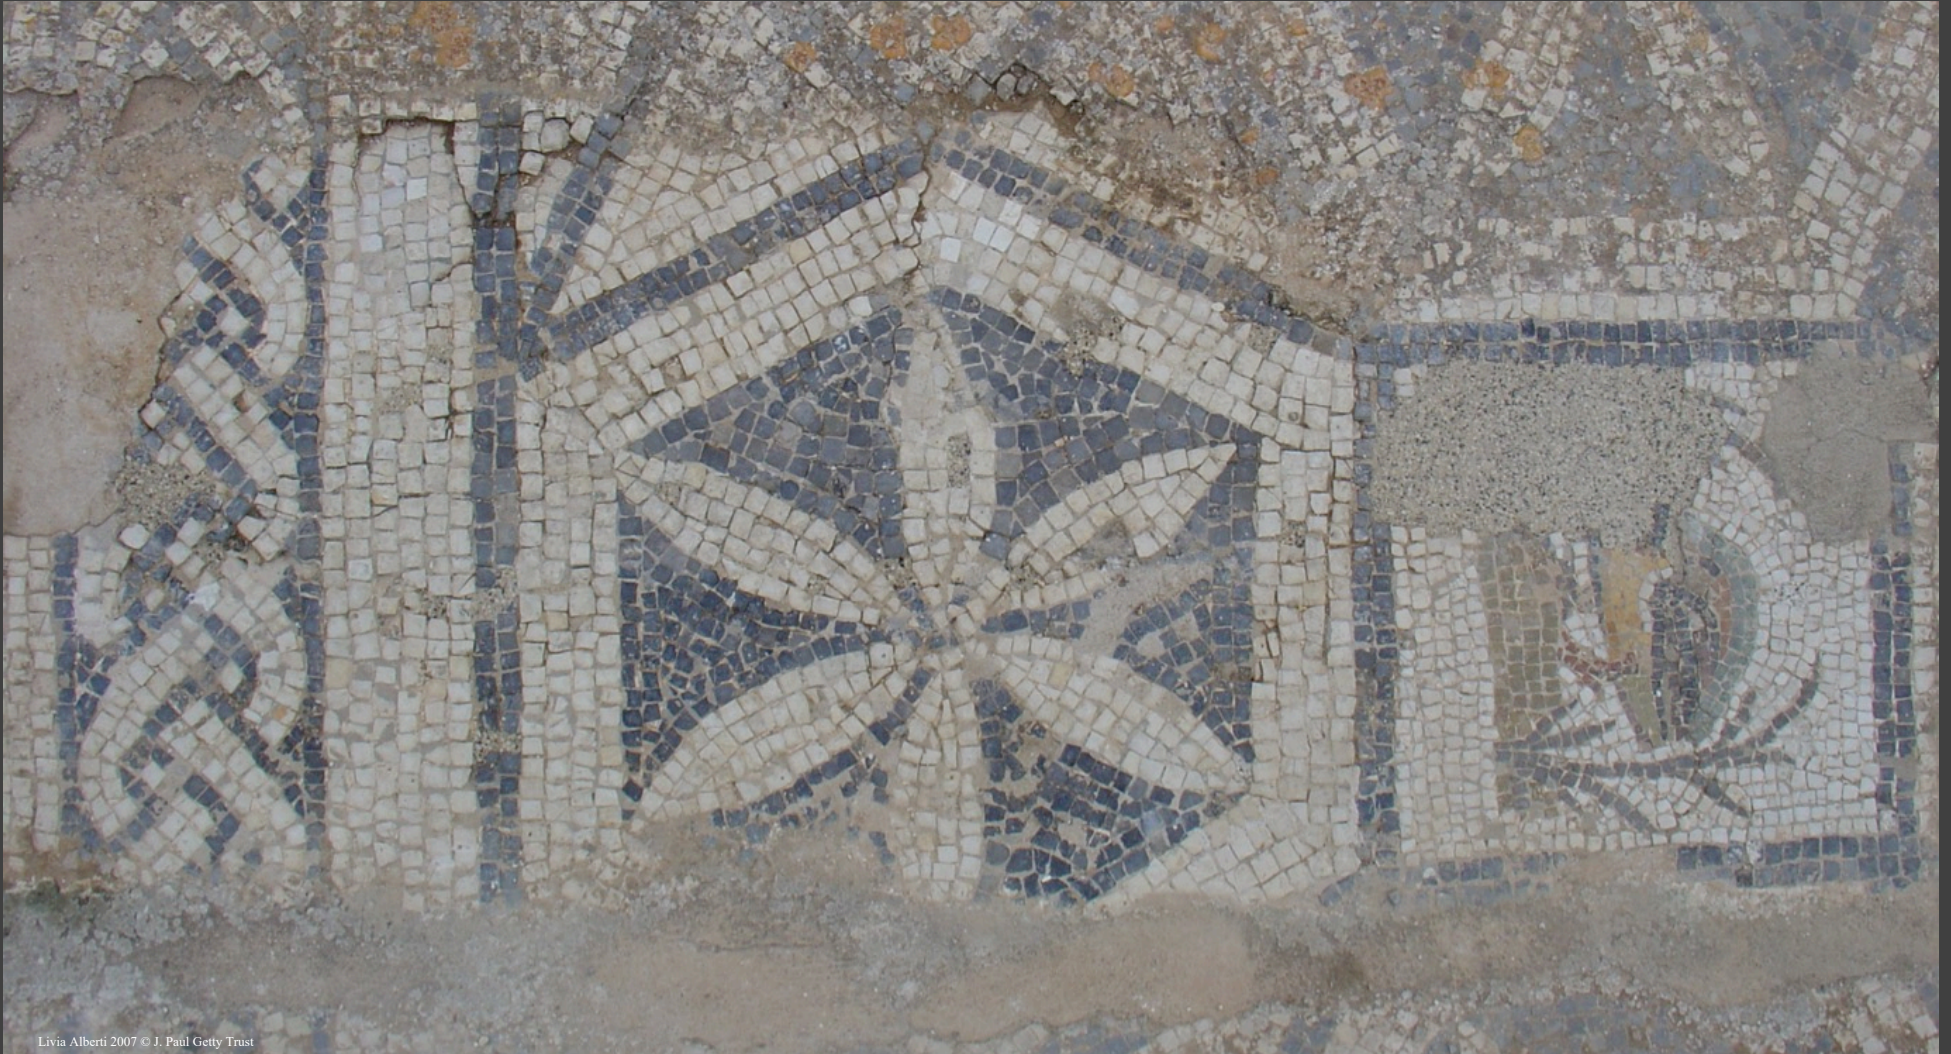
Removal of the facing, including the adhesive, and filling interstices, cracks and lacunae with mortar

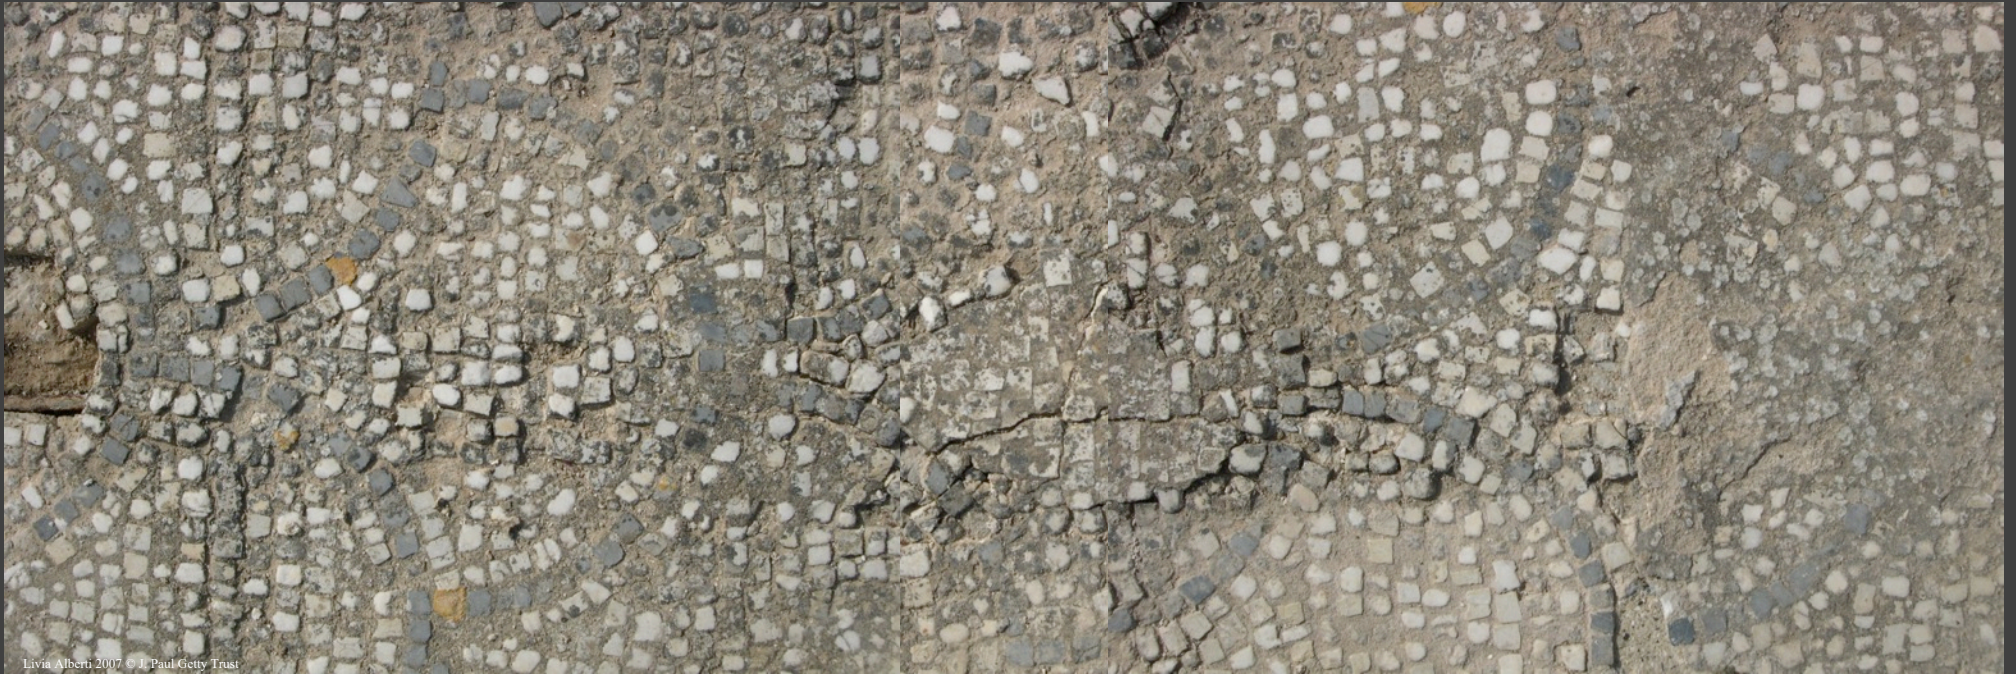
Stabilization by manually removing the tesserae using a “working aid” photograph

Before stabilization

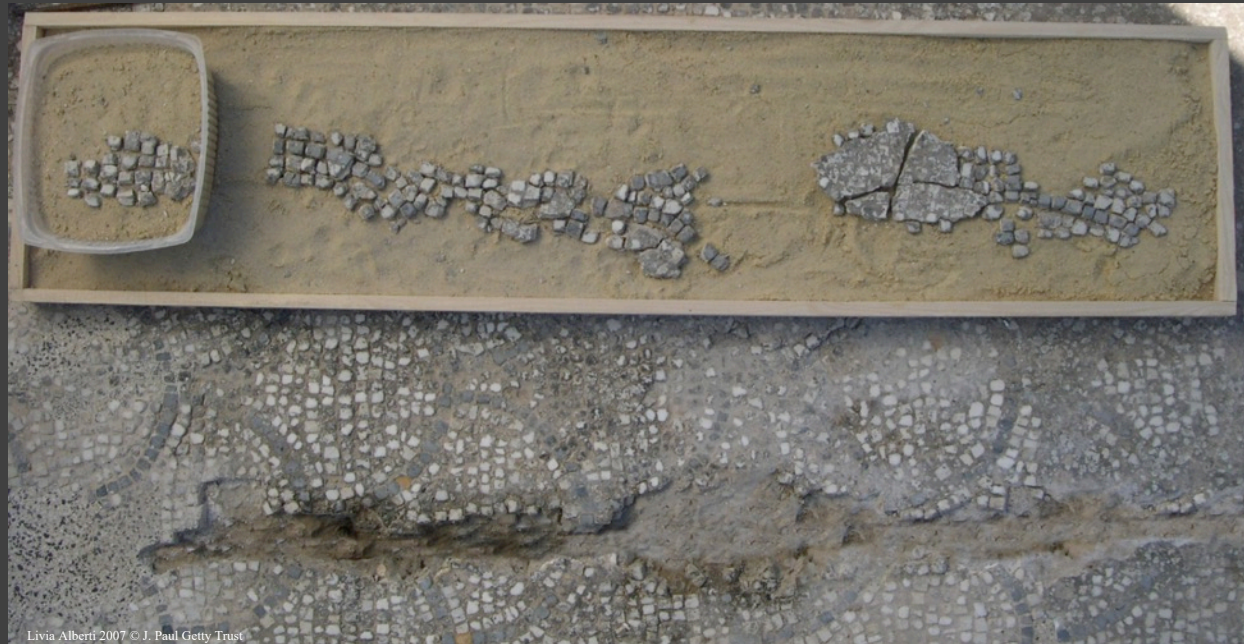
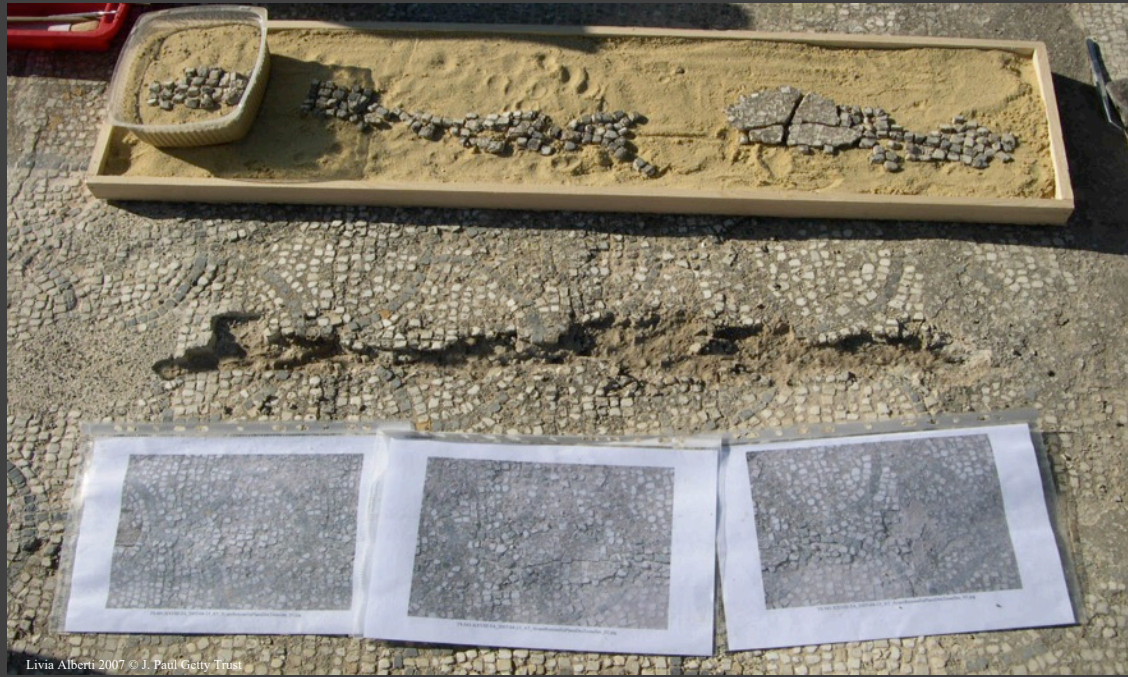
Removing and placing the detached tesserae on temporary sand bedding

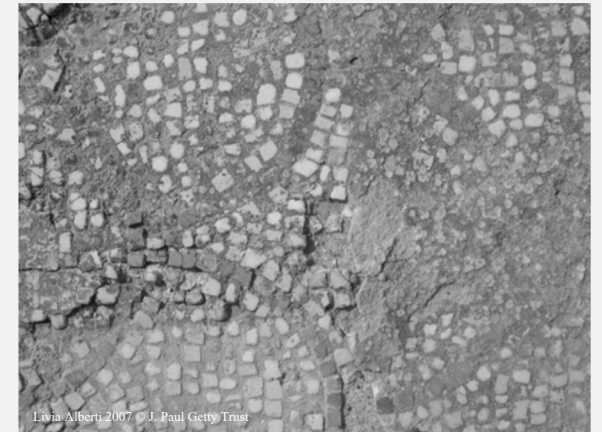
TS-M1-28_2007-04-06_6AT_Section3

Using a “working aid” photograph

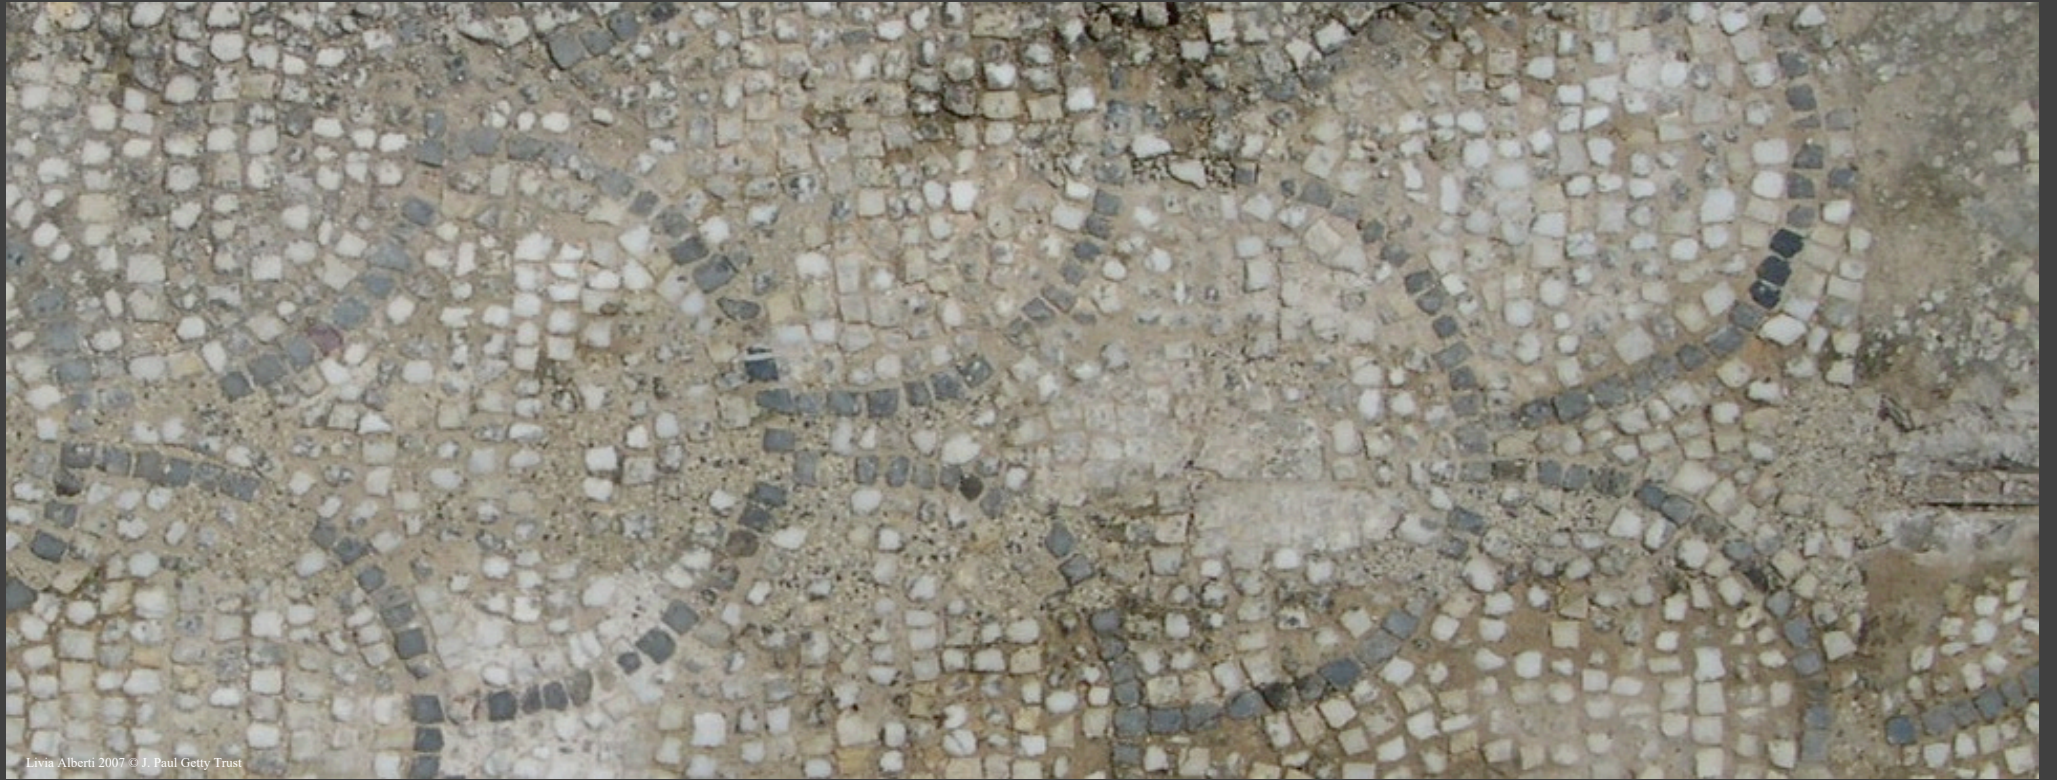
Resetting the tesserae, filling interstices, cracks and lacunae with mortar
