## TECHNICIAN TRAINING FOR THE CONSERVATION OF MOSAICS

THE CONSERVATION OF ARCHITECTURAL REMAINS AND THEIR DECORATIVE SURFACES

## Structures and decorative surfaces: previous interventions and their documentation

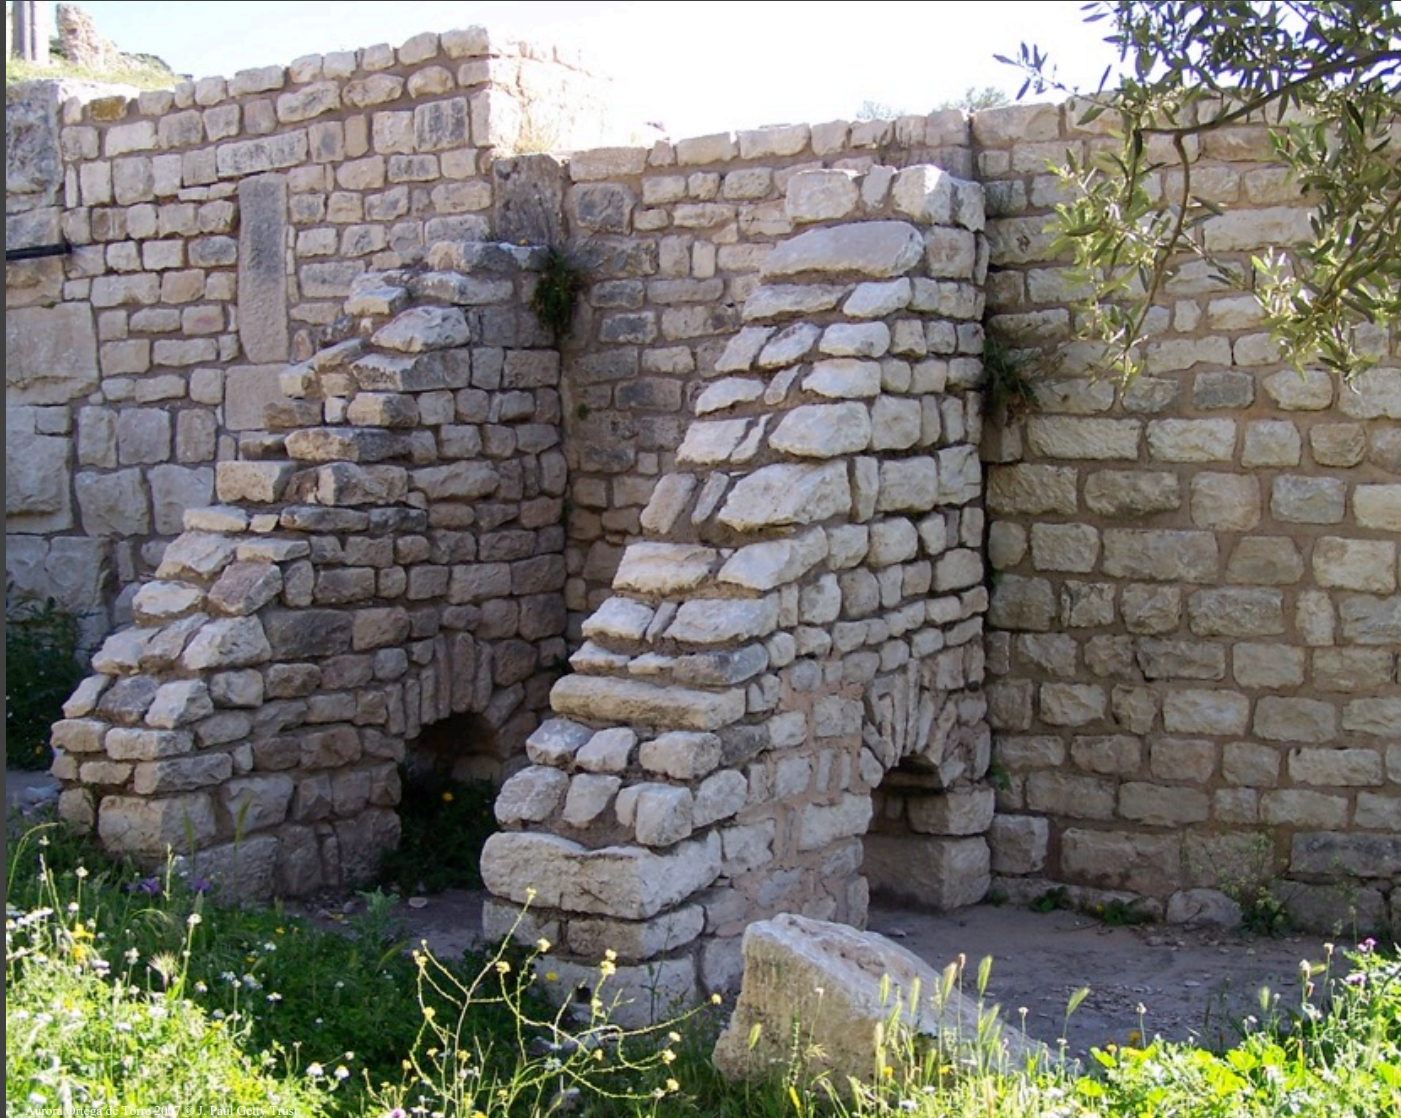
Masonry buttress

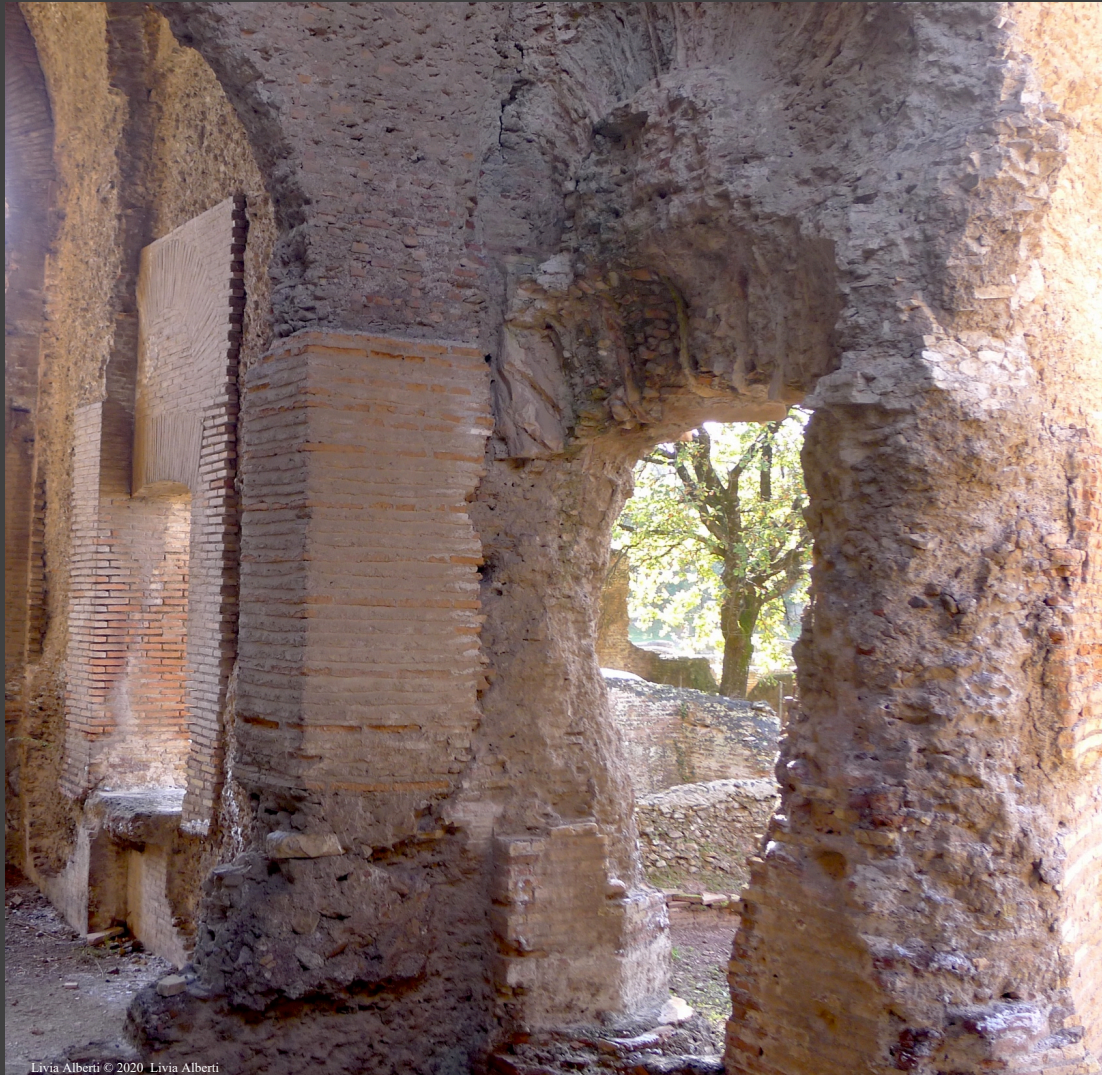
Reinforcement with masonry

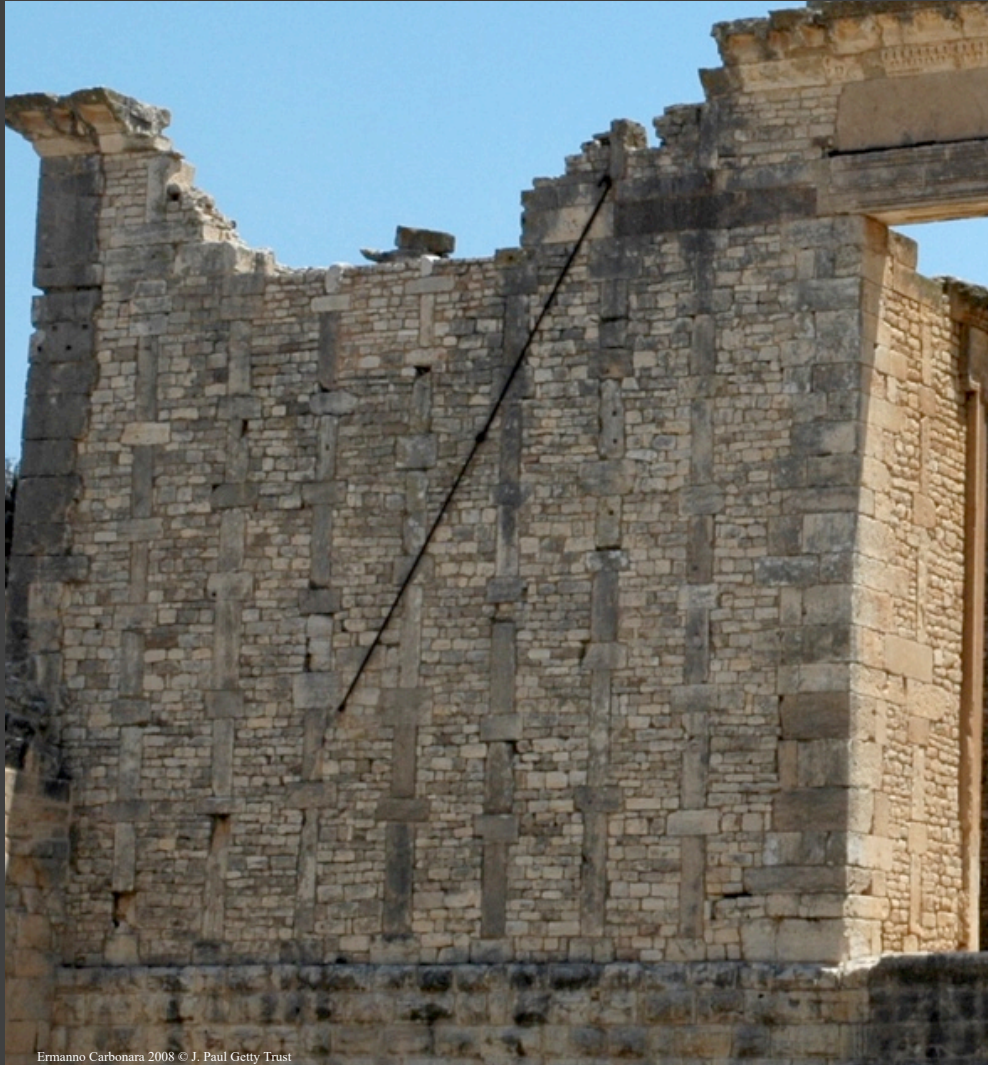
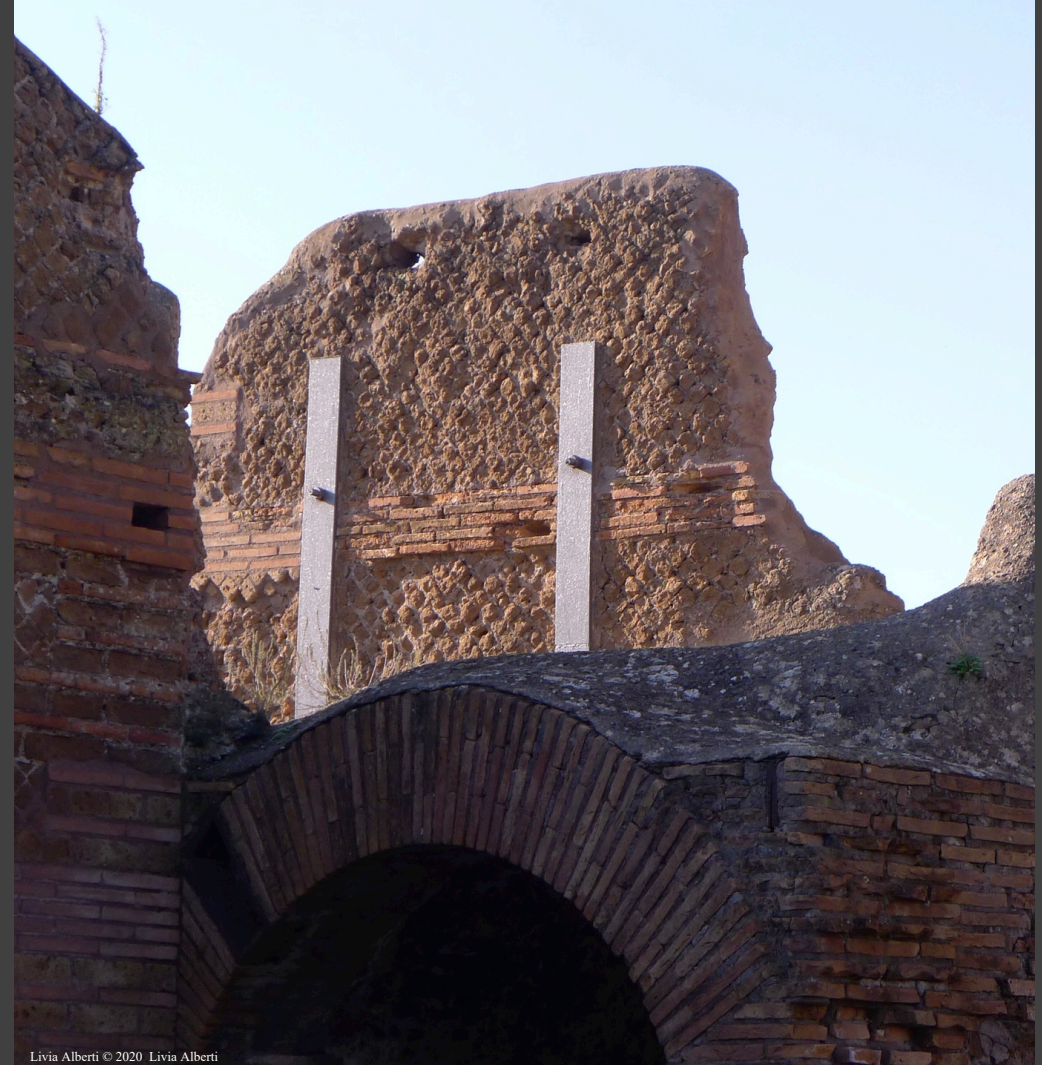
Reinforcement with metal elements

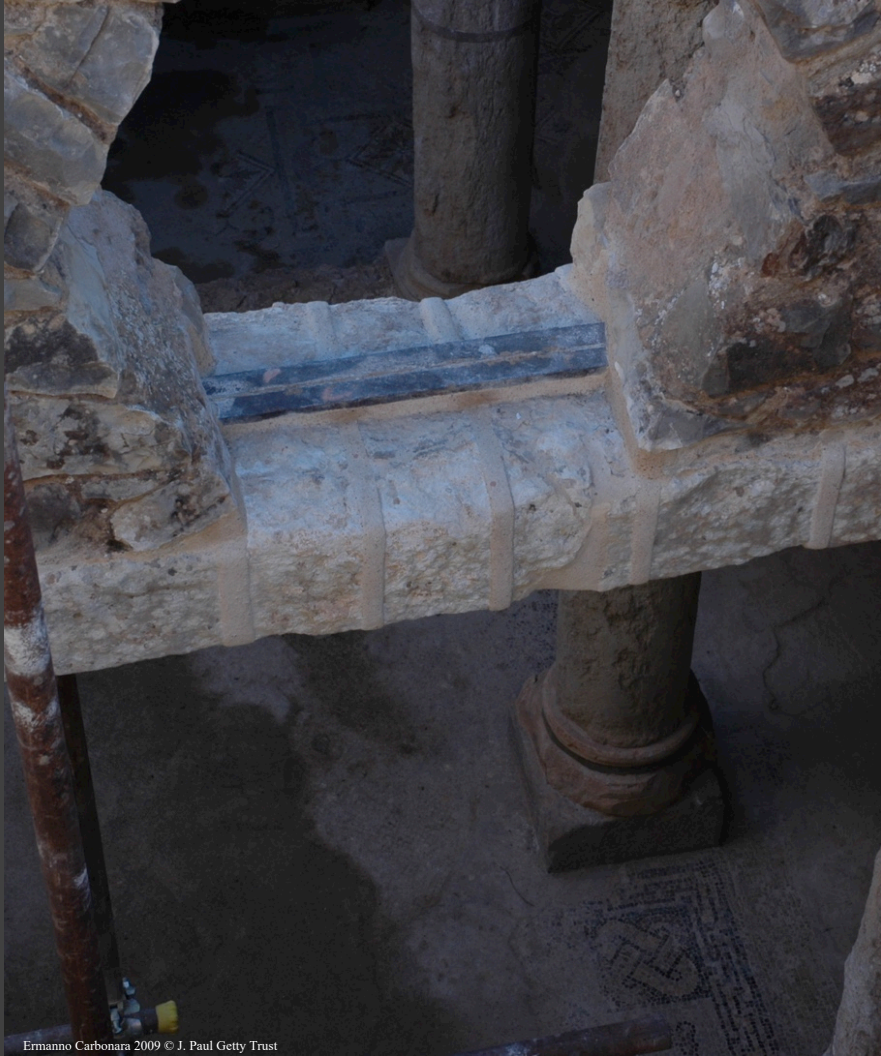
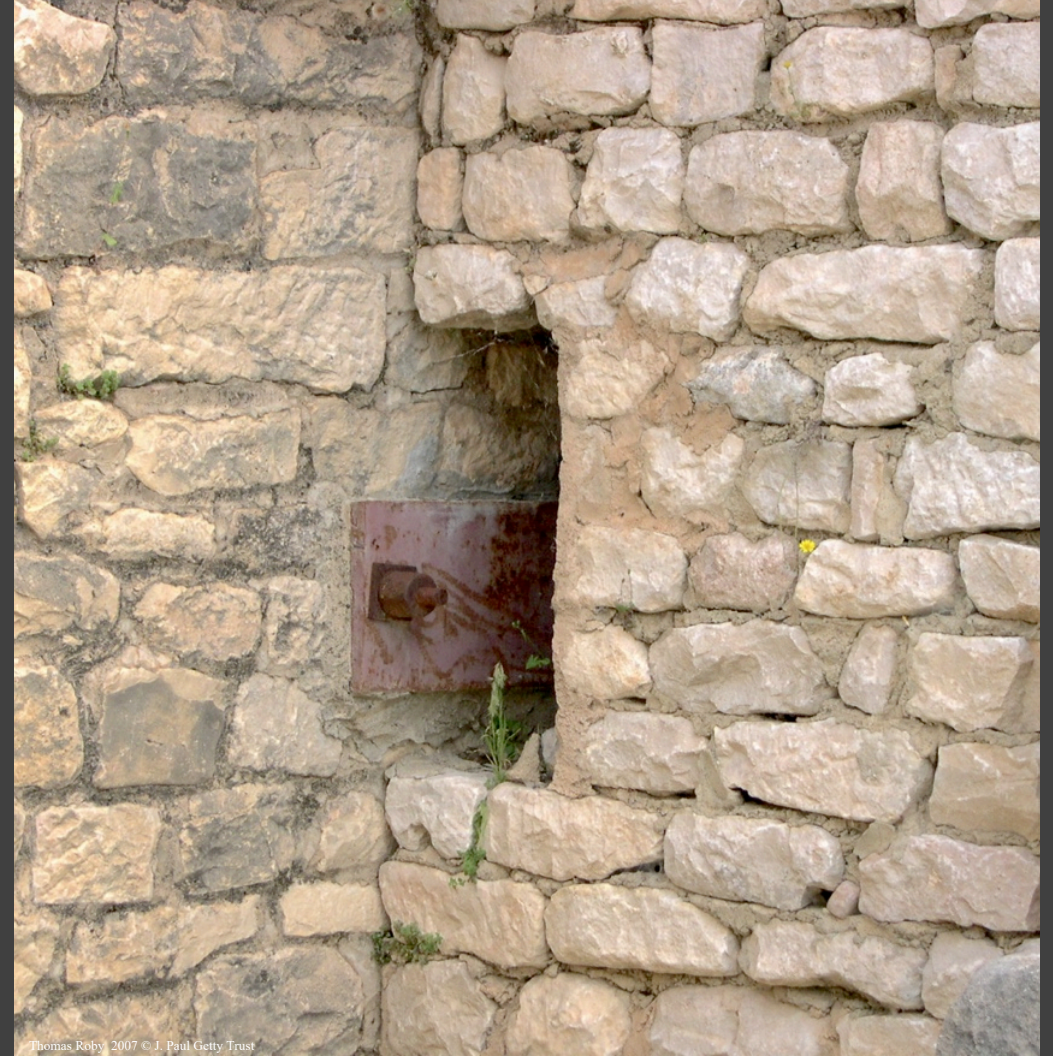
## Reinforcement with metal elements

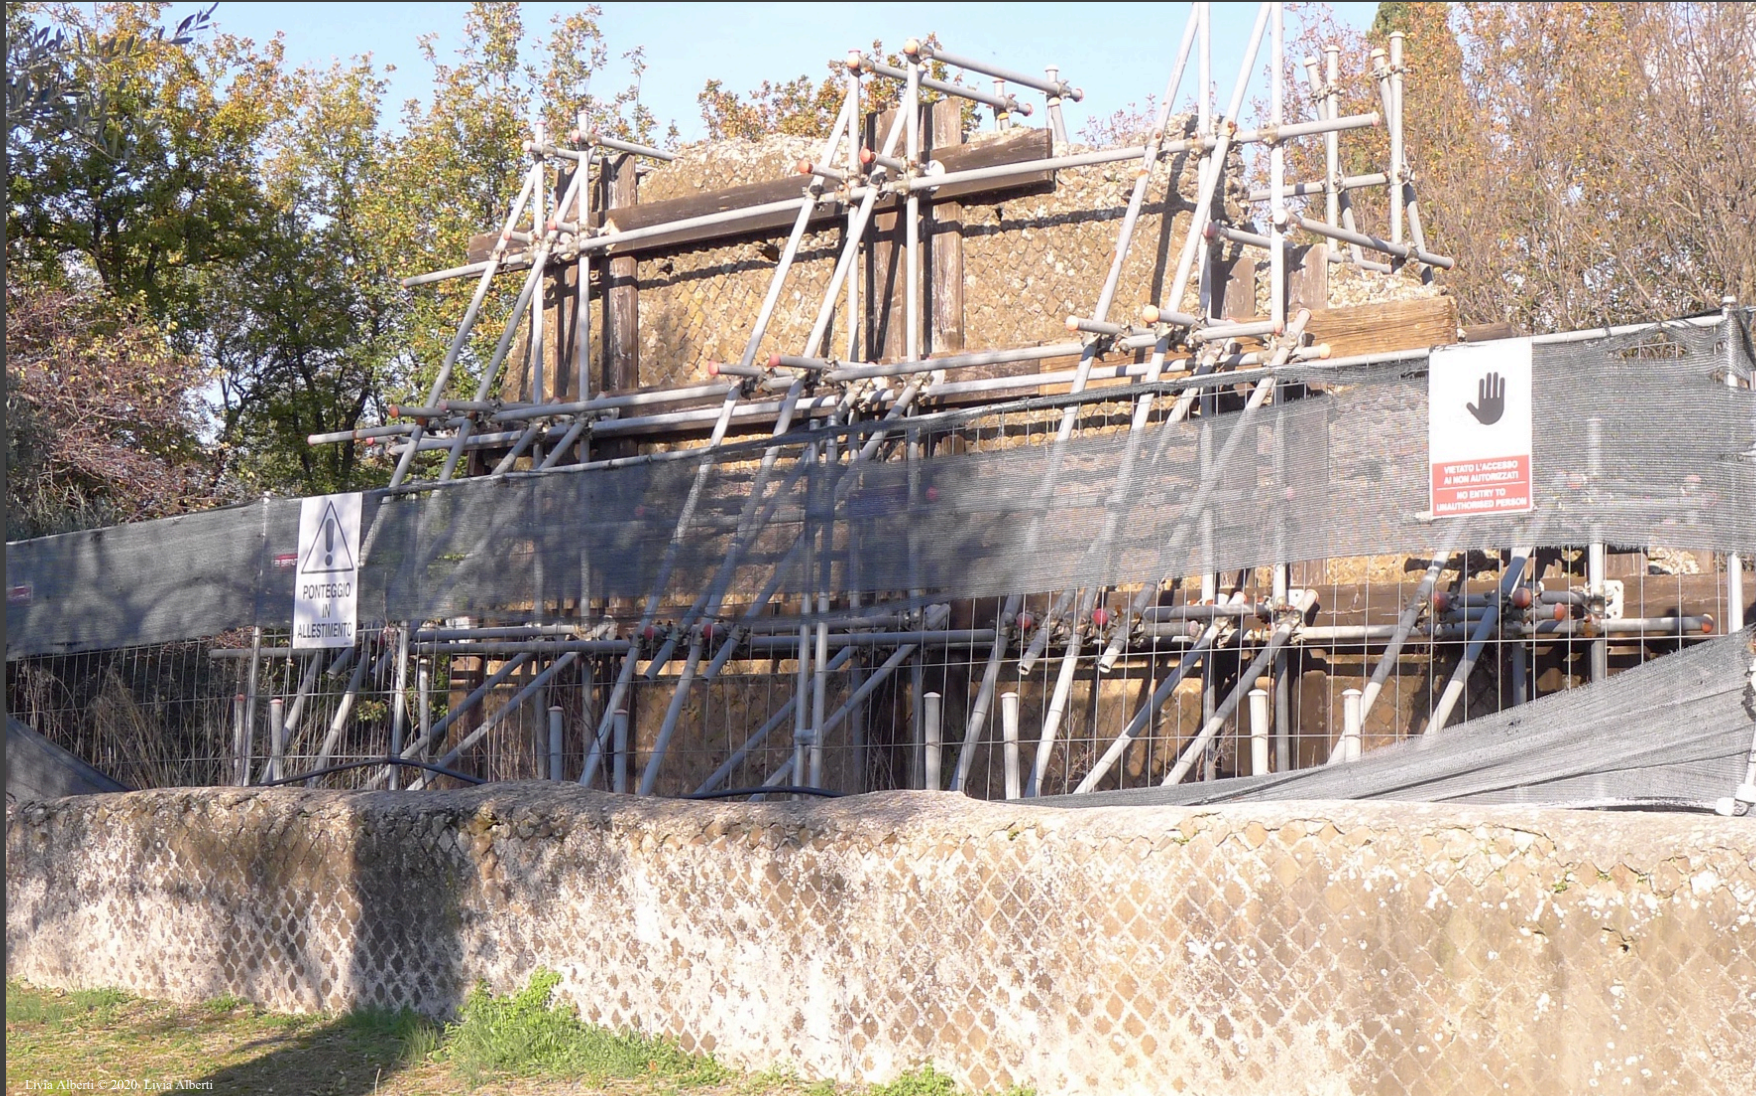
Temporary metal structure buttress

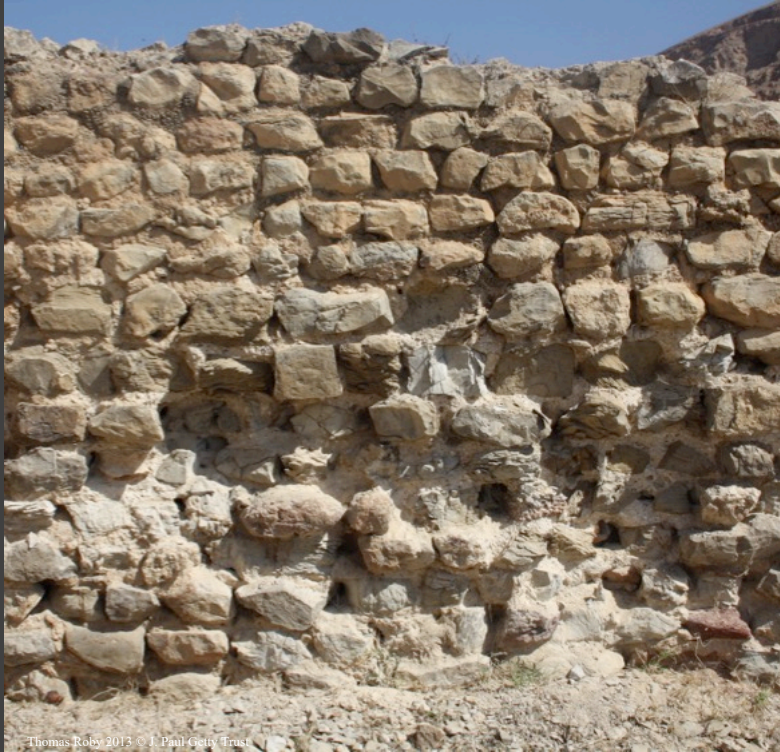
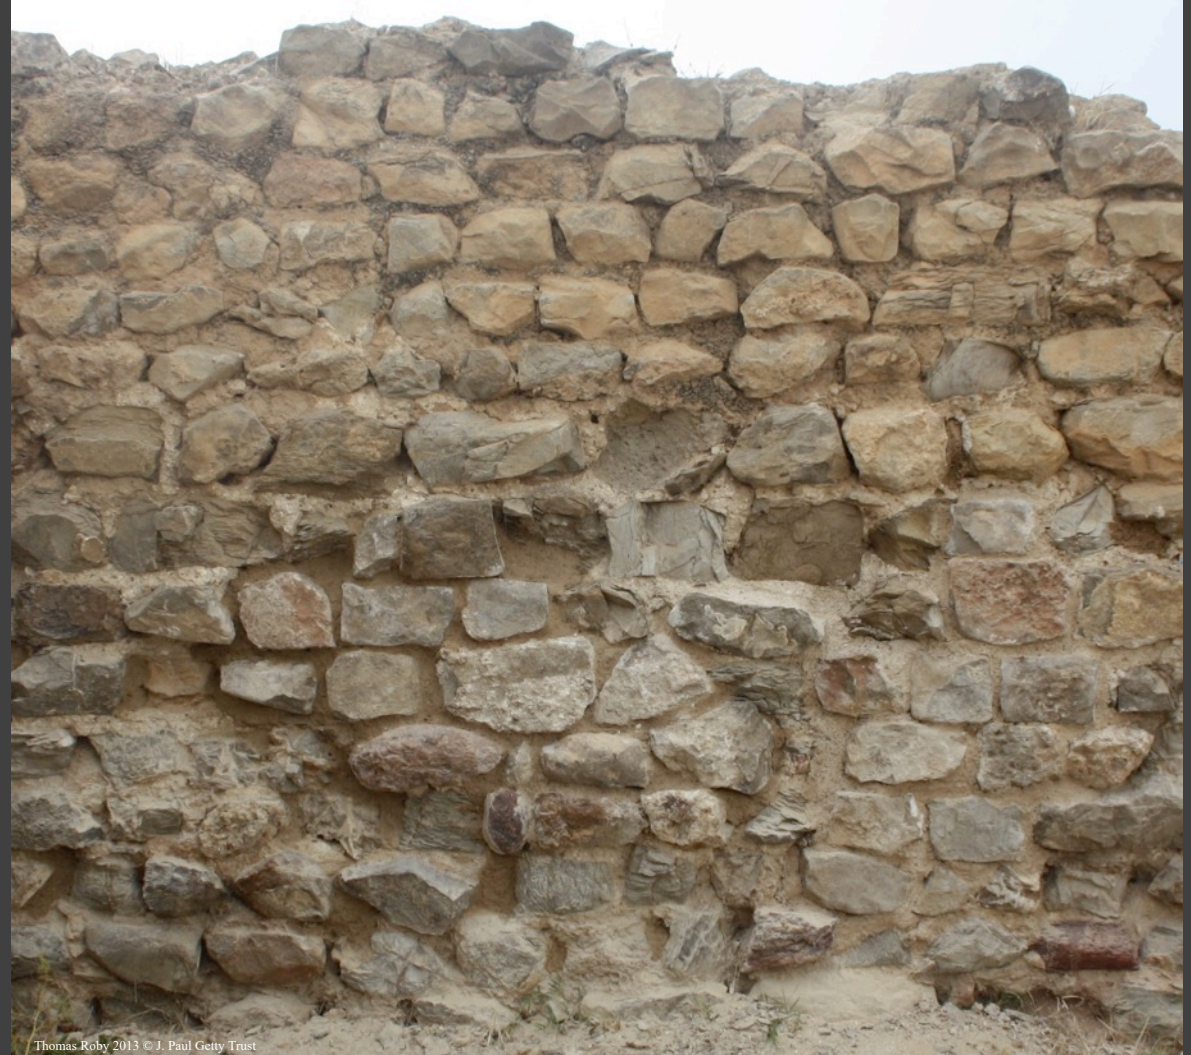
Using the same materials of the ancient construction

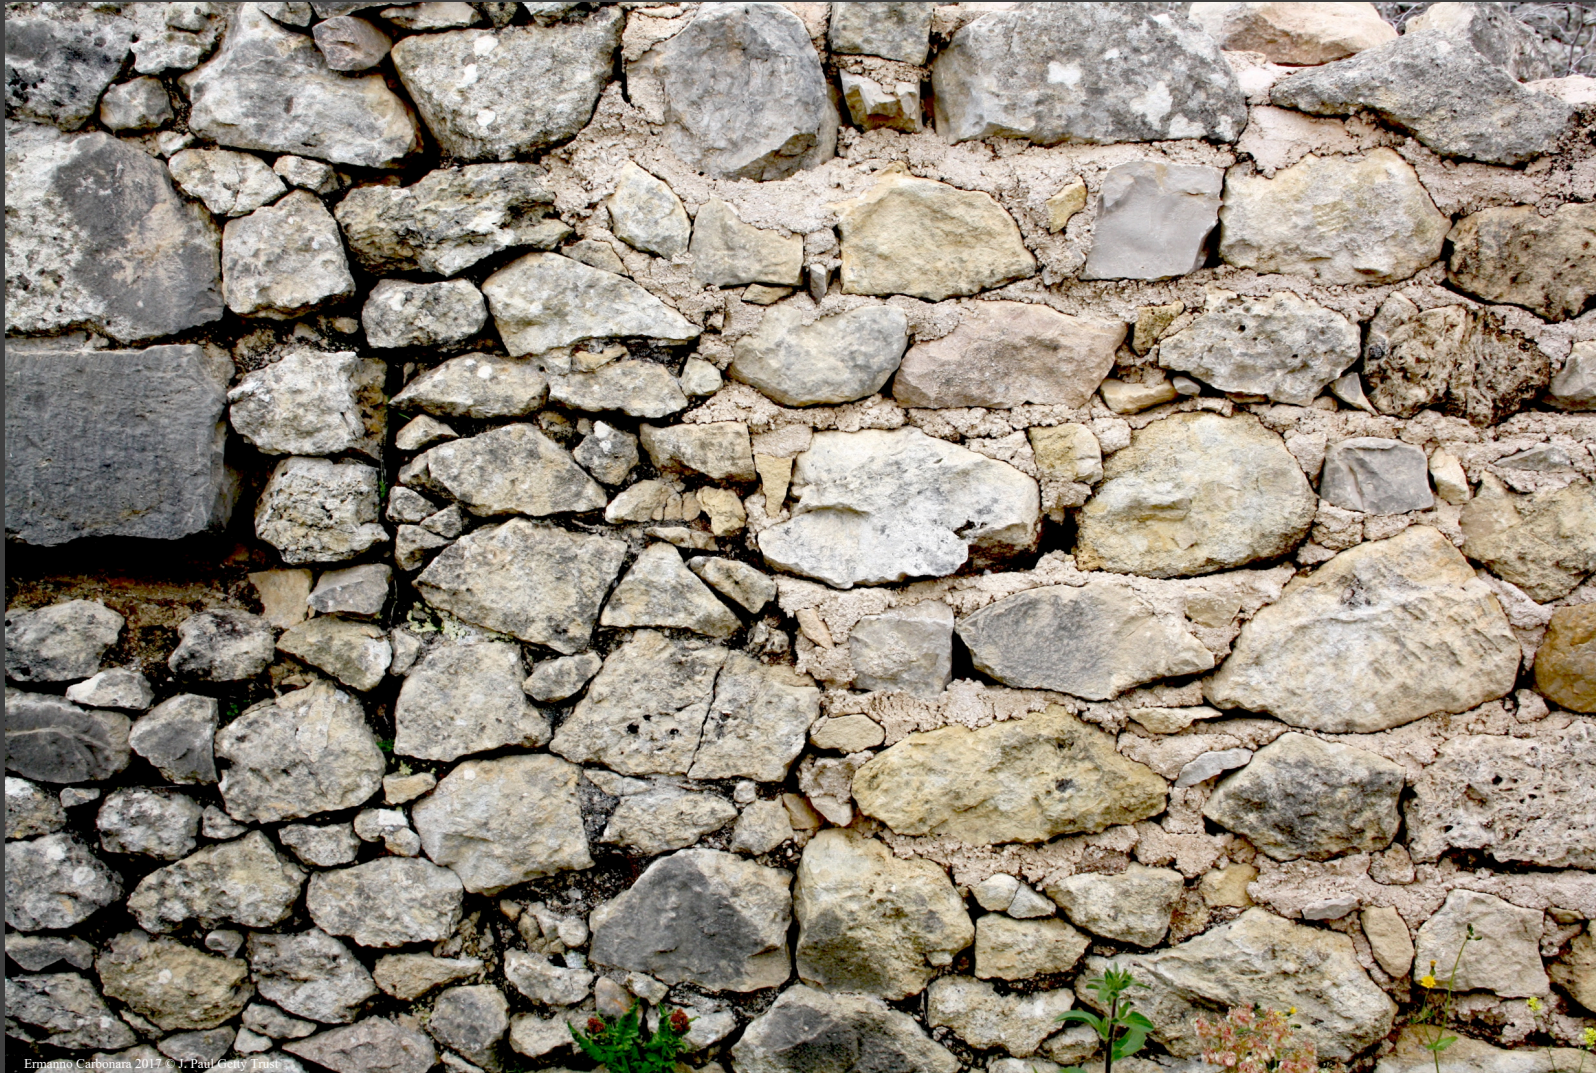
Using the same materials of the ancient construction

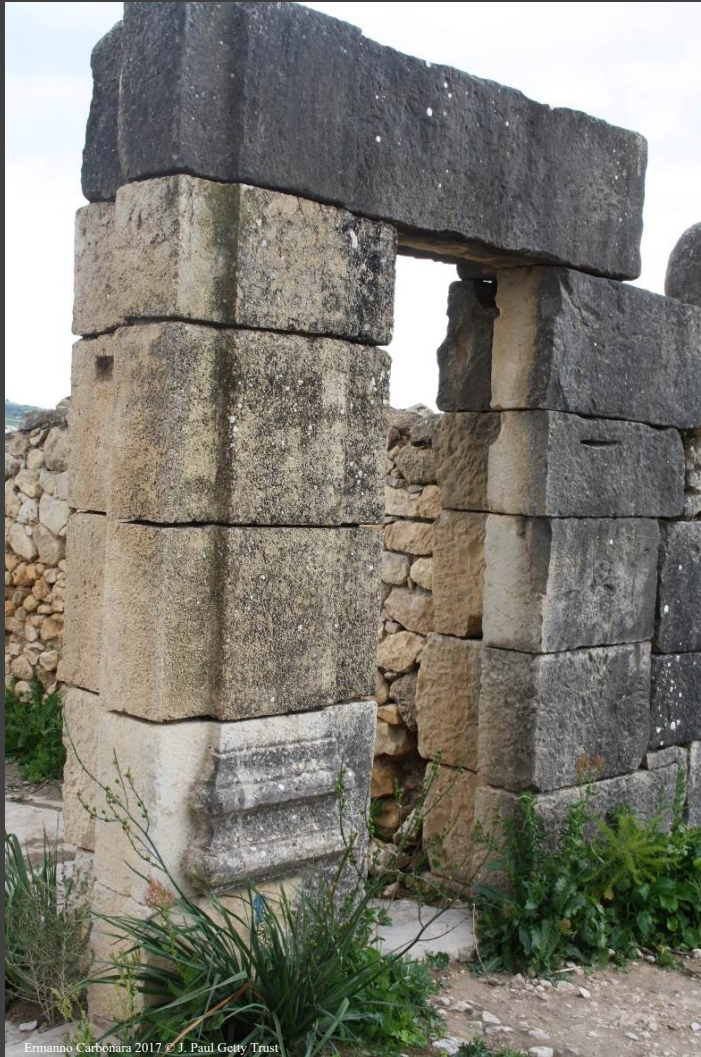
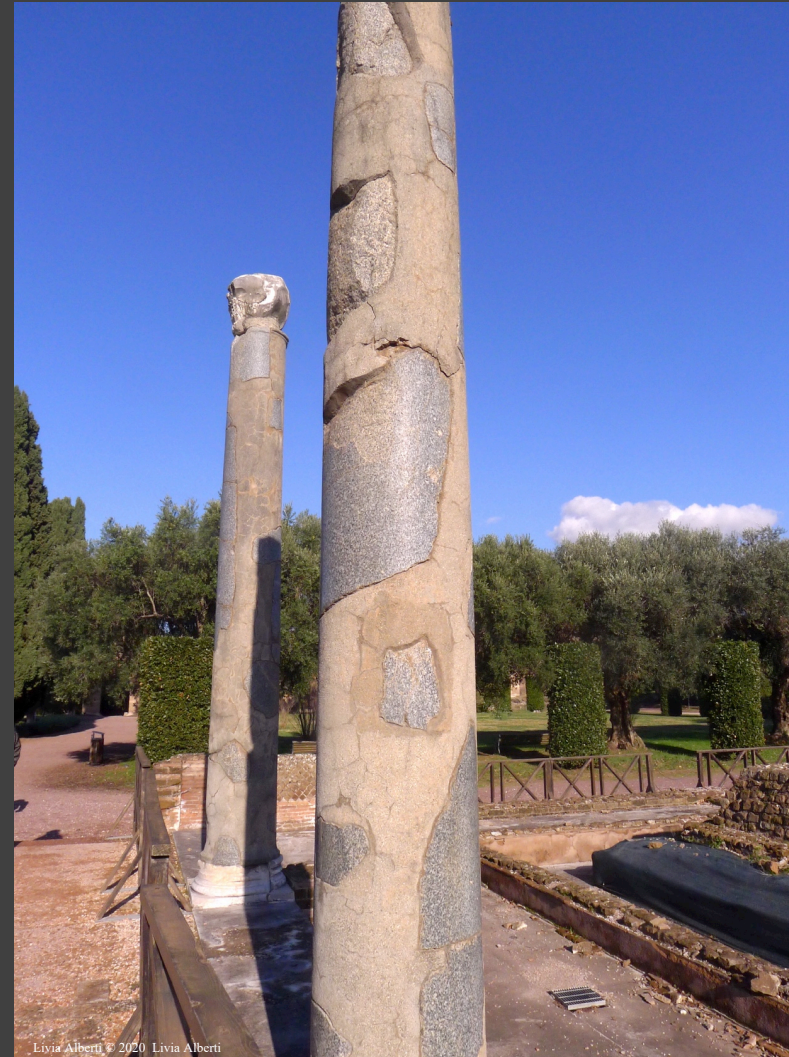
Using different materials from the ancient construction

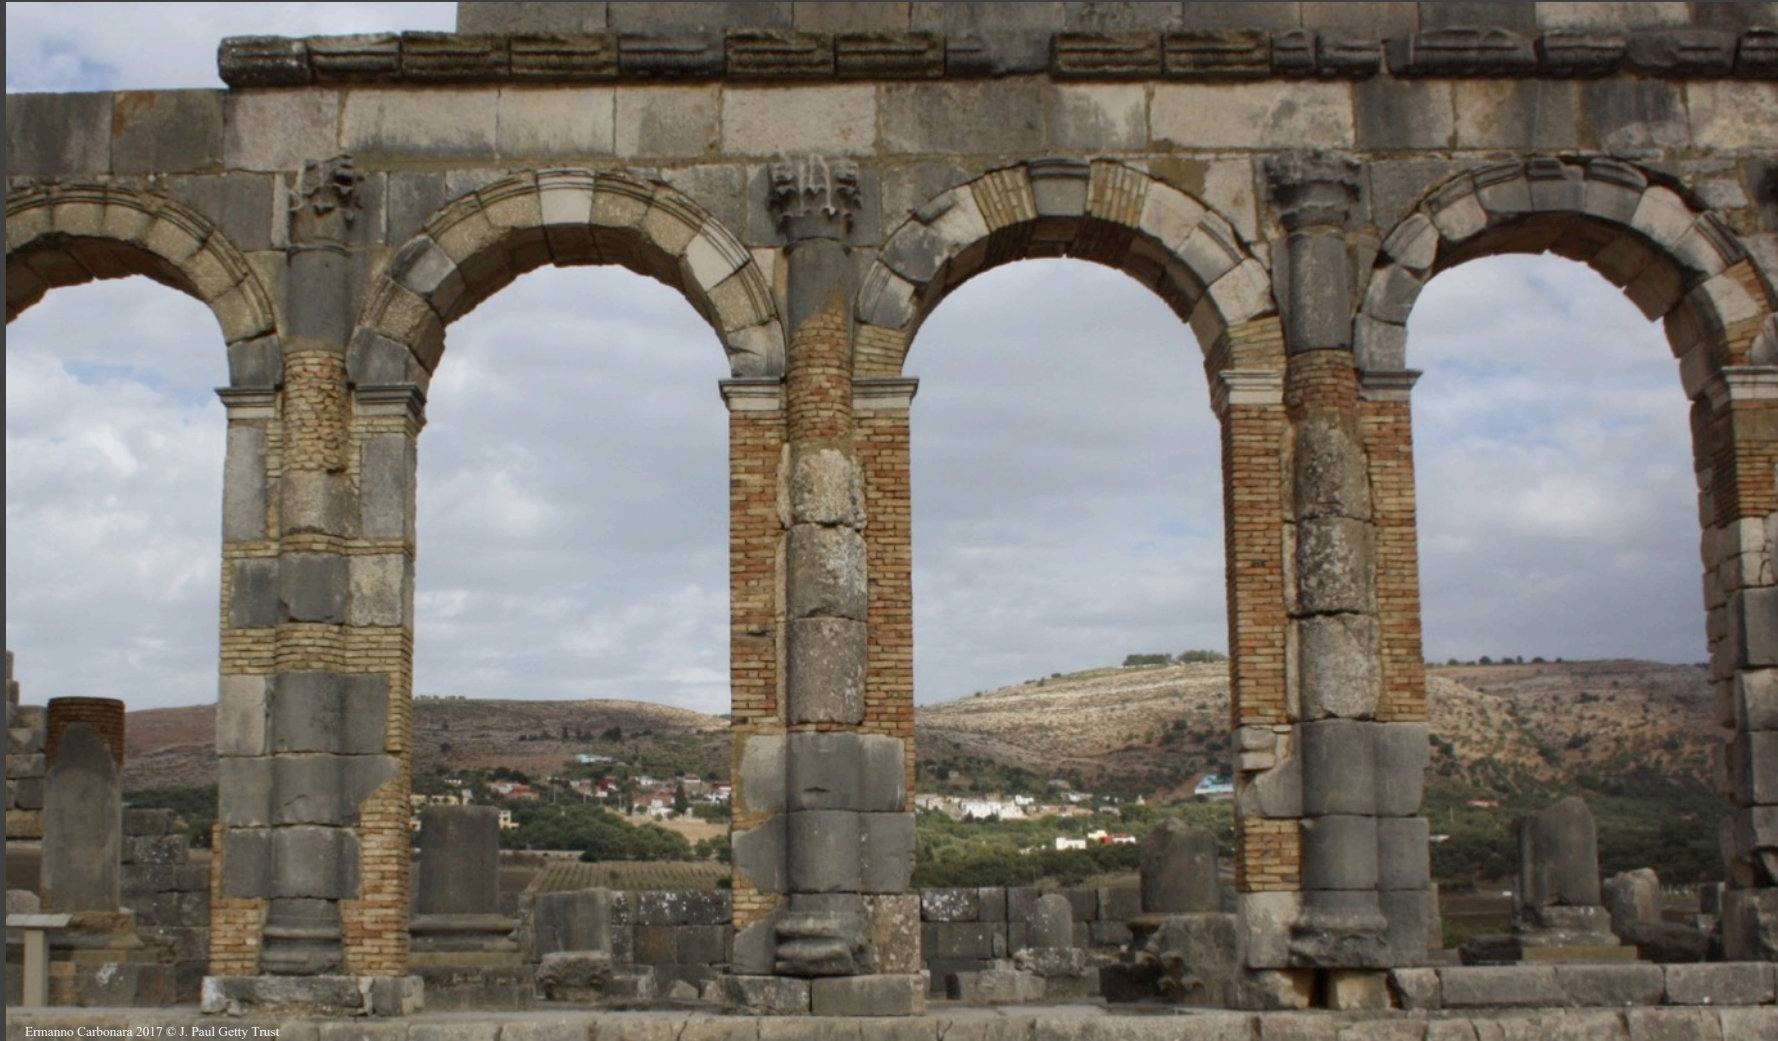
Using different materials from the ancient construction

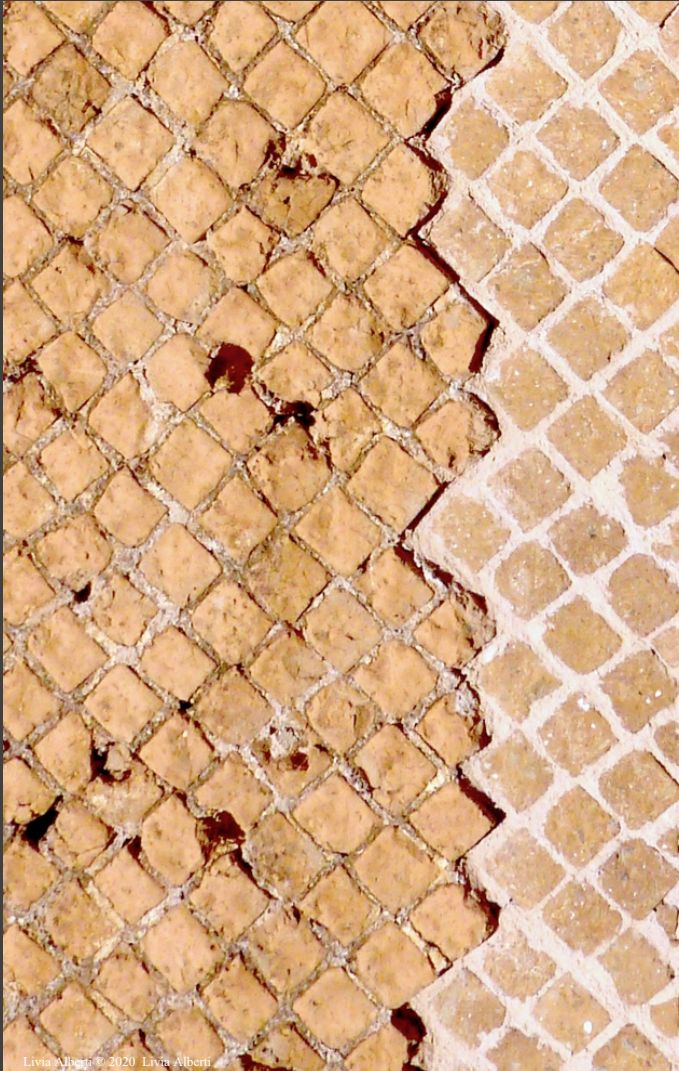
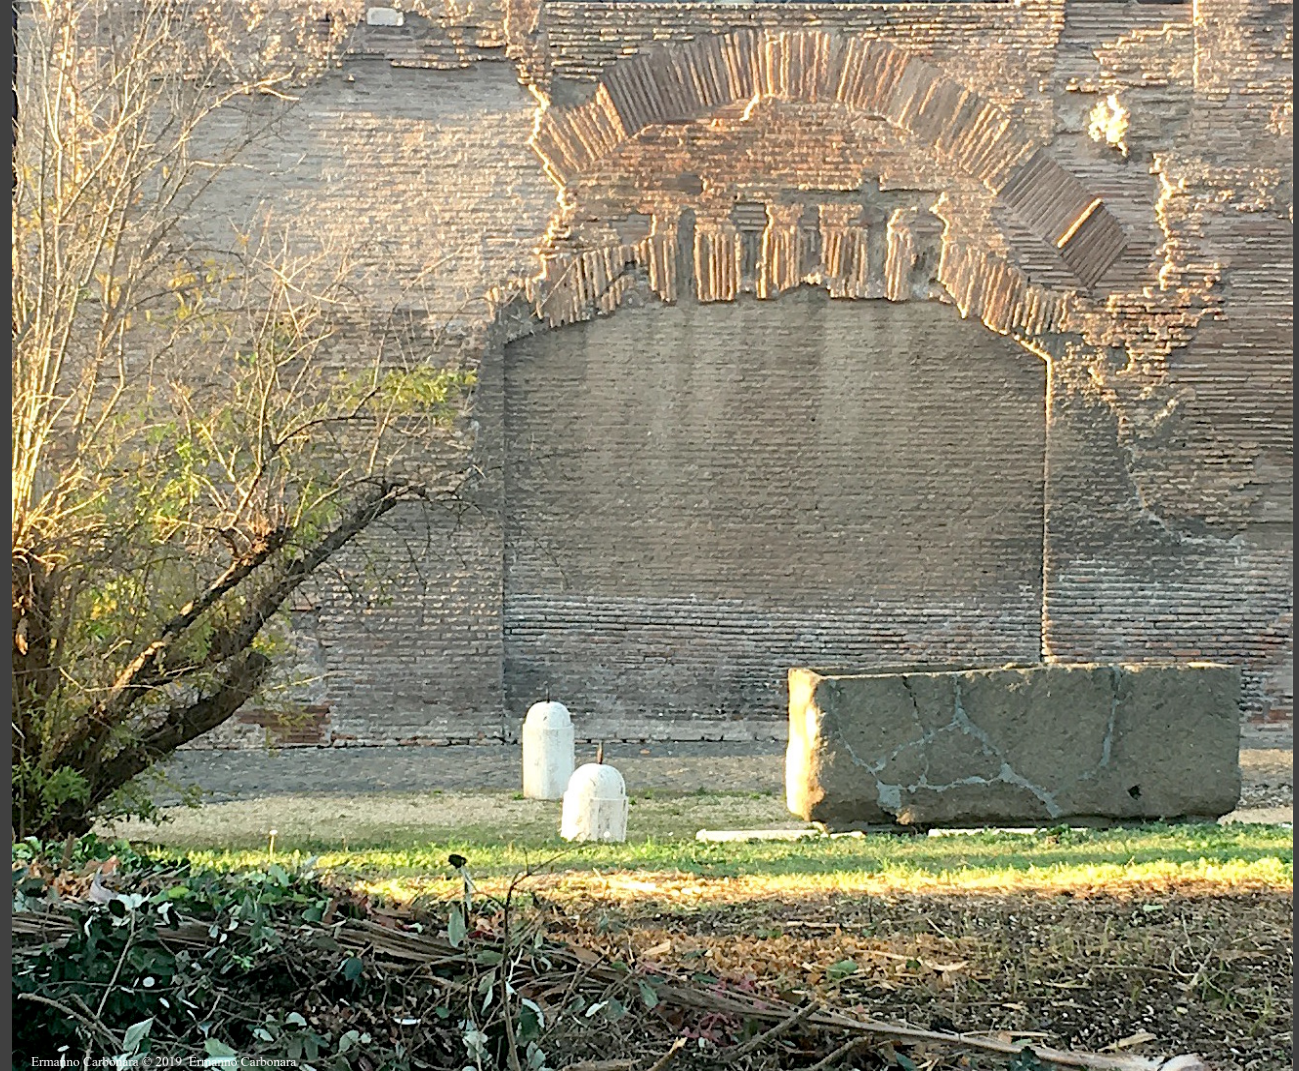
Using the same materials of the ancient construction but placed below the original surface level

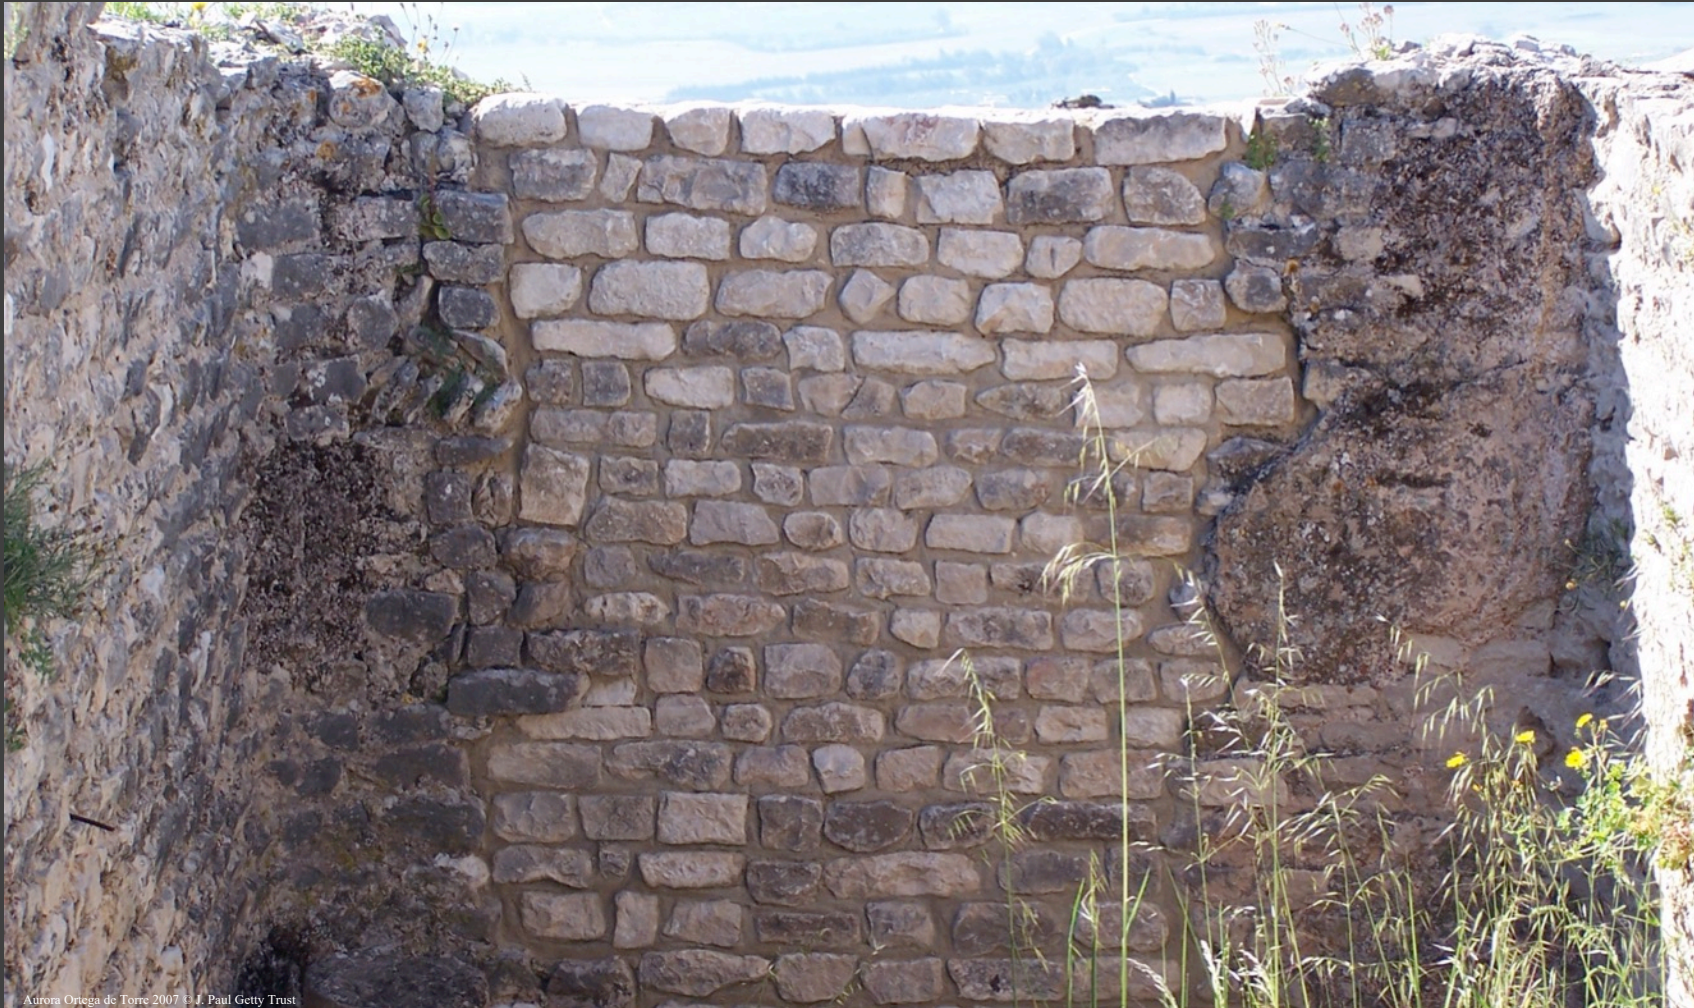
Using the same materials of the ancient construction but placed below the original surface level

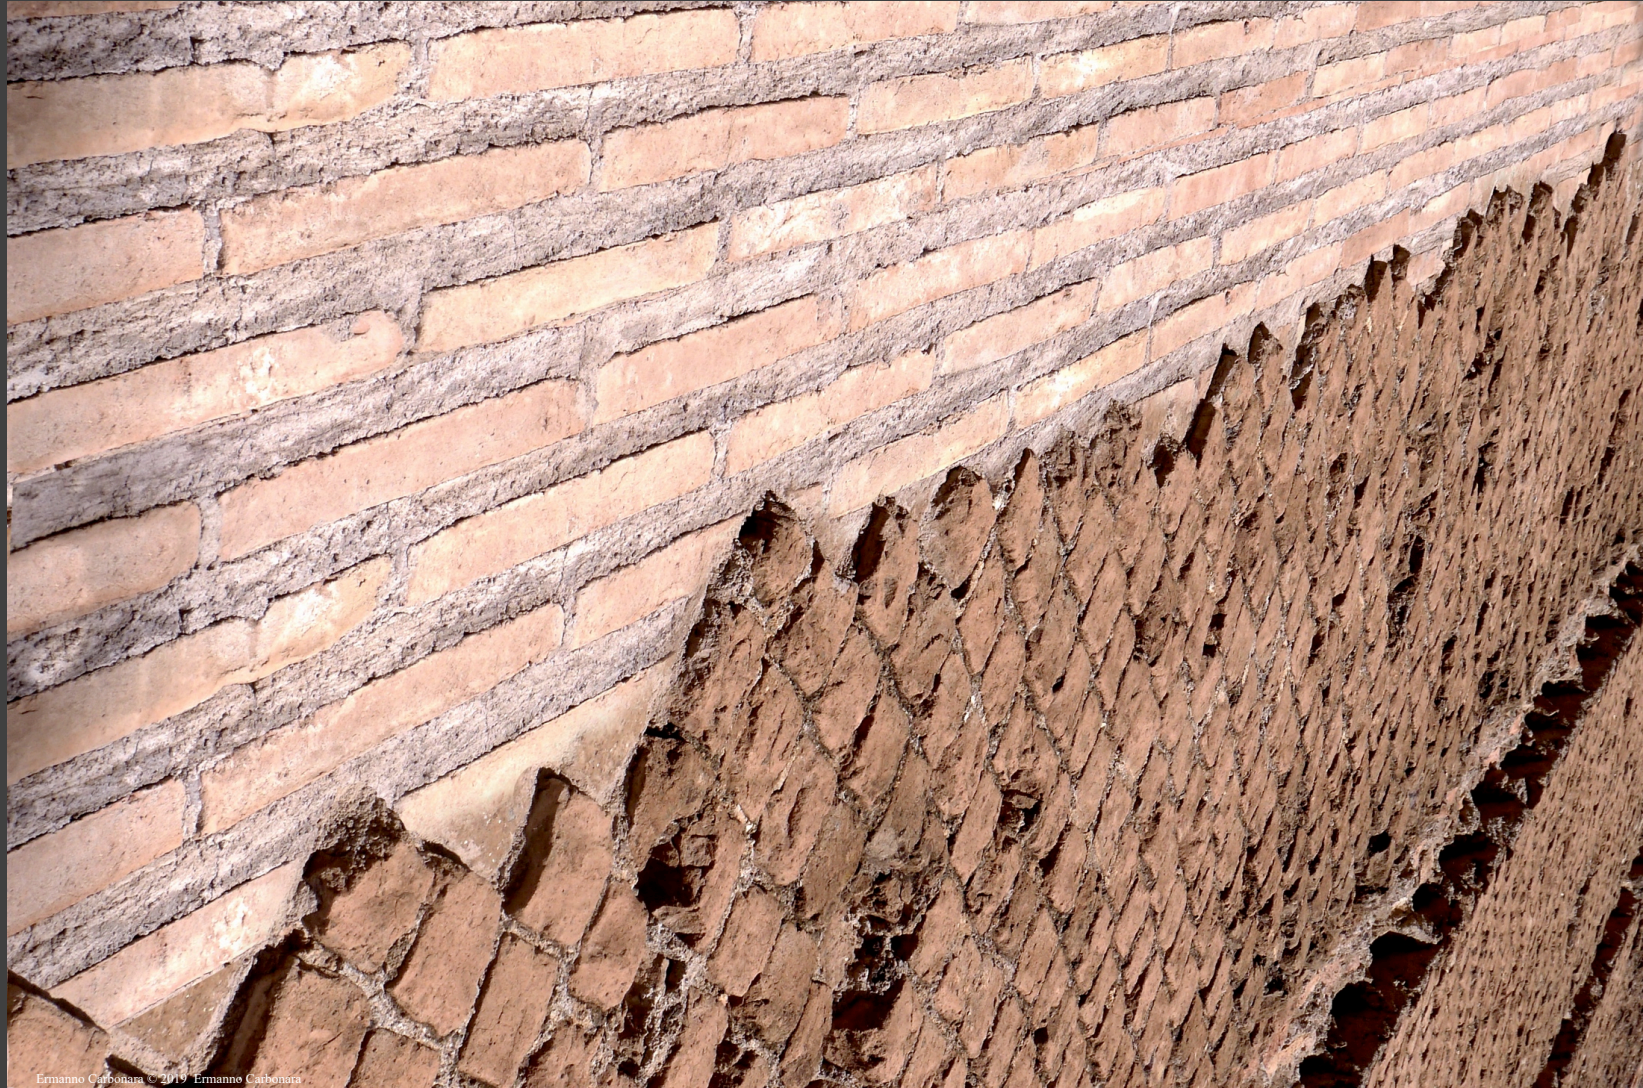
Using different materials from the ancient construction and placed below the original surface level
