## TECHNICIAN TRAINING FOR THE CONSERVATION OF MOSAICS

THE CONSERVATION OF ARCHITECTURAL REMAINS AND THEIR DECORATIVE SURFACES

## Structures and decorative surfaces: previous interventions and their documentation

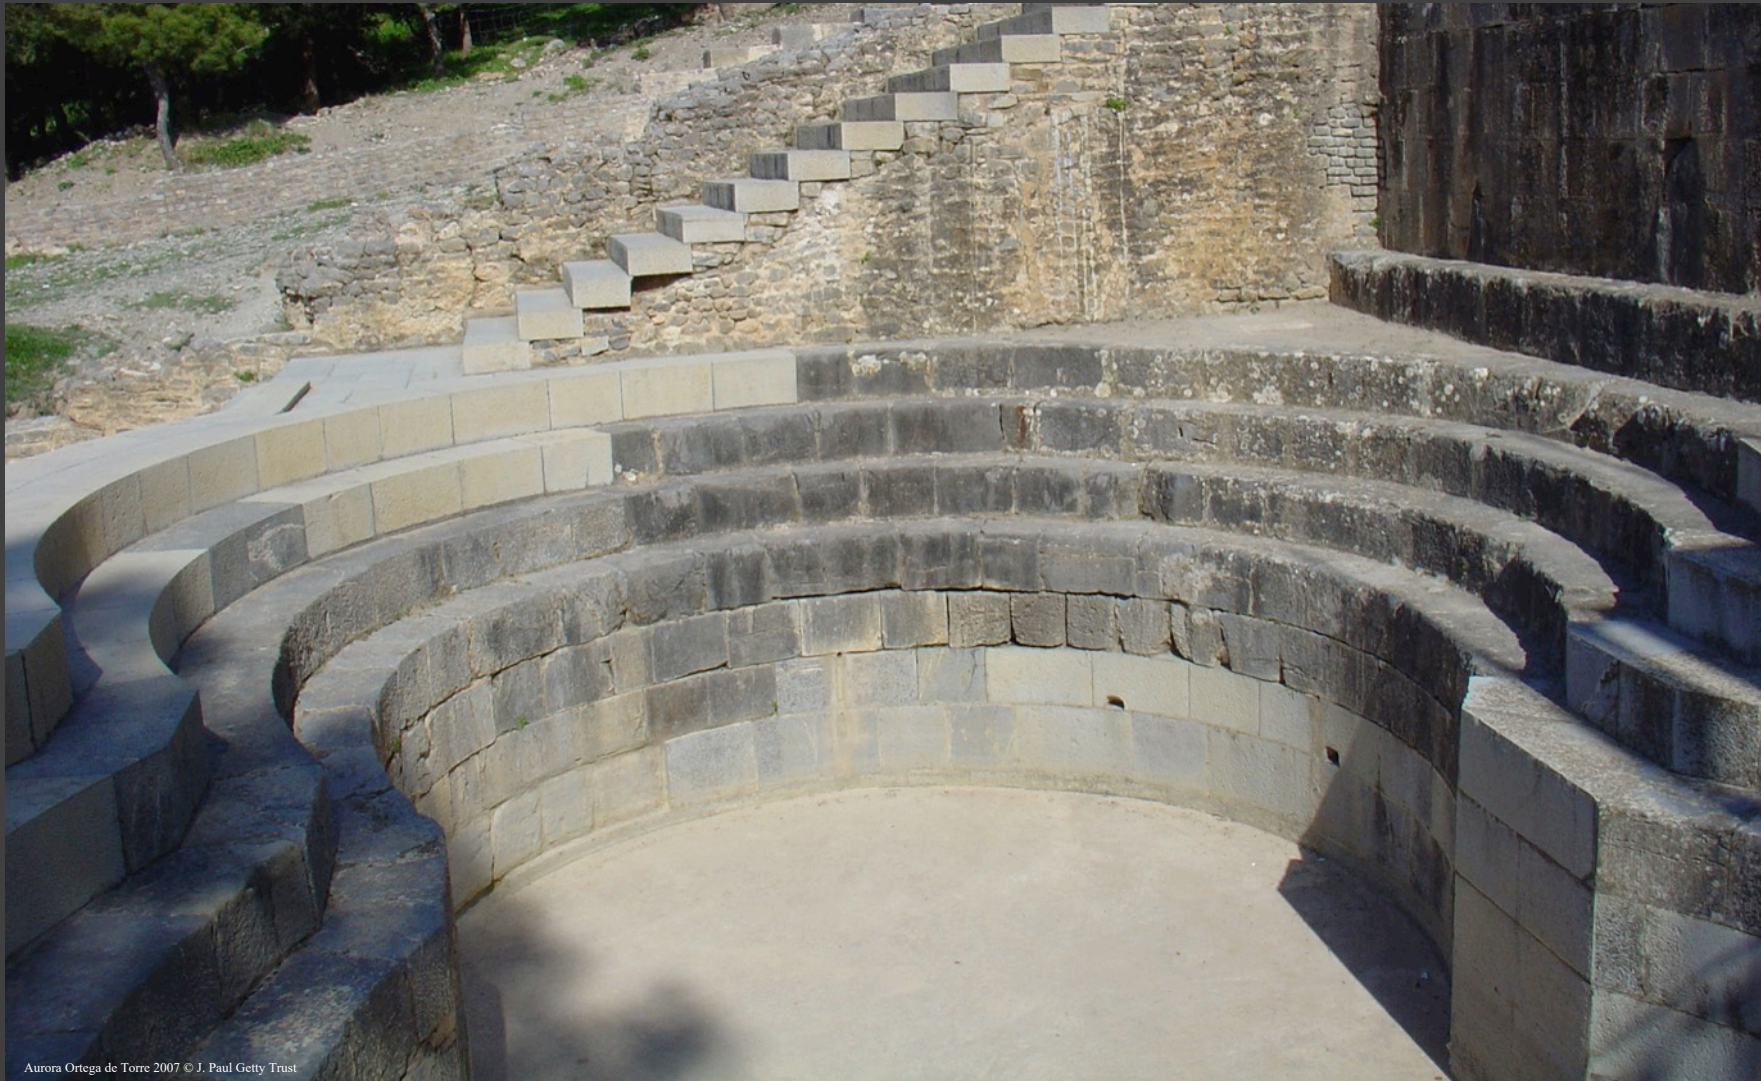
Replacement of ancient stones with new elements of the same material

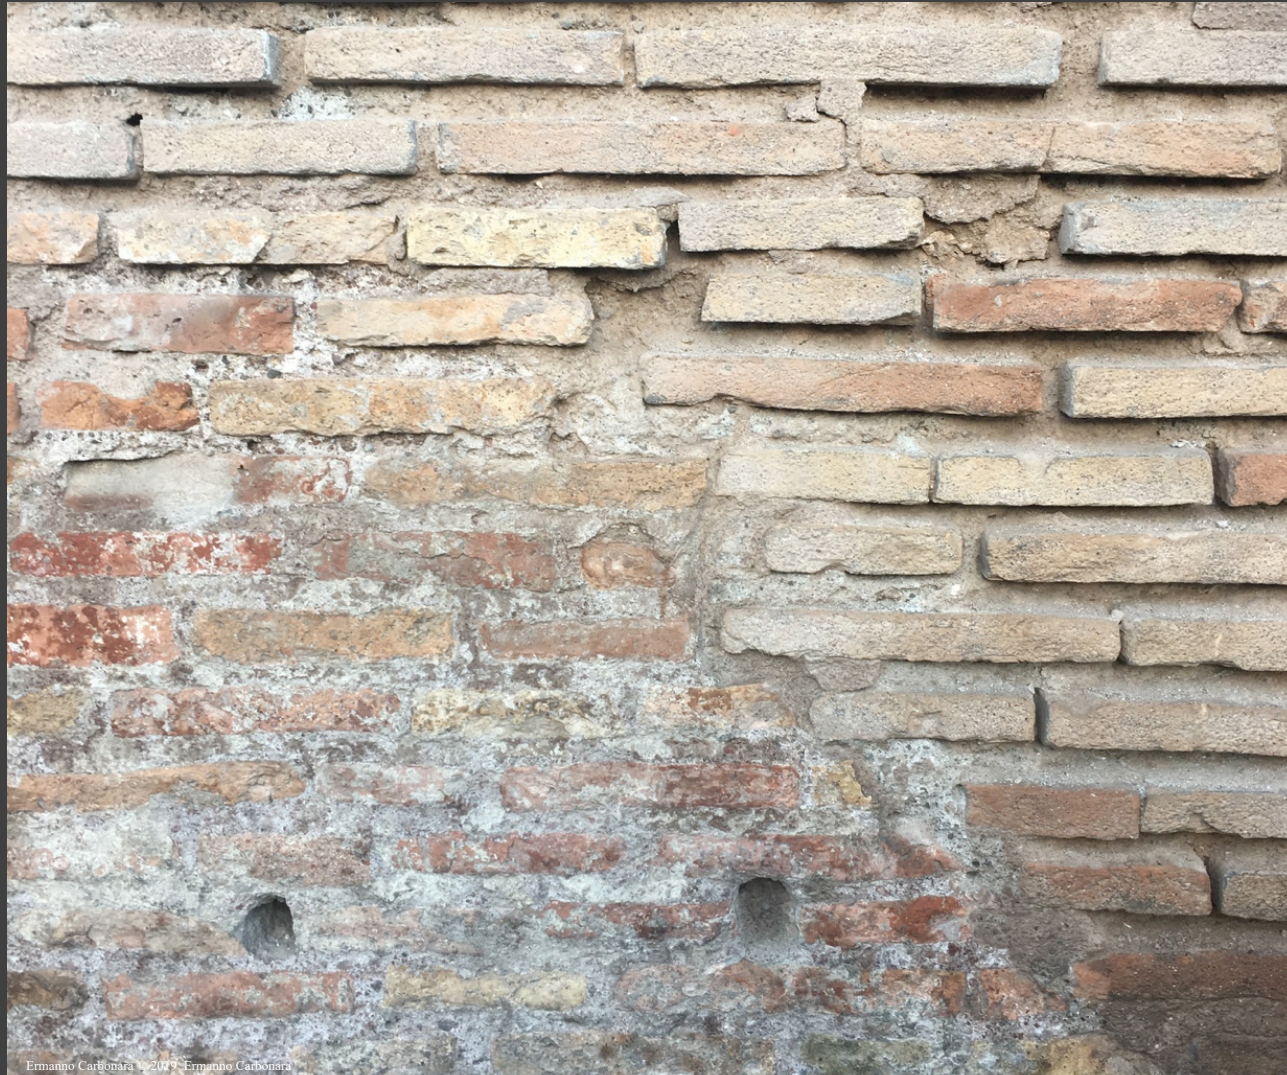
Replacement of ancient bricks with new elements of the same material

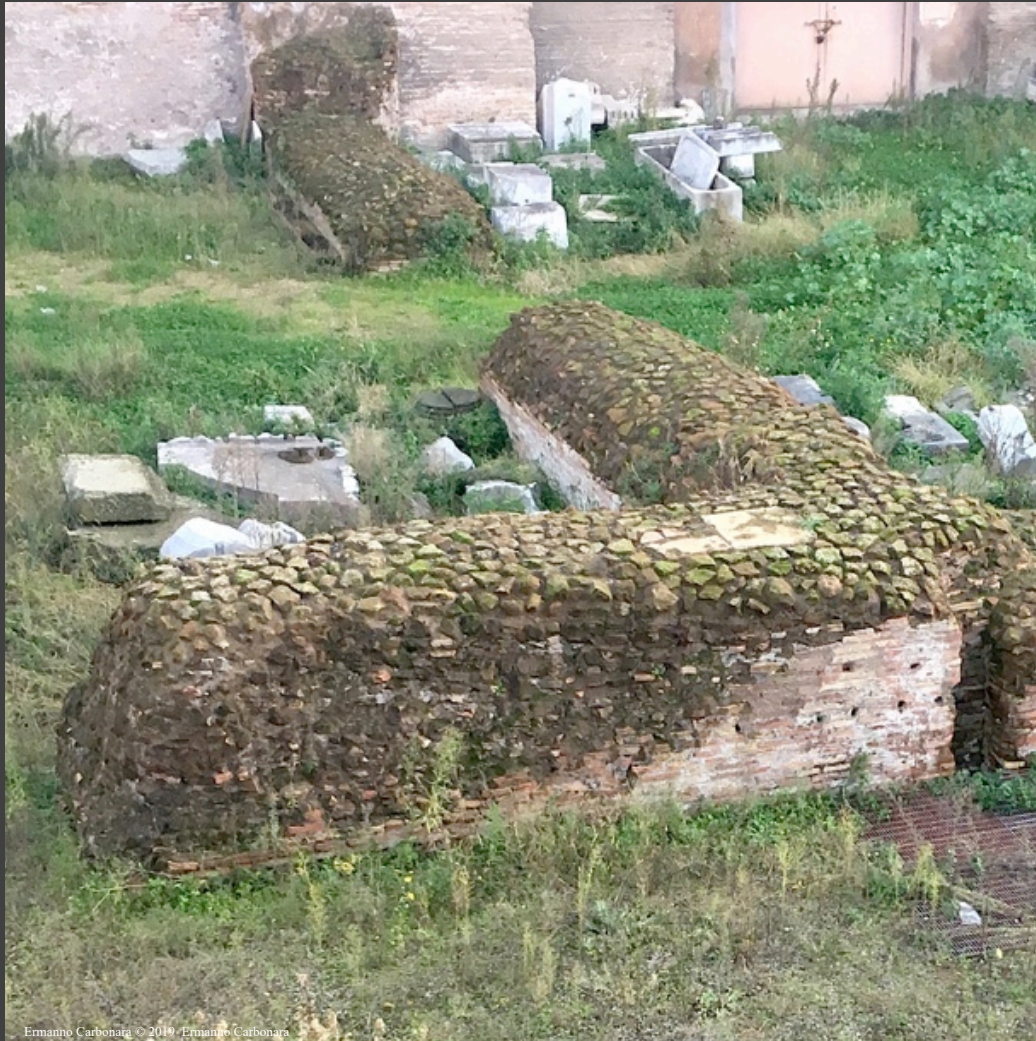
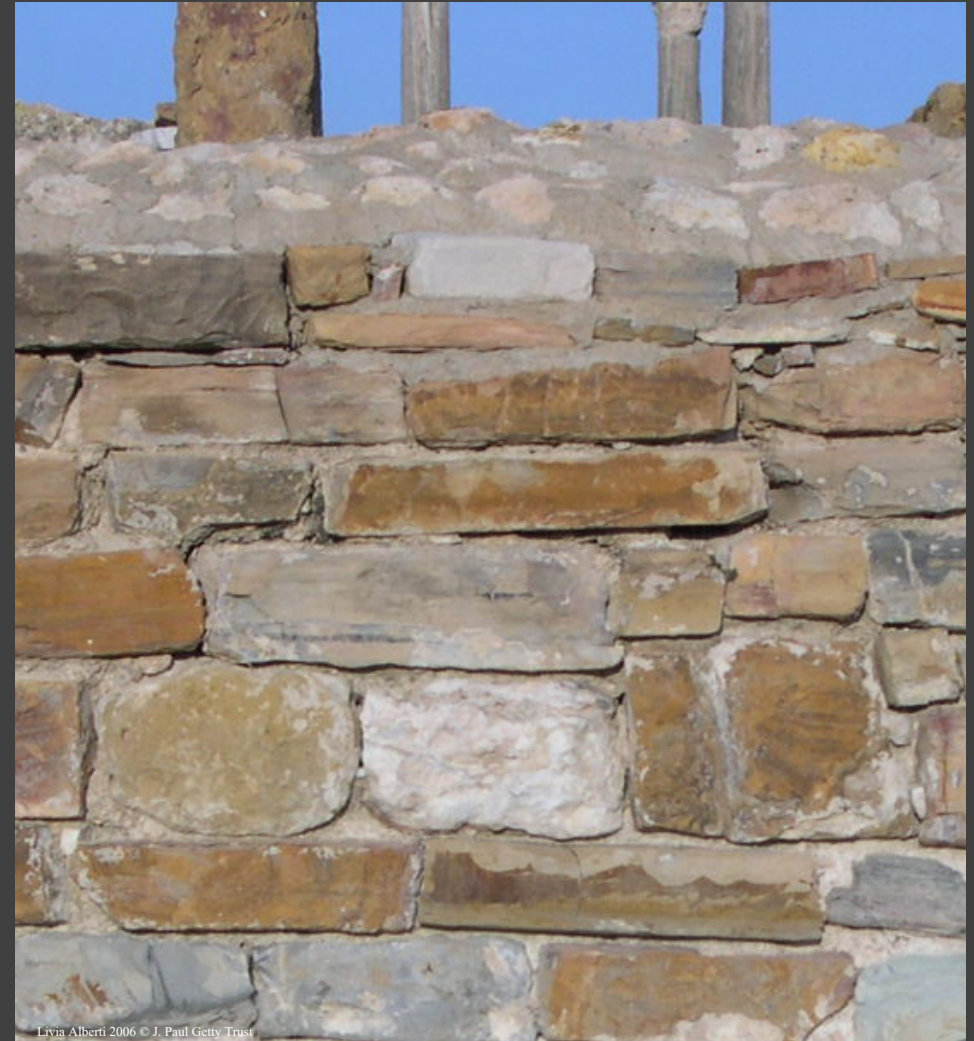
Wall capping using a layer of mortar and small stones

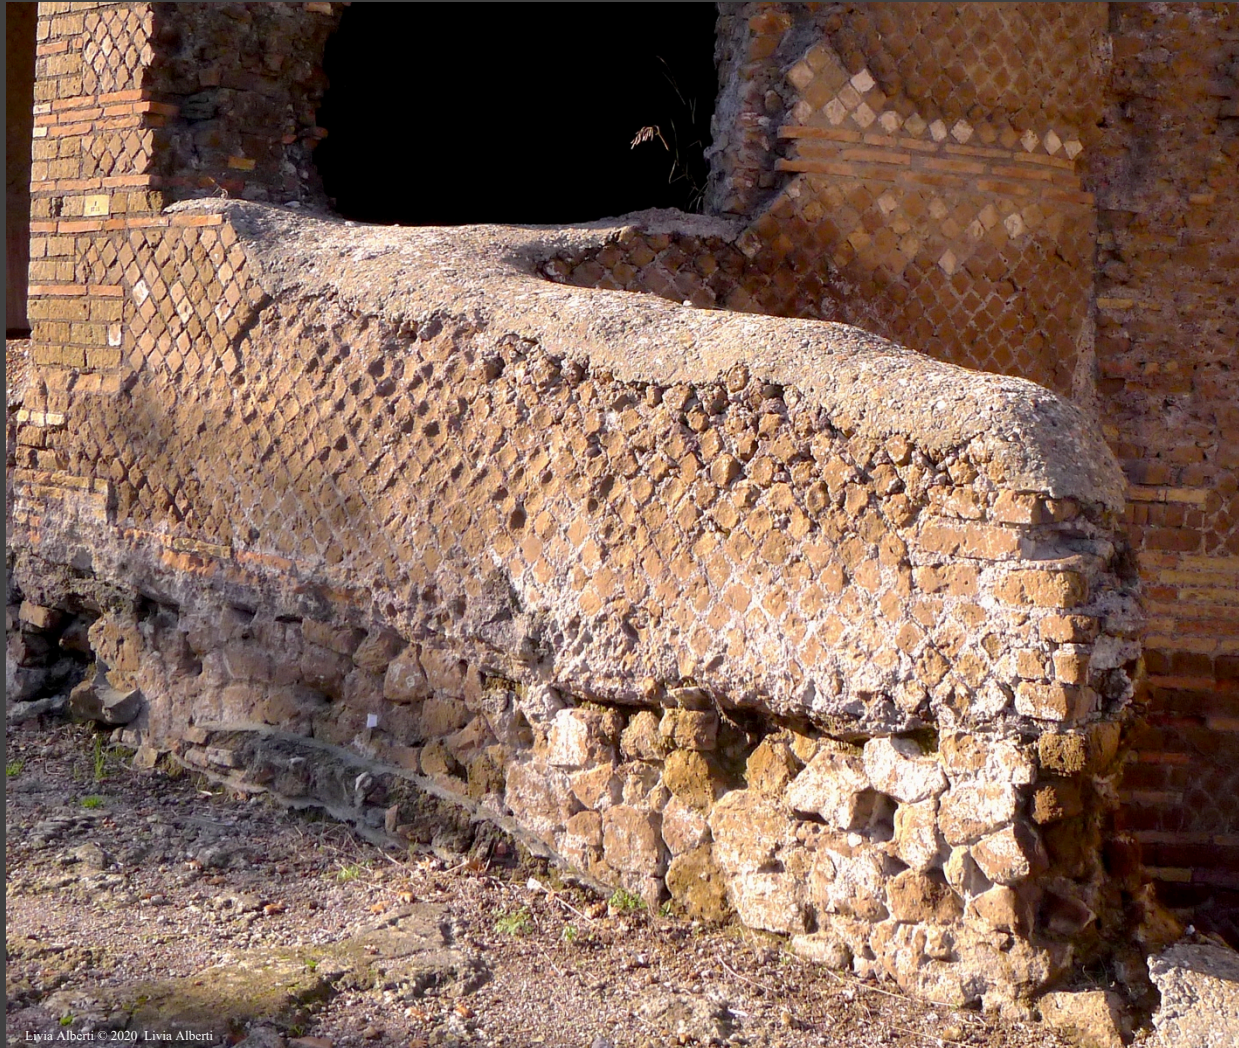
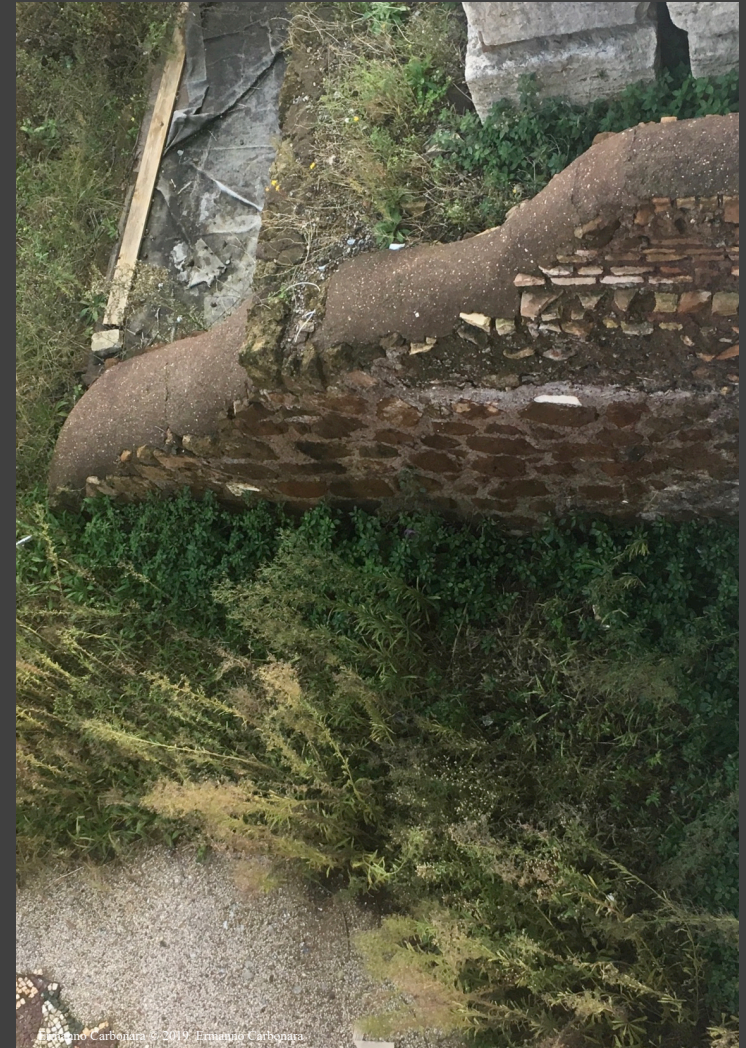
Wall capping using a layer of mortar

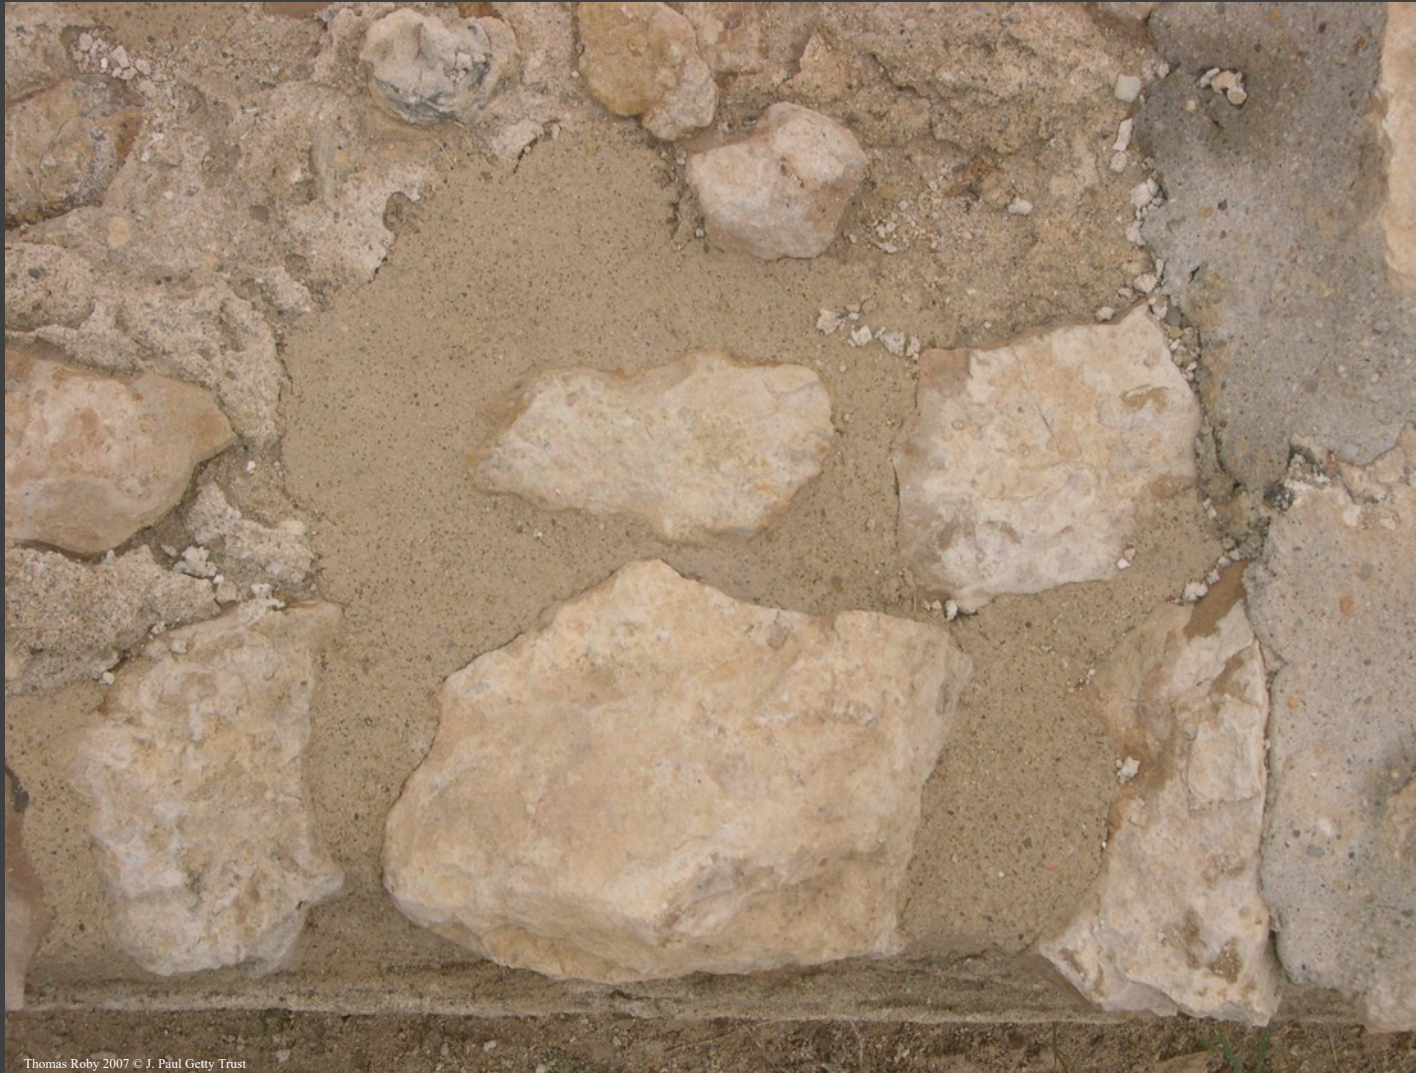
Infilling of lacunae with stones and mortar

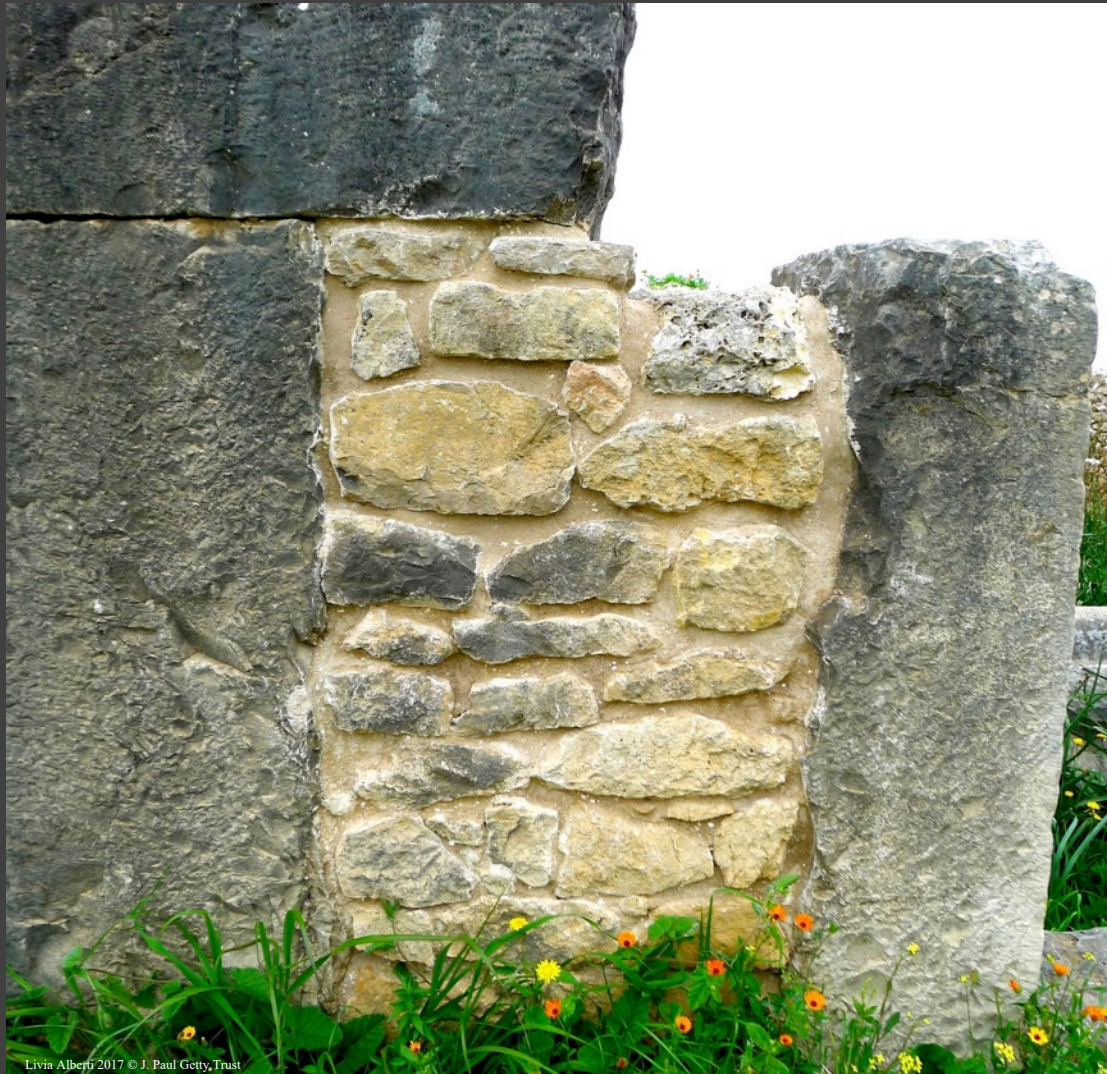
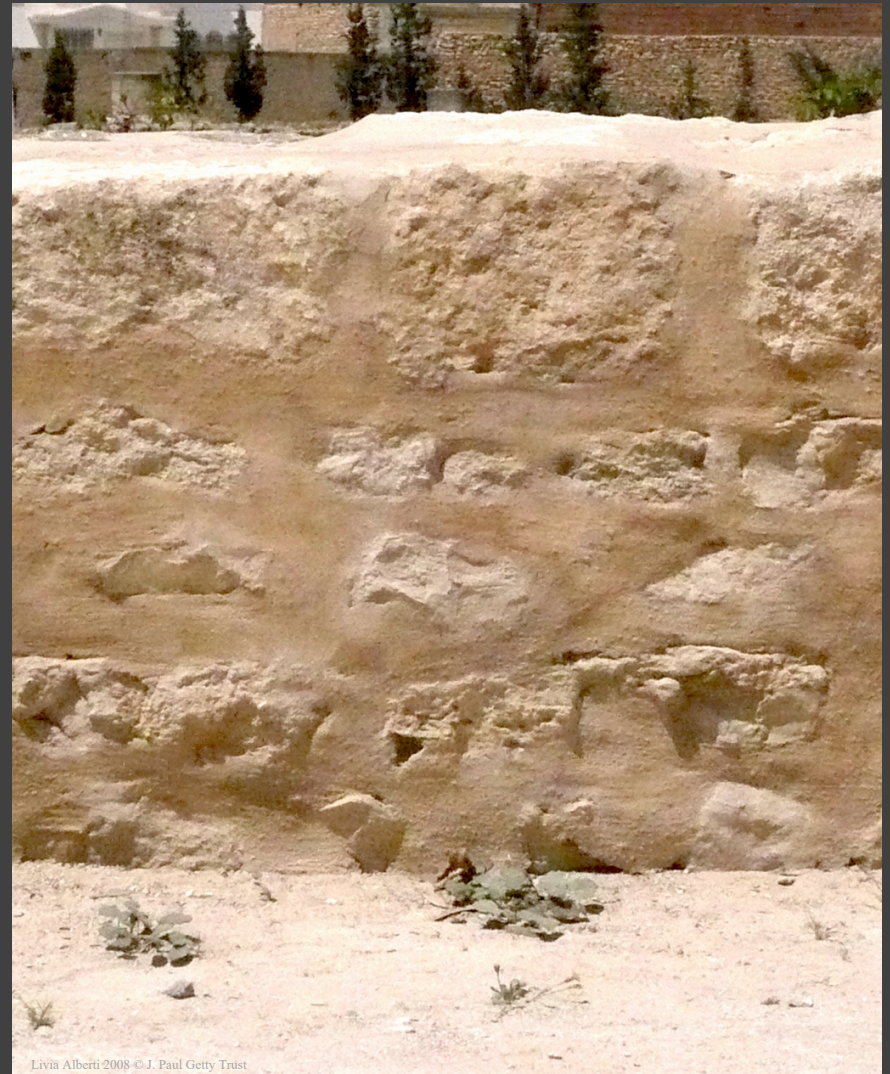
Infilling of masonry joints with mortar

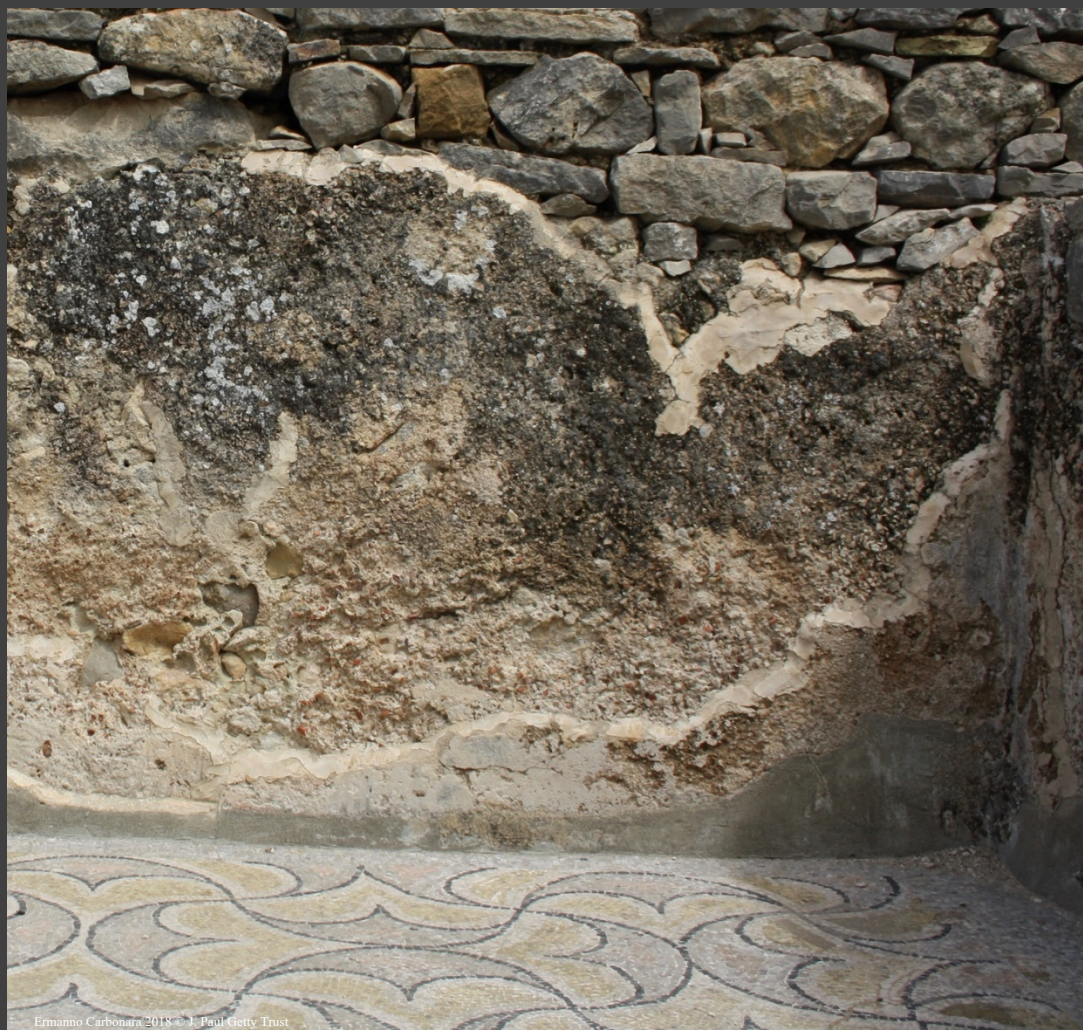
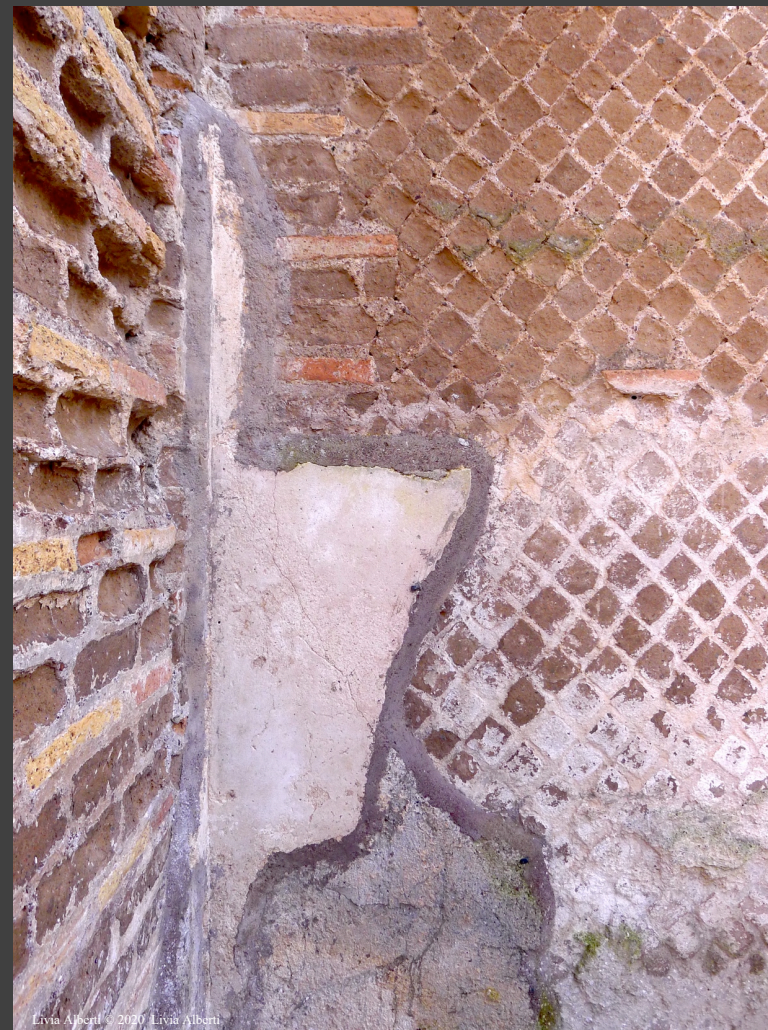
Edging repair

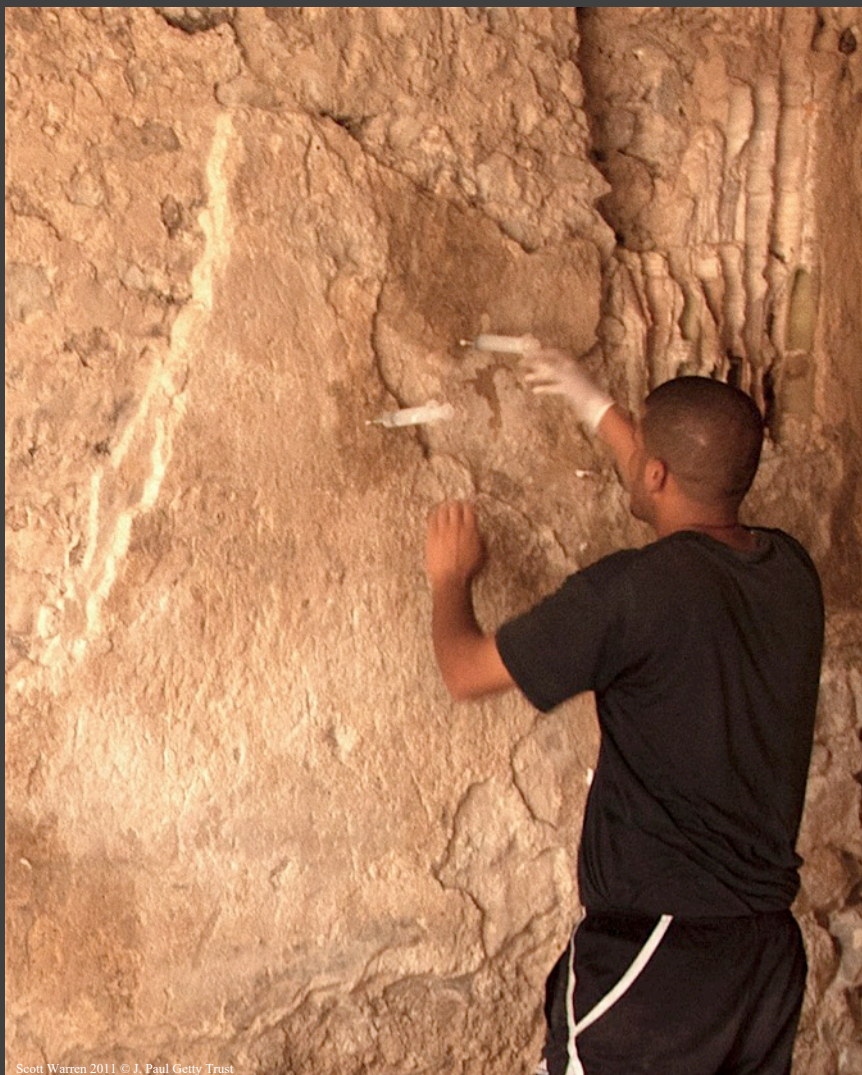
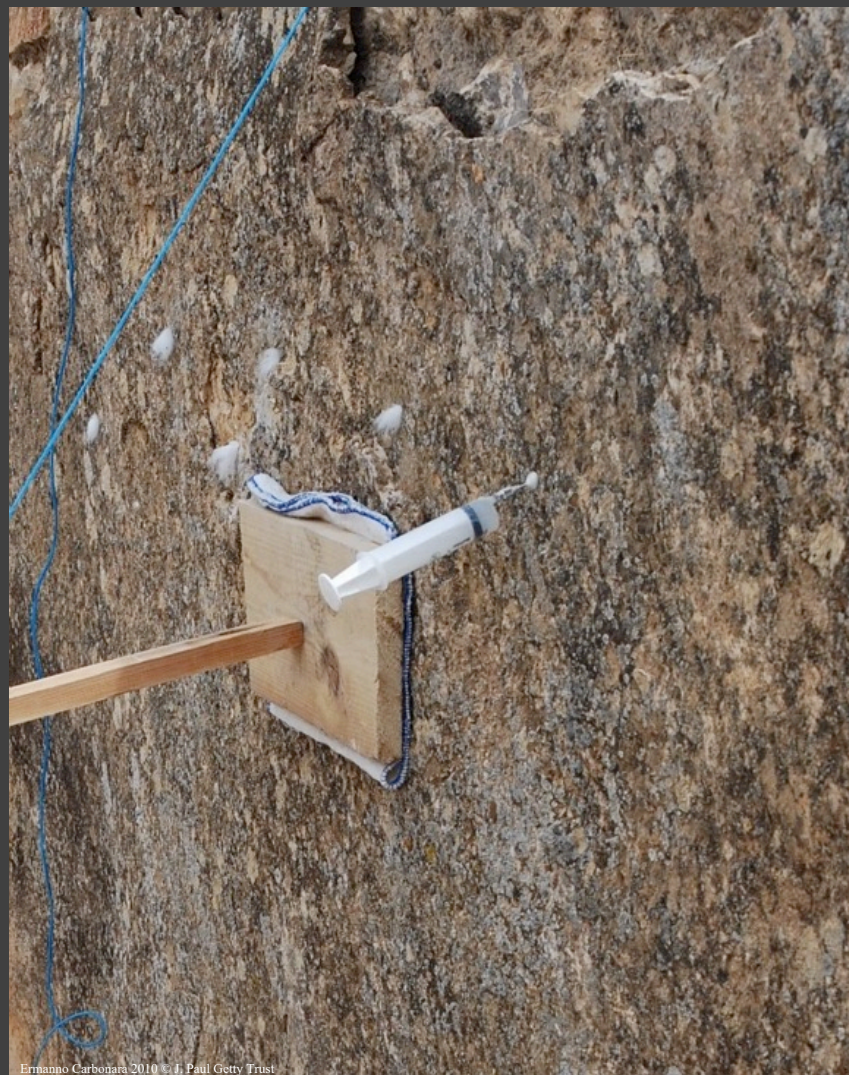
Grouting voids between preparatory layers

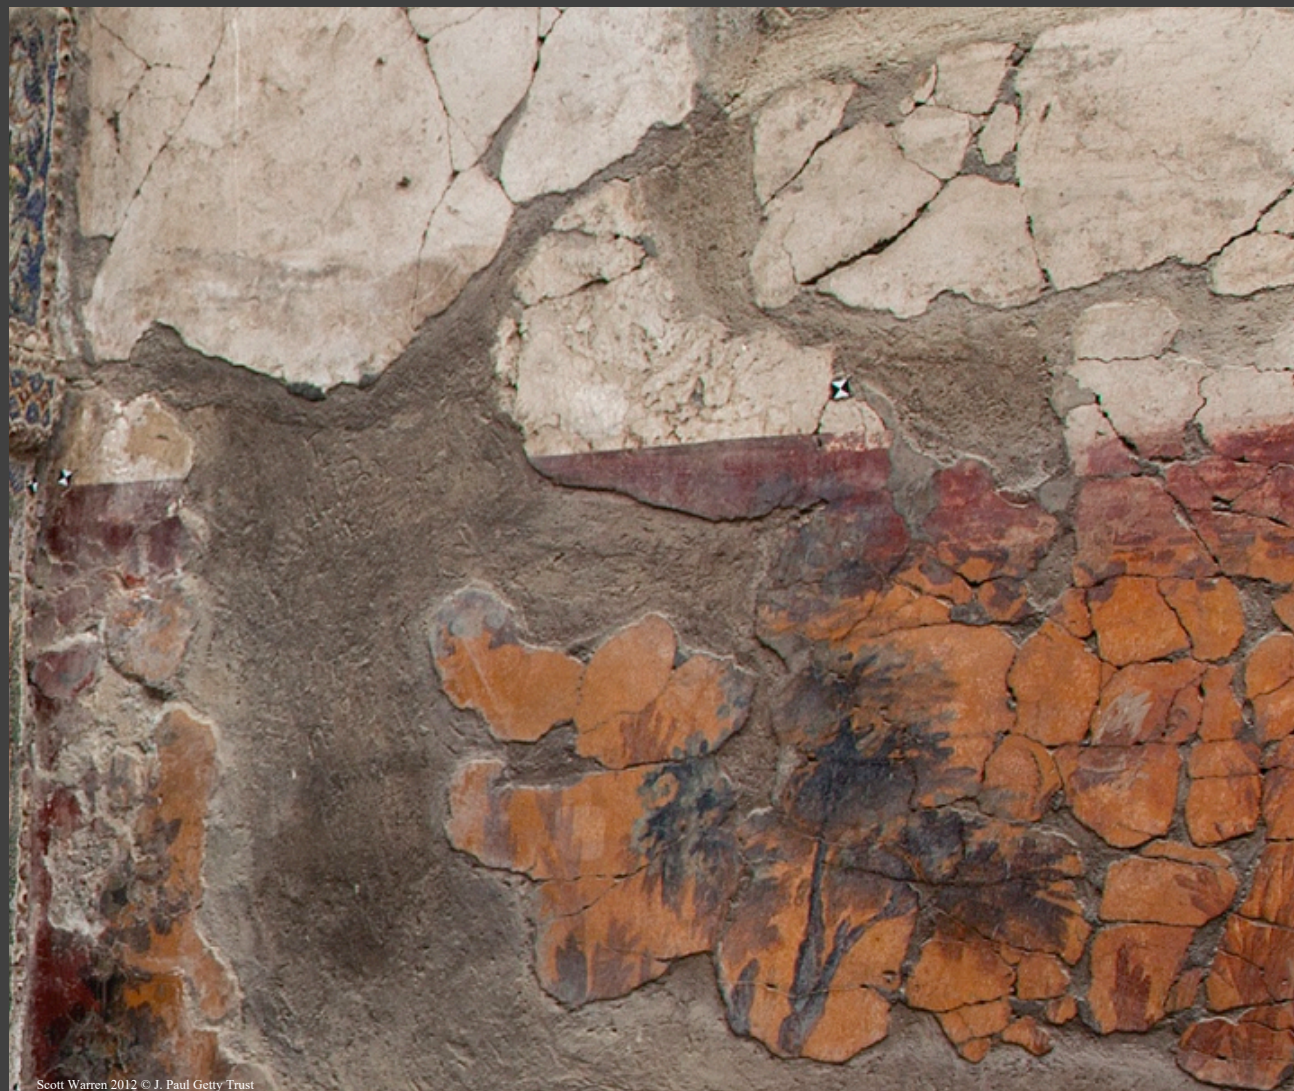
Recognizable integration below the original surface level

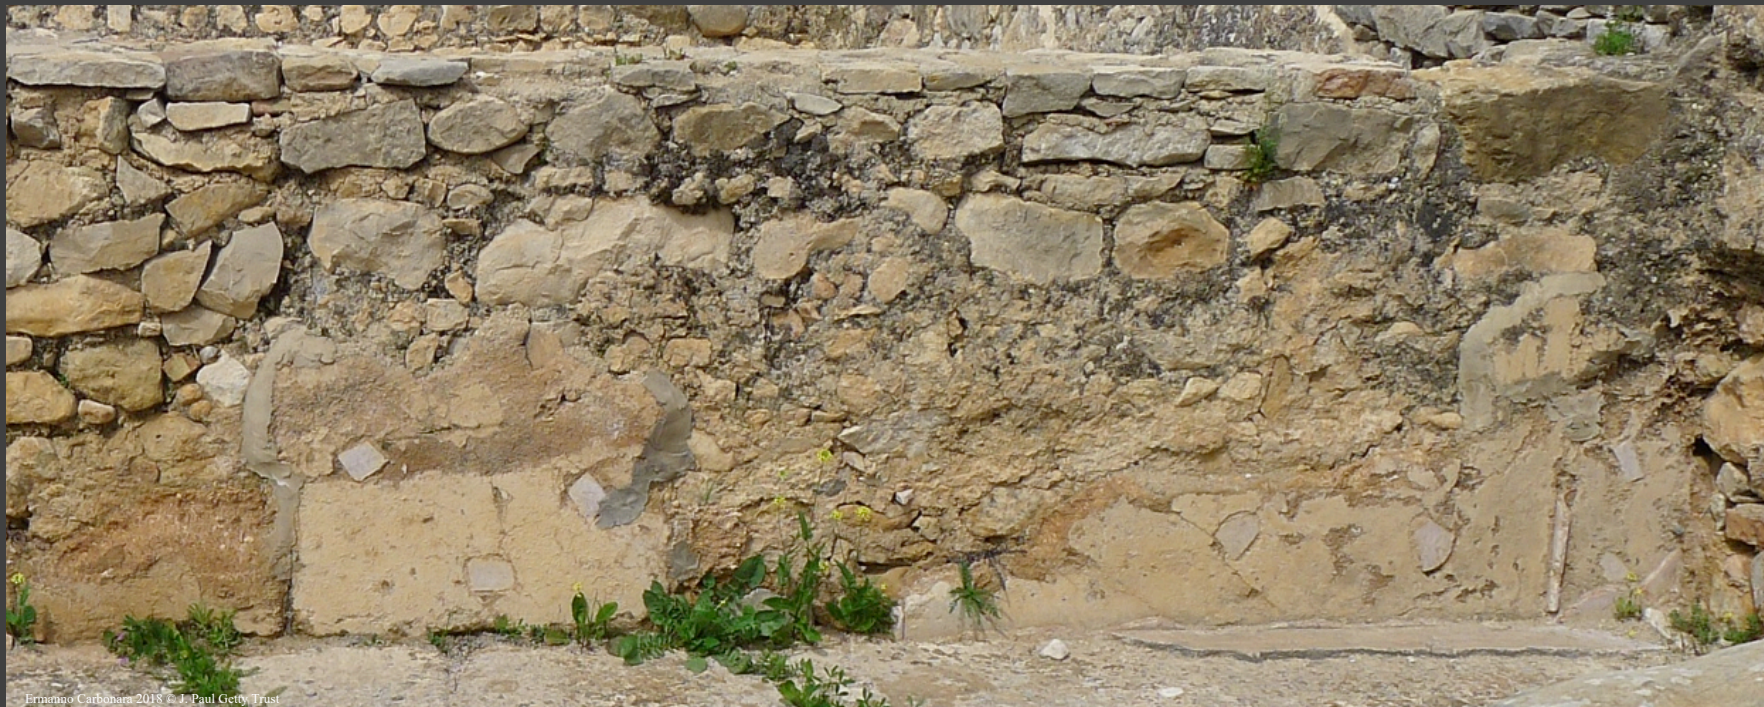
Volubilis, House of Orpheus

## Previous Interventions Map

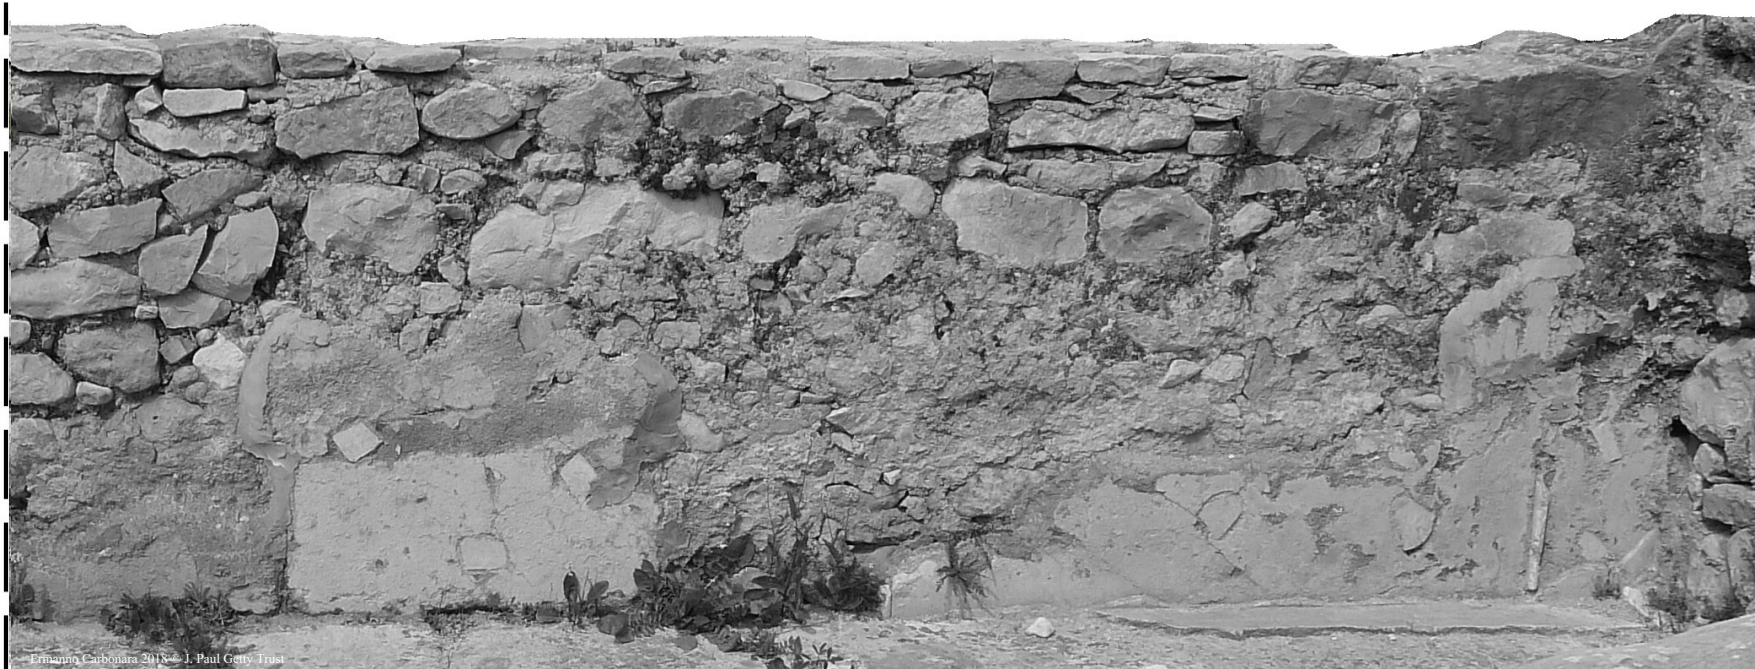
Vol-MOR-02-d-2

## Previous Interventions Map

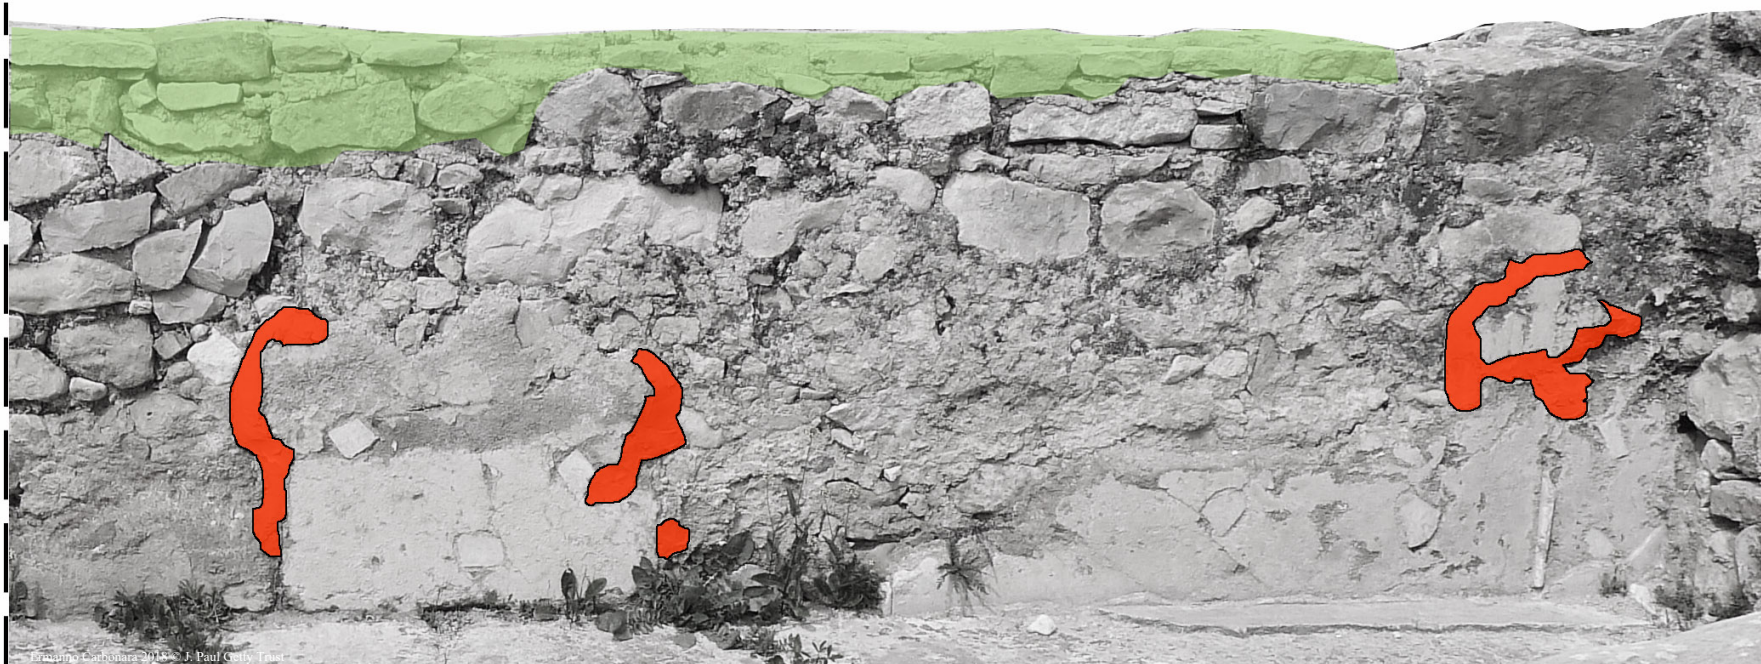
Vol-MOR-02-d-2

TITLE: Previous Interventions Map
