TECHNICIAN TRAINING FOR THE CONSERVATION OF MOSAICS

PART 1
THE CONSERVATION OF IN SITU MOSAICS

Water drainage interventions

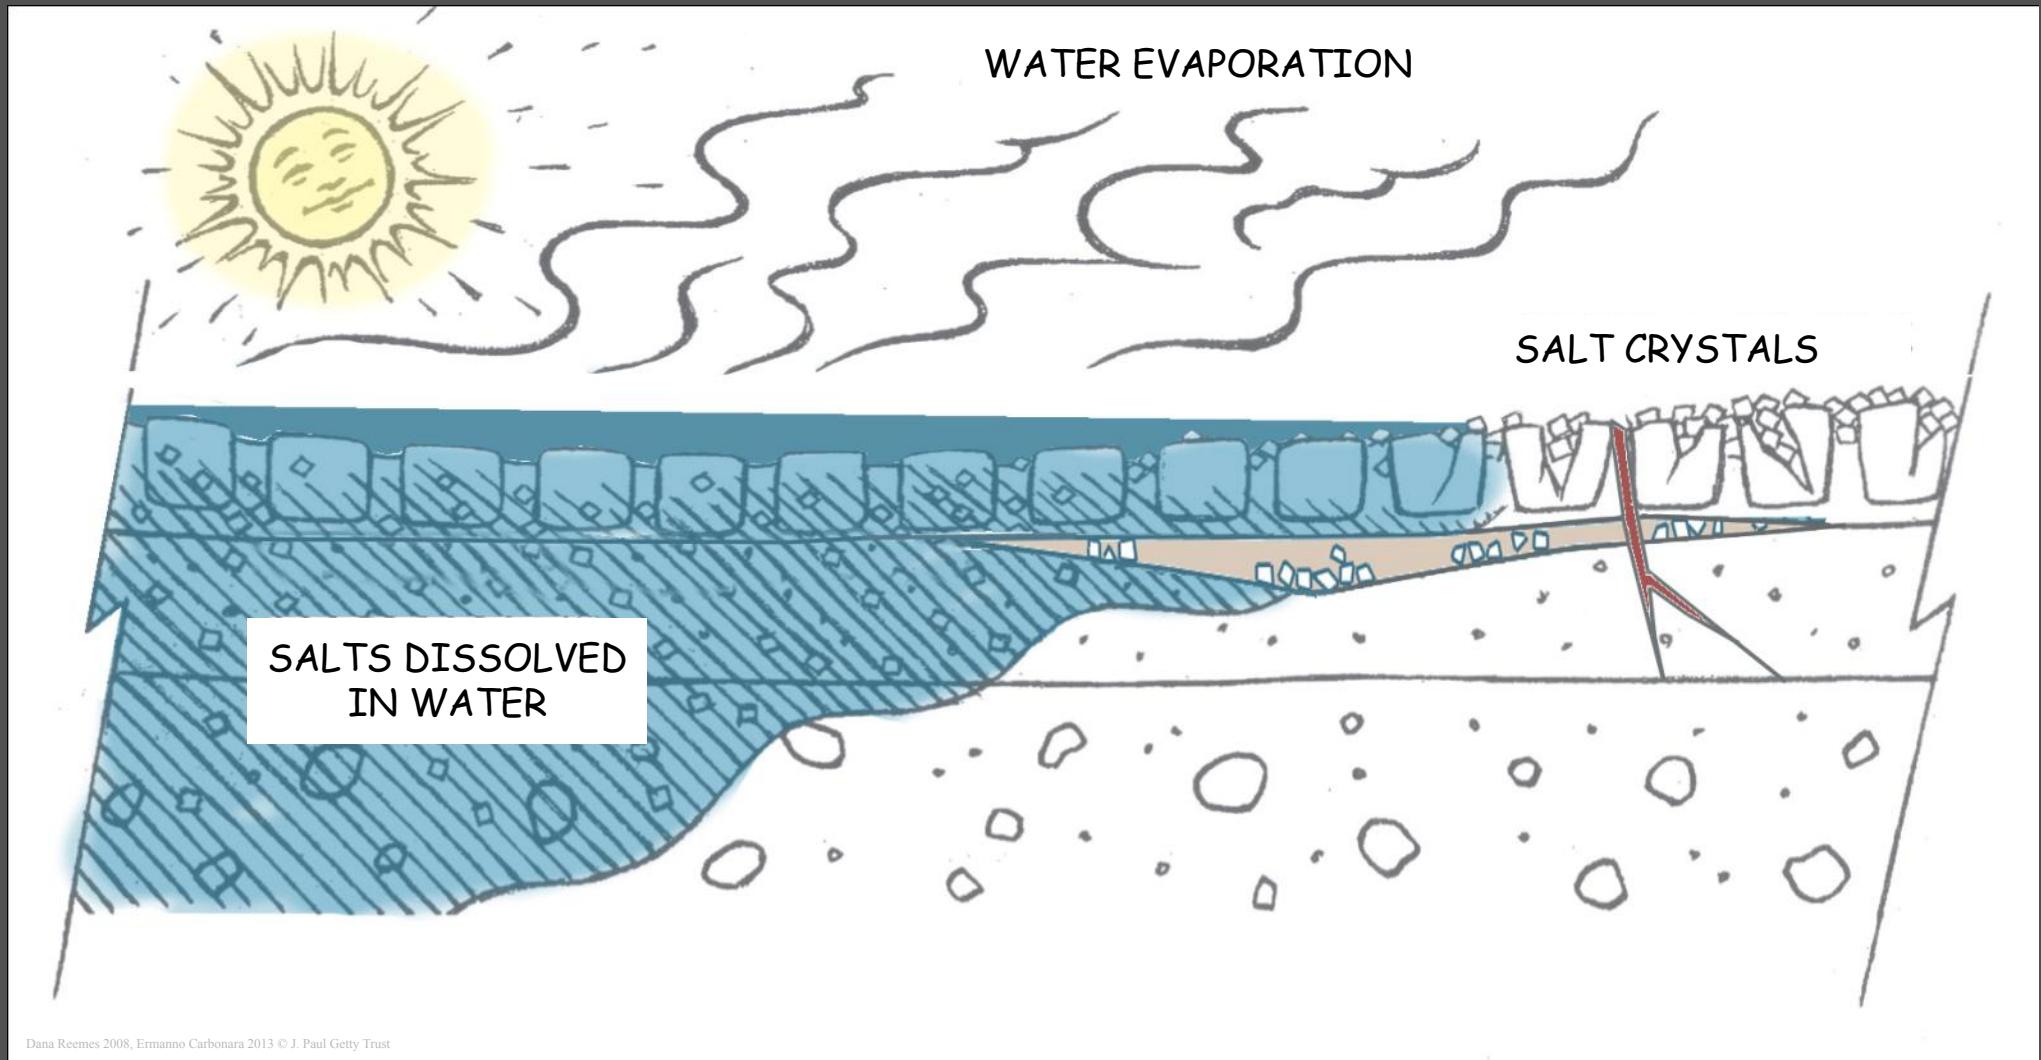
Deterioration linked to water pooling

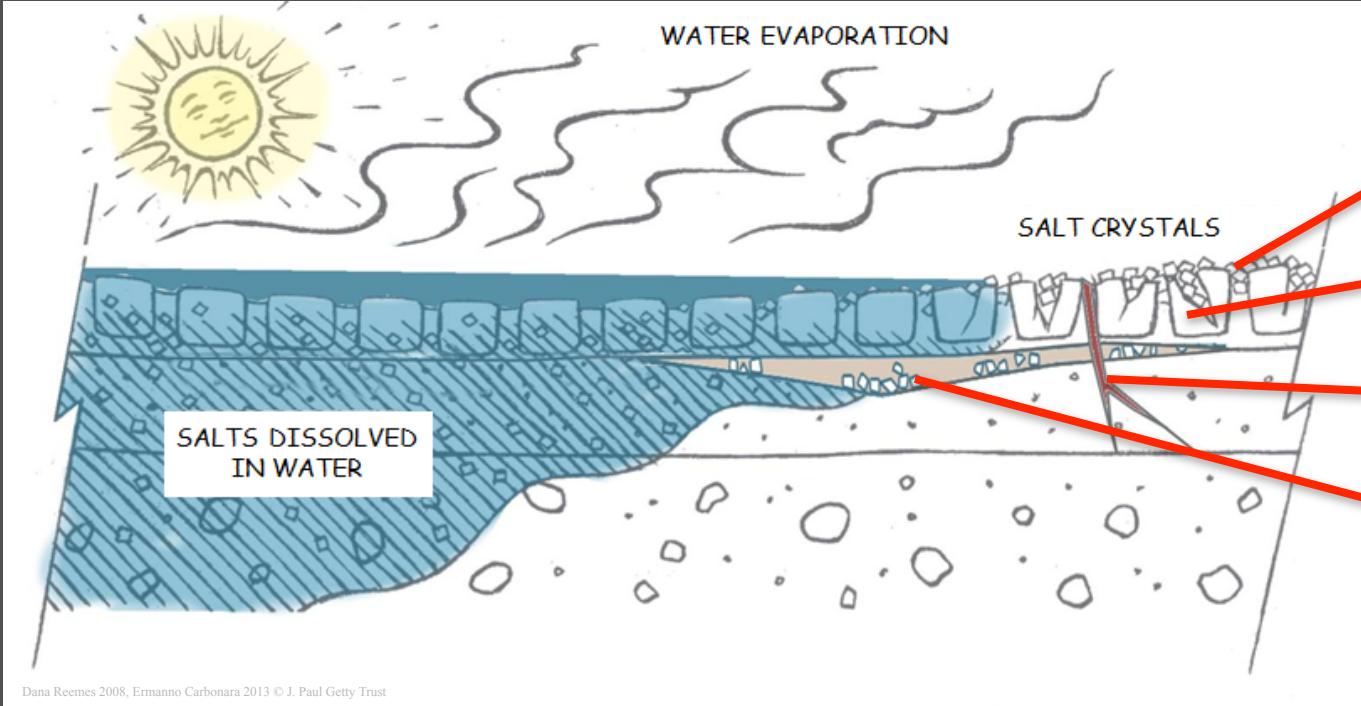
Deterioration phenomena linked to water pooling

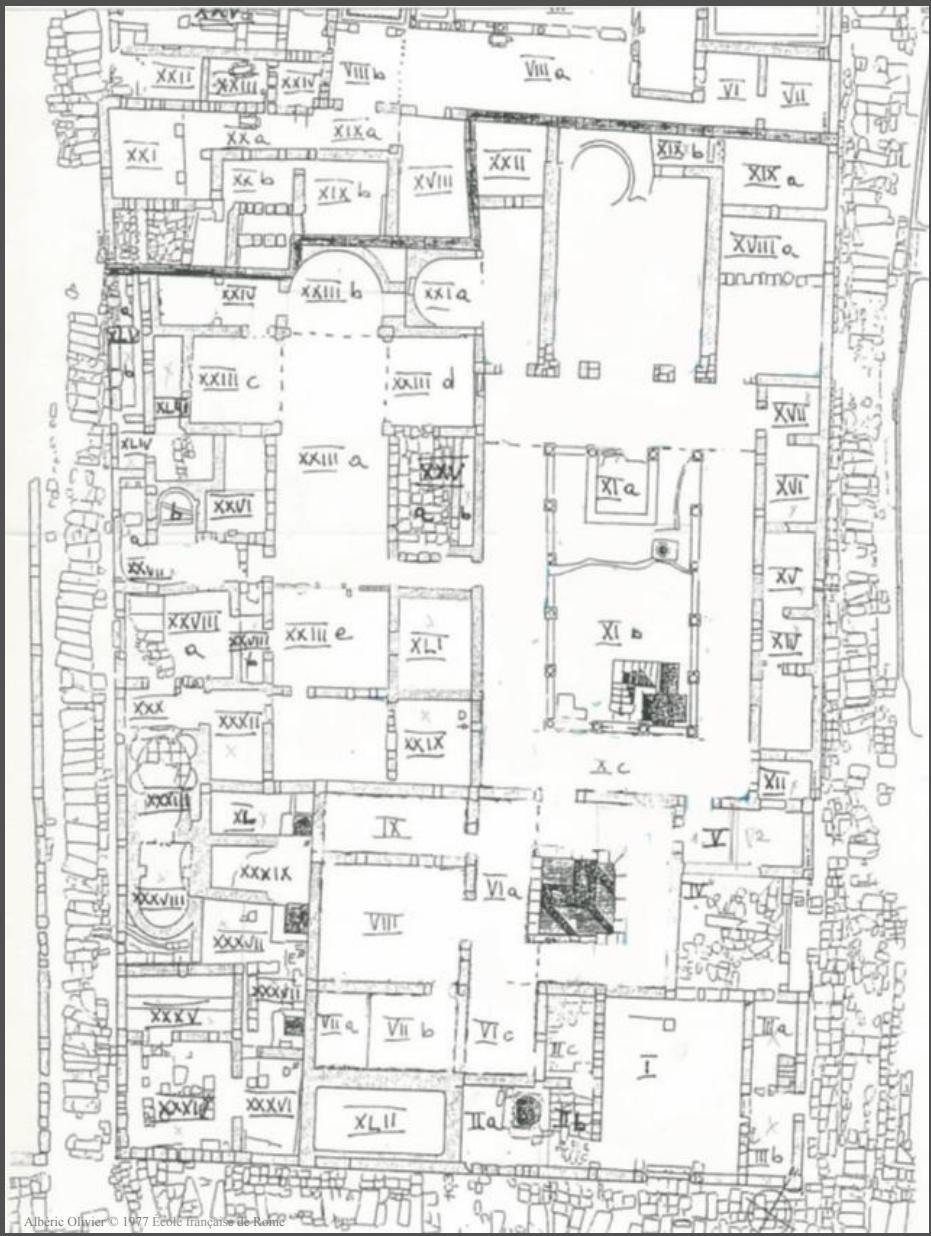
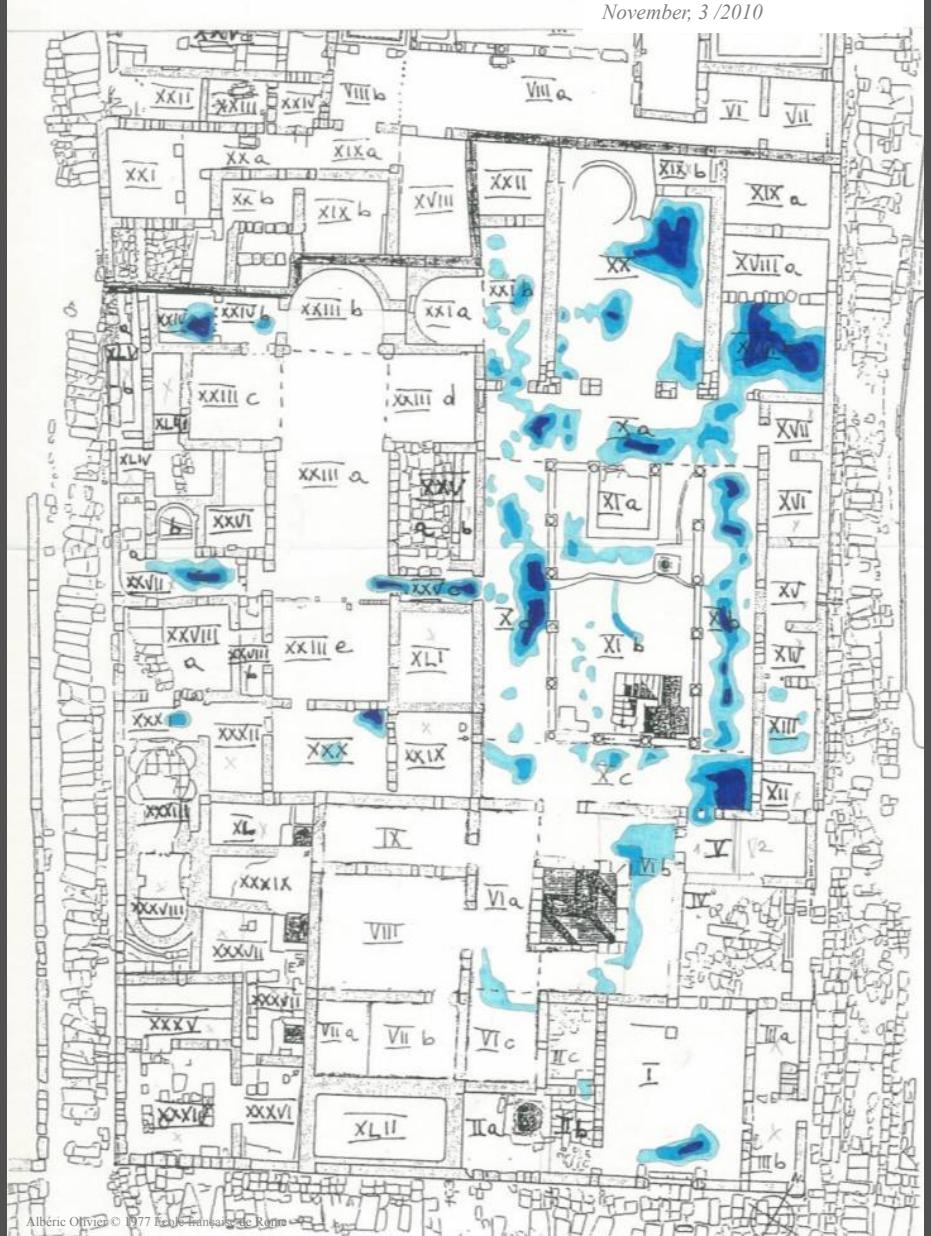
Water pooling map

After rain
After 2 hours
After 7 hours
(10am)
(12pm)
(5pm)

November, 3 / 2010

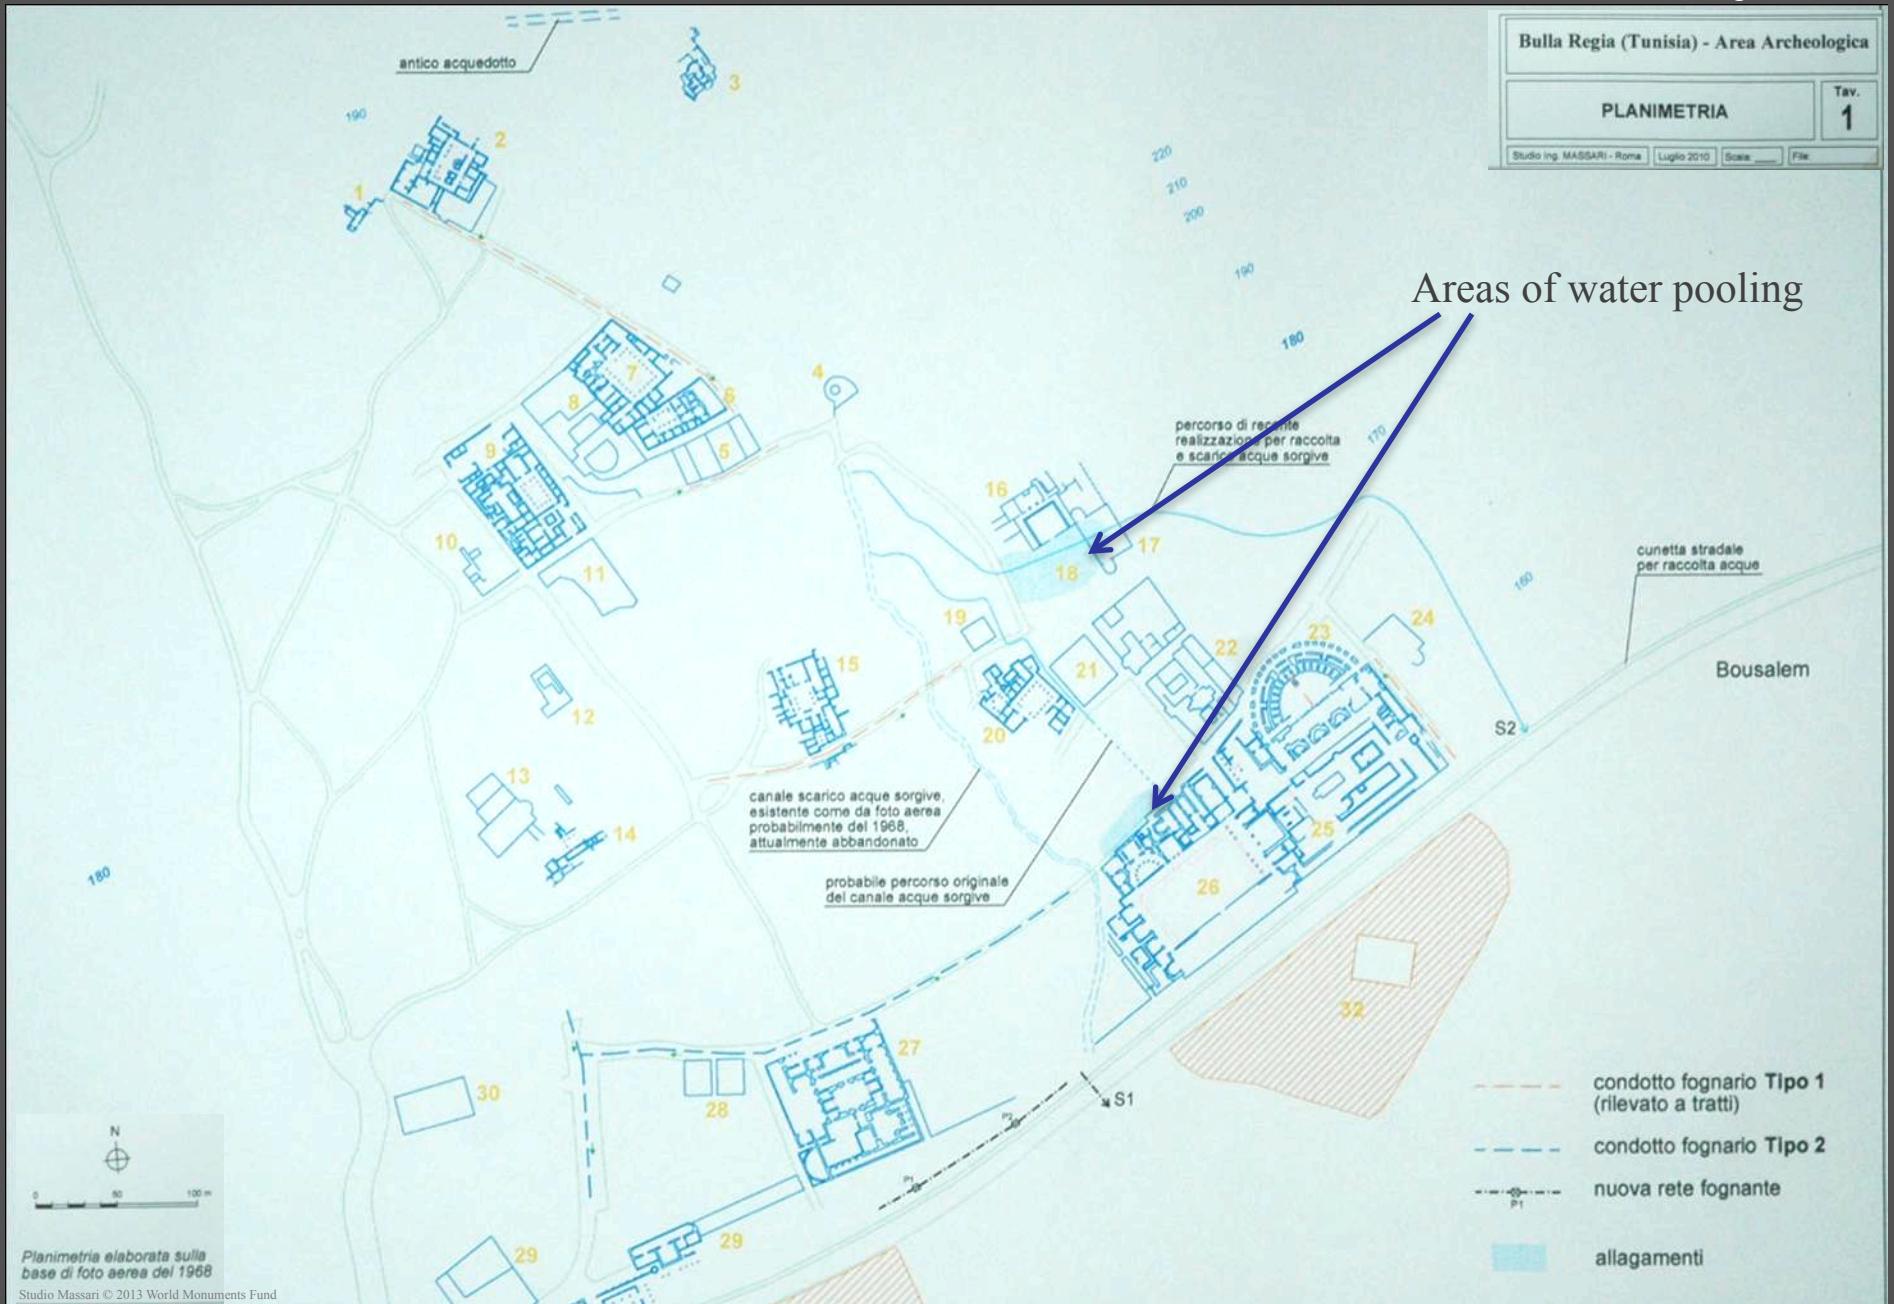
Site map with areas of water pooling

Bulla Regia, Tunisia

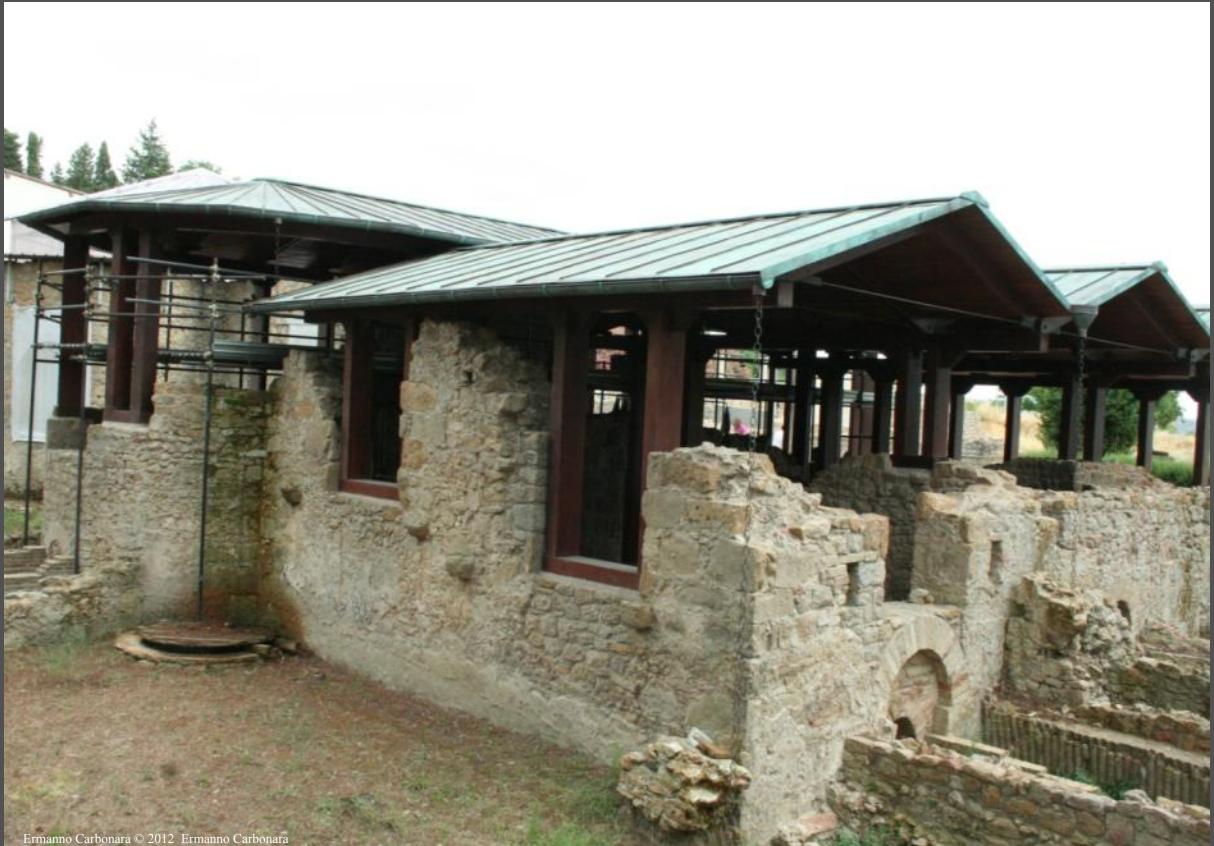
Long-term open shelter

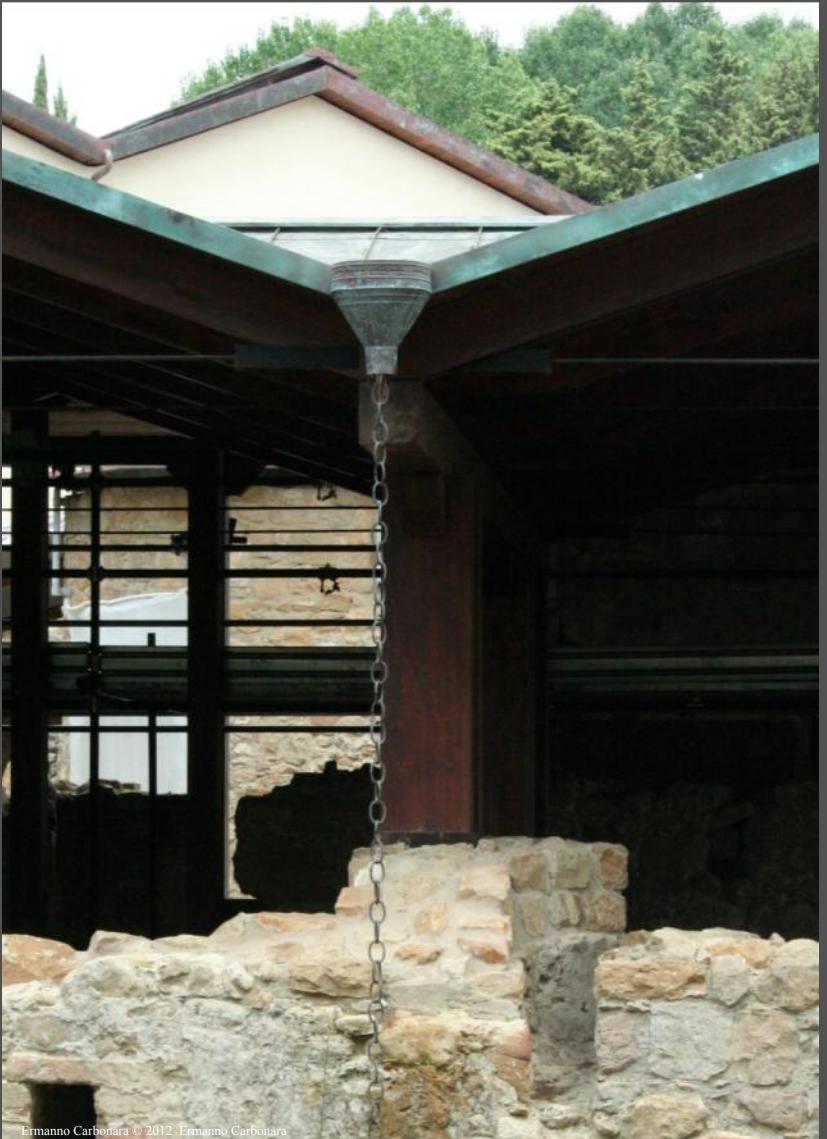
Rain water chain

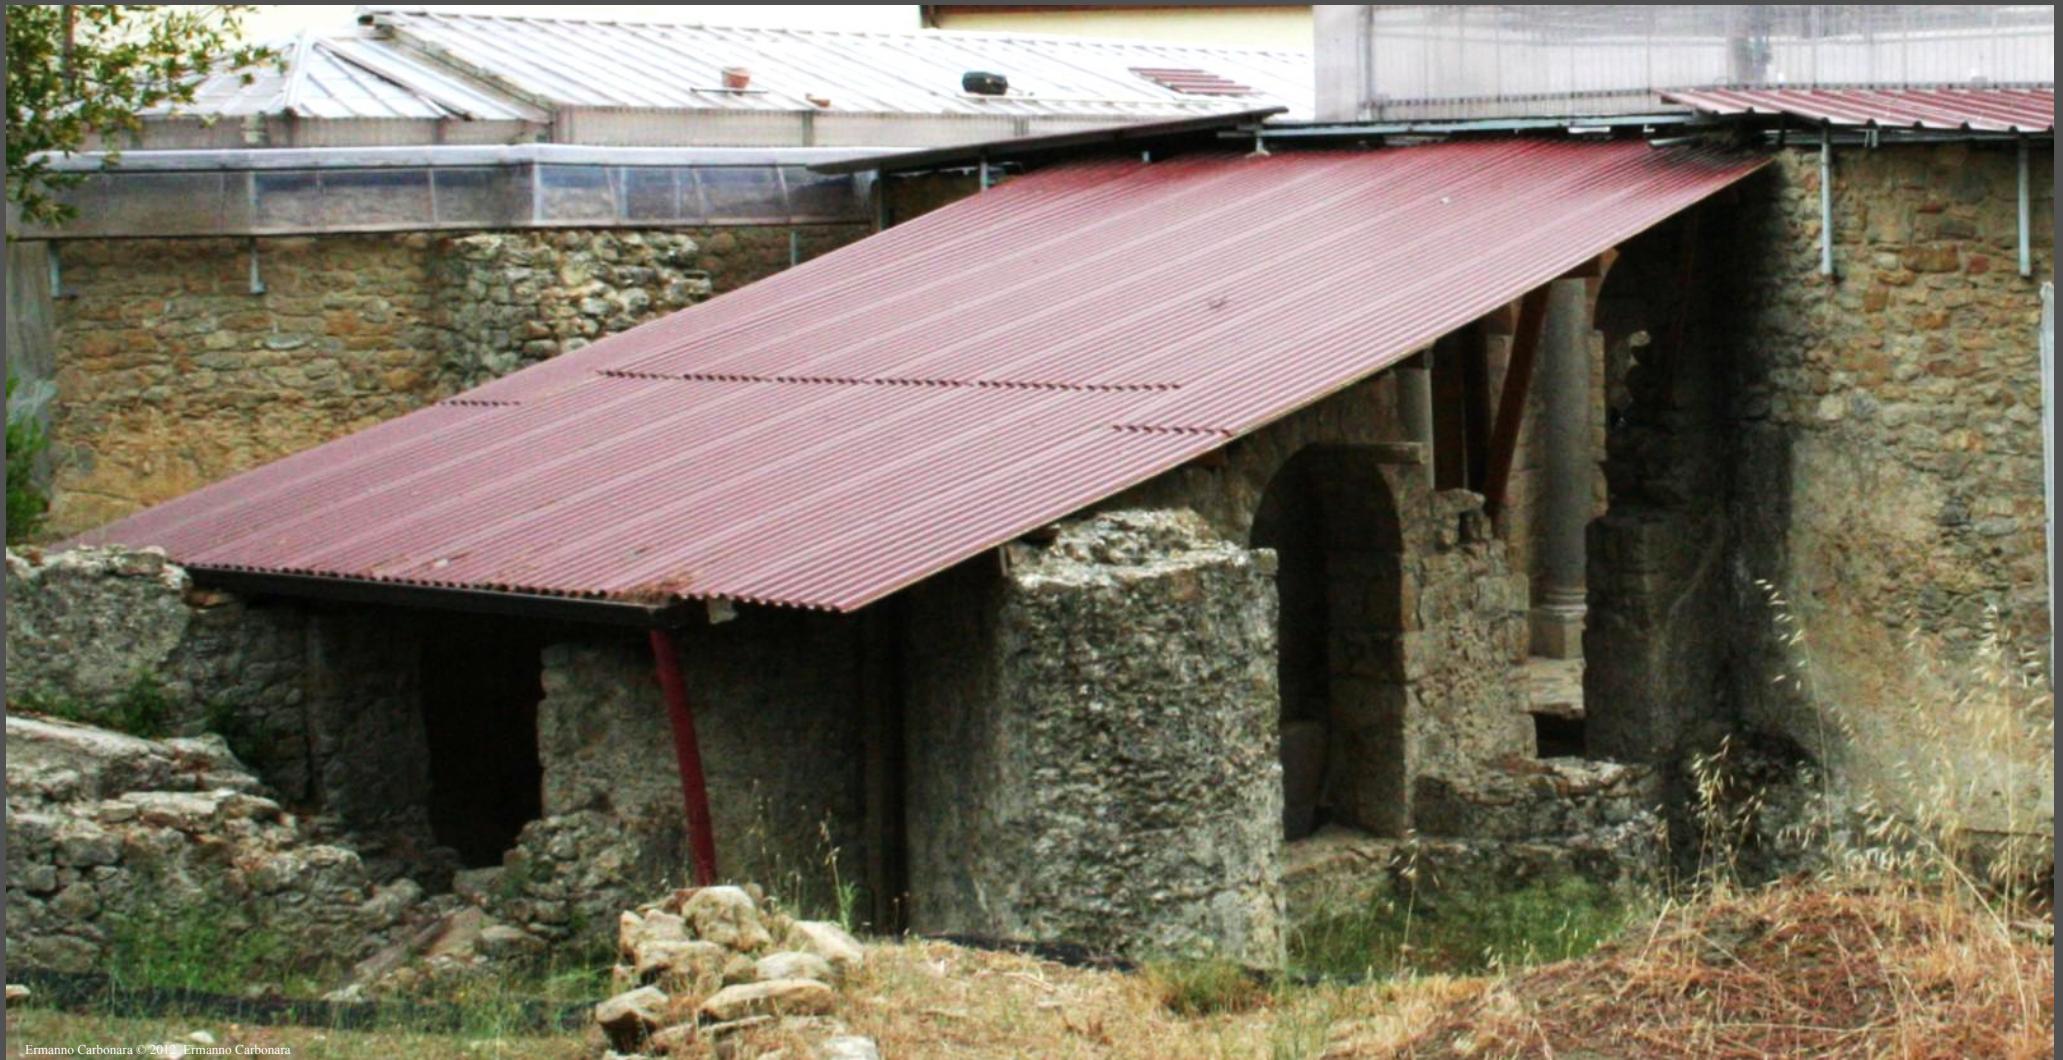
Temporary shelter

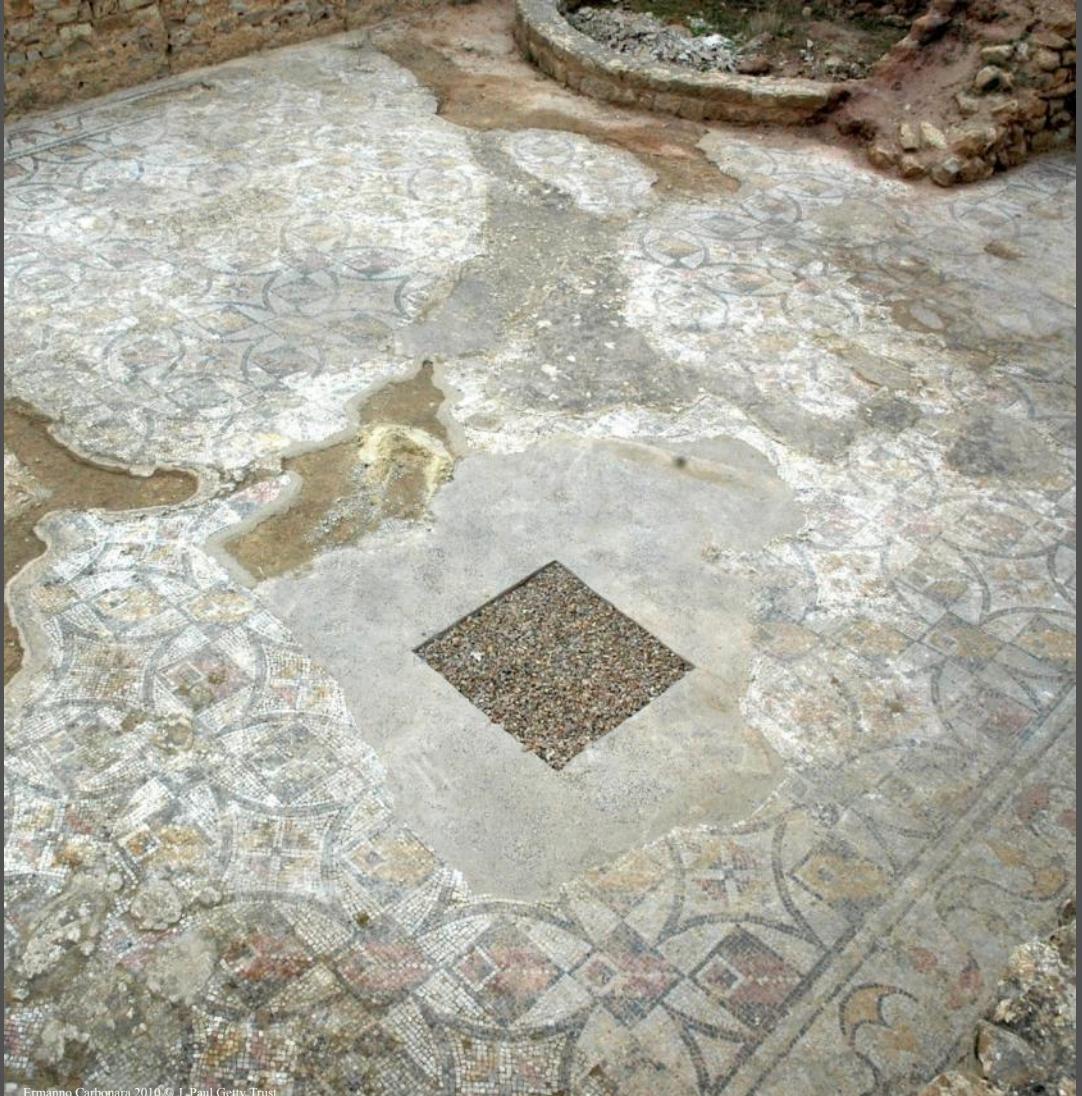
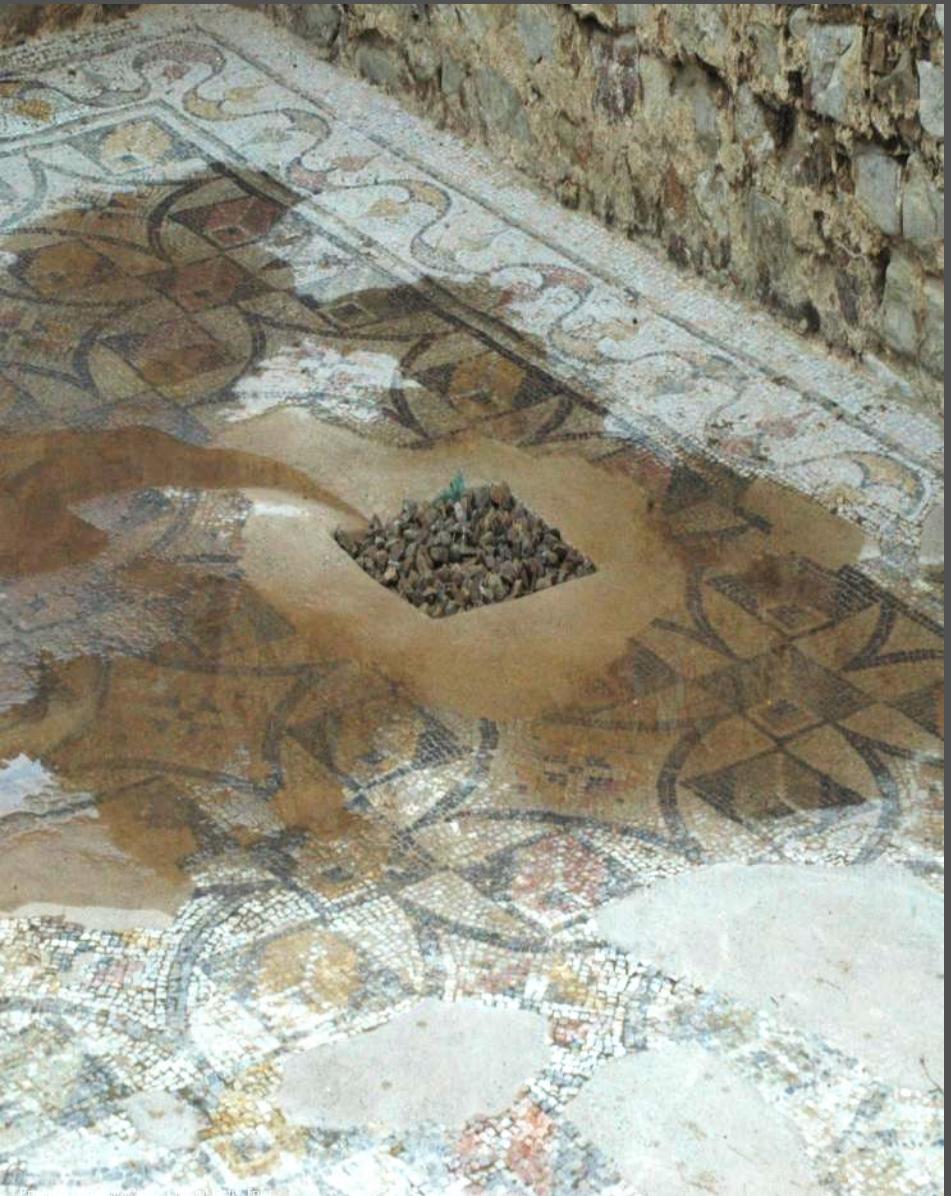
Water drainage systems

Drainage pit

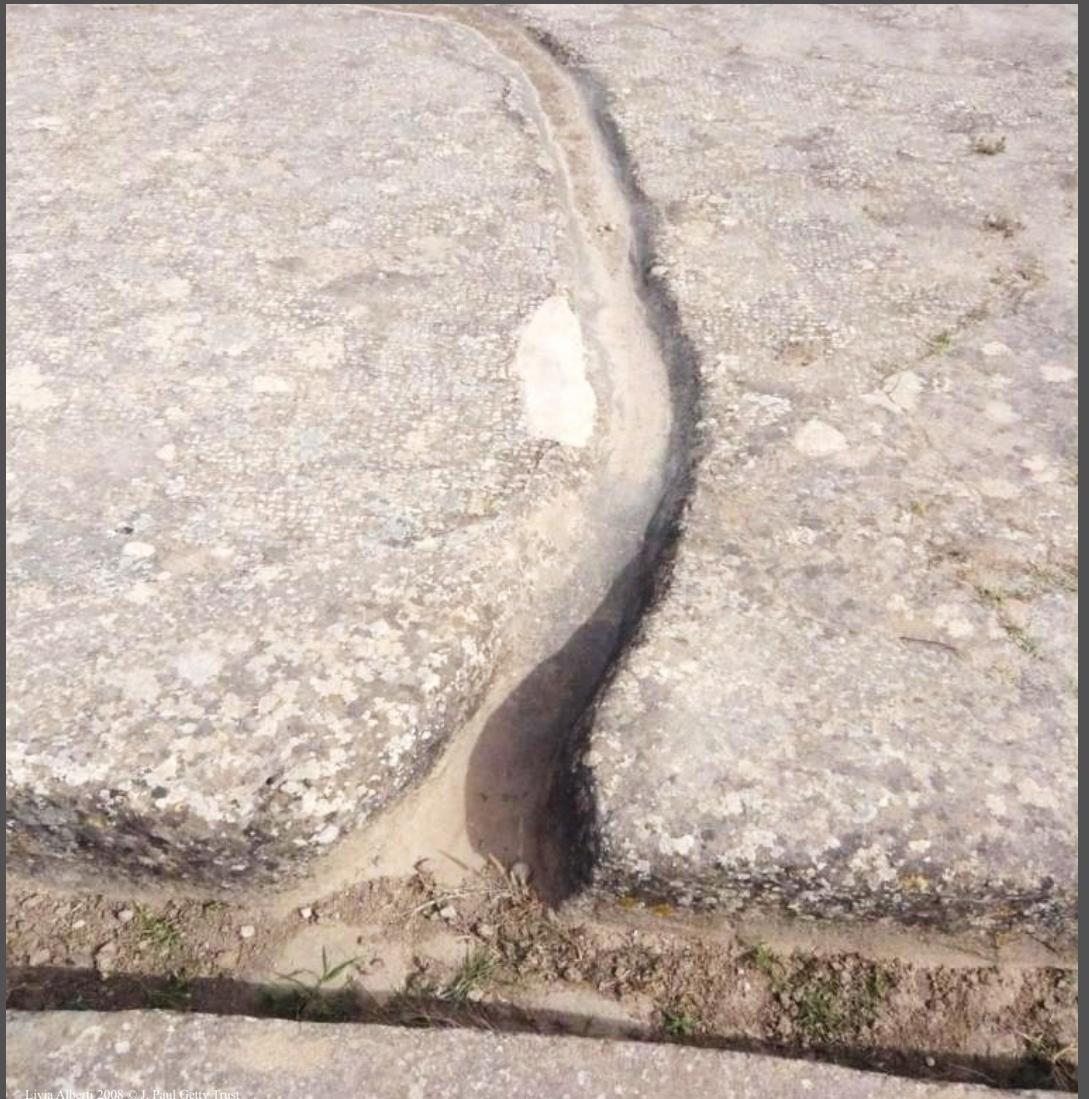
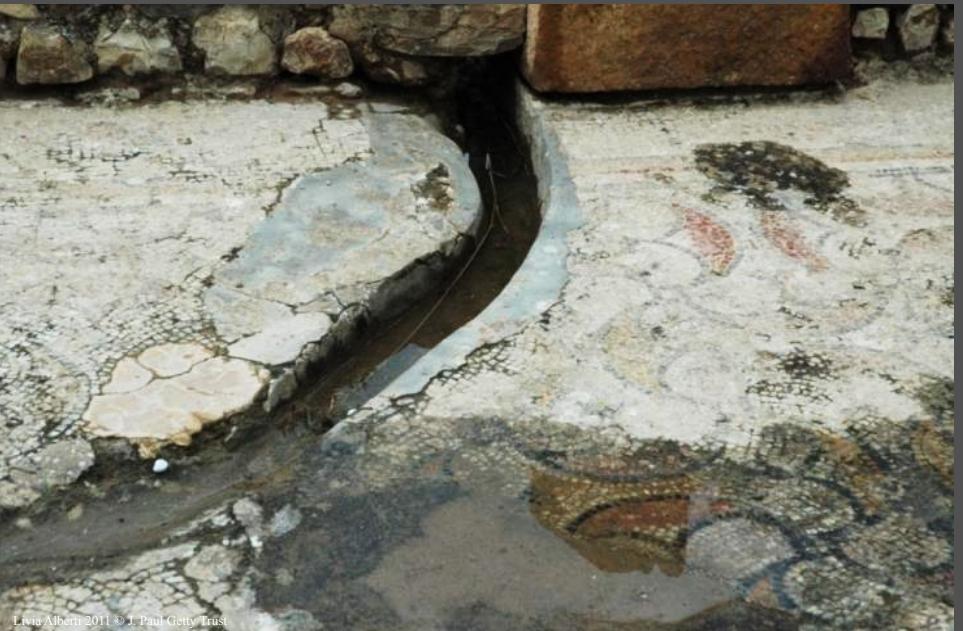
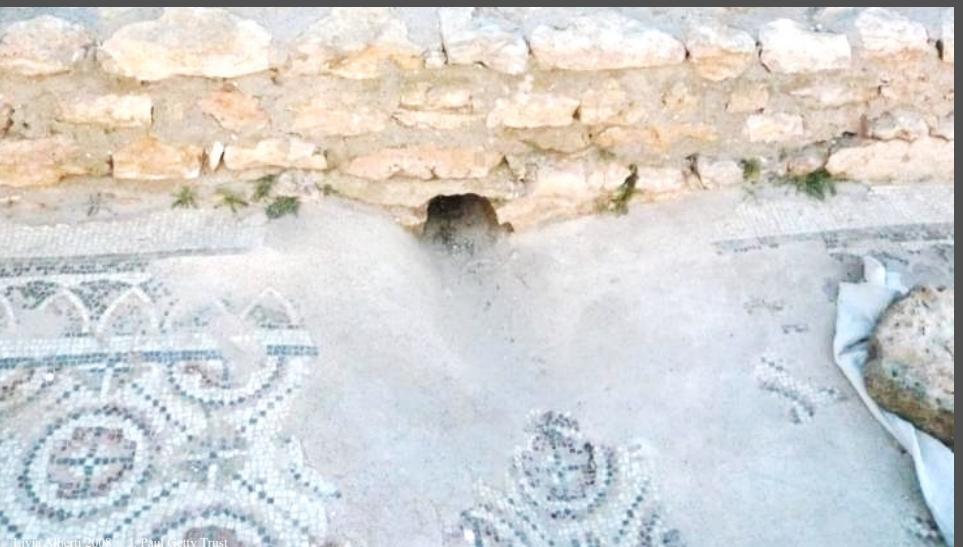
Water drainage systems

Water channel

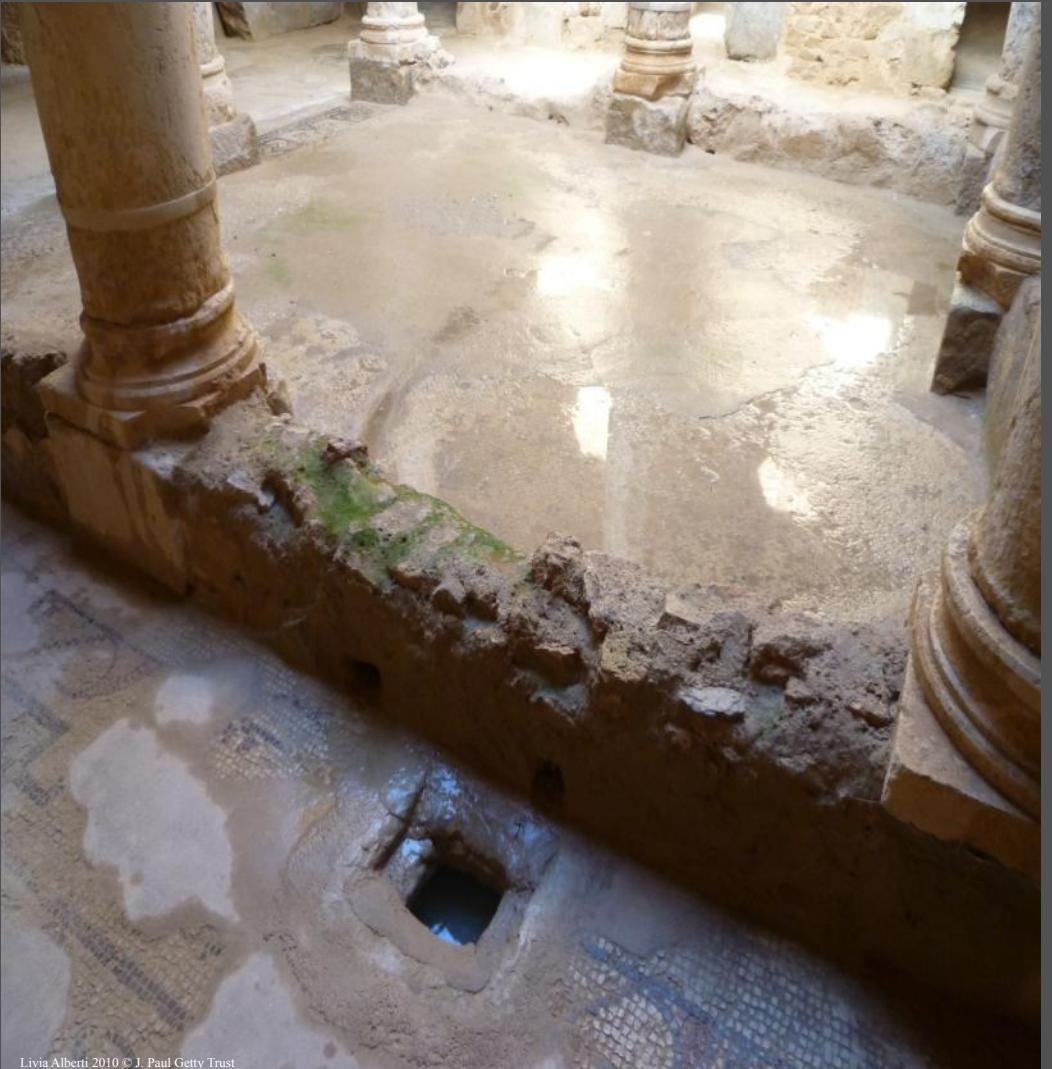
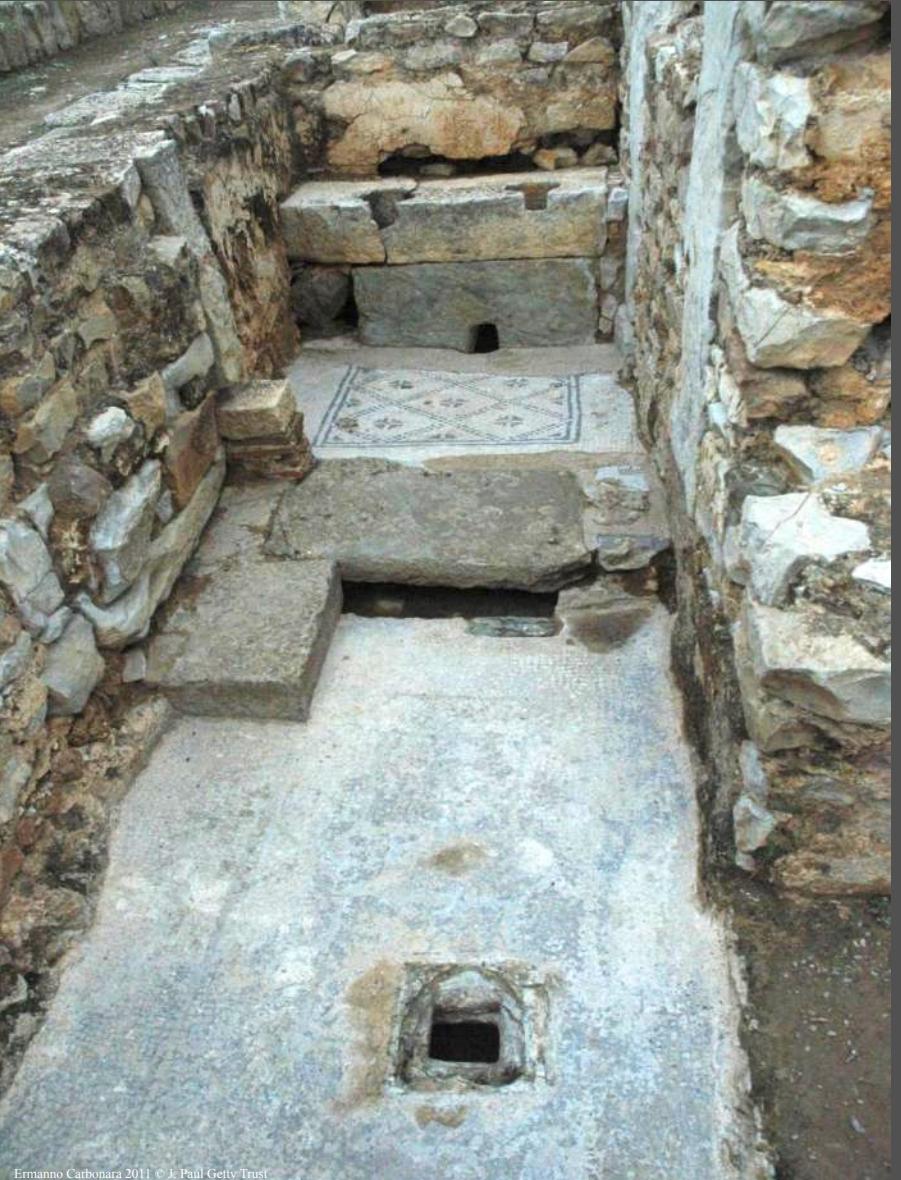
Water drainage systems

Re-use of ancient drainage

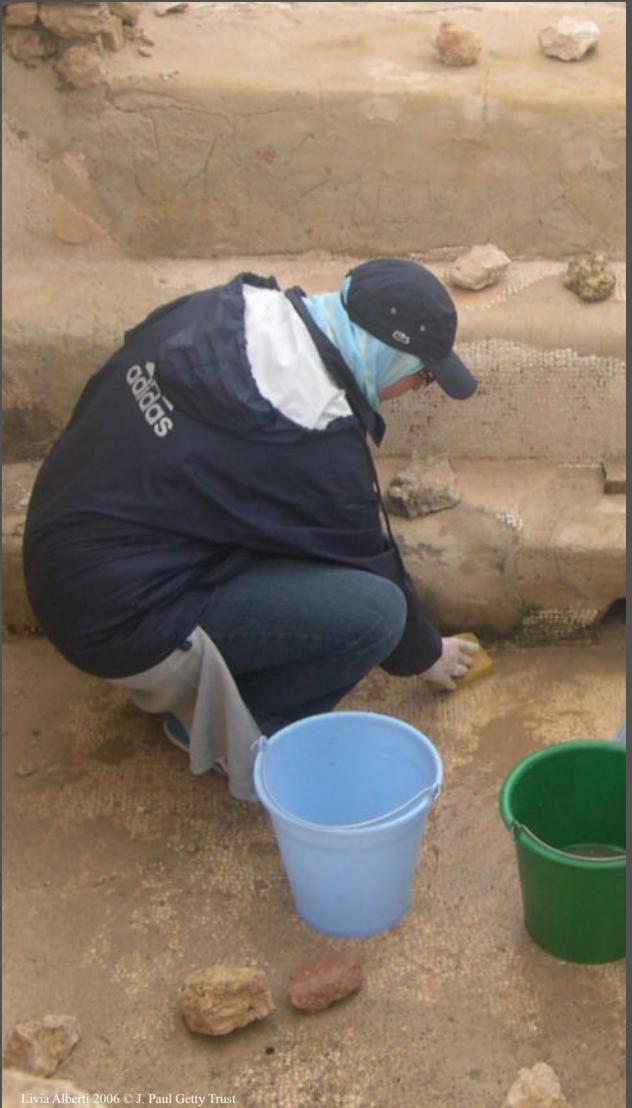
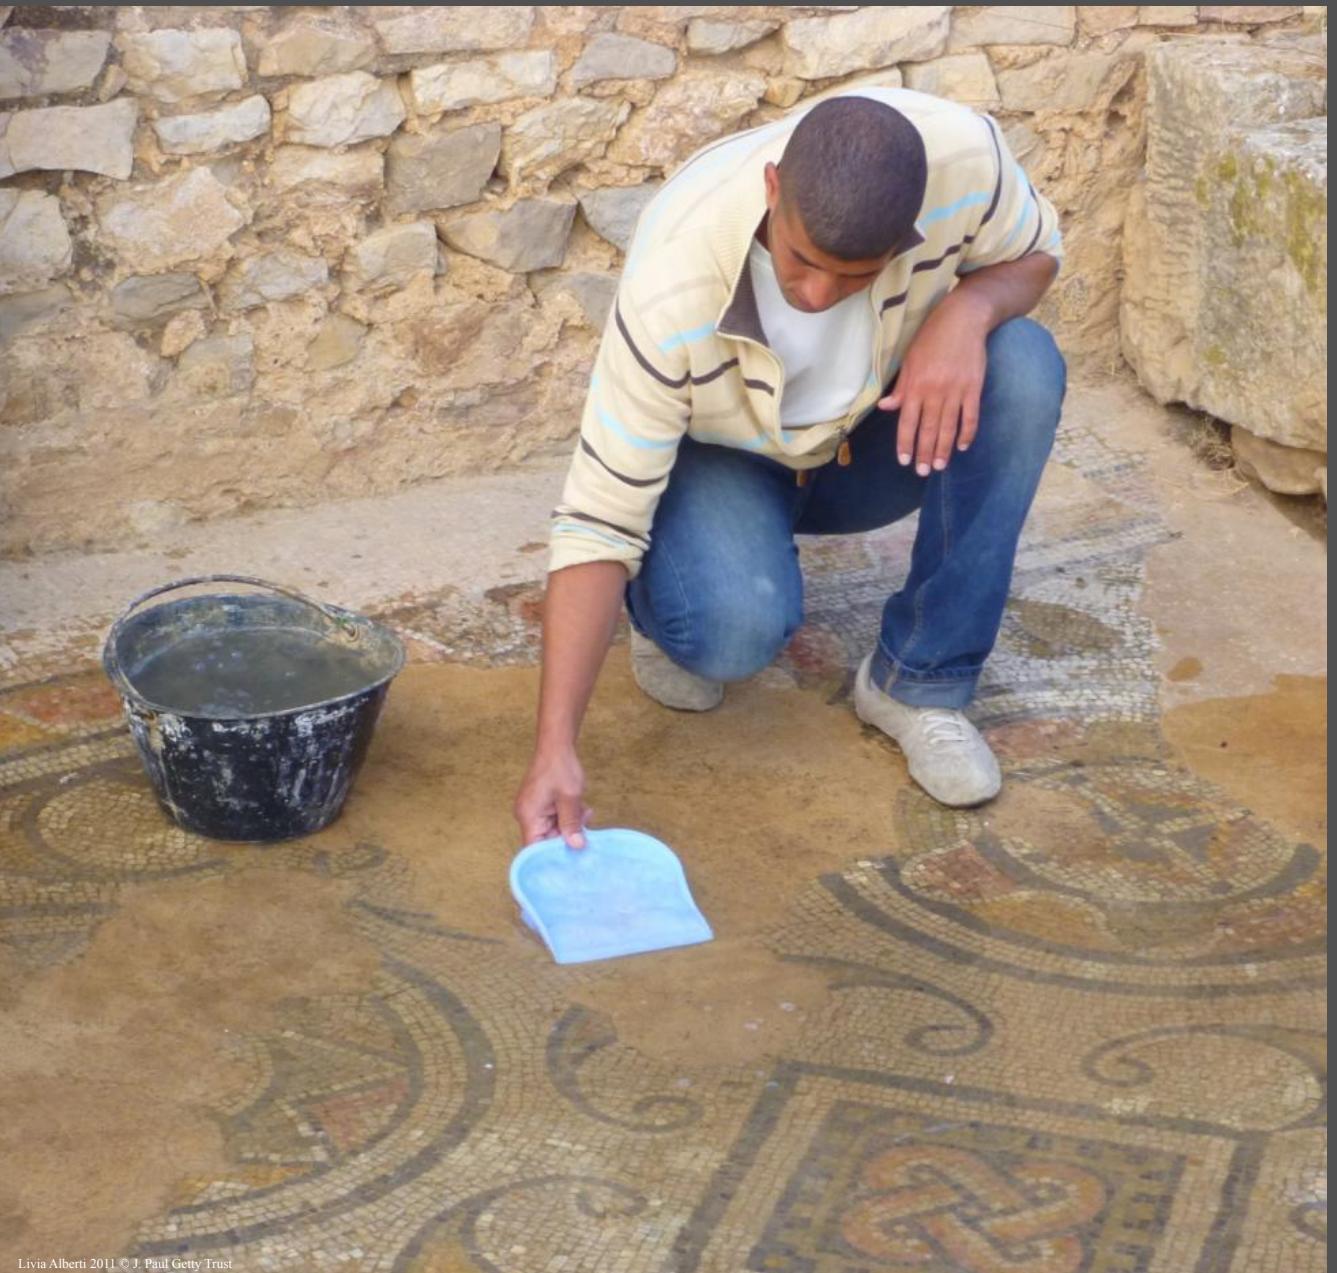
Maintenance

Manual removal of rain water

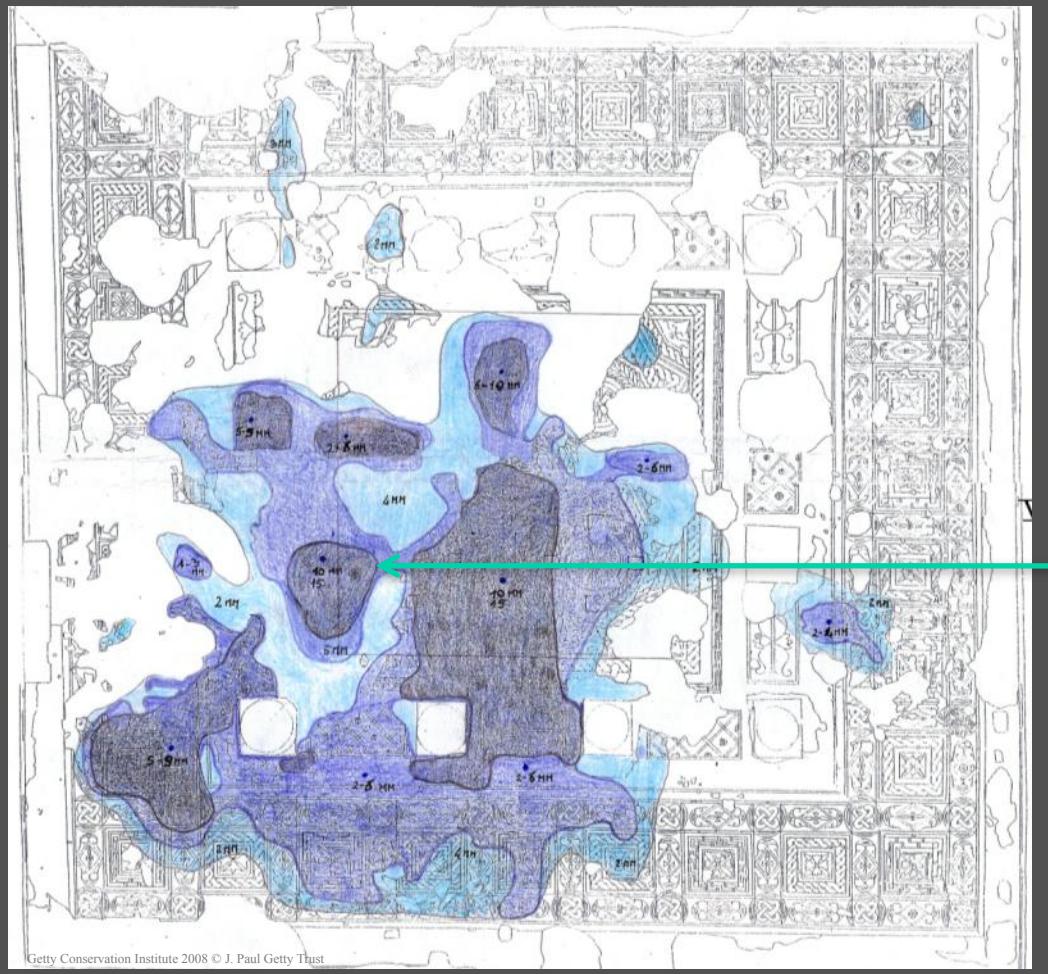
Water pooling map
