TECHNICIAN TRAINING FOR THE CONSERVATION OF MOSAICS

PART 1
THE CONSERVATION OF IN SITU MOSAICS

Water drainage interventions

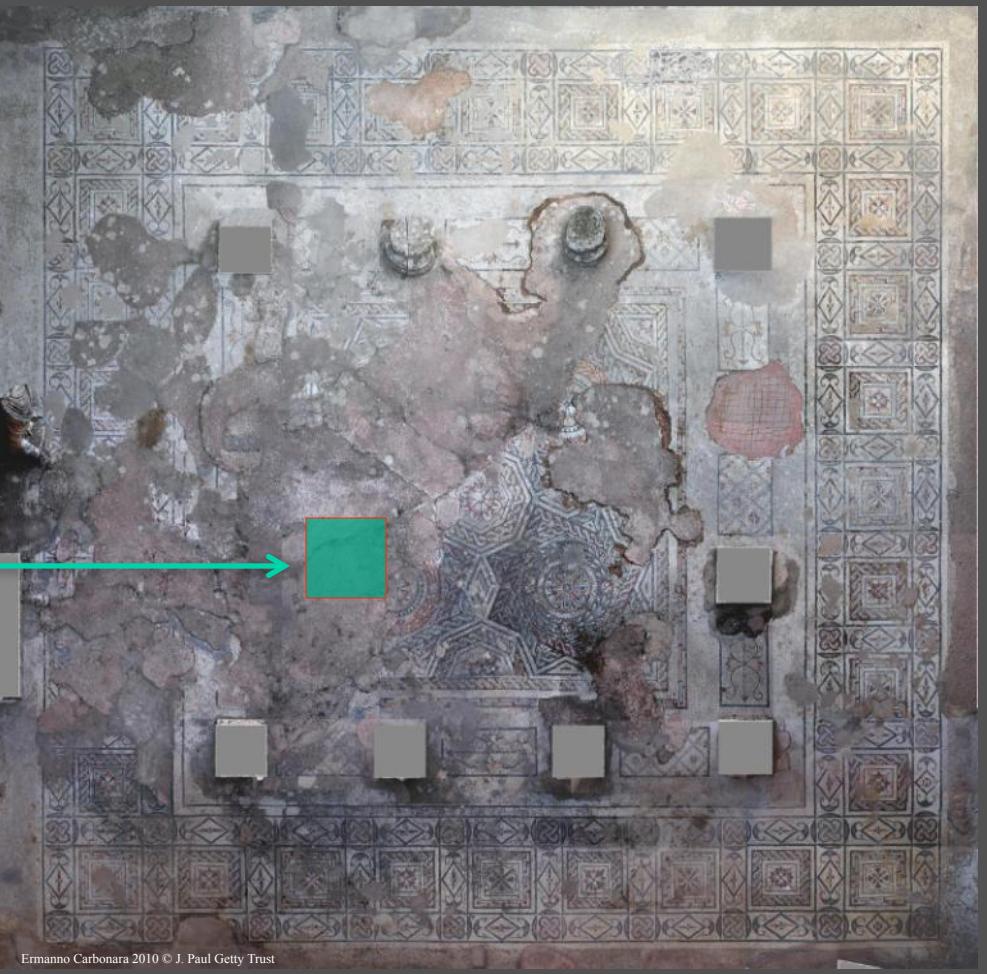
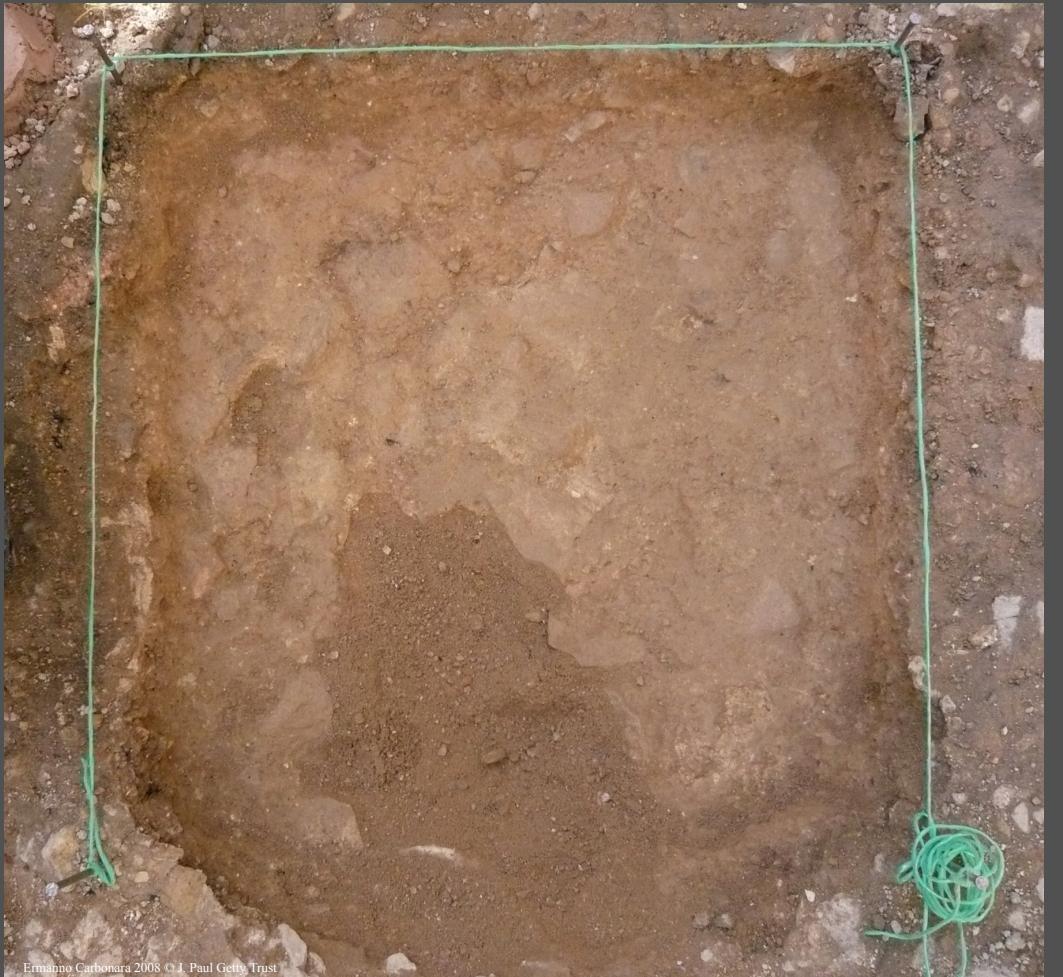
Excavation of the pit

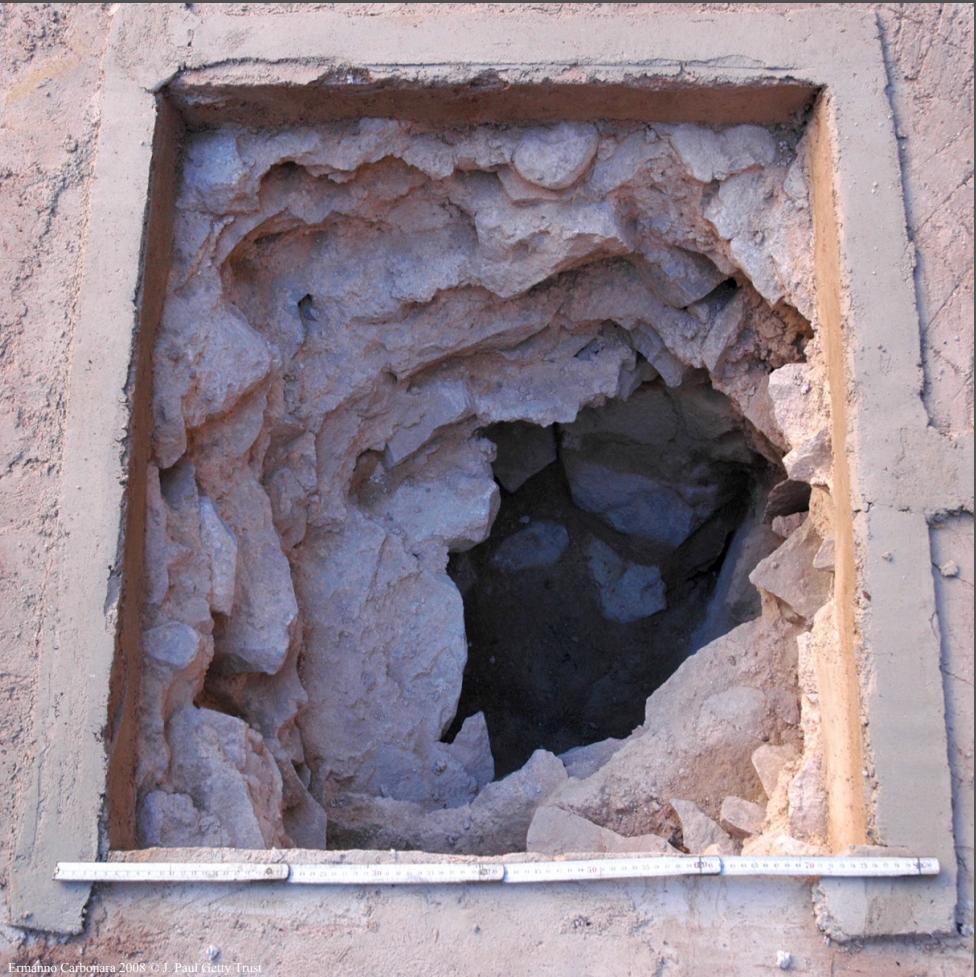
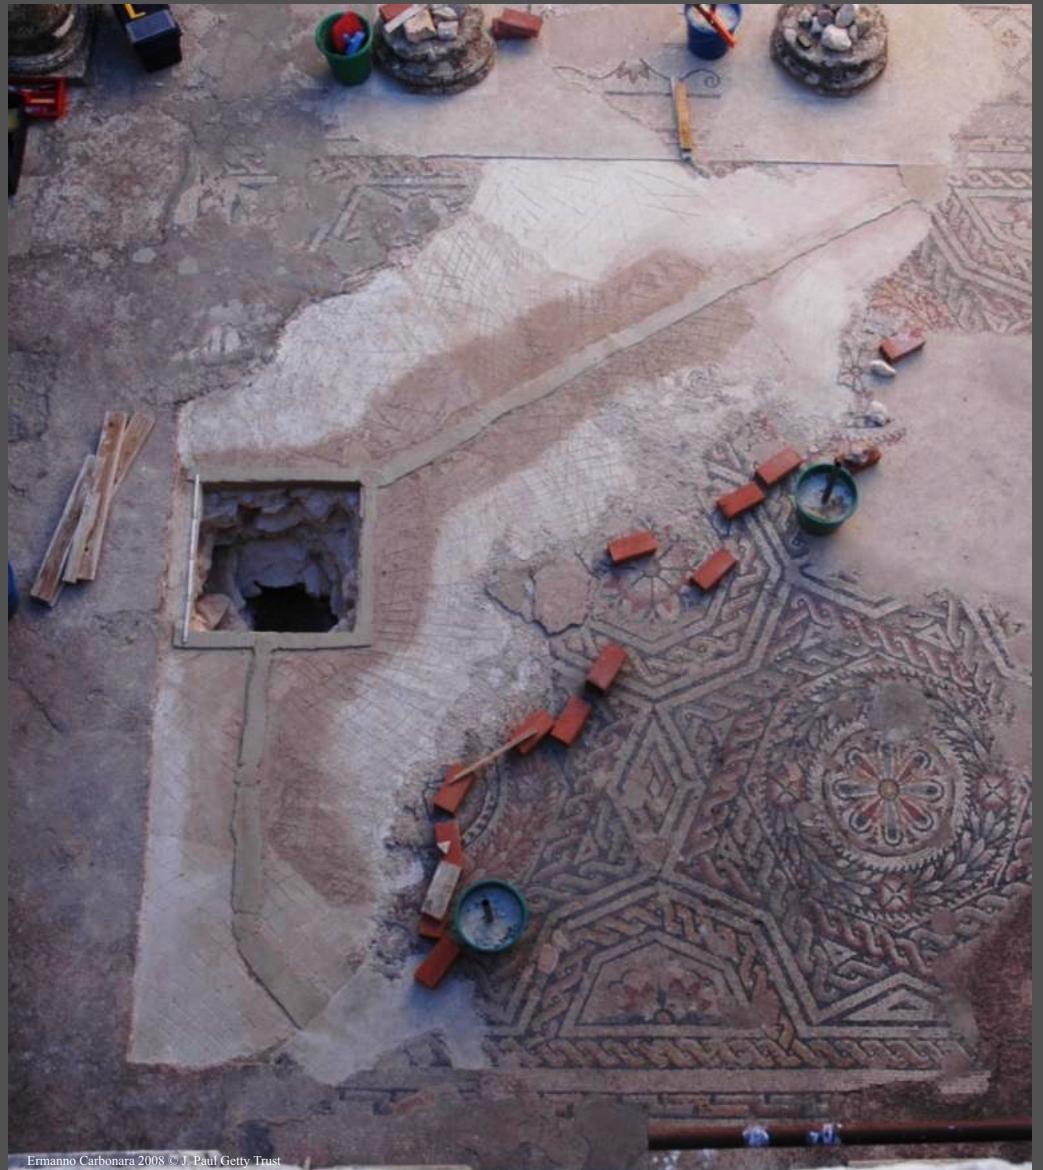
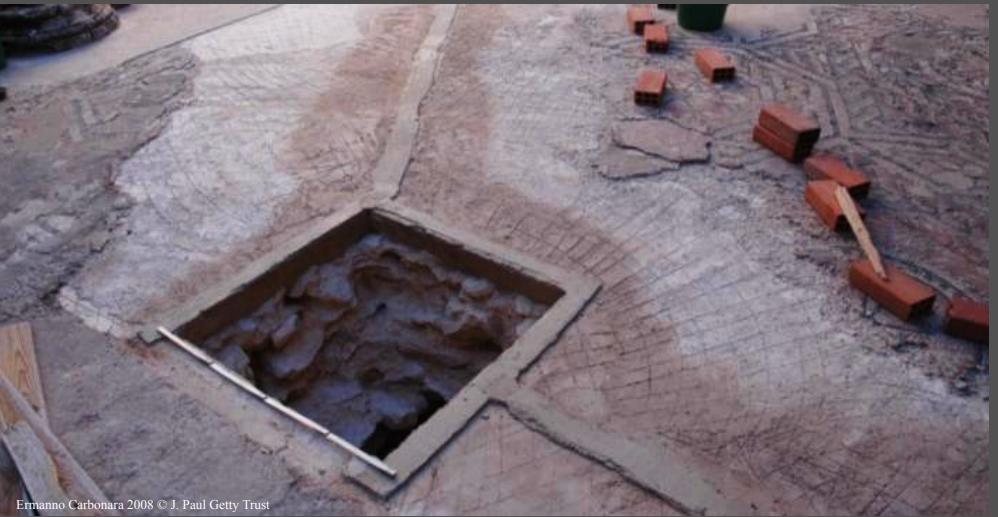
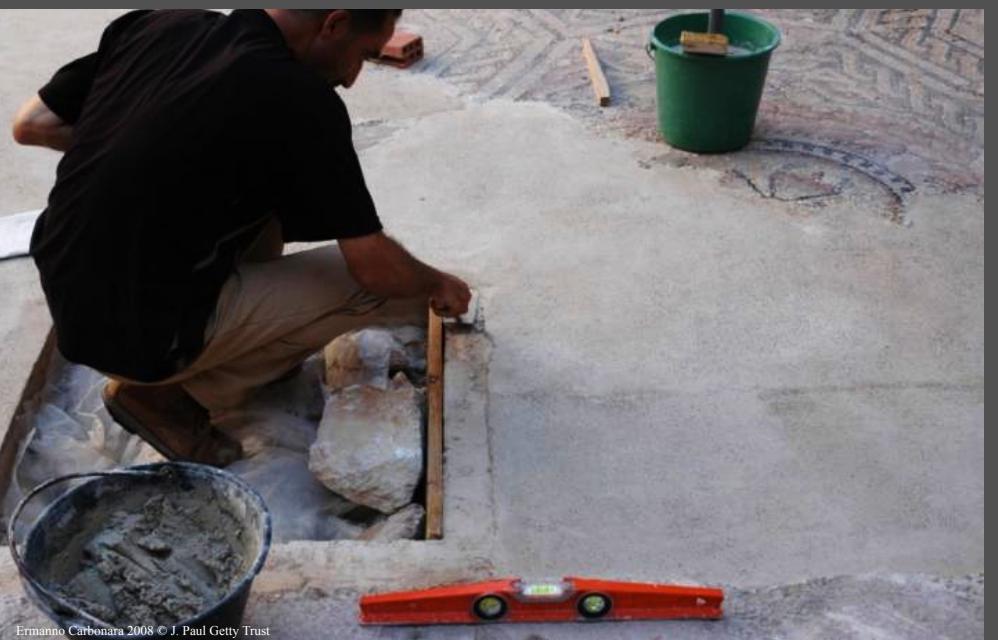
In-filling of lacuna with slope toward the drainage pit

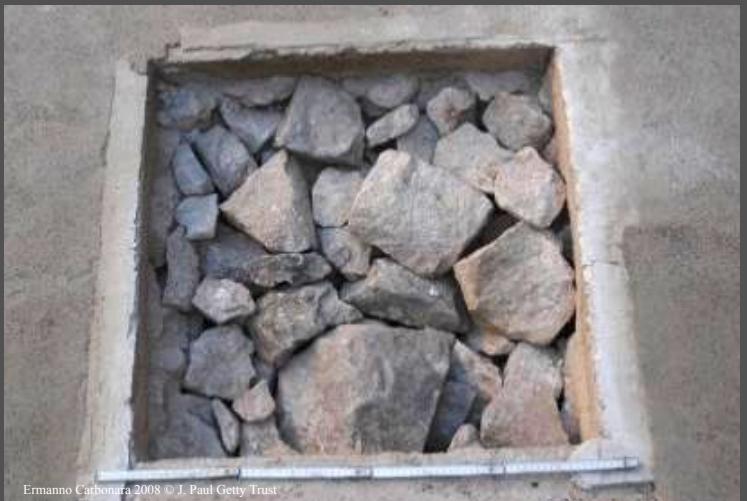
Filling the pit with drainage materials

1 – large stones

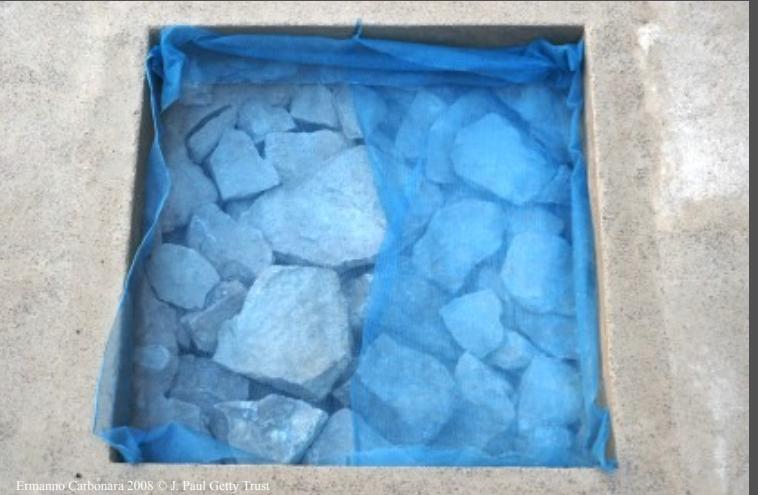
2 – separation membrane

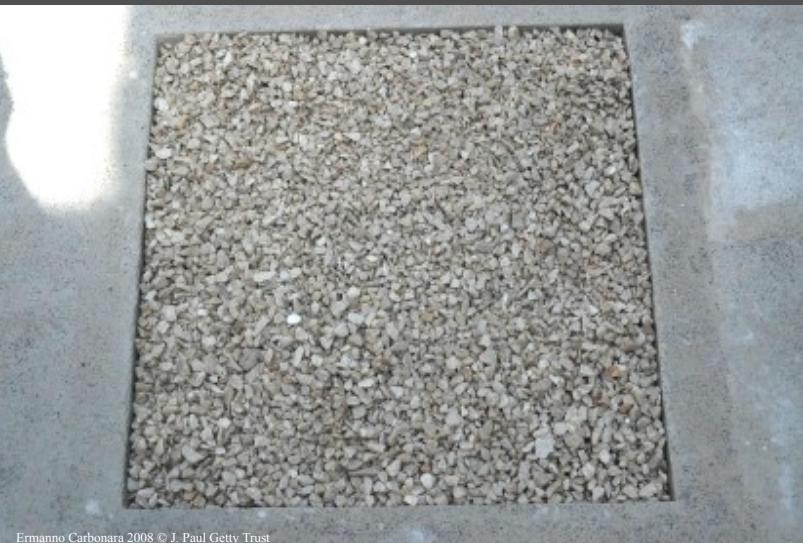
3 – gravel

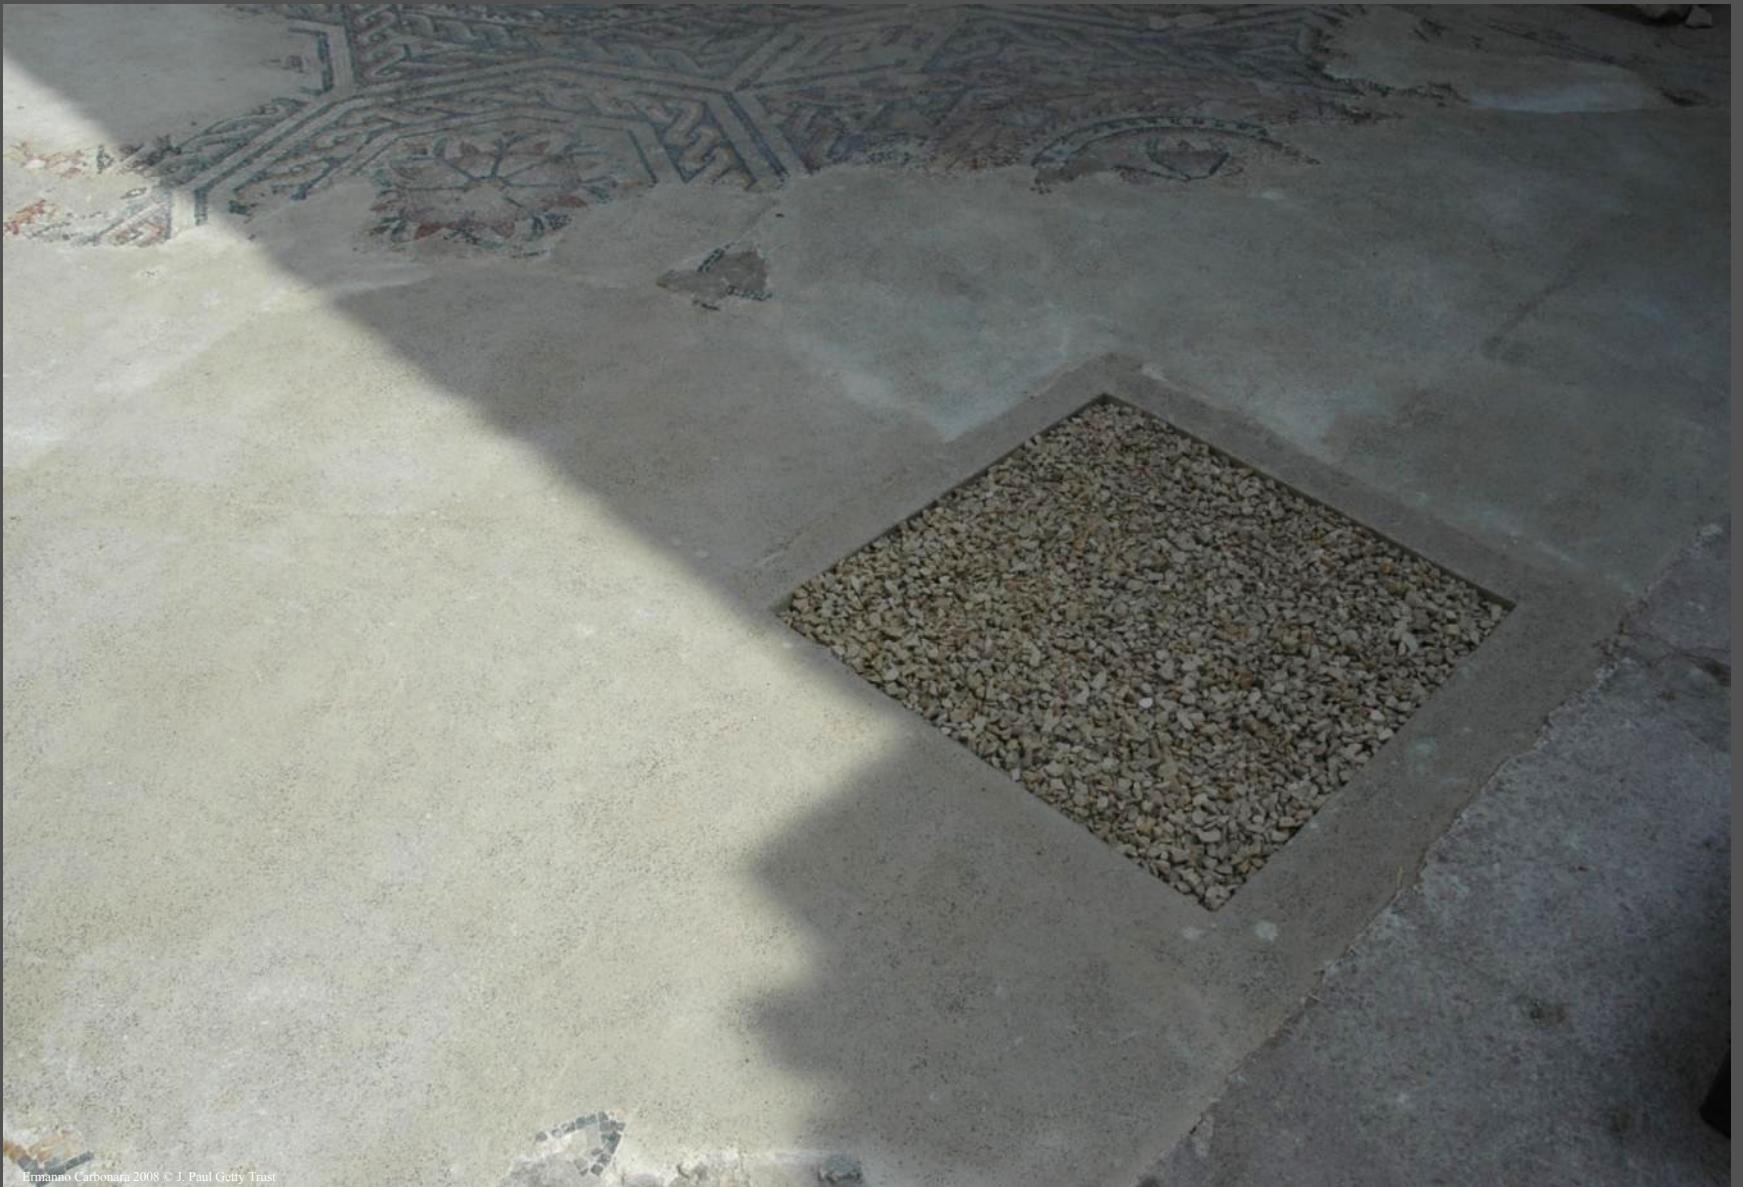
Completed drainage pit

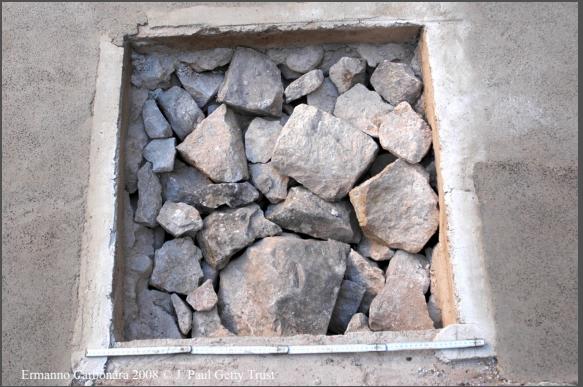
1 – large stones

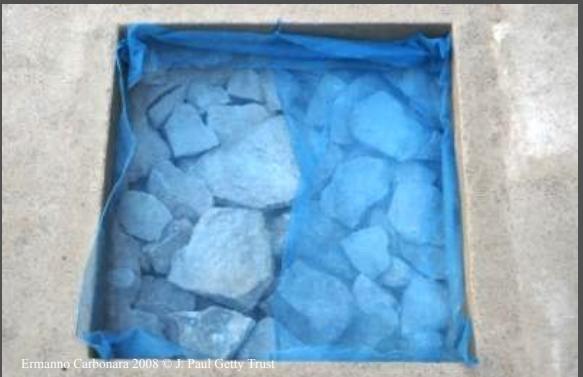
2 – separation
membrane

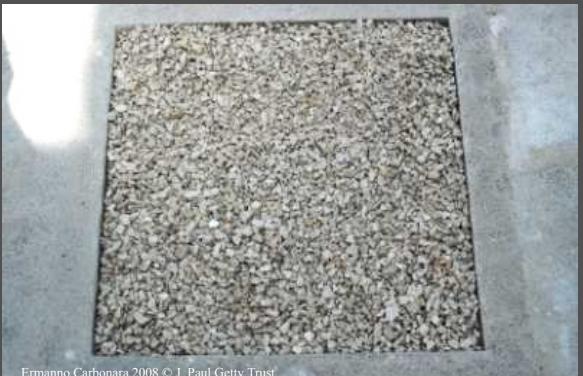
3 – gravel
