CENTENNIAL HALL IN WROCŁAW CONSERVATION MANAGEMENT PLAN

Autors (except chapter 6.): Jerzy Ilkosz, Hana Červinková, Grzegorz Grajewski, Jędrzej Nawara, Jadwiga Urbanik

Museum of Architecture in Wrocław
Wrocław 2016

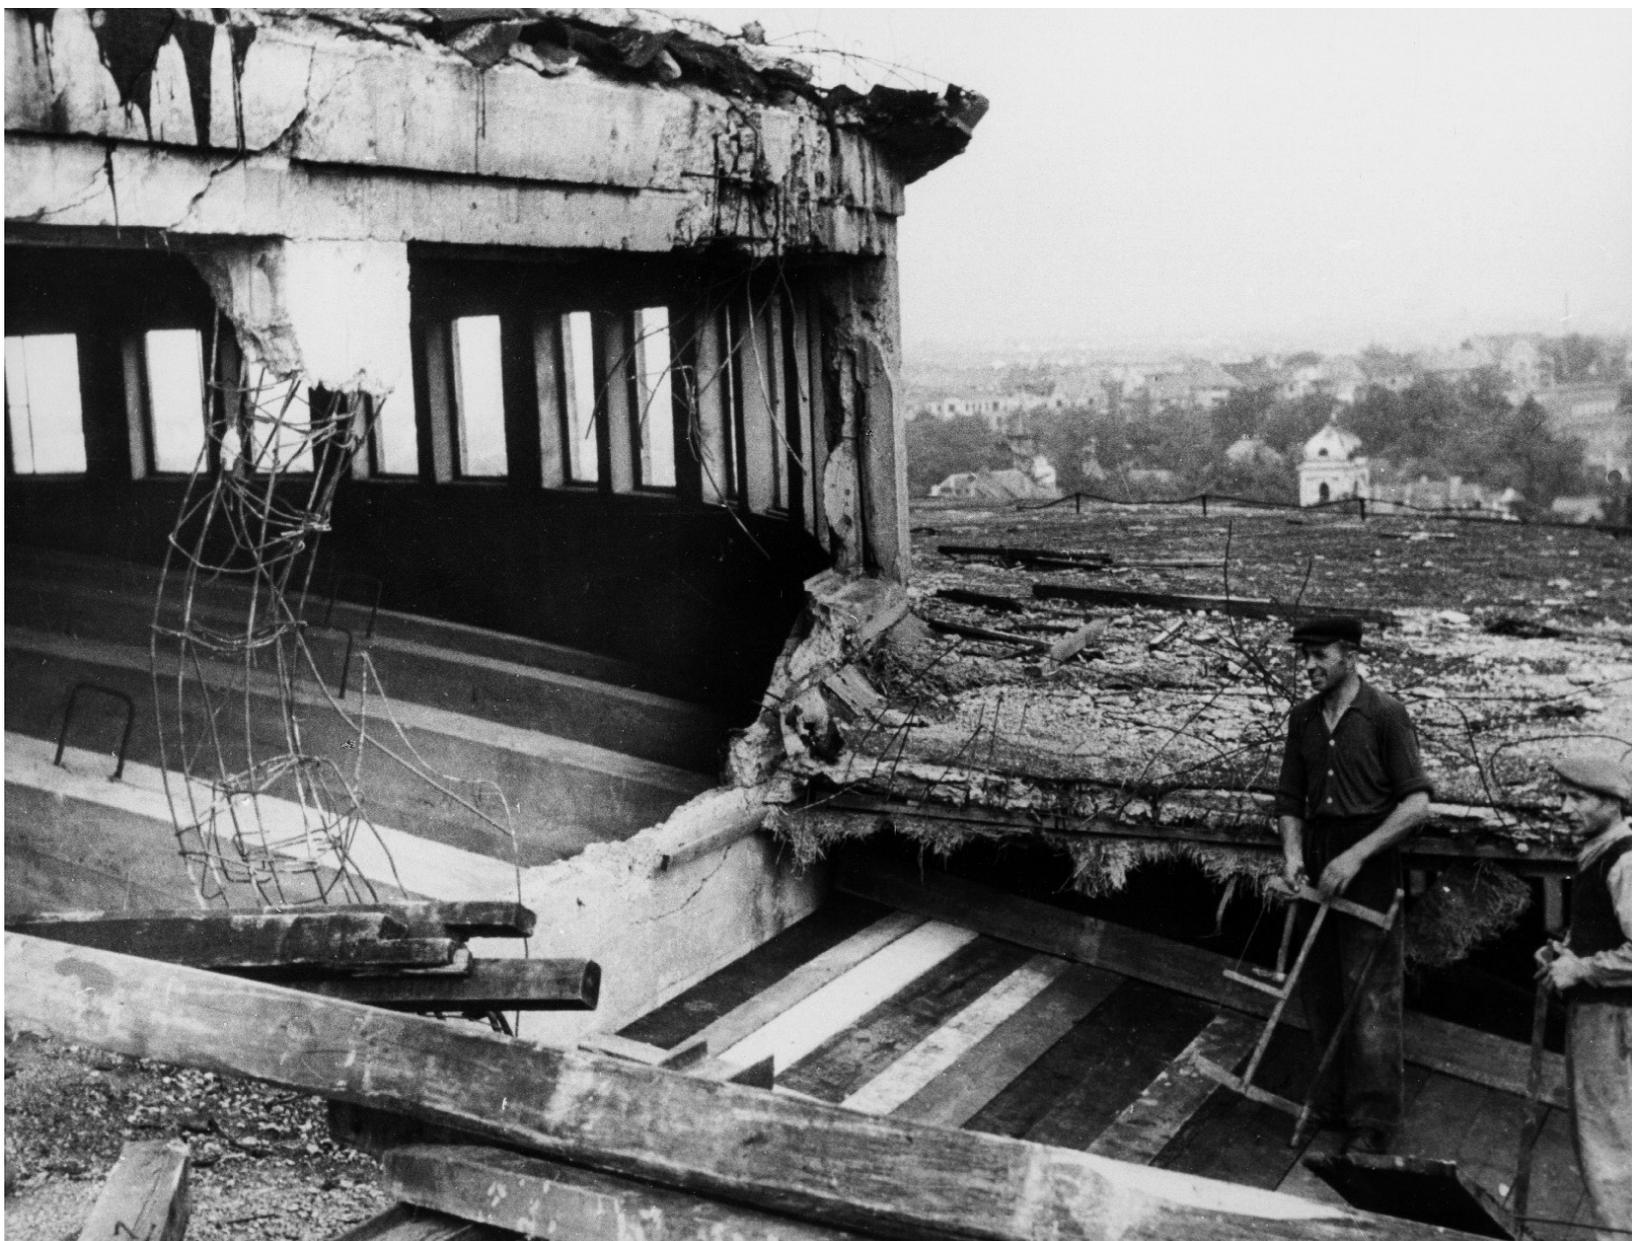
101 War damage to the Centennial Hall, photograph, 1945. Ossolineum, Wrocław

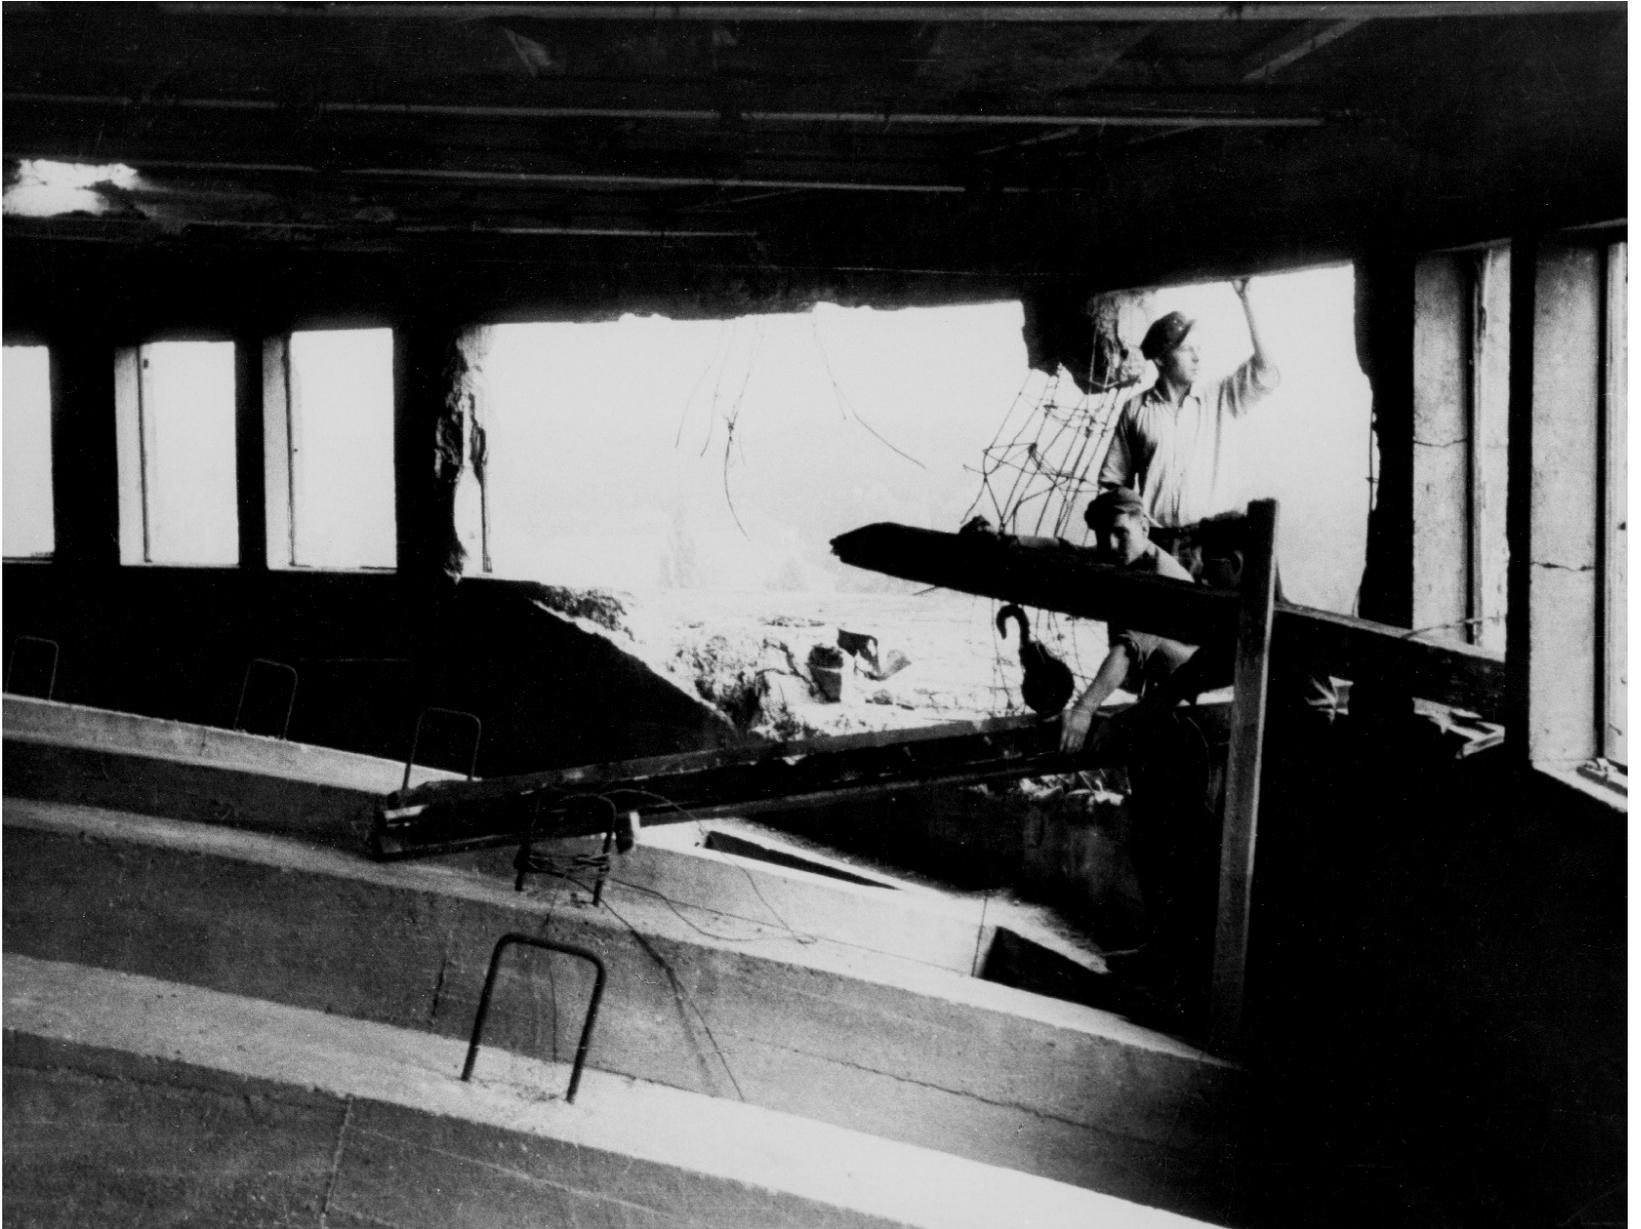
102 War damage to the Centennial Hall, photograph, 1945. Ossolineum, Wrocław

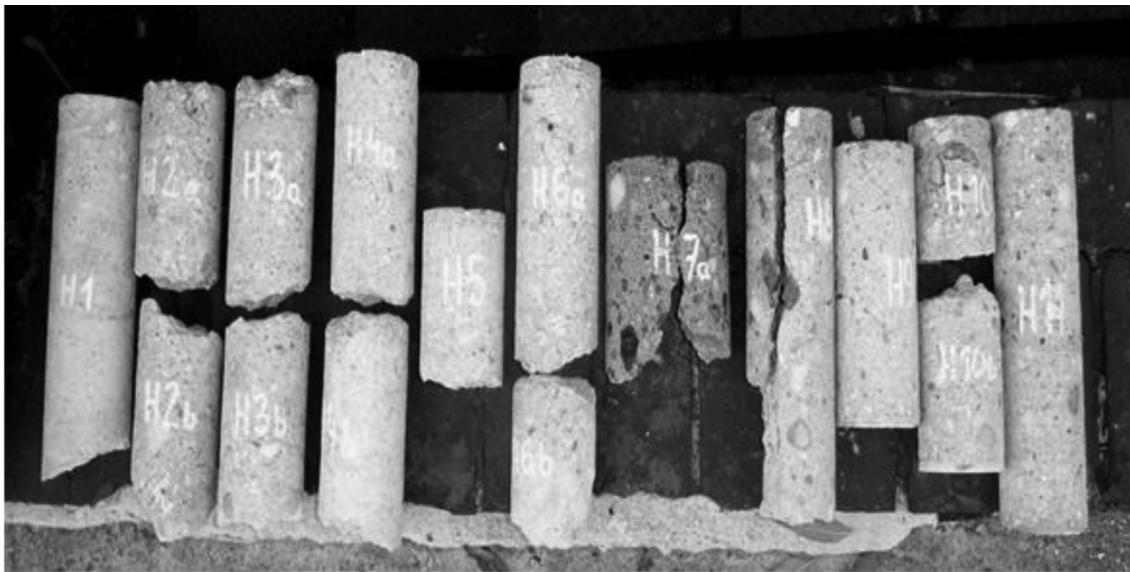
Fig. 3.1. Core samples, [4].

Eleven boreholes were made with a $\varnothing 80$ drill I (fig 3.1) as described in [4] in order to determine strength parameters and assess the absorbability of structural concrete. Core samples were extracted in selected locations in the Centennial Hall structure.

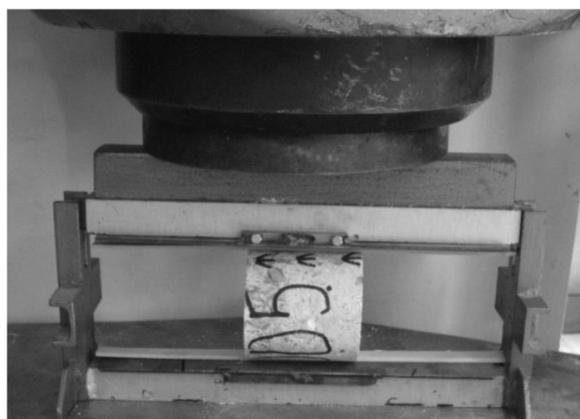
Fig. 3.25. The stand for concrete tensile failure testing.

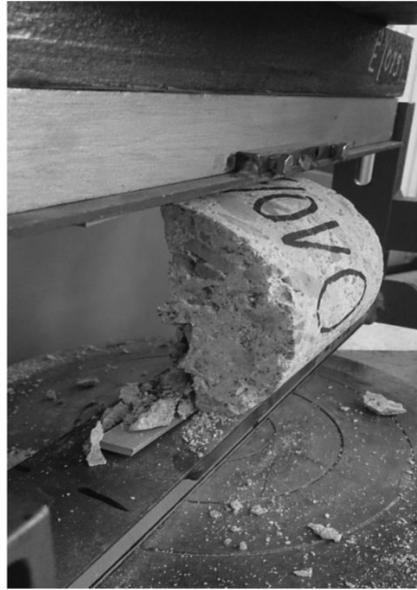
Fig. 3.39. Specimen **O-A1/1** after tensile failure.

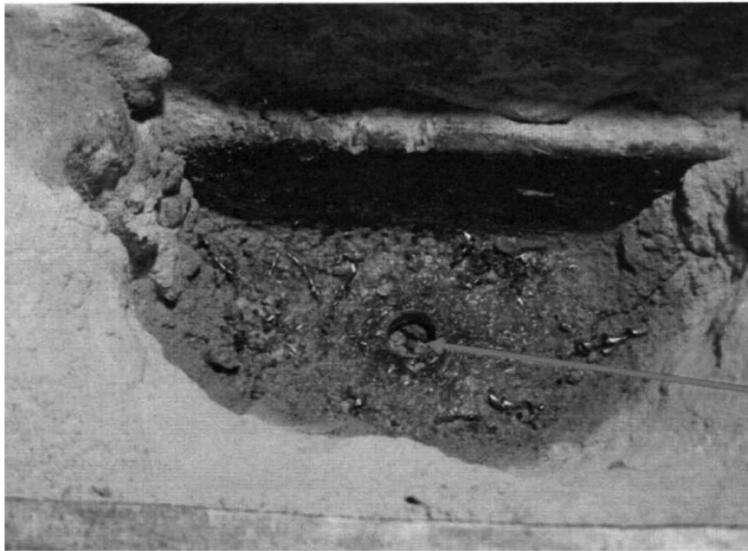
Fig. 3.64. Location of extraction of sample no 4 from the cross-bracing, [30].

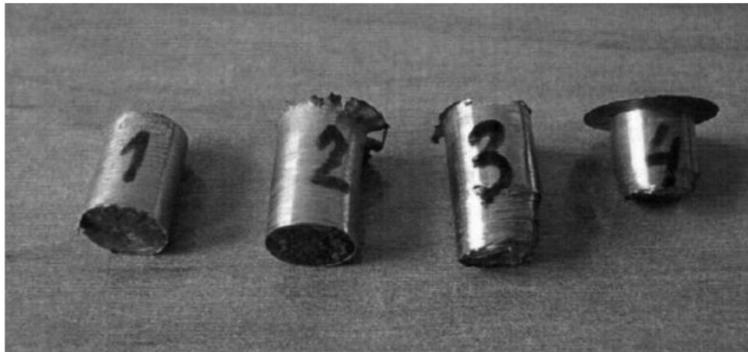
Fig. 3.65. Samples for testing, [30].

Thickness was measured on polished metallographic sections using a calliper with 0.1mm accuracy. The results were presented along with photomicrographs of the structures.

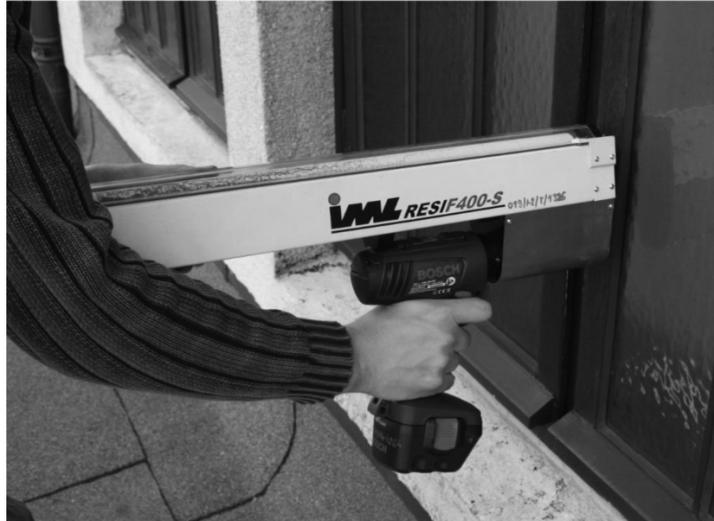
Fig. 3.80. The IML RESI F-400S device used for resistance drilling tests.

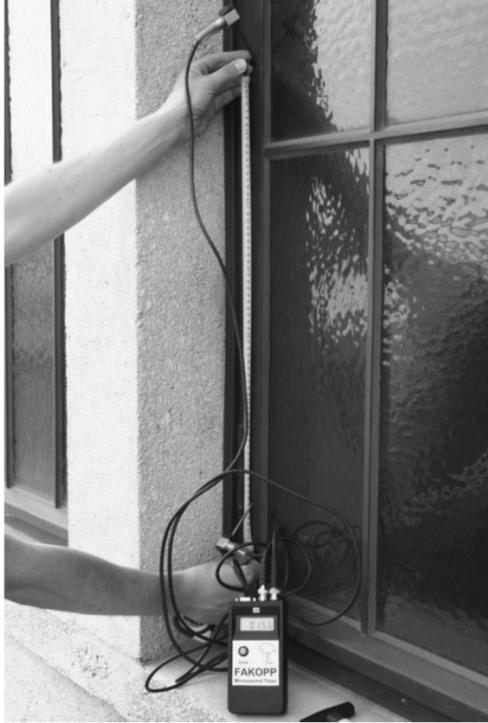
Fig. 3.94. The Fakopp Microsecond Timer device for stress wave testing.

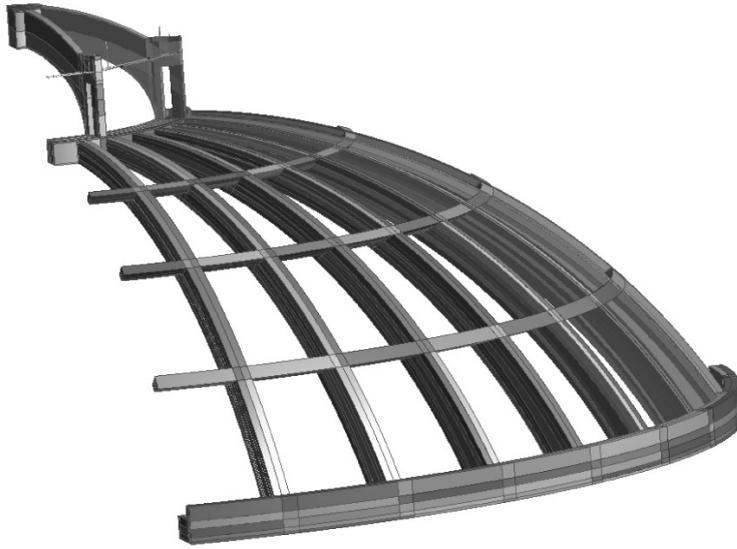
Fig. 4.103. The geometry of the load-bearing structure (a).

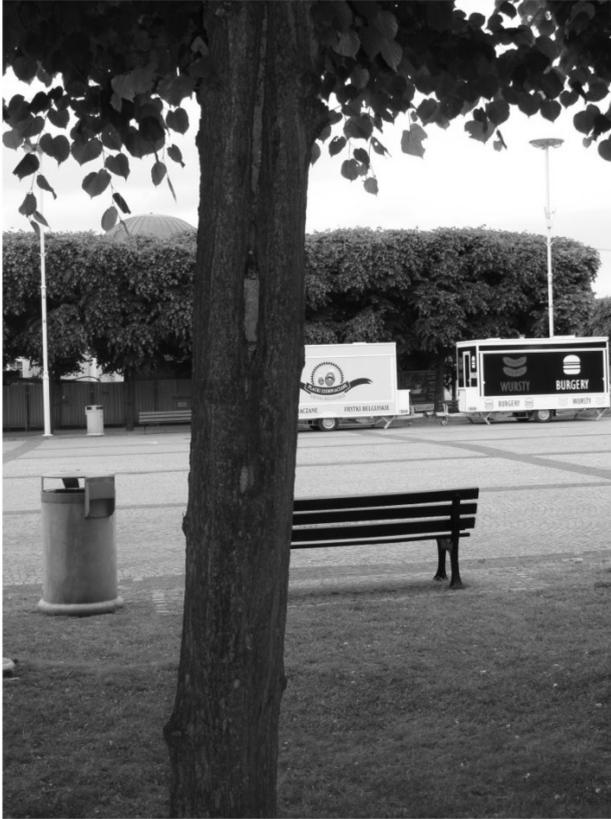
2.3. No. 13 Linden – trunk fissure filled with brick rubble and mortar

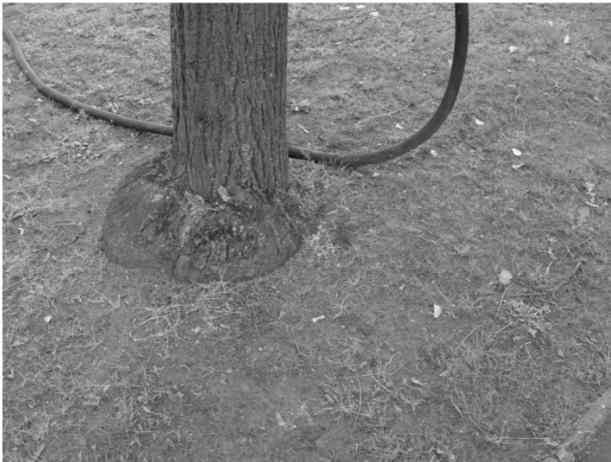
2.4. No. 15 Linden – callus traces of removed root offshoots on the trunk

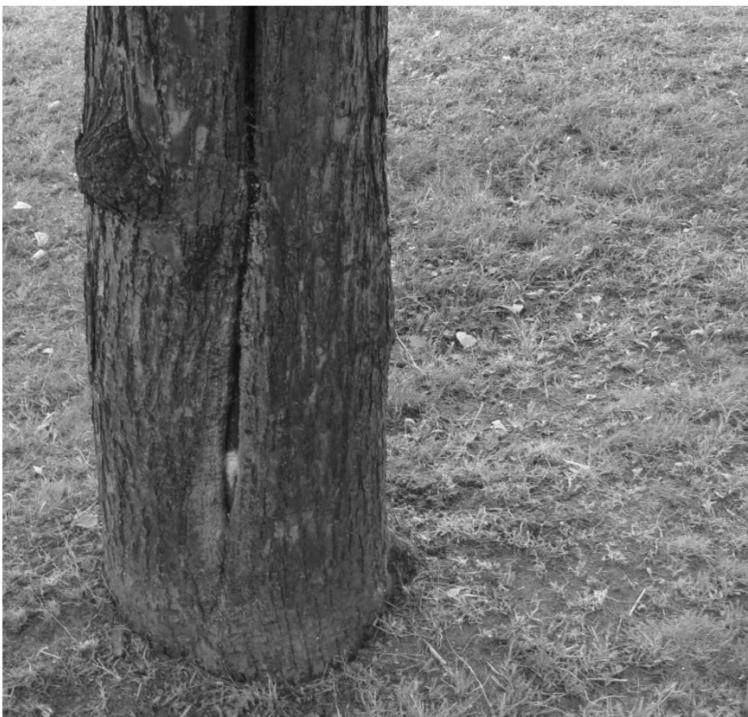
2.7b. No. 53 Linden – partly callus fissure on trunk

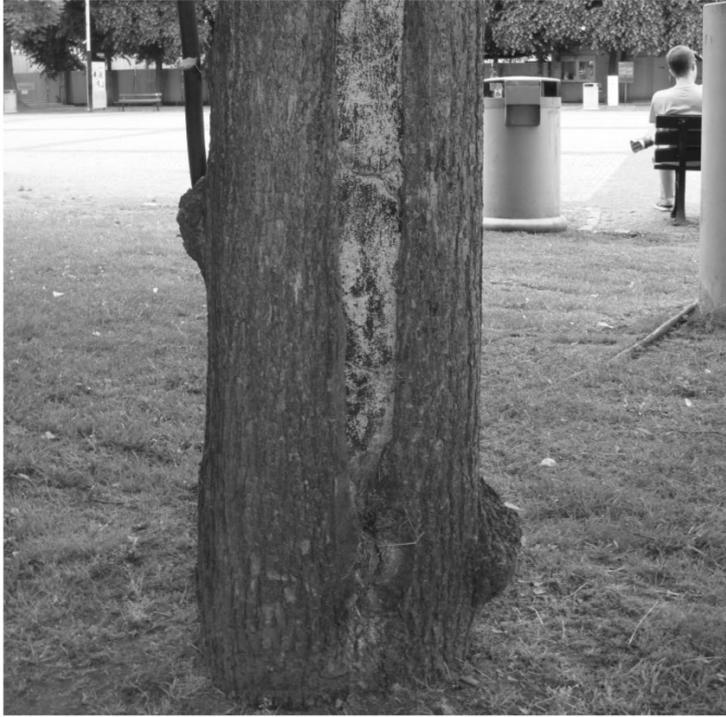
2.8. No. 64 Linden – fissure on the trunk filled with brick rubble and mortar

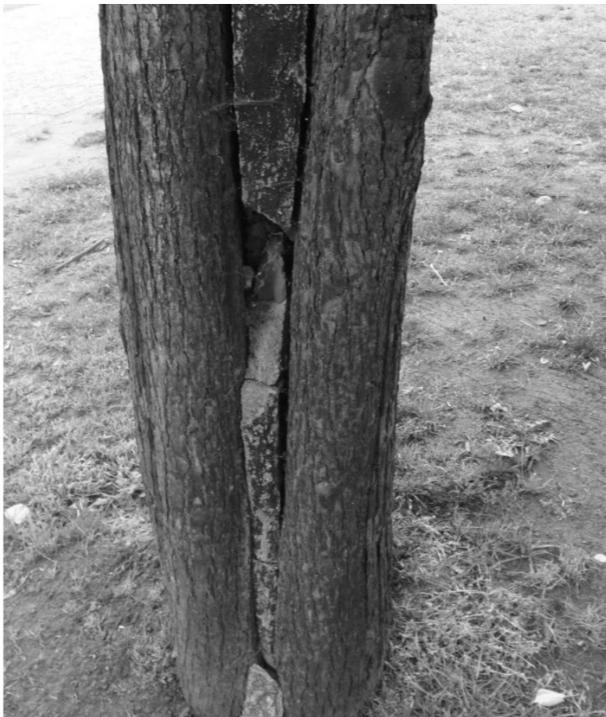
2.9. No. 68 Linden – cavity filled with brick rubble and mortar
