Keeping It Modern:  
**Centre International  
du Commerce Extérieur  
de Dakar (CICES)**

Conservation Management Plan  
01. 2023  
Dakar, Senegal

Written by  
Aziza Chaouni, Mourtada Gueye, Dana Salama

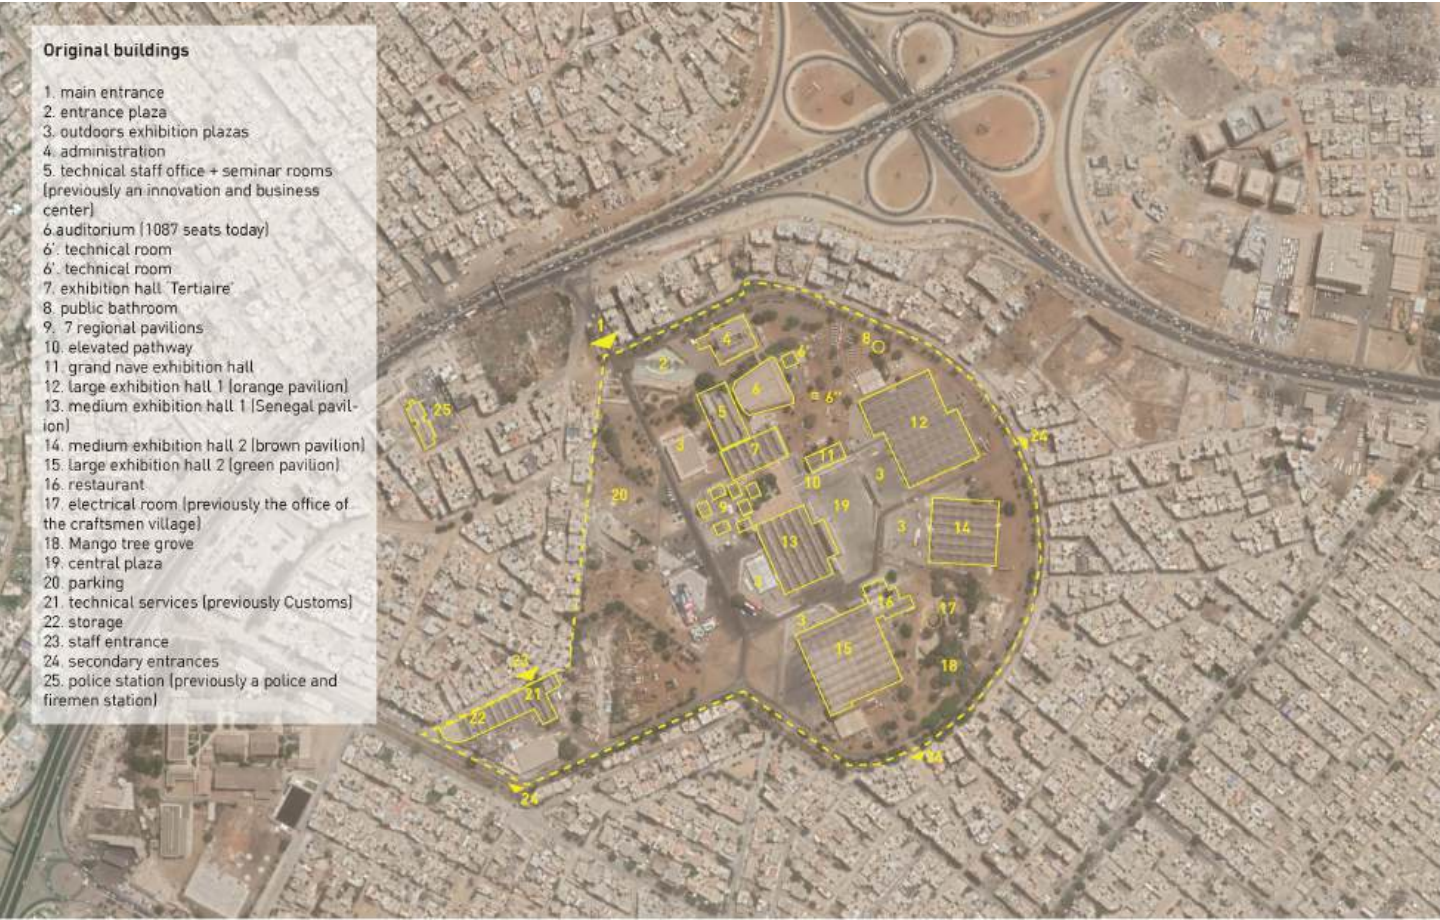
Fig.10: Original buildings of CICES on a satellite image of the site (2019) (Aziza Chaoui Projects, 2021).

Changes to the scope and scale of operations, as well as the shrinking of the site have further contributed to a sense of incoherence. The administration aisle (see figure 10, #4), which previously hosted the offices of the management staff of CICES, can now only house the offices of the directorship staff and the accounting team, which has grown in size. The service building (see figure 10, #21), where the customs and the technical team offices used to be, is currently a storage space, rented to private individuals.

- The geometric composition of the curvilinear road that forms the site's original boundary in relation to fanned placement of the Orange, Green and Yellow exhibition pavilions directly references African vernacular planning. This arrangement echoes the layouts of traditional villages, characterised by a rounded, non-hierarchical organisation. Similarly, the siting of the restaurant amongst mango groves presents similarities with the layout of typical African villages [despite the fact that the booths are squares and organised along a grid] (figure 10)

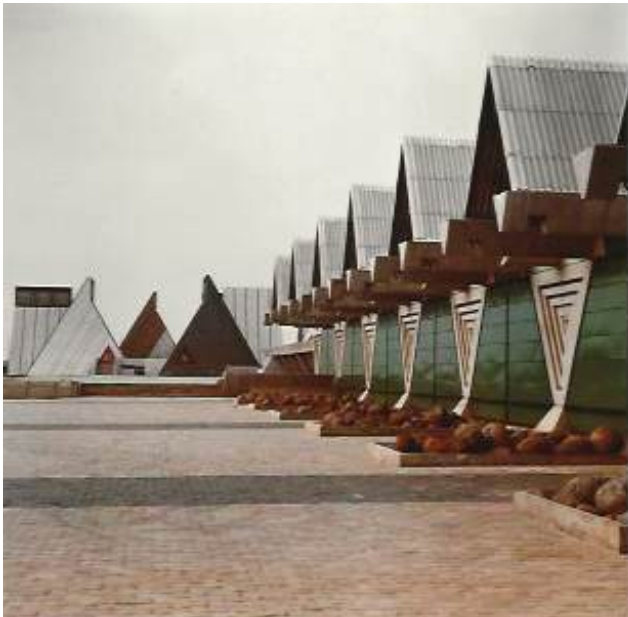
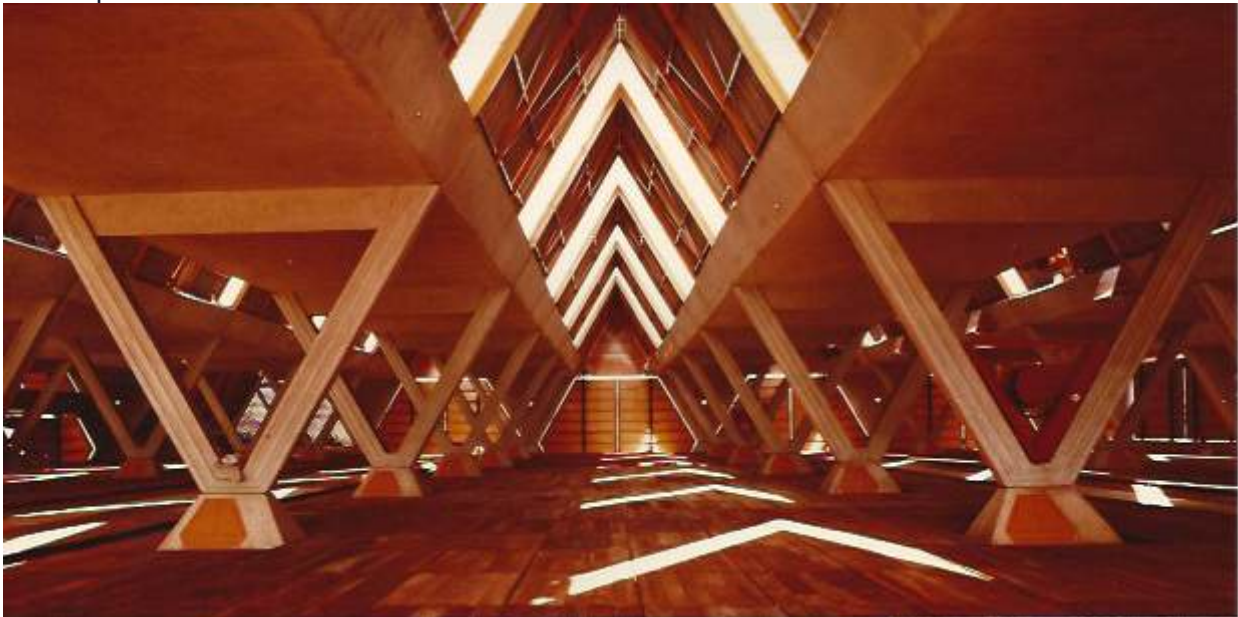
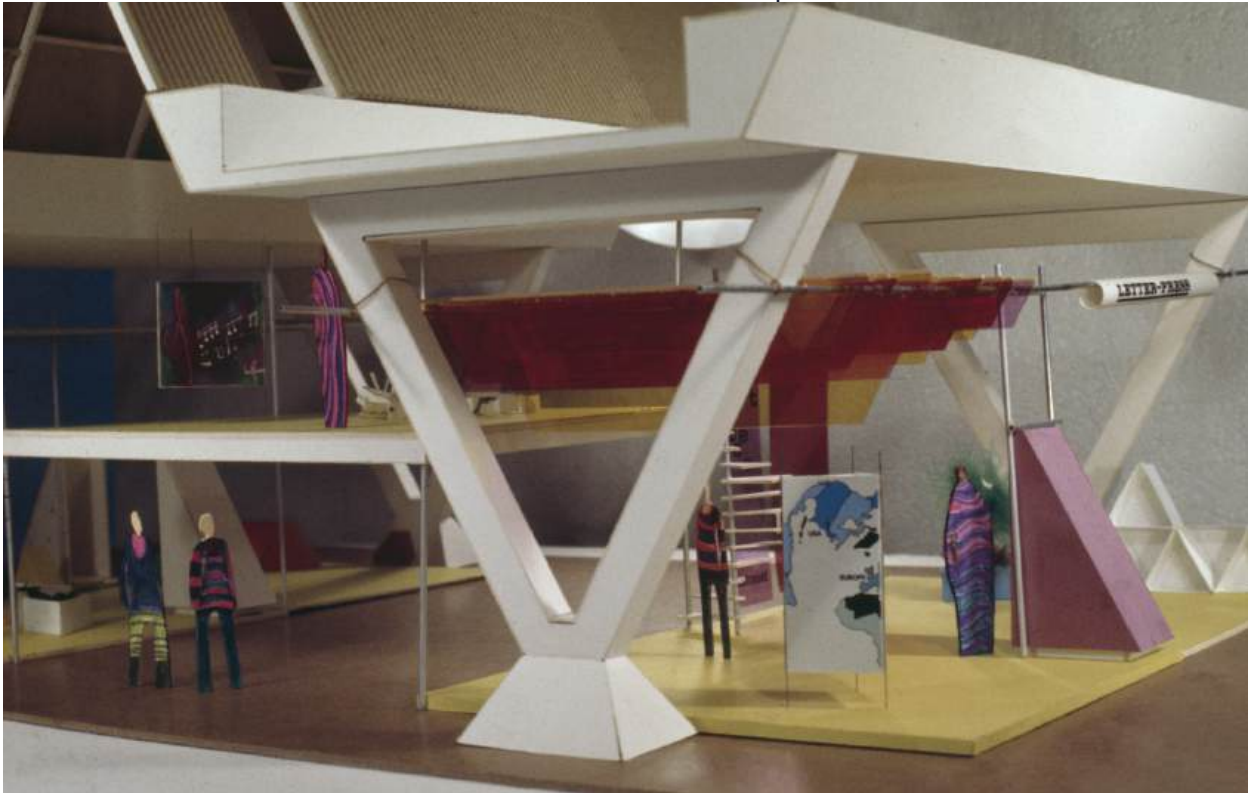
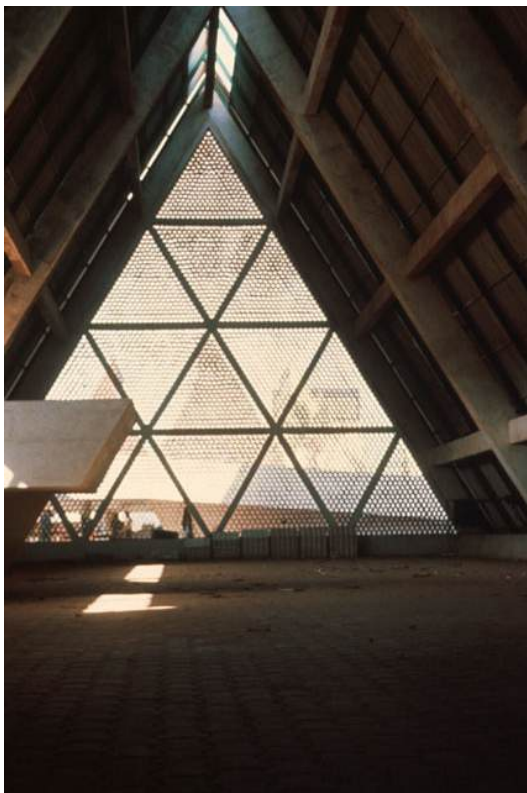
Fig.12: (A to D, top-left to lower-right): A: Image of the green pavilion facade (source: Le magasin du CICES); B: Image of Orange pavilion interior (source: Le magasin du CICES); C: Photograph of original model showcasing typical exhibition furniture for CICES - designed by Lamoureux and Marin (archives of J.L. Marin); D: photograph of Moroccan pavilion (Grand Nave) interior looking towards ventilated facade (archives of J.L. Marin).

CICES was designed with a series of indoor and outdoor exhibition spaces to accommodate goods and events from across Africa. The exhibition pavilions consist of two typologies (1) the ‘coloured’ exhibition pavilions - green, yellow/ Senegal, orange, and brown, and (2) the tertiary and Moroccan/ Grand Nave pavilions. The former are characterised by the repetitive profile of their triangular roofs (which alternate between high and low pitches) punctuated by coloured trapezoidal doors. The orange and green pavilions are slightly larger in footprint than the remaining coloured pavilions—with the green pavilion containing a restaurant. The latter pavilions contain variations on the first typology with the same architectural language (ventilated facades, trapezoidal doors, etc.) however their most noticeable geometry is a large triangular prism. The exhibition pavilions were designed to be passively ventilated and were modular to account for ease of construction and repairs. The columns are v-shaped precast concrete with electrical and water services integrated into the base of each column. Exhibition spaces continue on the outside of the pavilions with a series of trapezoidal plazas designed to accommodate heavy outdoor exhibition furniture. Many of the exhibition pavilions feature ventilated facades composed of cut PVC pipes. The most prominent example of this is the Moroccan pavilion.

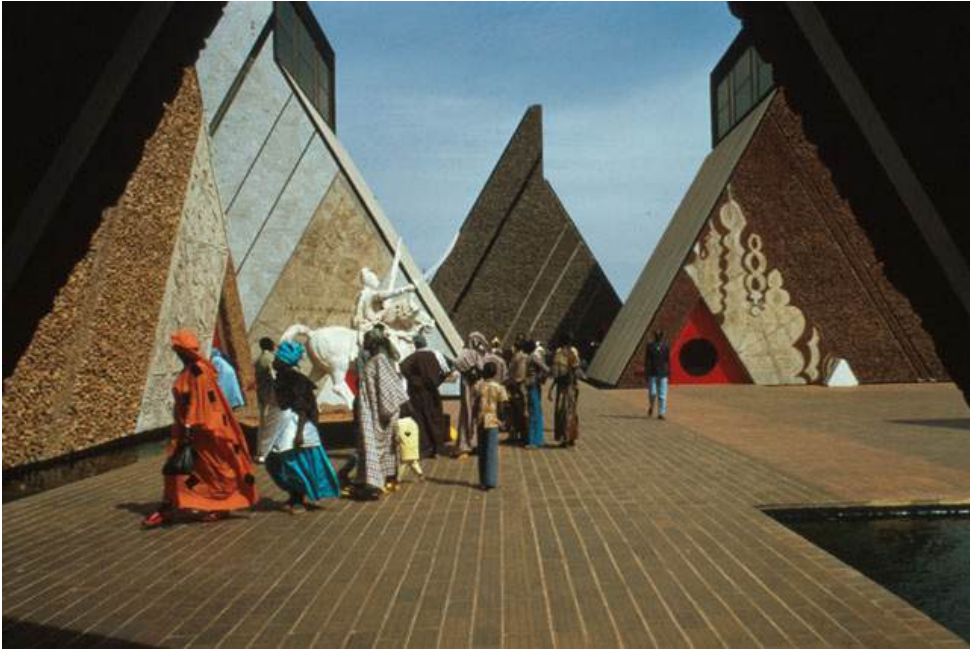
Fig.13: Image of the regional pavilion facades, view from the plinth level (source: Archidatum - c. 1974-5).

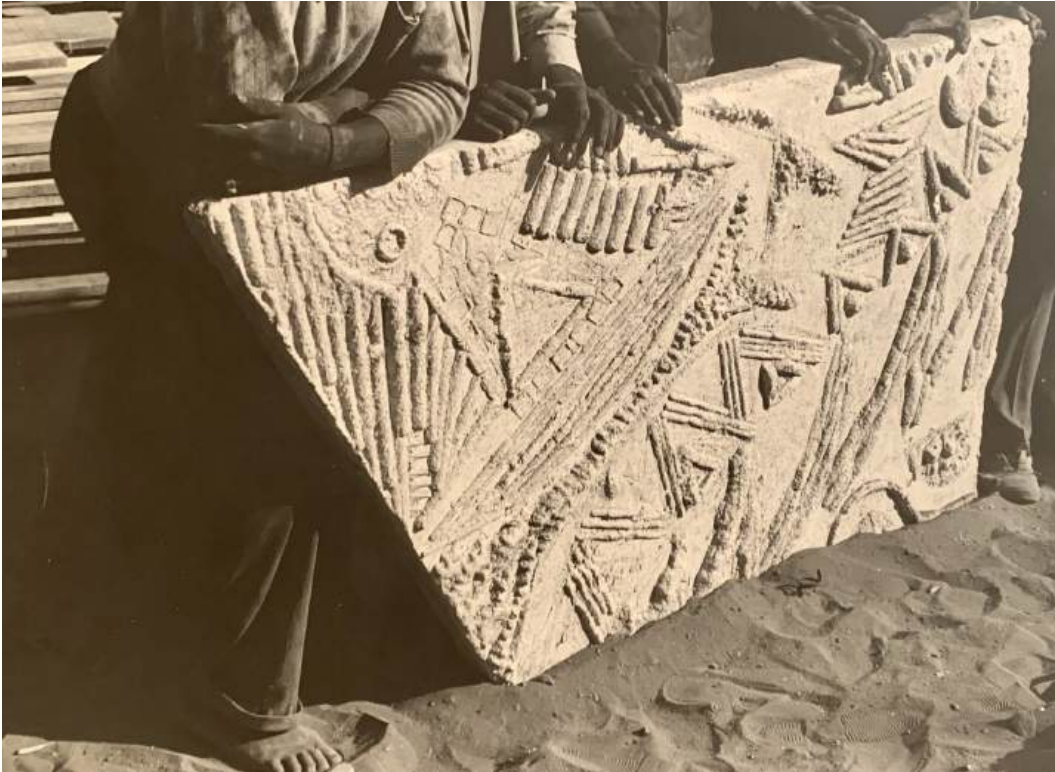
Fig.14: Workers holding a panel from the regional pavilions, created from a 1:1 styrofoam prototype (personal archives of Lamoureux, c. 1972-5).

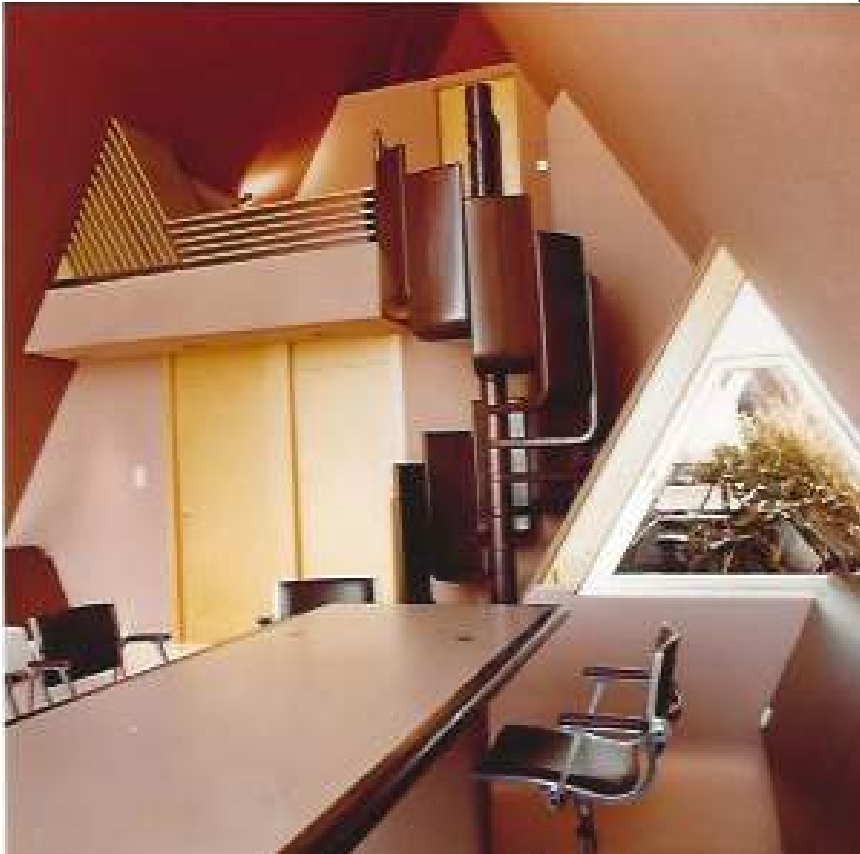
The administrative pavilion and innovation centre have characteristic facades raised on precast concrete pilotis with a triangular profile. They integrate a series of gardens and courtyards that create a cool microclimate on the building interiors and expand their indoor programs outwards. Their original materiality was exposed concrete with a precast fibre cement corrugated panel roof.

*Fig.16: A-C (left): Images of the Administrative Pavillion (source: scans of unknown magazine).*

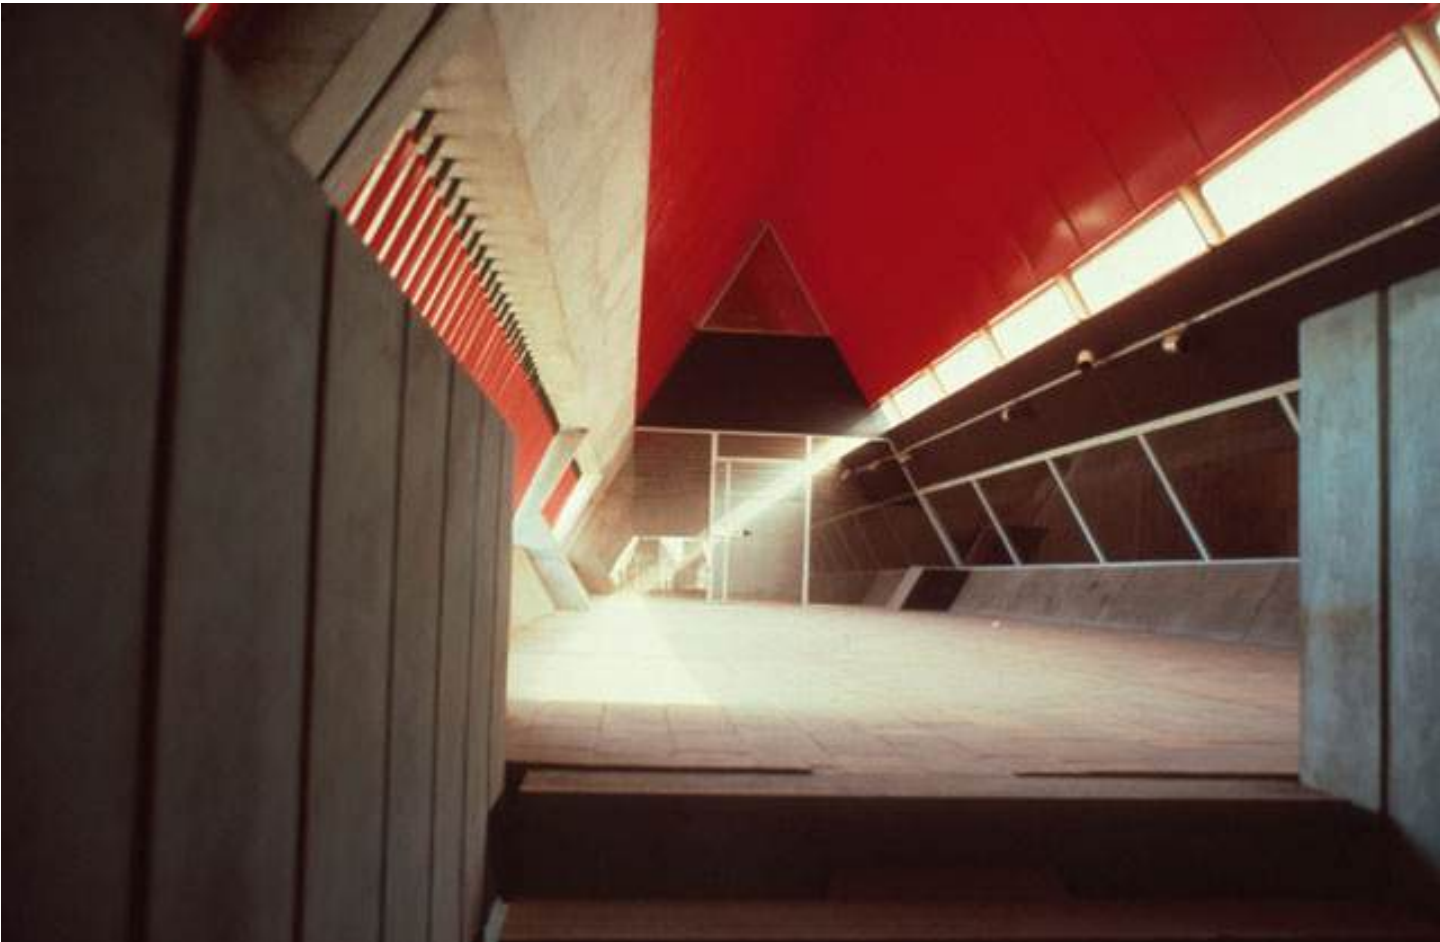
*Fig.17: (above) Archival photograph of the innovation centre interior (source: Archidatum).*

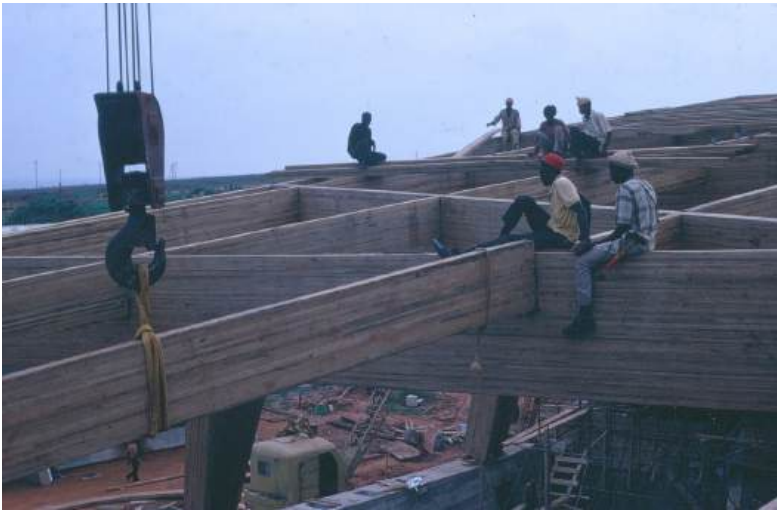
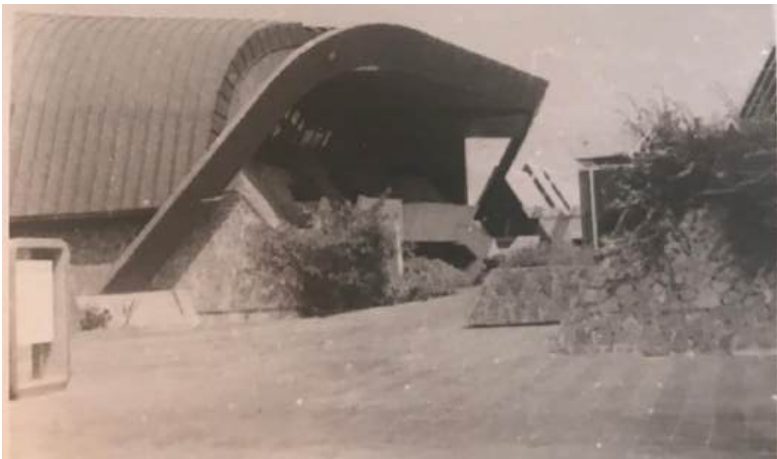
Fig.18: (A-C) (above): photographs of the CICES auditorium under construction c. 1972-3 (personal archives of Marin).

The original 1200-seat CICES auditorium is the centrepiece of the site and a standout typology. It was designed to resemble an inverted boat structure and originally had a corten steel roof. Its structure is composed of hand-carved glulam beams (spanning 48 m) and its base is in a dark volcanic stone (seen on some original ancillary buildings, landscaping elements, and the decorative facades on the regional pavilions). Like the regional pavilions, the auditorium features a double skin to promote natural ventilation. On the interior, the original central spine of the auditorium is a wood ceiling composed of intersecting struts.

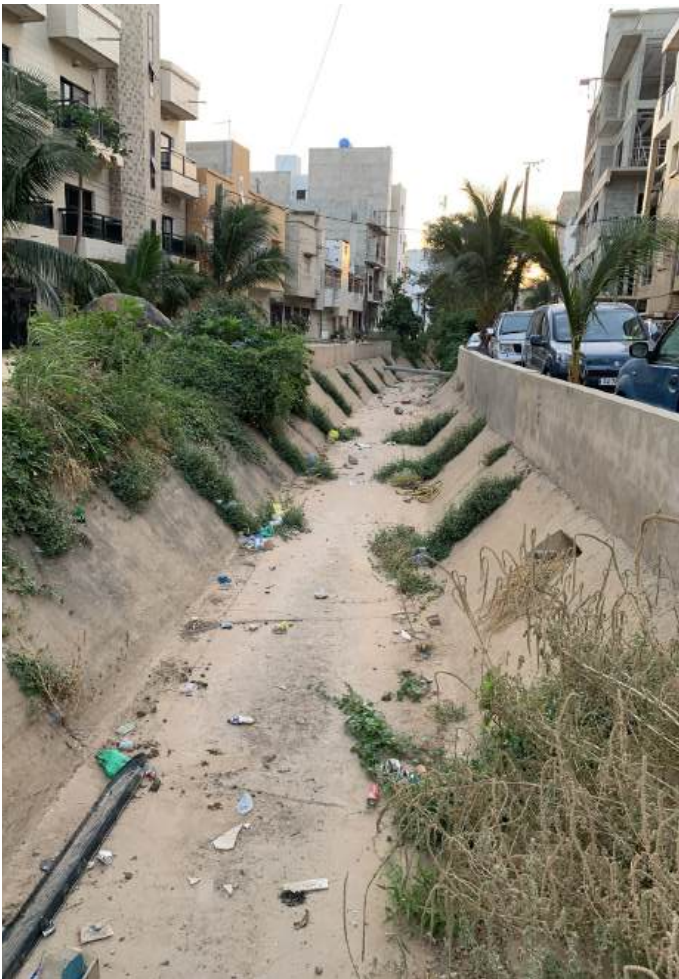
Fig.22: (left): image of the original drainage canal, which is integrated into the CICES Foire neighbourhood - originally part of the CICES grounds. In some areas, this drainage canal and the resulting green spaces it creates have become a linear garden of sorts (photo: Dana Salama, 2022).

Changes to the original site boundaries have (1) interrupted the original drainage design by Lamoureux and Marin, and (2) created an urban condition in the new residential area (CICES Foire) where the CICES drainage canal has been integrated as part of the neighbourhood. The portions of the drainage canal which fall outside the current CICES boundaries have become an overgrown urban greenspace, framing security checkpoints into the neighbourhood and walking trails.

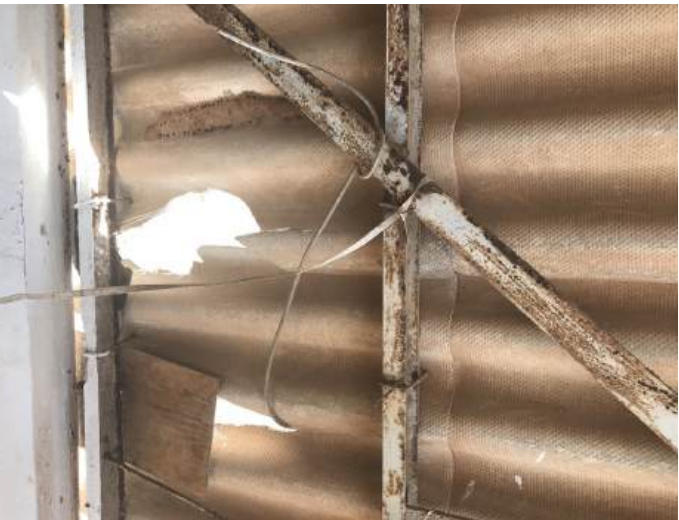
Fig.23: (above): image of roof damage, prevalent throughout CICES (photo: Dana Salama, 2022).

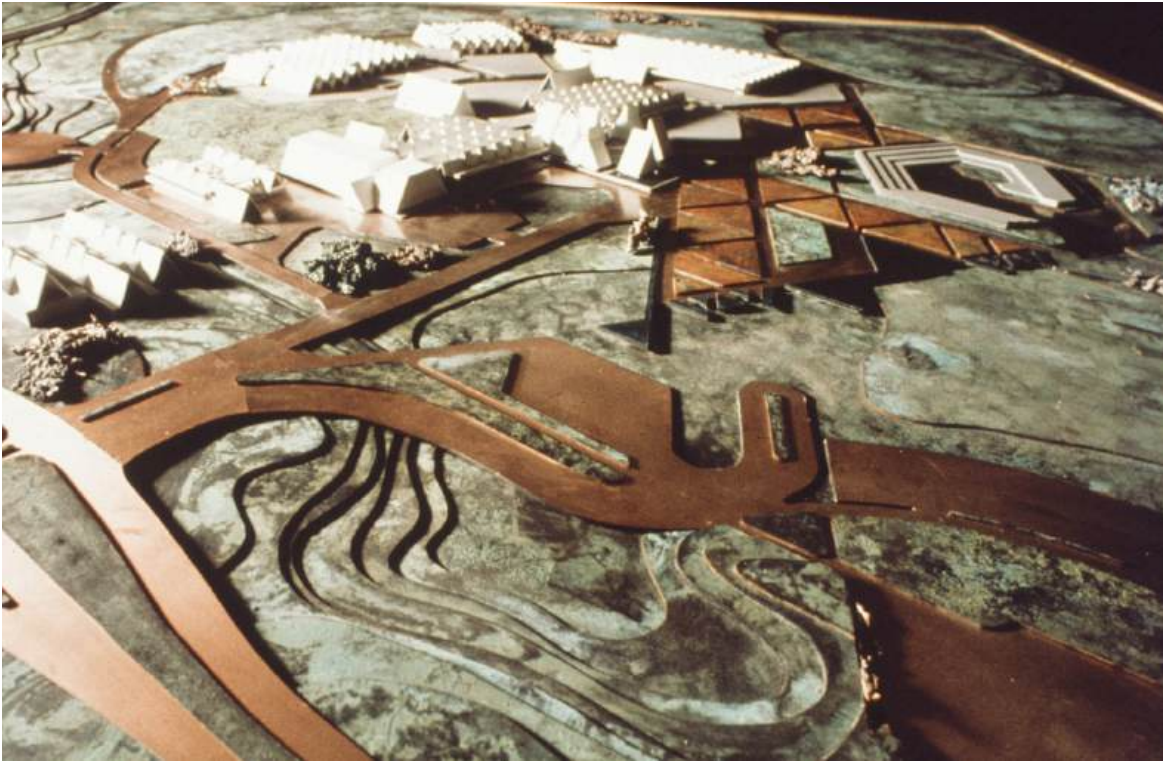
Fig.24: Photograph of a presentation model of CICES showcasing the western portion of the site (looking south). On the bottom right of the photograph, note the bus and taxi loops (destroyed by urban encroachment). Towards the top-right of the photo is an outdoor auditorium (never constructed). C. early 1970s (from the personal archives of Marin).

The curvilinear road around CICES and the fan-like organisation referenced vernacular African village typologies. The original CICES masterplan, which occupied a larger surface area, featured extensive landscapes, support programs (such as parking, bus and taxi loops) and wayfinding infrastructures. The northern (primary) site entrance was framed with a ceremonial entrance plaza (since destroyed). Towards the south of the site, a mango grove and exterior artisanal village with a bar pavilion anchored the site.

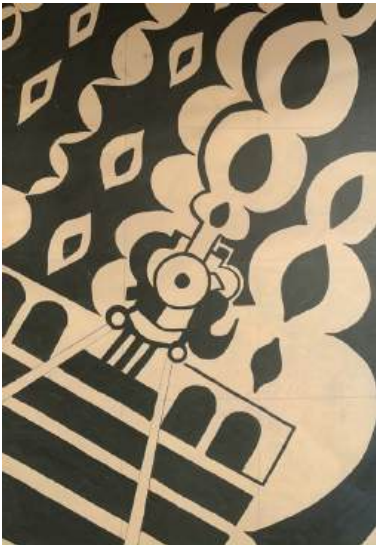
Fig.29: (top) sketch of the Thies pavilion facade (one of the seven regional pavilions) c. 1971-5 (from the personal archives of Lamoureux).

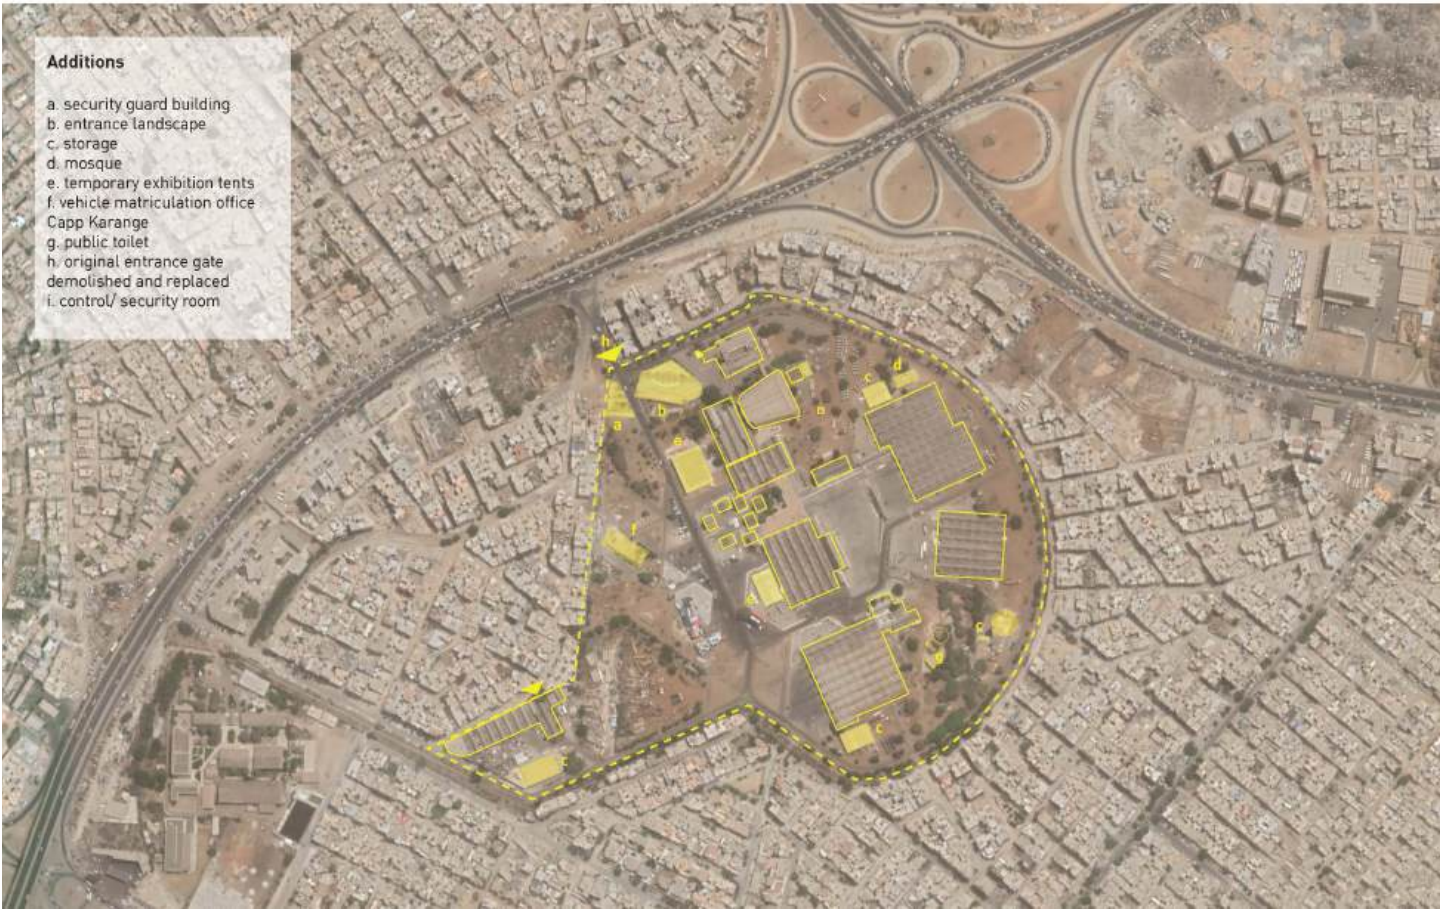
Fig.32: diagram on top of a satellite image of CICES (2019) showing additions to the site since it was originally constructed. This does not include informal pavilions that emerge on the site (such as utility buildings, sheds, supermarkets, outdoor exhibition booths, blocked off staging areas, etc., which often move) (Aziza Chaoui Projects, 2021).

A few new buildings were constructed to respond to contemporary needs. However these additions remain few and scattered amid the landscape on the fairs’ proper, and remain unattached from the original buildings. Overall, all recent additions include (figure 32):

- A security guard building
- Entrance landscape
- Storage
- Mosque
- Temporary exhibition tents
- Vehicle matriculation office Capp Karange
- Public toilet
- Original entrance gate (demolished and replaced)
- Control/ security room

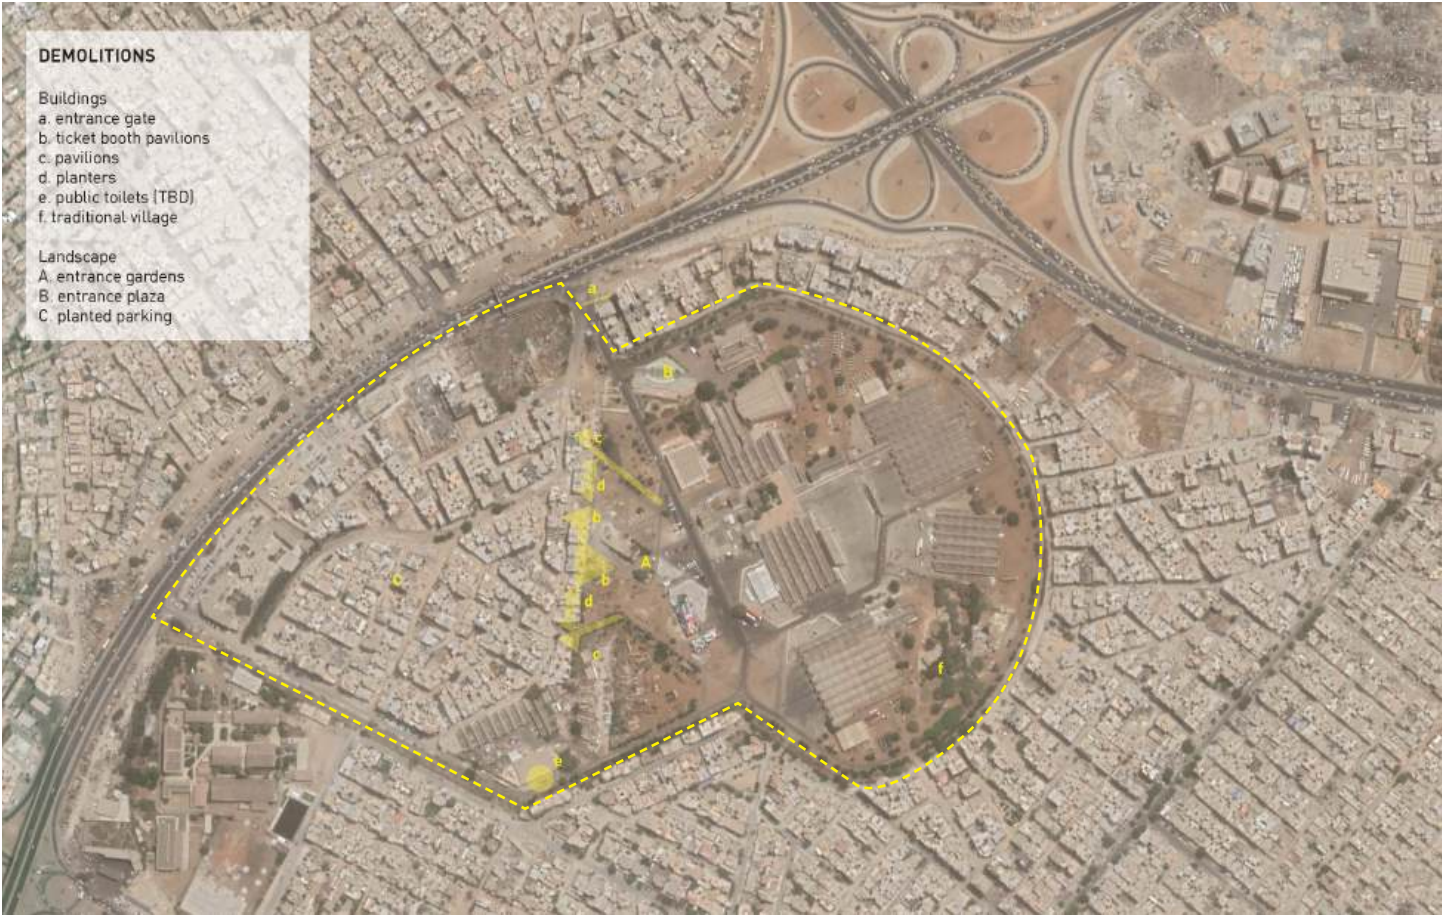
Fig.33: diagram on top of a satellite image of CICES (2019) showing demolitions on the site since it was originally constructed. This does not include areas demolished to accommodate the urban encroachment which would become the CICES Foire neighbourhood. The original site boundary is represented by a dashed yellow line (Aziza Chaoui Projects, 2021).

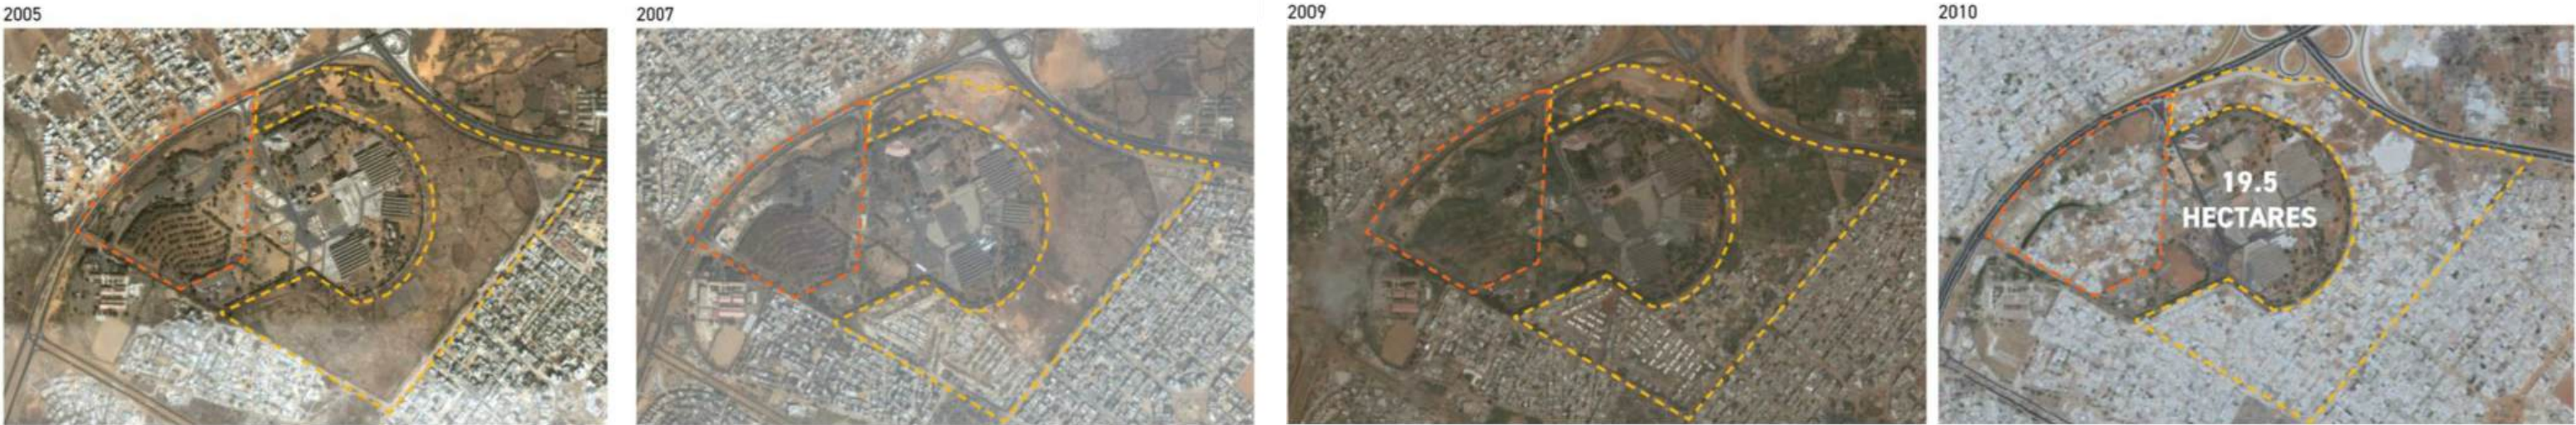
- area of the CICES parcel intended for its extension (phase 2)
- original parking areas + bus and taxi stops at CICES

Fig.34: (A-D) satellite views showing the morphology and encroachment of the CICES Foire neighbourhood on the original CICES grounds (Aziza Chaouni Projects, 2021).

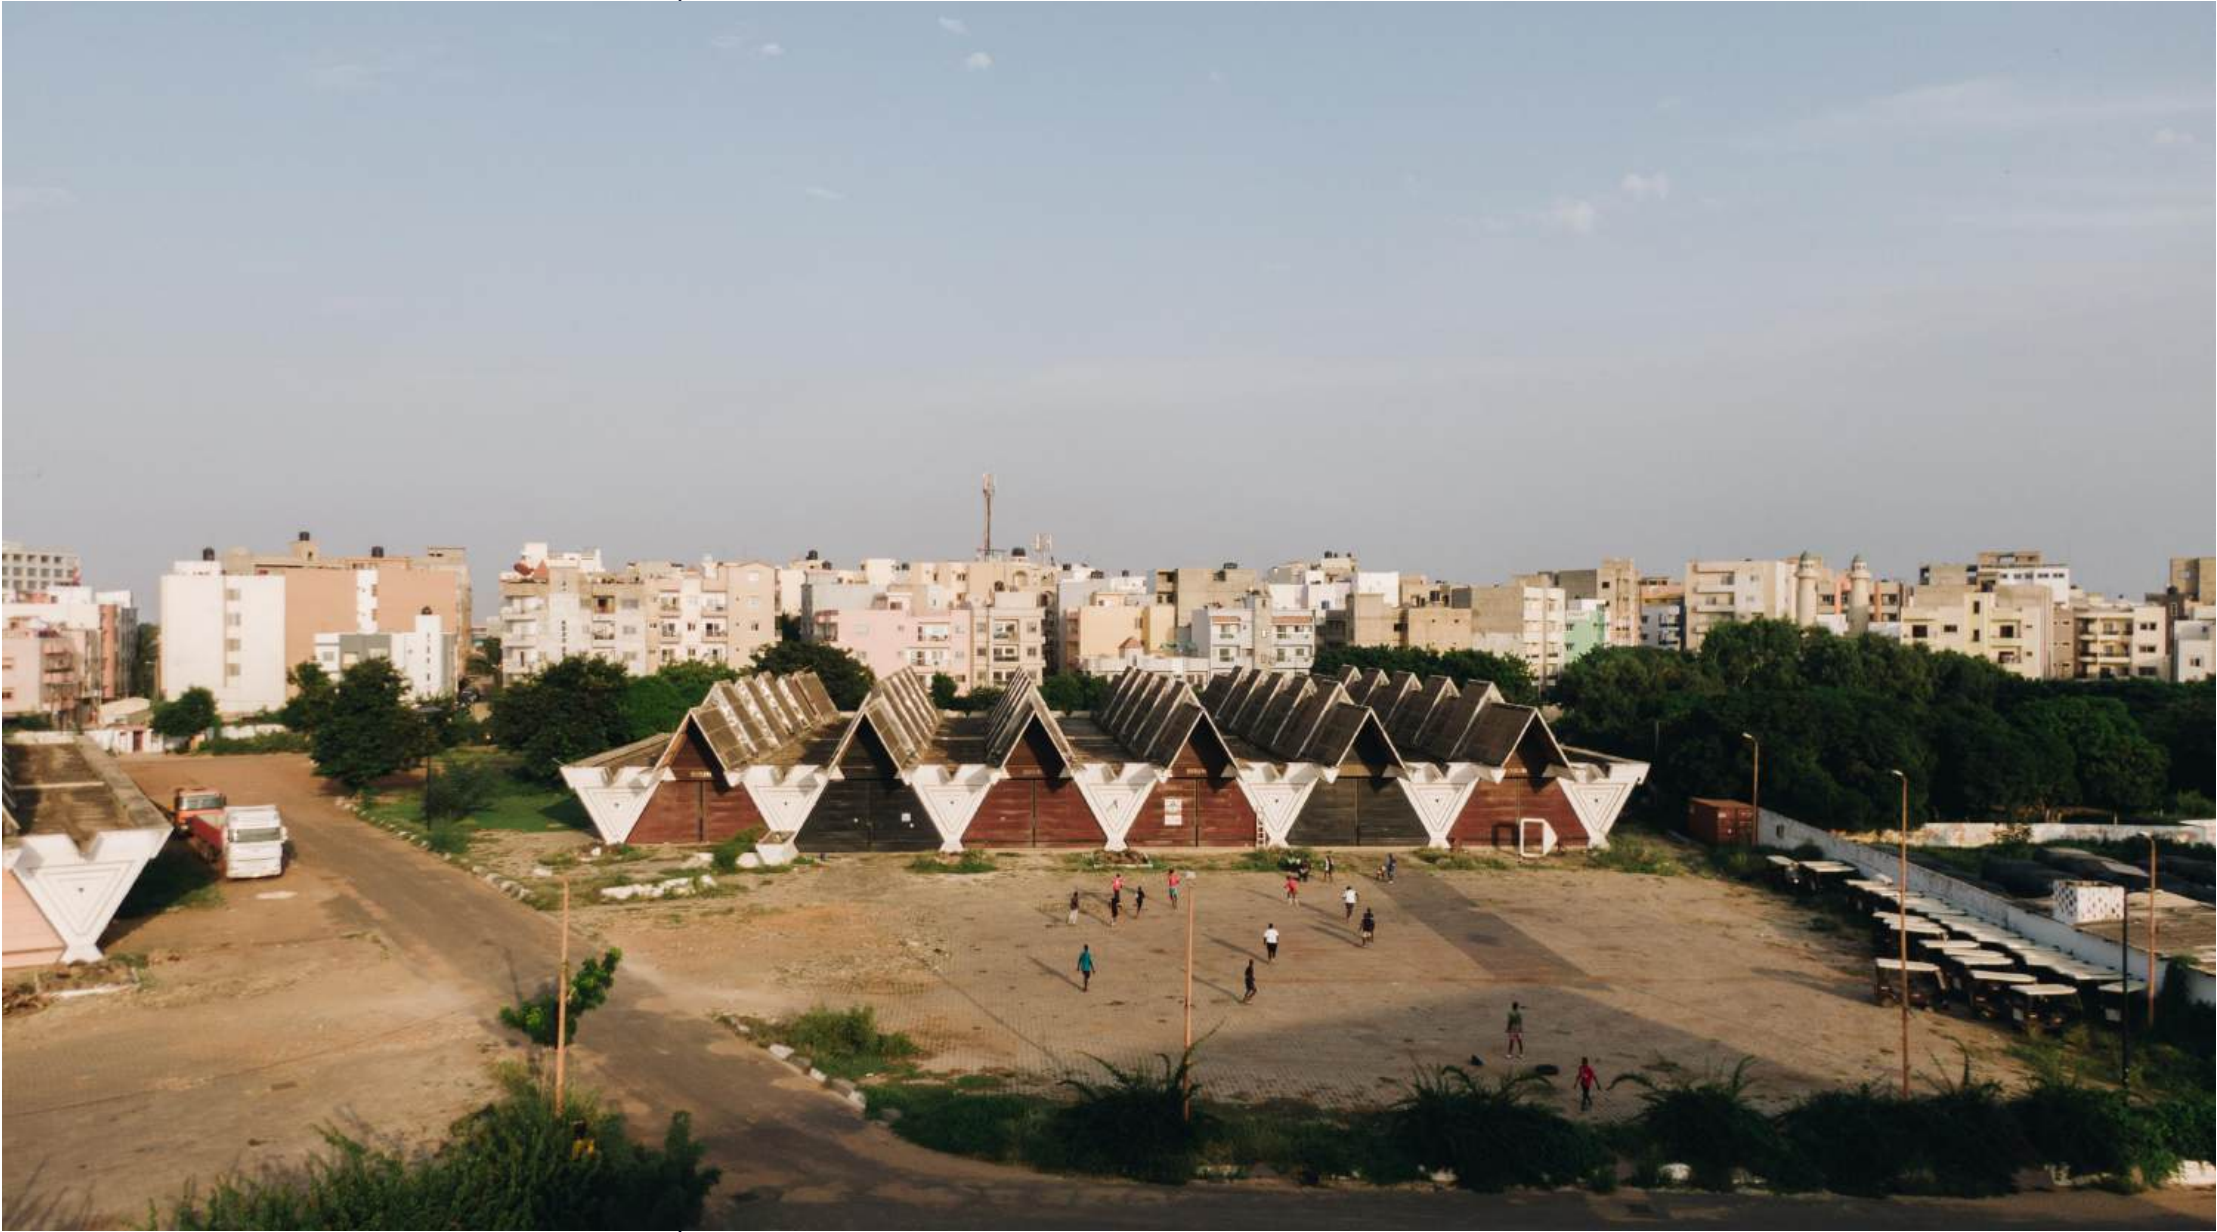
Fig.47: A bird's eye view of the brown exhibition pavillion, with CICES Foire in the background (photo: Seyni Ba, 2022).

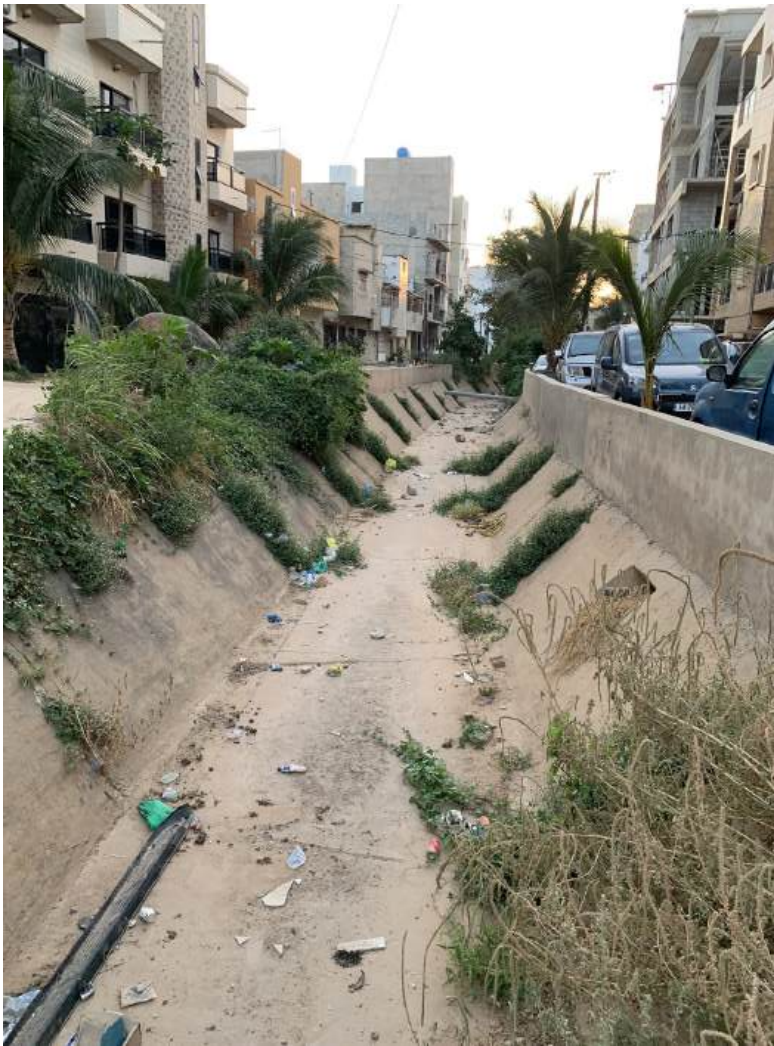
Fig.48: The original CICES drainage canal integrated into the CICES Foire neighbourhood (photo: Dana Salama, 2021).

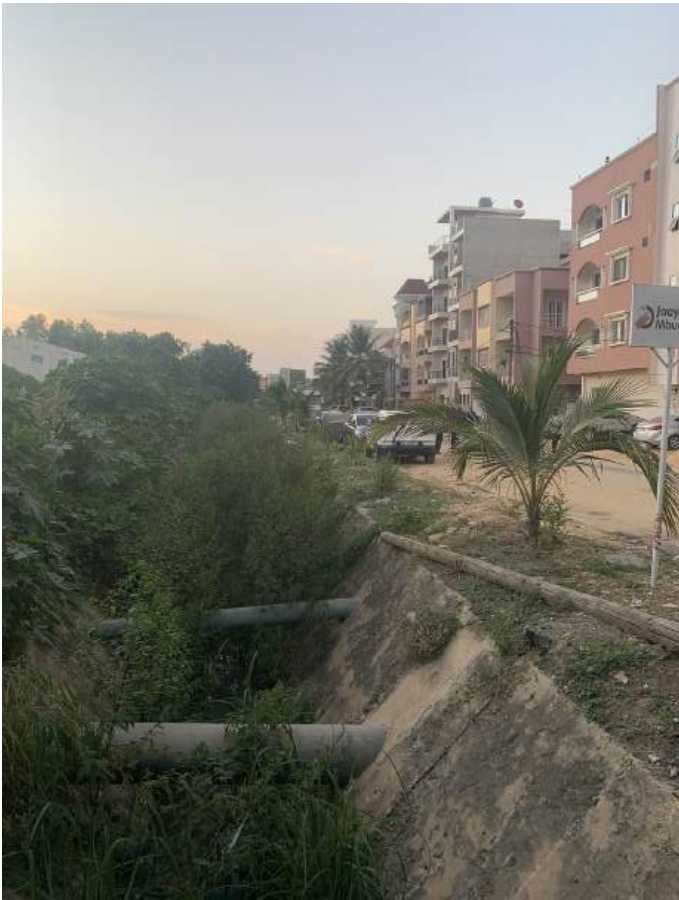
Fig.49: The drainage canal functions as a linear green park of sorts, with walkways alongside it and pedestrian bridges across (photo: Dana Salama, 2021).

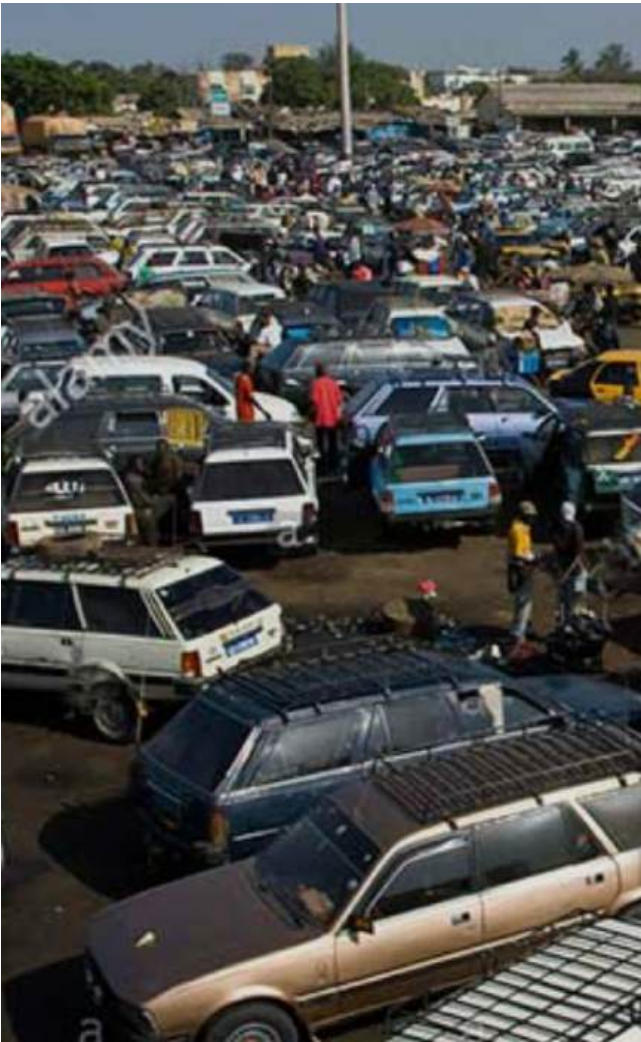
Fig.51: (above) Chaotic parking during events at CICES is the result of a lack of parking infrastructure since the original parking areas were sold off and became part of the CICES Foire neighbourhood.

The loss of parking space due to informal development within the original site boundaries has made informal parking necessary. This has resulted in serious damage to paving around the site and blocking sight lines towards major architectural features.

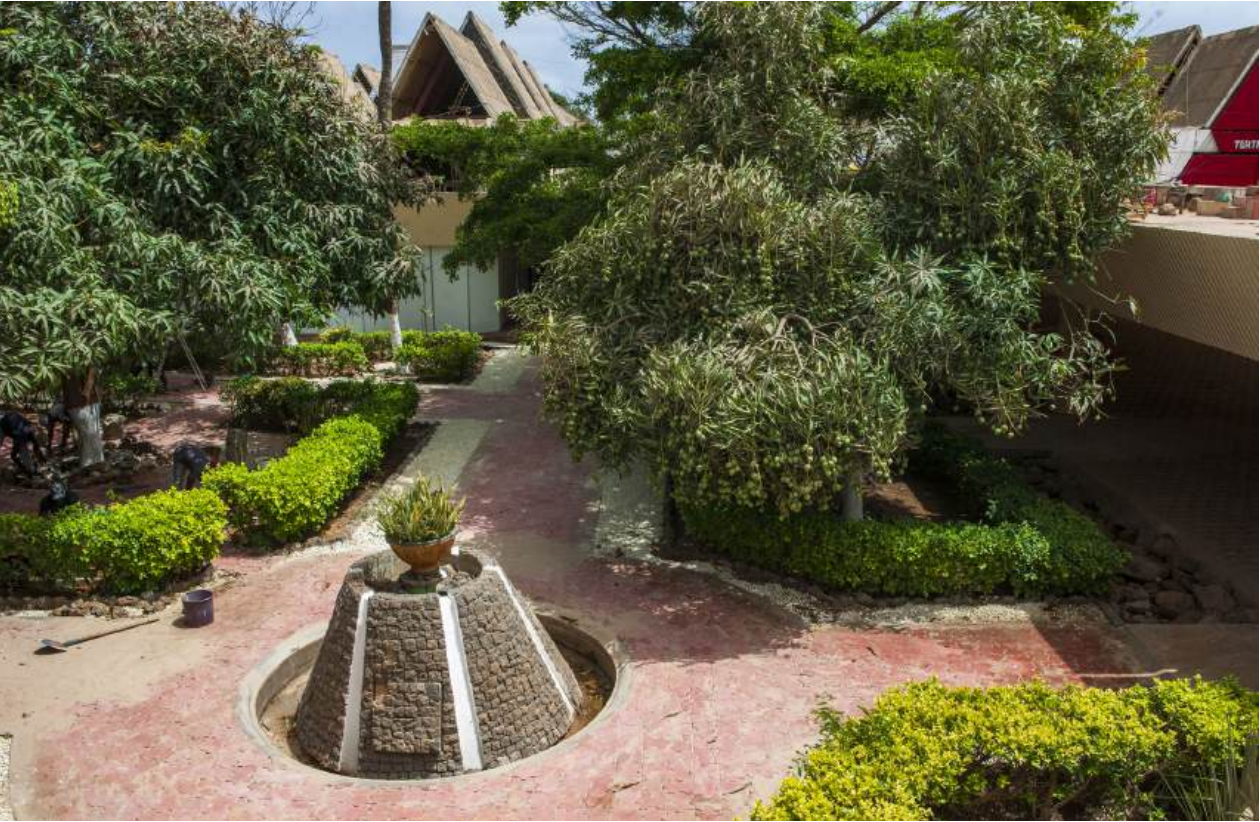
Fig.54: (above) The garden at the centre of the courtyard framed by the lower level of the regional pavilions, Tertiary Pavilion, and Senegal Pavilion. The garden has been heavily altered since the original design (see shrubs and paint) (photo: Elyse Fitte-Duvale, 2021).

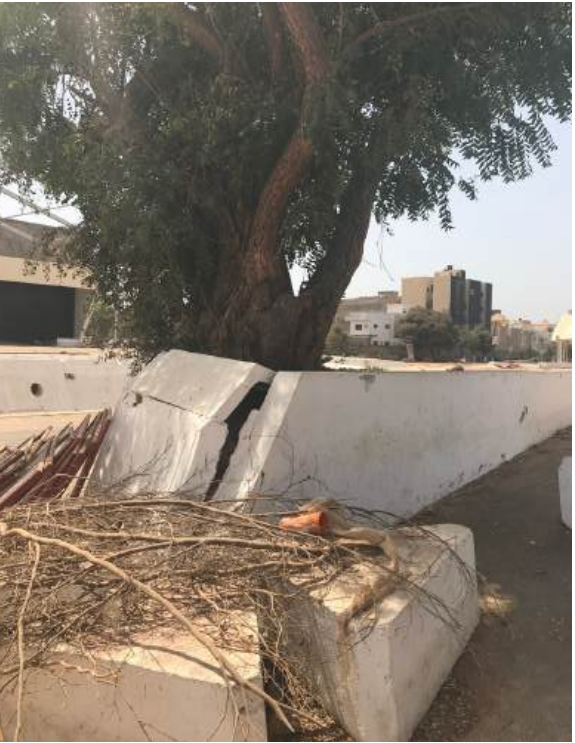
Fig.55:(right) overgrown vegetation has cause some concrete planters and paving to break on site (photo: Aziza Chaoumi, 2021).

- The overgrowth of vegetation can cause structural damage because the spreading of root systems causes cracking of concrete, tile, etc. This should be treated per the structural engineer’s advice.
