Keeping It Modern:  
**Centre International  
du Commerce Extérieur  
de Dakar (CICES)**

Conservation Management Plan  
01. 2023  
Dakar, Senegal

Written by  
Aziza Chaouni, Mourtada Gueye, Dana Salama

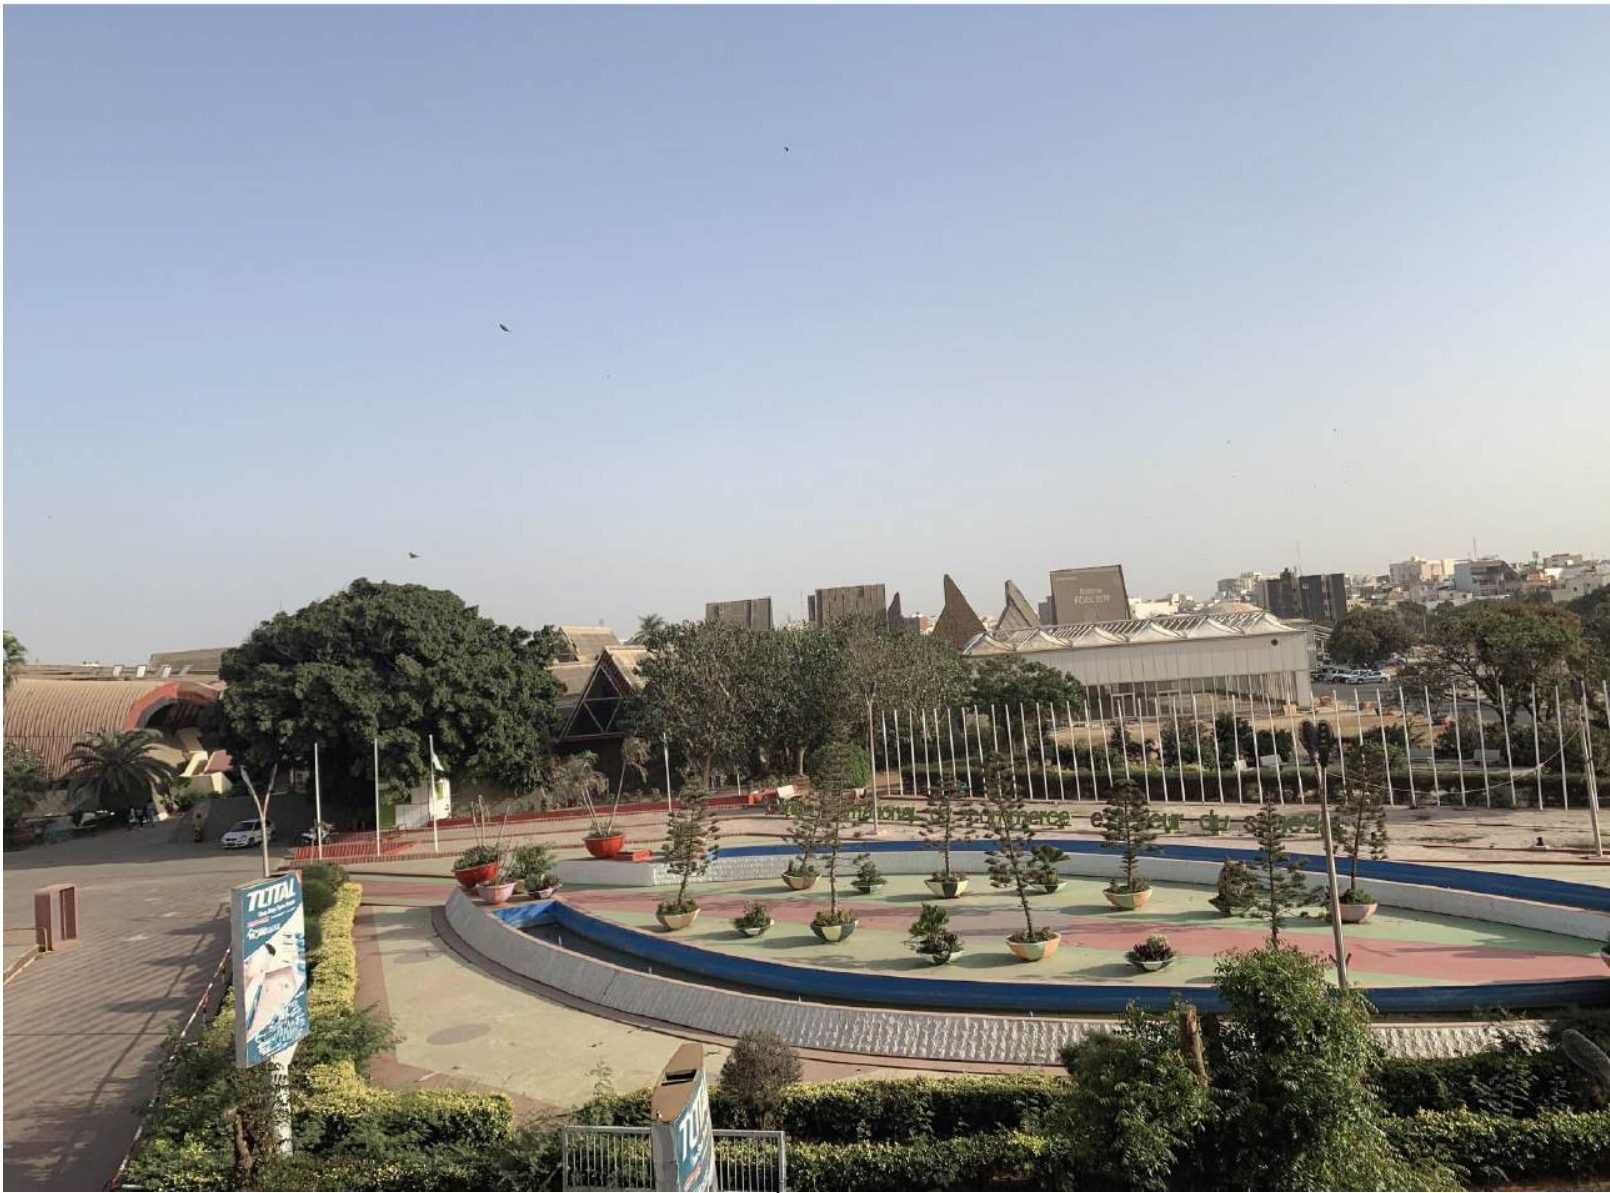
The plaza was entirely remodelled in 2002 by architect Atepa Goudiaby (figures 56-58). Concrete planters, pathways and fountains were added, as well as a bronze statue of King Lat Dior, a national hero and resistor of French colonialism. The water in the fountains is only activated during important events. The planters and flower beds are in good condition. The geometries and finishes in the new plaza have no relationship to the original architects’ scheme.

Fig.56: (top): image of the entrance plaza, transformed by architect Atepa in 2002. It bears almost no resemblance to the original design (photo: Elyse Fitt-Duvale, 2021).

With no wayfinding strategy present, and no formal relation to the original complex, the new entrance plaza is disorienting and out of place. As a highly visible node, it compromises the design integrity and identity of the site.

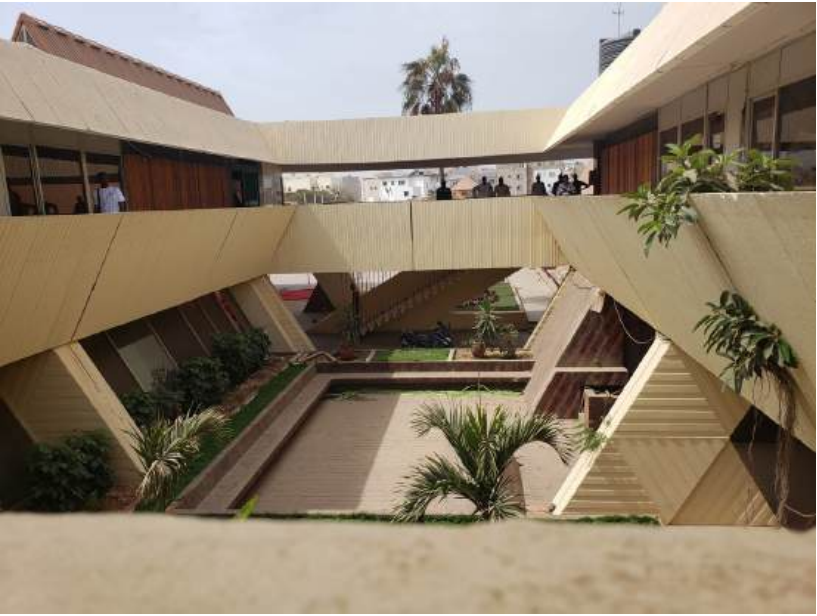
- The original green roof does not exist anymore.
- In 2002, the exterior walls were painted by Atepa Goudiaby.
- The interior courtyard was remodelled and painted with bright colours; the bar counter with its beautiful red tiles facing the courtyard is still intact and is only used during the FIDAK.
- In 2005, a covered pathway between the admin building and auditorium was added.
- In 1998, the original bar/cafeteria was transformed into a VIP salon, with new floor finishes, a new dropped ceiling, furniture, and a bathroom at the back.
- On the upper level, bathrooms were remodelled with new white tiles and all appliances were all replaced.
- A new security room was added in front of the administration building (date unknown).
- The building was painted by Atepa, obscuring its original brutalist aesthetic.

Fig.59: (centre) The principal facade of the administration building, originally in exposed concrete (photo: Elyse Fitte-Duval, 2021).

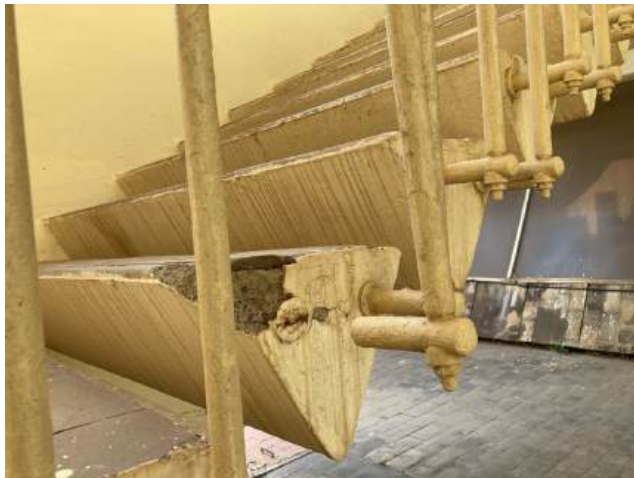
Fig.60: (bottom row, left to right) (A) corroding rebar in the suspended concrete stair causes spalling, (B+C) vegetation growing in the building's expansion joints, (d) non-original finishes in the offices (photos: Dana Salama, 2021).

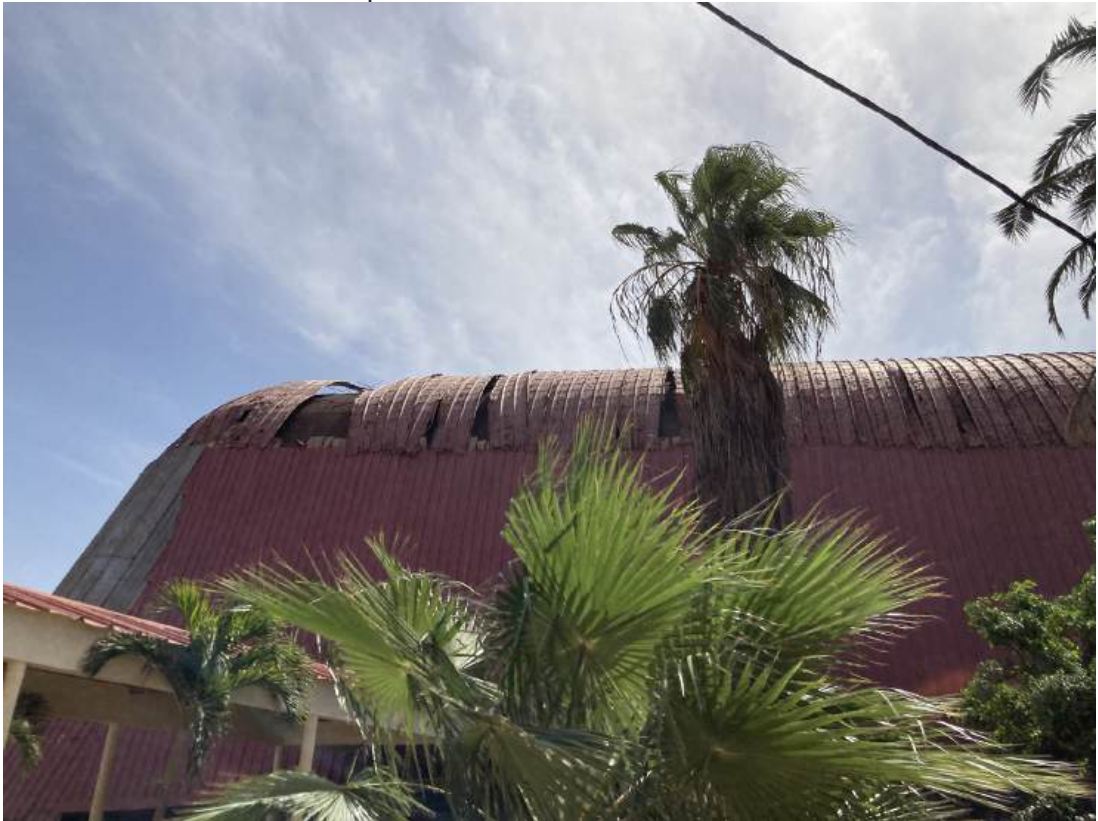
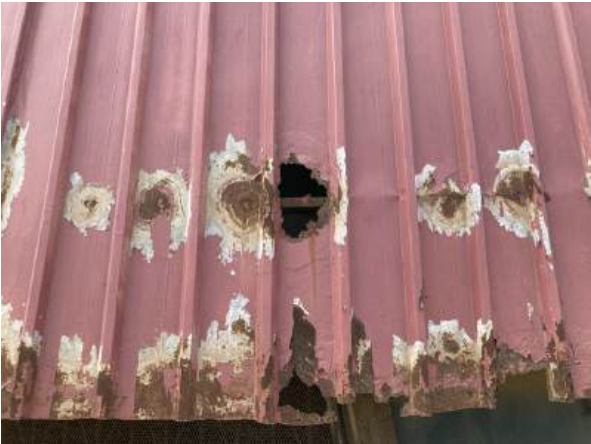
- The original Corten steel roof was replaced with corrugated metal (which is already falling apart and which the CICES is patching up). Damage is particularly apparent at the front of the building. This has impacted the profile of the building’s outer shell drastically.

Fig.63: (top-center): image of the replacement corrugated metal roofing on the auditorium rusting and leaving the substructure vulnerable to water infiltration (photo: Dana Salama, 2021).

The scale of changes in the auditorium’s exterior is vast and damage is widespread (corroding steel, spalling wood, non-original finishes and geometric profiles throughout). The shell of the building along with its exterior structure will likely have to be wholly replaced. However an investigation will need to be conducted to understand the assembly of Atepa’s metal roof structure prior to determining a solution.

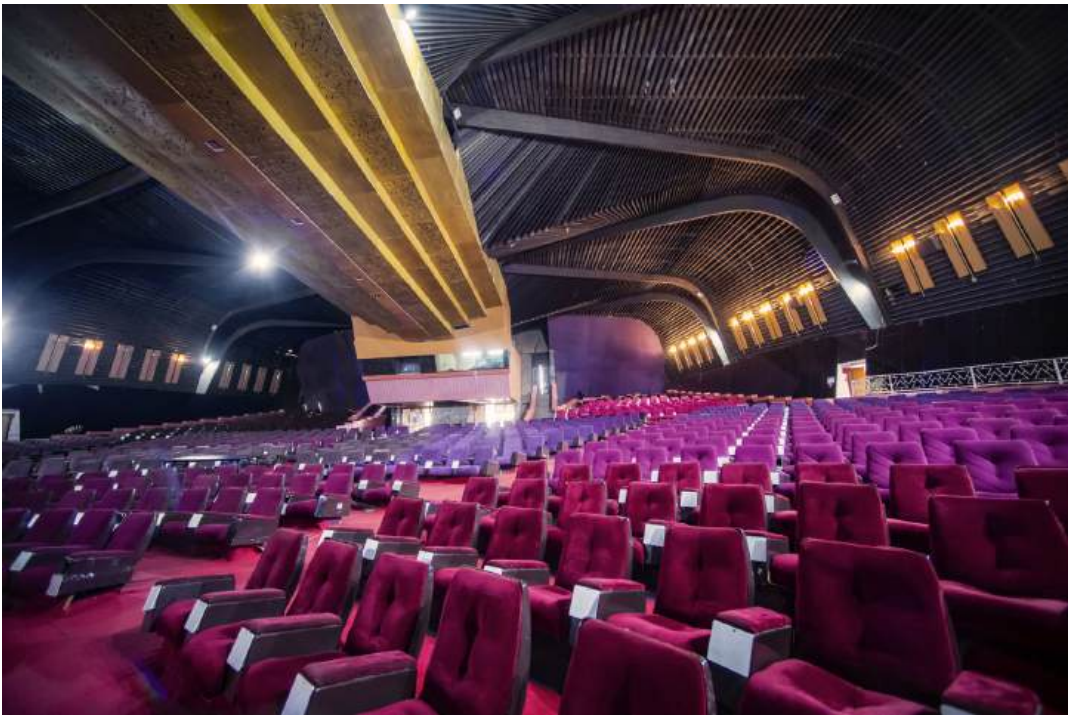
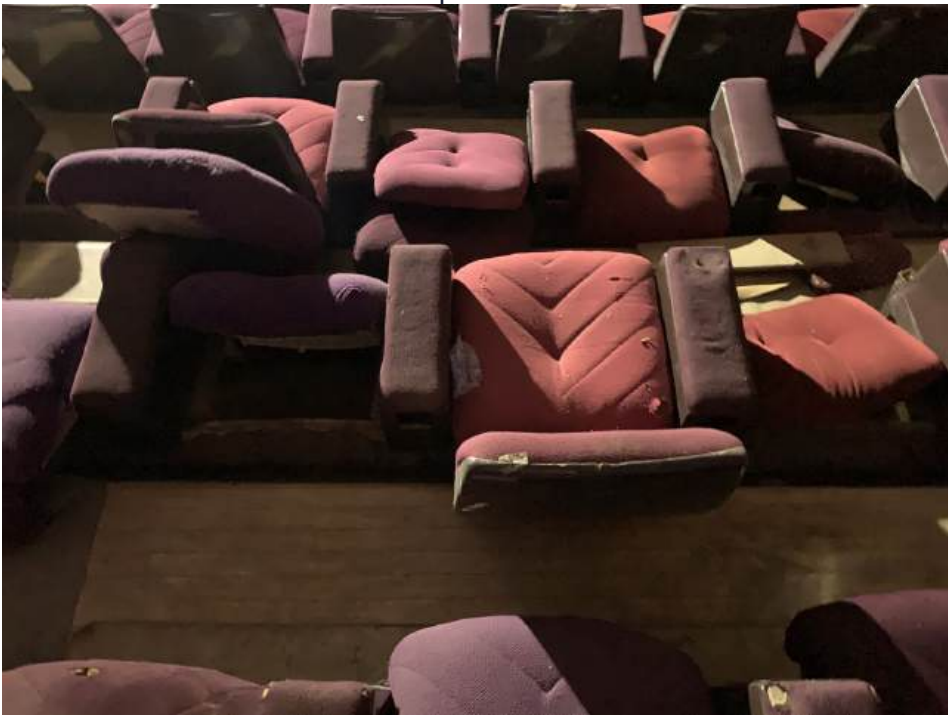
- The central part of the wood slat dropped ceiling was damaged by Atepa Goudiaby’s 2002 rehabilitation: the intertwining wood slats were cut to leave space for a rectangular golden metal box.

Fig.65: (bottom-left) interior view of the auditorium. The central piece on the ceiling was installed after splicing the intersecting wood struts that were part of the auditorium's original character (photo: Elyse Fitte-Duval, 2021).

Fig.66: (bottom-right) damaged seating in the auditorium (photo: Dana Salama, 2021).

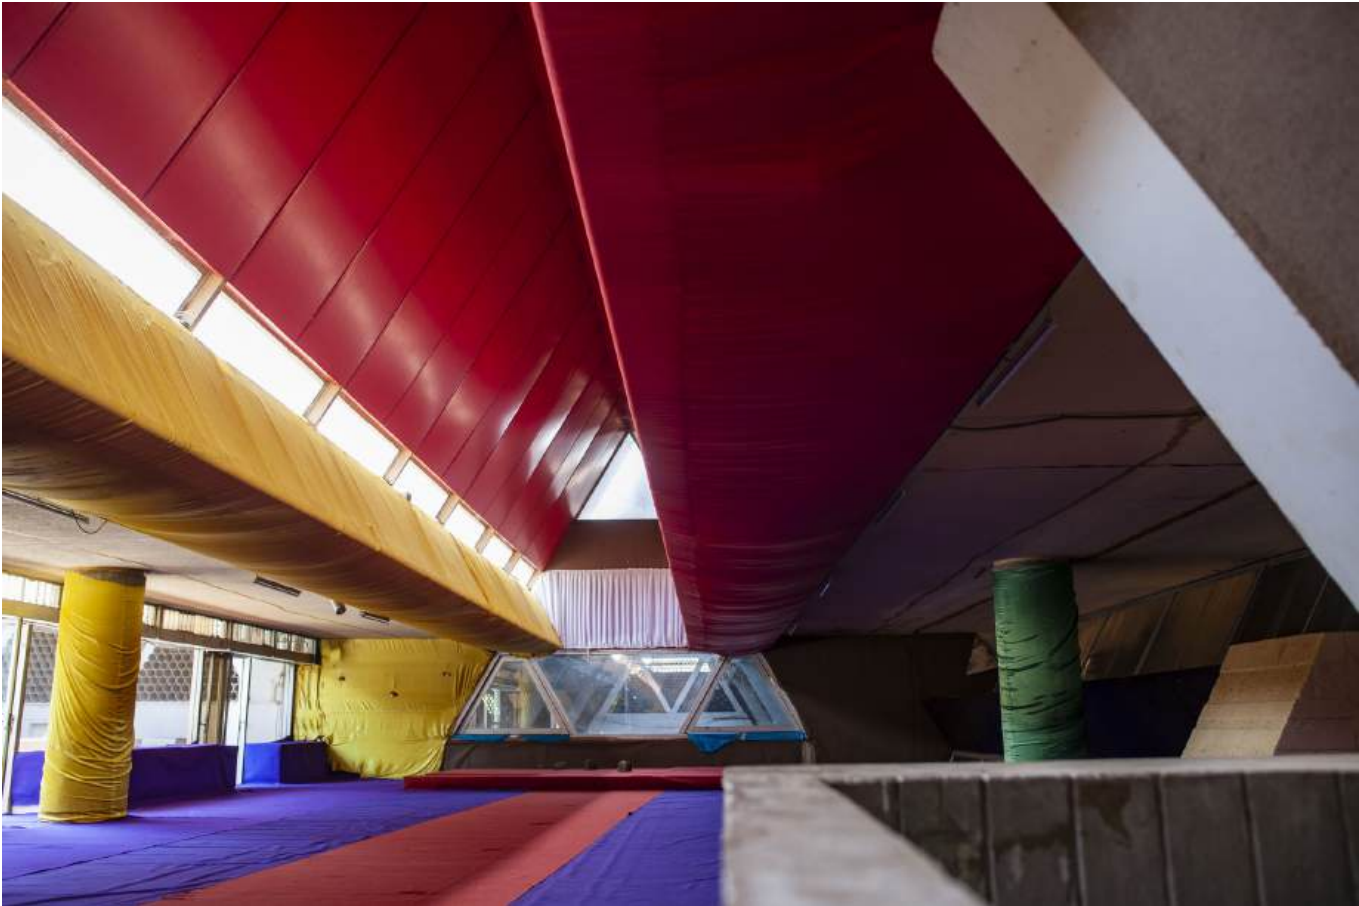
Fig.71: (top) interior of innovation centre, with many of the original finishes covered in paint or fabric (photo: Elyse Fitte-Duval, 2021).

The Innovation Centre once tied together the auditorium and exhibition buildings as a site of exchange. Growing bureaucratic and administrative needs at CICES have made the original program of the Innovation Centre obsolete. There is a need to reimagine its program to suit contemporary needs, and to find appropriate spaces for CICES’ growing administrative and operational needs.

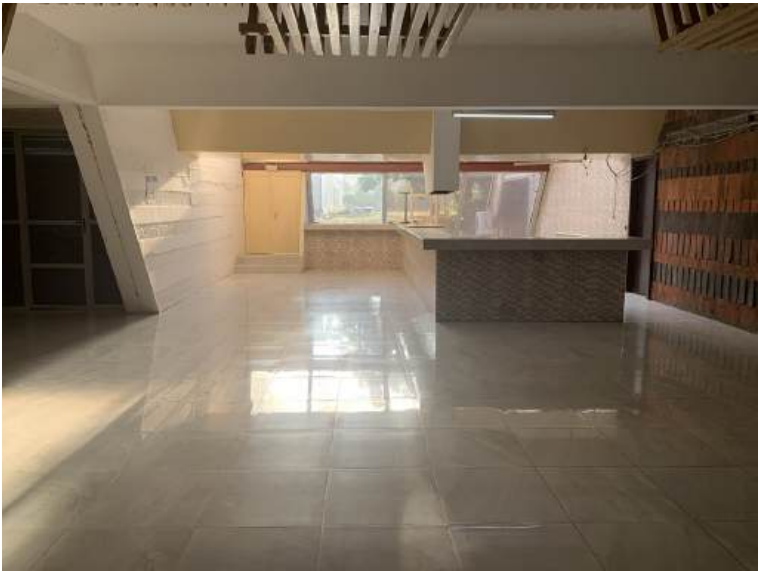
- The 6 translation cabins which service the large seminar room are closed, and not in use.
- The café was remodelled, its counter covered with white ceramic tiles (figure 72)

Fig.72: (bottom left) the newly installed bar/kitchen on the lower level of the innovation centre, and the non-priginal ceramic finishes and paint (photo: Dana Salama, 2021).

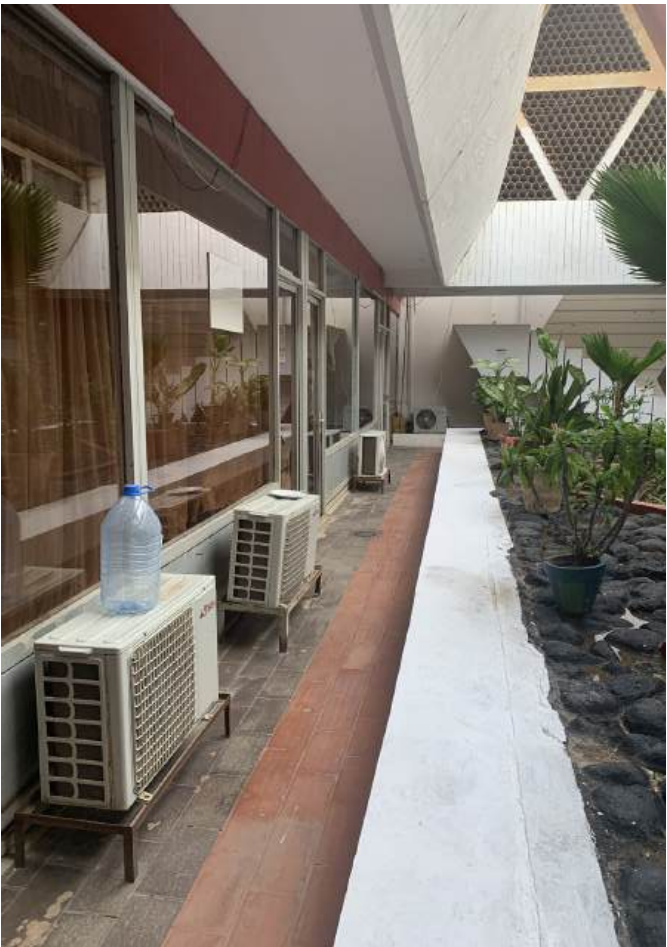
Fig.73: ( top) air conditioning units are endemic to the facades of the offices in the innovation centre. This is mostly due to passive climate strategies being defunct and overcrowding (photo: Dana Salama, 2021).

Due to the dilapidated state of the underground cooling system, many buildings have resorted to placing individual AC units on exterior facades. This undermines the overall appearance of major facades on site, and causes further issues: (1) the drill holes encourage water and air infiltration into buildings, (2) original finishes on the facades are damaged, and (3) water dripping from the AC units causes streaking on the facades and water damage.

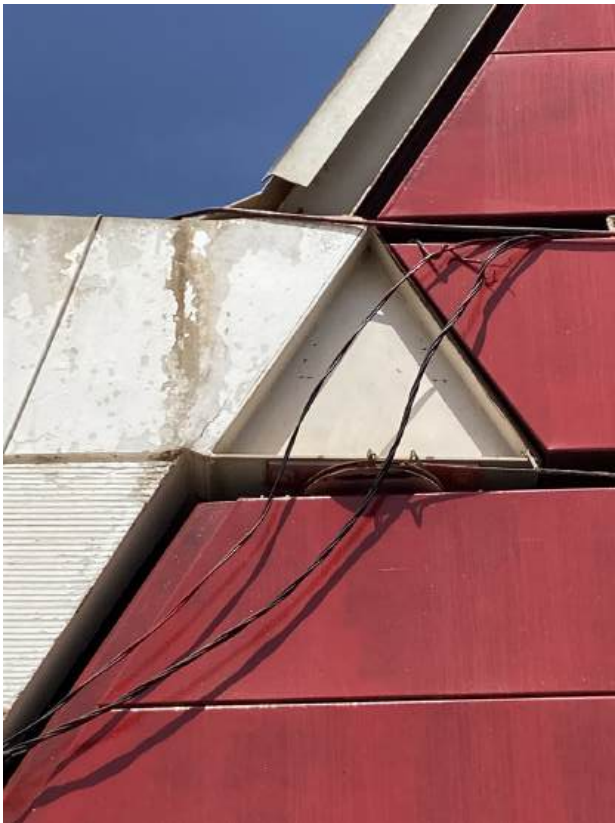
Fig.75: spalling concrete on a column at the entrance of the Tertiary Pavilion, supporting the plinth of the regional pavilions (refer to Appendix B) (photo: Dana Salama, 2021).

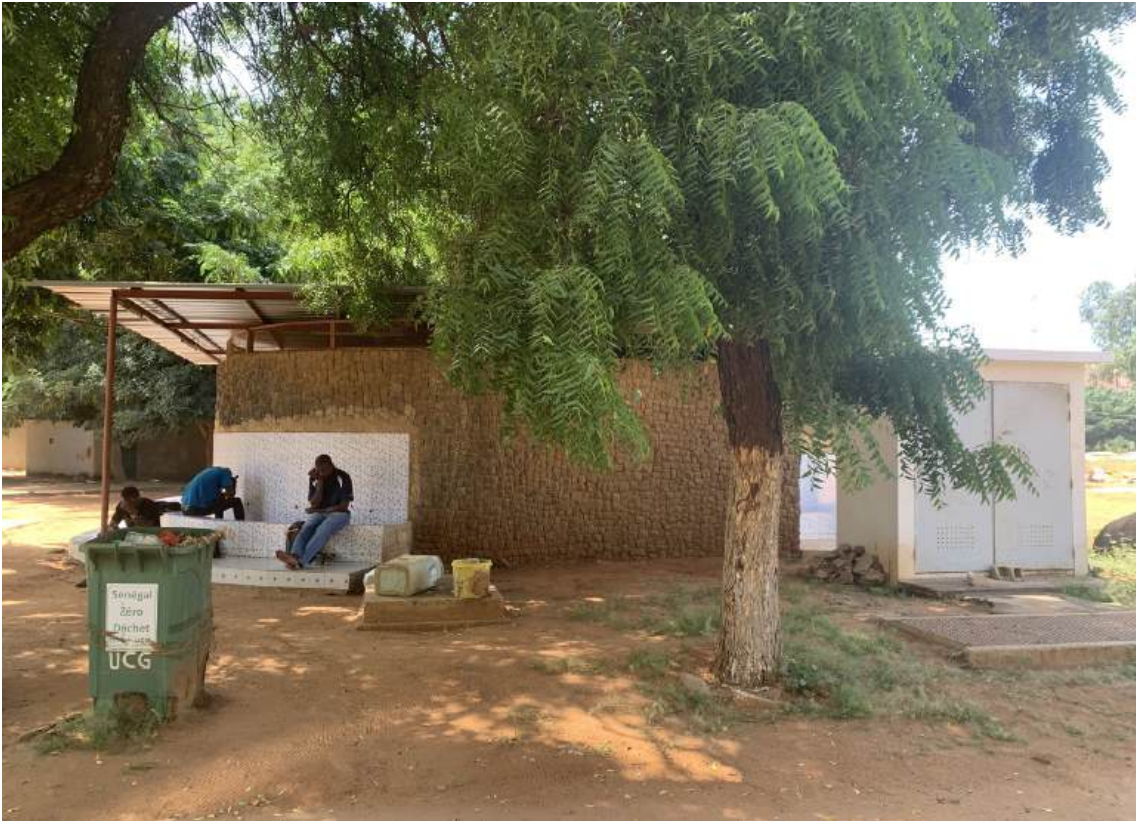
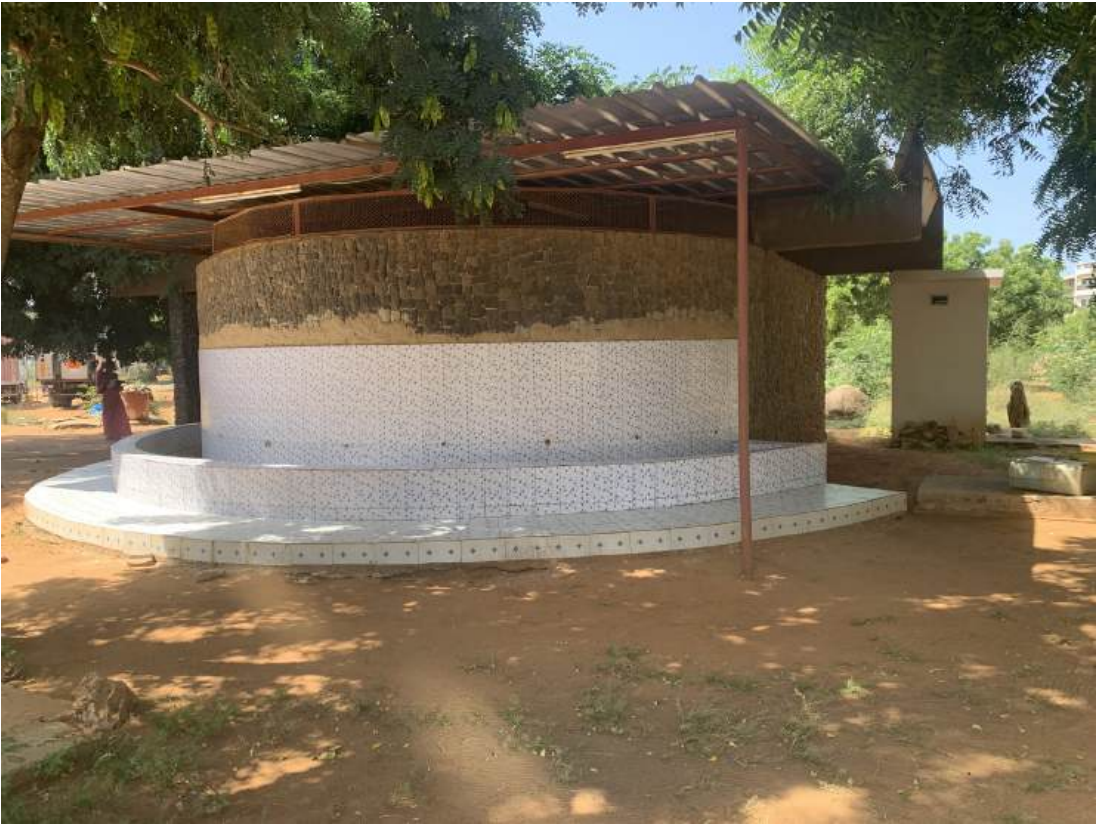
- A new tiled exterior ablution basin was added to the bathroom pavilion closest to the green pavilion, completely compromising its facade.

Fig.77: (A+B) exterior views of the bathroom pavilion, transformed into an ablution area(photo: Dana Salama, 2021).

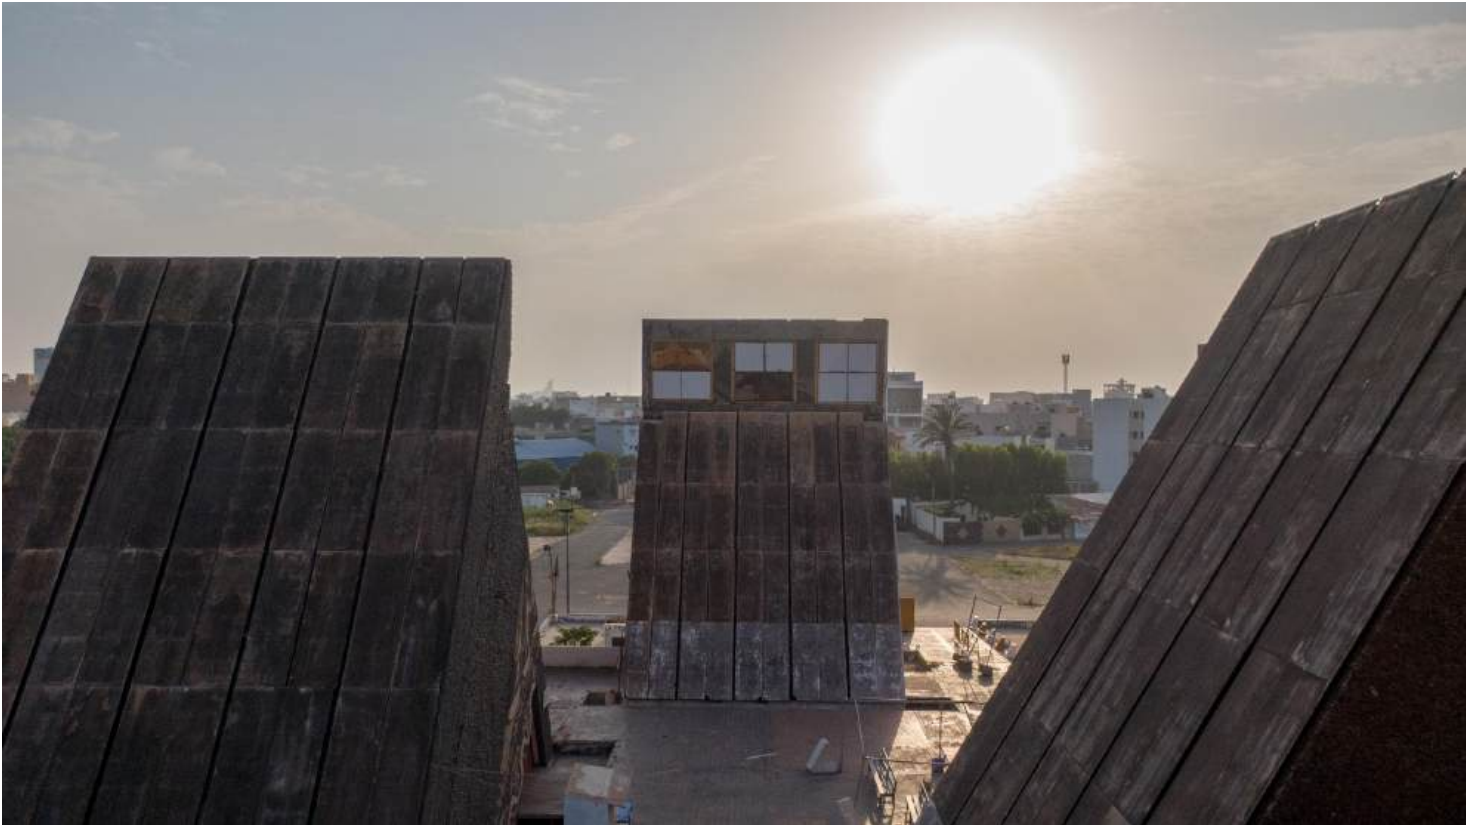
Fig.80: (top right) view from inside a motorcycle shop, now located inside the seven regional pavilions (photo: Dana Salama, 2021).

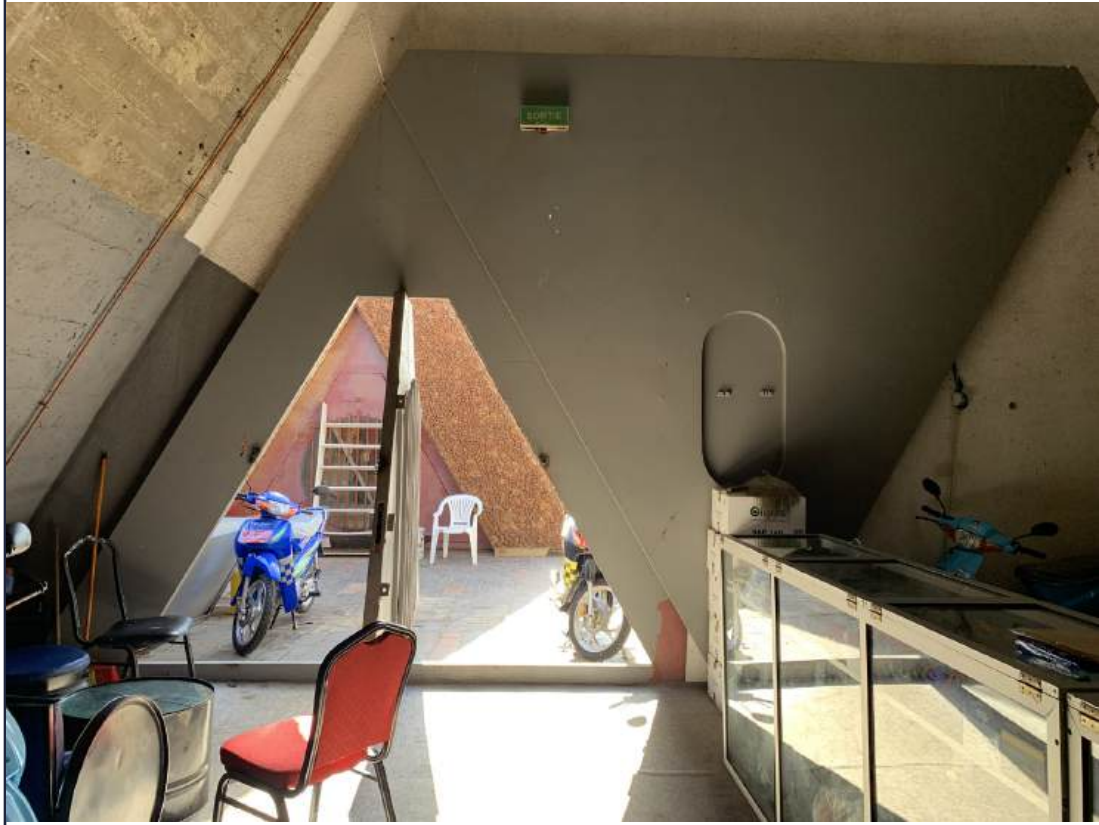
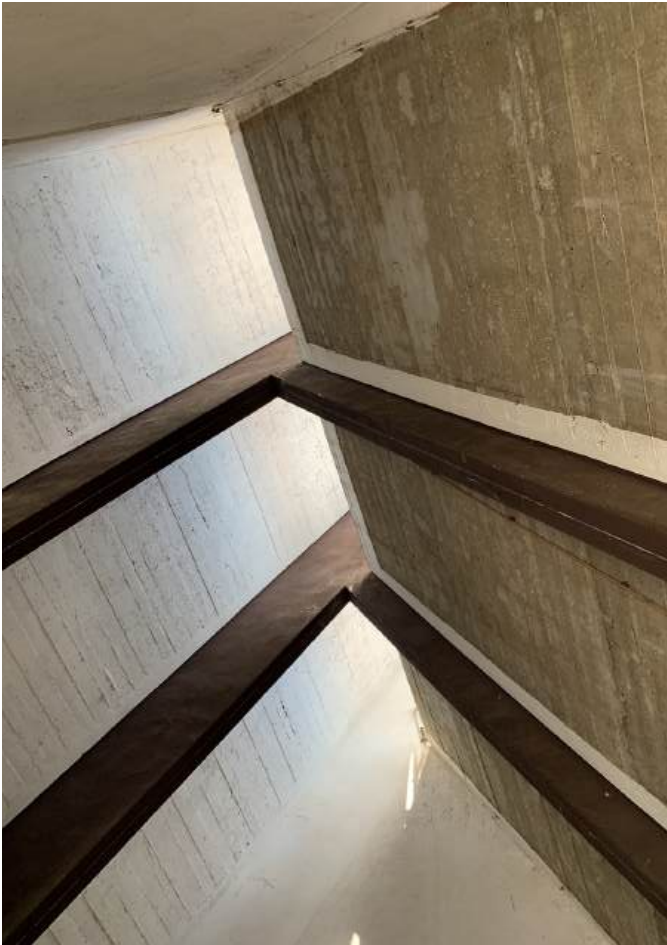
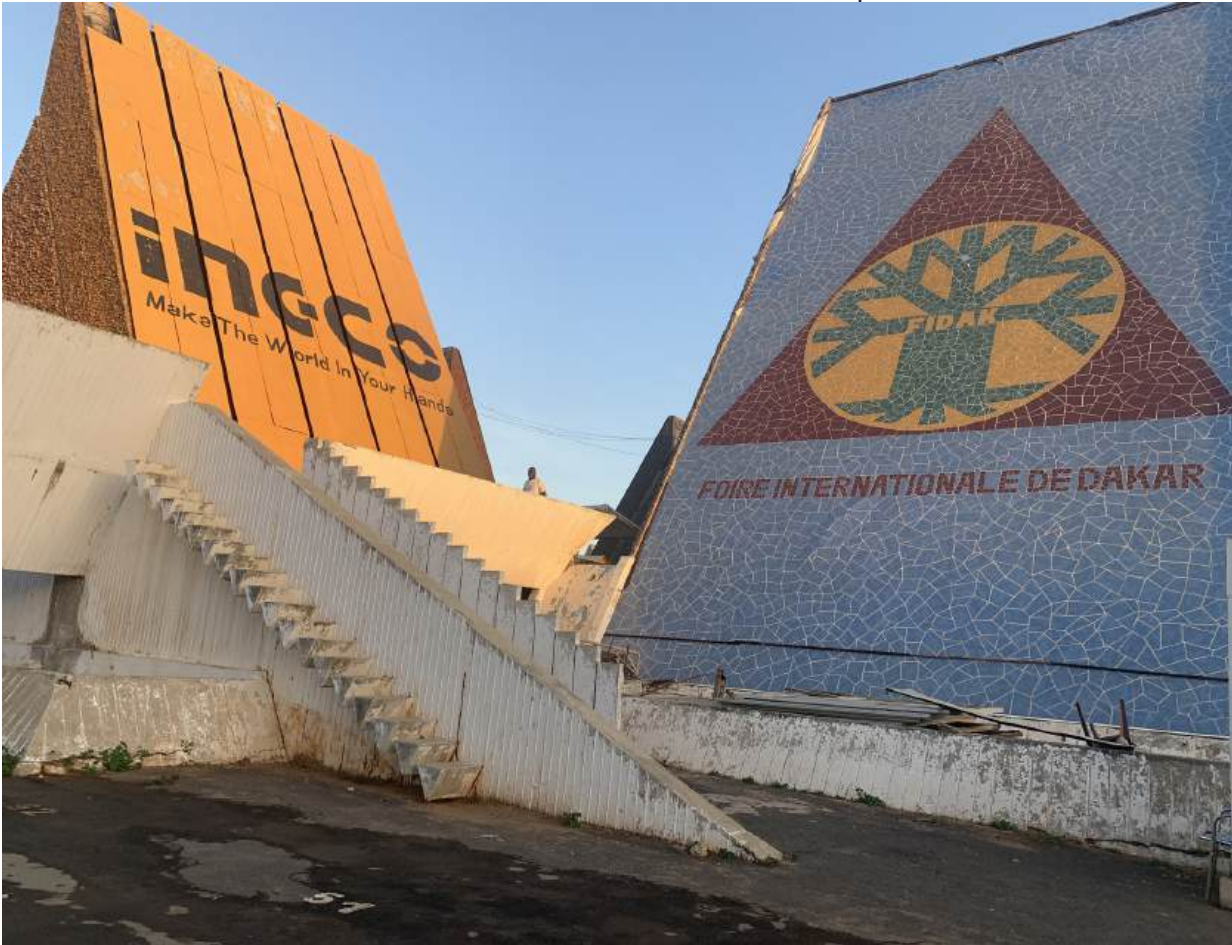
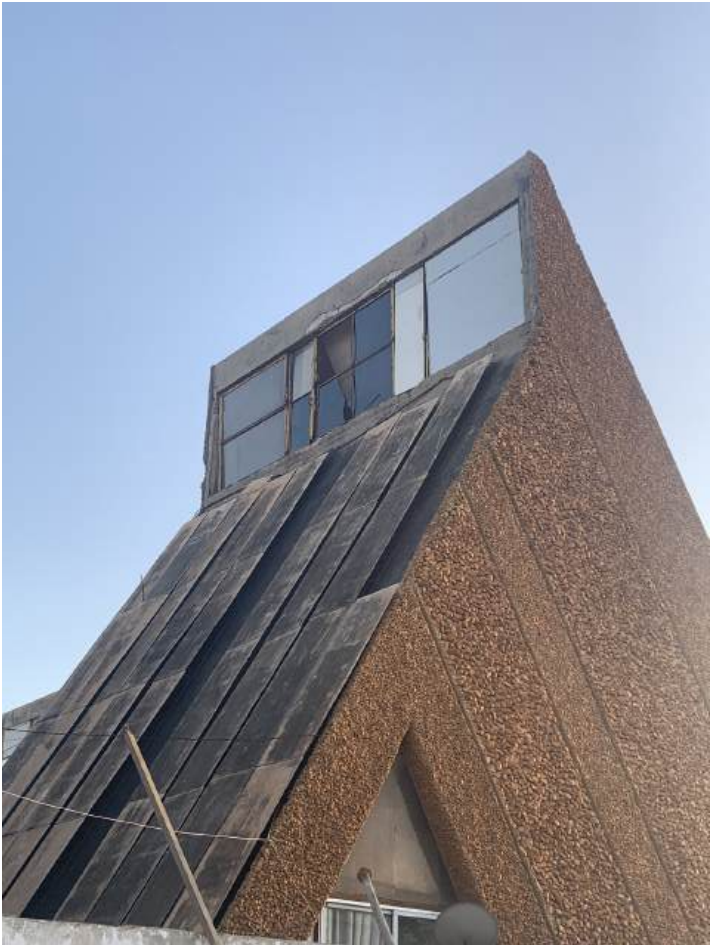
Left without any maintenance, the metallic truss system holding the asbestos panels on the facades of the regional pavilions has rusted and failed in many places. It has caused many of the asbestos panels to break or fail in some areas, with some panels now missing (figure 83.) In contrast, the concrete structure is spotless, except for two instances where the concrete was noticeably porous, likely due to the lack of proper compaction during construction.

Fig.82: (bottom centre) view of the stair up to the regional pavilion plinth level and the advertisements that have been placed on the facades of some pavilions (photo: Dana Salama, 2021).

Fig.83: (bottom right) view of the Diourbel regional pavilion facade showing missing roof panels (the roof panels also contain asbestos), and broken windows (photo: Dana Salama,

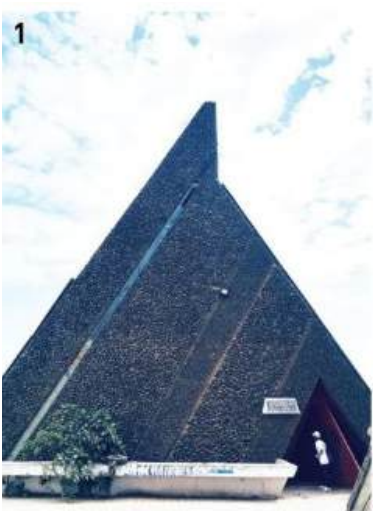
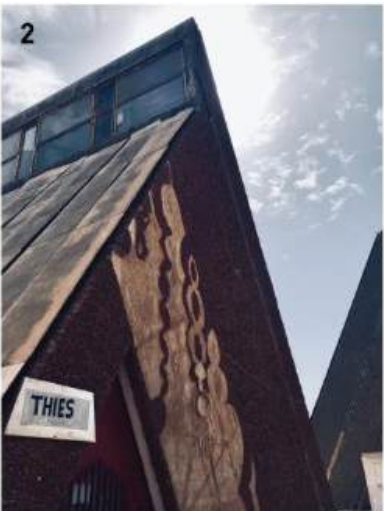
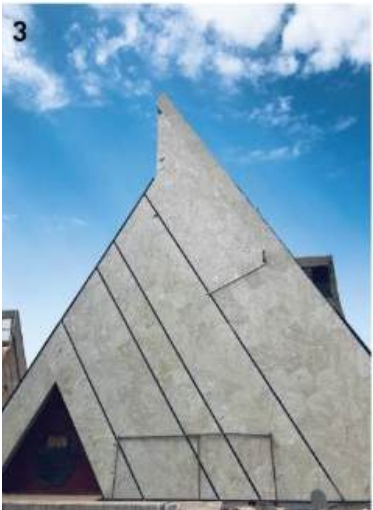
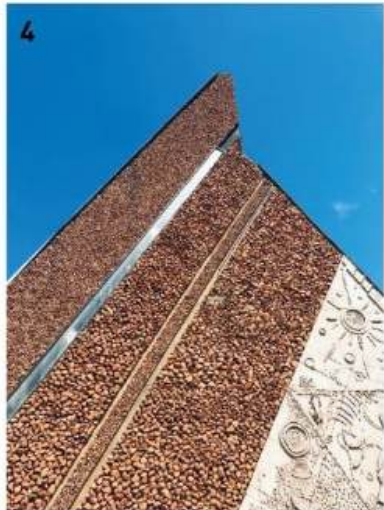
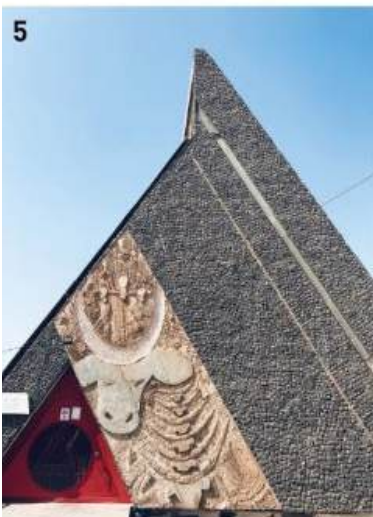
- 1.Cap Vert
- 2. Thies
- 3. Casamance
- 4. Diourbel
- 5. Fleuve
- 6. Senegal Oriental
- 7. Sine Saloum

Fig.84: regional pavilion facades (Aziza Chaoumi Projects, 2021).

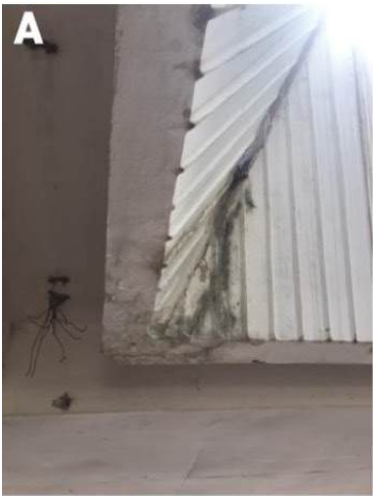
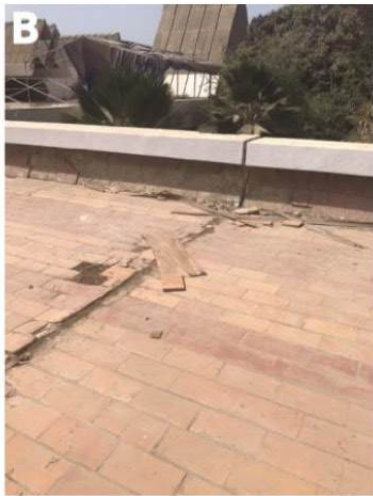
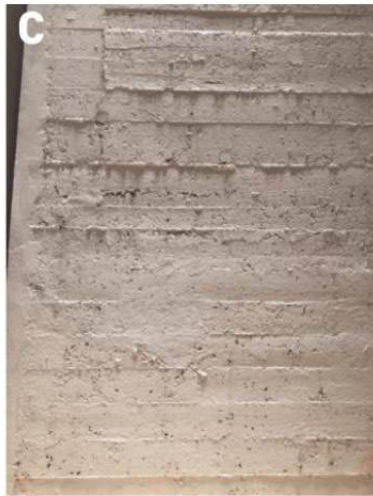
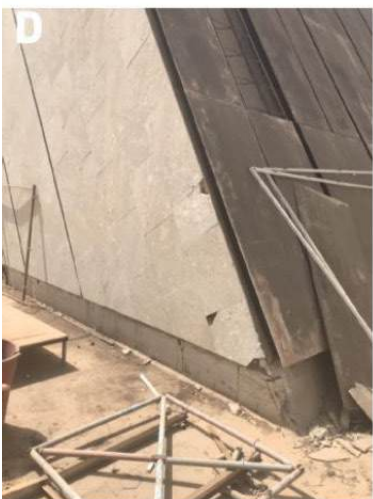
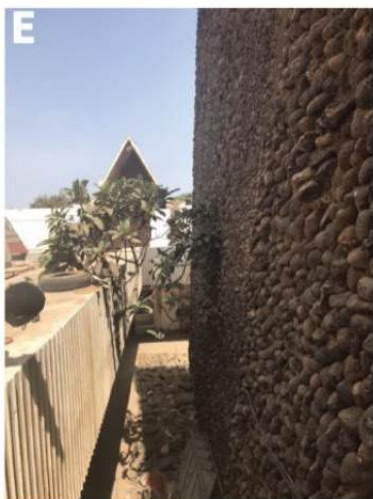
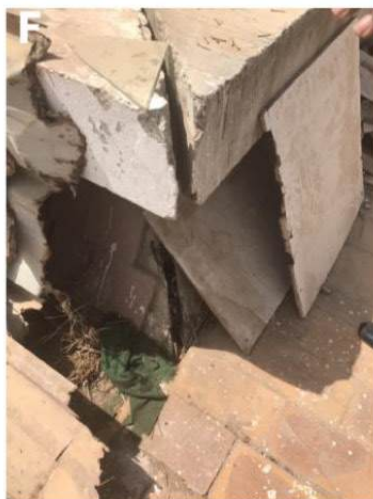
Fig.85: A selection of regional pavilion deficiencies (Aziza Chaoumi Projects, 2021).

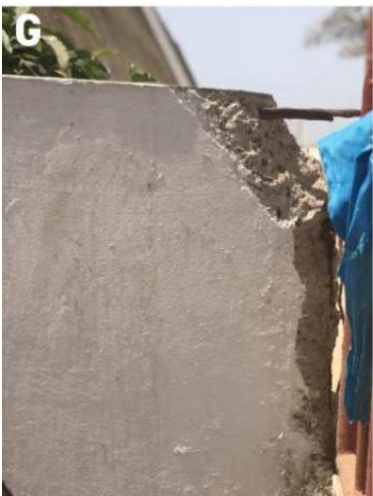
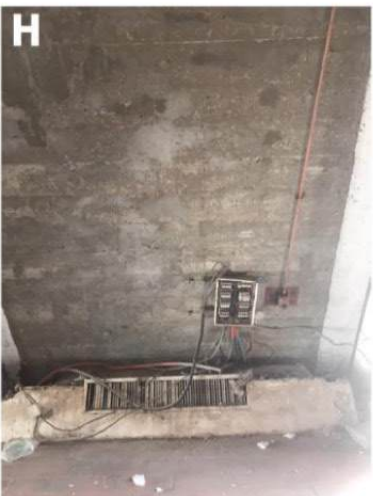
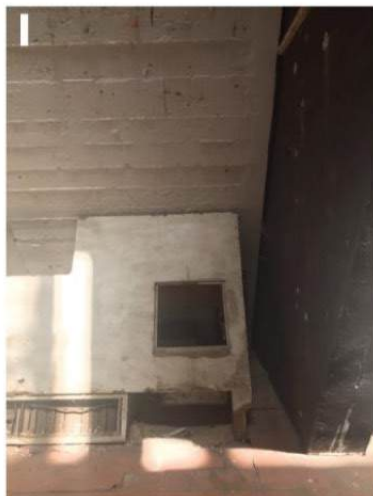
- The waterproofing membrane of the basins surrounding the regional pavilions is damaged, and water accumulation has caused cracks and spalling (figure 85, D.)

- Run-off water channels poorly conceived by the Architects have resulted in water draining from the platform down to the courtyards below, splashing and damaging the concrete slab—causing staining and spalling (figure 85, A.)

- Exposed wiring (figure 85, H.)
- Floor damage caused by the fixation of free-standing panels to create cubicles in the 3 pavilions by the Motor and Vehicle Department of Dakar.

- Replacement of original pavers with new flooring.
- Dilatation of expansion joints between floor tiles which were filled with concrete, causing cracks (figure 85, B.)

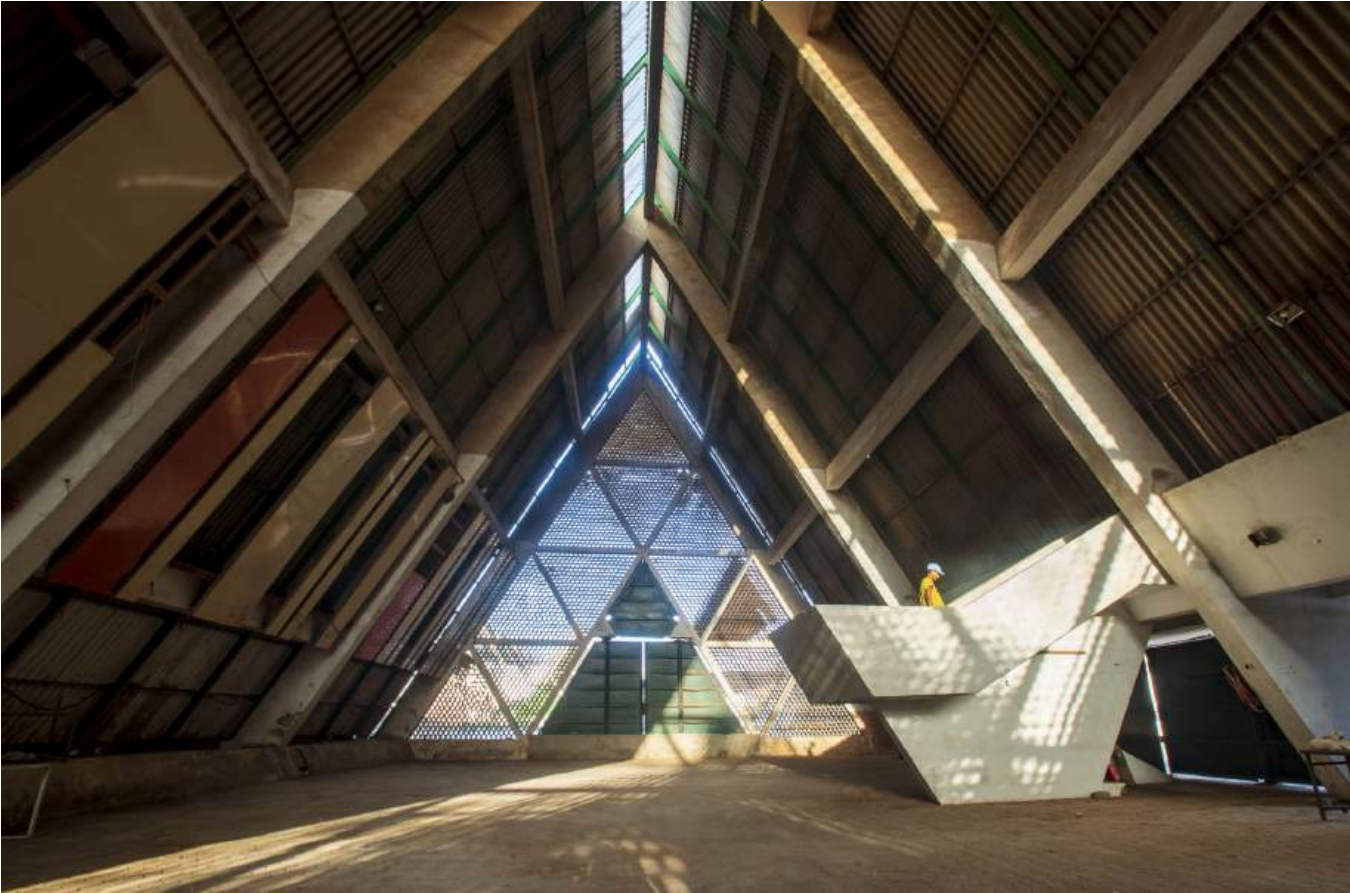
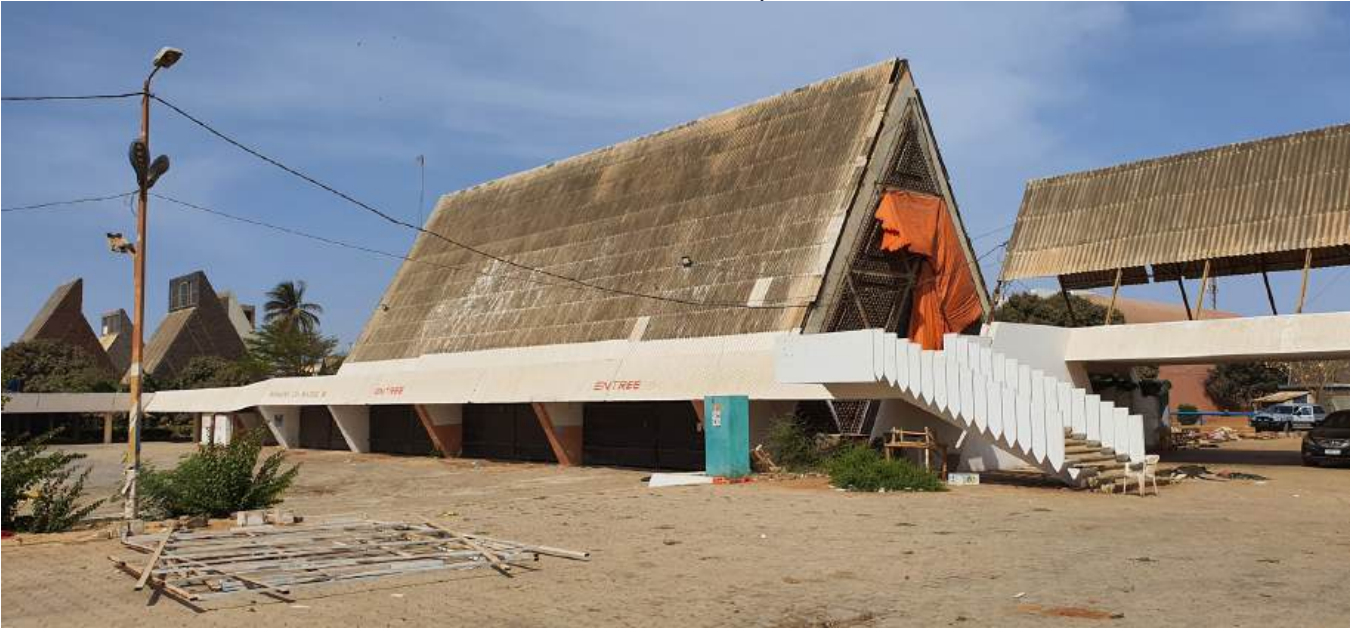
Fig.87: (top) interior of the Grand Nave/ Moroccan pavilion showing the ventilated facade constructed from PVC pipes, the sculptural stairs, and the vinyl panelling on the interior facades (photo: Elyse Fitte-Duval, 2021).

Fig.88: (bottom) exterior view of the Grand Nave/ Moroccan pavilion (photo: Elyse Fitte-Duval, 2021).

- The Grand Nave building is almost intact, aside from its rusting metal roof substructure and ageing cement fibre roof panels. Its structural elements are all in excellent condition, with no noticeable cracks or damage.
- The interior coloured mural composed of laminate panels is damaged and missing some panels.
- The asbestos pipes in the ventilated facade need remediation. In some places they have been displaced and trash/ newspapers are lodged in the facade to keep it intact.
- Today, the Grand Nave is mainly used as storage and as the Morocco pavilion during FIDAK.

- The triangular ventilated facades with PVC pipes contain asbestos and need rehabilitation immediately.
- There is cracking along the expansion joint that splits the building’s structure resulting in serious deflection (see Appendix B).
