Keeping It Modern:  
**Centre International  
du Commerce Extérieur  
de Dakar (CICES)**

Conservation Management Plan  
01. 2023  
Dakar, Senegal

Written by  
Aziza Chaouni, Mourtada Gueye, Dana Salama

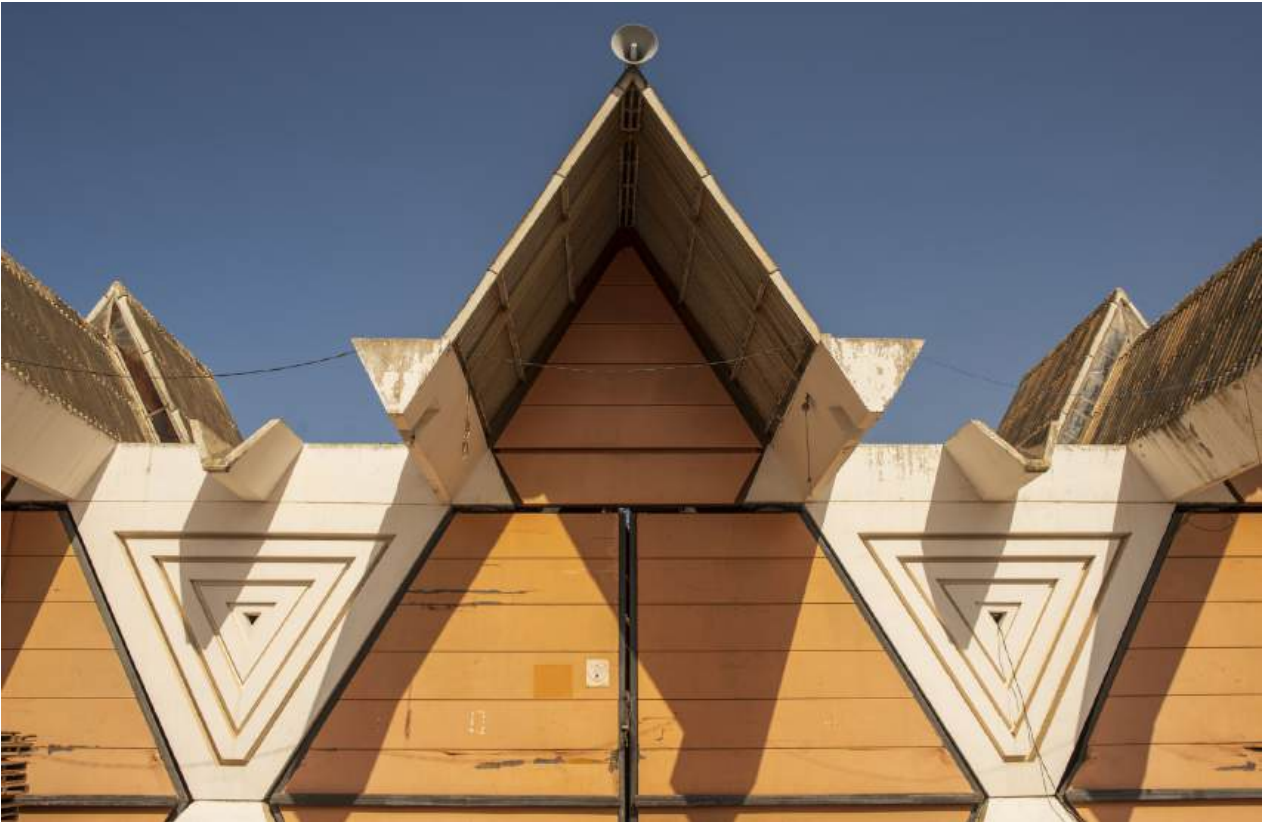
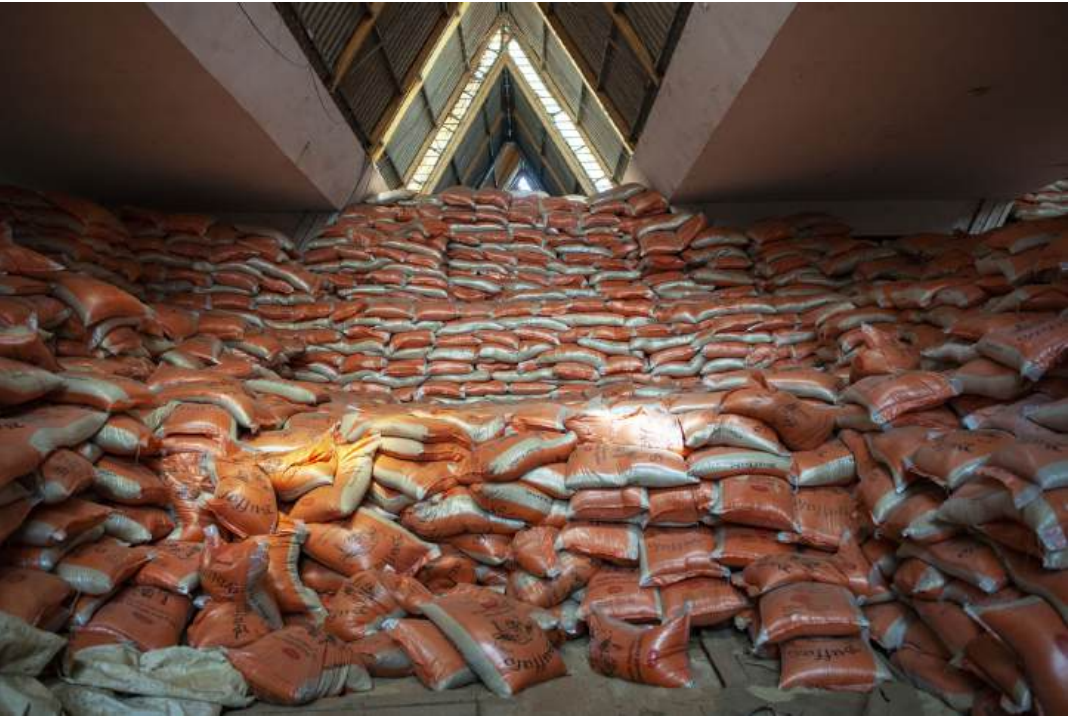
Like several other exhibition buildings, there are systemic issues impacting the state of the orange pavilion: (1) trucks hitting the bases of columns causing cracking and damage to the building infrastructure and denting in the trapezoidal doors, (2) water infiltration from the poorly maintained/ restored roofs causing rust, the growth of vegetation, and structural cracks.

- Some of the cracking at column bases (likely due to impact from vehicles) is pronounced, and should be addressed before potentially leading to more severe structural damage.

Fig.89: (top) exterior view of the orange exhibition pavilion facade (photo: Elyse Fitte-Duval, 2021).

Fig.90: (bottom) view of the interior of the orange exhibition pavilion being rented for rice storage (photo: Elyse Fitte-Duval, 2021).

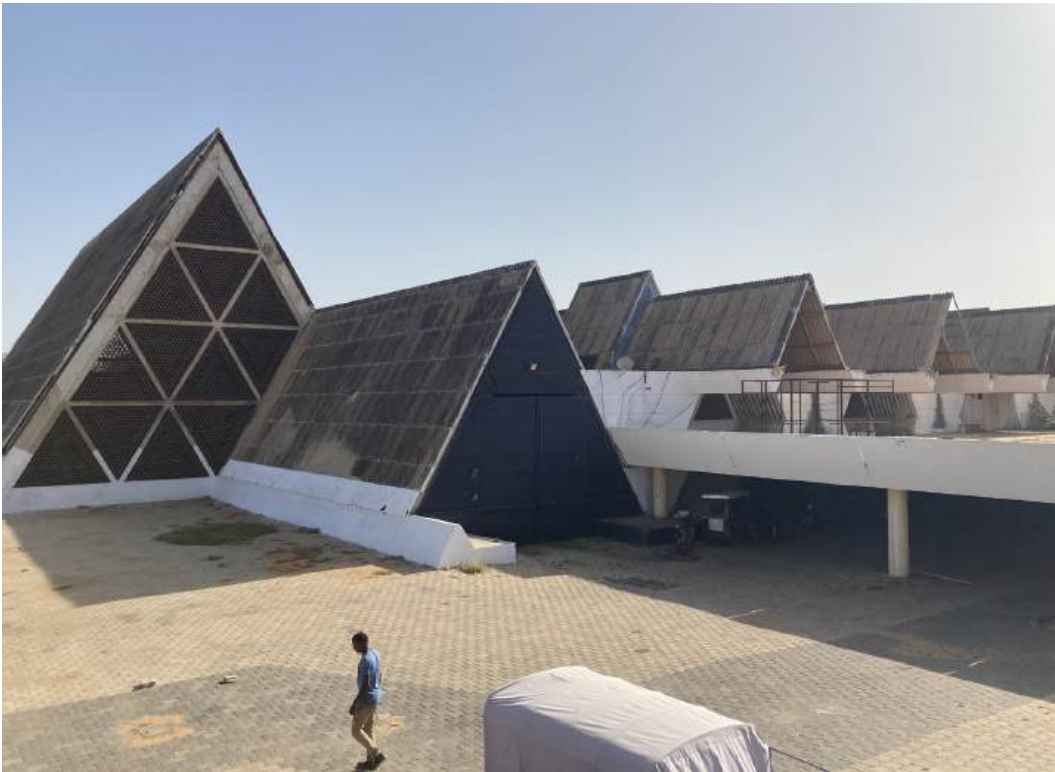
Fig.91: (top left) Senegal pavilion facade showing white paint chipping off and missing lights in the protruding exterior beams (photo: Elyse Fitte-Duval, 2021).

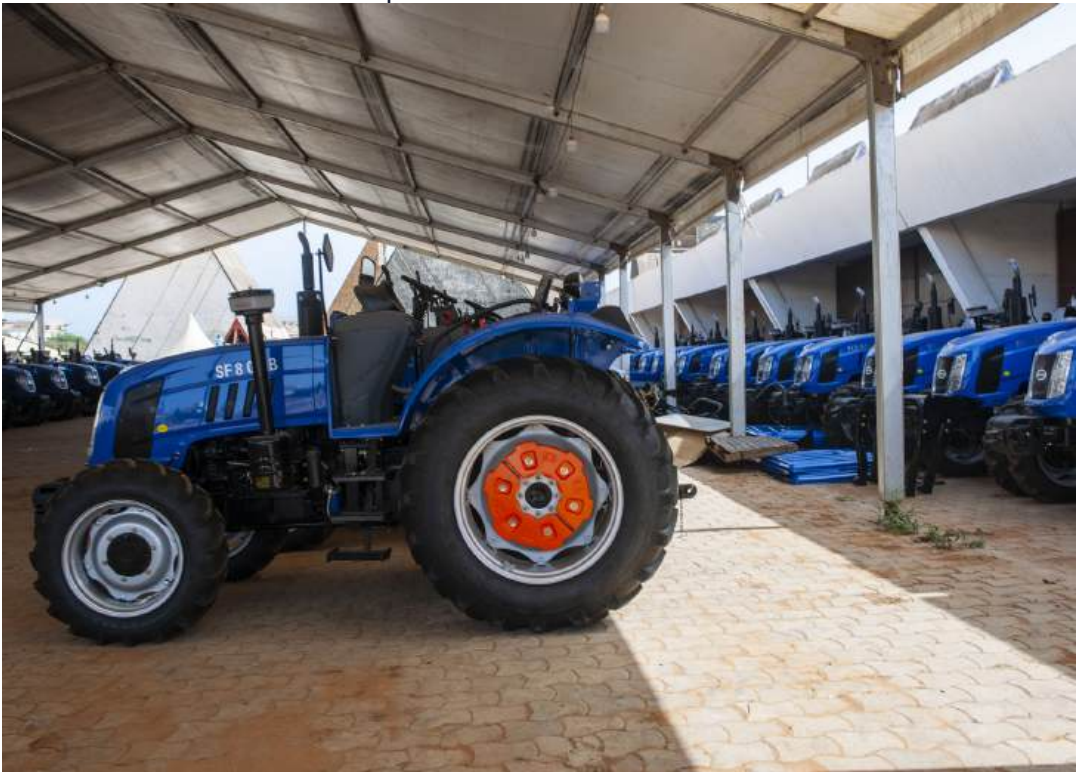
The Yellow/ Senegal pavilion is in relatively good condition. Its major issues include the covering of originally exposed concrete finishes with white paint, blocking stairwells with exhibition booths, partitions, and furniture, and destroying the original bathroom with the addition of cheap ceramic tiles.

The exterior of the building, like other exhibition pavilions, has exposed wiring, original finishes covered in paint, damaged doors, corroding roof panels, and overgrowing vegetation.

Fig.94: (bottom right) a temporary structure erected outside of the Senegal pavilion to protect merchandise blocks views of the site (photo: Elyse Fitte-Duval, 2021).

Fig.92: (top right) missing roof panels on the Senegal pavilion (photo: Elyse Fitte-Duval, 2021).

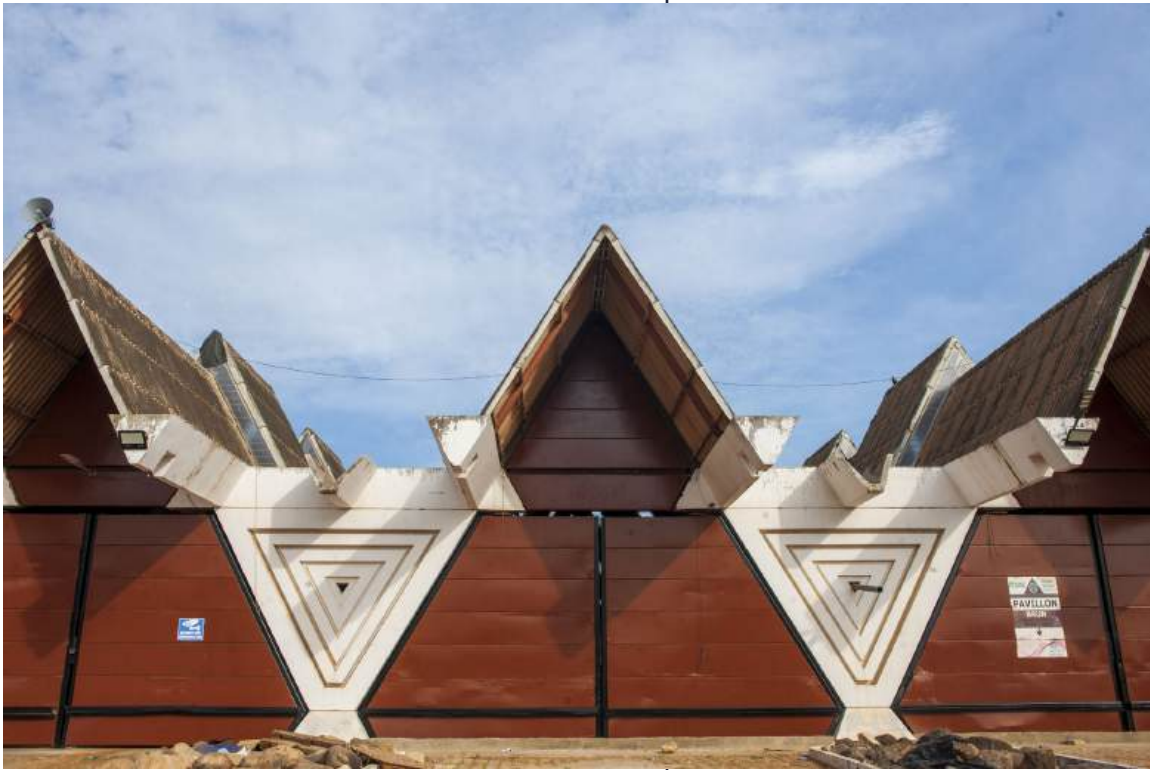
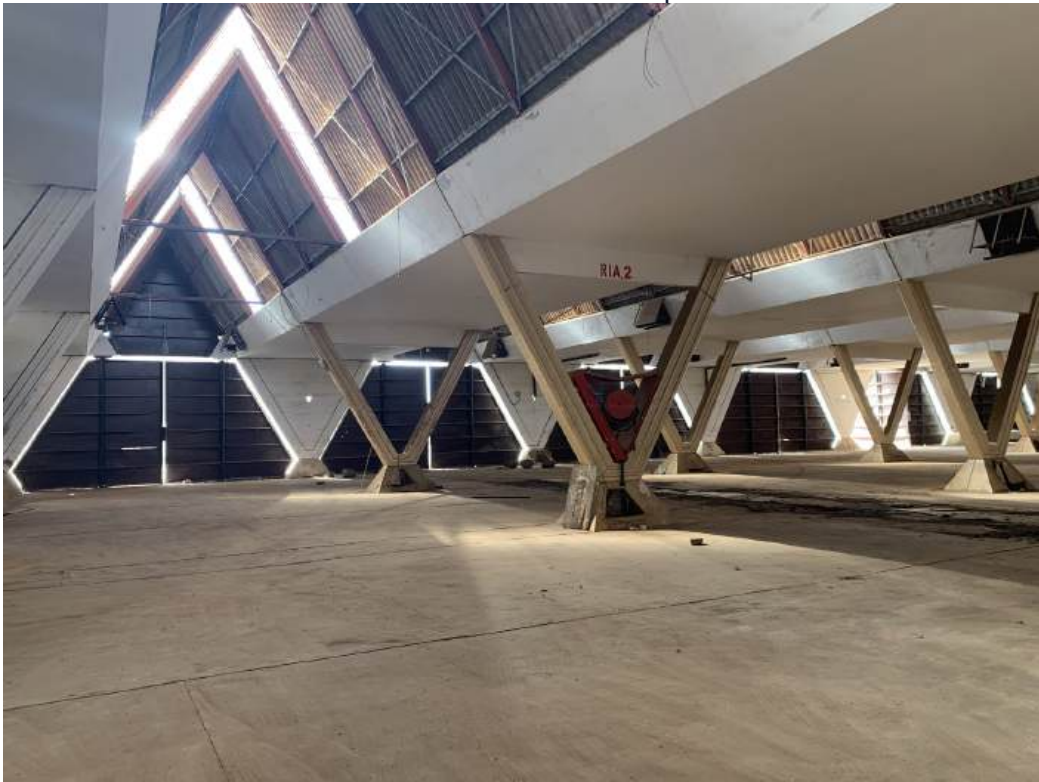
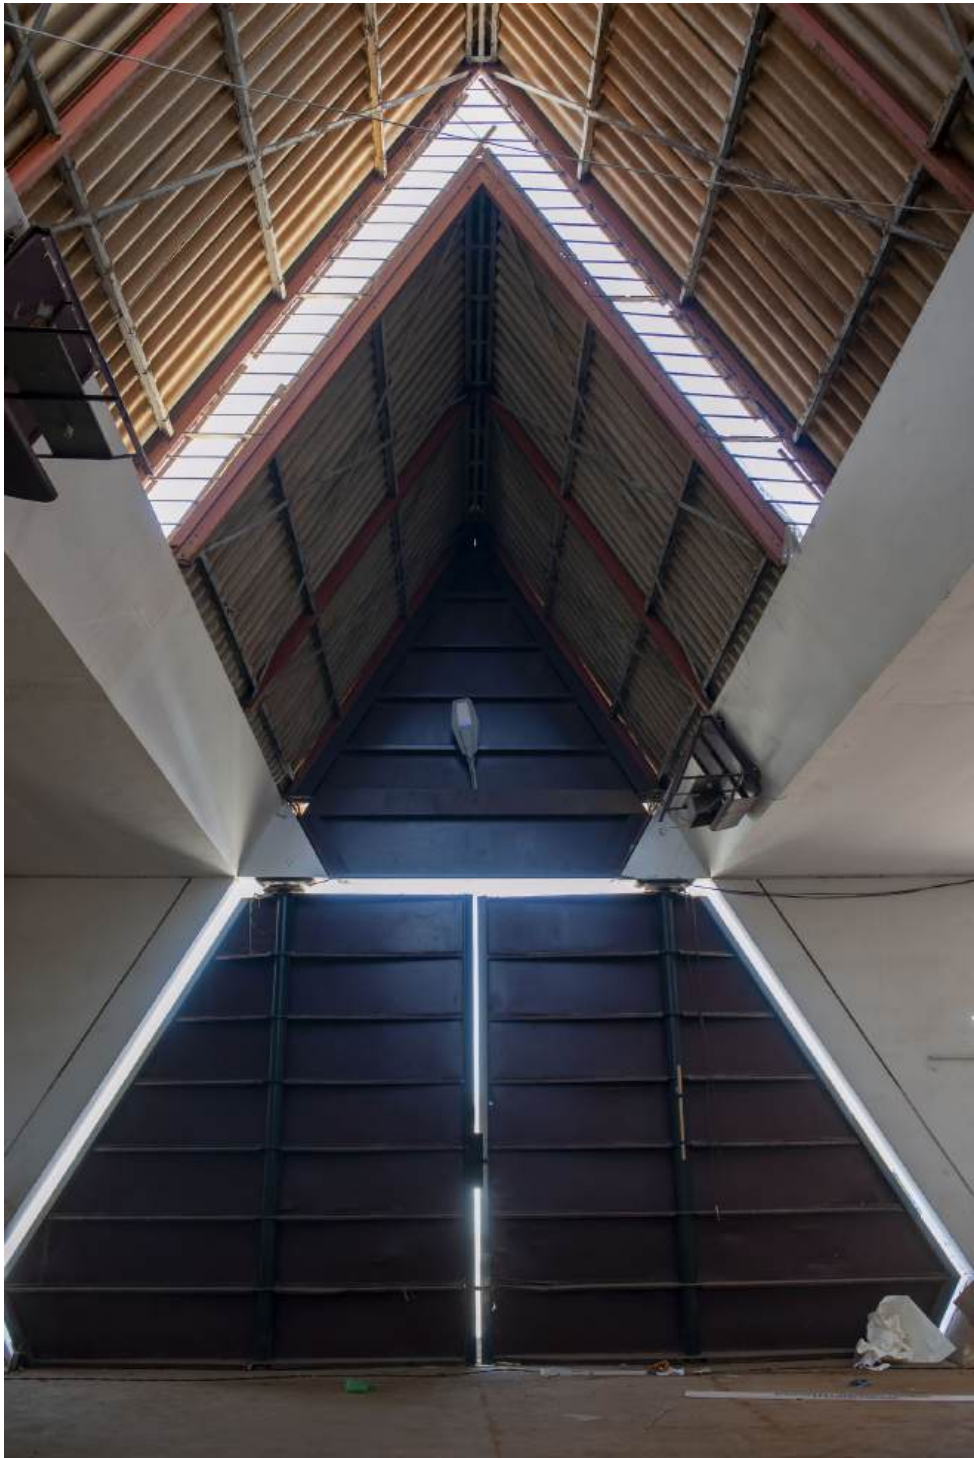
The major issues for the brown pavilion occur on the exterior: with non-original masonry fences on the perimeter of the building (separating the building form informal uses on/ adjacent to the site of the former artisan’s village), new cementitious paving around the exterior of the building, informal parking areas causing damage and clutter to the site surroundings, and blocking original parts of the facade.

*Fig.96: (bottom left) Brown pavilion interior with exposed concrete painted white, and some covers missing on the column bases which contain electrical receptacles (photo: Elyse Fitte-Duval,*

*Fig.97: (bottom left) Brown pavilion interiorview of trapezoidal door (photo: Elyse Fitte-Duval, 2021).*

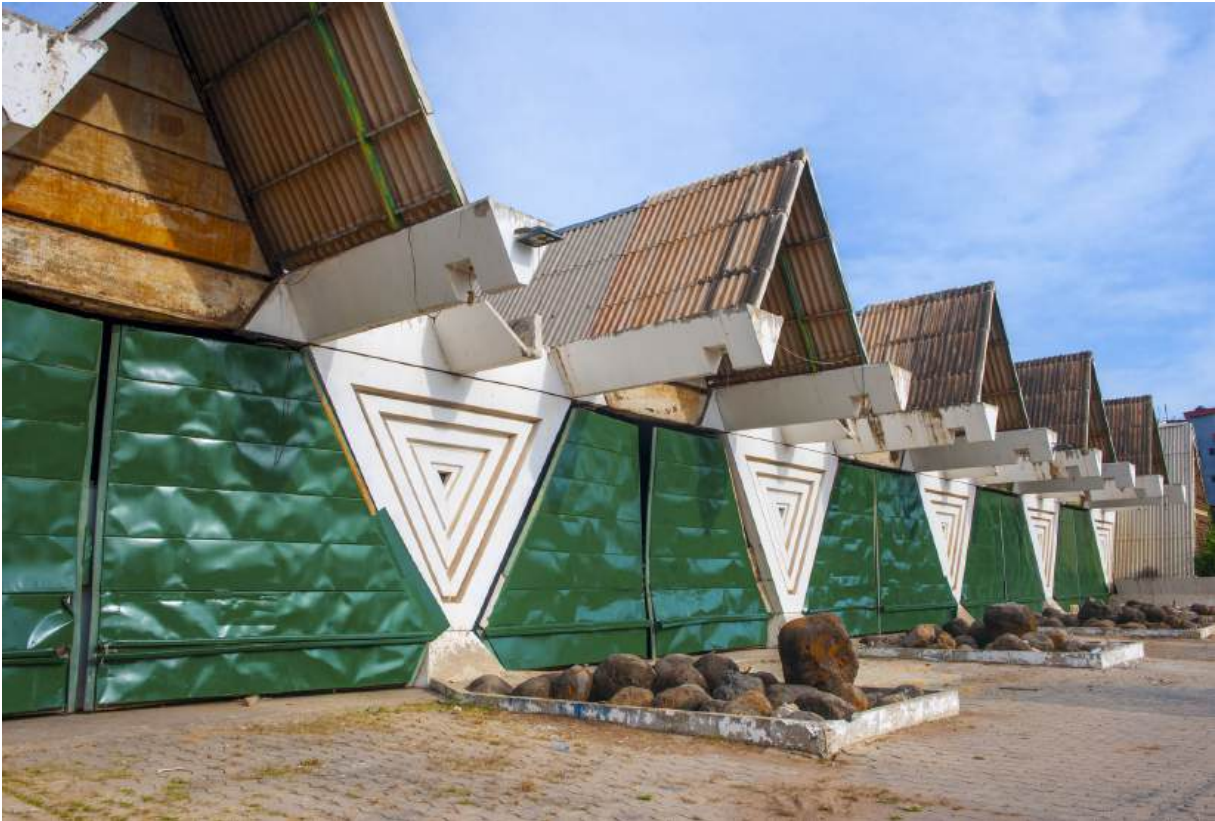
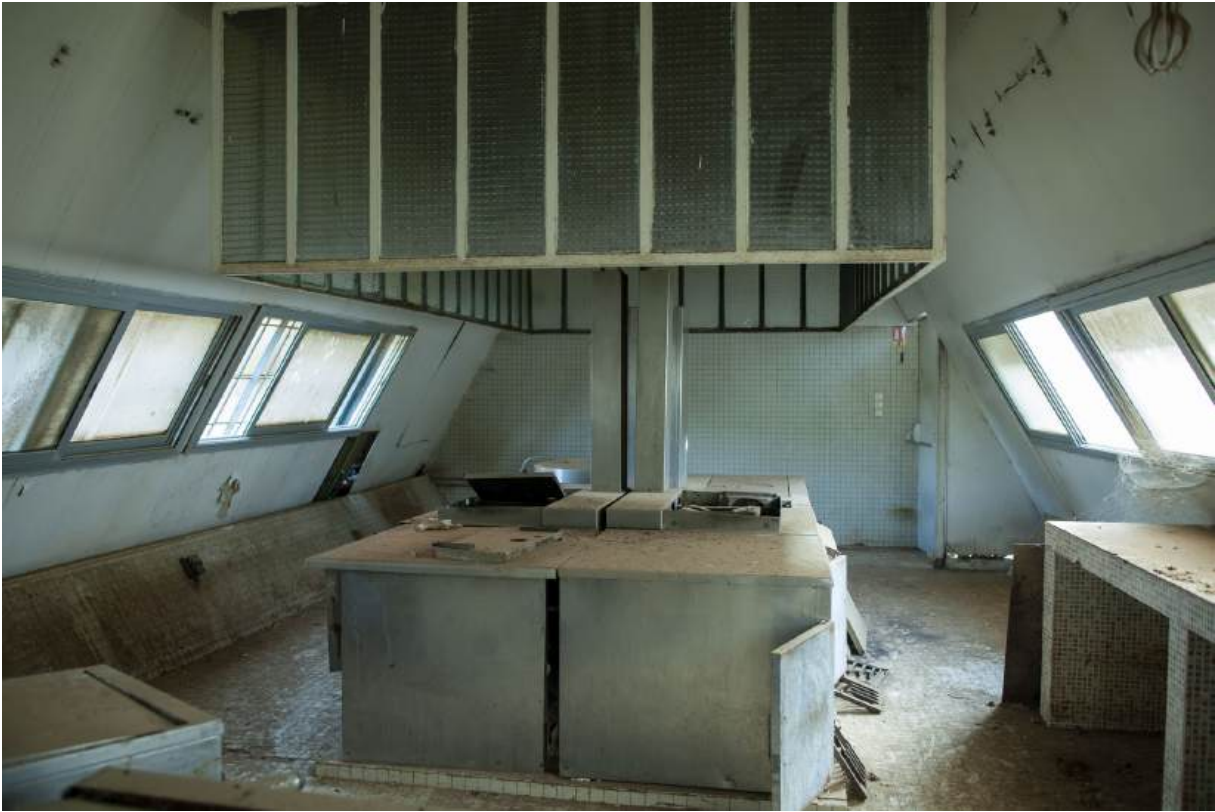
In December of 2019, informal wiring caused a major fire in the green pavilion, which caused structural damage. It appears as though much of the damage has been fixed, however the extent of the damage is no longer visible due to painting over the damaged portion of the building.

On the upper level of the restaurant (bar, kitchen, teaching areas), many of the original features are remarkably intact including the decorative service elevator. The wired glass central exhaust hood is still in place and in good condition, although the appliances themselves are missing or rusted. However in some cases the original counters have been damaged and poor (recent) plumbing and wiring work has compromised the original detailing.

Fig.98: (top) Green pavilion view of exterior facade showing concrete painted white and denting on the doors, likely from the effects of the fire (photo: Elyse Fitte-Duval, 2021).

Fig.99: (bottom) Green pavilion restaurant view of kitchen with origibnal glass hood and many of the original finishes intact (photo: Elyse Fitte-Duval, 2021).

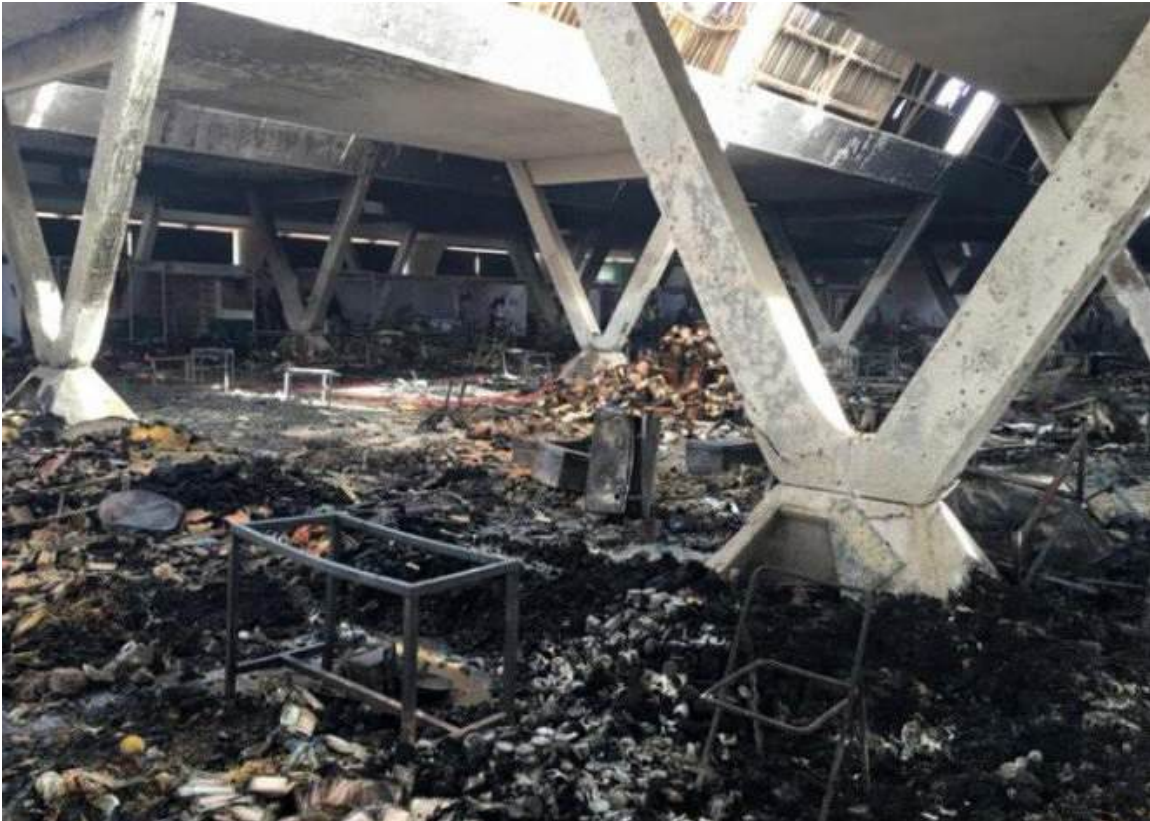
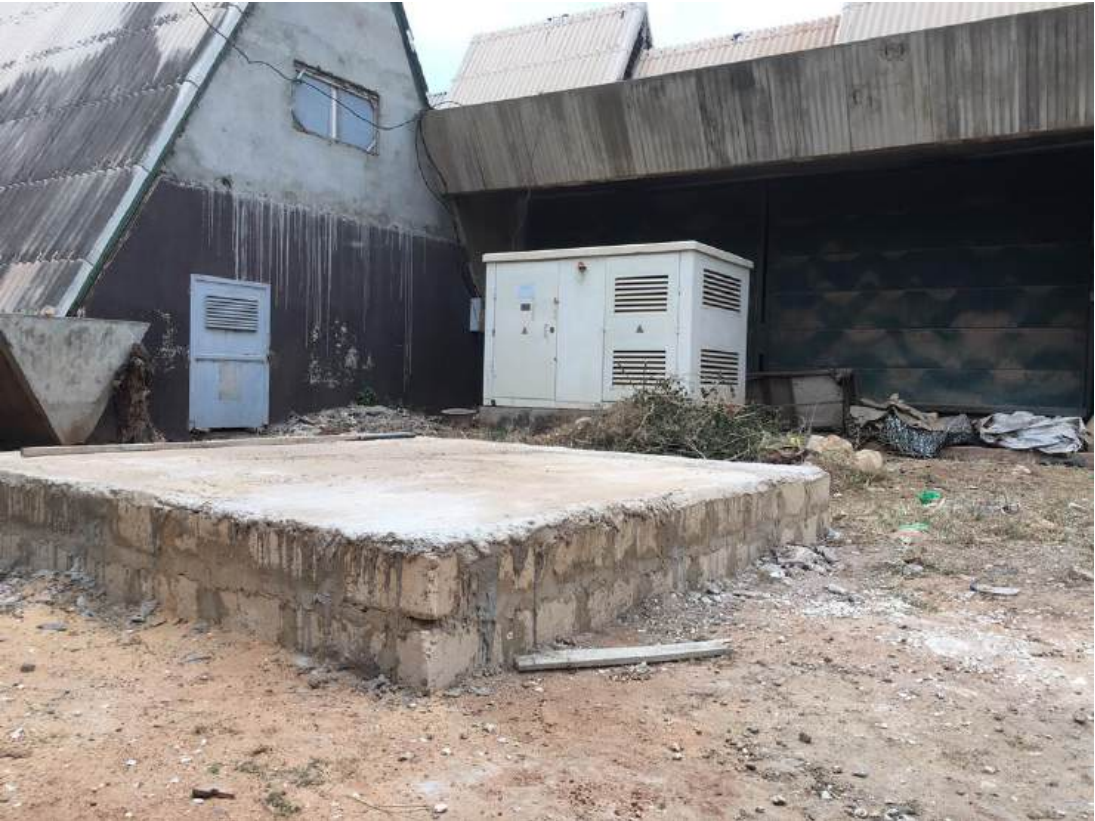
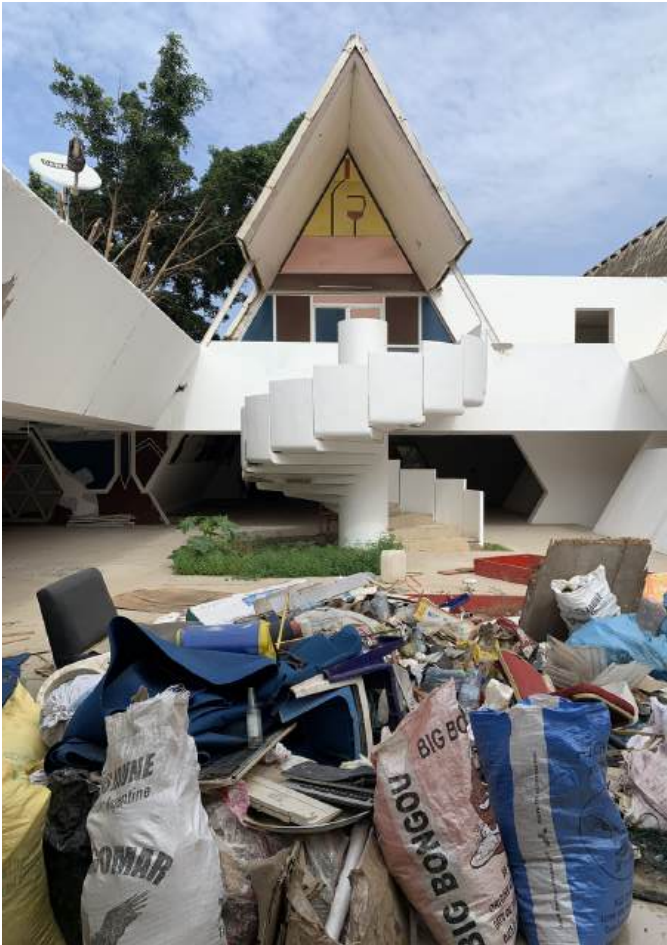
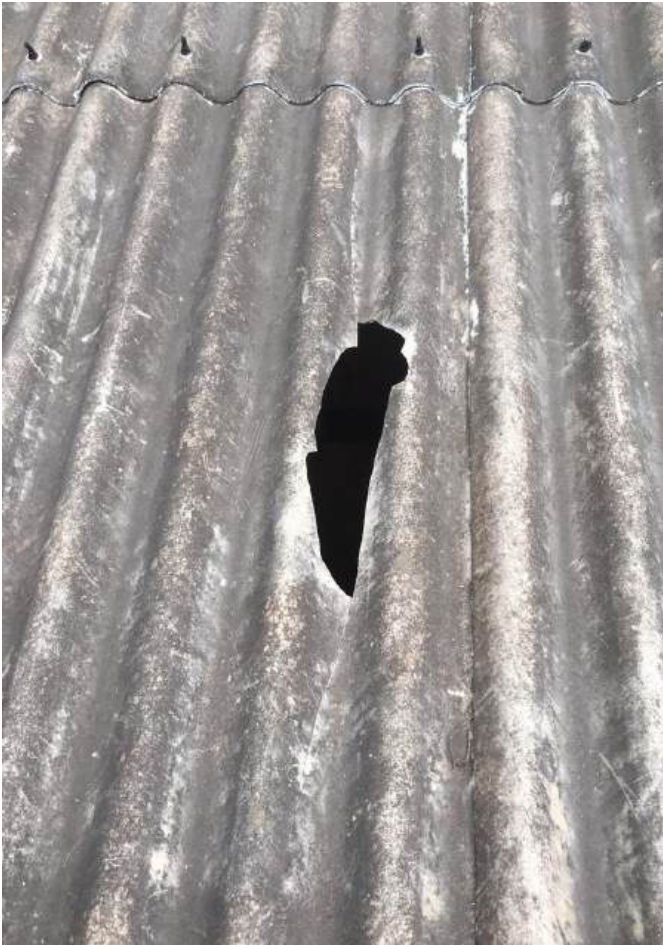
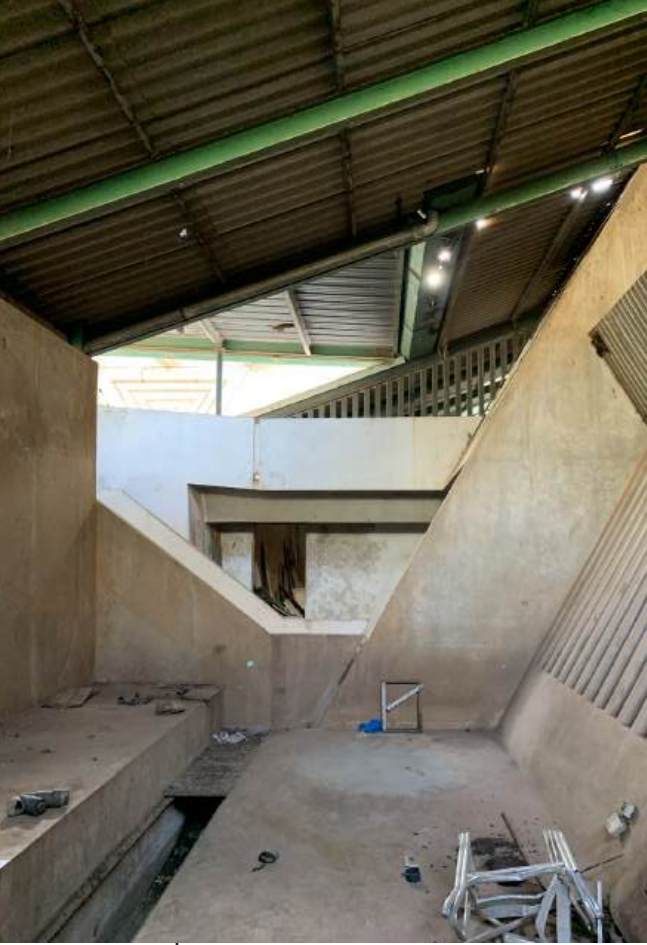
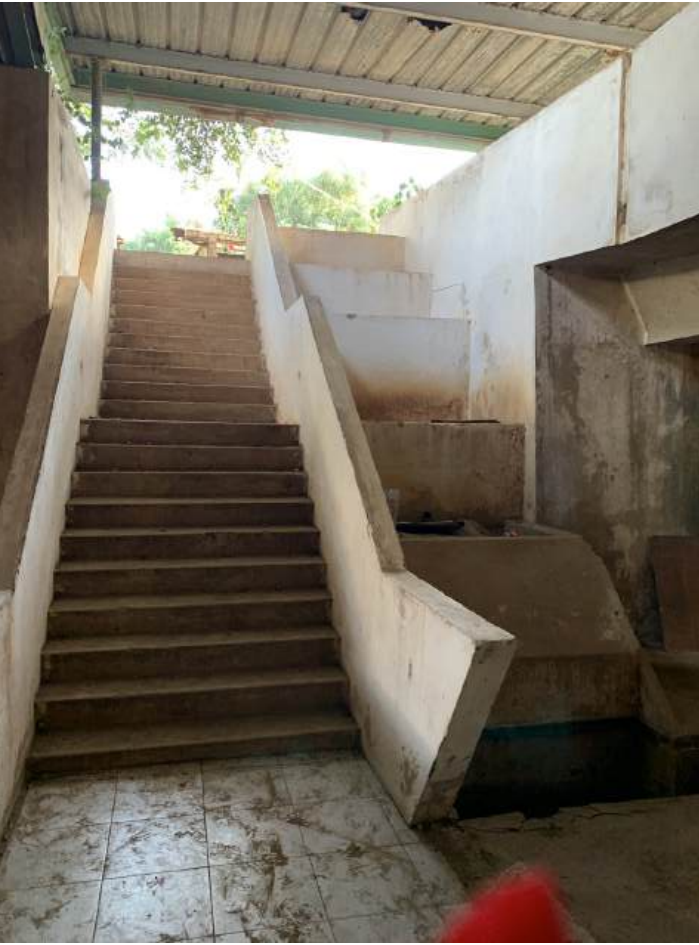
There are several areas on the green pavilion that are missing roof panels due to corrosion, weathering, or both. This causes increased risks of water infiltration during the rainy season which exacerbates degradation. There is also exposed and corroding rebar on the triangular concrete elements framing some of the triangular bays.

Fig.100: (top left) the aftereffects of the fire in the green pavilion (source unknown).

Fig.101: (top center) installation of exhibition booths inside the green pavilion (photo: Dana Salama, 2021).

Fig.104: (second from lower left) condition of green pavilion roof (photo: Dana Salama, 2021).

Fig.105: (second from lower right) lower level of green pavilion restaurant showing drainage canal (with missing cover) (photo: Dana Salama, 2021).

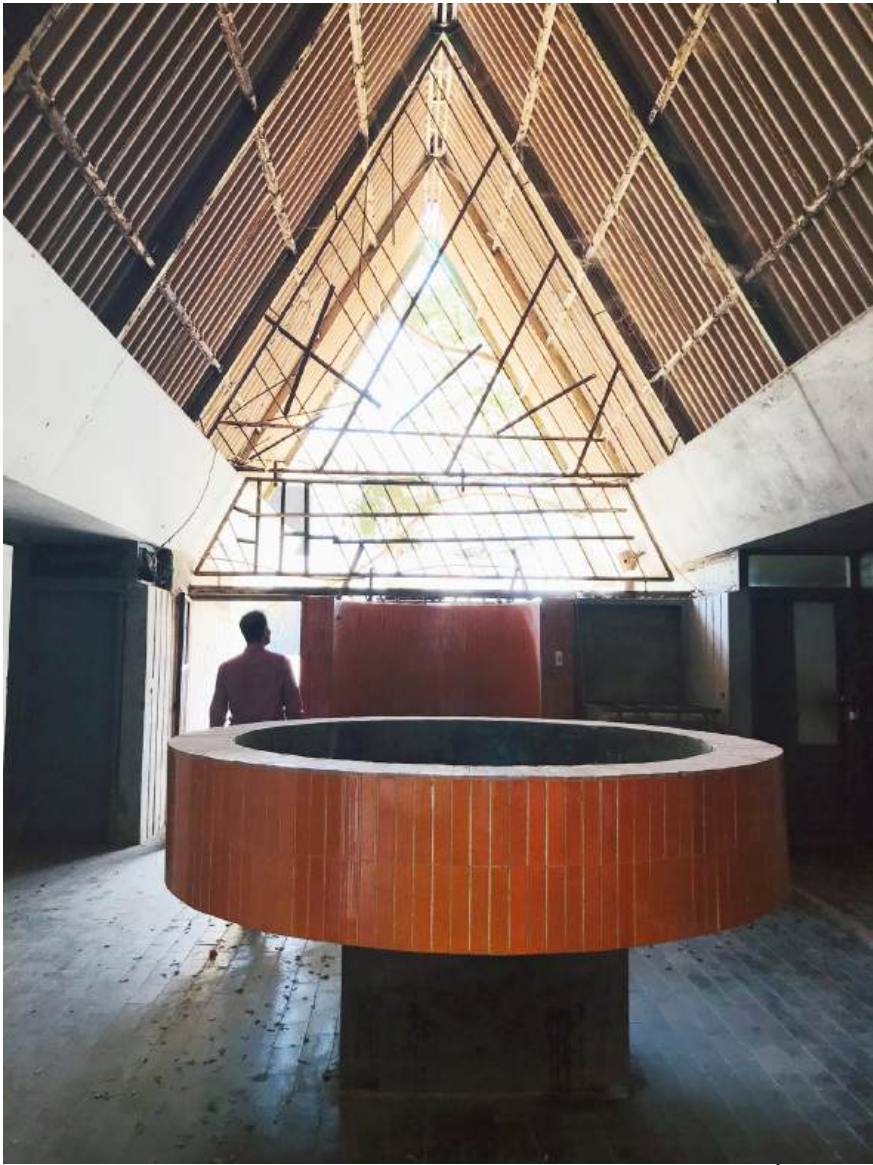
Fig.110: (left) interior view of Technical pavilion showing distinctive tile counter (photo: Aziza Chaouni, 2021).

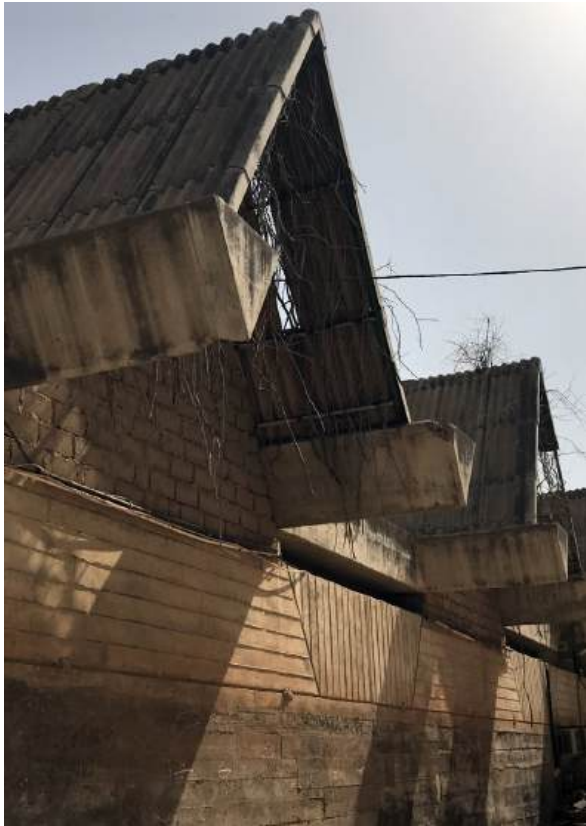
Fig.111: (right) view of the exterior facade of the technical pavilion showing infilling with brick, missing roof panels, and widespread overgrowth of vegetation (photo:

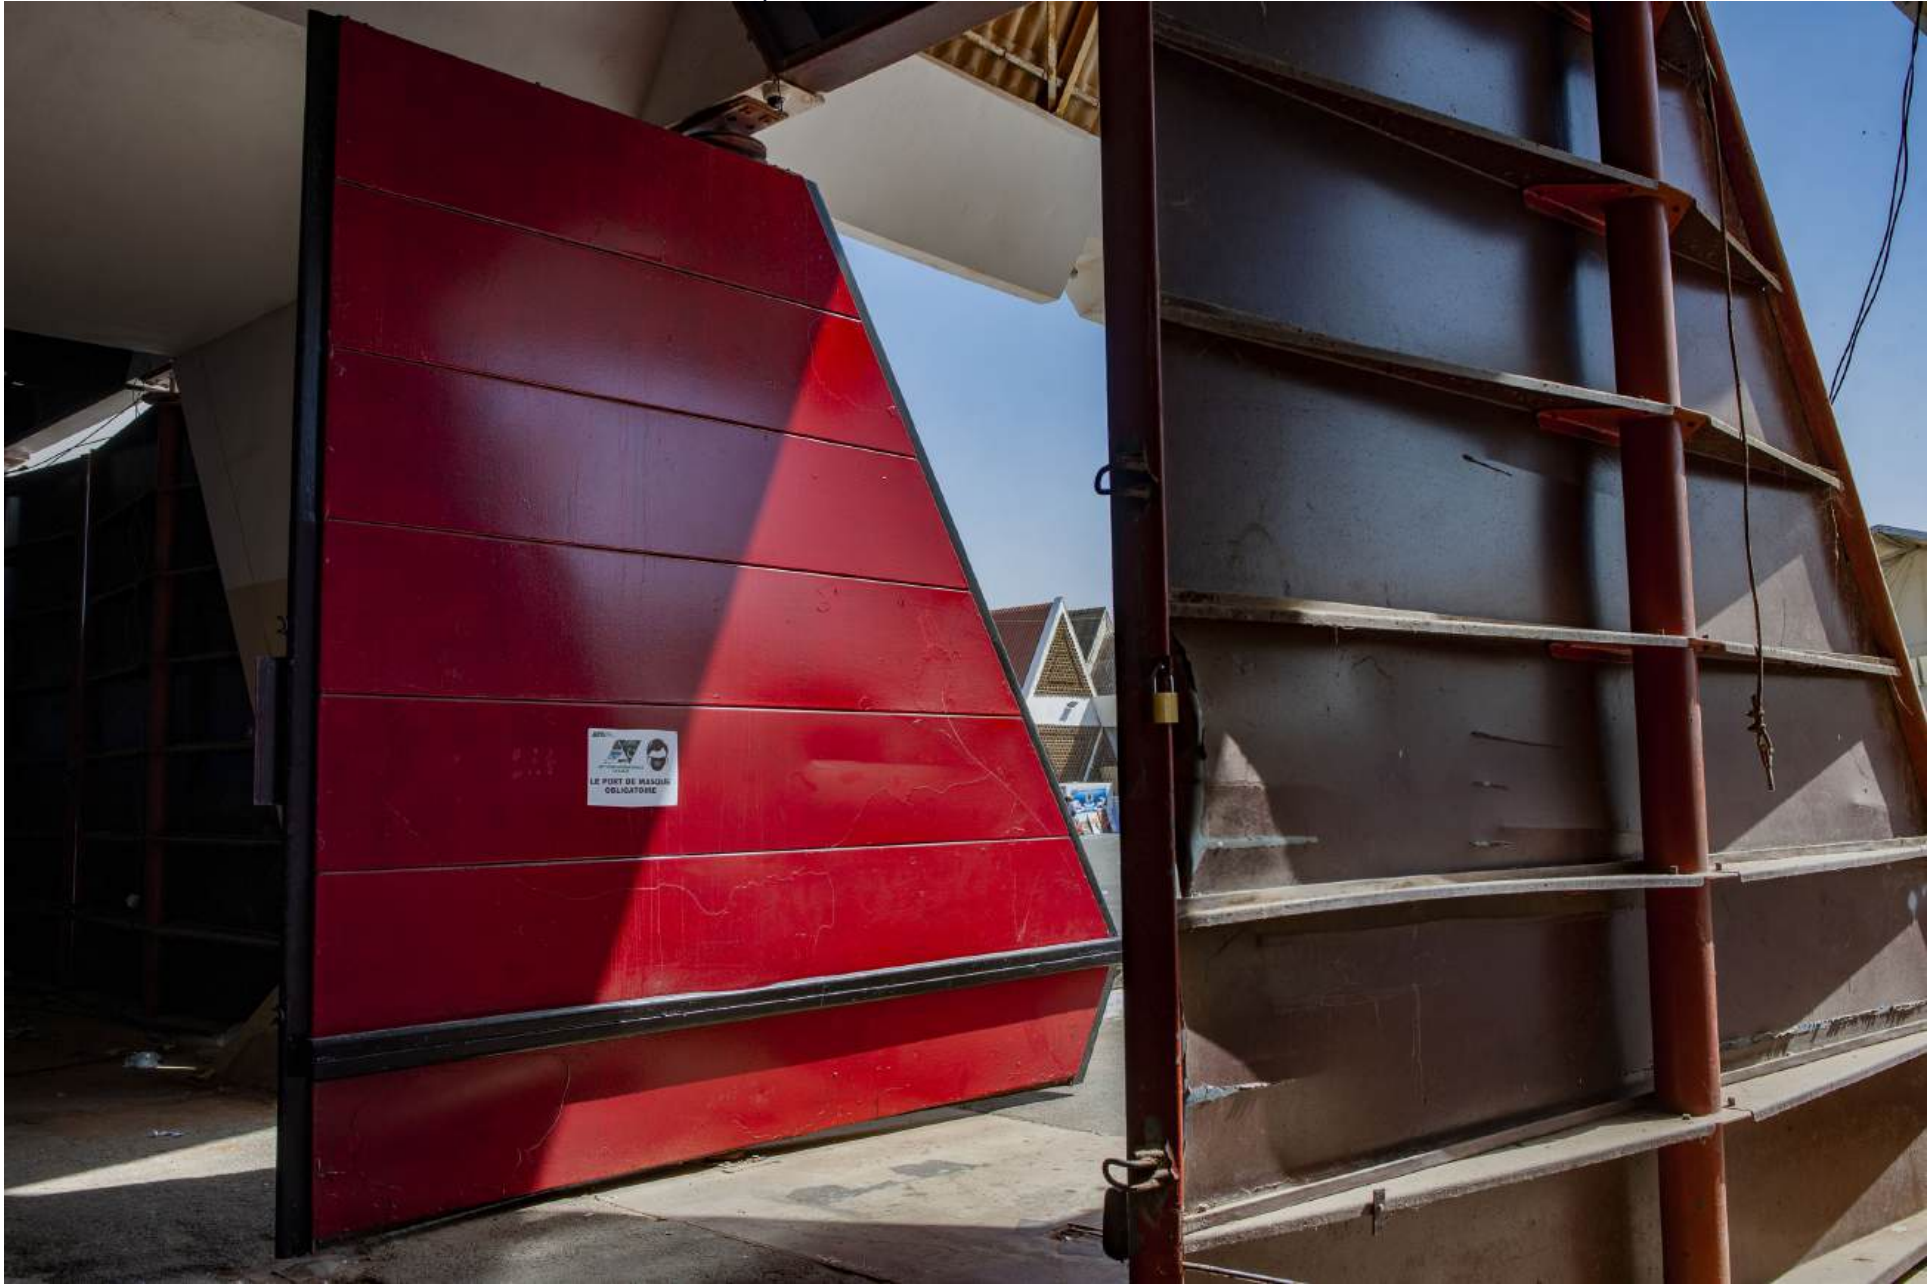
events to the highest degree possible. Trucks and cars entering the exhibition pavilions have caused damage to the exterior trapezoidal doors (denting) and have also damaged the column bases (which contain infrastructural connections).

*Fig.119: Trapezoidal doors on the Tertiary exhibition pavilion (photo: Elyse Fitte-Duval, 2021).*

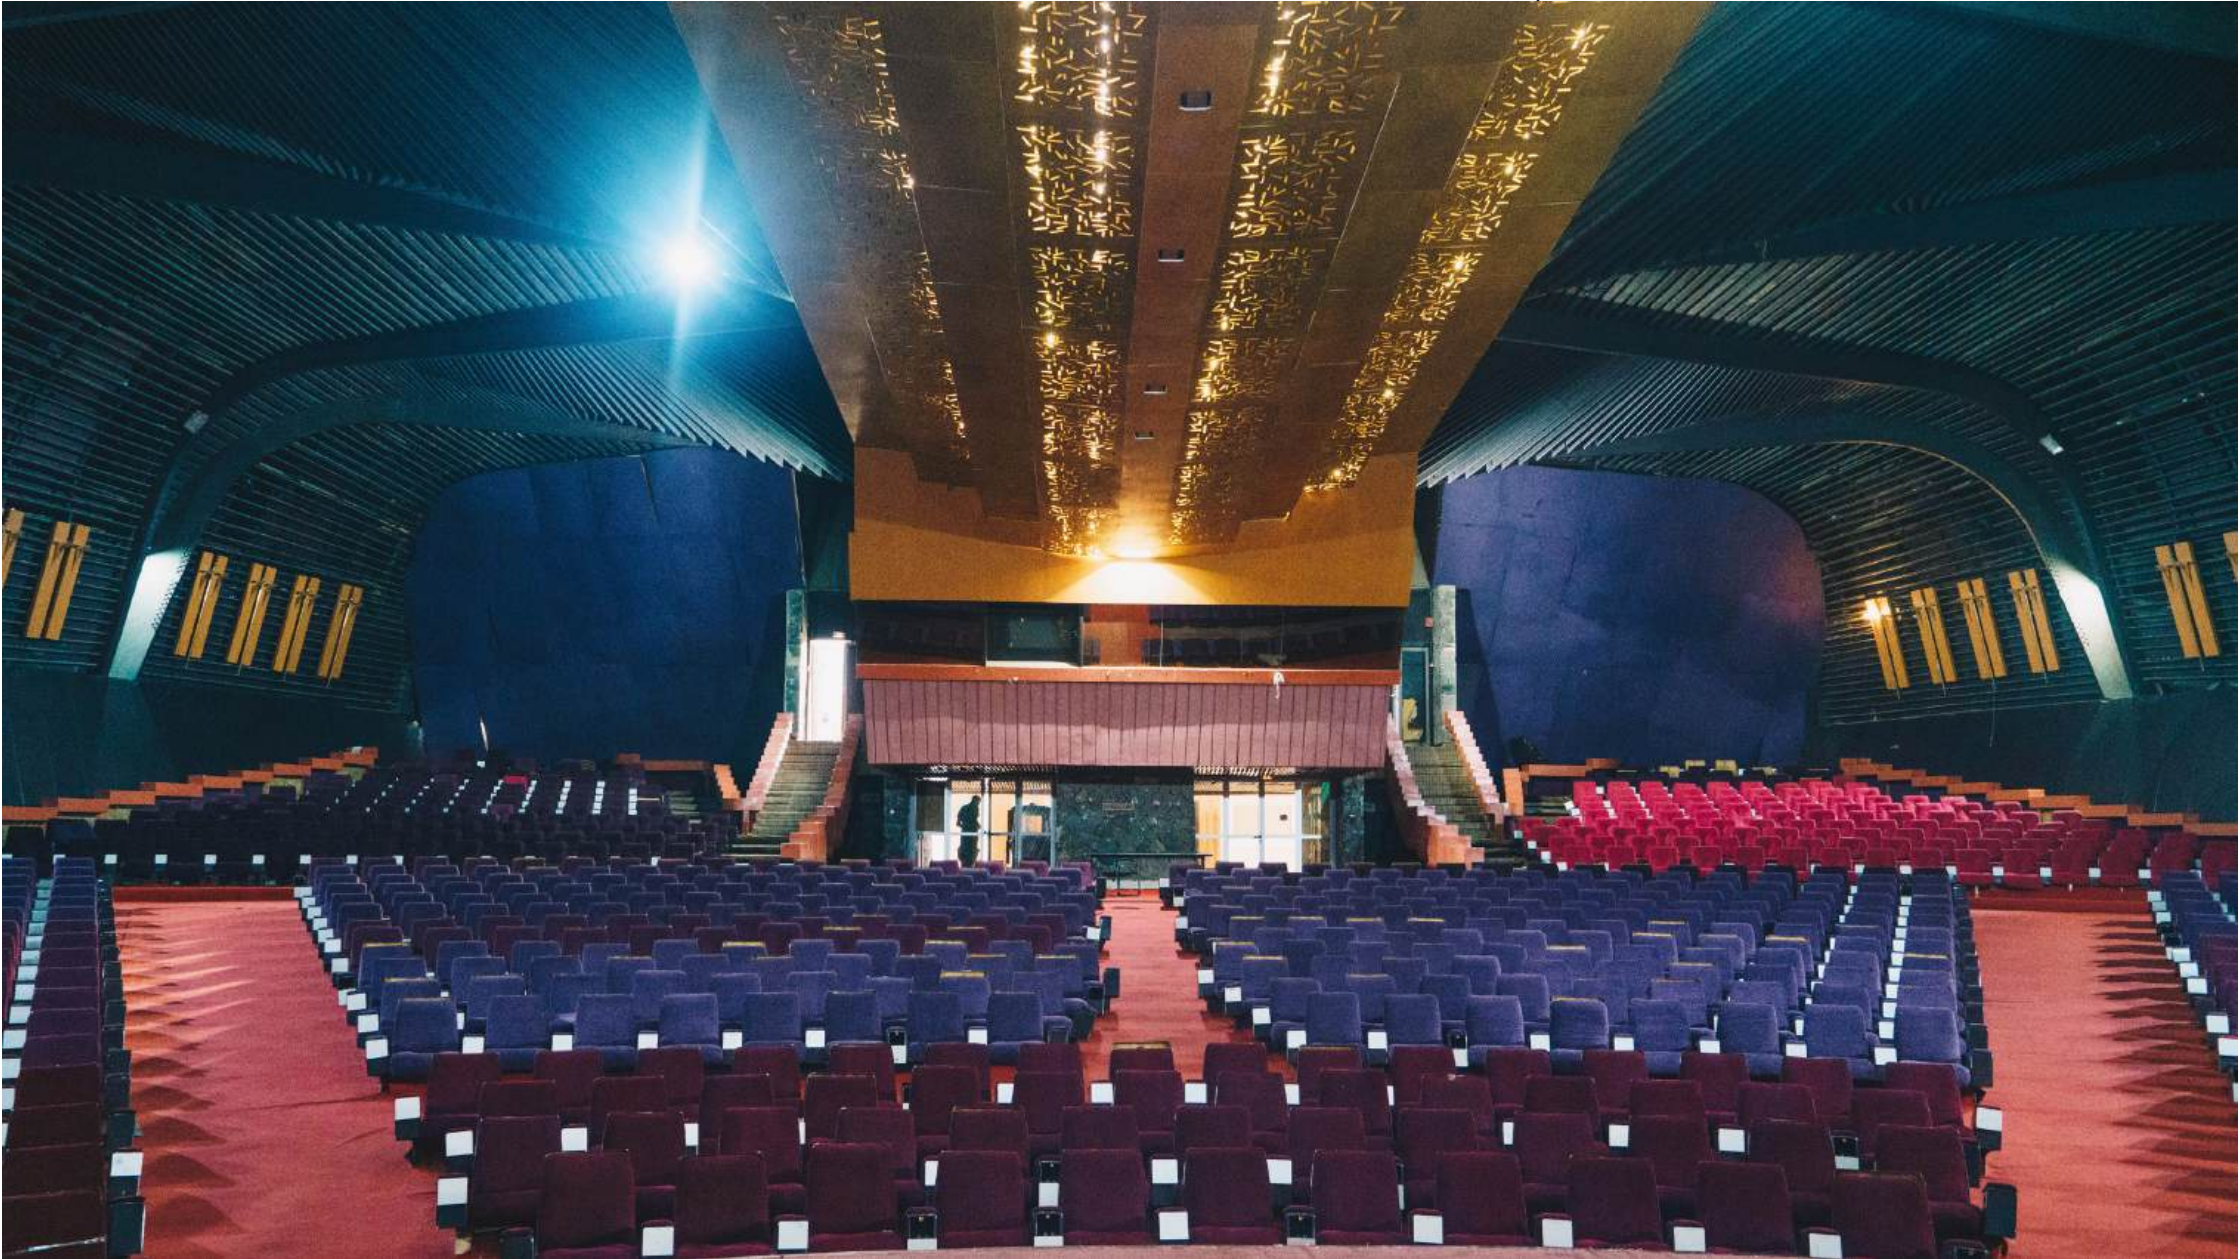
Fig.120: Interior view of the auditorium showing the gold central piece installed in the 2002 renovation, and the painted wooden struts (photo: Seyni Ba, 2022).

- The interior central spine of the roof is covered by a decorative piece. It was understood by the Project Team that the original criss-crossing glulam pieces were cut to achieve this. In order to restore the ceiling the full extent of the damage to the original scheme must be better understood.

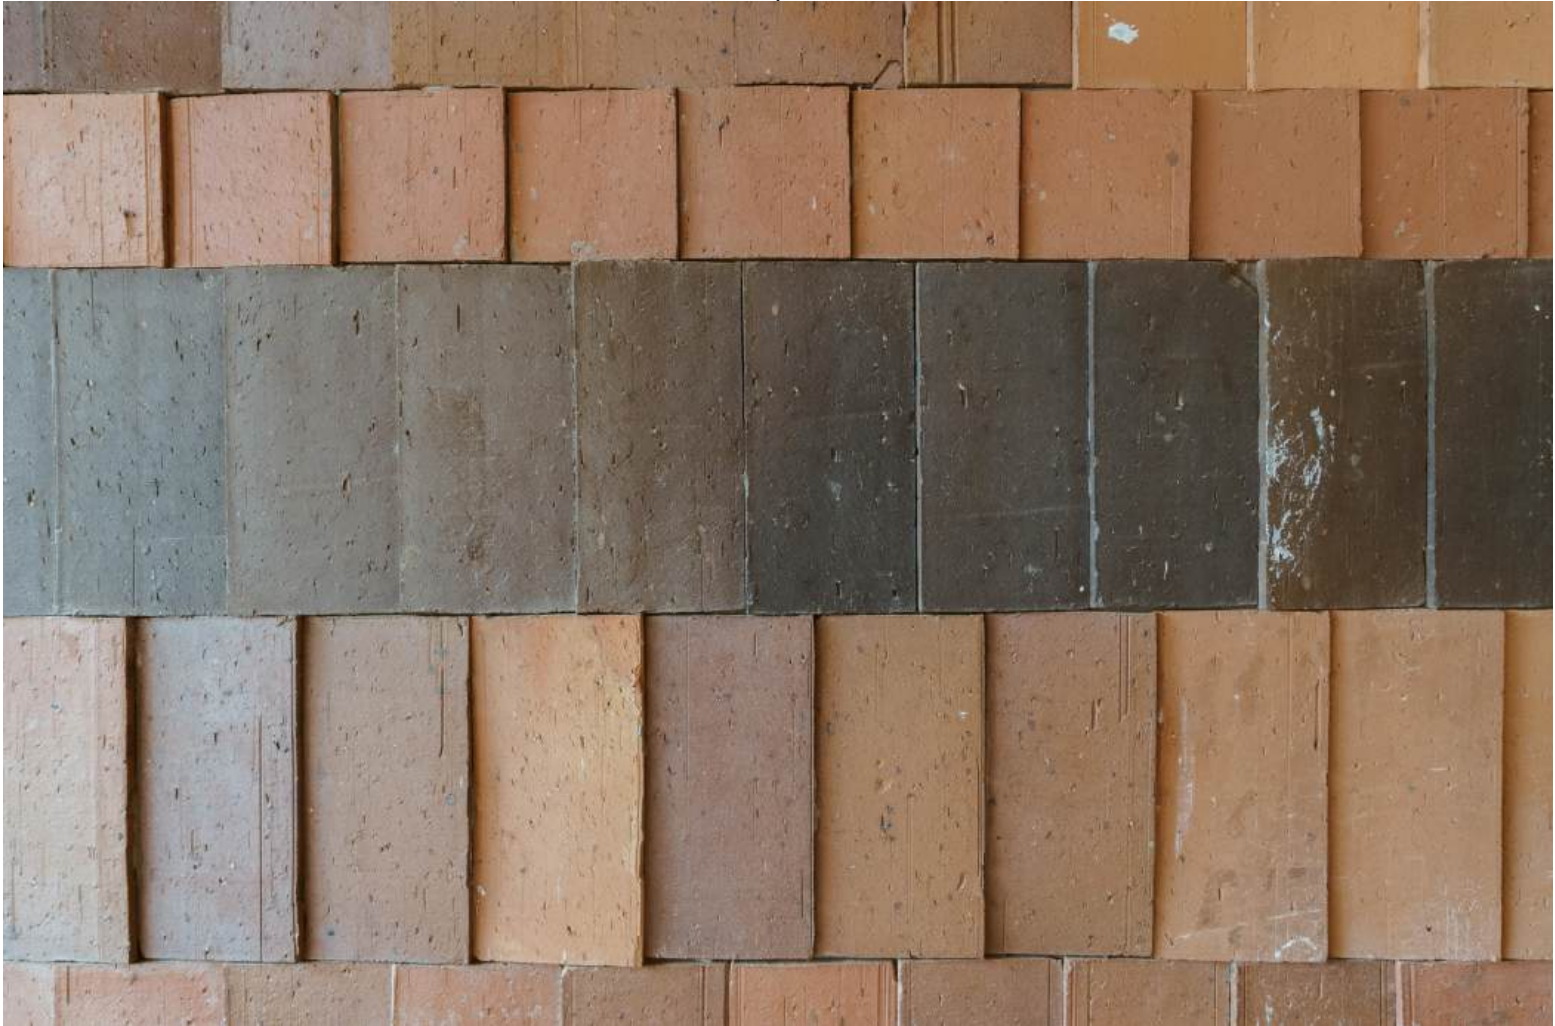
Fig.126: close-up of terracotta tile mural (photo: Seyni Ba, 2022).
