Keeping It Modern:  
**Centre International  
du Commerce Extérieur  
de Dakar (CICES)**

Conservation Management Plan  
01. 2023  
Dakar, Senegal

Written by  
Aziza Chaouni, Mourtada Gueye, Dana Salama

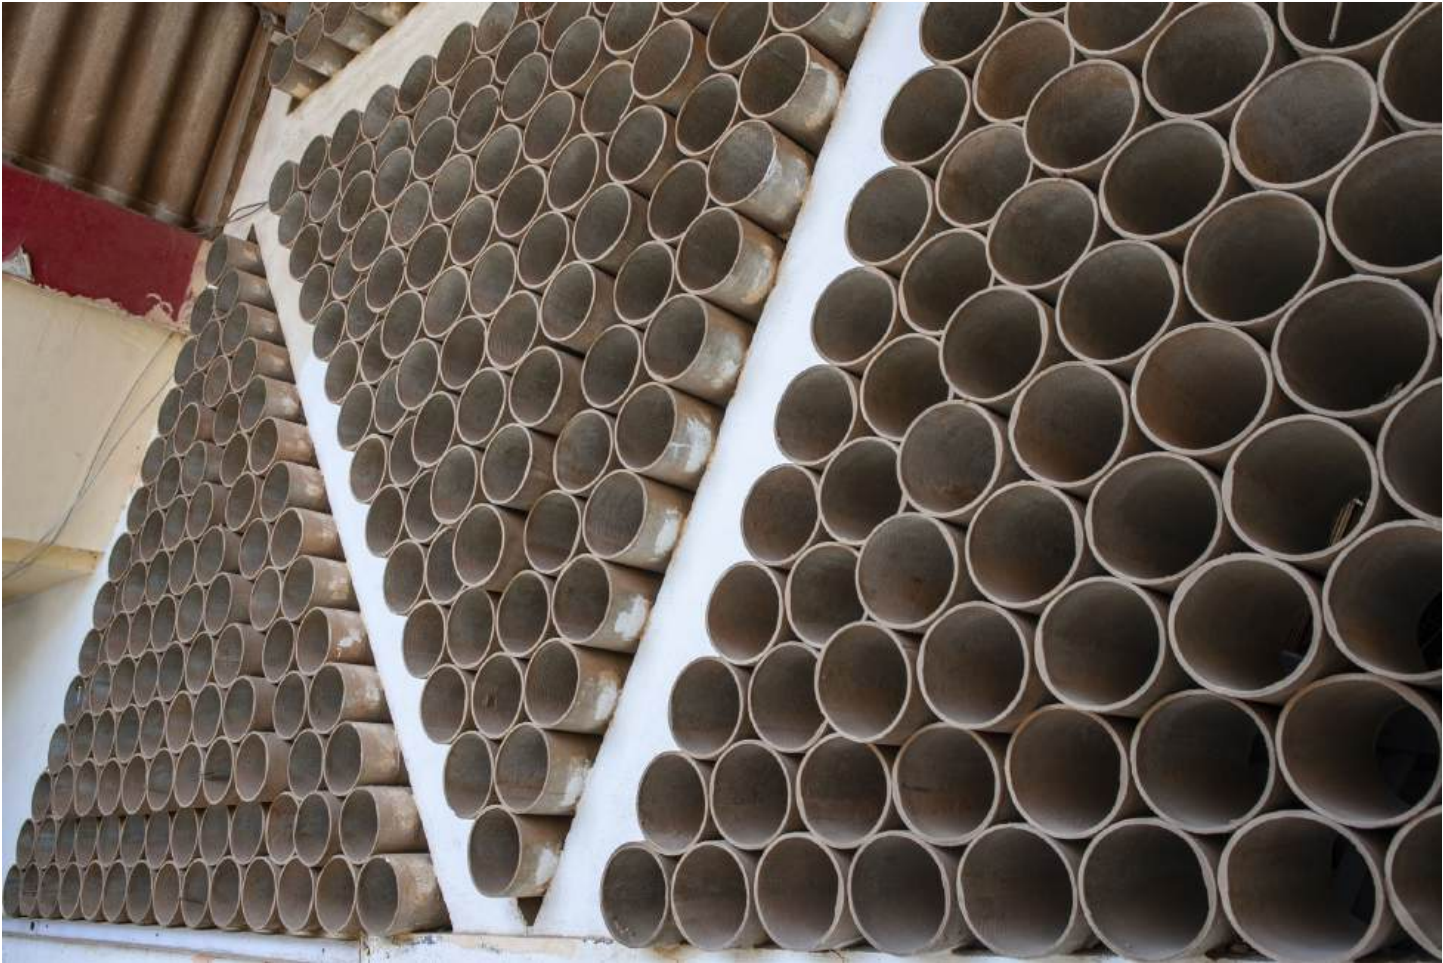
Fig.127: close-up of ventilated PVC pipe facade (photo: Elyse Fitte-Duval, 2021).

- The site contains several instances of asbestos that require abatement. First, the ventilated facades composed of PVC tubes require replacement with non-toxic alternatives of the same dimension and appearance. Many of these facades are disturbed, with PVC tubes out of place causing a larger health risk. Second, the roofs of the regional pavilions contain asbestos and are also disturbed. They should be replaced with corrugated galvanised metal sandwich panels of a similar size, texture, and colour.

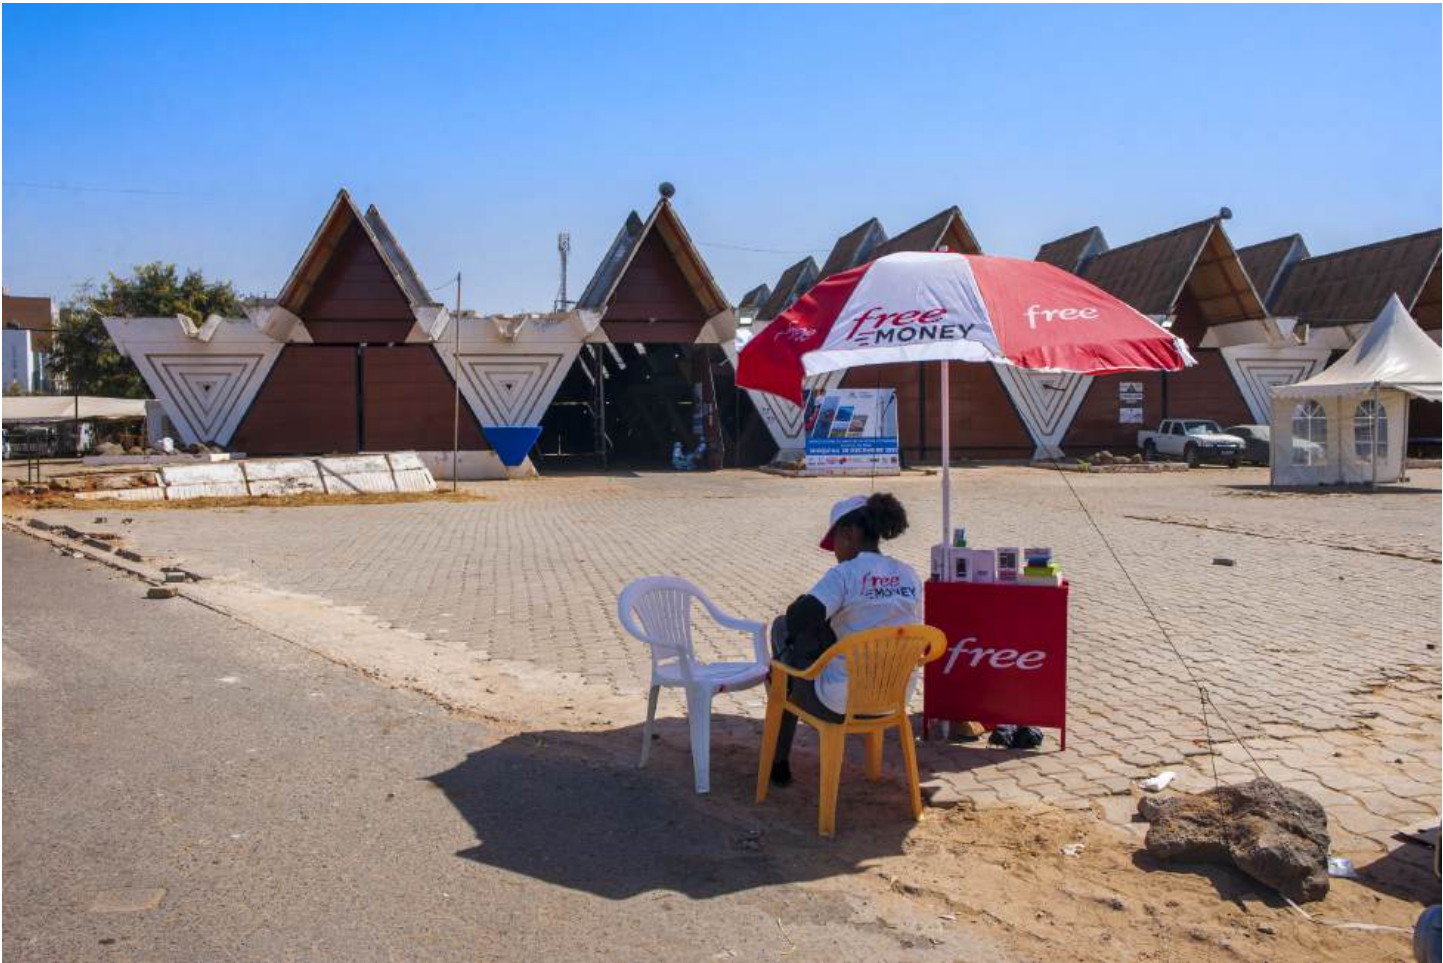
Fig.132: view of the brown exhibition pavilion facade (Elyse Fitte-Duval, 2022).

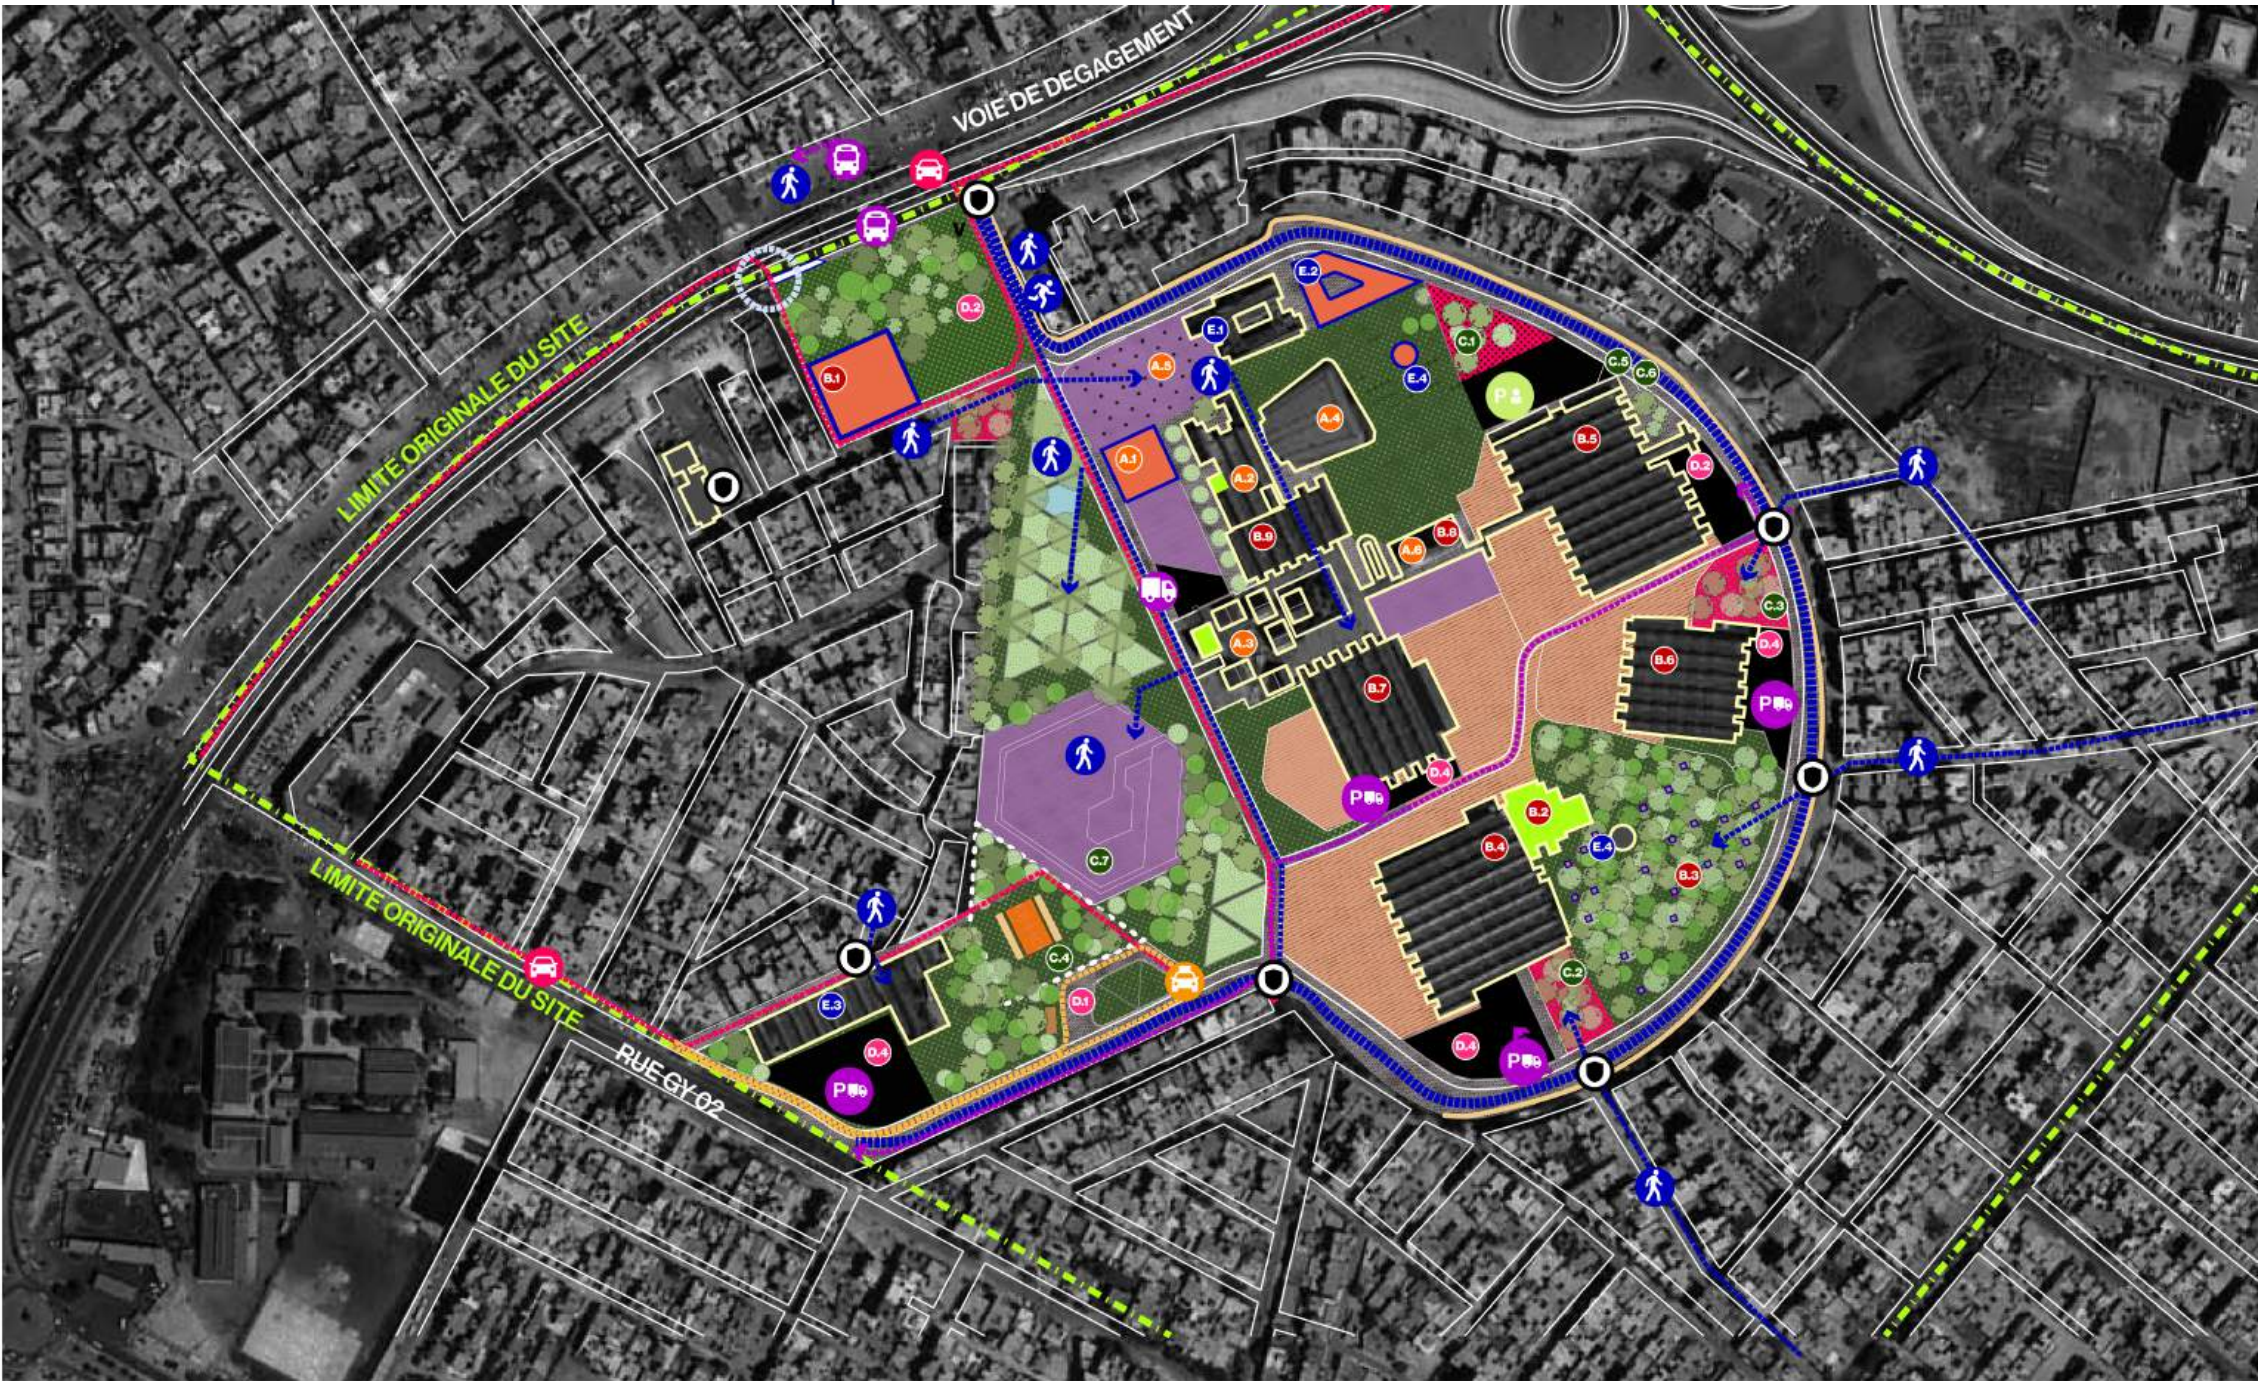
Fig.133: Future masterplan for CICES (Aziza Chaoui Projects and Mourtada Gueye Architects, 2022).

- E.1 Original administration
- E.2 Administration extension
- E.3 Service hall
- E.4 WC

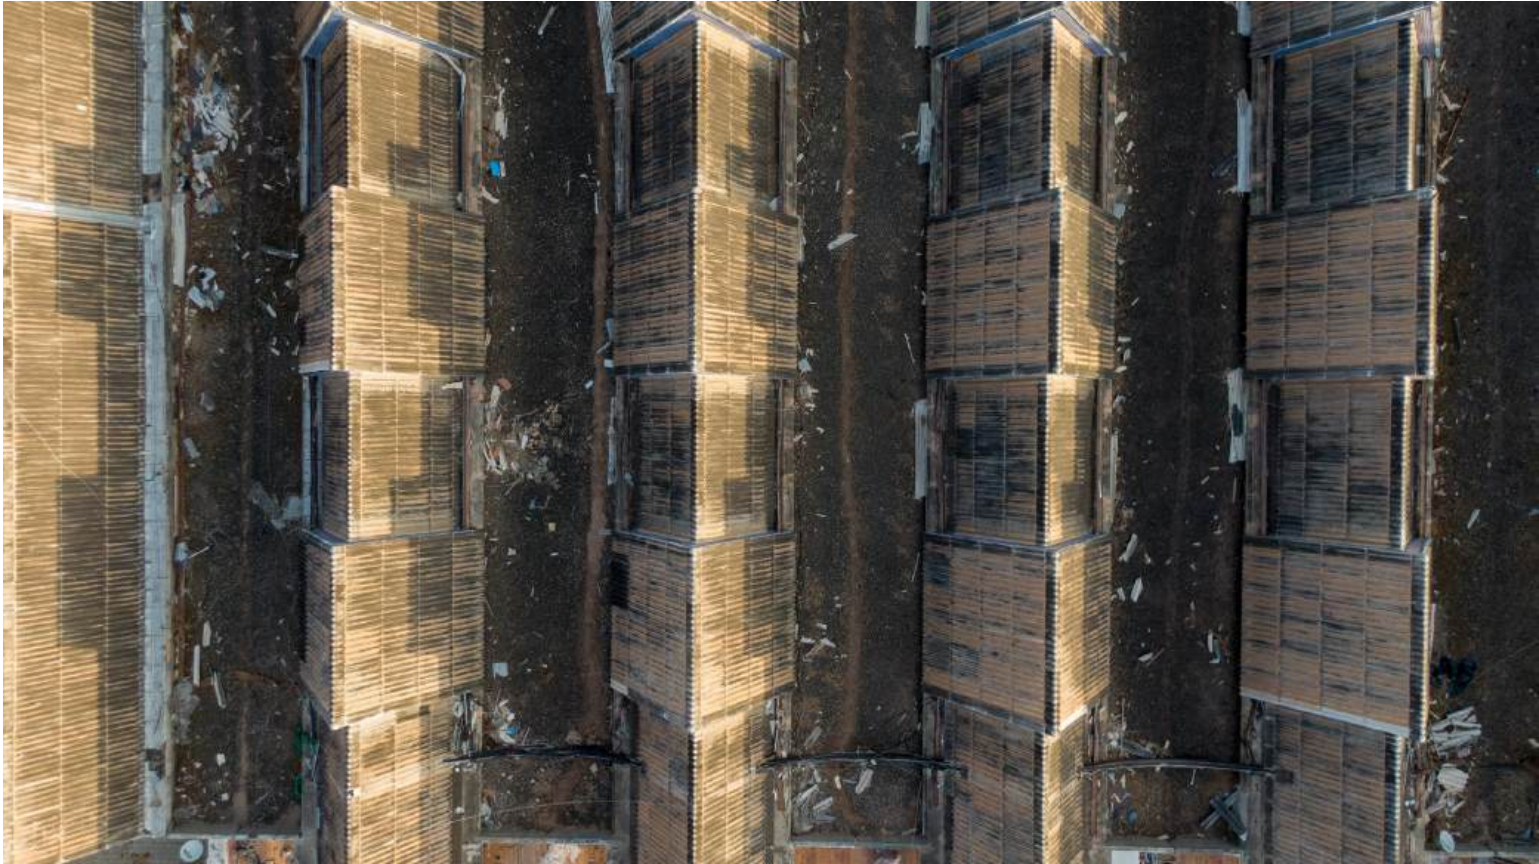
Fig.137: Top of an exhibition pavilion  
(photo: Seyni Ba, 2022).
