A WORK OF ART IN BRICK

SIGNIFICANCE AND RESTORATION OF HET SCHIP, AMSTERDAM
AN ICON OF SOCIAL HOUSING AND ARCHITECTURE, 1919-1921

This book is intended as the restoration management plan for the 2015-2018 restoration of urban block Het Schip in Amsterdam. It serves also as a documentation of the restoration project.

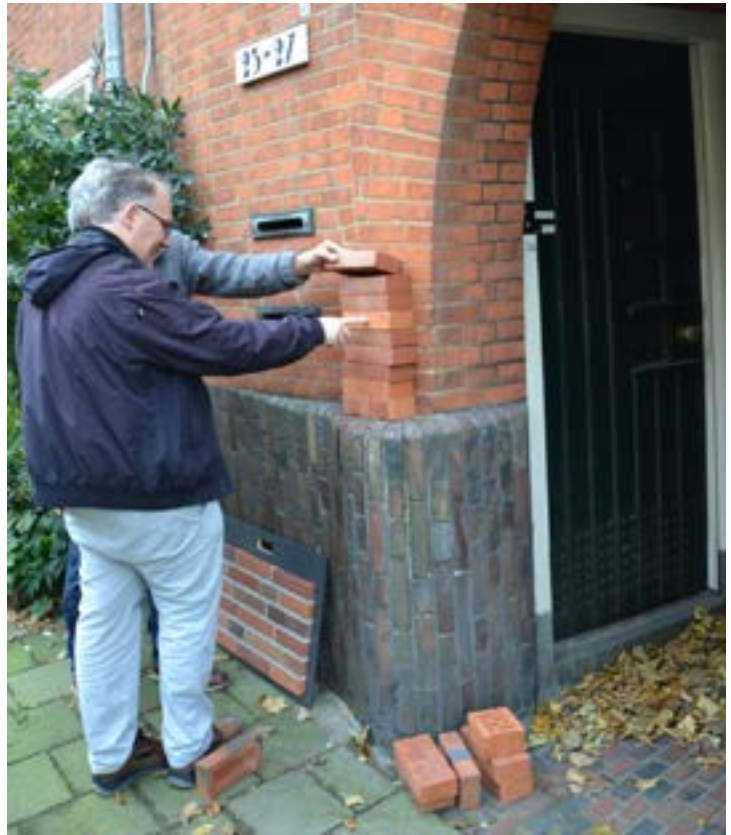
09.10 Assessing bricks from brick factory Gilrath on site.
09.11 The first batch of bricks.

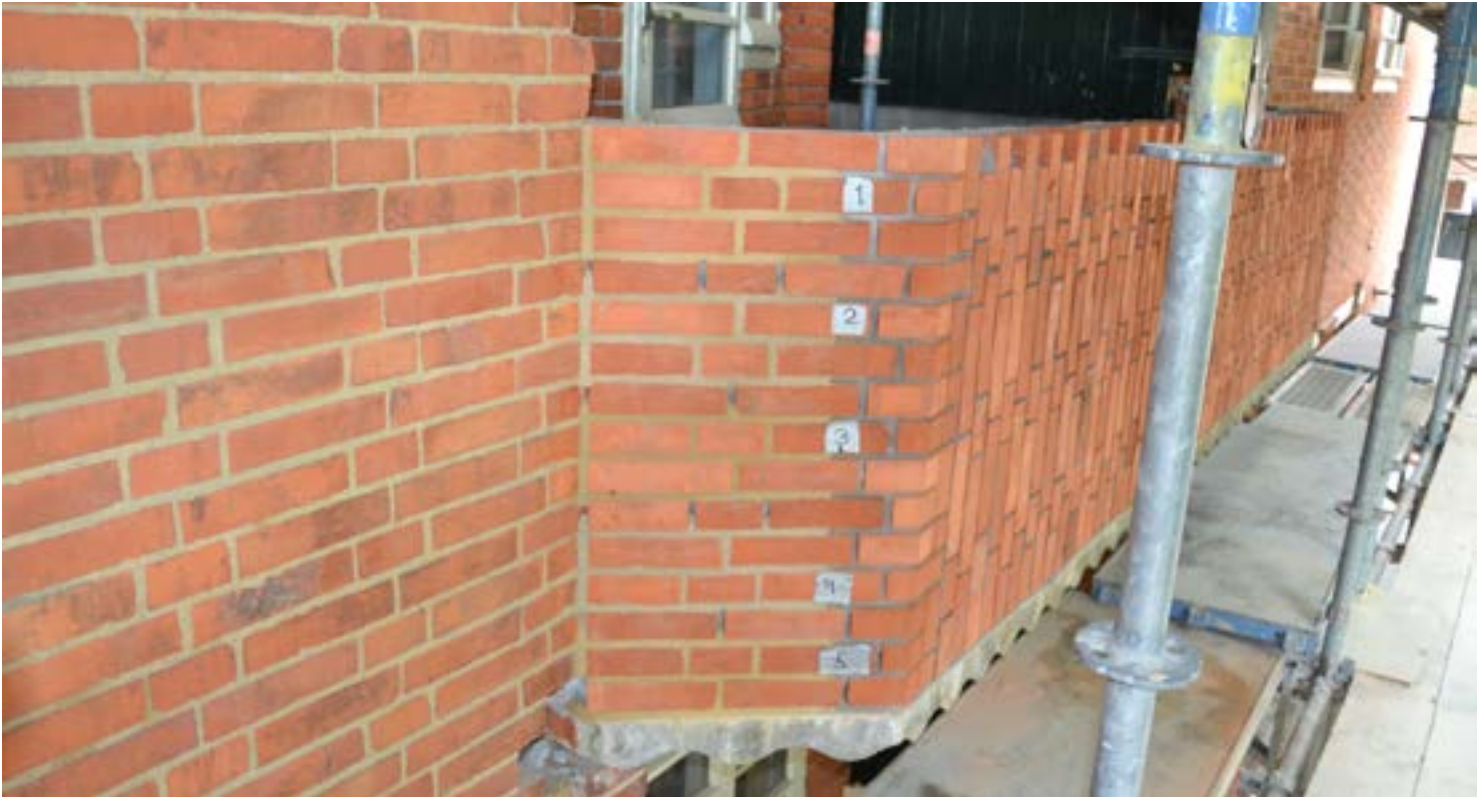
09.12 Testing the joints in reconstructed masonry of the balcony baluster.

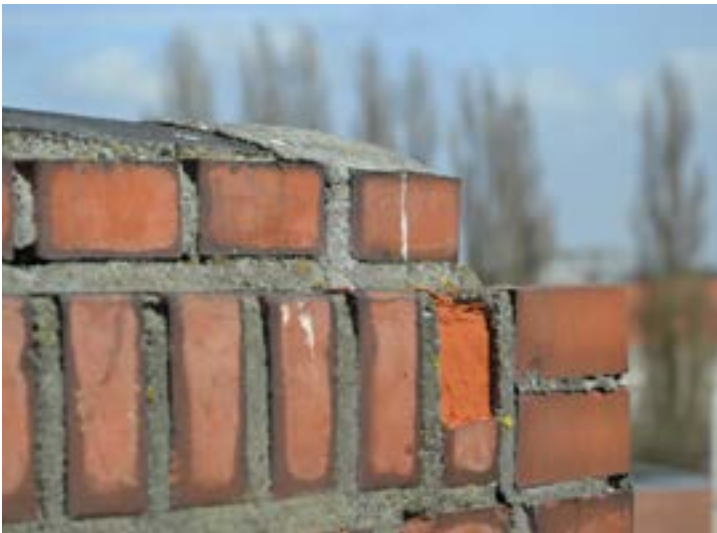
09.13 Damage to brick repair.

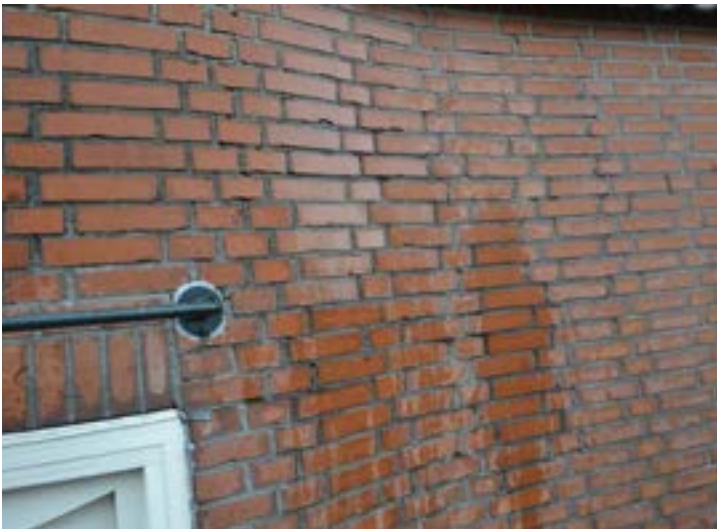
09.14 Damage by hydrophobic coating.

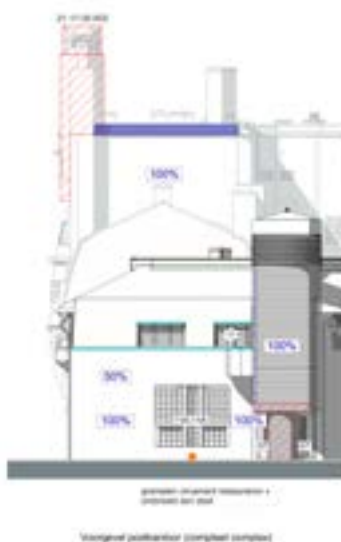
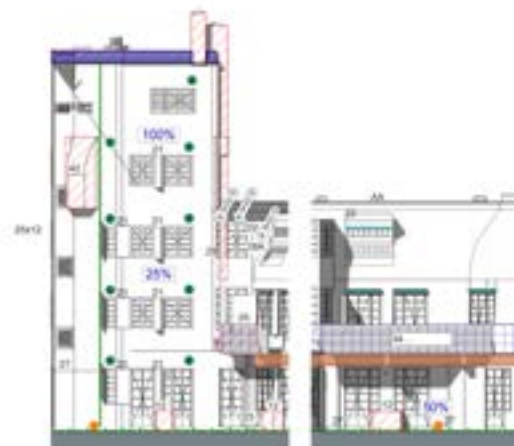
09.16
Archivolt architecten, assessment drawing.

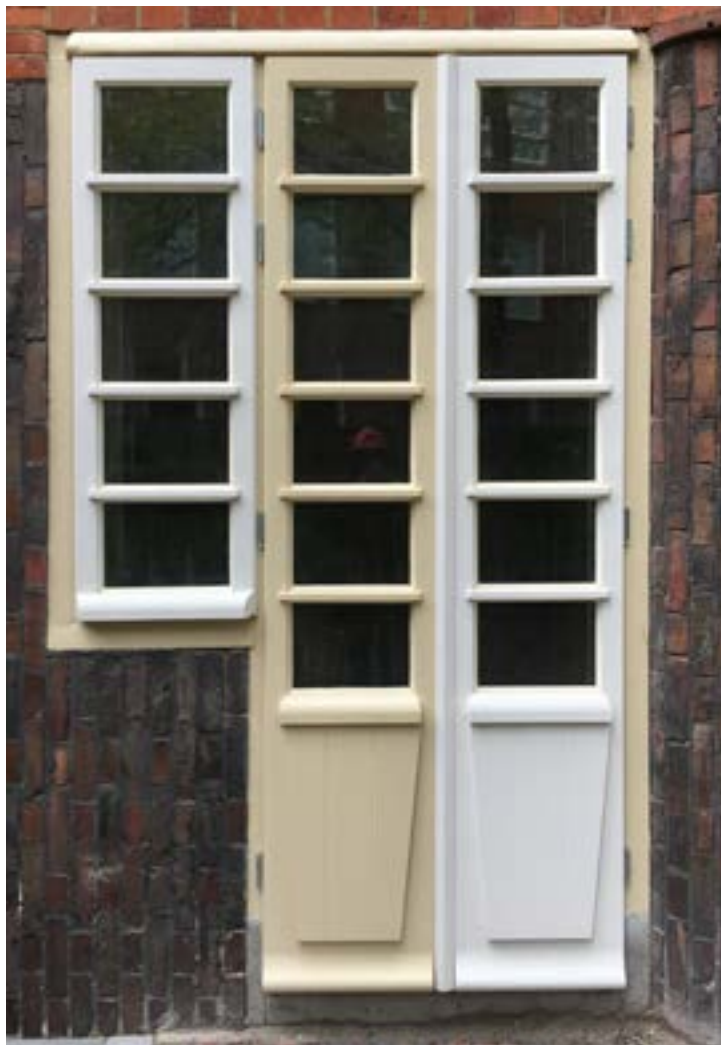
- 11.06 The simplified apartment door from 1979.
- 11.07 Apartment doors in the first Spaarndam block, also simplified in a renovation of 1973.
- 11.08 Original apartment door, saved from the demolition container by Mr. Ab Vos. This door served as the model for the reconstruction of all apartment doors.
- 11.09 archivolt architects, design for the reconstructed apartment door.
- 11.10 The newly reconstructed apartment door, in conformance with current fire safety requirements.
- 11.11 Tapering panels show the color differences.

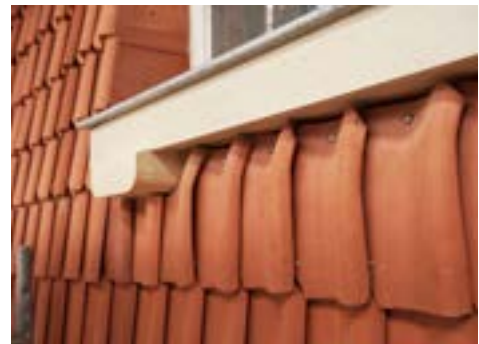
- 12.05 Detail of the upper roof slope and ridge on Hembrugstraat.
- 12.06 Ridge on Hembrugstraat.
- 12.07 Corner ridge tile set in colored mortar rear side Hembrugstraat.
- 12.08 Specially curved tiles underneath a gutter.

lip of the mono ridge tile was used to cover the front edge of the zinc lined gutter. This application was only possible because of the aesthetic function of the bottom slope, as the seams of the tile lips hardly cover, and the tiles hardly had any water retaining structure. The special mono ridge tile could not be easily produced, due to its large size. During the baking process, the tiles often crack or distort. After some experimentation, the verge tile was able to be stretched to a large enough size and could be used to restore the original appearance.

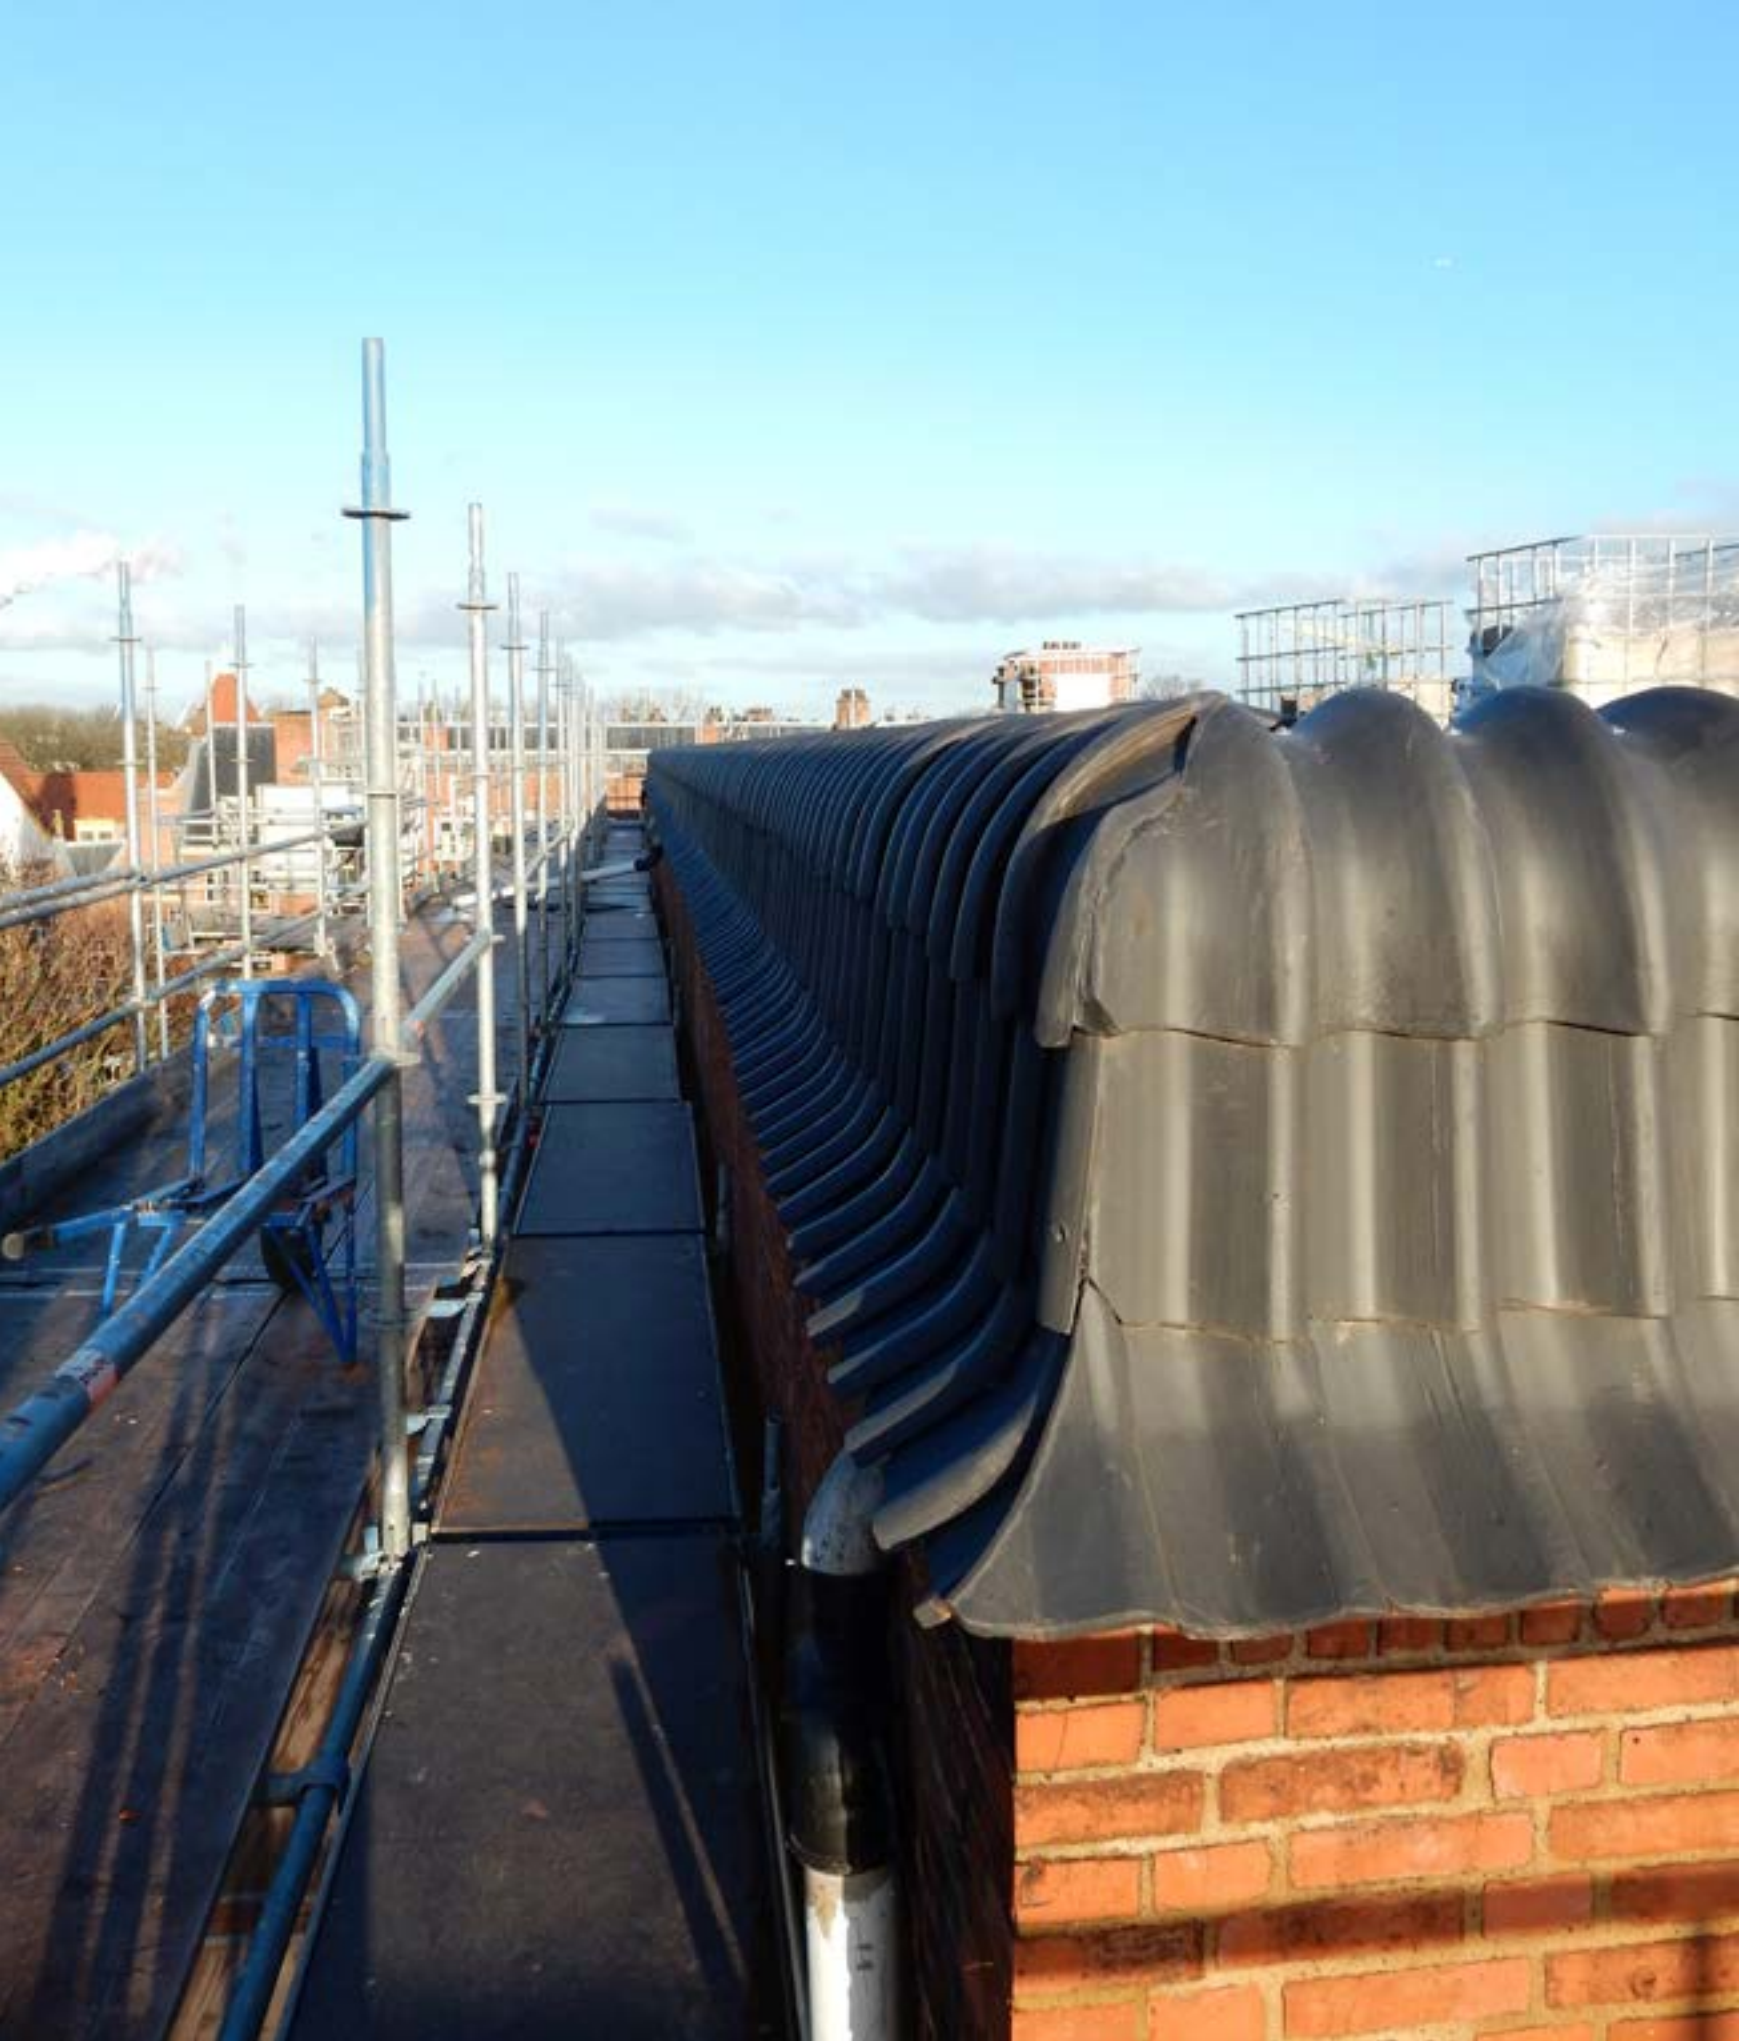
12.09
Corner detail of the roof edge with cut and glued corner tiles.

While De Klerk had finished the top side of the roof edge with a flat roof tile, providing a straight, horizontal alignment, the Public Works Department probably did not think this was sound engineering. A detailed 1925 drawing shows that, instead of flat tiles, the top side was finished with tiles with a round top. This way, the tiles could cover the roof edge in its entirety, creating a tighter water seal. The mortar layer used in the residential complex would eventually crack and require maintenance - this was avoided with the modified roof tile. Except for the edge, an entire roof surface covered with tiles was added. The wooden gutter elements on the original roof were replaced with roof tiles, which were installed on a slightly curved surface and function more as roof edging than as a real roof. A flat roof lies behind this edge.

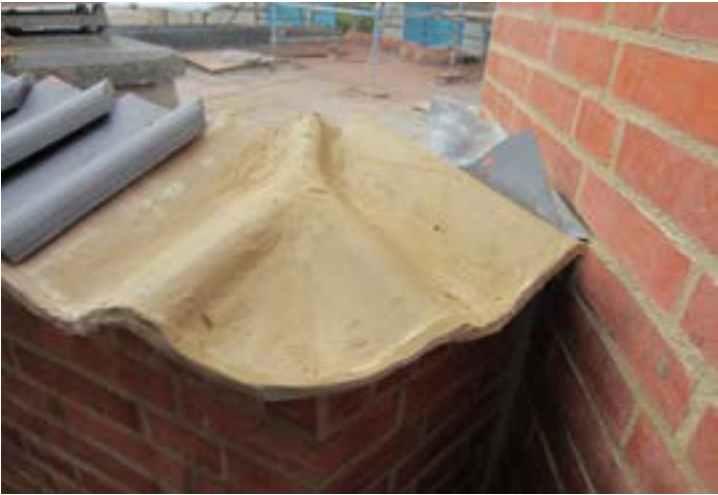
12.13 Special corner roof tile, clay model.
