Conservation Management Plan

St Brendan's Community School, Birr

Queen's University Belfast & John McLaughlin Architects

June 2021

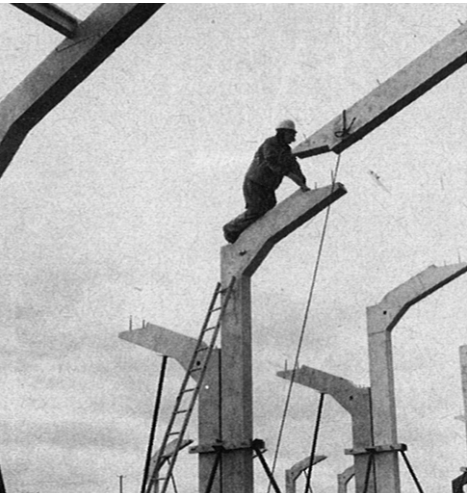
fig. 1.2a

Frame details

The concrete frame is evident in the archival images through images of its construction (fig. 1.2.(a)) which clearly shows the connection of column and rafter and also the relationship between the columns of the portal frames. Furthermore, fig. 1.2.(e) also indicates the sequence of construction of the portal frames with foundation, then column, then rafter being put in place. Figure 1.2.(j) shows a series of plans from the time of the competition. It indicates alternative plan configurations for the school using the portal frame system which was deployed by the designers as a construction method that could yield many different plan types. The section through the clerestory lights (fig. 1.2.(b)) shows the pre-cast concrete gutter in section that is an integral part of the portal frame system. The pre-cast purlins that run between the main frames are detailed in fig.1.2.(c) and these are shown with a curved section which accommodates hanging services and blinds in other locations.

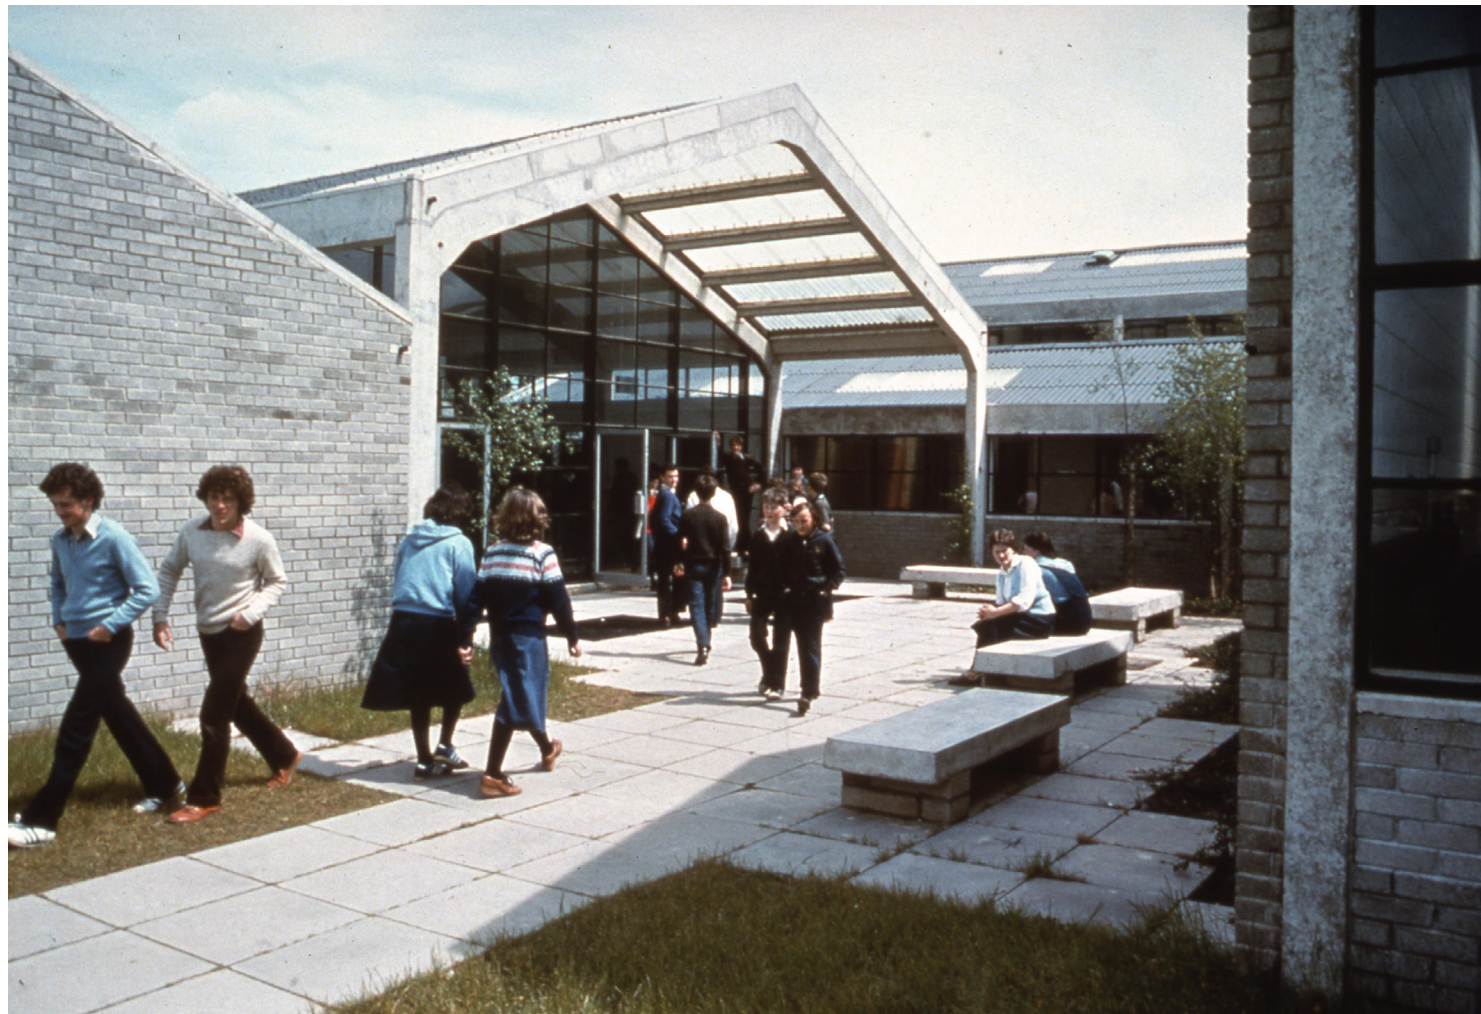
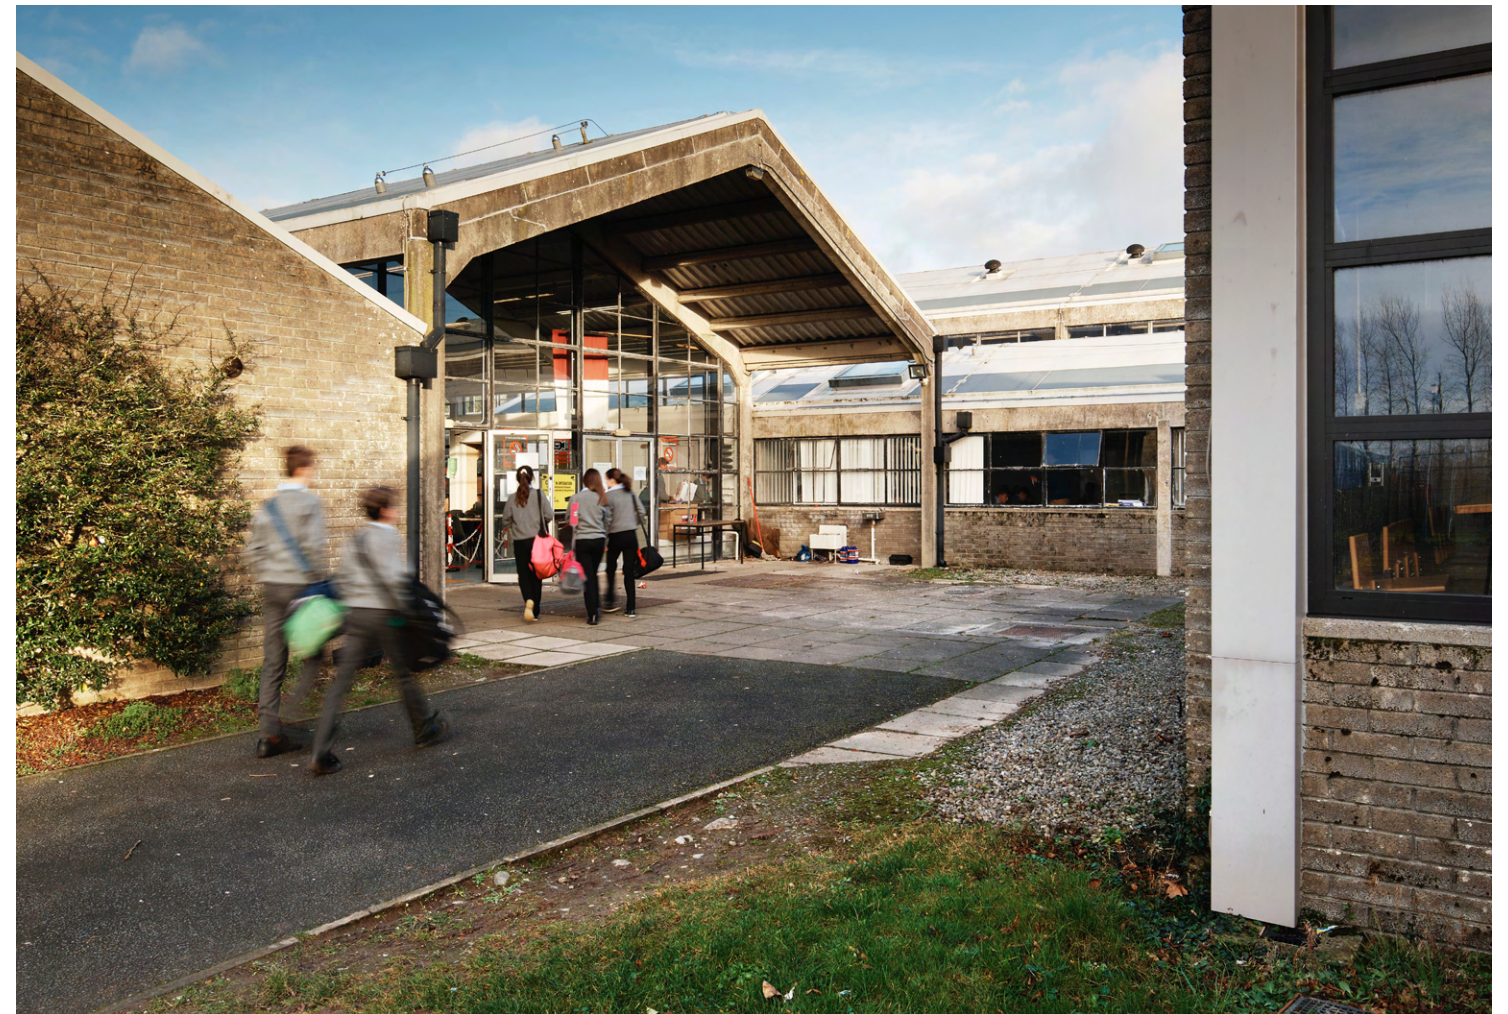
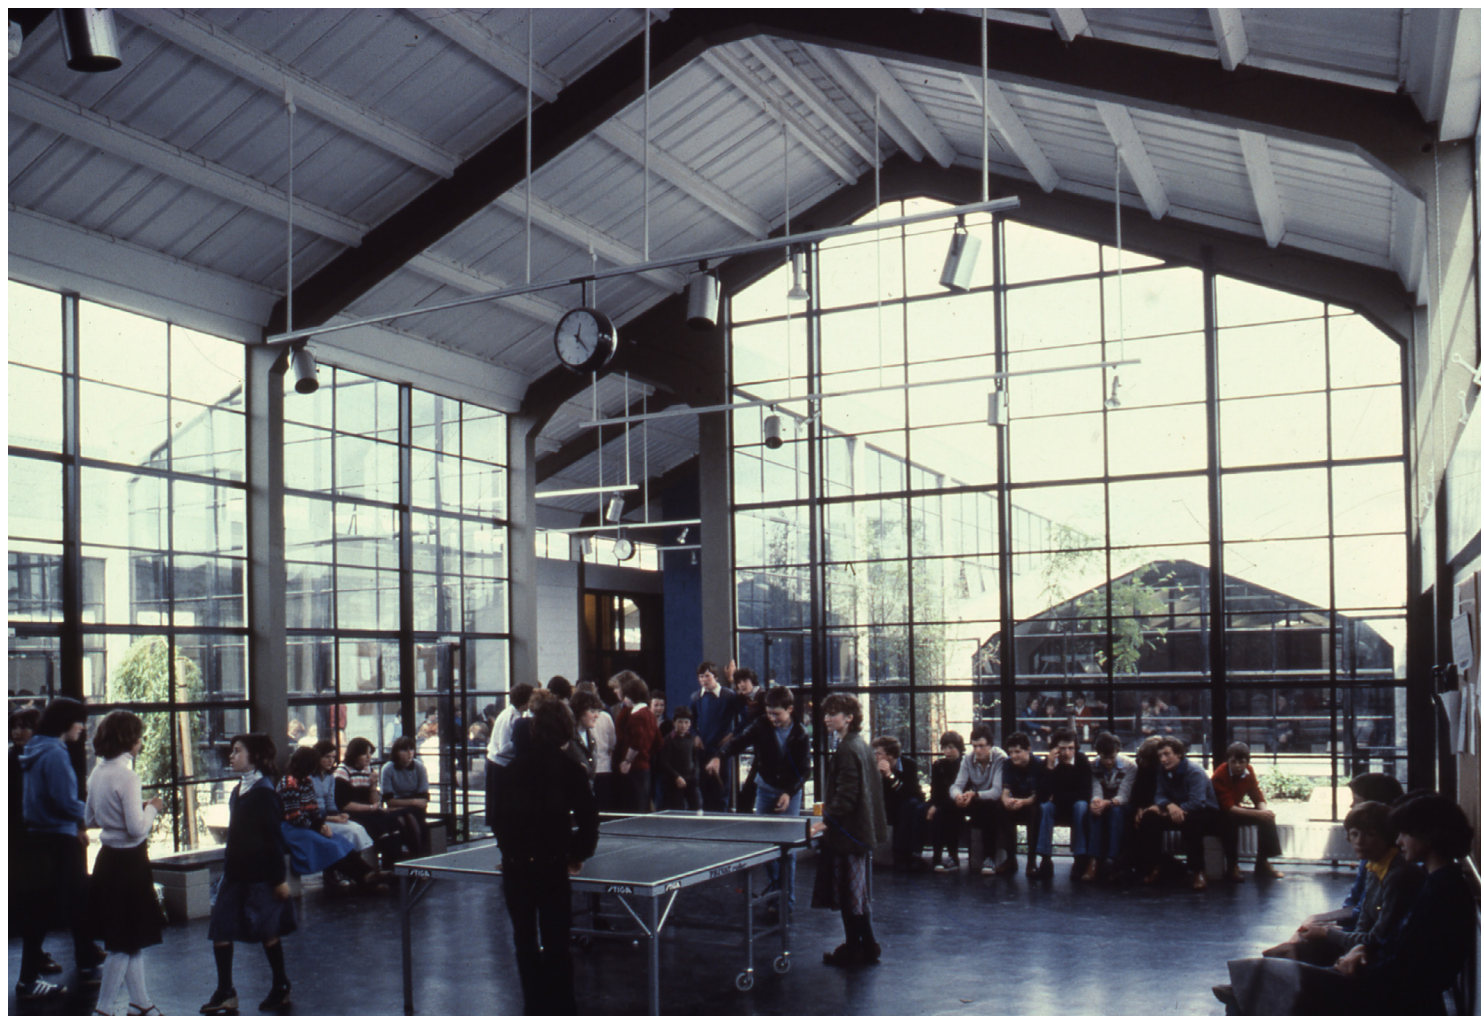
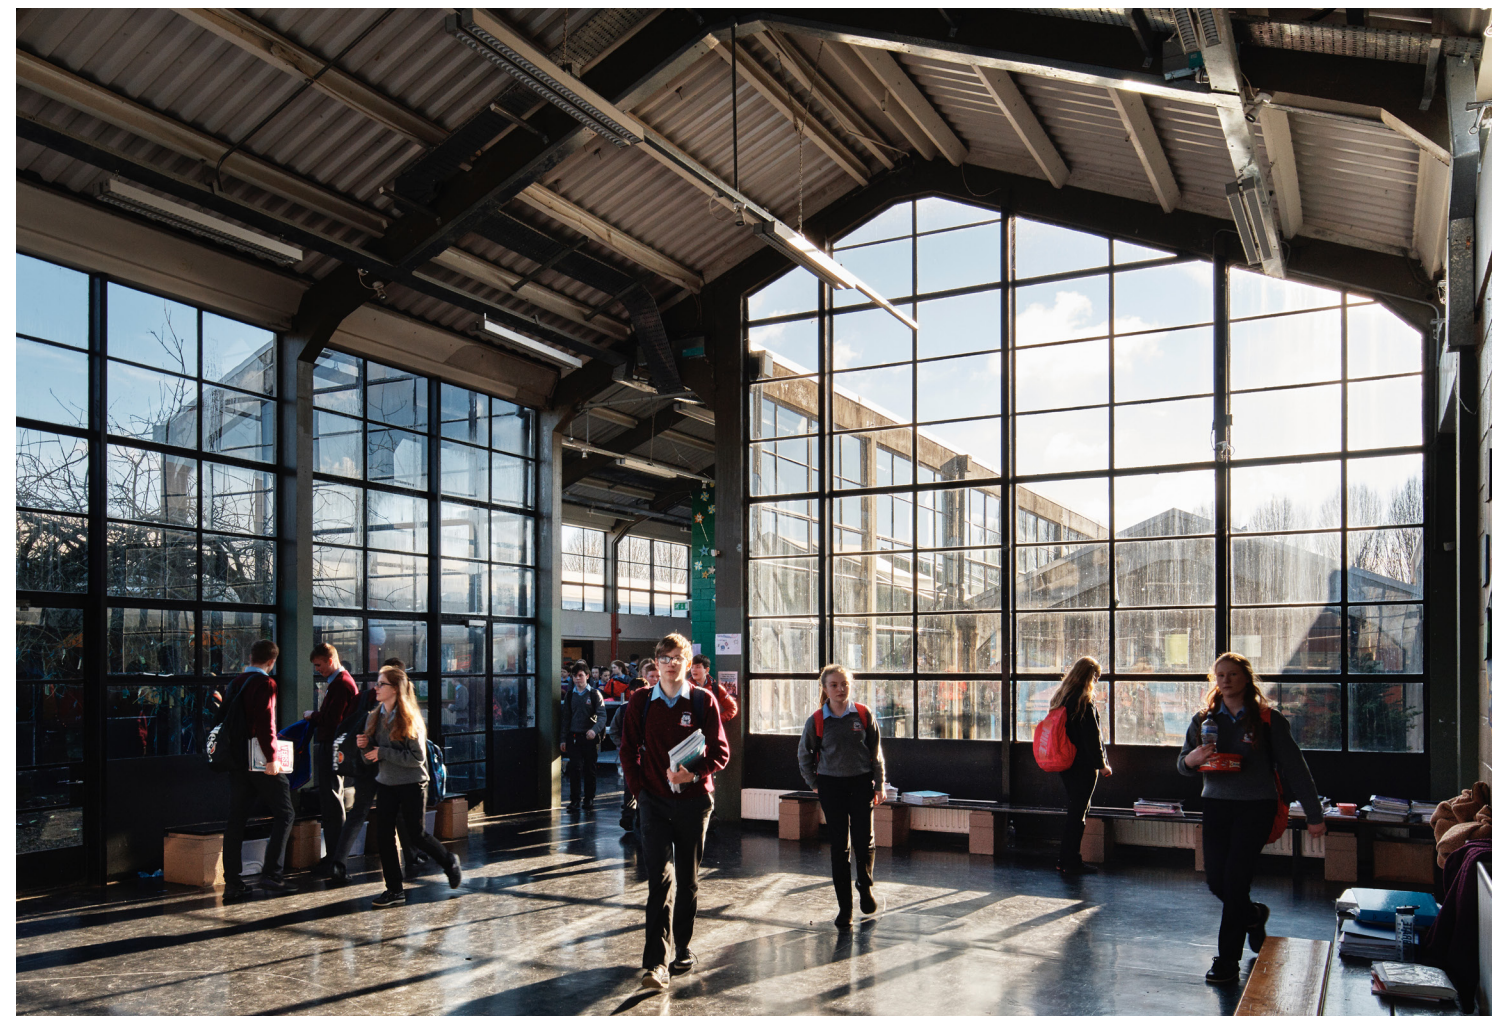
Indicated here are two examples of the comparative photography taken by Ros Kavanagh in 2019. These photos replicate the original iconic photos by John Donat. The photos serve as a record of the building today, while the original photos are an important archival source. The comparison of the 'then and now' highlights the changes and similarities between the two periods. From the point of view of fabric changes we can easily identify additions and omissions. From the point of view of the social life of the spaces, we can see the similarities in occupation between now and then.

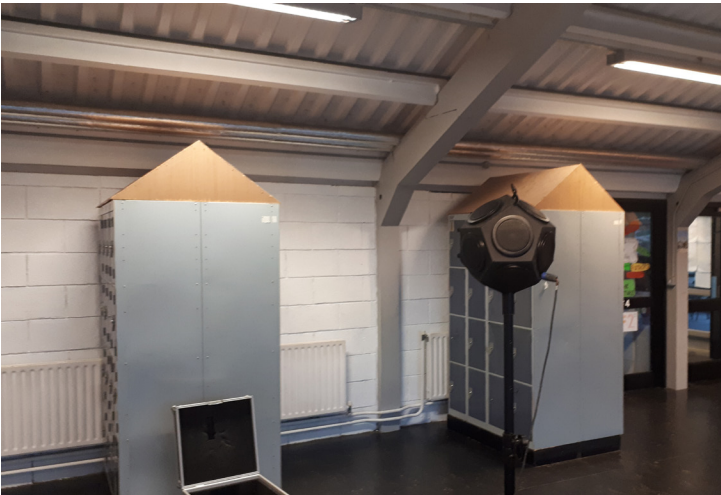
Sound Testing in Progress

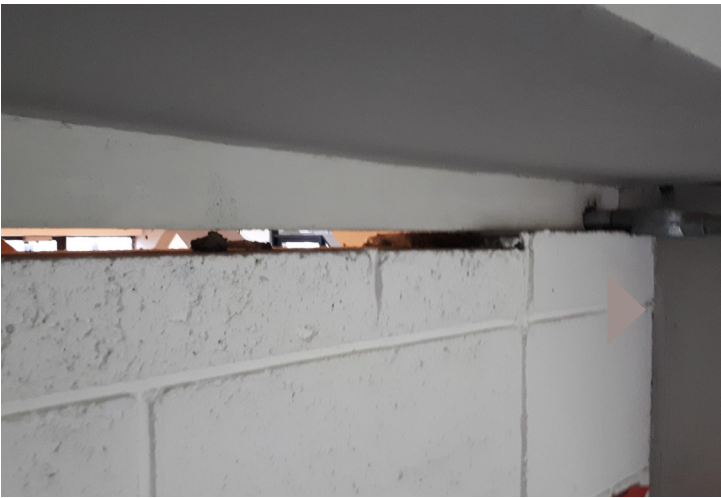
Air Gap between Wall & Beam

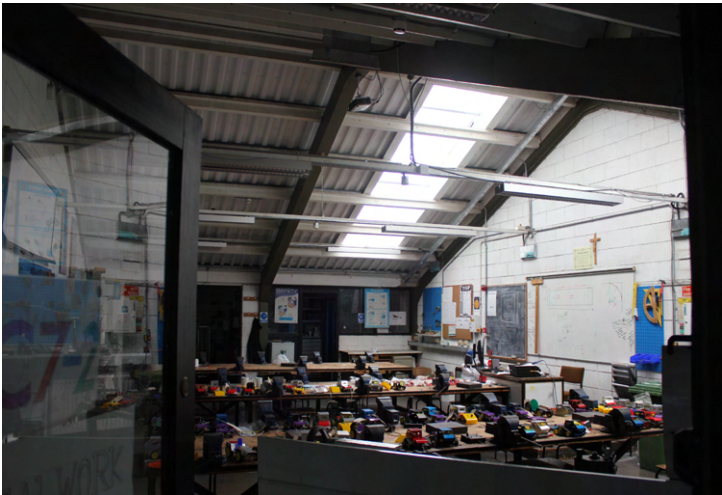
Woodwork Room

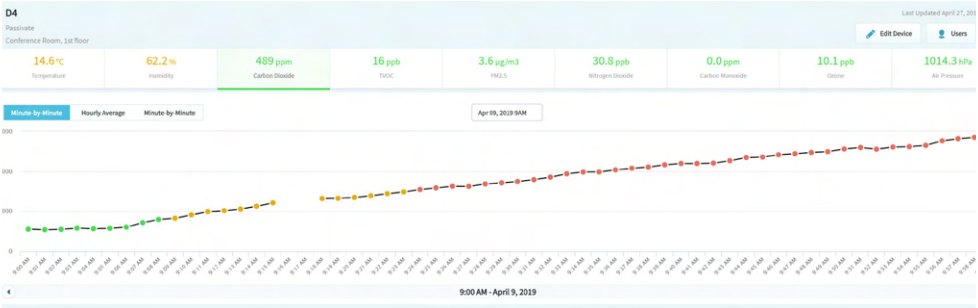
Below is a screenshot of the uHoo interface, indicating the CO₂ levels in classroom D4 on 9th April 2019. On the X axis is the time, in minutes, starting at 9:00am until 9:59am. This period relates to a class period. On the Y axis is the measurement of CO₂ in ppm indicated in uHoo's traffic light system of green, amber and red. What is noticeable is that the levels move from acceptable to problematic within 10 minutes of the classroom being occupied and by 9:24 the CO₂ levels are in the red zone.

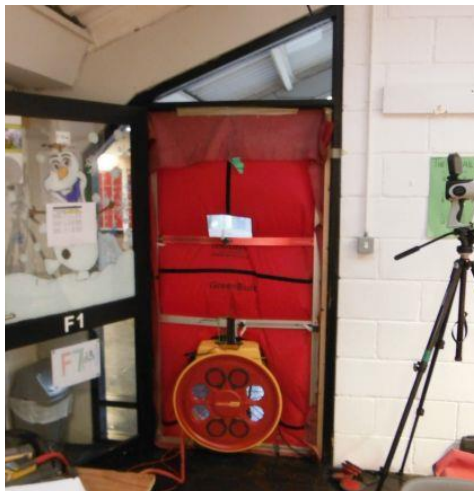
1. Floor
Anemometer shows a reading of 1.0m/s at floor and wall junction to F1

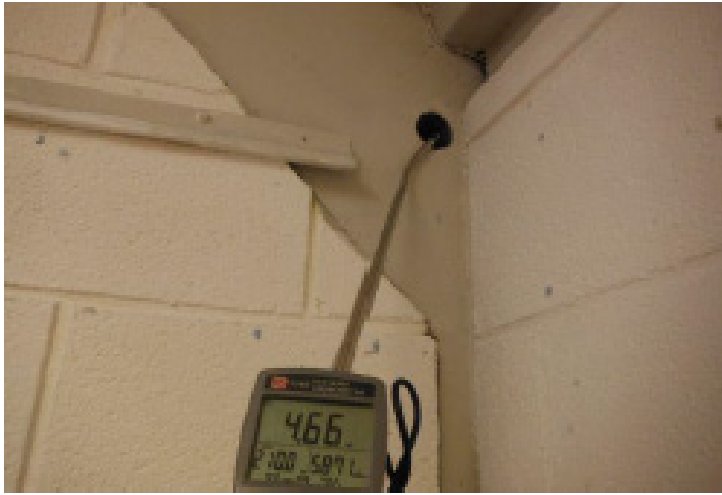
2. Holes in Concrete Columns
Holes in concrete column (F1) show an air leakage reading of 4.66m/s

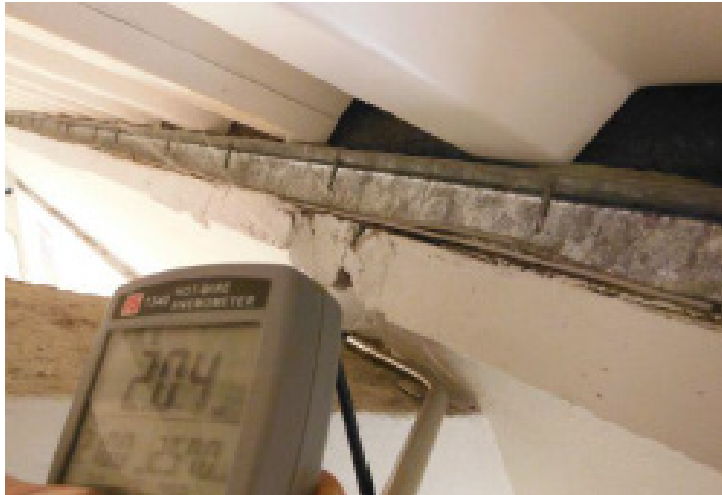
3. Column Junctions
Junctions of column with other construction show areas of air leakage. Here is junction with wall plate in F4 showing an air leakage of 2.04m/s.

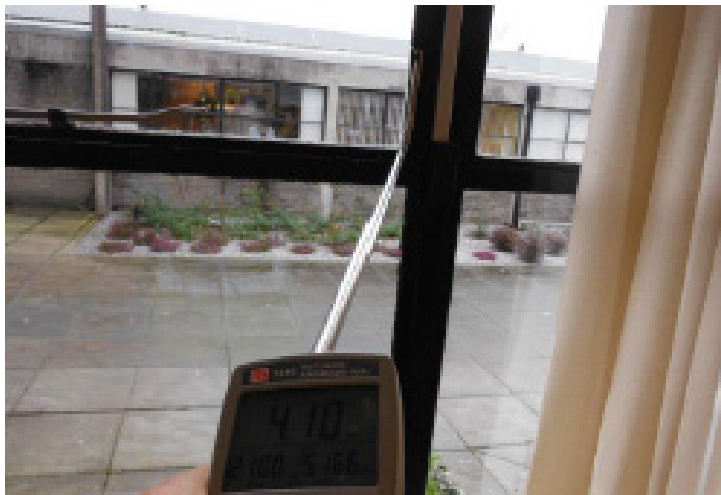
4. Window Junctions
Many air leakages were identified in the windows themselves. Here a reading of 4.10m/s is shown in the opening sash of window in F1.

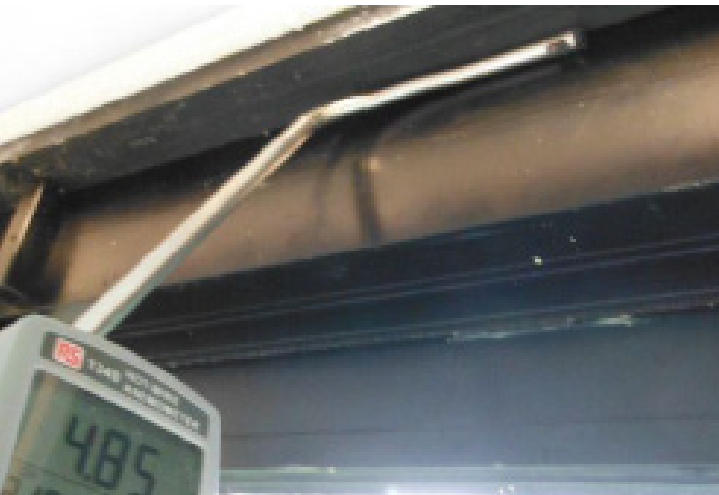
5. External Door
The exit door at D4 has considerable air leakage problems. Shown here is a reading at the head of the door showing 4.85m/s air leakage.

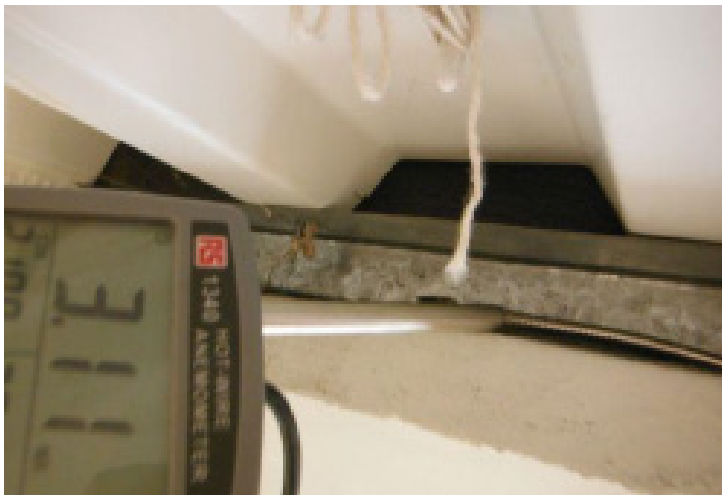
7. Wall Plate
Some of the wall plate to roof junctions showed leakages; here is a reading from F4 showing a leak of 3.11m/s.

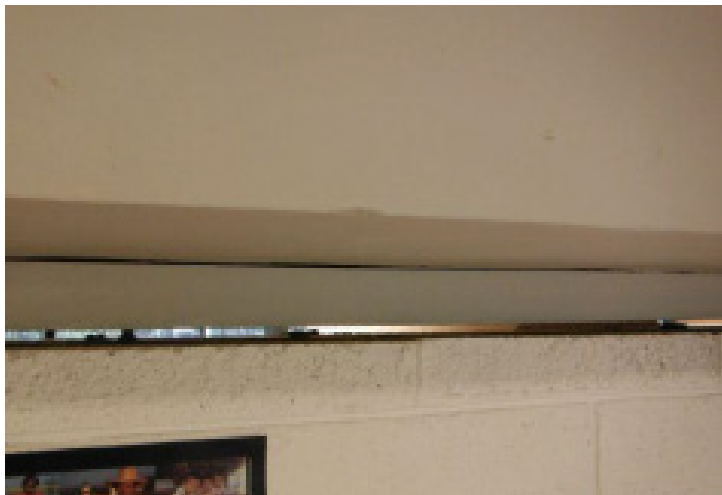
8. Leakage to Hall (F4)
Large gap identified at top of blockwork wall in F4.

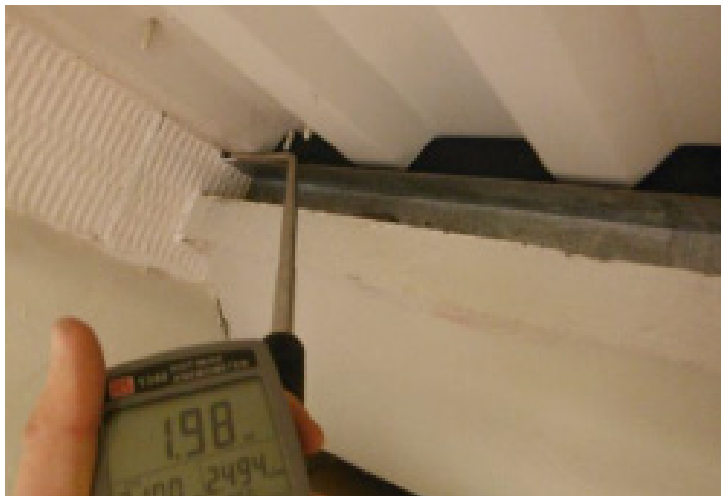
9. Fireseal
Small gaps were identified in this seal, here shown in F1 reading 1.98 m/s.

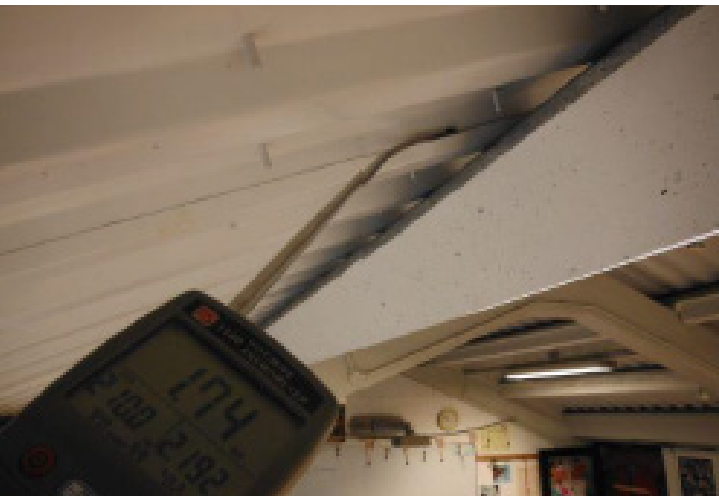
10. Roof Panels
Generally the roof was well sealed but some air leakage was detected in each room, here shown in F4 at 1.74m/s.

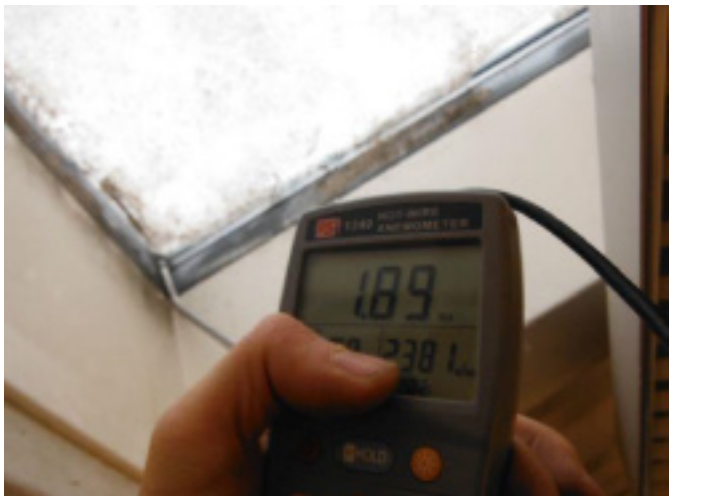
11. Rooflight
Generally these were well sealed, though some air leakage was identified, below shown in F1 at 1.89m/s.

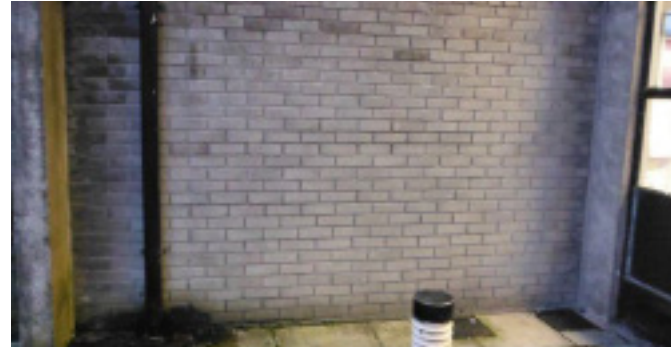
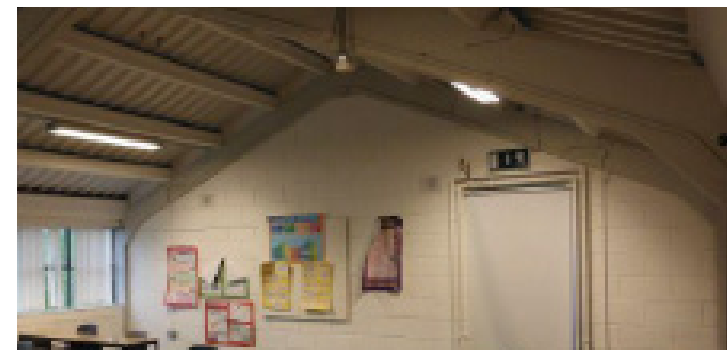
1. Spots on Brickwork

Externally shown here on wall at F1 - at least 8 spots visible on wall. Internally these are visible on gable of D4.

- 1. Spots on brickwork
One of the main items of note in each of the areas surveyed externally were thermal spots on the brickwork. These were present in several locations. In D4 they correspond to a certain degree with what appeared to have been repairs or other work to the brickwork. In a cavity wall, the appearance of this type of spot would often be associated with thermal bridges caused by either wall ties themselves, or mortar buildup on those wall ties.

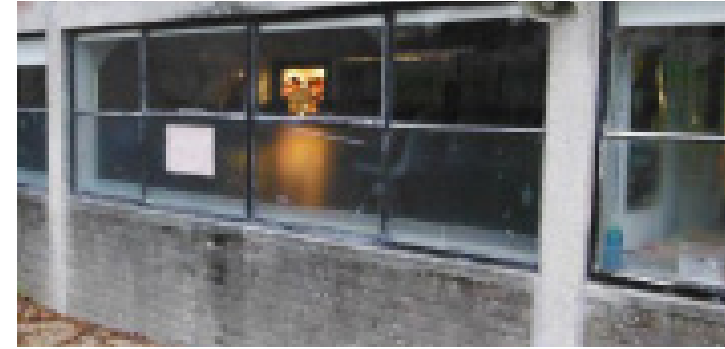
2. Concrete Columns

Note change in temperature from wall to column externally (F4). Internally the column is noticeably cooler than the wall (D4).

- 1. Concrete columns
The patterns visible from outside of elevated heat loss via the concrete columns is evident also from inside. Note the cooler pattern in the columns and beams and to the gable of D4.
- 2. Wall spots
The wall spots noted from the external imaging survey were in general not evident from the internal survey as the majority of the areas in question were behind radiators. However, the end gable wall of D4 showed some patterns.
- 3. Wall plate
The heat loss pattern from the wallplate was not as evident as might be expected. As the radiators were in general placed on external walls, then the heat rises and warms the wall plate level, washing them with heat and masking the heat loss pattern somewhat. However, some patterns of elevated heat loss were evident especially where wall plate and concrete columns meet.

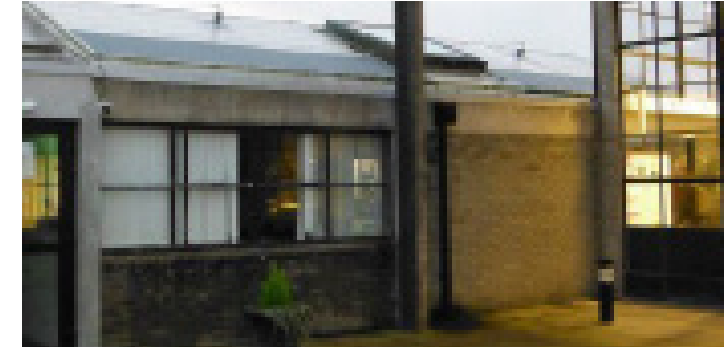
Elevated heat loss through wall plate is evident in a number of locations, shown externally and internally here on F1.

- 3. Wall Plate
Elevated heat loss patterns could be observed in some locations of the wall plate.
- 4. End emergency exit door in D4
The emergency exit door at D4 shows an interesting thermal pattern more or less around the perimeter of the door. On visual inspection there is no evident defect here. Therefore, this pattern is more likely due to additional heat production in the area, insulation anomalies, airtightness weakness, or all of the above. Two of these 3 items were shown during the survey – heating pipes at temperatures of up to about 60c run around the perimeter of the door from the inside, and at the airtightness test, the frame to reveal junction internally was very weak for airtightness.

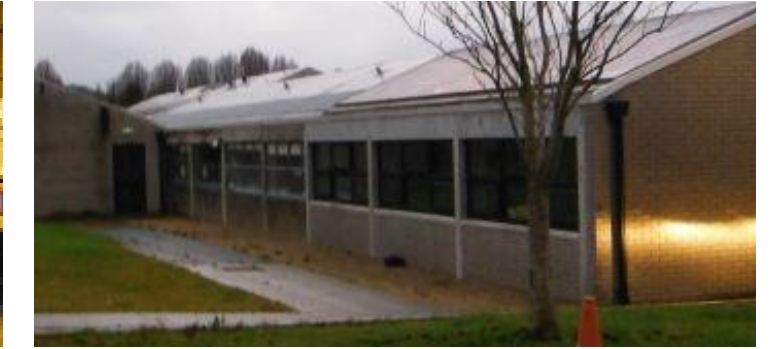
5. New Vs Old Construction

These images compare the exterior or adjoining original 1970s construction and new extensions from 2010s.

Line 1 (blue) - Window: As with roofs, windows must be treated with caution in thermal imaging, due to the danger of reflections from elsewhere. However here, as we are comparing windows to windows and the patterns are relatively even, we can be reasonably confident in saying there is a several degree surface temperature difference between the older and newer windows.

Line 2 (red) - Lower Walls: A clear temperature drop averaging about 1C is evident at the old/new junction, and the spikes for the columns are not evident in the newer section.

Line 3 (green) - Roof: Roofs must be treated with caution in thermal imaging survey due to condensation and other factors providing a layer to allow reflections from elsewhere appear as if it is the pattern on the roof itself. Here, a similar pattern is found at several view angles, indicating that the effect is not just a reflection from elsewhere, and therefore the different roof build up on the new section would appear to be better insulating.

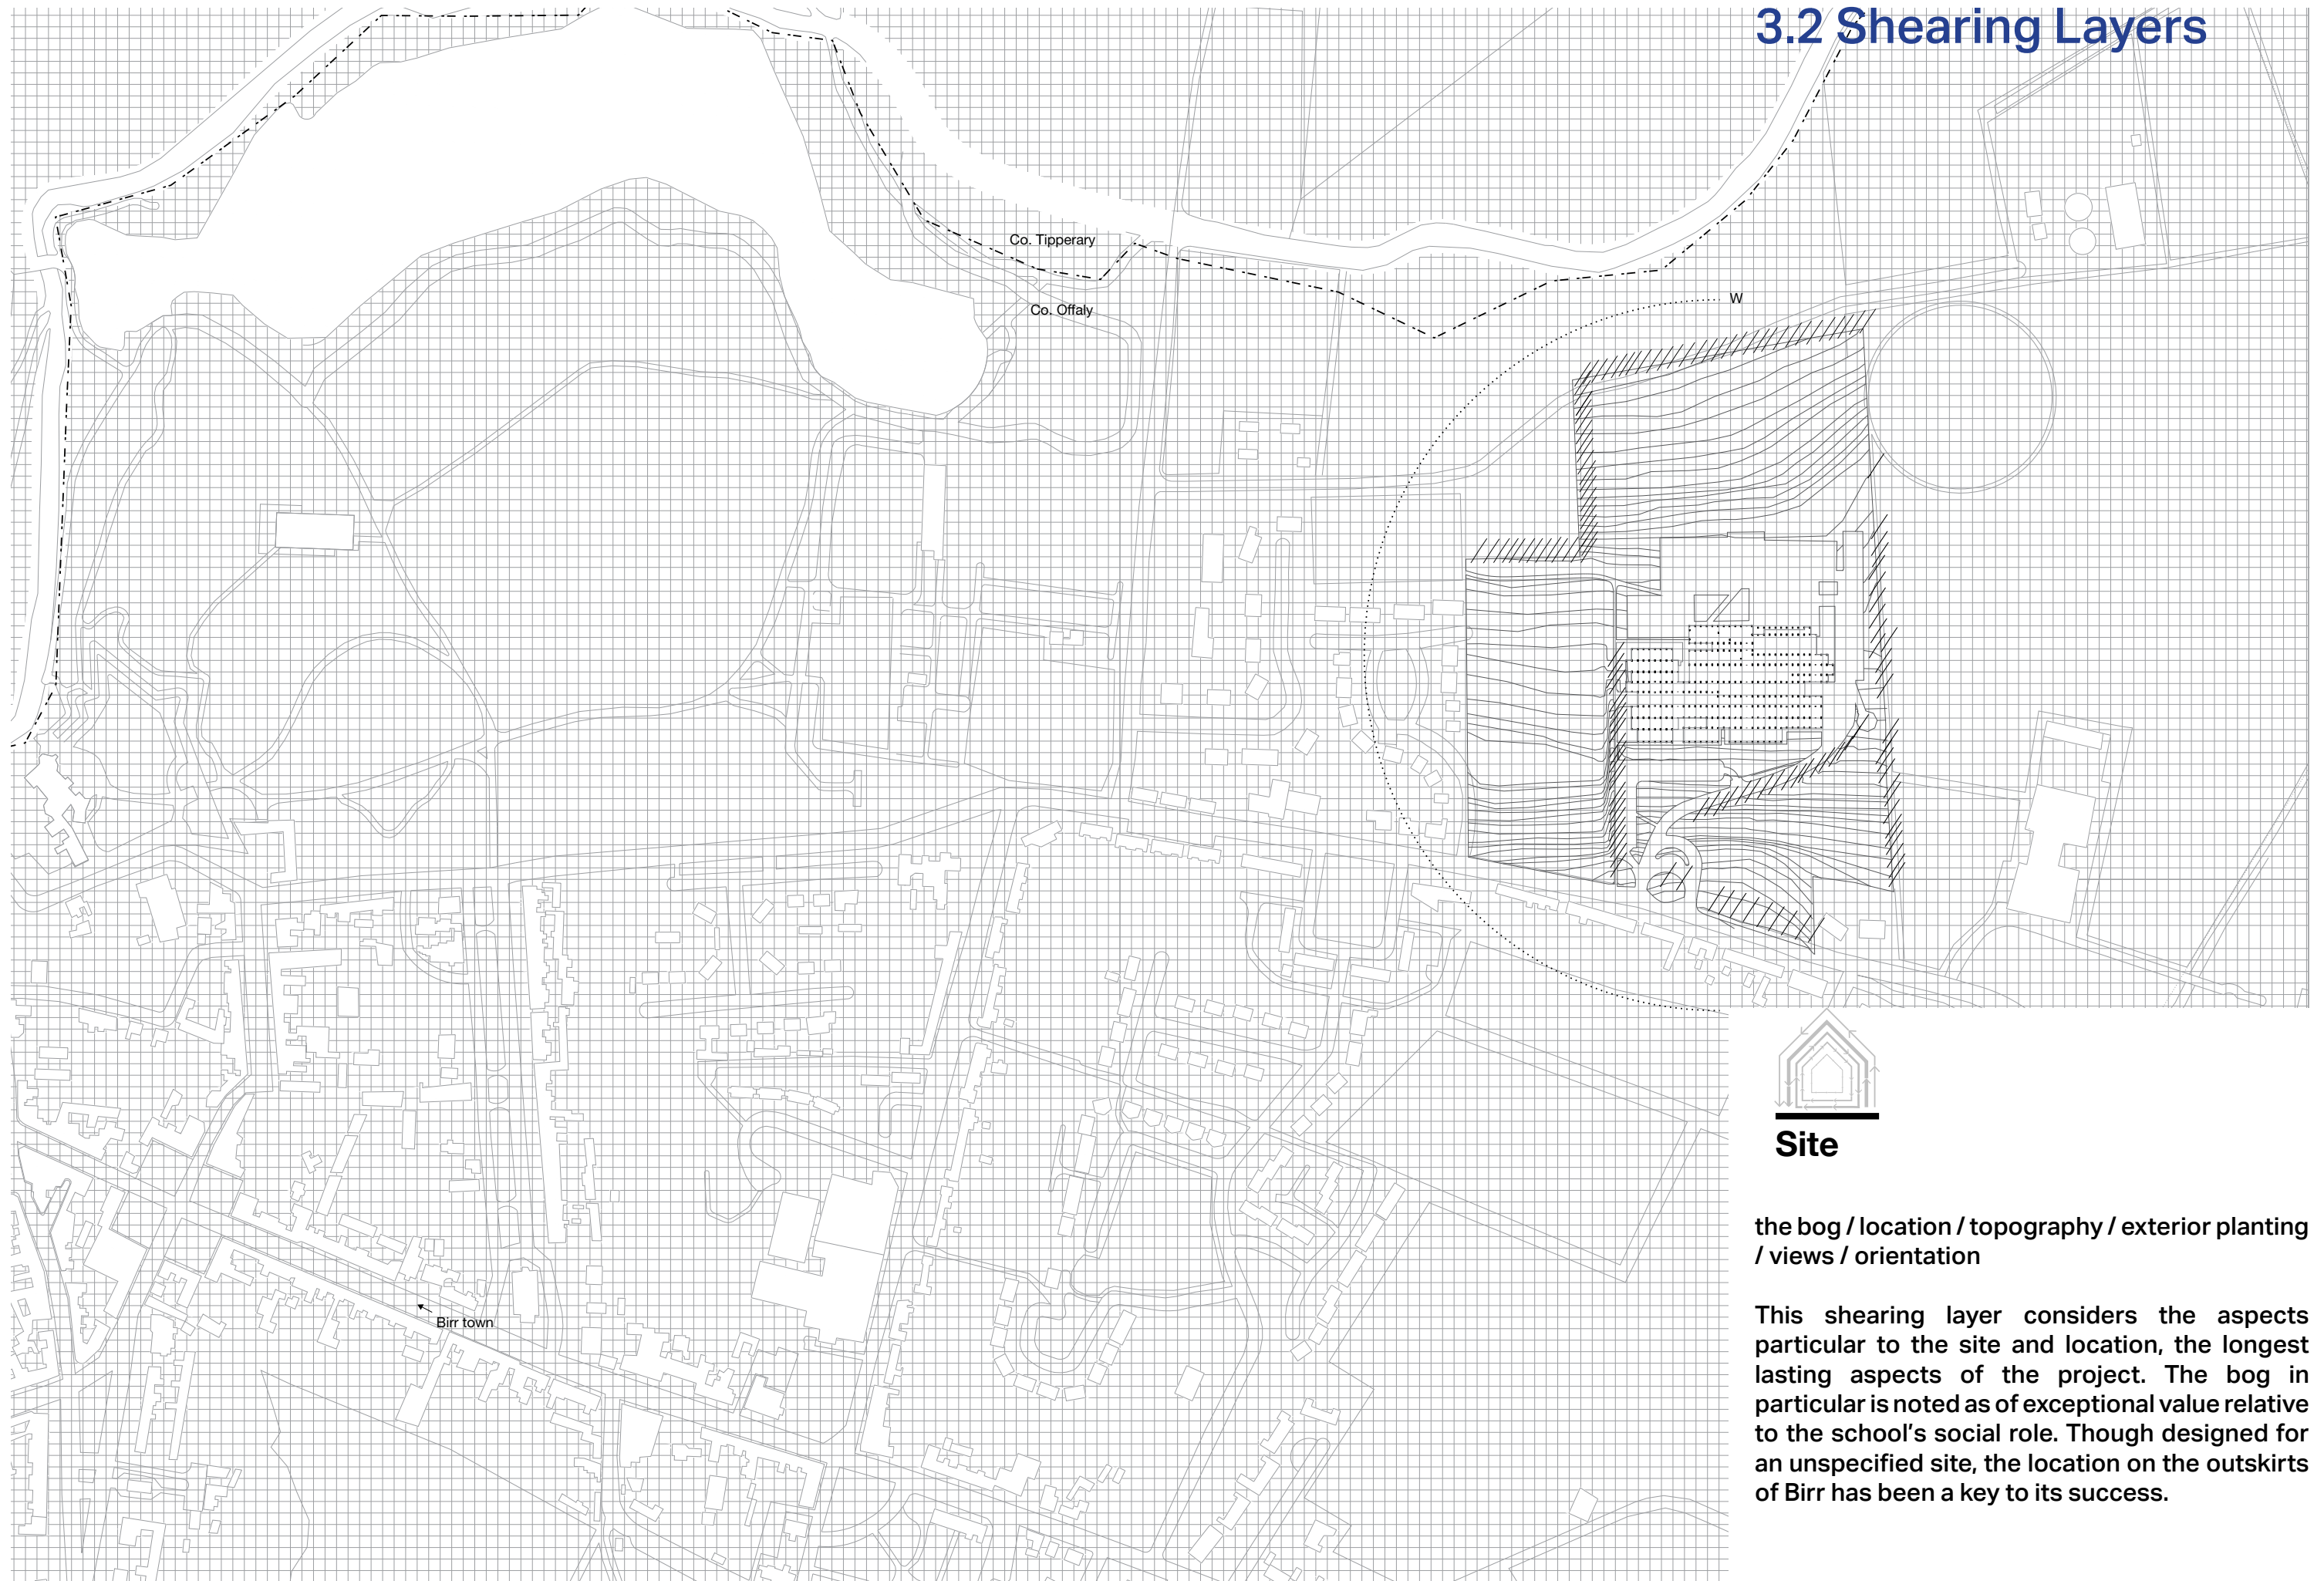
Site

the bog / location / topography / exterior planting
/ views / orientation

This shearing layer considers the aspects particular to the site and location, the longest lasting aspects of the project. The bog in particular is noted as of exceptional value relative to the school's social role. Though designed for an unspecified site, the location on the outskirts of Birr has been a key to its success.

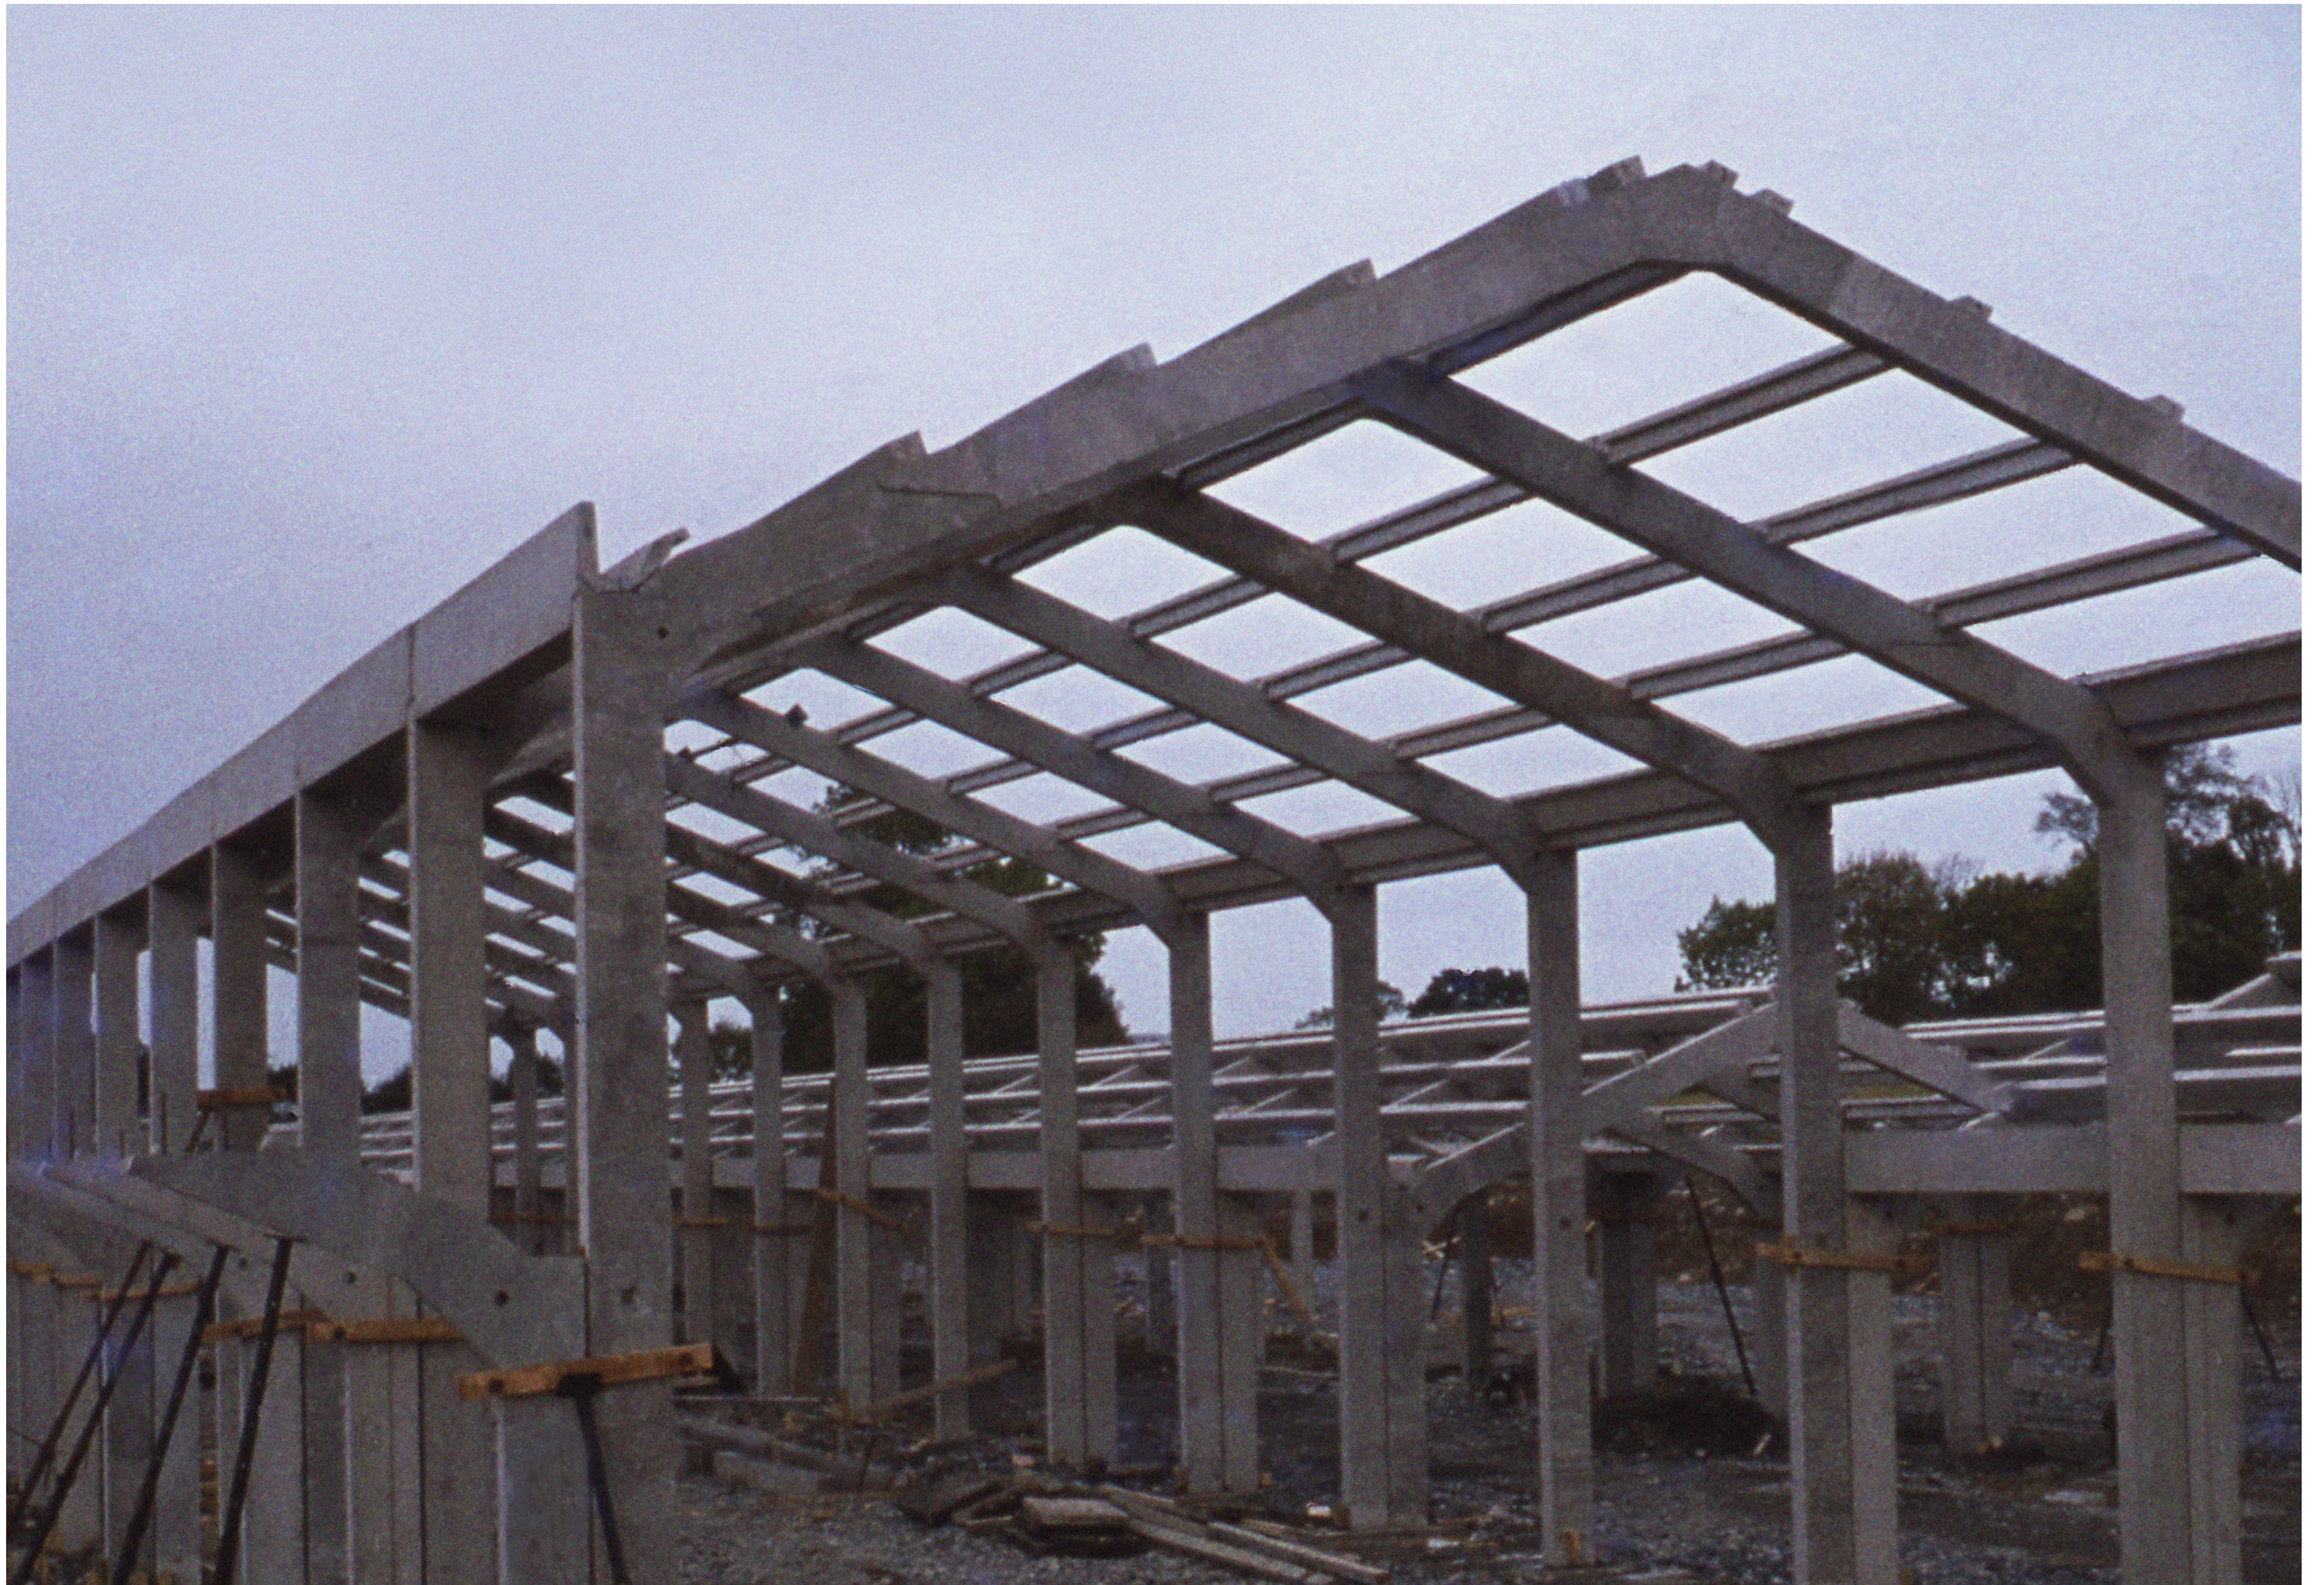
This shearing layer considers all elements of the envelope and enclosure including the roof. Of highest value here are the courtyard elevations. These are significant socially, through the light and transparency they offer; technically, in the expression of the means of construction and aesthetically in creating the visual experience in the 'street'.
