Conservation Management Plan

St Brendan's Community School, Birr

Queen's University Belfast & John McLaughlin Architects

June 2021

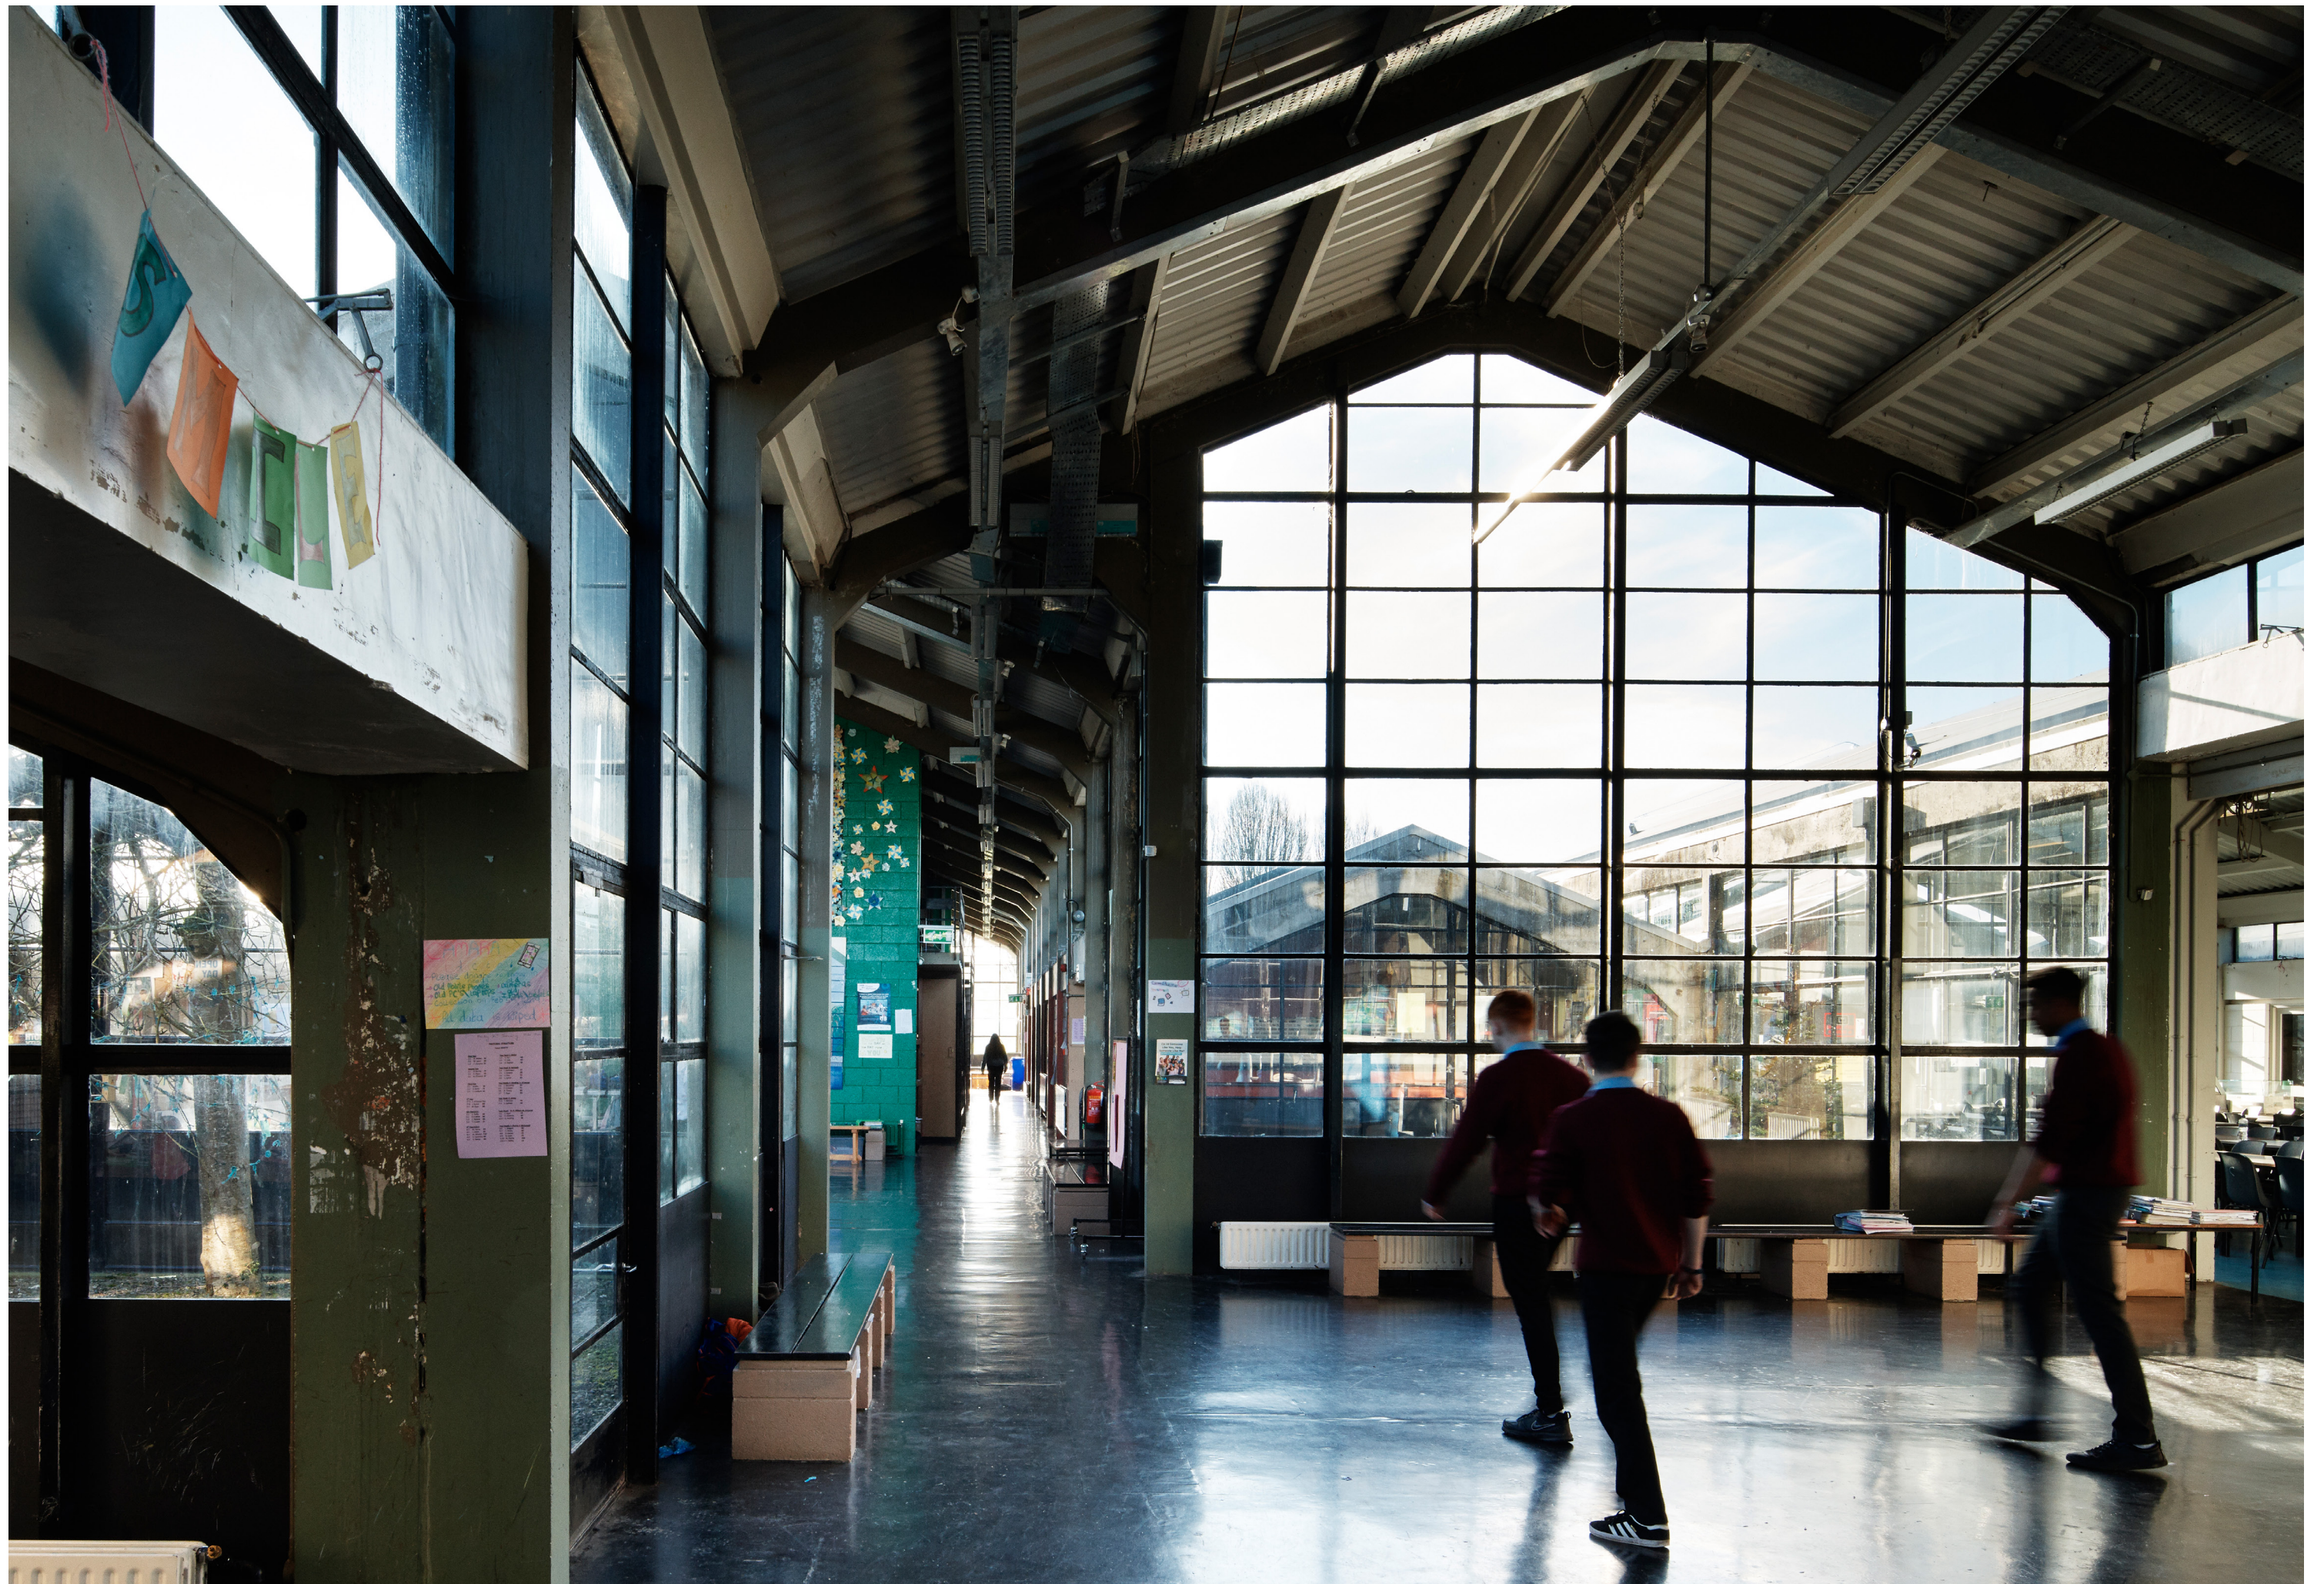
Core to the original project's design was the development of a pre-cast concrete portal frame structure that allowed for flexibility and adaptability in plan. The portal frame's expression and its impact on the spatial experience is of exceptional importance in the building.

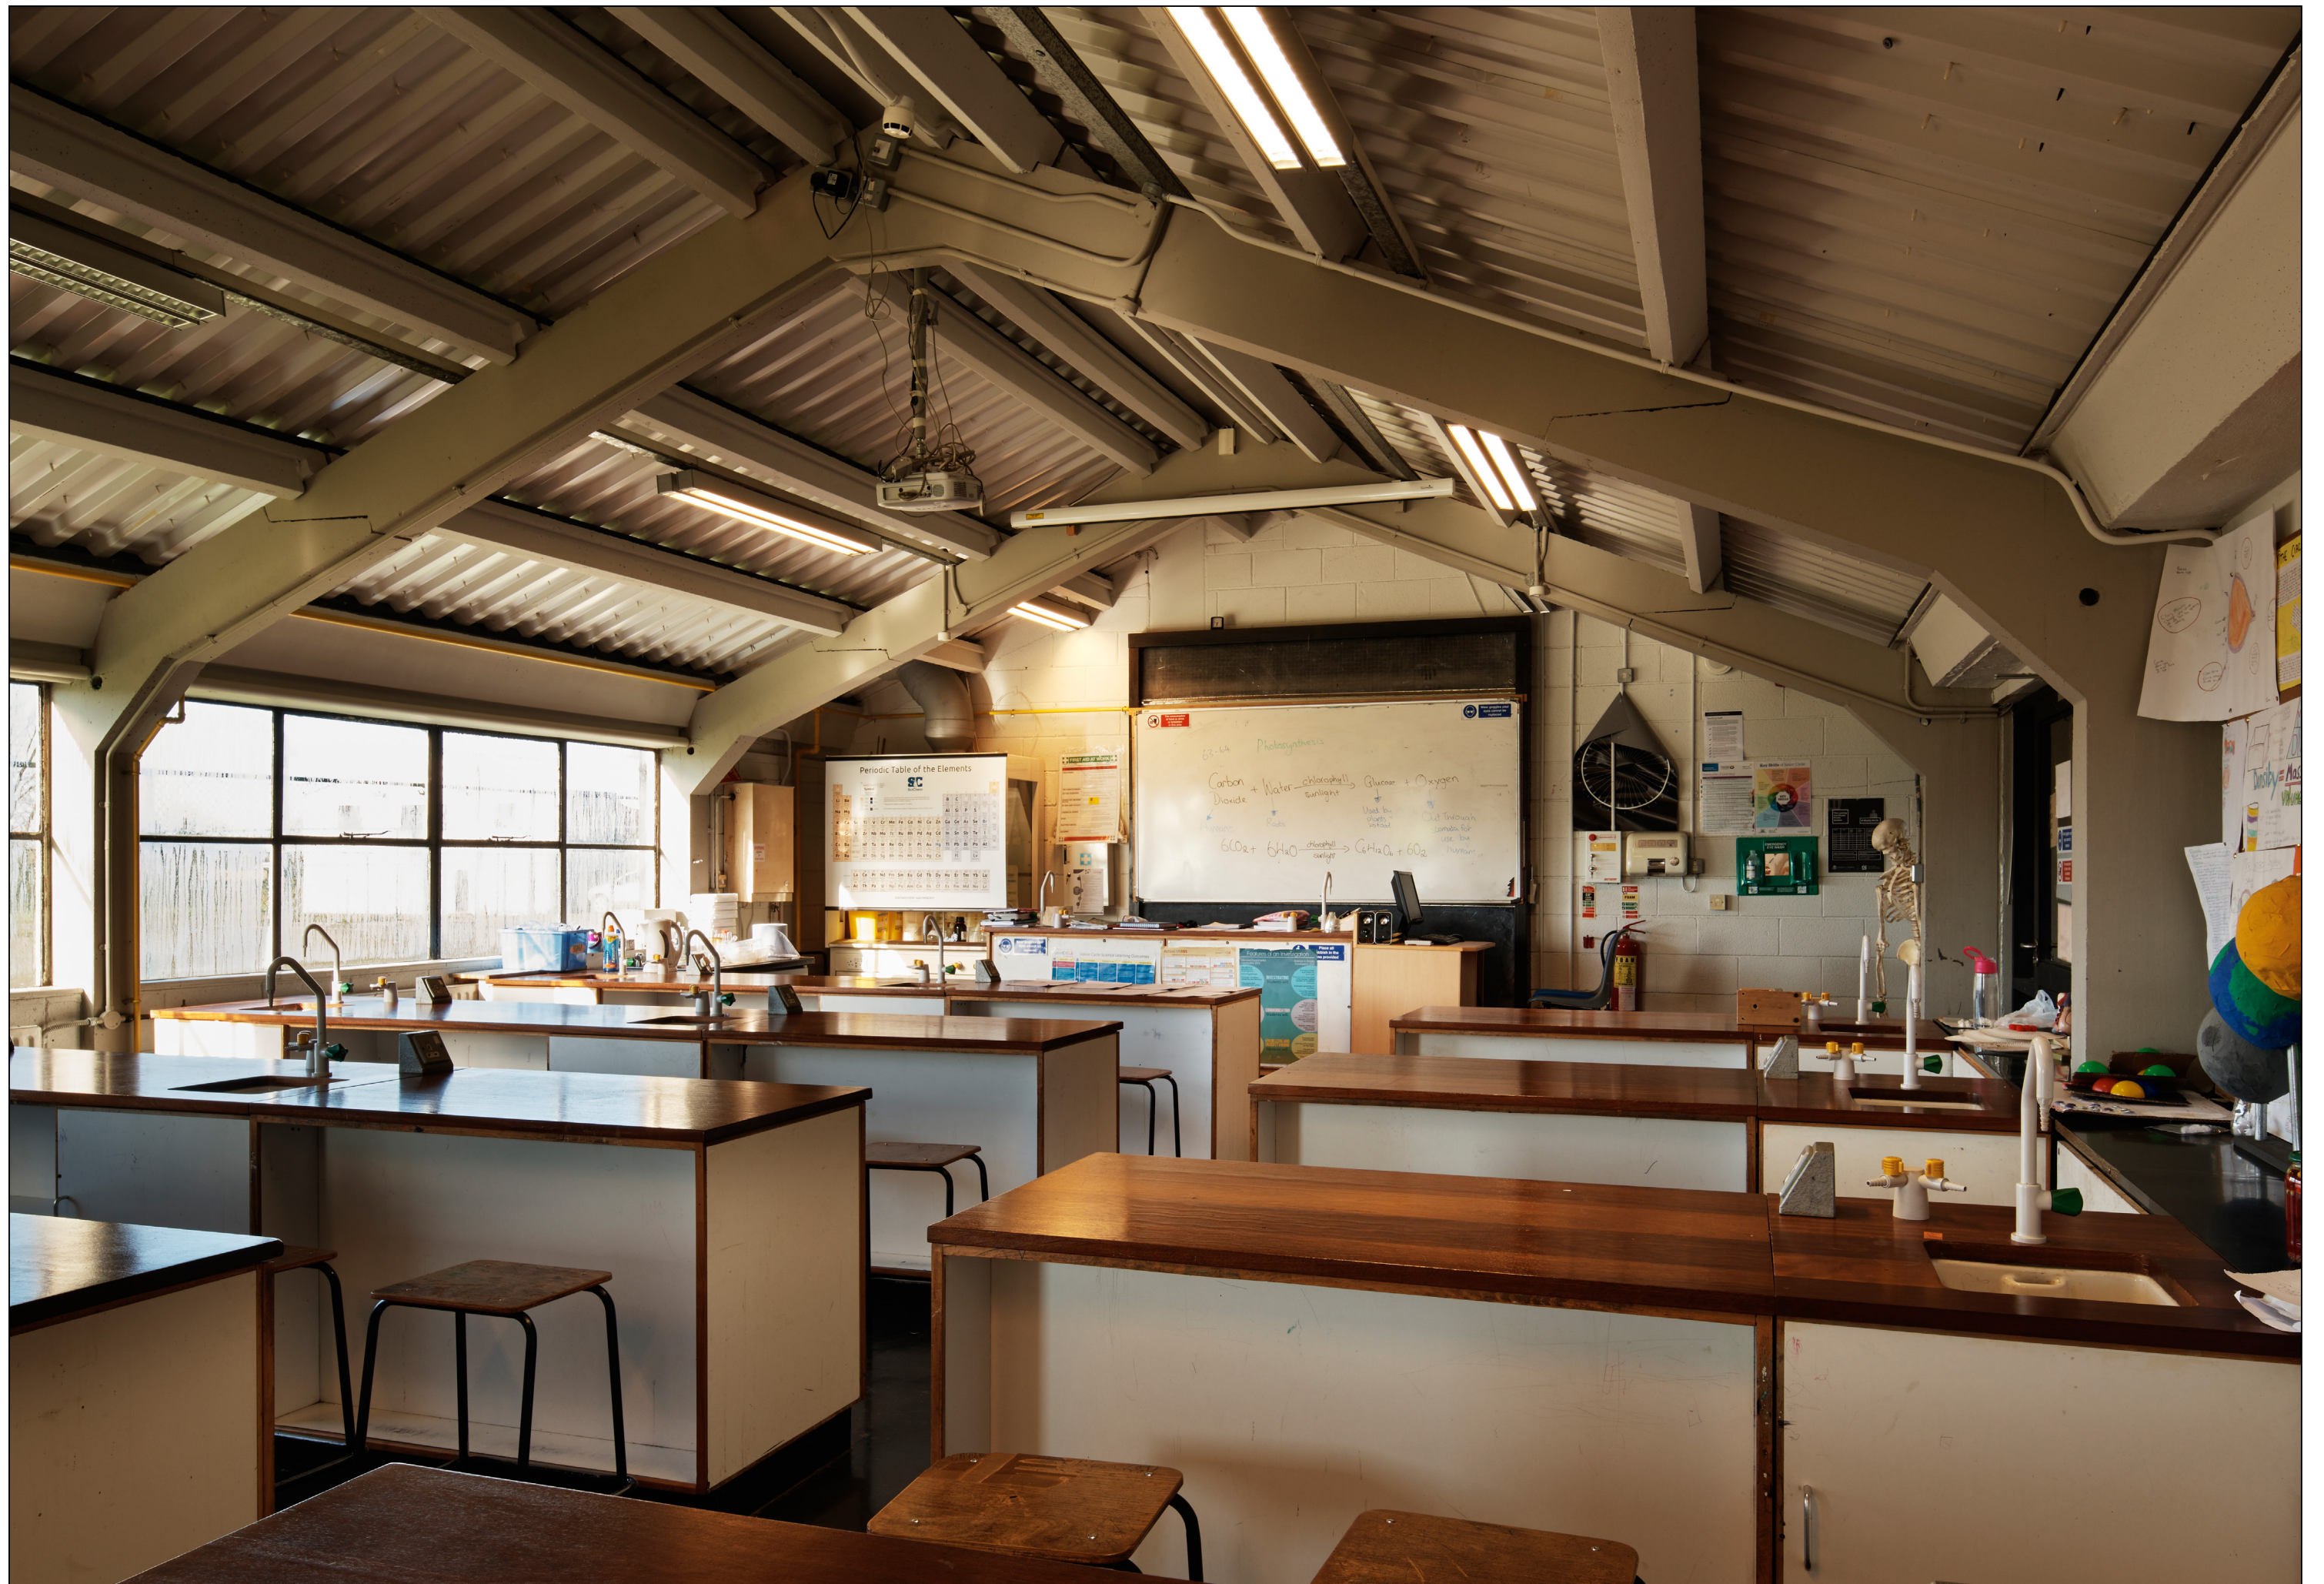
the grid / the street / programme arrangement
/ daylight / section / stair/vertical elements /
inside/outside / relationship to exterior

This shearing layer reflects the functional and intangible aspects of the spatial planning. In the school, the programmatic clustering around courtyards, connected by the spine of the 'street', underpinned by the grid, is of exceptional importance. This along with the considerable daylight and spatial experience allowed by the changing section and clerestory lighting creates a spatial plan centred on the street that is of exceptional value.

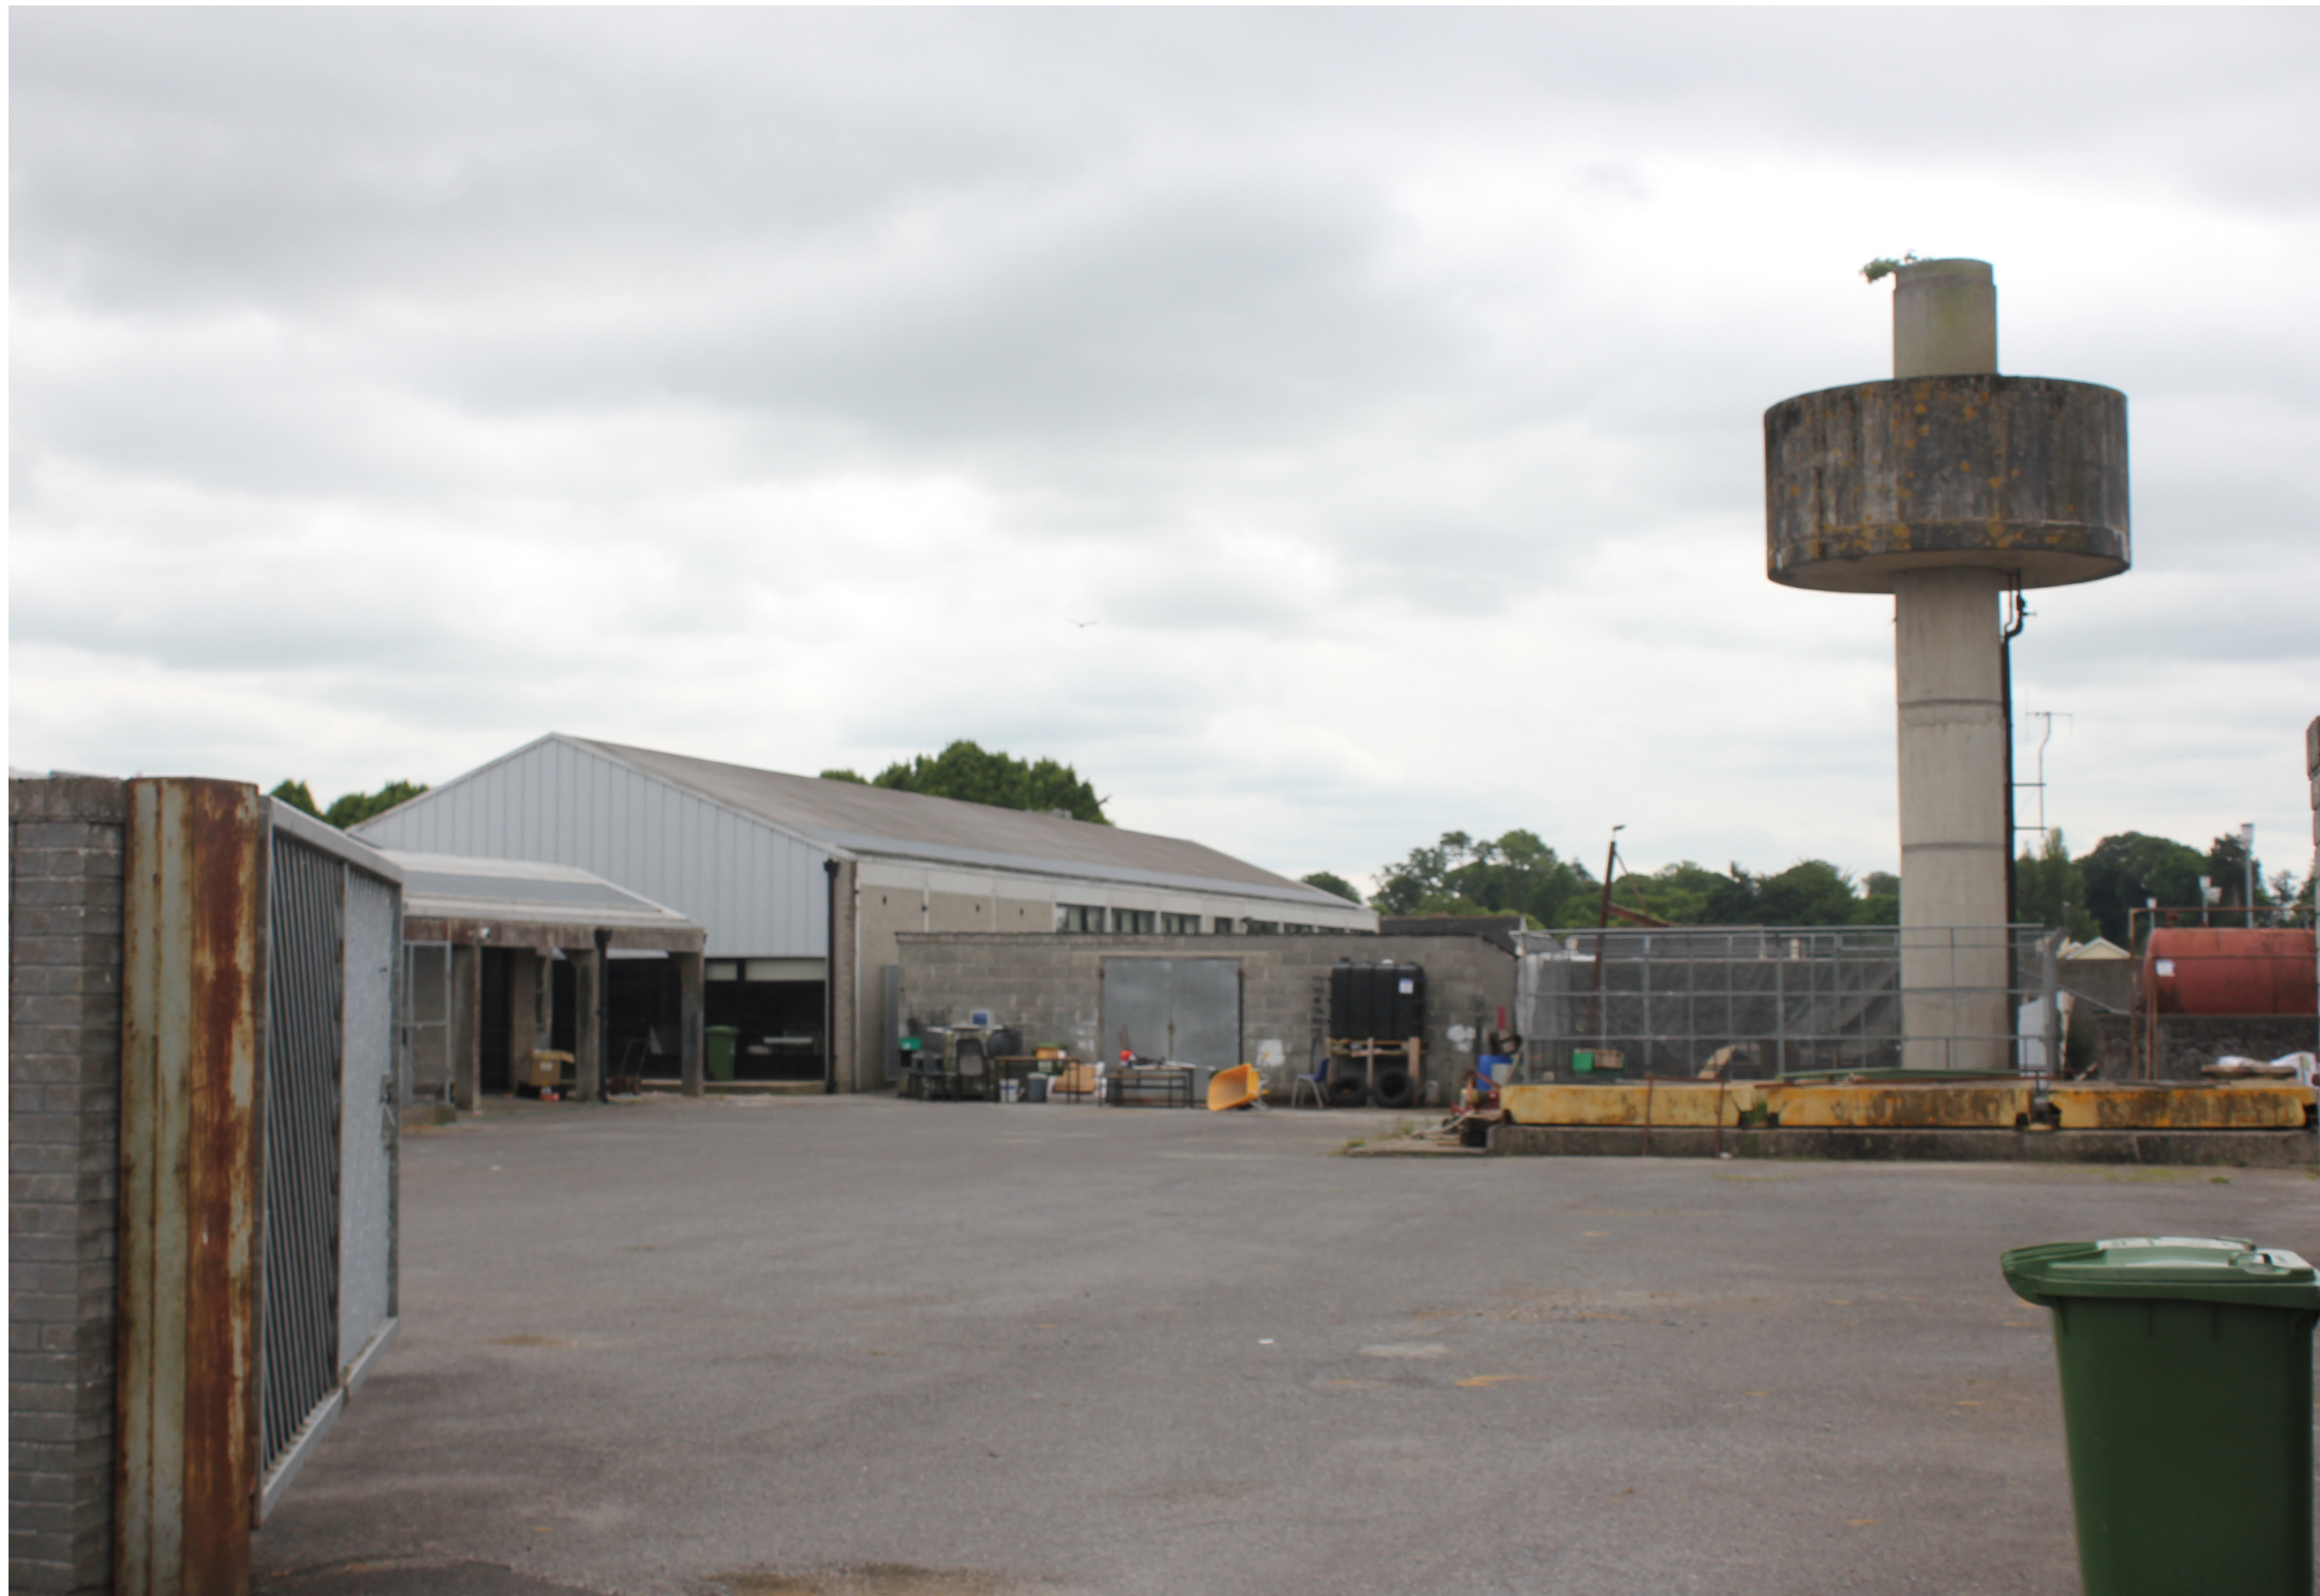
floor / blockwork internal walls / colour scheme
/ internal glazed screens

In this building there is considerable overlap between surface and structure. The expression of this construction is key to the experience of the space. The surfaces are the most immediate materials that determine the interior experience. The reflective dark floor is significant, as is the expression of construction evident in the blockwork internal walls. The original colour scheme was largely monochrome, except for the internal gable walls, though some of this has changed over time.

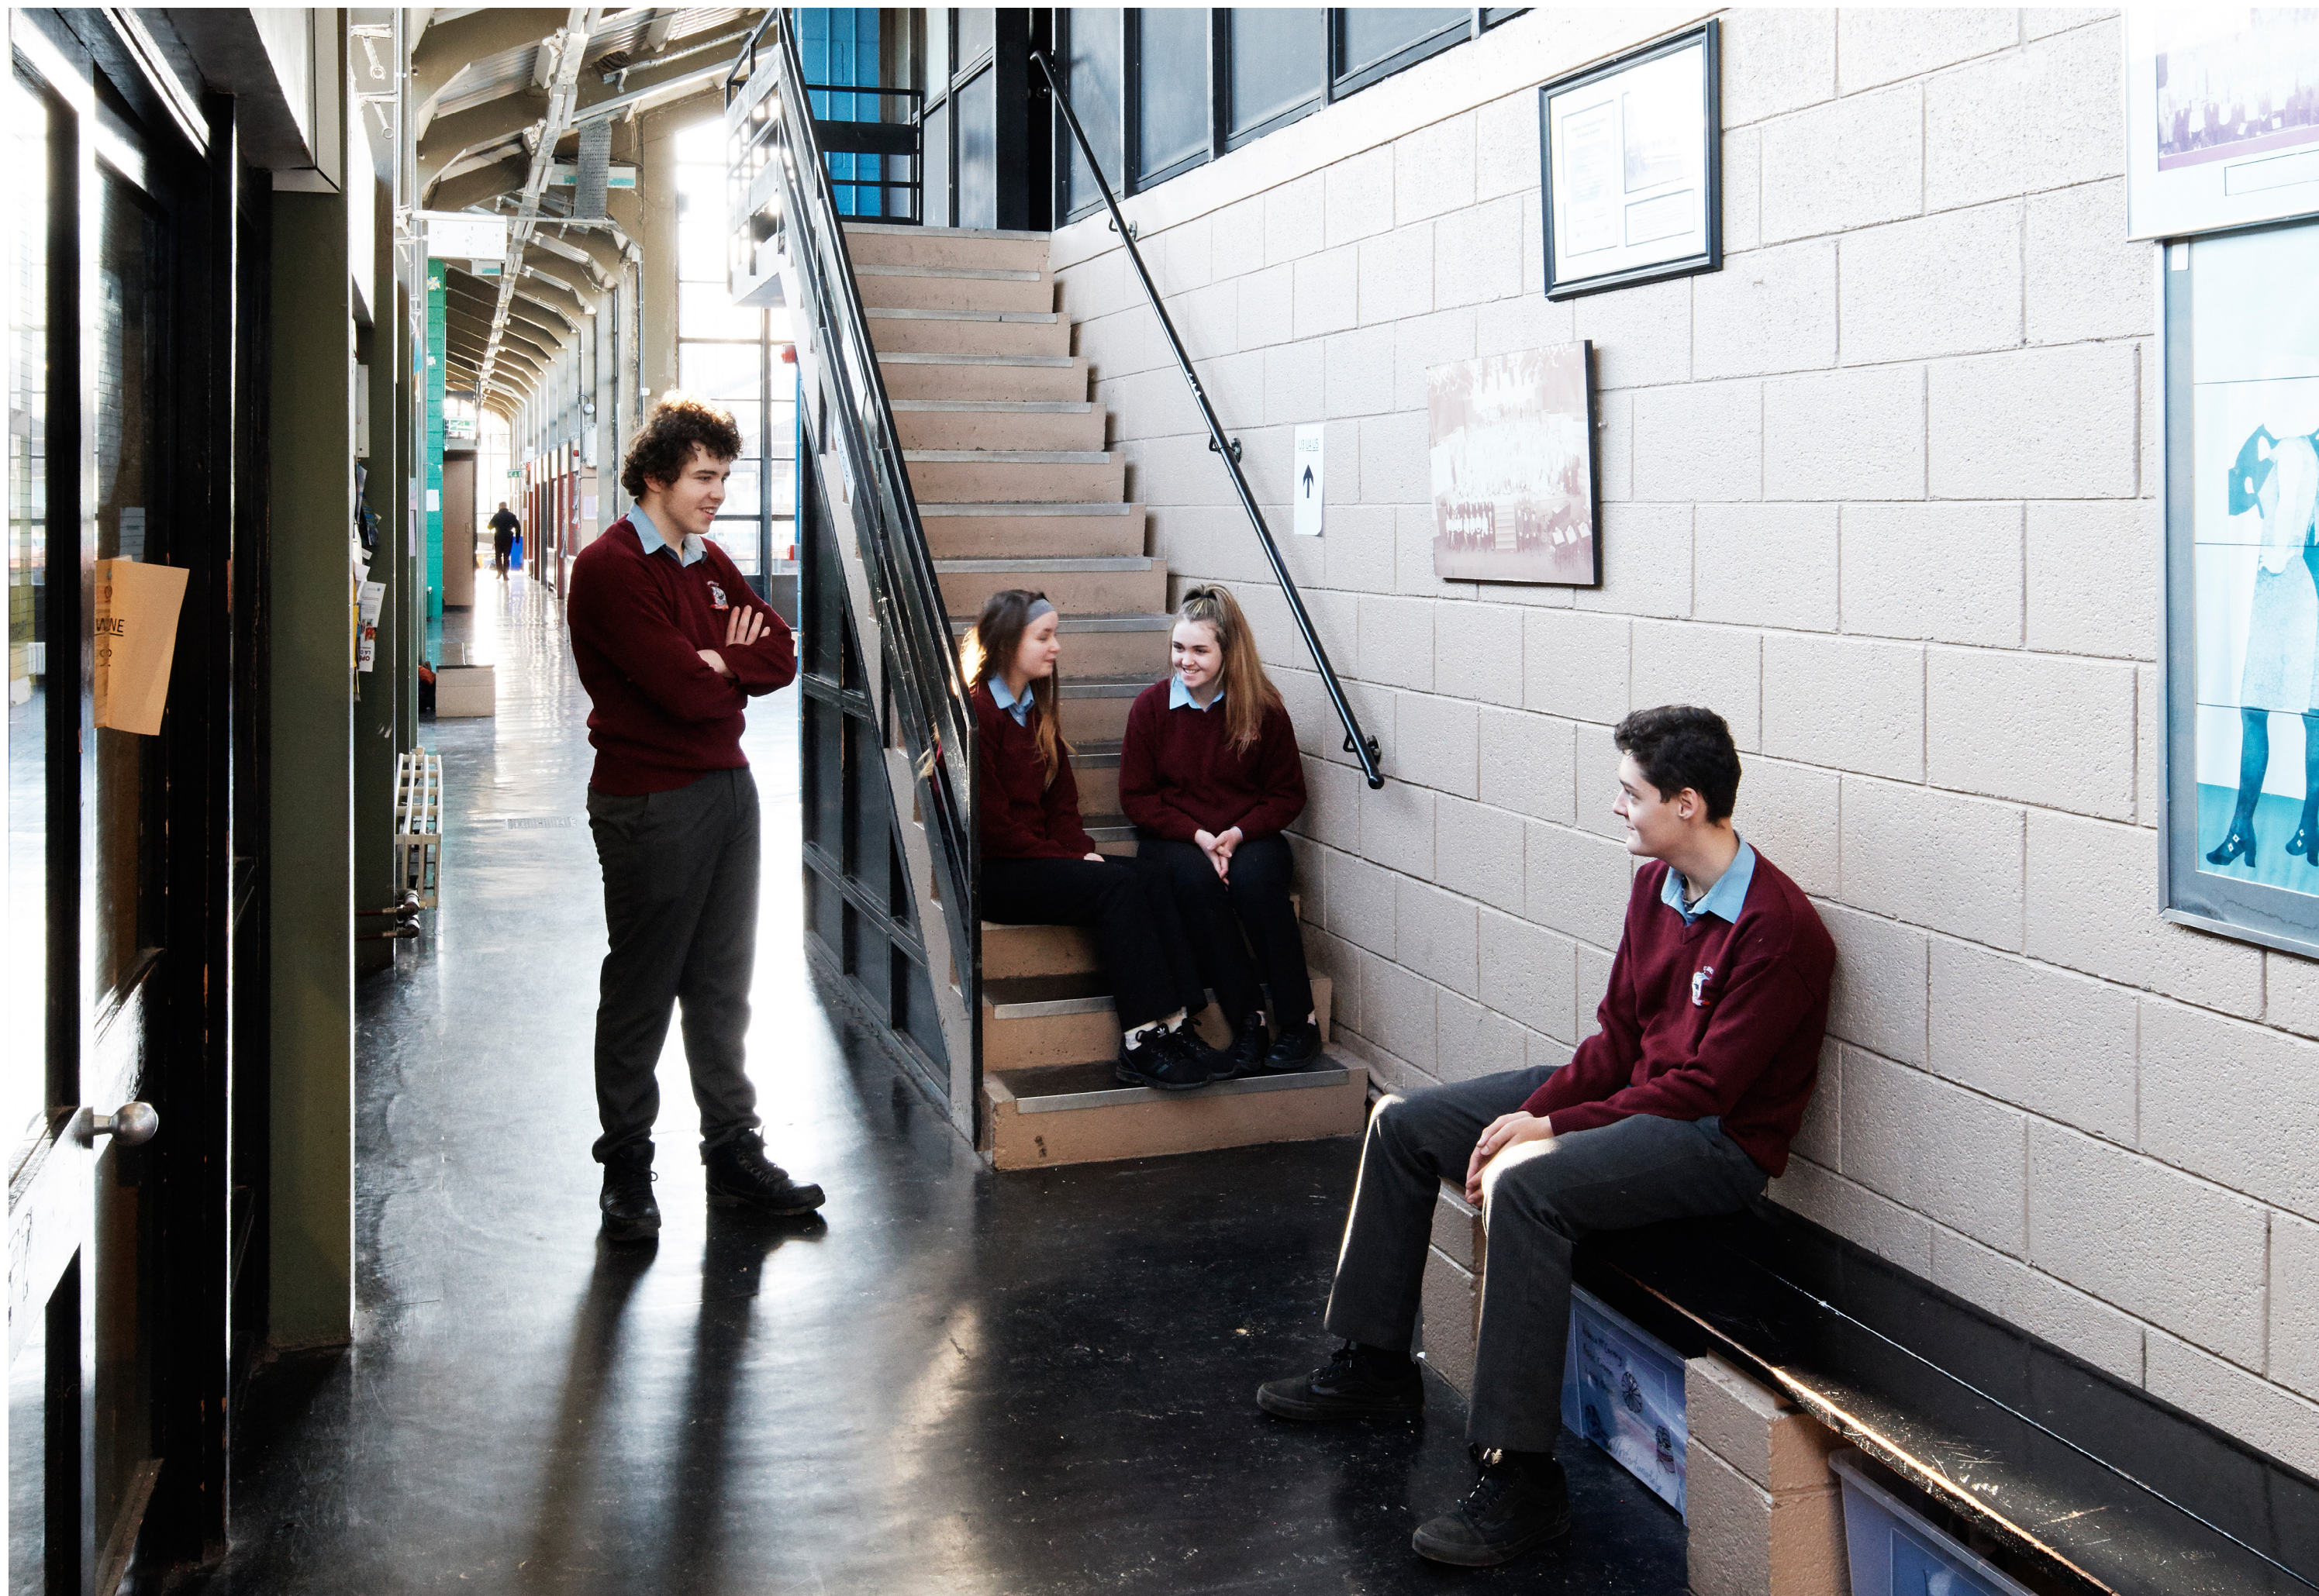
Services

lighting / heating / water tower/chimney

The original services were exposed and expressed for reasons of economy, though this also had an aesthetic value, as they were carefully aligned with the space plan. Upgrades to the services over the lifespan of the building mean the newest installations are not aligned with the original design intention. The original services chimney for the peat fired boilers also acted as a water tower, and is of exceptional significance, as a key element in post-war modernist design.

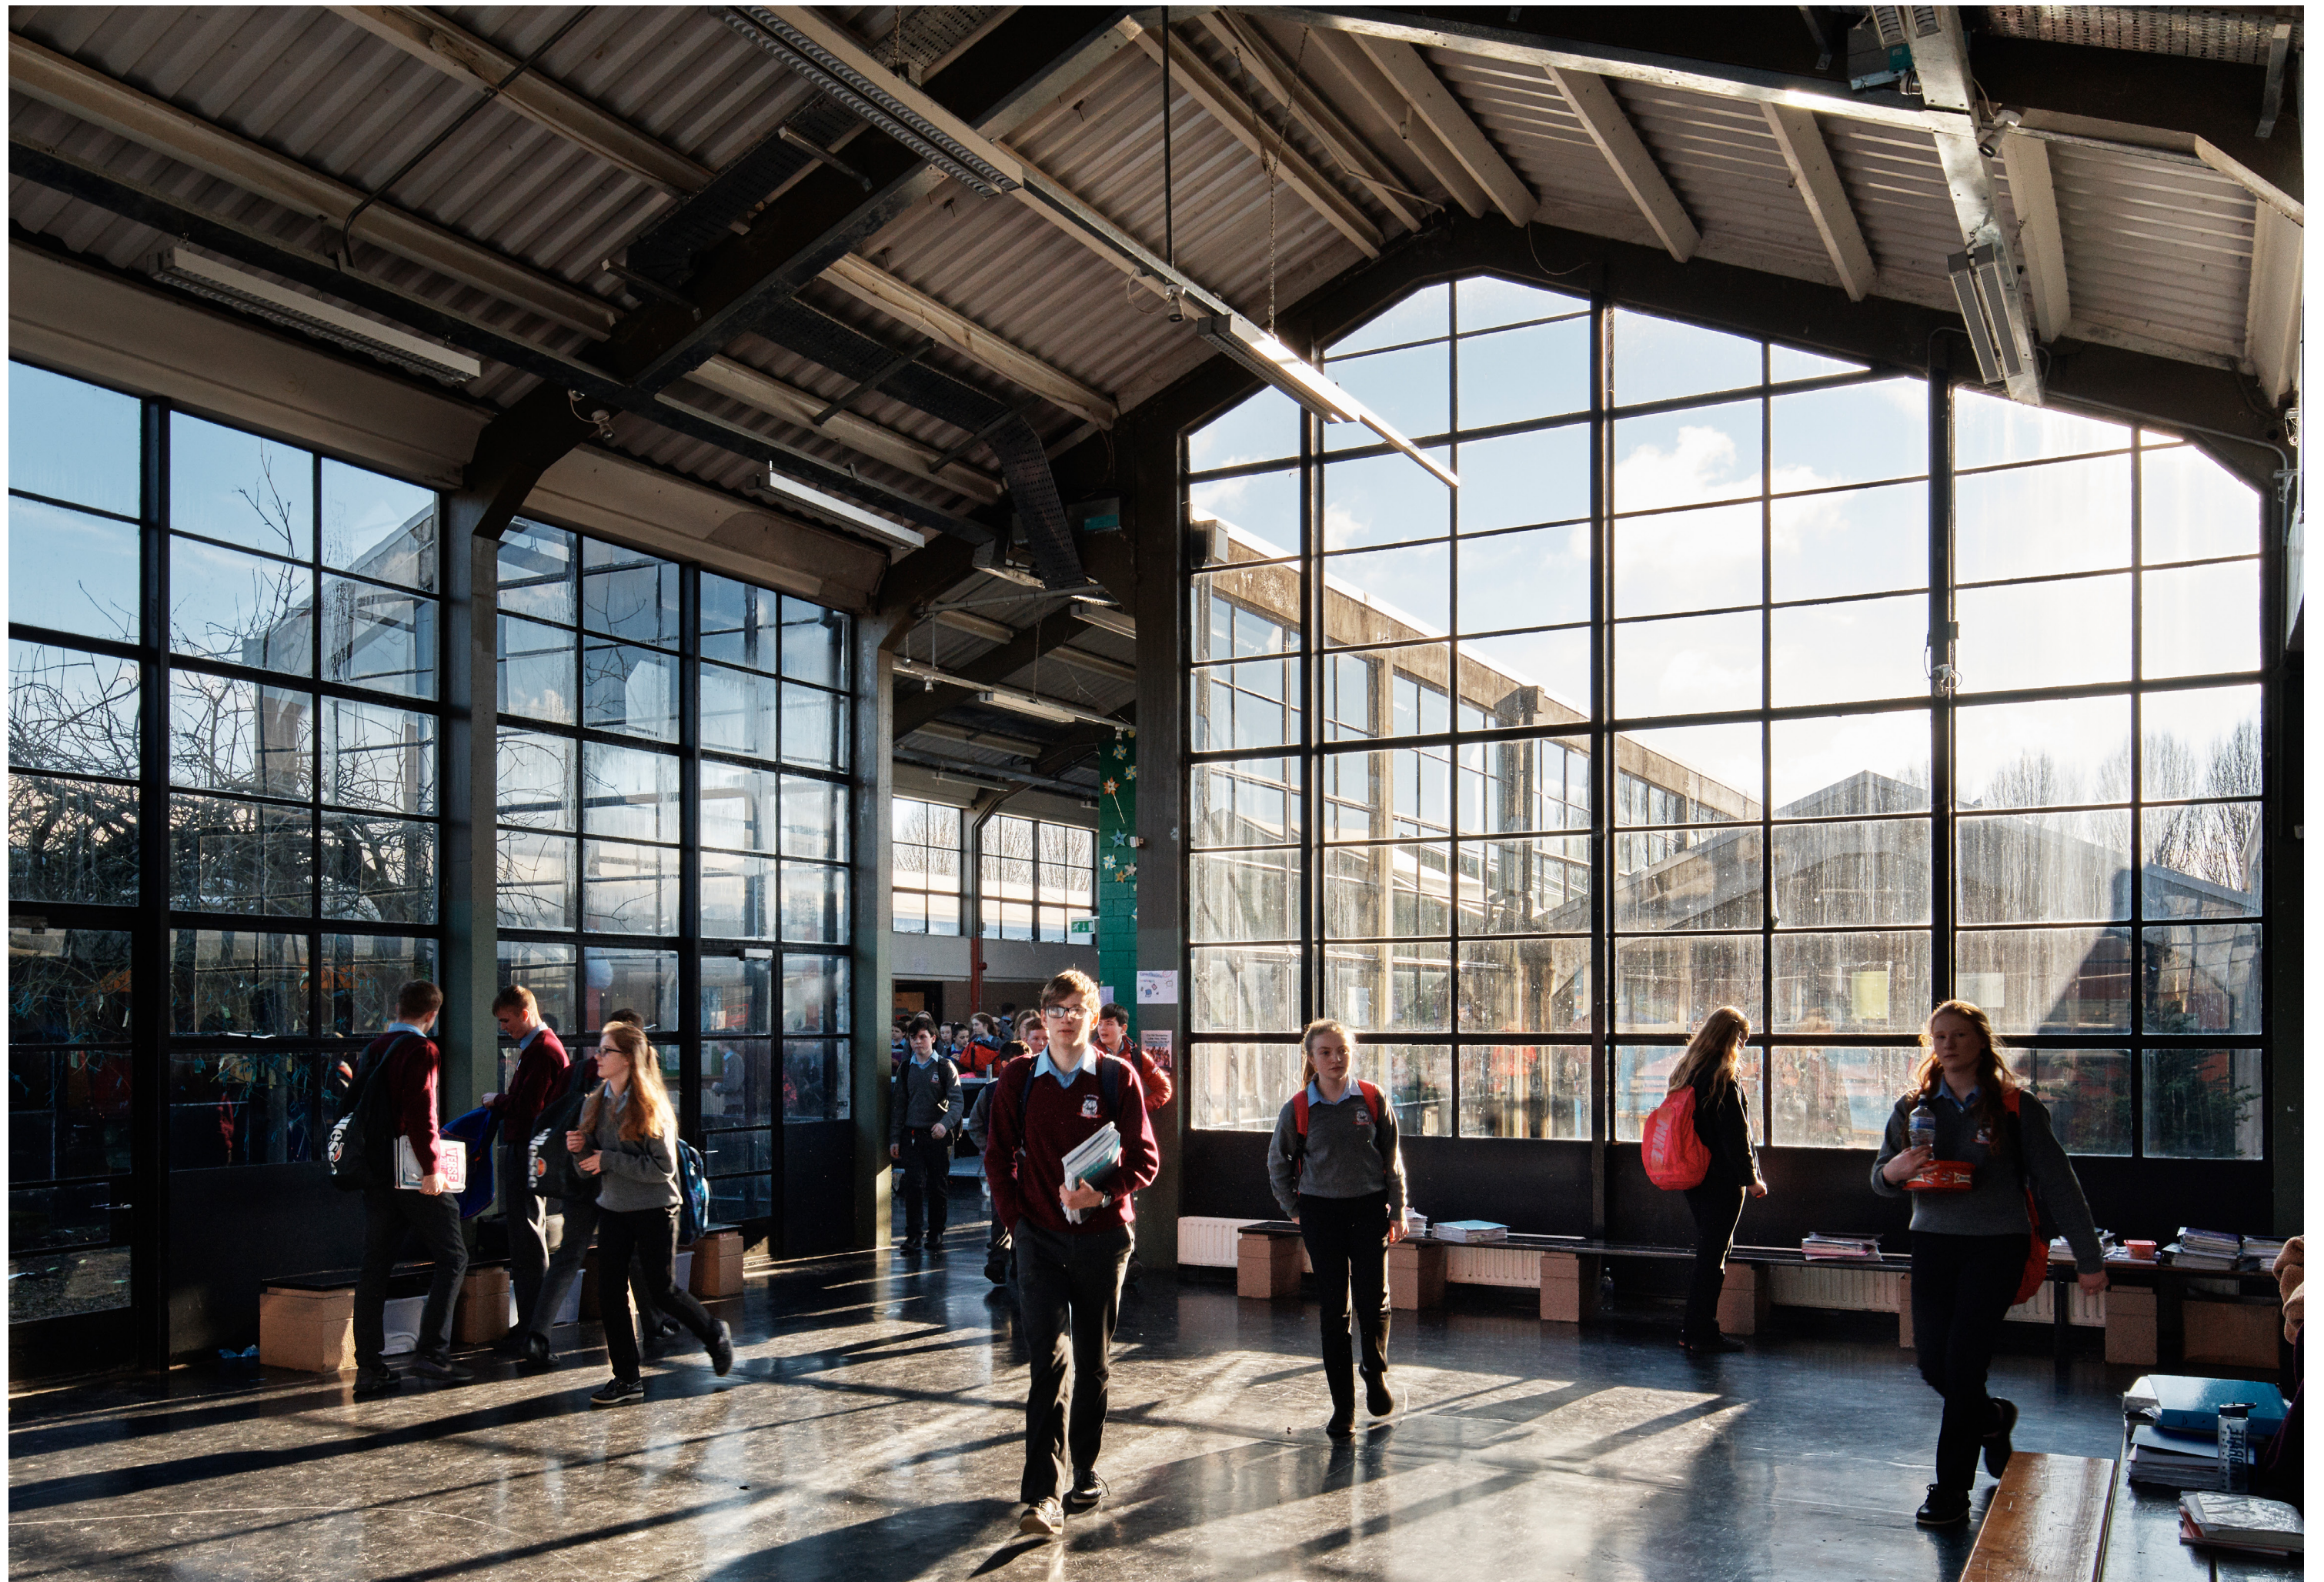
courtyard planting / benches / fitted furniture & clock

This shearing layer relates to the most ephemeral aspects of our occupation of a building, though these elements often have a high impact on our experience of the place. The planting in the courtyards is a key factor in the experience of the space. The benches, equally are of exceptional significance in the social performance of the school and in achieving the Doyles' ambition for the 'street'.

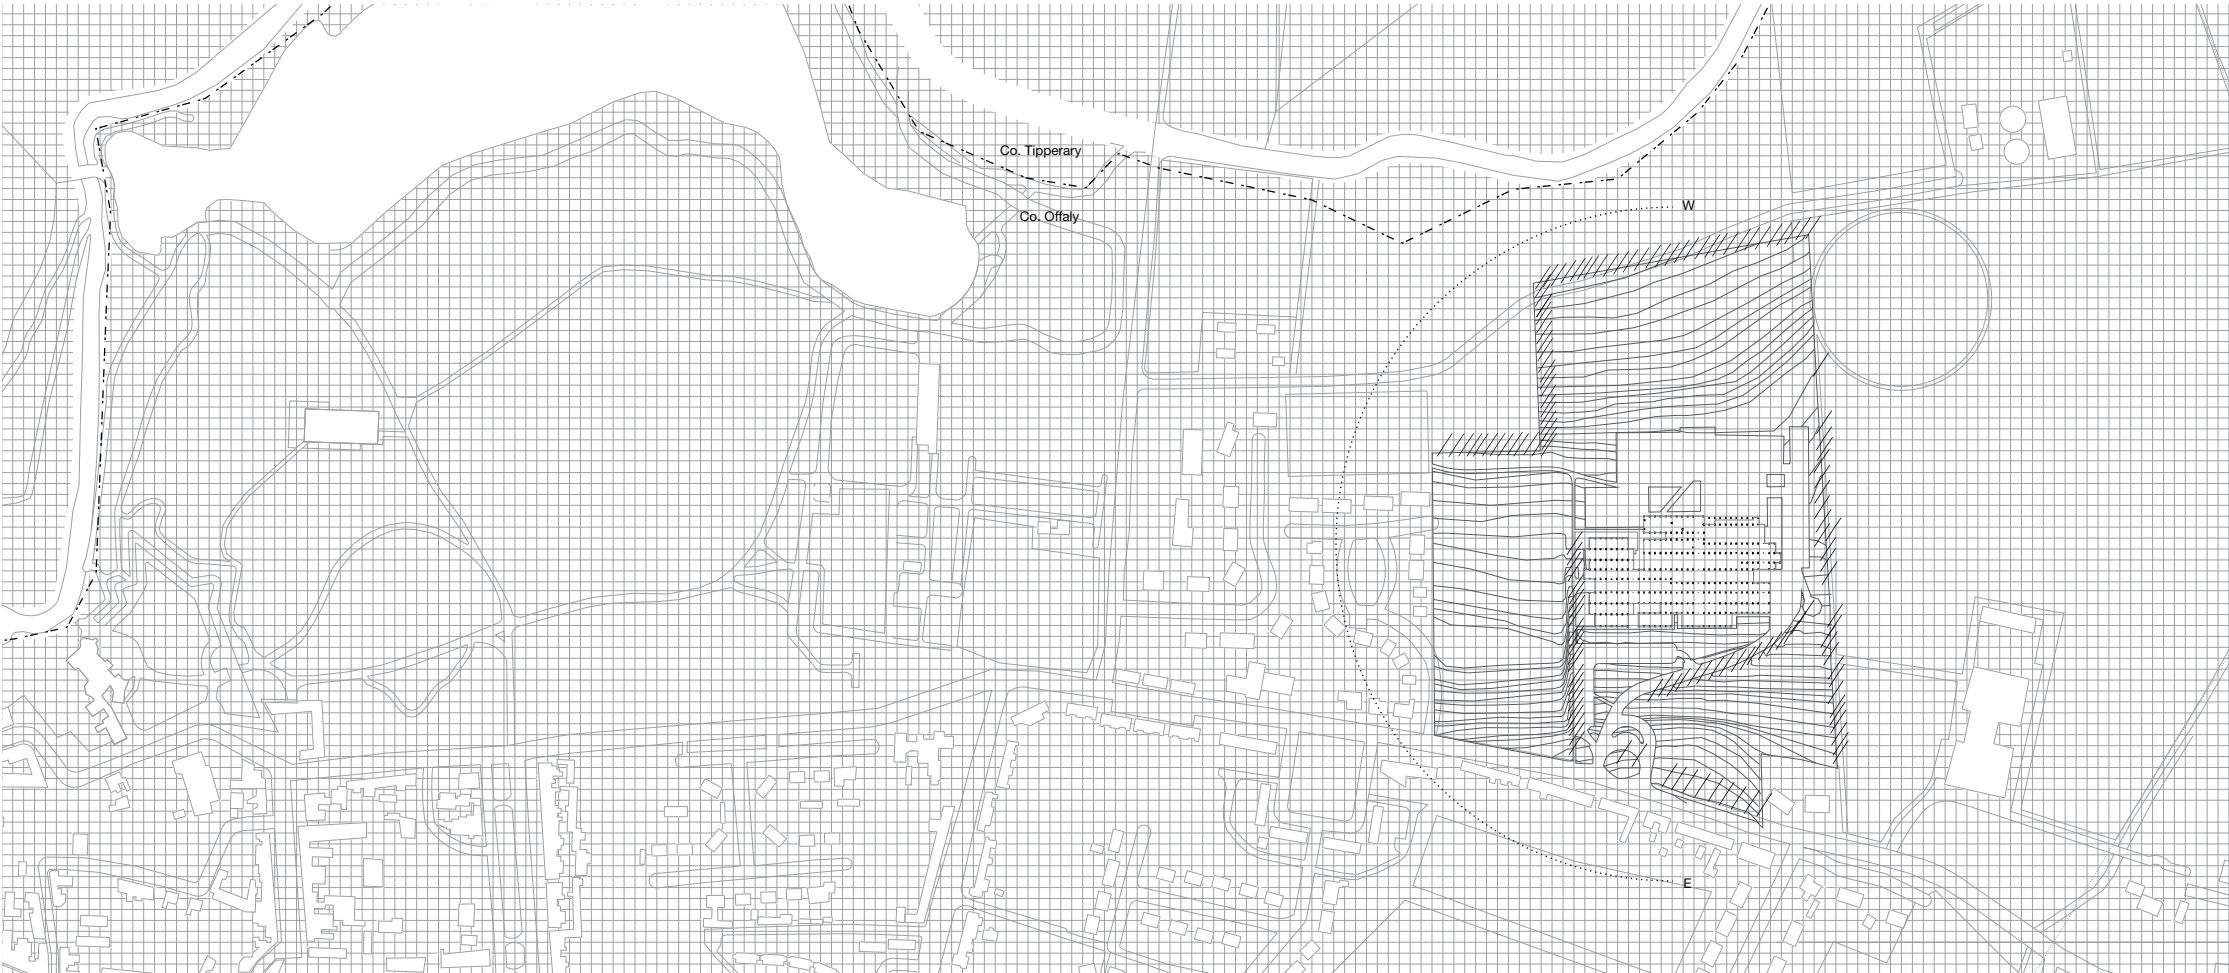
level of significance key

the bog / location / topography / exterior planting / views / orientation

This shearing layer considers the aspects particular to the site and location, the longest lasting aspects of the project. The bog in particular is noted as of exceptional value relative to the school's social role. Though designed for an unspecified site, the location on the outskirts of Birr has been a key to its success.

exceptional
high
moderate
little
intrusive
