Sydney Opera House
Concrete Conservation Project
Final Report Summary

August 2018

Concrete Conservation

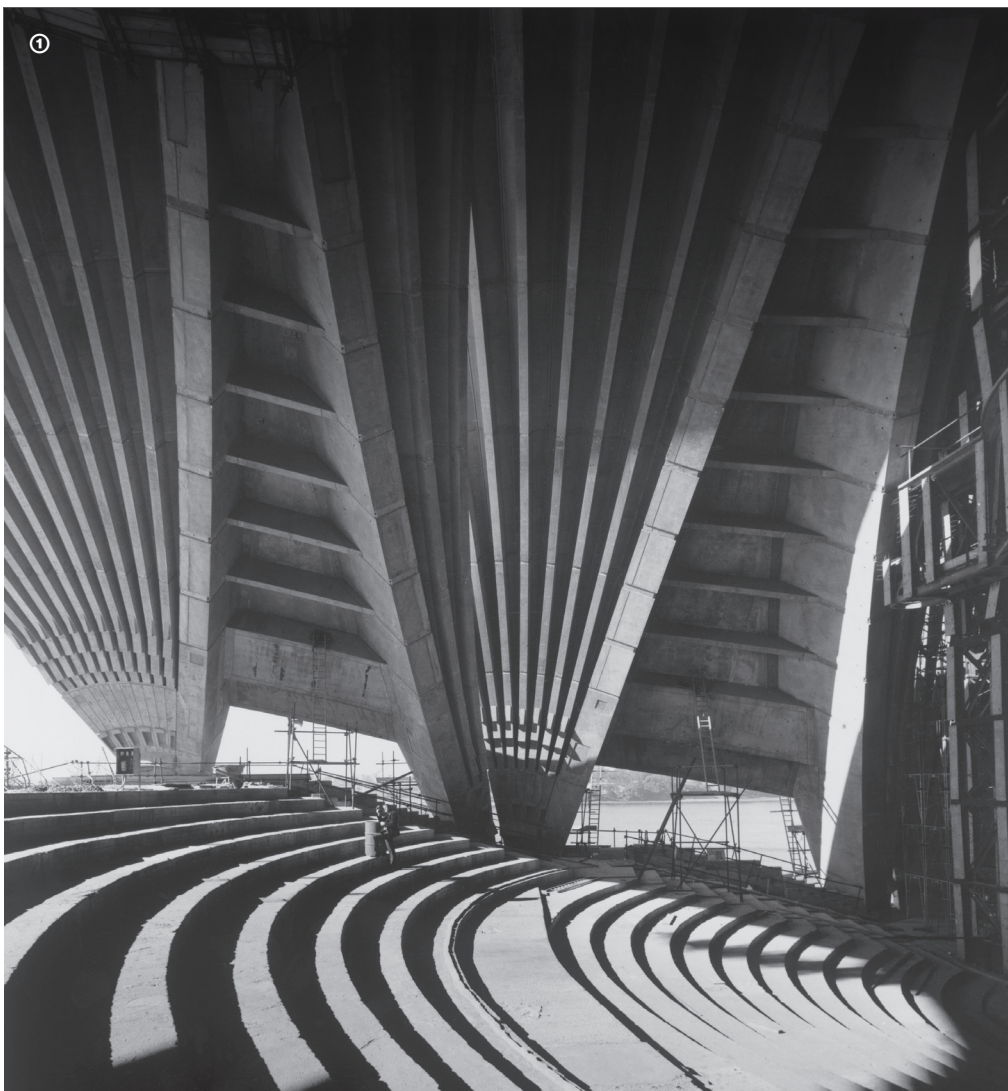
The rib structures were clad in 3,382 chevron-shaped prefabricated concrete tile lids, supporting around a million ceramic tiles. The tile lids have a slight spherical curve. The tile lids are bolted to the rib structure and sealed with epoxy polyurethane sealant. A protective epoxy grout is used between the individual tiles.

- ① Pre-cast rib element
- ② Pre-cast rib sections
- ③ Rib elements tacked to make the sails
- ④ Ribs being cast on site

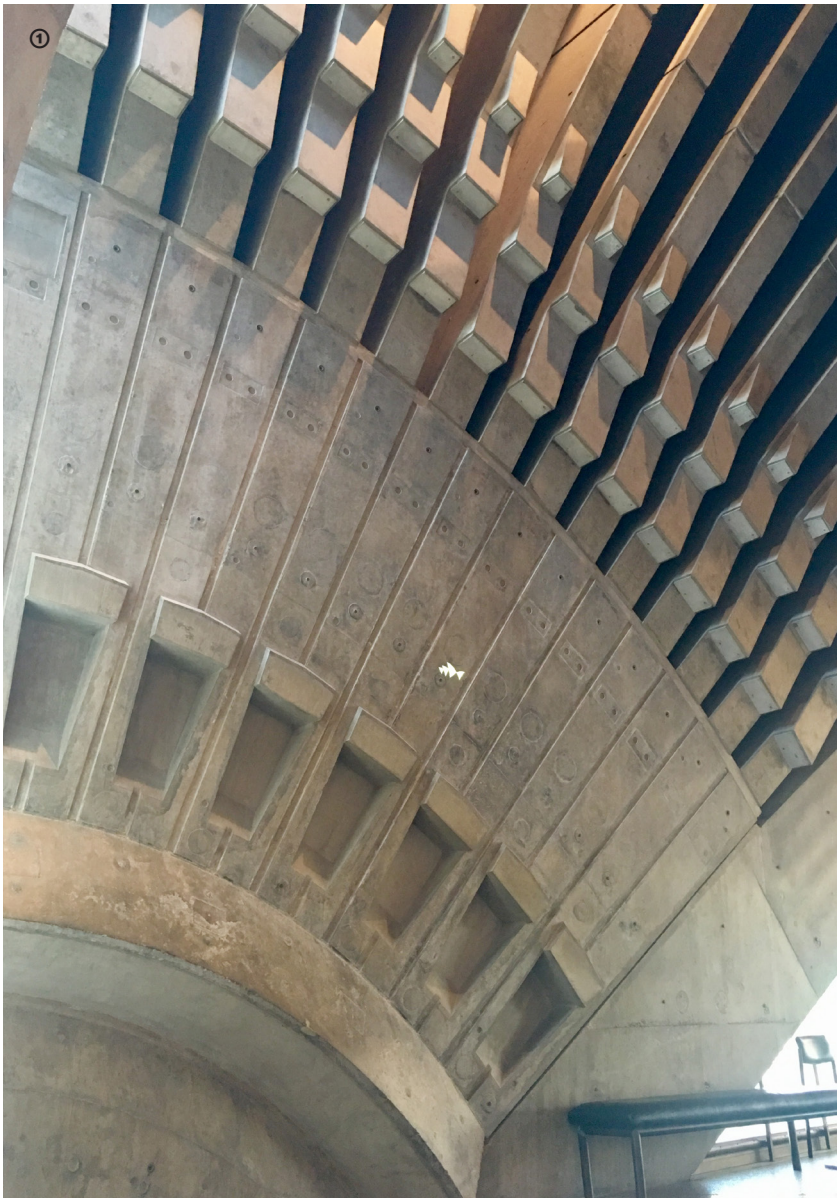
The points from which the sail ribs rise from the podium, and connect to the foundation columns, are known as the Pedestals. The Pedestals are made of reinforced concrete, cast in-situ, and can be seen on the building's exterior below the line of ceramic tiles, and in the interiors of the foyers to the Concert Hall and Joan Sutherland Theatre.

① In-situ concrete pedestal

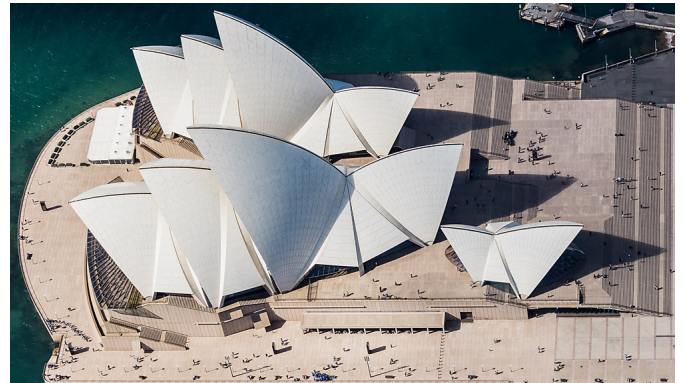
③ Aerial view of Western and Northern Broadwalks

BROADWALK STRUCTURES

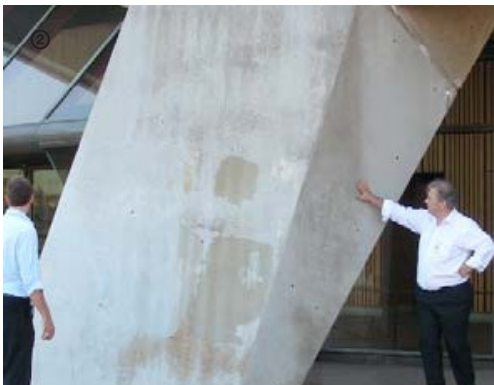
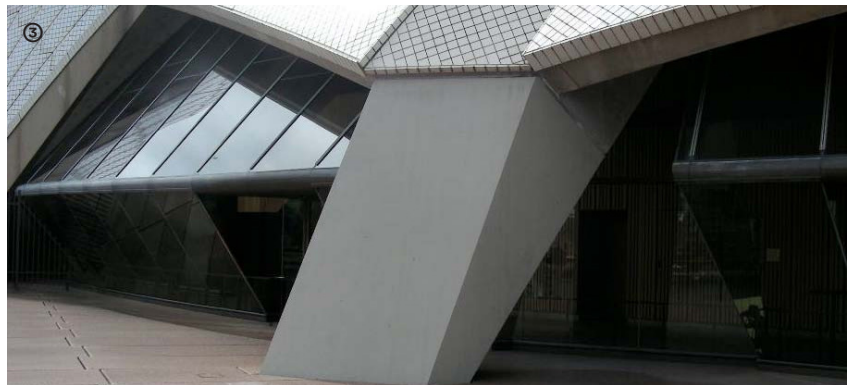
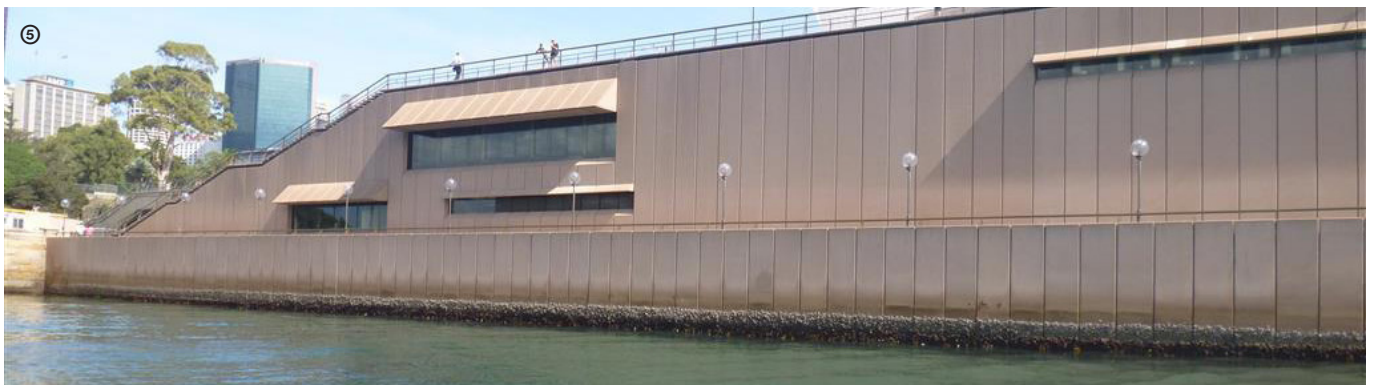
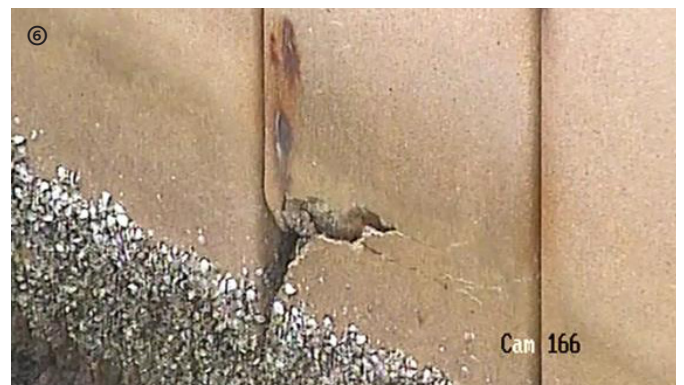
- tap testing tiles
- roof sealant inspections
- concrete cover surveys in the pedestals
- removal of organic growth
- cathodic protection maintenance and monitoring
- monitoring seawall skirting panels and mounting systems
- monitoring of reinforced concrete condition beneath the Broadwalks

- ① Tile-tapping inspection on sails, Concert Hall west elevation
- ② Pedestal - before sacrificial coating
- ③ Pedestal - with sacrificial coating
- ④ Concrete sub-structure under the Western Broadwalk
- ⑤ Seawall skirting panels
- ⑥ Seawall skirting panel deterioration

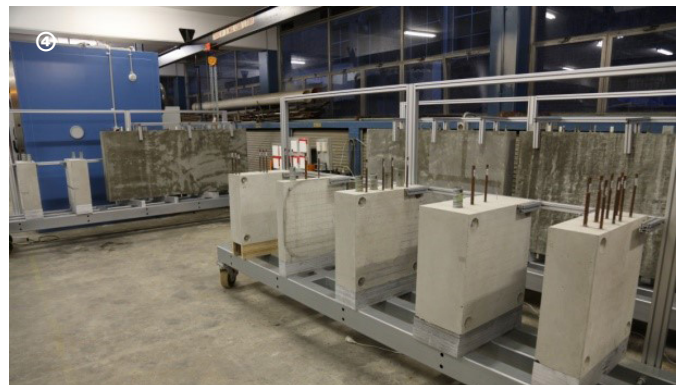
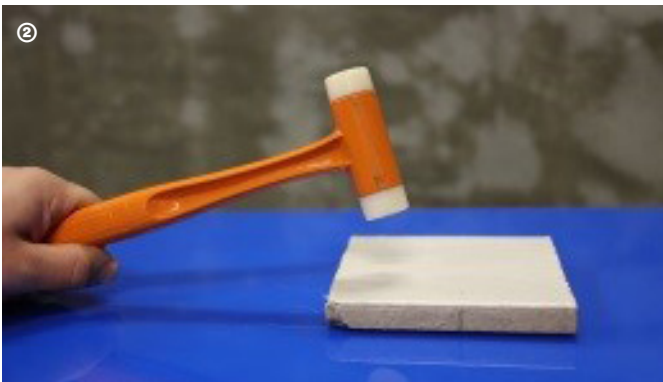
To aid with condition assessment of the tiles, excitation by predefined sound frequencies induced to the tiles was applied using vibration speakers. This technique aimed at reproducing a condition assessment procedure similar to tile tapping, without the need for the hammer. The identification and monitoring of different sources of environmental noise, such as passing harbour vessels, that can produce vibration in the structure is being considered for possible future study.

- ① Students involved in concrete cover readings
- ② Hammer used by Arup for tapping testing of tiles
- ③ Application of vibration speakers to aid condition assessment of the tiles
- ④ Benchmarking samples in the lab
- ⑤ Students involved in on-site NDT ultrasonic testing

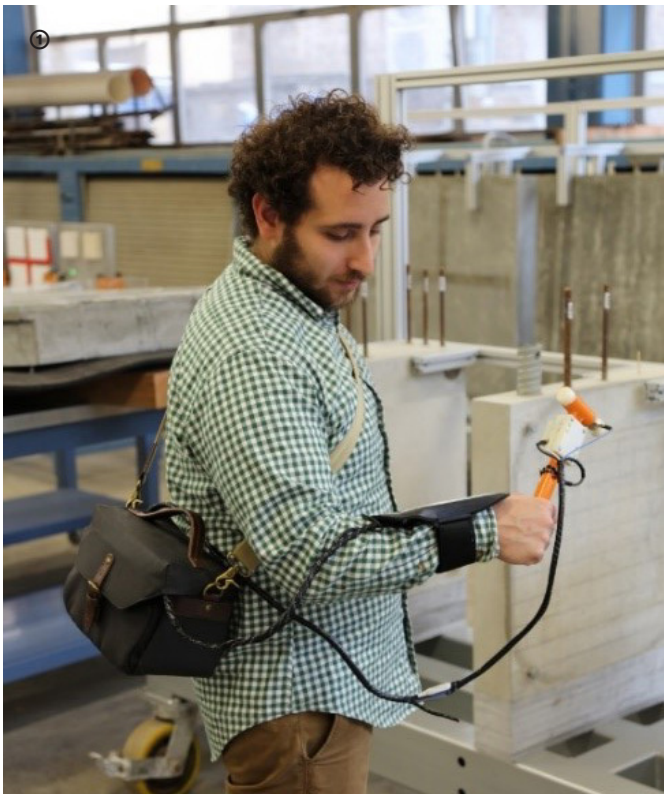
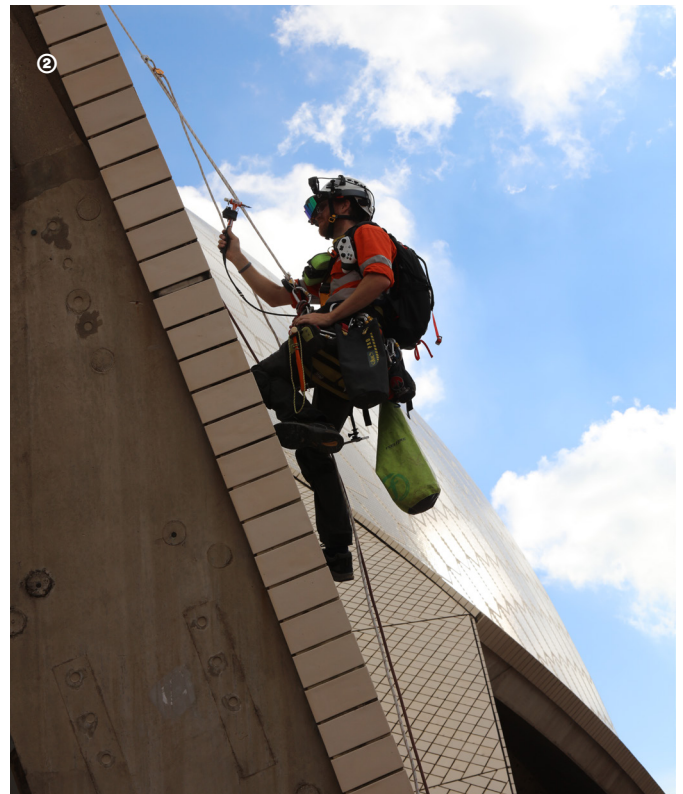
Different moments during the tile tap testing taken place in selected areas of the sails to trial the methodology are shown below.

- ① Initial prototype of the portable device developed as part of the project
- ② Operator performing tap testing of the tiles
- ③ Operator during tile tap testing using the proposed approach
- ④ View of operator during tap testing of the tiles
- ⑤ View of operator through the HoloLens during tap testing of the tiles

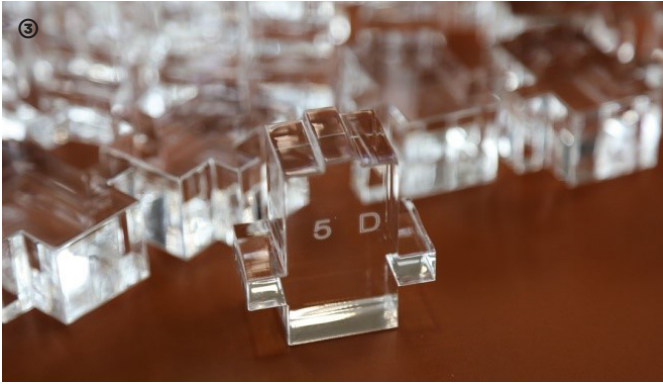
① Tile lid R6

3D printing was considered for the formwork, but the team soon abandoned this idea due to the costs involved in achieving high precision 3D printed models. Other options considered, but not pursued beyond preliminary experiments included waffle arrangements of plywood formwork, and deforming a sheet of any material (such as metal and timber) to produce the required 3D shape.

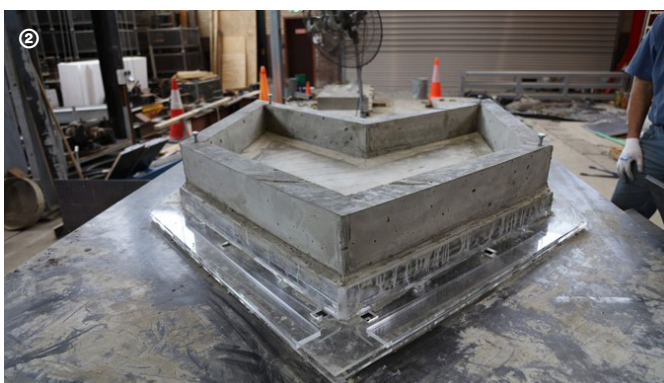
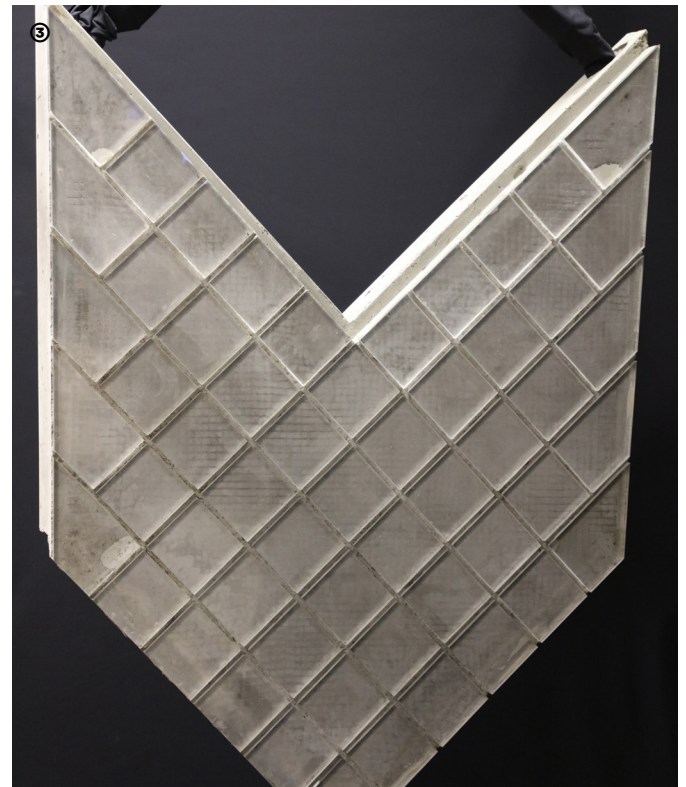
As had been done during construction of the Opera House wax was placed between tiles in the model to prevent leakage of water or ferro-cement during the casting procedure.

- ① Overview of the tile lid prototype after casting
- ② Tile lid prototype after removal of the side formwork
- ③ Tile lid prototype after completion
- ④ Plan showing pedestals of interest in first part of pedestal investigation

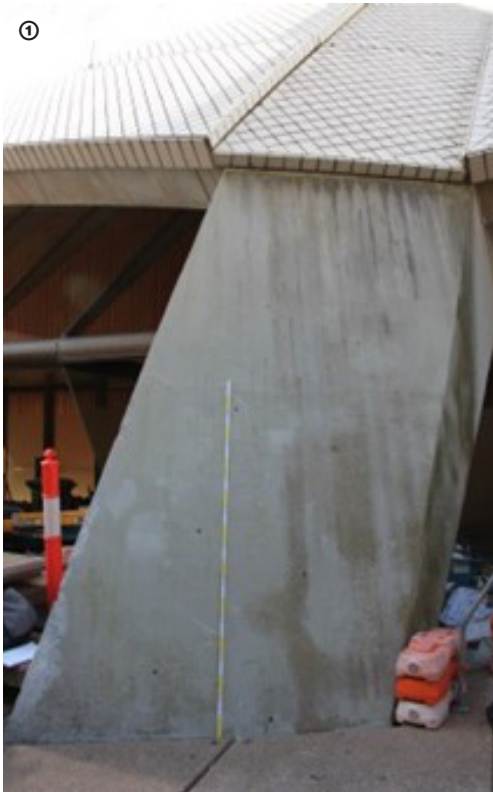
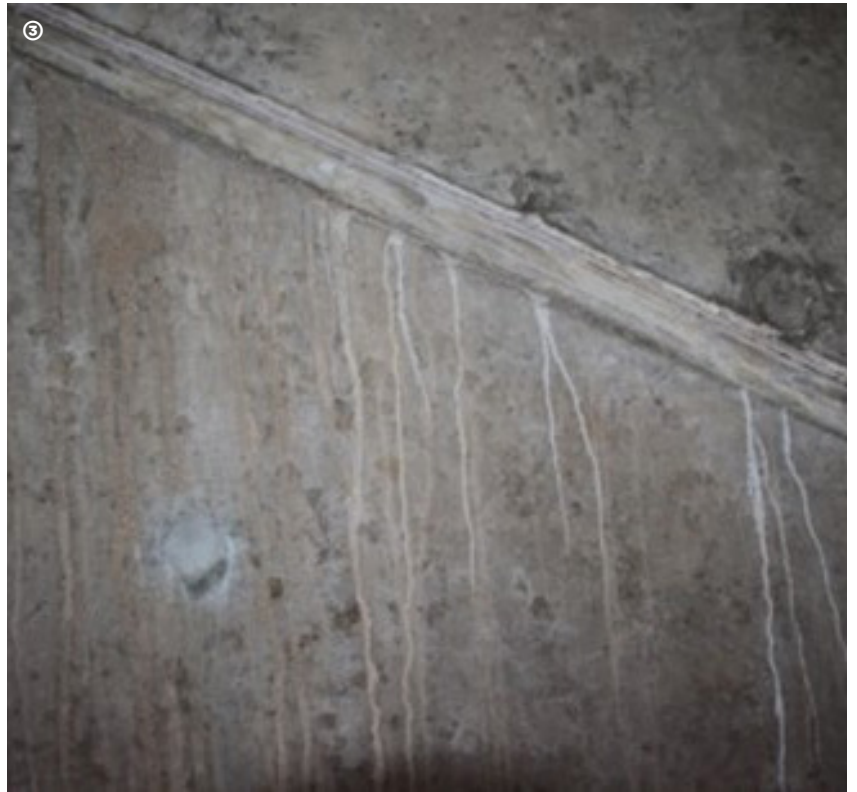
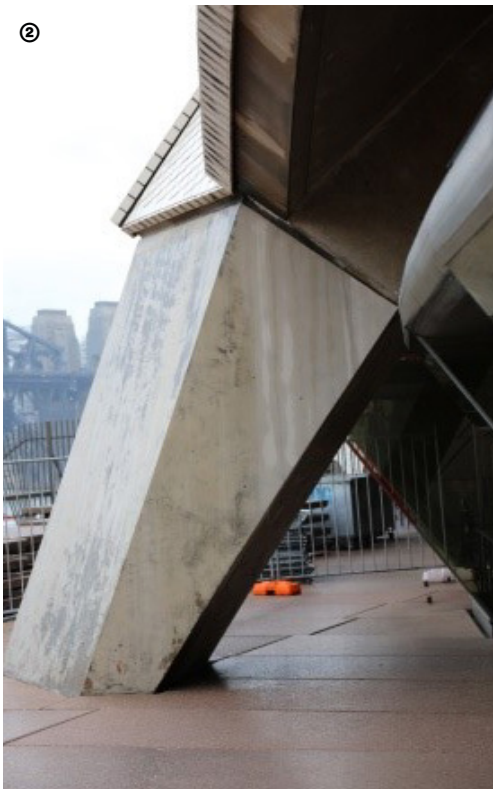
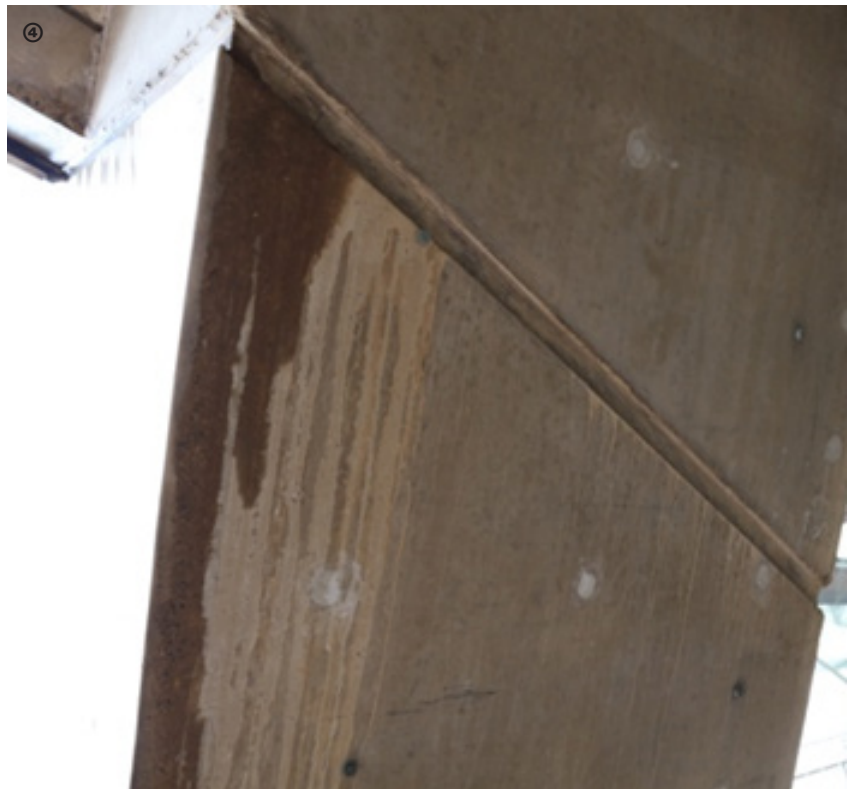
The main focus on the pedestal work in the project was devoted to reducing the amount of rain running on the pedestals. The project team experimented with the installation of prototype water deviators.

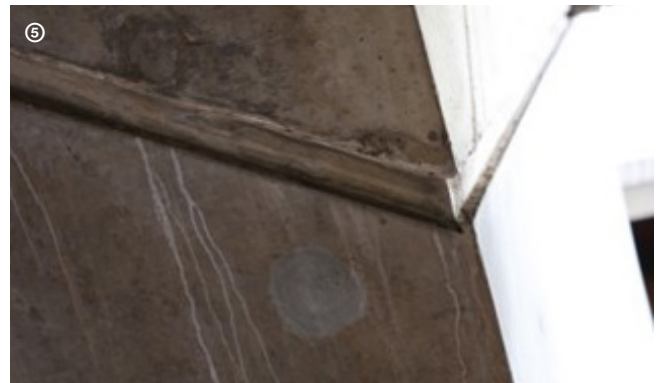
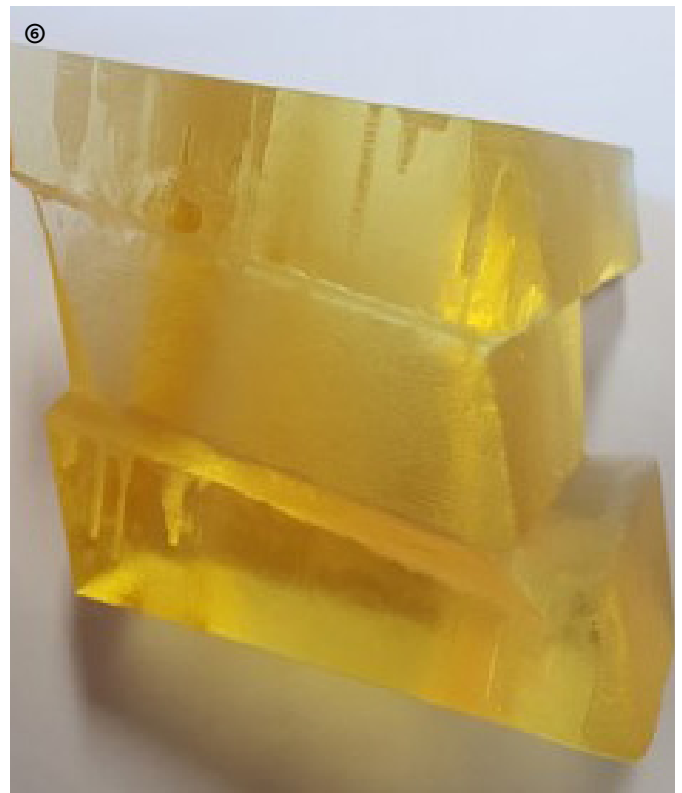
A set of prototype water deviators was placed at the corner between the back and side faces of the pedestals at the level of the re-entrant joint. A 3D model of the pedestal's corner detail was created in the University of Sydney laboratory to evaluate the effectiveness of different water deviators without interfering with the Opera House structure.

- ① ② Degradation of pedestals over front and side surfaces
- ③ ④ Degradation of pedestals over back surfaces after rain
- ⑤ Selected corner part of pedestal reproduced with 3D printing
- ⑥ 3D printed detail at corner between back and side faces

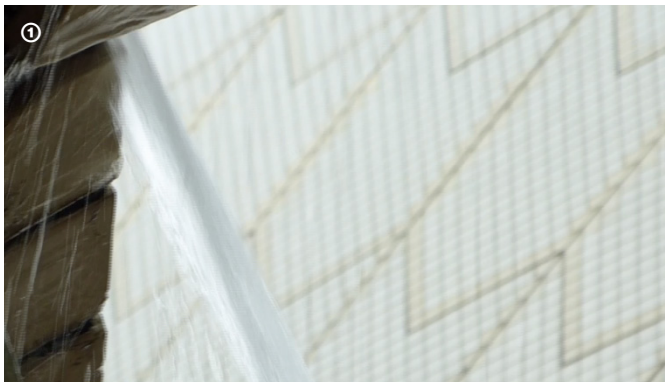
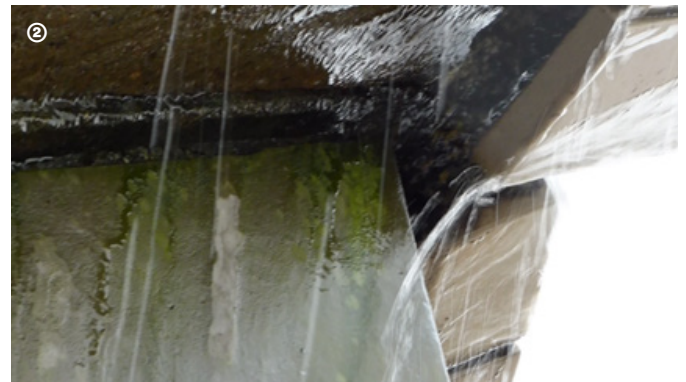
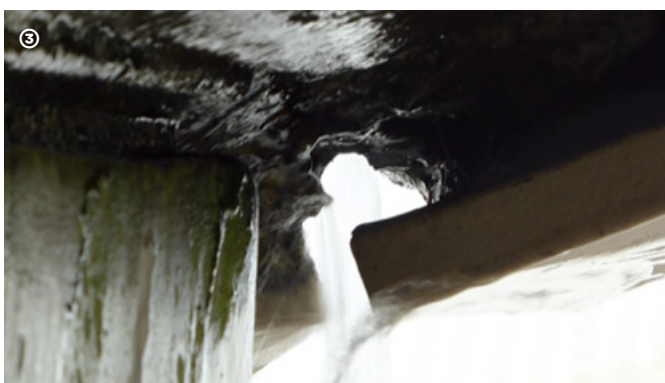
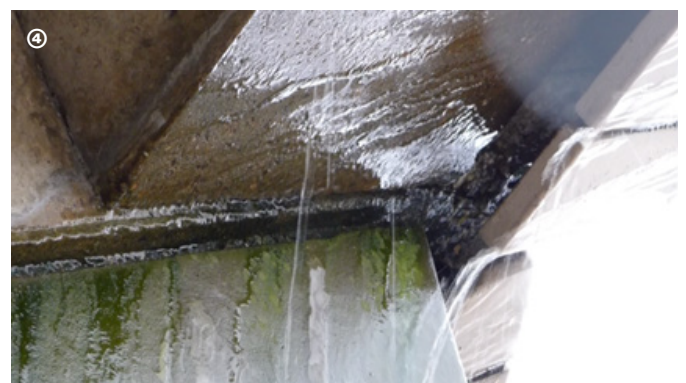
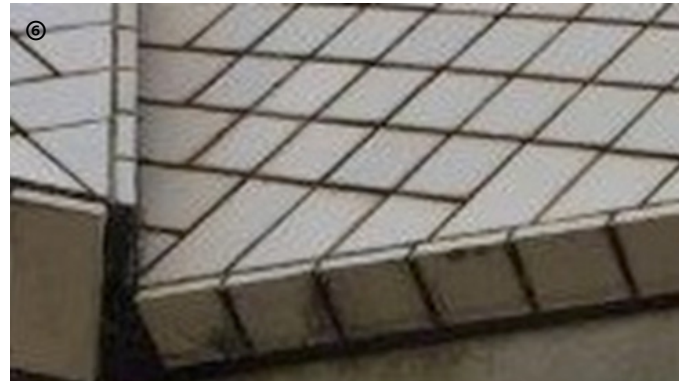
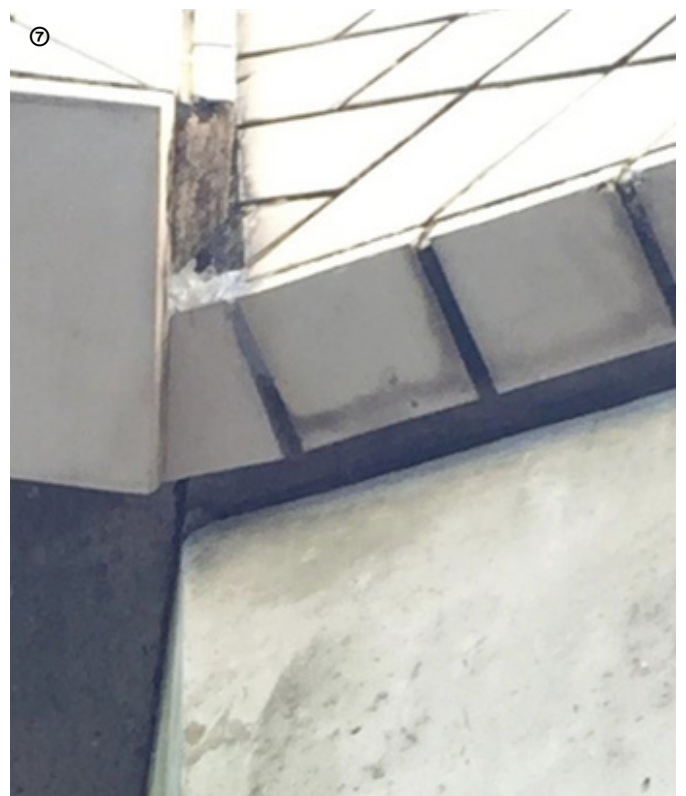
- ① - ④ Rain flow through gap between edge tiles
- ⑤ Current water flow during heavy rain
- ⑥ Before trial
- ⑦ After installation of tile component to close gap between the edge tiles

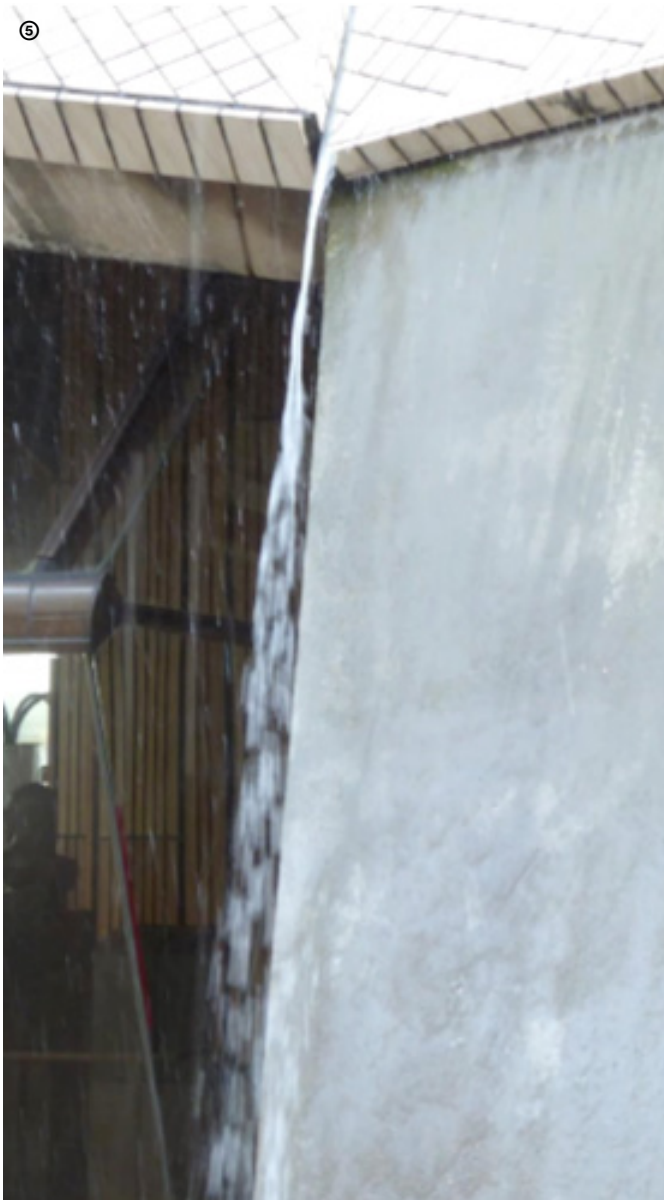
CLOSING THE GAP IN EDGE TILES
 Trial detail for the closure of the gap between the edge tiles.

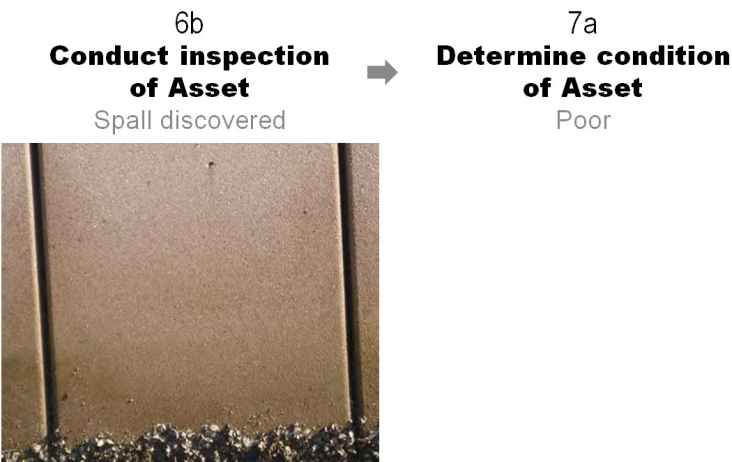
The asset skirting panel 90N is visually inspected by a trained Sydney Opera House inspector. The inspector takes a mobile device during the inspection. It contains photographic references that indicate types and severities of faults likely to be encountered for each asset and surface type.

The inspector determines that skirting panel 90N shows signs of spall.

Reference photos are comparable to a severe case of spall, therefore it is determined that the asset is in poor condition.
