# Conservation of Ancient Sites on the Silk Road

Proceedings of an International Conference on  
the Conservation of Grotto Sites

Conference organized by the Getty Conservation  
Institute, the Dunhuang Academy, and the Chinese  
National Institute of Cultural Property

Mogao Grottoes, Dunhuang  
The People's Republic of China  
3–8 October 1993

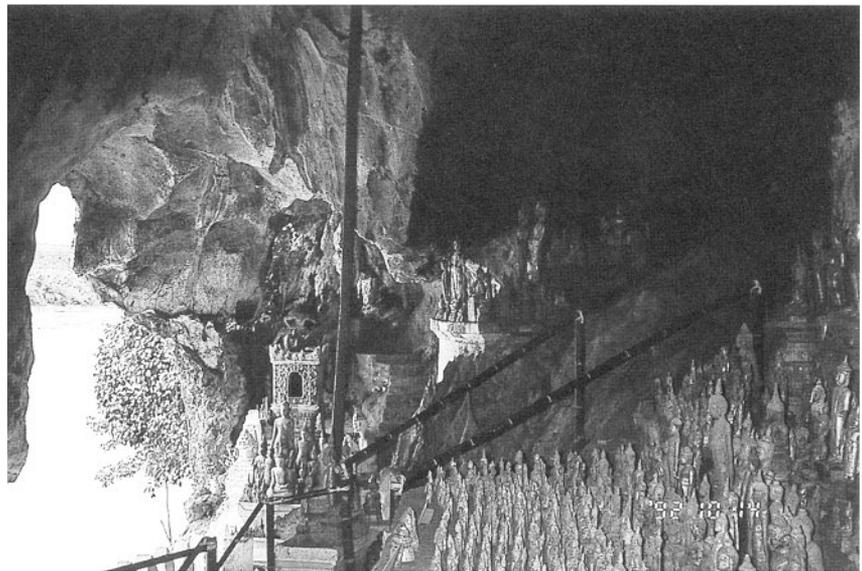
*Figure 3*  
Sculptural group, showing the size and number of sculptures as seen from the interior of the lower cave.

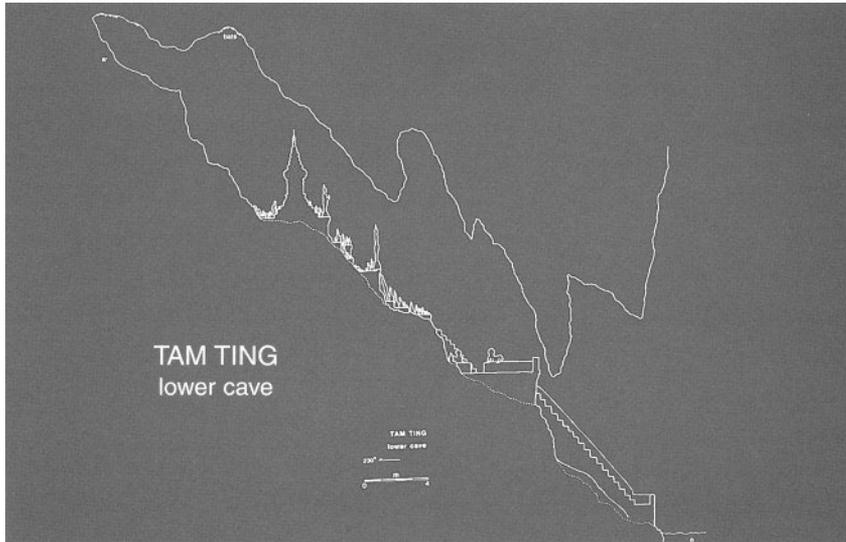
Figure 10  
Approximate cross section of the lower cave.

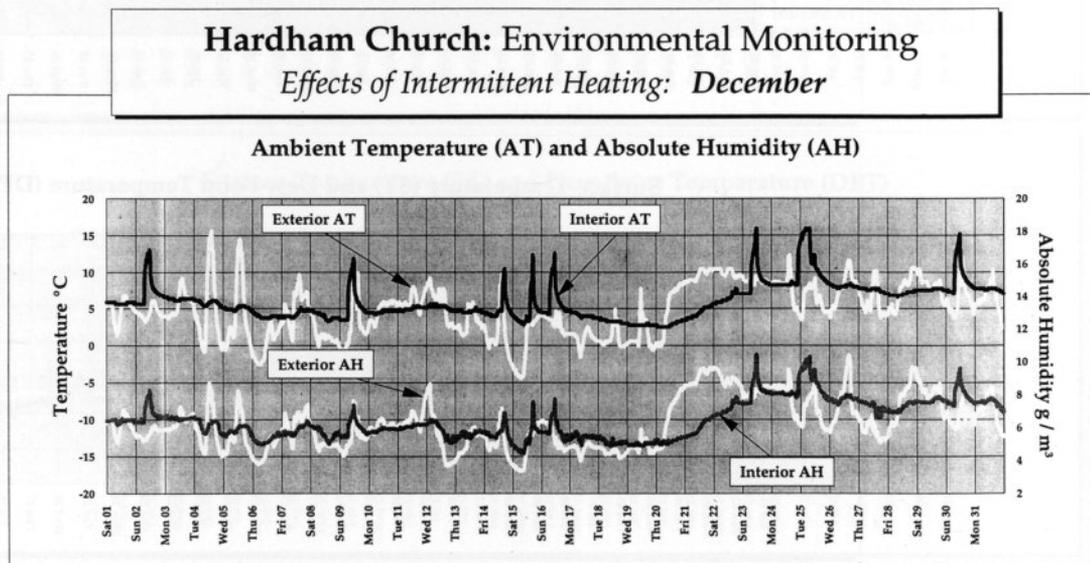
Figure 10  
Condensation caused by heating in December.<sup>8</sup>

salts, which then recrystallize when the relative humidity falls (Fig. 10). What, then, should be proposed? Reduce the ventilation and change the heating—two separate variables that contribute to the overall environmental conditions.

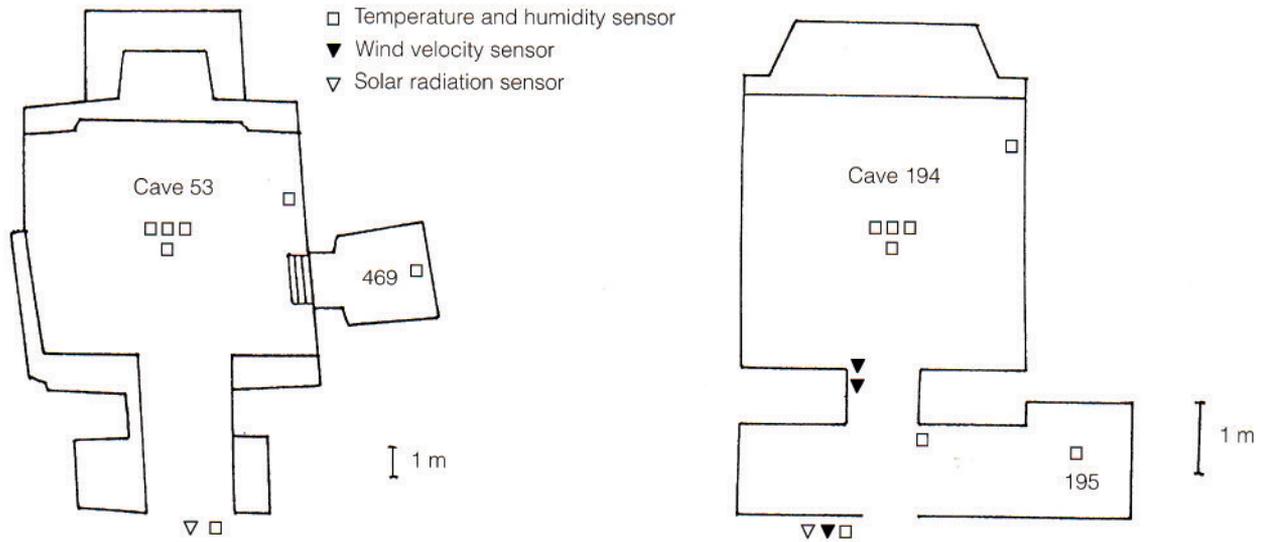
Figure 1  
Plan of Caves 53 and 194.

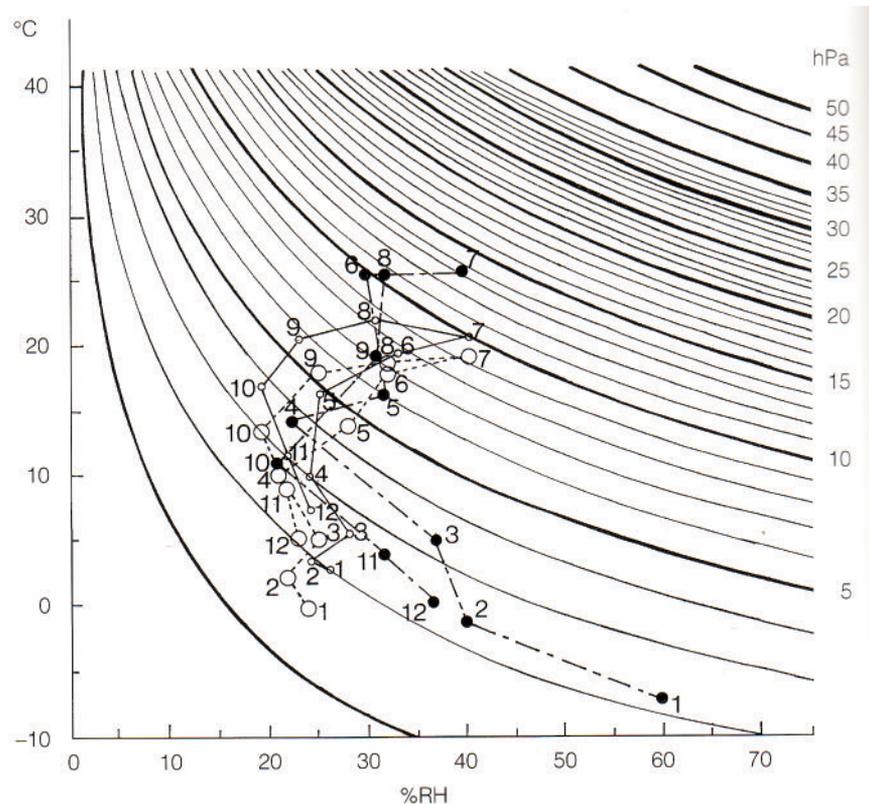
Figure 3  
 Temperature and humidity measurements taken in the holes in the ceiling of Cave 194 and the floor of Cave 53.

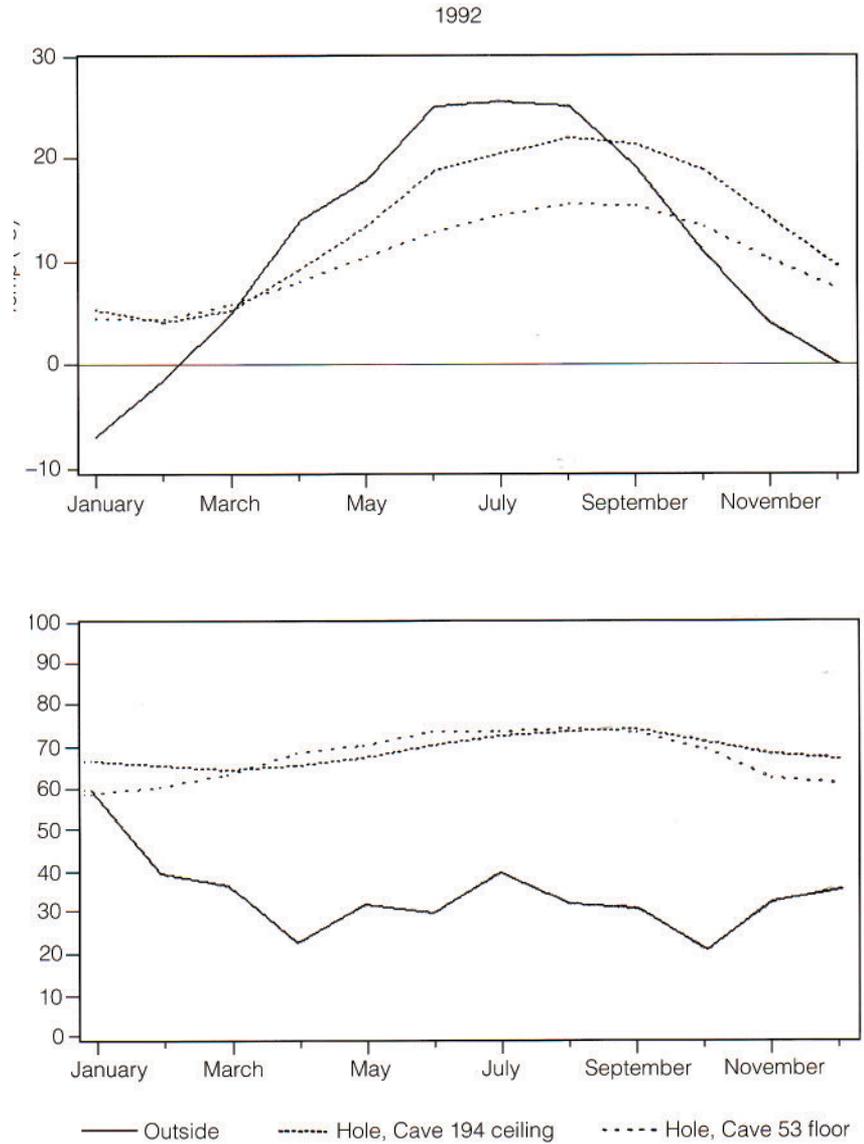
Figure 4  
 Absolute humidity measurements taken in the holes.

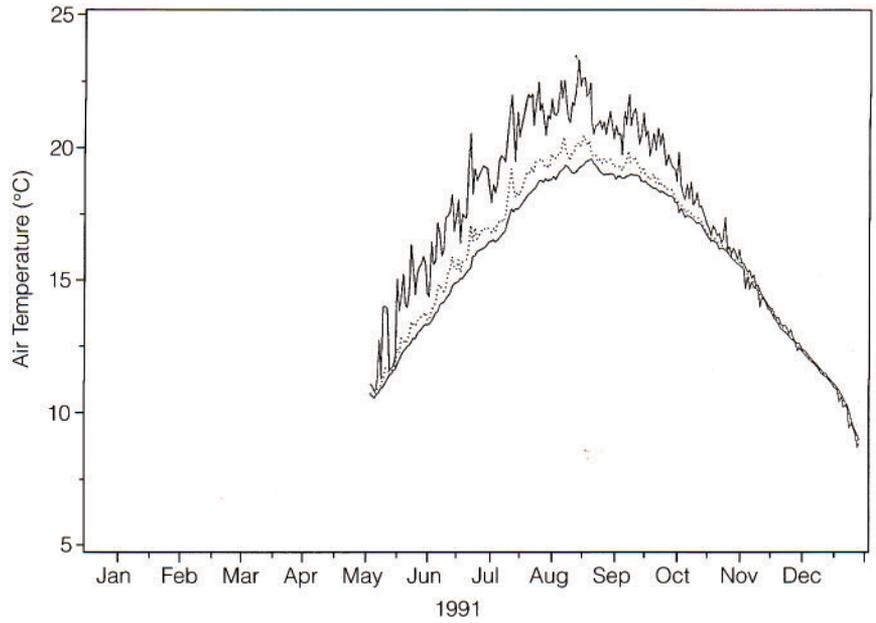
Figure 7  
Daily changes of air temperature in Cave 323 in August 1991.

recorded in the visited cave in August 1991. Two peaks were recorded daily, and larger peaks were often recorded in the afternoon, although more visitors were logged in the mornings, indicating the strong effect of warmer, outside air. By the next morning in summer months, the temperature recovered to its natural level. Outside air temperature was always higher than the temperature in the cave during visitation hours. This resulted in increased air temperature in the cave whenever the entry door was opened.

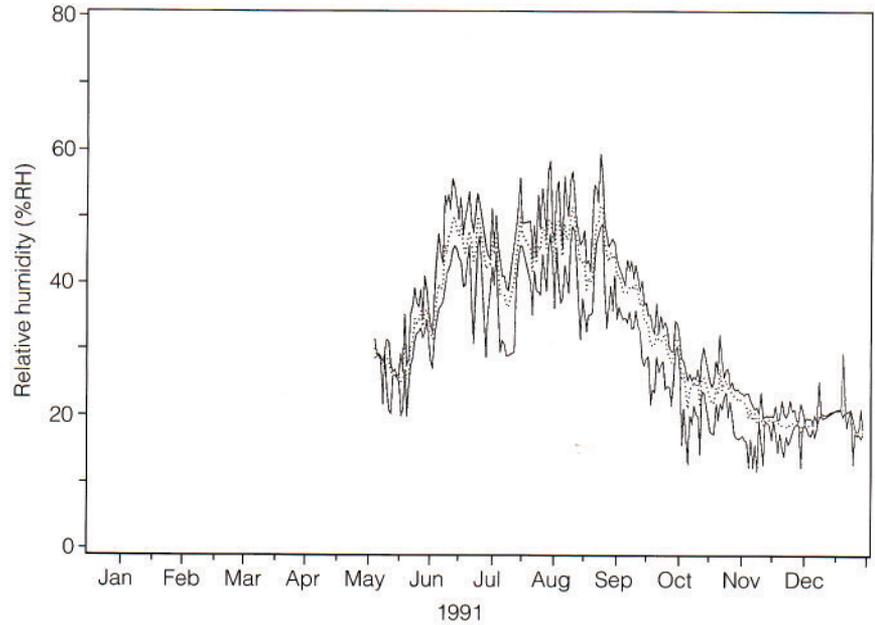
Figure 9  
Air temperature and relative humidity changes in Caves 323 and 335 in August 1991.

value, as seen in Figure 9. Negative spikes were always observed when the relative humidity in the cave was dropping for periods longer than a day; positive spikes were observed whenever the relative humidity was rising, which was due to changes of the moisture content of the outside air. The degree of influence of the outside climate on the microenvironment of the cave increased as the number of entries increased. The cause of these changes is due not only to the moisture released by the visitors, but also to the frequent opening and closing of the cave door and entry of visitors, which forced air exchange with the outside air.

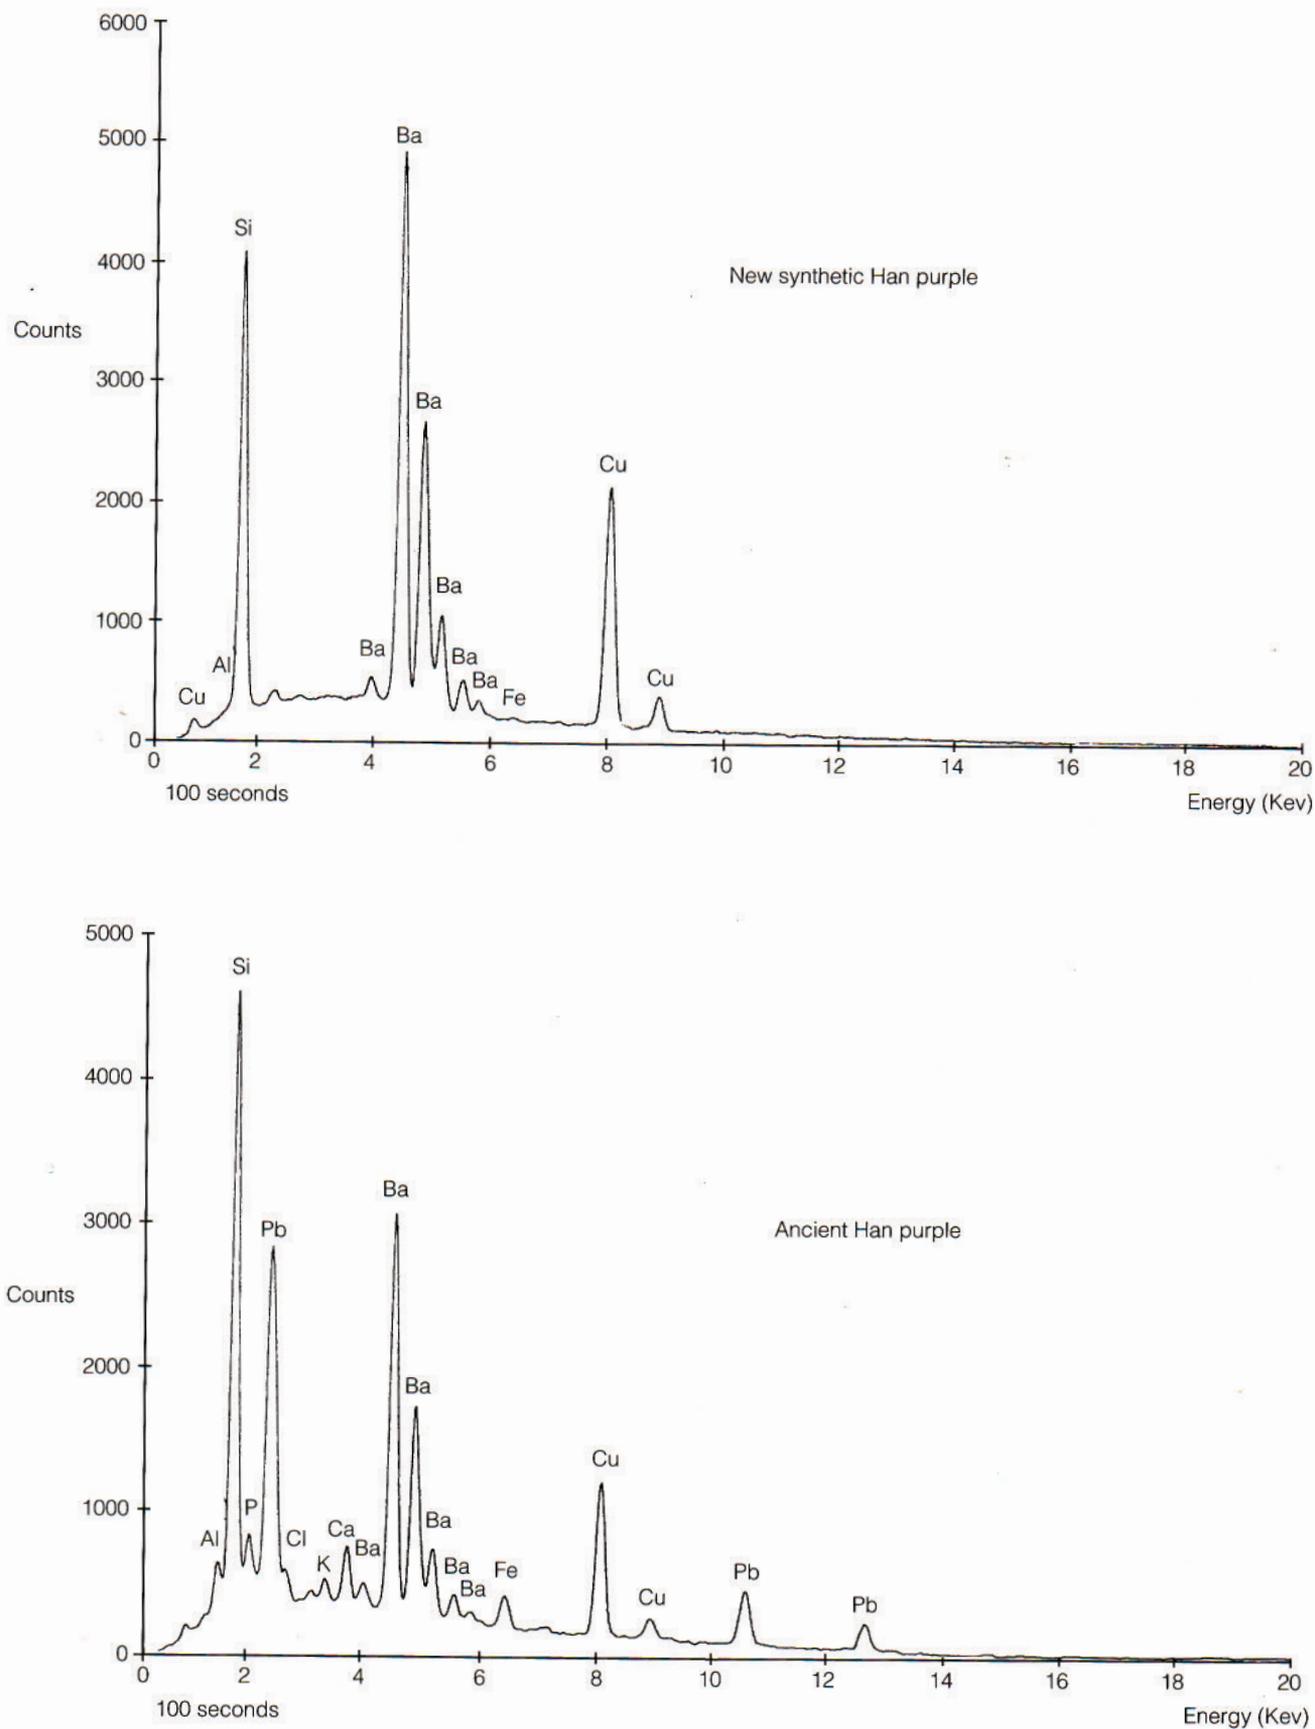
Figure 7  
Energy-dispersive X-ray analysis curves of  
synthetic and ancient Han purple.
