Giancarlo De Carlo “Collegi” in Urbino

Conservation Plan

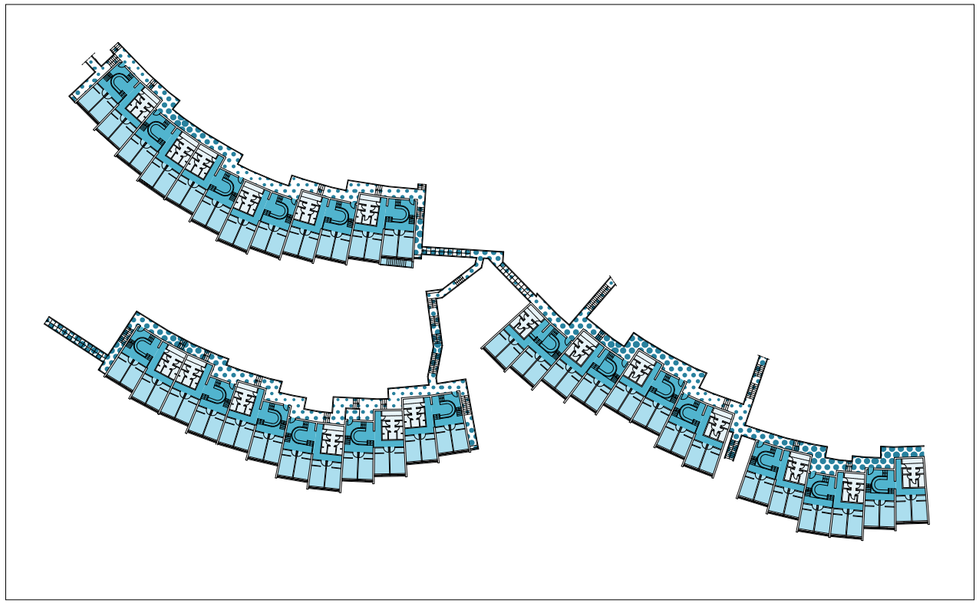
- Seepage of water form the roofs and terraces.
- A significant number of doors and windows has been changed.

The roof of the cells containing the bedrooms of the "Serpentine".

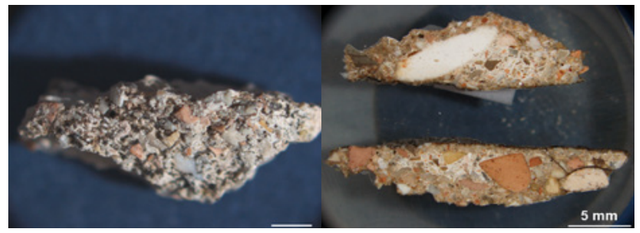
Figure 1. U13 comes from an external parapet in "Collegio del Colle"; Left: stereomicroscope microstructure observations. Right observation of the polished cross section.

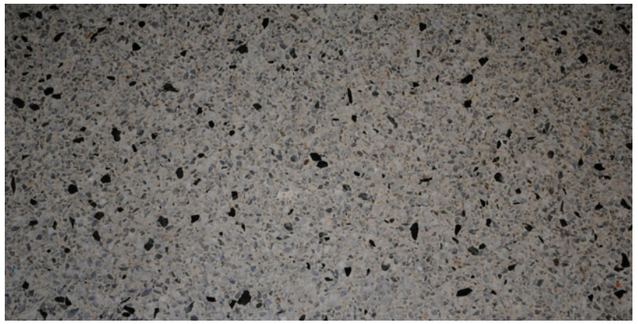
Fig.3

Figure 3. Sample U6: Polished Cross Section. Microscopic observation.

"Colle" service building. Flooring (Sample U6).

This result allows to suppose that as to this group of samples a common calcareous sand was used in the mix design of the mortar; on the contrary in samples U1, U2, U10, a silicatic aggregate with a rounded shape, has been highlighted; in this second case we are allowed to suppose that a quartz sand was specifically selected (Figure 5b). The terrazzo mix constituting the flooring in the "Colle" reception hall is an exception (Sample U6). In fact in this case the aggregate is composed by marble fragments quite big in size (Figure 3).

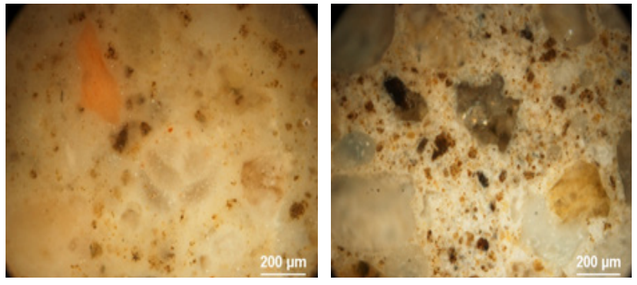
(4a) (4b)

Figure 4a. Polished Cross Section Microscopic Observation of Sample U5. It comes from a skylight in the "Collegio del Colle". The background colour is white.

Figure 4b. Polished Cross Section Microscopic Observation of Sample U1. It comes from an outdoor terrace parapet in the "Collegio del Colle". The background colour is greyish.

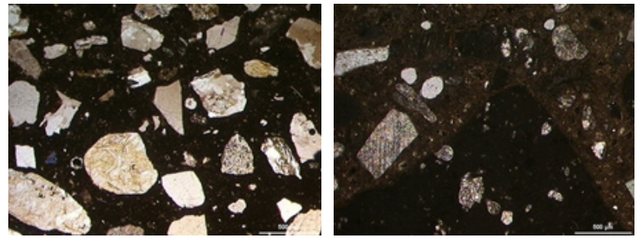
(5a) (5b)

The aggregate compositional analyses results corroborated the classification in two groups; in fact two distinct groups are proposed in function of the presence of a calcite ($CaCO_3$) component in the group formed by U3, U5, U7, U8, U9, U12, U13, U18 e U19 samples. The calcite fragments are well visible in the thin section microscopic observations (Figure 5a).

Figure 5a. Sample U1. Thin section observed at polarised light microscope (Nicol //): the aggregate is composed by quartz crystals and metamorphic rocks fragments with angular shape; the binder has a uniform microstructure with circular pores.

Figure 5b. Sample U3. Thin section observed at polarised light microscope (Nicol //): the aggregate is composed by limestone fragments with microfossils, with rounded shape (lower part) and by calcite crystals with angular shape; the binder is micro-crystalline with a not uniform structure and irregular pores.

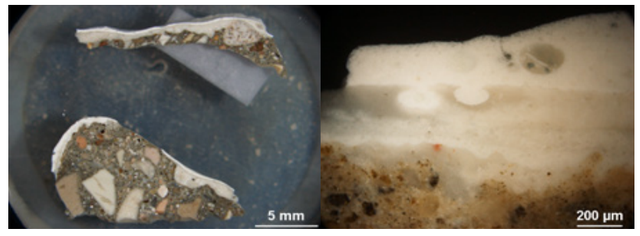
Figure 6. Two microscopic observation at different magnification showing microstructure of Sample U7 coming from a plaster in an interior in the "Collegio del Colle": to the right the sequence of several white finishes is showed.

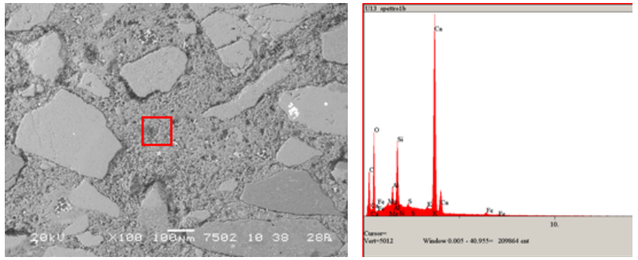
Analyses carried out at scanning electron microscope with energy dispersive microprobe, confirm what has been observed in optical microscopy. In particular in each of the binder fraction examined, the characteristic ratio in between calcium and sili-

con peaks shows the presence of hydraulic properties (Figure 7). Moreover the observations at high magnifications allows to observe the presence of organic substances used in the mix, in the samples U2 and U7 (as regards the white finishes), U13 and U18. In this latter case the organic substance is concentrated close to the outer surface.

Fig. 7. SEM Observation in BSD mode in low vacuum (28 Pa) of the sample and EDS Spectra corresponding to red frame in the binder matrix. It is confirmed the hydraulic properties by the ratio Ca/Si.

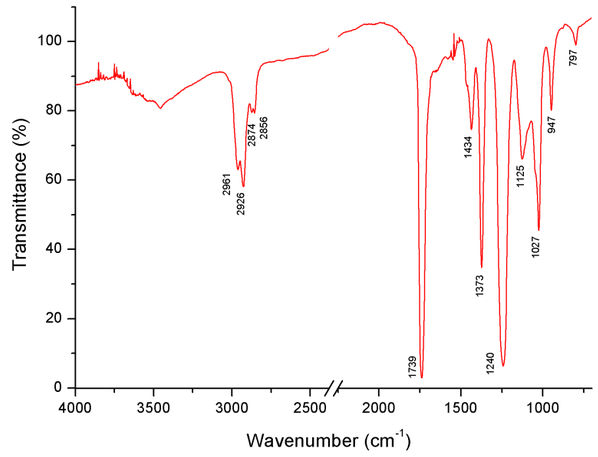
Figure 8. FTIR Spectra recorded in transmission of the sample U7. The spectrum has been obtained from a micro-particle coming from the near-surface region. Absorption peaks display the pattern of a co-polymer ethylene-vinyl acetate.

FTIR spectroscopy allowed to study in depth the composition of polymer based materials, when present; it is the case of Sample U7 in which the white finishes is bound with the aid of a synthetic resin. Observing the absorption pattern of the main peaks, it is possible to identify a copolymer ethylene vinyl-acetate (Figure 8). This class of resins is very common in paint industry, especially for building maintenance. In samples U9 and U17 also it was possible to identify resins classified in the group of epoxy, based on epichlorohydrin and bis-phenol A.

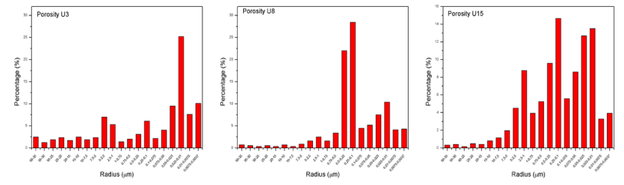
Porosity ranges in between 8,22% (sample U1) and 25,50% (sample U13), with an average pore radius ranging from 0,01 (sample U9) and 0,30 (sample U7) (Table 2). The pores size distribution is unimodal, bimodal and trimodal (Figure 9).

Figure 9. Some examples of different porosity distribution: bimodal in samples U3 and U8; trimodal in samples U15.

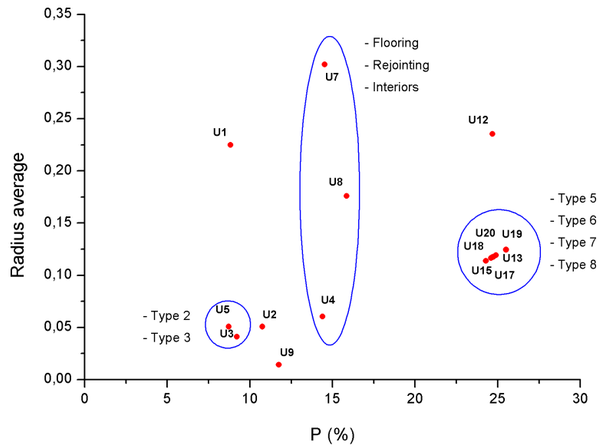
Figure 10. Classification of the samples studied in function of their porosimetric characteristics.

A comparison among porosimetric features, summarised in the diagram in Figure 10, allows to relate total pore amount (in percentage) with average pore radius. A further classification of the examined samples is then highlighted. This corroborate the classes already put in evidence with the other techniques. In fact is well evident that sample U1 is different from all the rest of the samples, while samples U13, U15, U17, U18, U19, U20 are characterised by very similar micro-structural features then constituting an homogeneous group. Another possible group is formed with U3 and U5 samples only.

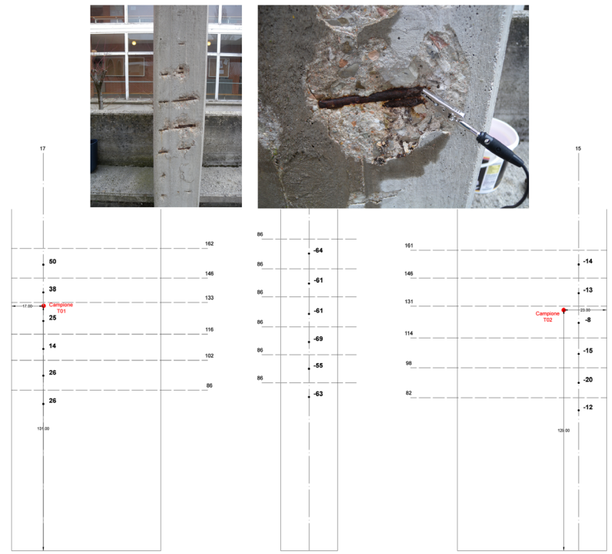
CAMPIONE C01 - COPRIFERRO

CAMPIONE C01 - MISURE POTENZIALE
parapetto spessore 10 cm h.85 cm

frontale pilastro
spessore 30,5 cm

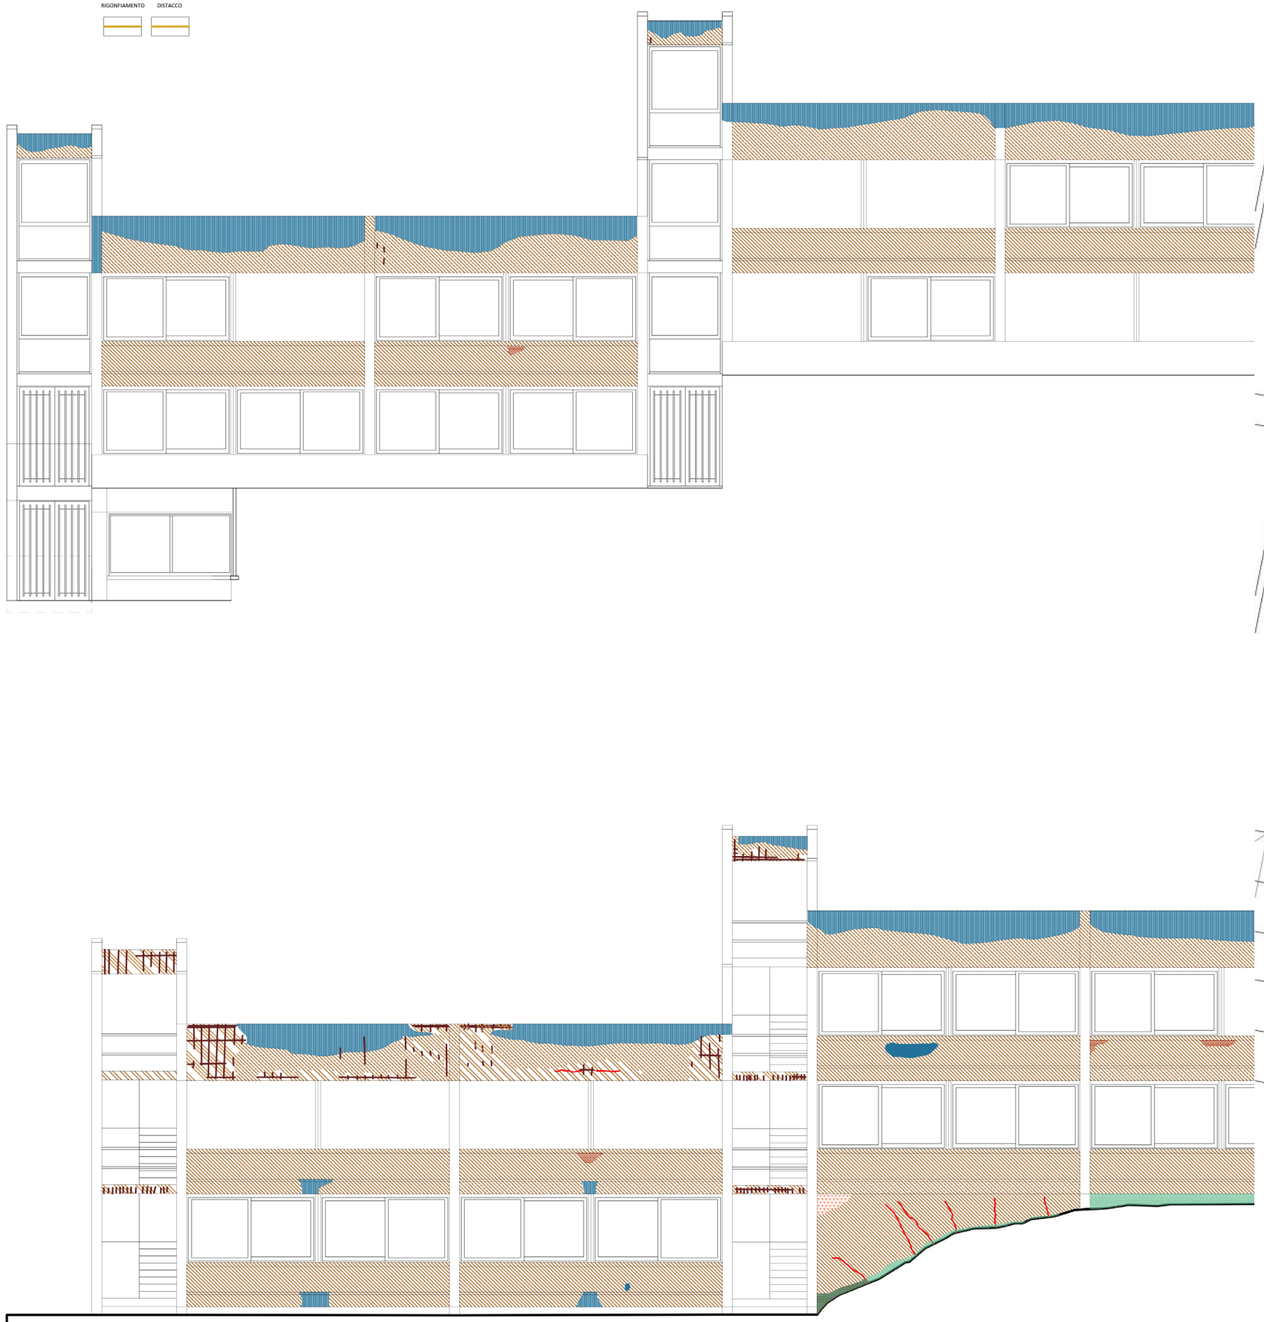
"Aquilone" residences. State of conservation of the façade.

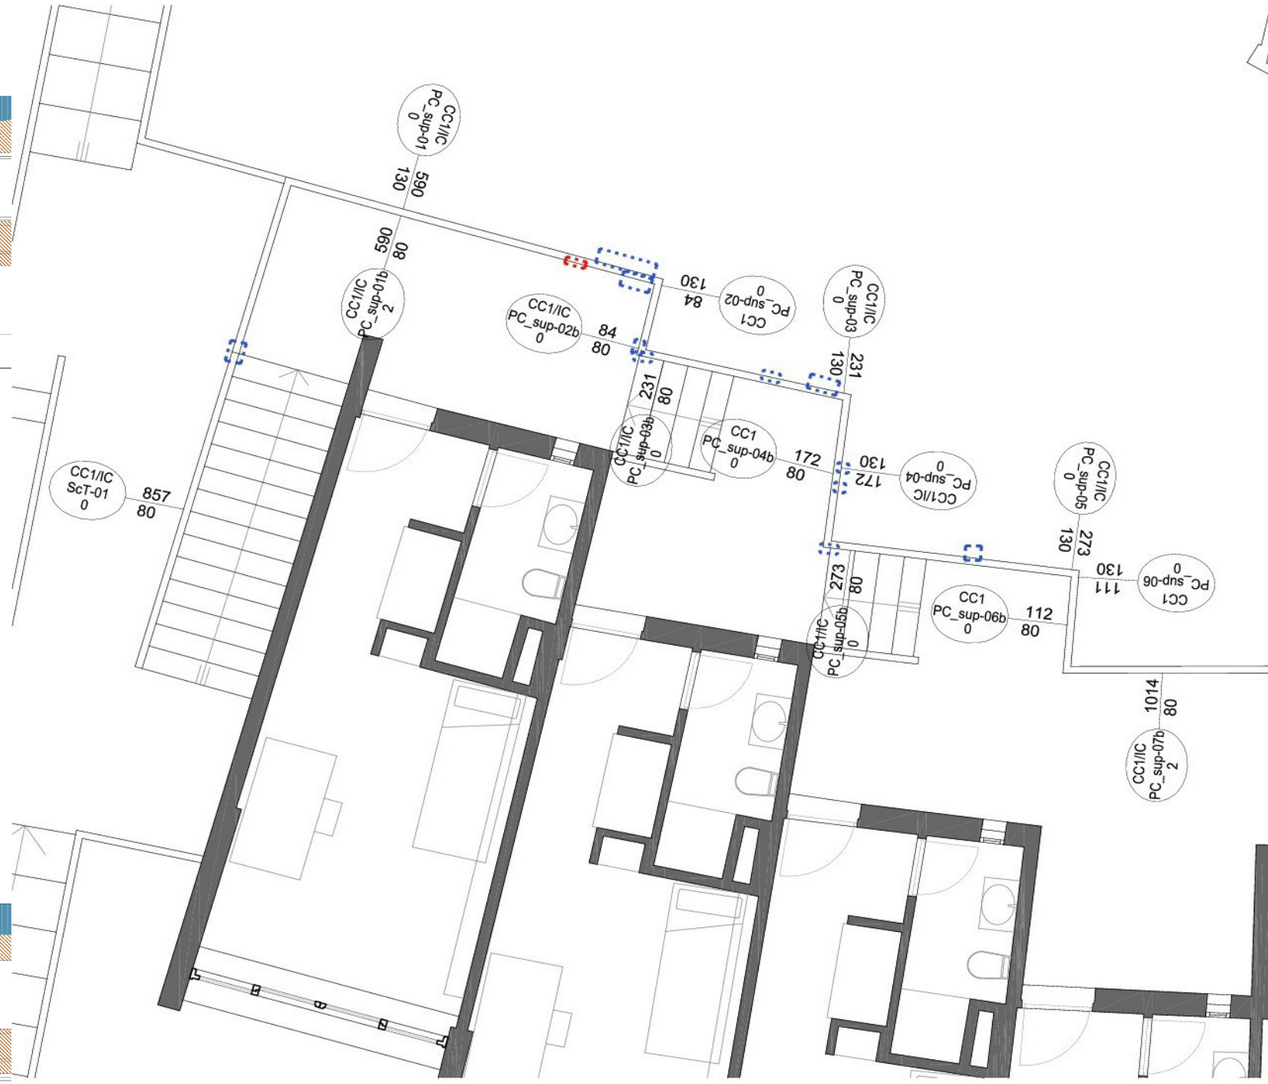
The codes and the score evaluation. In red: decays (exposed rebars, spalling); in blue: existing repairs.

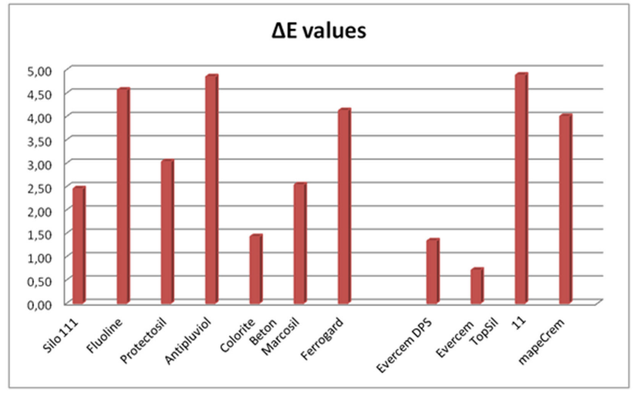
Observing Figure 2 it is possible to see that chromatic variations induced by the application of the products ranges between 0.71 and 4.88 ΔE units. References indicate that a chromatic variation detectable at the naked eye has a threshold of about 2.0-3.0 ΔE units, depending by the type of substrate. Taking this threshold into account the product 2, 4, 7, 11 and 13 have produced a colour variation over the visual damage threshold.

Fig. 2. Total Color Difference (ΔE) measured before and after treatments application.

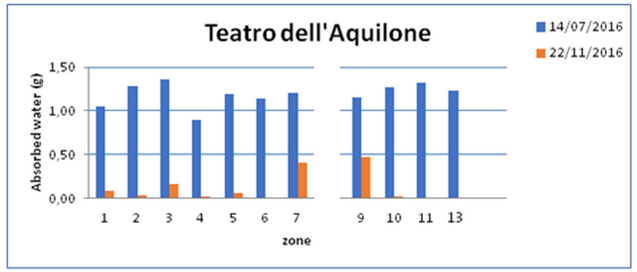
For what concern data obtained with absorption sponge method and summarised in Figure 3 and Figure 4, it is possible to observe that most of the products are able to abate water absorption. in particular the most performant products are able to reduce water absorption of 99% (products 6, 11 and 13). Data are confirmed by the "Colle" parapet areas, even if the reduction of water absorption is slightly less in this latter case. Most probably the material of the substrate in the "Colle" parapet has a greater porosity and consequently products arrange on the concrete substrate in a differente way.

Fig. 3. "Teatro dell'Aquilone". Water absorption by capillarity with the contact sponge method. Difference between before and after the treatment.

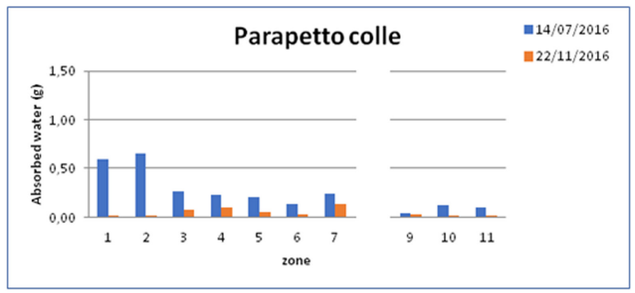
Fig. 4. "Parapetto del Colle". Water absorption by capillarity with the contact sponge method. Difference between before and after the treatment.

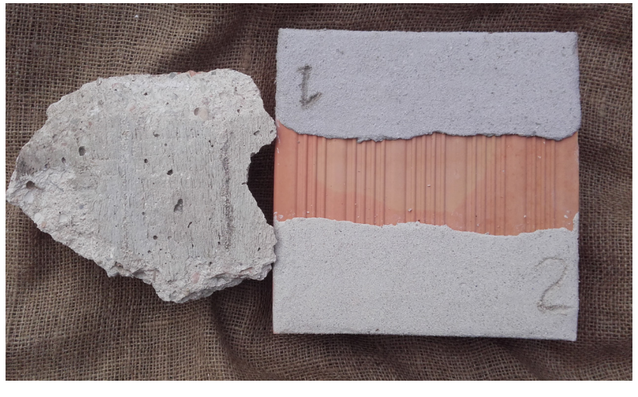
3 different tests have been realised, applying a site mix repair mortar on the whole part of material to be integrated, the same mortar with a 3% of acrilic resina (Acril33 di C.T.S.) and the same repair mortar as a finishing layer of about 1 cm, but using a commercial mortar for the deep repairs.

- rettangolo rosso: Mapegrout + finitura PR2
- rettangolo verde: PR2 + resina
- rettangolo blu: PR2

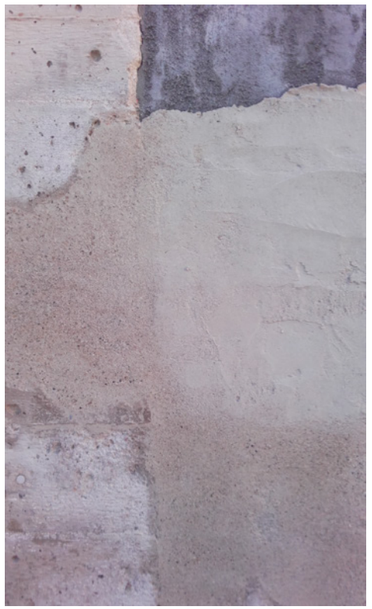
The repair mortar has been realised using a mix of white cement and local material (sand and gravel) with a binder/ aggregate ratio of 1:2 that match quite well with the surface (see the two tests in the image below). Nevertheless the different dimension of the aggregates and the texture of the surface makes the repairs immediately identifiable.

The identification of the repair mortar; two tests, compared to a sample of original material.[2]

Besides, different sampling have been prepared to test the shape of the repair, irregular or cutting the material to obtain a regular shape. After the application, the mortar has been buffered with a dump sponge to compact the material and avoid the shrinkage cracks; that treatment allows a better integration of the texture with the existing material.

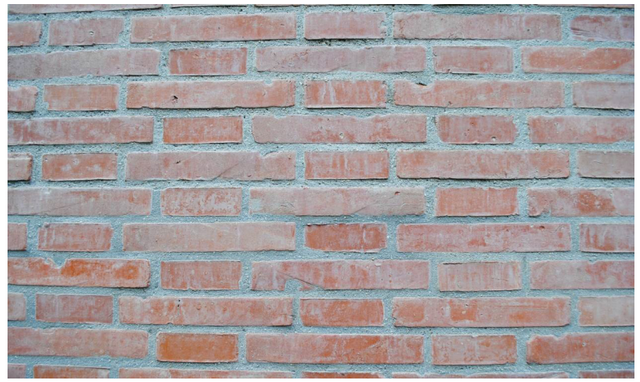
The patches designed by De Carlo are in relief with respect to the surface. A sample has been realised in which the patch has regular shape and is raised on the surface; nevertheless, when a significant amount of repairs are needed (and in most cases, the extension of the surfaces to be treated prevails over the areas in good state of condition) hat solution cannot be replicate without the risk of altering the appearance of the surface and introducing a new pattern. Besides, to avoid stagnation and infiltration of water, the patches should be preferentially coplanar to the surface.

A mixed cycle of interventions that combines a commercial product and a site mix mortar has therefore been designed, to ensure reliability and ease of application and guarantee the greatest aesthetic compatibility with different kinds of concrete. Indeed, a repair mortar can be used for the deep repairs, to speed the interventions whilst obtaining the best results in terms of durability andand a specific mortar, used for the finishing layer (about 1 cm), can ensure the visual matching with the existing concrete. The site mix mortar proved to be less expensive than a commercial product and can be used as a unique layer when the depth of the repairs is limited.

That cycle was developed by comparing some references, and in particular intervention realised at the Convent of La Tourette and in Paul Rudolph's Art and Architecture building in Yale where a "site mix" mortar have been formulated and used on the surface layer, whilst for the repair a commercial repair mortar was used, to ensure the maximum durability. In that cases, a new layer of concrete a paint wash composed by a mix of water and cement was applied both on the repair and on the original material, to unify the surface and hide the patches; in the Collegi, another solution was preferred, to find a good balance between the discernibility of the new material and the respect of the original texture and to recall the solution proposed by De Carlo. The geometric shape of the patches (that recalls the patches realised by De Carlo), the size of the aggregates and the line (which simplifies the trace of the formwork) identifies the new material without introducing excessive changes.

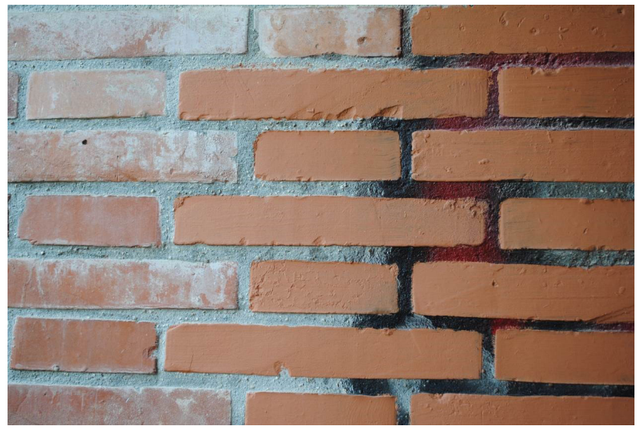
Delamination and efflorescences.

- Deposits
  - Efflorescence
  - Sub efflorescence
- Detachments
  - Delamination
  - Detachment of the brick cladding
- Stains
  - Graffiti
- Cracks and displacements
  - Cracks

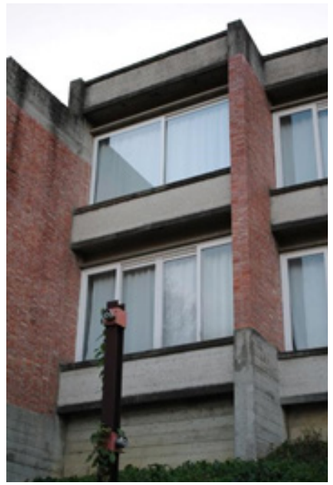
Materiali:
Telaio - legno
Vetro - singolo

Quantità: 2 elementi
Stati di conservazione:
1 - 2 elementi

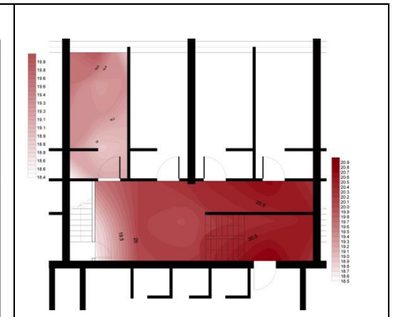
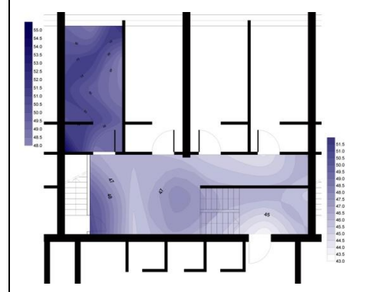
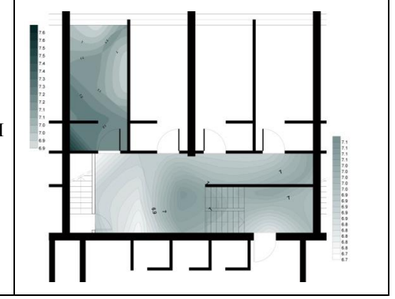
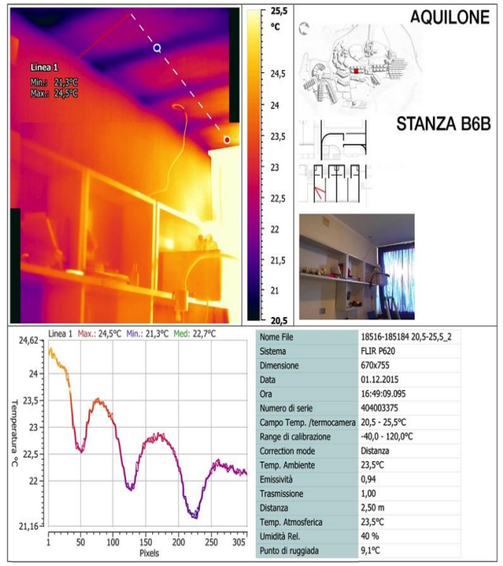
“Il Tridente” block 300-308

Thermographic survey and psychrometric mapping
red: T – blue: RH - green: SH

30.11.2015
outdoor conditions: T min 7°C - T max 12°C – RH min 43 UR% – RH max 71 UR%

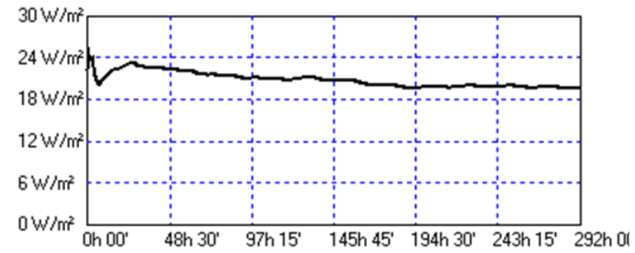
"Aquilone", room B6D, thermal conductance survey Layout

Thermal Conductance average 2.10.2017 – 22.10.2017

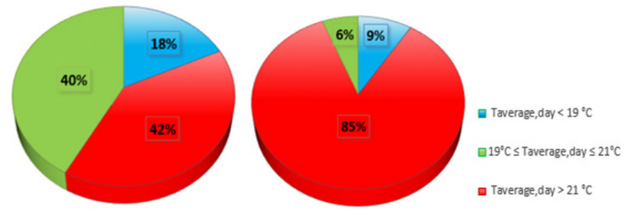
A high percentage of Warm Failure Index can be seen in Fig.4. Room B6a, in the right-side graph, has not external and dispersing walls. High values in temperature are thus due not only to the possible over-heating but also to the solar gains. The relative humidity acceptability intervals of all the sensors are respected for the:

Figure 4 - Average daily temperature - Verification of thermal comfort range for all the selected rooms (left) and for room B6a (right).

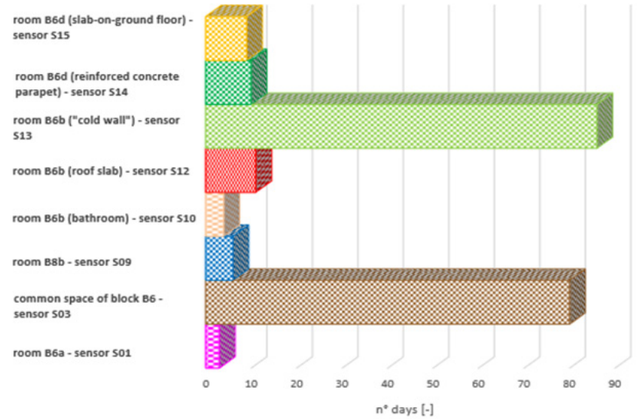
The analysis of the average daily temperature has been compared also to the average tempera-ture calculated during the heating hours, in order to verify the compliance with the temperature set-point. An average of 20 °C in all the rooms can be observed in Fig.5. Different values have been measured by the sensors placed into the block of the common spaces and by the sensor placed close to the external wall. In 50% of cases, the temperature in the common areas remains below 20° C. Common areas are large spaces separating the rooms from the outdoor environment. They cannot benefit from free solar gains as the rooms, because they have not any large window facing South-West, nor they can benefit from thermal gains due to the presence of people, as they are usually underused. Common areas are just equipped with some radiators placed around their perimeter but, considering the huge volume to be heated, the lack of an insulated envelope and the lack of temperature control, they are not sufficient.

Figure 5. Number of days with indoor temperature < 20° C from 8 am to 10 pm.

Near the dispersant wall in room B6B, air temperature was < 20° C for the 54% of the days monitored, thus highlighting a possible local discomfort. For this reason, it was decided to consider also the air operating temperature and not just the ambient air (see par. 3.2). Anyway, data show how the indoor climate and the internal comfort of the "Collegi" are influenced both by the low thermal inertia of the not-insulated building, both by the high thermal transmittance of the windows.

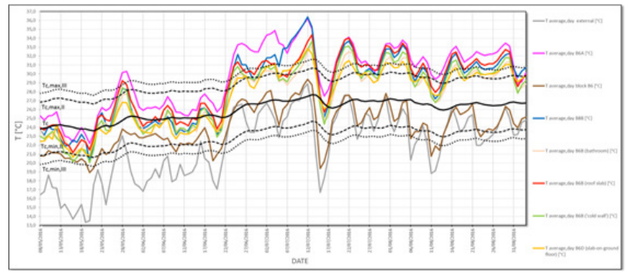
Since the building has no cooling system, the analysis of the summer monitoring period (08/05/2016 – 15/10/2016) requires, in accordance with the UNI EN 15251:2008 (UNI, 2008), a "thermal adaptive comfort model", which incorporates the definition of psychological well-being and considers the users' perception of the environment. The adaptive model consists in identifying a correlation between the thermal sensation and the main climatic variables. The acceptability interval Class II represents a normal level of expectation and should be used for new buildings and renovations. The acceptability interval Class III represents an acceptable, moderate level of expectation and may be used for existing buildings. They both have been verified. Fig.6 shows the trends of daily average temperatures for all the installed sensors and the acceptance bands of the adaptive method. The thick black line represents the comfort temperature under varying external conditions, calculated according to the adaptive method (ISO 15251). The dashed black lines represent the Class II comfort range. The black dotted lines represent the Class III comfort range. Fig.6 also shows that all rooms have excessive heating, especially room B6a (in magenta).

The summer period was analysed, with special regard to thermal excursions and to the influence of solar radiation, which increases the temperatures in the rooms in contact with the roof (12/07/2016), since these rooms disperse heat only towards neighbouring rooms and towards the roof slab and during summer the roof is the building component reaching the highest temperatures. Consequently, the measured indoor air temperatures are also very high, with a maximum of 41.3° C in B8b room (in blue), 39.6° C in B6a (in magenta) and 39.0° C in B6b (in red). Very high temperatures are also due to the incoming solar gains, since windows lack any kind of solar control. There is not any external screen to prevent overheating and indoor curtains made of cotton give the only protection. These rooms are thus very warm and dry (for example, in room B6a relative humidity is < 30% for the 66% of the days) negatively affecting the thermal comfort.

Figure 6. Daily average air temperatures with the acceptance bands according to the adaptive method.

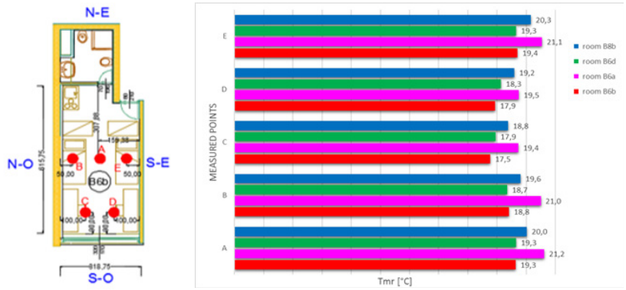
Fig.7 shows that the air temperature in room B6B is 20.6°C while the linear radiating temperature next to the dispersant wall (point C) is 17.5°C, thus resulting in a 3.0°C difference. During the nights, when the heating system is not operating, the temperature falls to 16,3°C. Considering the average of the two, an operating temperature of 19.1° C is obtained, thus resulting in a discomfort of 1.5° C. The thermal discomfort was detected in particular close to the dispersing walls and to the windows with high thermal transmittances (5,522 W/(m K).

Figure 7. Room B6b with the position of five measurement points. Mean radiant temperature when the heating system is operating (right).

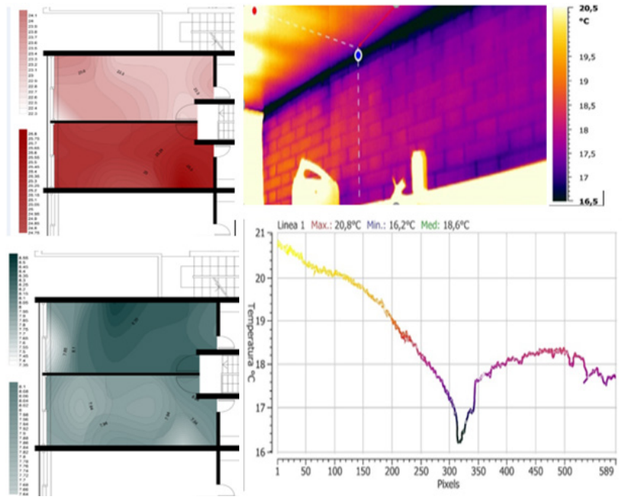
Figure 8. Distribution of temperature (top left) and specific humidity (bottom left) in B6b room (top) and B6a (bottom) of the building "Aquilone" – 31/11/2015. Thermal image of B6b room with the thermal bridge between the wall and the roof - 01/12/2015 (right).

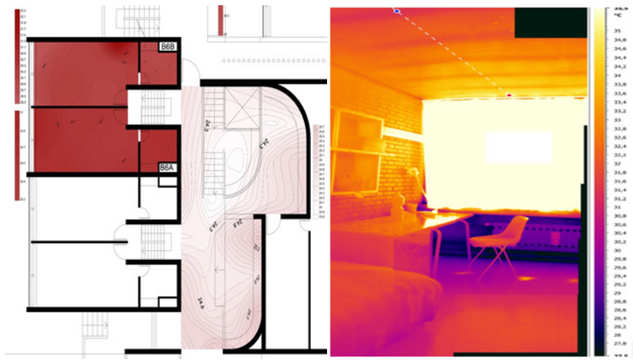
In Fig.9, the same rooms were analysed during summer. On the left, the temperatures in rooms B6b and B6a are compared to those in the common space of block B6. The latter shows a temperature of around 24°C while the rooms are excessively warm, with a temperature of around 30°C. In the thermal image,

the ceiling's concrete joists are perfectly visible, just like all the non-insulated structures. The concrete structure of the ceiling is also visible in the thermal imaging of other buildings of the complex. The surface temperature of the inner side of the roof reaches 35°C, which is a very high value and confirm the data gathered by the sensors mentioned in the previous paragraphs.

Figure 9. Distribution of temperature (left) in B6b room (top) and B6a (bottom) compared with the common space (in the middle) of the building "Aquilone" – 14/07/2016. Thermal image of B6b room - 14/07/2016 (right).

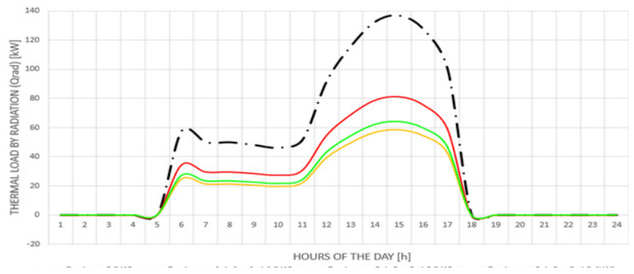
The preservation of the windows proved to be more difficult. This confirms that the results already acquired concerning the conservation of historic windows (Ortelli et al., 2012) may be useful even when dealing with the windows of a wide XX century complex, e.g. the "Collegi". Fig.11 shows that, by replacing the transparent components with a solar control glass, it is possible to obtain a consistent decrease of the total summer thermal load, since

the thermal load by solar radiation is drastically reduced. This is clear when we observe the gap between the continuous colored lines (solar control glasses) and black dot-dashed line (existing glass). The reduction of the radiation heat output was evaluated considering the solar factor, the emissivity and the selectivity of three different types of solar controlled glass. Solution 1 (red curve) results in terms of thermal power by radiation, a lower reduction compared to the case 0 (black curve) because the low emissivity glass has a solar factor (g) greater than the other two cases. In addition, the low-emissivity glass of type 1 has a lower emissivity on the inner surface. This generally results in a significant reduction of magnitude if the room is air-conditioned in summer. The selective glass of type 2 (yellow curve) is the most powerful in terms of solar factor, of emissivity of the outer surface and especially in terms of selectivity. This window allows the greatest reduction of the heat load in summer conditions given that the high selectivity (1.9) allows an increased light transmittance. The solar factor is the ratio between the solar incident energy on the total glazed incoming surface. The energy expenditure of an air conditioned room can be controlled by keeping this factor as low as possible in the summer. In fact the second type has the lower solar factor (0.31).

Figure 11. Thermal load by radiation in the existing windows and after the substitution of the window glass.

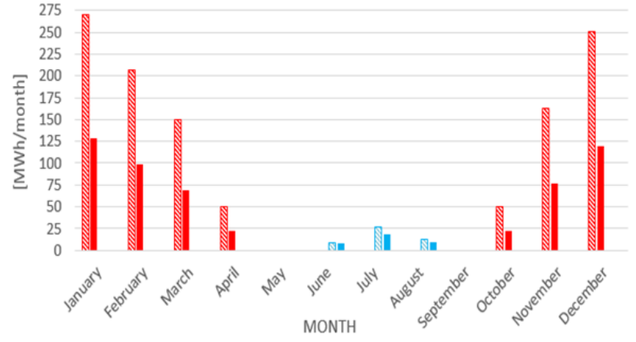
Figure 13. Comparison between the existing energy performances and the simulated ones with the chosen solution.

Fig.13 shows a simulated comparison between the existing and upgraded performances in the thermal energy required for heating (in red) and for cooling (in blue) the rooms; a potential decrease up to 52.9% is expected for the former, up to 23.7% for the latter.

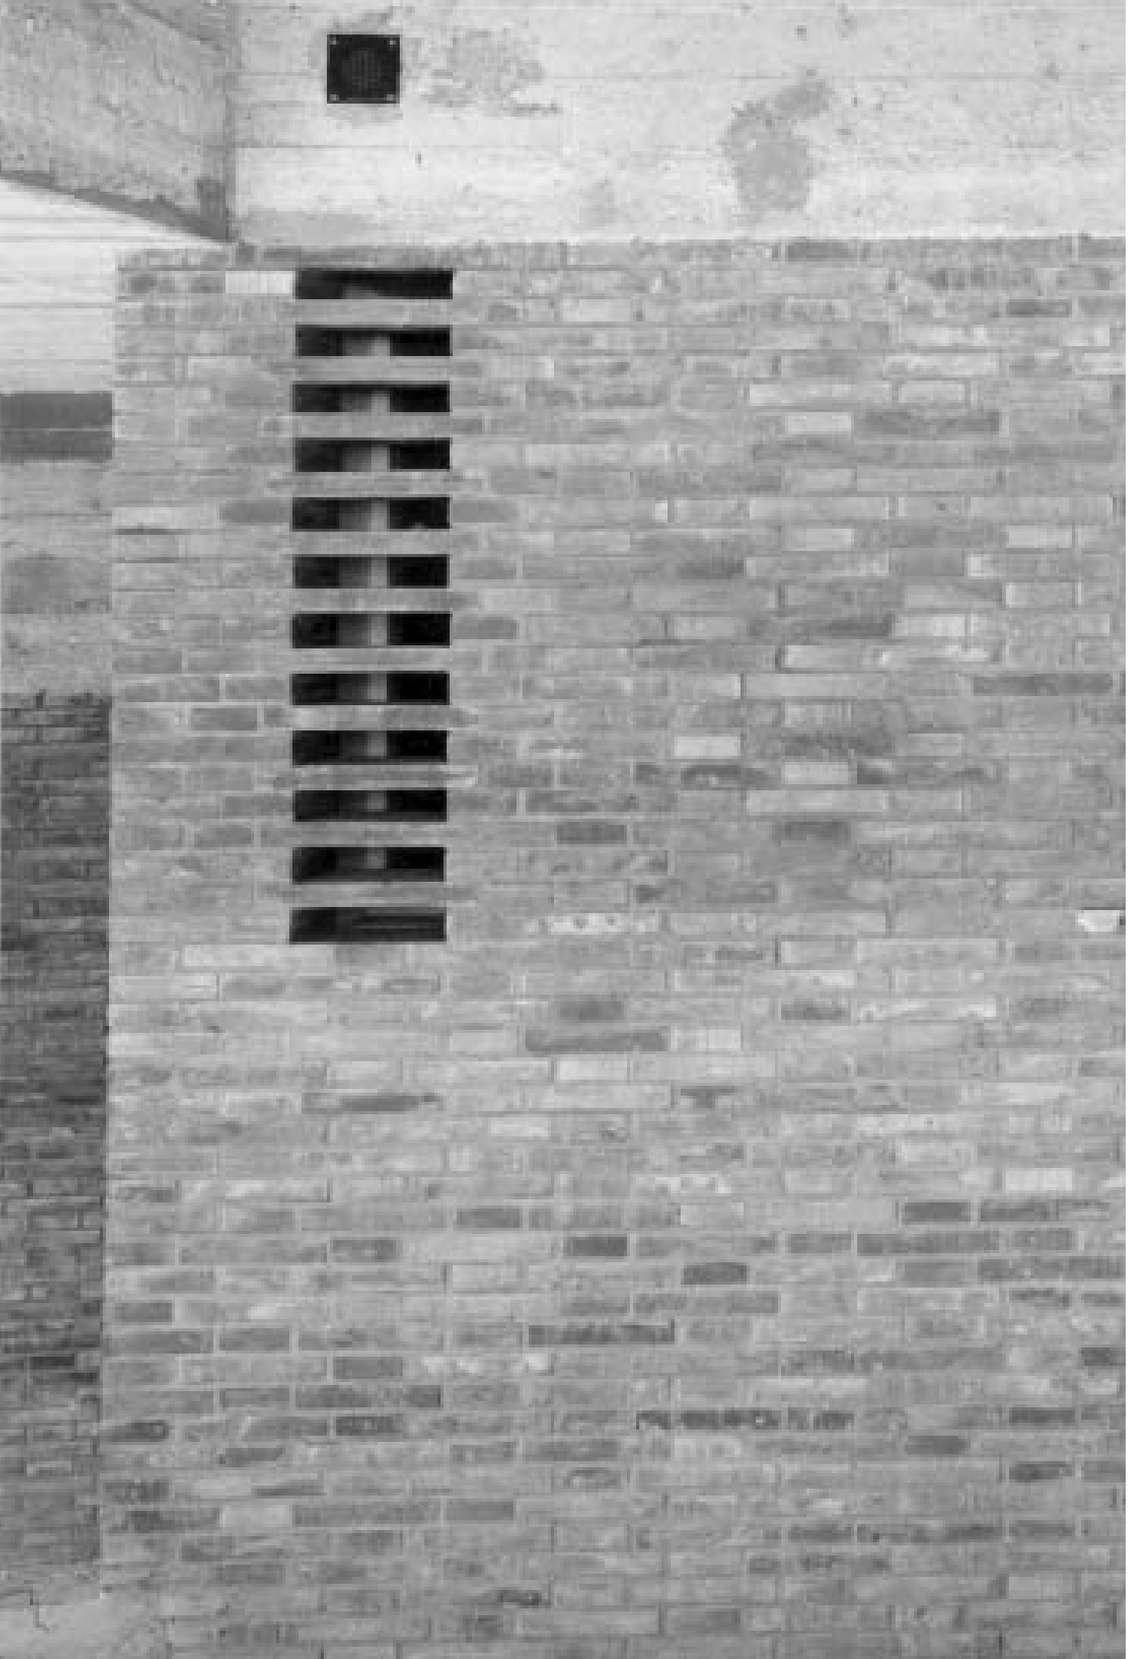
Pilot sites. test of the repair mortar

To provide overall protection a corrosion inhibitor and a coating should be applied on the surfaces.

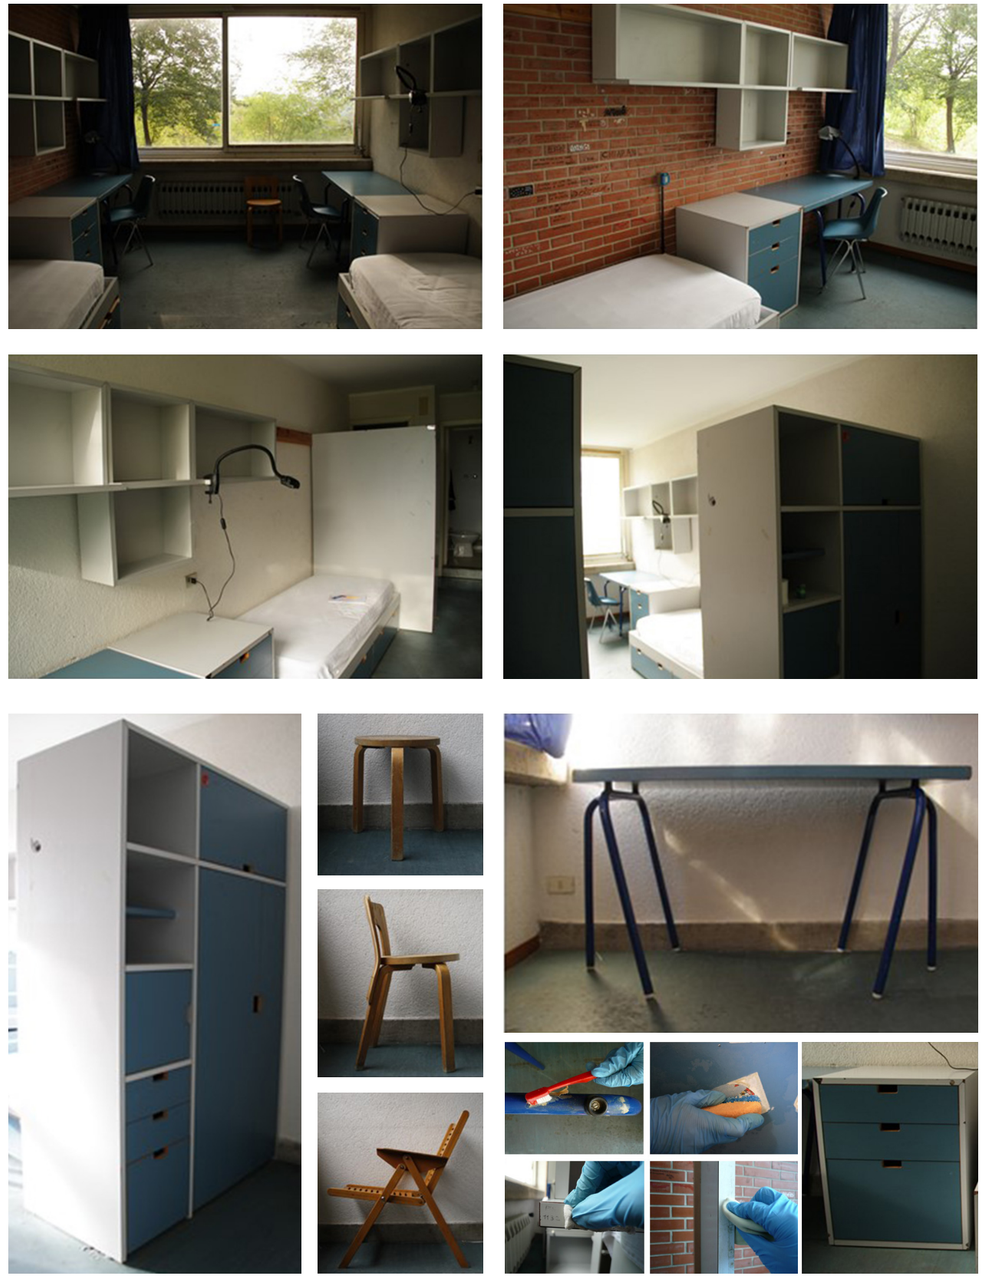
Fig.2 The room chosen for the restoration experiment at "Aquilone"

In a preliminary phase, every type of decay and its possible causes have been identified and mapped on a graphical database. The furniture deterioration was attested to be caused mainly by prolonged and often wrong usage; as a matter of fact, marker and pencil writings, various types of layered materials (adhesive labels, tape, etc.), compact deposits such as incrustations and oily/sticky residues have been found on the surfaces. Moreover, all the data concerning the real nature of all the materials were collected, and, together with their state of conservation, allowed the drafting of a sort of preliminary project that enabled the observation and understanding of the furniture complexity and entirety.

The aim of the intervention was to restore the original integrity state, both aesthetic and functional, through cleaning processes, potential replacement of not-functioning elements or parts, pasting, repairing facing gaps, polishing and reconditioning of abraded surfaces. The intervention project stated that in case of missing elements such as castors, locks, hinges, etc., the original ones were to be replaced by new, similar and compatible elements.
