殊像寺 建筑表面装饰、 塑像、陈设物 状况评估

Condition Assessment
of
Painted Architectural
Surfaces, Sculpture,
Furnishings and Objects

会乘殿 状况评估

Huicheng Hall Condition Assessment

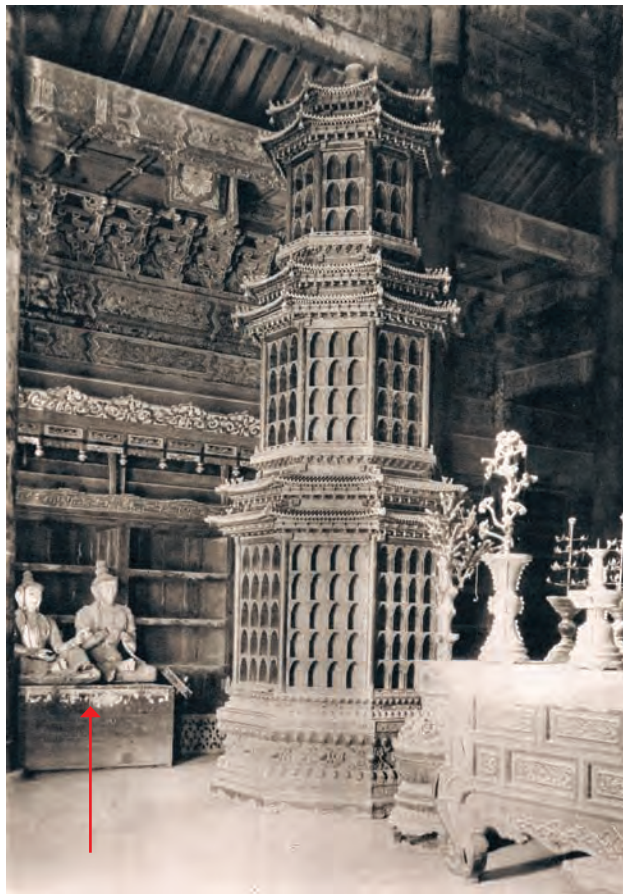
请注意1933年关野贞的照片有两尊塑像（这些塑像可能来自别处）。
Note the two sculptures in the 1933 Sekino photograph (these sculptures may have come from another temple).

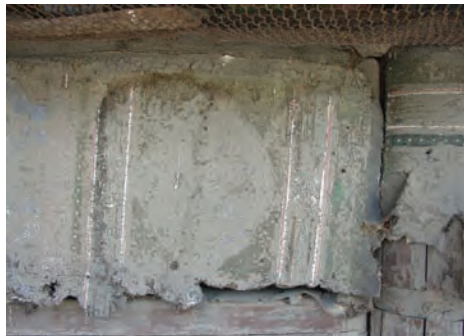
彩画表面总体来说残损严重。不同种类的画层起甲、细小裂缝及缺失，以及总体风化和灰尘堆积导致这一残损外观。这一局部取自东立面下檐南尽间。

The surface of the painting is generally very deteriorated. Different types of paint flaking, fine cracking and loss in addition to weathering and dirt deposition leads to this deteriorated appearance. This area is from the lower level of the east wall, southernmost bay.

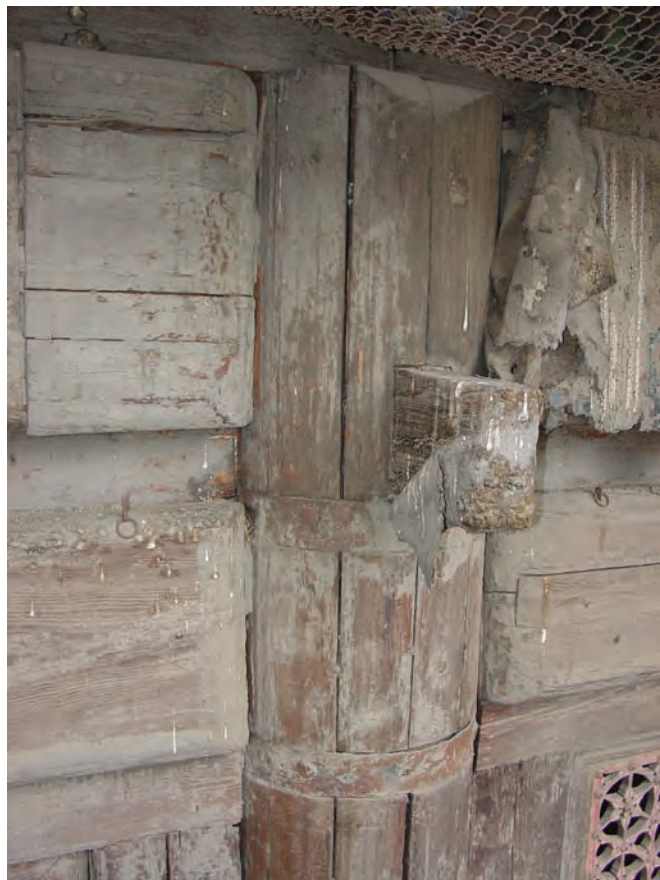
西次间西侧檐柱细部照片体现出其上彩画几乎全部脱落。

Detail of column on next west bay showing almost complete loss of painting.

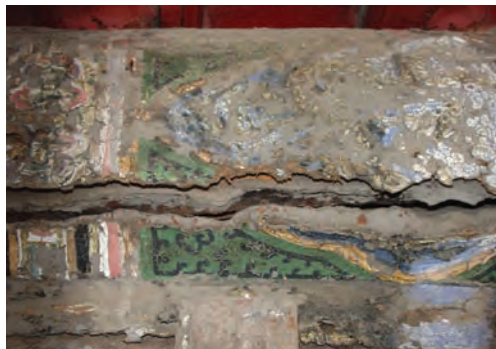
挑檐檩上的裂缝。

Cracking of an eave purlin.

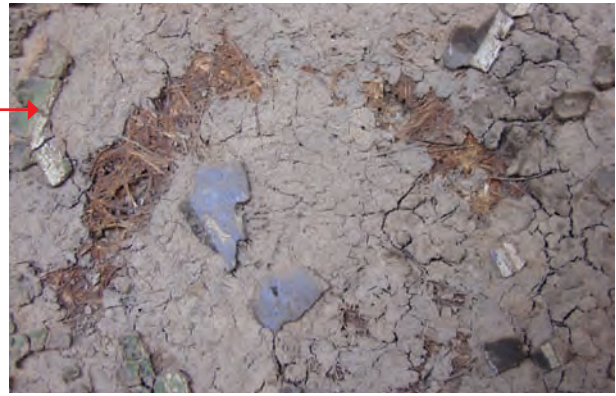
彩画层细部，显示出严重的风化。大量的颜料层与表层地仗脱落暴露出了其下的纤维层。

Detail of area of painting showing the advanced stages of weathering. Note the large extent of paint loss and losses in the upper plaster layer revealing the fiber layer below.
