研究与测试 Research and Testing

实施保护措施 Treatment Implementation

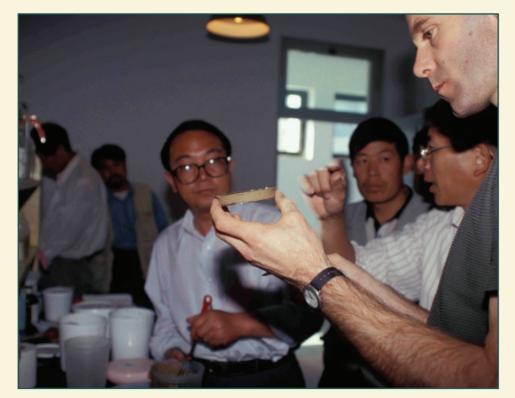
在筛选出加固壁画层的灌浆材料之前在实验室内对 80 多种不同配比的灌浆材料进行测试。

More than 80 different grout mixtures were tested in the laboratory before a material was selected to reattach areas of painted plaster.

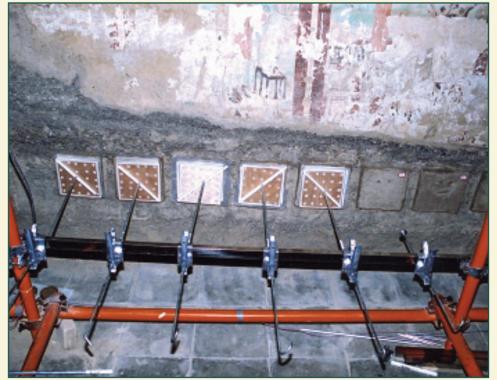
在第85窟内四壁下部的砂砾岩层(没有颜料层的区域) 上粘结新的模拟地仗试块进行灌浆材料试验。 Testing of grout mixtures was undertaken in Cave 85 at the base of walls (in unpainted areas) by adhering modern plaster panels to the conglomerate.

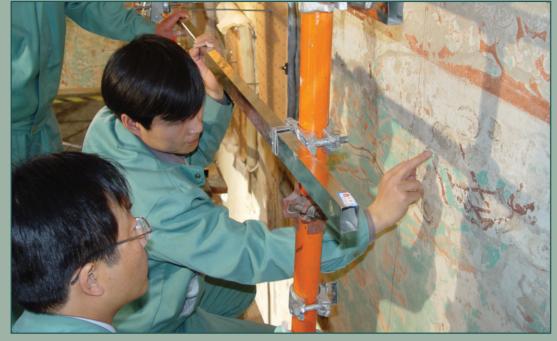
在病害治理前仔细检查每个区域。 Each area was carefully examined before treatment.

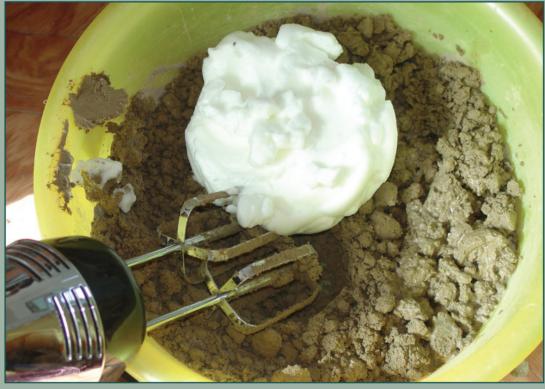
第85窟筛选出来的灌浆材料包括本地清洗过的粘土、玻璃微珠(Scotchlite K1®)、碾碎过的浮石、搅拌好的蛋清和蒸馏水。 The adhesive grout formulated for Cave 85 included local washed clay, glass microspheres (Scotchlite K1[®]), crushed pumice, whipped egg white and distilled water.

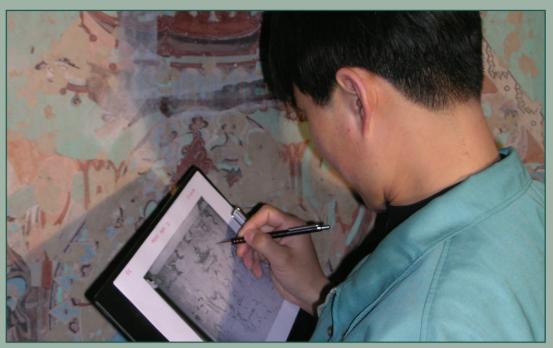
所有的区域在治理前后都有记录并且建立档案。 All areas were documented before and after treatment.
