Consolidation and Stabilization

Condition, Conservation, and Reinforcement of the Yumen Pass and Hecang Earthen Ruins near Dunhuang

Wang Xudong, Li Zuixiong, and Zhang Lu

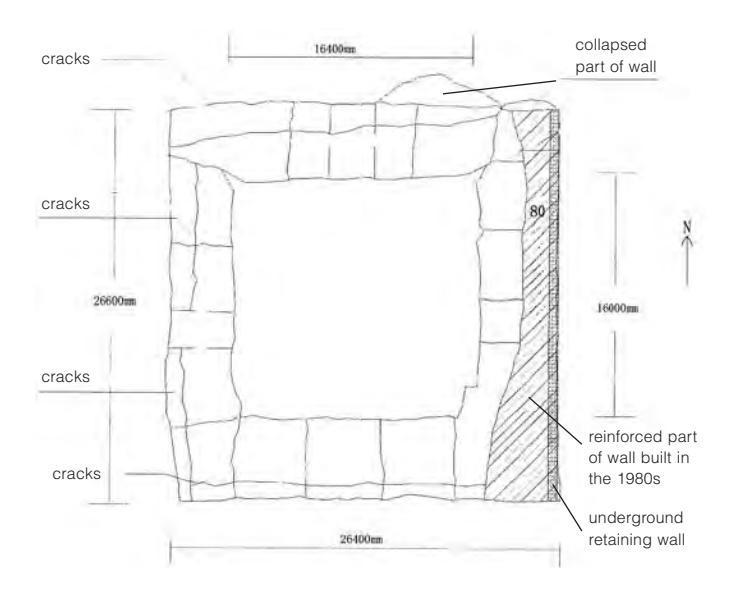
walls, approximately 10 meters high, were built of rammed earth (fig. 2).

FIGURE 2 Layout of the Yumen Pass.

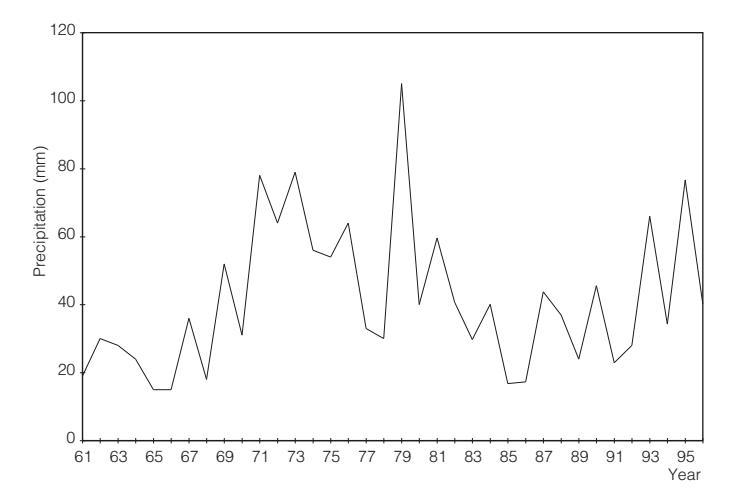
FIGURE 4 Yearly precipitation in the Dunhuang area.

Temperature and rainfall are two factors that affect the earthen structures. As shown in figure 4, annual precipitation in the Dunhuang area between 1961 and 1996 was characterized by extreme unstability. Meteorological records kept at the Dunhuang station show that 1979 and 1956 mark the two extremes, 105.5 millimeters and 6.4 millimeters, respectively. The annual precipitation is in general on the increase. The evaporation volume, however, is stable and falls between 2,200 and 2,700 millimeters.

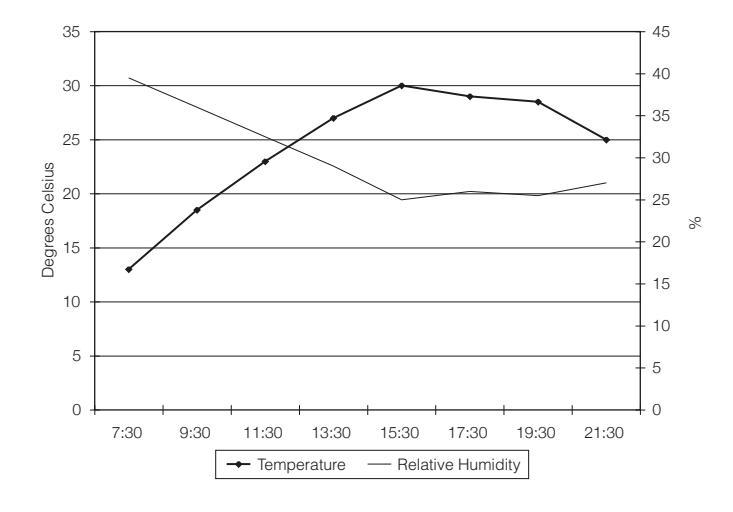
FIGURE 5 Humidity variations on August 27 at the Hecang Fortress.

During this period, daily mean temperature showed a declining trend, while the daily mean humidity rose slightly. For example, as shown in figure 5, on August 27 temperature rose from the lowest point at 7:30 to a high between 13:30 and 15:30 and thereafter began to drop. The relative humidity declined from the highest value at 7:30 to the lowest point between 13:30 and 15:30 and thereafter began a slow rise. The daily temperature fluctuation was large, with a maximum of 19.5°C, a minimum of 10.5°C, and an average difference of 14.96°C. The daily humidity change was also considerable. In sum, temperature at the Hecang Fortress was relatively high, with a wide fluctuation range, and humidity was low.

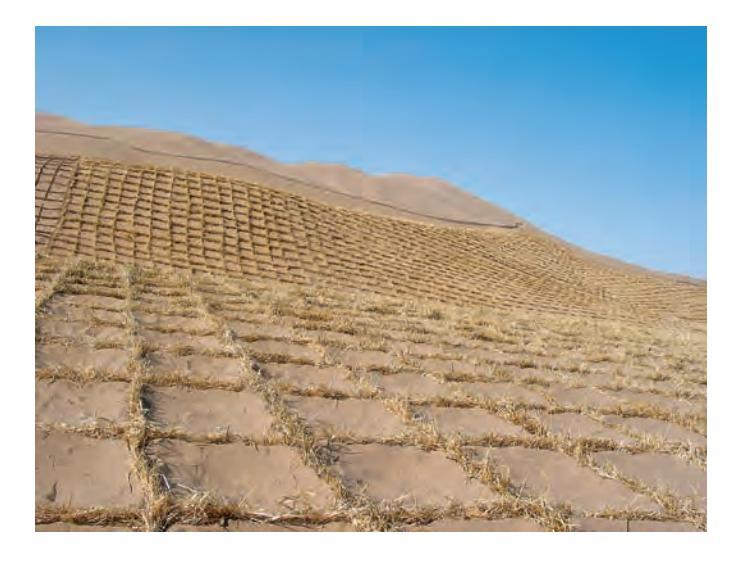
FIGURE 2 Half-buried straw checkerboard barriers.

The shifting sand is located in an area of small dunes and flat sand sheets at the front edge of the Mingsha megadune. A windbreak fence of open-knit nylon and half-buried straw checkerboard barriers (fig. 2) are the control measures here. The main function of the straw barriers planted in the sand in a square checkerboard grid is to stabilize the shift-

ing sand by changing the roughness of the surface. This decreases the impact threshold velocity, hence the rate of sand transport, and transport from the sand dune field is reduced. This also creates suitable conditions for growth of vegetation. The friction as a result of the straw checkerboard barriers in the areas of shifting sand and small dunes increases thirty to forty times, and the roughness of the surface also greatly increases.

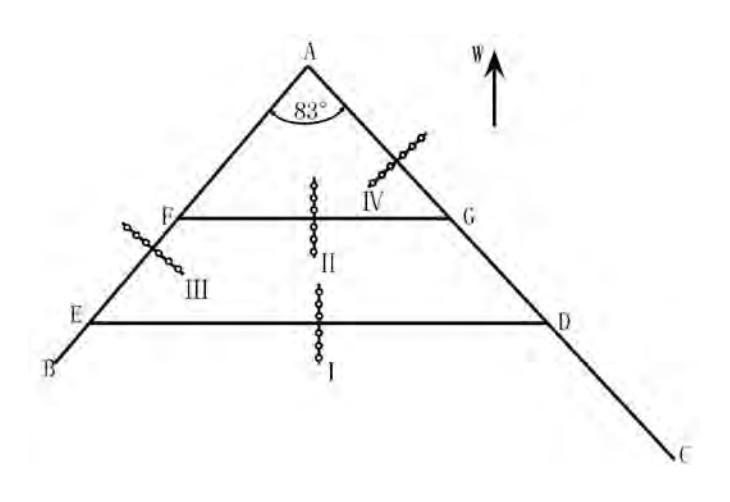
FIGURE 3 Schematic drawing of wind fence and sand depth monitoring sticks along lines I–IV.

Figure 3 shows the plan of the open-knit nylon fence, and figure 4 shows sand accumulation. Over seven years a

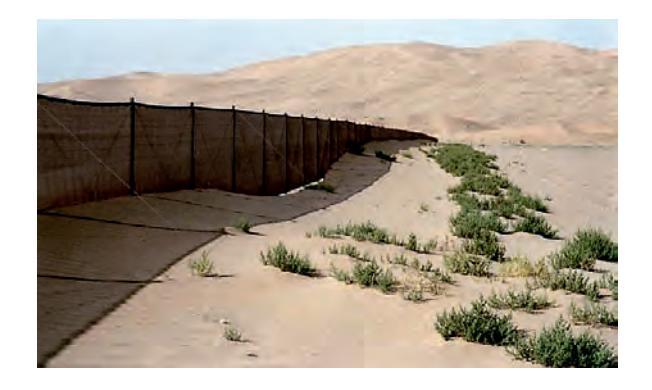
FIGURE 4 Sand accumulation around the wind fence.

total volume of 23,000 cubic meters of sand accumulated around the fences. Sand accumulation on the AC segment accounted for 13,000 cubic meters, which shows that the northwest direction is the main source under the control of the westerly winds. Sand accumulation on the AB segment to the southwest accounted for 5,400 cubic meters, which shows that the southwest is another sand source. Sand accumulations on the DE and FG segments were 3,600 and 1,700 cubic meters, respectively, showing sand mainly originating in situ.

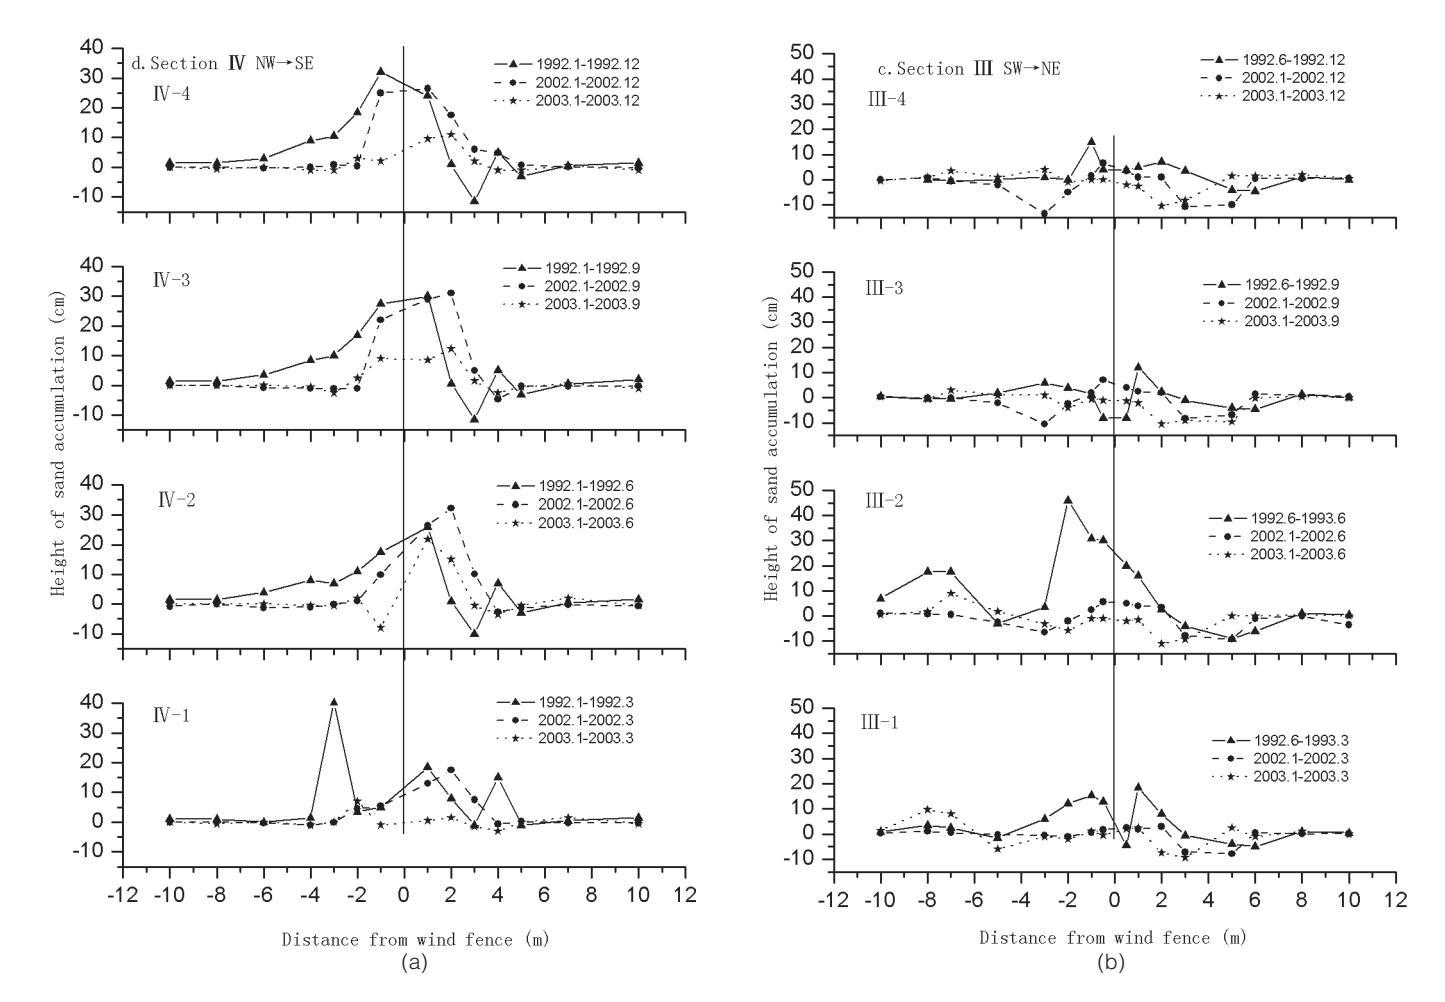
Section IV (see fig. 5a) shows that the profiles of sand accumulation under the control of the northwesterly winds vary seasonally and annually. Sand accumulates especially during the windy season, March to July. Sand accumulation in 1992 and 2002 was similar, reaching 30 centimeters.

FIGURE 5 (a) Section IV sand accumulation on a quarterly basis for the years 1992, 2002, and 2003, showing the upwind and downwind depths. (b) Section III showing sand depths under the influence of the southwesterly wind.

However, after the sand source was further controlled in 2002, the amount of sand around the fence decreased greatly, to about 10 centimeters annually.

Section III (fig. 5b) shows the comparable profiles of sand accumulation for the southwesterly winds. The processes of sand accumulation are most obvious and reach 25 centimeters during the March–July windy season. Wind erosion also occurs, reaching a depth of 10 centimeters.

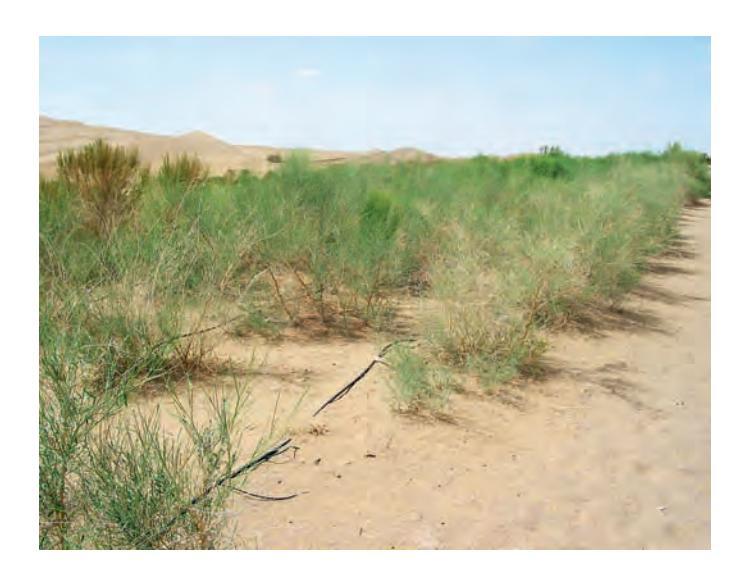
FIGURE 6 Vegetation wind fence and drip irrigation.

Figure 6 shows the vegetation windbreak on the plateau, in front of the Mingsha megadune. The airflow pattern near the shrub zone, which is 1.5 meters in average height and 50 percent permeation through the shrubs, is similar to that at the nylon wind fence, which has similar height and weave density. Based on the energy distribution, the flow pattern can be described as decelerating wind velocity that occurs before the shrub zone, decreasing speed in the shrub zone, recovering speed coming out of the shrub zone, and accelerating velocity that occurs far beyond the shrub zone. The shrub zone can obviously reduce wind speed, and a double line of shrub zones can reduce wind speed significantly. Wind speed downwind, at a distance of about twenty to thirty times the

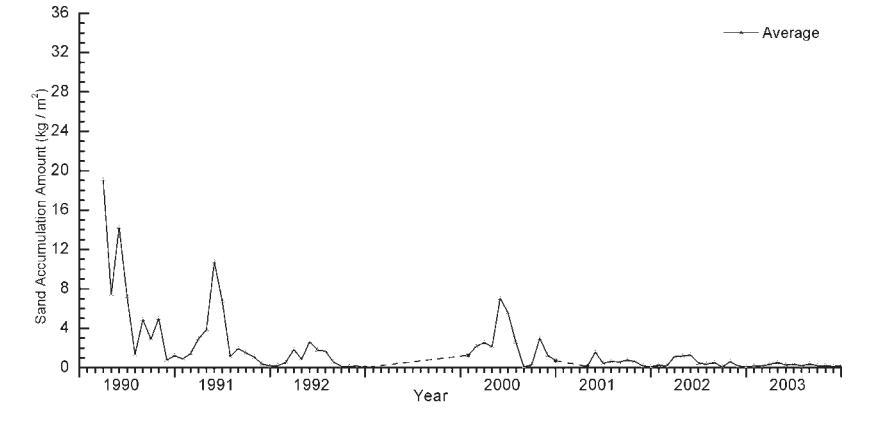
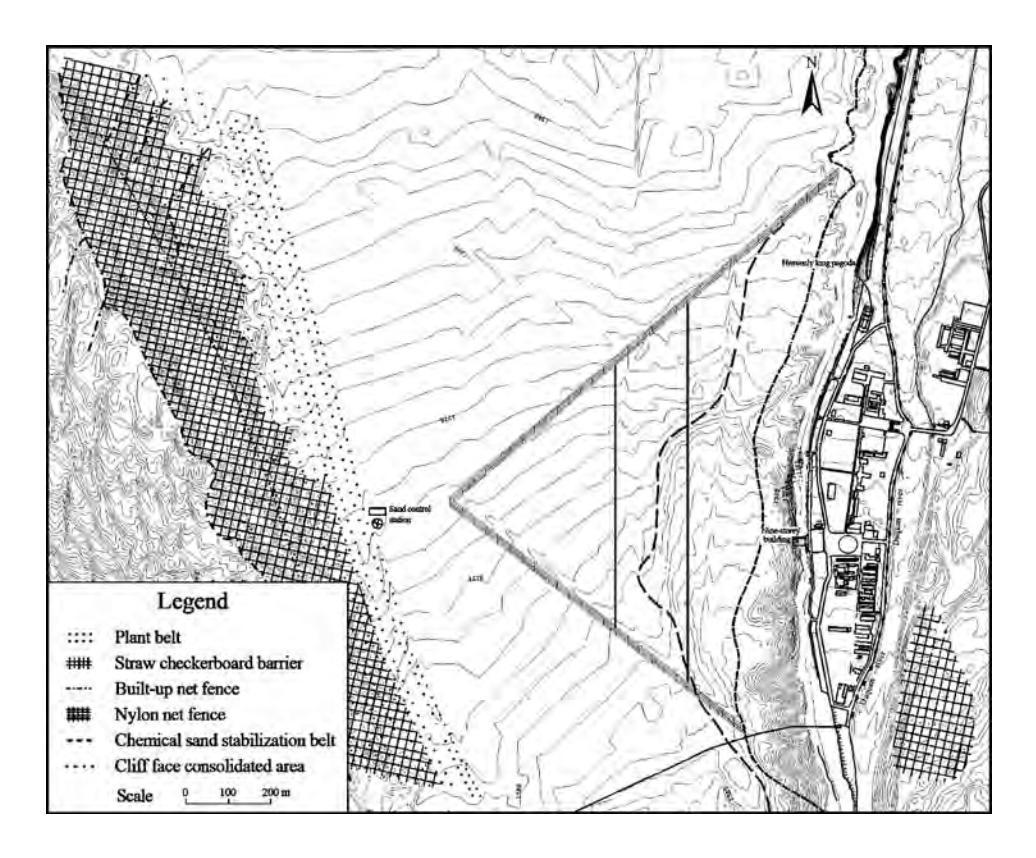
FIGURE 8 Plan of the Mogao Grottoes site showing the multifunctional sand control system.

In order to significantly reduce windblown sand accumulation at the site, a multifunctional protective system (fig. 8), including engineering, biological, and chemical measures, was established over a period of some twelve years. The strategy was to reduce sand coming from the Mingsha megadune and stabilize the in situ sand on the gobi surface between the dune and the grottoes. Under the control of multidirectional winds, some sand is arrested by the gravel and some is transported by the gobi sand stream. The latter may be a threat to the Mogao Grottoes in that the sand is transported by salta-

tion. The grit gobi surface inhibits sand transport. The combination of the upright sand-block fences, half-buried straw checkerboard barriers, drip-irrigated vegetation fences, and gravel "mulch" has so far proven an effective way to protect the Mogao Grottoes from the hazards of windblown sand.

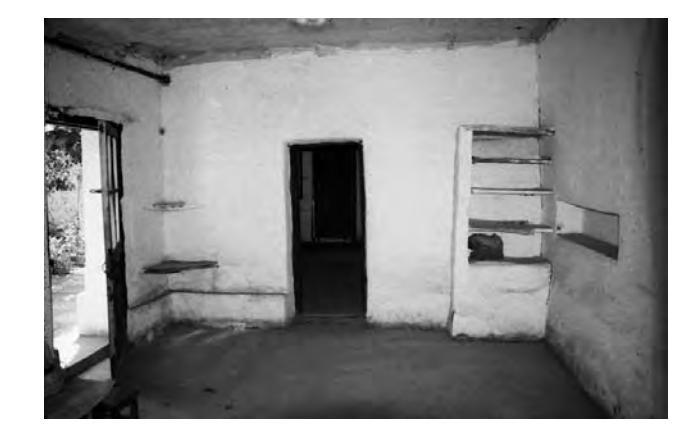
FIGURE 5 Chang Shuhong's residence in the 1940s, after the removal of nonoriginal interventions.

times could be preserved as witness to the early history of the Dunhuang Academy. Thus we achieved the aim of "restoring the relics to their original appearance" (figs. 4, 5).

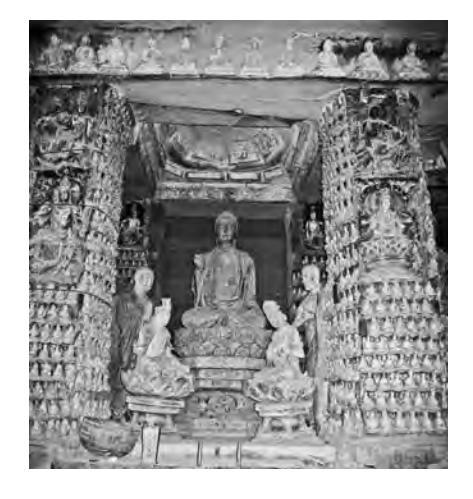
FIGURE 1 Buddha altar and carved stone pillars in the main cave of the Zhongshan Grotto.

The grotto is excavated out of a porous fine-grained sandstone rich in the mineral feldspar. The sandstone is gray, with some dark brown marks. Because of the grotto's location in the severe environment of northern China and its exposure to wind erosion, the stone surface has deteriorated seriously. Humidity combined with salts is another deterioration factor. Water migration has caused salts to accumulate in the rock, producing crystals that weaken the bonding between the sandstone grains. This deterioration results in heavy efflorescence on the rock surface, loss of the surface layers, loss of the binding materials between the grains of quartz, powdering of the stone, loss of detail of the sculpture, fading of the wall painting, and many fissures or cracks in the cave wall. The greatest deterioration is seen 2 meters above the ground, resulting from the capillary rise of water in the sandstone and the windy environment. This is especially noticeable on the side of the cave that backs to the mountain.

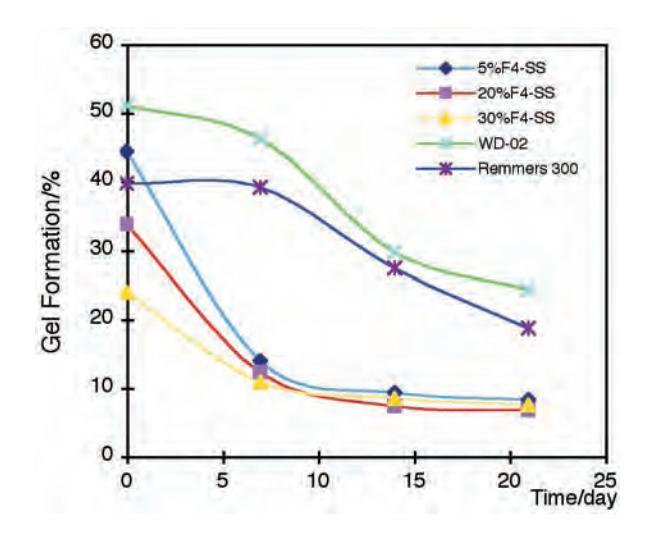
Figure 4 shows the gel formation over the four-week curing process. Samples treated with F4-SS had a constant weight after two weeks, but the samples treated with Remmers 300 and WD-02 needed at least a month to achieve constant weight. The initial absorption of the F4-SS was proportional to the viscosity of the preparation used. Because the 5 percent solution has the lowest viscosity, it had the largest absorption; conversely, the 30 percent high-viscosity solution had the least absorption. But the final gel content is proportional to the concentration of fluorinated polymers. The amounts of Remmers 300 and WD-02 absorbed by the samples were more than the amount of F4-SS absorbed because of their higher concentration.

FIGURE 4 Gel formation over the four-week curing process.

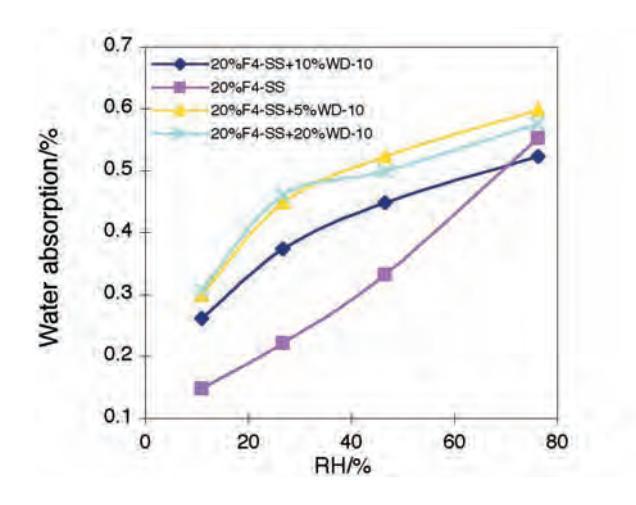
FIGURE 5 Water vapor absorption isotherms for different consolidants.

Water Vapor Absorption Isotherm. Different relative humidity environments were generated using four saturated salt solutions: 11 percent (LiCl), 35 percent (MgCl₂), 58–60 percent (NaBr), and 76 percent (KHSO₄). Figure 5 shows the water vapor absorption isotherms. Remmers 300 exhibited the largest water vapor absorption above 20 percent RH. The three fluorinated polymer concentrations did not significantly affect the samples, and treated samples exhibited water absorption similar to that of the untreated sample. The addition of WD-10 results in a little more water absorption than that achieved with the pure fluorinated polymers.

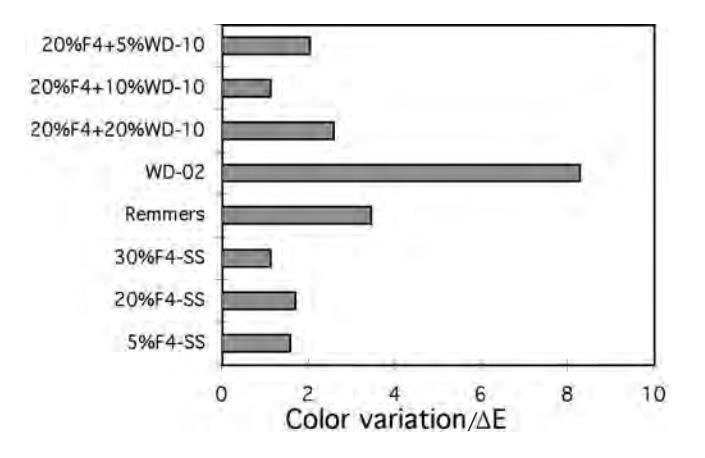
Color Variation. Figure 6 shows the color variation of samples treated with several consolidants. The results were obtained by comparison with an untreated sample. WD-02 caused the most color change; the fluorinated polymers and Remmers 300 caused a small amount of color change.

FIGURE 6 Color change measured for different consolidants.

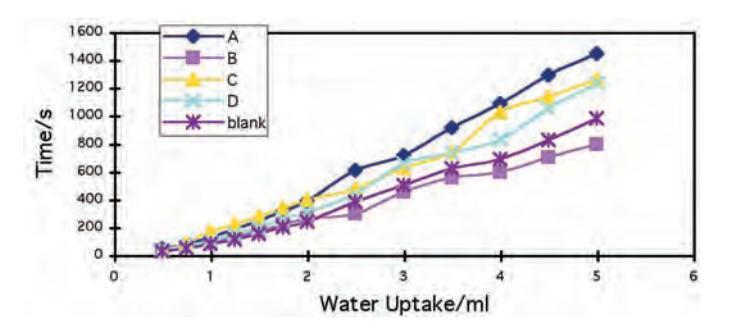
Figure 8 shows that the different consolidants perform similarly with respect to water absorption, with the exception of WD-02 in water uptake. The figure also shows that water absorption is continuous, without a turning point, which suggests also that the consolidation treatment is uniform from grotto surface to the interior. Because of exceptionally heavy precipitation in 2002, the test results should over time reflect the influence of water on the materials used.

FIGURE 8 Water uptake for test areas A–D of in situ consolidant demonstration.

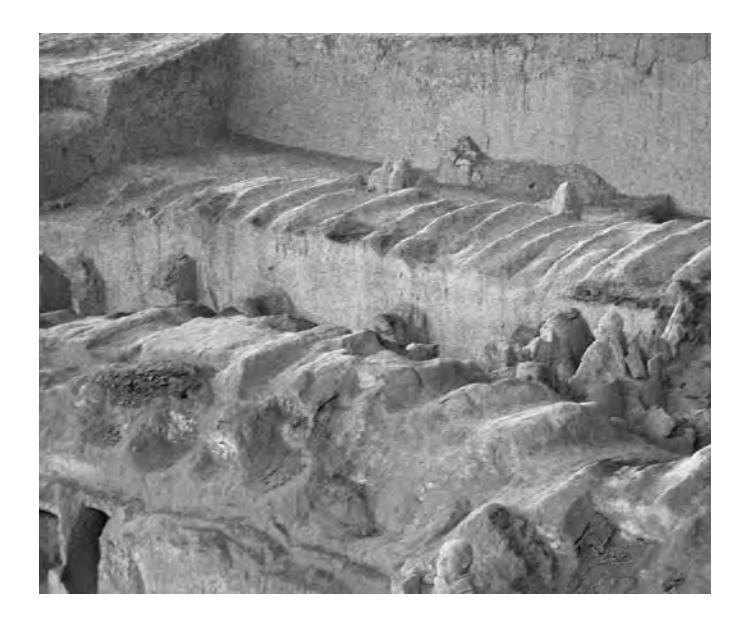
FIGURE 1 Consolidation of the dividing wall in pit 1 of the Terracotta Warriors. The front wall is untreated; the rear wall is treated.

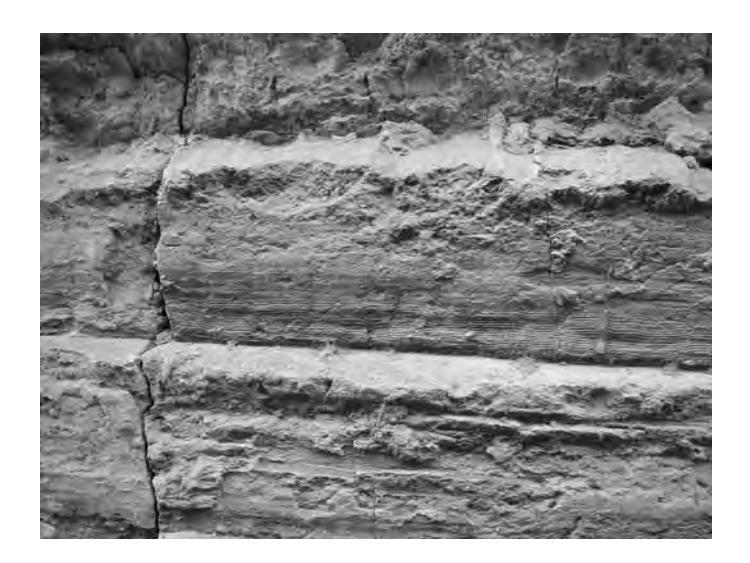
The Yang Mausoleum of Emperor Jing (r. 188–144 B.C.E.) of the Western Han is located in Xianyang City, Shaanxi province. The test was done on a wall of the tomb and a wall of the ramp where an imprint of a decayed wooden member occurred. Each area was 60 by 70 centimers and required 6 and 5 liters, respectively, of 31J at 2 percent concentration. The result was examined after five months and again after two years. The tomb surface was hard but had some color change (fig. 2). The wood imprint was hard; however, the unconsolidated areas showed signs of weathering.

FIGURE 2 Consolidation of the wall of the Yang Mausoleum. The left side is untreated; the right side is treated.

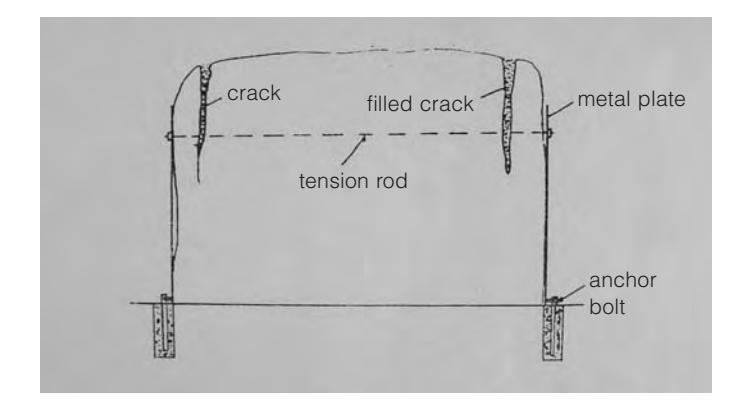
FIGURE 4 Steel plates for reinforcing the earthen partition wall.

In 1991 an additional measure was taken to stabilize the walls. Steel plates on both sides of a wall were secured with a steel bar through the wall and anchored into the ground with cement (fig. 4). Cracks were filled with earth to improve the visual effect (fig. 5). The method was used in parts of pits 1 and 3 instead of the U- and H-shaped steel supports.

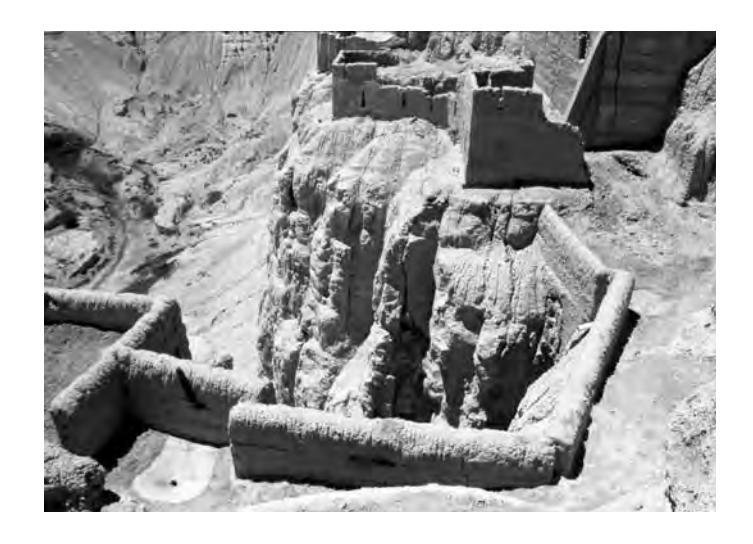
FIGURE 5 Drainage system.

quickly as possible were key factors. Retrofitting water outlets was achieved by reducing the number of outlets at the edge of the hill and consolidating large outlets with erosion-resistant materials (fig. 5).

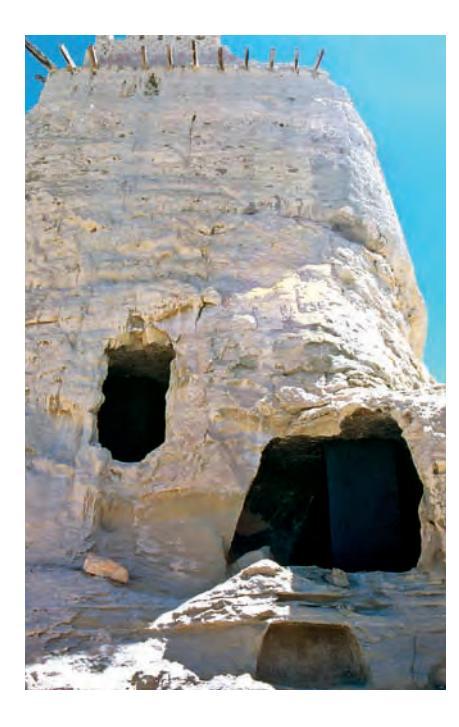
FIGURE 6 Ruin stabilization and support.

- Large flat areas were paved and drained.
- Pipes were added to the site to remove water.
- 3. Roofs: New roofs in the Tibetan style were added to extant buildings to prevent rainfall from affecting wall paintings and entering lower caves. The appearance of these roofs is consistent with the site's setting. Damaged roofs were restored in accordance with evidence discovered from investigation or archaeological work (fig. 6).
