Survey of Damage to Historic Adobe Buildings After the January 1994 Northridge Earthquake

E. Leroy Tolles
Frederick A. Webster
Anthony Crosby
Edna E. Kimbro

GCI Scientific Program Report 1996

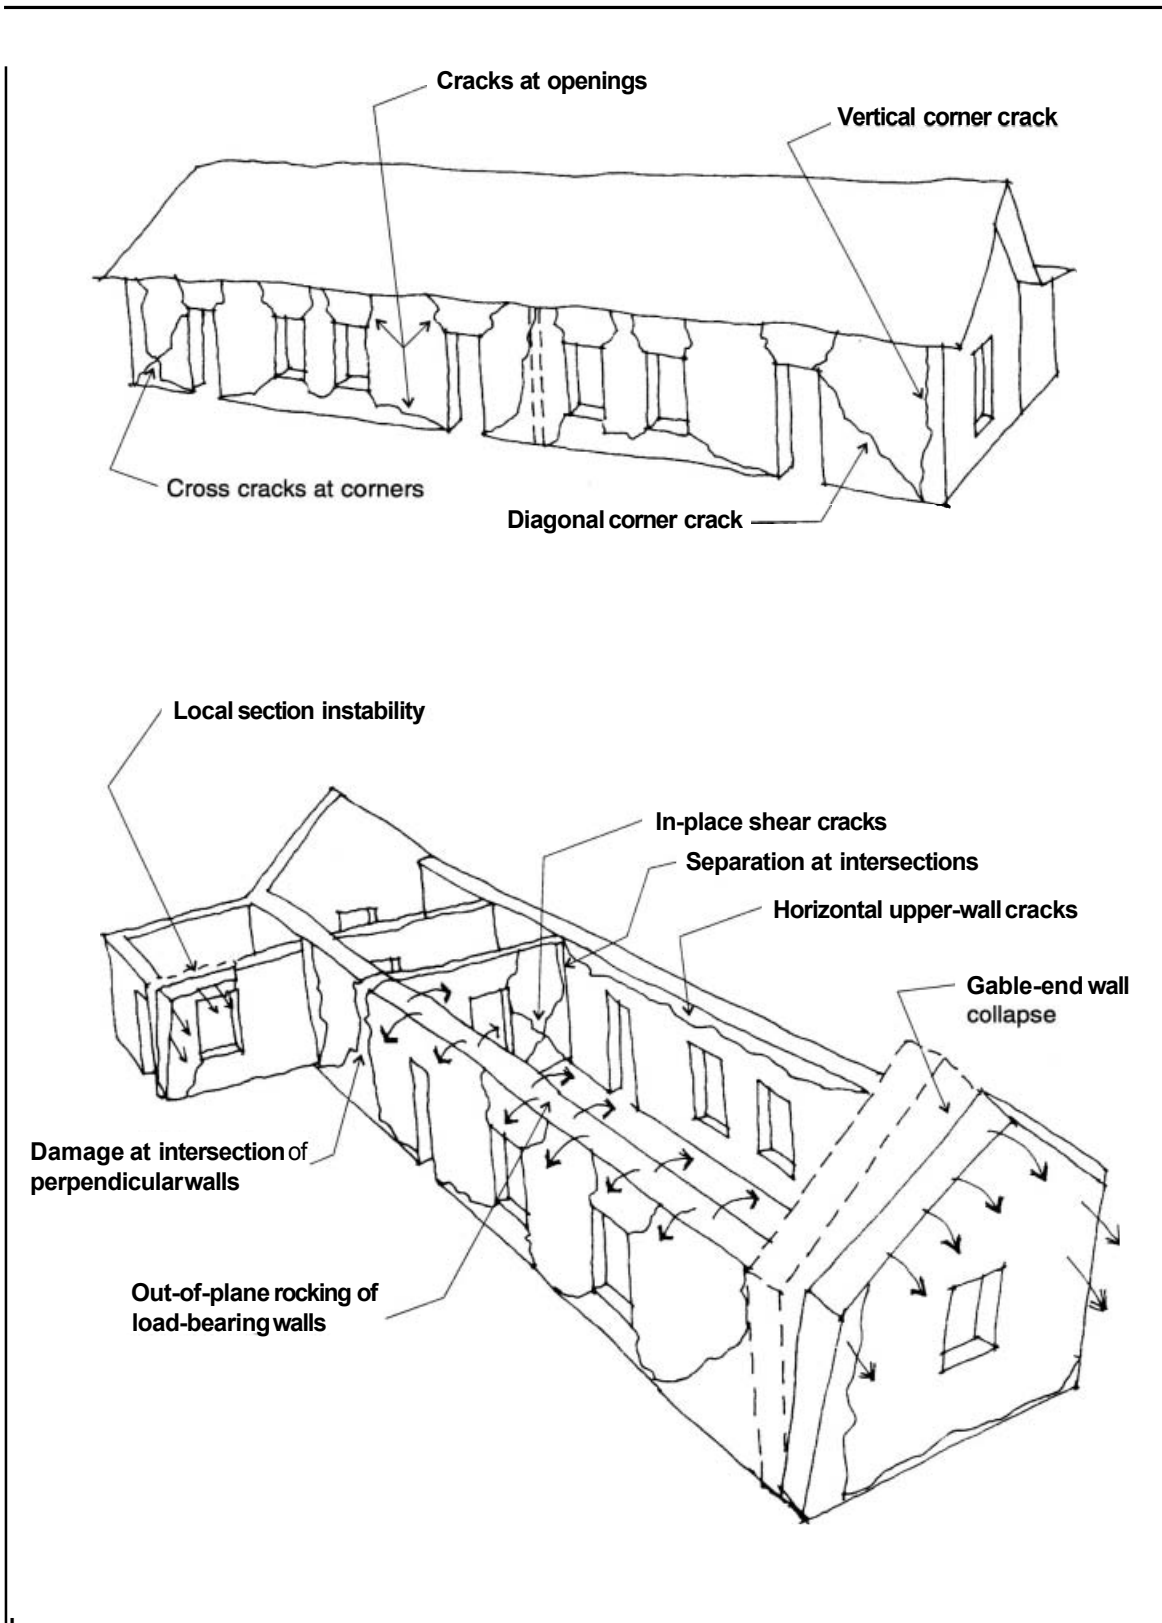
Figure 3.7. Typical failure typologies observed in historic adobe buildings after the Northridge earthquake.

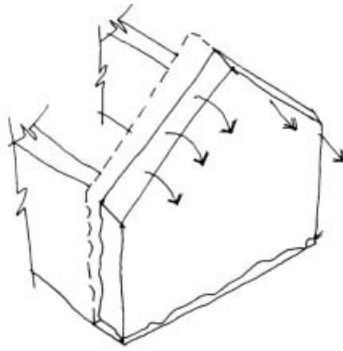
The De la Osa Adobe suffered the most complete collapse of any of the gable-end walls observed in the survey. The entire east end wall, starting at the base, overturned outward in one piece. The survey team was told that the window in the middle of the wall was still in the same relative position in the wall after the wall had collapsed.

Figure 3.2. *Diagram of complete collapse of gable-end wall.*

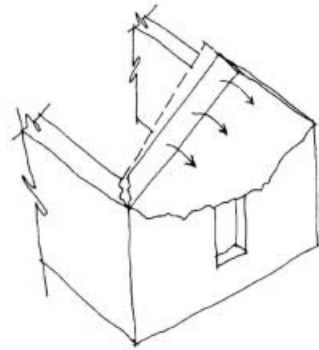
- overturning of the entire end wall, as occurred at the De la Osa Adobe (Figure 3.2);
- partial collapse of the upper level of the gable-end, as occurred at the Andres Pico Adobe (Figures 3.3–3.5);
- severe cracking without collapse, as occurred at Rancho Camulos.

Figure 3.3. *Diagram of the collapse of the upper portion of a gable-end wall.*

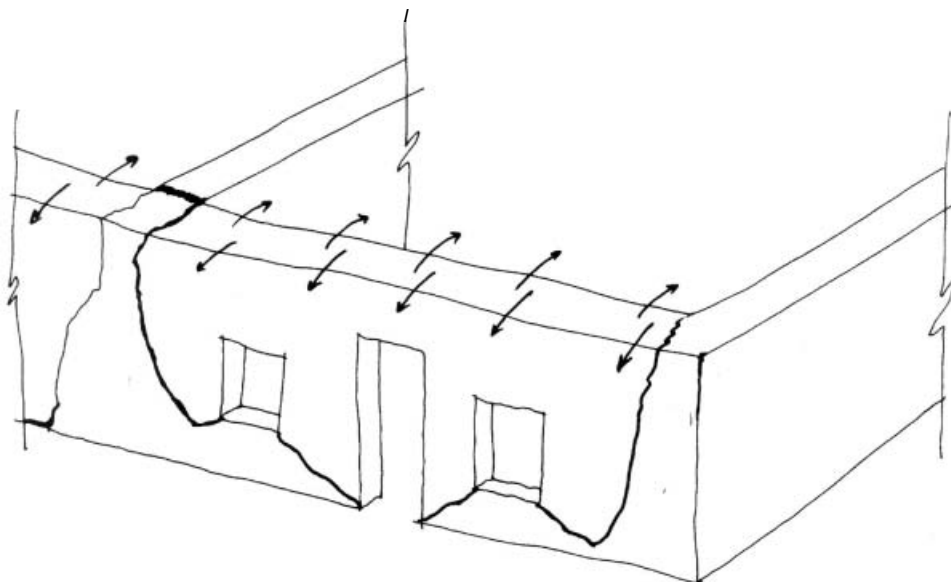
Out-of-plane flexural cracks are one of the first crack patterns to appear in an adobe building during a seismic event. This damage type and the associated rocking motion is illustrated in Figure 3.6.

Figure 3.6. Out-of-plane flexure of load-bearing walls.

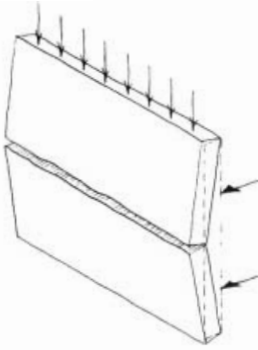
Figure 3.10.
Diagram of mid-height, out-of-plane flexural damage.

(Figure 3.10). This is a damage and potential failure mechanism usually observed only in thin-walled brick buildings.

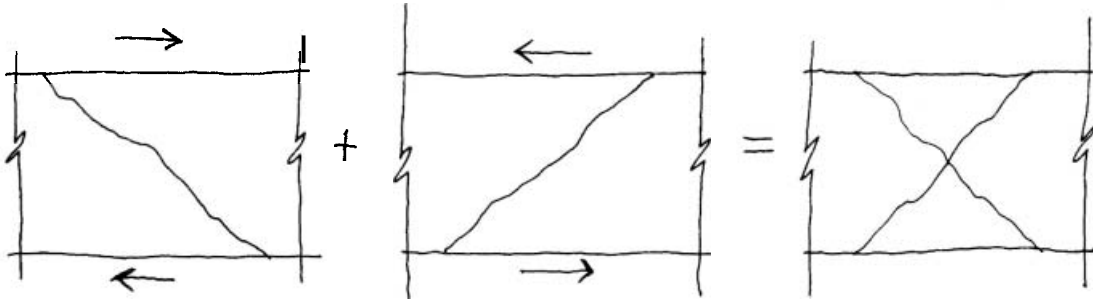
Diagonal cracks, as shown in Figures 3.11 through 3.13, are typical results of in-plane shear forces. The cracks are caused by horizontal forces in the plane of the wall that cause tensile stresses at approximately 45 degrees to the horizontal. The X-shape occurs when the sequence of ground motions causes the shear forces to go in one direction and then reverses and the shear forces go in the opposite direction (Figure 3.14). These cracks often occur in walls between openings.

Figure 3.14. X-shaped cracks result from a combination of shear cracks that have been caused by ground motion in two opposite directions.

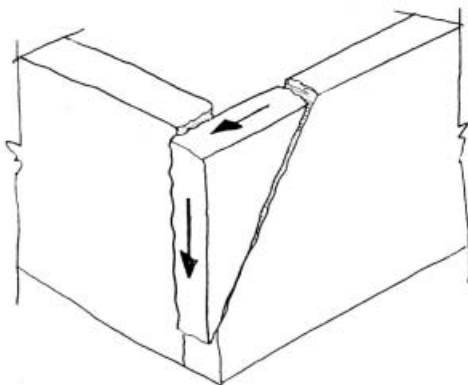
Diagonal cracks that start at the top of a wall and extend downward to the corner are caused by in-plane shear forces. This type of crack results in a wall section that can move laterally and downward during extended ground motions. This type of damage is difficult to repair and may require reconstruction. Illustrations of this damage type are shown in Figures 3.15 and 3.16.

Figure 3.15. Diagram showing vertical and horizontal displacement of a wall section at a corner.

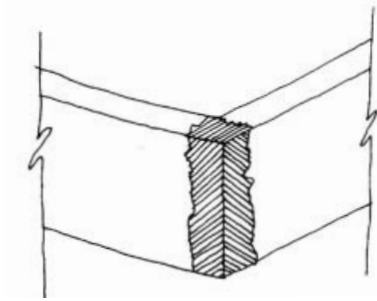
Vertical cracks often develop at corners during the interaction of perpendicular walls and are caused by flexure and tension due to out-of-plane movements. This type of damage can be particularly severe when vertical cracks occur on both faces allowing collapse of the wall section at the corner, illustrated by Figures 3.17 through 3.19.

Figure 3.17. Diagram showing how vertical cracks at a corner can lead to instability of the corner section of the wall.

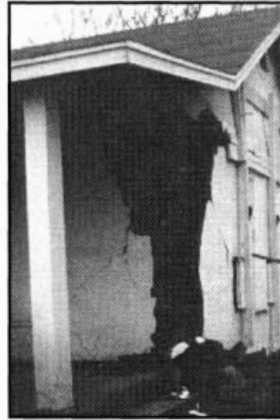
Figure 3.18. Sepulveda Adobe. Vertical cracks at this corner lead to collapse of the corner section.

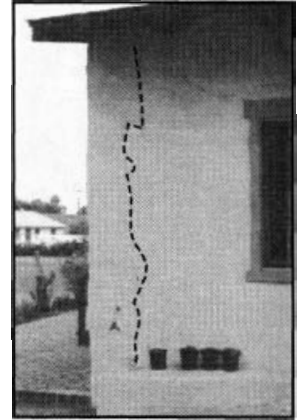
Figure 3.19. Pio Pico Adobe. Initiation of a vertical crack (dotted line along crack).

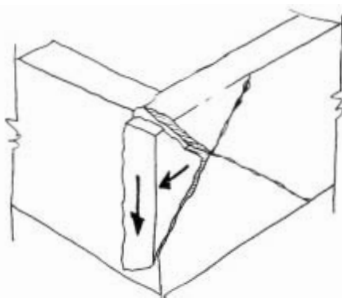
Figure 3.20. Diagram showing a combination of shear and flexural cracks that can lead to the instability to a portion of a wall after cracks have developed.

The combination of diagonal cracks and vertical cracks can leave an adobe wall severely fractured with several sections of the adobe wall susceptible to large offsets and/or collapse. An example of a wall section that is very vulnerable to serious damage is shown in Figure 3.16 and illustrated in Figure 3.20. The diagonal cracking at that location is at the southwest corner of the buildings leaving the cracked wall sections free to move outward.

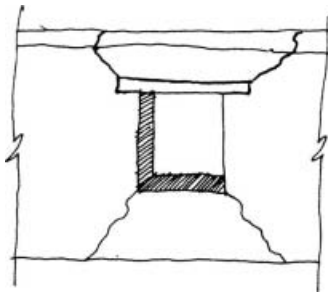
Figure 3.21. *Diagram of cracks that occur first at the upper corners of window openings and then at the lower corners.*

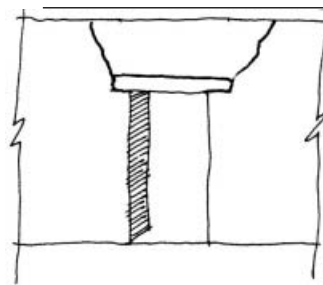
Figure 3.22. *Diagram of cracks at the upper corners of a doorway.*

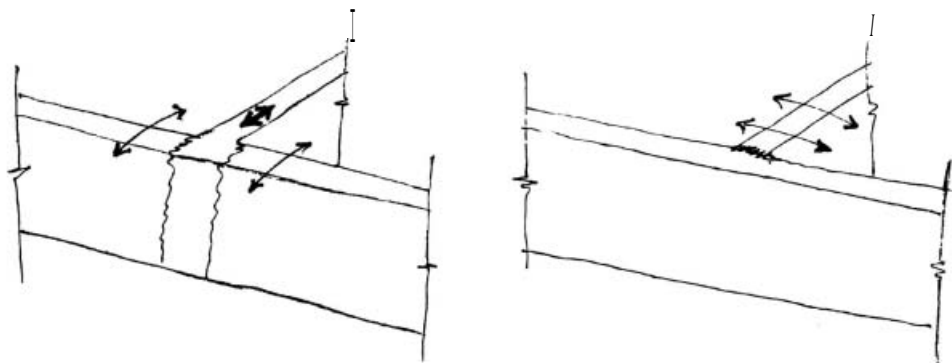
Figure 3.23. *Vertical cracks often develop at the intersection of perpendicular walls.*

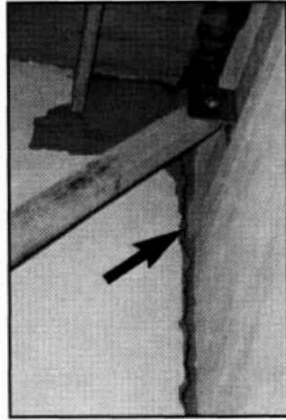
Figure 3.24. *Convento at the San Gabriel Mission. Separation between two interior walls.*

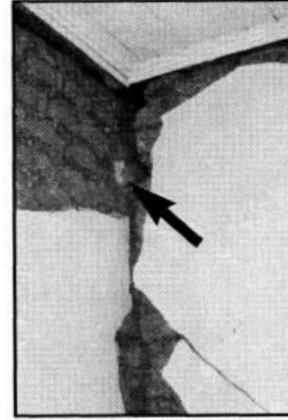
Figure 3.25. *De la Osa Adobe. Separation between interior wall (right) and exterior wall (left).*

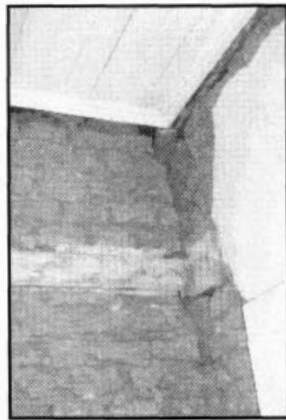
Figure 3.26. *Sepulveda Adobe. Slippage of ceiling relative to supporting walls.*

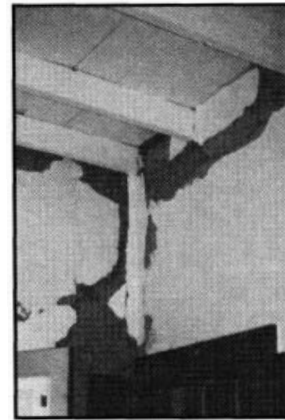
Figure 3.27. *Pio Pico Adobe. Slippage of tapanco floorjoists relative to supporting wall.*

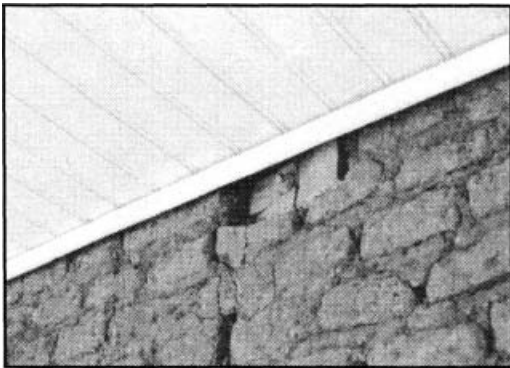
Figure 3.28. *Anchorage failure of steel tie rods. Anchor has pulled into wall allowing tie rod to sag and become ineffective.*

An anchorage at the De la Osa Adobe pulled into the wall and was ineffective in adequately restraining the out-of-plane motion of the wall (Figure 3.28). At another location in the De la Osa Adobe, cracks initiated at the anchorage location. However, there is little question that, regardless of the poor design of the tie-rod anchors at the De la Osa Adobe, they were effective in preventing more severe damage. At the Pio Pico Adobe, a few of the recently installed anchors attaching the attic (tapanco) floor to the exterior north wall were partially pulled out of the wall (Figure 11.4).

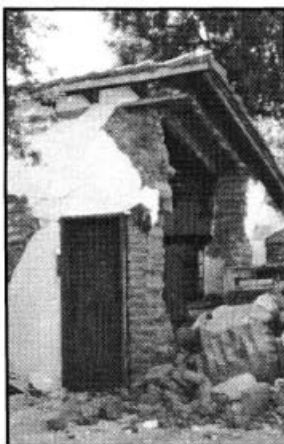
Figure 3.29. *Andres Pico Adobe garage structure. Failure was defined by cracks at the door and window openings. Also see Figure 3.23.*

openings are located too close to the corners. An example of this problem occurred in the garage of the Andres Pico Adobe. The collapsed corner is shown in Figure 3.29 and an explanation of the general problem is presented in Figure 3.30.

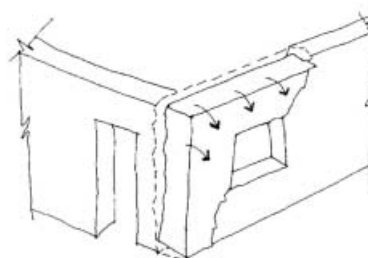
Figure 3.30. *A localized section of an adobe building may become unstable when the cracking pattern permits isolated wall sections to form which can lead to collapse.*

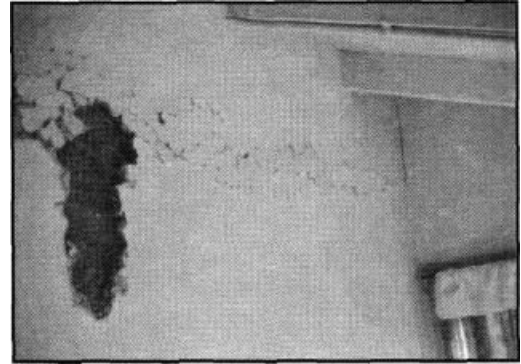
Horizontal cracks may occur in the upper section of walls when the walls are anchored to the roof system and/or when a bond beam has been installed. The cracks develop horizontally at or near the juncture of the wall and the bond beam or roof framing from either out-of-plane or in-plane movement (Figure 3.31). An example of this type of cracking occurred at the Lopez Adobe where a crack developed at the bottom of a concrete bond beam (Figure 3.32). The damage was not severe and the bond beam appears to have worked effectively.

Figure 3.32. *Horizontal cracking at the bottom of the bond beam, Lopez Adobe.*

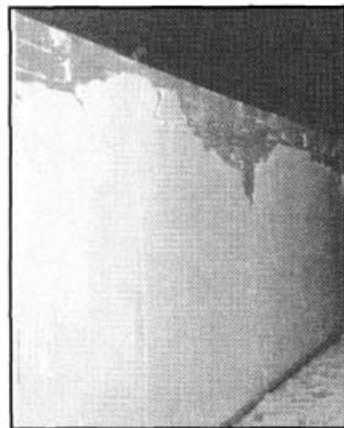
Figure 3.33. *Horizontal cracking in the upper section of the second story wall at the Andres Pico Adobe.*

Another example occurred in the upper section of the walls at the Andres Pico Adobe (Figure 3.33). From the evidence of this cracking, there appears to be some anchorage of the roof to the wall. Typically with no attachment, the roof or ceiling framing slips relative to the top of the wall before horizontal cracking develops.

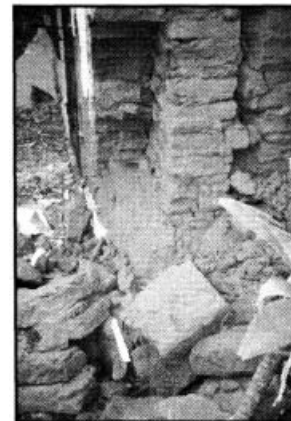
This condition is most clearly shown in Figure 3.35 where a corner of the kitchen wall at the Andres Pico Adobe failed. The adobe at the base of the wall has been weakened by repeated exposure to moisture causing the weak failure plane to develop. It appears that the wall slipped along this plane and collapsed.

Figure 3.35. *Moisture damage in this kitchen wall at the Andres Pico Adobe contributed to the collapse of the corner of the building.*

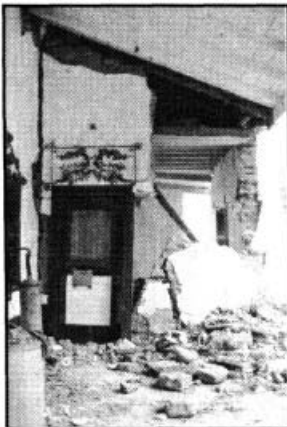
A similar failure mode is the probable cause of failure for several walls at Rancho Camulos shown in Figure 3.36. When a wall fails by overturning, the location of the rubble will be representative of rotation about the base. By contrast, the wall shown in Figure 3.36 appears to have collapsed down upon itself. The top of the wall is in the pile of rubble very

near to the original wall line. There is extensive moisture damage to many walls at Rancho Camulos; other collapsed walls at Rancho Camulos may have failed for the same reason.

Figure 3.36. *Collapsed wall of Ramona's room at Rancho Camulos. This thin, 12-inch-thick wall collapsed downward rather than falling outward. Moisture damage at the base of the wall contributed to the failure.*

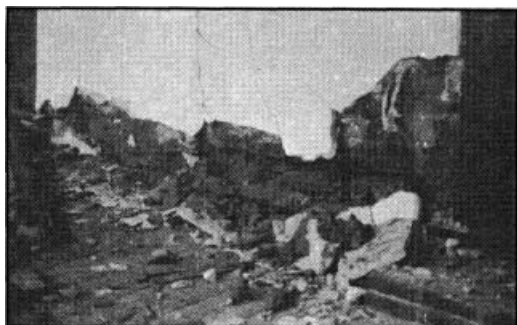
Figure 3.37. *Spalling of exterior stucco and adobe in a water-damaged section of wall at the Andres Pico Adobe.*

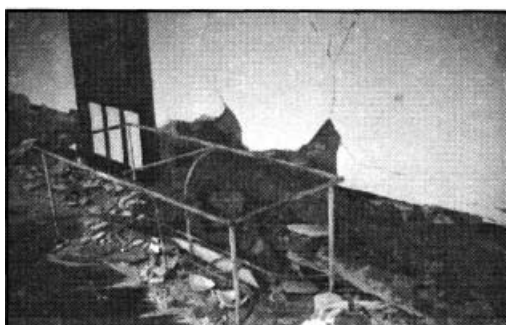
Figure 3.38. *A similar spalling of adobe and stucco on the exterior wall at the Del Valle Adobe at Rancho Camulos.*

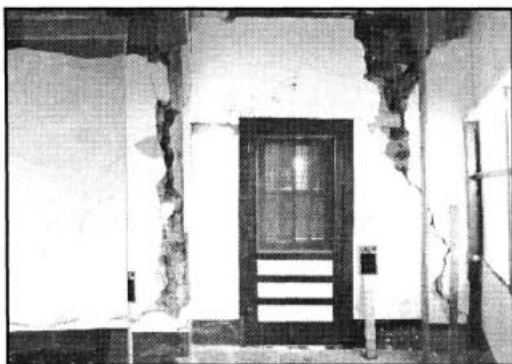
The stone-masonry north end of the west wing sustained major vertical separation cracks at the comers and a horizontal crack across the north wall at the window sill level, indicating out-of-plane rocking. However, at the east end of the wall, the crack pattern is

Figure 4.1. Northeast corner of west wing. Damage at the corner of the stone wall and at the interface between the stone and the adobe.

complicated by a major diagonal crack that runs from above the window lintel down to the base of the northeast corner. Damage to the northeast and northwest comers of this west wing are shown in Figures 4.1 and 4.2, respectively.

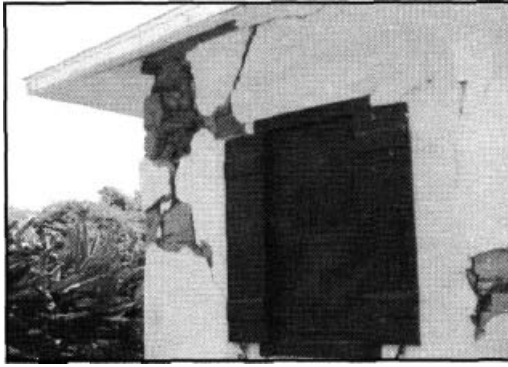
Figure 4.2. Northwest corner of the west wing. Damage at the corner of the stone wall.

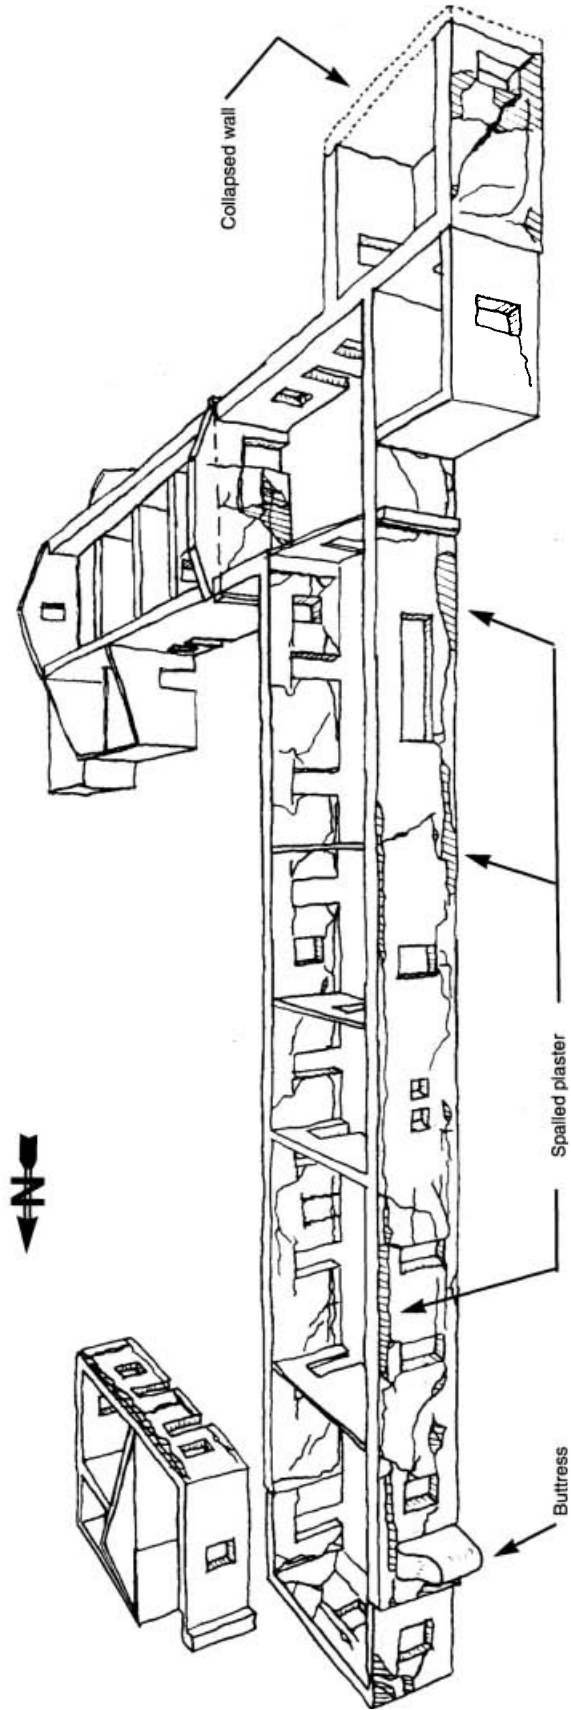
Figure 4.4. Drawing of Del Valle Adobe at Rancho Camulos, viewed from the west.

the adobe wall (Figure 4.4). There is a 3/4-inch separation between the wall and the top of the buttress at the top plate level. Several interior cross walls abut this long wall and provide restraint against inward motion. At a few locations, the horizontal crack pattern turns vertically, indicating the resistance of inward motion provided by the interior walls. The base of the wall has suffered severe moisture damage over a long period of time and has been patched with concrete, brick, and mortar. Much of the plaster along the base of the wall has spalled as a result of compressive stresses during rocking.

The south adobe wall of the southwest corner bedroom completely collapsed (Figures 4.4, 4.6, and 4.7), bringing down the ceiling joists and leaving nearly vertical interfaces at the abutting east and west walls. The roof remains intact as this south wall was not a primary load-bearing wall.

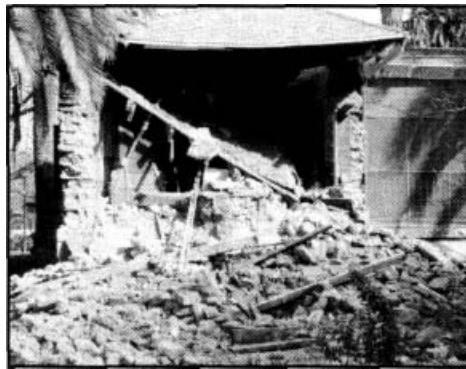
Figure 4.6. *Southwest corner bedroom. The south wall collapsed and the east and west walls of this room were also seriously damaged with large cracks and permanent offsets.*

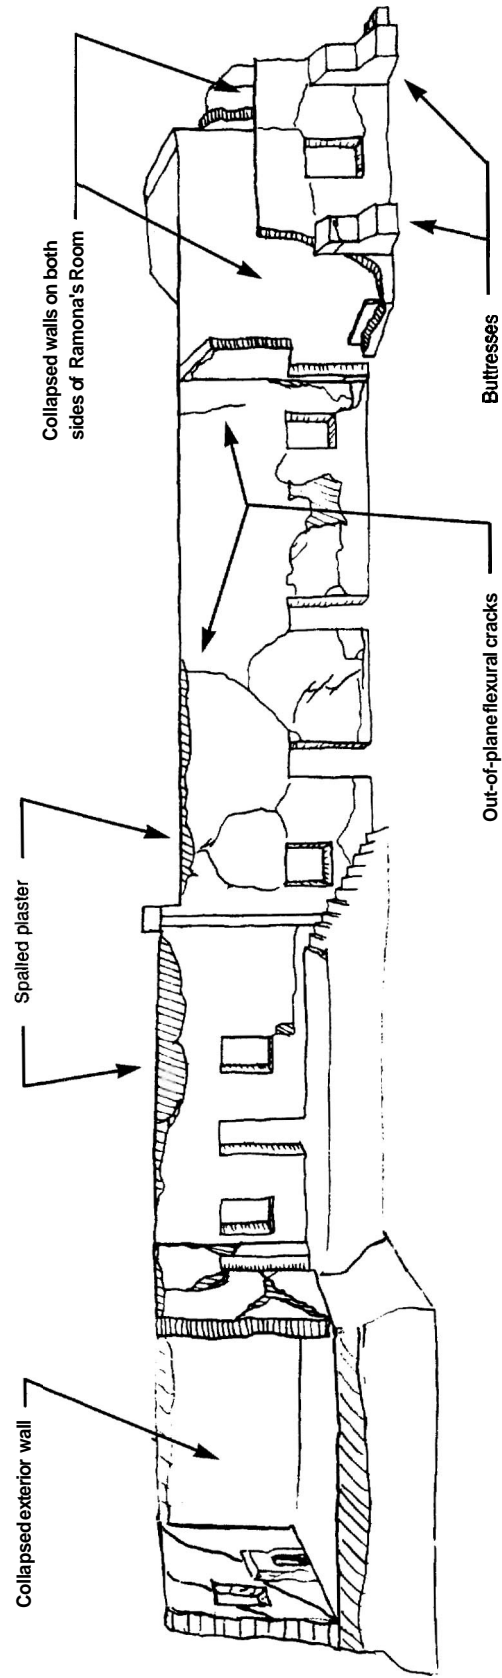
Figure 4.7. Drawing of Del Valle Adobe at Rancho Camulos. south elevation.

The south wall of the south wing changes elevation between the drawing room and the library. There is also a wooden pilaster at this juncture that anchors a steel tie rod that spans between the exterior long walls. Damage to the south wall appears to be mostly related to out-of-plane rocking with horizontal cracks and plaster spalling extending along the base of the wall at the lintel level and at the top plate level as well as vertical cracks at the cross walls and at mid-span between them (Figure 4.7). Adobe cross walls provide

Partial collapse of the west and south walls and complete collapse of the east wall occurred (Figures 4.7 through 4.9) during the Northridge earthquake. However, because the central portion of the south wall was supported by two buttresses, the ceiling did not collapse. It appears that much of the collapse mechanism was the result of through-wall shear failure of the water-damaged adobe cross-section at the base, as seen in Figure 4.8. This failure mechanism contrasts with overturning failure in which the entire wall collapses by falling outward perpendicular to the plane of the wall.

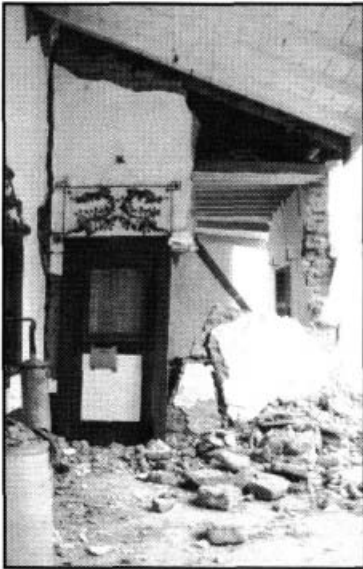
Figure 4.8. *West wall of Ramona's room. The majority of this wall collapsed leaving only the section of wall that is above the door.*

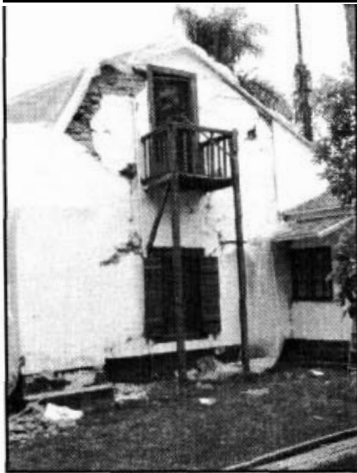
The east gable-end wall suffered severe crack damage (Figures 4.10 and 4.11) but did not collapse. The cracks in this wall extend upward from the top of the door, upward from the bottom of the door, between the door and windows, and horizontally from the top of the window. This section of wall is partially restrained by the roof rafter at the top edge of the wall.

There is a separation crack of 1 1/2 to 2 inches at the top of the buttress on the east wall and a horizontal crack at the base of the buttress, indicating that it rocked outward away from the east wall. The crack pattern in this wall suggests a mixture of out-of-plane flexure at the upper floor level and in-planeracking of the entire wall.

Figure 4.10. Gable-end wall of the south wing. The crack damage to this wall was extensive with cracks emanating from the corners of the door and window. Some restraint is provided on the inside of the wall by interior paneling.

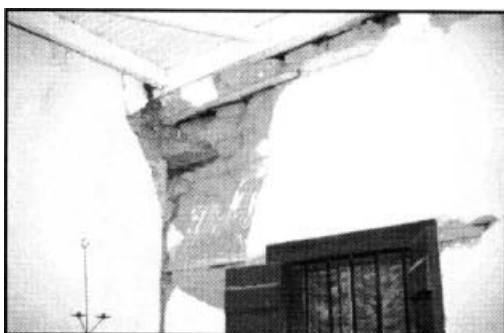
Figure 4.14. *Damage to the adobe at the reentrant corner of the L-shaped main residence. The adobe at this intersection was severely broken and some of the adobe spalled.*

At the west end of this wall is a reentrant corner where it abuts the east wall of the west wing. Damage to the adobe at this location is severe (Figure 4.14), showing the effects of separation, pounding and out-of-plane rocking.

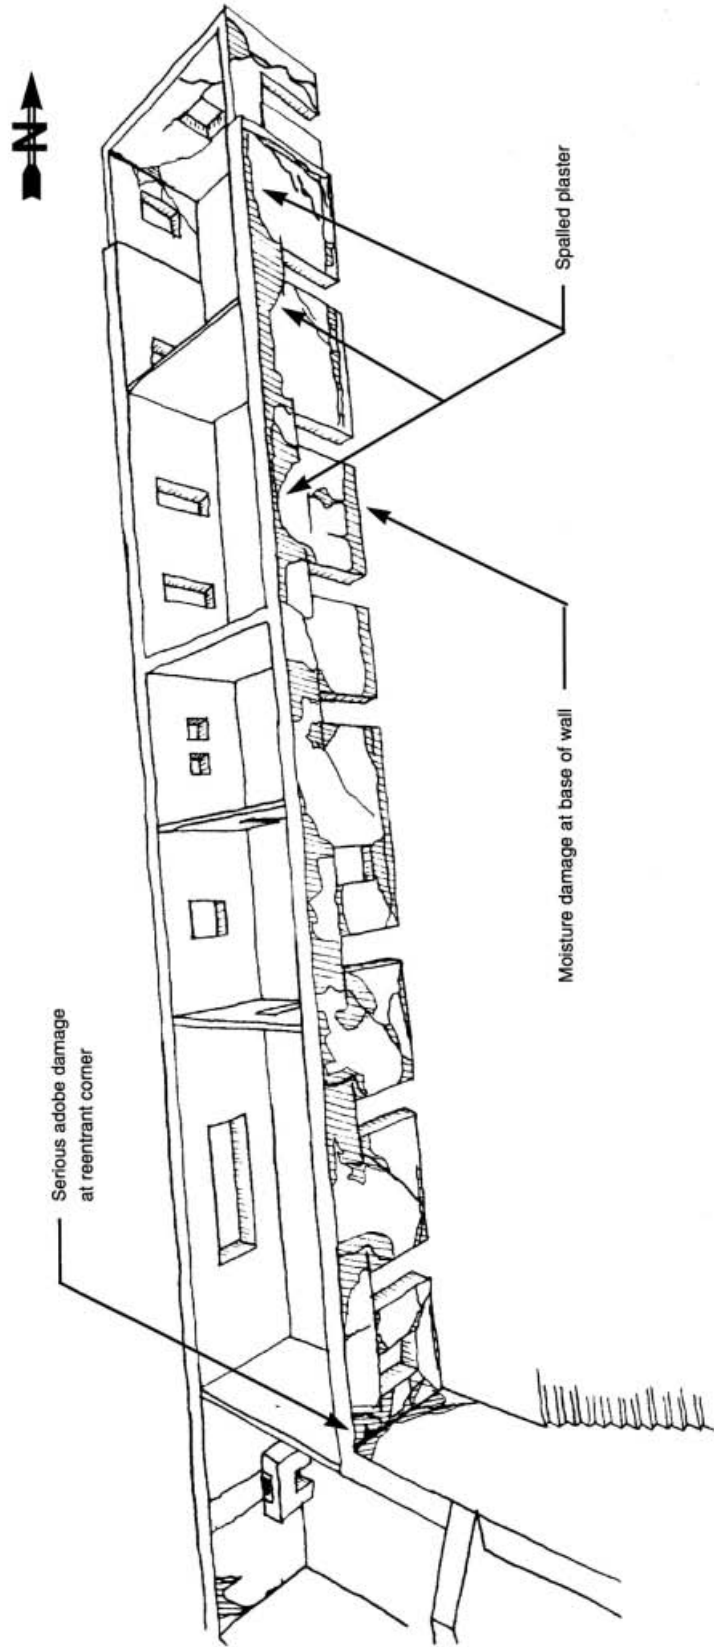
Figure 4.15. Drawing of Del Valle Adobe at Rancho Camulos. West wing viewed from the east.

The east wall of the west wing is long and, like the west wall, has almost no out-of-plane support except for a few interior wood-frame and one adobe cross wall (Figure 4.15). The crack damage along this wall includes diagonal shear cracks in most of the wall sections, usually starting at the lintel level and proceeding downward to the base of the wall. A couple of the wall sections with both door and window openings show evidence of in-plane pier rocking.

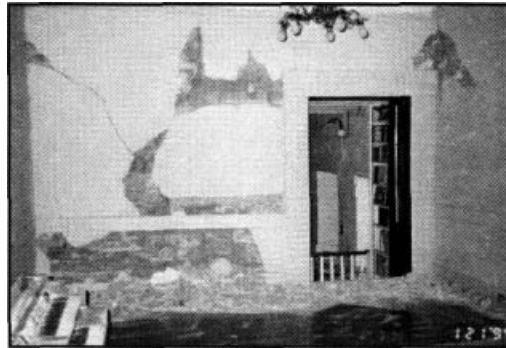
Figure 4.17. *Interior cross wall on west side of library. Diagonal shear cracks start at upper left and a gap between this wall and the exterior wall opened as shown on the right. The damage in the center of the wall reveals infilled openings, one above the other.*

Of particular note are the east and west cross walls of the library. In addition to the 2-inch separation gaps at the south longitudinal wall, there are significant diagonal cracks starting at the upper north corners and extending downward and across toward the south. In the west library wall the crack pattern is complicated by the presence of infilled door and/or window openings, one above the other. This was formerly the west exterior wall of the original adobe structure with a tapanco (loft) access high in the wall (Figure 4.17).

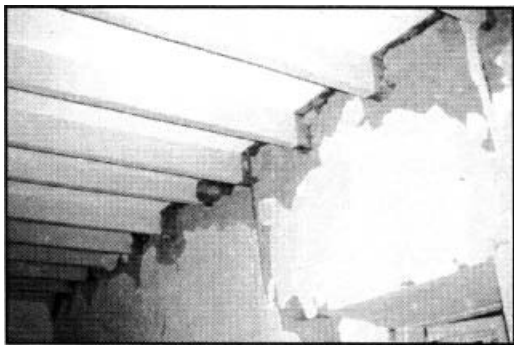
slid on top of the walls, causing adobe and plaster damage (Figure 4.18). Other damage was moderate but greatly influenced by preexisting conditions such as possible moisture damage to the east end wall and previously patched crack damage on the north wall.

Figure 4.18. *Damage at the interface between the ceiling joists and the adobe walls. This was typical throughout the structure.*

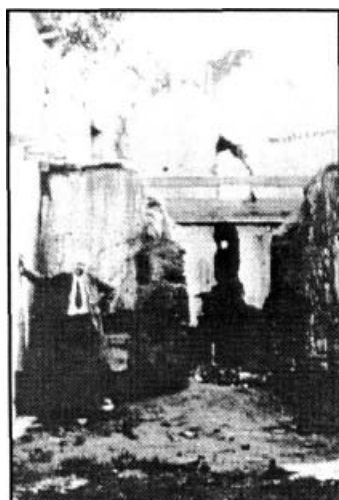
Figure 5.3. *The Andres Pico Adobe south wall before reconstruction, approximately 1930 (source: San Fernando Valley Historical Association).*

Historical photographs show that the south gable-end wall was badly cracked at the time of the Harrington rehabilitation. Cracks in the south gable-end wall were also observed and recorded in 1991 during the initial survey by the Getty Seismic Adobe Project team.

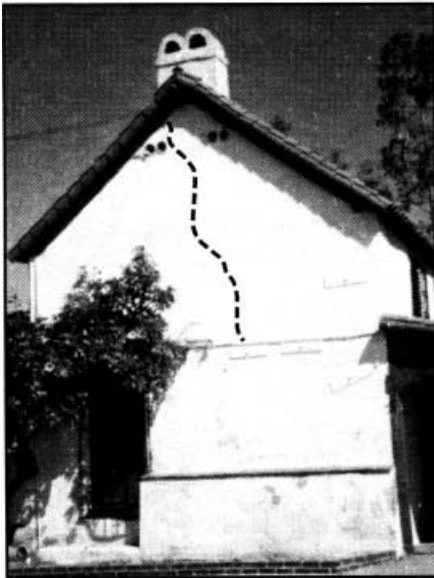
Figure 5.9. Drawing of damage to the Andres Pico Adobe from the southeast corner after the 1994 Northridge earthquake.

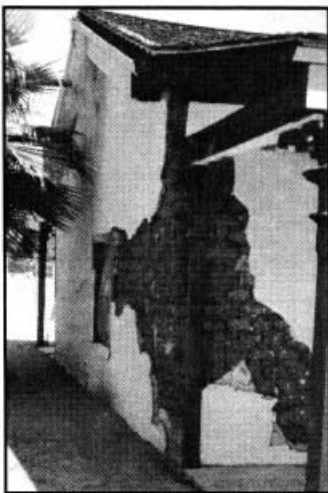
The upper half of the west gable-end wall is leaning outward, rotated about a horizontal crack that extends across the wall at the window level and pulled away from the north and south longitudinal walls 3 to 4 inches at the southwest corner. A vertical section of the southwest corner has also collapsed (see Figure 6.7).

Figure 6.7. West gable-end wall. A horizontal crack extends from the south wall to the north wall. The lower section is leaning outward. This wall is very susceptible to collapse.

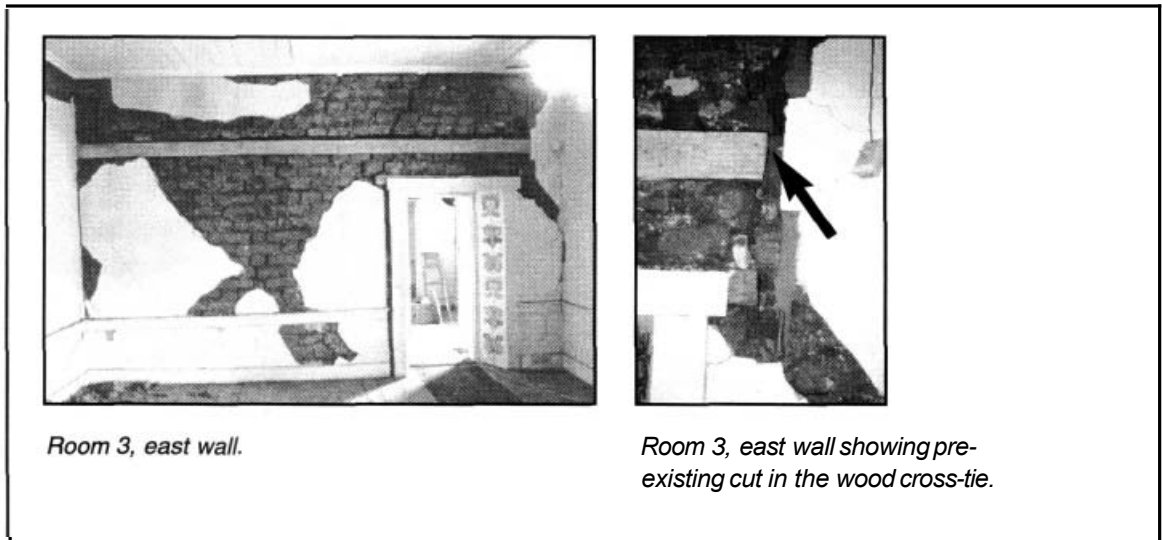
Figure 6.10. Wall between Rooms 2 and 3.

The transverse wall between Rooms 2 and 3 suffered a large separation crack near the south wall where the wooden tie beam was cut (Figure 6.10). A large X-shaped shear crack pattern is clearly visible on the west surface of this wall.

Room 3, east wall.

Room 3, east wall showing pre-existing cut in the wood cross-tie.

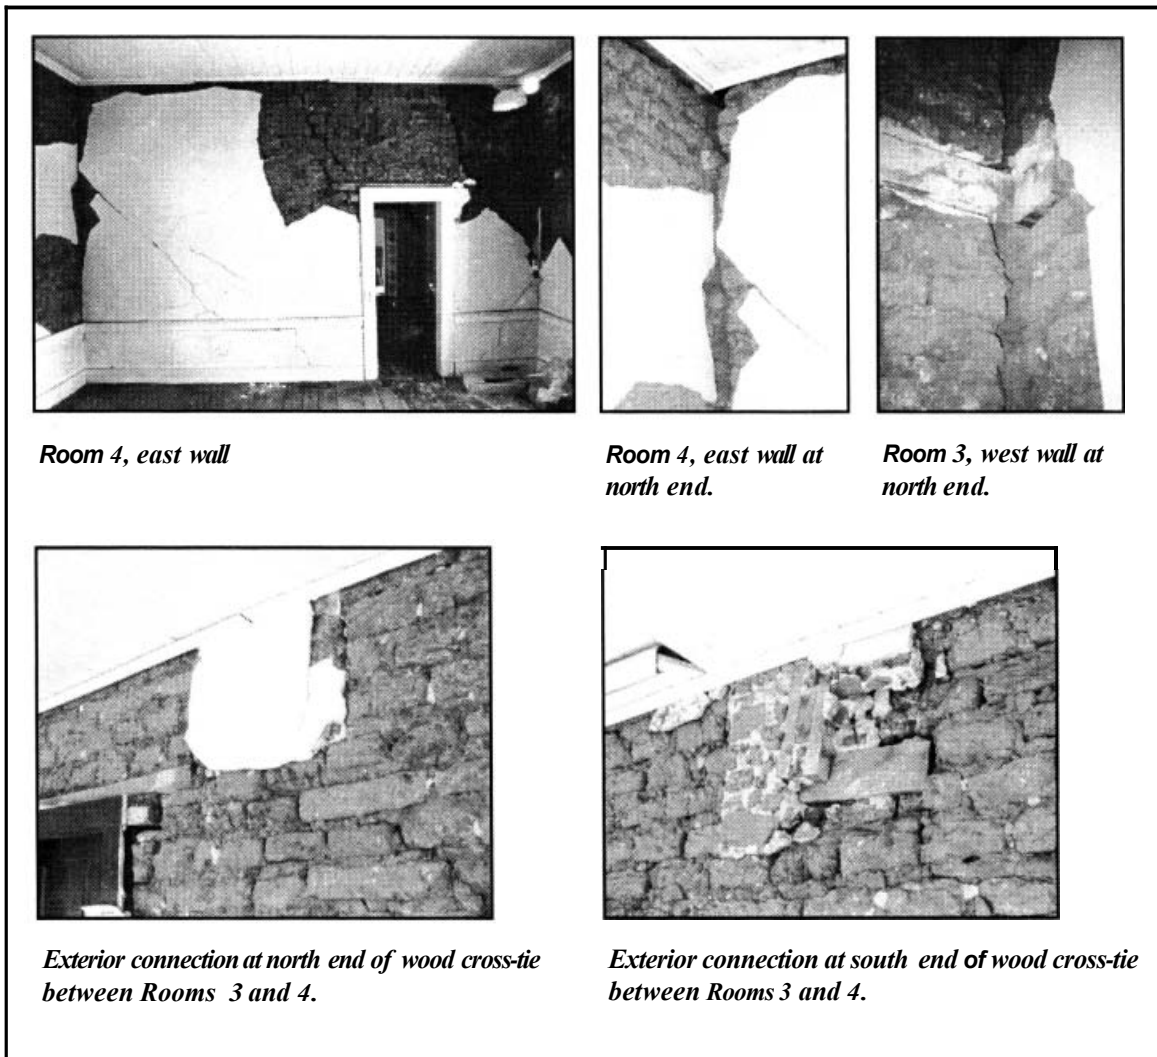
Figure 6.11. *Wall between Rooms 3 and 4.*

The transverse wall between Rooms 3 and 4 suffered substantial damage (Figure 6.11). A large vertical separation crack, 2 inches wide, occurred at the north wall

where anchorage of the wooden tie beam partially pulled through the exterior wall. This anchorage suffered damage at some earlier time and had been previously repaired. The failure at the anchorage permitted the separation between the transverse and exterior walls. Other crack damage includes vertical cracks at the corners of the doorway lintel. Horizontal separation at these cracks is in the range of 1 to 2 inches.

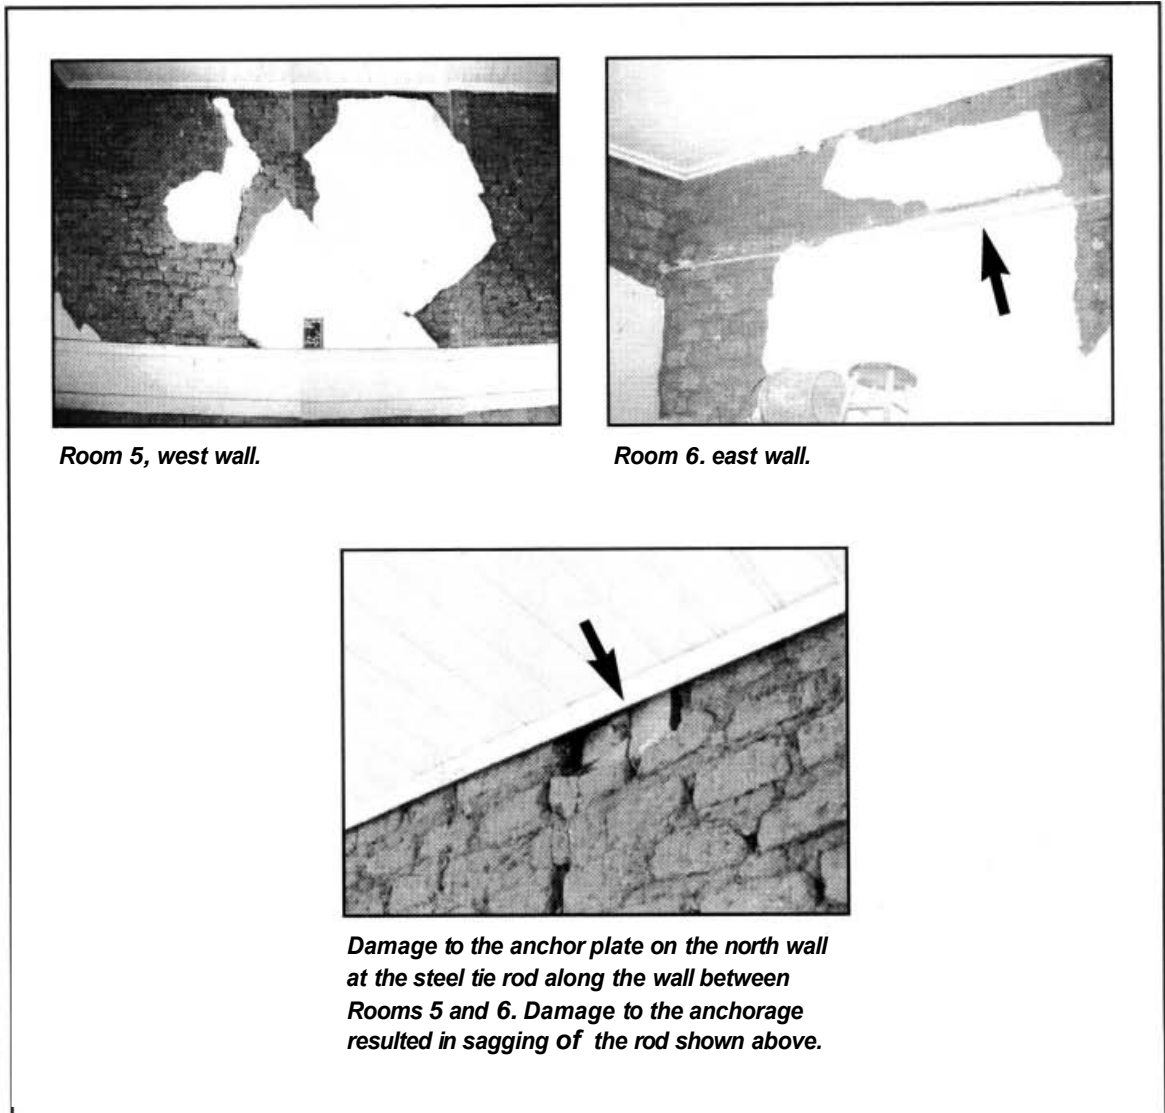
Figure 6.12. *Walls between Rooms 5 and 6.*

The transverse wall between Rooms 5 and 6 has an old vertical crack near the center of the wall that was previously patched with rubble and plaster. The steel tie rod on the

west surface of the wall is sagging about 4 inches at mid-span, resulting from the anchorage at the north wall being partially pulled through the exterior wall. A vertical separation crack has opened up at the north wall, and a wedge has formed at this end

with a diagonal crack starting at the ceiling and traversing the wall downward toward the north corner. Photographs of this wall are shown in Figure 6.12.

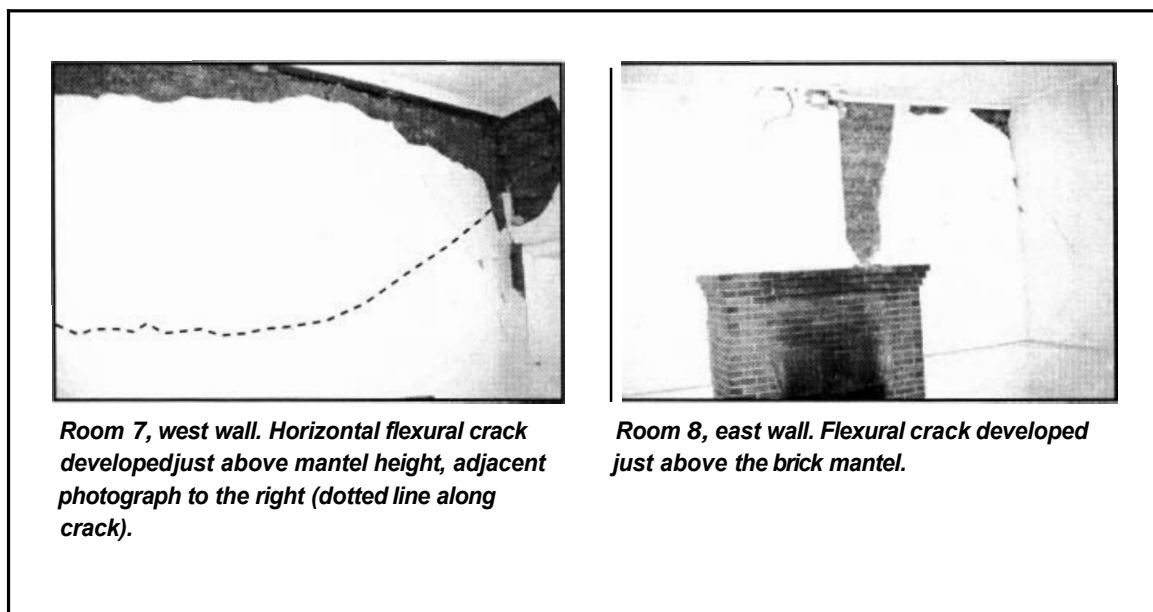
Figure 6.13. Wall between Rooms 7 and 8.

The transverse wall between Rooms 7 and 8 has a brick fireplace and chimney on the west side (Figure 6.13). It also has a steel tie rod connecting the north and south walls. This cross-tie did not pull through the exterior walls and therefore kept the long walls tight against the transverse wall. Damage to the wall was dictated by the presence of the chimney and mantel. It appears that the upper half of the wall rocked in a flexural mode about a horizontal crack at the mantel height that turns upward toward the north and south walls. The out-of-plane motion of the wall apparently pushed the ceilings on both

sides away 1 to 2 inches. An old vertical crack defined by the chimney also reopened. Separation at the north and south walls is minimal.

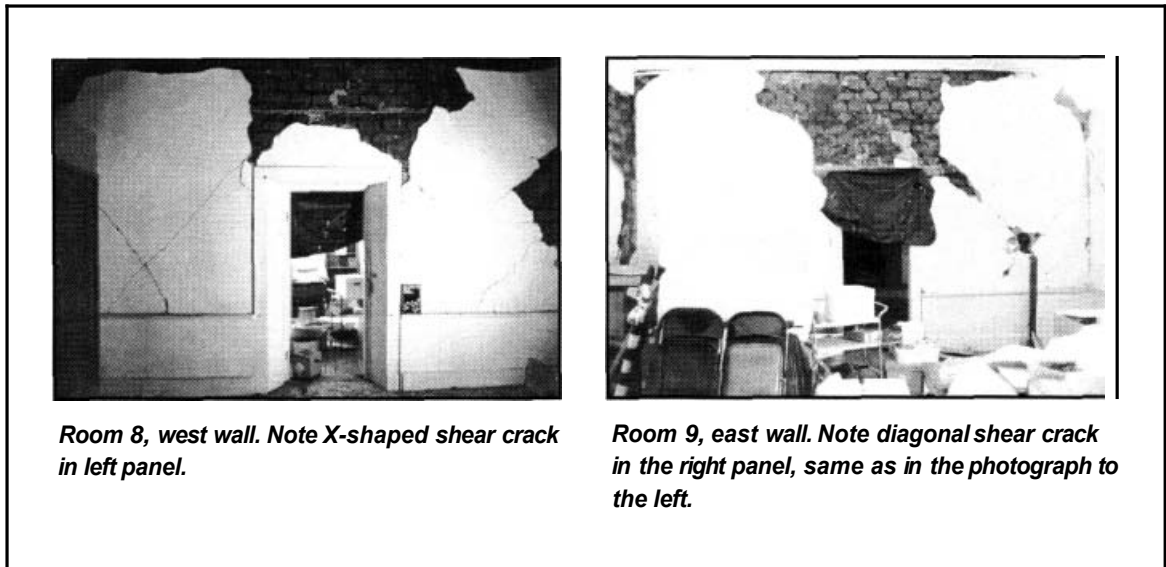
Figure 6.14. Wall between Rooms 8 and 9.

The cross-tie on the east side of the transverse wall between Rooms 8 and 9 was also not damaged, and the crack damage to the wall was moderate (Figure 6.14). There are no large offsets or separations between this wall and the exterior walls as the tie rod apparently held the north and south walls relatively tight to the cross wall.

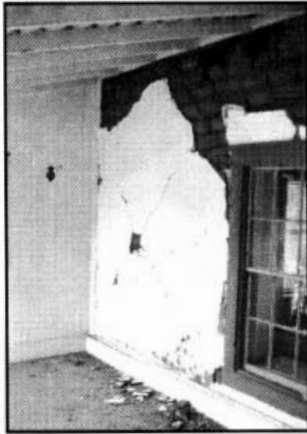
Figure 7.3. Crack damage in the south second-floor wall near the southwest corner. X-shaped cracking across this panel indicates shear failure.

The load-bearing north and south walls at the second-floor level suffered moderate to extensive crack damage that appears to have resulted from both in-plane and out-of-plane motions. A classic X-shaped shear crack developed at the west end of the south wall (Figures 7.3 and 7.5). A steeper diagonal crack that turns vertically upward at the west end is also present. At the east end, a vertical separation crack developed at the corner along with a 45-degree diagonal crack extending from mid-height of the southeast corner down toward the baseboard (Figure 7.4). A horizontal crack extends the length of the wall at the base. Both the vertical and diagonal cracks at the east end of the south wall are believed to have been caused by out-of-plane motion of the wall.

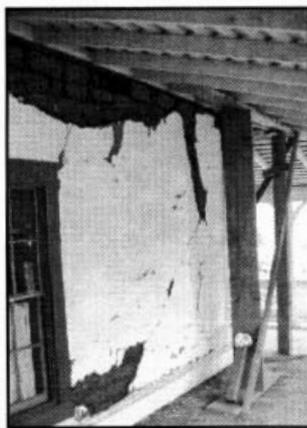
Figure 7.4. Crack damage in the south, second-floor wall near the southeast corner. The diagonal crack indicates a probable shear failure.

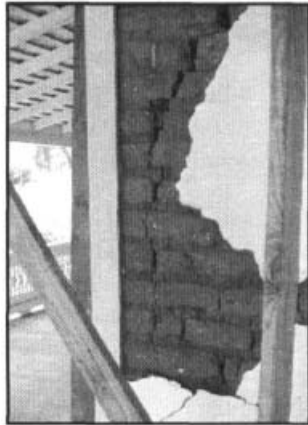
Figure 7.7. Vertical crack in the east face of the southeast corner of the second floor. The width of the crack is approximately 1 1/2 inches. A crack of this nature develops because of the tensile stresses in the adobe that develop as the south wall pulls away from the east wall.

(Figures 7.7–7.10). Both of the separation cracks of 1 to 2 inches in width were caused by tensile stresses in the adobe at the intersections of perpendicular walls. The diagonal crack extends from the southeast corner up to the wall top plate. This crack, which resulted from in-plane shear forces, has a horizontal offset of approximately 1 inch.

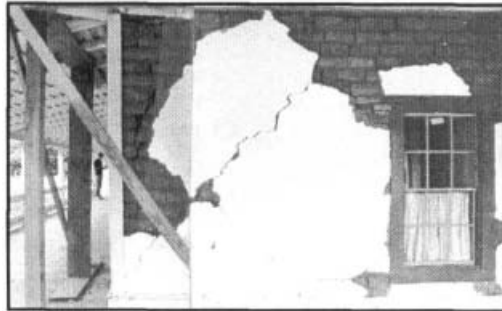
Figure 7.8. Diagonal crack on the east side of the southeast corner of the second floor. The width of the crack is approximately 1/2 inch. This type of crack can develop at corners, creating a wedge of material that will slide towards the corner

The diagonal crack in the east wall near the southeast corner also is serious because of the permanent offset. This crack was probably caused by a combination of in-plane shear in the east wall and the pullout forces generated by the out-of-plane motions of

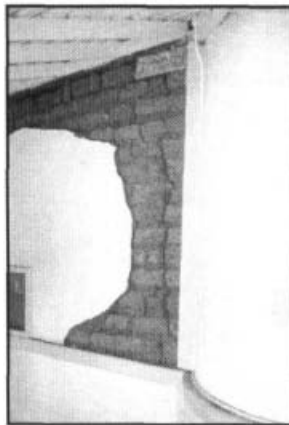
Figure 7.9. Vertical crack on the east side of the northeast corner of the second floor, similar to the cracks on the south end of this wall. A crack of this nature develops because of the tension in the adobe that developed when the south wall pulled away from the perpendicular wall.

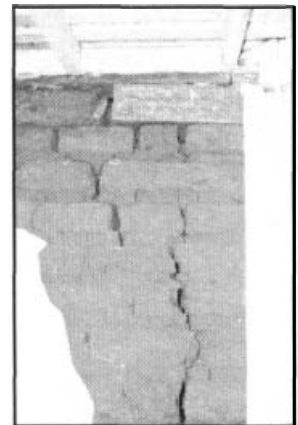
Figure 7.10. Close-up of crack shown in the previous photograph. The width of this crack is approximately 3/4 inch.

Four of the largest cracks are vertical separation cracks at the corners due to separation of the long walls from the transverse end walls during the out-of-plane rocking. Corners of adobe walls are susceptible to collapse because vertical cracks often develop on adjacent wall faces at the corner. This condition occurred at the southeast corner where the corner section of wall is nearly freestanding and could collapse outward during another shake; it was also observed at several of the other adobes in this survey. A similar set of vertical cracks has begun to develop at the same corner on the first floor (Figures 7.10 and 7.15).

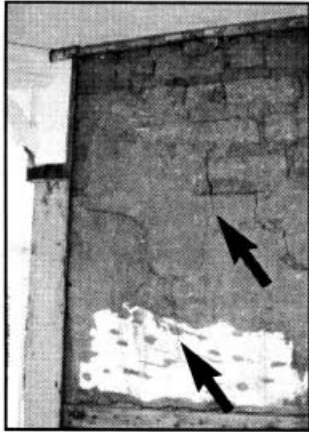
Wood siding covers most of the interior and exterior first-floor walls so that they could not be observed. Siding removed at the southeast corner revealed only slight crack damage (Figures 7.11 and 7.12). Slight cracking was also observed on the west

Figure 7.11. Southeast corner at the first-floor level. The damage is significantly more severe on the second-floor level directly above (Figure 7.7). The photograph shows a vertical crack at the interface of the two perpendicular walls and a diagonal shear crack that extends down to the right.
