Survey of Damage to Historic Adobe Buildings After the January 1994 Northridge Earthquake

E. Leroy Tolles
Frederick A. Webster
Anthony Crosby
Edna E. Kimbro

GCI Scientific Program Report 1996

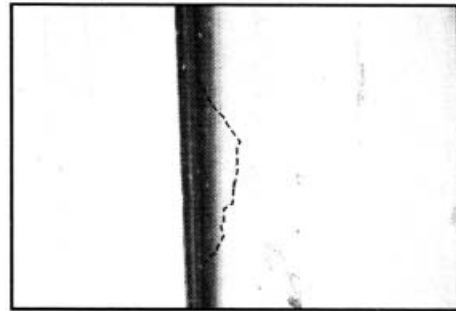
Figure 7.12. Slight crack at the edge of the wood-paneled south wall at the southeast corner at the first-floor level. The crack appears to extend the height of the wall. The photograph shows a vertical crack at the interface of the two perpendicular walls and a diagonal shear crack that extends down to the right (dotted line along crack).

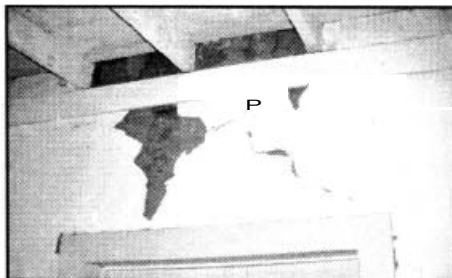
Figure 7.13. Crack damage over the doorway in the west wall, shed roof area, first-floor level. This area appears to have been previously damaged. A steel channel is hidden behind a horizontal wood element and anchored with lag bolts to a second-floor joist on the opposite side.

surface of the west wall at the first-floor level (Figure 7.13). This damage may have existed prior to the Northridge earthquake.

At the first-floor level the west wall suffered only minor vertical and diagonal cracks above the door lintel (Figure 7.13). It appears that the vertical crack is an old crack that reopened. These cracks are not typical of earthquake damage and may indicate a preexisting condition. It is unknown when the steel channel section was added to the wall, but it may have been in response to previous earthquake damage (Figure 7.14). The addition of this channel adds in-plane continuity and out-of-plane stiffness to the wall and may have helped to prevent additional damage.

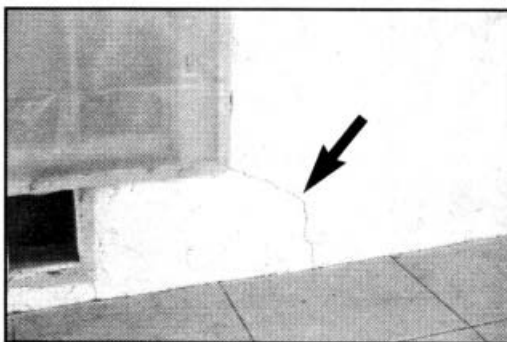
Figure 8.4. *Minor cracking to exterior stucco. All of the cracking to the exterior stucco is minor. This is one of the larger cracks.*

inspection of the adobe (Figures 8.4 and 8.5). The crack damage is more visible on the interior of the building where there is no stucco and wire-lath coating. There is wall cracking at the first-floor level, particularly within the living room. At the second-floor level the crack damage is concentrated at the interface between the concrete bond beam and the adobe wall.

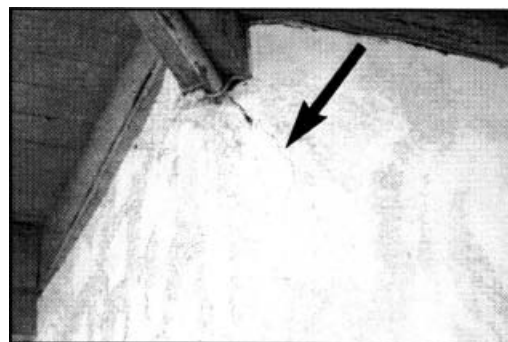
Figure 8.5. *Minor crack in the exterior stucco at the northeast corner of the building below the balcony. The crack extends to just above the balcony.*

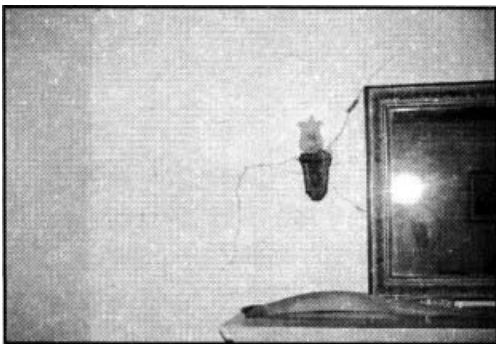
Crack damage at the first-floor level was slight to moderate. There are slight hairline cracks in the exterior plaster. However, damage is more visible on the interior. The south wall of the living room has cracks around the fireplace and hairline cracks at the corners of the doorway (Figure 8.6). The north wall of the living room has a horizontal crack that extends from the top of the window to the top of the doorway (Figure 8.7). The east wall of the living room is an interior wall, 12 inches thick, and has suffered some damage at the top of the arched doorway, which is wood-framed and finished with plaster in this area.

Figure 8.6. *Cracks in the south wall of the living room. Crack damage was more visible on the inside of the building.*

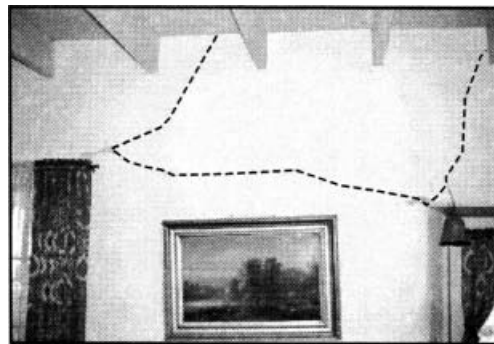
Figure 8.7. *Minor cracking on the north wall of the living room (dotted line along cracks).*

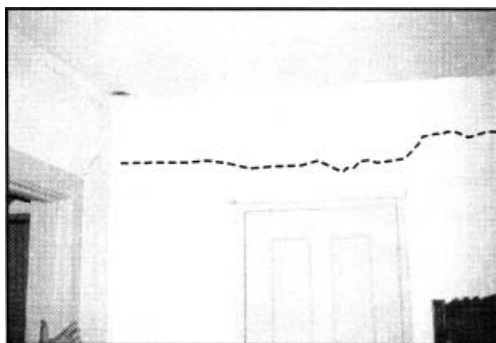
Figure 8.8. *Horizontal crack in an upstairs bedroom. A horizontal crack was apparent in several locations at the base of the concrete bond beam (dotted line along crack).*

Cracks developed in several locations along the base of the concrete bond beam at the second-floor level (Figure 8.8). However, there is no evidence of permanent offset. Horizontal cracking was observed on both the interior and exterior at the bond beam level, particularly on the south and west faces of the building near the southwest corner (Figure 8.9).

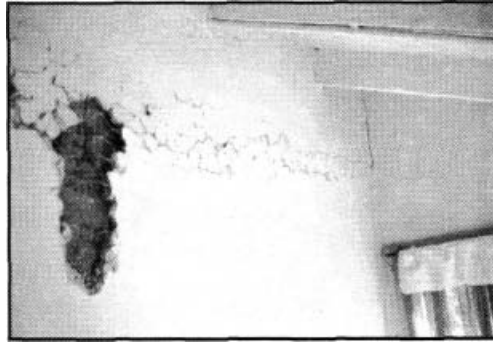
Figure 8.9. *Damage to the plaster inside the porch on the west side of the building at the bond beam level.*

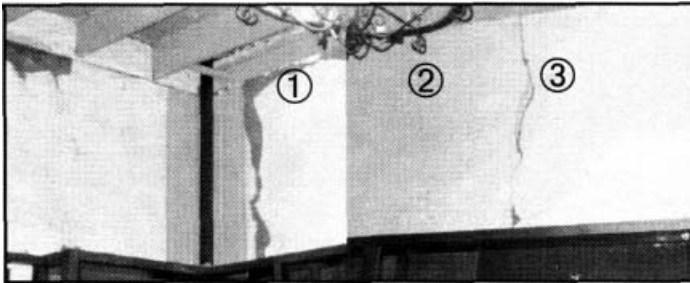
The condition of the convento was observed in 1991 by an inspection team as part of the Getty Seismic Adobe Project. Most of the cracks observed after the Northridge earthquake already existed following the Whittier earthquake; they only enlarged and caused greater instability. As an example of the increased damage, Figure 9.2 shows the condition of a portion of the building in 1991 and Figure 9.3 shows the same wall in 1994, following the Northridge earthquake.

Figure 9.2. Crack damage to interior cross walls of Room 10 after the Whittier earthquake. The crack damage worsened after the Northridge earthquake (see Figure 9.3; numbers identify cracks for matching to those in Figure 9.3).

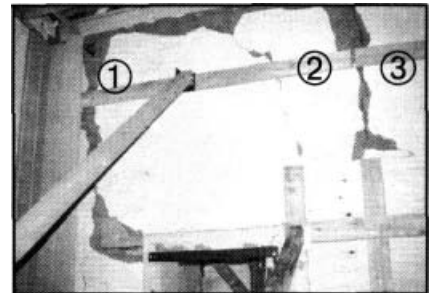
Figure 9.3. Recent condition of the wall at the northwest corner of Room 10. Cracks have worsened since 1991 (see Figure 9.2 for condition prior to Northridge earthquake).

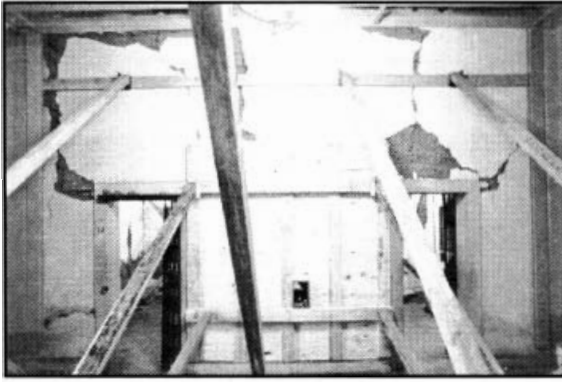
Transverse interior walls sustained crack damage that is more clearly a function of out-of-plane bending and displacements. The crack pattern that most clearly demonstrates the effect of out-of-plane bending is shown on the south wall of Room 10, between Rooms 9 and 10 (Figures 9.4 and 9.5). Here the crack pattern is dominated by flat-plate yield lines, the plate (adobe wall) being supported along three edges (top edge not supported). Yield lines, or flexural cracks, develop along lines of maximum flexural

Figure 9.4. North side of the transverse wall between Rooms 9 and 10. Figure 9.5 shows the opposite side of the wall.

or bending stresses. The major plate element is defined by a crack that starts in the upper left (east) corner, extends downward to the top left corner of the left-hand doorway, continues across the wall at the base to the right-hand doorway, and extends from the top right of this doorway to the upper right (west) corner of the wall forming a U-shaped crack pattern. Secondary yield lines, or flexural cracks, extend from the inside corners of both doorways to the top of the wall. This wall is the only transverse interior wall that has no central support from a perpendicular intermediate wall and most clearly demonstrates the out-of-plane behavior of slender adobe walls.

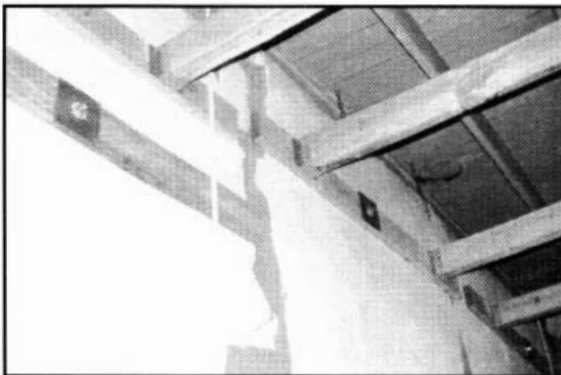
The south wall of Room 9 is also badly damaged. Again, there is an intermediate perpendicular wall that had an effect on the crack pattern, as it did with the north wall of Room 10. The east section adjacent to the intermediate wall is leaning toward the north approximately 4 inches at the top (Figure 9.6). The exposed surface at the intersection of these two abutting walls indicates that the adobe blocks were not bonded together when constructed, but abutted

Figure 9.6. Out-of-plane offset of approximately 4 inches at a crack in the south wall of Room 9. Although this wall is buttressed by a perpendicular wall behind, the central section has pulled away from the buttressing wall behind. Figure 9.7 shows the gap between this wall and the buttressing wall behind.

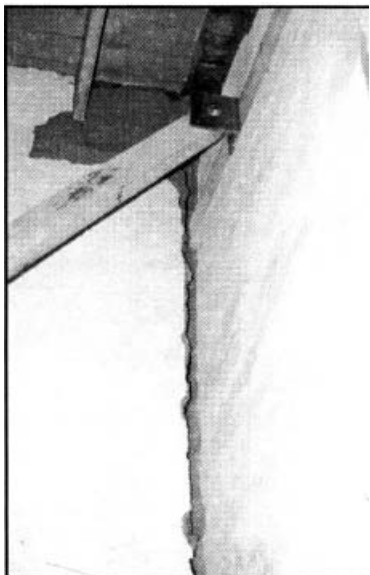
Figure 9.7. *Separation at the interface between perpendicular walls. The wall to the right is the south wall of Room 9. The clean break between these two walls indicates they were not interconnected at the joint.*

forming a cold joint. The intermediate wall may have been added at a later date. The gap that has opened between these two walls is shown in Figure 9.7.

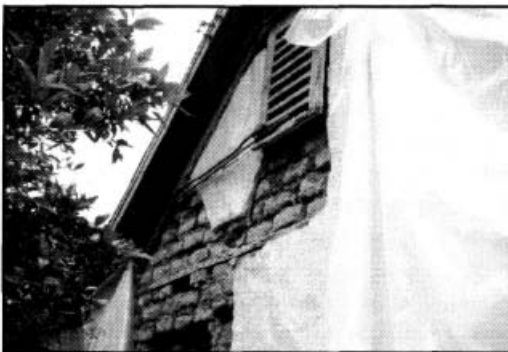
Figure 10.2. North gable-end wall. Plaster spalled from the exterior surface. A crack extends along the horizontal wood plate embedded in the adobe at the ceiling level. The roof rafter at the top of the wall provides some restraint against overturning of the upper section of the gable end.

The north gable-end wall was in poor condition at the time of this inspection (Figure 10.2). Much of the plaster has spalled and water damage has occurred to the upper portion of the wall. There is a horizontal crack along the wood plate located at ceiling height. Roof rafters on the exterior are snug against the adobe of the gable and appear to have provided some restraint

to outward movement. Two cracks extend from the top of the window lintel upward to the horizontal plate. The gable portion of the wall appears to have rocked during one of the recent past earthquakes because the vent framing is displaced outward about 1% inches.

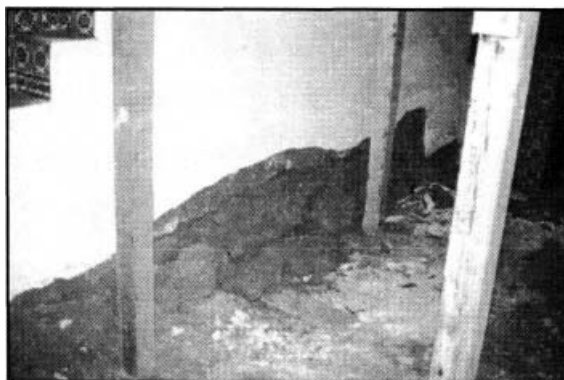
Figure 10.5. Slumping at the base of the east wall. The east wall also suffered considerable water damage that resulted in slumping and bulging of the wall at the base.

and 10.5) are most severe along the central portion and north end of the east wall. There is a large vertical crack just to the north of the fireplace and a diagonal crack that extends across a tile inset above the stove in the kitchen. There is only limited crack damage in the east wall at the south end.

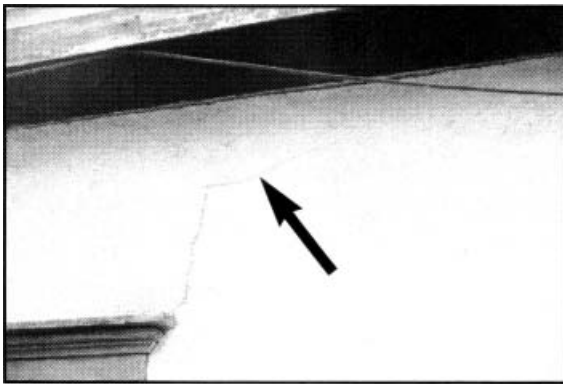
Along the west wall, there is a horizontal crack at the base that extends from the window on the south side of the central doorway over to the doorway. This crack continues north of the doorway along the rest of the west wall (Figures 10.8 and 10.9). At the windows the cracks turn upward to the sills. At the base of the wall and at some of the cracks, the plaster is compressed, again a sign of slumping of the adobe. Cracks at the upper corners of doorways and windows appear to be related more to slumping than to earthquake damage (Figures 10.6 and 10.7).

Figure 10.6. Crack at a window opening, west wall above the area shown in Figure 10.8. The window is just south of the central doorway. The crack tapers in width indicating that the wall has slumped in this area.

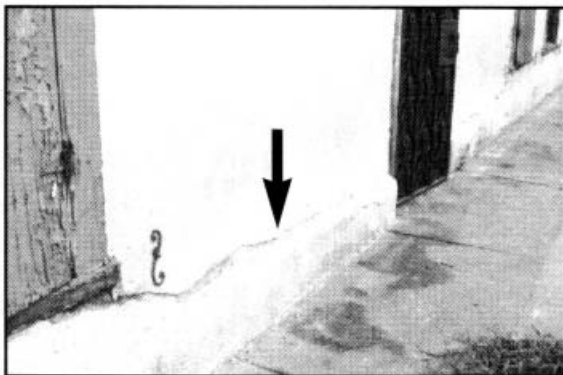
Figure 10.8. Crack at the base of the west wall caused by combined out-of-plane rocking and slumping.

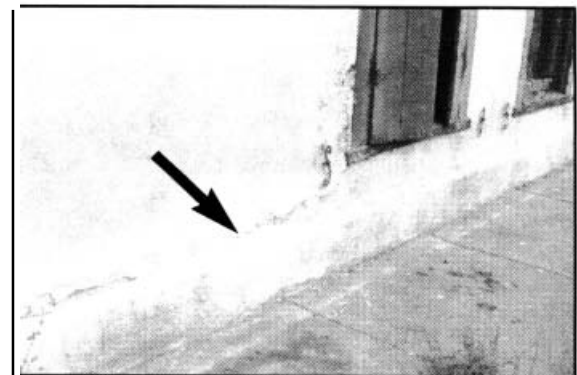
Figure 10.9. Continuation of crack shown in Figure 10.8 on the opposite side of the doorway. Slumping and out-of-plane rocking caused this crack.

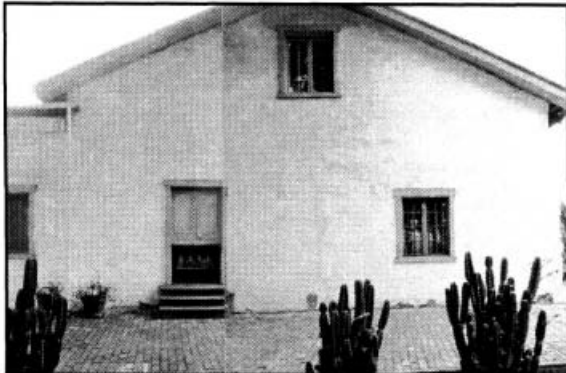
The north gable-end wall suffered slight to moderate damage. On the exterior, slight cracks developed adjacent to the window, Figures 11.2 and 11.3. On the inside of the tapanco, it is apparent that the wall slightly pulled away from the roof. There was slight pullout of the steel straps at the tapanco floor level, approximately 1/8 inch to 1/4 inch (Figure 11.4), and some permanent outward displacement at the roof level (Figure 11.5). There was also spalled adobe just below where the straps enter the wall. This is likely the result of the vertical component of the anchor reaction force caused by the 22% degree entry angle of the straps.

Figure 11.2. *Minor cracks in the north gable wall.*

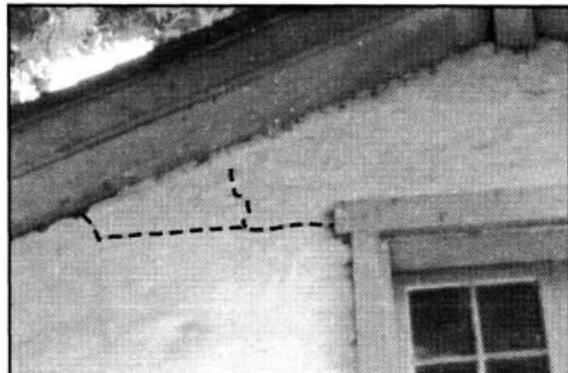
Figure 11.3. *Detail of a crack in the north gable-end wall (dotted line along crack).*

However, the slight to moderate damage that occurred to the north gable-end wall indicates that the stabilization measures implemented in this area may not have sufficient capacity to resist larger earthquake forces. At the top of the north gable wall, the vertical pins that anchored the top portion to the wall below, provided insufficient restraint to prevent offsets between the roof framing and the wall.

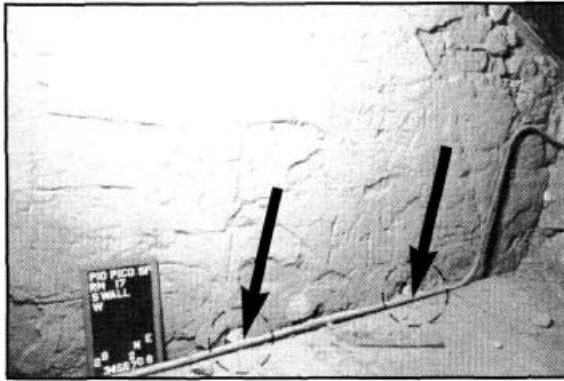
An anchorage at the De la Osa Adobe pulled into the wall and was ineffective in adequately restraining the out-of-plane motion of the wall (Figure 3.28). At another location in the De la Osa Adobe, cracks initiated at the anchorage location. However, there is little question that, regardless of the poor design of the tie-rod anchors at the De la Osa Adobe, they were effective in preventing more severe damage. At the Pio Pico Adobe, a few of the recently installed anchors attaching the attic (tapanco) floor to the exterior north wall were partially pulled out of the wall (Figure 11.4).

Figure 11.4. The north gable-end wall pulled away from the tapanco floor.

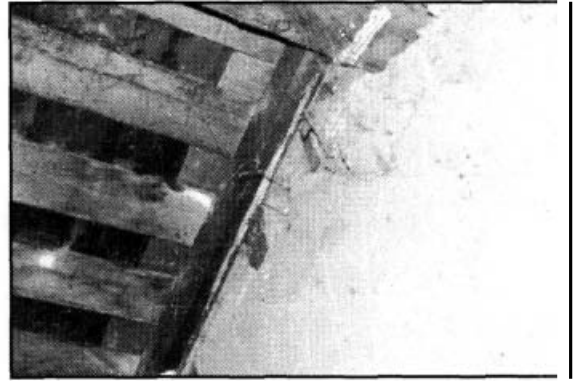
Figure 11.5. North gable-end displaced outward slightly from the roof framing.

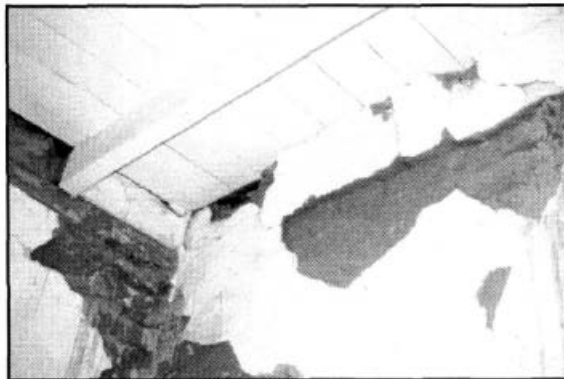
Figure 11.6. Damage to the interior wall on the south of Room 6. The wall suffered a slight offset at the top due to out-of-plane rocking of the wall.

There is a slight offset at the top of the interior wall on the south side of Room 6 (Figure 11.6). The wall apparently rocked during the earthquake and spalled some of the plaster at the ceiling joist level. There was little other significant damage to the interior walls.

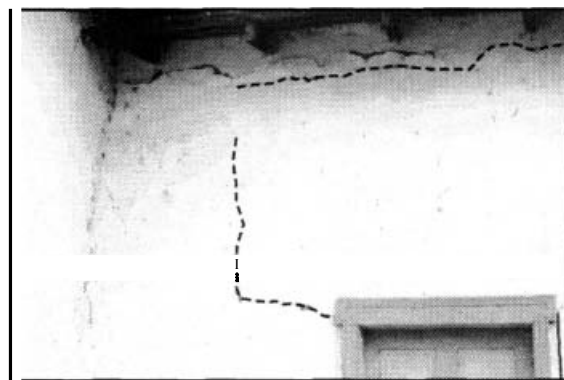
Figure 11.7. Additional minor damage at a window opening and the roof line in a wall near the southwest side of the building (dotted line along crack).

Some crack damage in other parts of the building were apparently caused by the Northridge earthquake. One of those areas is near the southwest corner of the structure. A horizontal crack at the top of the north wall developed underneath the eaves, and the plaster along this line spalled (Figure 11.7). On the interior of this room, loose adobe blocks slid at the top of the wall. There is also a crack at the top of the west wall that follows the eave line. However, there were no other signs of rocking or flexural wall damage such as separation cracks at comers. It appears that the roof over this single room wing attempted to shift relative to the walls.

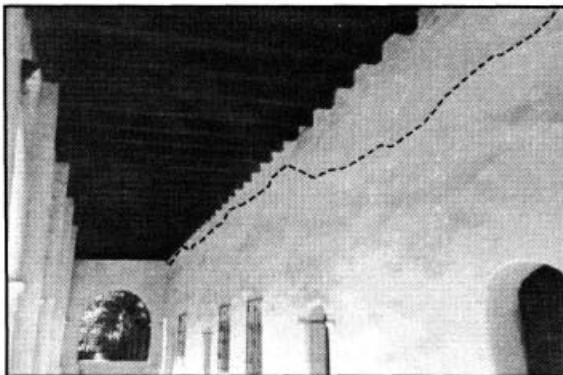
Although the exterior longitudinal walls of the convento at the San Fernando Mission are reasonably thick, the walls are comprised of two wythes that are poorly bonded together and have no header courses interconnecting them. Although the inner wythe is anchored to the second-floor joists, the outer wythe is not attached and effectively acted as a tall, thin, two-story wall. A mid-height crack developed in the exterior wythe on both sides of the building (Figures 12.2 and 12.3).

The buildings suffered moderate to extensive damage from examination of the exterior. The long walls of the building suffered horizontal cracks (Figures 12.2 and 12.3) and separation from the west end wall. The east-end wall was replaced after the 1971 San Fernando earthquake. The west-end wall suffered vertical and diagonal cracks as the wall tried to pull away from the building. The brick columns along the colonnade

Figure 12.2. Horizontal cracking in the upper section of the adobe wall along the colonnade of the convento at the San Fernando Mission. This crack extends approximately two-thirds of the length of the building (dotted line follows crack). Out-of-plane rocking is indicated by this crack, the horizontal crack in the wall on the opposite side of the building (Figure 12.3), and a crack along the base of this wall.

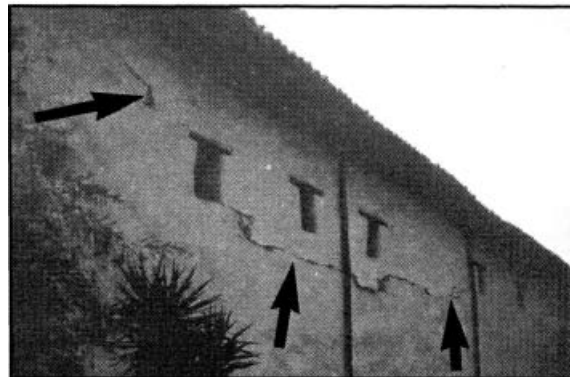
Figure 12.3. Horizontal cracking in the upper section of the adobe wall. This crack extends approximately two-thirds of the length of the building. Out-of-plane rocking is indicated by this crack and the crack on the opposite side of the building (Figure 12.2).

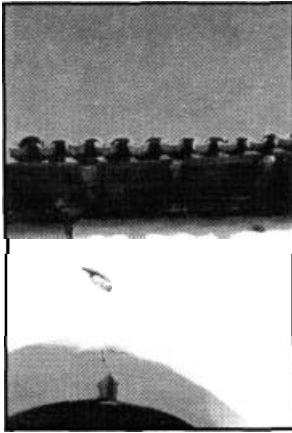
Figure 12.14. Cracking in one of the brick arches of the colonnade of the convento at the San Fernando Mission.

suffered some damage as cracking occurred at the tops of several arches (Figure 12.4) and at the base of the columns.

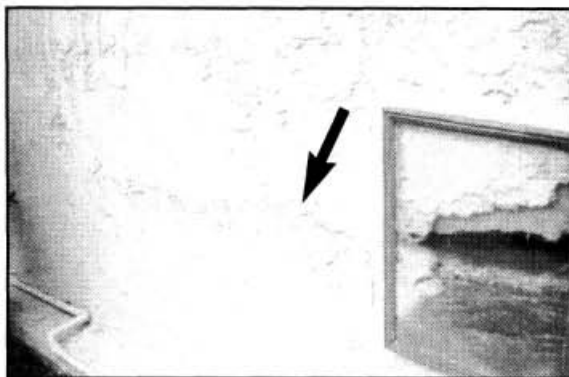
Moisture problems are evident along the lower portions of several walls (Figures 12.7 and 12.8). The south and east wall of the bedroom at the southeast corner has some deterioration on both interior and exterior wall surfaces. The same area of damage continues along the south wall of one of the easternmost original rooms. The moisture deterioration also extends along both east and west walls of the north entrance hall. Some of the

Figure 12.7. Purcell House. Moisture damage on the south wall is shown by the bulge in the wall and the eroded adobe shown inside the display window.

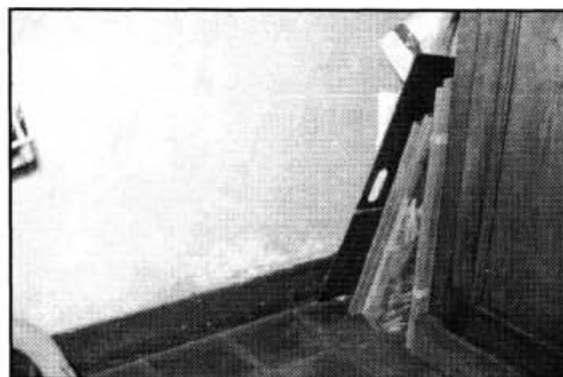
Figure 12.8. Purcell House. Moisture damage is also shown by peeling paint on the same wall as shown in Figure 12.7.

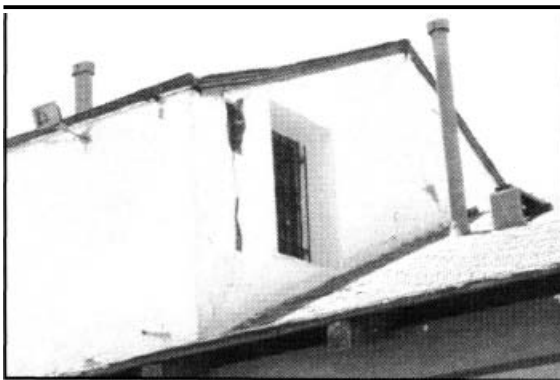
Figure 12.10. *Vicente Sanchez Adobe. Cracking at the corner of the upstairs gabled wall.*

The building suffered crack damage in the second-story walls (Figure 12.10). Separation developed between perpendicular walls in this area. The reinforced brick chimney collapsed over the adobe section (Figure 12.11). Some moisture damage was observed on the exposed exterior wall shown in Figure 12.12 although this damage was only superficial. Nevertheless, the main adobe section of the building appears to have additional moisture damage that has resulted in bulging of the wood paneling at the base of the walls.

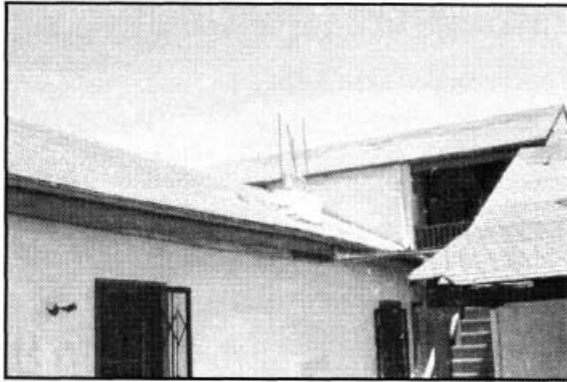
Figure 12.11. Vicente Sanchez Adobe. A collapsed chimney in the north section of the adobe. The chimney collapsed even though it had reinforcing rods which are now exposed.

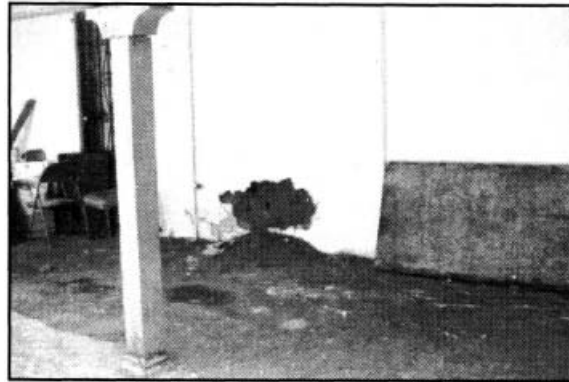
Figure 12.12. Vicente Sanchez Adobe. Moisture damage to an exterior wall in the south section of the building.

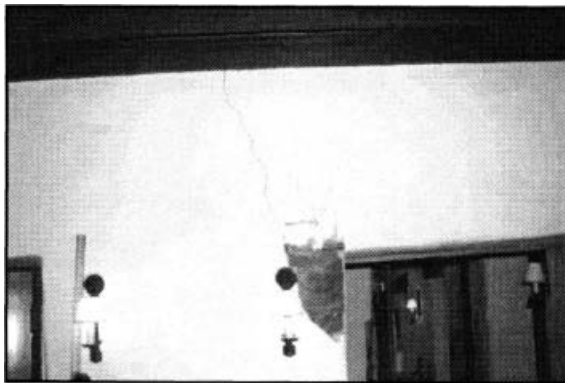
the interior walls (Figure 12.15). The tall, north gable-end wall shown in Figure 12.16 suffered some crack separation at the connection to the east and west walls.

Figure 12.15. Rocha Adobe. Minor cracking in one of the interior walls.

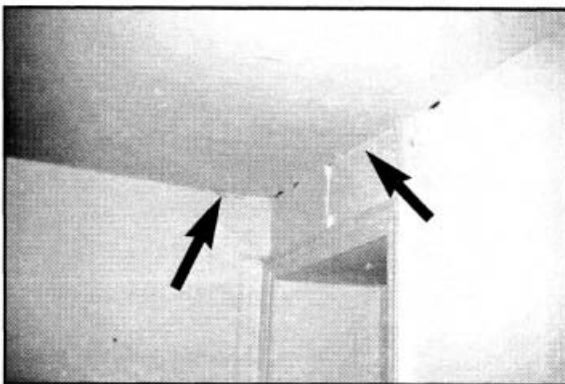
Figure 12.18. *Centinela Adobe. Minor cracking developed in many locations at the ceiling line. Most adobe buildings have poor attachment between the roof and ceiling framing and the walls.*

The Centinela Adobe is a long, one-story building with a series of connecting rooms (Figure 12.17). There was slight to moderate damage that primarily expressed itself near the ceiling level as the roof and ceiling framing shifted on top of the walls (Figures 12.18 and 12.19). Other minor damage was observed in a few locations such as the interior wall that suffered diagonal cracking (Figure 12.20).

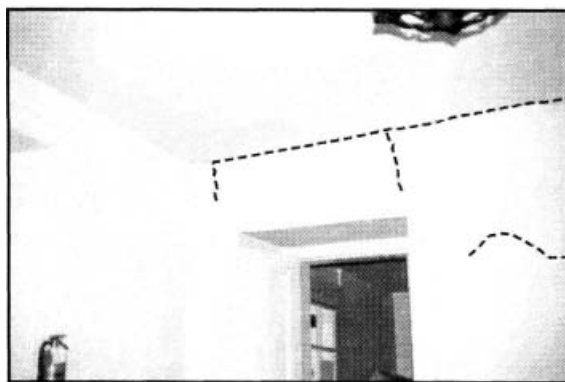
Figure 12.19. *Centinela Adobe. Minor damage to the adobe wall over the doorway (dotted line along crack).*

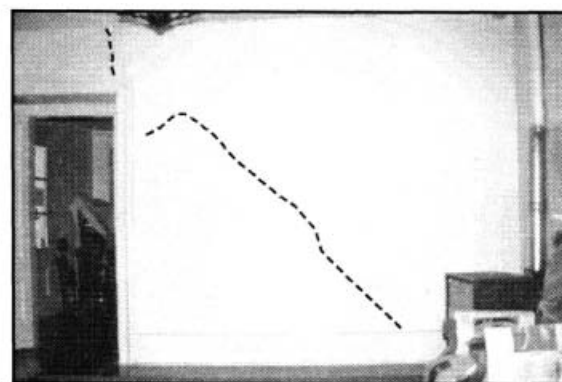
Figure 12.20. *Centinela Adobe. A diagonal shear crack was slightly worsened during the Northridge earthquake in this interior wall (dotted line along crack).*

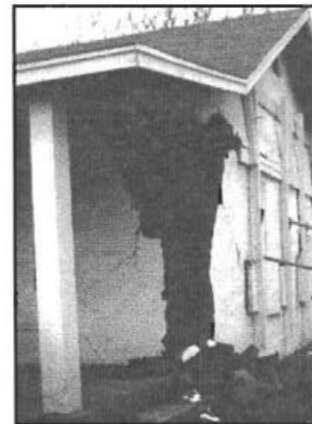
Survey team observations were limited to the exterior of the Sepulveda Adobe due to a lack of access to the interior (all openings were boarded up). The building suffered crack damage throughout the structure. The north gable end is braced and the northeast corner collapsed (Figure 12.22).

Figure 12.22. *Sepulveda Adobe. Vertical cracks at the corner led to collapse of the corner section.*

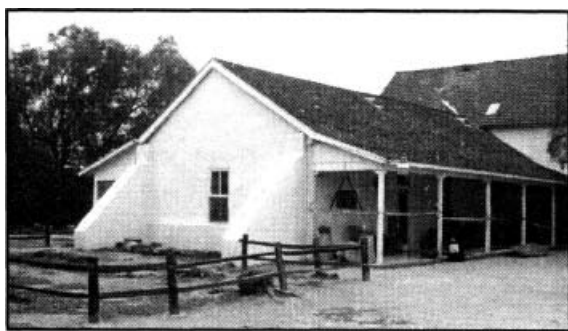
Figure 12.23. Simi Adobe. *The rear section of the building is one story and constructed with adobe. The front section of the building is two story and wood framed.*

The brick chimney above the roof over the wood-framed section of the building collapsed. Also, a section of the gable-end wall above the tapanco access collapsed and had been largely removed before the survey team's arrival. This gable-end wall is between the adobe section and wood-framed section of the house. Other than these two areas, there were very minor cracks to some of the walls, more visible on the interior of the building. There were also some minor cracks around the two buttresses shown in Figure 12.23. The damage state is estimated to be moderate.

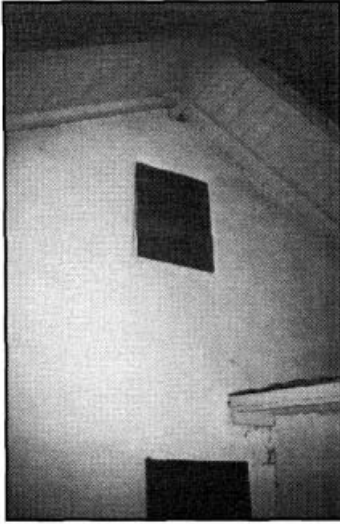
Figure 12.24. Reyes Adobe. Gable-end wall suffered minor damage during the Northridge earthquake.

The Reyes Adobe was inspected only from the exterior, being boarded up and not available for interior observation. The building, which is approximately 15 miles southwest of the epicenter, felt a maximum horizontal ground acceleration in the range of 0.2g to 0.3g. The estimated MMI was between VI and VII. Some cracking was observed in the exterior walls (Figure 12.24). The damage state, based on observations of the exterior, is between slight and moderate.

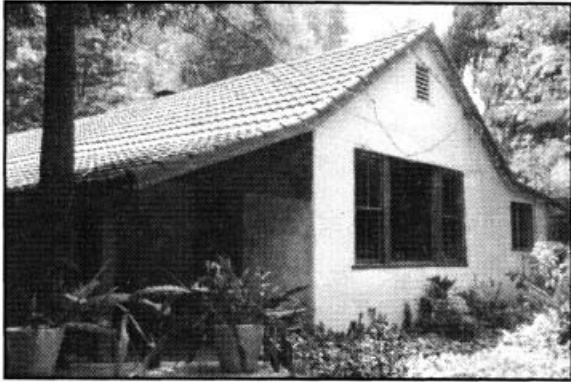
Figure 12.26. Catalina Verdugo Adobes.

Although the interior was not inspected, the exterior was found to be in good condition, with little obvious earthquake damage to the walls (Figure 12.26). Based on the isoseismal map, Figure 2.4, it is estimated that the maximum horizontal ground motion at the site was between 0.3g and 0.4g and the estimated MMI was between VI and VII. The damage state is estimated to be between none to slight.

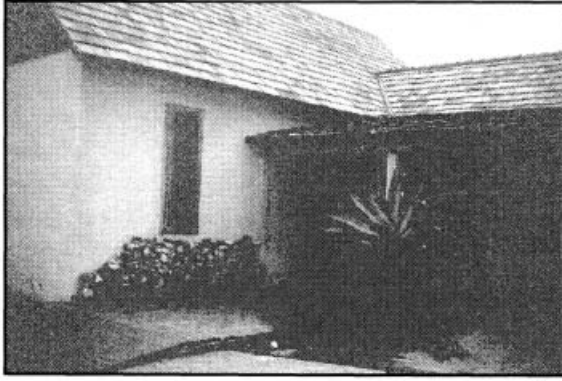
Figure 12.28. *Miguel Blanco Adobe.*

The damage state is estimated to be none. Visual inspection was made of all sides of the building (from outside a protective fence) but no damage was observed (Figures 12.27 and 12.28).

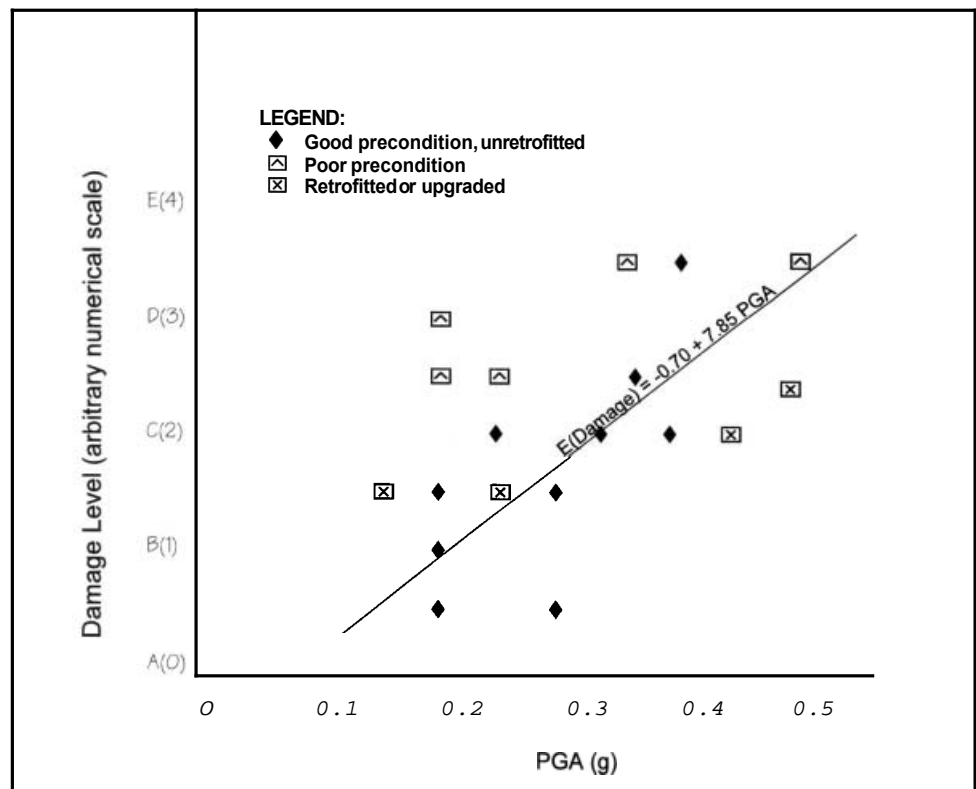
For well-maintained historic adobes Figure 13.1 shows the relationship between ground shaking and damage. Ground shaking in the range of 0.1g to 0.2g PGA seems to be necessary to initiate damage in well-maintained adobe buildings. At this level of ground motion, cracks begin to form at door and window openings and at the intersections of perpendicular walls. At the adobe sites studied where the PGA was in this range, the Miguel Blanco Adobe was undamaged, the Purcell House suffered slight damage, while the Centinela Adobe suffered slight to moderate damage. These adobes were well maintained, but were without reinforcement or retrofits.

Preexisting conditions are also seen to greatly affect the resulting damage level. In Figure 13.1, all data on buildings with preexisting water and earthquake damage are found above the expected damage line for well-maintained adobes, indicating that severe damage can be expected for buildings in poor condition. Even for ground motions of moderate intensity (0.1g-0.2g), poorly maintained buildings are likely to suffer substantial damage.

Also plotted in Figure 13.1 are data for retrofitted adobes. It appears that the real value of retrofitting does not become apparent until relatively high PGA levels are reached (i.e., above 0.4g-0.5g). At lower levels of ground shaking, it appears that the

Figure 13.1. Damage level vs. estimated horizontal peak ground acceleration for historic adobe buildings after the Northridge earthquake, January 17, 1994.

retrofits do not markedly affect performance; these buildings behave much like the well-maintained unretrofitted adobes.
