Seismic Retrofitting Project: Assessment of Prototype Buildings

Volume 1

Research Report

Claudia Cancino and Sara Lardinois

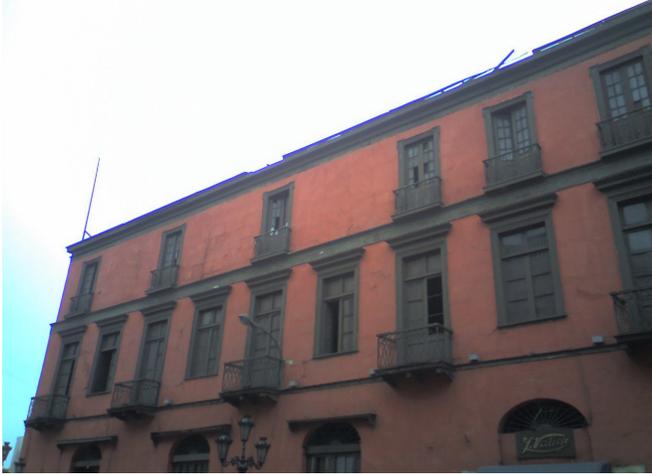
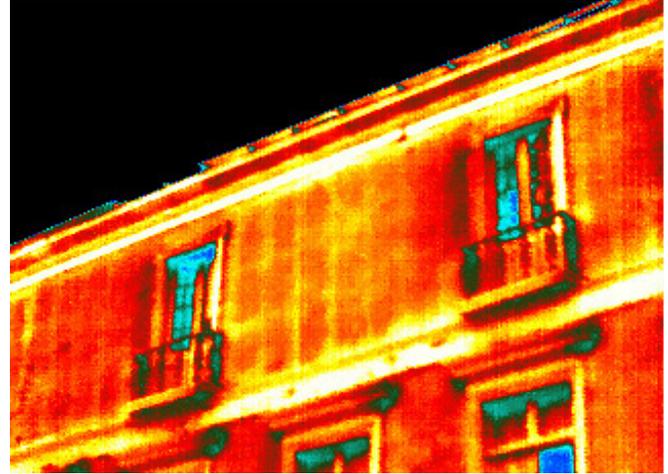
FIGURES 2.16 (LEFT) AND 2.17 (RIGHT)
Northwest façade of Hotel El Comercio: photograph (left) and thermal image (right) of the same sector, indicating the location of the internal wood posts in the third floor quincha walls.
Images: Amila Ferron.

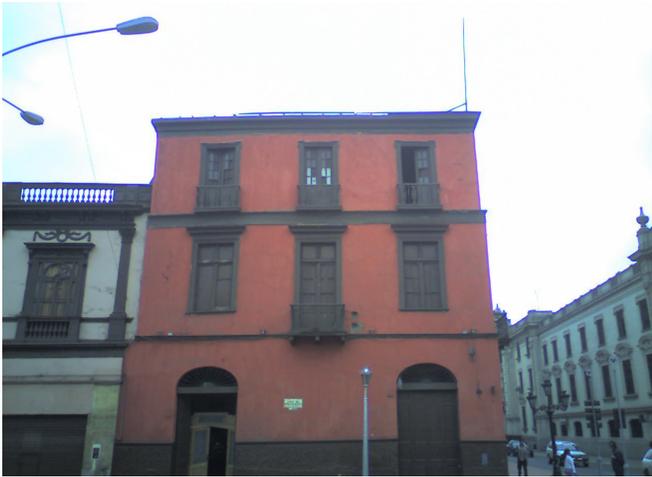
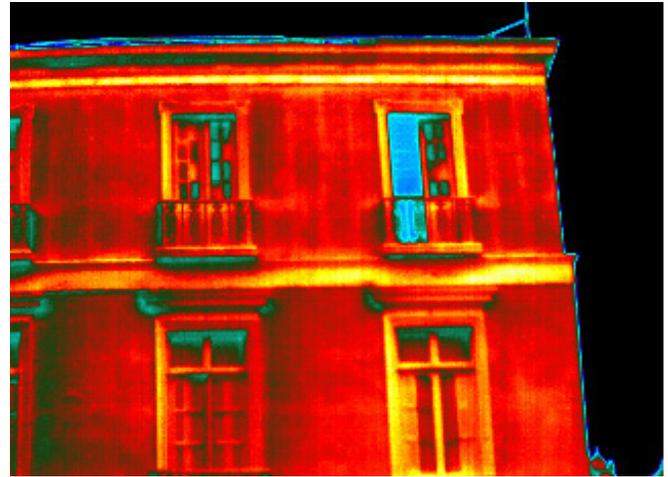
FIGURES 2.18 (LEFT) AND 2.19 (RIGHT)
Northeast façade of Hotel El Comercio: photograph (left) and thermal image (right) of the same sector, indicating the location of the internal wood posts in the third floor quincha walls.
Images: Amila Ferron.

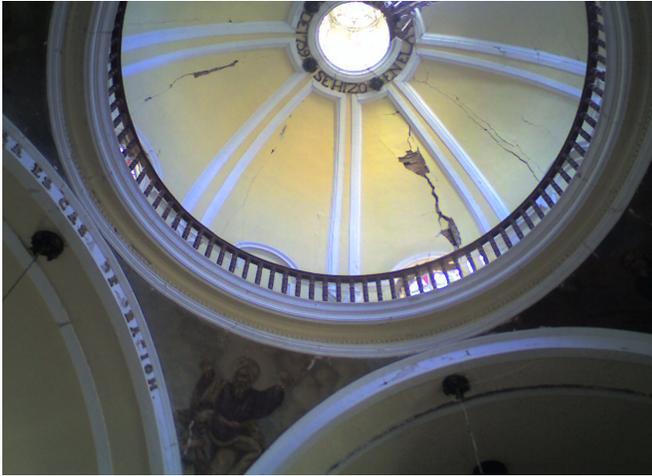
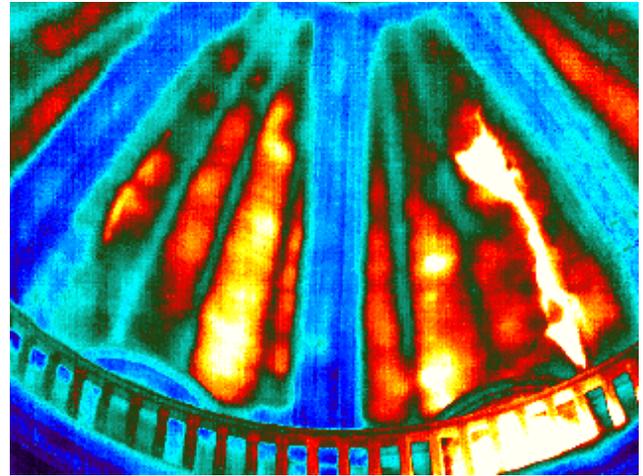
FIGURES 2.20 (LEFT) AND 2.21 (RIGHT)
Dome of the Cathedral of Ica: photograph (left) and thermal image (right) of the same sector, indicating the location of the internal wood ribs or arches.
Images: Claudia Cancino.

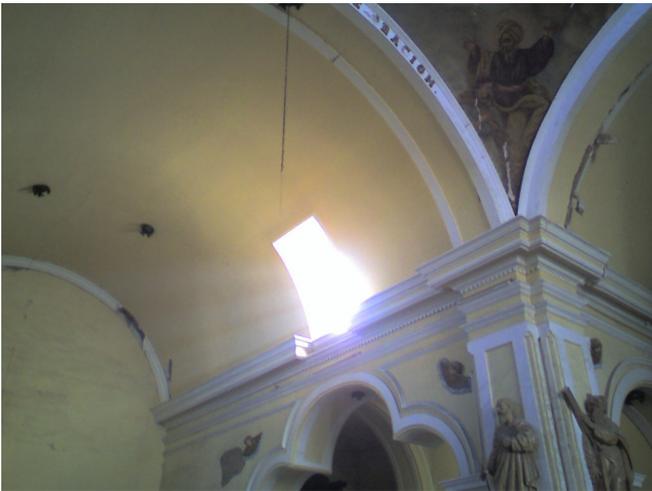
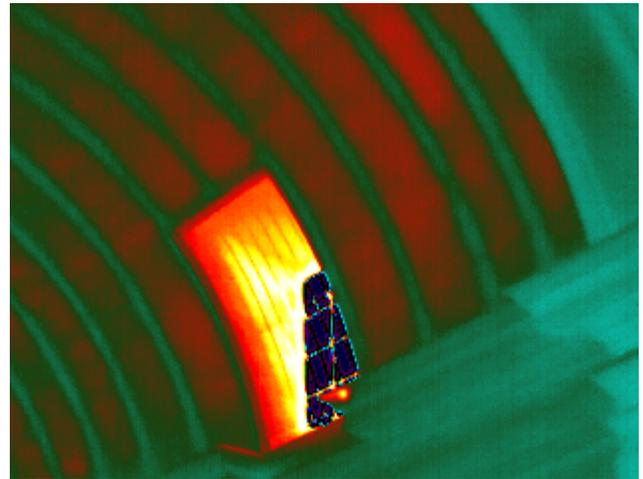
FIGURES 2.22 (LEFT) AND 2.23 (RIGHT)
Barrel vault over altar at the Cathedral of Ica: photograph (left) and thermal image (right) of the same sector, indicating the location of the internal wood ribs or arches.
Images: Claudia Cancino.

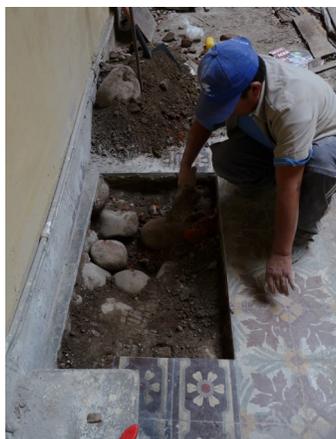
FIGURE 2.24

Prospection in the patio of Hotel El Comercio to determine the foundation configuration.
