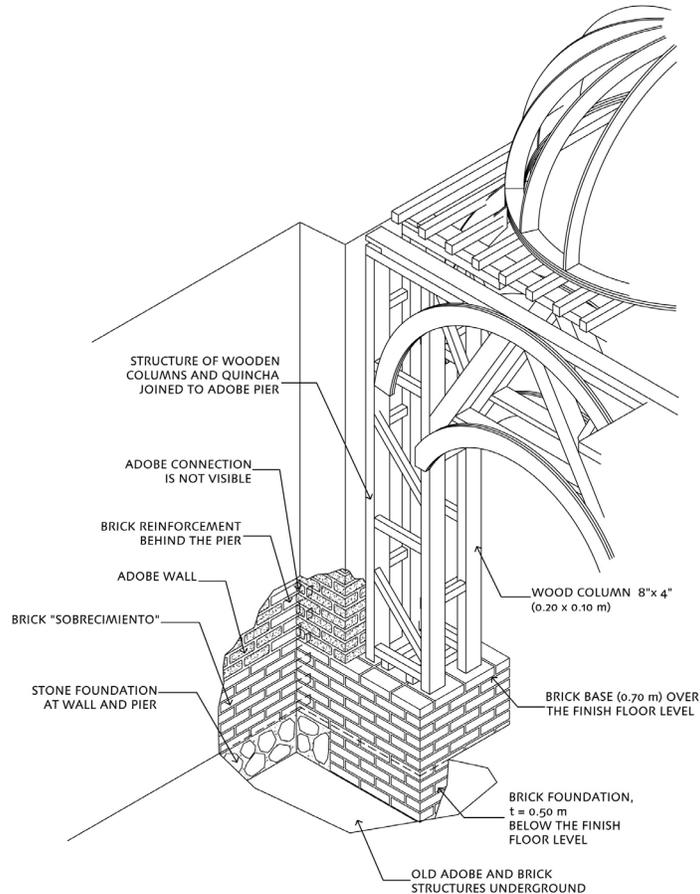
FIGURE 4.20

Propsection IS-2—IW-6, showing the fired brick reinforcing behind the mud brick piers along the south lateral wall.

- Bricks at the pier bases do not interlock with the brick base course along the lateral wall. The lack of connection is thought to explain the vertical cracking that was observed between the pilasters and lateral walls.

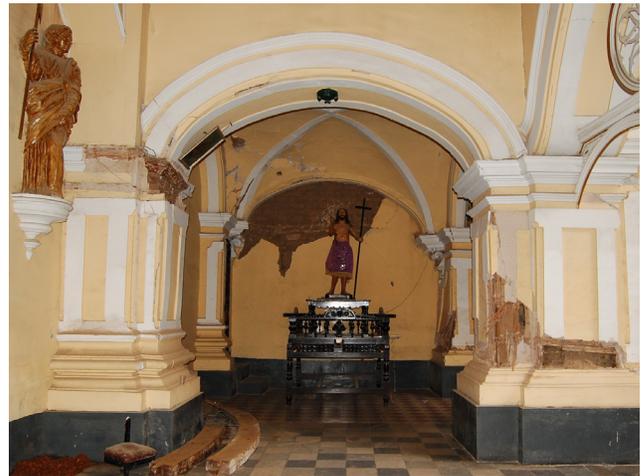
- Horizontal and vertical cracking along the perimeter of all arches and piers at the north lateral wall, in the altarpiece J (Saint Rose of Lima) space.
- Disconnection between the rib vault at the northeast corner and the north lateral wall.
- Deformation of the choir loft floor and the choir screen below.
- Vertical cracking along the pillars separating the sotacoro from the nave and structural disconnection between the pillars and adjacent choir screen.
- Total collapse of the rib-vaulted ceiling and flat roof above the altarpiece K space (southeast corner), occurring after the 2007 earthquake sometime between November 2007 and May 2009 (Figs. 4.43, 4.44).
- Collapse of the barrel vault that originally covered the choir loft.

FIGURE 4.43 (TOP)
View of sotacoro, looking south and showing the intact rib-vaulted ceiling above altarpiece K, 2007.
Image: Instituto Nacional de Cultura del Perú.

FIGURE 4.44 (BOTTOM)
View of roof and ceiling above altarpiece K, after collapse, 2010.
Image: Sara Lardinois.
