## CHAPTER 6

# Casa Arones

### 6.1 Summary

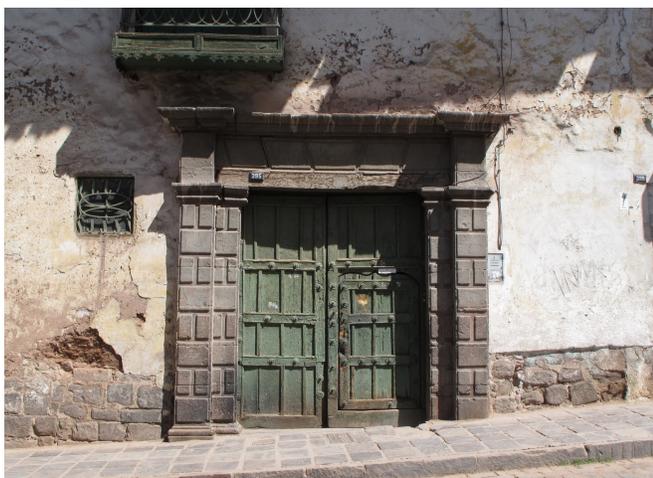
**FIGURE 6.8**  
Detail view of entrance portal at east façade.  
Image: Sara Lardinois.

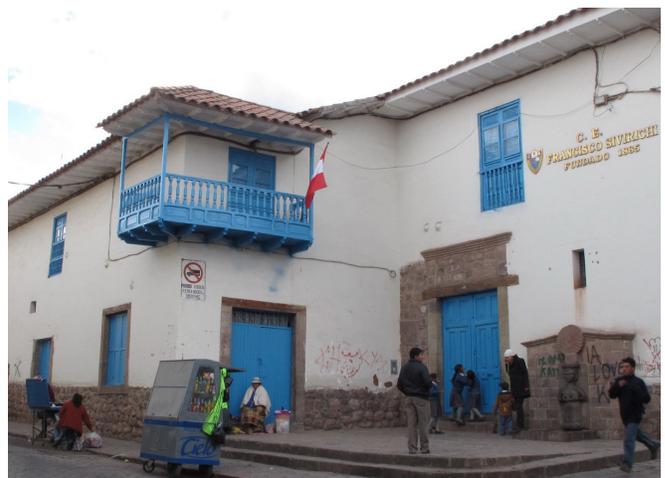
**FIGURE 6.9**  
An example of an extant balcony at a nearby building on Calle Arones. The sawn-off beam ends at the northeast corner of Casa Arones suggest that it once had a similar balcony.  
Image: Sara Lardinois.

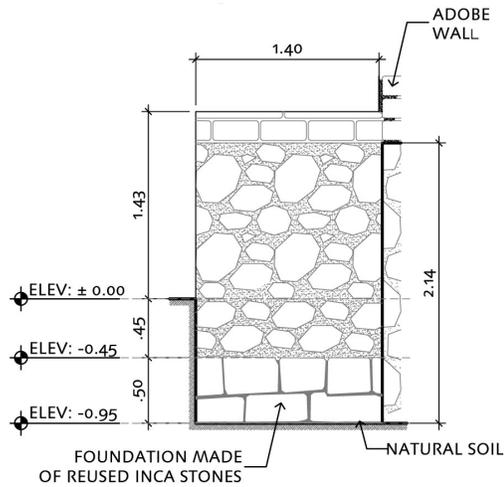
**FIGURE 6.19**  
Prospection IS-2, illustrating the foundation configuration at the east façade wall at the southeast corner of the building, sector A1.  
Drawing: Mirna Soto, for the GCI.

- **Sector A1:** At the southeast corner of sector A1, in room A-103, soil prospection IS-2 revealed a 2.0 m high rubble stone masonry foundation with a mud and lime mortar, extending approximately 1.2 m above the floor level. At the base of the foundation along Calle Arones, two courses of large cut stone blocks are present, which are likely reused stones from the Inca period. This reused stonework is approximately 0.5 m high and extends approximately 0.5 m beyond the face of the rubble stone foundation above. The reused Inca stones are also set in what appears to be a mud and lime mortar (Figs. 6.19, 6.20).

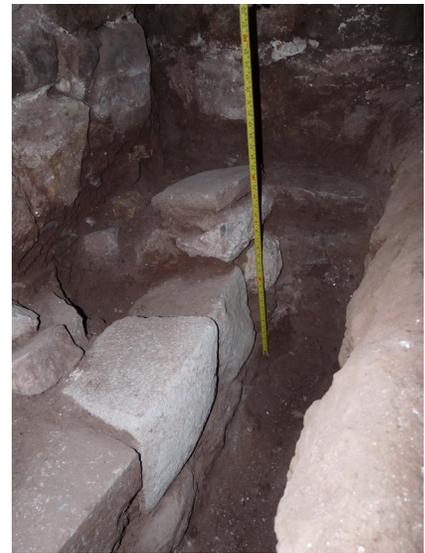
**FIGURE 6.20**  
Prospection IS-2, photographic view of reused Inca stones.  
Image: Mirna Soto, for the GCI.

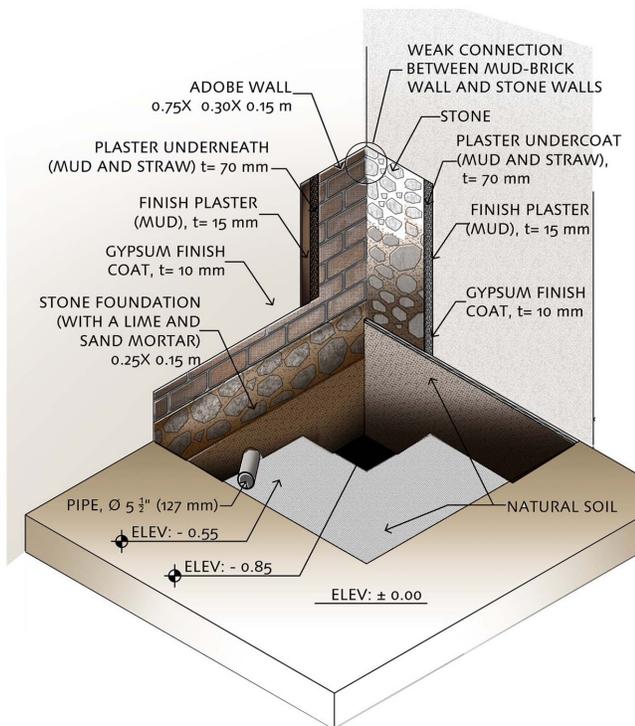
**FIGURE 6.21**  
Prospection IS-1, showing the foundation and base course configuration at the southwest corner of room A-110, sector A1.  
Rendering: Jabdiel Zapata, for the GCI.

- **Sector A1:** At the southwest corner of room A-110, soil prospection IS-1 revealed two different foundation configurations. Along the south wall, there is a 0.47 m high rubble stone masonry foundation, which extends approximately 0.25 m above the floor level. The west wall marks a change in floor level between room A-110 and room C-109 to the west that is related to the natural upward slope of the site from east to west. In this location, the bottom of the rubble stone masonry foundation corresponds to the floor level in room A-110 and extends upwards to a height of at least 1.42 m; and it is possible that the stone construction extends across the whole height of the wall at the first floor. The average face size of the foundation stones is  $0.25 \times 0.15$  m. A sand and lime mortar is used (Fig. 6.21).

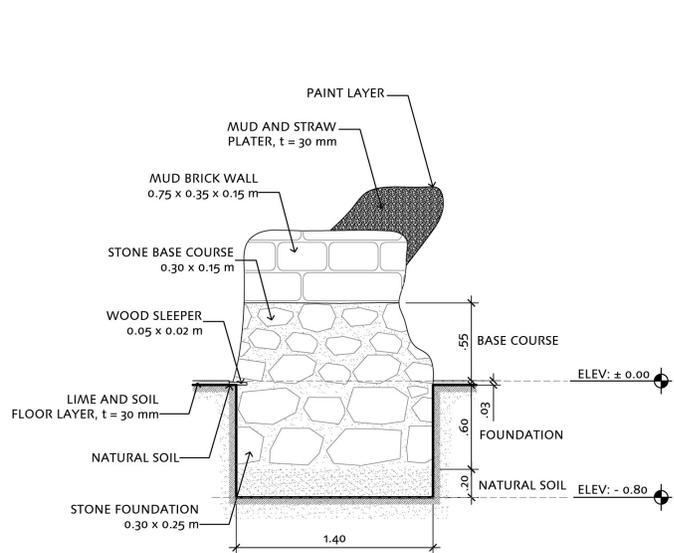
**FIGURE 6.22**  
Prospection IS-3, illustrating foundation configuration at north wall of room A-111, sector A4.  
Drawing: Mirna Soto, for the GCI.

- **Sector A4:** Soil prospection IS-3 revealed a 0.55 m high rubble stone masonry base course over a 0.60 m deep foundation. The typical face dimensions of the base course stones are  $0.30 \times 0.15$  m, and the foundation stones typically measure  $0.30 \times 0.25$  m. The stones are bonded with a lime mortar (Fig. 6.22).

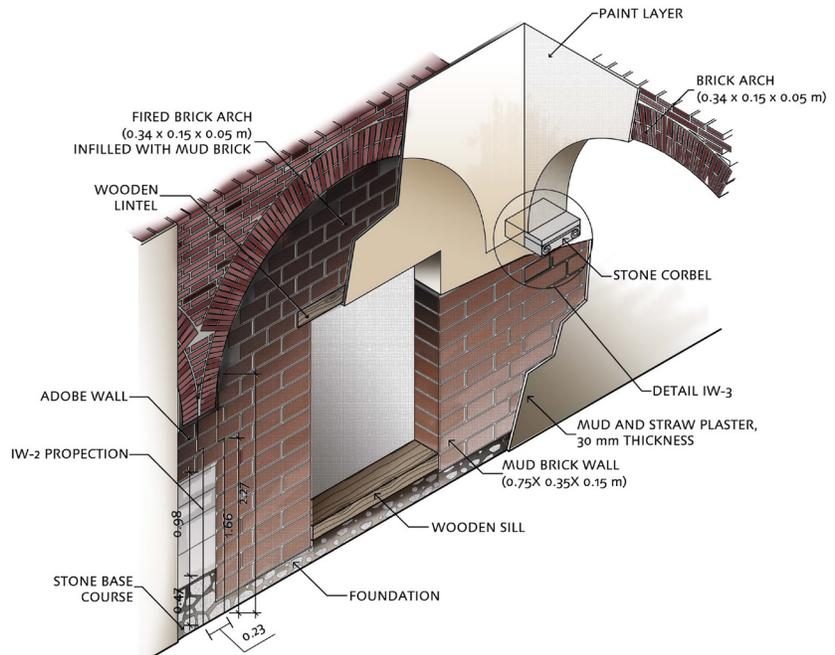
**FIGURE 6.26**  
Prospection IW-2, showing fired brick arch with adobe infill at the north side of gallery 116. The door opening provides access to storage C-109.  
Rendering: Jabdiel Zapata, for the GCI.

The arcades at the north and south sides of the patio are typically constructed with cut stone masonry with lime mortar; however, fired brick masonry is used for the first floor arches at the north side of the patio. Each arcade consists of four stone or fired brick arches at the first floor and eight smaller stone arches over a low stone parapet at the second floor (Figs. 6.24, 6.25). The arches are supported by stone columns or end brackets embedded in the adjacent mud brick construction. Most of the stone and fired brick is covered with a painted mud plaster; however, the stone columns are exposed. Fired brick arches were also observed within the mud brick wall construction at the north, east, south and west sides of the north gallery (room 116). The arches of the north side were originally open and later infilled with mud bricks (Fig. 6.26).

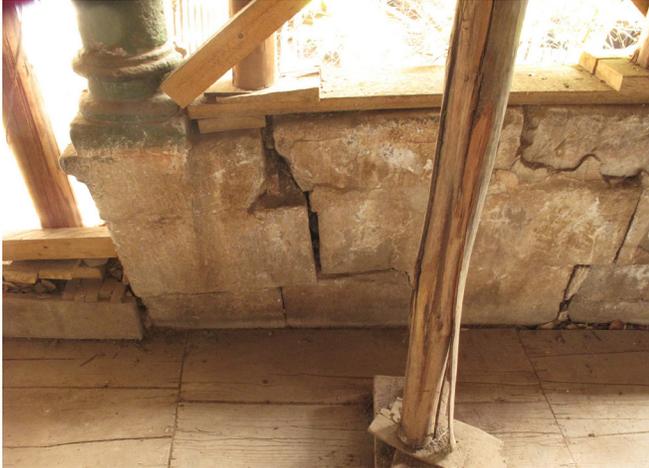
The fired brick and stone masonry arcades are in poor condition and unstable (Fig. 6.45). While the stones themselves are in good condition, there is significant loss of mortar. The arcade walls have long spans, which are poorly restrained. As a result, they exhibit some outward displacement and the arches themselves were in danger of collapse prior to the installation of a temporary shoring system. The west ends of both the north and south arcade walls appear to be the most unstable, with cracking and separation between the stones (Fig. 6.46). This may also be the result of displacement in the adjacent mud brick wall at the west side of the patio, brought on by the collapse and demolition of the adjacent construction. Portions of the second floor arcade at the south side of the patio have been infilled with mud bricks (Fig. 6.47).

**FIGURE 6.46**  
West end of stone masonry parapet wall at south arcade, as viewed from room B-206.  
Image: Sara Lardinois.

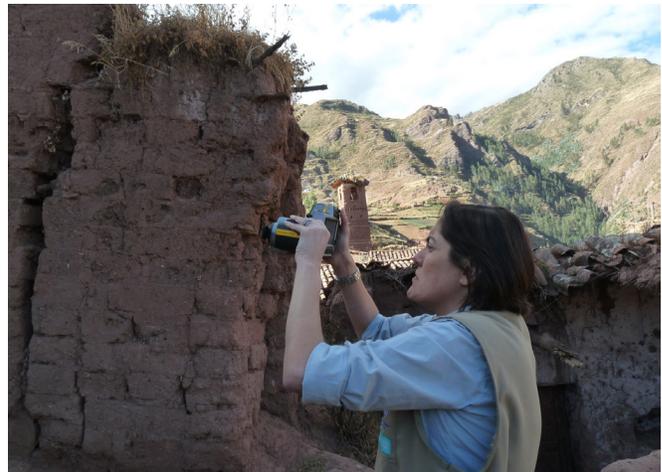
- After initial on-site trials, thermal imaging was found to hold potential for nondestructive investigation of earthen sites. In particular, thermal imaging was able to reveal structural information that was not possible to obtain through visual observation only, thus supplementing the information obtained through the limited number of prospections. Many additional nondestructive investigation methods are available and may provide viable options for surveying earthen buildings. Ground penetrating radar, portable X-ray, and sonic pulse transmission are a few of the techniques that could be researched further for possible use in this project or others. The availability of instrumentation and expertise in Peru seems to be the limiting factor; but, if they can be found it would be interesting to see what types of information these investigation methods could produce when used on earthen buildings (Fig. 7.5).

The prospections were supplemented by thermal imaging, which revealed structural information that was not possible to obtain through visual observation alone.
